Re: Dominion Transmission, Inc. Southeast Reliability Project, Multi County, ER 14-1475

Thank you for your letter of March 14, 2016, concerning the above-referenced undertaking. We have reviewed the *Addendum: Architectural Reconnaissance Survey of the Atlantic Coast Pipeline Project Corridor, Northampton, Halifax, Nash, Wilson, Johnston, Sampson, Cumberland and Robeson Counties, North Carolina* report and offer the following comments.

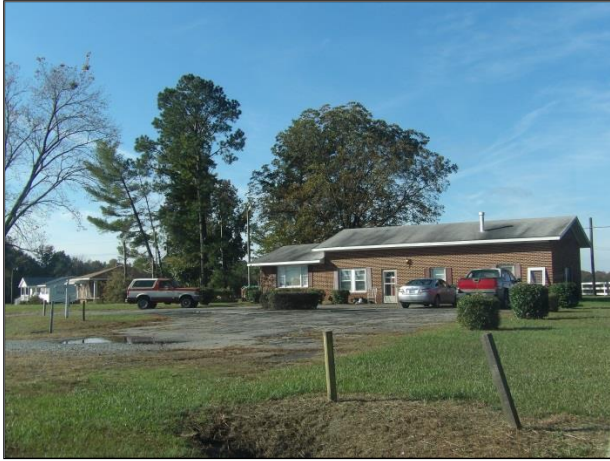
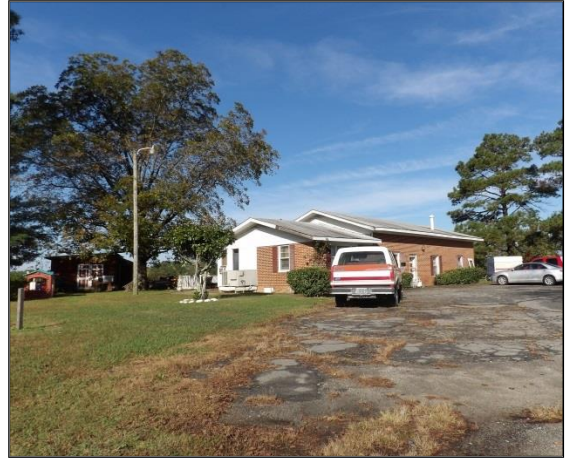
Photo 4: House, 2069 U.S. Highway 301, Northeast Oblique (Left) and Southeast Oblique (Right).

The resource at 2069 U.S. Highway 301 was constructed in circa 1960 and is a one-story house built in the Ranch style (Photo 4, p. 11). Its concrete-slab foundation supports what is most likely a wood-frame structural system clad in running-bond brick veneer. Its side-gabled roof is sheathed in asphalt shingles and contains an interior-slope metal flue (Photo 5, p. 11). The primary entrance is located on the southeast elevation and is filled by a single-leaf, wood, paneled door with a fanlight, and a metal-framed storm door. Window openings throughout the building are filled with one-over-one, double-hung, replacement windows covered by aluminum storm windows. A circa-1970 shed is located southwest of the primary resource (Photo 6, p. 11).

The house at 2069 U.S. Highway 301 does not exhibit high artistic value as the work of a master nor is it an outstanding example of its style or property type. Modifications, such as the replacement windows, diminish the historic integrity of the building. Therefore, it is recommended that this resource be considered not eligible for the NRHP under Criterion C. It has no known association with any significant event or person, and is, therefore, recommended not eligible for the NRHP under Criteria A or B. It was not evaluated under Criterion D. In sum, this resource is **recommended not eligible for NRHP under Criteria A, B, or C.**

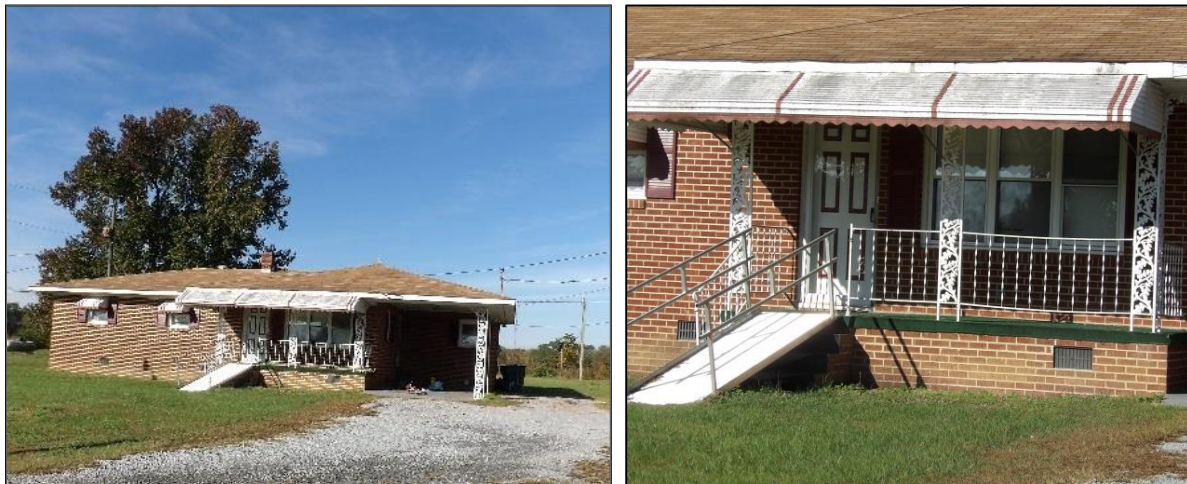
Photo 7: House, 2051 U.S. Highway 301, Southwest Elevation (Left) and Porch Detail (Right).

The resource at 2051 U.S. Highway 301 was constructed in circa 1960 and is a one-story house built in the Ranch style. Its continuous brick foundation supports what is most likely a wood-frame structural system clad in running-bond brick veneer (Photo 7). Its hipped roof is sheathed in asphalt shingles and contains an interior-slope chimney. The primary entrance is located on the southwest elevation and is filled by a single-leaf, wood, paneled door and a metal-framed storm door. Window openings throughout the building are filled with one-over-one, double-hung, vinyl sashes (Photo 8, p. 13). A partial-width porch is built upon a continuous brick-veneered foundation with decorative metal posts supporting an aluminum awning. A recessed carport is located on the northeast corner of the building and is supported by decorative metal posts.

The house at 2051 U.S. Highway 301 does not exhibit high artistic value as the work of a master nor is it an outstanding example of its style or property type. Therefore, it is recommended that this resource be considered not eligible for the NRHP under Criterion C. It has no known association with any significant event or person, and is, therefore, recommended not eligible for the NRHP under Criteria A or B. It was not evaluated under Criterion D. In sum, this resource is **recommended not eligible for NRHP under Criteria A, B, or C.**

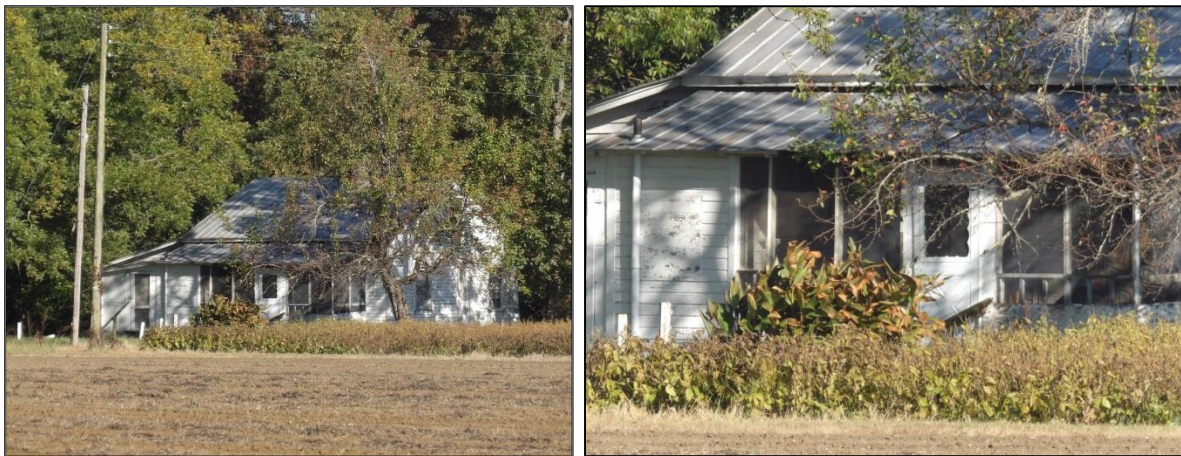
Photo 9: House, 213 Walden Way, South Oblique (Left) and Porch Detail (Right).

The resource at 213 Walden Way was constructed circa 1930 and is a one-story house built in a style that is vernacular to this region of Northampton County and the era in which it was built (Photo 9). Although its foundation is not visible, it supports what is most likely a wood-frame structural system clad in weatherboard siding. Its side-gabled roof is clad in v-crimp metal. The primary entrance is located on the southwest elevation but is obscured by a partial-width, shed-roofed, screened porch (Photo 10, p. 14). Window openings throughout the building are filled with six-over-six, double-hung, wood sashes. A shed-roofed addition has been added to the northwest elevation.

The house at 213 Walden Way has compromised integrity due to the construction of a sizable addition on the northwest elevation. It is built in a form and style that is commonly found in the area and in the era in which it was constructed. It does not exhibit high artistic value as the work of a master nor is it an outstanding example of its style or property type. Therefore, it is recommended that this resource be considered not eligible for the NRHP under Criterion C. It has no known association with any significant event or person, and is, therefore, recommended not eligible for the NRHP under Criteria A or B. It was not evaluated under Criterion D. In sum, this resource is **recommended not eligible for NRHP under Criteria A, B, or C.**

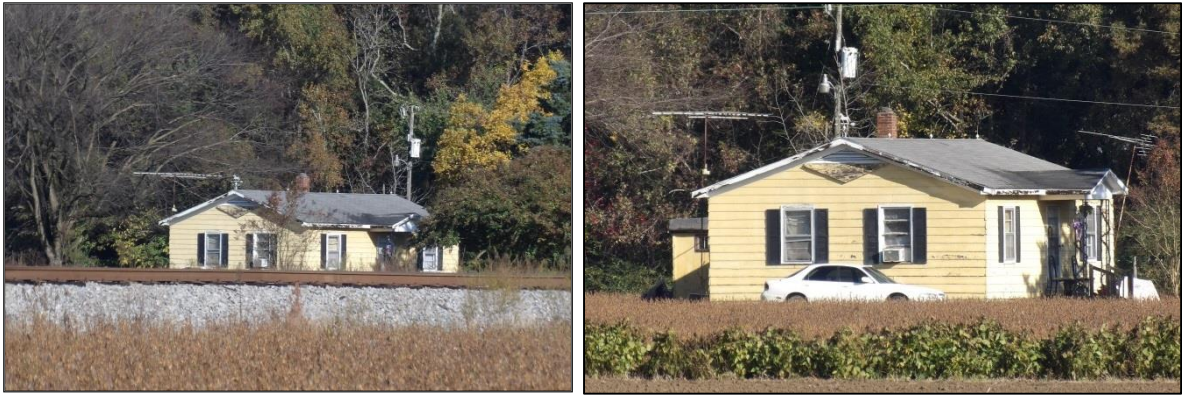
Photo 11: House, 166 Walden Way, South Oblique (Left and Right).

The resource at 166 Walden Way was constructed circa 1960 and is a one-story house built in a vernacular style (Photo 11, p. 15). Although its foundation is not visible, it supports what is most likely a wood-frame structural system clad aluminum siding. Its side-gabled roof is sheathed in asphalt shingles. The primary entrance, centrally located on the southeast elevation, is filled with a single-leaf, wood, paneled door and an aluminum storm door. A partial-width porch provides access to the entrance and is sheltered by a shingled, front-gable roof supported by decorative metal posts (Photo 12, p. 15). Window openings throughout the building are filled with six-over-six, double-hung, wood sashes covered by aluminum storm windows framed by aluminum shutters. A circa-1960, one-story garage is located southwest of the primary resource. Although not visible from the roadway, aerial images show an outbuilding located near the north corner of the primary resource.

The house at 166 Walden Way does not exhibit high artistic value as the work of a master nor is it an outstanding example of its style or property type. Therefore, it is recommended that this resource be considered not eligible for the NRHP under Criterion C. It has no known

association with any significant event or person, and is, therefore, recommended not eligible for the NRHP under Criteria A or B. It was not evaluated under Criterion D. In sum, this resource is **recommended not eligible for NRHP under Criteria A, B, or C.**

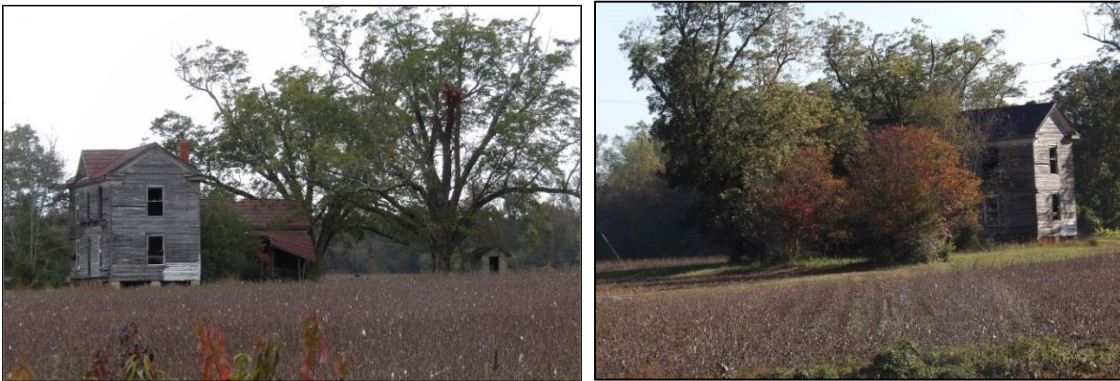
Photo 13: House, 1716 U.S. Highway 301, Southwest Elevation (Left) and West Oblique (Right).

The resource at 1716 Highway U.S. 301 was constructed circa 1895 and is a two-story, three-bay, frame house built in a style that is vernacular to this part of Northampton County and common for the late-nineteenth century (Photo 13 and Photo 14, p. 16). Its brick- and concrete-pier foundation supports a wood-frame structural system clad in weatherboard siding (Photo 15, p. 17). Its side-gabled roof with a decorative, central peak is covered with v-crimp metal sheeting and features an interior-slope brick chimney. The eaves of the roof are lined with a wooden cornice, and return eaves are located on the gable ends. The primary entrance is centrally located on the northwest elevation and does not have door. Some of the window openings are filled with one-over-one, double-hung, wood sashes but most are

missing their glass and many have no sashes at all. A collapsing, one-story gabled ell addition is located on the southeast elevation. A circa-1950 well house is located southeast of the primary resource.

The house at 1716 U.S. Highway 301, as a result of vacancy and abandonment, has lost many of its original materials including windows, doors, and porches which negatively impact its historic integrity of materials, design, feeling, and workmanship. It is not the known work of a master. Therefore, due to its condition, it is recommended that this resource be considered not eligible for the NRHP under Criterion C. It has no known association with any significant event or person, and is, therefore, recommended not eligible for the NRHP under Criteria A or B. It was not evaluated under Criterion D. In sum, this resource is **recommended not eligible for NRHP under Criteria A, B, or C.**

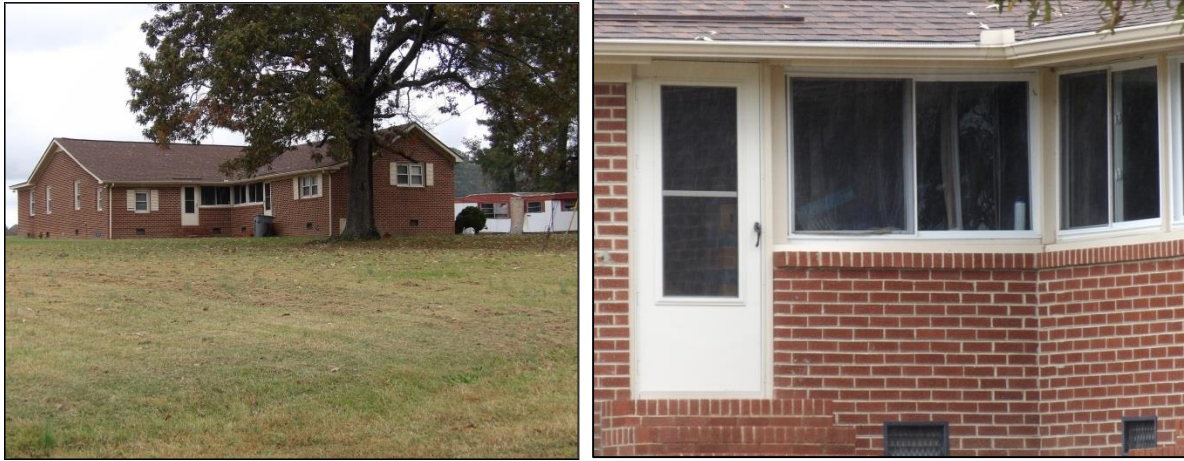
Photo 16: House, 106 Grant Street, South Oblique (Left) and Primary Entrance Detail (Right).

The resource at 106 Grant Street was constructed circa 1960 and is a one-story, three-bay house built in the Ranch style. Although its foundation is not visible, it is covered with a running-bond, brick veneer and supports what is most likely a wood-frame structural system clad in running-bond brick veneer (Photo 16, p. 18). Its side-gable roof is sheathed in asphalt shingles. The primary entrance, covered by a metal-framed storm door, is located on the southeast elevation and accessed by a brick stoop. Windows throughout the building are one-over-one, double-hung, wood sashes. A gabled addition has been added to the northwest elevation, and a front-gabled addition has been added to the southeast elevation. Both additions have building materials that are concurrent with the original core of the dwelling. A recessed screened porch is located on the primary elevation and extends into the front-gabled ell addition. A circa-1970 mobile home and a circa-1990 shed are located east of the primary resource (Photo 17, p. 18).

The house at 106 Grant Street contains a number of alterations that diminish its historic integrity of design, materials, workmanship, and feeling. It does not exhibit high artistic value as the work of a master nor is it an outstanding example of its style or property type. Therefore, it is recommended that this resource be considered not eligible for the NRHP under Criterion C. It has no known association with any significant event or person, and is, therefore, recommended not eligible for the NRHP under Criteria A or B. It was not evaluated under Criterion D. In sum, this resource is **recommended not eligible for NRHP under Criteria A, B, or C.**

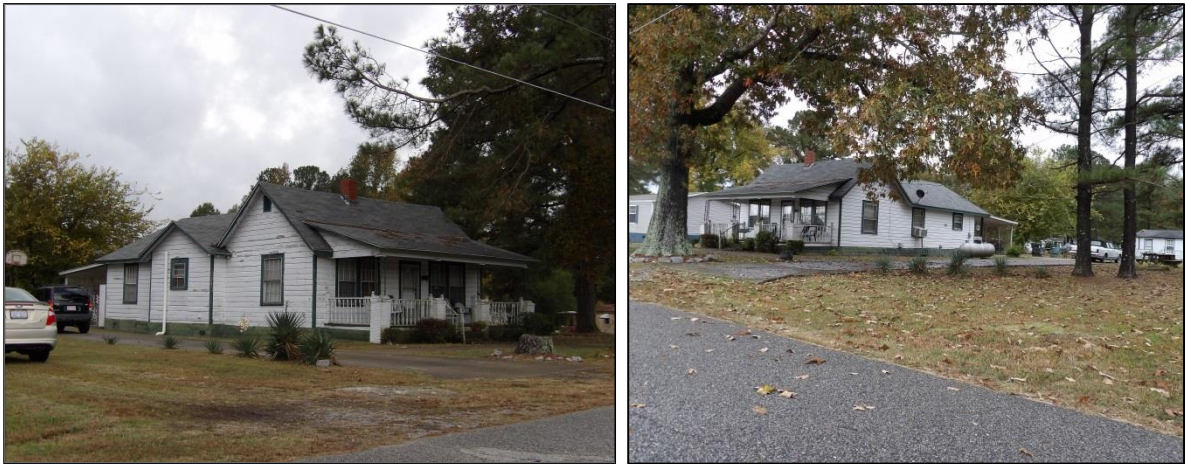
Photo 18: House, 101 Roosevelt Street, North Oblique (Right) and West Oblique (Left).

The resource at 101 Roosevelt Street was constructed circa 1935 and is a one-story, three-bay house built in a style that is vernacular to this region of Northampton County and the era in which it was built (Photo 18, p. 19). Although its foundation is obscured by metal sheeting, it supports a wood-frame structural system clad in German siding. Its side-gabled roof is covered in asphalt shingles and contains an interior-slope brick chimney (Photo 19, p. 19). The primary entrance is centrally located on the northwest elevation and is filled by a single-leaf, half-glazed, wood, paneled door and an aluminum storm door. The doorway is sheltered by a wood, partial-width, shed-roofed porch. The porch roof is clad in asphalt shingles and is

supported by replacement decorative metal posts set upon square brick piers (Photo 20, p. 20). Window openings are filled with eight-over-eight, six-over-six, and two-over-two, double-hung, wood sashes. A front-gabled addition is located on the southeast elevation and has building materials that are concurrent with those of the original core of the dwelling. A shed-roofed, lean-to addition located on the southeast elevation is open to the elements and appears to function as a carport.

The house at 101 Roosevelt Street was built in a form and style that is commonly found in the area and in the era in which it was constructed; however, it does not exhibit high artistic value as the work of a master nor is it an outstanding example of its style or property type. Therefore, it is recommended that this resource be considered not eligible for the NRHP under Criterion C. It has no known association with any significant event or person, and is, therefore, recommended not eligible for the NRHP under Criteria A or B. It was not evaluated under Criterion D. In sum, this resource is **recommended not eligible for NRHP under Criteria A, B, or C.**

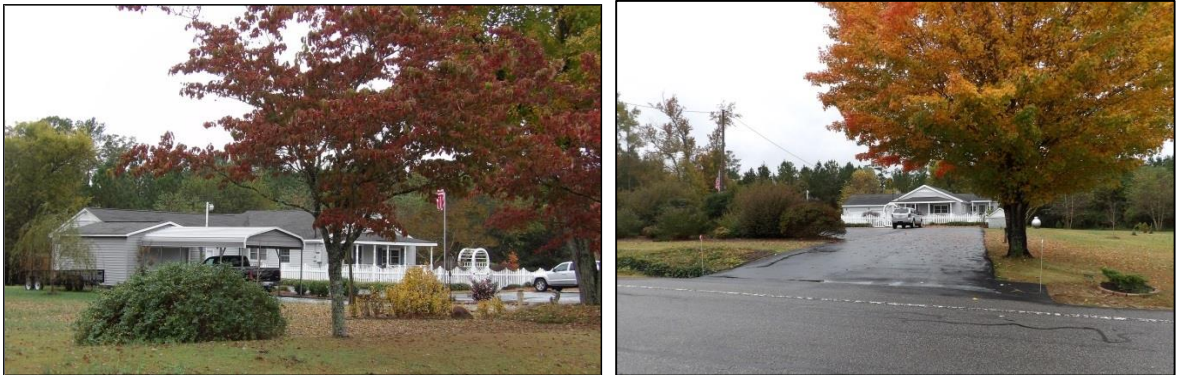
Photo 21: Turner’s Tax Service, 13392 N.C. Highway 903, East Oblique (Left) and Northeast Elevation (Right).

The resource at 13392 N.C. Highway 903 was constructed in 1945 and is a one-story, three-bay, frame house built in a vernacular style typical of the mid-twentieth century. Although its foundation is not visible, it supports what is likely a wood-frame structural system clad in vinyl siding (Photo 21, p. 25). Its front-gabled roof is sheathed in asphalt shingles. The primary entrance is located on the northeast elevation and filled by a single-leaf, wood, paneled door and a metal storm door (Photo 22, p. 25). The doorway is sheltered by a partial-width, hipped-roofed porch. The roof is sheathed in asphalt shingles and supported by turned wooden posts. Window openings throughout the building are filled with one-over-one, double-hung, vinyl sashes.

Turner’s Tax Service at 13392 N.C. Highway 903 contains a number of alterations, such as the construction of several additions and replacement of original windows with vinyl ones. Substantial modifications to this resource over time have diminished its historic integrity. It does not exhibit high artistic value as the work of a master nor is it an outstanding example of its style or property type. Therefore, it is recommended that this resource be considered not eligible for the NRHP under Criterion C. It has no known association with any significant event or person, and is, therefore, recommended not eligible for the NRHP under Criteria A or B. It was not evaluated under Criterion D. In sum, this resource is **recommended not eligible for NRHP under Criteria A, B, or C.**

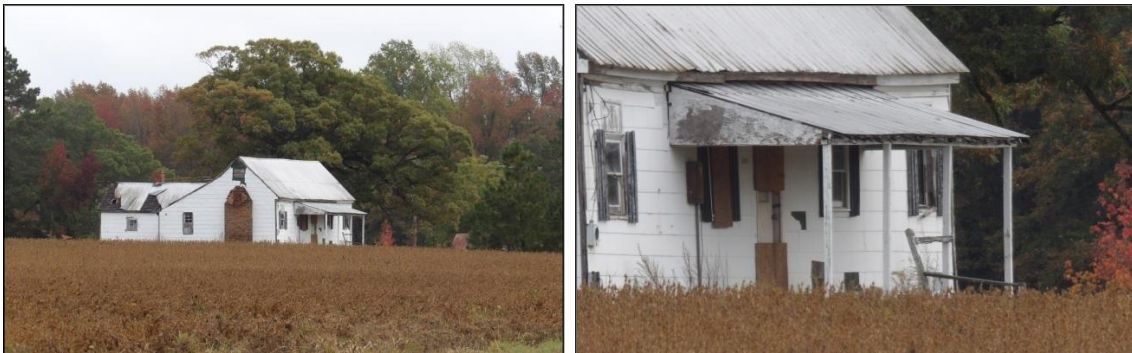
Photo 23: House, 18656 N.C Highway 561, Southwest Oblique (Left) and Porch Detail (Right).

The resource at 18656 N.C. Highway 561 was constructed in 1900 and is a one-story, five-bay, frame house built in a style that is vernacular to turn-of-the-century Halifax County. Built upon a brick-pier foundation with poured-concrete infill, the wood-frame structural system is clad in asbestos siding that appears to have been placed over weatherboard siding (Photo 23, p. 26). Its side-gabled roof is clad in wood shingles that are largely covered by standing-seam metal. An exterior-end brick chimney is located on the west elevation (Photo 24, p. 27). The primary entrance is centrally located on the south elevation and is filled by a single-leaf, half-glazed, wood door. The doorway is sheltered by a partial-width, shed-roofed porch. The roof is clad in standing-seam metal and supported by square wood posts. Window openings throughout the building are filled with one-over-one and six-over-six, double-hung, wood sashes. A gabled ell addition is located on the north elevation and features a central-interior brick chimney. A shed-roofed enclosed porch is attached to the east end of the north elevation. These additions have building materials that are concurrent with those of the original core of the dwelling. Two circa-1920 agricultural outbuildings are located north of the primary resource (Photo 25, p. 27).

Abandonment and vacancy has negatively impacted the house at 18656 N.C. Highway 561. The loss of historic fabric and material deterioration has resulted in a diminished integrity of design, workmanship, feeling, and materials. It does not exhibit high artistic value as the work of a master nor is it an outstanding example of its style or property type. For these reasons, it is recommended that this resource be considered not eligible for the NRHP under Criterion C. It has no known association with any significant event or person, and is, therefore, recommended not eligible for the NRHP under Criteria A or B. It was not evaluated under Criterion D. In sum, this resource is **recommended not eligible for NRHP under Criteria A, B, or C.**

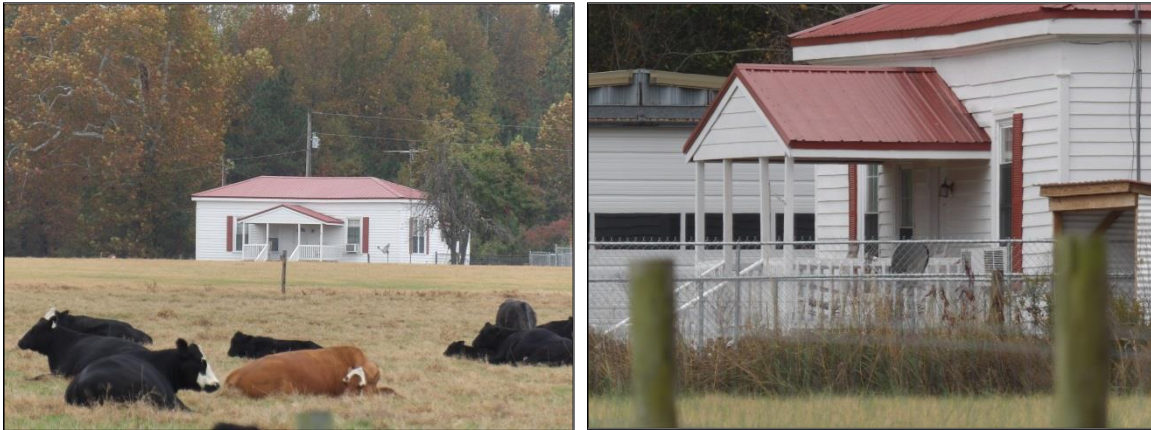
Photo 26: House, Grapevine and Gregory Farm Roads, South Elevation (Left) and Porch Detail, Looking West (Right).

The resource at the intersection of Grapevine Road and Gregory Farm Road was constructed in 1900 and is a one-story, three-bay, frame vernacular house. Although the foundation is not visible, it supports what is likely a wood-frame structural system clad in weatherboard siding (Photo 26, p. 28). Its hipped roof is sheathed in v-crimp metal. The primary entrance is centrally located on the south elevation and is filled by a single-leaf, replacement door with a fanlight. It is sheltered by a partial-width, wood, front-gabled porch. Window openings throughout the building are filled with four-over-four, double-hung, wood sashes that are framed by aluminum shutters. A hipped-roof addition is located on the north elevation. Its building materials suggest it was built at the same time as the original core of the dwelling. A shelter and a metal carport, both constructed around 2000, are located east of the dwelling. Situated west of the primary resource is a circa-1960, one-story garage and to the northeast is a circa-1935 well house (Photo 27 and Photo 28, pp. 28–28).

The house at the intersection of Grapevine Road and Gregory Farm Road has compromised integrity due to the construction of a sizable addition on the north elevation and abundant use of replacement materials. It does not exhibit high artistic value as the work of a master nor is it an outstanding example of its style or property type. Therefore, it is recommended that this resource be considered not eligible for the NRHP under Criterion C. It has no known association with any significant event or person, and is, therefore, recommended not eligible for the NRHP under Criteria A or B. It was not evaluated under Criterion D. In sum, this resource is **recommended not eligible for NRHP under Criteria A, B, or C.**

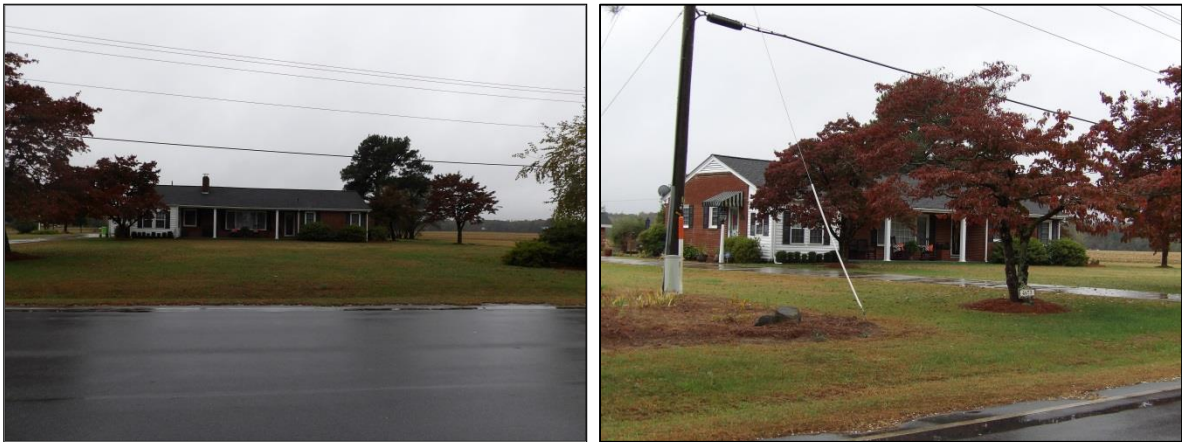
Photo 29: House, 4673 Ringwood Road, North Elevation (Left) and Northeast Oblique (Right).

The resource at 4673 Ringwood Road was constructed in 1953 and is a one-story, five-bay house built in the Ranch style. The building has a concrete-slab foundation that supports a structural system, possibly concrete-block, clad in a running-bond brick veneer (Photo 29, p. 29). The side-gabled roof is sheathed in asphalt shingles and contains an interior-slope brick chimney. The primary entrance is located on the north elevation and is filled by a single-leaf, replacement door with a fanlight, and a metal storm door (Photo 30, p. 30). The partial-width recessed brick porch is supported by square wood posts, and its east end has been enclosed and clad in vinyl siding. Window openings throughout the building are filled with one-over-one, double-hung, vinyl sashes that are framed by vinyl shutters. A gabled addition is located on the south elevation. Its building materials are the same as the original core of the dwelling. Associated with this resource are a circa-1990 garage, a circa-2000 storage shed, a circa-1960 agricultural outbuilding, and a circa-1980 agricultural outbuilding (Photo 30, p. 30).

The house at 4673 Ringwood Road contains a number of alterations, such as the construction of an addition and the enclosure of its porch. It is built in a form and style that is commonly found in the area and in the era in which it was constructed. It does not exhibit high artistic value as the work of a master nor is it an outstanding example of its style or property type. Therefore, it is recommended that this resource be considered not eligible for the NRHP under Criterion C. It has no known association with any significant event or person, and is, therefore, recommended not eligible for the NRHP under Criteria A or B. It was not evaluated under Criterion D. In sum, this resource is **recommended not eligible for NRHP under Criteria A, B, or C.**

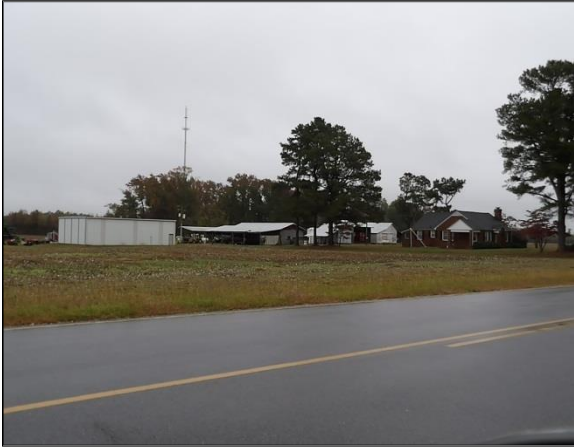
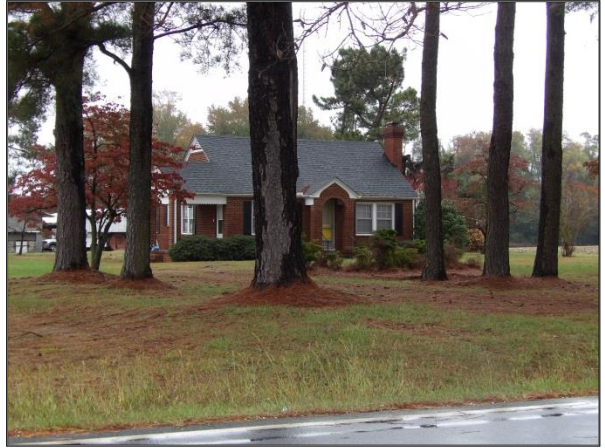
Photo 31: House, 4696 Ringwood Road, View of Resource Looking Northeast (Left) and South Elevation (Right).

The resource at 4696 Ringwood Road was constructed in 1946 and is a one-story, three-bay house built in the Minimal Traditional style. The building has a concrete-slab foundation that supports a structural system, possibly concrete-block, clad in a running-bond brick veneer (Photo 31, p. 31). The side-gabled roof is sheathed in asphalt shingles and contains an exterior-end brick corbelled chimney (Photo 32, p. 31). The primary entrance is centrally located on the south elevation and is filled by a single-leaf, wood, panel, half-glazed door covered by a metal-framed storm door. A single-bay porch is covered by a gabled roof that is supported by brick columns joined together with a brick arch. Window openings throughout the building are filled with six-over-six, double-hung, wood sashes covered with aluminum storm windows and flanked by aluminum shutters. A single-bay, side-gabled, brick porch is located on the west elevation. A gabled addition, with an attached shed-roofed addition, is located on the north elevation. All of the building materials in these additions match those of the original dwelling. A metal, shed-roofed porch has been added to the east elevation. Associated with this house is a large agricultural complex composed of one-story buildings that range in date from circa 1940 to circa 1990 (Photo 33, p. 31).

The house at 4696 Ringwood Road retains a relatively high level of integrity, but is built in a fairly common style to the area and in the era in which it was constructed. It does not exhibit high artistic value as the work of a master nor is it an outstanding example of its style or property type. Therefore, it is recommended that this resource be considered not eligible for the NRHP under Criterion C. It is not associated with any significant event or person, and is, therefore, recommended not eligible for the NRHP under Criteria A or B. It was not evaluated under Criterion D. In sum, this resource is **recommended not eligible for NRHP under Criteria A, B, or C.**

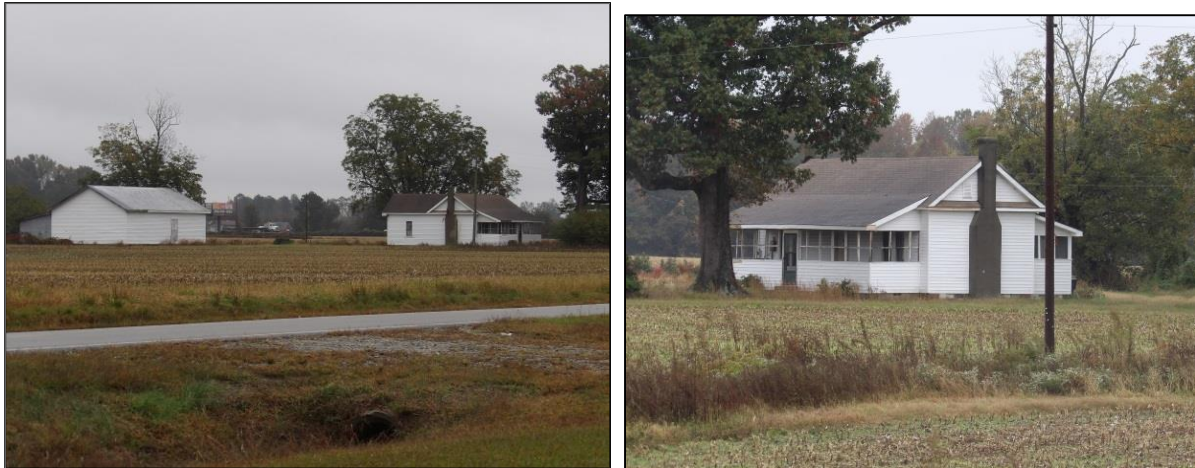
Photo 34: House, 5204 Ringwood Road, Southwest Oblique (Left) and Southeast Oblique (Right).

The resource at 5204 Ringwood Road was constructed in 1925 and is a one-story, five-bay house built in a style that is vernacular to this region of Halifax County and the era in which it was built. Its brick pier foundation with poured-concrete infill supports what is likely a wood-frame structural system covered in vinyl siding (Photo 34 and Photo 35, p. 33). The side-gabled roof is clad in asphalt shingles and contains two exterior-end, parged, and brick chimneys. The primary entrance is centrally located on the south elevation and is filled by a single-leaf replacement door. A full-width screened-in porch lines the façade and is supported by a poured-concrete foundation. Its shed roof is covered with asphalt shingles. Window openings throughout the building have four-over-two, double-hung, wood sashes. A one-story, front-gable addition and a shed-roofed porch has been added to the south elevation. Associated with this resource is a circa-1945 domestic outbuilding (Photo 36, p. 33).

The house at 5204 Ringwood Road does not exhibit high artistic value as the work of a master nor is it an outstanding example of its style or property type. Therefore, it is recommended that this resource be considered not eligible for the NRHP under Criterion C. It has no known association with any significant event or person, and is, therefore, recommended not eligible for the NRHP under Criteria A or B. It was not evaluated under Criterion D. In sum, this resource is **recommended not eligible for NRHP under Criteria A, B, or C.**

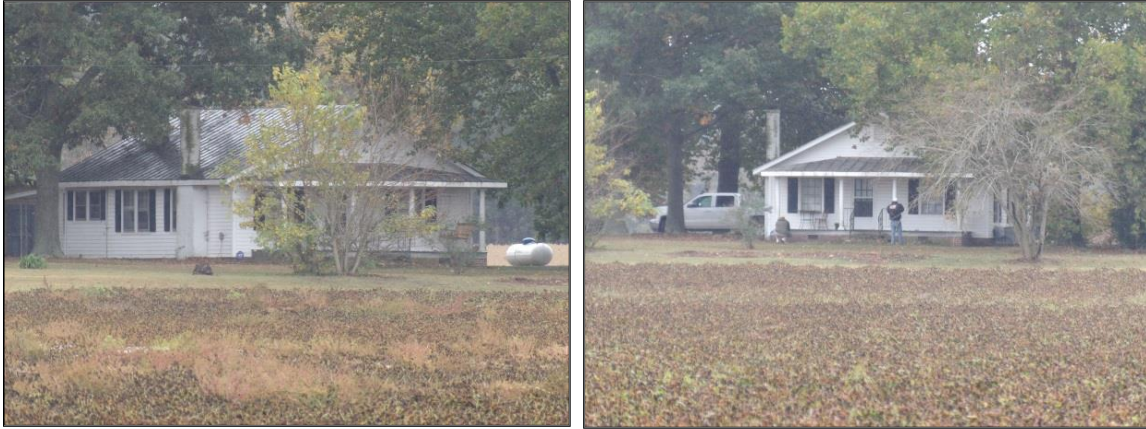
Photo 38: Lee May House, Northwest Oblique (Left) and West Elevation (Right).

The resource at 3399 North Old Carriage Road was constructed in 1905 and is a one-story, three-bay, frame house built in a style that is vernacular to this region of Nash County and the era in which it was built (Photo 38, p. 40). Its continuous brick foundation supports what is likely a wood-frame structural system covered in aluminum siding. The front-gabled roof is clad in standing-seam metal and contains an exterior-side brick chimney. The primary entrance is centrally located on the west elevation and is filled by a single-leaf half-glazed door. Window openings throughout the building are filled with six-over-six, double-hung, wood sashes. A full-width porch extends across the façade and has a continuous brick foundation with a hipped-roof is supported by Tuscan columns. Although not visible from the roadway, aerial photos indicate the presence of domestic outbuildings on the property (Google Maps 2015).

Although the house at 3399 North Old Carriage Road appears to be intact, it does not exhibit high artistic value as the work of a master nor is it an outstanding example of its style or property type. Therefore, it is recommended that this resource be considered not eligible for the NRHP under Criterion C. It has no known association with any significant event or person, and is, therefore, recommended not eligible for the NRHP under Criteria A or B. It was not evaluated under Criterion D. In sum, this resource **is recommended not eligible for NRHP under Criteria A, B, or C.**

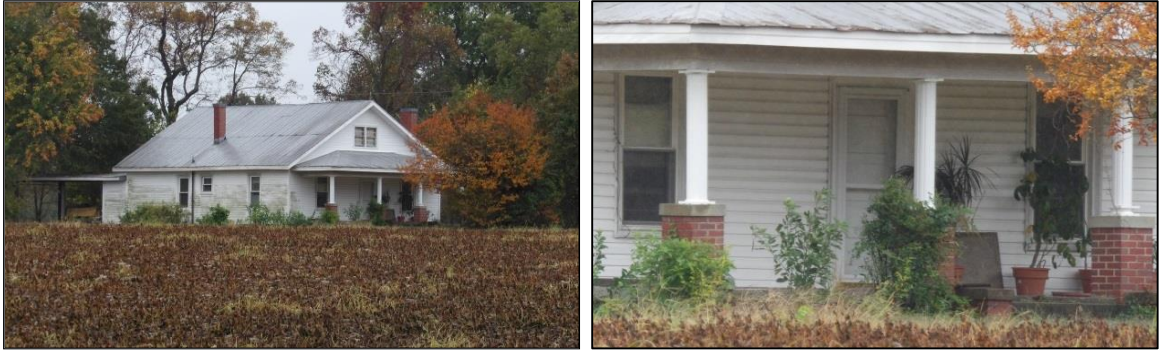
Photo 39: House, 3011 Big Jim Road, North Oblique (Left) and Porch Detail (Right).

The resource at 3011 Big Jim Road was constructed in 1930 and is a one-story, three-bay, frame house built in a local vernacular style (Photo 39, p. 41). Although its foundation is not visible, it supports what is likely a wood-frame structural system covered in vinyl siding. The front-gabled roof is clad in v-crimp metal and contains one interior-slope and one exterior-end brick chimney (Photo 40, p. 41). The primary entrance is centrally located on the northwest elevation and is filled by a single-leaf, wood, paneled door and a metal-framed storm door. A full-width porch is supported by a concrete foundation with a brick veneer and is topped by a hipped roof supported by fluted columns atop brick piers (Photo 39, p. 53). Window openings throughout the building have multiple sash types including two-over-two and one-over-one, double-hung, wood sashes. Several additions have been added to the building. Aerial photos show the Whitfield Cemetery located on this parcel southeast of the primary resource (Google Maps 2015).

The house at 3011 Big Jim Road contains a number of alterations and replacement materials. It is built in a form and style that is commonly found in the area and in the era in which it was constructed. It does not exhibit high artistic value as the work of a master nor is it an outstanding example of its style or property type. Therefore, it is recommended that this resource be considered not eligible for the NRHP under Criterion C. It has no known association with any significant event or person, and is, therefore, recommended not eligible for the NRHP under Criteria A or B. It was not evaluated under Criterion D. In sum, this resource is **recommended not eligible for NRHP under Criteria A, B, or C.**

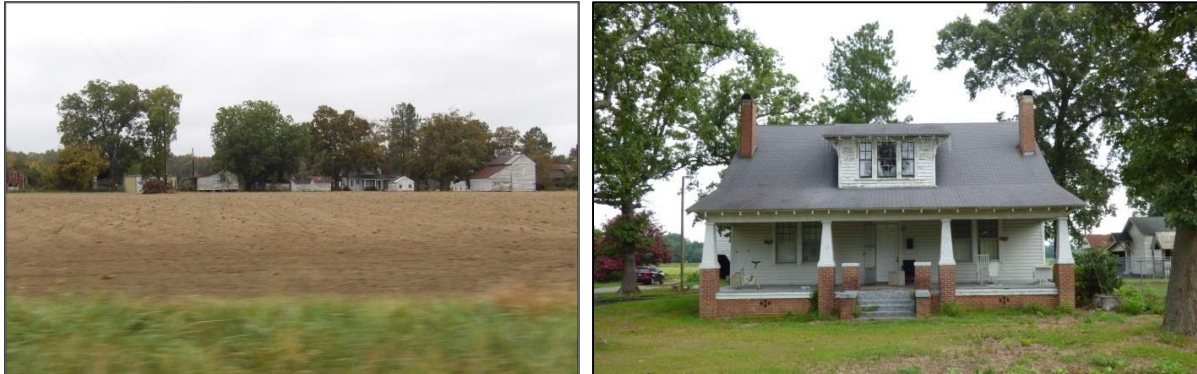
Photo 41: Farm, 4170 East Old Spring Hope Road, View to the South (Left) and House, South Elevation (Right).

The resource at 4170 East Old Spring Hope Road was constructed in 1934 and is a one-and-a-half-story, five-bay house built in the Craftsman style (Photo 41, p. 42). Its continuous brick foundation supports what is likely a wood-frame structural system covered with weatherboard siding. The side-gabled roof is clad in asphalt shingles and contains two exterior-end brick chimneys and an interior-slope chimney. Both roof slopes feature shed-roofed dormers with exposed rafter tails. The primary entrance is centrally located on the south elevation and is filled by a single-leaf, wood, panel door and a glass and aluminum storm door. A full-width porch has a continuous brick foundation and is covered by a shed roof supported by brick piers topped with battered wood posts. Window openings are filled with a mix of nine-over-one and four-over-one, double-hung, wood sashes covered with aluminum storm windows. A gabled addition is located on the north elevation which has a screened, wrap-around porch attached to its west and north elevations.. All of the addition's building materials are concurrent with those of the original core of the dwelling. A farm

The farm at 4170 East Old Spring Hope Road appears to retain many of its original character-defining elements including windows, door, and porch features. In addition, many historic domestic and agricultural outbuildings survive. Dovetail **recommends that the Farm at 4170 East Old Spring Hope Road needs additional study to fully assess this resource’s architectural significance, historic integrity, and NRHP eligibility.**

- Please provide an appropriate determination of "eligible" or "not eligible" for the May House (NS0650) and the Farm (NS1493).

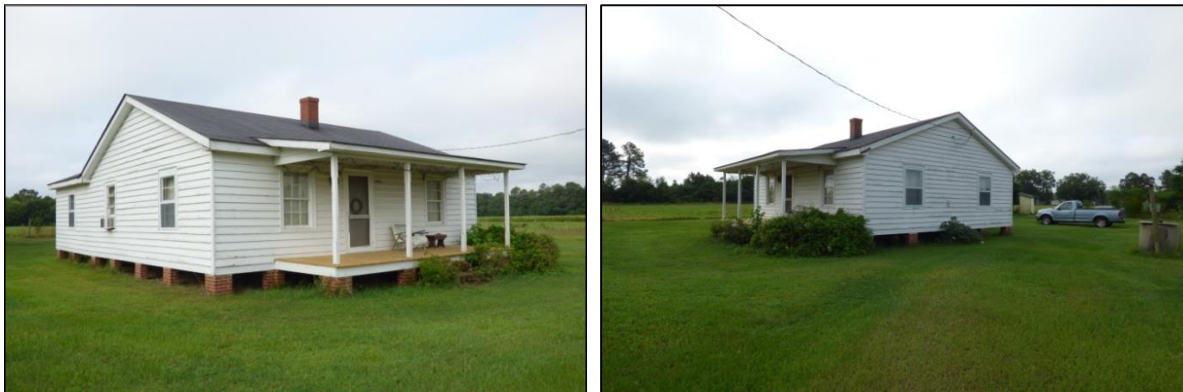
Photo 47: House, 2943 Eastern Avenue, Northeast Oblique (Left) and Northwest Oblique (Right).

The resource at 2943 Eastern Avenue was constructed in 1930 and is a one-story, three-bay house built in a vernacular style common in the first half of the twentieth century (Photo 47). Its brick-pier foundation supports what is likely a wood-frame structural system covered in weatherboard siding. The side-gabled roof is clad in asphalt shingles and contains an interior-slope brick chimney. The primary entrance is centrally located on the north elevation and is filled by a single-leaf door covered by a wood screen door. A partial-width wood porch is supported by a brick pier foundation, and its shed-roof is supported by square wood posts. Window openings throughout the building have multiple sash types and include six-over-six; one-over-one; and two-over-two double-hung, wood sashes covered by metal storm windows. A one-story, gabled addition and a shed-roofed porch have been added to the south elevation (Photo 48, p. 45). A circa-1935 domestic outbuilding is located southeast of the primary resource (Photo 48, p. 45). Built upon a concrete-block foundation, its wood framed walls are clad in wood siding. Its front-gable roof is covered in v-crimp metal. A shed-roofed addition has been added to its south elevation. A circa-1920 outhouse is located southeast of the primary resource (Photo 48, p. 45). Although its foundation and structural system are not visible, the walls are clad in vinyl siding.

The house at 2943 Eastern Avenue contains a substantial alteration with its gable-front and porch additions. It is built in a form and style that is commonly found in the area, and in the era in which it was constructed. It does not exhibit high artistic value as the work of a master nor is it an outstanding example of its style or property type. Therefore, it is recommended that this resource be considered not eligible for the NRHP under Criterion C. It has no known association with any significant event or person, and is, therefore, recommended not eligible for the NRHP under Criteria A or B. It was not evaluated under Criterion D. In sum, this resource is **recommended not eligible for NRHP under Criteria A, B, or C.**

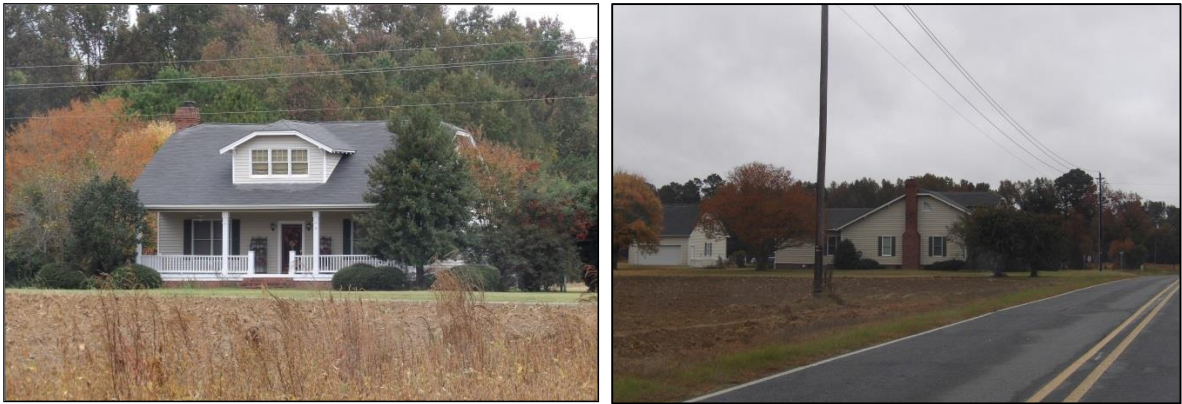
Photo 50: House, 4611 Old Beulah Road, Southeast Elevation (Left) and Southwest Elevation (Right).

The resource at 4611 Old Beulah Road was constructed in 1921 and is a one-and-a-half story, three-bay house built in the Craftsman style (Photo 50, p. 51). Its continuous brick foundation supports what is likely a wood-frame structural system covered in vinyl siding. The side-gabled, jerkinhead roof is clad in asphalt shingles and contains an exterior-end, corbelled, brick chimney and, on its southeast slope, a jerkinhead dormer. The primary entrance is centrally located on the southeast elevation and is filled by a multi-light, wood-framed, single-leaf door. A full width, recessed porch is supported by a brick foundation. The porch roof is supported by brick piers topped by square wood posts—all of which appear to be replacement materials.

Window openings throughout the building are filled with one-over-one, double-hung, vinyl sashes. A large one-story addition has been added to the northwest elevation and is clad in vinyl siding. It is covered by a jerkinhead roof clad in asphalt shingles. A circa-1990 garage is located northeast of the primary resource (Photo 51). Although its foundation is not visible, it supports walls clad in vinyl siding and a side-gabled, jerkinhead roof clad in asphalt shingles. A domestic outbuilding, although not visible from the road, is seen in aerial photos located east of the primary resource.

The house at 4611 Old Beulah Road contains a number of alterations and an abundance of replacement materials. It does not exhibit high artistic value as the work of a master nor is it an outstanding example of its style or property type. Therefore, it is recommended that this resource be considered not eligible for the NRHP under Criterion C. It has no known association with any significant event or person, and is, therefore, recommended not eligible for the NRHP under Criteria A or B. It was not evaluated under Criterion D. In sum, this resource is **recommended not eligible for NRHP under Criteria A, B, or C.**

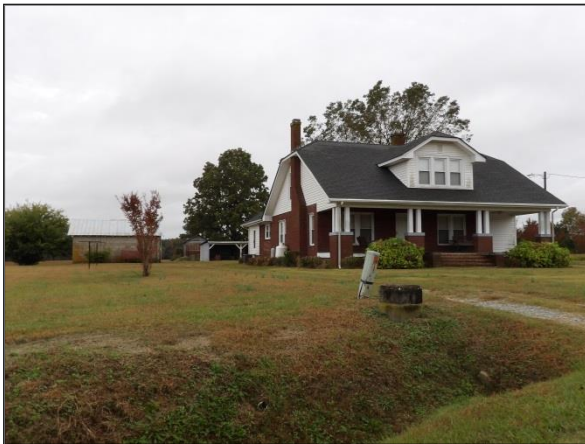
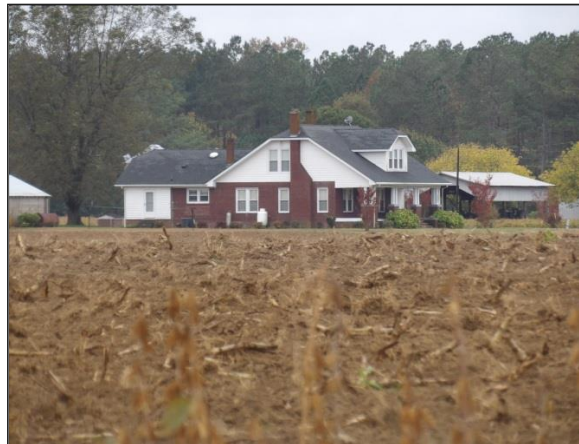
Photo 52: House, 4354 Old Beulah Road, Northeast Oblique (Left and Right).

The house at 4354 Old Beulah Road contains a number of alterations and abundance of replacement materials. It does not exhibit high artistic value as the work of a master nor is it an outstanding example of its style or property type. Therefore, it is recommended that this resource be considered not eligible for the NRHP under Criterion C. It has no known association with any significant event or person, and is, therefore, recommended not eligible for the NRHP under Criteria A or B. It was not evaluated under Criterion D. In sum, this resource is **recommended not eligible for NRHP under Criteria A, B, or C.**

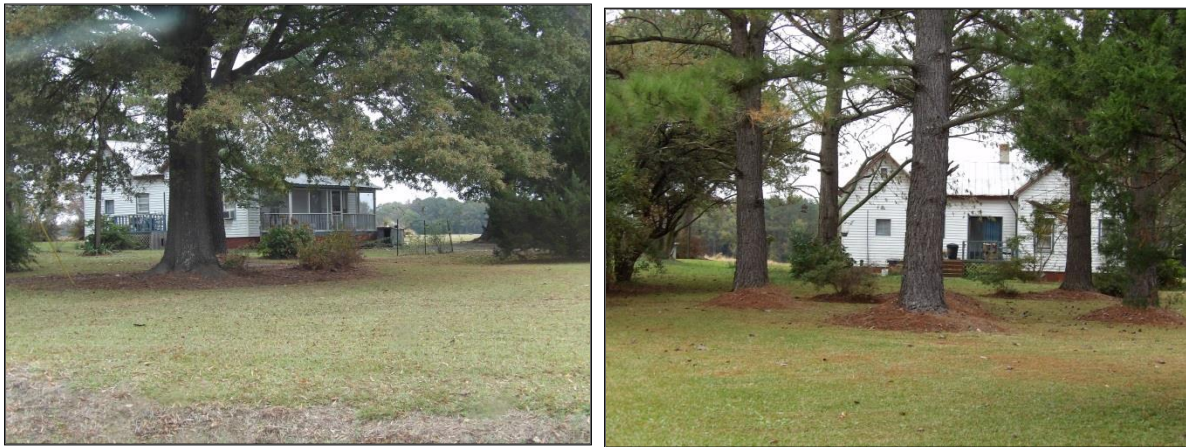
Photo 55: House, 2290 Davis Homestead Road, Southwest Oblique (Left) and West Elevation (Right).

The house at 2290 Davis Homestead Road contains a number of alterations, such as the construction of several additions and the application of aluminum siding. It is built in a form and style that is commonly found in the area, and in the era in which it was constructed. It does not exhibit high artistic value as the work of a master nor is it an outstanding example of its style or property type. Therefore, it is recommended that this resource be considered not eligible for the NRHP under Criterion C. It has no known association with any significant event or person, and is, therefore, recommended not eligible for the NRHP under Criteria A or B. It was not evaluated under Criterion D. In sum, this resource is **recommended not eligible for NRHP under Criteria A, B, or C.**

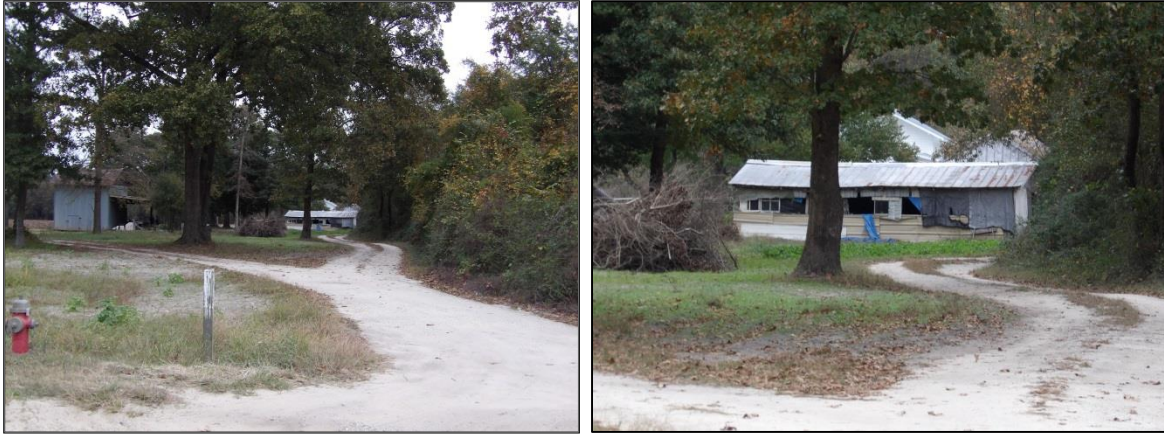
Photo 58: Outbuildings, 9919 South N.C. Highway 96, Southwest Oblique (Left) and West Elevation (Right).

The house at 9919 South N.C. Highway 96 was not completely visible during the current study from the public ROW. As such, insufficient information was gathered regarding the resource's architectural significance and historic integrity. Dovetail **recommends that the House at 9919 South N.C. Highway 96 needs additional study to assess its eligibility evaluation.**

- Please provide an appropriate determination of "eligible" or "not eligible" for the House located at 9919 South NC Highway 96 (JT1885).

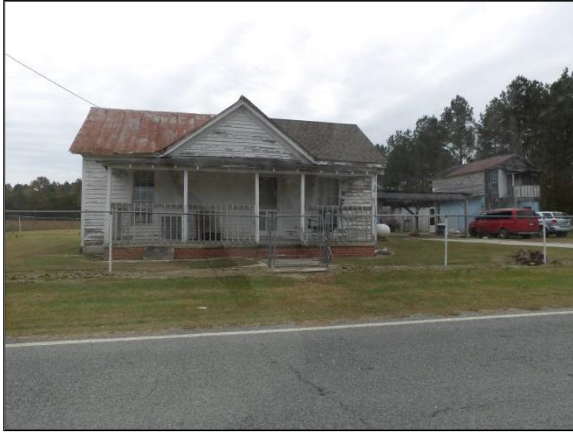
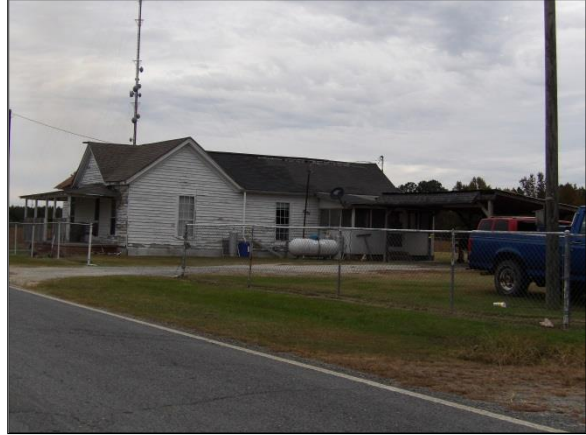
Photo 59: House, 54 Yelverton Grove Road, West Elevation (Right) and Southwest Oblique (Left).

The house at 54 Yelverton Grove Road has been modified over time and contains a number of replacement materials. It does not exhibit high artistic value as the work of a master nor is it an outstanding example of its style or property type. Therefore, it is recommended that this resource be considered not eligible for the NRHP under Criterion C. It has no known association with any significant event or person, and is, therefore, recommended not eligible for the NRHP under Criteria A or B. It was not evaluated under Criterion D. In sum, this resource is **recommended not eligible for NRHP under Criteria A, B, or C.**
