Re: Phase I Historic Architectural Survey of the Atlantic Coast Pipeline Project, Addendum 4
and Updated NRHP Findings, Multi County, ER 14-1475

Report prepared by Laura Voisin George, Jeffery L. Holland, Kimberly Barnard, Emily Tucker-Laird,
Mary Beth Derrick, and Larissa A. Thomas, Ph.D.

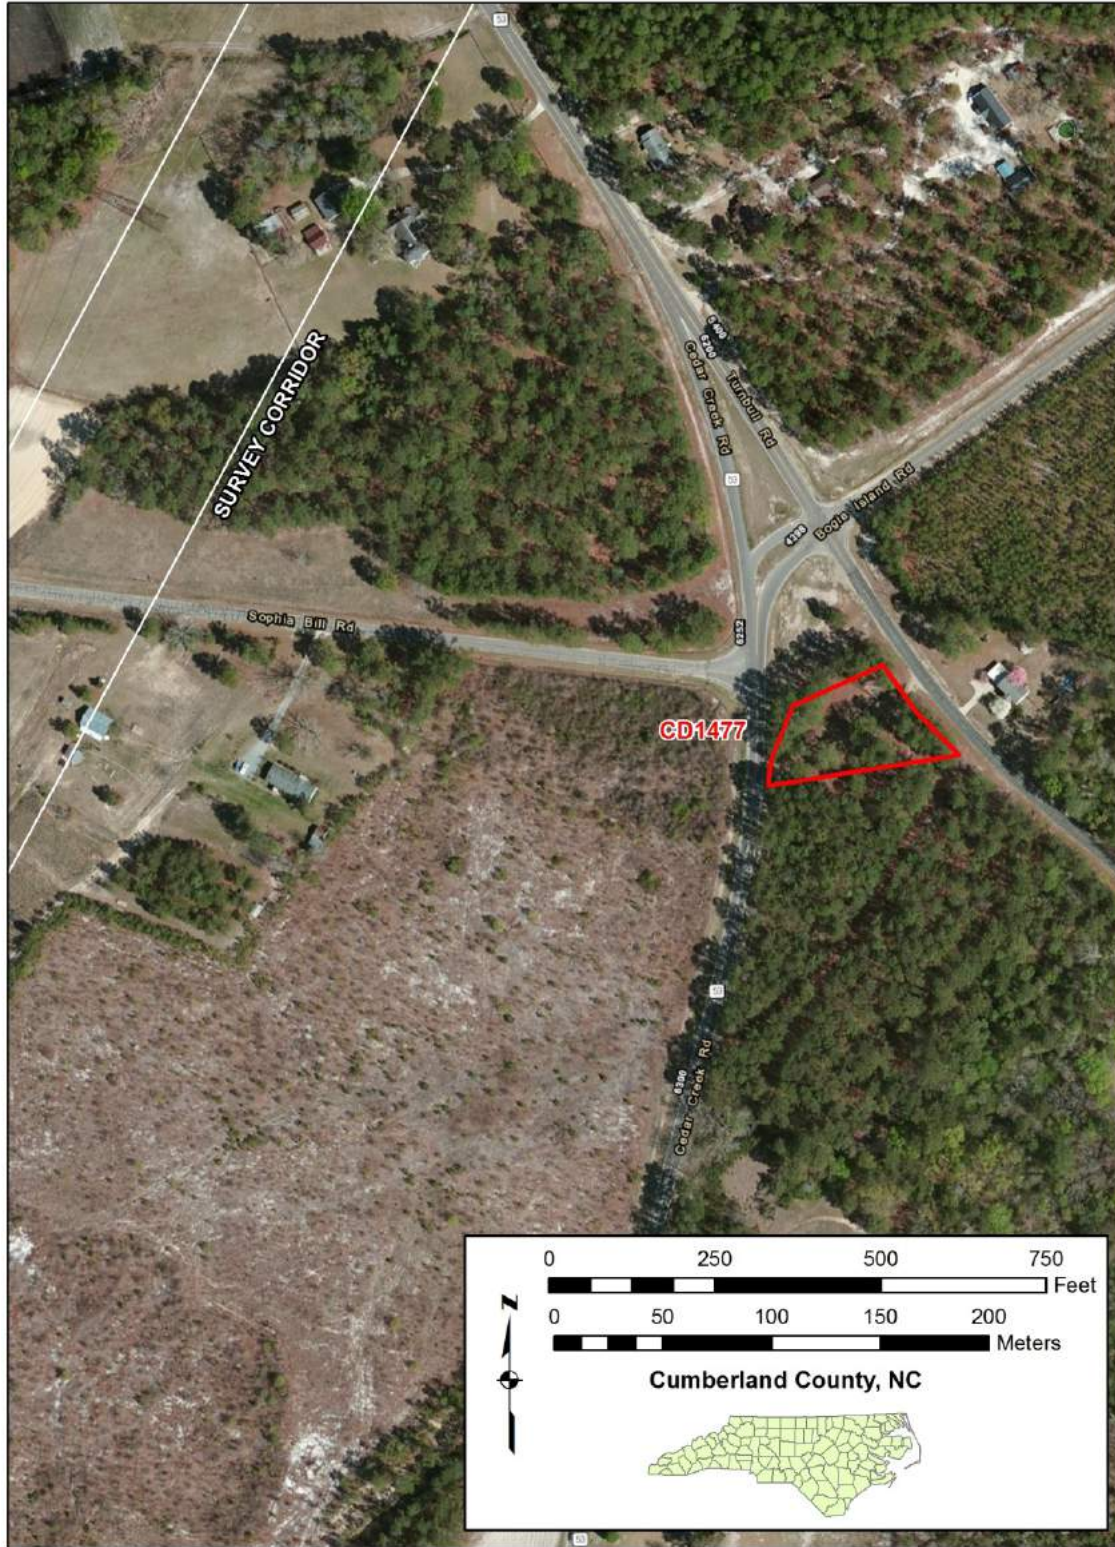
Figure 3. CD1477 (Cedar Creek Fire Tower), proposed NRHP boundary and relationship to Project.

NRHP Assessment: The last state fire lookout towers were constructed in the late 1960s and by the 1990s the Division of Forestry Resources had begun to abandon the use of fire towers. Although many are still standing, these towers represent a significant period in the history of the close relationship between public resource conservation and the state's timber industry. The Cedar Creek Fire Lookout Tower retains many of its original features and its setting is well-preserved. ERM recommends that CD1477 is eligible for the NRHP under Criterion A for its role in local conservation and fire prevention efforts in the twentieth century, and for its construction by the CCC. The CCC, a New Deal agency that provided jobs during the Depression through civil works projects, assisted the U.S. Forest Service as well as the states in the construction of fire towers (Forest History Society 2017; NCD CD 1934). The design and materials of the tower are typical of the period, and the resource displays a high degree of integrity. While the fire tower is not distinctive or uncommon and does not represent the work of a master, it is an intact and increasingly rare example of an engineering structure that has served as a highly visible local landmark, connected to an important aspect of the area's twentieth century history. However, while the exterior of the structure appears to retain sufficient integrity for NRHP eligibility under Criterion C, the condition of the interior of the cab could not be evaluated during

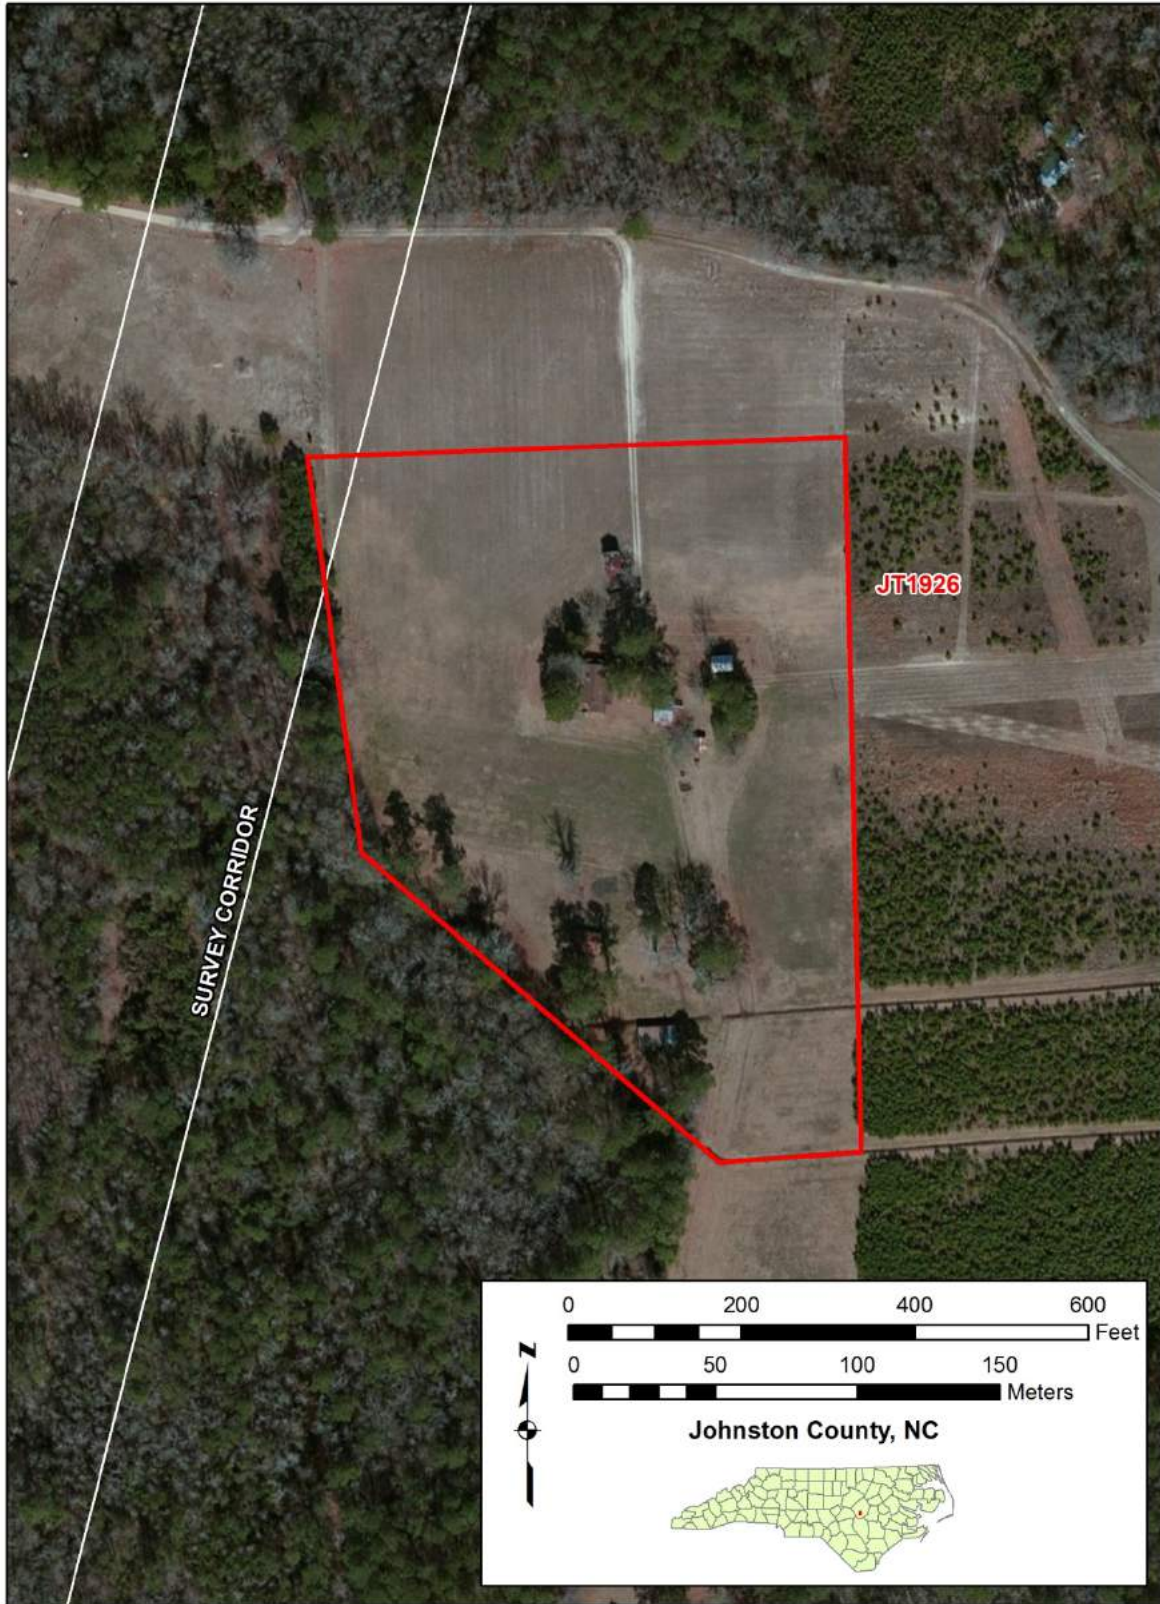
Figure 16. JT1926, proposed NRHP boundary and relationship to Project.

NRHP Assessment: As the resource is not visible from the road, in accordance with guidance from the NC HPO, it is ERM's recommendation that the resource be treated for Project purposes as if it is eligible for the NRHP until an assessment and determination of eligibility can be conducted (Figure 16).

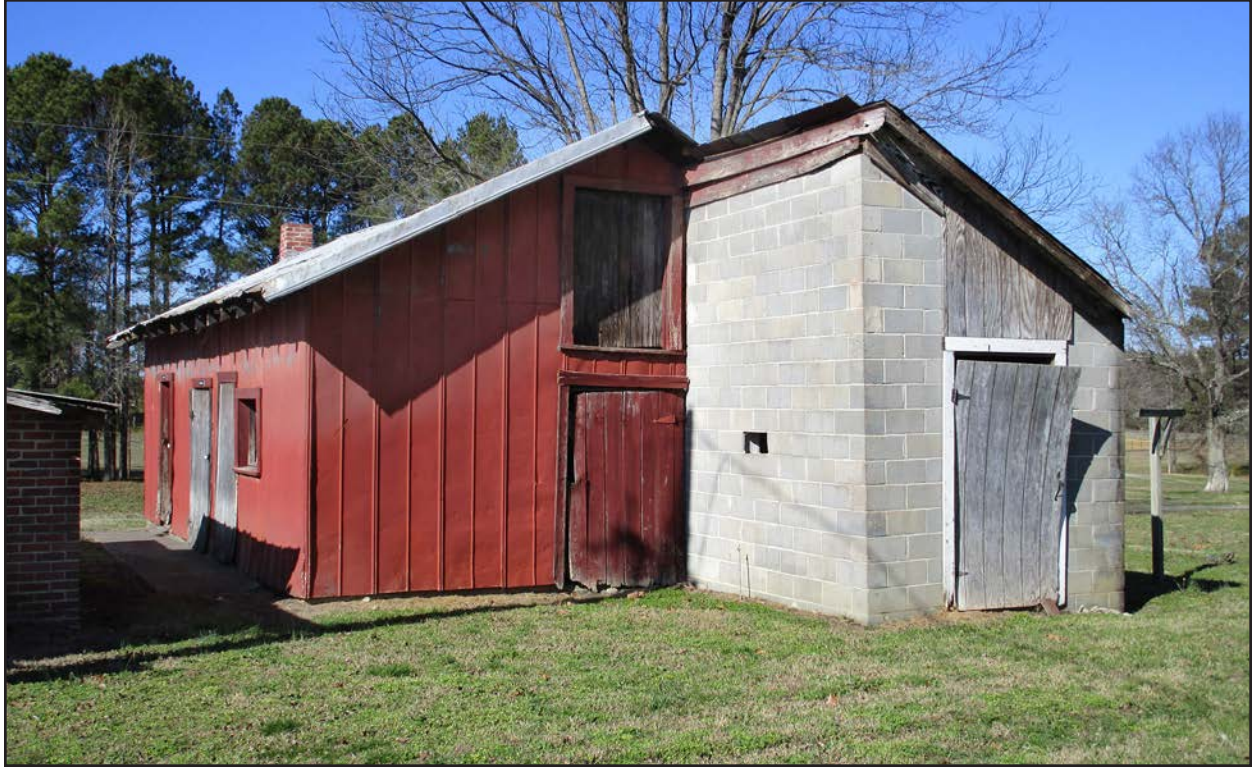
Photo 23. HX0021, wash room/laundry, shed roof addition, facing north-northwest.

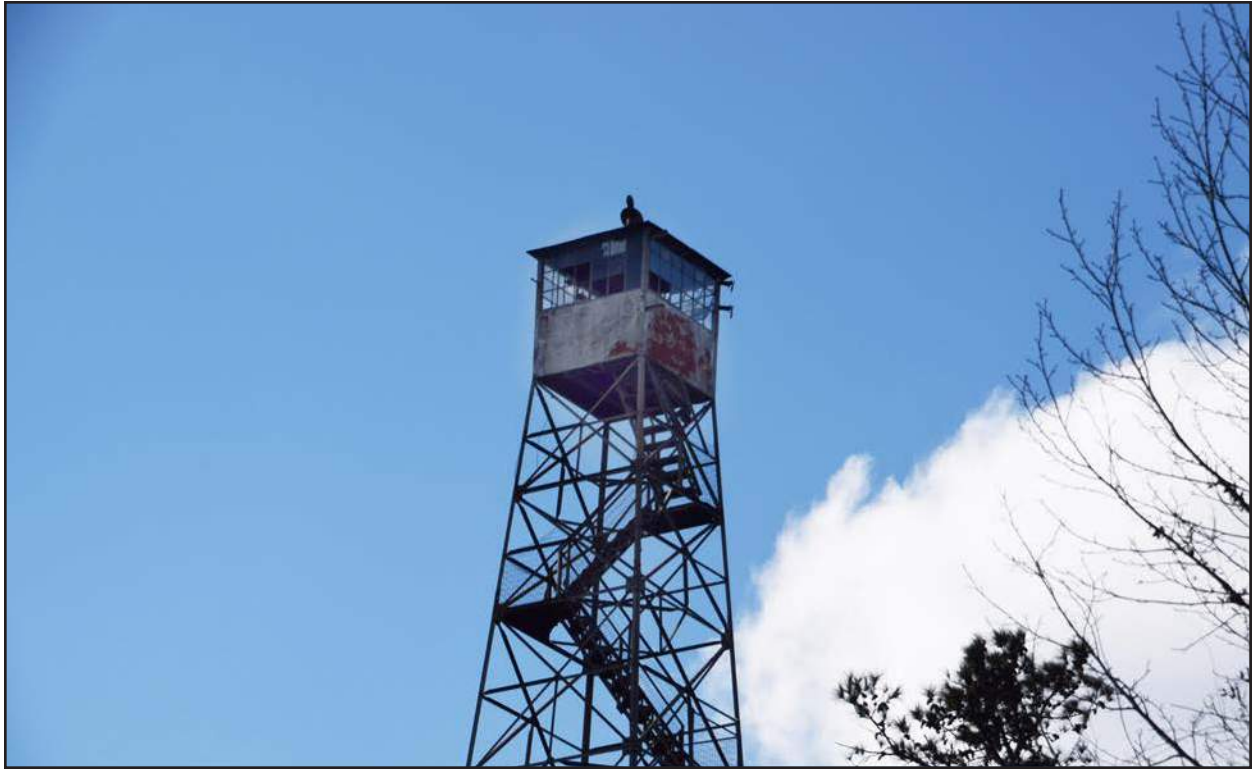
Photo 75. JT1860 (Smithfield Fire Lookout Tower), fire tower observation box, facing west-southwest.

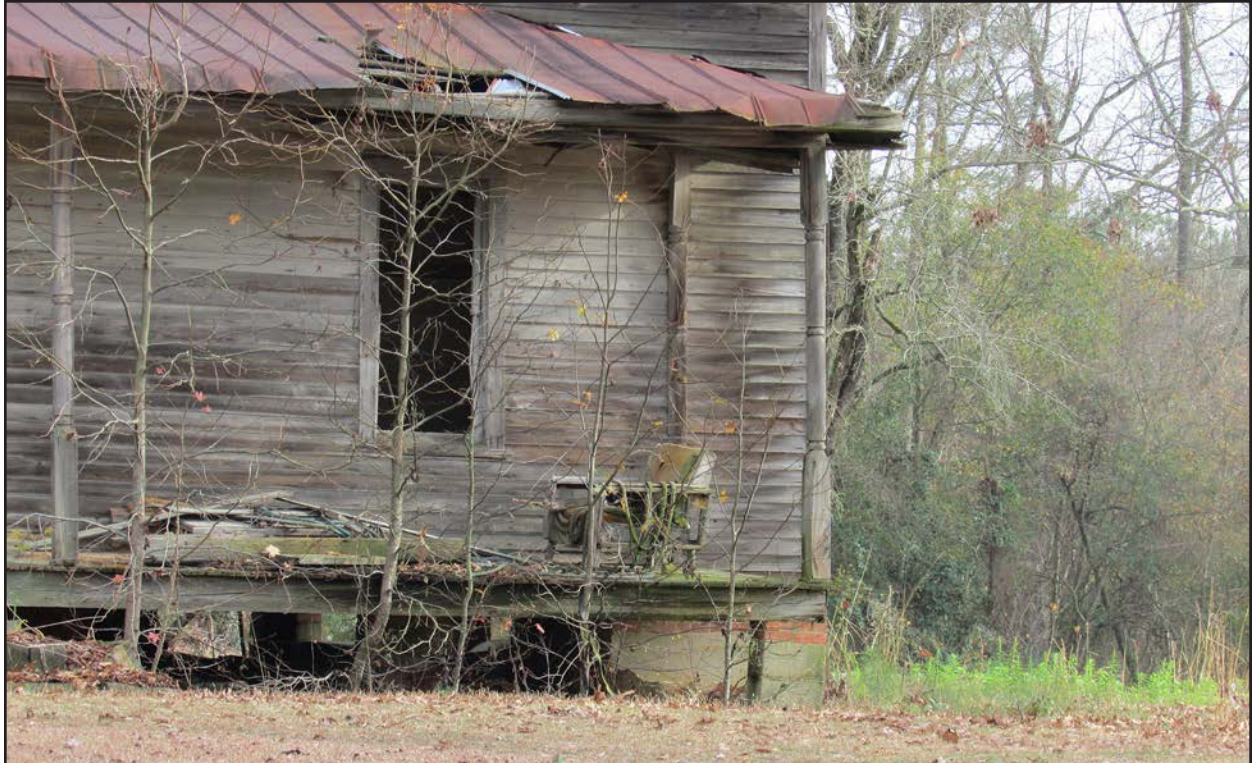
Photo 112. JT1937, foundation, facing southeast.
