SUBJECT: Historic Structures Survey Report for widening and upgrade NC 125/SR 1142
(Prison Camp Road) from NC 903 to SR 1172 (East College Road), R-4705,
Martin County, ER 15-0346

HISTORIC ARCHITECTURAL ELIGIBILITY EVALUATION

WIDEN AND UPGRADE

NC 125/SR 1142 (PRISON CAMP ROAD)

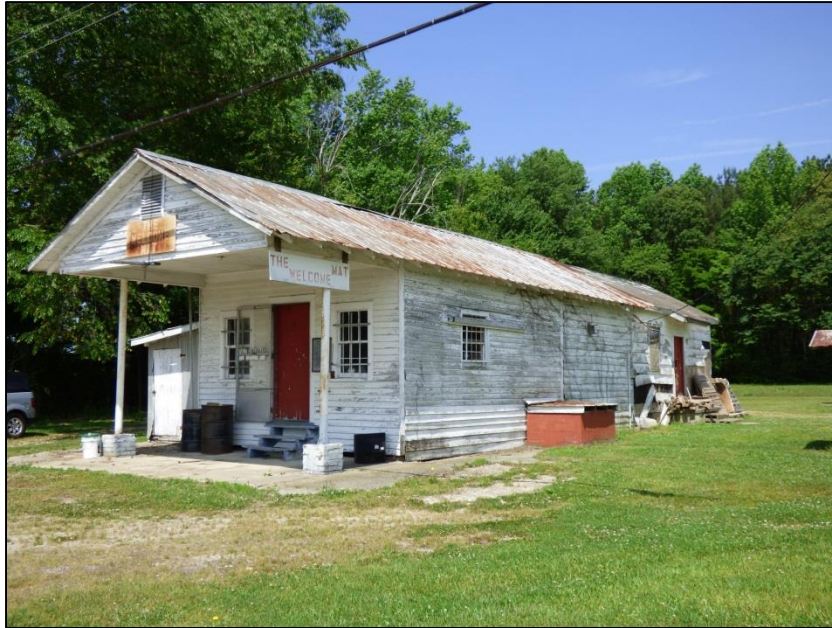
Photo 1: Store, East Oblique.

The S & M Grocery is a one-story, three-bay commercial building constructed in the 1930s (Photo 1, p. 10). While interior access was not granted during the current survey, Donna Dodenhoff performed a survey in 1992 from which information pertaining to the interior is gained. In her survey, Dodenhoff describes the interior as being “sheathed with beaded boards” and lined with simple shelves on which goods are stocked. Additionally, the building is described as “typical of roadside stores built across North Carolina during the state’s major highway improvement era” (NC-HPO 1992a).

The brick-pier foundation of the store supports the wood-frame structural system that is visible on the southwest elevation due to the removal of some of the siding. The exterior walls are clad in weatherboard siding. The grocery is capped by a front-gabled roof sheathed in v-crimp metal with exposed rafter tails on the northeast and southwest elevations. Directly abutting the southwest elevation is a concrete-block chimney.

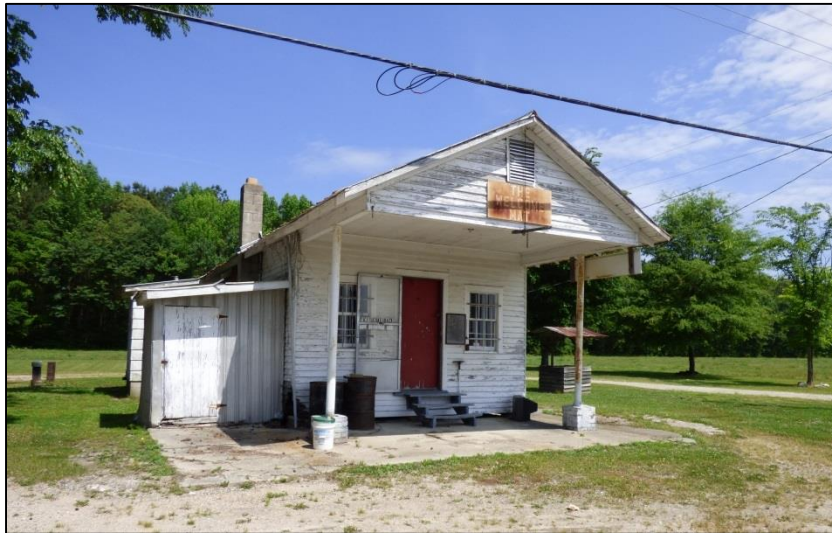
Photo 2: Store, Southeast Elevation.

The primary entrance is sheltered under a one-story recessed porch on the façade (Photo 2, p. 10). This, too, is a common feature of rural, roadside general stores in North Carolina (Fearnbach 2012:72). Two small metal posts with brick bases rest on a poured-concrete slab. A front-gabled roof with weatherboard and a metal vent in the gable is sheathed in v-crimp metal. The ceiling is covered with beaded boards.

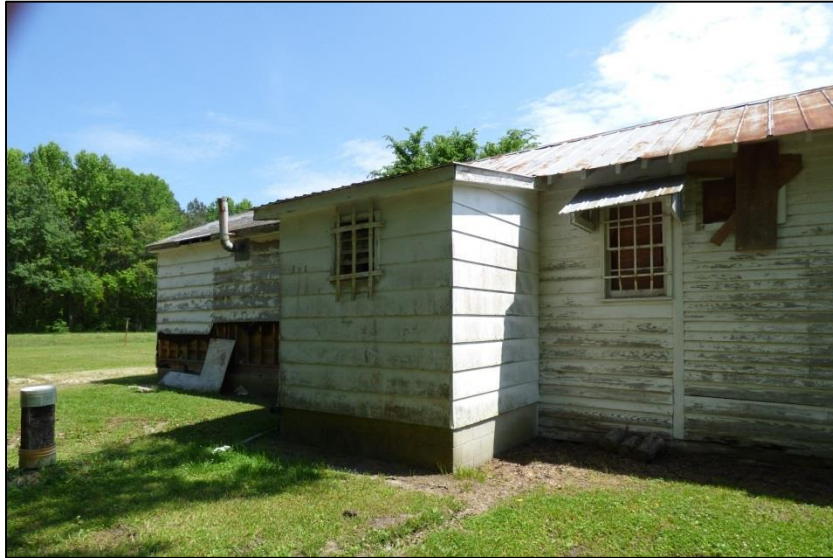
Photo 3: Addition on the Store, Southwest Elevation.

The building is extended by an addition located on its north elevation (Photo 3). It is deduced that this addition was constructed in the mid 1950s and is accentuated by a change in the exterior wall sheathing. Aerial photography displays the building being transformed from a square building to a rectangular building (Figure 8) (USGS 1957, 1964). With the exception of one four-over-four, double-hung-sash wood window covered by a v-crimp metal awning, the addition features building materials concurrent with those of the original portion of the building.

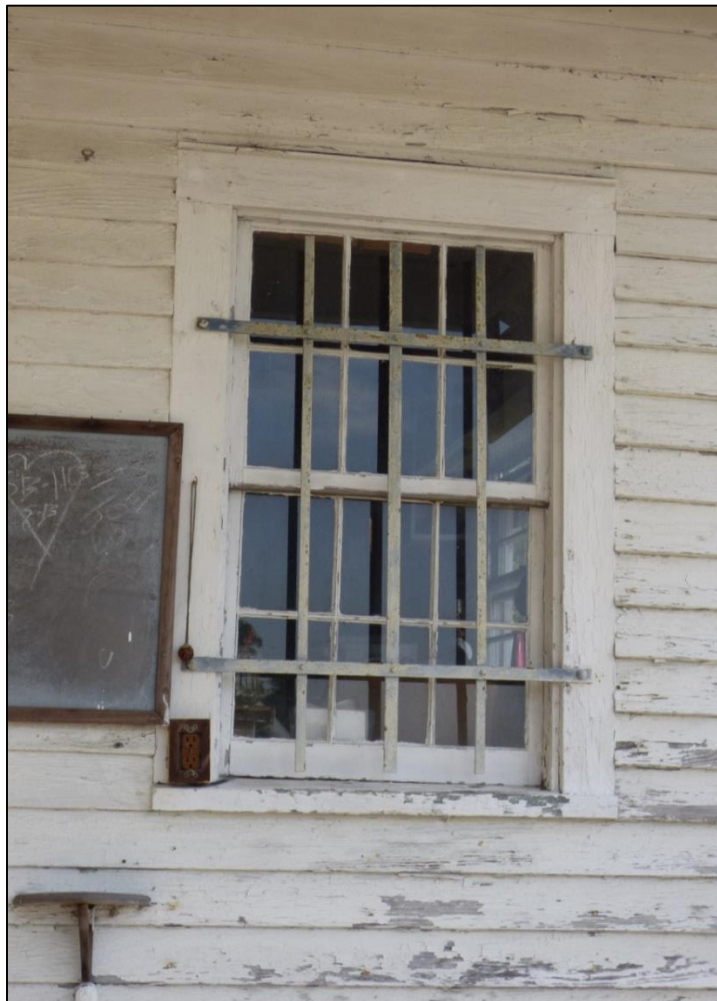
Photo 4: Window Detail on the Store, Looking Northwest.

Another small shed-roofed addition extends from this addition's southwest elevation. It rests on a concrete-block foundation, and the exterior walls are clad in asbestos siding. The shed-roof with an unadorned wooden box cornice is sheathed in v-crimp metal. Fenestration includes four-over-four, wood sash windows covered by metal bars (Photo 4).

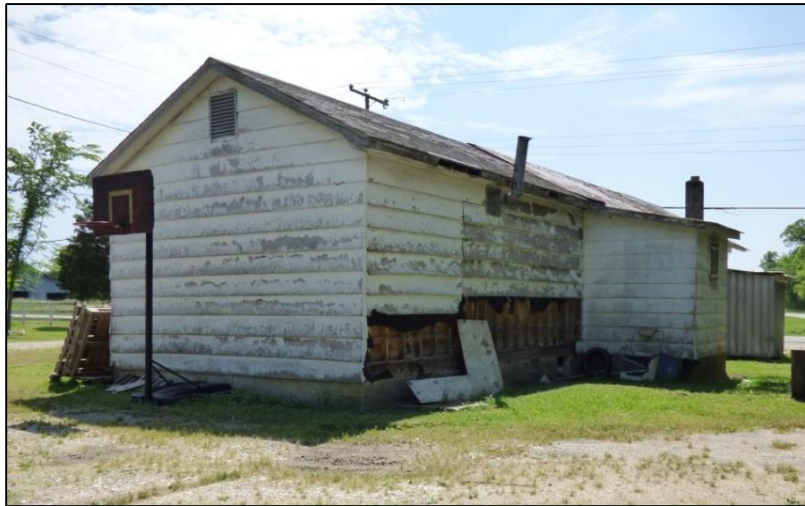
Photo 5: Store and Additions, West Oblique.

A one-story gabled addition extends from the rear (northwest) addition (Photo 5, p. 13). The addition sits on a continuous concrete-block foundation. The wood-frame structural system, which is visible due to the removal of wall sheathing on the southwest elevation, is clad in particle board siding. A front-gabled roof sheathed in asphalt paper covers the addition. A metal flue projects from the southwest elevation. A single-leaf, three-light wood door situated on the addition's northeast elevation opens to a concrete-block stoop and staircase and is covered by a small shed extension of the roof. Other fenestration includes six-over-six, double-hung sash, wood windows.

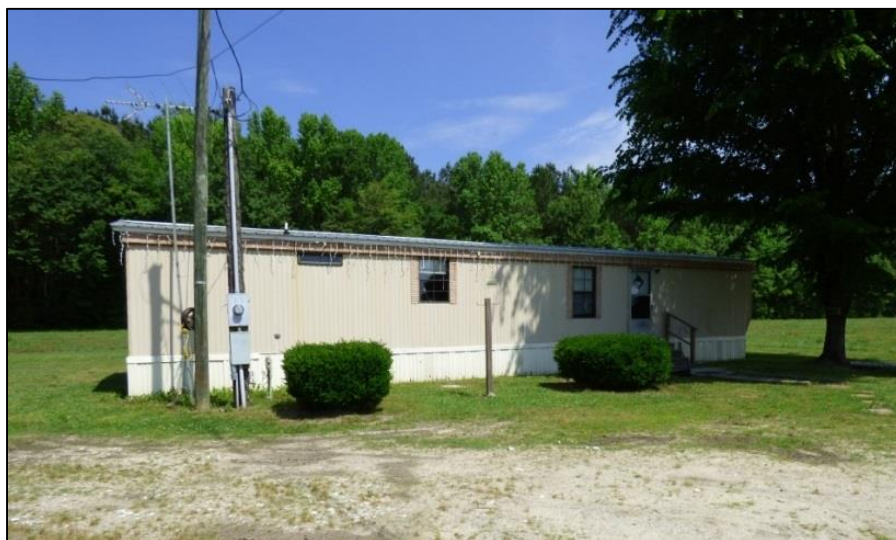
Photo 6: Mobile Home, Southeast Elevation.

Constructed in the mid-1990s is a one-story, three-bay mobile home (Photo 6) (Google Earth 1993, 1998). The dwelling is located approximately 25 feet north of the S & M Grocery. The resource's non-visible foundation is covered by aluminum sheeting. The metal frame structural system and arched roof are sheathed in corrugated metal. The main entry, filled by a single-leaf, wood door with a single diamond-shaped light, covered by a metal and glass storm door, is located on the southeast elevation. A secondary entrance, filled by an identical door, is located on the northwest elevation. Other fenestration includes one-over-one, aluminum sash windows flanked by fixed, aluminum, louvered shutters. Located directly in front of the primary entrance is a small wood staircase. A wood deck extends from the northwest elevation. It rests on square wood posts and is accessed by wooden stairs on the southwest elevation.

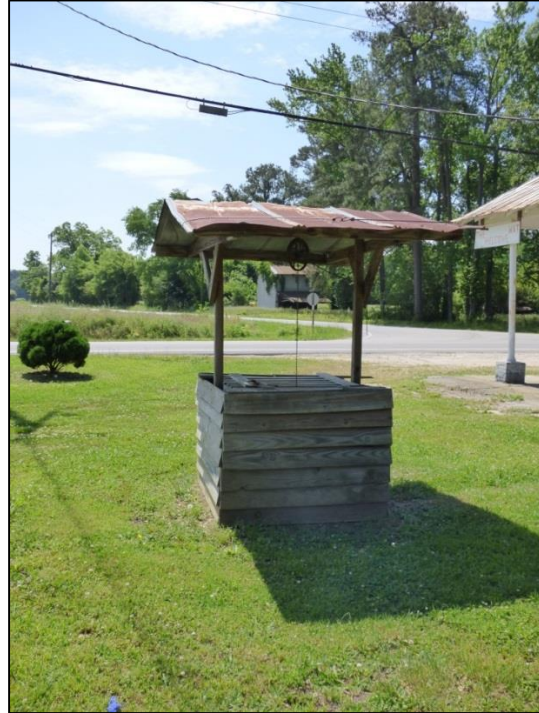
Photo 7: Well House, Looking South.

Located approximately 10 feet northeast of the store is a one-story, circa-1990 well house (Photo 7). It is supported by square wood posts with up-bracing. The poured-concrete, circular well is clad in wood siding and covered by a gabled roof sheathed in v-crimp metal.

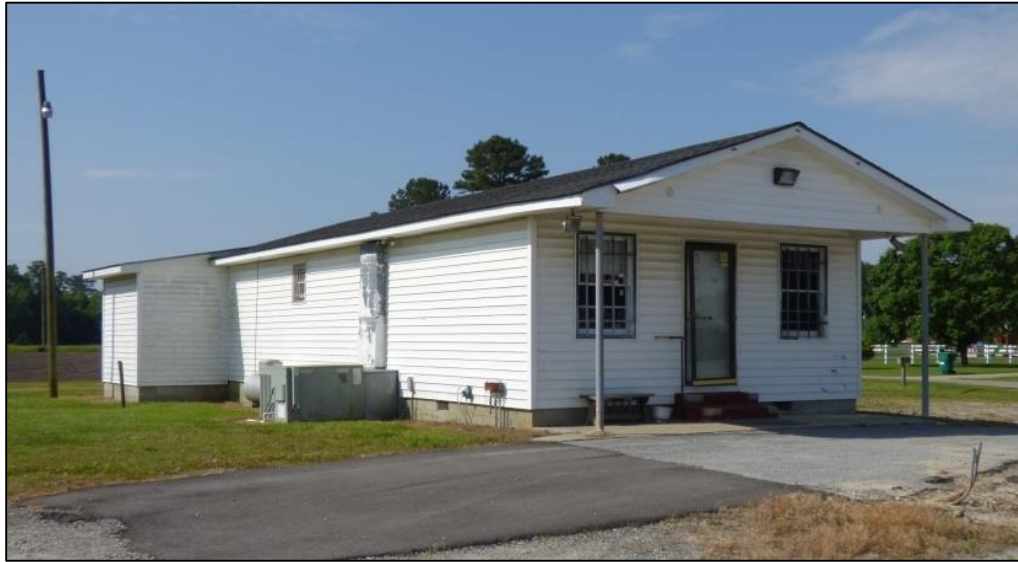
Photo 9: Ed's Grocery East of the Intersection of Ed's Grocery Road (SR 1106) and Prison Camp Road (SR 1142).

Ed's Grocery (Photo 9, p. 19) is located 1.25 miles southwest on Prison Camp Road (SR 1142) east of its intersection with Ed's Grocery Road (SR 1106). The store is a one-story, three-bay, frame general store which likely dates to the 1930s. While various improvements have been made to this store including exterior wall and roof sheathing replacement, the overall form has not been altered.

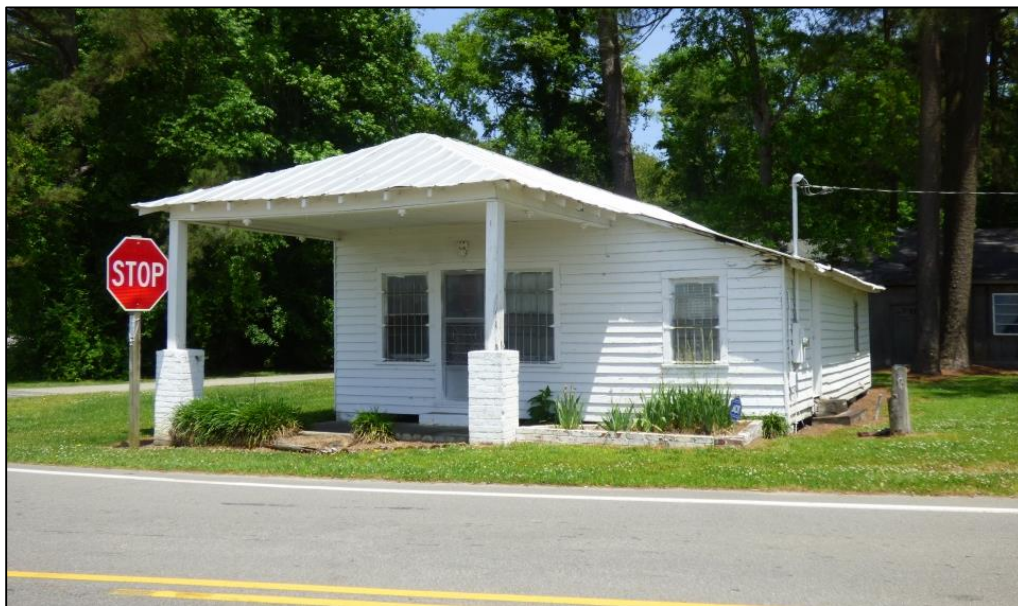
Photo 10: (Former) Fred McDaniels Store (MT0397) at the Intersection of Ed's Grocery Road (SR1106) and Everetts Road (SR 1138).

An additional similar resource, the early-twentieth century (former) Fred McDaniels Store (MT0397), is located approximately 7 miles southwest of S & M Grocery just east of the intersection of Ed's Grocery Road (SR1106) and Everetts Road (SR 1138) in Martin County (Photo 10, p. 19). The frame structural system of this one-story, four-bay commercial building is clad in weatherboard siding and covered by a hipped roof sheathed in standing seam metal. A deep canopy shelters the front entry and original wood-frame windows. Although the building has a shed-roof addition on its south elevation, it retains many of the

features common in these early- to mid-twentieth century commercial buildings including the original porch supports, exterior wall and roof sheathing, as well as the original fenestration.

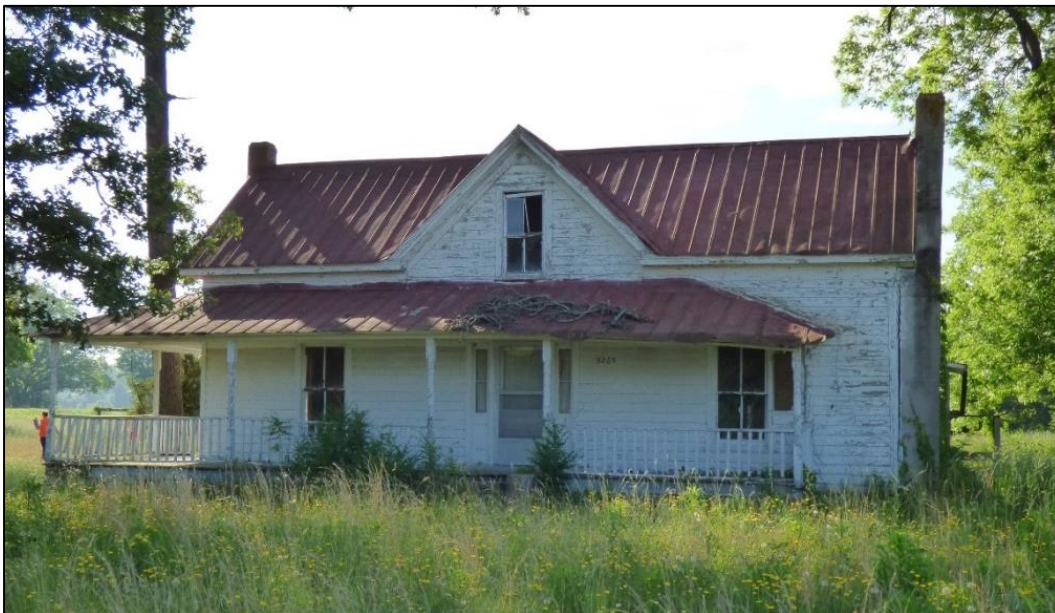
Photo 11: Dwelling, Northwest Elevation.

The primary resource of the Bowen Farm is a circa-1910, story-with-a-jump, three-bay farmhouse constructed in the triple-A form—a plan that is found elsewhere in Martin County (Photo 11, p. 22). General access to the property was granted by the current owner, J. Melvin Bowen, whose family has owned and farmed the property since the early-twentieth century. Due to severe overgrowth, some exterior features were undiscernible because of potentially unsafe plantings. Interior access was not obtained at this time; however, Donna Dodenhoff completed a survey in 1992 where she was able to document the exterior and interior of the building. During Dodenhoff’s detailed investigation, she states that the interior “follows a one-room deep, center hall plan extended by two rear ell additions and a shed room” (NC-HPO 1992b). Bowen family tradition states that they lived in the house until they moved into the Town of Williamston during the 1930s when John M. Bowen began to work as a merchant. Since then, the farmhouse has been utilized by tenant farmers who worked with the Bowens until at least the early 1990s (NC-HPO 1992b). Currently, the house is uninhabited but the property is still being farmed.

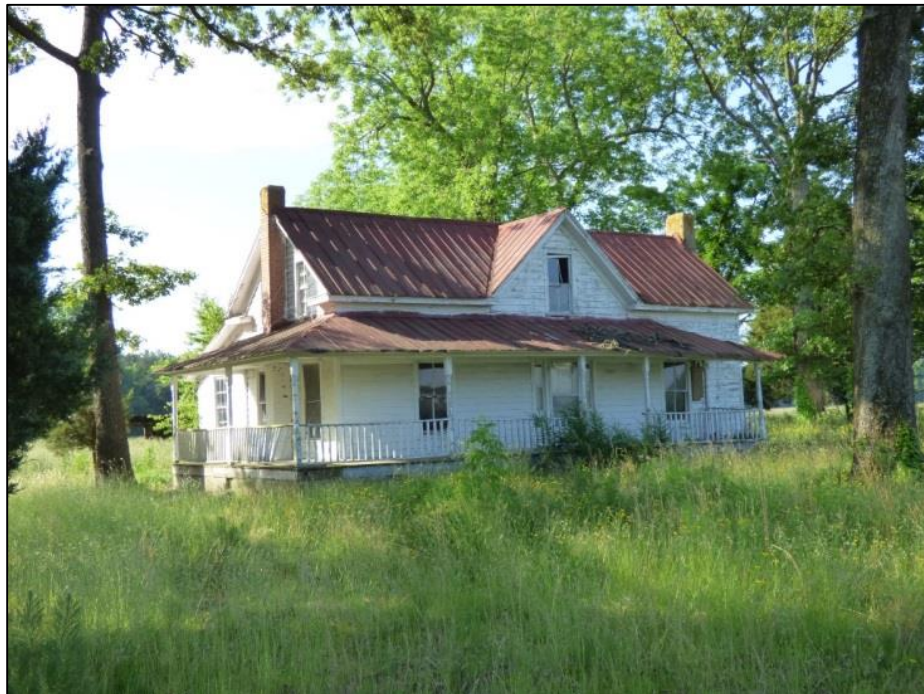
Photo 13: Dwelling, North Oblique.

A one-story, four-bay, wrap-around porch partially spans the primary elevation and covers the width of the northeast elevation (Photo 13, p. 25). The wood porch presently sits on a continuous, concrete-block foundation and is sheltered by a low-pitched, hipped roof sheathed in v-crimp metal. The roof is supported by turned, wood posts and the porch is lined with a squared, wooden balustrade. Dondenhoff called these turned posts “a typical Victorian millwork element” in her 1992 survey (NC-HPO 1992b). The porch is accessible by a set of stairs located directly in front of the primary entrance that are constructed of an unknown material due to poor visibility. Another set of stairs, constructed of concrete-block, is located on the northeast elevation on the southeast end of the porch.

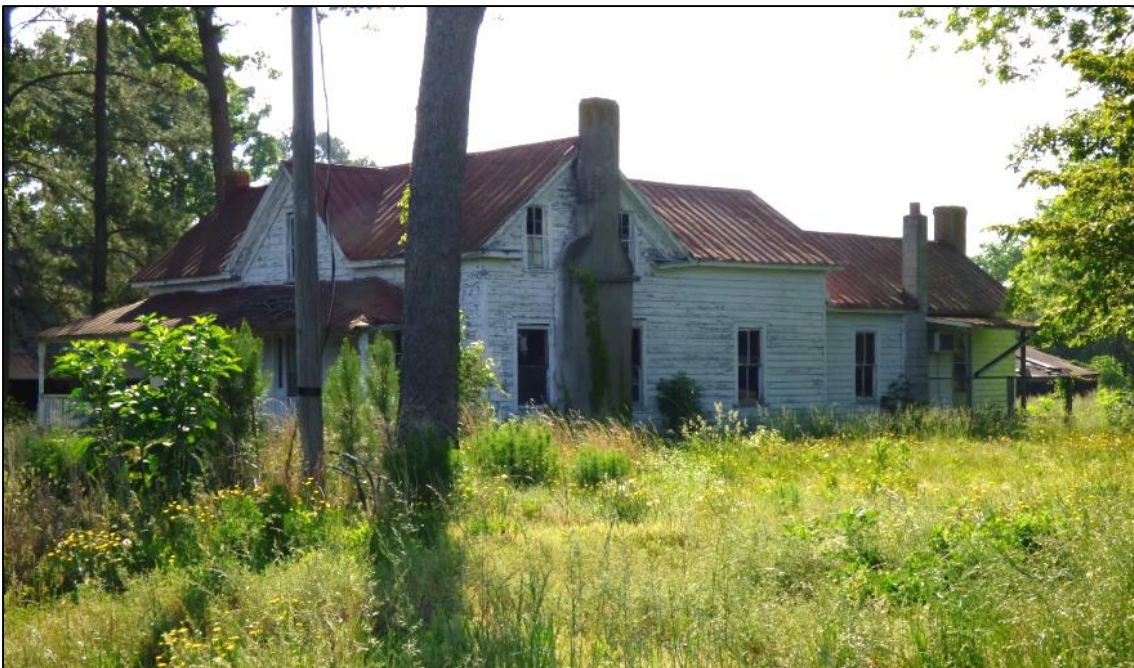
Photo 14: Dwelling and Additions, West Oblique.

A circa-1920, story-with-a-jump, rear ell addition extends off of the southern portion of the southeast elevation (noted as No. 2 in Figure 13, p.24; Photo 14, p.26). The foundation of the

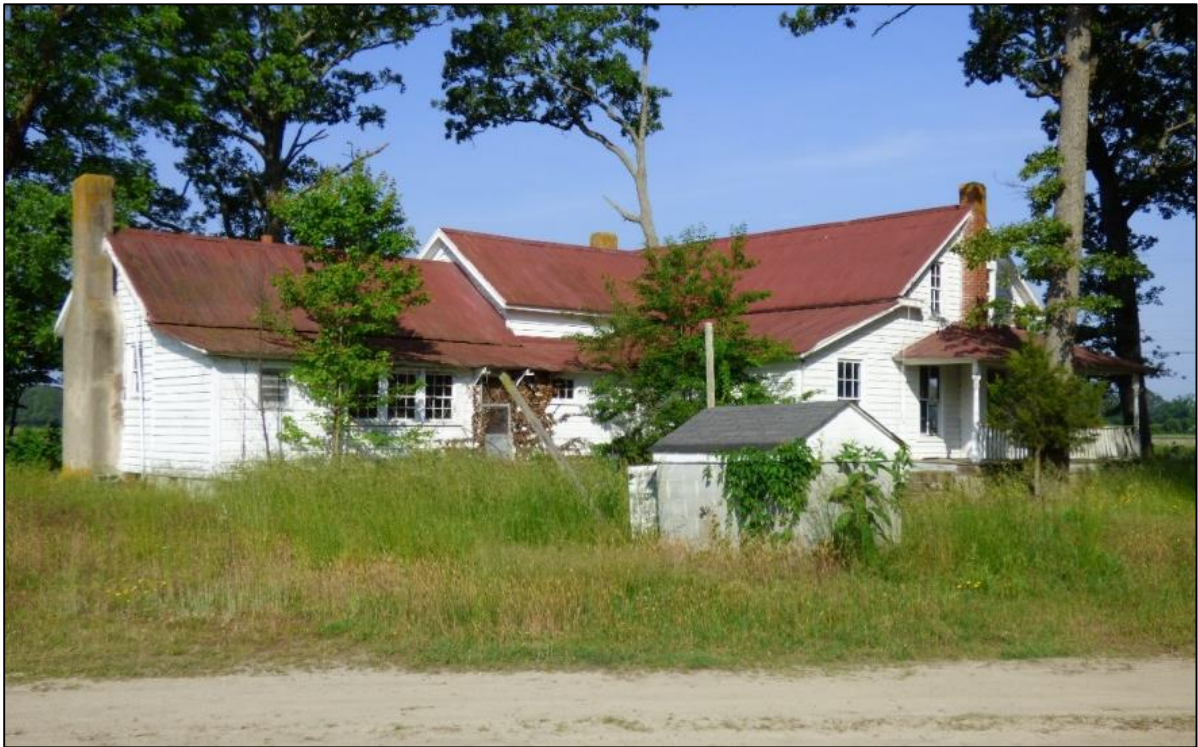
Photo 15: Dwelling and Additions, East Oblique.

A circa-1930, one-story, gabled-roof addition extends off of the southeast elevation of the rear-ell addition (noted as No. 3 in Figure 13, p.24; Photo 15, p. 27). The addition sits on a brick-pier foundation with concrete-block infill, and lapped, weatherboard siding covers the timber-frame structural system. The gabled roof is clad in v-crimp metal with boxed eaves. An exterior-end, parged brick chimney is centrally located on the southeast elevation of the addition. Another exterior-end, concrete-block chimney is located on the southwest elevation. Fenestration includes single, two-over-two, double-hung sash, wood-frame windows with vertical and horizontal muntins. A secondary entrance is located on the southwest elevation and is filled with a single-leaf door with an exterior, metal and glass, storm door. A wooden porch raised on wooden posts is located in front of the entrance. It is covered by a shed roof sheathed in v-crimp metal and it is supported by squared, wood posts.

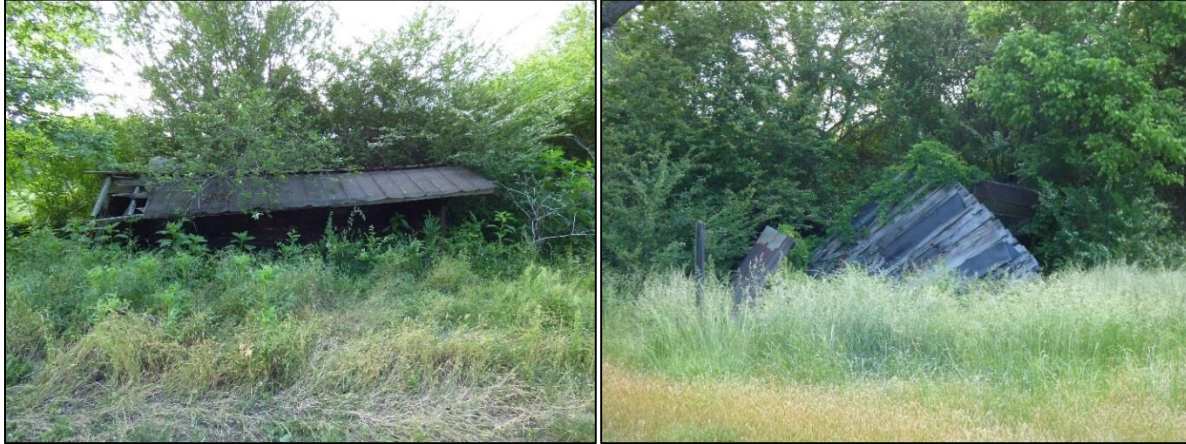
Photo 16: Collapsed Machine Shed (Left) and a Collapsed Possible Tobacco Barn (Right).

The Bowen Farm has approximately 12 secondary resources consisting mainly of agricultural outbuildings. Two of the historic agricultural outbuildings are completely deteriorated or have collapsed and are unidentifiable (Photo 16, p. 28). Dodenhoff mentions in her 1992 survey that there are three flue-cured tobacco barns of frame construction and only one was visible during the current survey (NC-HPO 1992b). These collapsed buildings may have been tobacco barns. Another collapsed building appears to have been a circa-1930 machine shed of timber-frame construction covered by a gabled or salt-box roof sheathed in v-crimp metal. One domestic outbuilding located east of the farmhouse, a well house, is a recent (circa-1980) construction of concrete-block and is covered by a gabled roof sheathed in asphalt paper.

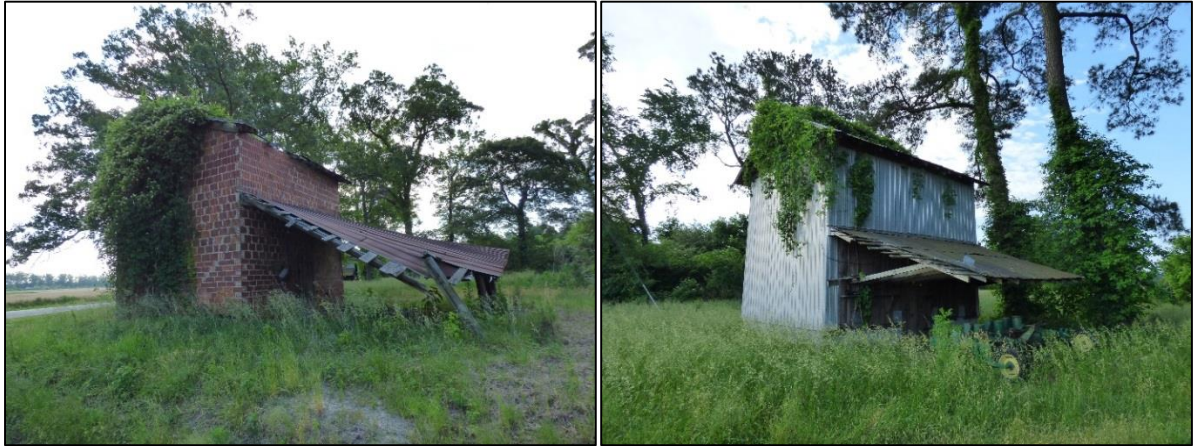
Photo 17: Clay-Block, Flue-Cured Tobacco Barn, West Oblique (Left) and a Frame, Flue-Cured Tobacco Barn, North Oblique (Right).

Two extant flue-cured tobacco barns are very different examples of these types of barns. The barn in the northeast corner of the parcel, located 212.7 feet northeast from the farmhouse, is a circa-1935, two-story, one-bay, flue-cured tobacco barn (Photo 17, p. 29). It is constructed on texturized, red clay block and is covered by a gabled roof with exposed rafters and a ridge ventilator that is sheathed in standing-seam metal. The primary entrance is located on the southwest elevation, and is filled with a single-leaf, wood door. Another entrance located on the southeast elevation sits open. A one-story, full-width open shed, situated on the southwest elevation, is covered by a shed roof clad in standing-seam metal that is supported by squared, wood posts. The other flue-cured tobacco barn, located 311.5 feet east the farmhouse along Henry Mizelle Road, is a two-story, one-bay building constructed around 1910 (Photo 17, p. 29). It sits on a continuous, concrete-block foundation and the timber-frame structural system was originally clad in vertical wood siding but is presently covered by pressed metal siding. The building is covered by a moderately pitched, side-gabled roof sheathed in v-crimp metal with exposed rafters and a ridge ventilator. A centrally located entrance on the northwest elevation is filled with a single-leaf, wood door. Another possible ventilator, a wooden sliding window, is located in the gabled end on the southwest elevation. A shed-roofed awning spans the northwest elevation, and is sheathed in v-crimp metal and is supported by wood brackets. The building has been covered to create a machine storage building which is signaled by a large, vehicular opening on the southwest elevation.

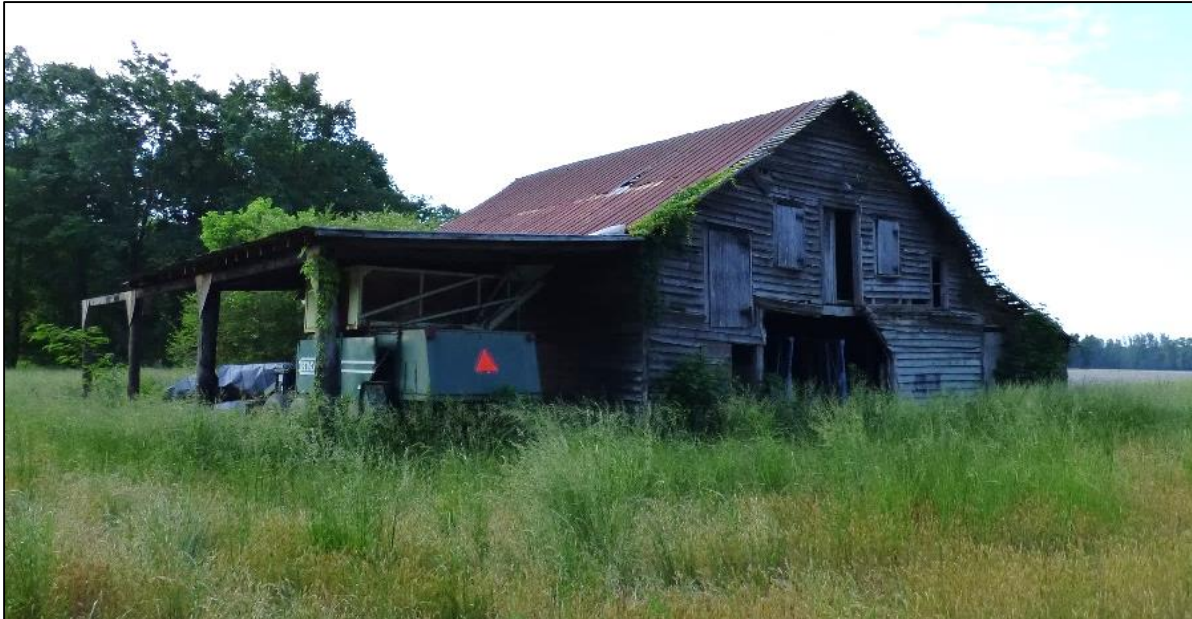
Photo 18: Frame Multi-purpose Barn, North Oblique.

A circa-1900, multi-purpose barn that was once possibly a packhouse, is located 119.4 feet south from the farmhouse and is in poor condition (Photo 18, p. 30). This barn was mentioned as a mule or horse barn by Dodenhoff but recently has shifted into a multi-purpose barn (NC-HPO 1992b). The one-and-one-half-story barn is of timber-frame construction clad in lapped, weatherboard siding. The central-drive barn with flanking sheds is covered by a steeply pitched, front-gabled roof sheathed in v-crimp metal with exposed rafters. The central, bracketed open drive on the northwest foundation has a pedestrian

opening located immediately north which is filled with a single-leaf, board-and-batten door. Other fenestration includes second story window and door openings that are boarded up on the primary (northwest) elevation. One visible opening is filled with a single, one-over-one, double-hung sash, wood-frame window. The northeast, open shed is currently used for machine storage. The shed roof is supported by rounded, wood posts. The southwest shed is enclosed in the west half and open in the southern half. The northern half is accessed by a single-leaf, board-and-batten door located on the northwest elevation.

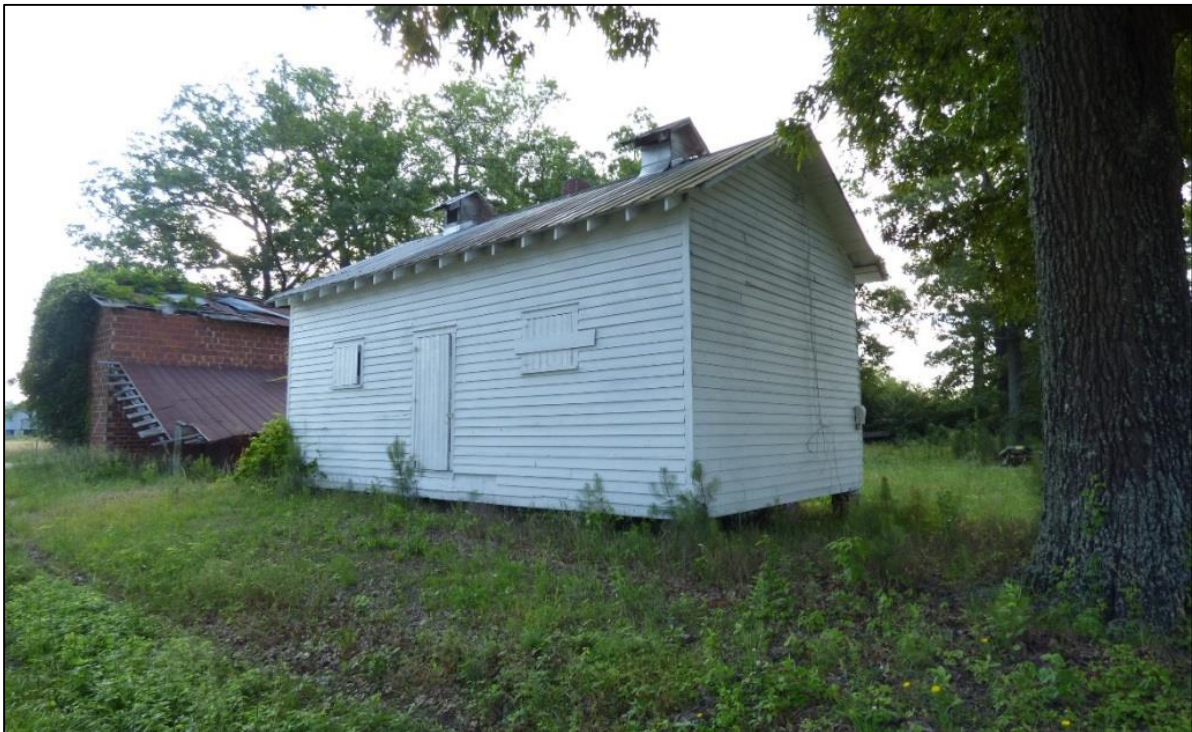
Photo 19: Potato House, West Oblique.

Another notable outbuilding constructed for a specific commodity is a large, circa-1910, one-story, three-bay potato house that is located 162.1 feet northeast of the farmhouse and immediately southwest of the clay block tobacco barn (Photo 19, p. 30). The building's brick-pier supports a timber-frame structural system covered in weatherboard siding with cornerboards. The moderately pitched, side-gabled roof with exposed rafters is sheathed in v-crimp metal. Two gabled, wood air vents pierce the ridge of the roof. A central-interior, brick chimney pierces the roof on the northwest side of the ridge. The main entrance, filled with a single-leaf, wood panel door with triangular metal hinges, is centrally located on the southeast elevation. A secondary entrance is located on the northwest elevation and filled with a similar door. Other fenestration includes window openings are filled with single-leaf, wood panel covering supported by triangular, metal hinges. Once potatoes are harvested, they need to be stored and cured in a cool, dark place until it is time for them to be shipped or consumed. Because of the saturated soil in North Carolina, potato houses could not be built partially below ground as in some other states (Visser 1997). The potato houses of North Carolina were typically painted white with roof ventilators, as seen on the Bowen Farm, to help keep the produce cool during warmer months. In order to avoid freezing in winter months, a chimney is added to the building (Visser 1997).

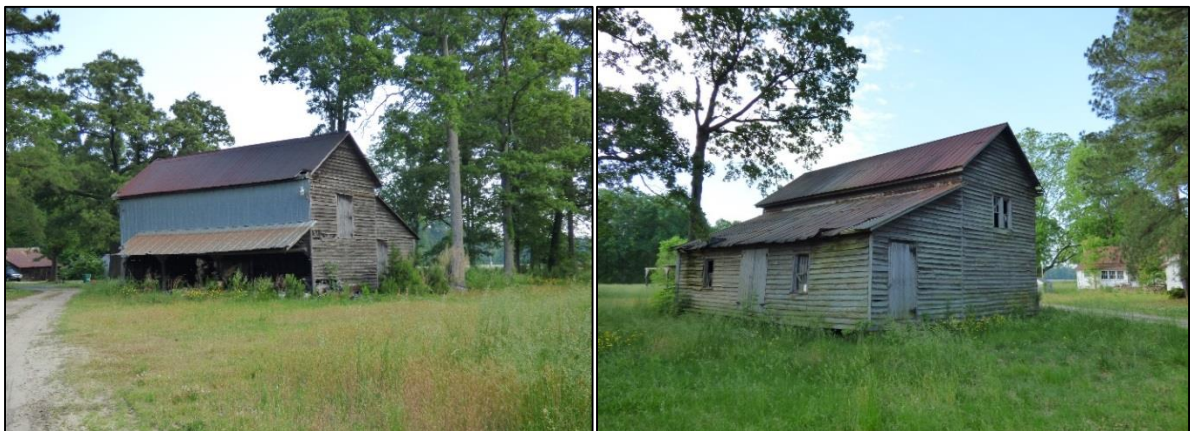
Photo 20: Packhouse, South Oblique (Left) and North Oblique (Right).

In the 1992 survey, Dodenhoff mentions a “two-story, side-gabled packhouse with a one-story rear shed used for egg storage” that is mapped southeast of the farmhouse (NC-HPO 1992b). Currently, the circa-1910 packhouse has been repurposed for storage of farm

equipment (Photo 20). The two-story, multi-bay packhouse sits on a brick pier foundation and the timber-frame structural system is mostly clad in weatherboard siding. The southwest elevation is clad in v-crimp metal. The building's moderately pitched, side-gabled roof is sheathed in v-crimp metal. The original entrance to the building has been removed and instead, three open bays span the width of the southwest elevation. In this area, the structural system is supported by log posts with wooden braces. Two of the bays are protected by a shed awning sheathed in v-crimp metal supported by wooden braces. A secondary entrance is located in the second story of the southeast elevation and is filled with a single-leaf, wood panel door. Other fenestration includes paired, four-over-four, double-hung sash, wood-frame windows. Spanning the width of the northeast elevation is a one-story, shed roof addition that Dodenhoff asserts was used for egg storage (NC-HPO 1992b). The addition sits on a brick pier foundation, and the timber-frame structural system is clad in weatherboard siding. The shed roof with exposed rafters is covered in v-crimp metal. Several secondary entrances located in the addition are filled with single- and double-leaf, wood panel doors supported by triangular, metal hinges. Other fenestration includes single, four-over-four, double-hung sash, wood-frame windows.

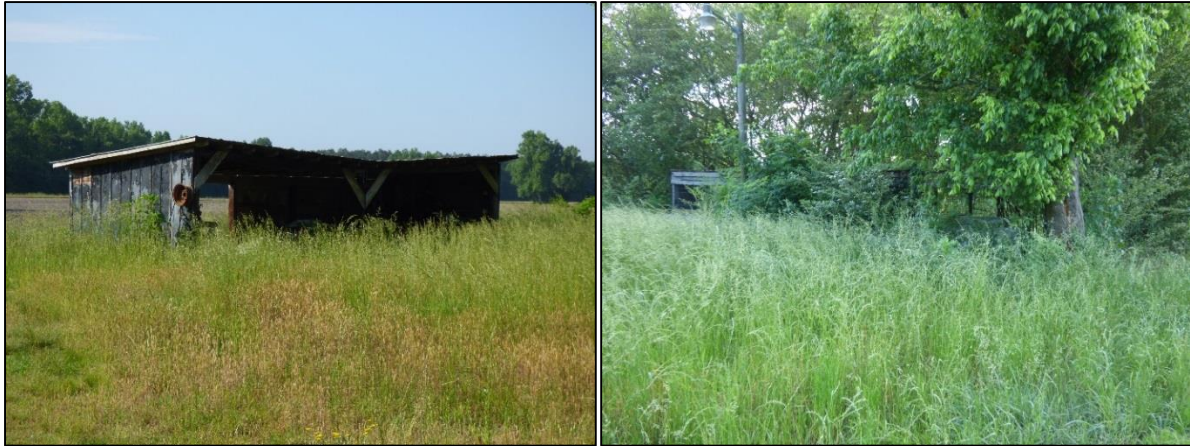
Photo 21: Machine Shed, North Oblique (Left) and Chicken Coop, West Oblique (Right).

A circa-1920, one-story, two-bay, machine shed is located 57.8 feet south of the farmhouse (Photo 21, p. 32). The reclaimed log structural system is sheathed in v-crimp metal on the southwest, southeast, and northeast elevation. The northwest elevation is left open where wood braces are visible. The building is covered by a shed roof with exposed rafters sheathed in v-crimp metal. A circa-1940, one-story, multi-bay, deteriorated chicken coop is situated amongst trees and overgrowth 155.2 feet southeast from the farmhouse (Photo 21, p. 32). The chicken coop is of wood-frame construction clad in a combination of chicken wire and v-crimp metal and covered by a flat roof. A single-leaf, wood door is located on the southwest elevation.

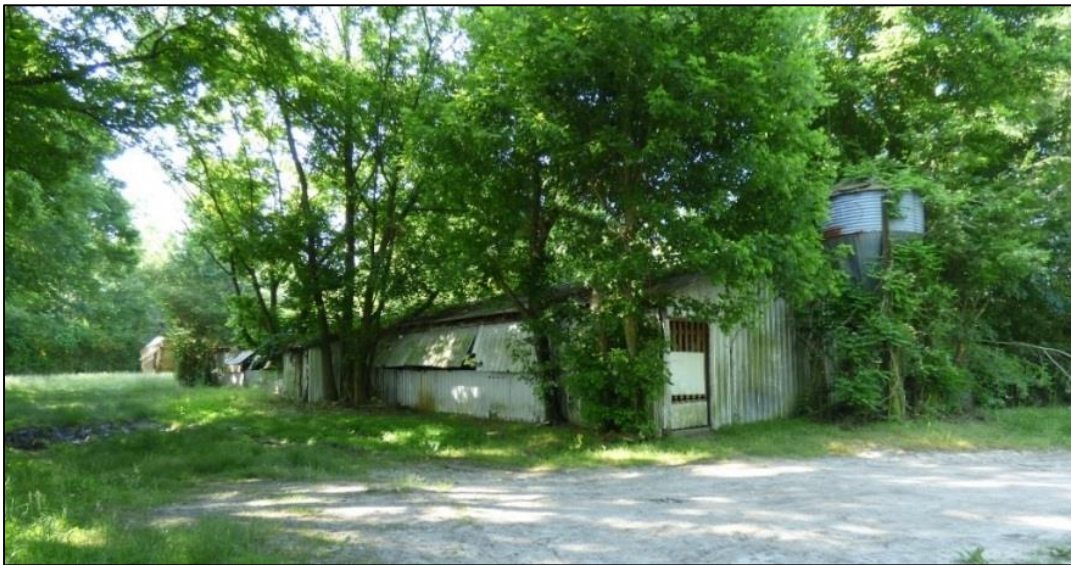
Photo 22: Dog Kennel and Silo, North Oblique.

A circa-1970 dog kennel is located 422.01 feet southeast of the farmhouse (Photo 22). This one-story, timber-frame building is clad in pressed metal and covered by a side-gabled roof. The southwest elevation is lined with dog pens enclosed by metal, chain-link fencing. A single-leaf, wood door is located on the northwest elevation. The northeast elevation is lined with pressed metal awnings. A small silo that sits on a wood pier foundation and is clad in corrugated metal and is located immediately next to the northwest foundation. The building does not appear on aerials until 1977 (USGS 1977). There is a possibility that a foundation was used from a previous building.

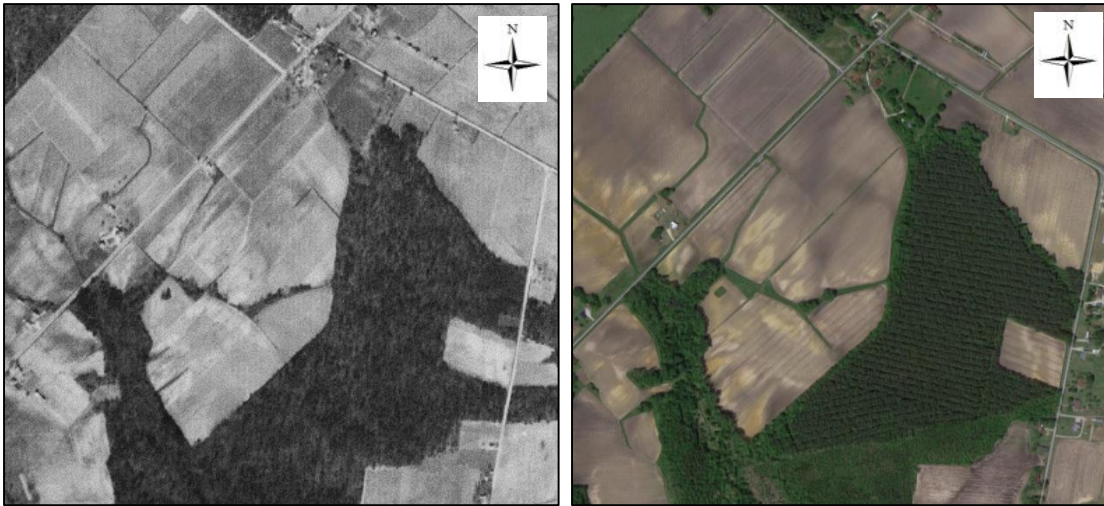
Figure 16: The Fields and Tree Lines of the Bowen Farm Appear to be Unaltered (USGS 1957 [Left]; Google Earth 2015 [Right]).

The Bowen Farm is one of several surviving early-twentieth century farm complexes in Williamston Township and Martin County. The complex, with all buildings seemingly in their original place, is an excellent example of a cash-crop farm of the early-twentieth century in this area. Although it has seen steady and continuous use since its construction, the surviving buildings are in good condition with scarcely any alterations. Any such alterations that were made give light to the changing agricultural patterns and practices in rural Martin County (Figure 16). This area of Williamston Township has avoided any major modern development along the historic Prison Camp Road and continues to be used for agriculture. For these reasons, it is recommended that the Bowen Farm is eligible for listing in the NRHP under Criterion A.

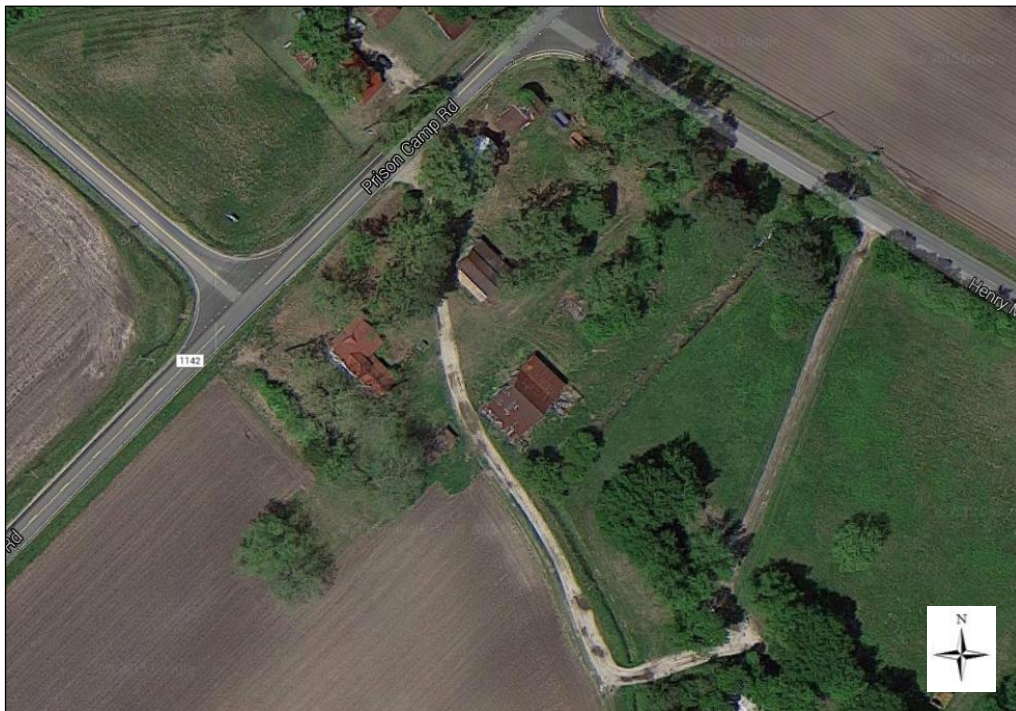
Figure 17: Aerial Depicting the Organization of the Bowen Farm Complex (Google Earth 2015).

In order to be eligible for listing in the NRHP under Criterion C, a rural resource must demonstrate an “organization of space, visible in the arrangement of fields or siting of farmsteads, may illustrate a pattern of land use significant for its representation of traditional practices unique to a community” (McClelland et al. 1999). The rural resource may also be eligible under Criterion C if the “buildings and outbuildings, whether high-style or vernacular, may be distinctive in design, style, or method of construction, and be representative of historic local or regional trends” (McClelland et al. 1999). The Bowen Farm farmhouse is a representative of a form that was popularized in the late-nineteenth to early-twentieth centuries once balloon framing came into acceptance (Photo 26, p. 40). The additions are also typical of an early-twentieth century farmhouse, the primary core of the building is discernable, and the original plan has not been changed. The organization of the complex as a whole is also distinctive of regional agricultural practices of the time with a concentration of outbuildings with the domestic outbuilding being situated closer to the farmhouse and the agricultural outbuildings being set slightly further away and closer to fields (Figure 17, p.40). Historic aerials also indicate that farm lanes, cultivated fields, and tree lines have not been altered (USGS 1950, 1957). Consequently, it is recommended that this resource is eligible for listing in the NRHP under Criterion C.

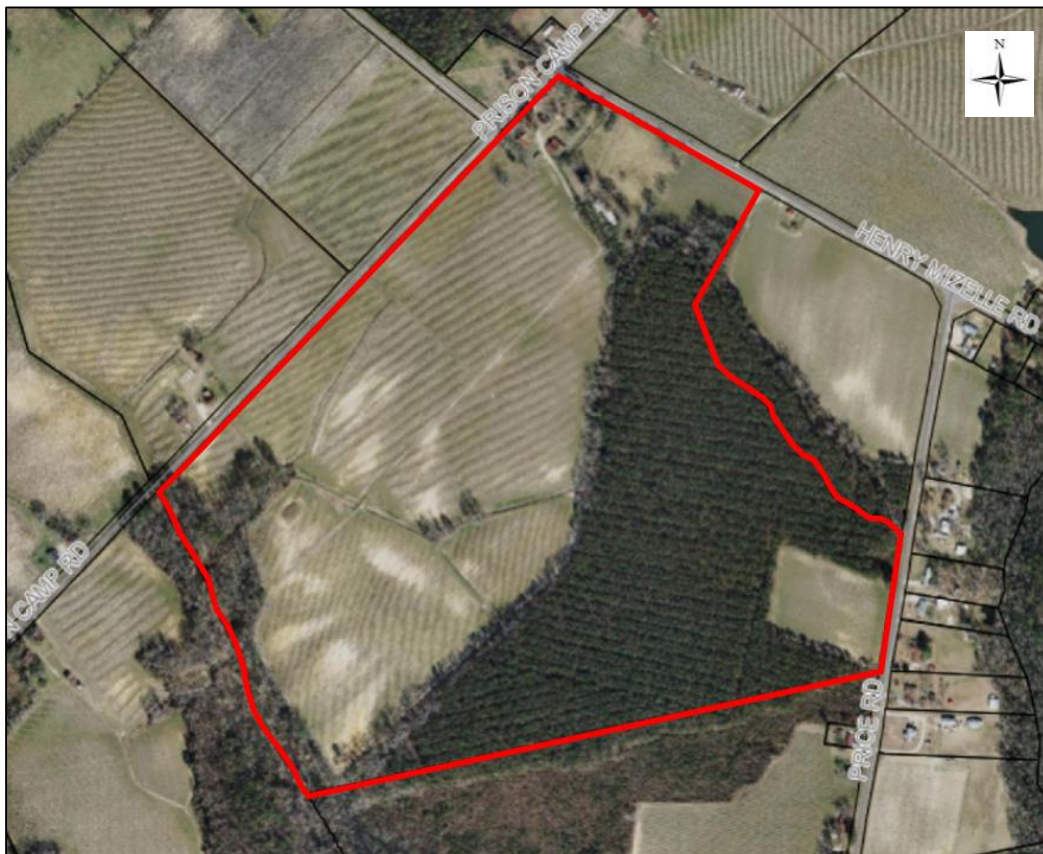
Figure 18: Proposed NRHP Boundaries of the Bowen Farm (MT0626) as Shown in Red (Martin County GIS 2015).

In sum, the Bowen Farm is **recommended eligible for the NRHP under Criteria A and C**. The NRHP boundaries for the Bowen Farm as determined during the current investigations conform to the existing tax parcel. The boundary follows the existing right-of-way along Prison Camp Road and continues southeast down the right-of-way along Henry Mizelle Road and extends south to the southernmost point of the existing tax parcel (Figure 18, p. 41). The boundaries include the farmhouse, potato barn, several flue cured tobacco barns, packhouse, and several storage and machine sheds, all of which contribute to the property's eligibility. Also within the boundaries are two secondary resources that do not contribute to the building's eligibility: a dog kennel with attached silo and a well house.

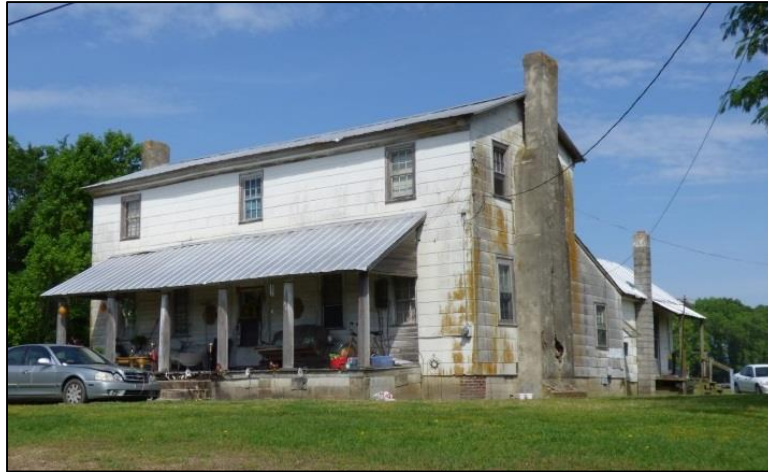
Photo 27: East Oblique of John Brown House/Jackie Brown Spring House (MT0032).

The John Brown House/Jackie Brown Spring House is a two-story, five-bay, I-house with elements of the Greek Revival style (Photo 27, p. 44). Interior access was not granted during the current survey; however, the 1992 survey notes various details. Dodenhoff states that “the interior follows a one-room deep, center hall plan extended by both a rear shed room and two-room ell” (NC-HPO 1992e). Additionally, Dodenhoff describes the various Greek Revival elements including paneled doors with two-part surrounds and mantels exhibiting friezes and tapered pilasters (Butchko 1998:462; NC-HPO 1992e).

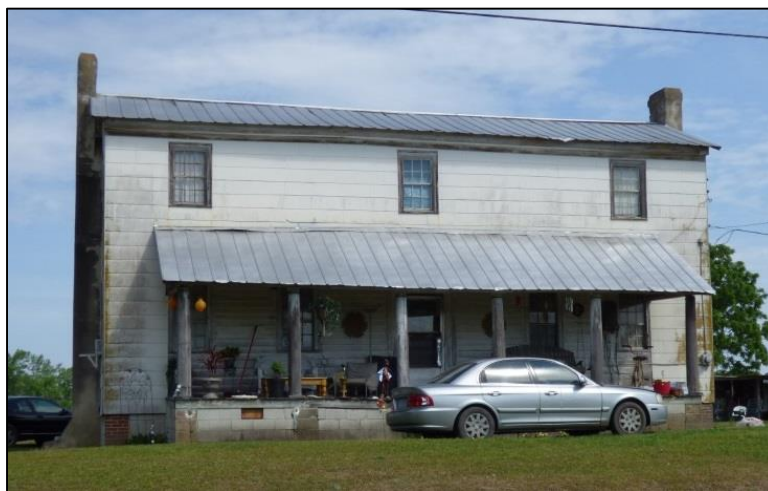
Photo 28: Façade (Southeast Elevation) of the John Brown House/
Jackie Brown Spring House (MT0032).

The building's brick pier foundation has been infilled with concrete blocks and supports the "heavy timber framed" structural system as noted by Dodenhoff in her 1992 survey (NC-HPO 1992e). The original weatherboard is displayed under the porch on the southeast elevation. All other elevations are clad in asbestos siding (Photo 28). This was likely an improvement that took place in the early- to mid-twentieth century. Starting in the 1920s, the National Board of Fire Underwriters encouraged asbestos siding instead of wood exterior wall sheathing materials, which are susceptible to flame (Jones & Bartlett Learning, LLC 2012). A low-pitched, side-gabled roof sheathed in v-crimp metal caps the building. Present on the eaves of the façade and rear (northwest) elevation is a wooden box cornice. Two double-shoulder chimneys flank the dwelling on the southwest and northeast elevations. They are composed of the original brick but have been parged with cement which is currently spalling.

The dwelling's main entrance, centered on the symmetrical façade, features a single-leaf, half-light, wood door covered by a metal and glass storm door. Other fenestration includes four nine-over-six, double-hung-sash windows on the first story of the façade and six-over-six, double-hung-sash, wood windows on the remainder of the original core of the dwelling. The rear extension contains four-over-four, double-hung-sash wood windows. All fenestration includes a two-part, wood surround.

A one-story, partial-width porch spans the southeast elevation. It rests on a concrete block pier foundation infilled with concrete blocks. Tapered Doric columns composed of rounded vertical wood boards held together by small metal belts support the shed roof sheathed in v-crimp metal. The original weatherboard is featured within the gables of the porch.

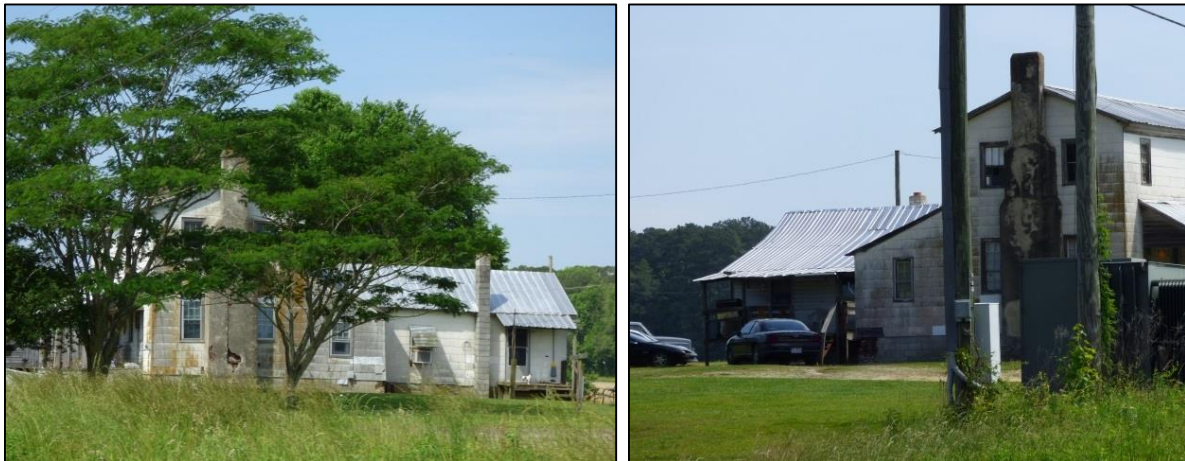
Photo 29: Addition on John Brown House/Jackie Brown Spring House (MT0032), Northeast Elevation (left) and Southwest Elevation (right).

A one-story addition extends from the northwest elevation (Photo 29). The addition rests on a brick-pier foundation, and the non-visible structural system is clad in vinyl siding. An exterior concrete-block chimney is flush against the addition's northeast elevation. Two secondary entrances covered by metal and glass storm doors are located on the northeast and southwest elevations. An aluminum awning shelters the window on the northeast elevation. Limited access to the property prevented the recordation of additional details and fenestration. Extending from the southwest elevation of the rear addition is a one-story porch which rests on small wood posts and is covered by a shed roof sheathed in v-crimp metal. The porch is circled by a simple wood banister and accessed by a small wood staircase. An additional one-story porch is located on the northeast elevation. It is supported by square wood posts covered by a shed roof sheathed in v-crimp metal. Because access to the property was not permitted, not enough architectural data was collected to determine an approximate date of this addition.
