SUBJECT: Historic Structures Survey Report for widening and upgrade NC 125/SR 1142
(Prison Camp Road) from NC 903 to SR 1172 (East College Road), R-4705,
Martin County, ER 15-0346

HISTORIC ARCHITECTURAL ELIGIBILITY EVALUATION

WIDEN AND UPGRADE

NC 125/SR 1142 (PRISON CAMP ROAD)

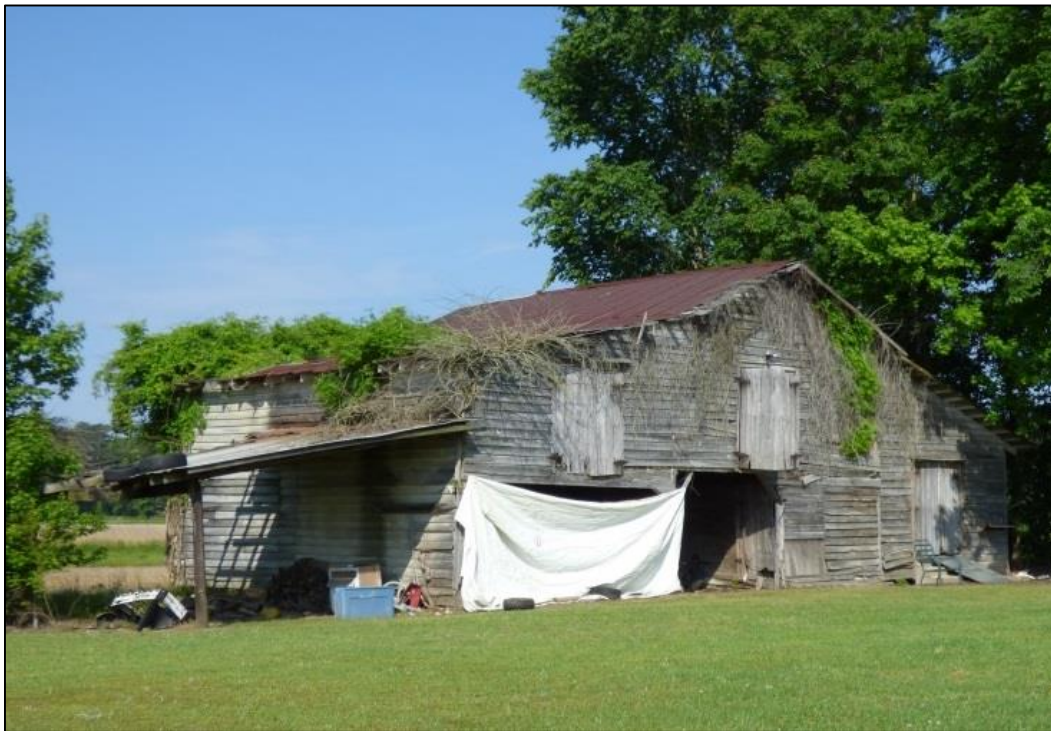
Photo 30: Pack House, East Oblique.

Situated across the driveway, southwest of the dwelling, sits a two-story, multi-bay pack house (Photo 30) likely constructed around the 1920s. The foundation and structural system, while not visible, are clad in weatherboard siding. A low-pitched, front-gabled roof sheathed in v-crimp metal with open eaves and exposed rafters below covers the building. The building is flanked by shed-roof extensions on the northwest and southeast sides. Two large open bays pierce the northeast elevation. Other entrances are filled with single-leaf, board-and-batten doors with metal strap hinges. Featured on the northwest extension is a double-leaf, board-and-batten door accessed by concrete-block stairs covered by a ramp. A one-story addition extends from the southeast elevation. The shed roof is sheathed in v-crimp metal supported by round wood posts.

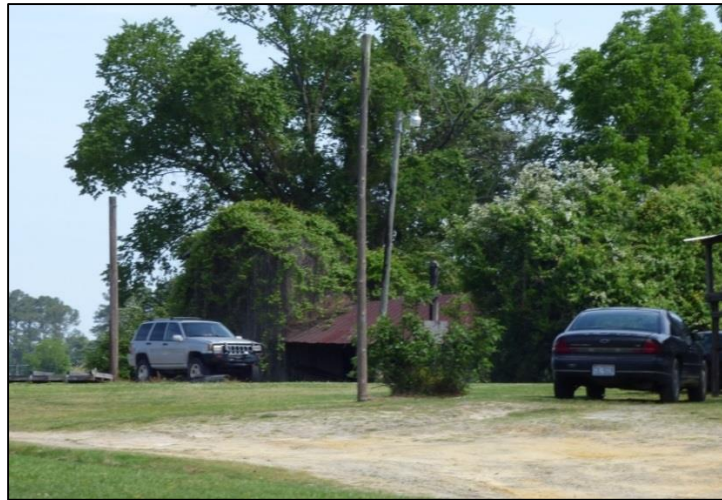
Photo 31: Tobacco Barns and Hyphen, Looking North.

Located approximately 150 feet north of the dwelling is a pair of circa-1920 flue-cured tobacco barns connected by a central hyphen (Photo 31, p. 47). Due to the amount of underbrush and limited access to the property, little information can be ascertained pertaining to the resource. The foundation and structural system are not visible but are clad in vertical wood boards and covered by a moderately-pitched, front-gabled roof sheathed in v-crimp metal. Wood posts support the open-air central hyphen, covered by a gabled roof sheathed in v-crimp metal.

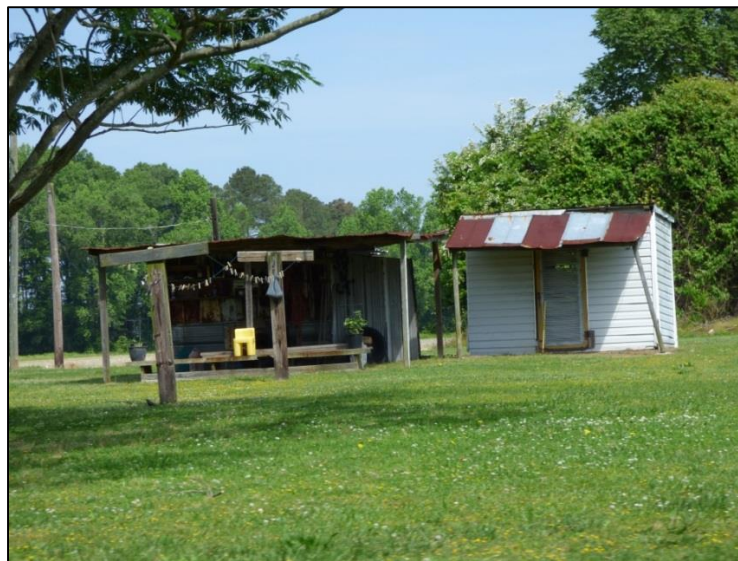
Photo 32: Sheds, Looking North.

Three mid-twentieth century sheds are situated directly northeast of the dwelling (Photo 32). The northernmost shed is clad in vinyl siding with vinyl cornerboards and covered by a shed roof sheathed in v-crimp metal. Access is gained through a single-leaf louvered metal door with a wood surround on the southeast elevation. A shed-roof awning covers the entry and is clad in v-crimp metal and supported by wood up-bracing.

The southernmost shed is clad in corrugated metal and covered by a shed roof with a one-story, shed-roof extension on the southeast elevation. Directly northwest of the sheds is a small, one-story wood shed. No further details can be ascertained pertaining to these secondary resources.

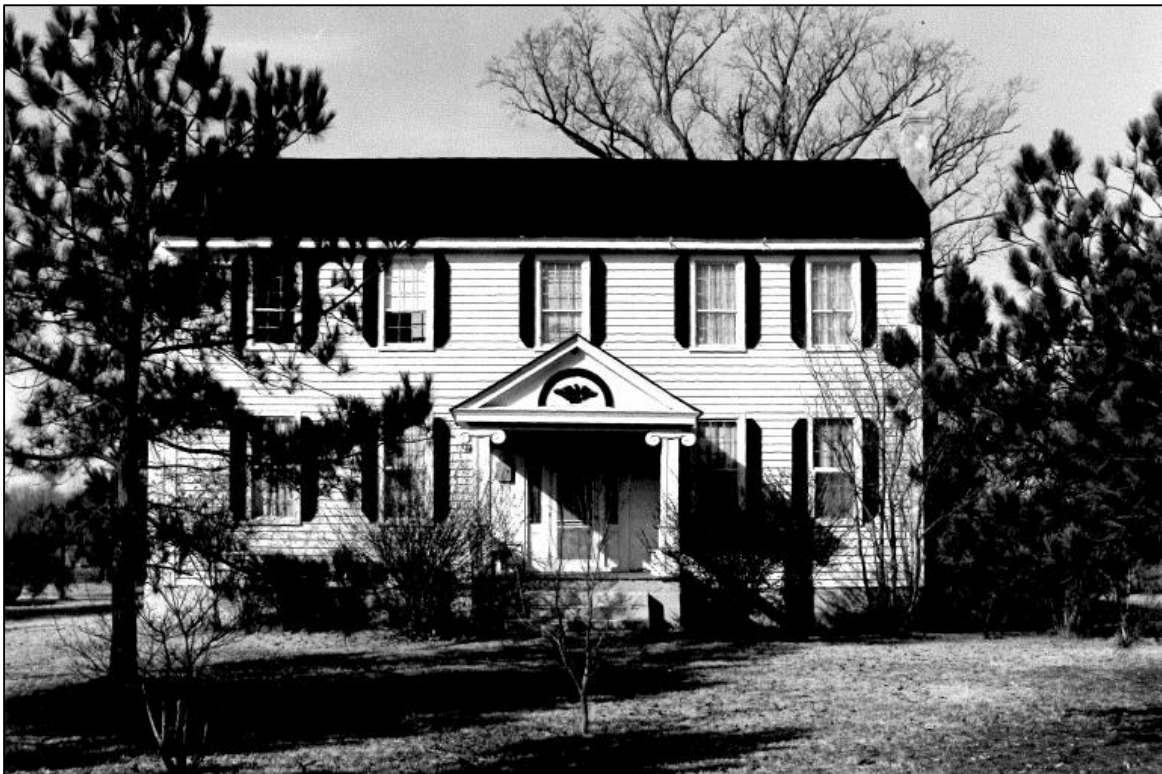
Photo 33: Sherrod Farm, Façade of House (Little and Sumner 1984).

The I-house was common throughout Martin County. This type of two-story, one-room deep housing dominated the rural landscape among prosperous planters prior to the Civil War and by the late-nineteenth century had become synonymous with middle-class farmers (Butchko 1998:63–65). Other representative examples of this housing type are extant in the region which maintain more of their original building fabric and are in better condition. One is the two-story, five-bay, single-pile Sherrod Farm (MT0099) constructed in 1843 (Photo 33) (Little and Sumner 1984). The Sherrod Farm and the John Brown House/Jackie Brown Spring House exhibit differences including the size of the porch; however, the overall massing and period of construction are the same. The exterior walls are clad in weatherboard siding, and it is covered by a side-gabled roof. Double-shoulder brick chimneys flank the dwelling.

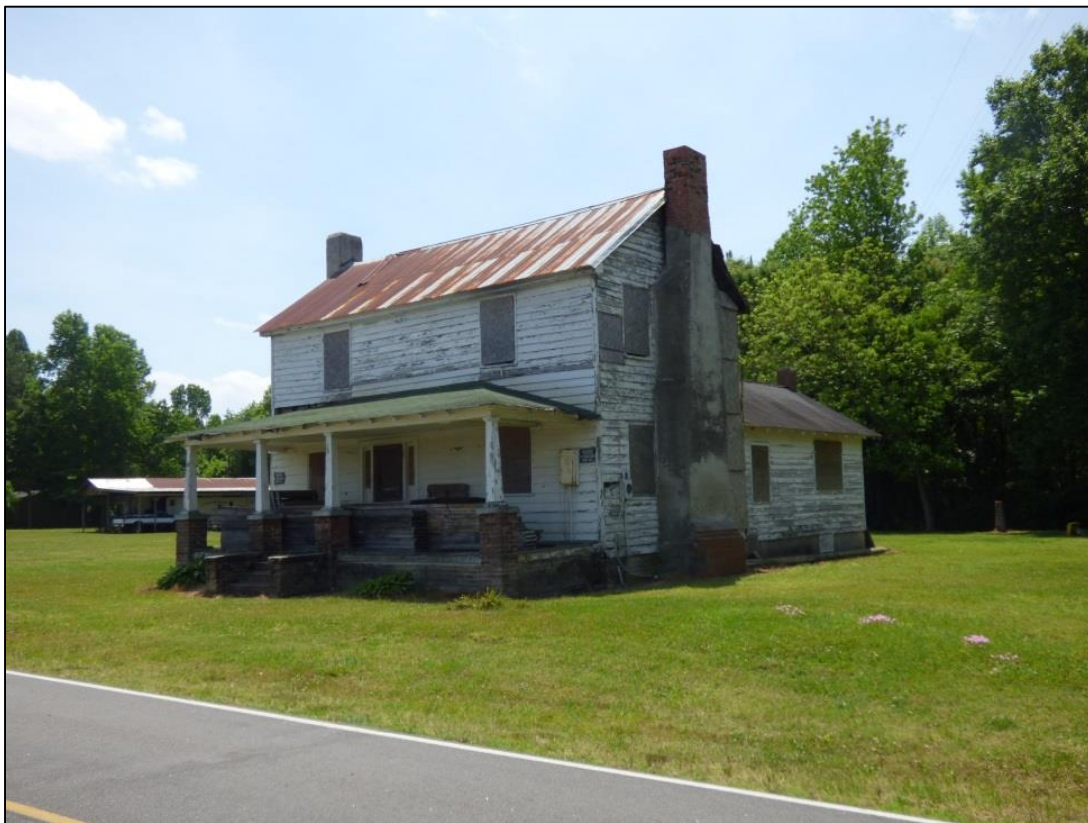
Photo 34: House on the 2000 Block of Bailey Road.

An additional similar dwelling is located on the 2000 block of Bailey Road. Although the scale is smaller than that of the John Brown House/Jackie Brown Spring House, its overall form is nearly identical (Photo 34). The two-story, three-bay dwelling sits atop a brick-pier foundation, which has been filled in with concrete blocks. The original weatherboard siding is preserved in this example, and the building is covered by a low-pitched, side-gabled roof sheathed in v-crimp metal. A pair of parged, brick, exterior-end, double-hipped chimneys with thick, sloped bases flank the dwelling. Although the fenestration is covered, it is likely that the original windows are situated under the plywood covers. A full-width porch spans the façade. A one-story ell, likely a later addition and similar to the John Brown House/Jackie Brown Spring House addition, extends from the dwelling's rear elevation. All original outbuildings associated with this dwelling have been demolished.

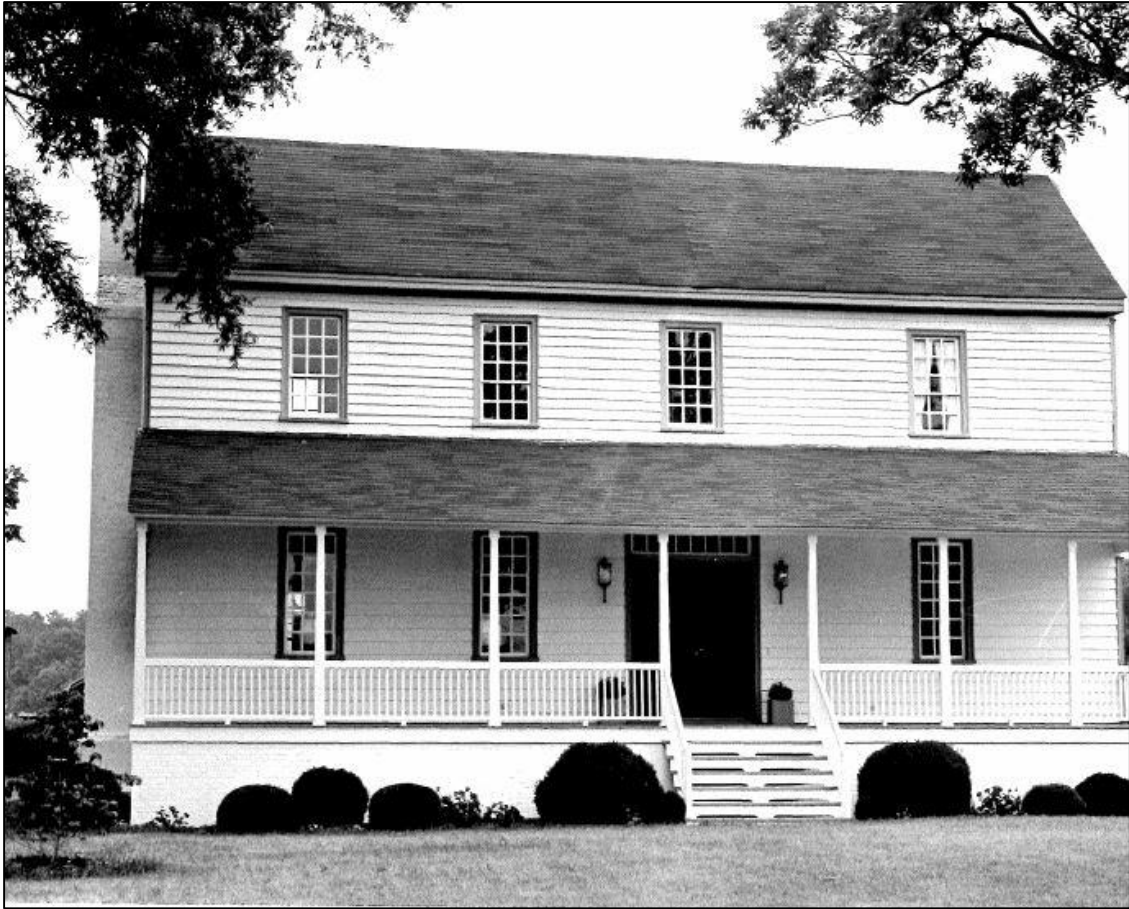
Photo 35: The Jesse Fuller Jones House (Bullock 1980).

Another example of the pre-Civil War I-house in Martin County is located on the northeast side of Spring Green Road. The Jesse Fuller Jones House (MT0037) is a two-story, four-bay, single-pile dwelling that rests on brick piers which have been infilled with brick (Photo 35, p. 53) (Bullock 1980). The house is clad in weatherboard siding and covered by a side-gabled roof. A full-width porch supported by wood posts spans the façade. The dwelling is flanked by hipped, brick chimneys.

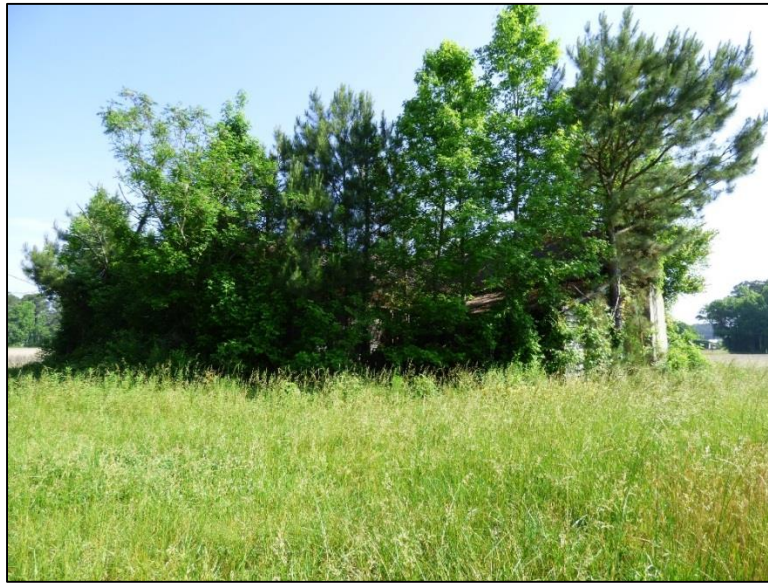
Photo 36: Tenant House, North Oblique.

The primary resource of the H.A. Bowen Tenant House is a one-story, multi-bay farmhouse constructed around 1920 that has been uninhabited for over a decade (Photo 36, p. 58) (Google Earth 2005). The foundation of the primary core of the building was not visible due to major overgrowth during the time of survey. The timber-framed structural system is clad in lapped, weatherboard siding. The building is covered by a moderately pitched, side-gabled roof sheathed in v-crimp metal. Two exterior-end, brick chimneys are centered on the northeast and southwest elevations. Both chimneys were barely visible during the time of survey due to overgrowth and details were not obtained. Although the building is barely visible, some similar buildings were found throughout Martin County that resemble the form of the house.

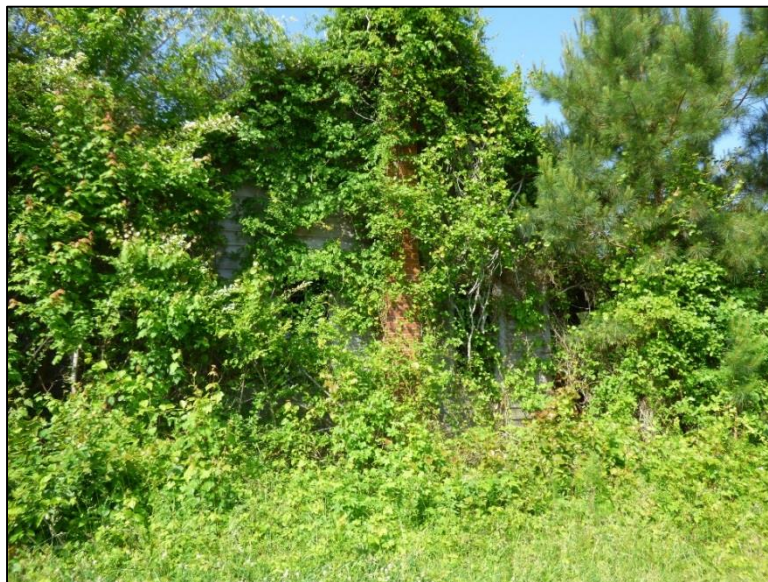
Photo 37: Tenant House, Northeast Elevation.

The main entrance is situated on the northwest elevation of the building and is filled with a single-leaf door of an unknown material due to poor visibility (Photo 37). Other fenestration on the primary core of the building includes single, two-over-two, double-hung sash, wood-frame windows with vertical muntins. A one-story, four-bay porch spans the entirety of the northwest elevation. The foundation of the porch is non-visible, and it is sheltered by a hipped roof sheathed in v-crimp metal. The roof is supported by squared, wood posts.

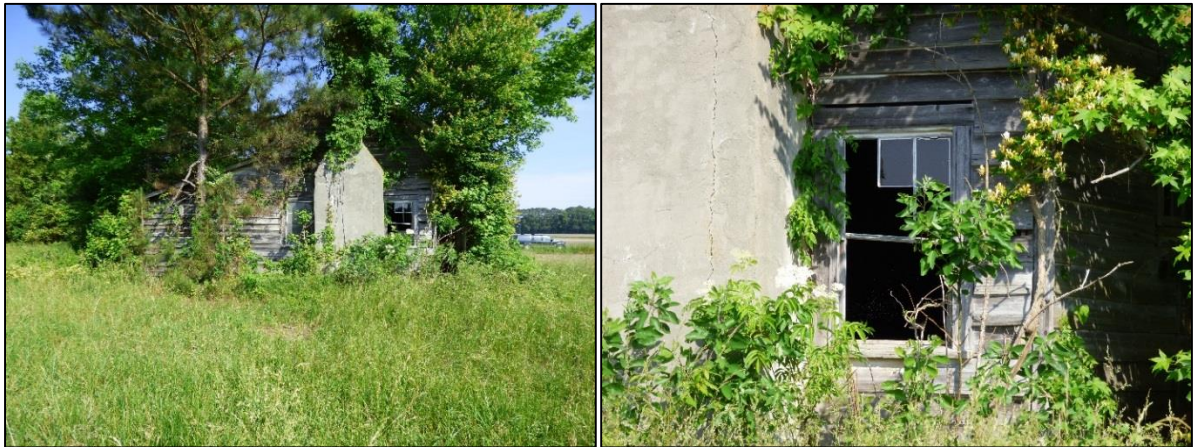
Photo 38: Tenant House Rear Ell Addition, Southeast Elevation (Left) and Detail of Wood-Frame Window on Rear-Ell Addition (Right).

A one-and-one-half-story, rear-ell addition was constructed in the early-twentieth century (Photo 38). It extends off of the east half of the southeast elevation. The brick pier foundation with poured-concrete infill supports a timber-framed structural system clad in weatherboard siding. The addition is covered by a gabled roof clad in v-crimp metal. An exterior-end, parged brick chimney is centered on the southeast elevation. Fenestration includes single, six-over-six, double-hung sash, wood-frame windows.

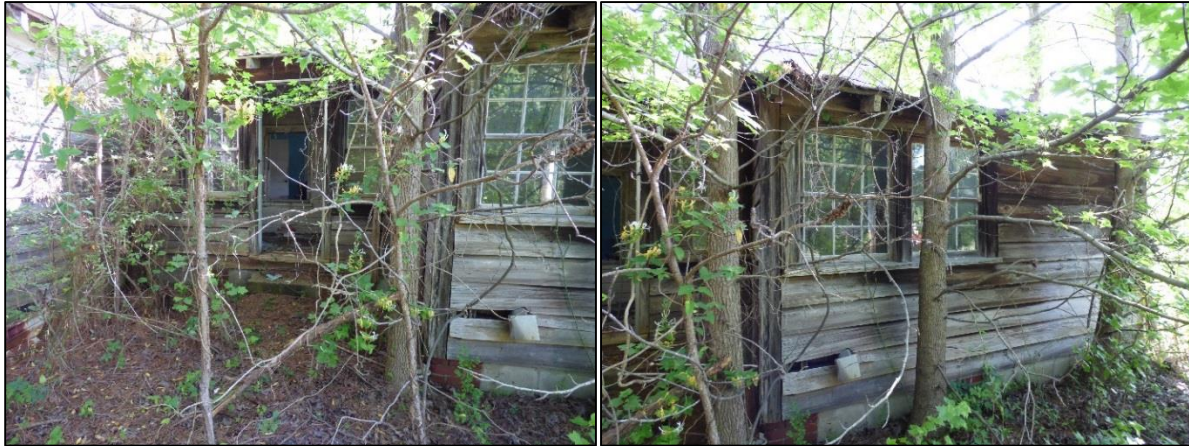
Photo 39: Multiple Shed-Roof Additions Extend Off of the Rear-Elk Addition of the H. A. Bowen Tenant House.

An early-twentieth century, one-story, shed-roof addition extends off of the south half of the southeast elevation of the ell addition and was also constructed in the early-twentieth century (Photo 39, p. 60). This addition sits atop a brick pier foundation with concrete infill, and the wood-frame structural system is clad in weatherboard siding. The shed roof is sheathed in v-crimp metal with exposed rafters in the southwest eave. Fenestration includes single, six-over-six, double-hung sash, wood-frame windows.

An estimated mid-twentieth century, one-story addition was constructed on the south half of the southwest elevation or the rear ell (Photo 39, p. 60). It is situated on brick piers with concrete-block infill. The wood-frame structural system is clad in weatherboard siding, and the shed roof is sheathed in v-crimp metal with exposed rafters. Fenestration includes single, six-and-six, double-hung sash, wood-frame windows. A metal pipe pierces the wall on the southwest elevation of this addition indicating that a kitchen or laundry is located in this area of the building. Another one-story, enclosed porch addition extends off of the rear ell addition. It is situated in the west half of the southwest elevation of ell addition and connects the shed roof addition and the primary core of the house. The addition also sits on brick piers with concrete infill and the wood-frame structural system is clad in weatherboard siding. The shed roof is sheathed in v-crimp metal and exposed, wood rafters are located in the southwest eave. A secondary entrance is located on the southwest elevation and is missing a door. The door is flanked by single, six-over-six, double-hung sash, wood-frame windows. The door is accessed by a set of concrete-block stairs. This addition may have been constructed to be an enclosed porch or sunroom.

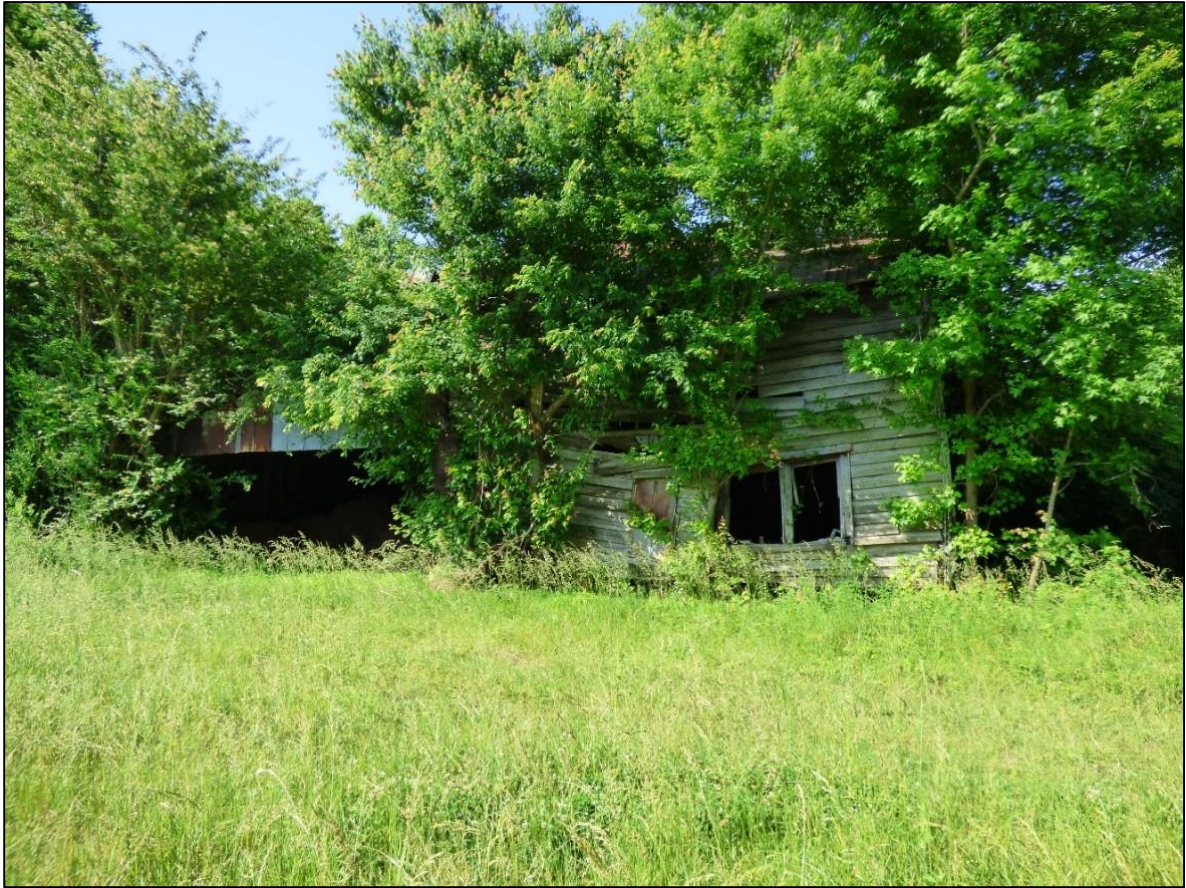
Photo 40: Possible Secondary Dwelling or Barn; Northeast Elevation.

Several secondary resources appear to be associated with the H.A. Bowen tenant farmhouse including two agricultural buildings and a cemetery. Immediately south of the primary resource is a possible secondary dwelling or barn that is completely encased by overgrowth (Photo 40, p. 61). Due to the attention to detail in the construction of the building, such as cornerboards and window framing, as well as its close location to the tenant house, it is reasonable to suggest that this building was originally meant for domestic use or at least partially so. Its estimate date of construction is around 1910 due to the types of windows that are still extant. However, it appears that since the time of its construction, its use has been converted into agricultural storage. When this change occurred is not clear.

The two-story building sits atop brick piers, and the timber-frame structural system is clad in lapped, weatherboard siding with wood cornerboards. The building is covered by a front-gabled roof with exposed rafter tails that is sheathed in v-crimp pressed metal. A chimney was not observed during the time of survey due to overgrowth; however, a possible chimney flue is visible on current online aerials on the southeast elevation. A primary entrance was visible on the northwest elevation. It is located in the north half of the elevation and is currently filled with a single-leaf, vertical wood board door with triangular, metal, strap hinges. A possible second entrance is located directly above the primary entrance in the second story. Other fenestration includes single and paired, three-over-one, wood-frame, double-hung sash windows with vertical muntins, although most of the windows have been broken or are boarded up with pressed metal. A paired window on the secondary (northeast) elevation has a small metal awning to possibly divert rain water. A one-story, shed roof addition extends off of the southeast elevation. The addition has a timber-frame structural system that is clad in v-crimp pressed metal. The shed roof has exposed rafters in the eaves. A large, full-width, open bay is located on the northeast elevation of the addition. This portion of the building is currently being used for hay storage.

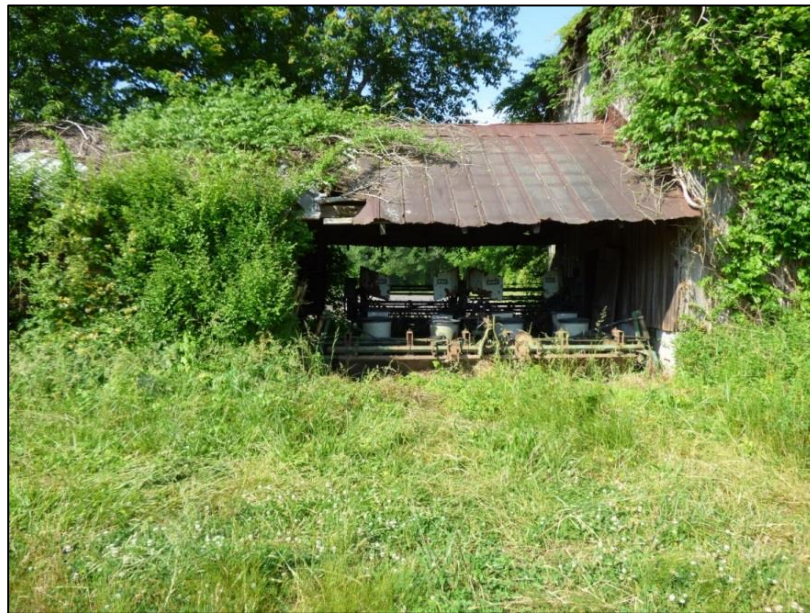
Photo 42: Detail of Hyphen Connecting Tobacco Barns, Southeast Elevation.

The open-air hyphen, which is approximately 22.6 feet in length, connects the two tobacco barns (Photo 42). The hyphen is sheltered by a moderately pitched, side-gabled roof with exposed rafter tails that is sheathed in v-crimp metal. The roof, constructed of a timber-frame truss system, is supported by squared, wood posts that sit on concrete-block piers. A small section in the middle of the hyphen is protected by v-crimp metal sheeting on the northeast and southwest elevations. The hyphen currently shelters modern farm equipment.

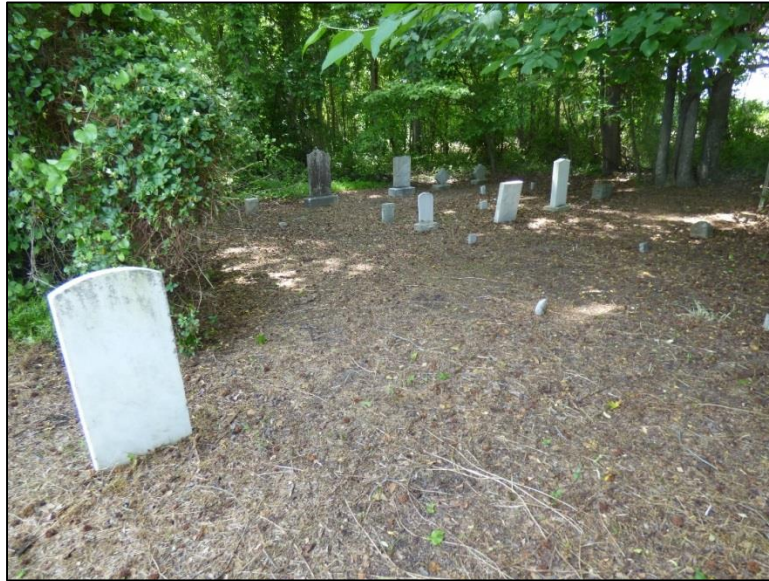
Photo 43: Overview of Mizell Family Cemetery, Looking Northwest.

Located approximately 1,472.4 feet south of the farmhouse is a small family cemetery that is situated in a thick patch of trees and overgrowth (Photo 43, p. 63). It is rectangular in shape and measures about 0.5 acres. It is situated amongst cultivated fields to the north, east, and

south and a wooded area to the west. The cemetery is accessed through a break in the tree line on the south side of the patch. It is not fenced off or marked by any signage but the boundary seem to be delineated by squared, sawn, wood posts that stand in the northeast and southwest corners. There are about 19 known interments that are marked with headstones or grave markers. The headstones and grave markers are composed of marbled, stone, and brick. Some headstones are inscribed with death dates ranging from 1892–1938. The Mizell/Meizell name is on a majority of the engraved headstones, while some other surnames include Barren, Wynn, and Lealand (Photo 44).

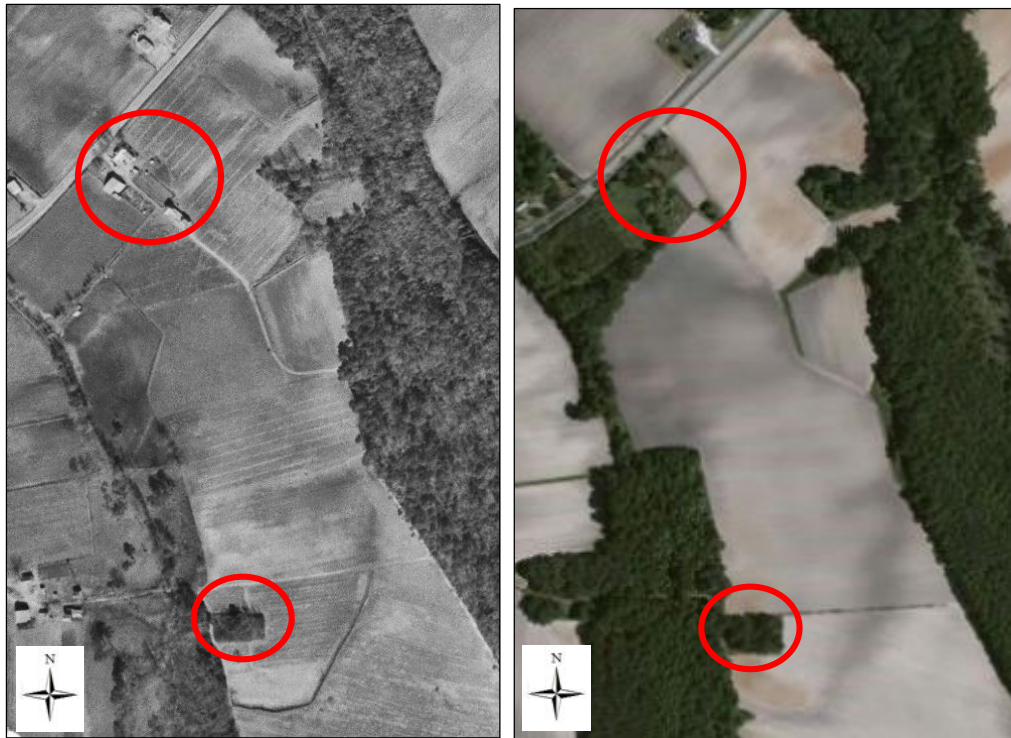
Figure 25: A Historic Aerial Indicating the H. A. Bowen Tenant House Complex, Farm Lands, and Cemetery In Use (Left) Compared to a Current Aerial Showing Neglect (Right) (USGS 1957; Google Earth 2015). *Note:* Buildings and Cemetery Circled in Red.

The H. A. Bowen Tenant House retains integrity of location as the house and surviving outbuildings seem to be in their original location (Figure 25, p. 67). The additions to the house are historic and typical alterations of an early-twentieth century farmhouses but are atypical of most tenant houses in Martin County; therefore, it does retain some integrity of design. The farm has a low level of workmanship and materials; although the building retains a majority of exterior, historic architectural fabric such as original siding, fenestration, and porch, it has been neglected for over a decade and is in very poor condition. The complex continues to function as a farm that is located along a historic roadway that has seen little modern development; however, the buildings are no longer in use except for the tobacco barns, which are now used for machine storage. As a result, the complex retains a moderate-to low-level of integrity of setting, feeling and association.

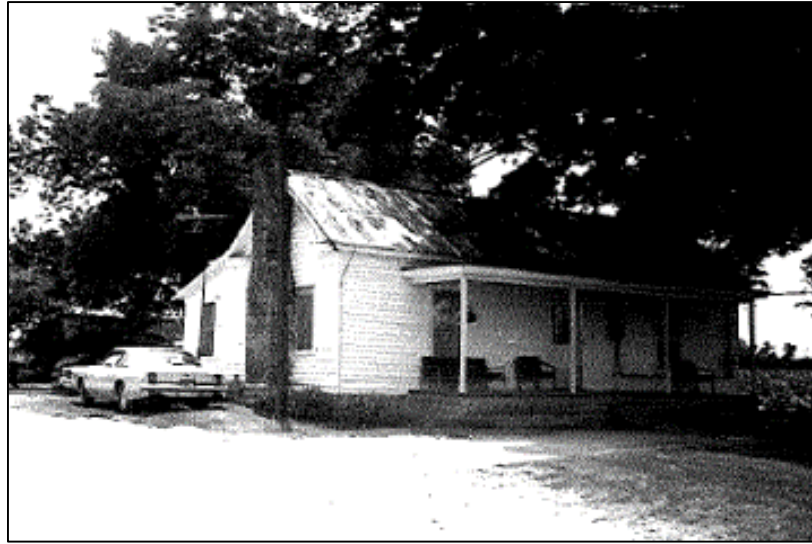
Photo 45: Edmonson Homeplace/Tenant House No. 4 (MT0466) During a Survey in 1992 (NC-HPO 1992d).

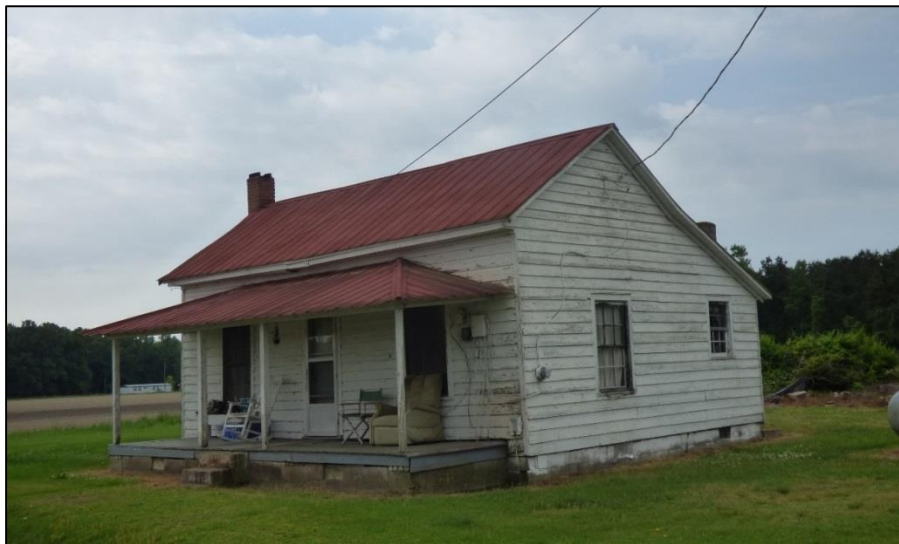
A good example of a possible tenant house in the Williamston Township is located nearby on Henry Mizelle Road, southeast from the Bowen Farm (Photo 46) (MT0626). This circa-1920 house, which currently sits on a continuous concrete-block foundation, abuts the public road and is within view of the Bowen Farm (MT0626). The one-story, wood-frame building retains its original weatherboard siding, wood-frame windows, full-width porch, and brick exterior-end chimney. Unlike the H. A. Bowen Tenant House, the building appears to stand alone along the road at the beginning of a field.

Photo 46: A Tenant House Located on Henry Mizelle Road, Williamston, North Oblique.

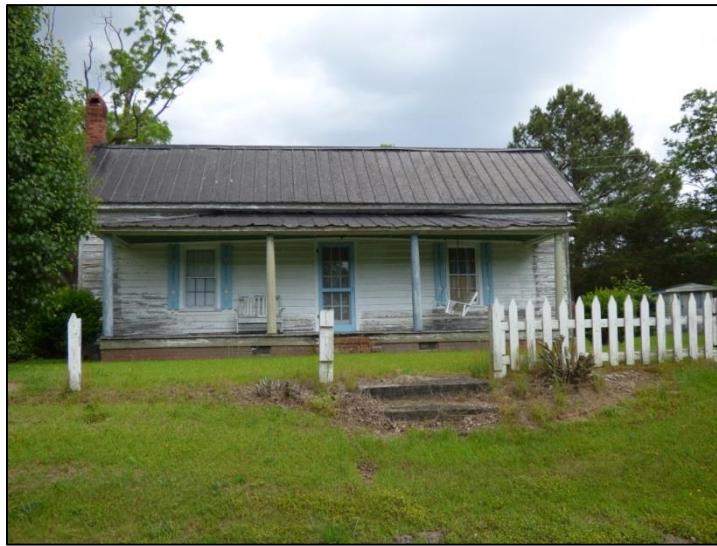
Along the railroad tracks on the southeast side of the Town of Williamston is another good example of a possible tenant house (Photo 47). Located along Reddicks Grove Church Road, north of the intersection with Holly Springs Church Road, is a one-story, wood-frame dwelling that almost abuts the road with crop fields immediately to the north. The house retains its original weatherboard siding, side-gabled roof sheathed in standing-seam metal, exterior-end brick chimney on the gabled end, wood-frame windows, and full-width porch with a hipped roof. Although some characteristics do differ from the H. A. Bowen Tenant House such as one gabled-end chimney rather than two and decorative, wood columns the support the porch roof rather than modest, squared posts. The house, which is currently still occupied, has several complimentary historic outbuildings.

Photo 47: A Tenant House Located Along Reddicks Grove Church Road, Williamston, Northwest Oblique.

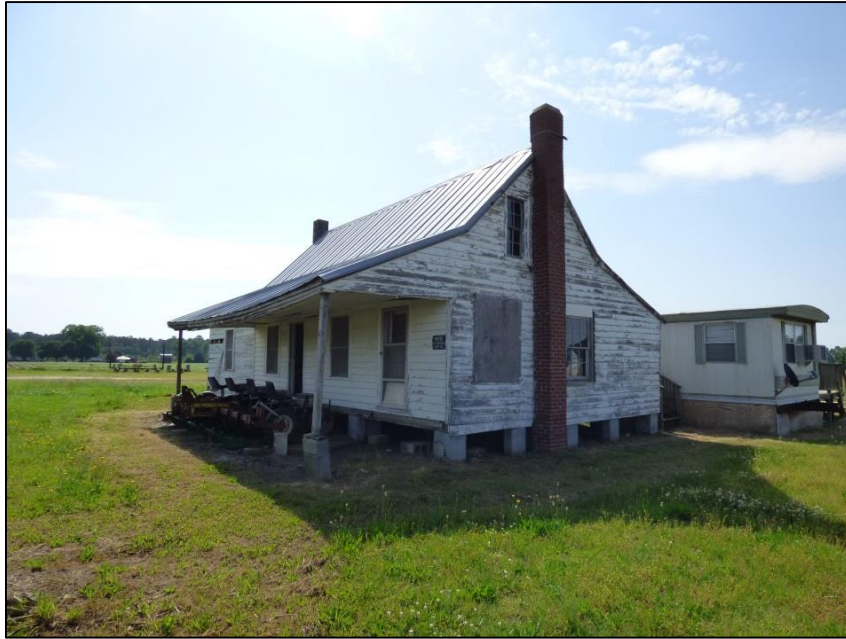
The Alexander Mobley House is a one-story, four-bay single-family dwelling (Photo 48, p. 73). During the current survey, interior access was not granted; however, a 1992 survey completed by Donna Dodenhoff included information pertaining to the dwelling's interior. In the aforementioned survey, the dwelling is described as a "Pre-Civil War, hall-and-parlor plan, costal cottage" (Butchko 1998:149–150; NC-HPO 1992f). This folk style of housing was common throughout the southeastern United States and remained the primary housing form for middling farmers into the twentieth century. Commonly, hall-and-parlor houses were added onto in a variety of ways including the addition of porches, rear additions, and differing chimney placement; however, they remain relatively unchanged (McAlester 2013:140–141). Dodenhoff notes the dwelling's heavy timber framing and the sleeping loft which was previously accessed by an enclosed stair. Additionally, she notes that the building was moved east of its original location in 1970; however, it is unknown how far east the building was moved (NC-HPO 1992f).

The foundation, composed of contemporary concrete-block piers, supports the wood-frame structural system sheathed in weatherboard siding. A side-gabled, double-kick roofline sheathed in v-crimp metal covers the dwelling. While the original brick chimneys are no longer extant, two replacement chimneys flank the dwelling (NC-HPO 1992f). The western chimney is constructed of brick, and the eastern chimney is constructed of concrete blocks.

Photo 48: Alexander Mobley House, Northwest Oblique.

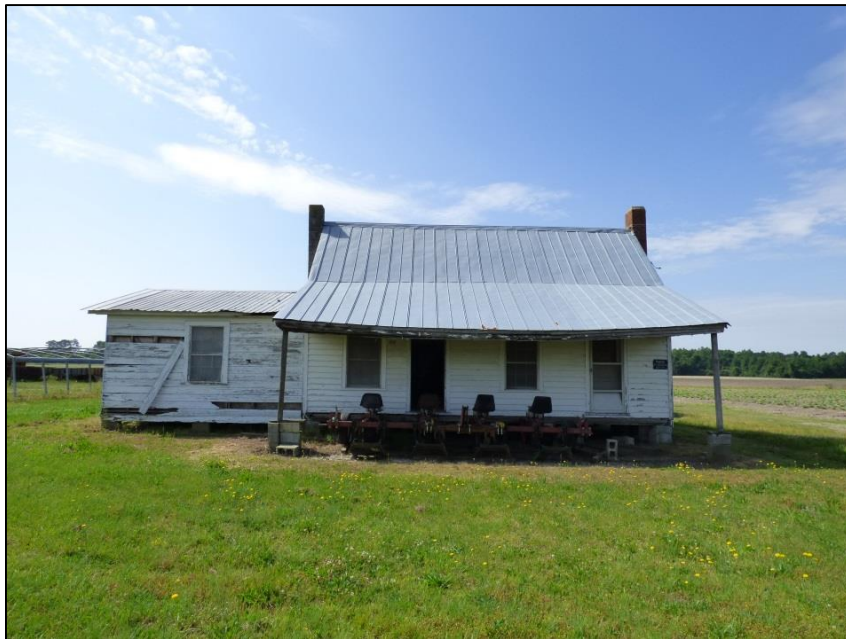
A semi-engaged porch spans the north elevation (Photo 49). In recent years, the foundation and floor of the porch were removed to provide shelter to farm equipment. Small, square, wood posts support the shed-roof sheathed in v-crimp metal. The removal of the central post has resulted in significant sagging of the porch roof.

Photo 49: Façade (North Elevation) of the Alexander Mobley House.

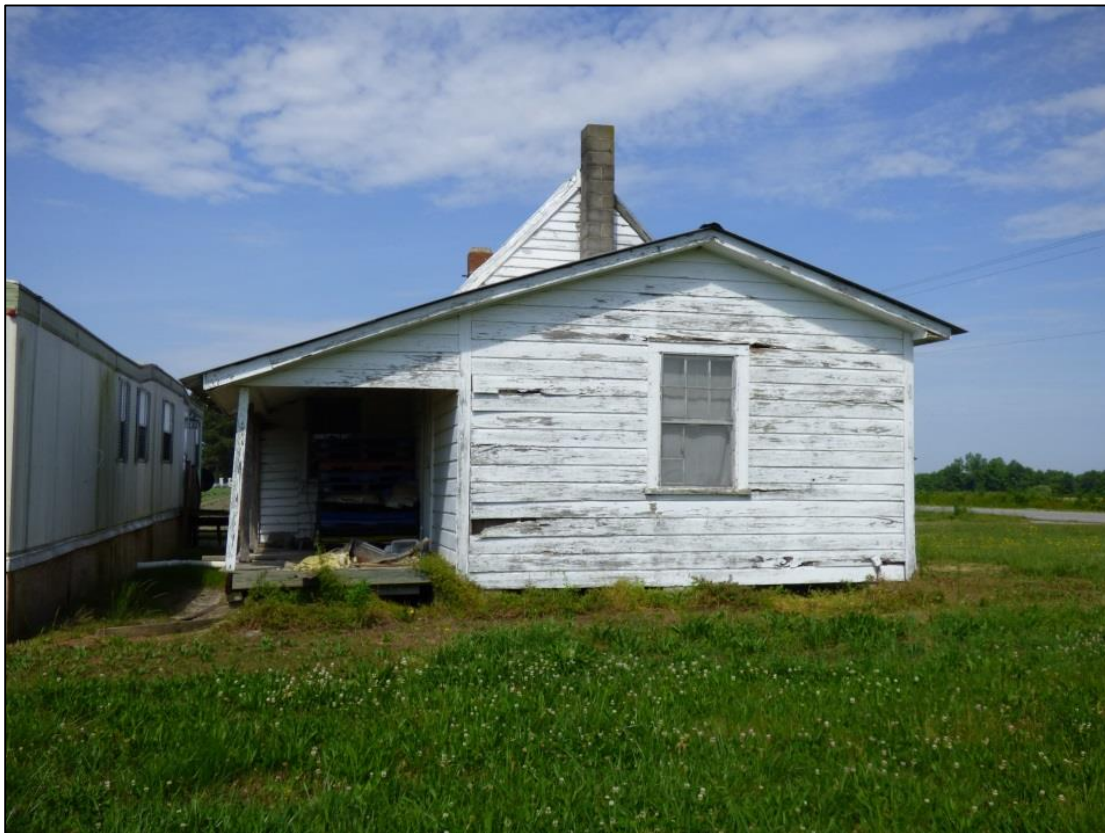
Concurrent with local construction trends around this time period, a member of the Mobley family “added a side ell kitchen [to the east elevation] in the early twentieth century” (Photo 50) (Bryant 1922:54; NC-HPO 1992f). The addition rests on concrete block piers. The wood-frame structural system, which is visible due to portions of removed or deteriorated exterior wall sheathing, is clad in German siding. Access is gained through a five-paneled wood door on the south elevation. Six-over-six, double-hung sash, wood windows are featured on the addition. Present on the addition’s south elevation is a semi-engaged porch which rests on concrete-block piers and is supported by square, wood posts and German siding in the gables.

Photo 50: Addition on the Alexander Mobley House, East Elevation.

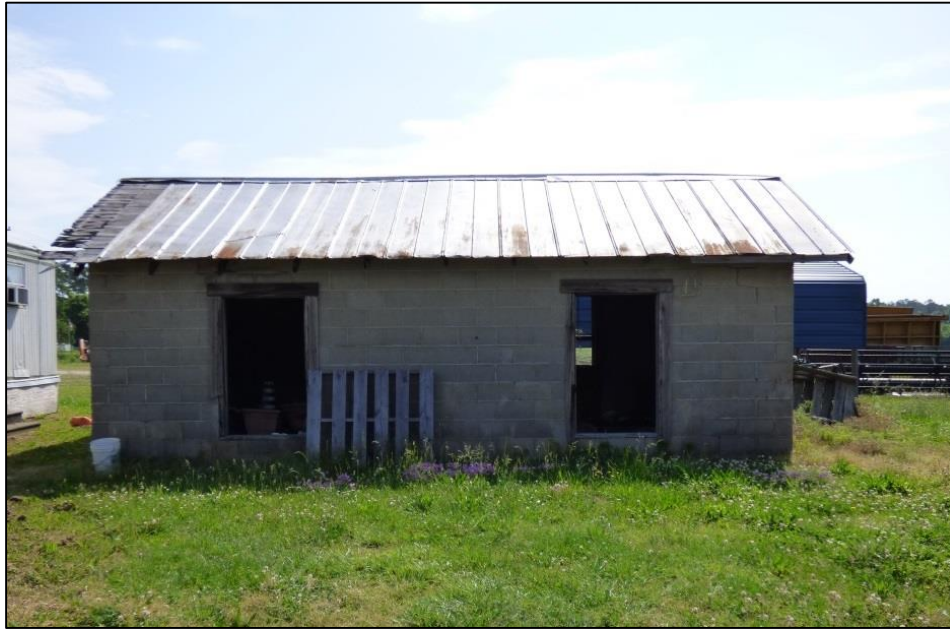
A one-story, two-bay, concrete-block outbuilding sits south of the dwelling (Photo 51, p. 75). With the aid of historic aerial imagery, it can be deduced that this outbuilding was constructed between 1957 and 1977 (Figure 27, p. 75) (USGS 1964, 1977). The outbuilding’s concrete-block foundation and structural system are capped by a side-gabled roof sheathed in v-crimp metal with weatherboard in the gables. Access is gained through

two non-filled openings on the west elevation. Other fenestration includes double-hung sash, wood windows on the east elevation.

Photo 51: Concrete-Block Outbuilding, West Elevation.

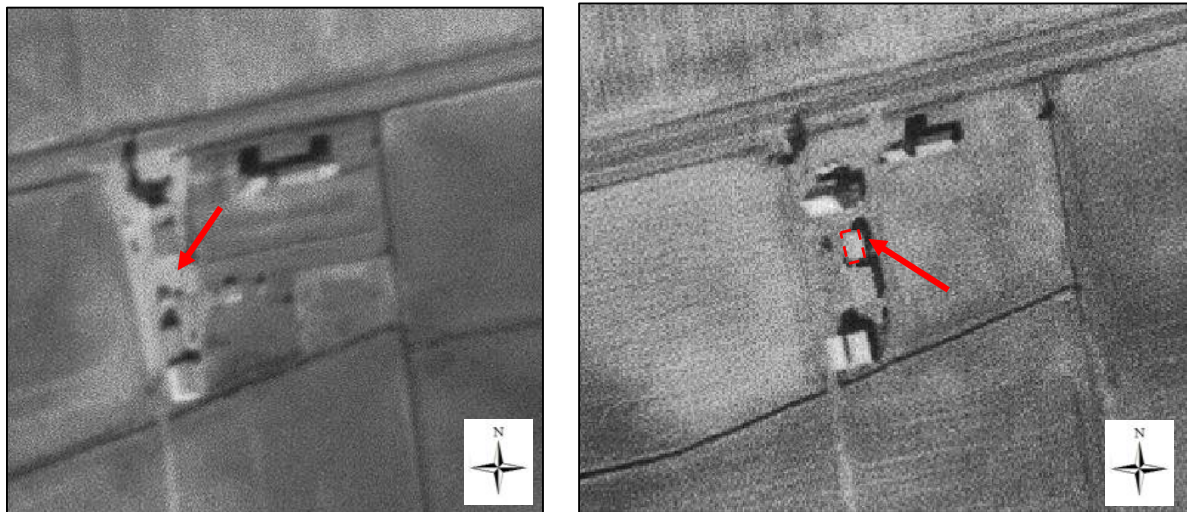
Figure 27: 1957 Aerial Photograph of the Alexander Mobley House and Associated Outbuildings Noting the Absence of the Concrete-block Outbuilding (Left), 1977 Aerial Photograph of the Alexander Mobley House and Associated Outbuildings Noting the Presence of the Concrete-block Outbuilding in Red (Right) (USGS 1964, 1977).

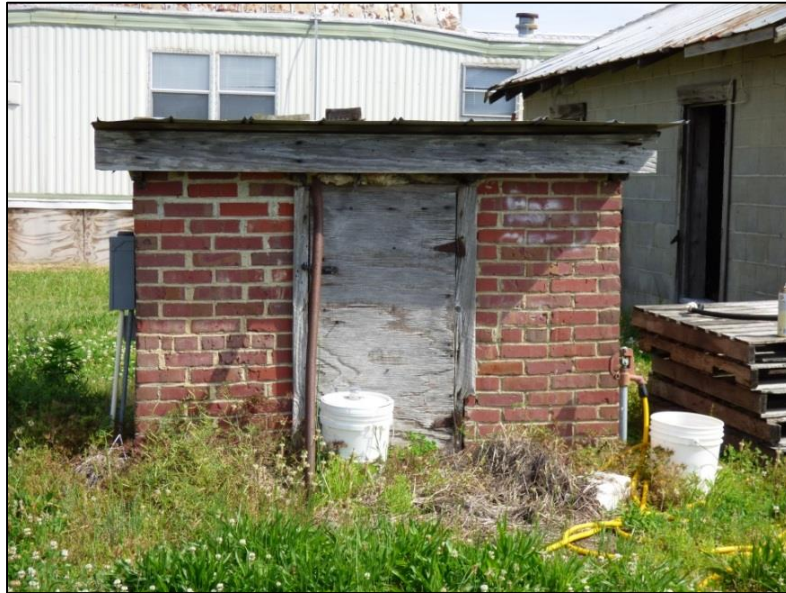
Located approximately 25 feet south of the dwelling is a one-story pumphouse (Photo 52). It was constructed prior to 1957 (USGS 1957). The brick foundation and structural system

support the shed roof sheathed in v-crimp metal with an unadorned wood box cornice. A single-leaf plywood door with strap hinges is centered on the south elevation.

Photo 52: Pumphouse, South Elevation.

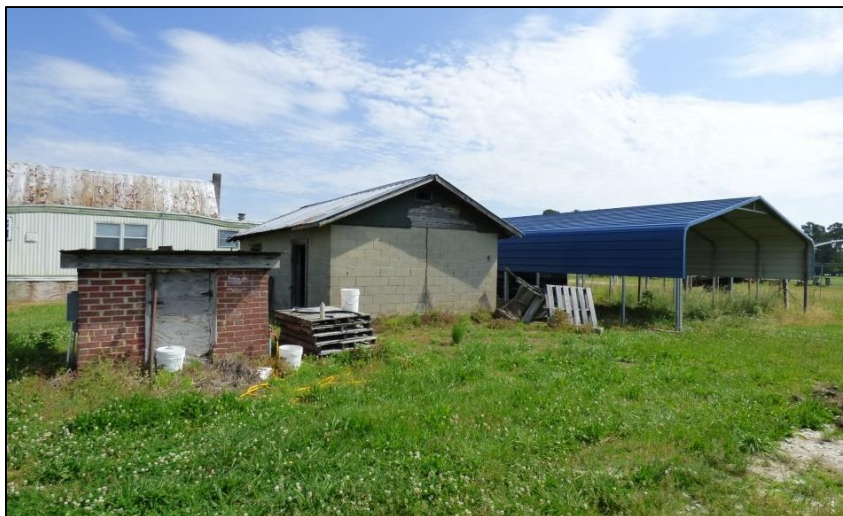
A one-story carport (Photo 53), constructed in 2011, rests southeast of the dwelling (Google Earth 2011). This open-air carport is supported by small metal posts and covered by a front-gabled roof sheathed in v-crimp metal.

Photo 53: Pumphouse, Concrete-Block Outbuilding, and Carport, Looking Northeast.

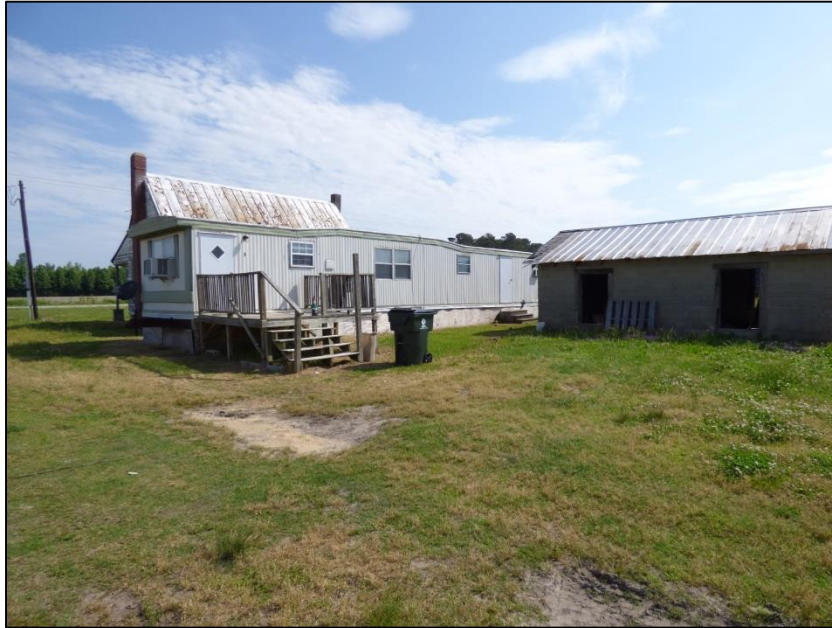
Directly south of the dwelling sits a mobile home (Photo 54). This building was placed on the property in 2012 (Google Earth 2012). The secondary dwelling rests on a non-visible foundation covered by plywood. The structural system, likely wood frame, is clad in metal

siding and covered by an arched roof sheathed in metal. Three entrances provide access to the secondary dwelling. The primary entrance is located on the south elevation and features a single-leaf door with a fixed, diamond-shaped light. Two secondary entrances are filled with single-leaf doors and are located on the easternmost bay of the south elevation and the westernmost bay of the north elevation. Other fenestration includes single and paired one-over-one, double-hung-sash aluminum windows. The windows on the north and west elevations are flanked by louvered, aluminum shutters.

Photo 54: Mobile Home, Southwest Oblique.

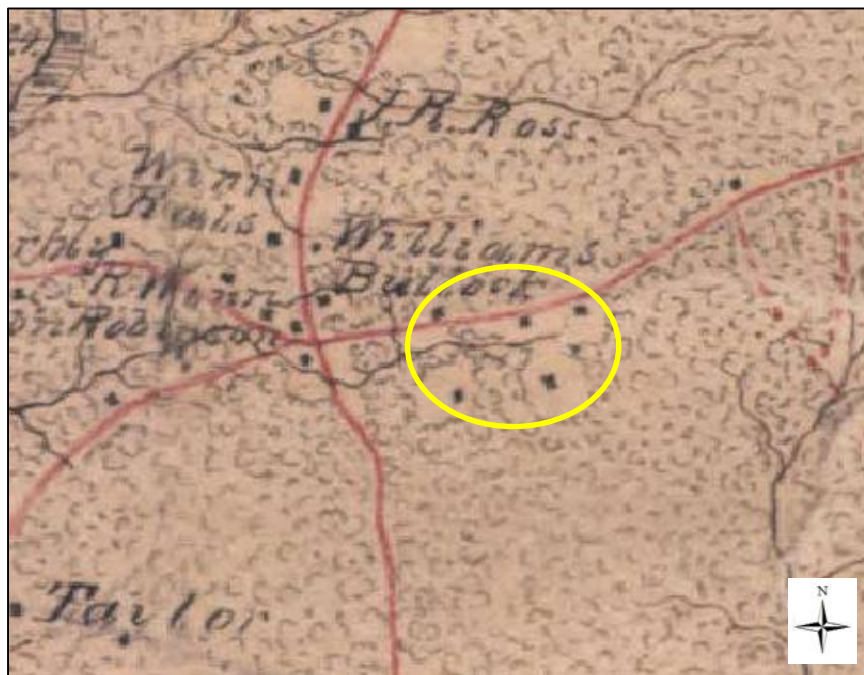
Figure 28: An 1864 Map of Eastern North Carolina Noting the Presence of Various Buildings on the Mobley Land in Yellow (Gilmer 1864).

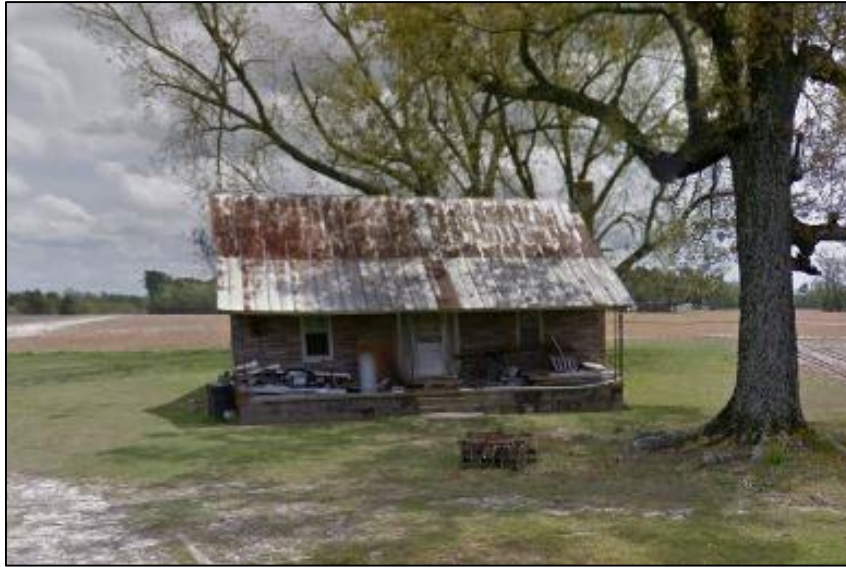
Photo 55: Peel-Taylor House (Google Street View 2015).
