SUBJECT: Historic Structures Survey Report for widening and upgrade NC 125/SR 1142
(Prison Camp Road) from NC 903 to SR 1172 (East College Road), R-4705,
Martin County, ER 15-0346

HISTORIC ARCHITECTURAL ELIGIBILITY EVALUATION

WIDEN AND UPGRADE

NC 125/SR 1142 (PRISON CAMP ROAD)

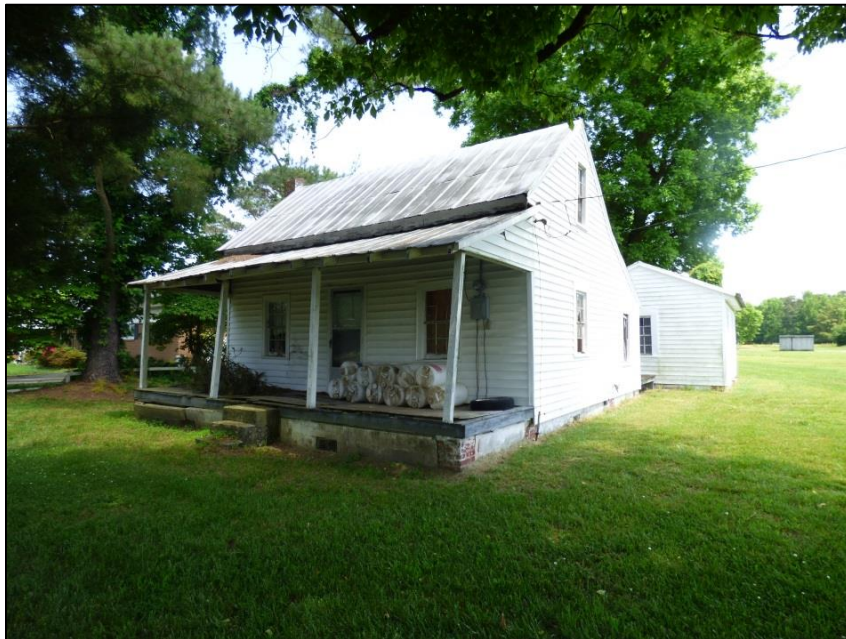
The Carson-Roebuck Farmhouse (MT0371) (discussed in further detail on page 156) is located approximately 2 miles southwest of the Alexander Mobley House on the south side of Prison Camp Road. It is a one-story, timber-framed, side-gabled farmhouse. Like the Alexander Mobley House, it is a coastal cottage constructed in the mid-nineteenth century. While the Carson-Roebuck Farmhouse is in good condition, it has lost many of its original building materials including the chimney and original porch.

Photo 56: Carson-Roebuck Farmhouse, West Oblique.

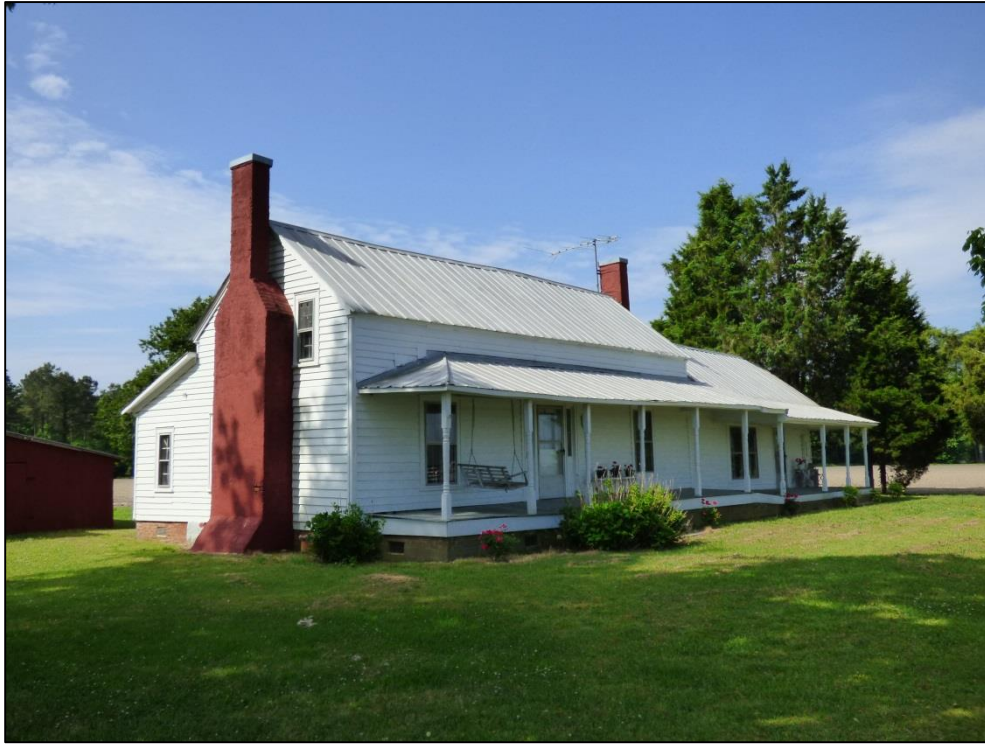
The primary resource at the Wynn Home Place is a circa-1845 farmhouse. The original core is known as a “story-with-a-jump”—built to be between a one-story and a one-and-a-half-story building—three-bay, single-family dwelling. It is raised on a brick-pier foundation with brick infill laid in a stretcher-bond configuration (Photo 57, p. 85). The southwestern pier was replaced, possibly in the mid-twentieth century, with a poured-concrete pier. Below the house is a crawl space accessed by an opening just south of the chimney on the east elevation. The wood-frame structural system is clad in weatherboard with wooden cornerboards and is capped by a moderately pitched, side-gabled roof sheathed in replacement v-crimp metal. The eaves of the roof are lined with a wooden rake on the gable (east and west) elevations and a wide fascia board on the rear (south) elevation. There are two exterior-end, parged, brick chimneys with stepped shoulders and metal coping. They flank the house on the east and west elevations (Photo 58, p. 85).

Photo 57: Dwelling, Northwest Oblique.

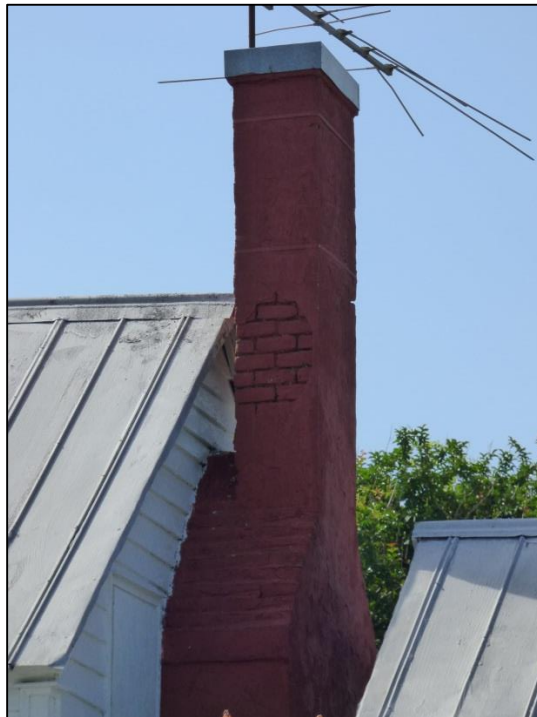
Photo 58: Dwelling, West Elevation Chimney Detail.

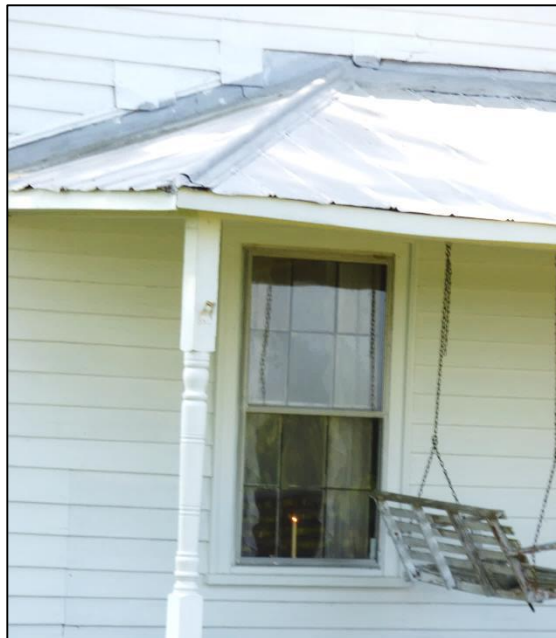
The main entry is centered on the original core of the north elevation. It is filled by a wooden door, comprising rectangular panels on the bottom and a fixed light at the top, and a metal storm door. The entry is flanked by two two-light side lights. Additional fenestration includes wood-frame, six-over-six, double-hung sash windows on the north elevation and wood-frame, four-over-four, double-hung sash windows on the east elevation (Photo 59). The visible windows on the west elevation are boarded over with wood. According to a 1992 survey of this building, three narrow windows are located on the half story of the primary (north) elevation; however, they are covered over in weatherboard siding (NC-HPO 1992g).

Photo 59: Dwelling, North Elevation Window Detail.

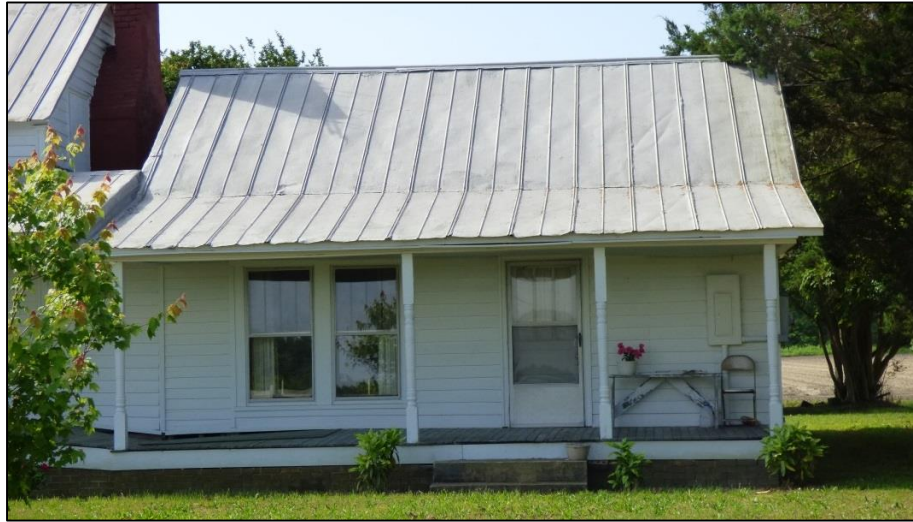
An early-twentieth-century kitchen/dining room addition is located west of the original core (Photo 60, p. 87). This one-story, two-bay building is attached to the main core of the house by a one-story hyphen. Both the addition and the hyphen have a wood-frame structural system clad in weatherboard. The addition is covered by a side-gabled roof sheathed in v-crimp metal; an exterior-end, brick chimney is located at the west elevation. Off-centered on the north elevation is a secondary entry, filled by a wooden, paneled door with three fixed

lights at the top and a metal storm door. Paired four-over-one, wood-frame, double-hung sash windows are located east of the entry. A one-story, three-bay porch covered by a shed roof and supported by a wooden turned posts connects to the porch that lines the original core. It is raised on a brick foundation and accessed by poured-concrete steps. A one-story, shed-roofed addition extends from the south elevation (Photo 61). A rear entry is located on this elevation. Access to the interior was not permitted at this time; furthermore, Donna Doddenhoff was unable to survey the interior during her 1992 survey. As such, there is no information about the interior.

Photo 60: Kitchen/Dining Room Addition, North Elevation.

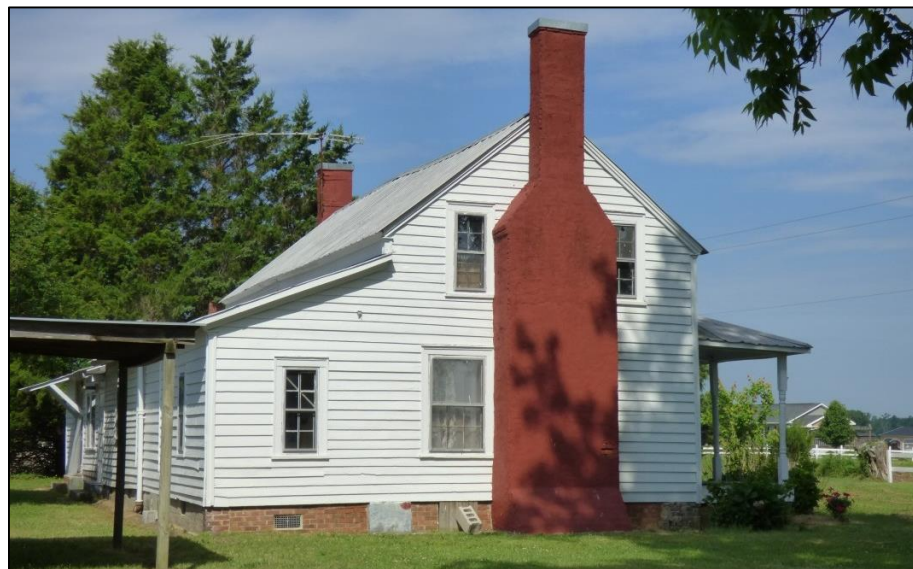
Photo 61: Southeast Oblique, Showing the Rear Shed-Roof Addition.

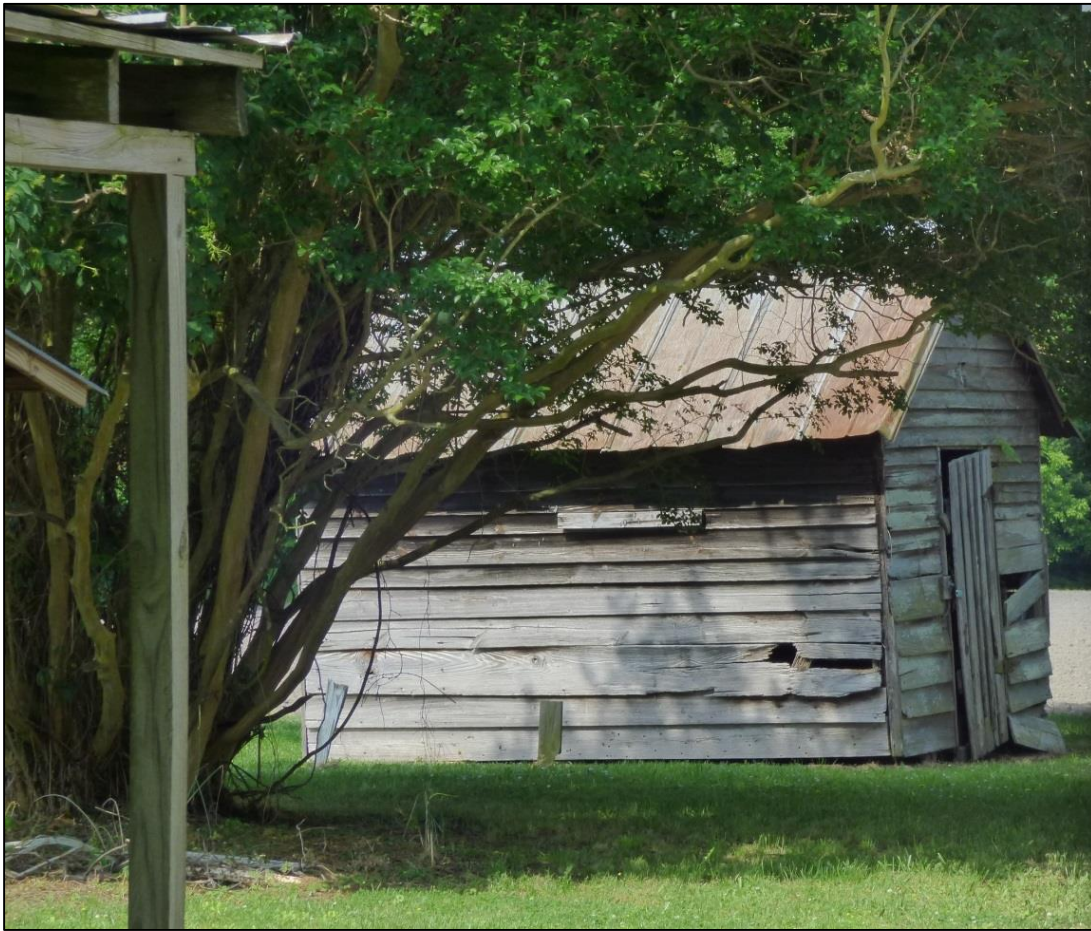
A circa-1900 smokehouse is located south of the primary resource. Full access to the property was not granted for this survey, so the notes on architectural details of the outbuildings are limited. The wood-frame structural system is clad in weatherboard and covered by a front-gabled roof sheathed in v-crimp metal (Photo 62). A single-leaf entry covered by a wooden door is centered on the north elevation. The door is attached with metal strap hinges. At the time of the survey, no evidence of a chimney or vent was visible.

Photo 62: Smokehouse, Northeast Oblique

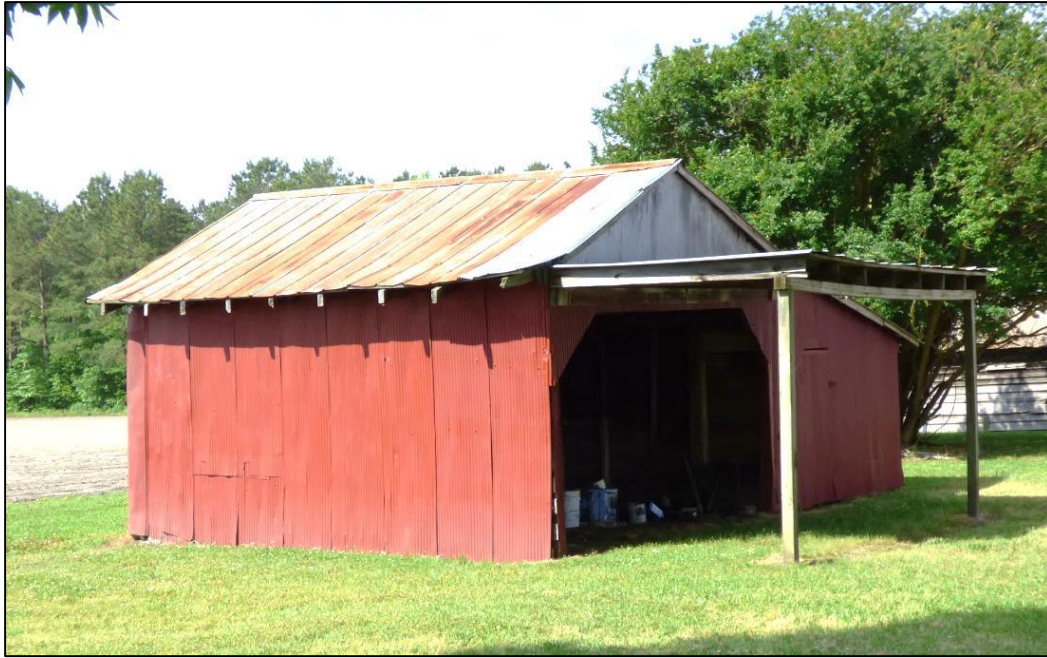
Southeast of the dwelling is a circa-1940 garage. This one-story, single-bay outbuilding with a lean-to addition on the west elevation has a frame, post-in-ground structural system clad in horizontal, wooden boards covered by corrugated metal (Photo 63, p. 89). The garage is capped by a front-gabled roof sheathed in v-crimp metal with exposed wooden rafters on the east and west elevations. The vehicular opening with clipped corners is located on the north elevation. There is one single-leaf opening secured by a metal door on the north elevation of the addition.

Photo 63: Garage, Northeast Oblique.

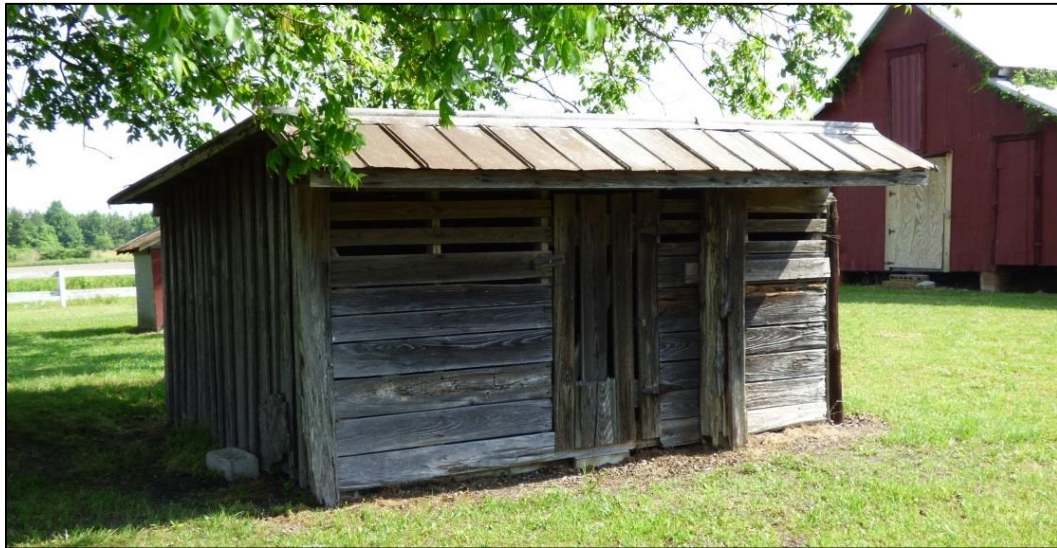
A one-story chicken coop is located east of the primary resource. This circa-1920 outbuilding has a frame structural system clad in weatherboard on the south (main) elevation and board-and-batten siding on the secondary elevations (Photo 64). Built-in vents in the form of gaps in the siding are located on the top half of the south elevation. A saltbox roof sheathed in v-crimp metal covers the building. There is one opening filled by a single-leaf, wooden door on the south elevation.

Photo 64: Chicken Coop, Southwest Oblique

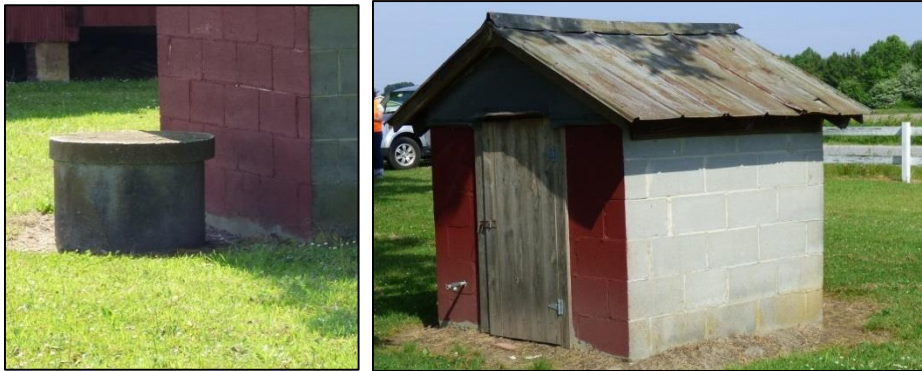
Photo 65: Well (Left) Looking Southeast and Well House, Southeast Oblique.

A one-story well house is located east of the primary resource. It likely dates to the mid-twentieth century (Photo 65). This concrete-block structure is covered by a front-gabled roof sheathed in v-crimp metal and features an opening on the south elevation. Immediately adjacent to the well house is a circular, early-twentieth-century well. The poured-concrete, circular well is covered by a poured-concrete, circular cap.

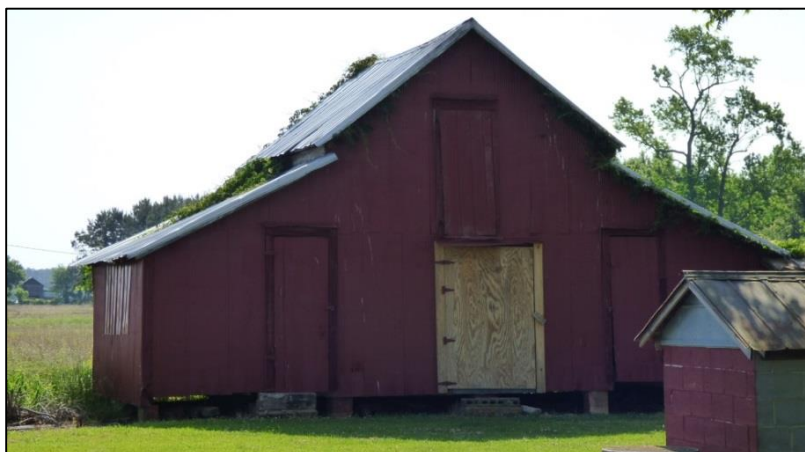
Photo 66: Packhouse, West Elevation.

A one-and-a-half-story packhouse is located northeast of the house and just south of Prison Camp Road (NC-HPO 1992g). This circa-1900 structure is raised on brick piers and the structural system, likely frame, is clad in corrugated metal (Photo 66). The building is covered by a moderately pitched, front-gabled roof sheathed in v-crimp metal. There are two shed-roofed wings attached to the building, one on the east north elevation and one on the south elevation, that have the same foundation and siding as the main (central) core. The main entry was recently remodeled and now features a centered single-leaf, plywood door attached with four metal hinges: two T-hinges and two strap hinges. There are three additional entrances on the primary (west) elevation: two on the first story and one centered within the gable. Each is a single-leaf door clad in corrugated metal attached with metal strap hinges.

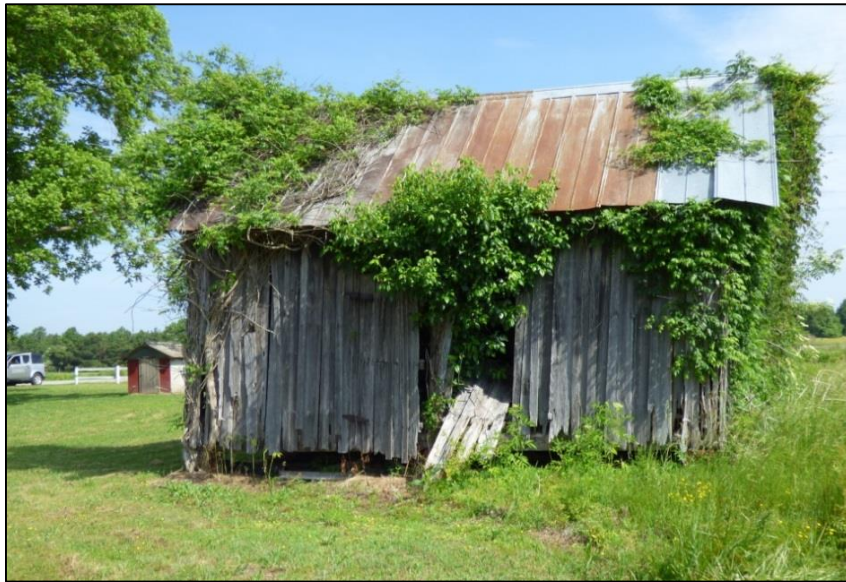
Photo 67: Corn Barn, South Elevation.

A one-story structure identified during the 1992 survey as a corn barn is located east of the dwelling resource and south of the packhouse (NC-HPO 1992g). The building was likely constructed around 1900 and is raised on brick piers and the frame structural system is clad in board-and-batten siding (Photo 67). The side-gabled roof is sheathed in standing-seam metal. A shed-roofed lean-to addition clad in v-crimp metal extends from the north elevation. Originally a double-leaf, wooden door attached by metal strap hinges was centered on the south elevation. Today, overgrown vegetation from inside the building has ripped off one door. Acting as a hyphen between the packhouse and corn barn is a one-story machine shed. Likely building around 1920, the saltbox roof is supported by wooden posts (Photo 68).

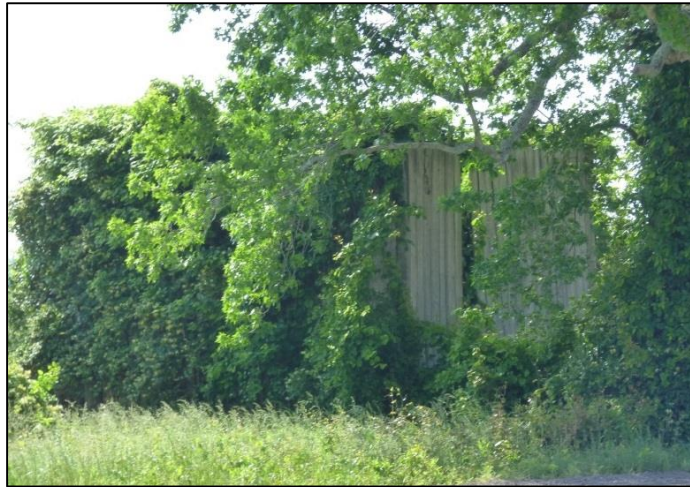
Photo 69: Tobacco Barn, North Elevation.

A one-story, circa-1900 tobacco barn is located southeast of the primary resource (NC-HPO 1992g). It is clad vertical wood boards and the roof has collapsed (Photo 69). Access to this outbuilding was not permitted and the building is covered in overgrown vegetation; as such, few details could be obtained.

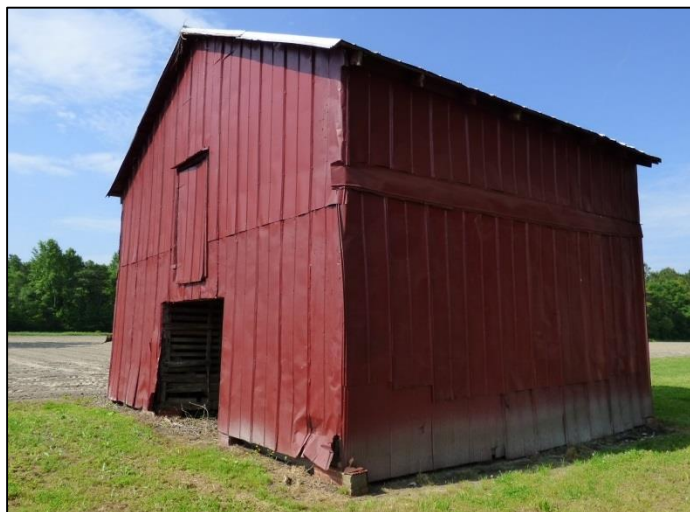
Photo 70: Mule Stable, Northeast Oblique.

A two-story, circa-1910, mule stable is located southeast of the house (NC-HPO 1992g). The frame structural system is set on brick piers and clad in v-crimp metal (Photo 70). This structure is covered by a moderately pitched, gabled roof sheathed in v-crimp metal with exposed wooden rafters on the north and south elevations. The building features a through passage at the central bay of the east and west elevations. A secondary entry is located at the hay loft; it is filled with a single-leaf door attached with metal strap hinges and covered with sheets of metal.

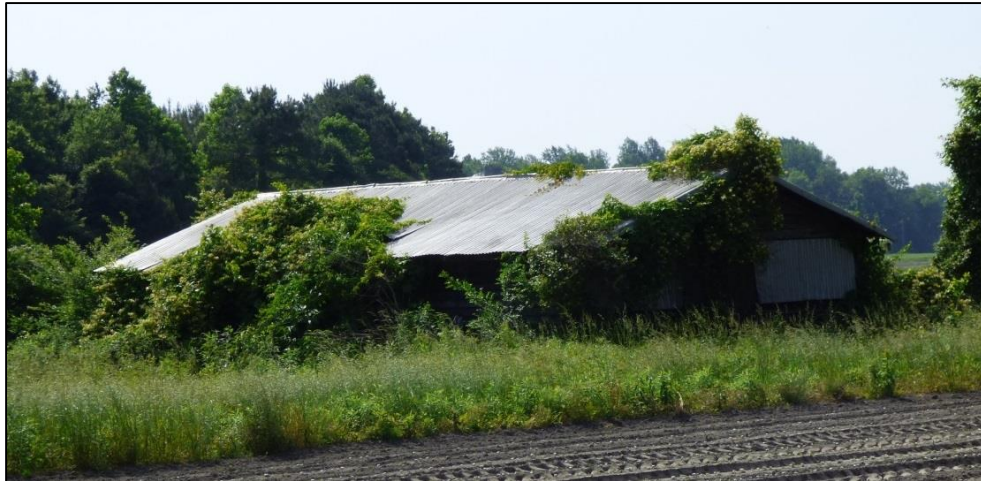
Photo 71: Hog Parlor, Northwest Oblique.

A one-story, circa-1940 barn that once functioned as a hog parlor is located southeast of the primary resource (NC-HPO 1992g). The through-passage structure has a frame structural system clad in weatherboard and is covered by a front-gabled roof sheathed in corrugated metal (Photo 71). The window openings are covered with sheets of metal. Access to this outbuilding was not permitted during the current survey.

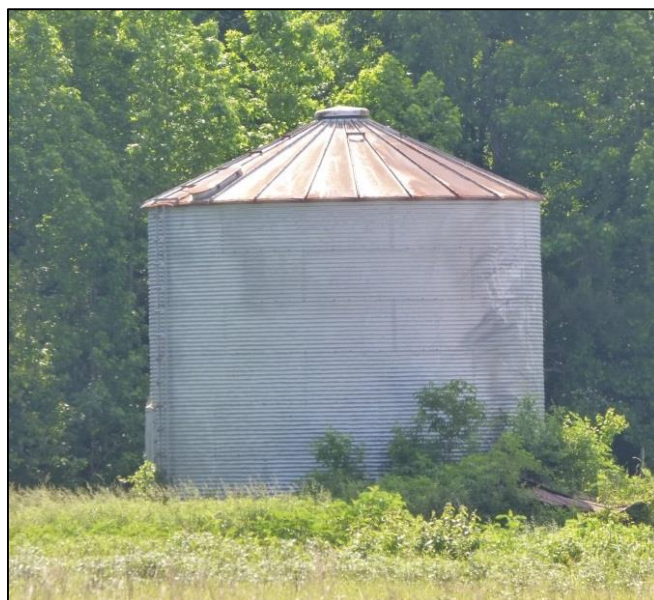
Photo 72: Silo, Looking Southeast.

Situated southeast of the main cluster of buildings associated with the Wynn Home Place is a mid-twentieth-century silo (Photo 72). It is circular in shape and sheets of metal cover the structural system (likely metal). It is capped by a conical roof and a metal ladder on the north side provides access to the roof.

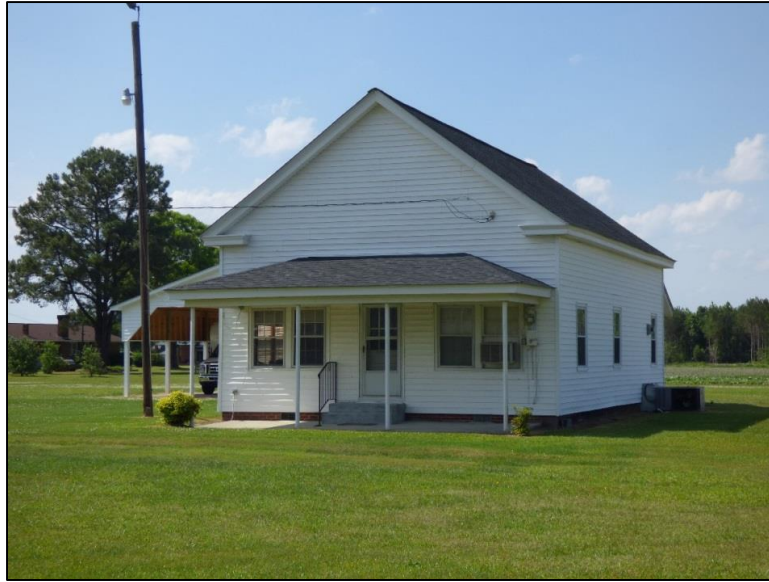
Photo 74: Primary Resource, Southeast Oblique.

The primary resource, the Church Cross Roads School, is a one-and-one-half-story, three-bay schoolhouse constructed around 1900 (Photo 74, p. 103) (Butchko 1998:148). Although access to the property was granted during this current effort, interior access was not obtained. Interior documentation was also not conducted in the previous survey conducted by Donna Dodenhoff in 1992 (NC-HPO 1992h). Dodenhoff determined that “this typical early twentieth century schoolhouse” is a form “typical of Martin County’s one- and two-room rural schools of the pre-consolidation period” (Butcho 1998:88; NC-HPO 1992h). After consolidation with two other schools in 1931, the school was converted into a six-room parsonage for the pastors at the Christian Chapel Church (Honican 2013; Manning and Booker 1974:6, 231; Butchko 1998:148). Today, the schoolhouse has been moved a short distance east of the circa-1950 church and is used for youth services (Honican 2013).

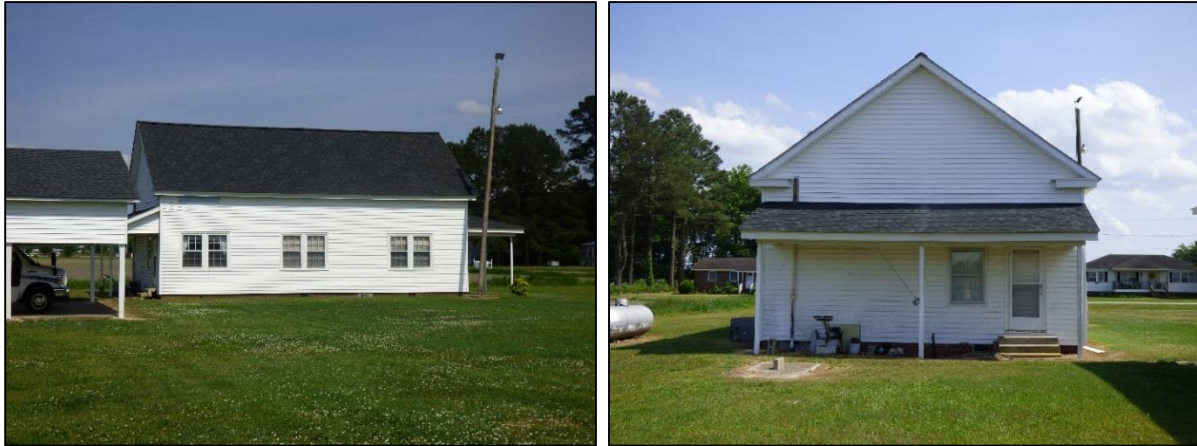
Photo 75: Primary Resource, West Elevation (Left) and North Elevation (Right).

The building currently sits on a replacement, continuous, brick foundation laid in an all-stretcher bond. The timber-frame structural system is clad in vinyl siding that covers the original weatherboard siding documented by Dodenhoff in 1992 (Photo 75, p. 104). The front-gabled roof is sheathed in replacement asphalt shingles. The roof is complete with a boxed, wood cornice with prominent returns. A window vent used to be present in the gabled end of the primary elevation, but is now covered by vinyl siding (Butchko 1998:148). A chimney was not visible during the time of survey or in the photos taken by Dodenhoff in 1992 (NC-HPO 1992h).

The primary entrance is centrally located on the south elevation, and is filled with a single-leaf, three-paneled, wood door with six lights with a metal, storm door. It is accessed by a set of poured-concrete stairs that is lined with an iron rail. Other fenestration consists of single and paired, six-over-six, wood-frame, double-hung sash windows. A secondary entrance is located in the west corner of the north elevation and it is filled with a single-leaf, five-paneled, wood door with a metal storm door. A one-story, three-bay porch spans the façade. The concrete slab foundation is sheltered by a hipped roof with boxed eaves sheathed in asphalt shingles. The roof is supported by metal posts. A one-story, two-bay porch spans the rear (south) elevation which shelters the poured-concrete steps that access the secondary entrance. The porch is covered by a shed roof sheathed in asphalt shingles and is supported by squared, metal posts (Photo 75, p. 104). Both of these porches are visible in the photos taken by Dodenhoff in 1992; however, she does mention that they have been altered since the buildings original construction (NC-HPO 1992h). Apparent post-1992 alterations to the porches include replacement posts and roof shingles. Interior renovations to the school were noted by Thomas Butchko in 1998 but were not visible during the time of survey (Butchko 1998:148). Resources state that the school was converted into a six-room parsonage around 1940 (Honicon 2013).

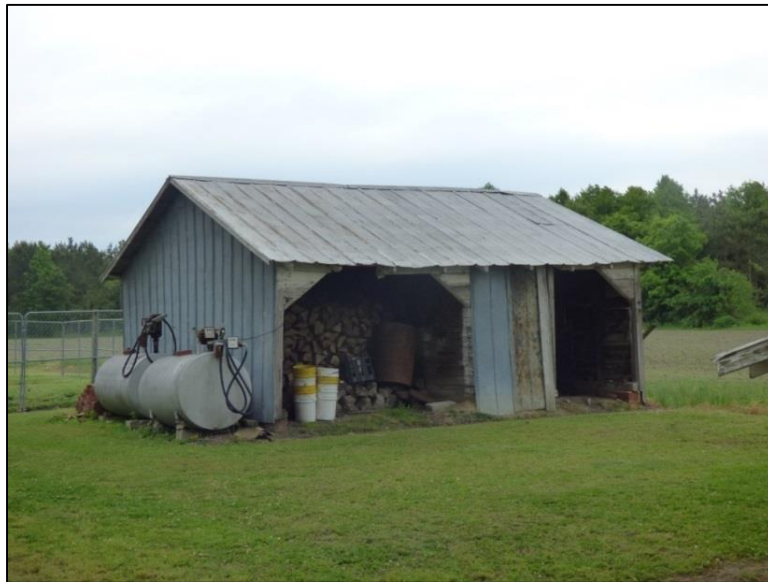
Photo 76: Old School Carport Now Located on Frank Wynne Jackson's Property, Southwest Oblique.

During the current survey, Frank Wynne Jackson, owner of the land on which the old, wood-framed church (MT0375) currently sits, informed surveyors that an old carport north of the school was once used by the Church Cross Roads School for vehicles and storage (Photo 76, p. 104). The circa-1935, one-story, two-bay, carport is now situated 374.8 feet northwest of the school in the southeast corner of Jackson's property on the east side of Wynn Road. The carport is elevated on brick piers and the timber-framed structural system is clad in a combination of wood siding and v-crimp metal siding. The building is covered by a moderately pitched, side-gabled roof with exposed rafters sheathed in v-crimp metal. Two open bays are located on the south elevation. Currently, Jackson uses the building for fire-wood storage (Frank Wynne Jackson, personal communication 2015).

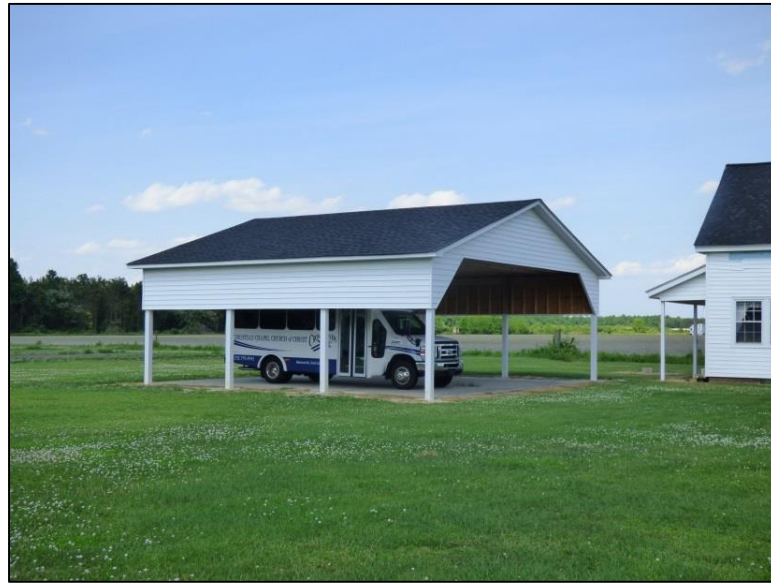
Photo 77: Carport, Southwest Oblique.

A circa-2010 carport is situated immediately northwest of the school building (Photo 77, p. 105). The one-story, one-bay carport sits on a poured-concrete slab and sheltered by a front-gabled roof sheathed in asphalt shingles with slight, boxed eaves and a short return. The roof is supported by squared wood posts. The north and south elevations have bracketed open bays with vinyl siding beneath the roofline. Vinyl siding is also located on the east and west elevations beneath the roofline.

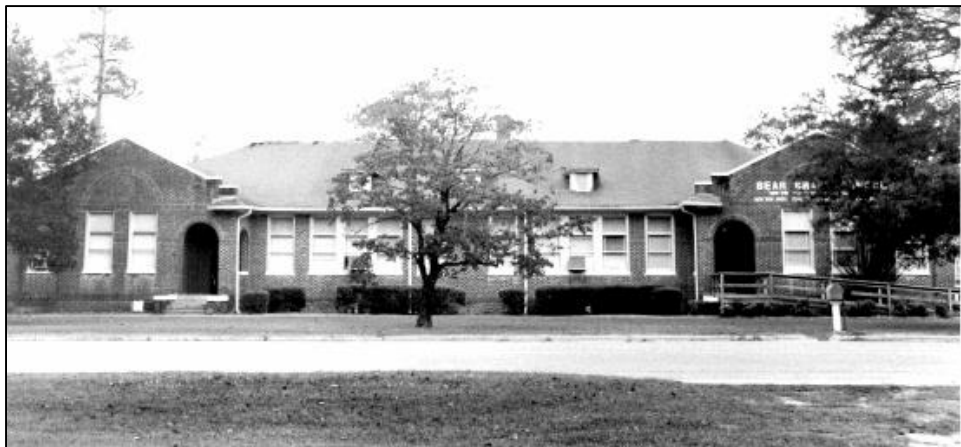
Photo 78: Bear Grass School (MT0417), Southeast Elevation (Keane 2004).

One excellent example of a surviving one-room school in Martin County that is listed in the NRHP is the Bear Grass School (MT0417) (Photo 78). The Bear Grass School, constructed in 1925, was originally a one-story, brick school located in Bear Grass, Martin County, but has been remodeled and has had multiple additions. The building is listed in the NRHP under Criterion A for its educational significance in Martin County and as a representative of the school consolidation movement of North Carolina. It is also listed under Criterion C for its representation of the Colonial Revival style during a period of focus on North Carolina educational buildings and its association with a noted school architect, Eric Flanagan (Keane 2004). The Bear Grass School represents a style of schoolhouse construction that reflected the changing views of education in rural communities in North Carolina.

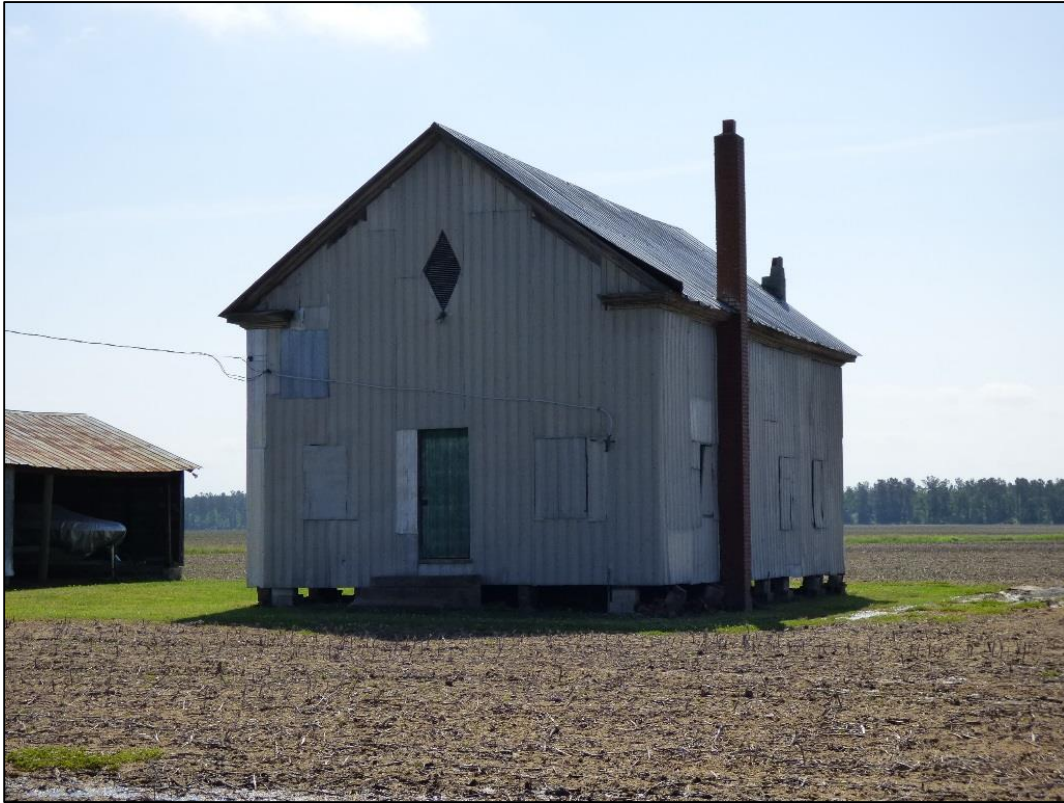
Photo 79: Getsinger School (MT0106), West Oblique.

Constructed around the same period as the Cross Roads Church School is the Getsinger School (MT0106), which is a good example of a surviving one-room frame school house in Martin County (Photo 79, p. 110). The school house is a one-and-one-half-story, three-bay school house constructed around 1890. In a survey conducted in 1992, Donna Dodenhoff, states that the frame building was clad in weatherboard siding but currently it is covered pressed metal siding (NC-HPO 1992i). The building still retains its original brick pier foundation and front-gabled roof with boxed eaves and prominent returns but the foundation has been reinforced with concrete block. Although all fenestration has been covered by pressed metal siding, their location is still visible, and the building still retains a triangular-shaped, wooden vent situated in the gabled end. An exterior-end brick chimney is still extant; however, it does not look original to the building. The building still retains its integrity of location and setting, being located on the side of a historic road (E. H. Williams Road) across from the Piney Grove Baptist Church (MT0105) in the Farm Life vicinity.

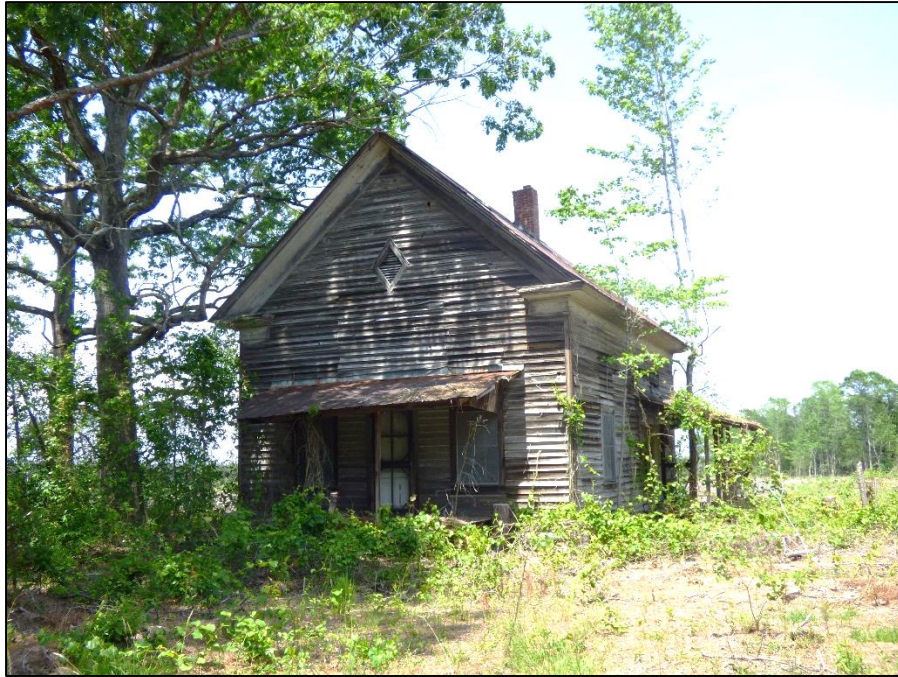
Photo 80: Peele's/Turkey Swamp School (MT0393), Northeast Oblique.

Another good example of a “well-preserved, turn-of-the-century school” is the Peele/Turkey’s Swamp Schoolhouse (MT0393) located in Bear Grass community (Photo 80, p. 111) (NC-HPO 1992j). This typical, two-room, frame schoolhouse retains its original weatherboard siding, central-interior brick chimney, and v-crimp metal covering the front-gabled roof. In a 1992 survey, it was noted that “the interior is sheathed with both beaded boards and flush planks” (NC-HPO 1992j). Some additions were also noted during this survey such as a shed roof porch and a small rear ell. Although the building was considered well-preserved in 1992, it is currently in danger of loss of integrity due to neglect.

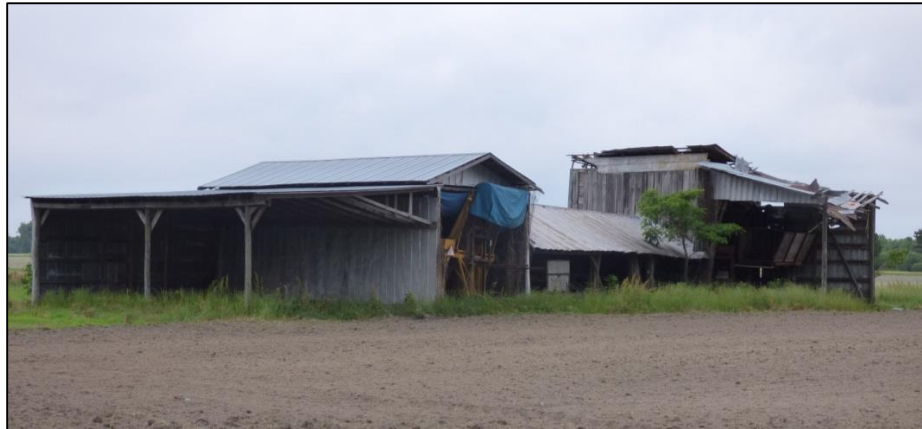
Photo 83: Tobacco Barn and Additions, Looking Northwest.

One surviving building within this community was likely constructed during the second quarter of the twentieth century (USGS 1950) (noted as resource 1 on Figure 38, p. 113). The original core of this building likely originally functioned as a tobacco barn. The frame structural system is clad in sheets of metal and is covered by a front-gabled roof sheathed in v-crimp metal (Photo 83, p. 115). The building was heavily altered when the façade (east elevation) was removed to become a large machine entry. A one-story, shed-roofed wing

supported by wooden posts extends from the south elevation. A large, partially collapsed building is situated immediately north of the tobacco barn. It had a frame structural system clad in vertical wooden boards and is connected to the barn by a one-story, side-gabled hyphen. This building is currently used as machine storage.

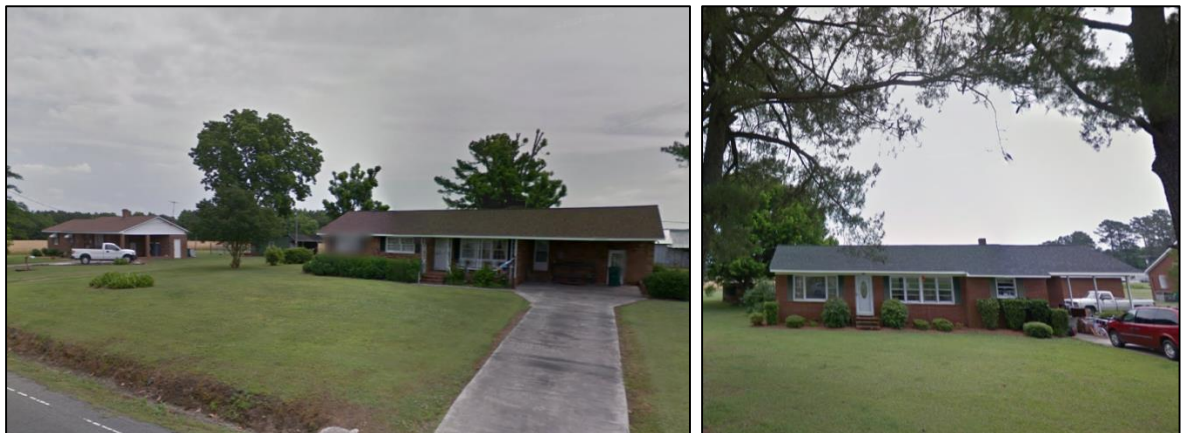
Photo 84: Three Ranch Dwellings on Wynn Road (Google Street View 2015).

A majority of the buildings currently located at Church Cross Roads were constructed between 1950 and 1975, including four residential buildings, two agricultural buildings, one church, one garage, and one store. The four residential buildings are representative of the Ranch style and are clad in a brick, stretcher-bond veneer and covered by a side-gabled roof (noted as resources 10, 13, 14, and 15 on Figure 38, p. 113) (Photo 84). They appear to retain their original wood-frame windows and brick interior chimneys. The houses exhibit an attached, shed-roofed carport. Each has at least one associated outbuilding, such as a shed or workshop. Three of the buildings are clustered on the east side of Wynn Road and the fourth is situated south of the Prison Camp Road across from the Church Cross Roads School.

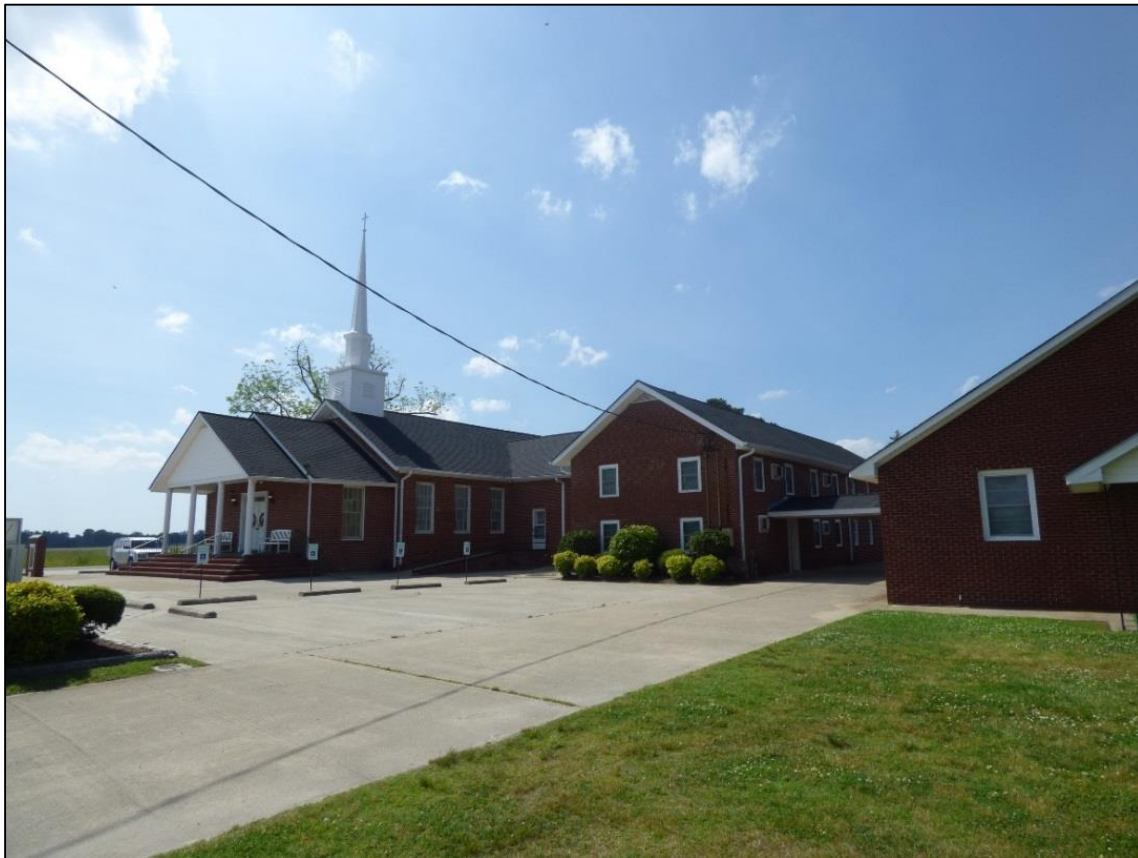
Photo 85: Circa-1950 Church and Education Building Addition, Southeast Oblique.

A circa-1950 church is located immediately northeast of the Church Cross Roads intersection (noted as resource 12 on Figure 38, p. 113). The one-story, one-bay church constructed in a cross-shaped form sits on a continuous foundation. Both the foundation and the structural system are clad in a brick, stretcher-bond veneer. The moderately pitched, front-gabled roof with boxed eaves is sheathed in asphalt shingles. A metal steeple with vents and an octagonal spire pierces the ridge of the roof in the southern portion of the building. This steeple was added to the church in 2001. The primary entrance is centered on a one-story, front-gabled projection clad in a brick veneer laid in an all-stretcher bond from the primary (south) elevation. It is filled with double-leaf, eight-paneled, wood doors with a fixed, single-light, transom decorated by a denticulated cornice. Fluted, wood, pilasters flank the entrance. Other fenestration includes single, eight-over-seven, wood-framed, double-hung sash windows filled with an opaque glass. The lower sash is a unique configuration with a row of four lights over a row of three lights with the central light measuring the width of two smaller lights. The windows are complete with a brick sill and flat, brick lentil. A one-story, three-bay portico spans the primary elevation. There are several additions that extend from the building included a circa-1965 baptistery addition, a 1962 education building, and a 1977 fellowship hall. Associated with this building is a shed, well house, and two signs.

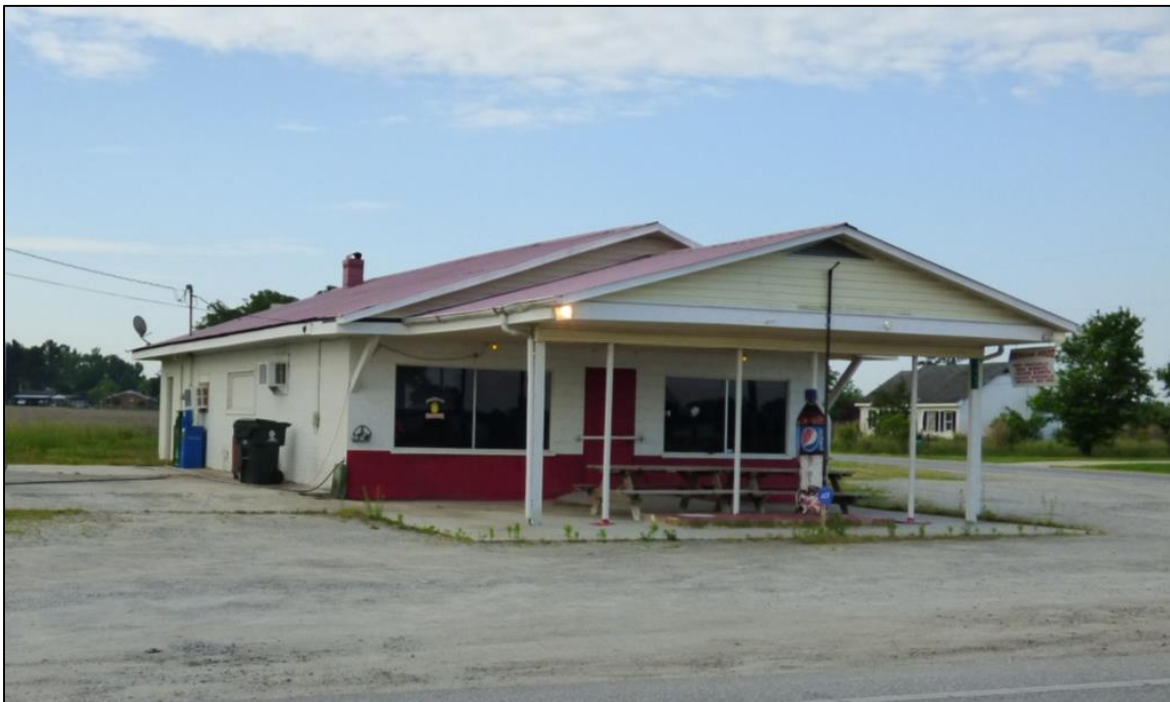
Photo 86: Store at Church Cross Roads, Northeast Oblique.

The store, formerly called Earl's Store, was constructed in the mid 1970s (noted as resource 8 on Figure 38, p. 113) in the site of an older store (USGS 1974, 1977). It is a one-story commercial building with a concrete-block structural system that is covered by a low-pitched front-gabled roof sheathed in asphalt shingles (Photo 86). A concrete-block chimney pierces the eastern slope of the roof near the rear (south) elevation. The primary entrance is off-centered on the north elevation and is filled by a replacement, metal door. There is a secondary, single-leaf entry on the east elevation. Other fenestration includes commercial, plate glass windows on the north elevation and filled-in fixed windows on the secondary elevations. A one-story awning extends from the façade (north elevation). It is supported by square, wooden posts and was formerly used as covered eating space. A one-story, lean-to was added to the west elevation.

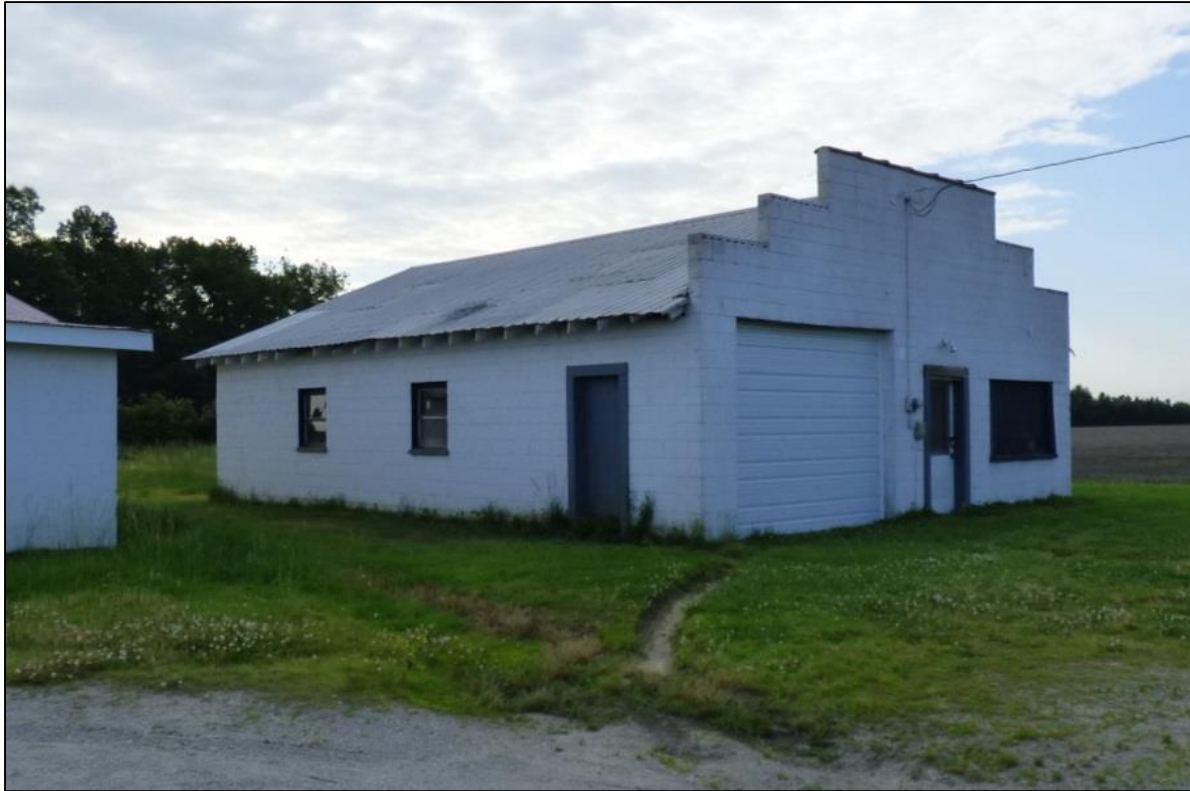
A mid-twentieth century garage is located immediately south of the store and was likely constructed around the same time (noted as resource 7 on Figure 38, p. 113) (USGS 1974, 1977). The one-story concrete-block building faces west toward Leggett Mill Road and is covered by a front-gabled roof sheathed in corrugated metal (Photo 87, p. 118). A stepped parapet with metal coping is located on the west elevation and exposed rafters are visible on the north and south elevations. There are two entrances on the west elevation: a single-leaf, pedestrian door and a metal garage door. A secondary entry is situated on the north elevation. Other fenestration includes a double-hung-sash windows and a fixed window.

Photo 87: Garage on Leggett Mill Road, Northwest Oblique.
