SUBJECT: Historic Structures Survey Report for widening and upgrade NC 125/SR 1142
(Prison Camp Road) from NC 903 to SR 1172 (East College Road), R-4705,
Martin County, ER 15-0346

HISTORIC ARCHITECTURAL ELIGIBILITY EVALUATION

WIDEN AND UPGRADE

NC 125/SR 1142 (PRISON CAMP ROAD)

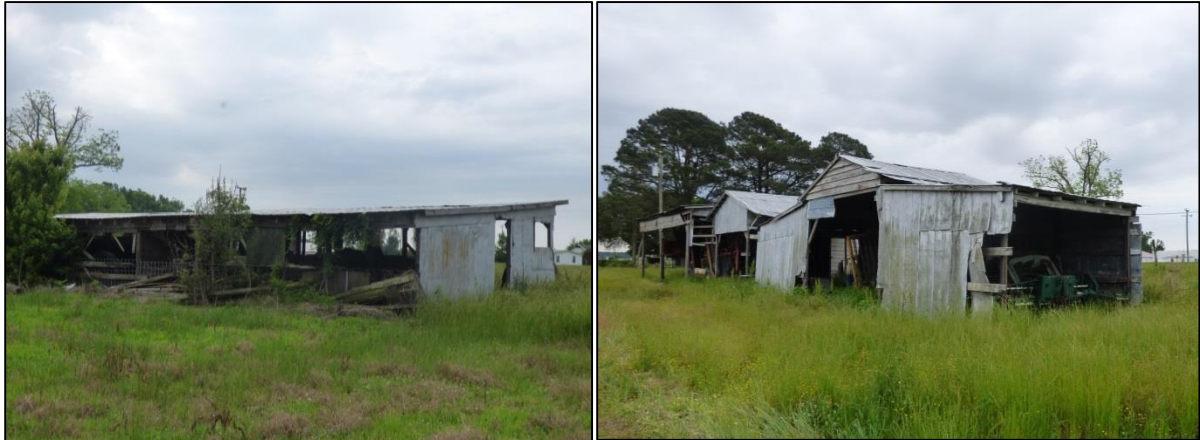
The remaining third-quarter of the twentieth-century buildings within Church Cross Roads are located on the west side of Wynn Road south and southeast of the Cross Roads Christian Church (USGS 1977). One of these is a one-story, multi-bay building constructed for machine storage (noted as resource 3 on Figure 38, p. 113) (Photo 88, p. 119). It faces south toward Prison Camp Road and has a frame structural system clad in sheets of metal on the eastern side and left open-air on the western half. It is covered by a shed roof sheathed in v-crimp metal. Southeast of the church is a cluster of outbuildings comprises three individual buildings constructed around the same time (noted as resource 4 on Figure 38, p. 113) (Photo 88) (USGS 1977). The westernmost building has a frame structural system originally clad in weatherboard and covered by a front-gabled roof sheathed in metal. It features an open bay for machine entry on the north elevation and a single-leaf pedestrian entrance on the east elevation. This building has two shed-roofed wings clad in metal: one that extends from the west elevation and one that extends from the east elevation. The central building has a rounded log framing system that predominately open-air, with the exception of the metal siding within the gable ends. The structure is covered by front-gabled roof. The easternmost building is the largest of the machinery sheds. It is a one-story, two-bay structure with a shed roof sheathed in v-crimp metal that is supported by round logs and simple bracing.

Photo 88: Machine Shed (Left) and Cluster of Outbuildings (Right) within Church Cross Roads.

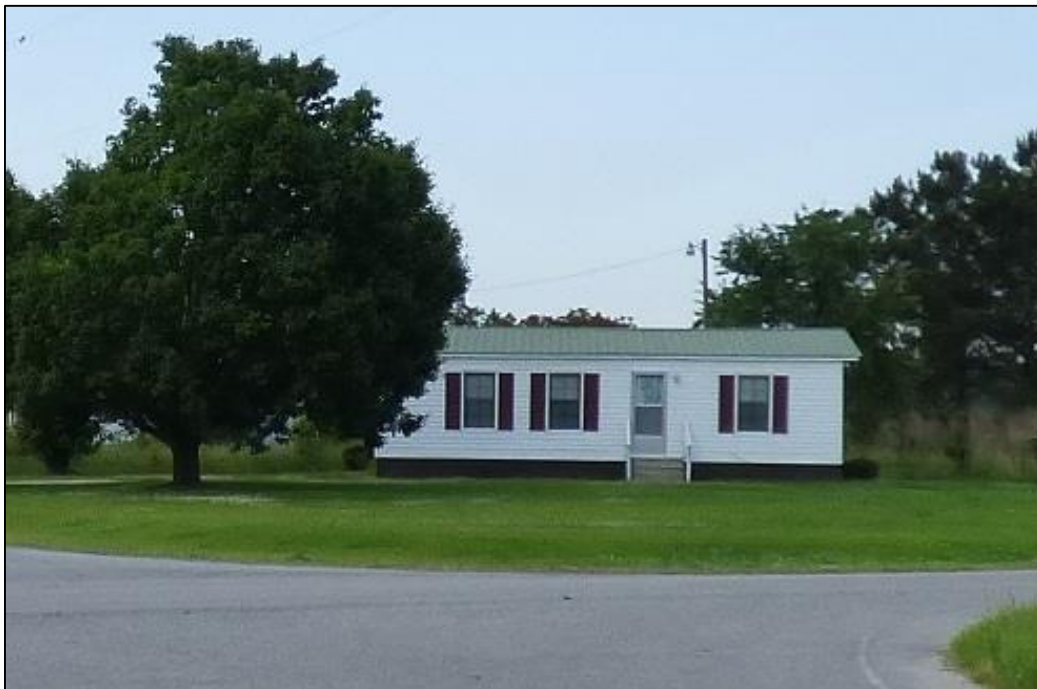
Three buildings, all residential, date to the fourth quarter of the twentieth century (Photo 89, p. 119). They are all one-story in height and are clad in vinyl siding. The dwellings are covered by side-gabled or hipped roofs sheathed in asphalt shingles. Each has vinyl windows and pressed wood doors and, on a whole, are not adorned with elements of great decorative detail. These are noted as resources 5, 6, and 9 on Figure 38, p. 113.

Photo 89: 1028 Leggett Mill Road, an Example of a Late-Twentieth Century House in Church Cross Roads, Looking Southwest.

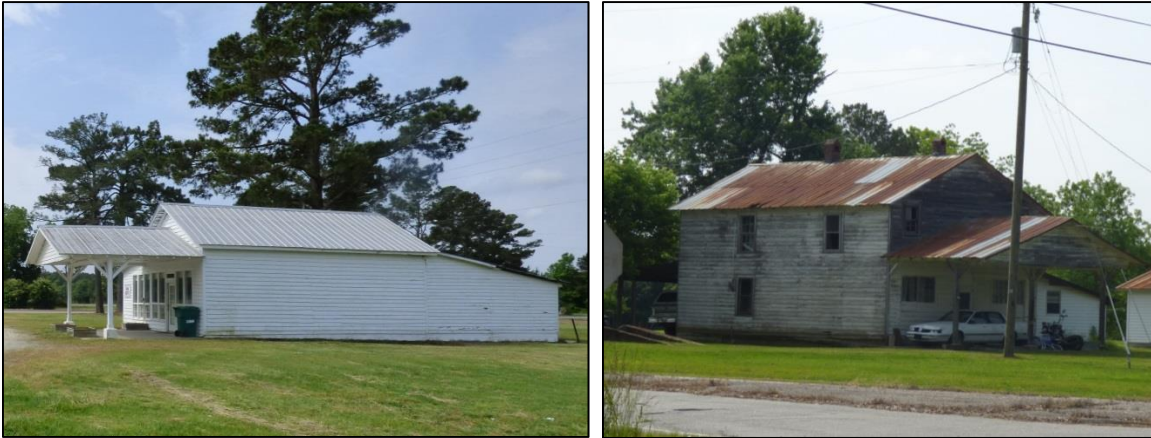
A good comparison of a rural, Martin County crossroads community is Corey's Crossroads (MT0287), located at the intersection of NC 17 and Smithwick Creek Church Road (SR 1106). This resource dates to the early-twentieth century—later than Church Cross Roads; however, it retains many of its original buildings including Corey's Store, Rogerson's Store, Rogerson House, Beecham House, and four circa-1915–1956 houses. On a whole, this community appears to retain a higher level of architectural integrity than Church Cross Roads. In 2011, Corey's Crossroads was determined not eligible for the NRHP under Criteria A–C (NC-HPO 1992l).

Photo 90: Corey's Store (Left) and Rogerson's Store (Right)
Within Corey's Crossroads (MT0287).

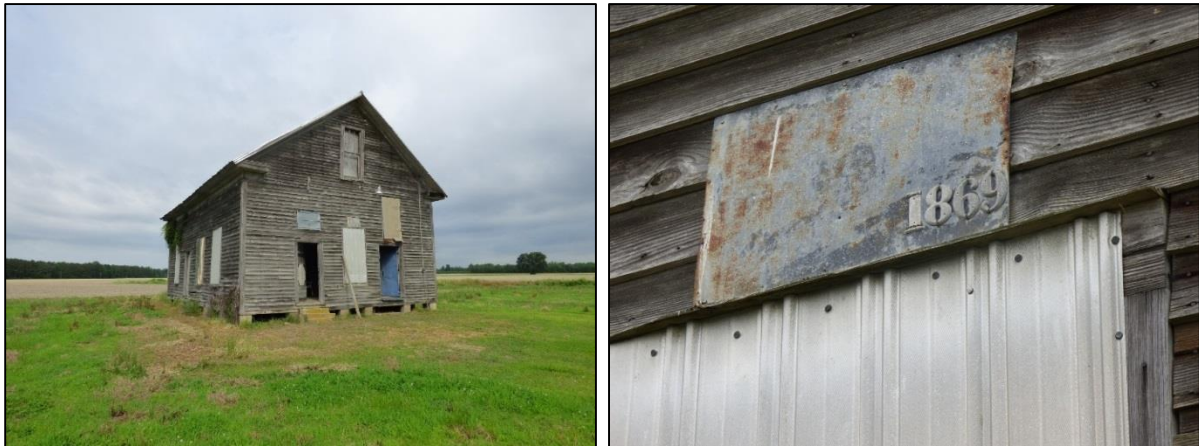
The primary resource is a one-and-one-half-story, three-bay church built circa 1890. Access to the property was granted by the current owner, Frank Wynne Jackson, and it was previously documented by Donna Dodenhoff during a survey conducted in 1992 (NC-HPO 1992m). During that investigation, Dodenhoff determined that the “austerely plain, tall-gable-front church is among a handful of Martin County rural churches that date to the third quarter of the nineteenth century” (NC-HPO 1992m). The church was organized in 1857 by Stanley Ayers and, at the time, services were held in a log building, constructed in 1869 located in Crossroads Township (Manning and Booker 1974:125). According to Jackson, a 20-foot long log from the log building was utilized in the construction of the foundation of the wood-framed church building. There is also a rectangular piece of flat pressed metal that is embossed with “1869” located on the primary (east) elevation of the building that is also said to have come from the log building (Photo 91) (Frank Wynne Jackson, personal communication 2015).

Photo 91: Primary Resource, Southeast Oblique (Left); Detail on Façade of Primary Resource (Right).

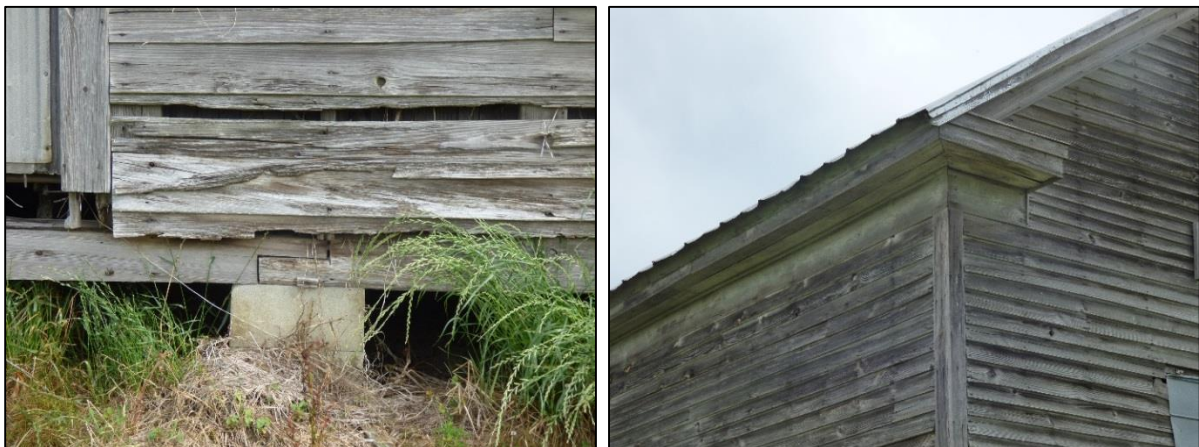
The resource is raised on a concrete-block pier foundation that is a replacement, most likely from when the building was moved in 1950. The log utilized from the old log building is used as a sill plate that is connected by squared notching to other timber sill plates. The timber-frame structural system is clad in lapped, weatherboard siding with wood cornerboards. The building is covered by a moderately pitched, front-gabled roof that features boxed eaves, a wooden boxed cornice, and prominent gable returns. The roof is sheathed in v-crimp metal which is a replacement of the original wood shingles (Photo 92, p. 129). In 1936, it was recorded that significant building improvements were made which included “a new roof, new ceiling, new mats on the floor, and new shades” (Honican 2013; Martin County Historical Society 1980:6). Although it is no longer visible from the exterior of the building, at one time a central-interior, brick chimney pierced the ridge of the roof. The brick chimney flue was visible from the interior of the building and it was connected to a metal stove in the middle of the church (Frank Wynne Jackson, personal communication 2015).

Photo 92: Primary Resource Detail of Foundation (Left); Detail of Roof Eave (Right).

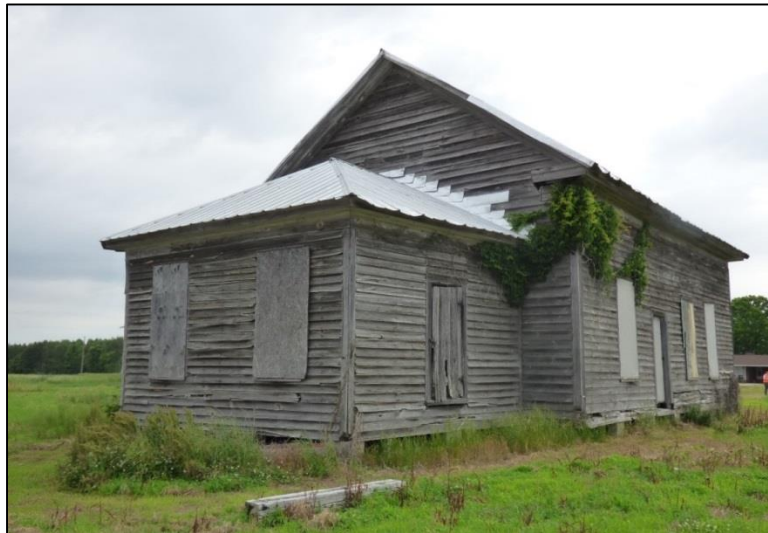
Possibly during the 1936 renovation, a one-story, pulpit addition spans the rear (west) elevation of the church (Photo 93, p. 130). The addition is also raised on concrete-block piers, and the timber-frame structural system is clad in lapped, weatherboard siding with wood cornerboards. The addition is covered by a hipped roof with boxed eaves sheathed in v-crimp metal. A secondary entrance is located on the west elevation and is filled with a single-leaf, board-and-batten door. The door was added into what was previously a window opening; this is affirmed by wood siding filling in the open space above the door. Other fenestration is covered by plywood board.

Photo 93: Pulpit Addition on Primary Resource, Southwest Oblique.

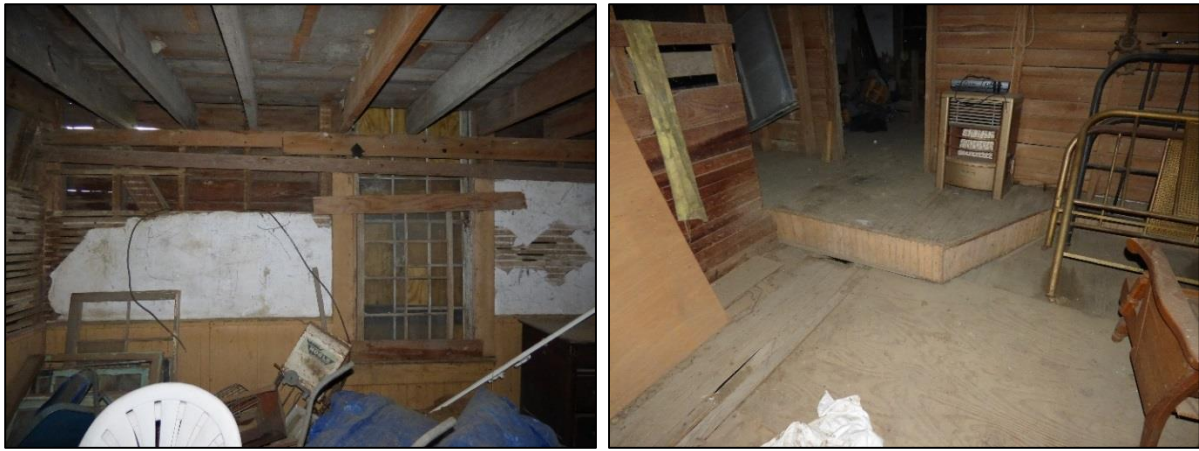
Jackson, Sr., attempted to keep a majority of the interior components untouched such as the original plaster walls, wainscoting, and flooring (Photo 94). However, Linwood Jackson, Sr. added a second-story floor and converted the building into general storage and multi-purpose, agricultural use. Currently, the interior walls are in fair condition. Lathing is exposed in a majority of the building where the plaster is falling off of the walls. Wood boards have also been nailed beneath the added second-story floor to hang tobacco (Frank Wynne Jackson, personal communication 2015). The original floor boards are partially protected by plywood boards and the pulpit is still extant in the western portion of the building.

Photo 94: Exposed Lathing and Boarded Window (Left); Pulpit Addition (Right).

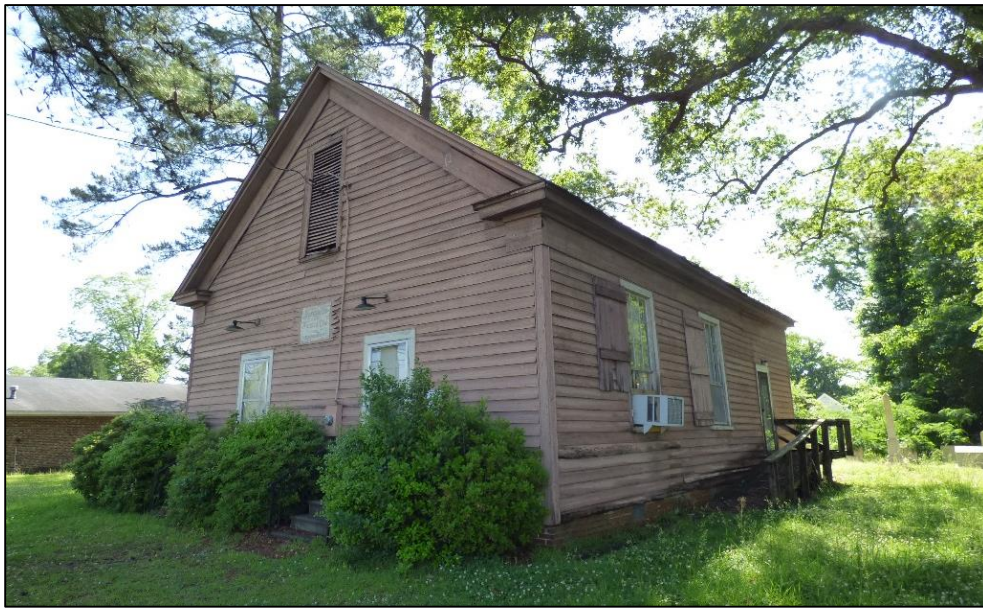
The Jamesville Primitive Baptist Church (MT0098), a one-and-one-half-story, frame, church located in Jamesville, was constructed between 1850 and 1870 and is a prime example of a rural church building in Martin County (Photo 95) (Little and Cross 1984). The building originally rested on a brick-pier foundation and features many original characteristics of the

construction such as weatherboard siding, a large box cornice with returns, wood-frame windows, and two entrances on the façade. The land that the building sits on was donated by a wealthy landowner and minister of the church, Clayton Moore (1814–1881). The frame church was constructed because the original church located on Moore’s plantation was burned during the Civil War. The property was given to the Jamesville Women’s Club in 1953, who continue to utilize it as their headquarters. The Jamesville Primitive Baptist Church is listed in the NRHP under Criterion C as the building “embodies the distinctive characteristics of churches [...] popular during the last half of the nineteenth century throughout North Carolina and is distinguished by double entrances and boxed cornices with returns” (Little and Cross 1984).

Photo 95: Jamesville Primitive Baptist Church, West Oblique (MT0098).

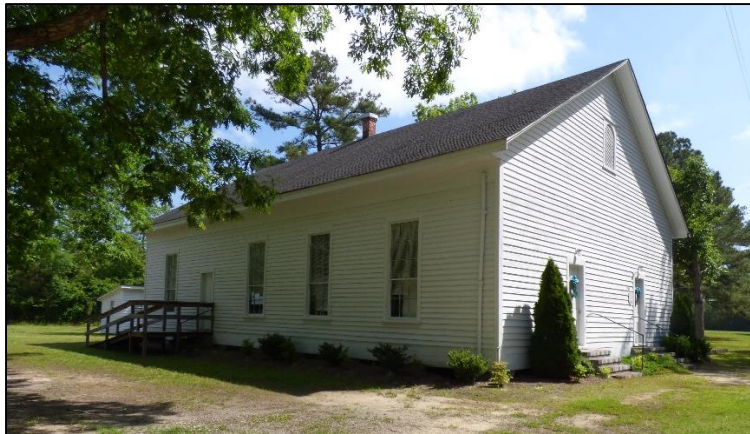
Another good example of a one-and-one-half-story, frame church is the Smithwick’s Creek Primitive Baptist Church (MT0267) located in rural Farm Life, Martin County (Photo 96, p. 138) (Sandbeck 2004). The church, constructed in 1897, still retains its original weatherboard siding, central brick chimney, wood-frame windows, boxed eaves, and two entrances on the façade. Associated with the church is a circa-1892, frame, baptismal house that was moved about a mile east to the current location. The resource is listed on the NRHP under Criterion C for its intact structural system and high-level of historic integrity and is an exemplary example of a “traditional front-gable frame meeting house format” (Sandbeck 2004). As a religious property, the church meets Criteria Consideration A for “its intact design and construction” (Sandbeck 2004).

Photo 96: Smithwick's Creek Primitive Baptist Church, Southwest Oblique (MT0267).

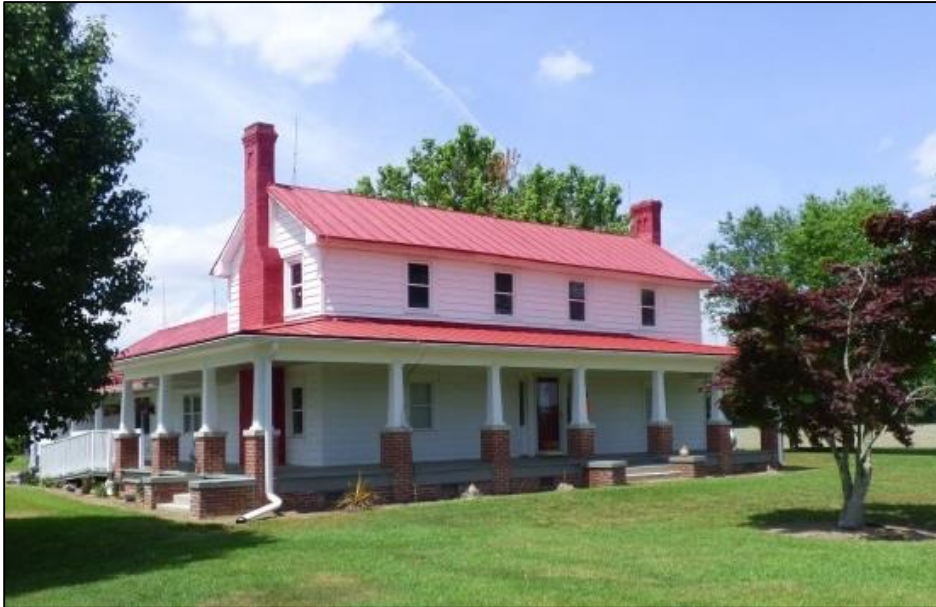
The primary resource of the Roebuck-Roberson Farm is a two-story, three-bay dwelling (Photo 97, p. 142). Although access to this property was not granted during the current undertaking, Donna Dodenhoff completed a survey in 1992, at which time access to the farm and interior of the house was permitted. During the detailed investigation of the building's exterior and interior, Dodenhoff determined that the "original section of the heavy-timber framed house, probably built in the 1835–1845 period, was a one-room deep, side hall plan dwelling with an enclosed winder stair rising to the upstairs room from a rear corner of the downstairs room" (Butchko 1998:150–151; NC-HPO 1992n). She also notes that "in the 1850s this house was expanded to a center-hall plan residence by the construction of the block to the left of the hall" (Butchko 1998:150–151; NC-HPO 1992n).

The building's foundation was not visible during the current survey but the timber-frame structural system is clad in vinyl siding (added between 1992 and 2015), which likely covers the weatherboard siding (NC-HPO 1992n). A moderately pitched, side gabled roof sheathed in standing-seam metal caps the house. A wooden box cornice lines the eaves on the south (primary) and north (rear) elevations. According to the 1992 survey, the gable ends were once adorned with wooden saw tooth trim; however, this is no longer present or visible. Two exterior-end, brick chimneys are located at the east and west elevations. The eastern chimney (likely original to the circa-1840 house) is larger than the one on the west elevation and

Photo 97: Southwest Oblique of the Primary Dwelling at the Roebuck-Roberson Farm.

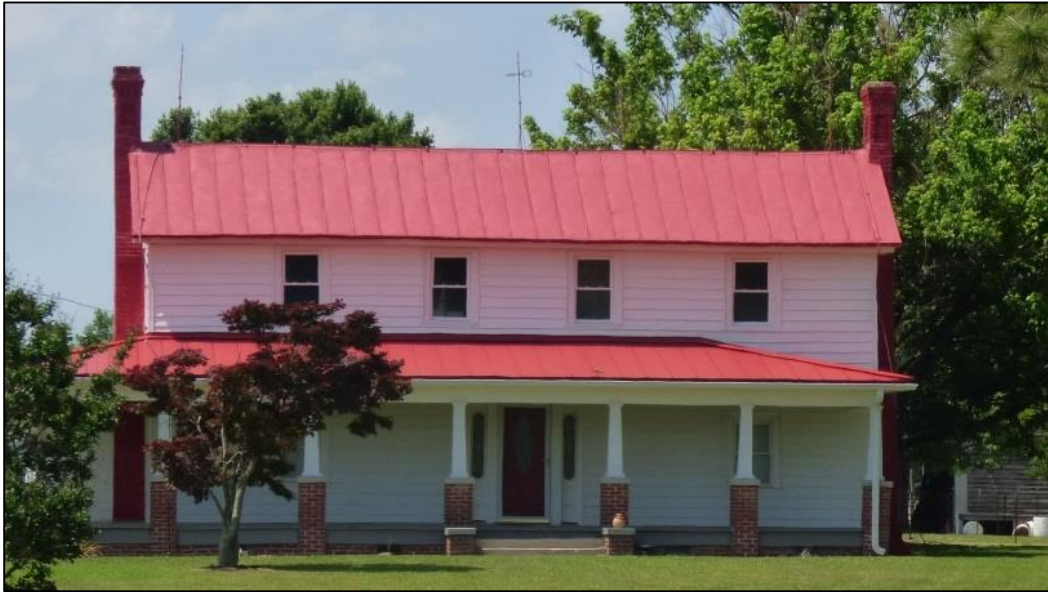
A one-story, wraparound porch extends from the south and west elevations (Photo 98, p. 143). The hipped roof is sheathed in standing-seam metal and supported by wooden, tapered posts set on square, brick plinths; these Craftsman-style posts suggest that the porch was constructed in the early-twentieth century (Butchko 1998:150–151; McAlester 2013:568–572). A continuous brick foundation supports the porch, which is accessed by a set of poured-concrete steps on the south elevation and another set on the west elevation.

Photo 98: South Elevation of the Primary Dwelling.

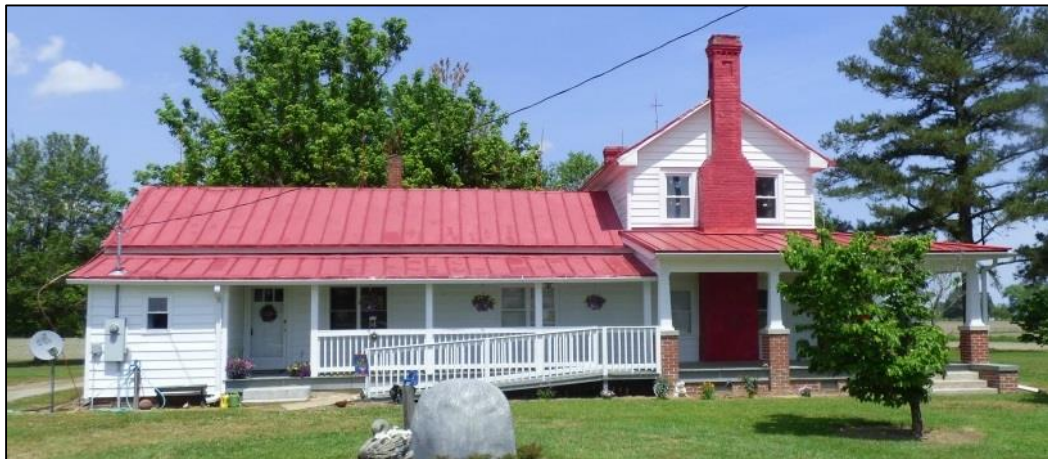
Photo 99: West Elevation of the Rear Ell.

A one-story, rear-ell addition was built onto the northeast elevation in the early-twentieth century (Photo 99, p. 143) (NC-HPO 1992n). It is set on a continuous brick foundation, and the structural system is clad in vinyl siding, which was likely placed on top of older siding. A gabled roof sheathed in standing-seam metal covers the addition; the eastern slope of the ell's roof is pierced by an interior, brick chimney. A single-leaf, wood-paneled door with three fixed lights at the top is located on the west elevation. Other fenestration on the ell includes paired, replacement one-over-one, vinyl windows. As a continuation of the wrap-around porch along the main core of the house, a one-story porch lined with a wooden balustrade is located on the west elevation of the ell. It is covered by a shed roof sheathed in standing-seam metal and supported by square posts. Since 1992, the owners added a wooden ramp to

the porch's west elevation. A one-story, one-bay, shed-roof addition extends from the northernmost bay of the ell's west elevation. It is set on a continuous, brick foundation and is clad in vinyl siding. It features a one-over-one, vinyl window on the west elevation. On the west elevation of the ell is a one-story, full-width addition. Similar to the other portions of the house, it is clad in vinyl siding and is covered by a shed roof sheathed in standing-seam metal. A brick, interior chimney pierces the slope of the roof. Because access to the property was not permitted, not enough architectural data was collected to determine an approximate date of this addition.

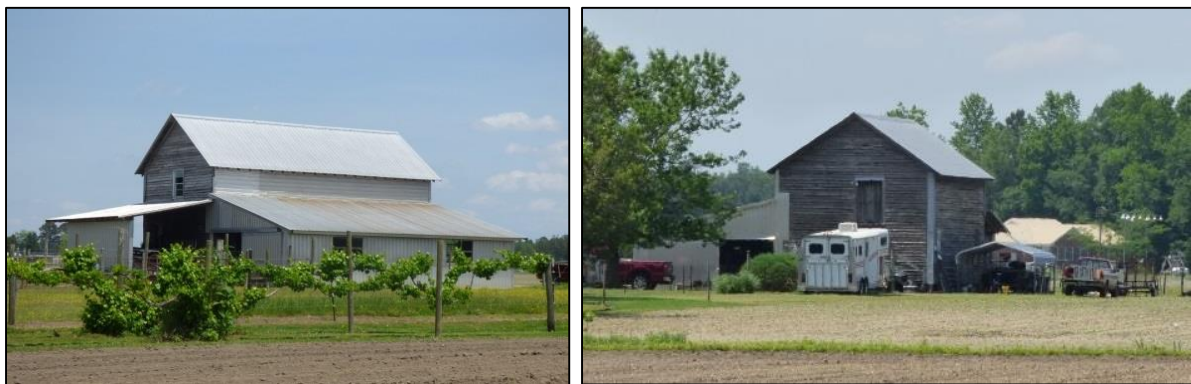
Photo 101: Northwest (Left) and Southeast (Right) Obliques of the Barn.

A barn is located east of the horse stable and north of the dwelling. Its form and massing are similar to the horse stable, which suggests that it was constructed around the same time (circa 1900) (Photo 101). This outbuilding was moved to its current site between 1993 and 1998 (Google Earth 1993, 1998; NC-HPO 1992n; USGS 1957). The 1957 aerial shows a cluster of medium- to large-sized agricultural outbuildings located immediately west of the farmhouse across Belmont Church Road (see Figure 48, p. 144). These structures are no longer extant; however, it is possible that this barn was moved from that location sometime after 1992 (NC-HPO 1992n; USGS 1957). The structural system, possibly heavy-timbered like the stable, retains some original weatherboard siding (north, south, and east elevations) and has replacement metal siding on the west elevation. It is covered by a front-gabled roof sheathed in metal with exposed, wooden rafters below along the eaves. There are two, single-leaf, wood doors on the primary (south) elevation: one on the first story and one on the second story. A secondary entrance is located on the north elevation. A one-story, one-bay, shed-roofed wing extends from the west elevation. It is clad in metal and features a sliding metal door on the south elevation. Another one-story, shed-roofed wing is located on the north elevation.

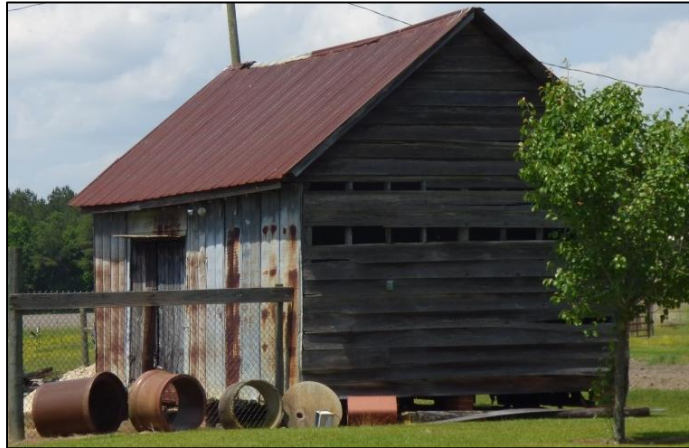
Photo 102: Southwest Oblique of the Corn Barn.

Immediately south of the horse stable is a structure that was noted during the 1992 survey as a corn barn. In 1992, there were two corn barns; however, today only one, the southernmost, survives (NC-HPO 1992n). This one-story, circa-1900 structure is raised on brick piers and rough weatherboard siding covers the frame structural system on the north, south, and east elevations and metal sheets are affixed on the west elevation (Photo 102). The corn barn is capped by a side-gabled roof sheathed in v-crimp metal with exposed rafters on the east and west elevations. Fenestration comprises an off-centered, wooden, double-leaf door attached to the west elevation with metal strap hinges.

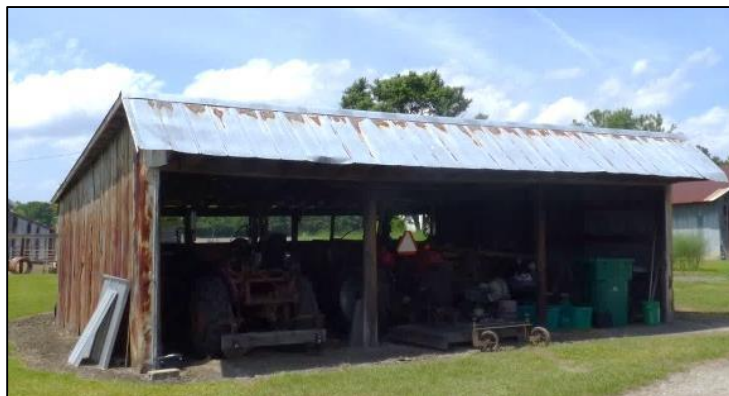
Photo 103: Southwest Oblique of the Garage/Machine Shed.

Situated just north of the driveway that extends from Belmont Church Road is a one-story, three-bay outbuilding that originally functioned as a garage; however, it is currently used as a machine shed. This circa-1950 structure is visible on a 1957 aerial photograph of the area (NC-HPO 1992n; USGS 1957). The post-in-ground frame system is set directly into the ground and is clad in v-crimp metal (Photo 103). A salt-box roof, also sheathed in v-crimp metal, covers the building; exposed wooden rafters are visible on the north elevation. Three rounded logs support the roof on the primary (north) elevation and create three open bays.

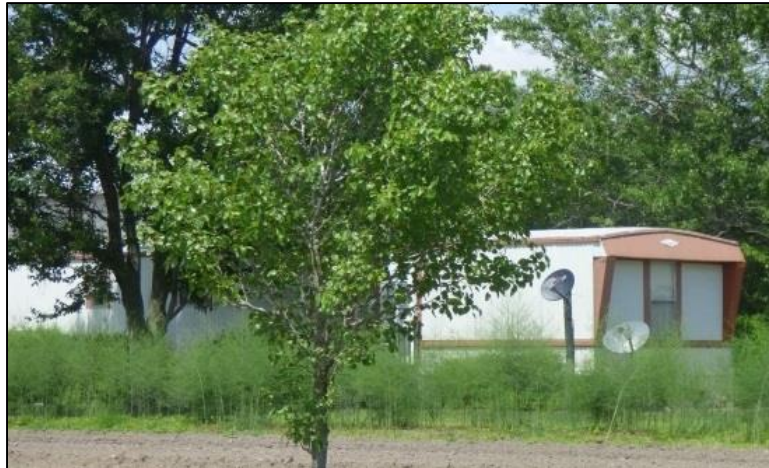
Photo 104: Southwest Oblique of the Trailer.

A circa-1980 mobile home is located north of the house and east of the corn barn. It is one-story in height and clad in metal (Photo 104). A low-pitched, arched roof sheathed in metal covers the structure. The main entrance is off-centered on the west elevation and is filled by a pressed wood door. Other fenestration includes one-over-one, metal, double-hung sash windows.

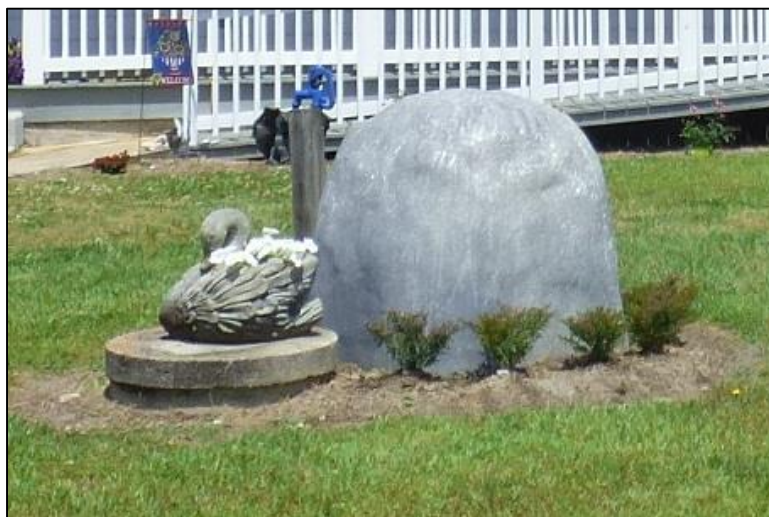
Photo 105: Two Wells, Looking East.

There are two wells located west of the farmhouse and south of the driveway (Photo 105). One was covered by a rock-shaped cover; as such no information could be obtained about this object. The second well likely dates to the mid-twentieth century. It is circular in shape and made of poured concrete and is covered by a poured-concrete cap. During the 1992 survey, Donna Dodenhoff noted a well house; it is unknown around which well the house was situated (NC-HPO 1992n).

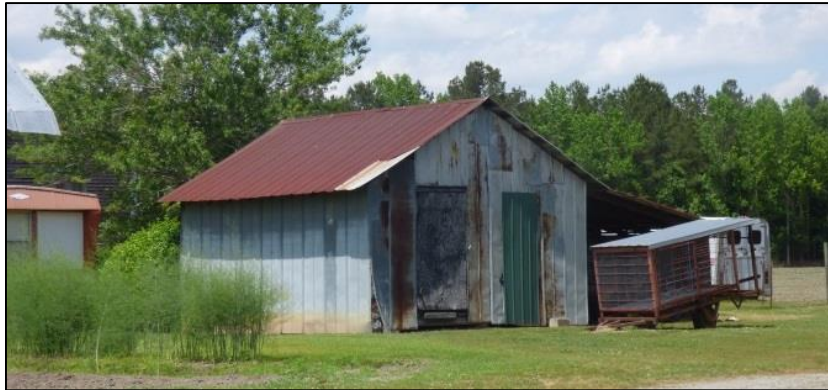
Photo 106: Shed, Southwest Oblique.

North of the house and south of the trailer is a circa-1940, one-story, two-bay shed (Photo 106). It is clad in v-crimp metal and is covered by a front-gabled roof sheathed in the same material. The primary entrance is off-centered on the south elevation. It is filled by a single-leaf, wooden door. A window, also on the south elevation, is covered by a sheet of metal. A one-story, shed-roofed wing extends from the west elevation.

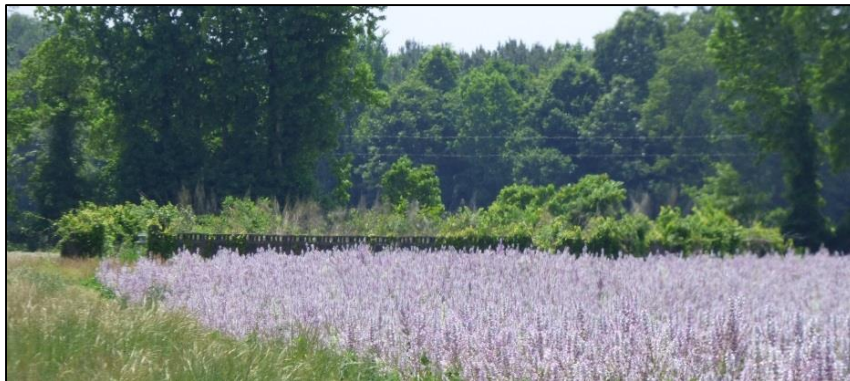
Photo 107: Cemetery Brick Wall Beyond the Sage, Looking West.

On the west side of Belmont Church Road is the Roebuck family cemetery (Photo 107). Access to the cemetery was not permitted during the current survey; however, aerial imagery shows that it square in shape and contains several marked interments. A brick wall is visible from the public right-of-way. It likely dates to the mid- to late-nineteenth century.

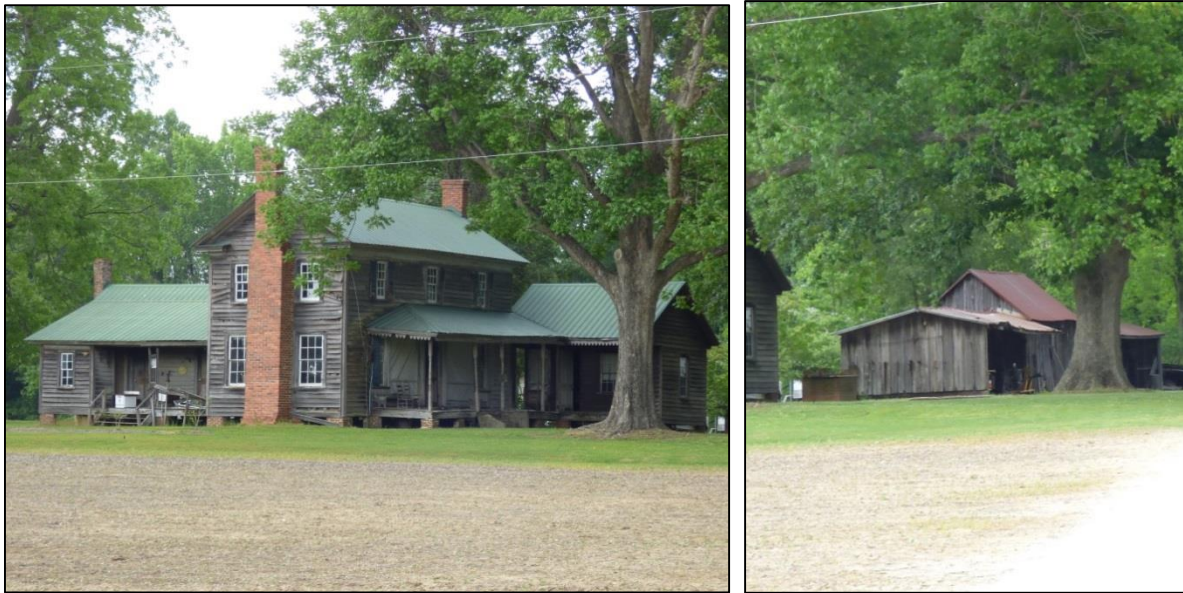
Photo 108: Dwelling (Left) and Outbuildings (Right) of the
W. W. Griffin Farm (MT0102)

Although it was constructed later than the Roebuck-Roberson house, a good example of a surviving farm with associated outbuildings is the W. W. Griffin Farm (MT0102) on Wendell Griffin Farm near Williamston in Martin County. The primary resource is a two-story, three-bay farmhouse constructed around 1902. The building, clad in weatherboard

siding, retains its original six-over-six, wood-frame windows, paneled door, sidelights with frosted glass, and wooden, carved, architrave trim (Photo 108). This building has a one-story porch on the façade and an ell on the rear elevation. In addition, the farm has a storage shed (circa 1920), machinery shed (circa 1970), corn crib (circa 1900) and attached garage (circa 1940) and machinery shed (circa 1960), cotton barn (circa 1910), hay barn (circa 1940), secondary dwelling (1994), and a well (circa 1930). Furthermore, the W. W. Griffin Farm retains a contributing agricultural landscape—including a cultivated field with a wooded border, a dirt farm lane, and two vineyards—which also contributes to the integrity of the farmstead. In 2001, the farm was listed in the NRHP under Criterion A for agriculture and Criterion C for its notable architectural style (Keane 2001).

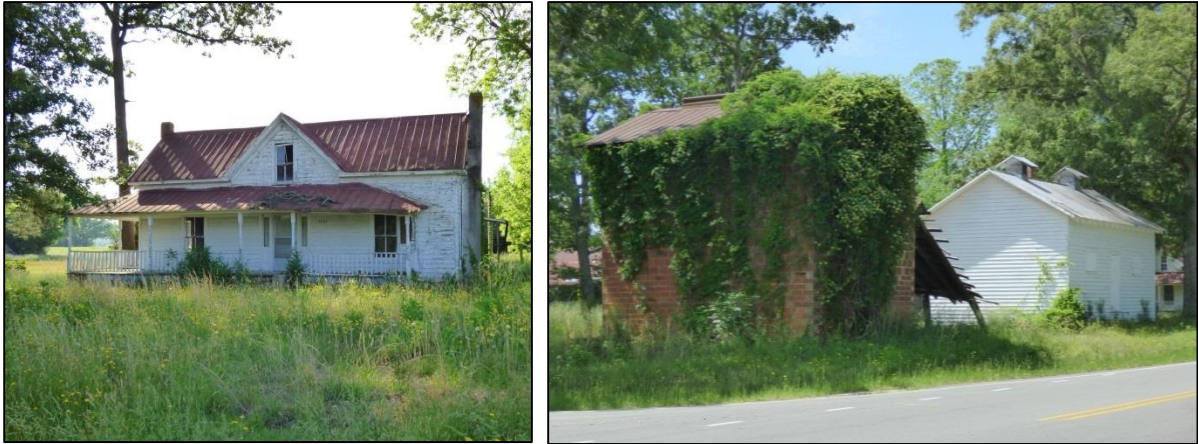
Photo 109: Dwelling (Left) and Associated Outbuildings (Right) of the Bowen Farm (MT0626)

Another great example of a surviving farmstead is the Bowen Farm (MT0626) (discussed in further detail on page 21). This nearby farm, located northwest of the Roebuck-Roberson Farm on Prison Camp Road, retains many historic outbuildings including a potato barn, tobacco barns (one clay and the remaining wood frame), several barns and stables, a chicken coop, machine shed, and a well and well house (Photo 109, p. 153). The Bowen Farm is a comprehensive early-twentieth century farm complex that represents many facets of Martin County farming.

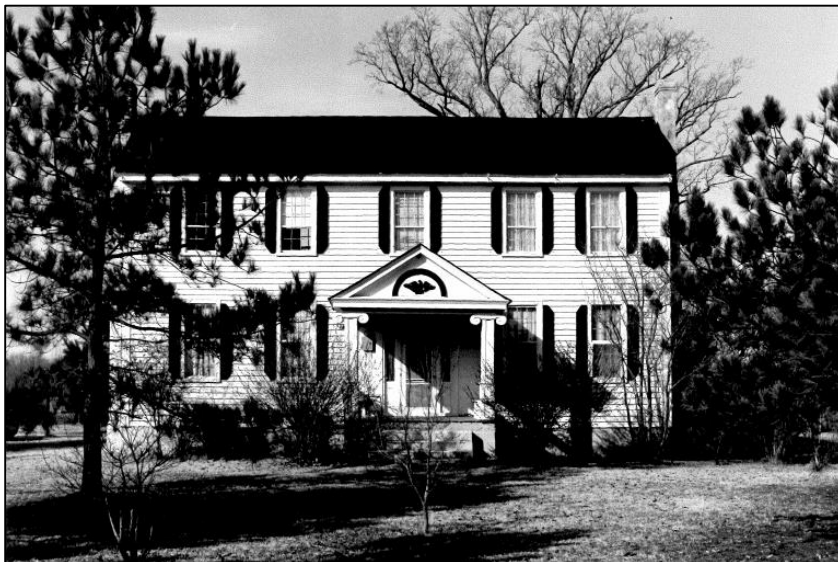
Photo 110: Sherrod Farm (Little and Sumner 1984)

There are several excellent examples of antebellum farms in Martin County that are architectural similar to the Roebuck-Roberson Farm. For example, the dwelling at the NRHP-listed Sherrod Farm (MT0099) is an antebellum farmhouse that was adapted throughout the nineteenth and twentieth centuries. The two-story, five-bay, single-pile house was constructed in the early-nineteenth century in the Federal style and after 1843, a one-story, Greek Revival-style portico was constructed to the façade. At the end of the nineteenth century, the owners expanded the one-story, rear ell to be two stories in height (Little and Sumner 1984).

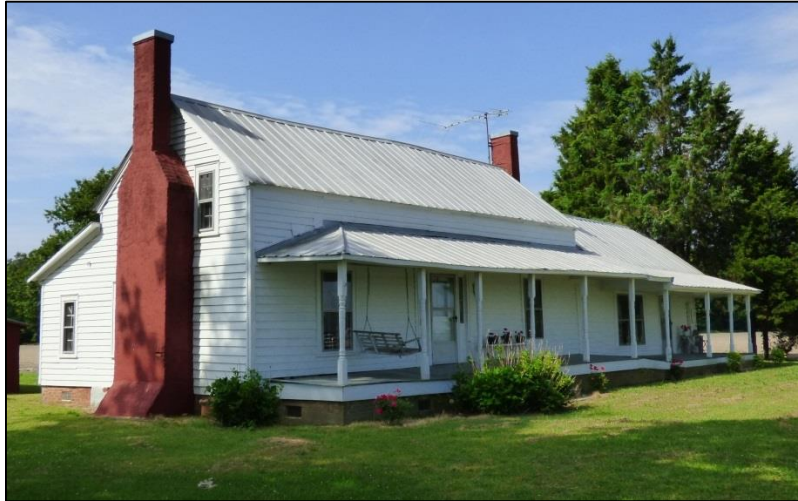
Photo 111: Dwelling of the Wynn Home Place.

A nearby example of an antebellum farmhouse that has good integrity is the Wynn Home Place (MT0384) (for an at-length discussion, see page 83). This story-with-a-jump, single-

family dwelling was constructed around 1845 and is set on a continuous brick foundation. The frame structural system is clad in weatherboard. The house retains much of its historic architectural fabric including: six-over-six and four-over four (on the second story), wood-frame, double-hung sash windows, wooden window surrounds, a wooden, paneled door with sidelights, and wooden corner boards. Furthermore, it retains many examples of both domestic and agricultural outbuildings including a smokehouse, chicken coop, tobacco barn, corn barn, and mule barn.

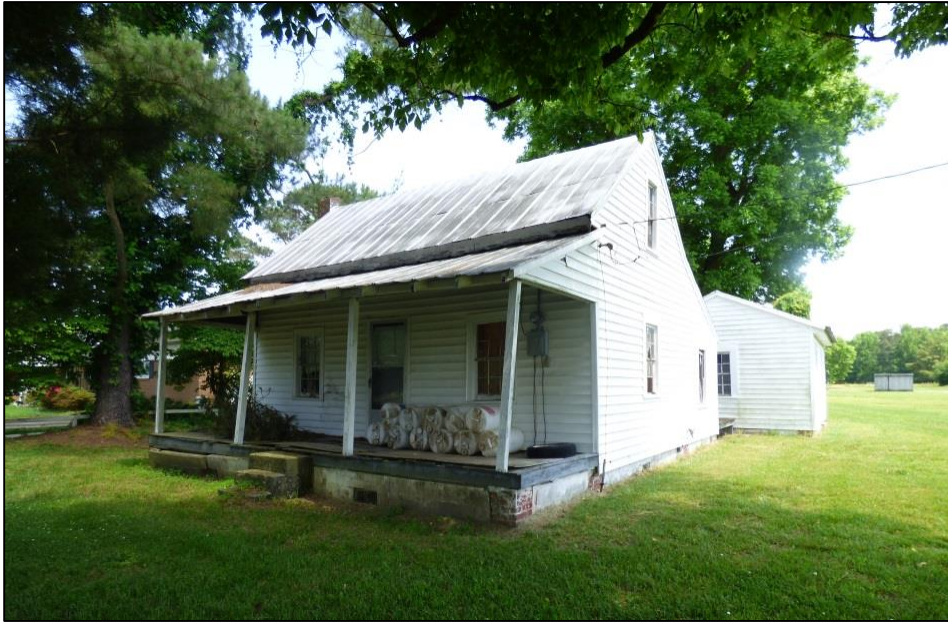
Photo 112: Carson-Roebuck Farmhouse, West Oblique.

The Carson-Roebuck farmhouse is a one-story, three-bay dwelling (Photo 112, p. 158). During the current survey, interior access was not granted; therefore, no details can be ascertained. However, a survey completed by Donna Dodenhoff in 1992 provides information pertaining to the interior of the dwelling. In her notes, Dodenhoff describes the dwelling as having “the hall-parlor plan characteristic of modestly scaled vernacular dwellings through the antebellum period. An enclosed winder stair rises from the parlor. The house is extended by both rear shed room and enclosed porch and breezeway that provide access to a one-room kitchen building” (NC-HPO 1992o). Dodenhoff also notes the Greek Revival features in the dwelling including mantels and doors (NC-HPO 1992o).

A brick-pier foundation with concrete-block infill supports what is likely a wood-frame structural system clad in vinyl siding. The house is capped by a side-gabled roof sheathed in v-crimp metal. Results from the 1992 survey state that rake boards adorned the flush gable ends (NC-HPO 1992o). These have since been replaced by a three-part vinyl cornice. An exterior-end brick chimney is flush against the northeast elevation.

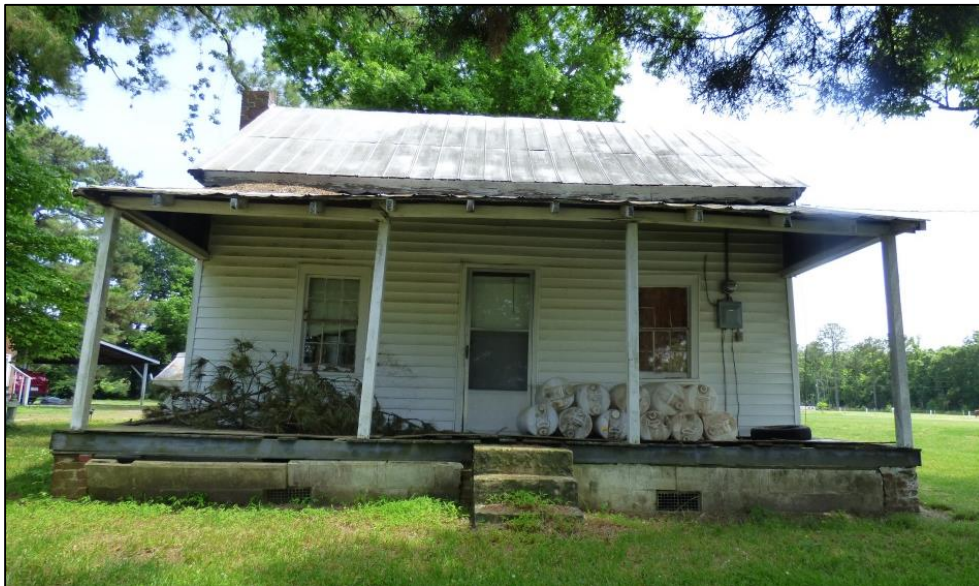
Photo 113: Façade (Northwest Elevation) of the Carson-Roebuck Farmhouse.

A one-story porch spans the northwest elevation (Photo 113, p. 158). It rests on a brick-pier foundation filled with concrete blocks and the v-crimp metal sheathed shed roof rests on squared wood posts. As noted by the findings in the 1992 survey, the porch was likely added in the 1920s. The porch roof exhibits exposed rafter tails with birdsmouth notching on the northwest elevation and a small concrete-block staircase provides access.

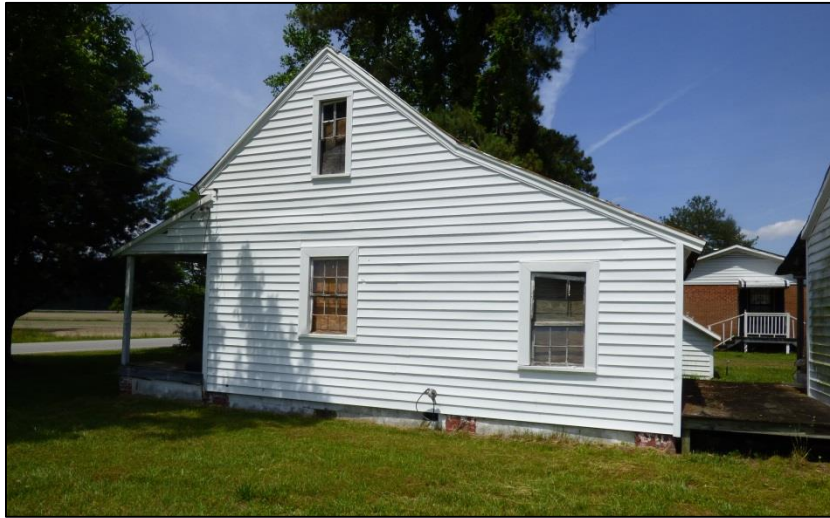
Photo 114: Carson-Roebuck Farmhouse, Southwest Elevation

Featured on the southeast elevation is a one-story extension (Photo 114). According to Dodenhoff's 1992 survey, a breezeway connected the main portion of the dwelling to a single-room kitchen just southeast of the dwelling (NC-HPO 1992o). The breezeway has since been removed, and a wood deck supported by square wood posts, covered by asphalt paper has been added.

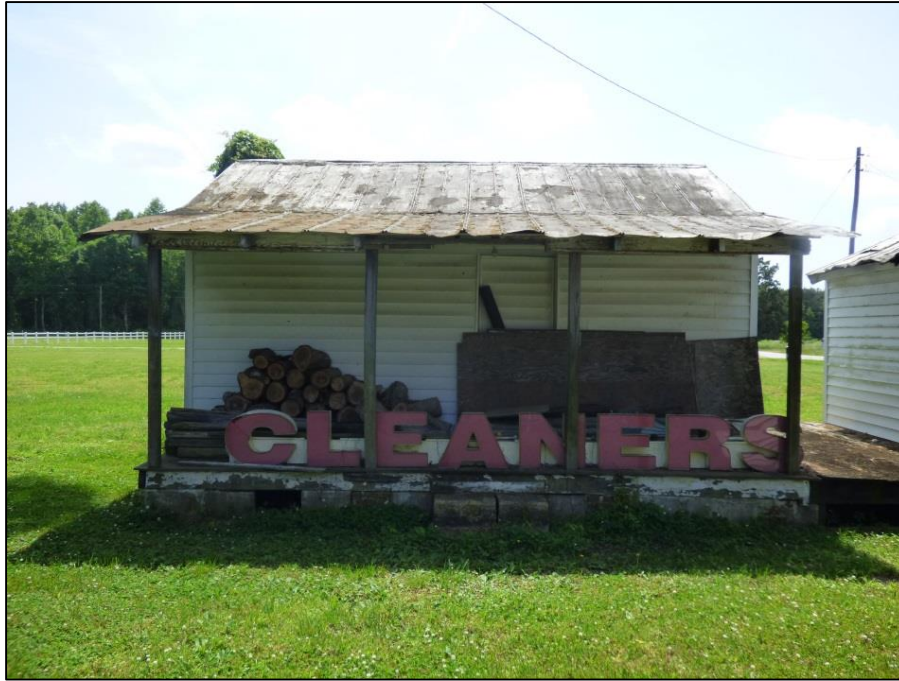
Photo 115: Detached Kitchen, Northeast Elevation.

The kitchen, located directly south of the dwelling, is a one-story, one-bay building (Photo 115). Typical of tenant houses throughout the region, kitchens were often added later (Bryant 1922:54). According to the 1992 survey, this kitchen was likely added in the 1920s (NC-HPO 1992o). The building rests on a brick pier foundation with concrete block infill. The exterior walls are clad in vinyl siding and covered by a low-pitched, side-gabled roof sheathed in v-crimp metal. The original brick chimney remains flush against the southeast elevation. The primary entry, a single-leaf door covered in vinyl siding, is located on the northeast elevation. Off-centered on the southeast elevation is a double-leaf door covered by vinyl siding. A one-story porch extends from the kitchen's northeast elevation. It rests on concrete blocks and is supported by square, wood posts. A shed roof sheathed in v-crimp metal with exposed rafter tails covers the porch. Since the porch exhibits similar construction methods and building materials as the porch on the Carson-Roebuck Farmhouse, it can be deduced that the porch on the kitchen was added in the 1920s (NC-HPO 1992o).

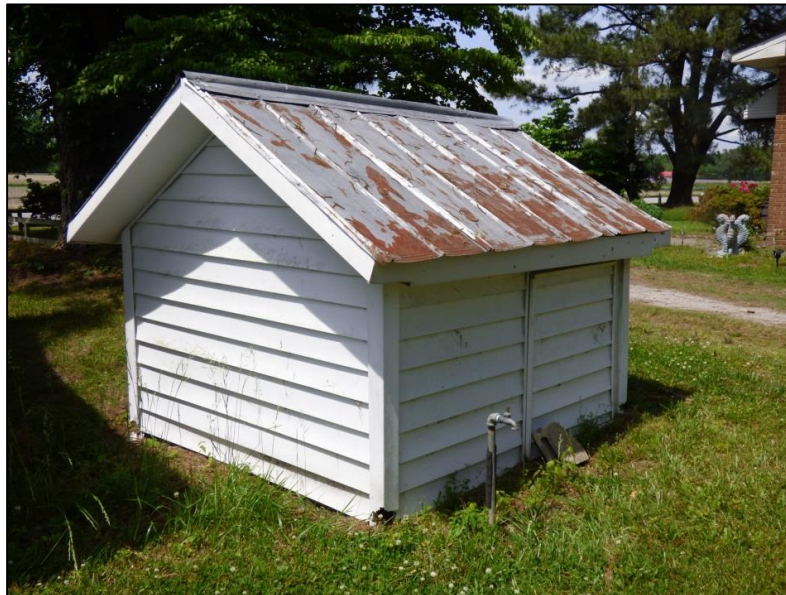
Photo 116: Pumphouse, South Oblique.

A one-story circa-1920 pumphouse sits directly east of the dwelling (Photo 116). The non-visible foundation and structural are covered by vinyl-siding cladding. The pumphouse is covered by a gabled roof sheathed in v-crimp metal.

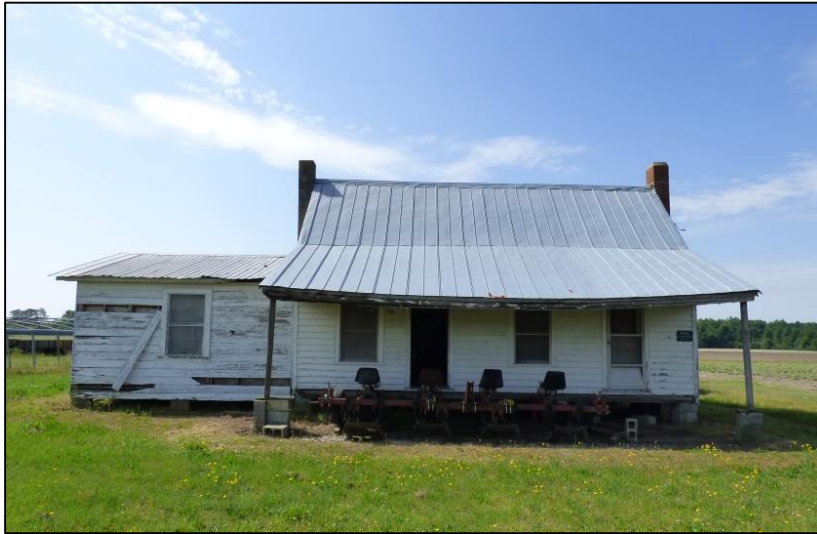
Photo 117: Façade (North Elevation) of the Alexander Mobley House.

The Alexander Mobley House (MT0385) exhibits a similar extended hall-and-parlor plan (Photo 117, p. 165). The one-story, side-gabled coastal cottage was built around 1840. The dwelling is situated on the south side of Prison Camp Road approximately 2 miles northeast of the Carson-Roebuck Farmhouse. The Alexander Mobley House has experienced deterioration and alterations including the removal of the porch floor, the sagging of the porch roof, the construction of various additions, and the construction of numerous non-

contributing outbuildings immediately surrounding the building. For further discussion, see the detailed write-up on page 71.

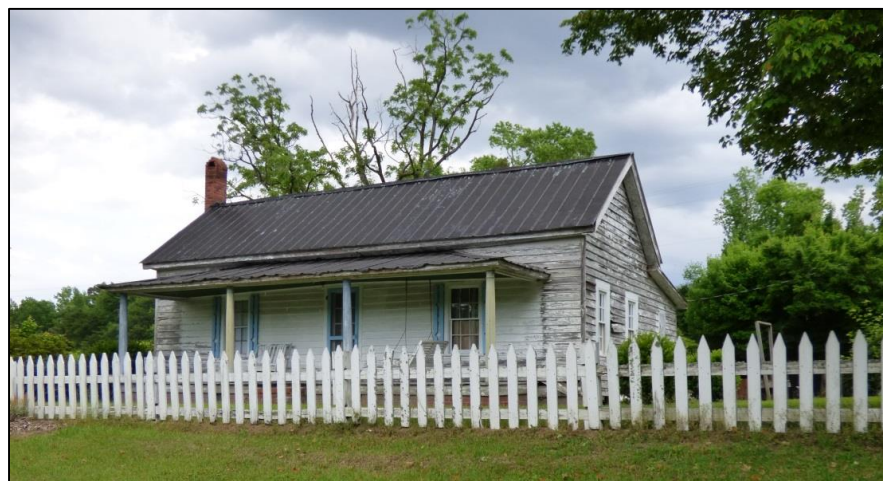
Photo 118: House, 1430 Reddicks Grove Church Road.

The dwelling at 1430 Reddicks Grove Church Road is a one-story, extended hall-and-parlor plan likely constructed in the mid-nineteenth century (Photo 118, p. 165). The dwelling rests on brick piers and is clad in weatherboard siding. A steeply pitched, side-gabled roof sheathed in v-crimp metal covers the dwelling. An exterior-end brick chimney is flush against the north elevation. Fenestration includes six-over-six, double-hung-sash, wood-framed windows. A porch supported by rounded wood posts and covered by a hipped roof spans the façade. While a later addition extends from the rear, the dwelling contains many similar features to the Carson-Roebuck Farmhouse.

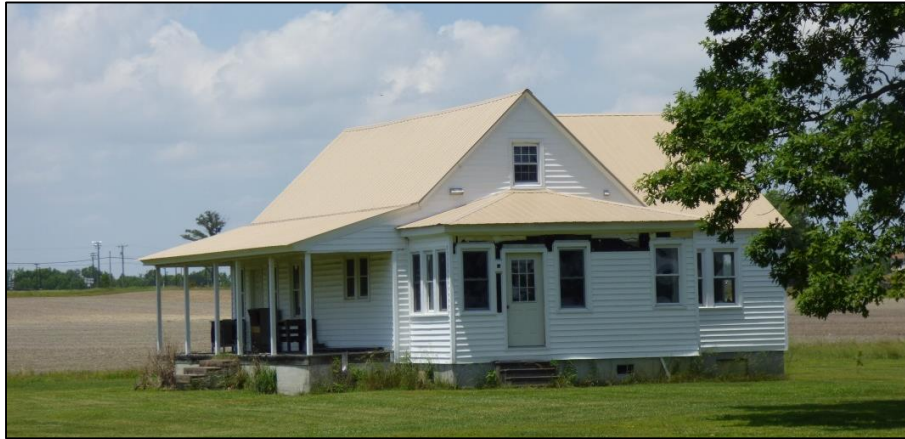
Photo 119: House, Bailey Road.

Another example of an extended hall-and-parlor dwelling in Martin County is located on Bailey Road (Photo 119, p. 166). This resource, a one-story, seven-bay, single-family dwelling, was likely constructed in the mid-nineteenth century. It contains numerous modifications and additions; however the overall form of the dwelling remains intact. The resource rests on a concrete-block foundation, and its structural system, likely wood frame, is clad in vinyl siding. A steeply pitched, side-gabled roof covers the dwelling. All original windows have been replaced. Similar to the Carson-Roebuck Farmhouse, a window is featured in the gable end. A one-story porch spans the non-symmetrical façade.
