SUBJECT: Historic Structures Survey Report for widening and upgrade NC 125/SR 1142
(Prison Camp Road) from NC 903 to SR 1172 (East College Road), R-4705,
Martin County, ER 15-0346

HISTORIC ARCHITECTURAL ELIGIBILITY EVALUATION

WIDEN AND UPGRADE

NC 125/SR 1142 (PRISON CAMP ROAD)

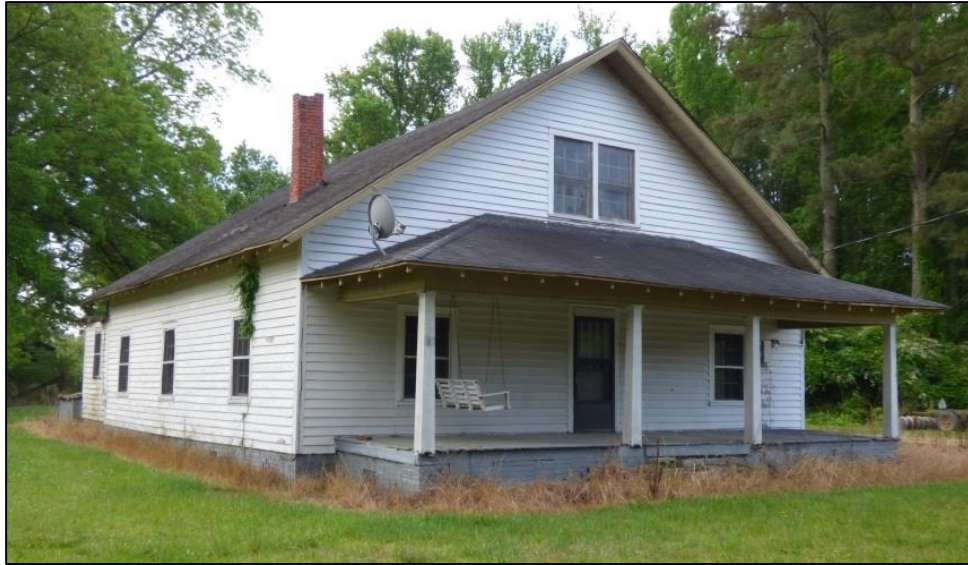
Photo 121: C.M. Wynn House, Northeast Oblique.

C.M. Wynn House is a one-and-a-half story, three-bay single-family dwelling constructed around 1920. A one-and-a-half story and a story-and-a-jump dwelling both have a usable living space within the sloping roof; however, a story-and-a-jump house features a slightly extended half-story wall above the top plate. The style and form of this house is common among early-twentieth-century residences throughout the rural regions of Martin County (Photo 121, p. 171). The building sits upon a brick foundation laid in a stretcher-bond configuration; built-in, metal vents are visible on the east and west elevations. It is of frame construction and clad by nailed weatherboard with wooden corner boards located at each corner. A moderately pitched, front-gabled roof sheathed in asphalt shingles covers the building. The eaves of the roof are lined with a wooden rake board on the north (primary) and south (rear) elevations and exposed rafters are visible on the east and west elevations. A hole in the roof is located on the east elevation. There are two, interior-slope, brick chimneys laid in a stretcher-bond configuration: one on the east elevation and one on the west elevation.

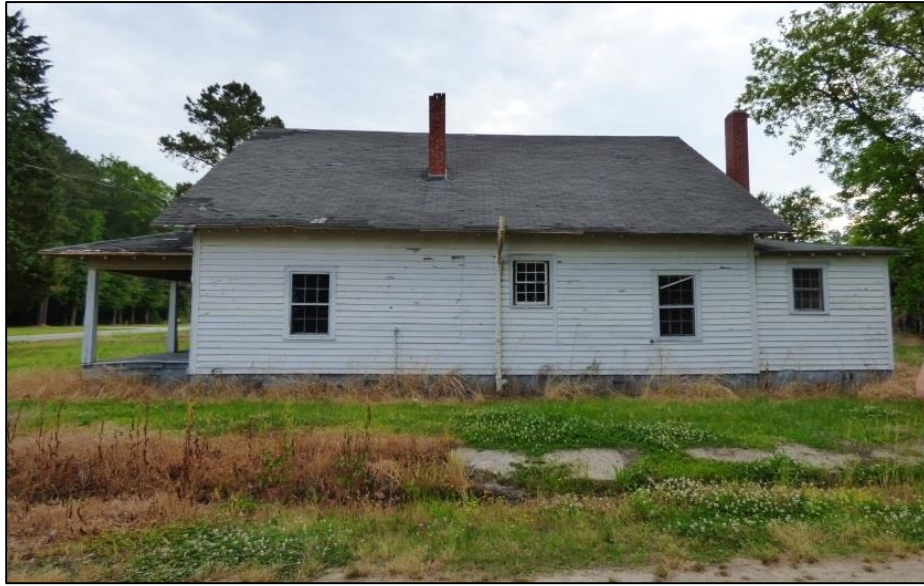
Photo 123: C.M. Wynn House, West Elevation.

The main entry is centered on the north elevation and filled by a wooden, paneled door with five fixed lights at the top and an exterior metal storm door (Photo 122, p. 171). Other fenestration include single and paired, wood-frame, six-over-six, double-hung sash windows. Visual evidence suggests that a full-size window was once located on the west elevation; however, it was replaced with a smaller, six-over-six, wood-frame double-hung sash window (Photo 123, p. 172). One side of the original wooden window frame remains.

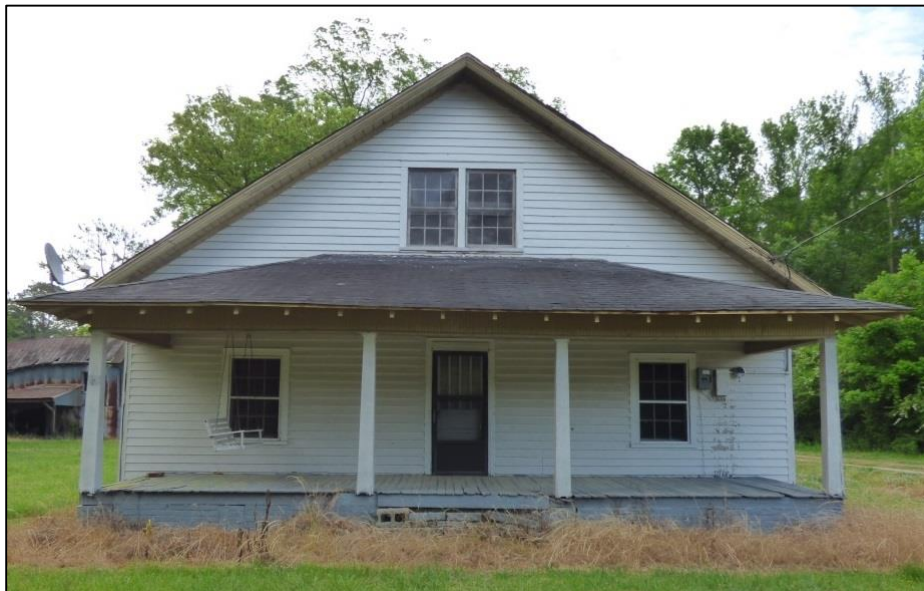
Photo 124: C.M. Wynn House, North Elevation.

A one-story, three-bay porch extends from the north elevation (Photo 124). It is likely that this was constructed at the time the main building was erected or shortly thereafter. The porch has a brick-pier foundation with brick, stretcher-bond infill. Originally, access to the deck of the porch was gained by set of steps centered on the north elevation; however, they have been removed. A hipped roof sheathed in asphalt shingles and supported by square, wooden, tapered columns that extend to the base of the wooden fascia board covers the porch.

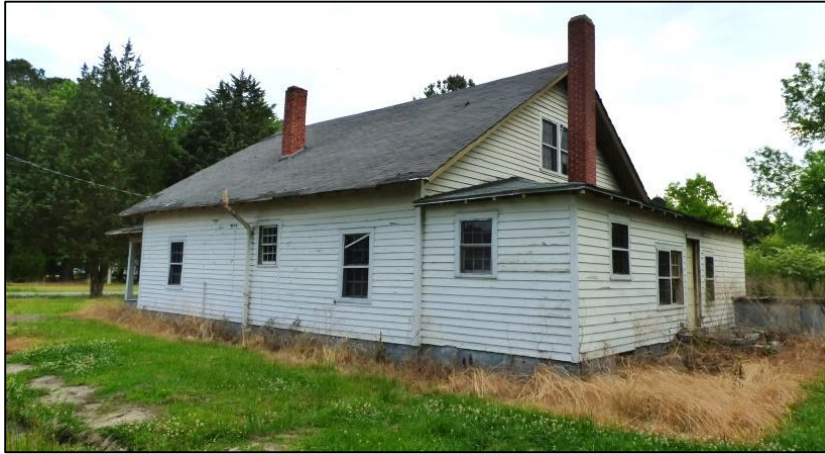
Photo 125: C.M. Wynn House, Southwest Oblique.

A circa-1940, one-story addition extends from the south elevation. It is raised on a concrete-block foundation and frame structural system is clad in weatherboard (Photo 125). A hipped roof with exposed, wooden rafters on the south, east, and west elevations covers the additions. A tall, interior, brick chimney pierces the roof. A secondary entry, filed with a five-panel, wooden door, is located on the addition's south elevation. Additional fenestration include six-over-six, double-hung sash, wood-frame windows. Access to this entrance is a poured-concrete stoop and a step. Access to the house was not granted at this time.

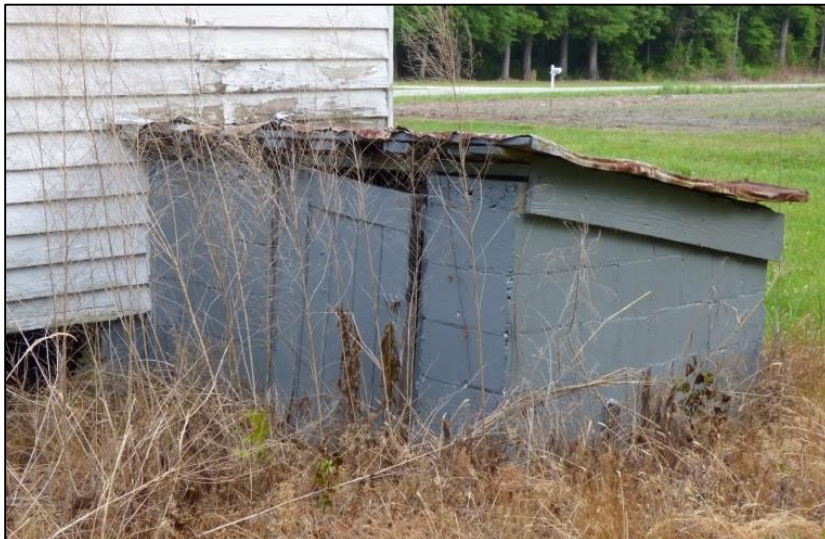
Photo 126: Cistern, Southwest Oblique.

Located immediately adjacent to the easternmost bay of the addition's south elevation is a circa-1930 cistern (Photo 126). The concrete-block structural system is covered by a shed roof sheathed in v-crimp metal. There is one opening secured by a wooden door on the west elevation.

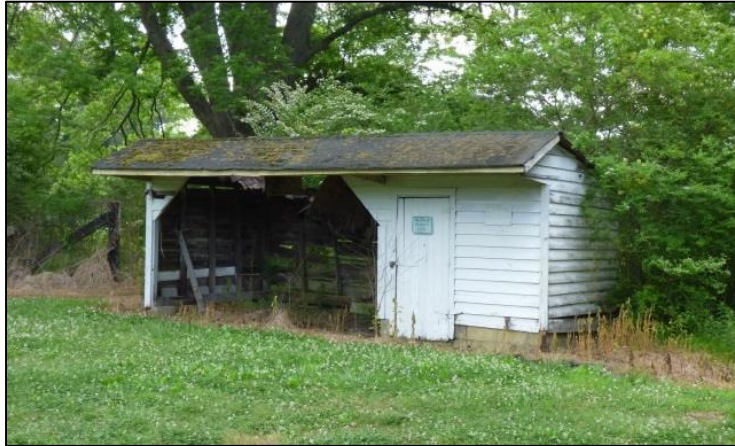
Photo 127: Machine Shed, Northwest Oblique.

South of the dwelling is a one-story, two-bay, circa-1950 machine shed (Photo 127). The eastern half of the structure is open to act as a space to cover equipment. This framed portion is clad in widely spaced wooden boards and the northern elevation functions as a full-width entry with clipped corners. The western half is enclosed to function as a shed. This section is raised on a concrete-block foundation and is clad in weatherboard. A single-leaf, wooden door attached with metal strap hinges is situated on the north elevation. This machine shed is covered by a partially collapsed saltbox roof sheathed in asphalt shingles.

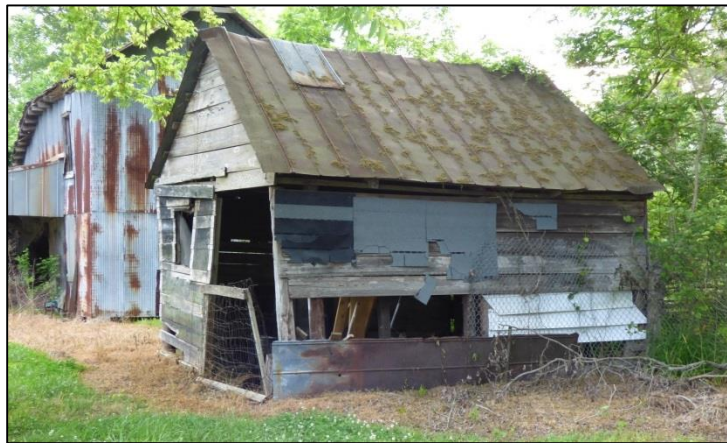
Photo 128: Shed, Northwest Oblique.

Southeast of the house is a circa-1930 shed (Photo 128). The one-story, two-bay structure rests on concrete-block piers and the frame structural system is clad in weatherboard with patches of metal, wire, and asphalt paper to replace missing boards. A moderately pitched, front-gabled roof sheathed in v-crimp metal covers the building; wide, wooden boards cover the gable ends. An open entry is off-centered on the north elevation. Other fenestration includes a window void of sashes just east of the entry on the north elevation.

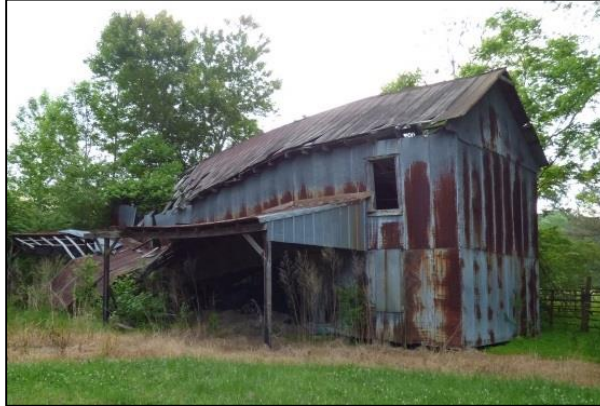
Photo 129: Barn, Northwest Oblique.

A circa-1920, partially collapsed barn is located southeast of the C.M. Wynn House resource (Photo 129). This two-story agricultural outbuilding rests on a concrete-block foundation and it features a frame structural system clad in sheets of corrugated metal. A side-gabled roof, sheathed in v-crimp metal, covers the building. The only surviving fenestration is a wood-frame window opening on the second story of the north (primary) elevation. A one-story, one-bay, shed-roofed awning sheathed in metal extends from the north elevation. The eastern half of the building is collapsed.

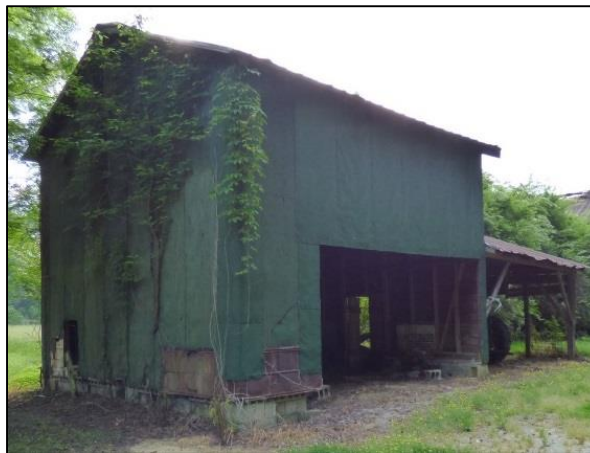
Photo 130: Outbuilding, Northwest Oblique.

South of the C.M. Wynn house is a circa-1920 agricultural outbuilding accessed by a dirt path (Photo 130). This building has been heavily modified since its construction. The frame structural system, clad in weatherboard and sheets of metal, rests on a concrete-block foundation. There is one single-leaf, wooden door on the south elevation and a partially covered-over, single-leaf entry off-centered on the north elevation. A large, machine-entry is cut into the west elevation. A one-story, side-gabled machine cover supported by squared pieces of timber and the roof is sheathed in v-crimp metal extends from the south elevation.

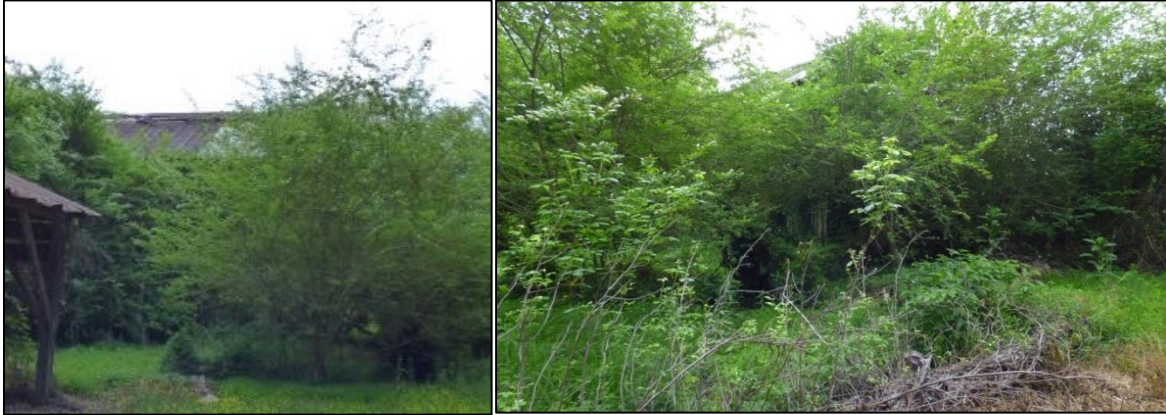
A circa-1920 outbuilding is located south of the house. During the current survey it was almost entirely covered over in thick vegetation. It has a frame structural system clad in metal. The building is covered by a gabled roof sheathed in v-crimp metal (Photo 131).

Photo 131: Outbuilding Overgrown with Vegetation, North Elevation (Left) and Northwest Oblique (Right).

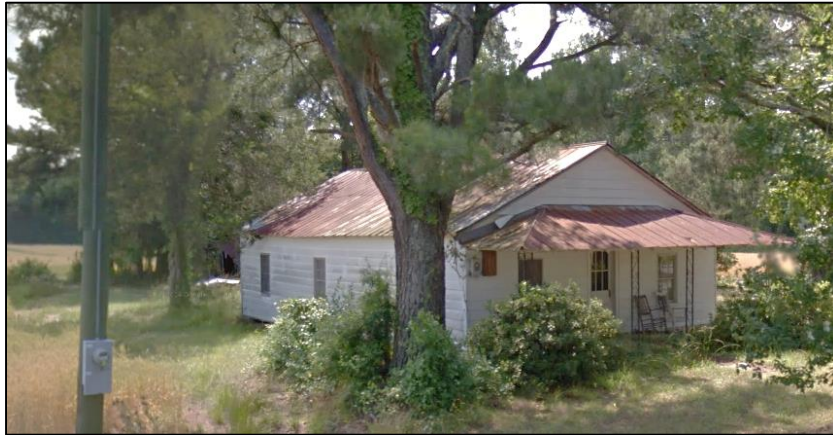
Photo 132: House at 3000 block of Leggett Mill Road (Google Street View 2015).

Martin County's rural roads are dotted with similar early-twentieth century, small- to medium-scale farms. One comparable property is located approximately 5 miles southeast of the C.M. Wynn House on the 3000 block of Leggett Mill Road. This one-story, front-gabled single-family dwelling likely dates to the early-twentieth century (Photo 132, p. 179). This

resource appears to retain many of its original materials and one outbuilding, a historic shed, located east of the dwelling.

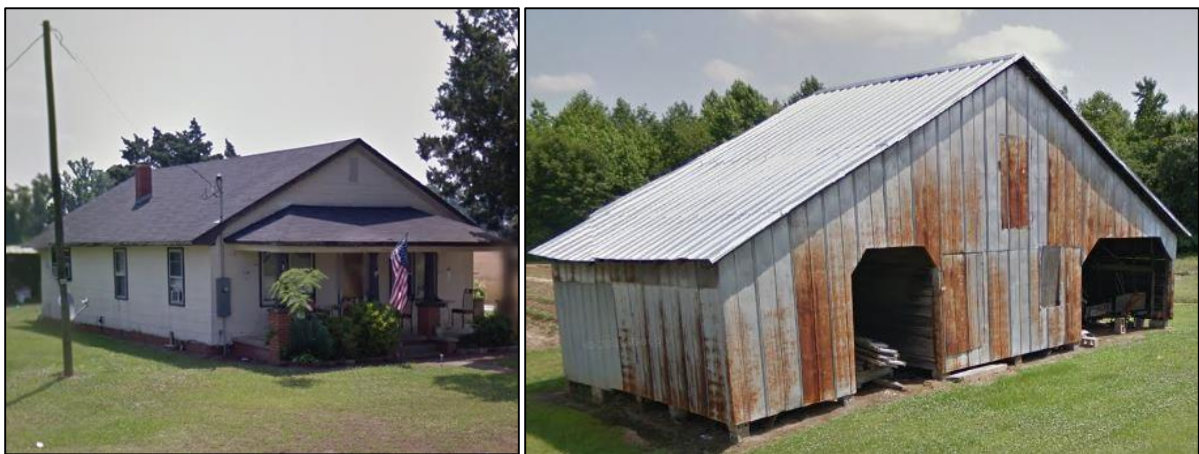
Another nearby house that is similar to the C.M. Wynn resource is located on the 2500 block of Archie Mobley Road, just north of its intersection with Leggett Mill Road. This building is a one-story, three-bay dwelling that is set on a brick foundation and covered by a front-gabled roof (Photo 133). The front-porch's hipped roof is supported by Craftsman-inspired square, tapered posts set on brick plinths. Surviving historic elements include the form/design, wood-frame, two-over-two, double-hung sash windows, and interior chimney. This early-twentieth-century house retains some associated resources including a machine shed, well, cistern, and agricultural outbuilding. Unlike the C.M. Wynn House complex, all of the secondary resources appear to be in good condition. This house on the 2500 block of Archie Mobley Road also differs from the C.M. Wynn House because it does not appear to show signs of neglect and deterioration.

Photo 133: House (Left) and Outbuilding (Right) at the 2500 block of Archie Mobley Road (Google Street View 2015).
