SUBJECT: Grade, Drain, Base, & Pave SR 1137, Justus Road, PA 14-02-0006, Watauga County,
ER 15-0439

HISTORIC ARCHITECTURAL ELIGIBILITY EVALUATION

**GRADE, DRAIN, BASE, AND PAVE SR 1137
(JUSTUS ROAD), WATAUGA COUNTY,
NORTH CAROLINA**

February 2015

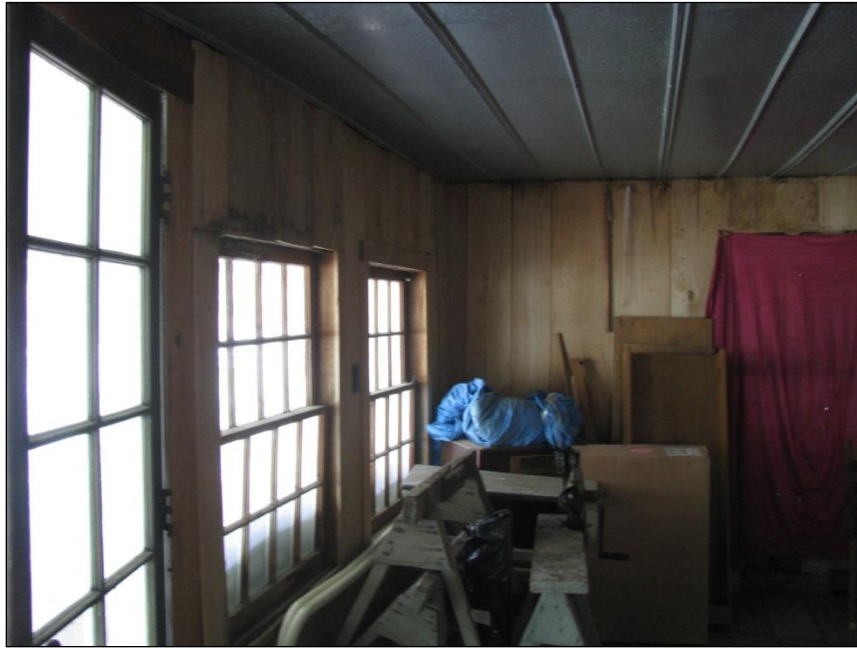
Photo 3: Interior of Former Loom Room, Looking South, with Windows and Paired Door on Left Side (Courtesy of Jon and Inge Townsend).

Within the Clark's Creek Rural Historic District, resident Zettie Clark, the wife of Hardie Clark, was one of many women in western North Carolina to not only demonstrate a talent for weaving, but also to sell her work. Mrs. Clark used the entire second floor of her family's cellar house for weaving-related activities, and sold her coverlets and other woven goods from her house (Townsend, personal communication 2014). The loom room is actually two rooms. There is a smaller anteroom, 9 feet 11 inches by 13 feet and 1 inch. This anteroom still retains its manufactured beaded board sheathing (Figure 3). The larger room's sheathing has been stripped to reveal the upper story's box frame construction (Photo 3, p. 7) and its ceiling has been secured by standing seam metal; it is a long, narrow room, 26 feet, 1 inch by 13 feet, 1 inch. Both rooms show various weaving supplies—woolen skeins hanging from the ceiling, loom wires, shuttles—throughout, but the loom is no longer in place (Photo 4–Photo 5, p. 8).

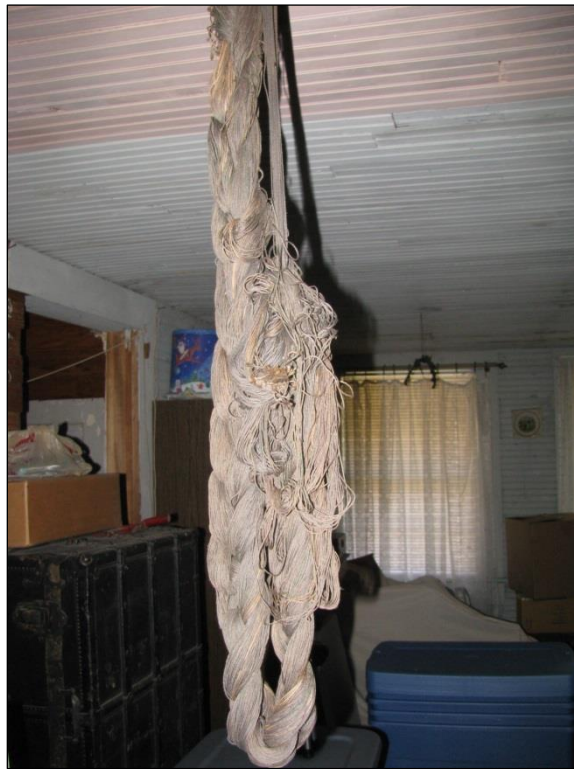
Photo 4: Partial Skein Hanging From Ceiling, Former Storage Room for Loom Room (Courtesy of Jon and Inge Townsend).

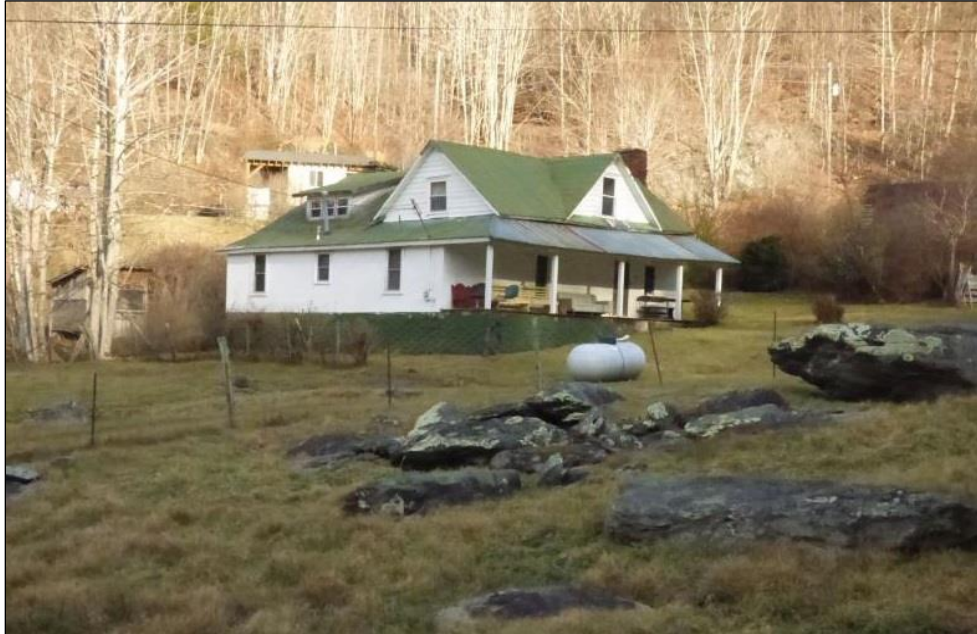
Photo 8: Oblique of Primary (South) and West Elevation, Moody Townsend House, with Pasture in the Foreground.

The Moody Townsend House was built for nineteenth-century resident Moody Townsend, the father of Zettie Townsend Clark of the Hardie Clark House (Property No. 4). The Townsends were farmers and millers who attended both the local Lutheran and Seventh-day Adventist churches. This house passed out of family ownership within the last 25 years. The dwelling is a one-and-a-half-story, balloon-frame “Triple-A” dwelling, faces south-southwest on Clark’s Creek Road, at a rise overlooking the junction of Clark’s Creek and Justus roads (Photo 8, p. 14). The house, which rests on a masonry foundation concealed by asphalt tile skirting and whose weatherboards are now covered by replacement vinyl and stucco siding, was constructed in the last quarter of the nineteenth century. A side-gable roof, which features the decorative center gable behind the term of “Triple-A,” covers the core section of the house, while a gabled roof protects the rear ell; both rooflines have a standing seam metal covering. A 1920s–1930s small shed dormer was added at the rear ell’s west elevation. The house’s original exterior-end chimney, located on the east elevation, and the rear ell’s interior chimney are both composed of mortared river rock or ashlar masonry, suggesting, along with the ell’s small dormer, a 1920s–1930s Craftsman influence (Photo 9, p. 14). Doors and windows have been replaced with modern materials; the façade’s off-center entrance suggests that the house’s interior plan is more akin to a hall-and-parlor plan than a center hall plan. The replacement metal and glass door is covered by an earlier wood and mesh screen door. Windows are all replacement one-over-one glass and metal sash. The house’s wraparound hipped- roof porch was enclosed at its west elevation, and is now clad in stucco. At the front elevation, the full-façade porch also has a standing-seam metal roof and is supported by plain wood posts. There is a small rear shed extension attached to the ell and accessed at its southeast elevation by a wood, four-panel door.

of Clark's Creek Seventh-day Adventist Church. The house, expanded in the early-twentieth century, also retains many period outbuildings. It is recommended that this property is a contributing element to the district.

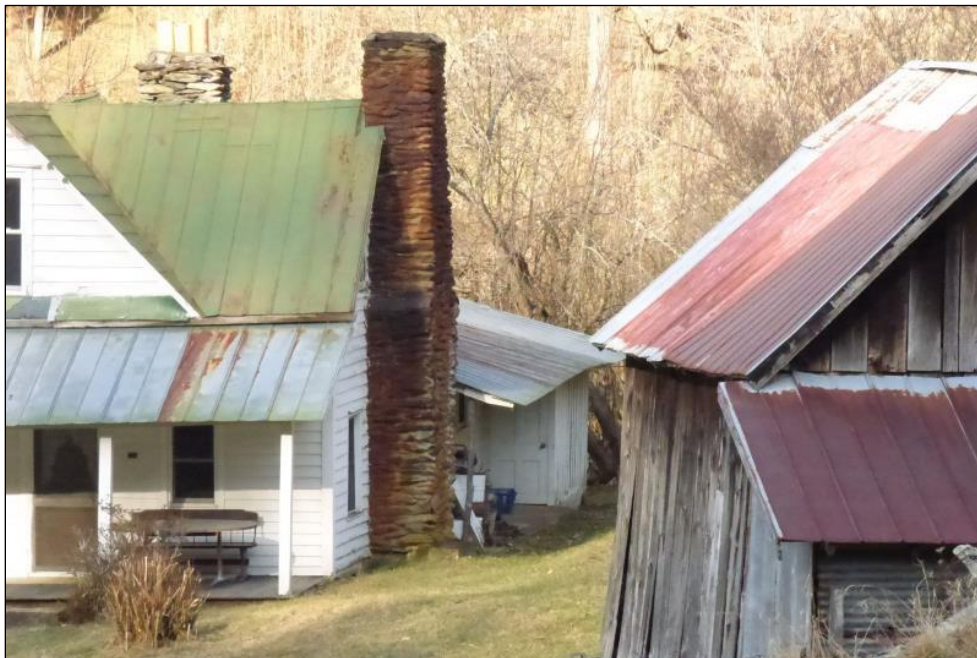
Photo 9: Moody Townsend House, Detail of Primary (South) and East Elevation Oblique with Chimneys at East Elevation and Behind Roof Ridge.

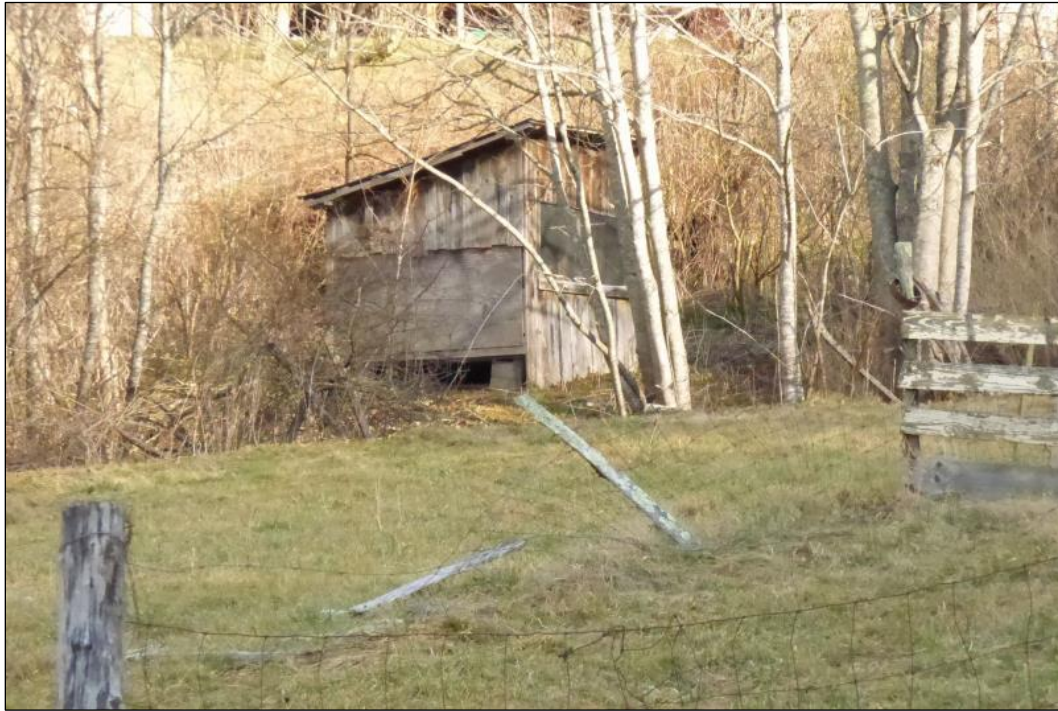
Photo 10: Moody Townsend House, South and East Elevations of Chicken Coop.

Five frame outbuildings are sited around the Moody Townsend House, four of which stand east of the house, on the west side of an access road off Clark’s Creek Road. They include a single-pitch shed roof frame shed, likely a chicken house (Photo 10, p. 15), a small gabled barn, also sheathed with vertical boards (Photo 11, p. 15), and two small frame sheds, both with single-pitch roofs covered with corrugated metal; one or both of these may be outhouses. The last outbuilding is a small, gabled frame shed sheathed with vertical wood boards (Photo 12, p. 16).

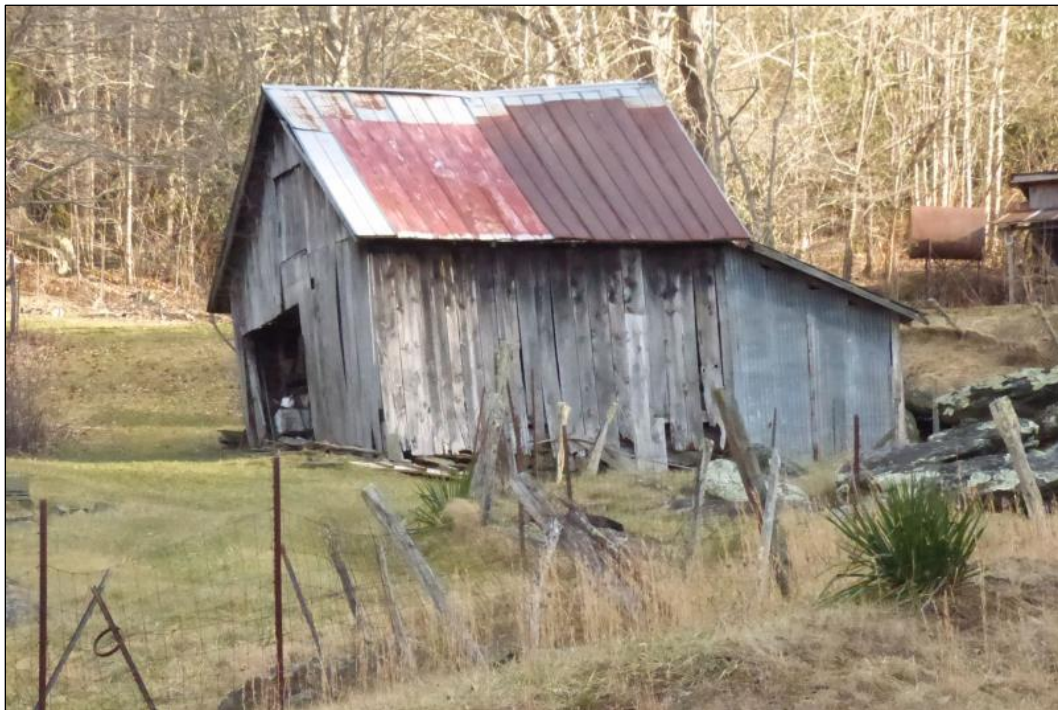
Photo 11: Moody Townsend House, Small Barn, North and West Elevations.

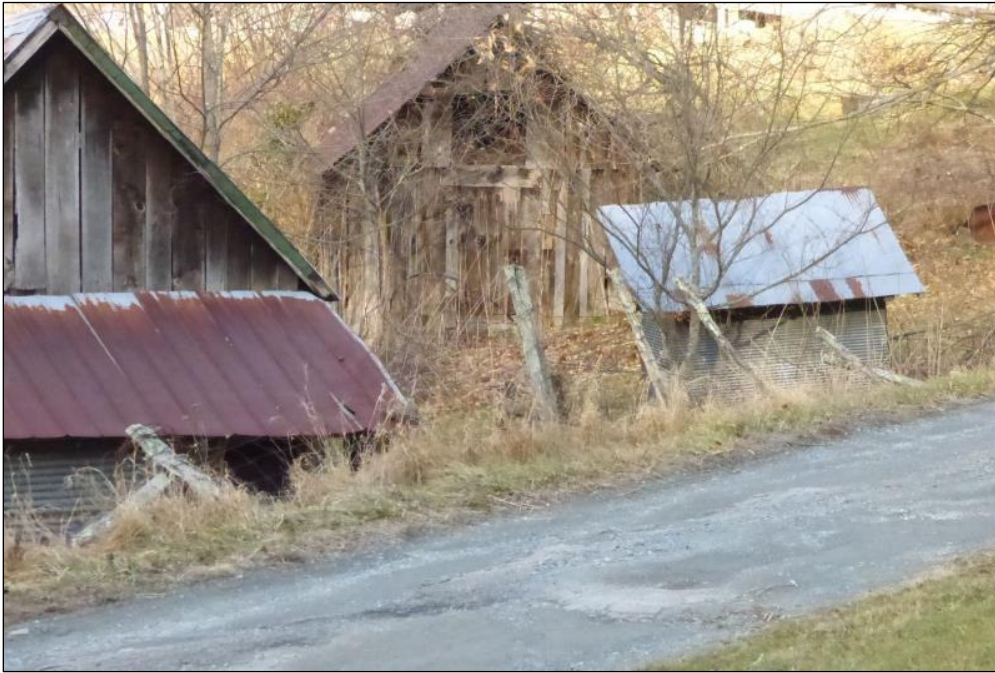
Photo 12: Moody Townsend House, Outbuildings (Shed and Front-Gable Small Barn in Background) from Southwest Angle.

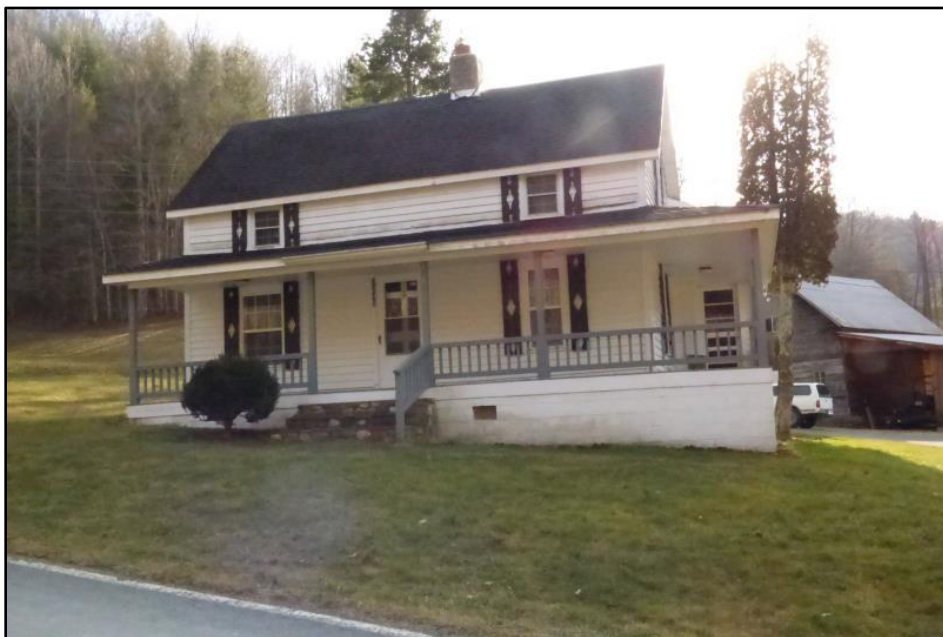
Photo 13: Lowrance House, Primary (North) Elevation, with Barn in Background.

This dwelling was constructed during the prime building episode of the district and has a notable tie to the Lowrance family, one of the founding members of the community. It also retains an outbuilding hailing from the district's twentieth-century period of farming burley tobacco. Thus, the Lowrance House is recommended to be a contributing element to the historic district.

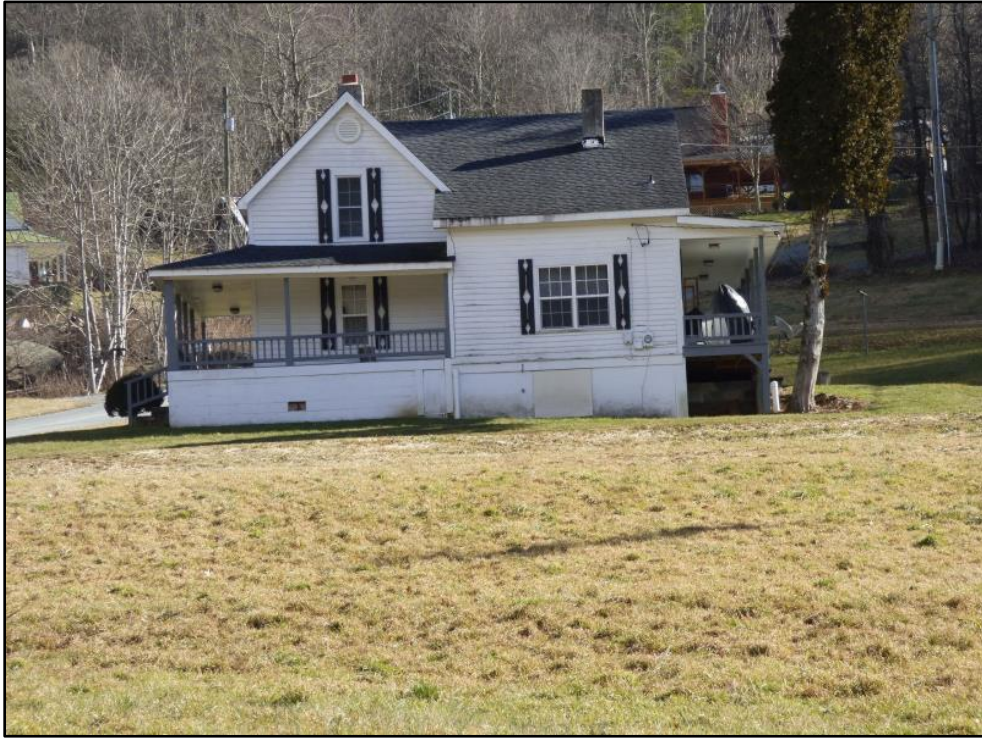
Photo 14: Lowrance House, West Elevation.

The Lowrance family, longtime Clark’s Creek residents and members of Clark’s Creek Seventh-day Adventist Church, built this house. Ed and Ellen Lowrance each took turns as the community’s postmaster or postmistress before Andrew Townsend became “Goo-Goo’s” postmaster in 1907 (*Watauga Democrat* 1907; Townsend, personal communication 2014). This vernacular “story-and-a-jump” frame dwelling faces north on Clark’s Creek Road (Photo 13–Photo 15, pp. 17–18). “Story-and-a-jump” is a North Carolina term, describing houses with a shallow upper story; often these dwellings would have small windows placed in the narrow space between porch and roof (Photo 16, p. 19). The side-gabled house’s foundation is painted concrete block, likely replacing an earlier stone pier foundation. Its frame construction is covered by a variety of siding—at the house’s upper story, some earlier weatherboards exist, but other cladding is vinyl weatherboard siding. The wide gabled rear

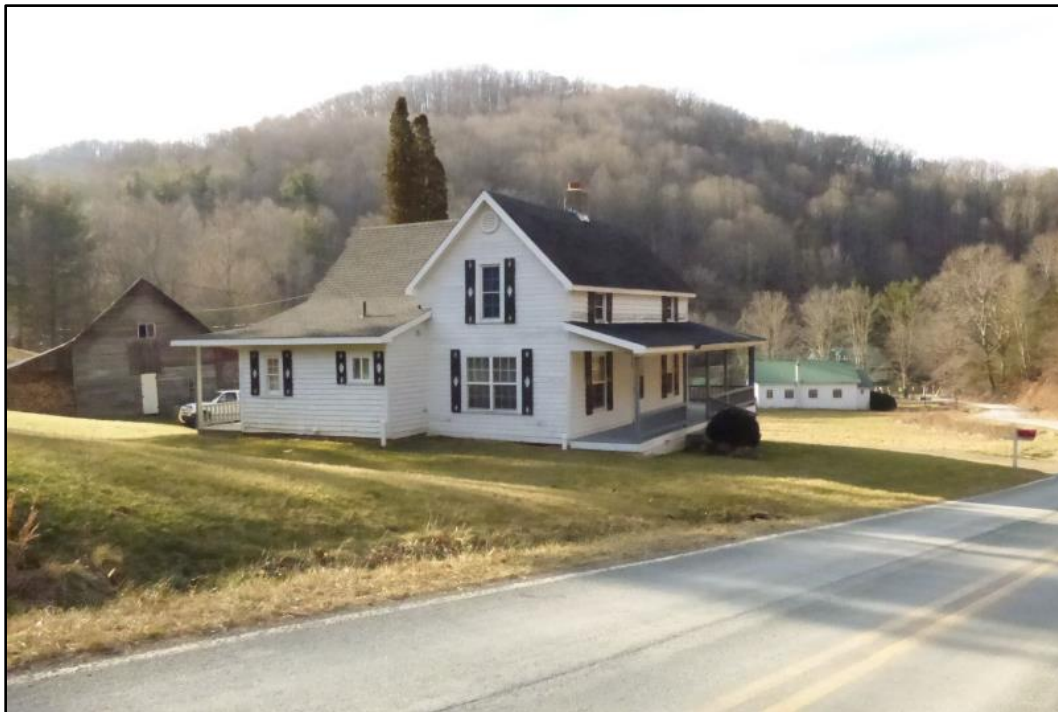
Photo 15: Lowrance House, Oblique of East and North Elevations.

ell, like the main section's side-gable roof, is covered by asphalt-tile roofing. There is a plastered cement interior chimney flue where the side-gable and the rear ell's rooflines join, and also a smaller concrete block flue at the rear ell, also plastered in concrete. Doors, first at the façade's center entrance and then at the porch's west termination into the rear ell, are replacements. Windows are replacement vinyl sash, except for a small fixed, two-pane window at the rear ell's east elevation. The house's shed roof, full-façade porch wraps around to the house's west side and is supported by plain wood posts with an equally plain balustrade; the concrete-block porch foundation, which features a crawl space, replaced an earlier porch foundation which was likely of either stone or wood stumps. The rear ell has a comparable shed-roof porch at its south elevation, wrapping around to the house's east elevation, which is enclosed.

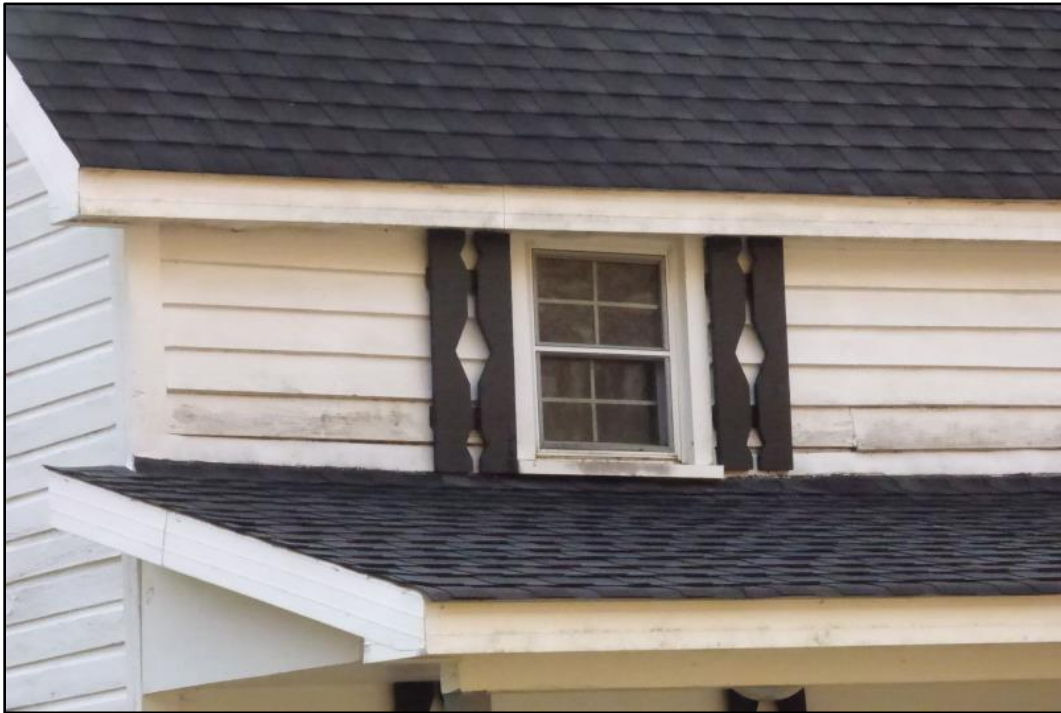
Photo 16: Lowrance House, Detail of Upper-Story Window (Replacement Sash).

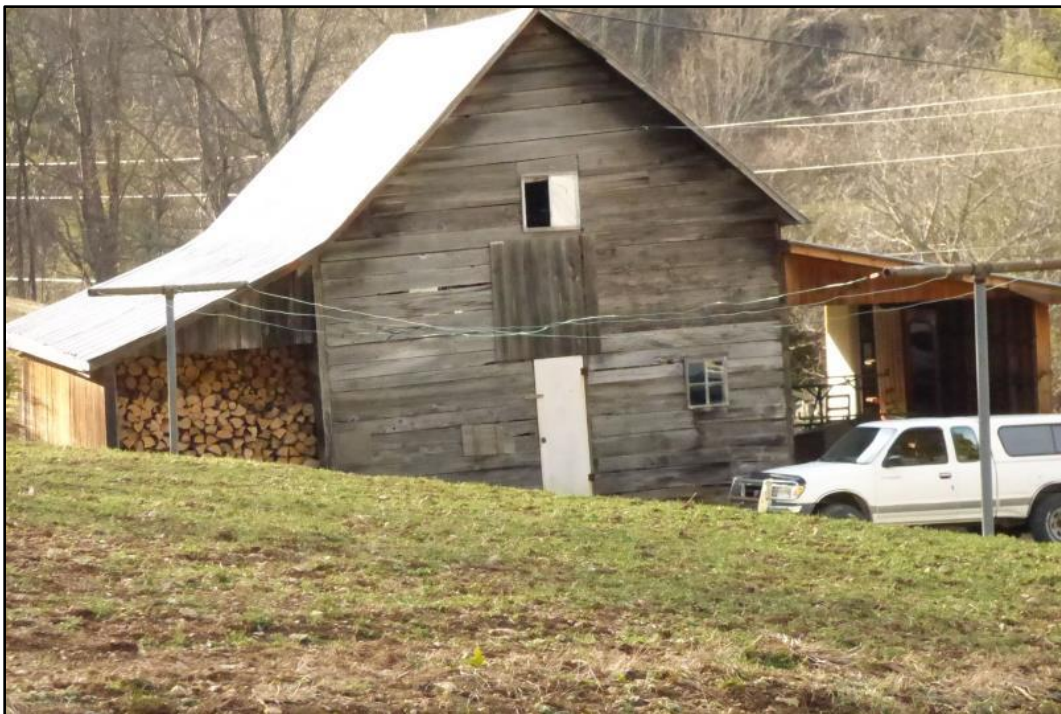
Photo 17: Lowrance House Barn (Pack House), East Elevation.

The Lowrance House has lost many outbuildings over the years, but retains a very plain, two-story, gabled frame barn with horizontal siding (Photo 17–Photo 18, p. 19). Apparently not a livestock barn, the barn's center doorway has been replaced with a modern, narrow metal door and a window was cut above the earlier hayloft. A surviving “pack house” further north was used for storing and grading burley tobacco and, although altered, follows a similar form and design to this outbuilding (Photo 19, p.20) (Billy Townsend, personal communication 2015). It is believed that this barn is also a pack house (Townsend, personal communication 2014)

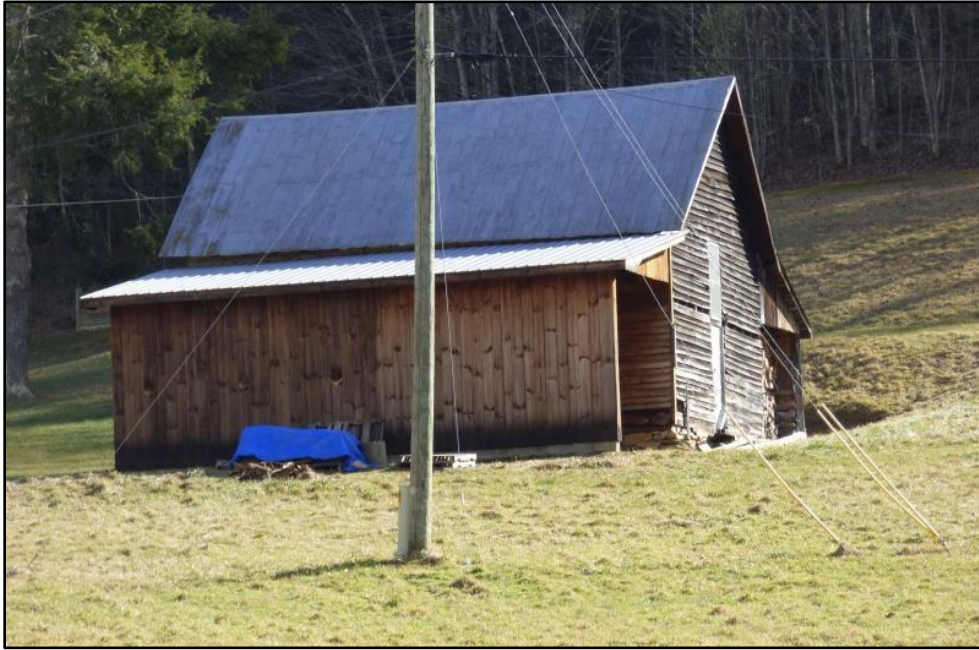
Photo 18: Lowrance House Barn (Pack House), North and West Elevations.

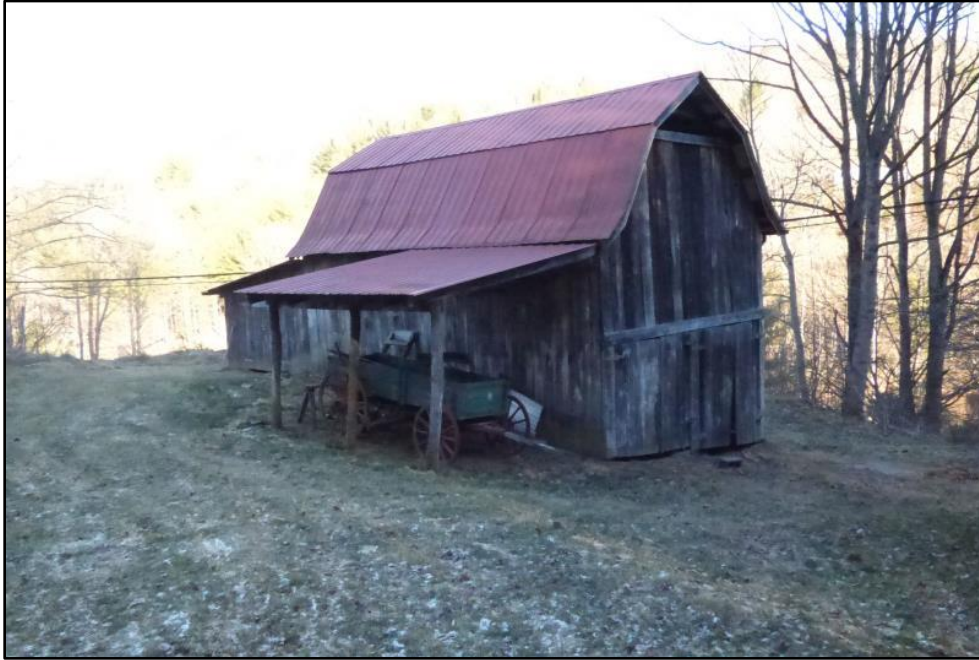
Overlooking Clark’s Creek Road and facing south, this small one-bay, one-and-a-half-story barn stands on a replacement concrete-block foundation (Photo 20, p. 22). Constructed between 1920 and 1945, its framing is simple, with nailed vertical sheathing of circular-sawn boards and wire nails (Photo 21, p. 22). V-crimp metal covers the gambrel roof barn, its open side shed, and a later enclosed shed extension at the north elevation. Paired wooden hinged doors provide access to the barn’s south elevation; a smaller set of hinged doors are at the enclosed shed’s west elevation (Photo 22, p. 23). An upstairs shutter on the barn’s north elevation opens into a hay loft, above which are remnants of the gable’s former louvered gable ventilator. This barn has no window openings. Due to its construction date and direct ties with the agricultural use of this area by notable residents such as Hardie Clark, it is recommended that this resource is a contributing feature to the historic district.

Photo 20: Barn, Oblique View of South and West Elevations.

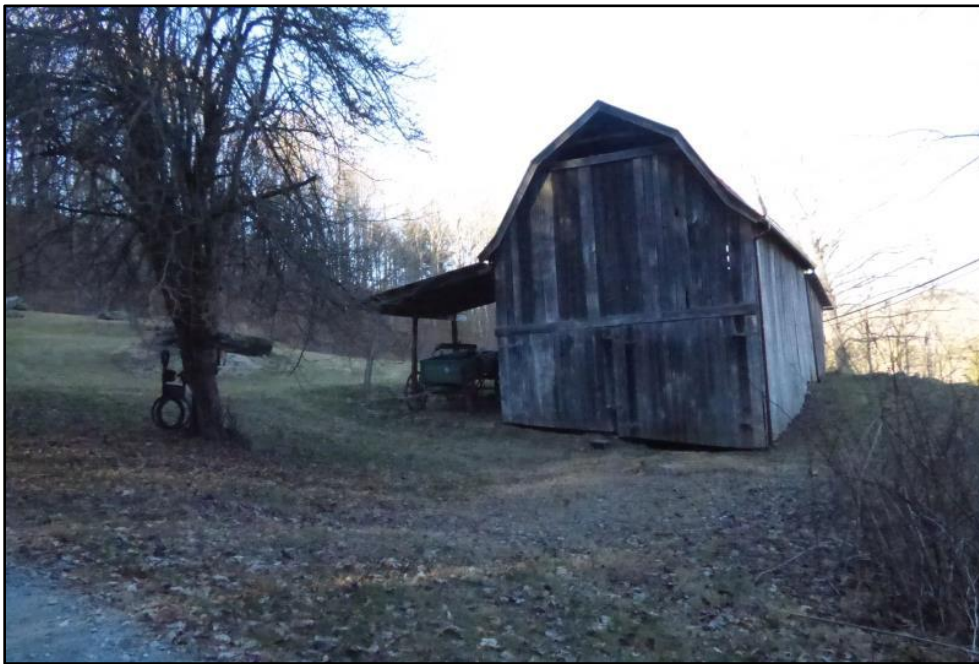
Photo 21: Barn, South Elevation with Pear Tree in Foreground.

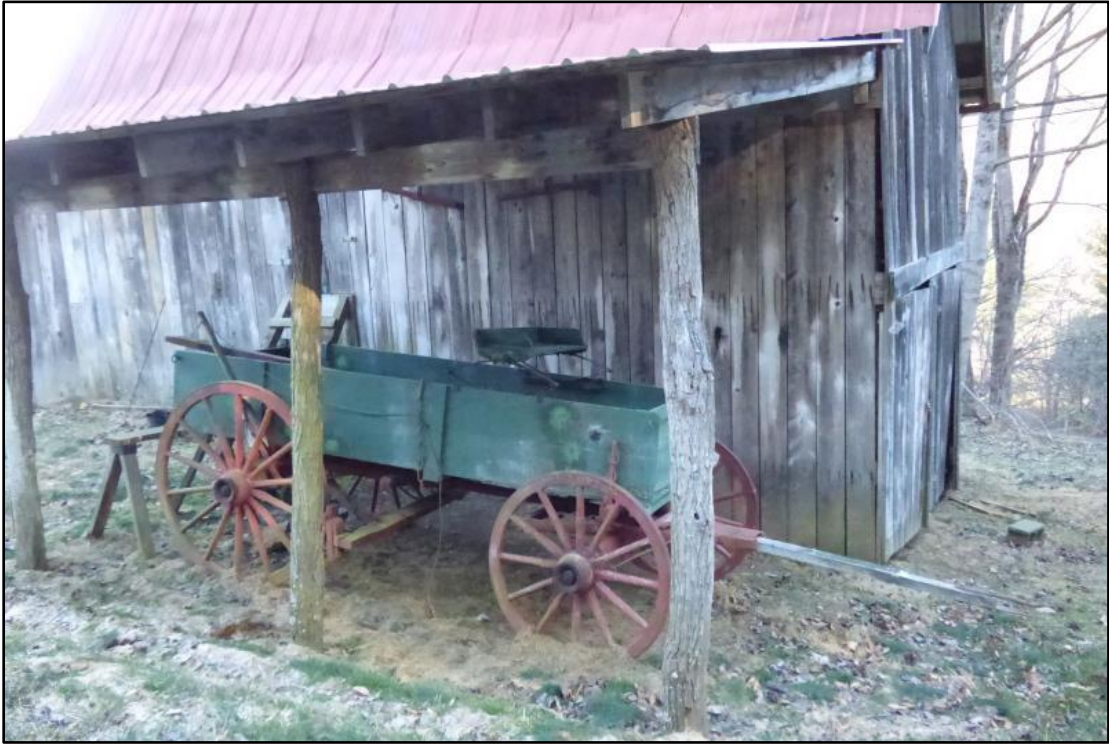
Photo 22: Barn, Detail of West Elevation Side Shed and Wagon.

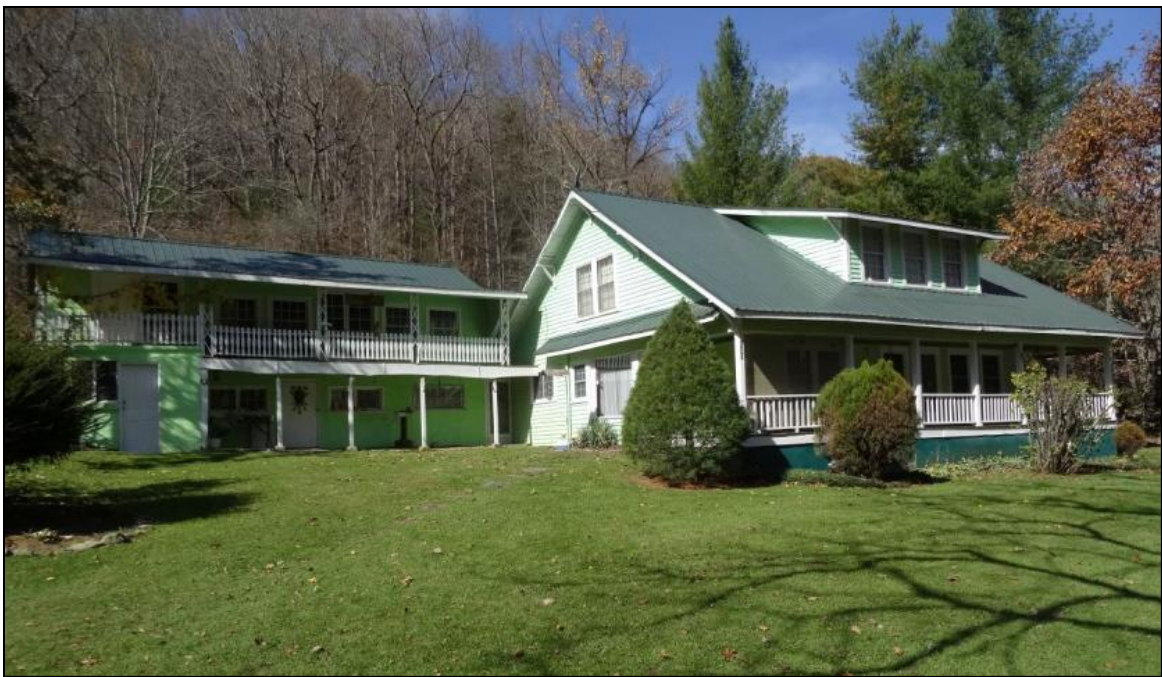
Photo 23: View of Southeast Oblique of Hardie Clark House Showing Cellar House from Clark's Creek and Justus Road.

The Hardie Clark House rests upon a stone- and concrete-block, pier-type foundation that was infilled with concrete-block walls and covered by cement plaster sometime prior to 1960. Composed of a balloon-frame structural system, the house is clad in its original circular-sawn weatherboard siding, said to have been milled by Hardie Clark himself, and secured with wire nails. The widely-pitched, side-gabled roof was once covered by metal sheathing painted green, is now sheathed with v-crimp metal roofing. A small pent roof extends along a portion of the south elevation, sheltering a part of the porch and a picture window near the southeastern corner of the house. A sloping, single-pitch shed roof covers the house's two rear shed additions, as well as the two-story extension's side-gable roofline. The house's one brick chimney was an interior stack sited near the house's south gable but, according to the owner, it was taken down in the 1990s.

The primary entrance is filled by a 15-pane, wood-and-glass French door that is protected by a decorative 1950s screen door, and windows are all uniformly, double-hung sash, with six-over-six panes and plain surrounds; of these, four windows at the house's front (east) elevation and three at the west elevation have been replaced by vinyl windows

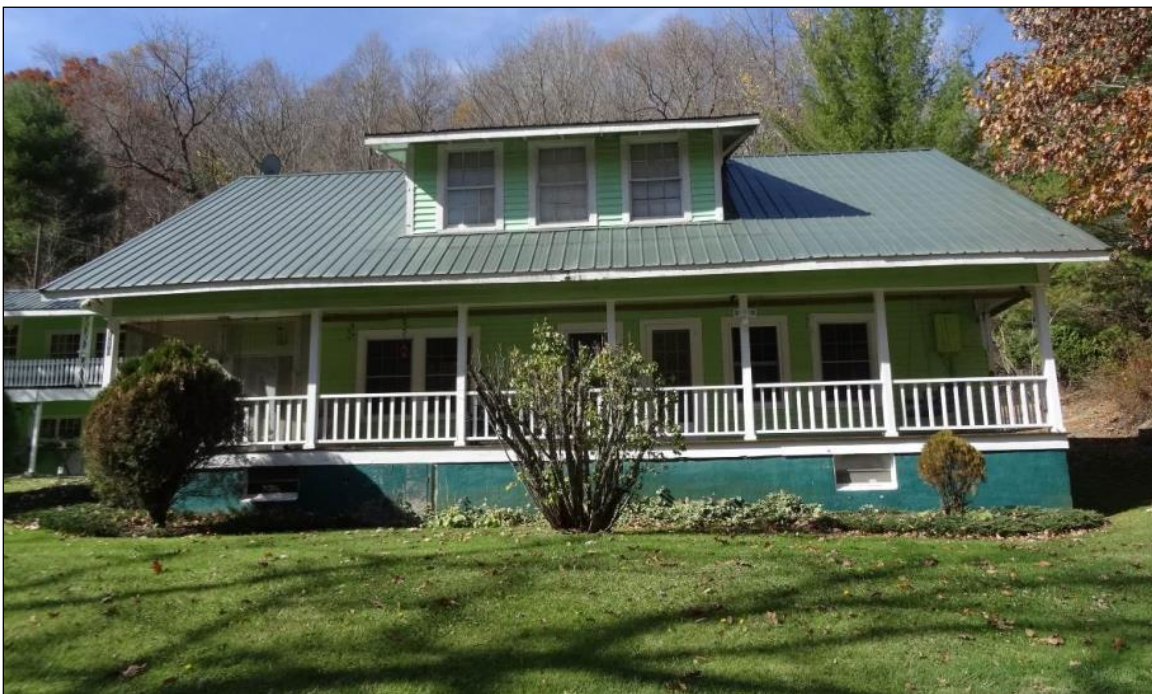
Photo 24: View of East Elevation and Porch Features, Clark House.

As with most Craftsman bungalows, the Hardie Clark House's front porch is considered an extension of interior living space. Its foundation is in keeping with that of the main massing of the house. The porch is supported by single, square wood posts connected by a plain wooden balustrade that the property owners have recently restored (Photo 24). The porch was once accessed by a set of concrete steps, but the stairs were removed in the mid-twentieth century (Photo 25, p. 25).

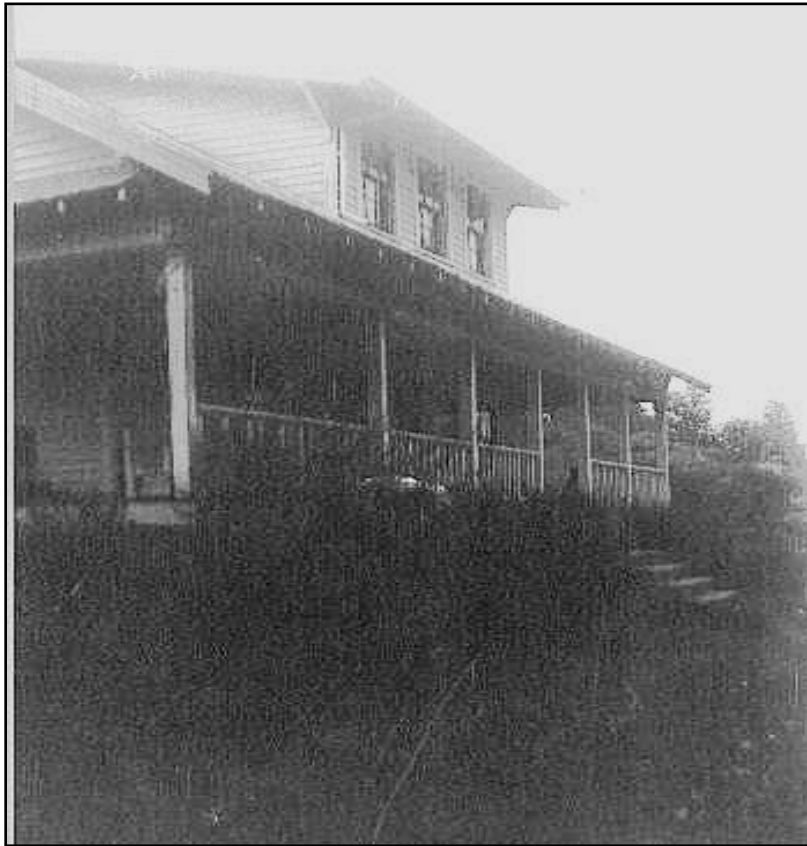
Photo 25: Hardie Clark House, Circa 1940, Showing Porch and Original Concrete Steps to Front Entrance (Courtesy J. Jon and Inge Townsend).

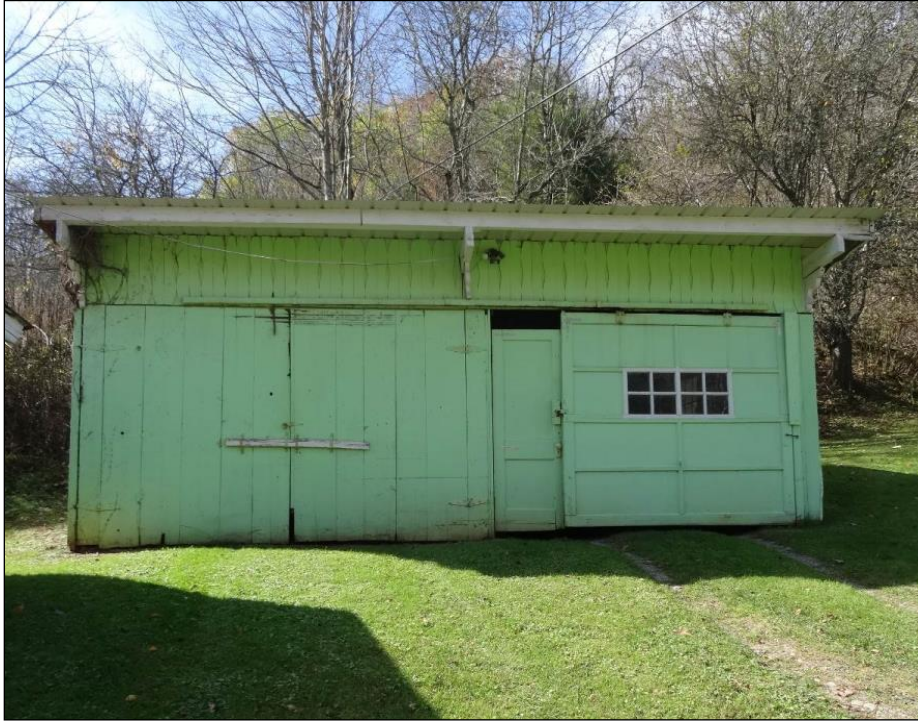
The Hardie Clark House's four outbuildings include a garage, a workshop with an attached granary, a small animal barn, and a cellar house with a loom room at its second story. Constructed circa 1930, the one-story, two-bay, garage rests on a stone- and concrete-block foundation. It is of frame construction and clad with both vertical nailed planks and a novelty-shingle siding (Photo 26, p. 26). According to the owners, the frame, one-story, front-gabled workshop-granary was constructed circa 1925–1930 and was originally only used as a granary where the Clarks stored their corn, wheat, and rye (Photo 27, p. 26). The structure rests on a stone-pier foundation with some circa 1940s concrete block underpinnings. Siding varies from tongue-and-groove boards at the north, east, and west elevations to the standing-seam metal covering the upper portion of the south elevation.

Photo 26: East Elevation of Garage.

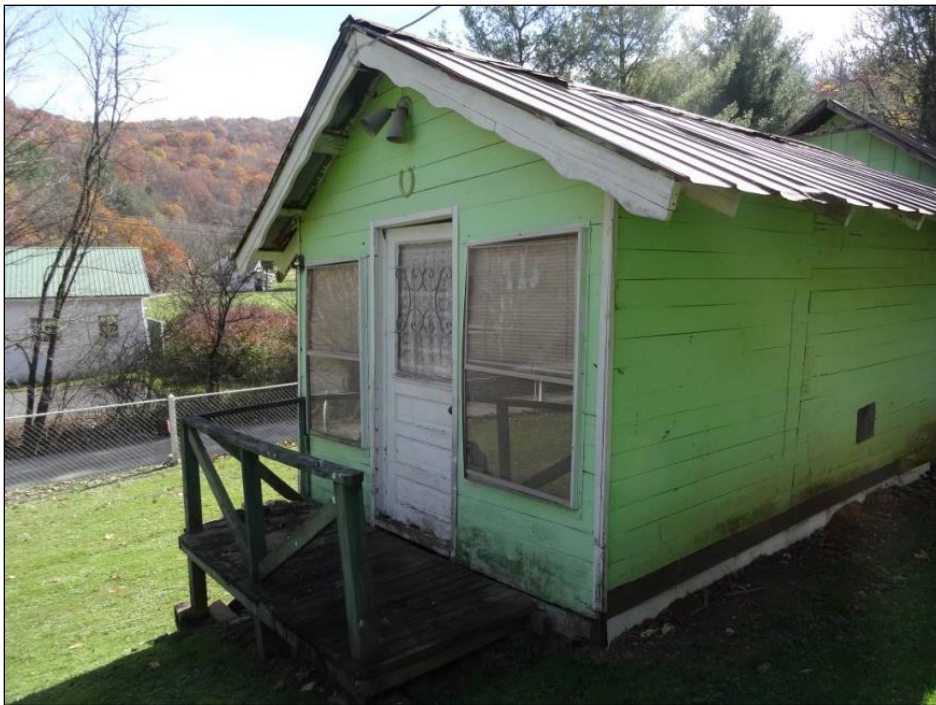
Photo 27: View of North Elevation of Workshop and Granary (Workshop).

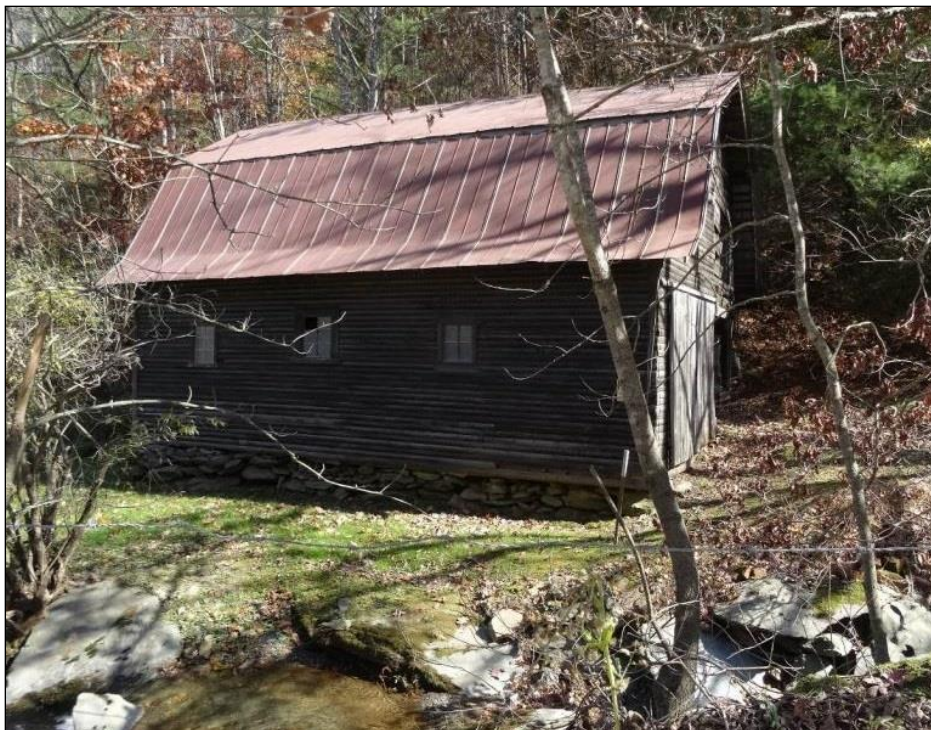
Photo 29: View of West Elevation of Barn across Clark's Creek.

Facing the house, on the east side of Clark's Creek Road, is a one-and-a-half story, gambrel-roofed, two-bay, barn (Photo 28, p. 27). It rests on a continuous, dry-laid, fieldstone foundation with some additional concrete blocks supporting its east elevation. The barn is of balloon frame construction with convex wood siding. The roof is covered by standing-seam metal sheeting. The form of the barn is marked by a side drive that passes through the entire structure while the other bay is filled with stalls. Evenly spaced along the west elevation are three small, four-pane, fixed, wooden-sash windows (Photo 29, p. 27). A small opening is also visible to the hayloft that extends across the entire barn.

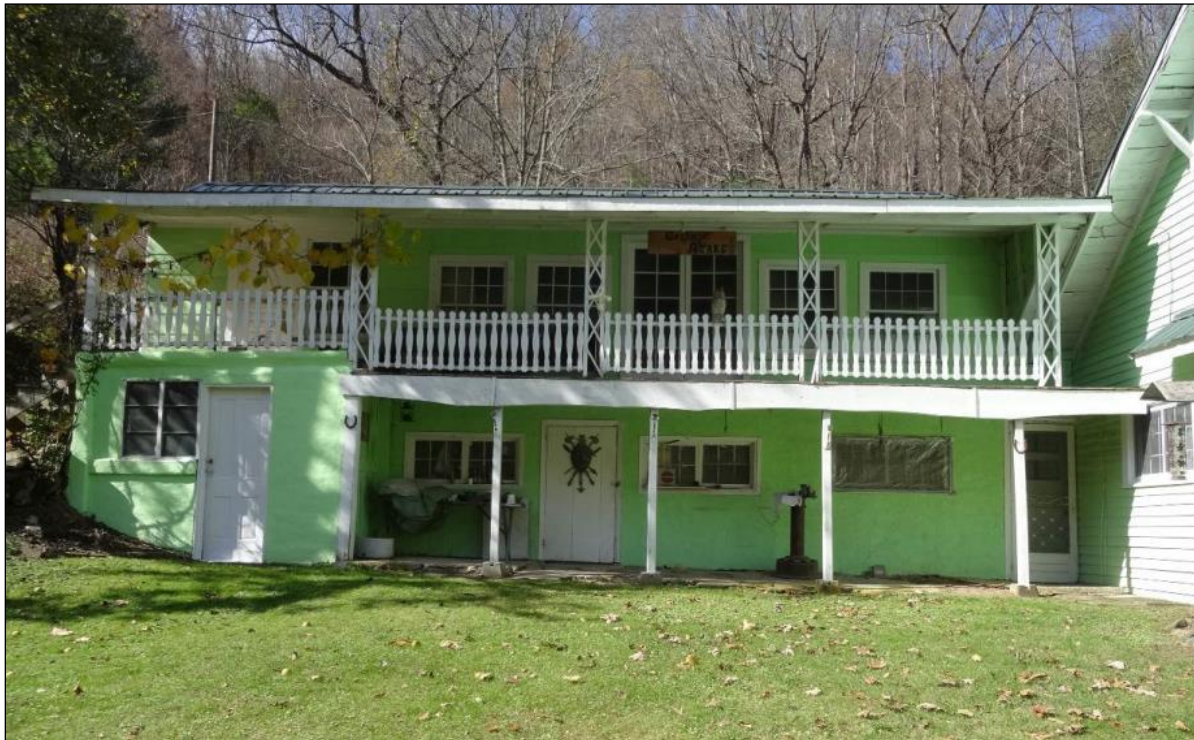
Photo 30: East Elevation of Cellar House and Loom Room (Second Floor).

A two-story, single pile, frame- and concrete-block, side-gabled outbuilding is attached to the Hardie Clark House at the house's southwest corner (Photo 30). The outbuilding, its first floor described as a cellar house, rests on a stone and cement block foundation. The first floor's masonry is covered by plastered concrete, and the second floor is clad in weatherboards. As the lower half of the cellar house was built into the hillside slope, only the weatherboarded, second story is visible at south and west elevations. This lower story was for storage of goods, including vegetables, preserved food, and other staples.

The interior of the second floor, according to the owners, is where Zettie Clark kept her wooden loom and weaving supplies. A two-story, full-width porch is appended to the primary elevation of the outbuilding. The roof system of the lower level is supported by replacement wooden posts; the upper level porch is supported by latticework wooden posts, with a decorative rail balustrade.

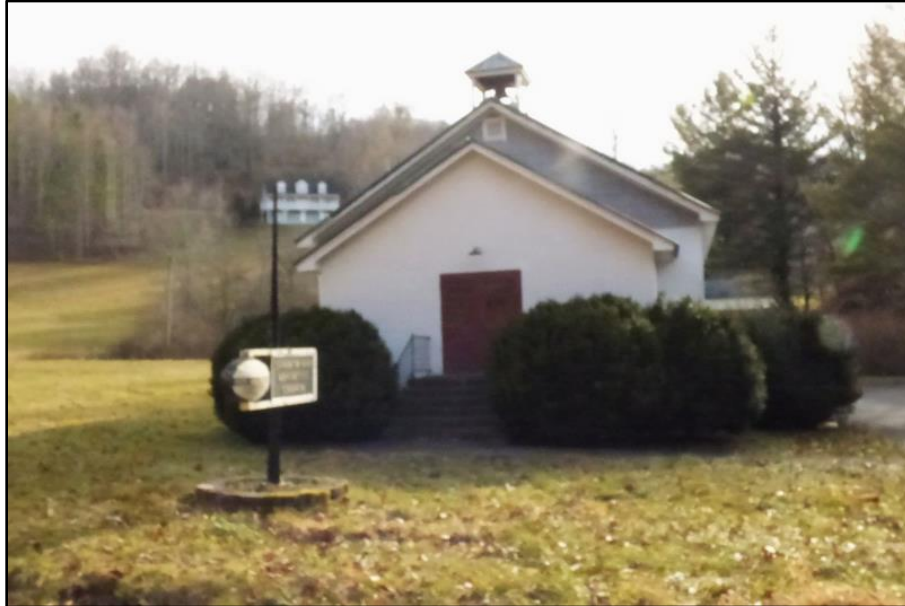
Photo 31: Clark's Creek Seventh-day Adventist Church, Primary (North) Elevation.

This late Moderne-style building, whose front-gable form and belfry merge institutional and traditional church forms, stands on a concrete block pier foundation and is composed of concrete block, with a cement plaster surface coat. Its front-gable roofline has a v-crimp metal covering, above which is positioned a small, pyramidal-roof open belfry that retains its original wooden spire. The church facade's front gable is sheathed with asphalt shingles and retains a louvered wooden ventilator at its apex (Photo 31, p. 30). A single concrete block exterior flue, located at the church's east elevation, is the building's sole source of heat (Photo 32, p. 30). There is only one access to the interior, which is on the front-gable entrance; there, paired nine-light paneled sash doors above a small concrete stoop open into a small vestibule (Photo 33, p. 31). The church retains its original nine-light and eight-light metal casement windows, with four lighting the building at each side of its east and west elevations (Photo 34, p. 31). The vestibule's small fixed two-light windows are on its east and west elevations as well. Inside, the church retains its small vestibule with double wooden-paneled doors that open into the sanctuary and altar space which highlight modifications made to the interior in the 1960s and 1970s (Photo 35, p. 32).

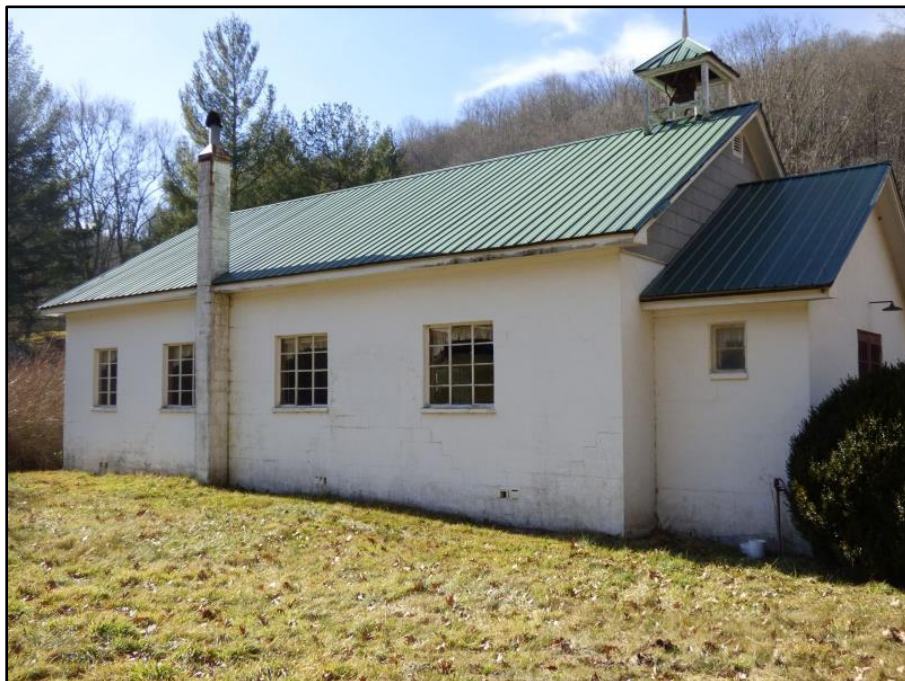
Photo 32: Clark's Creek Seventh-day Adventist Church, Partial Oblique of North and East Elevations.

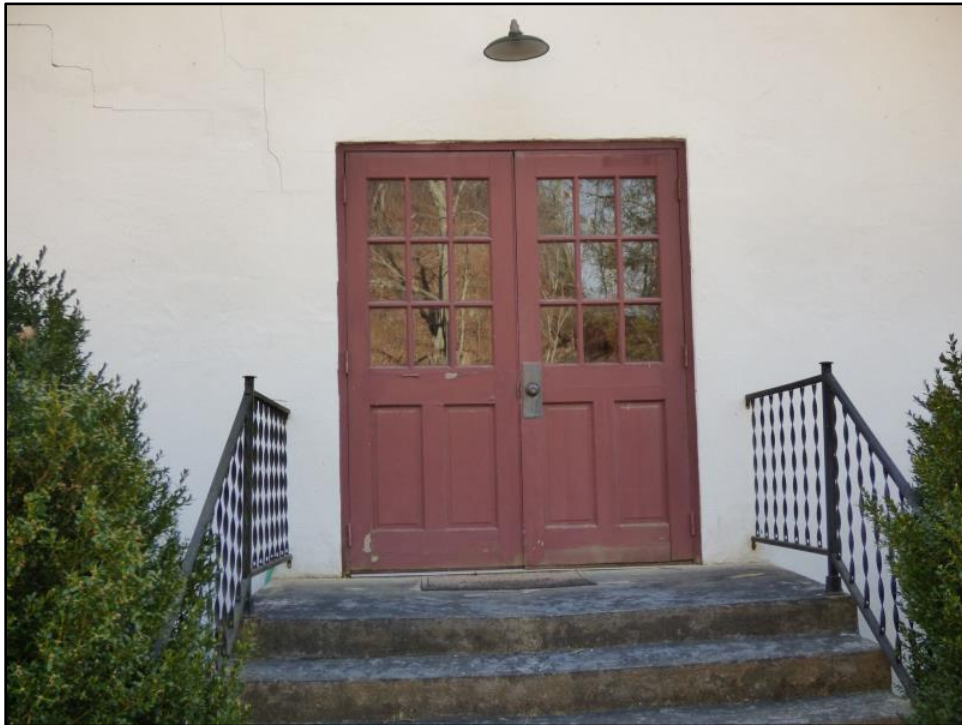
Photo 33: Clark's Creek Seventh-day Adventist Church, Primary Entrance.
