SUBJECT: Grade, Drain, Base, & Pave SR 1137, Justus Road, PA 14-02-0006, Watauga County,
ER 15-0439

HISTORIC ARCHITECTURAL ELIGIBILITY EVALUATION

**GRADE, DRAIN, BASE, AND PAVE SR 1137
(JUSTUS ROAD), WATAUGA COUNTY,
NORTH CAROLINA**

February 2015

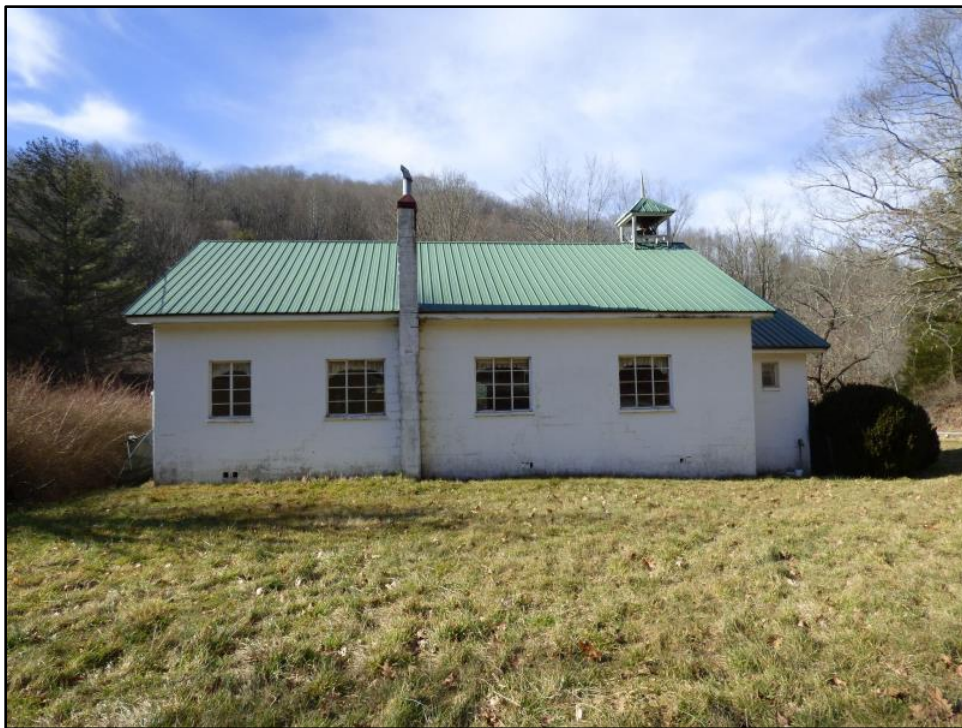
Photo 34: Clark's Creek Seventh-day Adventist Church, East Elevation.

This late Moderne-style building, whose front-gable form and belfry merge institutional and traditional church forms, stands on a concrete block pier foundation and is composed of concrete block, with a cement plaster surface coat. Its front-gable roofline has a v-crimp metal covering, above which is positioned a small, pyramidal-roof open belfry that retains its original wooden spire. The church facade's front gable is sheathed with asphalt shingles and retains a louvered wooden ventilator at its apex (Photo 31, p. 30). A single concrete block exterior flue, located at the church's east elevation, is the building's sole source of heat (Photo 32, p. 30). There is only one access to the interior, which is on the front-gable entrance; there, paired nine-light paneled sash doors above a small concrete stoop open into a small vestibule (Photo 33, p. 31). The church retains its original nine-light and eight-light metal casement windows, with four lighting the building at each side of its east and west elevations (Photo 34, p. 31). The vestibule's small fixed two-light windows are on its east and west elevations as well. Inside, the church retains its small vestibule with double wooden-paneled doors that open into the sanctuary and altar space which highlight modifications made to the interior in the 1960s and 1970s (Photo 35, p. 32).

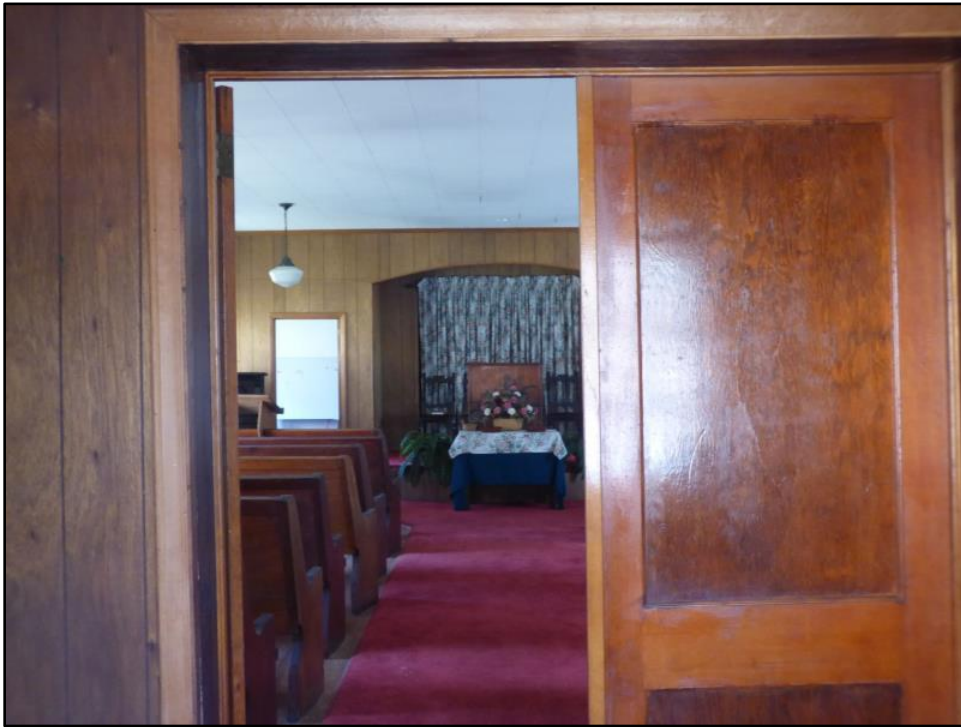
Photo 35: Clark’s Creek Seventh-Day Adventist Church, View beyond Interior Vestibule to Sanctuary.

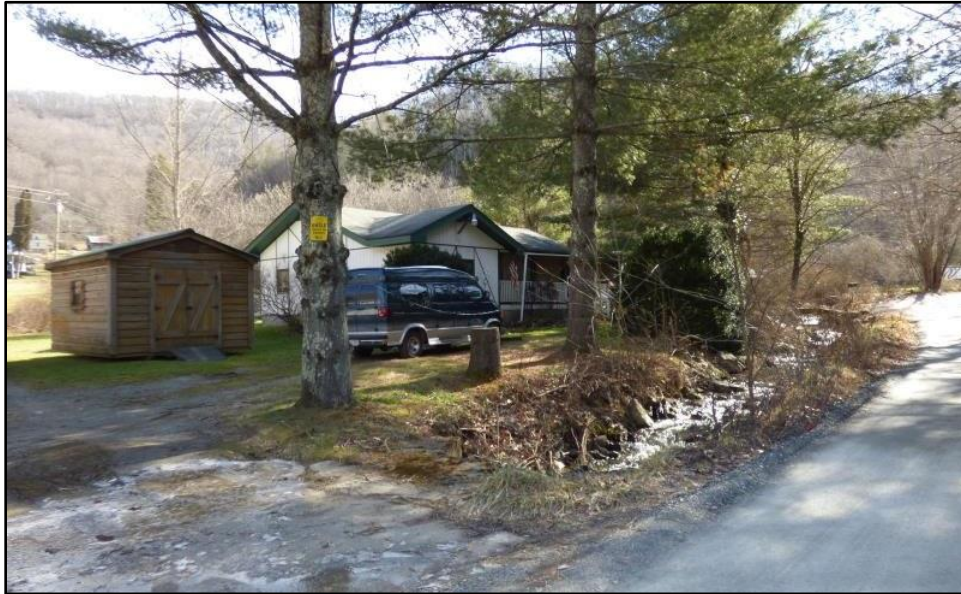
Photo 36: 127 Justus Road, Oblique of the House's North and West Elevations with the Wooden Storage Outbuilding to the North.

Access to this property was limited, due to posted “No Trespassing” signs and vehicles blocking the house. The Ranch-style dwelling faces west and is one-story high and four bays wide, with a concrete block foundation and frame infrastructure (Photo 36, p. 33). The exterior is clad with painted T-111 sheathing, and contrasting boards, creating a “Tudoresque” effect. The widely pitched side-gable roof, which extends at the façade to form a three-quarter shed roof porch and a projecting front-gable bay, is covered with asphalt shingles. The house does not appear to have a chimney or any flue. Doors, where seen, are modern metal-and-glass openings. Windows are metal and glass one-over-one, double-hung sash. The shed porch has plain posts and a plain wooden balustrade. There are no seen additions to this building. The only outbuilding seen on this property is a one-story, one-bay frame gabled storage shed, located just north of the house.

This house is an example of a later construction within the core of the historic district. It also has no known ties to area social history or notable residents. As such, it is recommended to be a non-contributing element to the district.

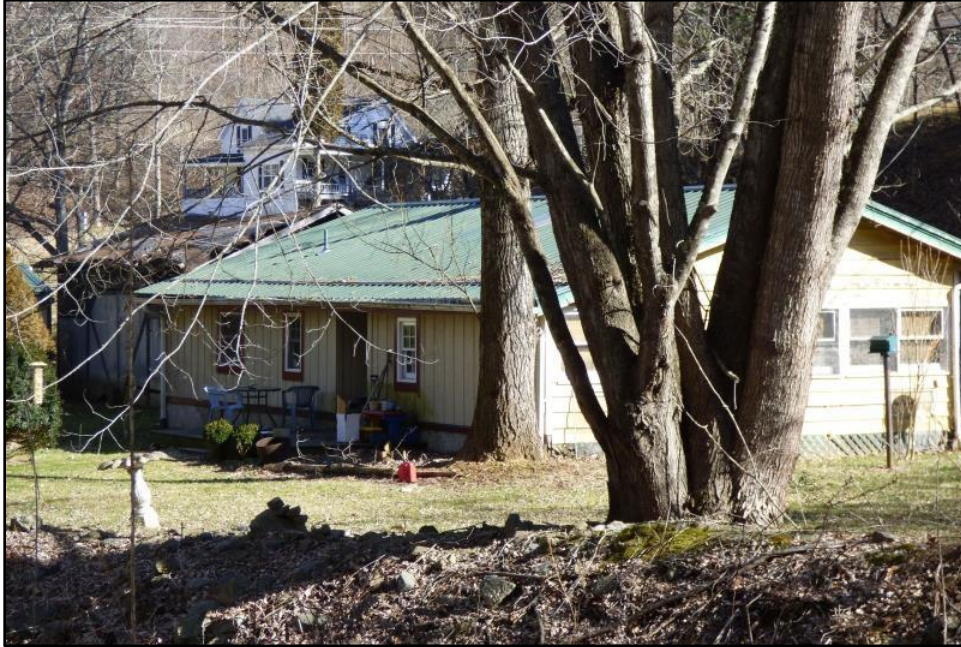
Photo 37: 157 Justus Road, West and South Elevations.

A wide, one-story, four-bay Ranch-style house on a skirted foundation stands facing west on Justus Road (Photo 37, p. 34). It is of frame construction, with board-and-batten siding at the west elevation, and weatherboards at the other elevations (Photo 38, p. 34). The side-gable roof extends to form a small shelter along all four elevations and is covered by a v-crimp metal. There appears to have been a chimney at the house's north elevation (which was very difficult to photograph due to the proximity of other buildings) but it has been removed. The primary entry is a glass-and-metal door accessed by an off-center recessed entrance on the façade. Windows along the façade are replacement double-hung metal and glass sash. The band of one-over-one, double-hung sash windows at the house's south elevation attests to the house's earlier 1960s appearance. Apart from a deck at the rear of the house, there is not a porch other than the shelter at the façade entrance. Two frame outbuildings, both built circa

1970–2000, are located behind the house. This is a later development within the historic district with no known ties to area social history or notable residents. It is recommended as a non-contributing element to the district.

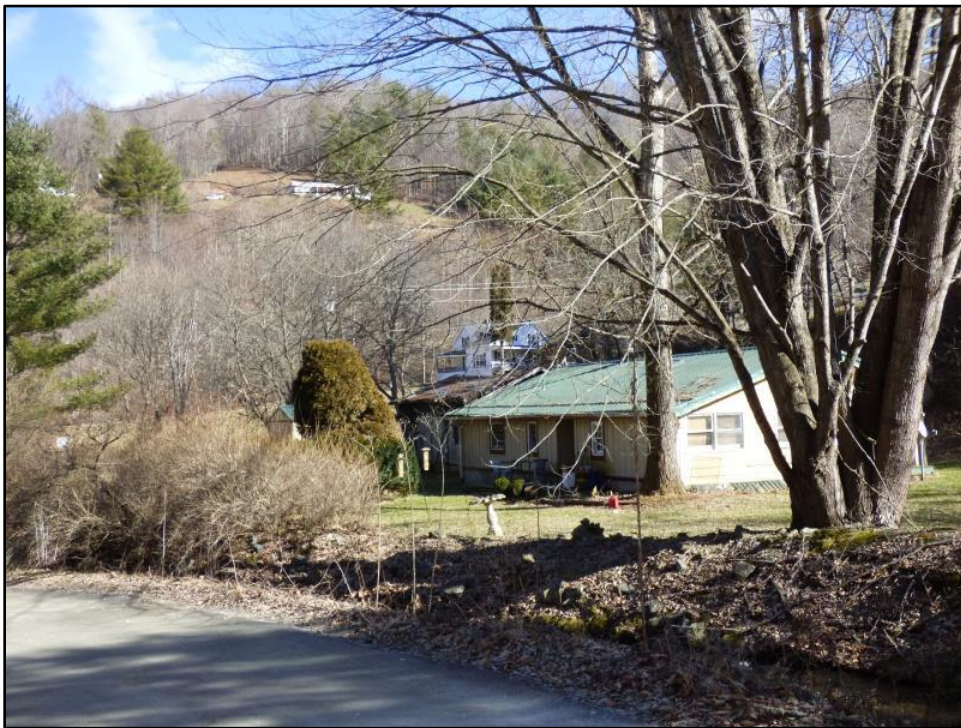
Photo 38: 157 Justus Road within its Setting.

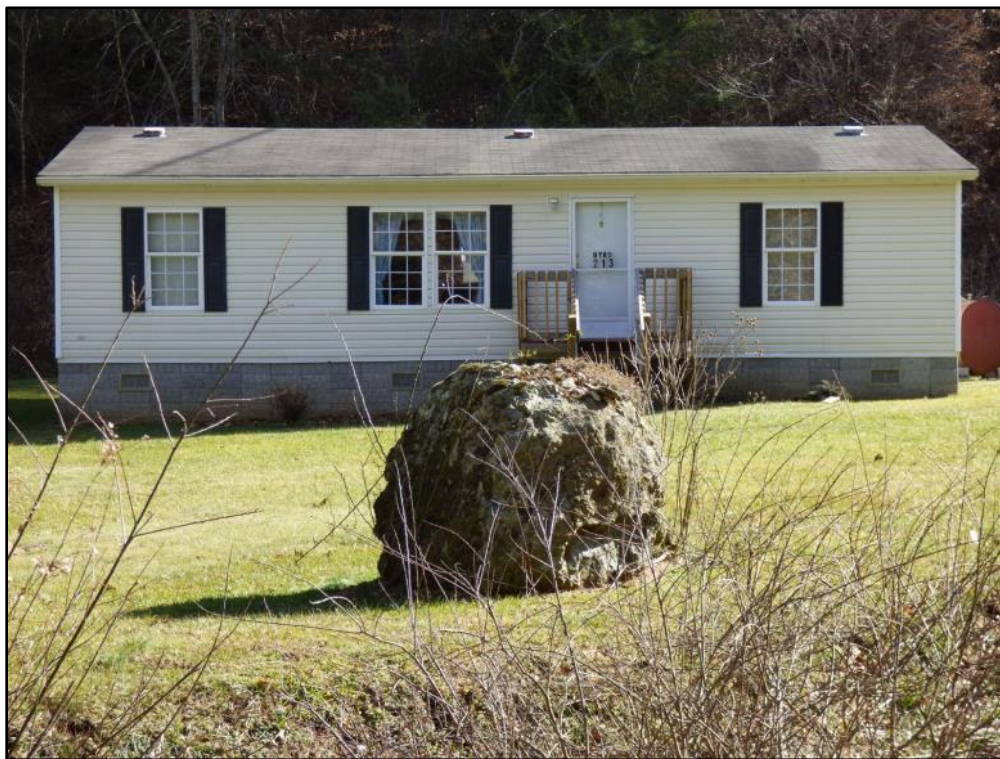
Photo 39: 213 Justus Road, Primary (West) Elevation.

A side-gable, one-story, three-bay manufactured house faces west on Justus Road. The house stands on a raised concrete block foundation and is of simple frame construction, with vinyl weatherboard siding (Photo 39). The roof is covered by asphalt tile, and there is no discernable chimney. The façade entrance is a plain paneled metal door accessed by a small raised wooden stoop. Single and paired windows composed of double-hung vinyl sash with metal strips to evoke six-light and nine-light muntins, pierce the dwelling. The house has no porch. Behind the house are a small, single-wide metal trailer, built circa 1970–1985, and a wooden, gabled, modern storage building. The house is set back from the road (Photo 40, p. 36), so that it does not interfere with the area’s viewshed.

This house is an example of a later construction within the core of the historic district. As such, it is recommended to be a non-contributing element to the district.

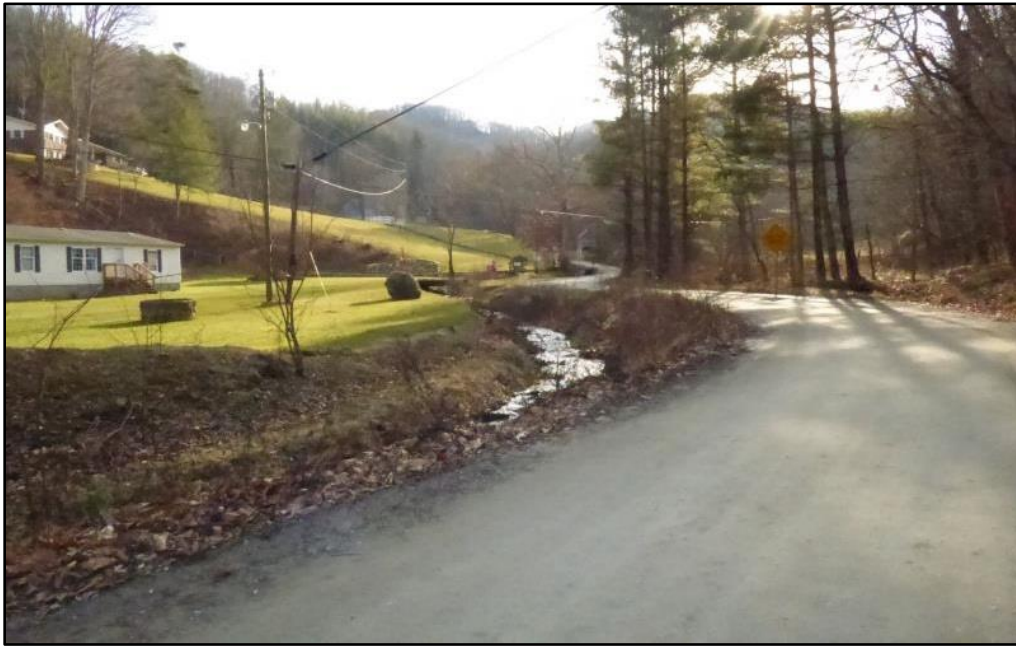
Photo 40: 213 Justus Road, Looking Southeast.

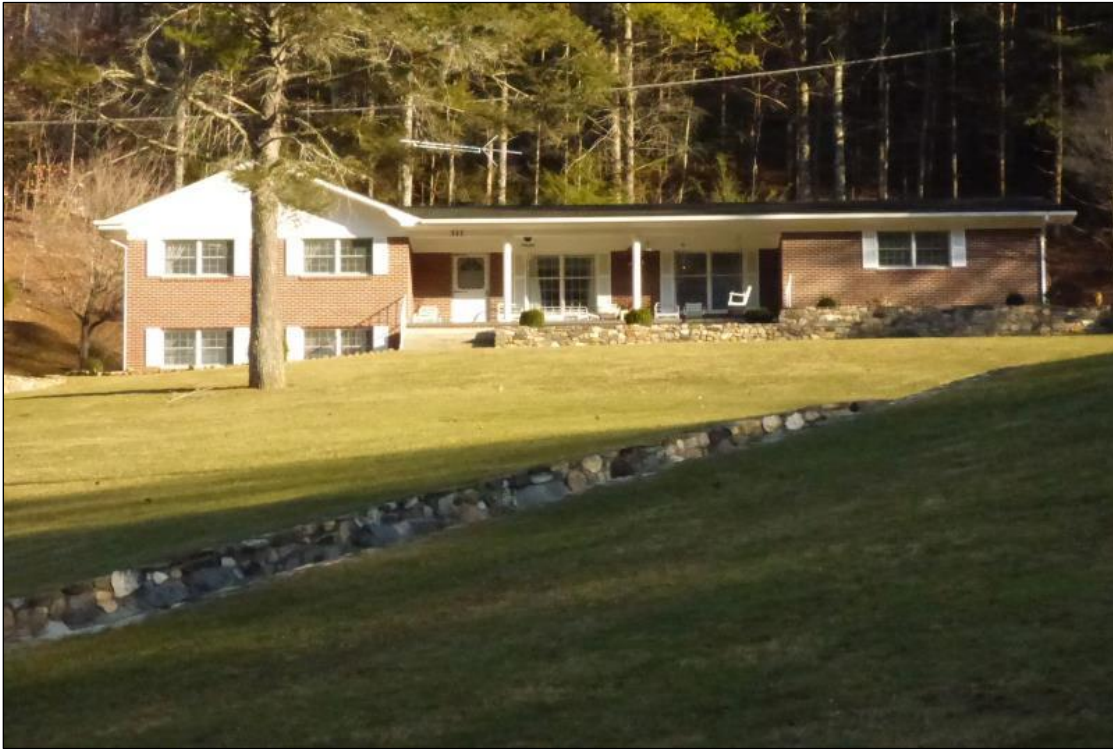
Photo 43: Johnny Byrd House, Primary (West) Elevation.

Johnny Byrd built this one-story, six-bay, split-level Ranch-style house in 1972. Resting on a concrete-slab foundation and with a semi-subterranean basement, Byrd's house is of frame construction with a running brick veneer exterior. The long, low-hipped roof covering the house's main section recesses to create an engaged front porch that is bounded by the north end's cross-gable projecting wing; both the cross-wing and hipped roof sections are covered by asphalt shingles. The roof has deep soffits, and simple gable returns typical of Ranch houses, with the cross-gable's apex sided with weatherboards and pierced by a circular louvered ventilator. A brick chimney is located behind the front slope of the roofline. The primary entrance, located within the recessed front porch, is a metal and screen door over a plywood door with a fan-shaped glass sash, typical of 1960s and 1970s doorways. A variety of double-hung sash windows are seen along the façade and north elevation, nearly all paired; the cross-gable wing and south end of the house have smaller eight-over-eight paired windows, the windows at the porch are large, elongated six-over-nine paired windows. At the house's south elevation, earlier garage doors have been replaced by a wall of windows, suggesting that this was rehabilitated into living space some years beforehand. The recessed front porch is supported by plain, square wood posts and consists of a raised, poured concrete floor enlivened by an adjacent rock-faced terrace (Photo 43, p. 39). Another rock-faced terrace wall stands just southwest of the house's cross-gable. There is a two-bay, front-gable brick outbuilding built into a slope south of the house (Photo 44, p. 39).

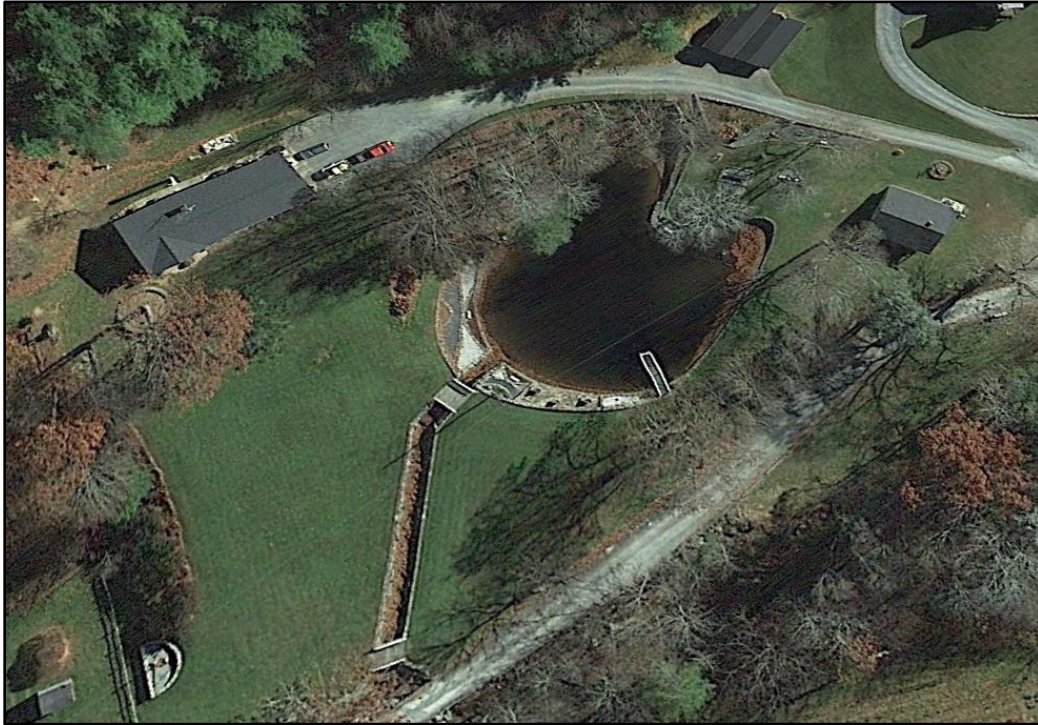
Photo 45: Johnny Byrd House, Aerial View of House, Manmade Pond and Canals (Google Earth).

West of the house is a 2-acre manmade pond and canal system created by Johnny Byrd (Photo 45, p. 40). According to Mr. Byrd, the pond, faced with concrete and stone, came first along with a concrete canal of similar treatment built within the slope leading from his house to the pond. These were initially constructed in 1972, the year his house was built (Byrd, personal communication 2015). Because of stability issues—the pond's dam broke in the 1990s—Byrd created another canal, whereby pond runoff would course into Clark's Creek (Byrd, personal communication 2015). Terraced rock platforms and walls, designed for picnics, surround the pond on all sides (Photo 46, p. 40).

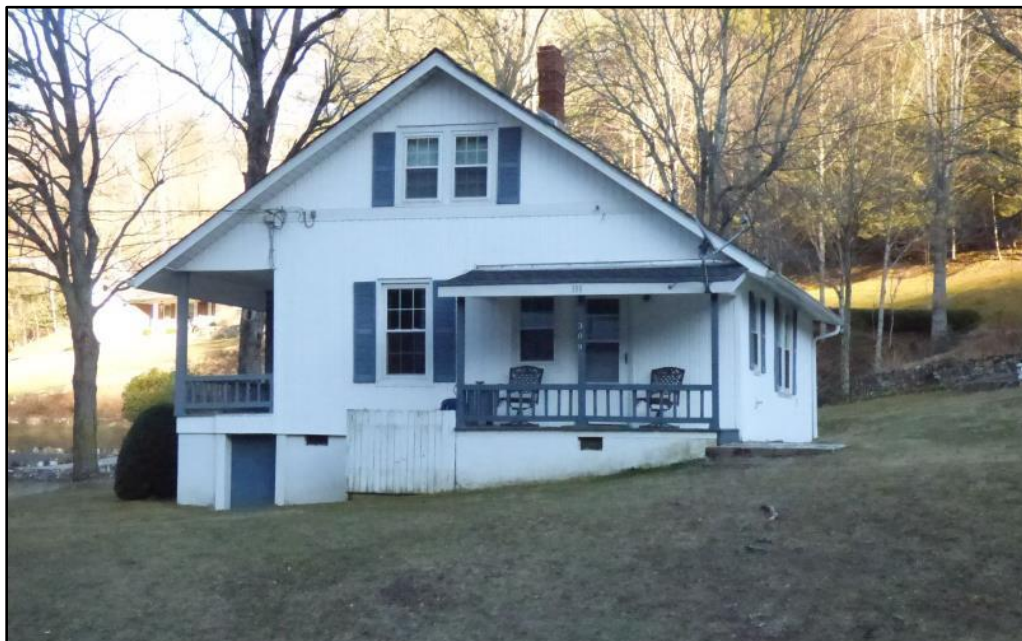
Photo 47: Wilson House, West Elevation.

According to longtime residents Johnny Byrd and Jon Townsend, this one-and-a-half story, three-bay frame bungalow belonged to the Wilson family and was built in the 1920s. The house, which faces north away from Justus Road, stands upon a concrete-block foundation and has frame infrastructure that was initially covered by weatherboards but is now faced with vertical T-111 siding (Photo 47). The wide, side-gable roofline extends to shelter the house's full-façade porch at its north elevation. The roof is covered by replacement asphalt shingles. The tall brick chimney stack at the house's south slope is original. The plywood door at the house's principal entrance, with its pierced fanlight, appears to be original; the single and paired double-hung sash windows are replacement. The porch's tall wood posts and rail balustrade, which repeat at the house's west elevation shed porch, are replacement (Photo 48, p. 42). There are no corresponding outbuildings on this property.

Although the house has been updated, the dwelling still retains its original massing and scale and represents 1920s-era construction in the district. It is recommended as a contributing element to the historic district.

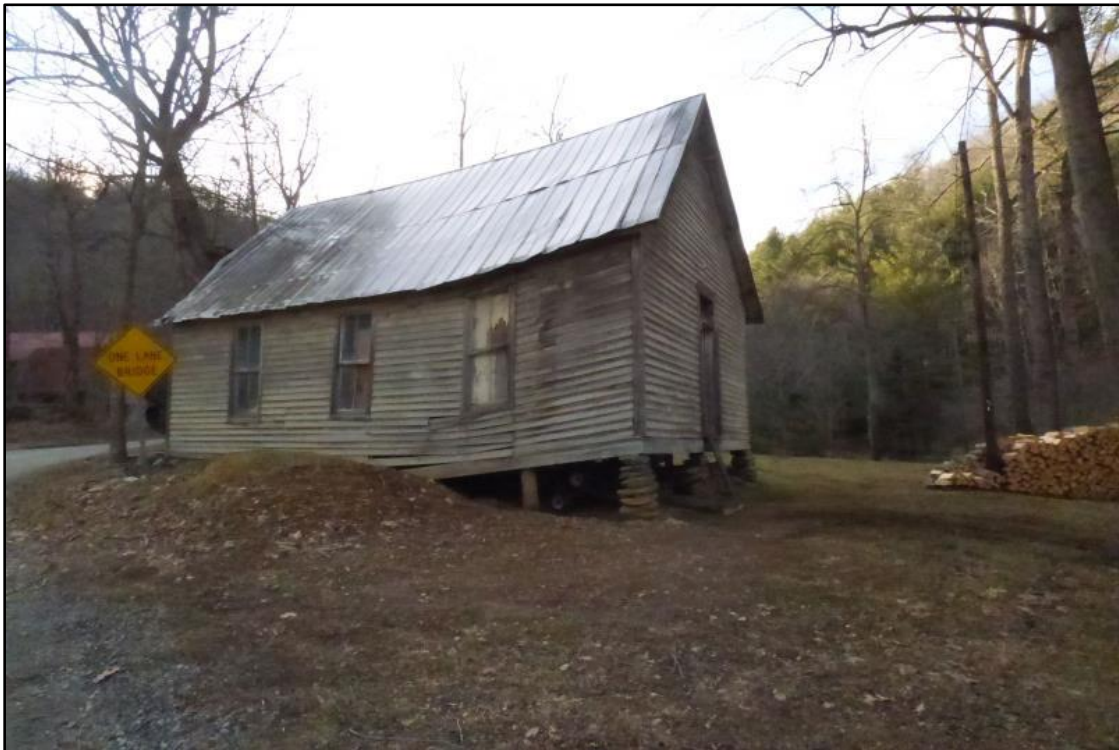
Photo 49: Clark's Creek Baptist Church, Oblique of East and Primary (North) Elevations.

Now resting on stone and wood piers, the balloon-frame, gabled former sanctuary is in deteriorated condition due to termite damage at its east elevation. It retains its original weatherboard cladding, secured by cut nails, as well as plain cornerboards. The exterior is devoid of ornament seen with other late nineteenth-century churches, such as prominent gable returns, molded window and door surrounds, or decorative brackets or posts. The

This building was erected as one of the first churches in the Clark's Creek community. Although it has been moved, this action was taken in the 1930s as part of the redevelopment of this crossroads area by a prominent local citizen for the construction of a new religious facility. The church retains its original form and exterior elements, and its interior is still discernable as having been a gathering place. Given its ties to the social history of the area, it is suggested that this is a contributing element to the district.

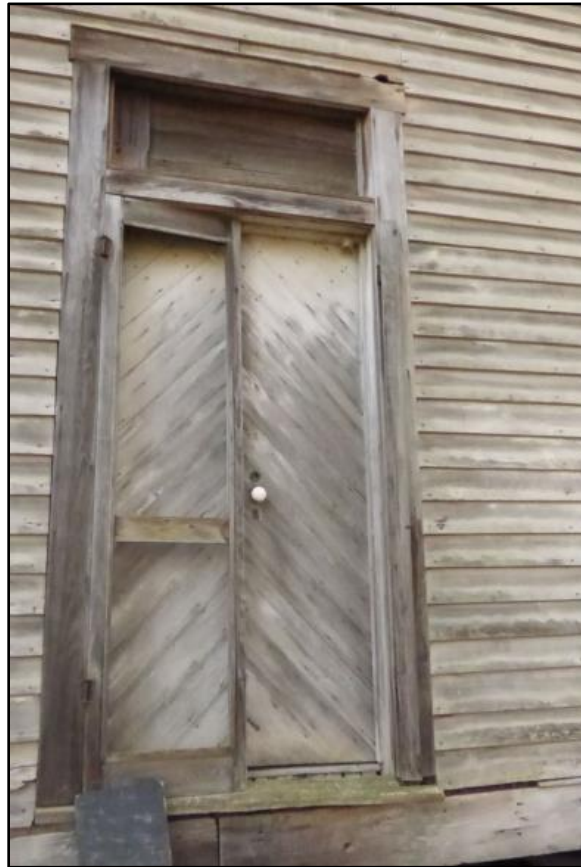
Photo 52: Clark's Creek Baptist Church, Detail of Entrance.

gabled roof is covered with standing seam metal. The flue chimney, which was positioned at the church's west elevation, was removed some years ago. The former entrance at the church's north elevation, is positioned at the center with paired, herringbone-sheathed doors and a wide overhead transom (Photo 52, p. 45); at the south elevation, there is a glass and wood panel door dating from the early twentieth century. Window openings are plain, filled by double-hung, one-over-one, wooden sashes. Three windows on each side light the former church's east and west elevations. There is no indication of an earlier or original porch for the Baptist church, but a shed roof supported by wood posts shelters the south entrance. Inside, the interior is still sheathed by plain tongue-and-groove siding, and a small vertical board wainscot and chair rail (Photo 53, p. 45).

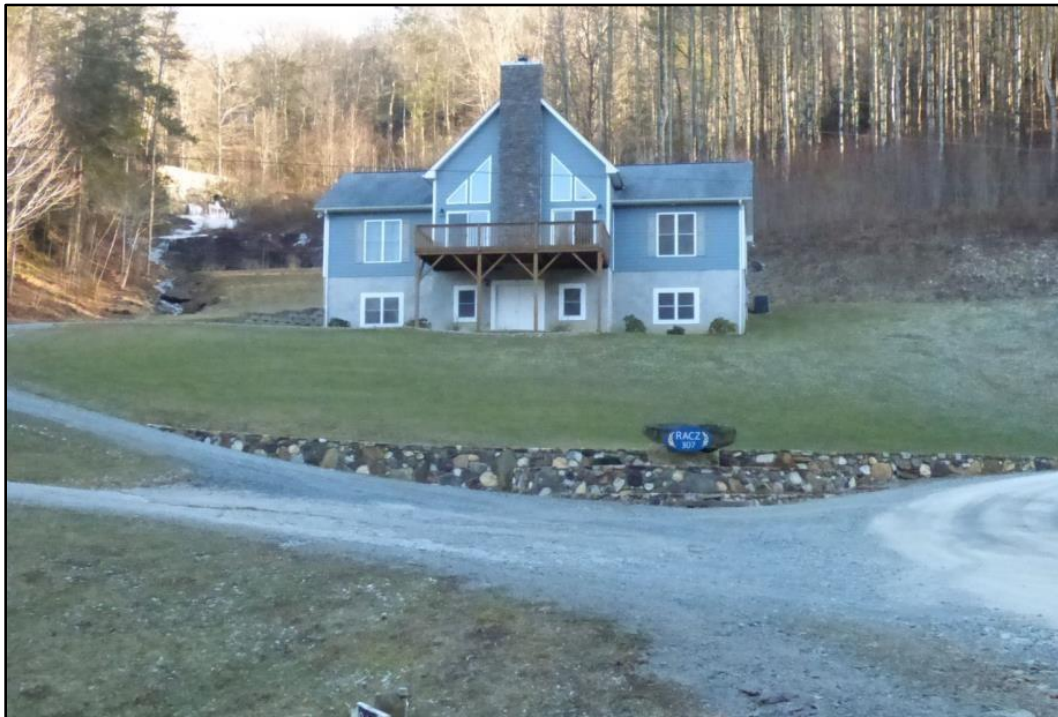
Photo 54: Byrd-Racz House, Primary (Southeast) Elevation.

A two-story, frame side-gable house with an imposing front-gabled center portion, the Byrd-Racz House faces northwest toward Justus Road and Clark’s Creek. It stands on a cement slab foundation. Its lower story is plastered concrete block, while its upper story is sheathed in hardie-plank weatherboard siding and the roof is covered by asphalt shingles. A stone chimney, its stack flush against the center gable, breaks through the center gable’s apex (Photo 54). The house’s large, double-hung and triangular eyebrow windows are vinyl and glass, with a front entrance of paired metal doors beneath a wooden deck. One outbuilding, a storage shed, is located west of the dwelling (Photo 55, p. 47).

This house is an example of recent development within the historic district. It is recommended as a non-contributing resource.

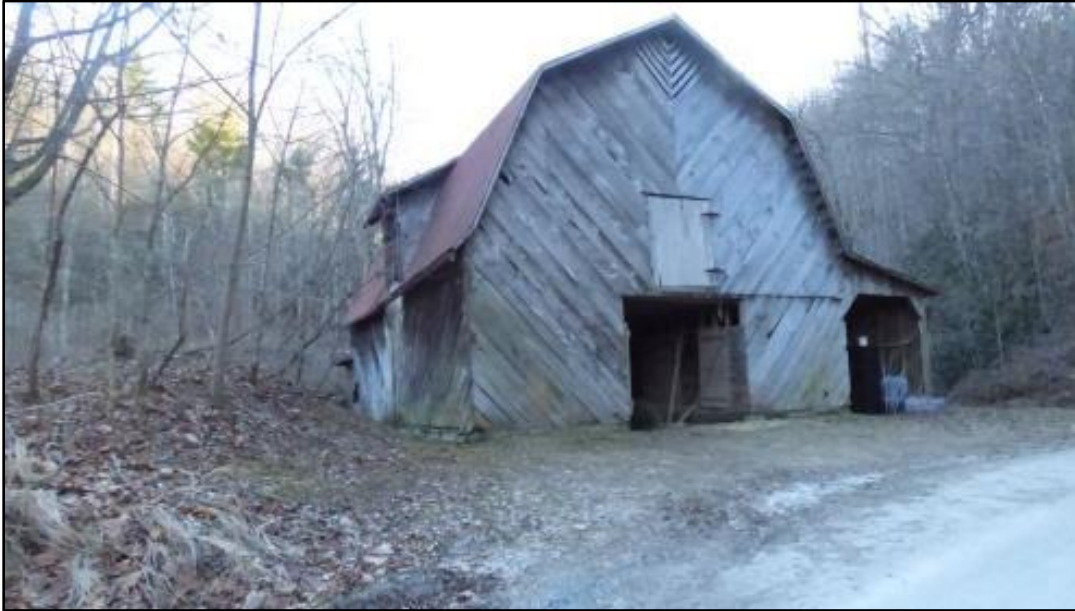
Photo 56: Barn, North Elevation.

Associated with the nearby Charles Clark House, this frame, gambrel roof dairy barn stands on a stone and concrete-block foundation, facing north toward Justus Road and on the east bank of Clark's Creek (Photo 56, p. 48). It has patterned and nailed vertical wood siding, in addition to a decorative lozenge louvered wood ventilator at the front gable's apex. The barn, which has a thru-passage with three cribs to each side, is covered by a standing seam metal roof. Its hay hood is located at the east elevation, and has a shed roof dormer (Photo 57–Photo 58, p. 49). Besides the central pass-thru, other openings at the front elevation include the overhead hinged door at the second floor for the hayloft. The barn has an attached open shed at its west elevation. This property, along with woods and wetlands on the opposite bank of Clark's Creek (PIN 1879-96-1110-000), are designated Farmland Preservation areas within Watauga County (Watauga GIS 2014; Watauga Voluntary Farmland Preservation Program [VFPP] 2014).

This barn is among the most intact outbuildings in the district and retains nearly all its fenestration and exterior details. Due to its construction date and direct ties with the agricultural use of this area by residents important to this immediate area's history, it is recommended that this resource is a contributing element to the historic district.

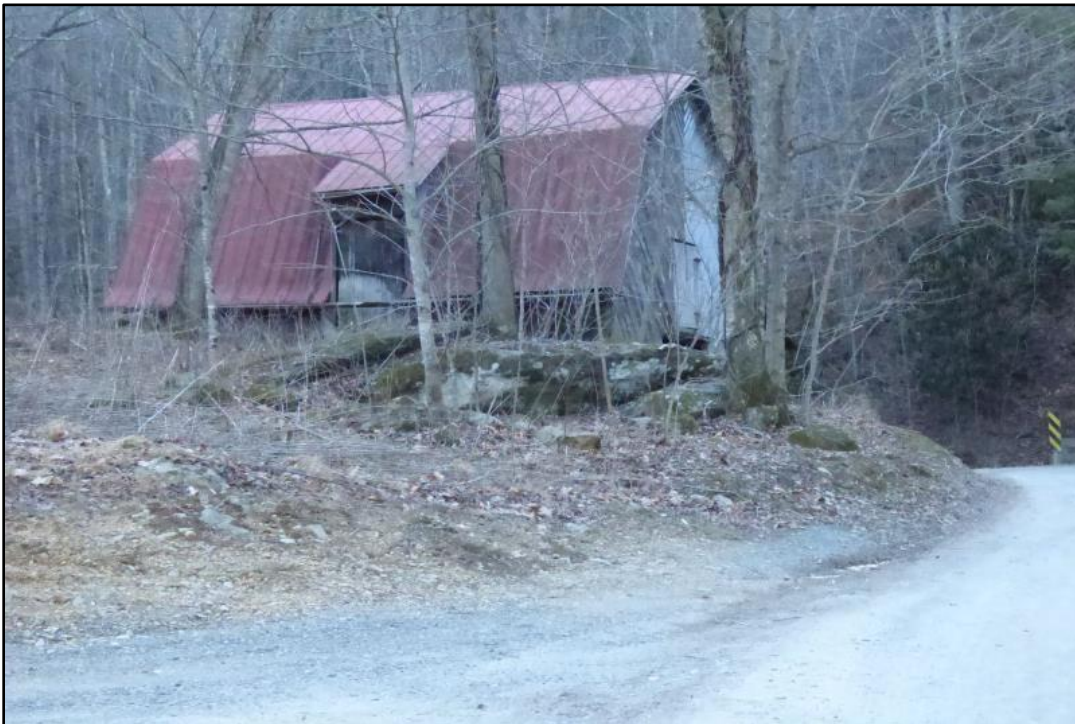
Photo 57: Barn, East Elevation Showing Shed-Roof Hayloft.

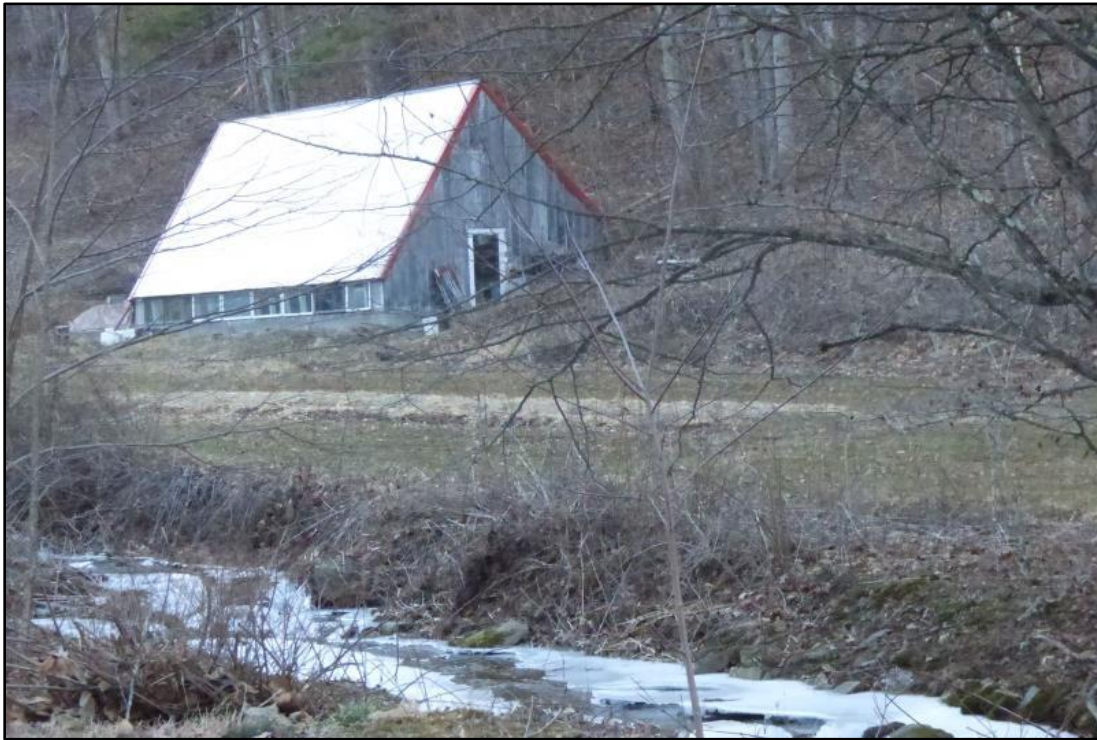
Photo 59: Greenhouse, West Side Justus Road.

This gabled greenhouse and former pen enclosure are sited in bottomland on the west bank of Clark's Creek (Photo 59, p. 50). The foundation of the greenhouse could not be discerned due to limited access. It is of frame construction and sheathed with nailed, vertical wood boards. The gabled roof has a standing-seam-metal cover. Fenestration includes a band of single-pane windows along the greenhouse's south and north elevations, and a single entrance on the east elevation. East of the greenhouse, closer to Clark's Creek Road is a post-and-rail animal pen (Photo 60, p. 50), apparently for fencing small livestock.

Although this building has an association with the continued agricultural use of this area, it is modern construction and does not date to the primary period of farming activity in Clark's Creek. It is recommended to be a non-contributing element to the district.

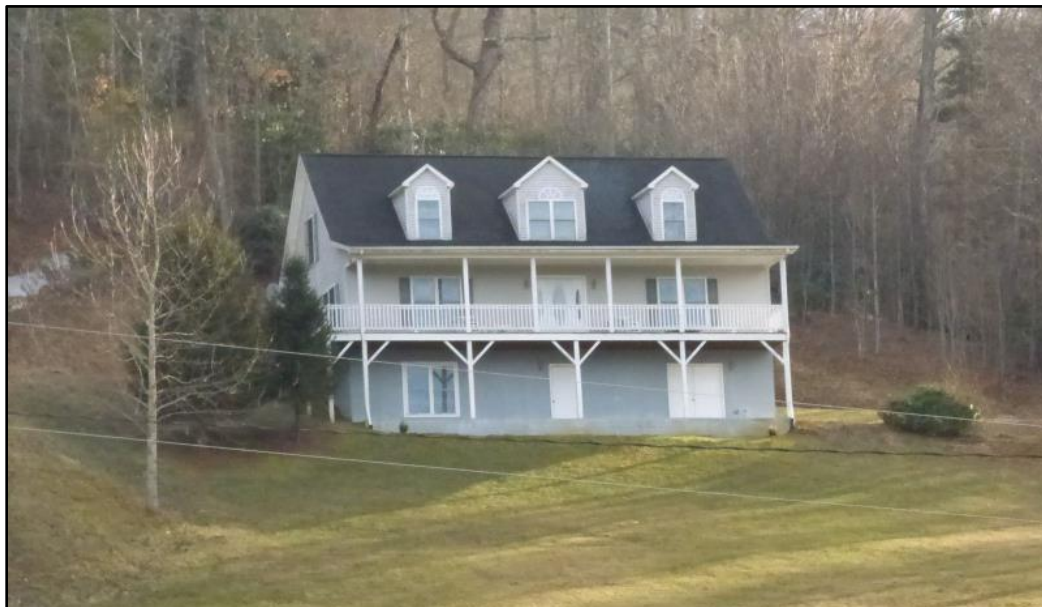
Photo 61: 2502 Clark’s Creek Road, Primary (Southeast) Elevation.

Sited on a slope above Clark’s Creek’s upper valley, this two-story, three-bay dwelling faces northwest (Photo 61, p. 51). Its foundation could not be determined due to limited access but the frame building is sheathed by weatherboards. The side-gable roof, which extends to form a shelter along the façade, is covered by asphalt shingles and pierced by three front-gable dormers. No chimney is visible from the northwest or side (northeast and southwest) elevations. Fenestration is symmetrical, with metal doors at the lower story and a central wooden door on the second-story façade, lit by sidelights and a center oval glass panel. The building is lit by single and paired vinyl-and-glass, double-hung sash windows. There is a two-story, full façade porch at the front elevation, supported by metal posts and a rail balustrade at the second floor. As can be seen from Photo 62 (p. 52), this house is visible in the upper Clark’s Creek valley viewshed, but at some distance from the cluster of community buildings, in addition to which its traditional side-gable form is more in keeping with older buildings in Clark’s Creek.

This is an example of recent development within the community, and it is recommended to be a non-contributing resource to the historic district.

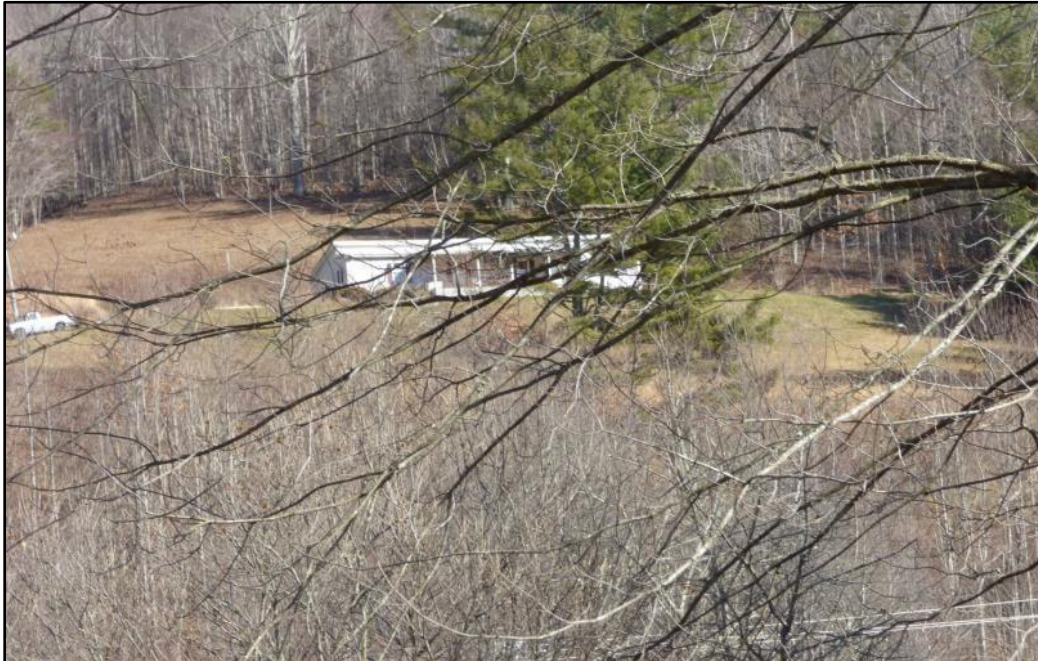
Photo 64: 2222 Clark's Creek Road, Primary (South) Elevation.

Above the north side of Clark’s Creek Road, a side-gable manufactured house stands facing south, its south (primary) elevation screened by trees three seasons of the year (Photo 64, p. 54). To its west, is a mid-twentieth-century, gabled frame barn (Photo 65, p. 54). This property is marked by “No Trespassing” signs so that access was not possible. However, the house’s siting behind trees on a mountain slope above Clark’s Creek is not obtrusive, as the trees screen the house from the valley’s overall viewshed. Over 50 years of age, the barn appears to be in fair to poor condition. Little can be ascertained of its form and function.

this area, it has extremely compromised integrity and all vestiges of its association with other contributing elements are gone. It is recommended that this resource does not contribute to the historic district.
