Re: Removal of Little Buck Creek Dam, Tusquitee Ranger District, Nantahala National Forest,
Clay County, ER 15-0758

**Historic Structure Documentation and Assessment of the Little Buck Creek Dam
Tusquitee Ranger District, Nantahala National Forest,
Clay County, North Carolina**

MANAGEMENT SUMMARY

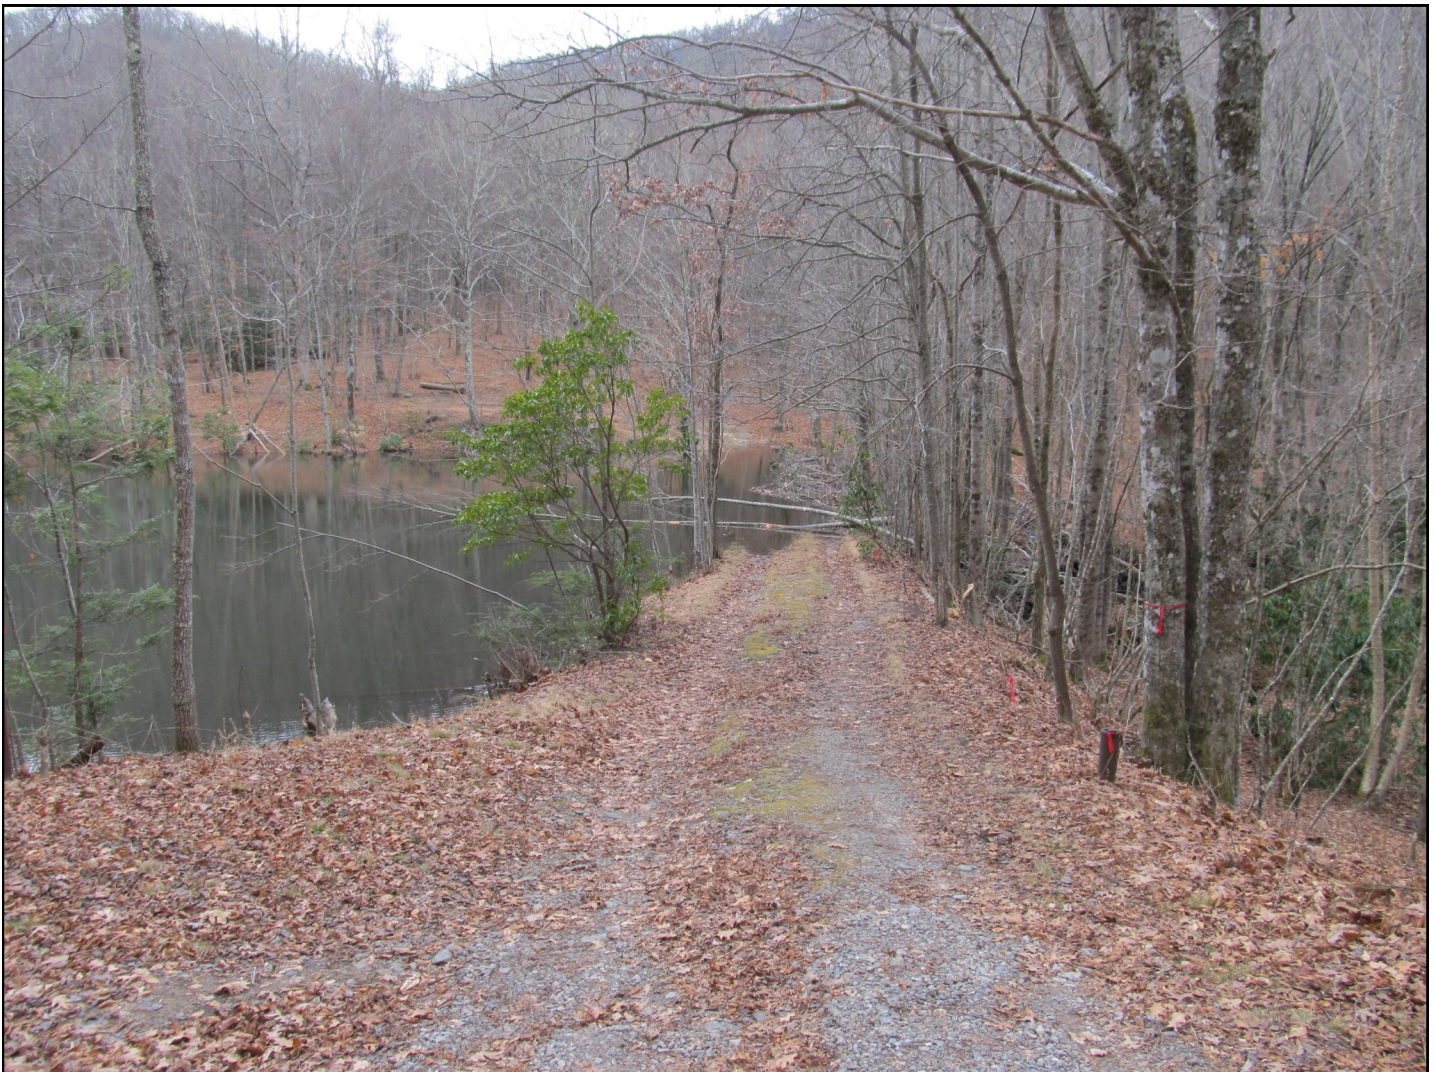
Plate 1. View south, showing the approximately 150 feet long, 18-foot tall earthen dam across Little Buck Creek. Photograph taken from FS Road 71. Note in the background that the water level is above the roadway across the dam due to beaver activity.

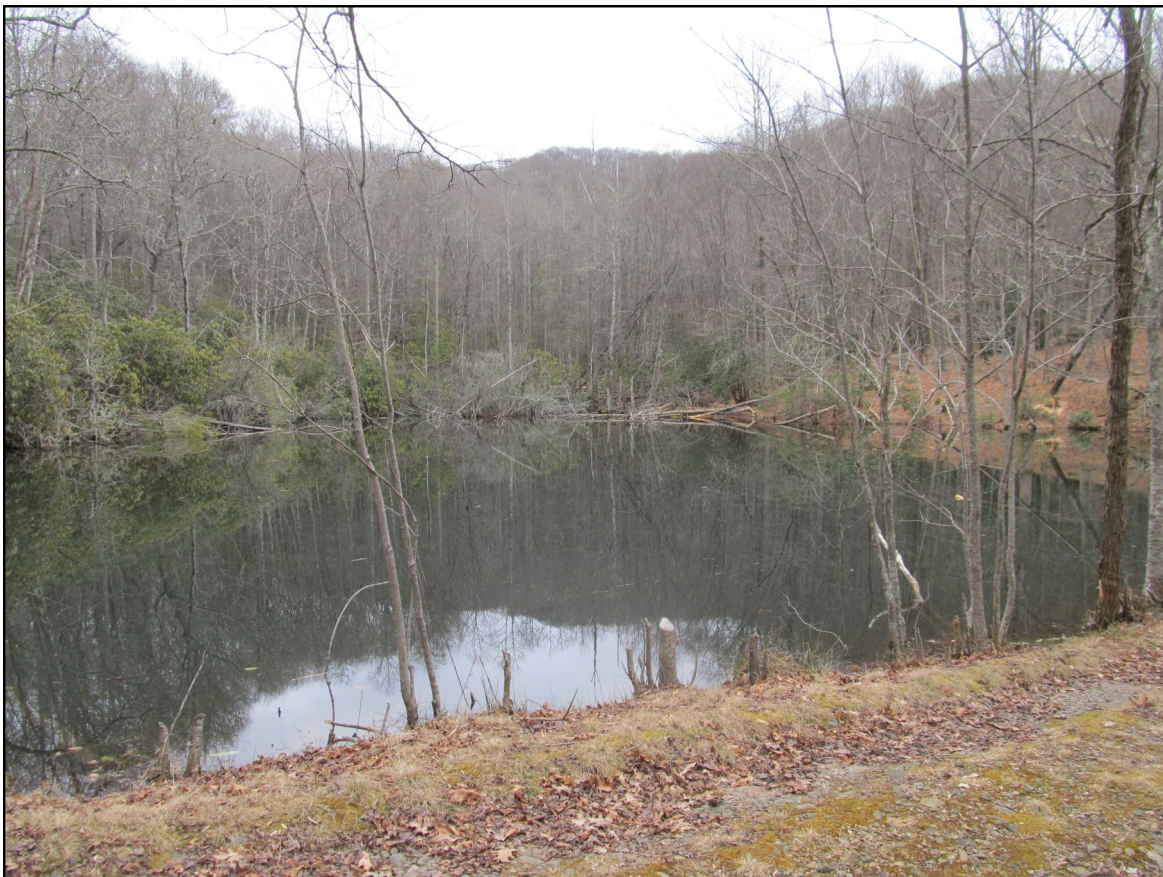
Plate 2 (top).
Showing the 1 acre
pond created by
the Little Buck
Creek dam.

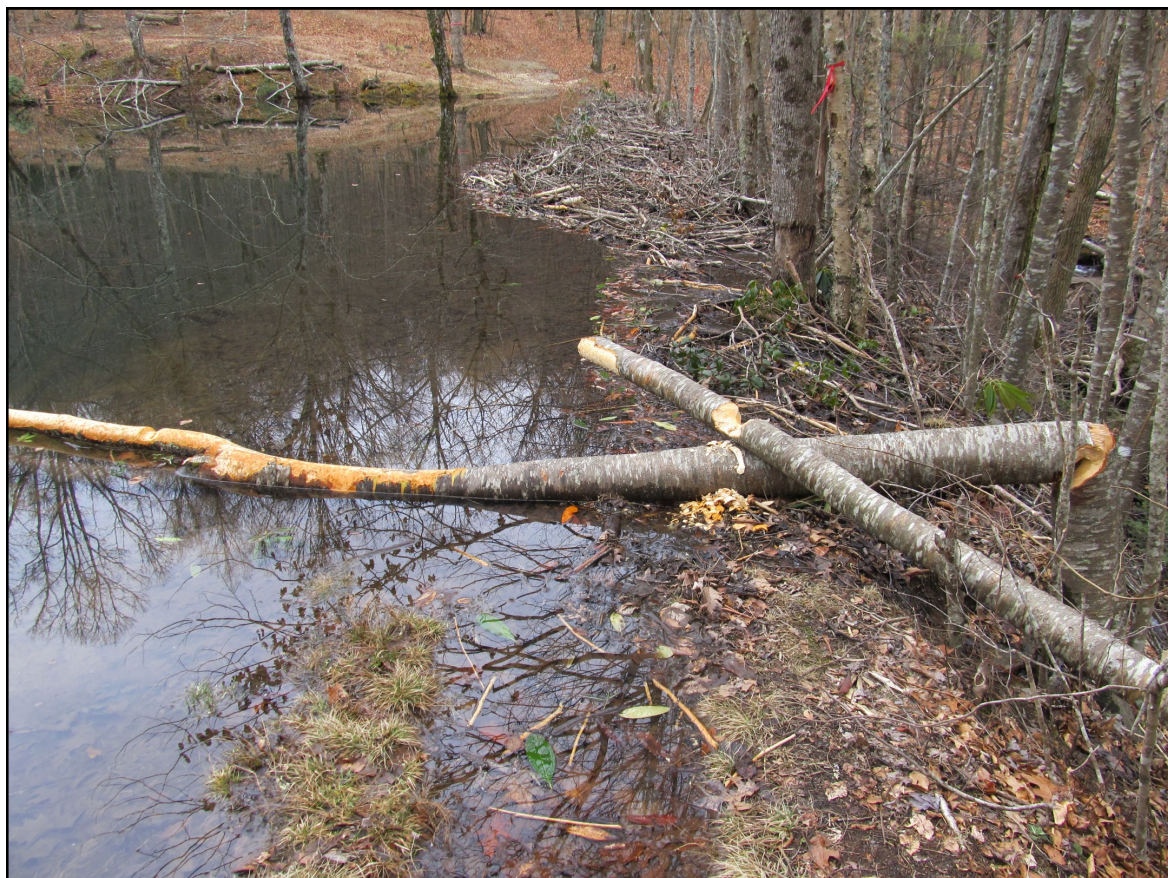
Plate 3 (bottom).
Beaver dam across
the top of the
bridge and recent
beaver activity.

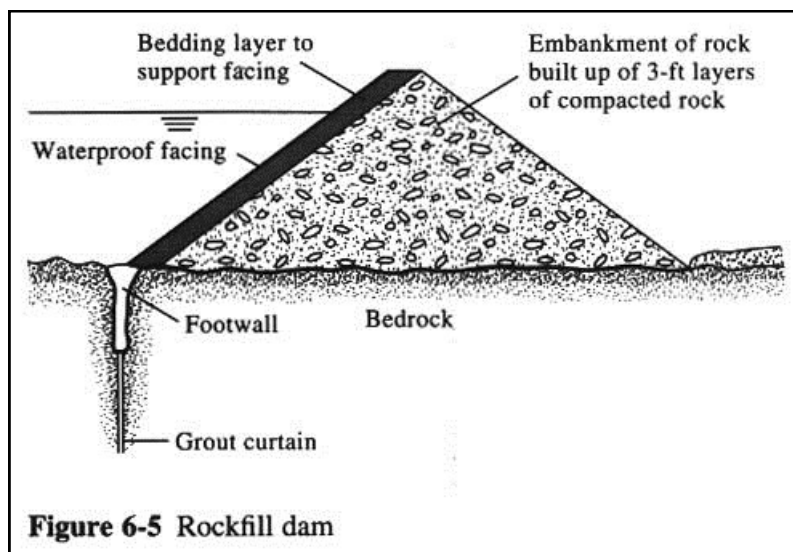
Figure 4. A cross-section diagram showing the construction of a typical rockfill dam. The description of the construction of this type of dam states the rock is laid down in layers and each layer is subsequently compacted. Diagram and description copied from website (http://parra.sdsu.edu/roberson_chapter06.html)

The exact method of construction for the Little Buck Creek dam is unknown, but based on its setting and the amount of exposed rock in the downstream face of the dam (Plates 5 and 6), it is thought to be a rock-filled dam with an earthen inner slope. The screen shot below was taken from *Earth Dams: a Study*, written by Burr Bassel, and published by the Engineering News Publishing Company of New York City in 1904 (https://npdp.stanford.edu/sites/default/files/other_materials/earth_dams.pdf).

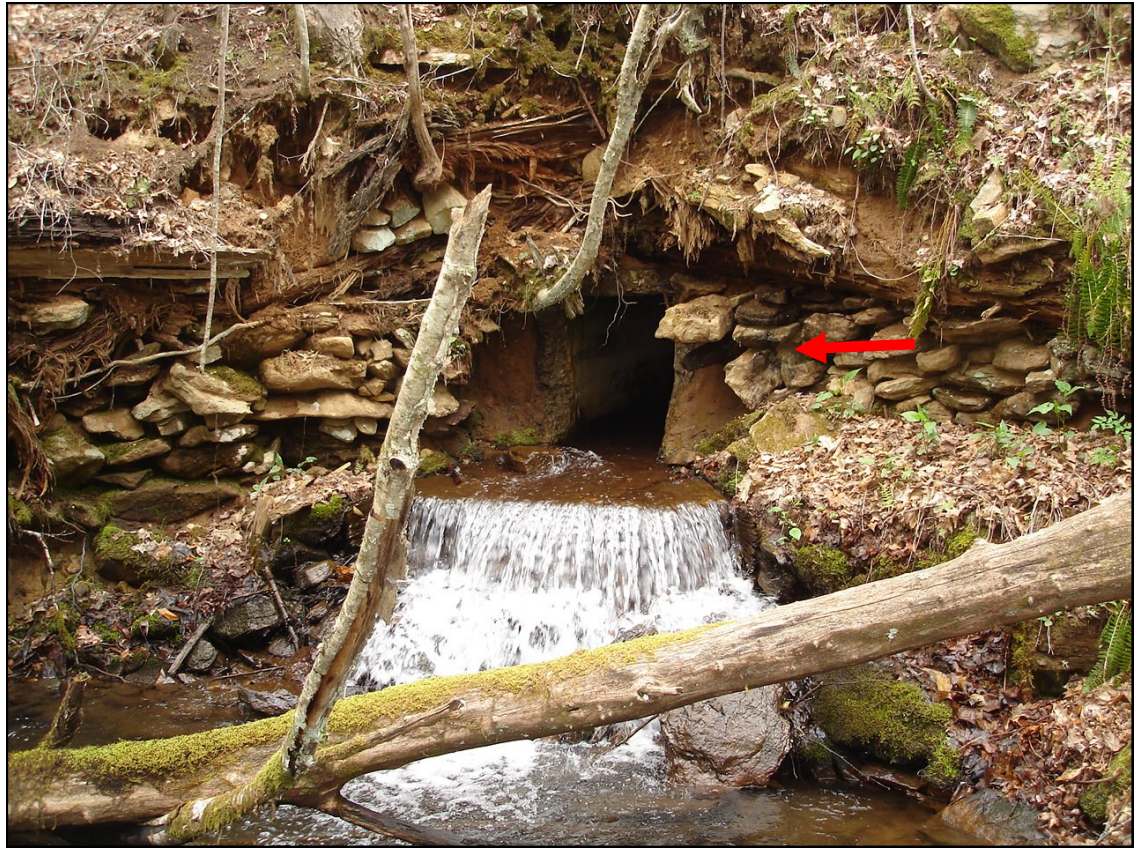
Plate 5 (right).
Showing the spillway
(red arrow) of the
Little Buck Creek dam
in 2009.

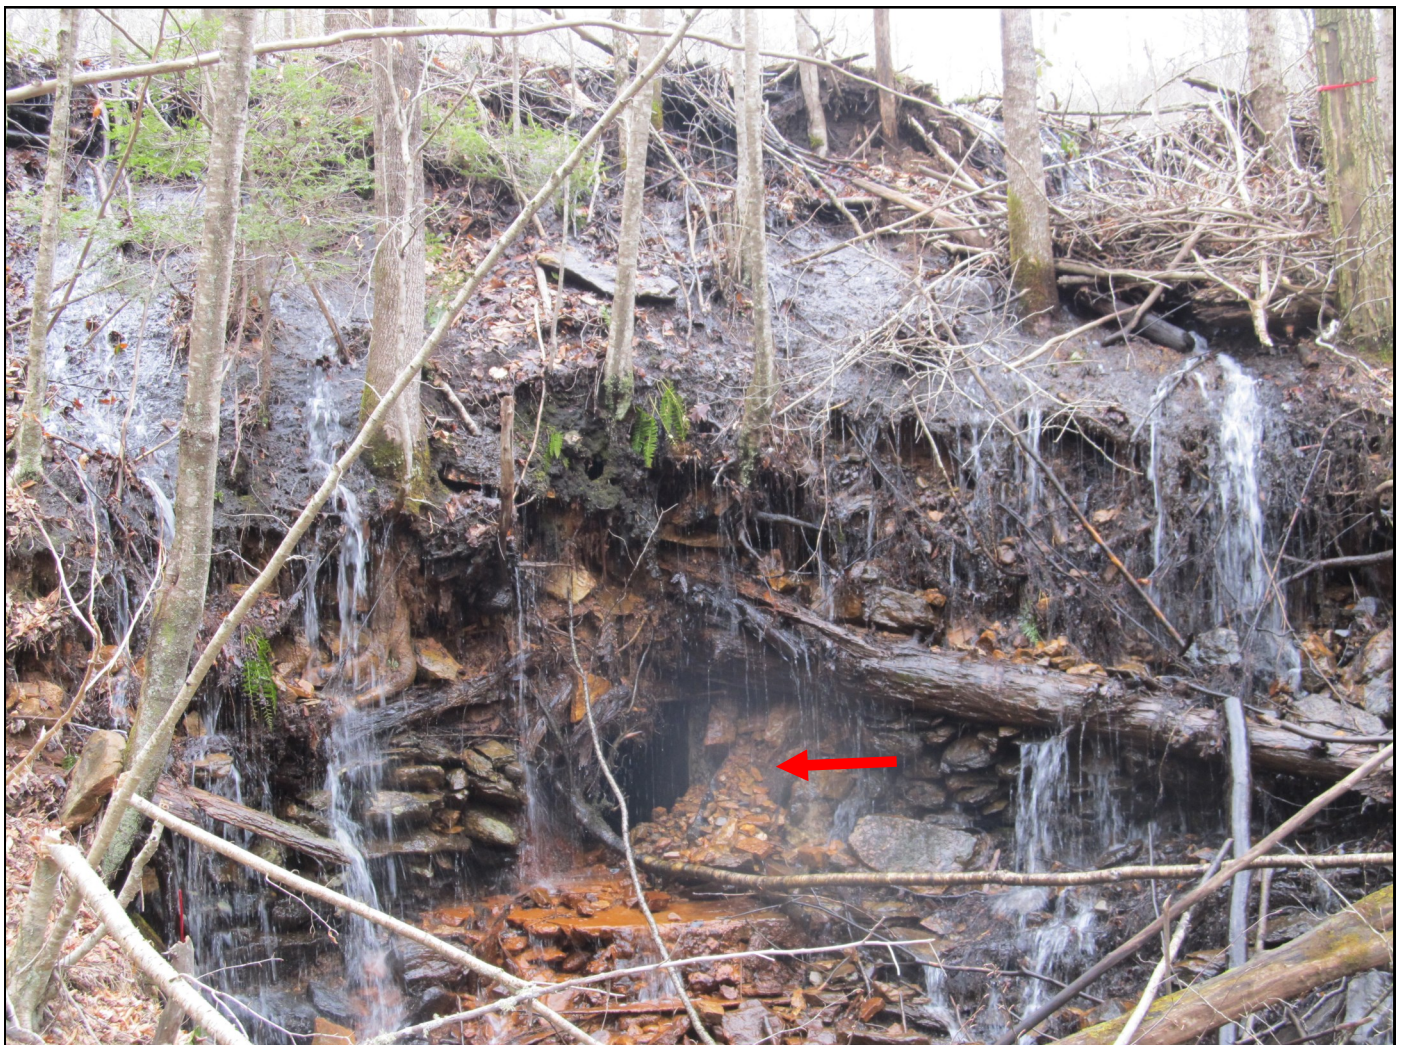
Plate 6 (below).
Showing the spillway
(red arrow) and
downstream face of the
dam in 2015. Note the
amount of erosion that
has taken place due to
water topping the dam
because of beaver
activity.

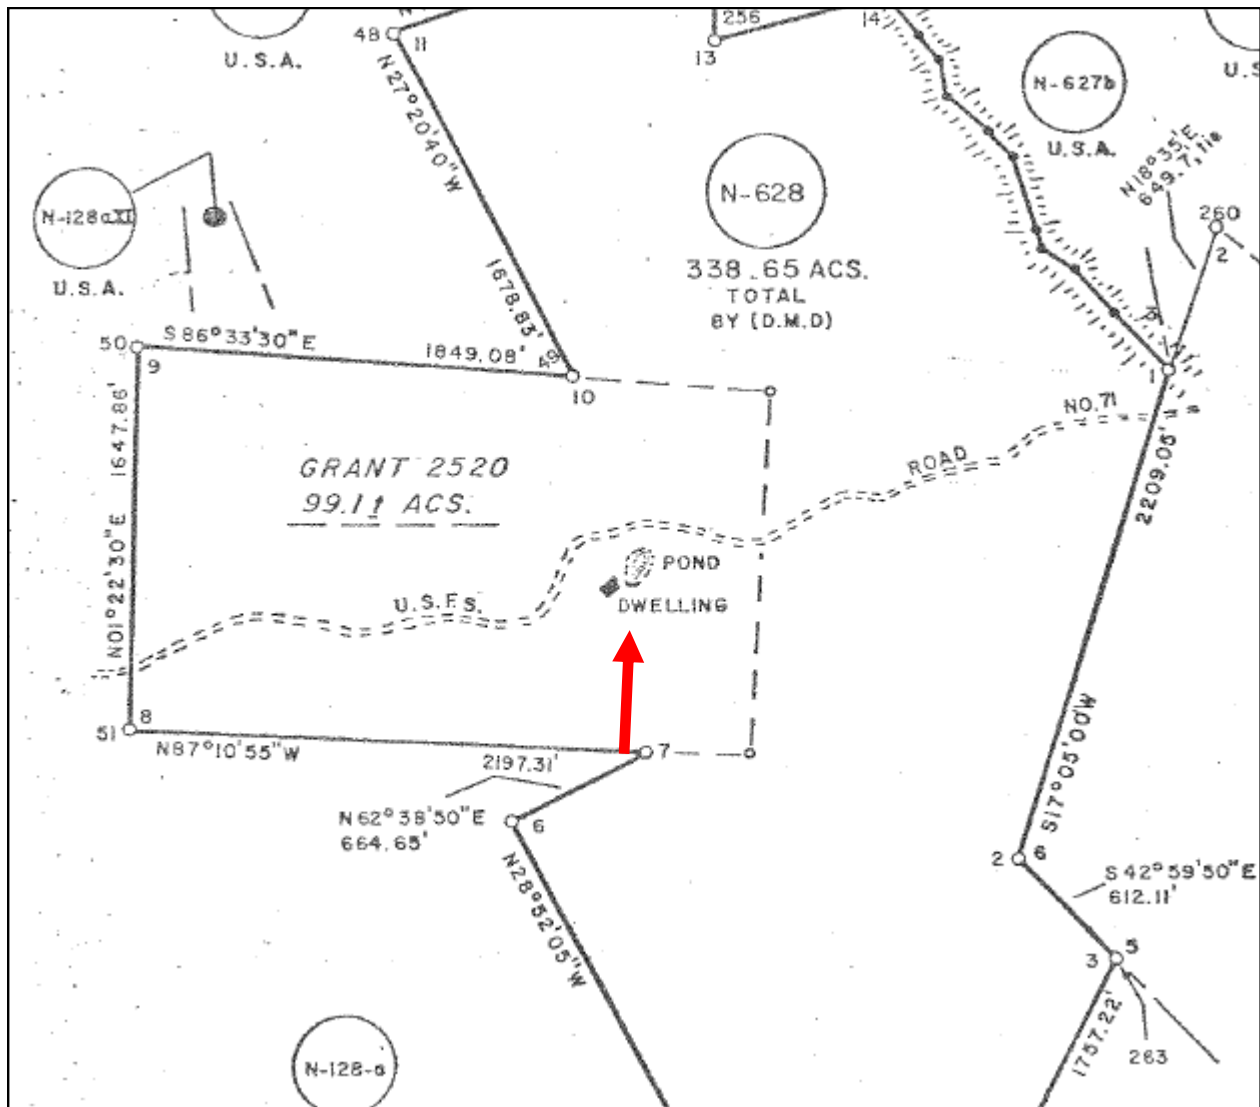
Figure 5. Survey map of Tract N-628, created when the U.S. Forest Service was in negotiations to purchase the property in 1977.

The tract of land on which the dam is located (Tract N-628, in Figure 2) was purchased by the U.S. Forest Service from Leroy H. Simpkins in June of 1977. Records indicate that when the property was purchased by the Forest Service that it had been abandoned for some time.
