Re: Blackbird Stream and Wetland Mitigation Site, SAW-2015-01800, Johnston County, ER 15-1819

# PUBLIC NOTICE

Resource Environmental Solutions, LLC proposes to undertake stream and wetland restoration work at Parker's Mill Pond in Johnston County. The project area is on the west side of NC Highway 96 in Johnston County. The project area (figure 1) is located just south of the crossroads community of Peacocks Crossroads and a little over seven miles southeast of Benson and fifteen miles south-southwest of the county seat of Smithfield. The Area of Potential Effect (APE) for the proposed project encompasses Parker's Mill (DOE, 2004), which consists of the mill pond, the mill house, dam, and spillways, and the Willie F. Parker Service Station, a circa 1930 frame former gas station and store, a previously undocumented historic service station. The historic structures are located on the east end of the mill pond (figure 2).

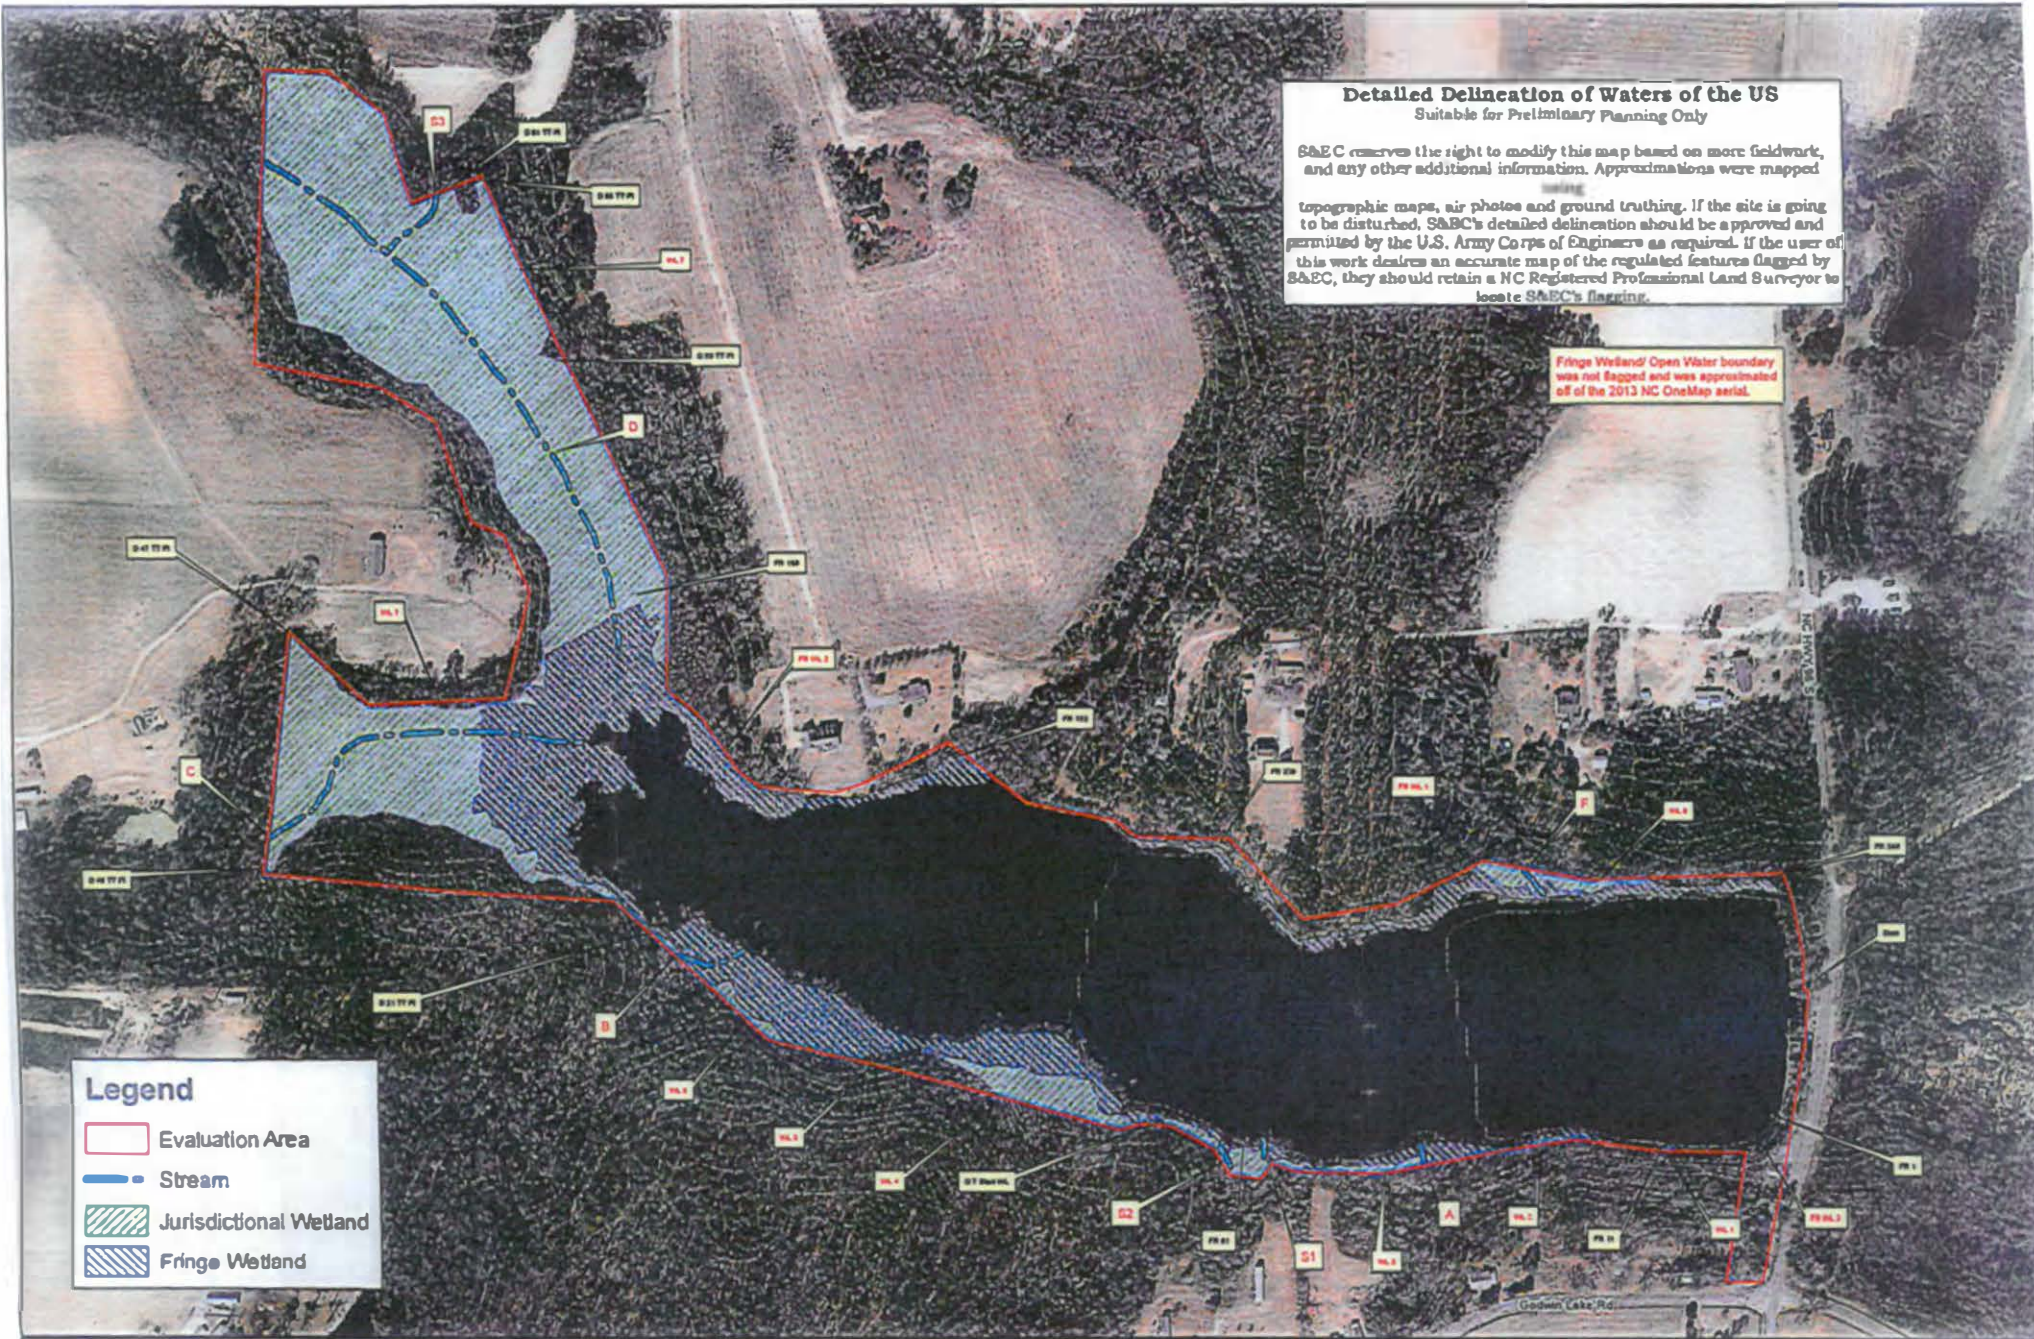
**Detailed Delineation of Waters of the US**  
 Suitable for Preliminary Planning Only

S&EC reserves the right to modify this map based on more fieldwork, and any other additional information. Approximations were mapped using topographic maps, air photos and ground truthing. If the site is going to be disturbed, S&EC's detailed delineation should be approved and permitted by the U.S. Army Corps of Engineers as required. If the user of this work desires an accurate map of the regulated features flagged by S&EC, they should retain a NC Registered Professional Land Surveyor to locate S&EC's flagging.

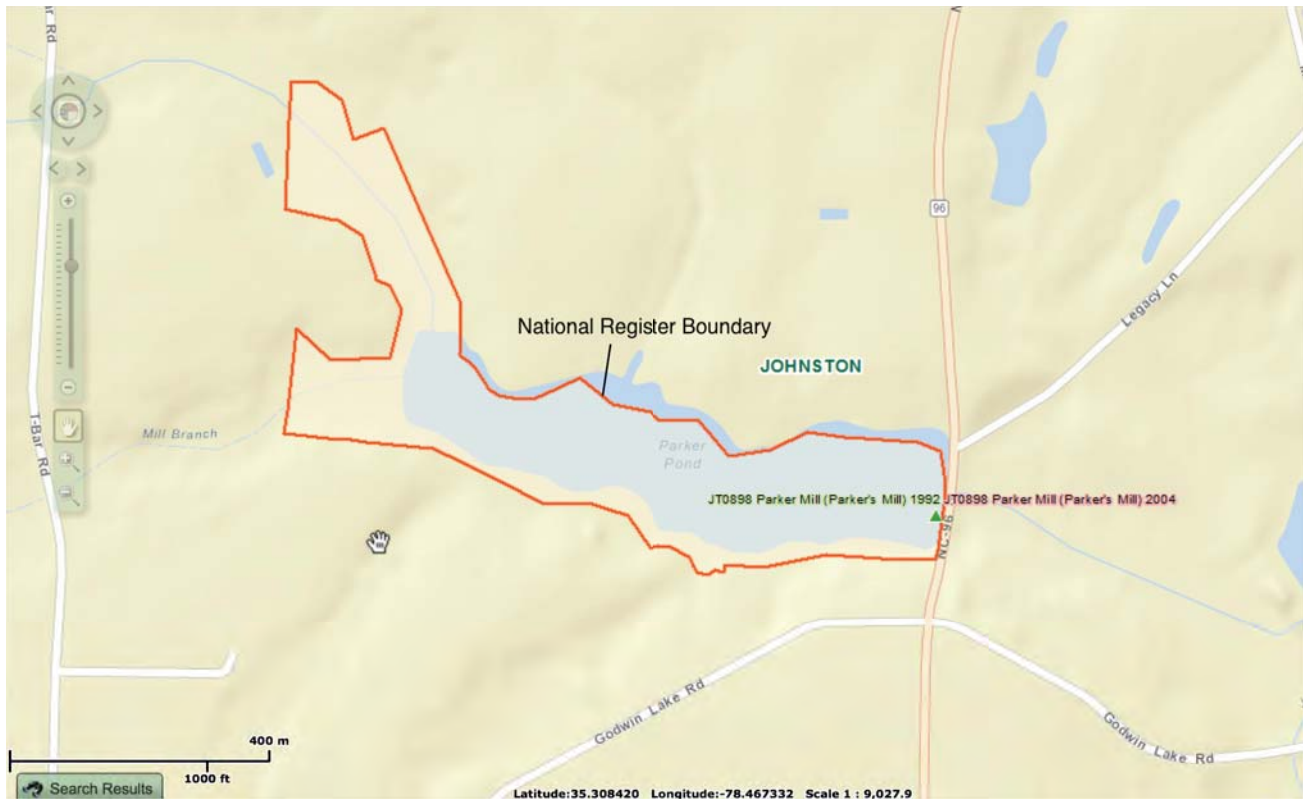
Figure 15: National Register boundary for Parker's Mill

The National Register boundary (figure 15) for Parker's Mill encompasses the mill house, dam, spillways, and pond and the edges of the wetlands and streams on the pond's edges. The eligible boundary does not include the Willie F. Parker Service Station standing to the south of the millhouse, but on the same parcel as Parker's Mill. The boundary is shown on the map that follows and includes approximately 53 acres containing the mill house, dam, spillways, and pond.

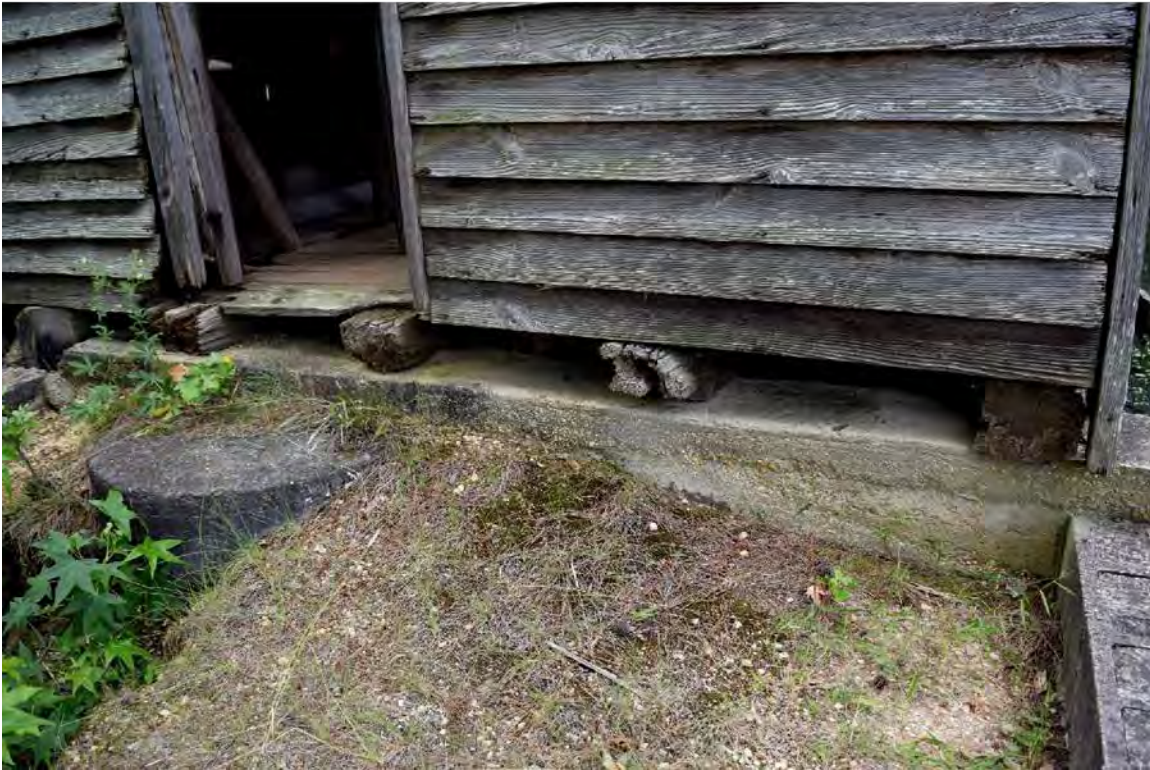
Figure 7. Original millhouse north elevation; foundation detail showing the concrete stepping stone and the cinder block retaining wall along Parker Mill Pond.

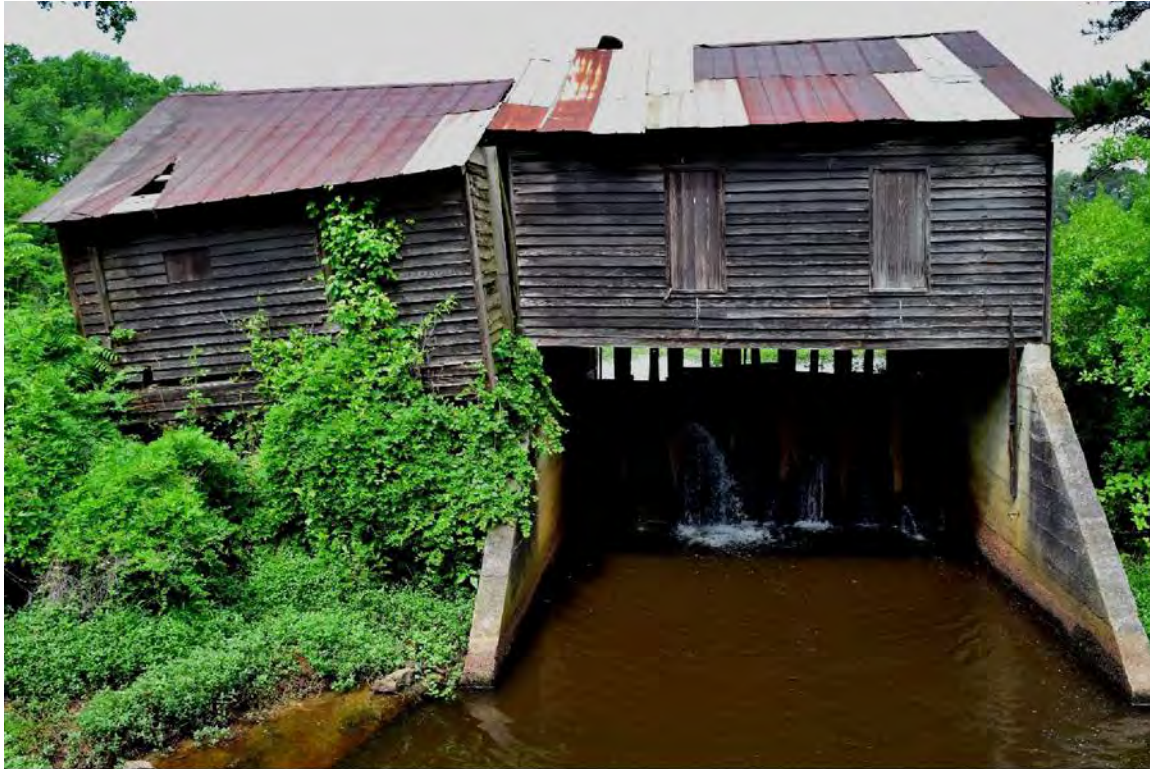
Figure 8. Original millhouse (right) and addition (left) east elevation showing the concrete spillway and wing walls along the tailrace.

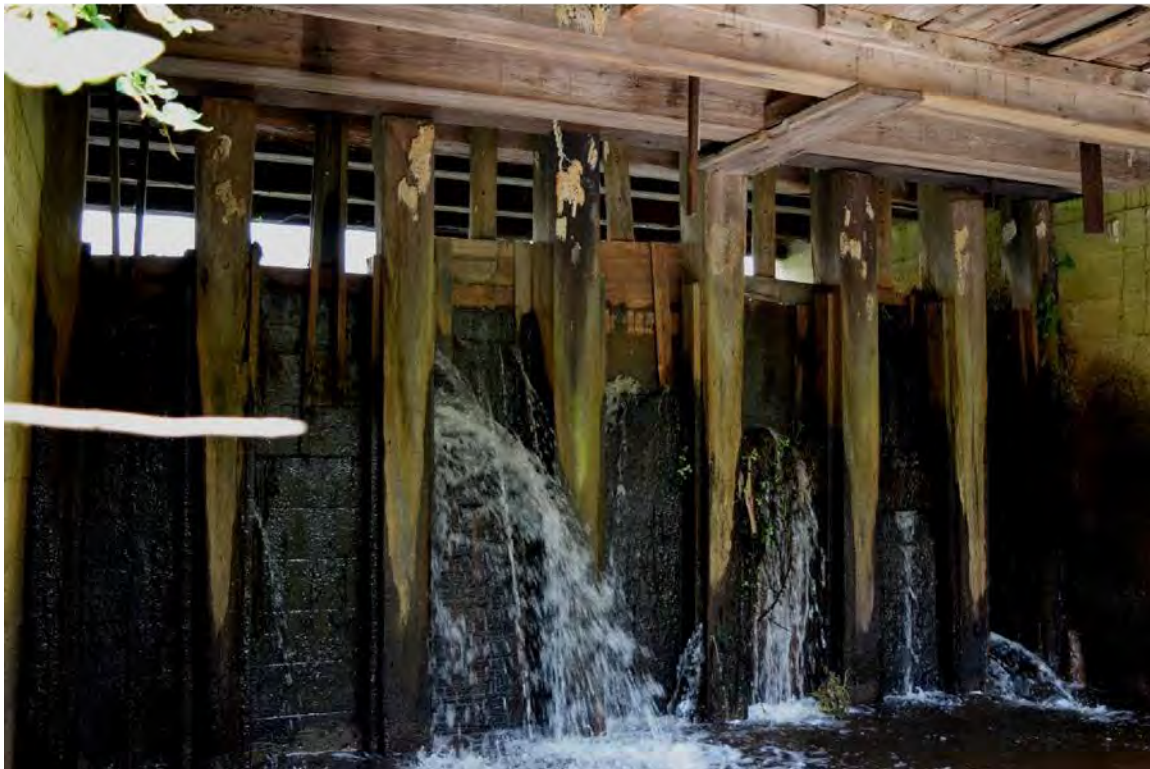
Figure 9. Spillway showing sluice gate below the original millhouse, view from the tailrace.

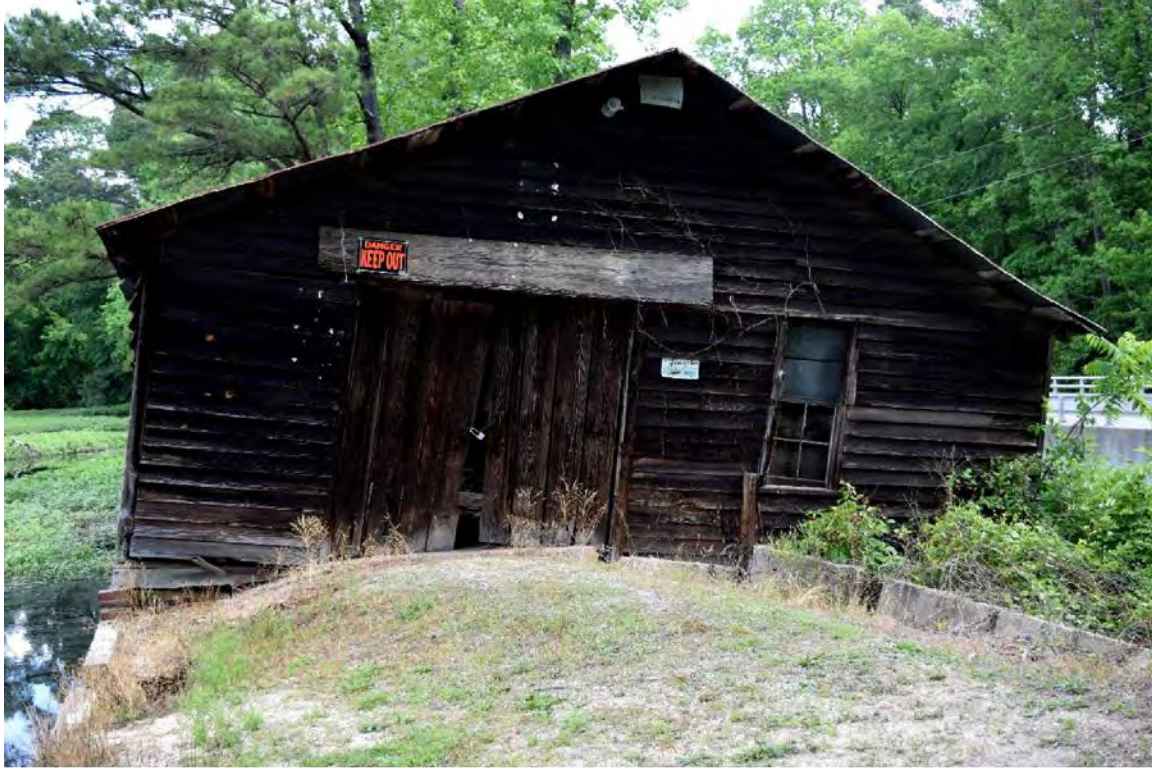
Figure 12. Millhouse addition south elevation showing the concrete retaining wall along the earthen dam/millhouse road; Parker Mill Pond on the left and the NC 96 bridge on the right.

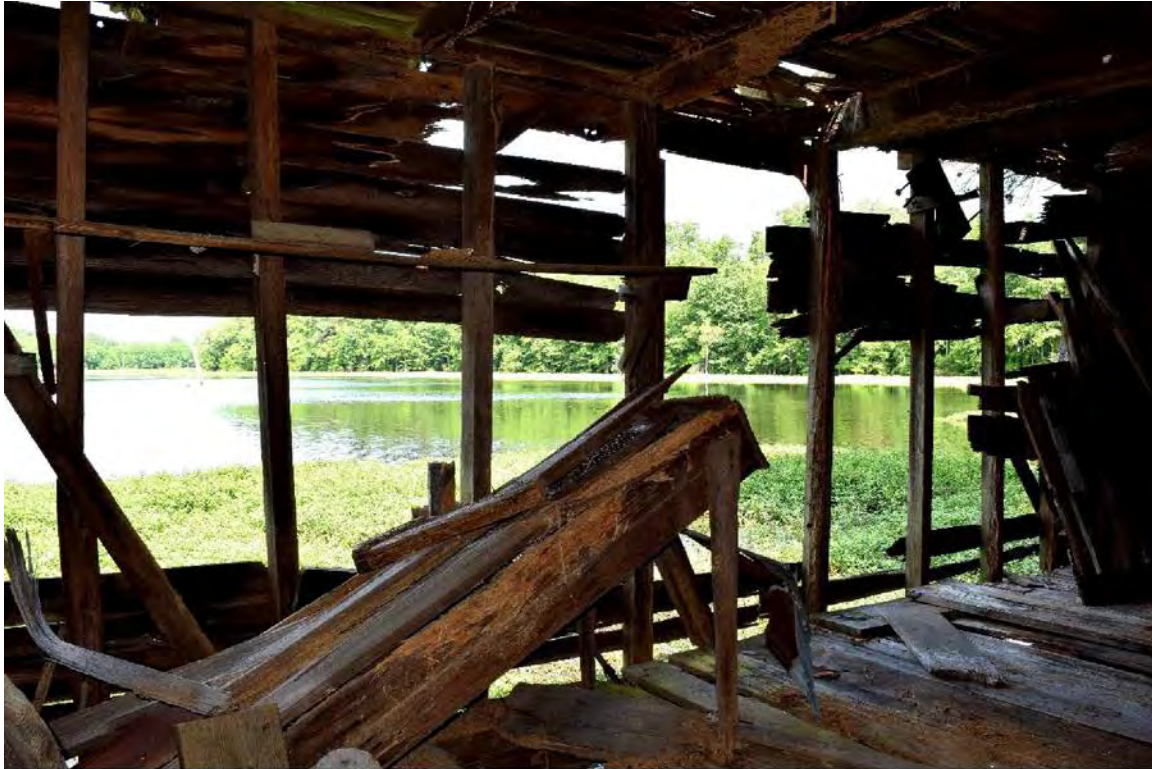
Figure 28. Original millhouse interior, view of the west wall showing the rolling screen. Parker Mill Pond in the background.

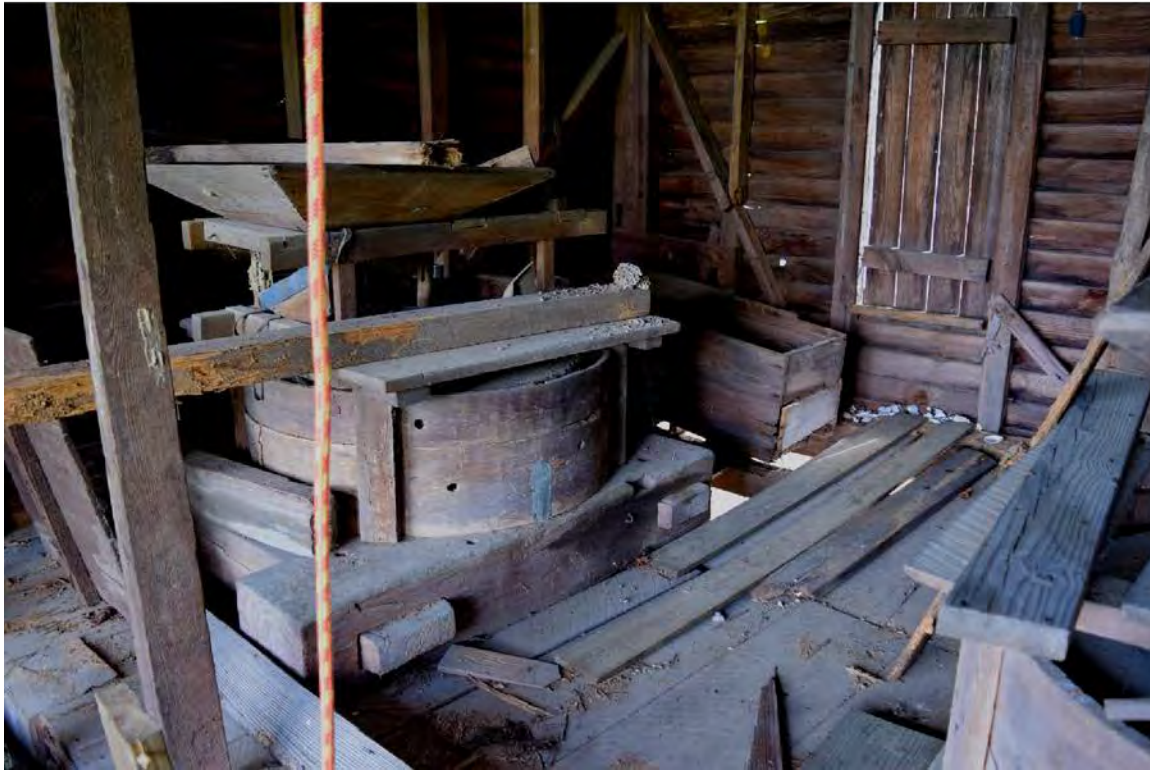
Figure 31. Original millhouse interior, northeast corner showing one of the corn grinding machines and one of the wooden-shuttered windows on the east wall of the original mill house.

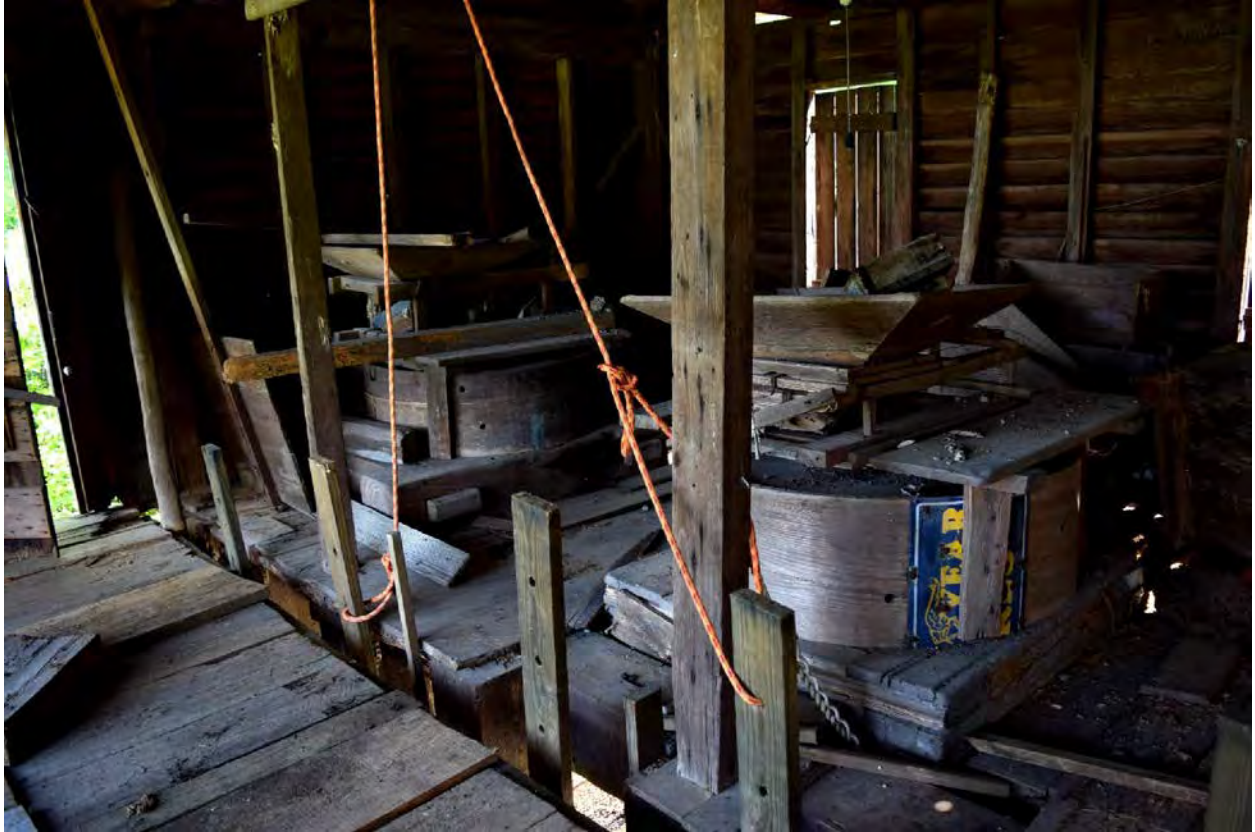
Figure 32. Original millhouse interior, northeast corner showing two corn grinding machines, one of the wooden-shuttered windows on the east wall of the original mill house, and the sluice gate controls.

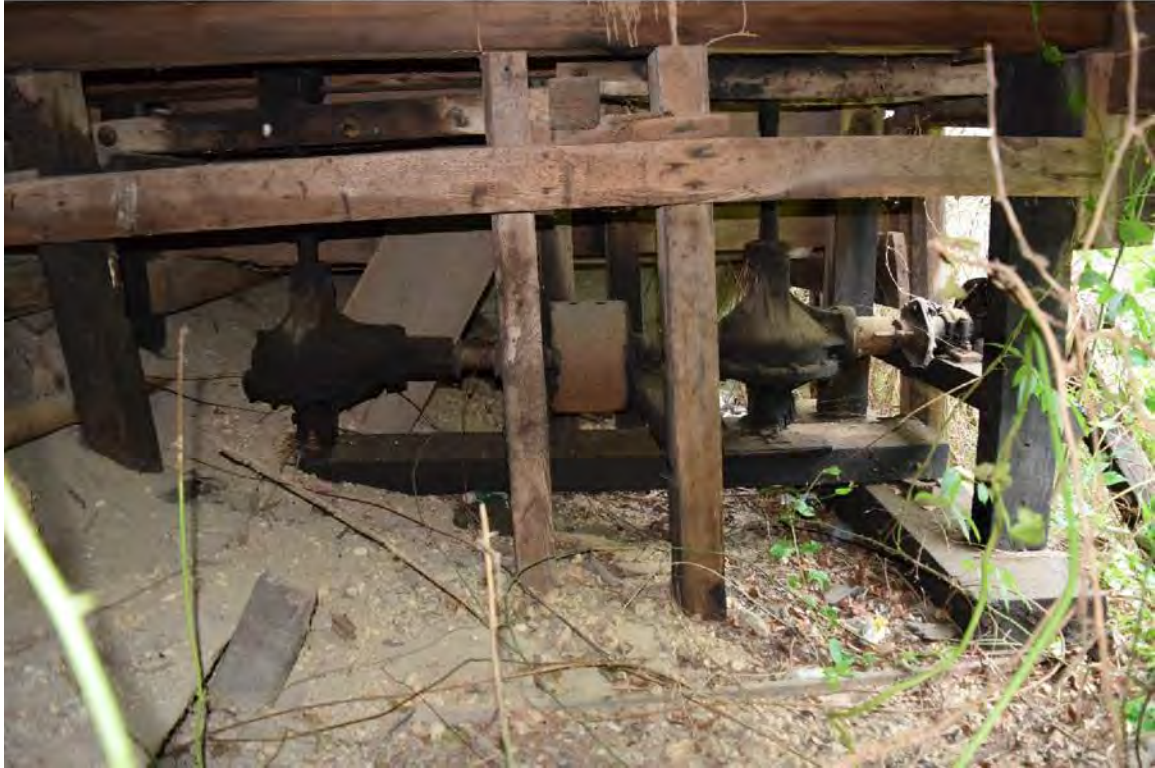
Figure 38. Millhouse addition, Case motor under the building.
