SUBJECT: Replacement of Bridges 14 and 28 on SR 1005 (Neuse Road) over Beard Creek and Cedar Gut, B-4595 and B-4596, Pamlico County, ER 15-2012

**Historic Architectural Resources Evaluation Report  
Replacement of Bridge Numbers 14 and 28 on SR 1005 (Neuse Road)  
over Beard Creek and Cedar Gut, Pamlico County  
Final Identification & Evaluation**

**TIP Nos. B-4595 and B-4596  
WBS No. 38425.1.2**

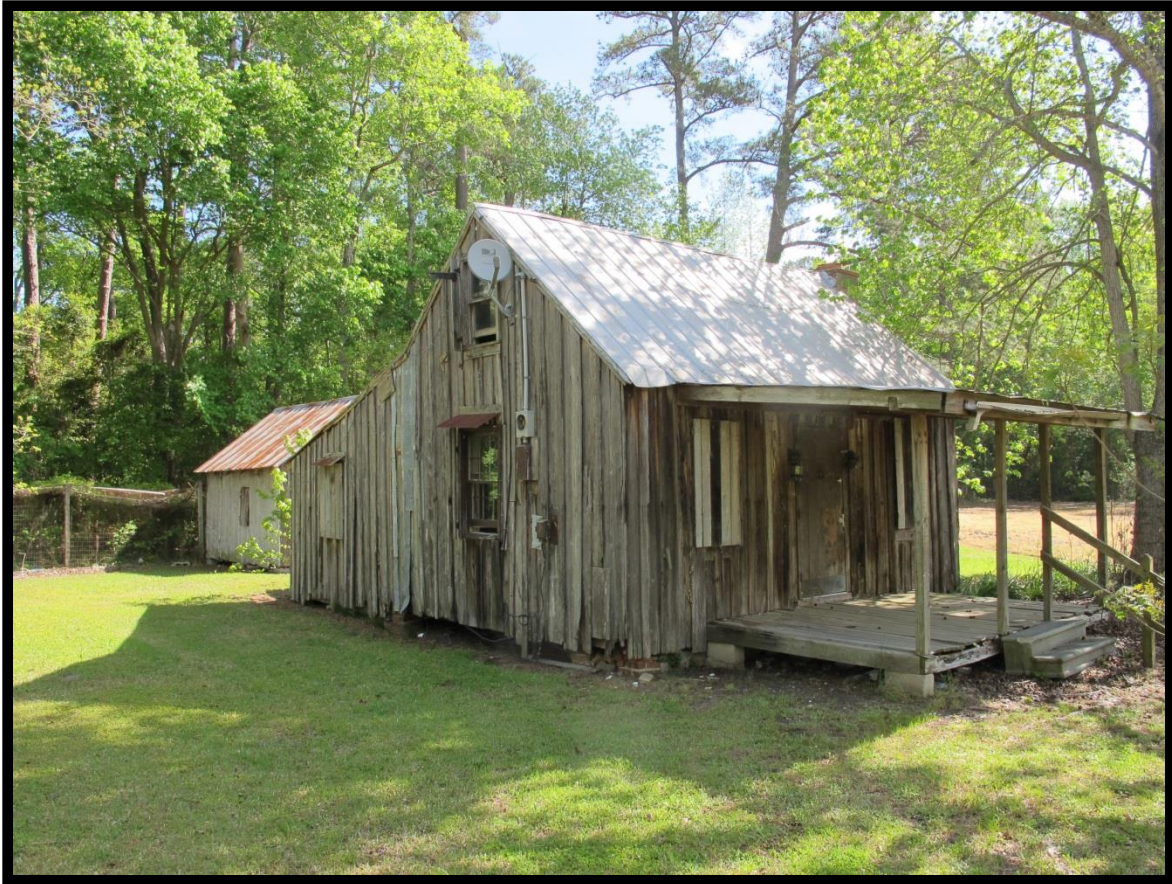
Figure 3: Alex Brinson House (# 1), Looking Northeast.

The Alex Brinson House is located on the north side of Neuse Road (SR 1005), less than 200 feet east of its crossing of Beard's Creek. The house sits approximately 150 feet back from the road and is surrounded by several mature trees, with a wooded area to the north and a small agricultural field to the east (Figures 3 and 4).

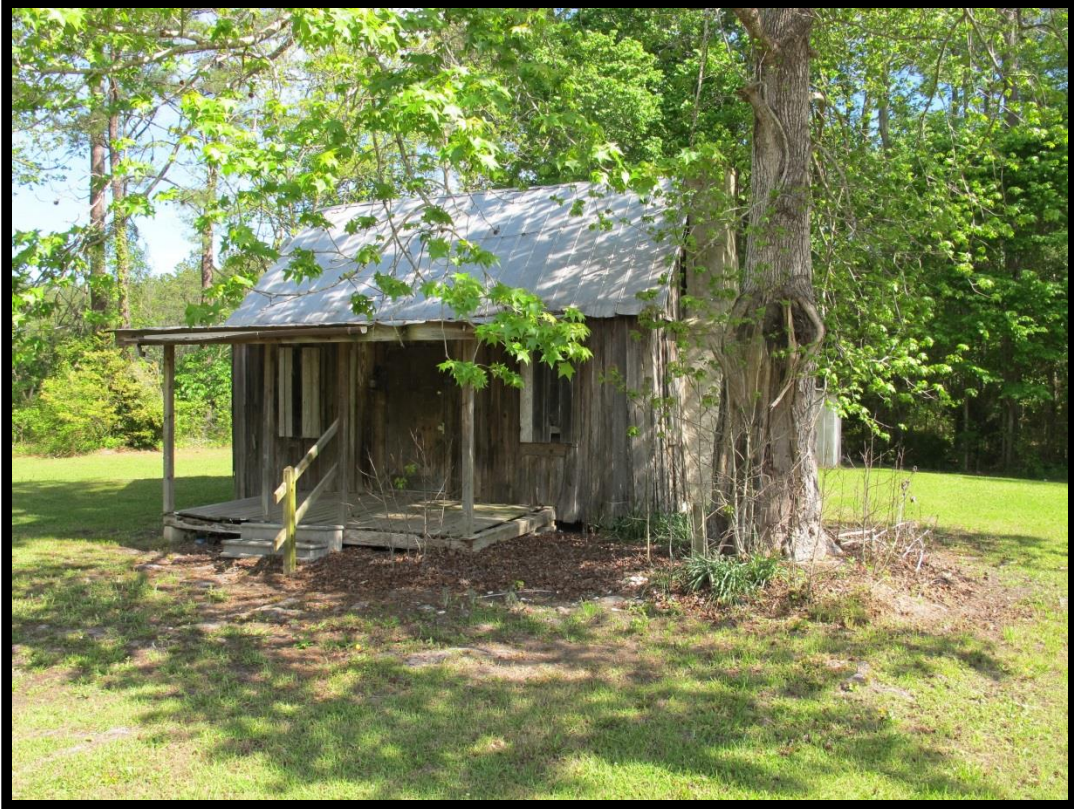
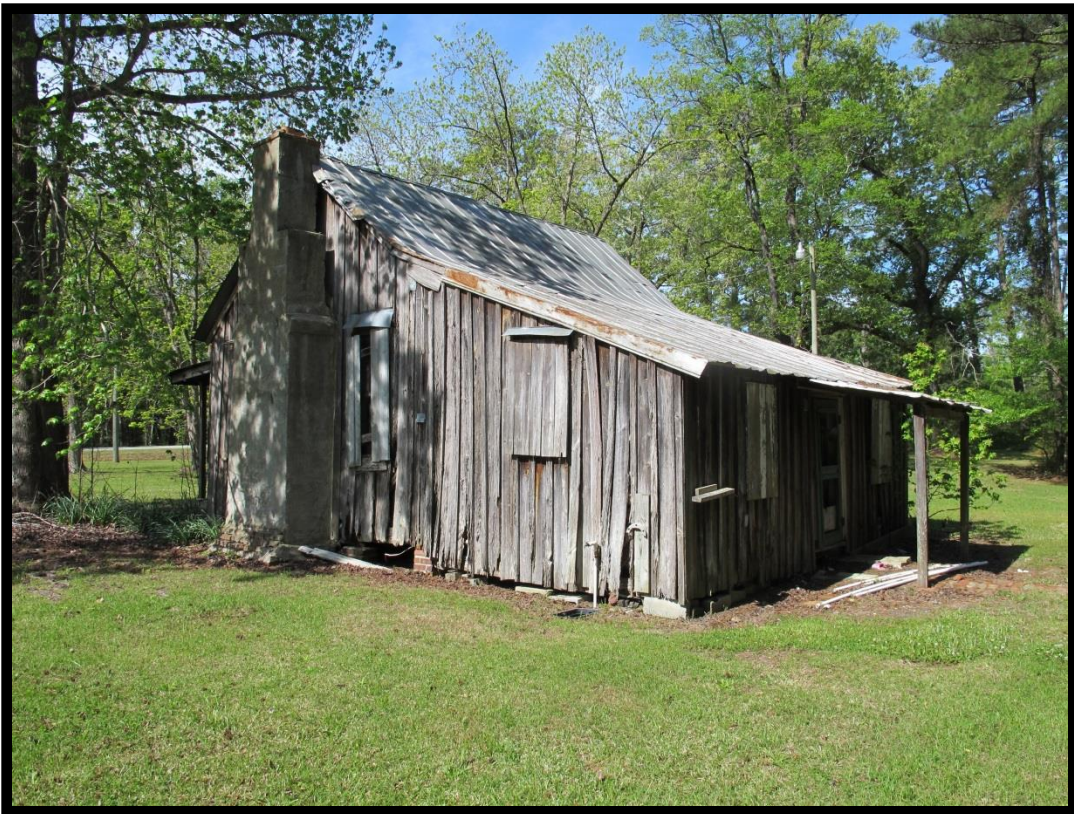
Likely built around 1871, the Alex Brinson House is a small one-story, side-gabled unadorned frame dwelling.<sup>3</sup> A simple shed-roofed porch supported by plain studs shelters the three bays on the south (front) elevation of the dwelling, and a deep shed-roofed section, containing the kitchen, extends off the north (rear) elevation of the main block. Located against the east gable end is a stuccoed double-shouldered chimney on a brick footing.<sup>4</sup> The building is clad in board-and-batten siding, has a metal roof, has six-over-six vinyl sash replacement windows, and rests on brick piers (Figures 5 and 6).

Figure 5: Alex Brinson House (# 1), Looking Northwest.

Figure 6: Alex Brinson House (# 1), Looking Southwest.

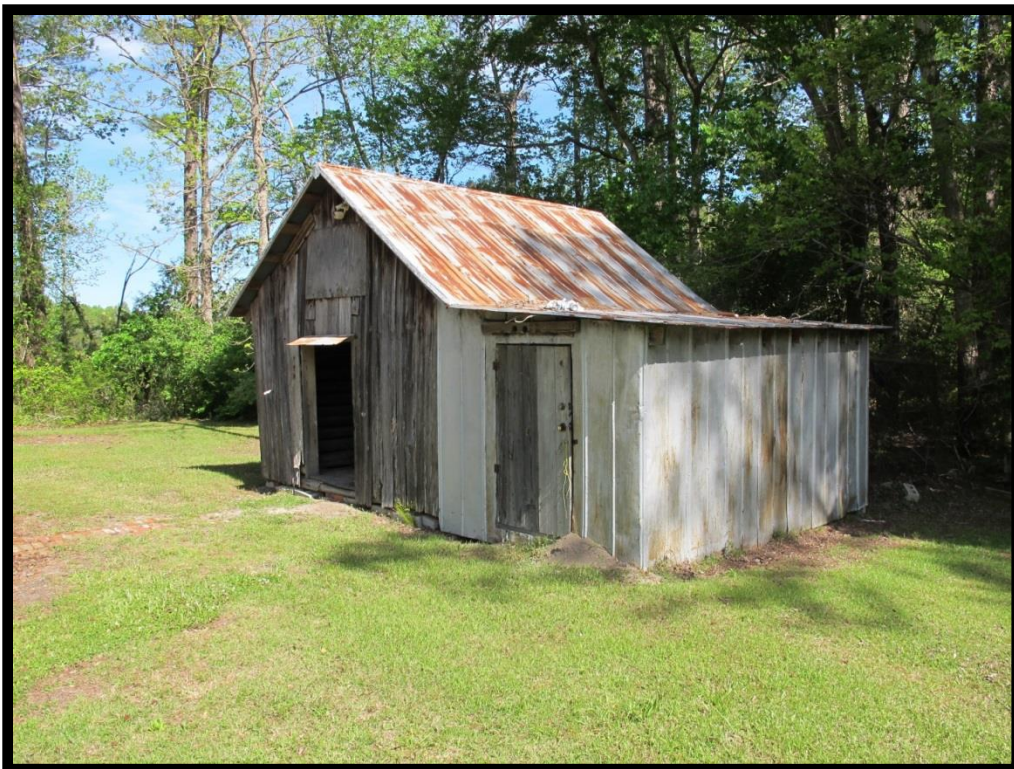
Located behind the dwelling is a former front-gabled log smokehouse (late nineteenth century) clad in vertical board and metal siding with a small shed-roofed addition off the east (side) elevation (Figure 9).

Figure 9: Alex Brinson House (# 1), Smokehouse Looking Northwest.

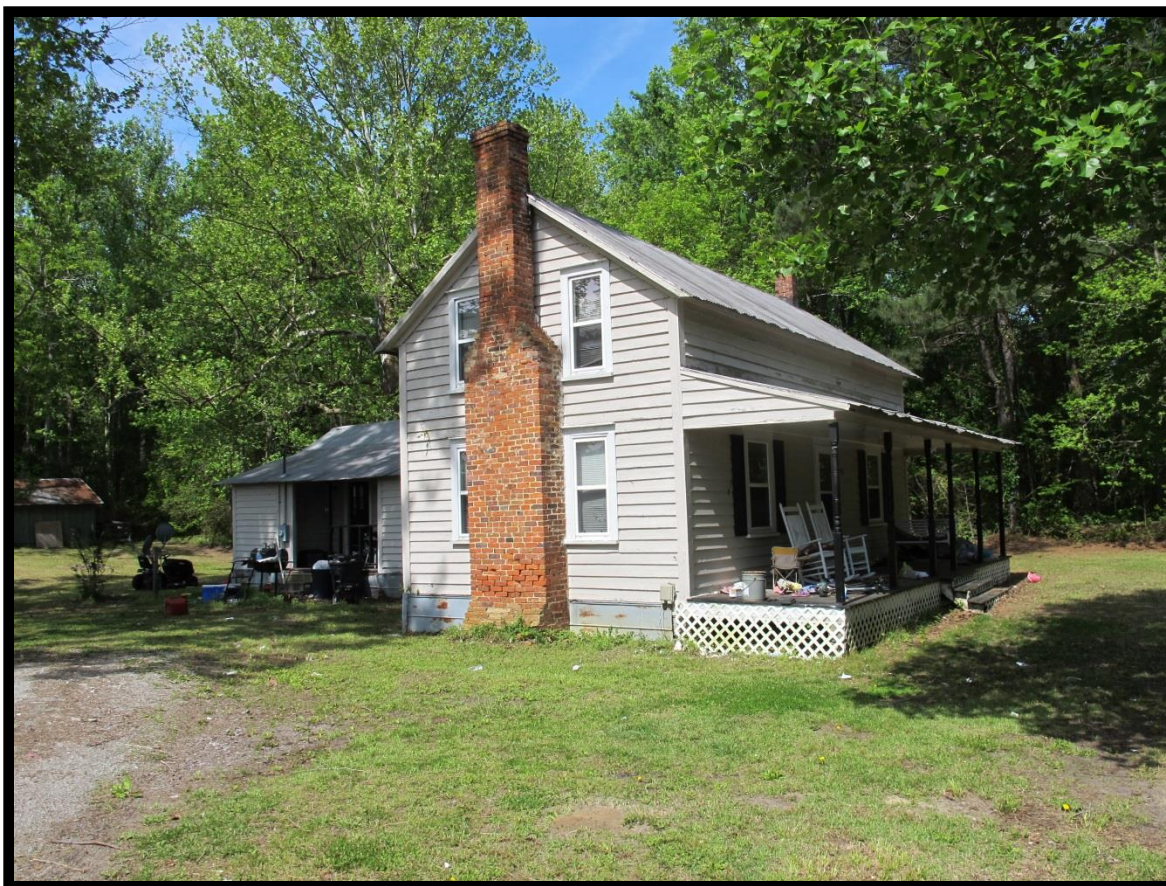
Figure 13: George R. Brinson (# 2), Looking Southwest.

The George R. Brinson House is located on the south side of Neuse Road (SR 1005) between Howell Road and Cedar Gut. The house sits approximately 50 feet back from the road and is surrounded by a wooded area to the west which separates it from Cedar Gut and agricultural fields to the east extending up to Howell Road. The house itself is surrounded by several mature trees (Figures 13 and 14).

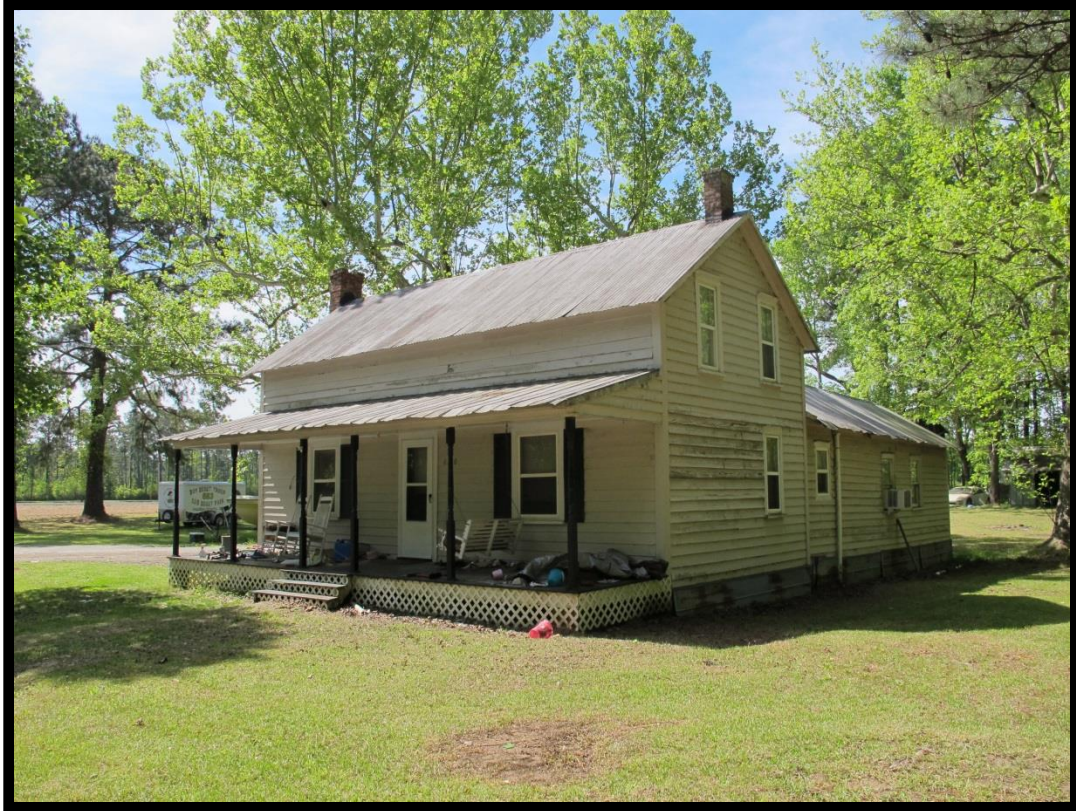
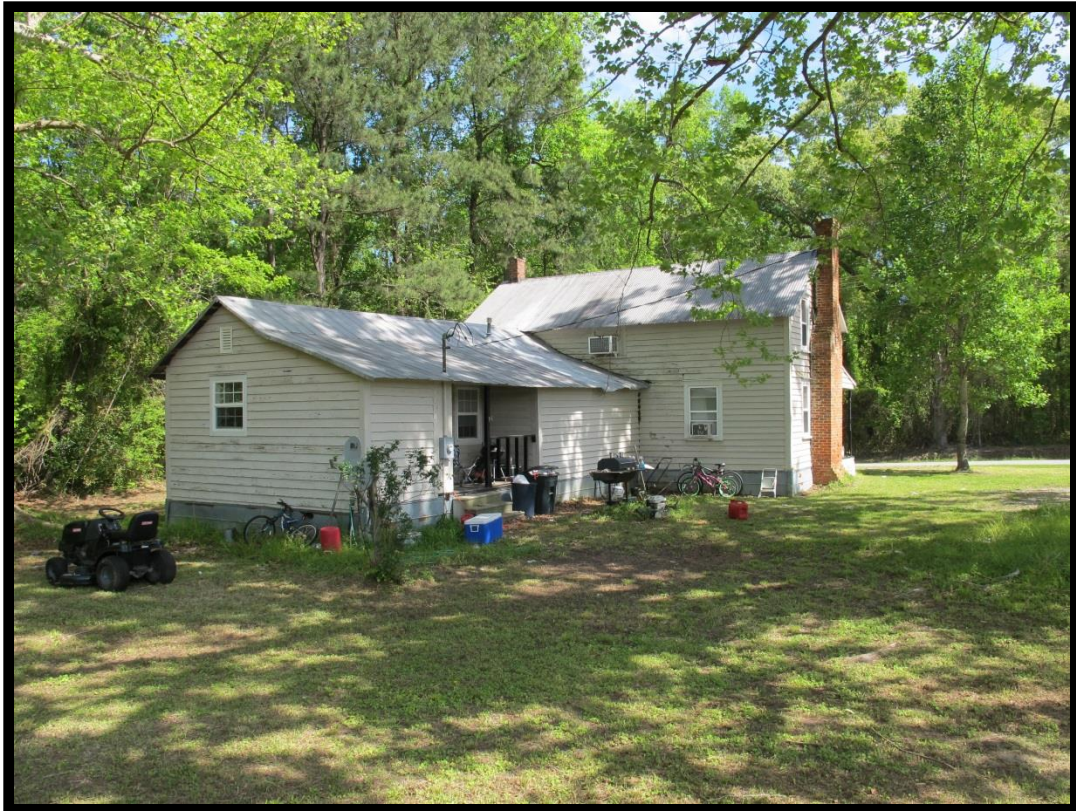
southwest (rear) elevation, giving the dwelling an L-shaped footprint.<sup>15</sup> A one-story, shed-roofed porch, supported by turned posts, shelters the three bays on the northeast (front) elevation of the building. The main section of the dwelling has a single-shouldered brick chimney on the southeast gable end, and an interior brick flue at the northwest gable end. There is evidence for a central flue on the rear wing, and an integral shed-roofed porch with two enclosed sections runs along the southeast elevation of the rear wing. The building is clad in plain weatherboard siding with simple corner boards, it has a combination of one-over-one, and six-over-six vinyl sash replacement windows, and a corrugated-metal roof on the front section of the dwelling and a 5V-crimp-metal roof on the rear wing. The foundation is covered with metal siding (Figures 15 and 16).

Figure 15: George R. Brinson House (# 2), Looking Southeast.

Figure 16: George R. Brinson House (# 2), Looking Northwest.

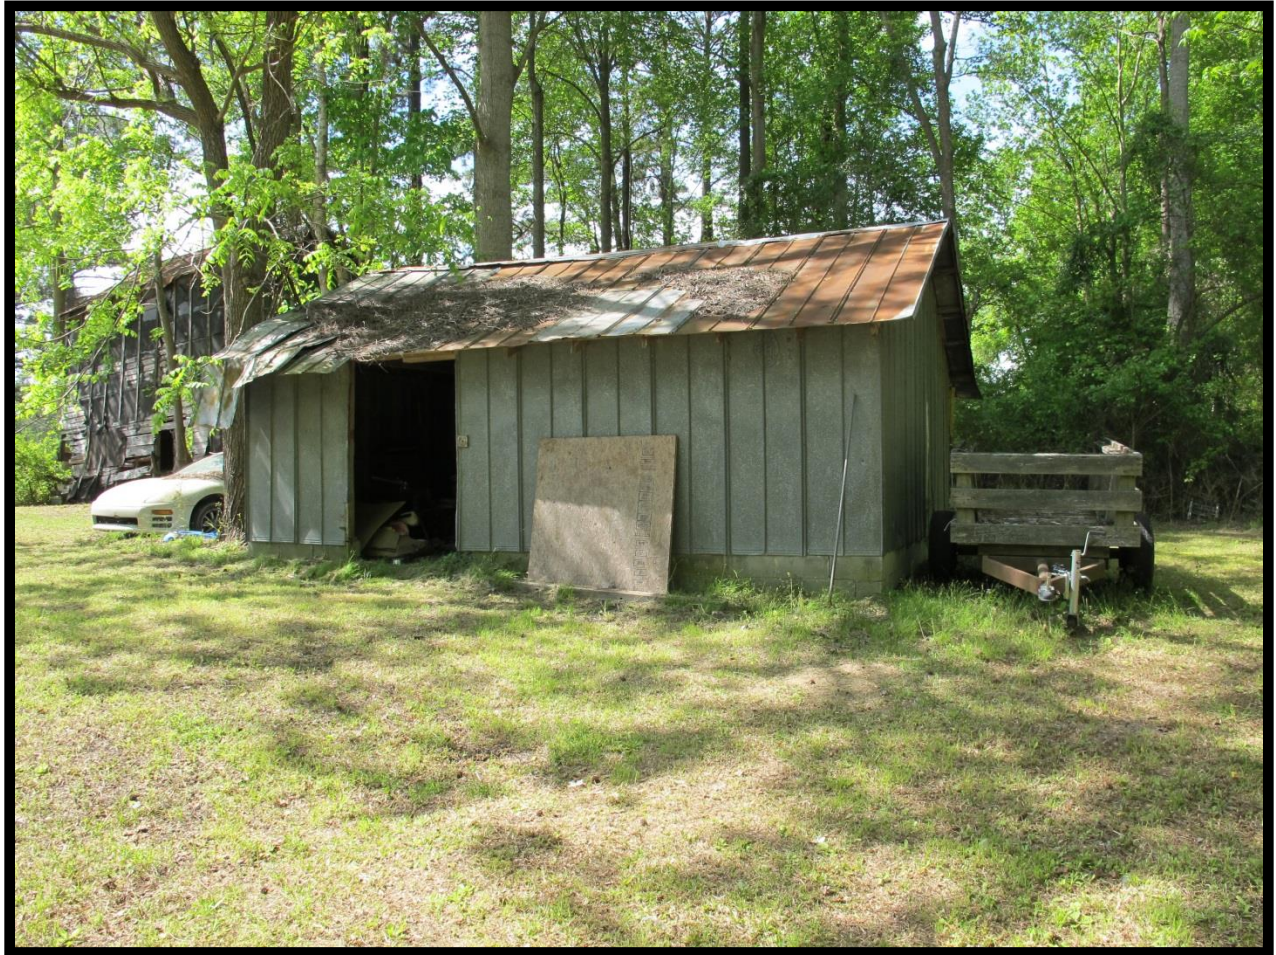
Figure 17: George R. Brinson House (# 2), Outbuilding Looking Southeast.

Located southwest of the dwelling is a one-story, side-gabled frame outbuilding (ca. 1960), which sits on a concrete-block foundation and has a 5V-crimp-metal roof and siding (Figure 17). Located to the southeast is a deteriorated front-gabled, two-story frame pack house (ca. 1900) (Figure 18).

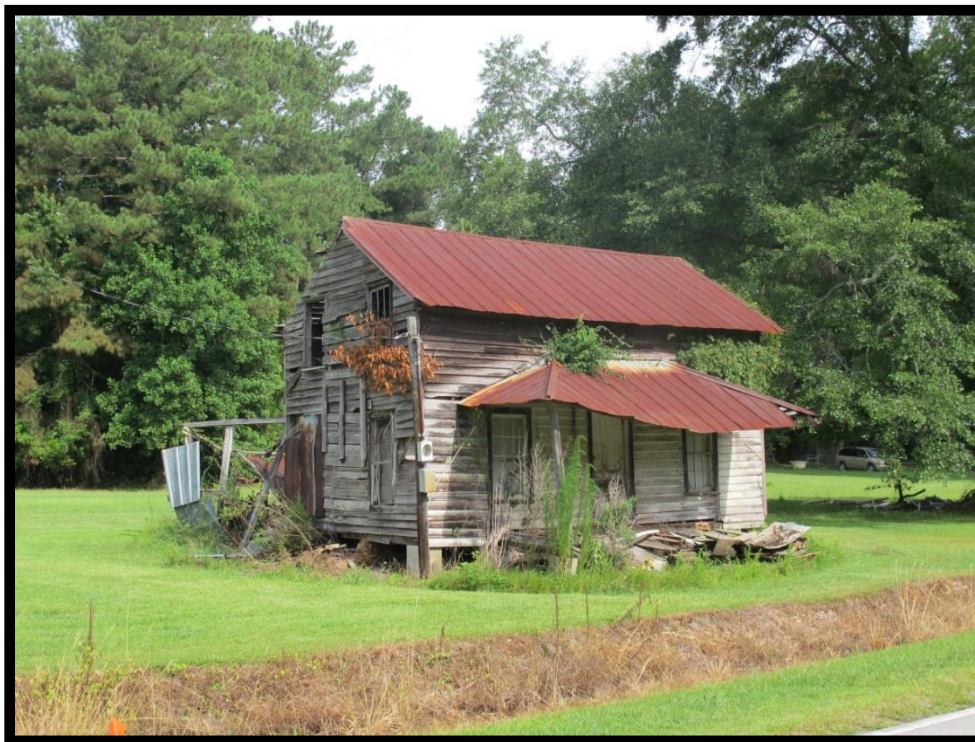
eligible.<sup>28</sup> Located in the northeast corner of the county is Harvey Dunn House (PM0334), a similar story-and-a-jump dwelling although heavily dilapidated (Figure 19). A well-preserved example of a story-and-a-jump dwelling can be found in New Bern: the George N. Ives Rental House (CV1531), which was an important part of Beard's Creek Landing's economic network (Figure 20). Several story-and-a-jump dwellings are also located in the eastern part of the county near Hobucken and Lowland, such as the Noah Ireland House (PM0397) and the Buell T. Potter House (PM0419), the latter of which appears to retain both its original siding and windows (Figure 21). The George R. Brinson House retains a fair level of integrity despite the use of vinyl replacement windows; however, it compares less favorably with some of the examples cited above and generally lacks significance. It therefore is not recommended as eligible for listing in the National Register under Criterion C for architecture.

Figure 19: Harvey Dunn House (PM0334), Looking Northwest.

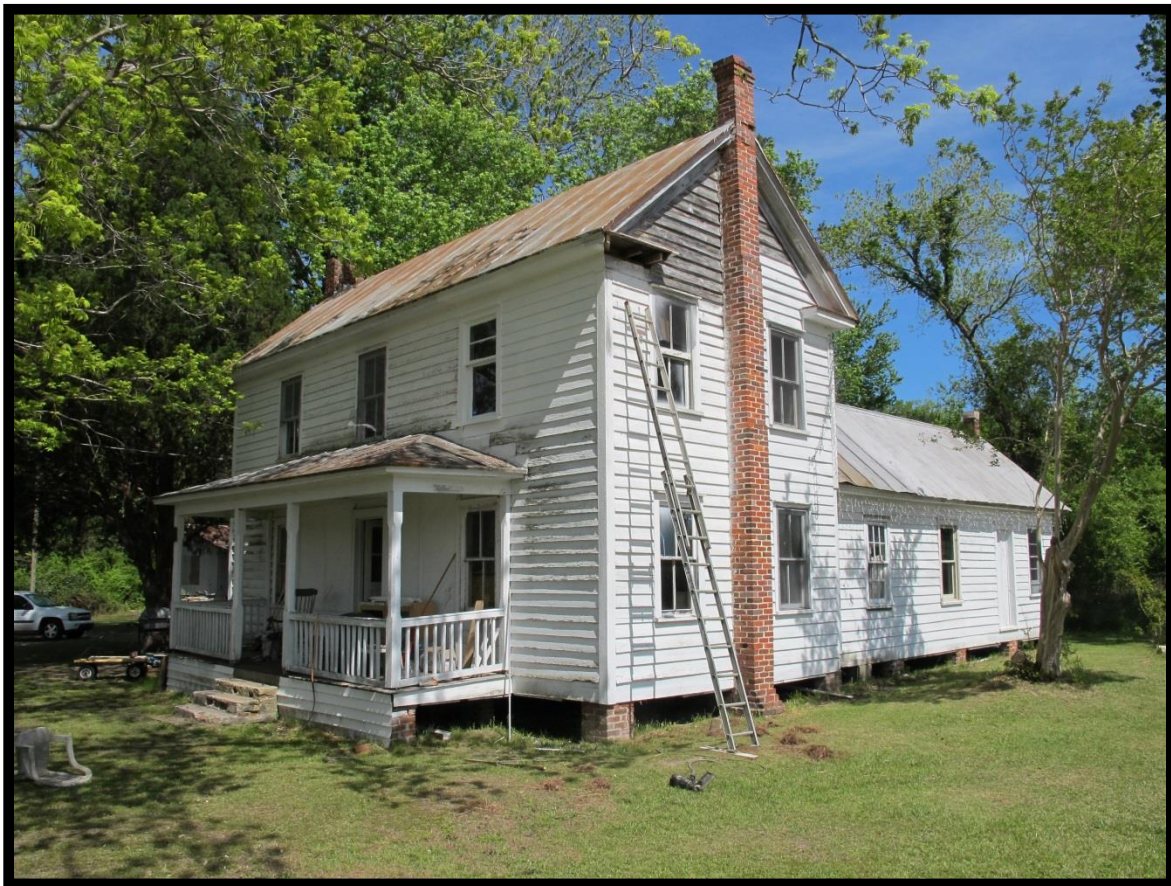
Figure 22: Levin Paul House (# 3), Looking Northwest.

The Levin Paul House is located on the north side of Neuse Road (SR 1005) approximately 100 feet west of the intersection with Howell Road. The house sits approximately 80 feet back from the road and is surrounded by a wooded area to the west which separates it from Cedar Gut and agricultural fields to the east. The house itself is surrounded by several mature trees (Figures 22 and 23).

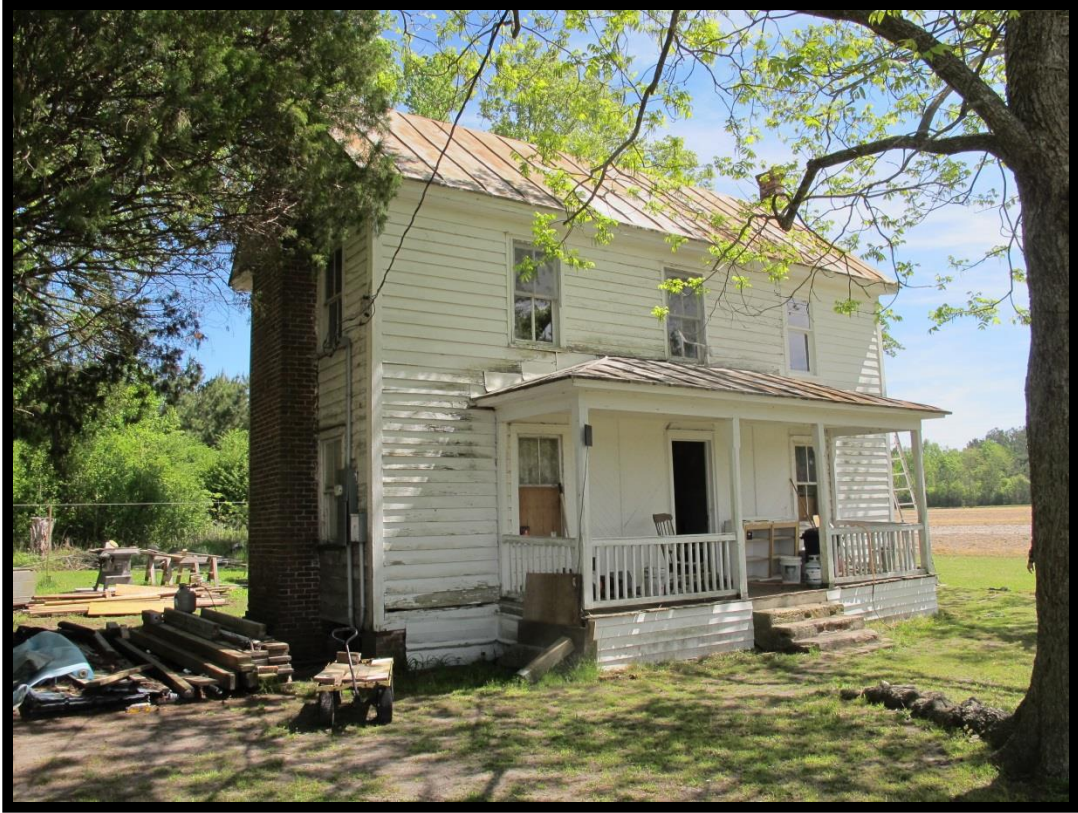
Figure 24: Levin Paul House (# 3), Looking Northeast.

Built around 1900, the dwelling is a typical example of a so-called I-house (i.e. a two-story, single-pile dwelling). A hip-roofed porch, supported by chamfered posts, shelters the three bays on the southwest (front) elevation of the dwelling. A contemporaneous one-story, gable-roofed wing extends off the northeast (rear) elevation of the main block, giving the dwelling an L-shaped footprint. Located against the northwest gable end is a single-shouldered brick chimney, and a brick flue is located against the southeast gable end. A second brick flue pierces the ridge of the kitchen wing at the northeast gable end. Originally, an integral shed-roofed porch ran along the northwest elevation of the kitchen wing, with a shed pantry at the northeast gable end, but the current occupant is enclosing the porch with particle board and will ultimately clad it in vinyl siding. The original sections of the building are clad in plain weatherboard with simple corner boards and a box cornice with returns in the gable ends of the two-story block. A distinct decorative feature is the narrow wainscot and diagonal boards, which create V-shape that are located between the entry door and the windows on the front elevation of the dwelling (Figures 24 through 27). The building sits on brick piers, has a metal roof, and a combination of the

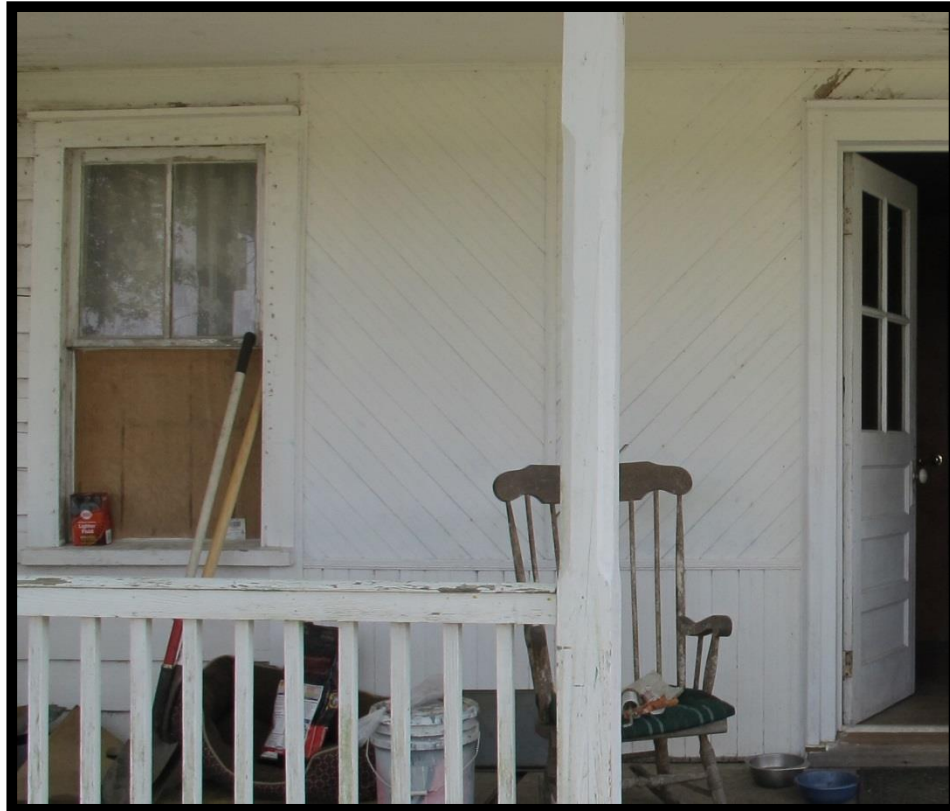
Figure 27: Levin Paul House (# 3), Detail of Sheathing on Southwest (front) Elevation.

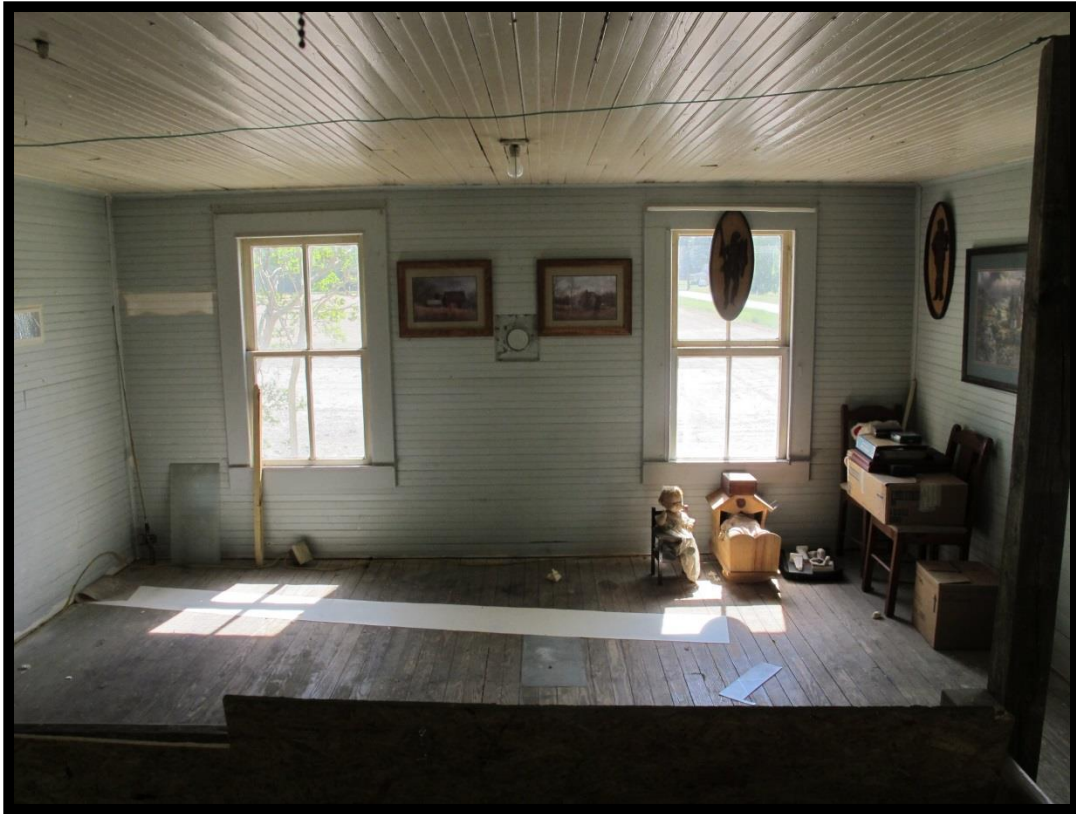
Figure 30: Levin Paul House (# 12), Interior, Second Floor, Looking East.

The main section of the house has a central stair passage with a single room (hall and parlor) on either side. The hearth on the parlor is blocked, but the mantel with raised panels survives, and the walls are covered in lath and plaster (Figure 28). A stove heated the hall, which was connected to the kitchen wing. The kitchen wing is currently being remodeled and all of the original partition walls have been removed creating a single open space, with the walls and ceilings clad in narrow beaded boards. The stair leading to the second floor has a simple chamfered newel post and plain square balusters (Figure 29). Originally, the second floor was divided into a stair landing with a room on either side, but the partition wall of the eastern room was removed creating a two-room plan. The walls and ceilings are clad in narrow beaded boards (Figure 30).

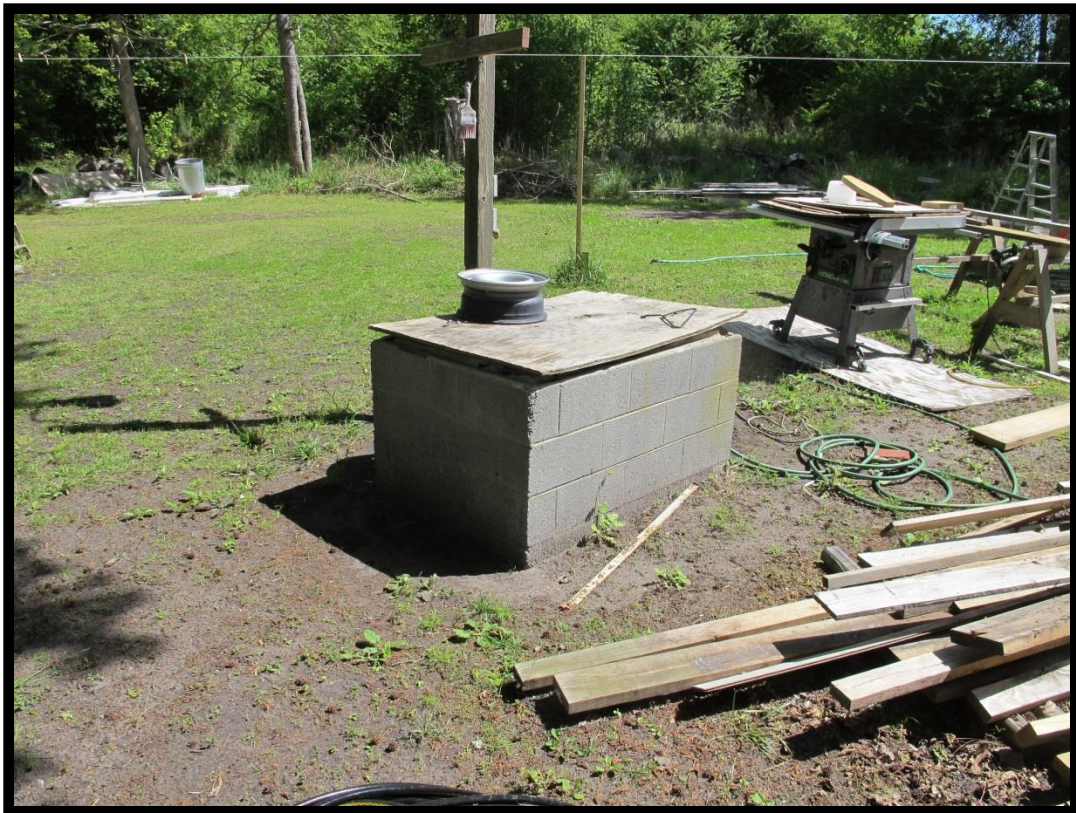
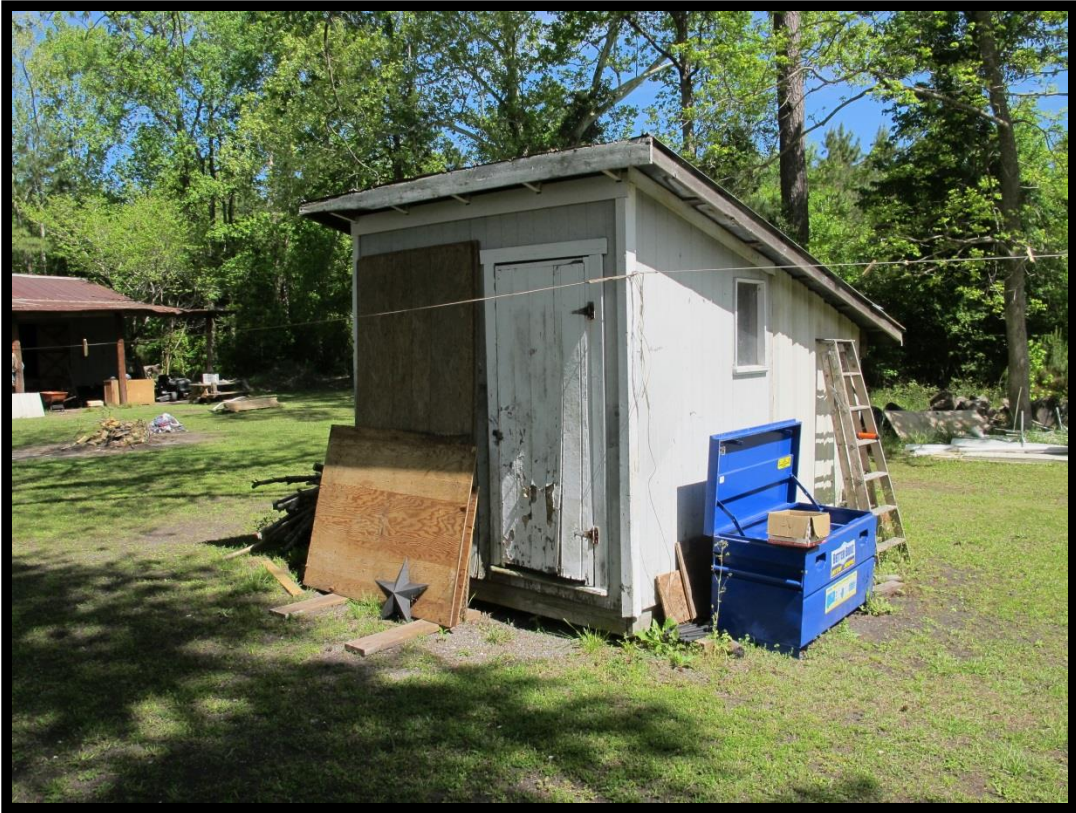
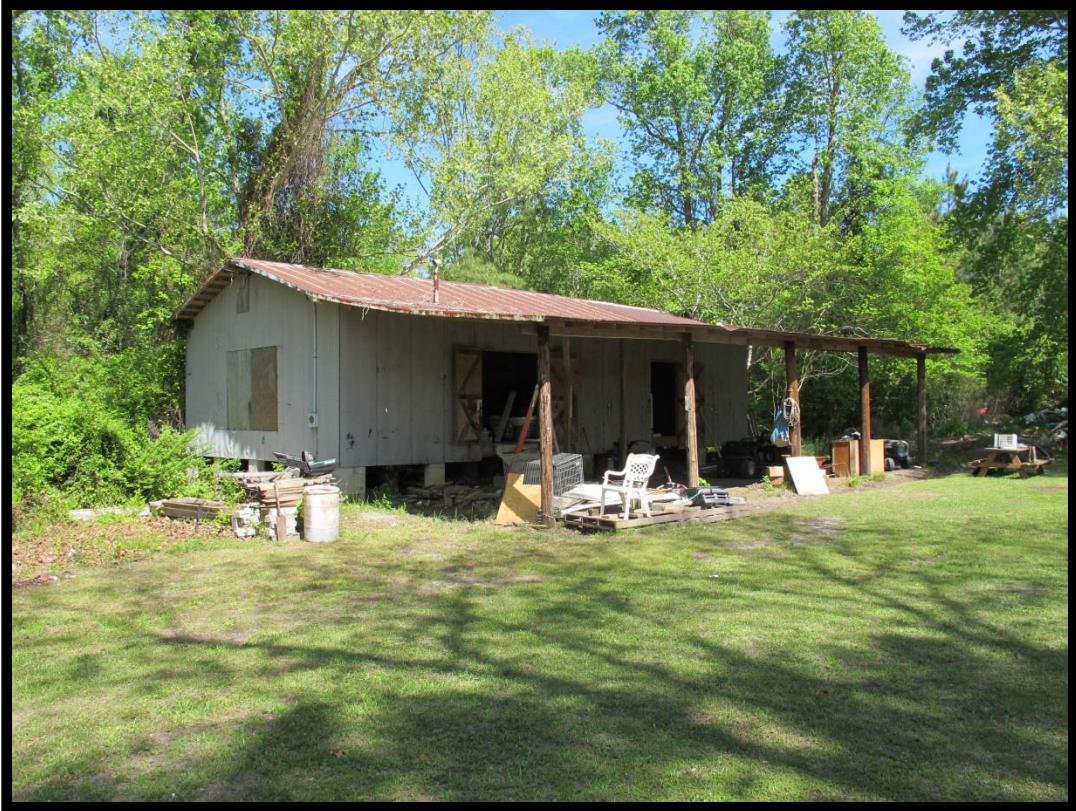
Located around the house are three ancillary structures: a concrete-block well (ca. 1980) with a plywood cover, a small shed-roofed outbuilding clad in vertical composition-board siding (ca. 1970), and a side-gabled barn (ca. 1930) with a deep open-shed addition off the southeast (front) elevation. The barn is clad in asphalt siding, has a metal roof, and sits on concrete-block piers (Figures 31 through 33).

Figure 31: Levin Paul House (# 12), Well, Looking North.

Figure 32: Levin Paul House (# 3), Shed, Looking Northwest.

Figure 33: Levin Paul House (# 3), Barn, Looking Northwest.

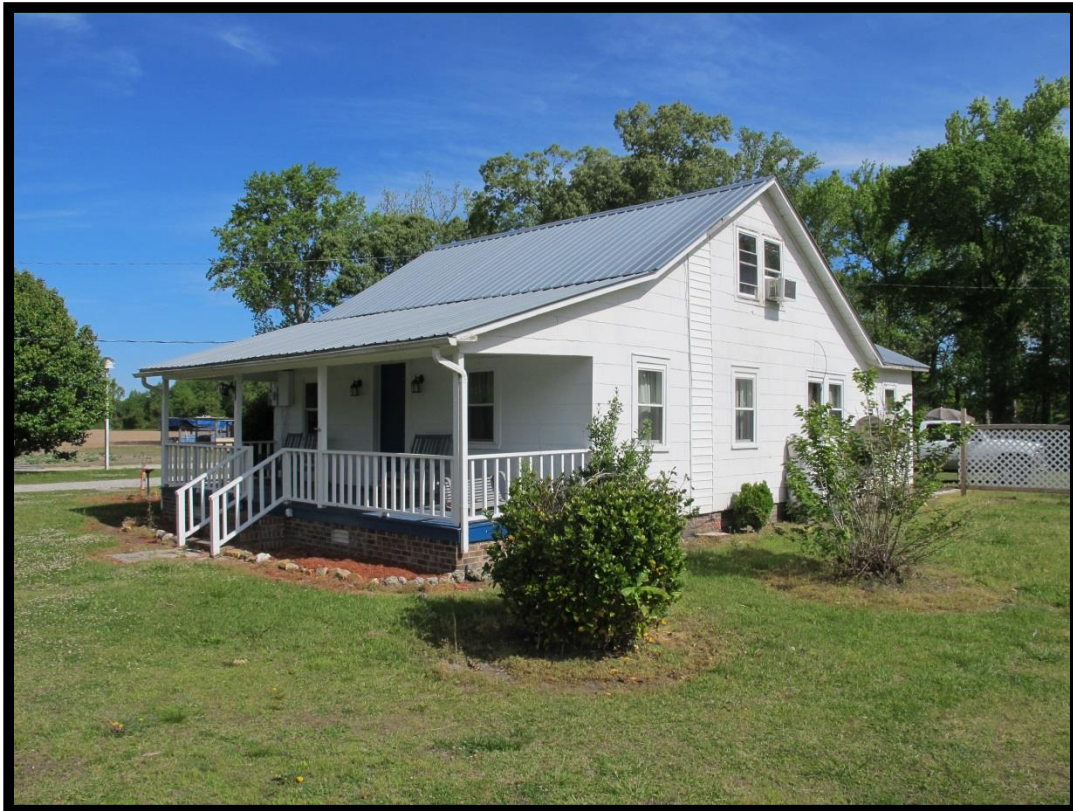
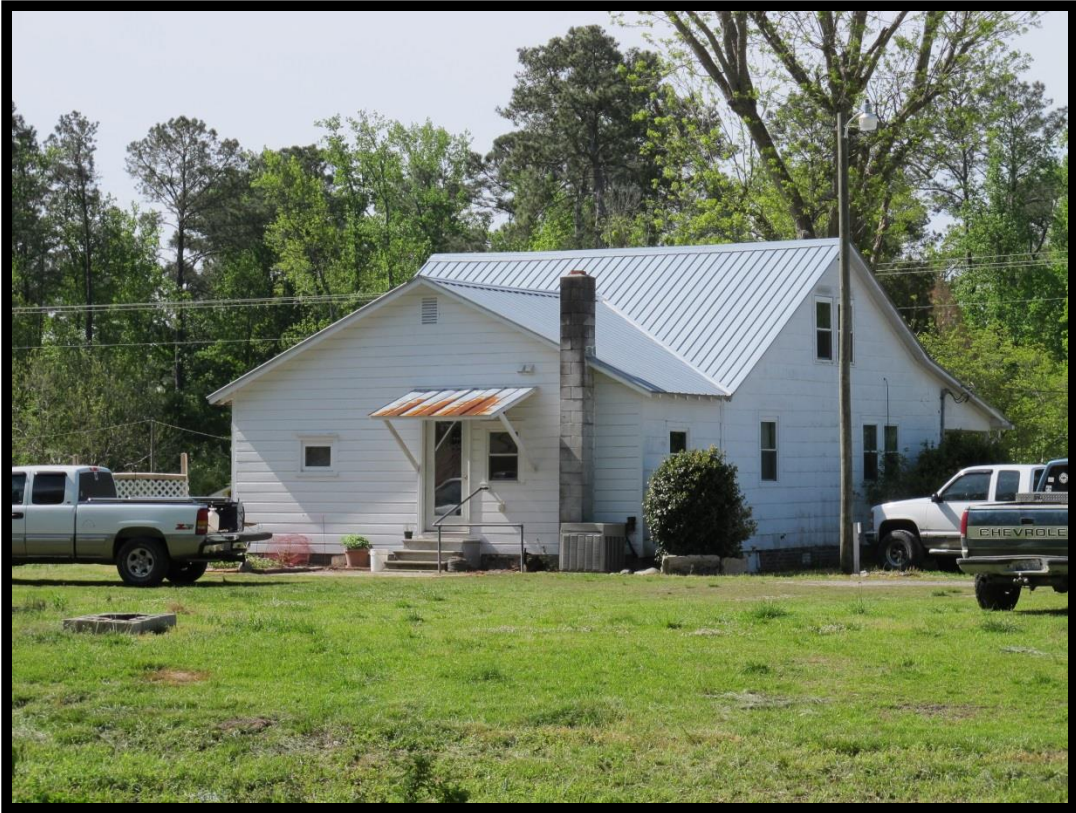
Built around 1850, this one-and-a-half-story, three-bay, side-gabled vernacular dwelling has an integral shed-roofed porch, supported by plain posts, sheltering the southwest (front) elevation of the dwelling. A one-story gable-roofed wing extends off northeast (rear) elevation of the dwelling across its entire width. The building sits on a solid brick foundation, is clad in asbestos shingles, and has one-over-one vinyl sash replacement windows. The dwelling has a metal roof and a chimney/flue was removed from its southeast gable end (Figures 40 and 41).

Figure 40: Benjamin Brinson House (PM0254), Looking Northwest.

Figure 41: Benjamin Brinson House (PM0254), Looking South.

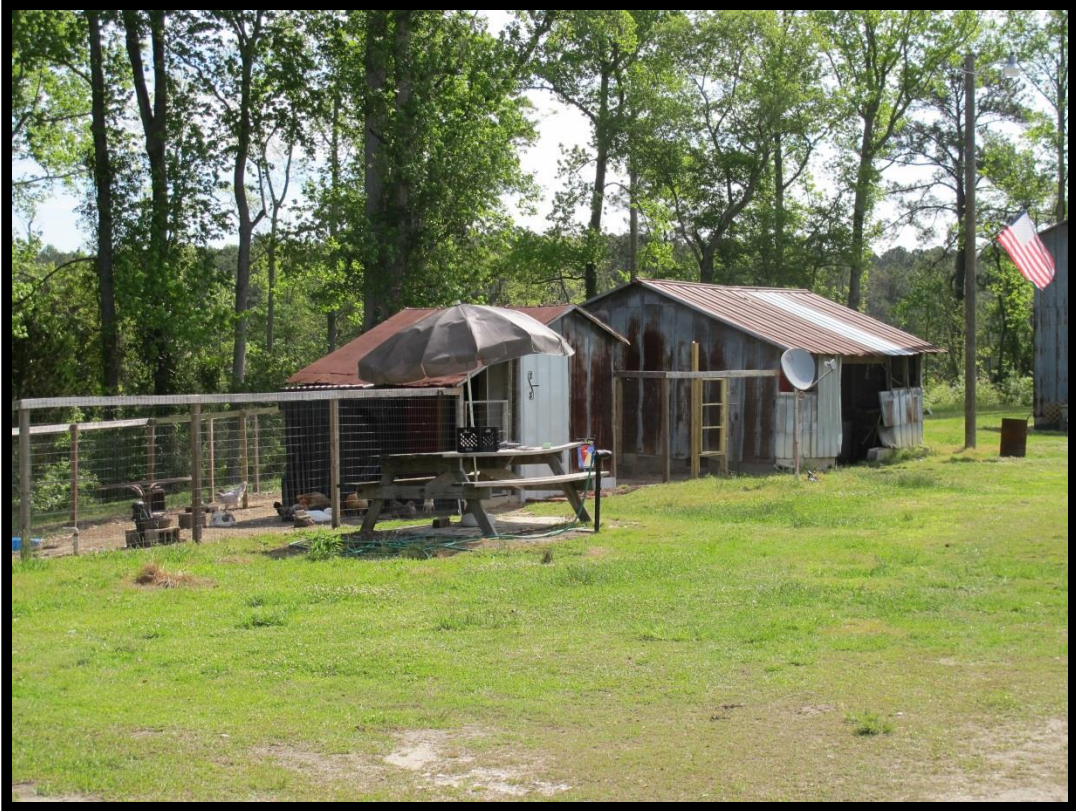
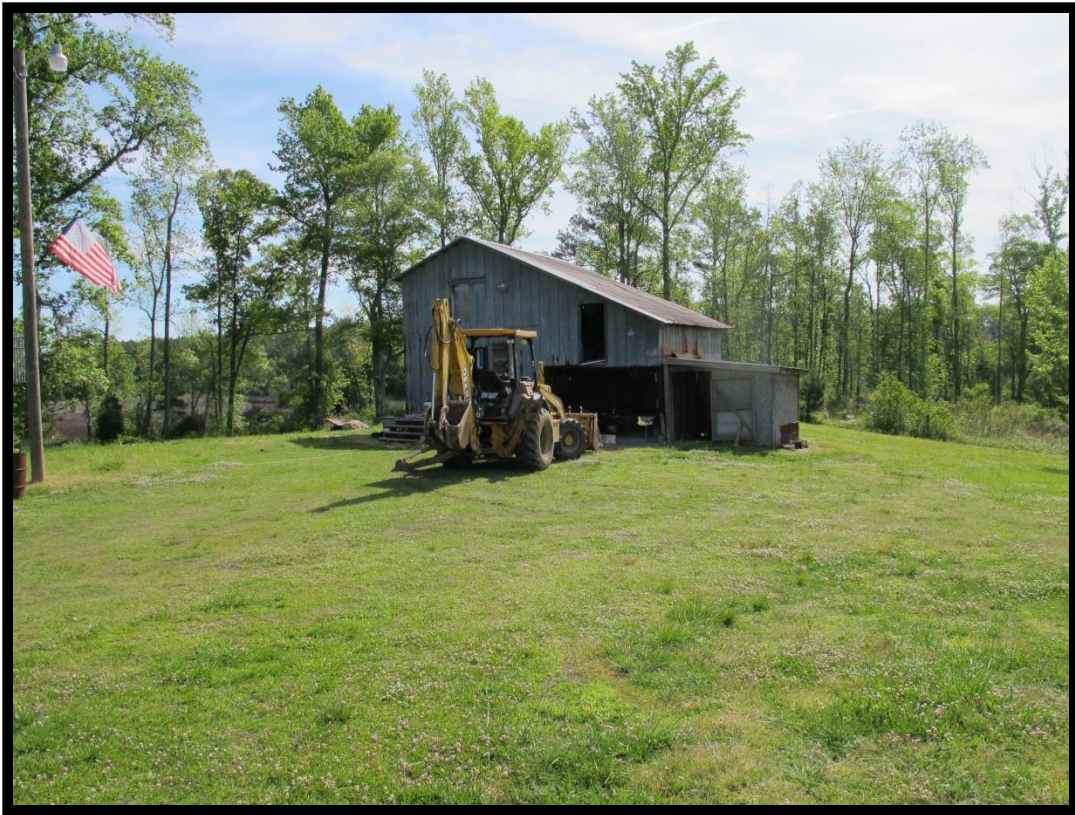
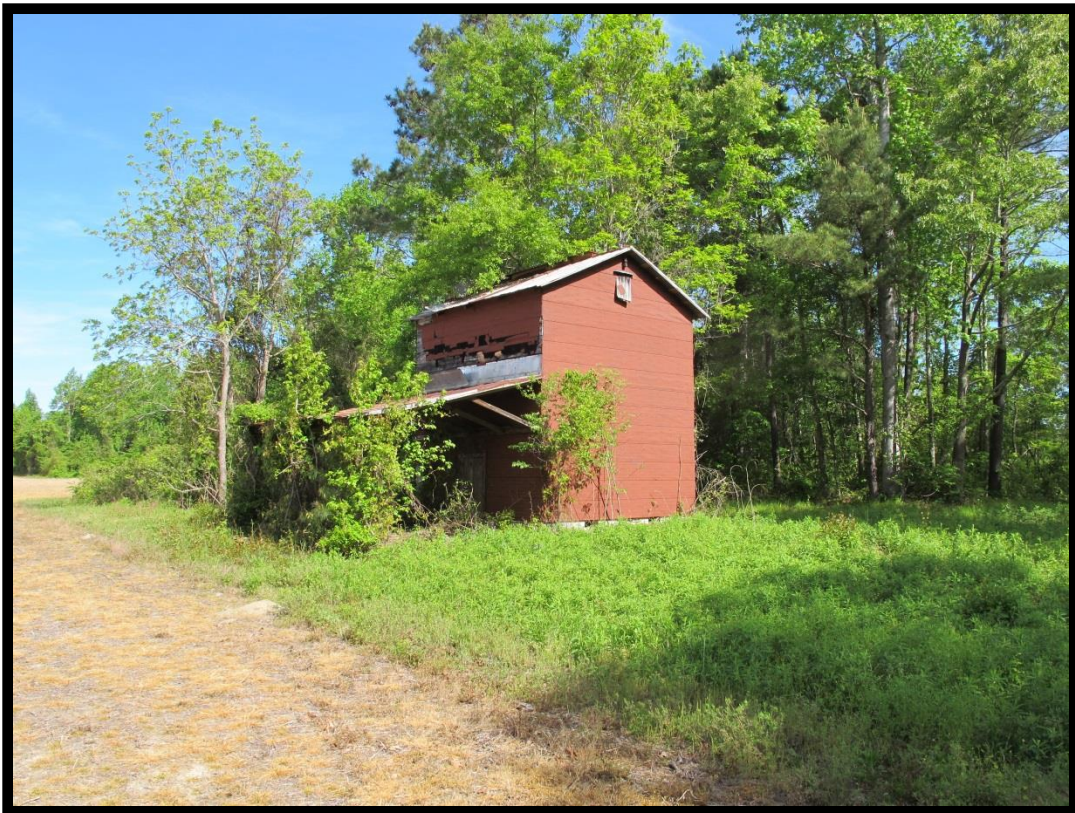
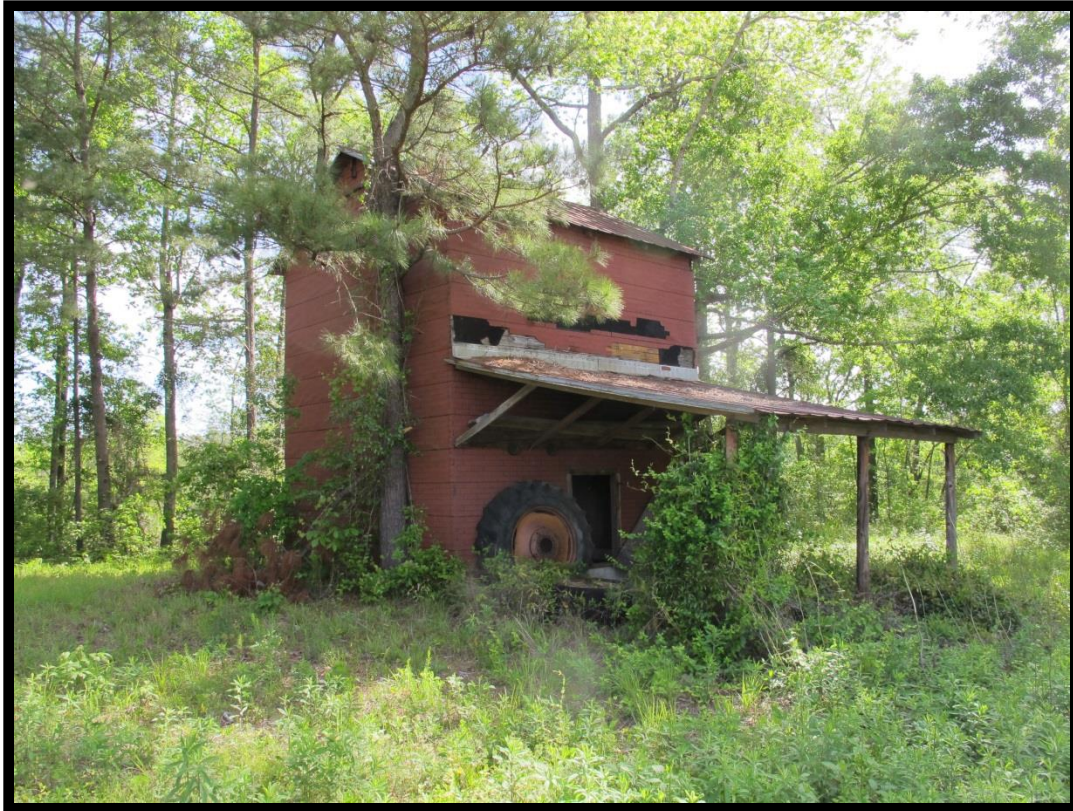
Located near the house are several outbuildings, including two chicken coops, a two-story, front-gabled pack house with a partially open shed-roofed wing off the south elevation, and two frame tobacco barns on concrete-block foundations (Figures 42 through 45).

Figure 42: Benjamin Brinson House (PM0254), Chicken Coops Looking Northeast.

Figure 43: Benjamin Brinson House (PM0254), Pack House, Looking Northeast.

Figure 44: Benjamin Brinson House (PM0254), Tobacco Barn, Looking Northwest.

Figure 45: Benjamin Brinson House (PM0254), Tobacco Barn, Looking Northeast.
