SUBJECT: Replacement of Bridges 14 and 28 on SR 1005 (Neuse Road) over Beard Creek and Cedar Gut, B-4595 and B-4596, Pamlico County, ER 15-2012

**Historic Architectural Resources Evaluation Report  
Replacement of Bridge Numbers 14 and 28 on SR 1005 (Neuse Road)  
over Beard Creek and Cedar Gut, Pamlico County  
Final Identification & Evaluation**

**TIP Nos. B-4595 and B-4596  
WBS No. 38425.1.2**

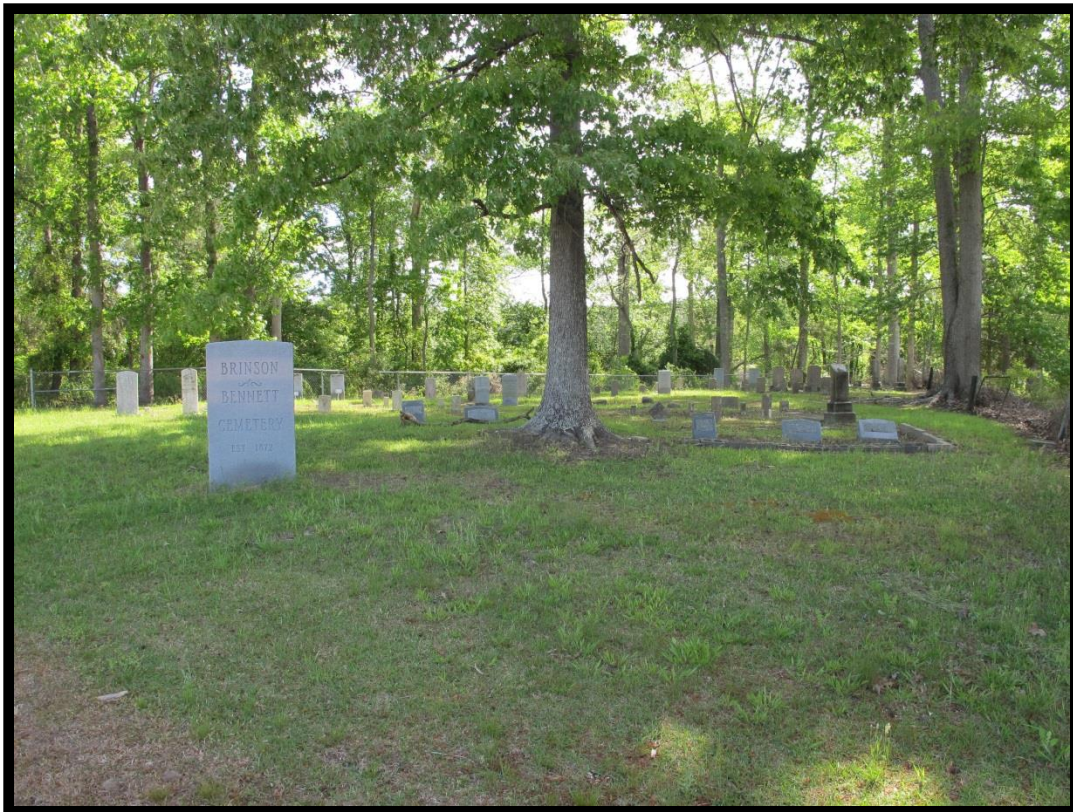
Figure 46: Benjamin Brinson House (PM0254), Cemetery, Looking Northeast.

Located to the north of the house is the Brinson Bennett family cemetery. The cemetery contains approximately forty-four burials dating from 1835 to 1963. The majority of the stones are plain with simple segmental arches and there are a few early twentieth-century obelisks. The oldest burial is that of Cason Brinson IV (1785-1835) (see Figure 46).

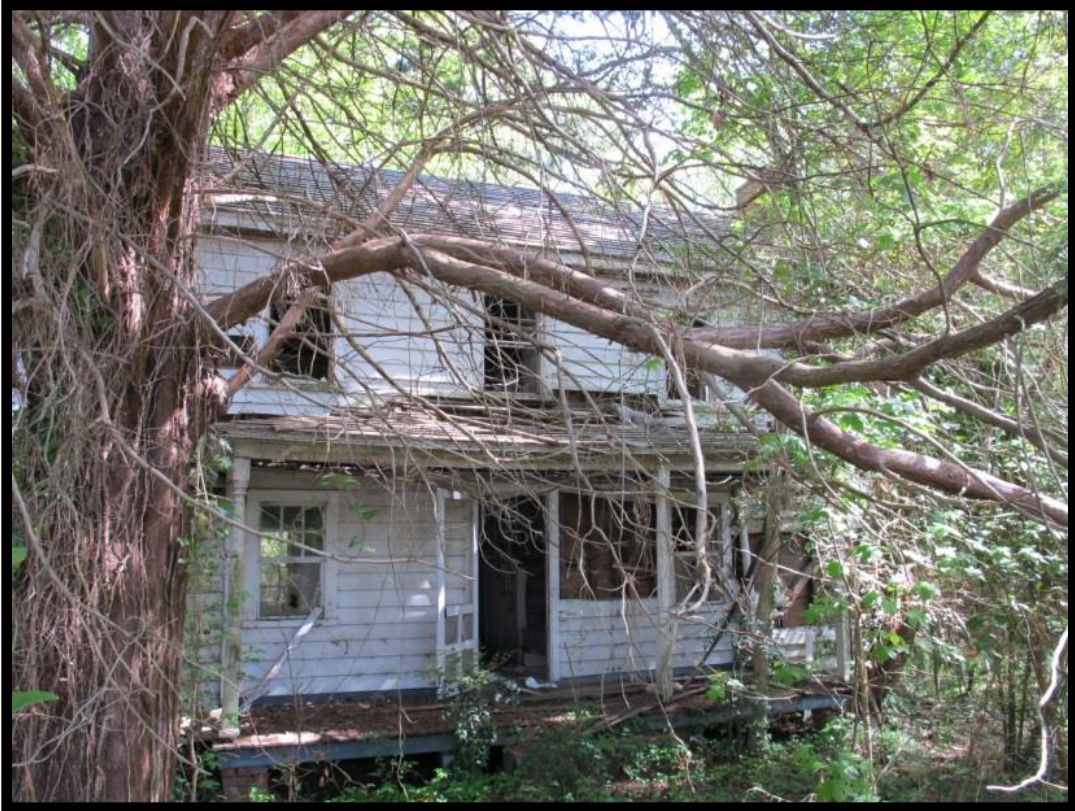
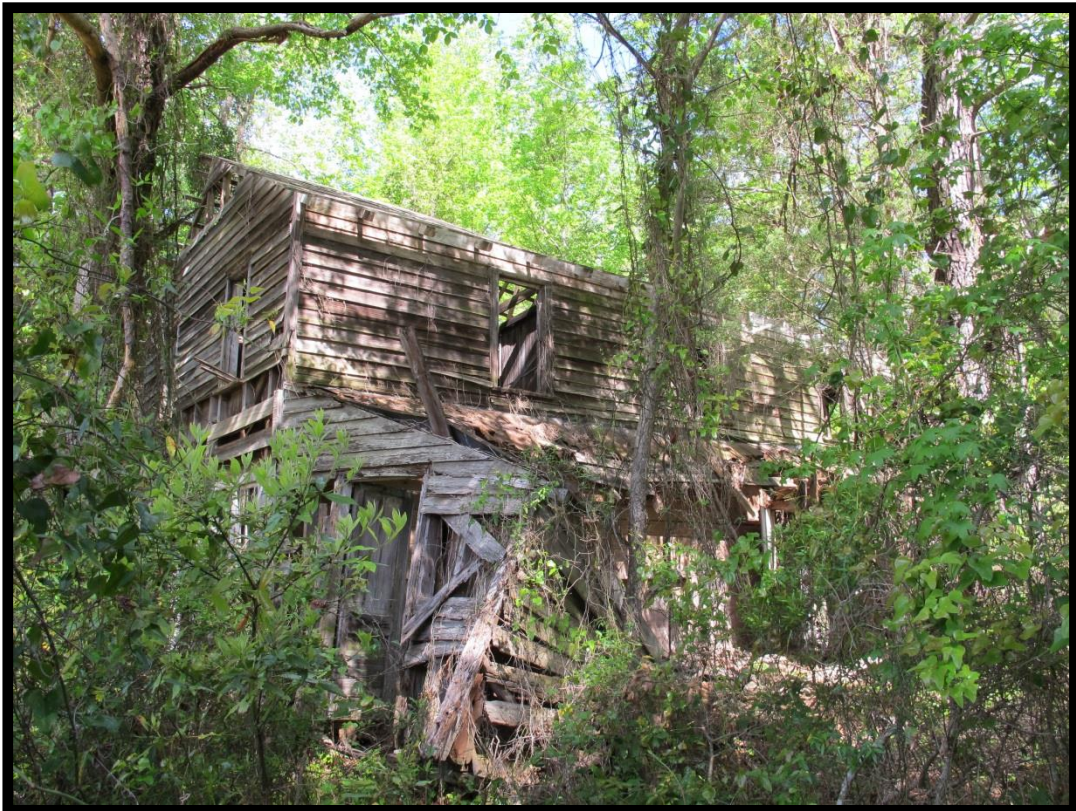
The Reel House and Store are located on the north side of Neuse Road (SR 1005), approximately 0.14 miles east of its crossing of Beard's Creek. The buildings sits approximately 50 feet back from the road and are heavily overgrown and deteriorating (Figures 47 and 48).

Figure 47: Reel House (PM0256), Looking Northeast.

Figure 48: Reel Store (PM0256), Looking Northwest.

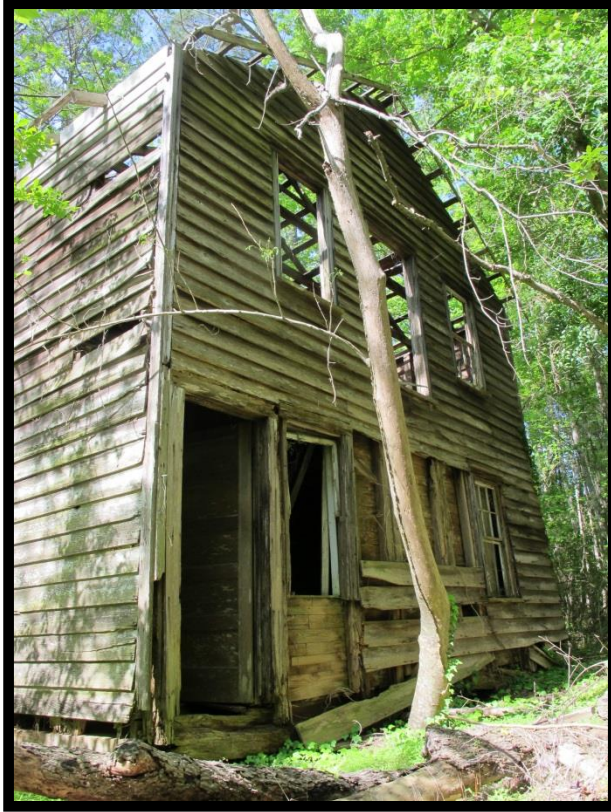
Figure 51: Reel Store (PM0256), Rear Gable End, Looking Southwest.

The property received the Reel name during the initial HPO survey. The name may be related to J. E. Reel, one of the local merchants at the time of Alexander C. Brinson. Built around 1887, the dwelling is a typical I-house with a shed-roofed porch, supported by turned posts sheltering the three-bays on the south (front) elevation of the building. A two-story wing extends off the north (rear) elevation of the main block giving the dwelling an L-shaped footprint (Figures 49 and 50). Located approximately 40 feet to the west of the house is the store, which was built around 1890. It is a two-story, front-gabled commercial building with a one-story shed-roofed wing running along the east (side) elevation of the building. The store was located on the first floor and a stair accessible from a door on the north (rear) gable end gave access to the second floor (Figures 51 and 52).

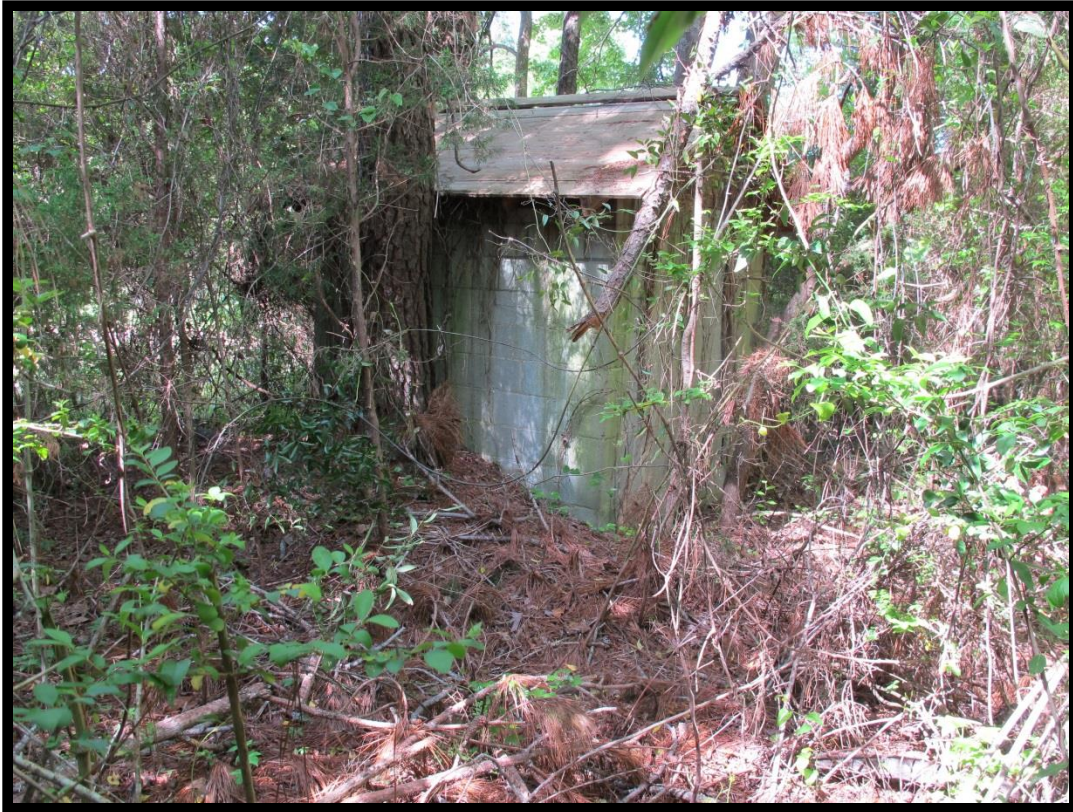
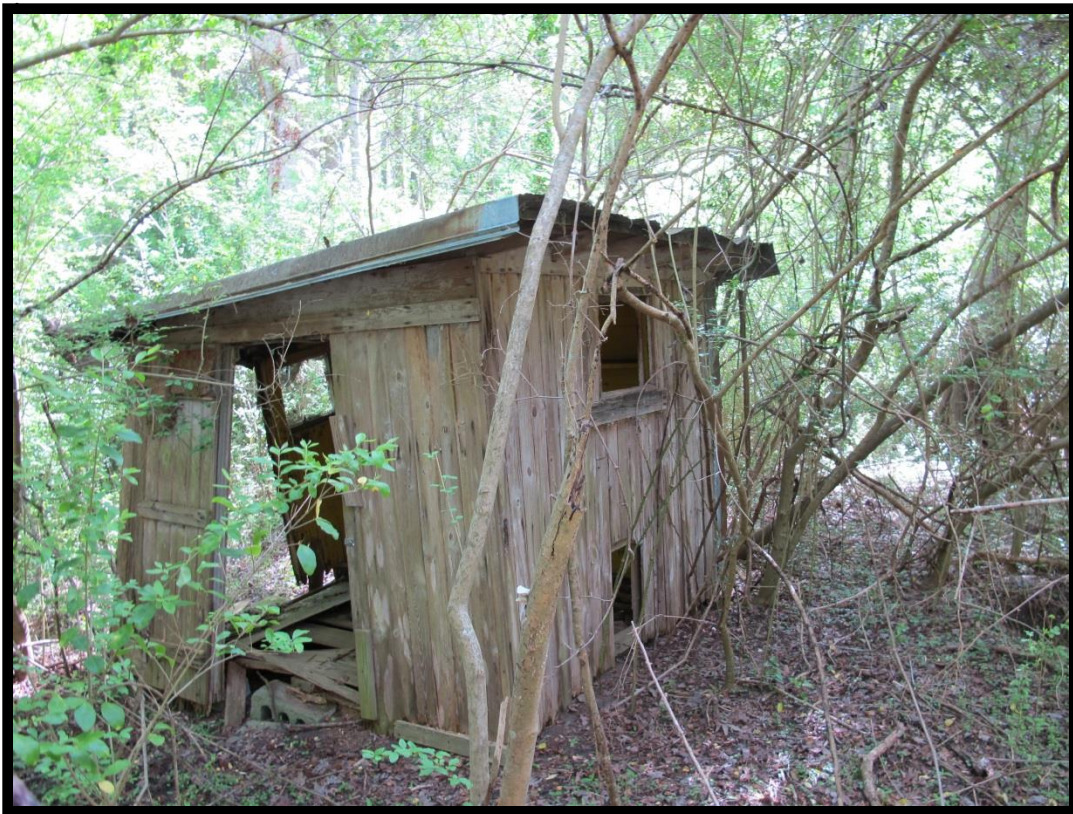
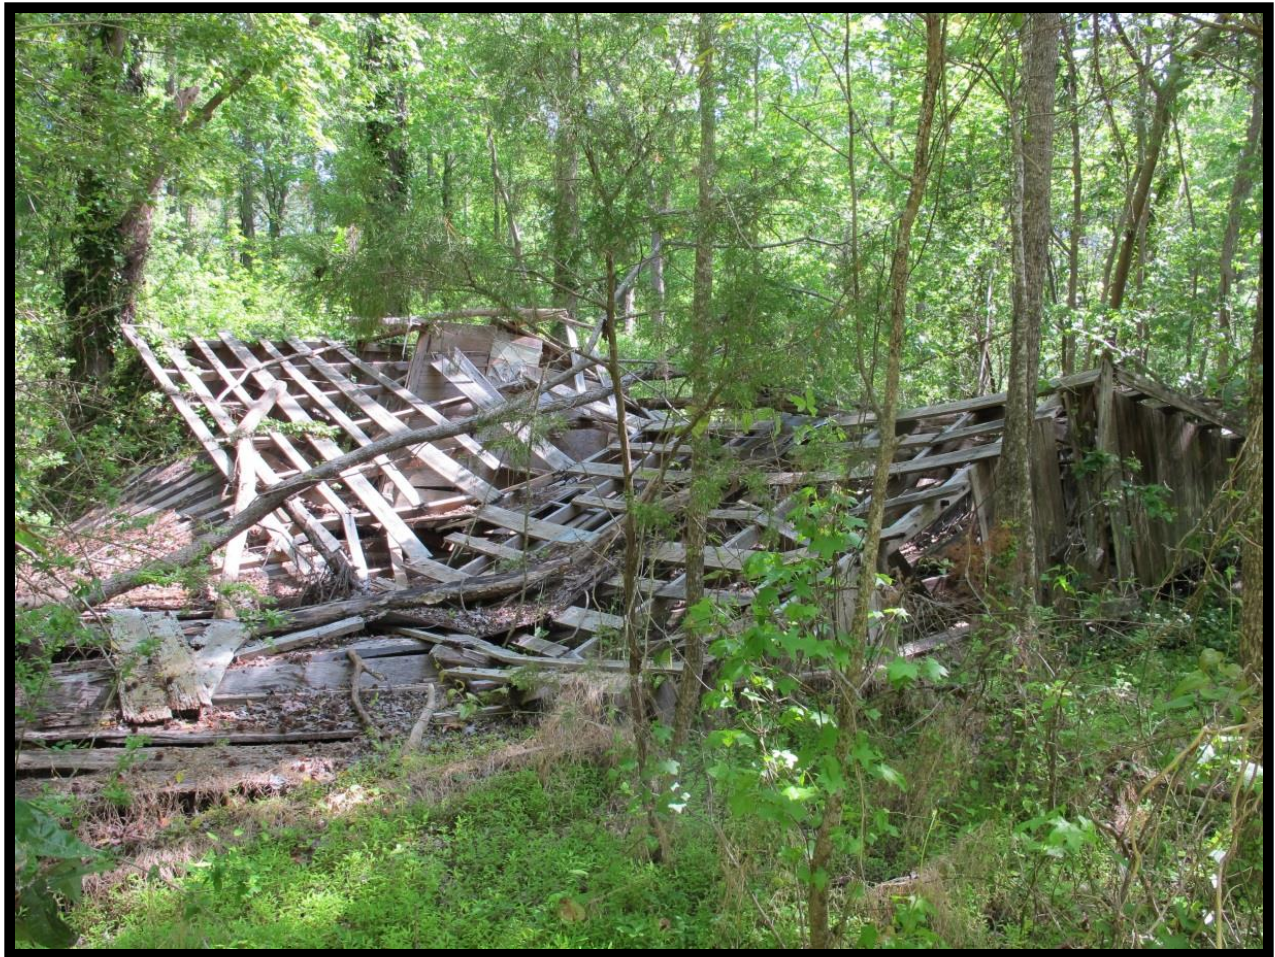
Located around the house are three ancillary structures; a front-gabled concrete-block well house, a shed-roofed chicken coop and a collapsed barn (Figures 53 through 55).

Figure 53: Reel House and Store (PM0256), Well House, Looking Northwest.

Figure 54: Reel House and Store (PM0256), Chicken Coop, Looking Northeast.

Figure 55: Reel House and Store (PM0256), Barn, Looking Northeast.

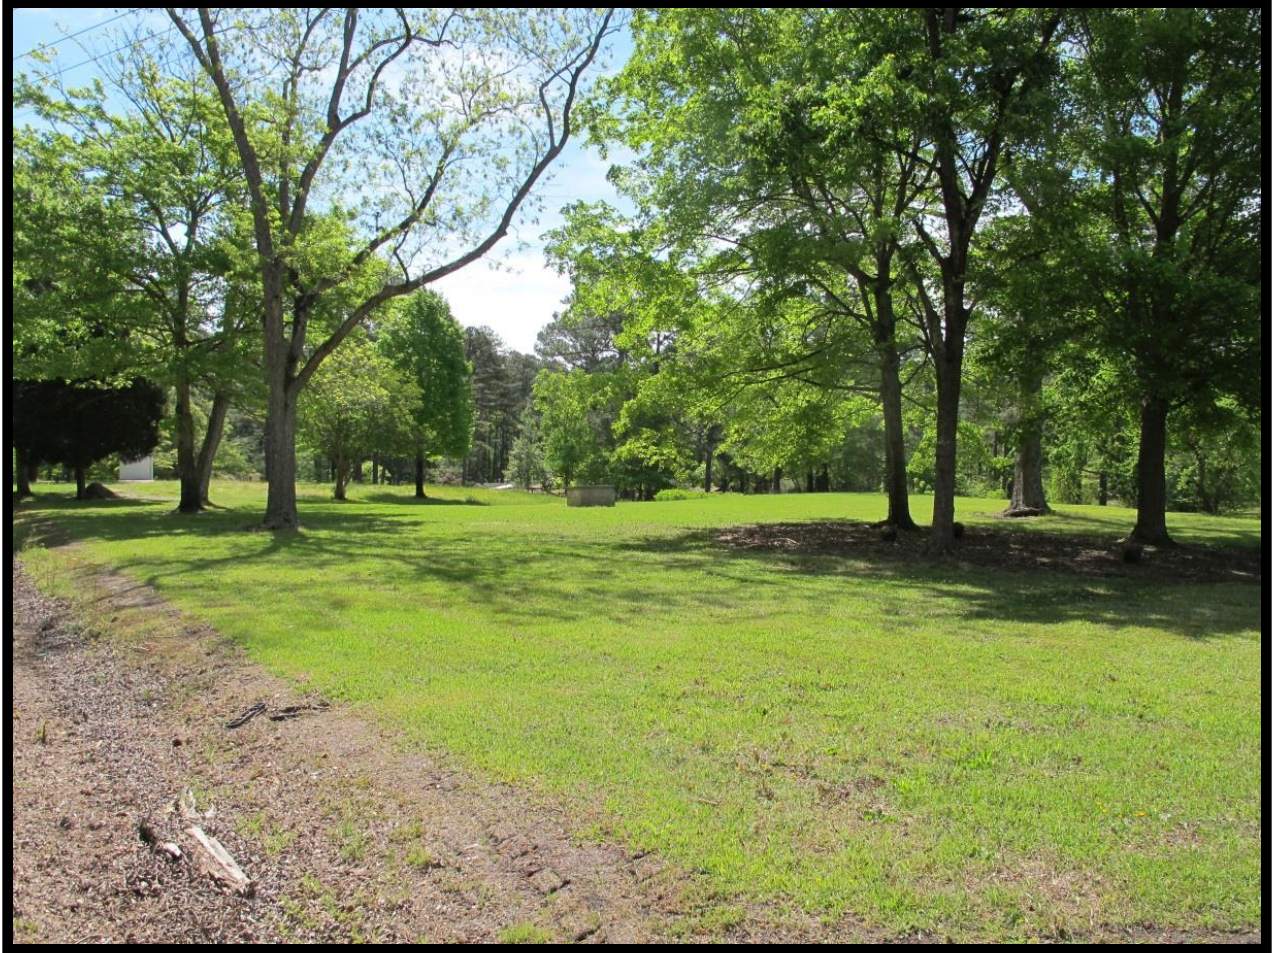
Figure 56: Joe Brinson House (PM0256), Former Site, Looking Southeast.

Built around 1890, the building was a two-story, four-bay, side-gabled dwelling with a one-story shed-roofed porch on the northwest (front) elevation.<sup>47</sup> The building is no longer extant (Figure 56).

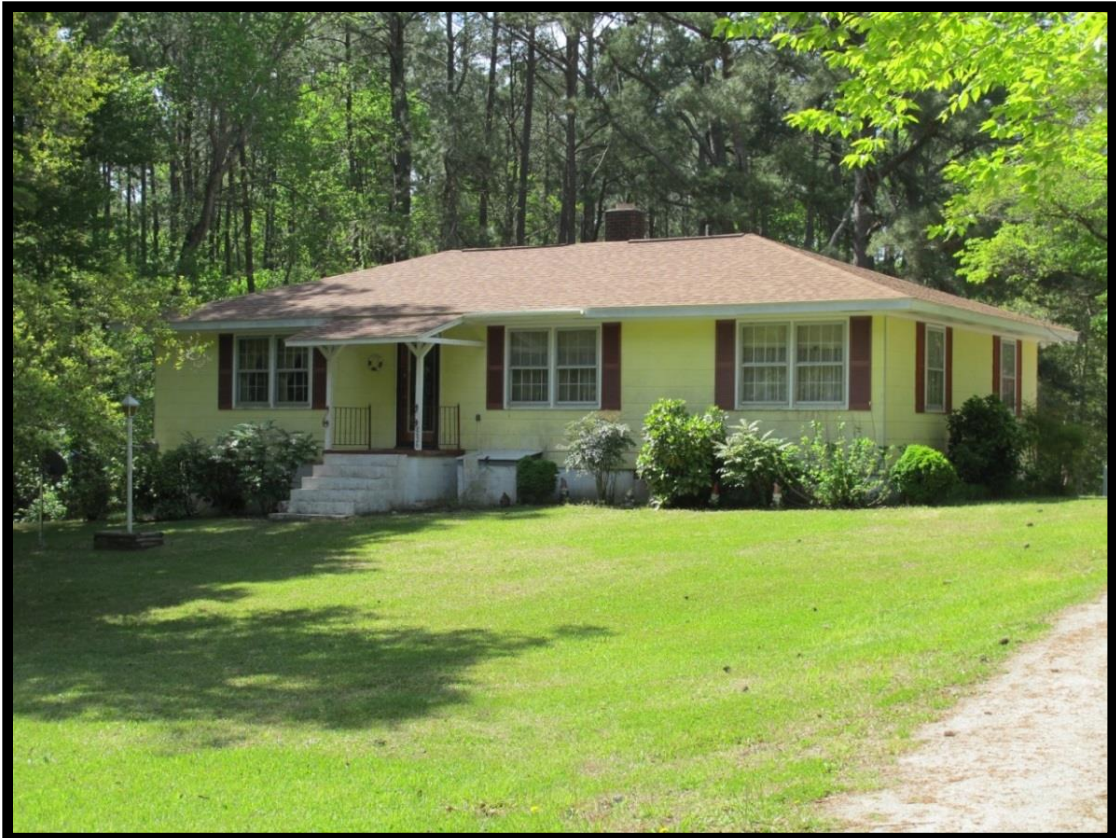
Located just southwest of where the Joe Brinson House (PM0257) used to stand is a modern one-story, side-gabled dwelling (E) on a raised foundation with a double front-gabled bay on the northeast (front) elevation, built around 2006 (Figure 59). On the north side of Neuse Road (SR 1005), northwest of where the Joe Brinson House stood, is a trailer home (Figure 60). Located to the east, approximately 400 feet west of Cedar Gut are a side-gabled Ranch-style dwelling (F), built around 1976, with an integral carport on the southwest gable end (Figure 61), and a hip-roofed Ranch-style dwelling (G) clad in asbestos shingles, built around 1959 (Figure 62).

Figure 62: House (G), Looking Southeast.
