Re: Upgrade Main Street, Huntersville, U-5908, Mecklenburg County, ER 15-2365

**ARCHITECTURAL SURVEY  
ROADWAY IMPROVEMENTS, NC 115, N. MAIN STREET,  
S. MAIN STREET, AND GILEAD/HUNTERSVILLE-CONCORD  
ROAD, TOWN OF HUNTERSVILLE, MECKLENBURG  
COUNTY, NORTH CAROLINA  
ADDENDUM FOR IN-DEPTH EVALUATION OF THE RANSON  
HOUSE AND HUNTERSVILLE TOWN JAIL  
TIP# U-5908; ER# 15-2365**

**ADDENDUM:  
IN-DEPTH EVALUATION OF THE RANSON HOUSE (MK1351) AND  
THE HUNTERSVILLE TOWN JAIL (MK3299)**

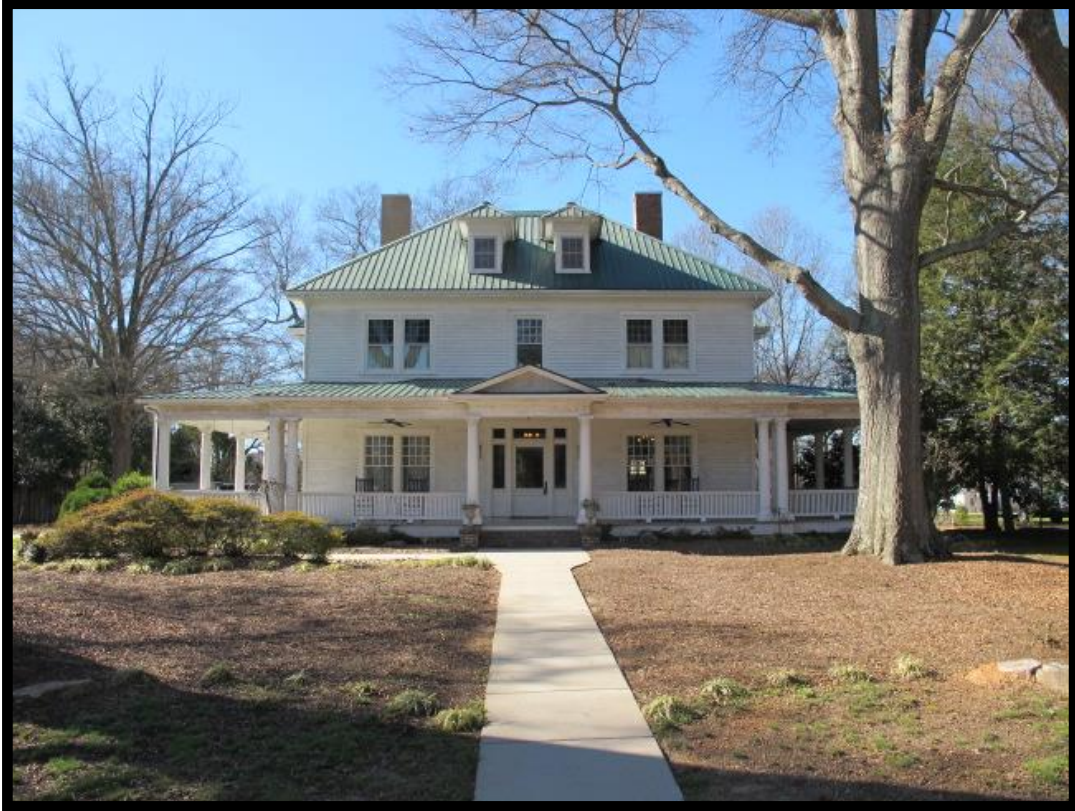
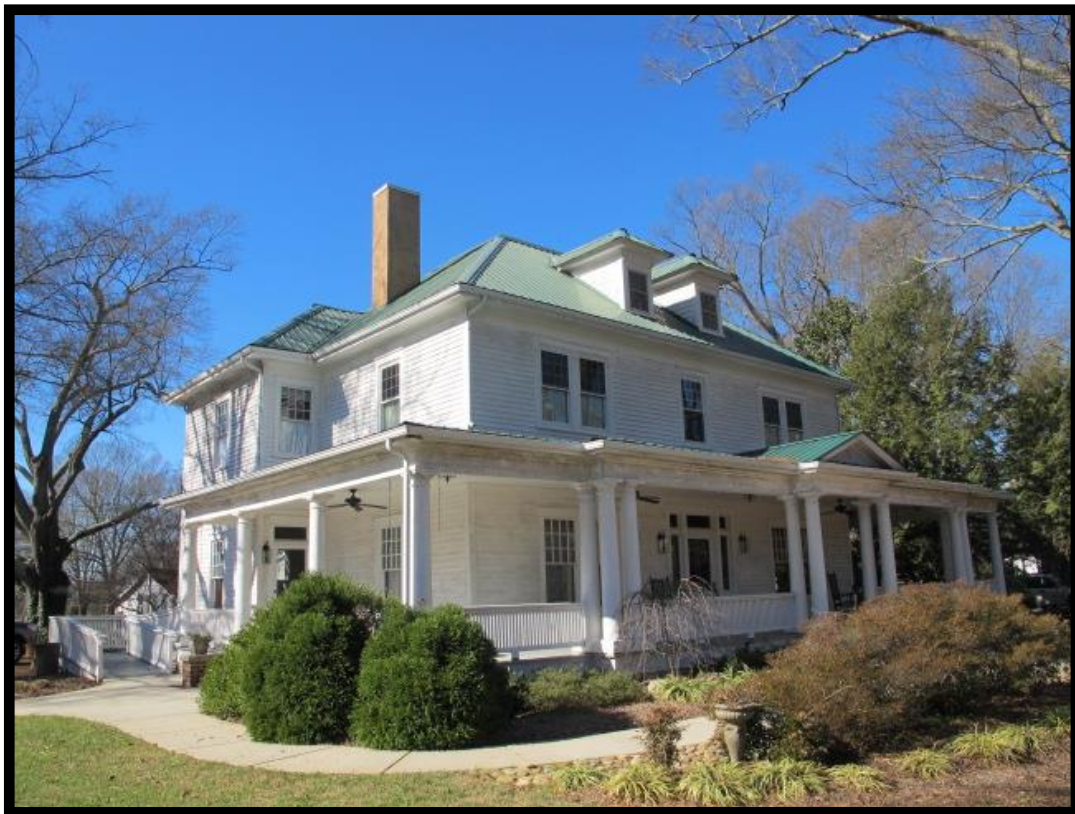
***Description:*** The Ranson House is located at the northwest corner of the intersection of Old Statesville Road (NC 115) and Mt. Holly-Huntersville Road (SR 2004). It is a two-and-a-half-story, three-bay, hip-roofed frame dwelling, clad in plain weatherboard with a (recent) M-panel metal roof, that was once the centerpiece of a 3,200-acre dairy farm (Figure 2.2-1). The dwelling contains elements of the Colonial Revival style, which was popular from the 1880s through to the early 1950s. The building sits on a stuccoed-brick

Figure 2.2-1: View of Ranson House (MK1351), Looking West.

Figure 2.2-2: View of Ranson House (MK1351), Looking Northwest.

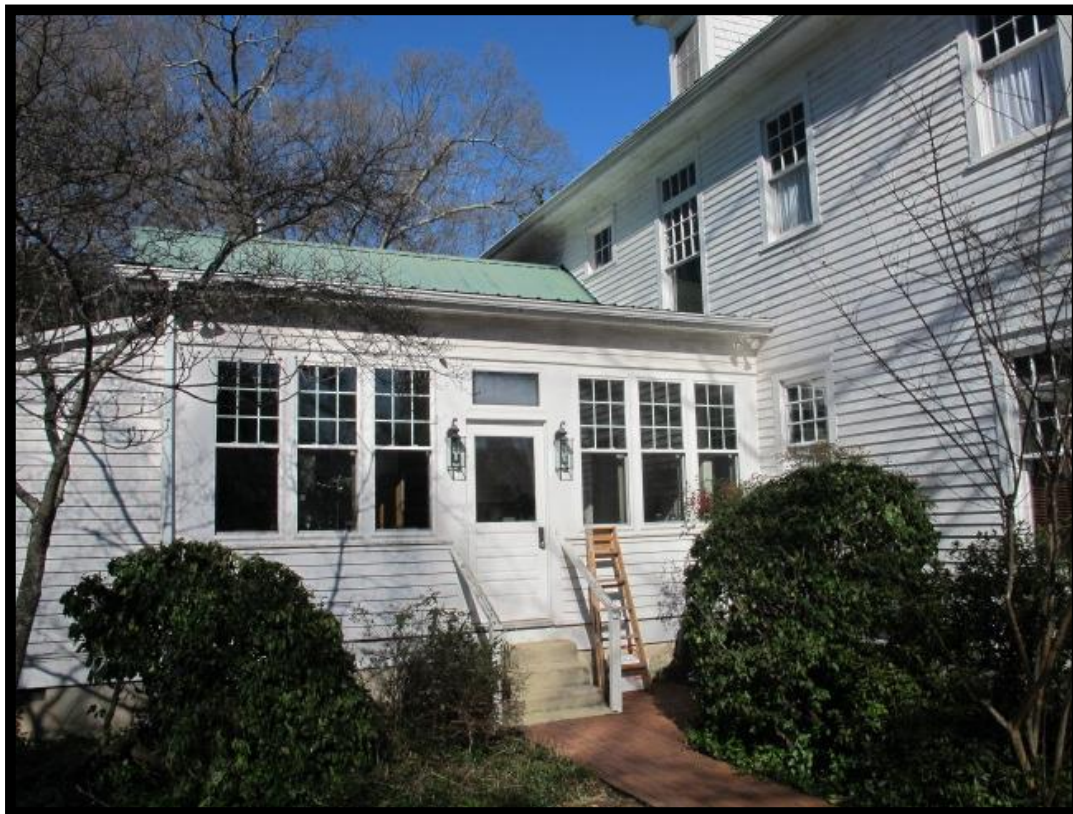
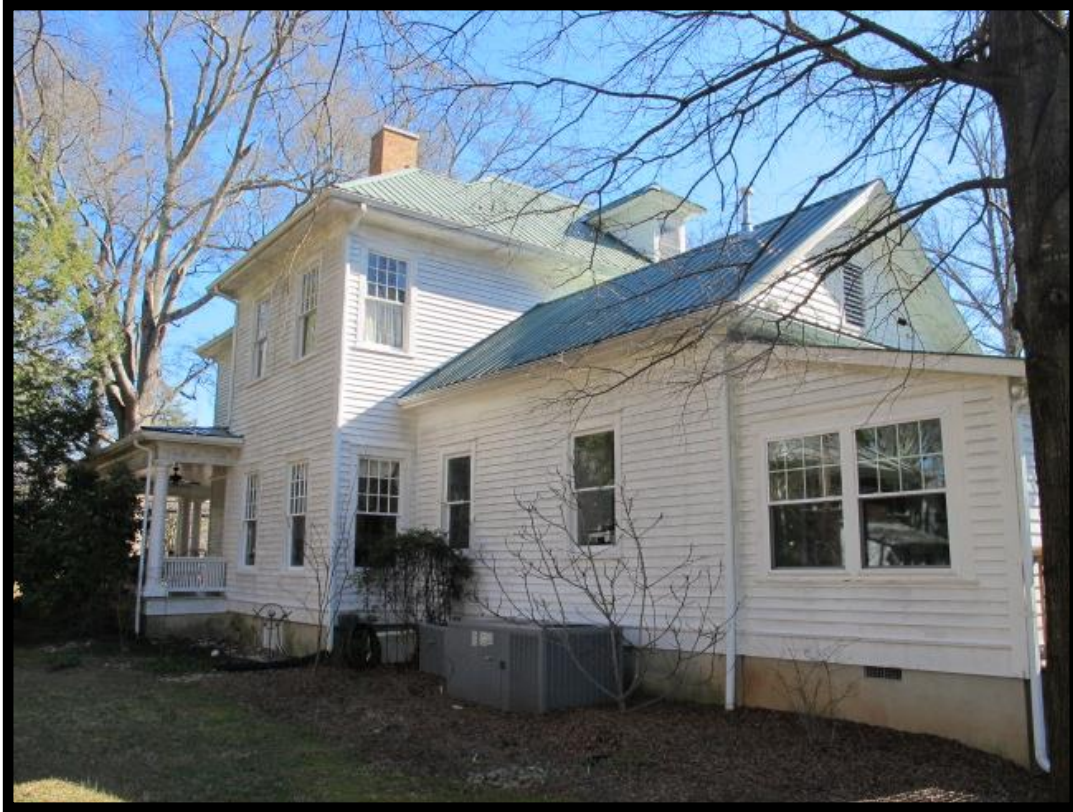
foundation, and (capped) brick chimneys pierce the north and south slopes of the roof. A hip-roofed porch, supported by Tuscan columns, extends across the east (front) elevation of the dwelling and wraps around the north and south (side) elevations where it connects with projecting bays on each side elevation. The projecting bays give the main block of the dwelling a truncated T-shaped footprint (Figure 2.2-2). A centrally located cross-gabled section of the porch marks the location of the main entrance on the front elevation. Sidelights and a transom light surround the glazed entry door, which is flanked by double twelve-over-one wooden sash windows (Figure 2.2-3 and 2.2-4). Two hip-roofed dormers clad in wooden shingles sit on the front slope of the roof, and a single hip-roofed dormer is centered on the rear slope of the roof (Figure 2.2-5). A one-story, gable-roofed wing extends off the west (rear) elevation of the main block; this has enclosed shed-roofed porches running along the south (side) elevation and west (rear) gable end (Figures 2.2-6 and 2.2-7).

Figure 2.2-6: View of Ranson House (MK1351), Rear Wing Looking Northeast.

Figure 2.2-7: View of Ranson House (MK1351), Rear Wing Looking Southeast.

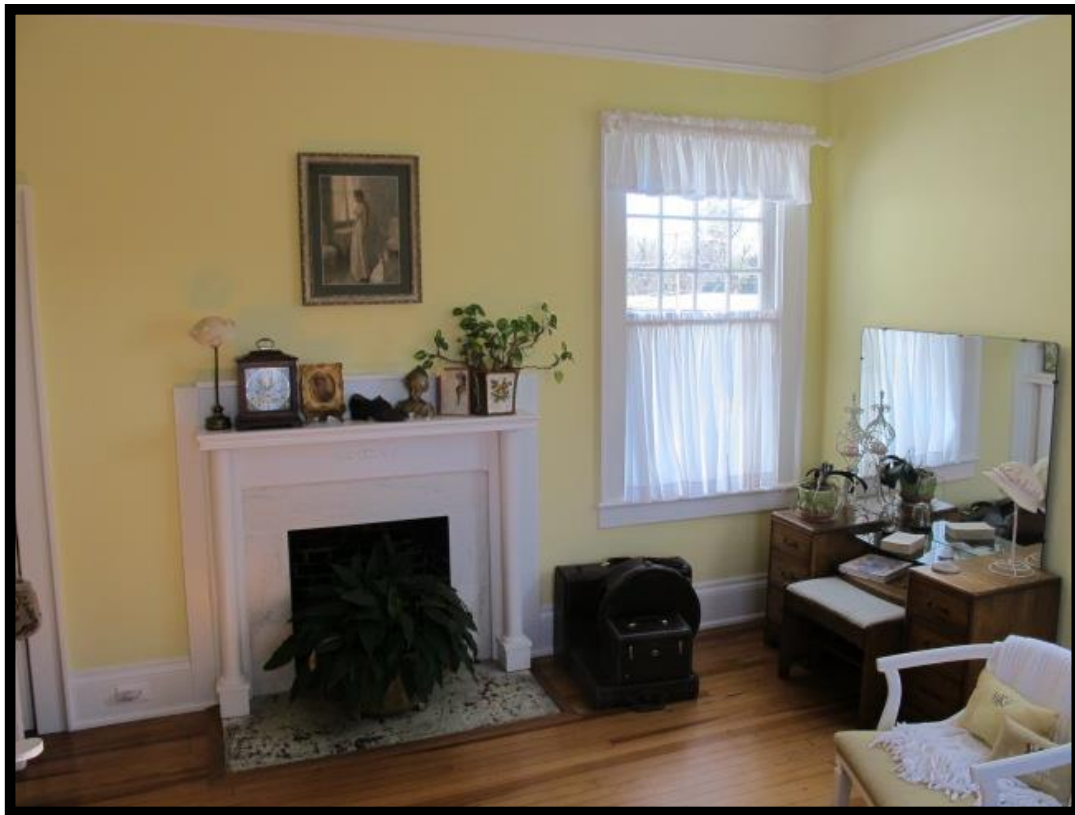
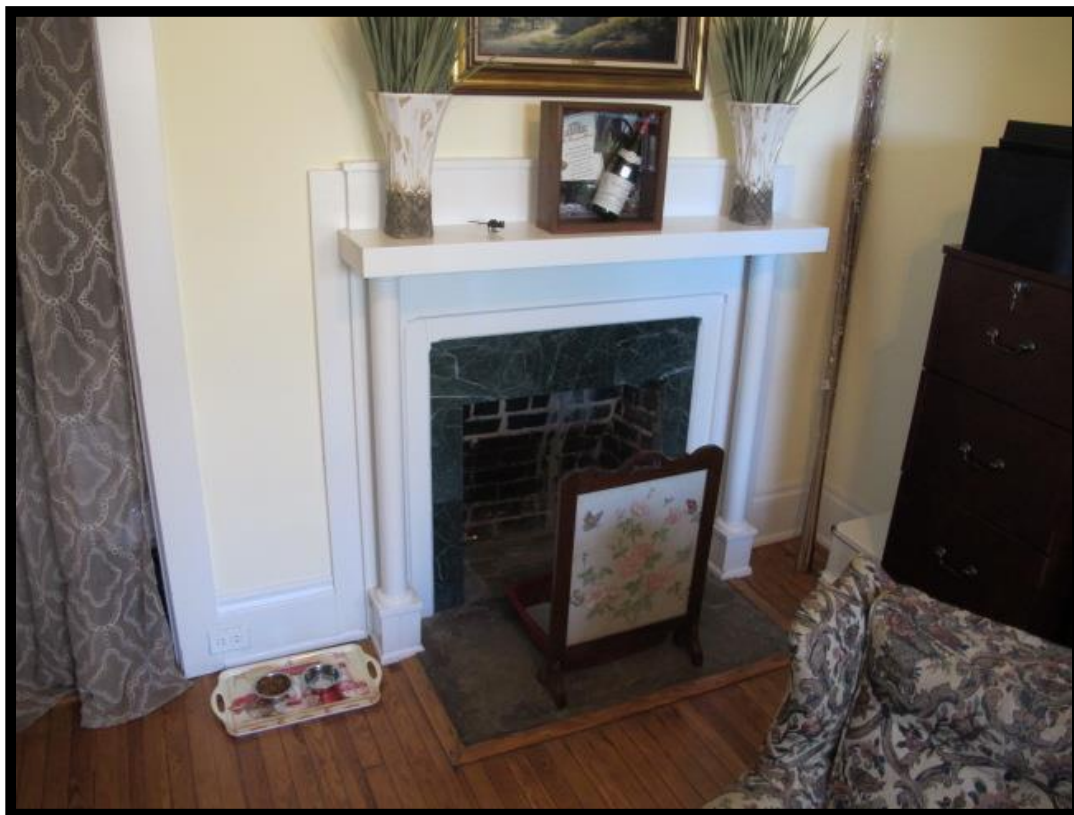
The interior of the Ranson House has a center-passage double-pile plan. Double five-panel doors divide the passage/hallway into two sections, and a stair, which gives access to the second floor, is located in the rear section of the hallway (Figures 2.2-8 and 2.2-9). Four of the five rooms on the first floor are heated – the fifth room is an original bathroom – and three of the four mantels have a mirrored overmantle flanked by attenuated classical columns (Figures 2.2-10 through 2.2-13). An unusual feature on the first floor is the presence of elaborate pressed-tin coved ceilings that are usually more common in the commercial buildings of the period. The hallway has a coffered ceiling with an egg-and-dart cornice, and the rooms have a geometric pattern – square tiles with diamonds with inset paterae – and an egg-and-dart cornice (Figures 2.2-14 and 2.2-15). The second-floor plan mirrors that of the first floor, with a center passage double pile plan. The finishes on the second floor are much plainer than on the first floor, with narrow-board ceilings and simple mantelpieces (Figures 2.2-16 through 2.2-20).

Figure 2.2-16: Ranson House (MK1351),  
Second Floor Hallway Looking West.

Figure 2.2-18: Ranson House (MK1351), Second Floor Mantel in Southwest Room.

Figure 2.2-19: Ranson House (MK1351), Second Floor Mantel in Southeast Room.

Figure 2.2-20: Ranson House (MK1351), Second Floor Mantel in Northeast Room.

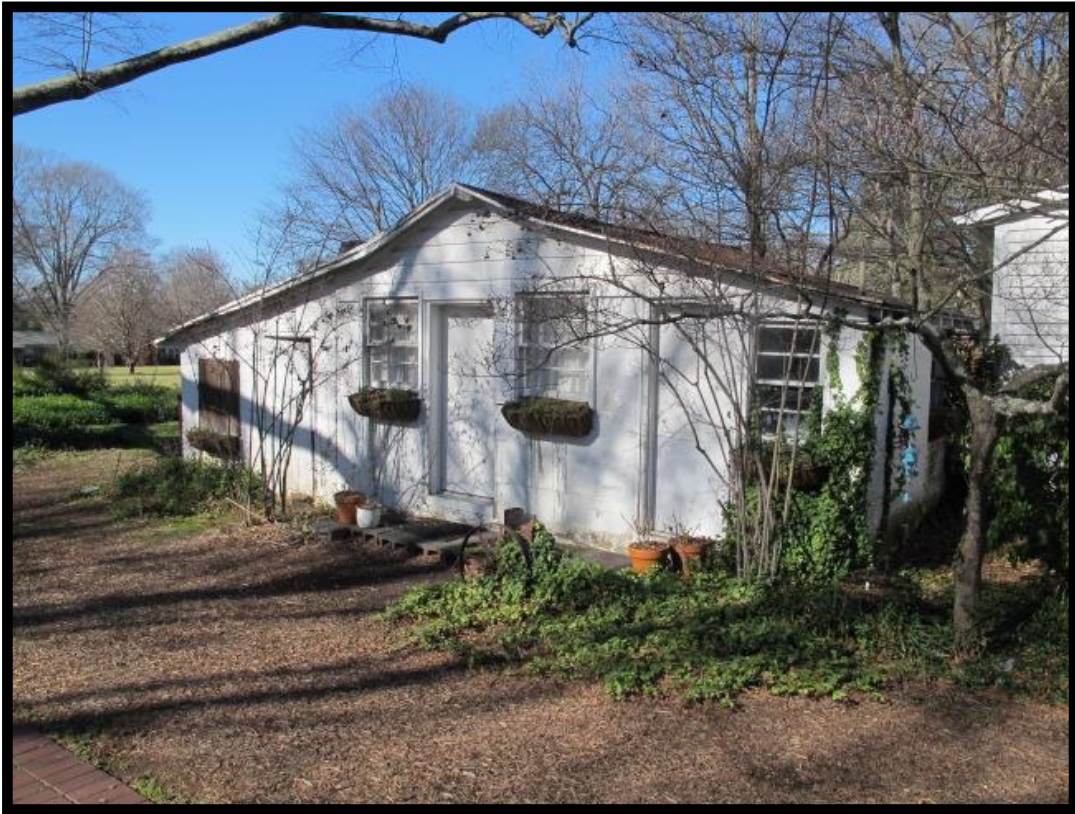
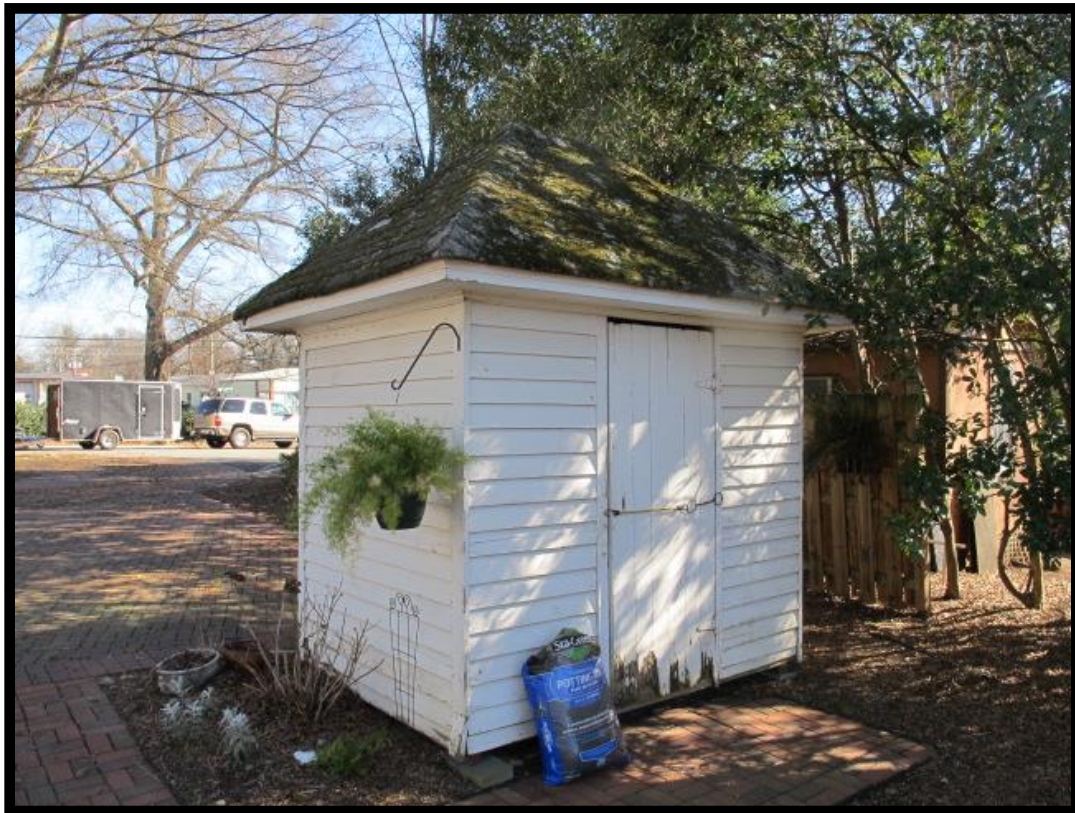
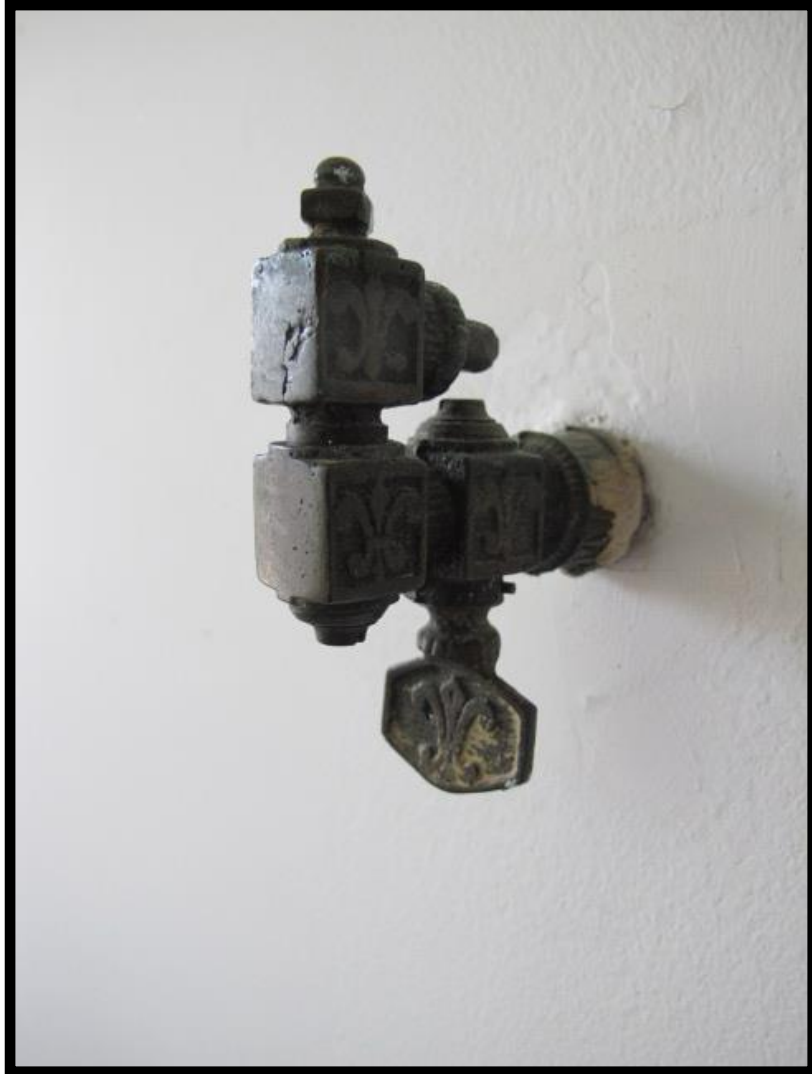
Located behind the house are two historic outbuildings. Off the southwest corner of the rear wing is a one-story, side-gabled structure. The tripartite, concrete-block and brick building was originally associated with the dairy operations at the farm. Located to the southwest of the dairy is a small hip-roofed frame building that originally functioned as the gashouse for the Ranson House before it was electrified. After the introduction of electricity the small building served various purposes and was moved around the property several times (Figures 2.2-21 through 2.2-23).

Figure 2.2-21: Ranson House (MK1351), Dairy Looking Northwest.

Figure 2.2-22: Ranson House (MK1351), (former) Gashouse Looking Southeast.

Figure 2.2-23: Ranson House (MK1351), Only Surviving Original Gas Fixture in Second Floor Bathroom.

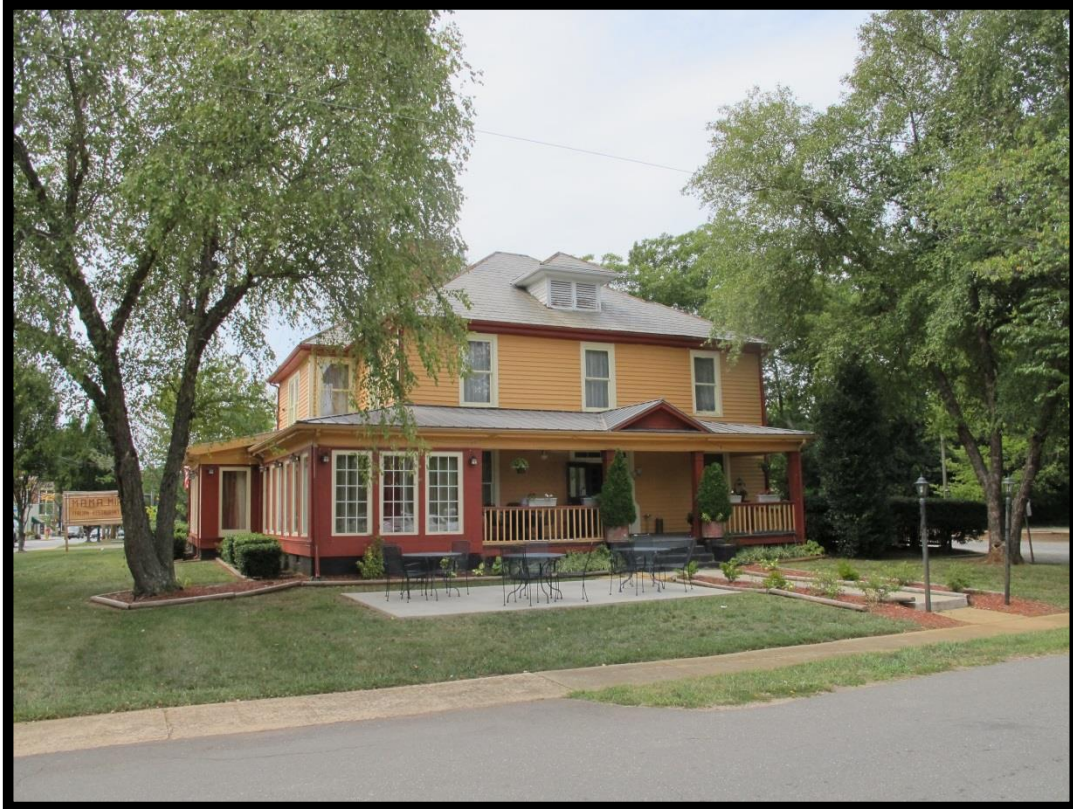
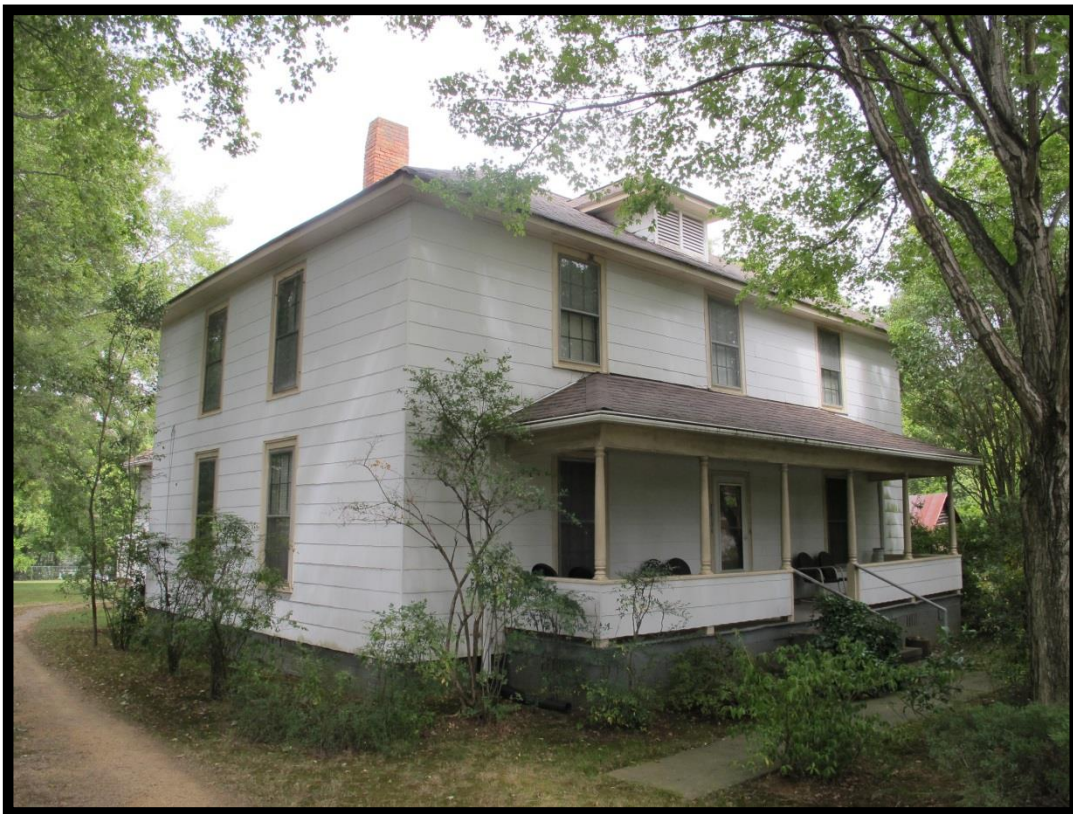
According to the HPOWEB database, twenty-eight (28) properties have been surveyed in Mecklenburg County that have been identified as Colonial Revival, ten of which are considered eligible for the NRHP. Two nearby examples are the R. C. Biberstein House (MK0139), of ca. 1906 and the John C. Kilgo House (MK0160) of ca. 1915. Both houses are located in Charlotte, and the Biberstein House was determined eligible in 2006, and the Kilgo House was listed in the National Register in 2009. Both houses are examples of a more modest Colonial Revival-style dwelling similar to that of the Ranson House and retain high levels of integrity (Figures 2.2-24 and 2.2-25). In Huntersville two similar houses survive from the beginning of the twentieth century, the Holbrooks House (MK1334) and the Hunter-Mayberry House (MK1341); however, both resources lack the same level of integrity as the Ranson House (Figures 2.2-26 and 2.2-27).

Figure 2.2-26: View Holbrooks House (MK1334), Looking Northwest.

Figure 2.2-27: View of Hunter-Mayberry House (MK1341), Looking Northeast.

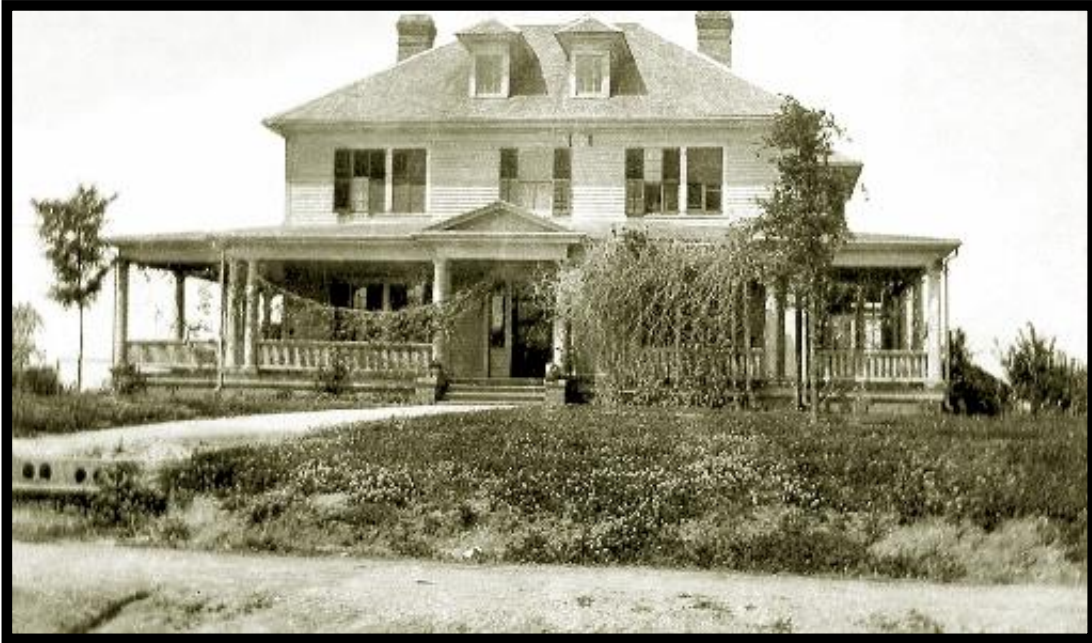
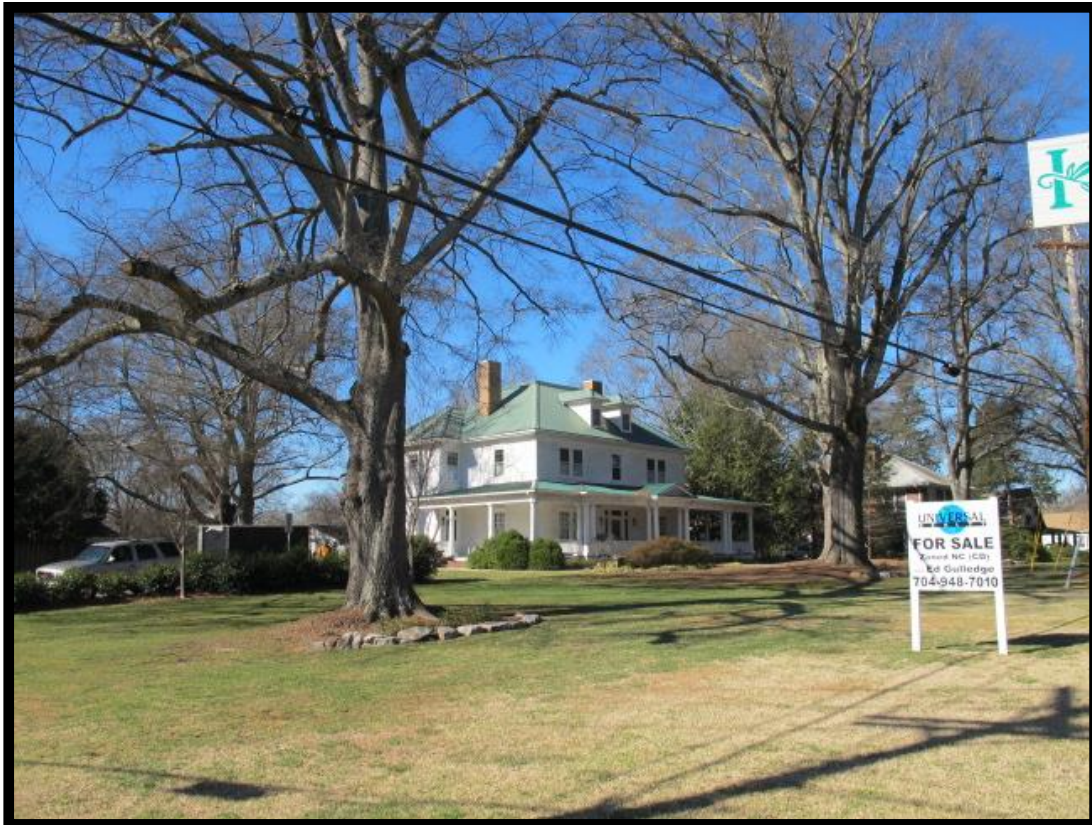
The Ranson House embodies the distinctive characteristics of a Colonial Revival-style dwelling as they were built across the South during the first decades of the twentieth century. It has the typical two-story, center-passage, double-pile massing and a hipped roof. It lacks the two-story portico characteristic of more high-styled Southern Colonial dwellings, but it does have a one-story porch that extends along the front elevation and wraps around the side elevations. The dwelling retains the integrity of location, design, materials, and workmanship. Any changes that have occurred have been sympathetic to the overall feeling of the design. The dwelling has lost some of its original setting as a farmhouse, due to the loss of most of its outbuildings and the subdivision that developed around it after World War II, but several of the trees that were planted when the house was built survive (personal communication Rehnea Raines, January 2016) (Figures 2.2-28 and 2.2-29).

Figure 2.2-28: View of Ranson House (MK1351) Circa 1915, Looking West (Charlotte-Mecklenburg Historic Landmarks Commission 2007a).

Figure 2.2-29: View of Ranson House (MK1351), Looking Northwest.

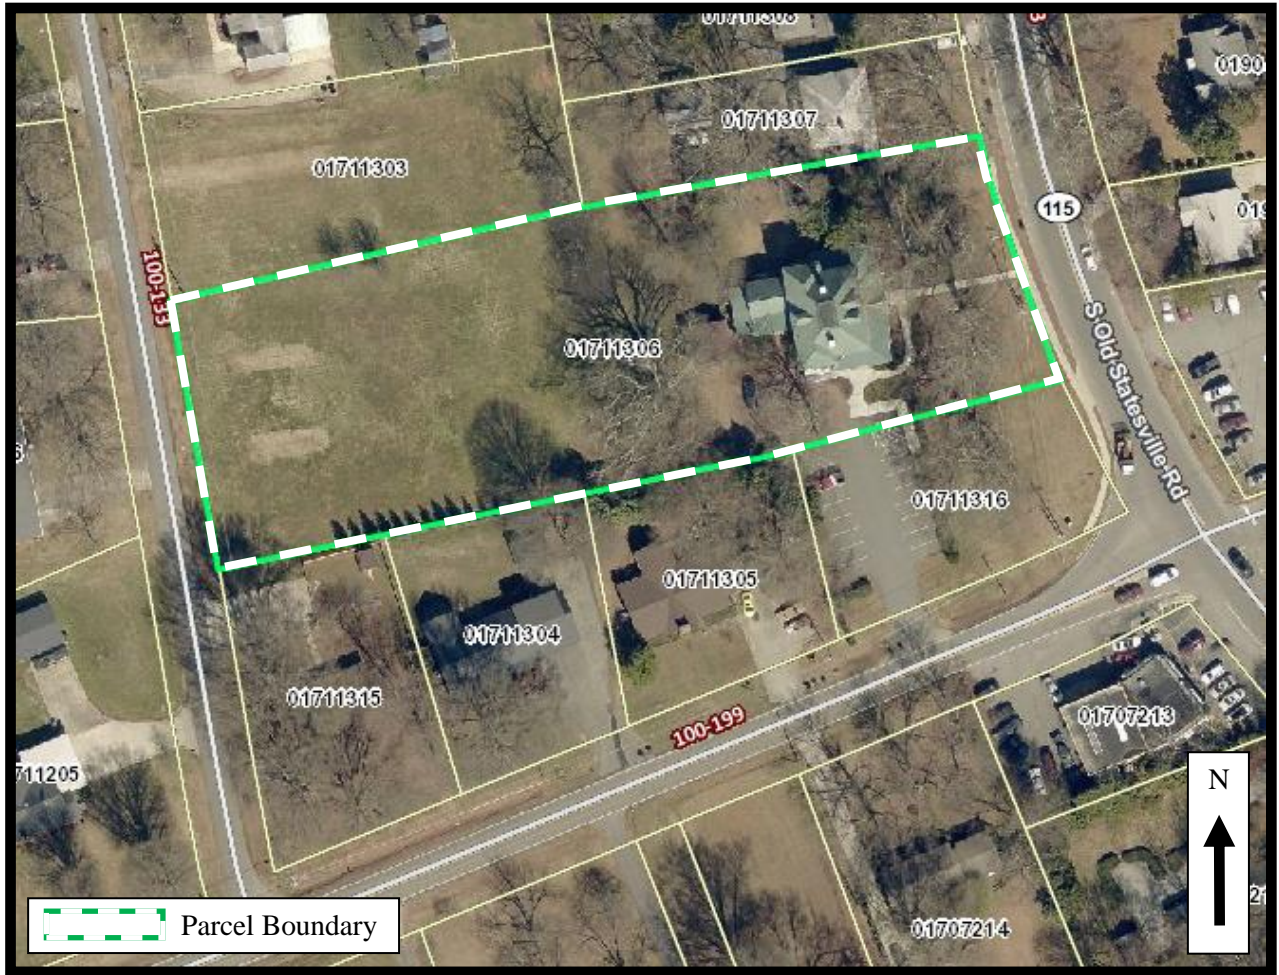
The proposed NRHP Boundary is defined by the current tax parcel, which contains the dwelling, the dairy house, the gashouse, and the majority of the historic trees (1.7 acres; Mecklenburg County Parcel ID 01711306) (Figure 2.2-30).

Figure 2.2-30: Aerial View of the Ranson House (MK1351), Showing Proposed NRHP Boundary.

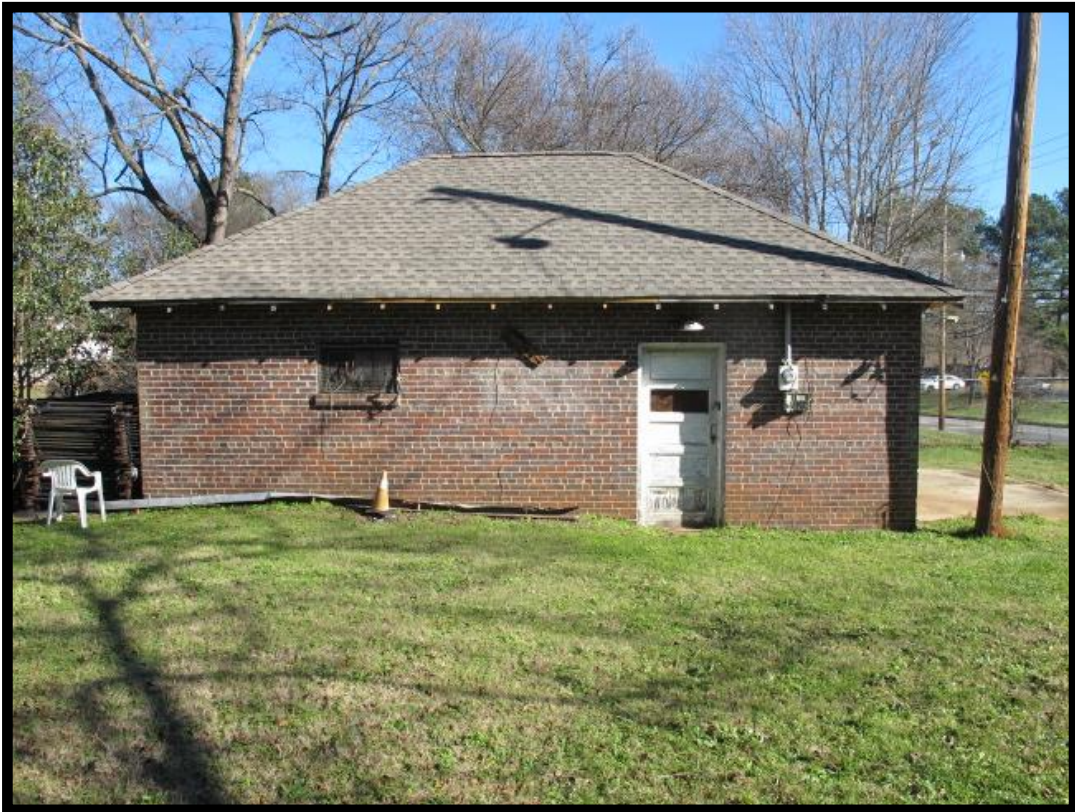
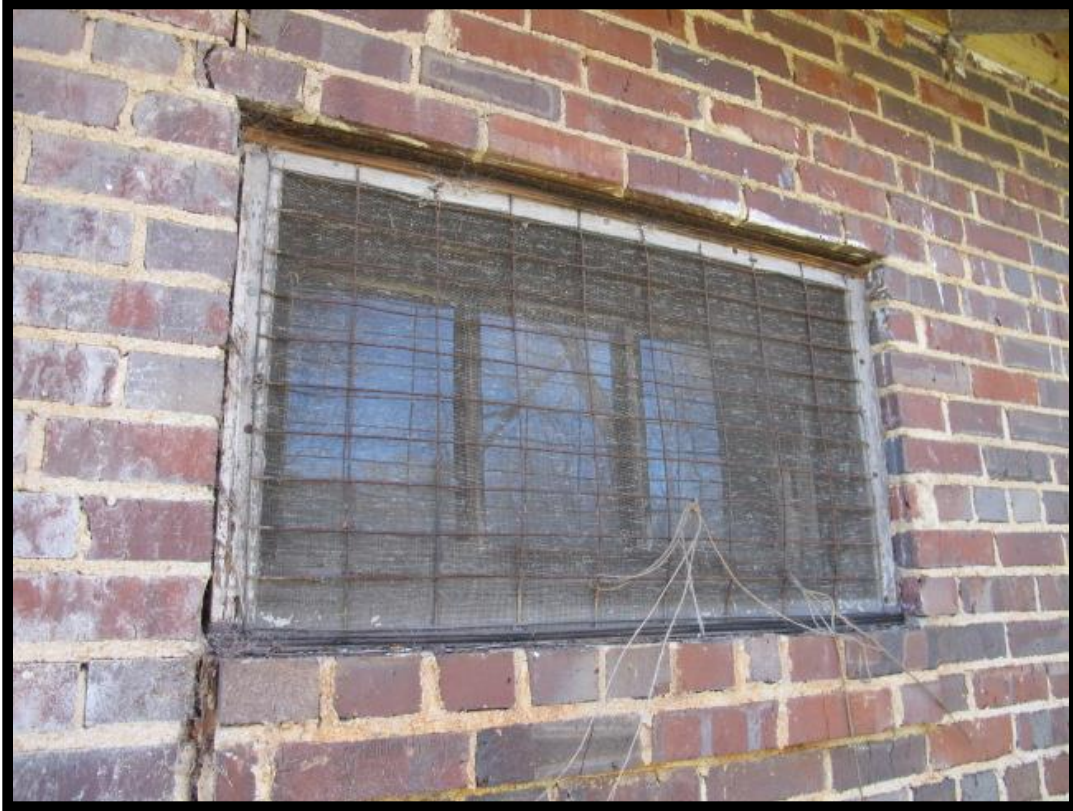
**Description:** The Huntersville Town Jail is located on the north side of Huntersville-Concord Road (SR 2448), approximately 185 ft east of the intersection with North Church Street. It is a one-story hip-roofed brick building with an interior brick chimney against the east wall. The roof has exposed rafter tails, and the walls are laid in five-over-one common bond (Figure 2.2-31). The building is placed perpendicular to the street with two (boarded-up) six-over-six wooden sash windows facing south towards Huntersville-Concord Road. The only door is a five-panel door located in the west elevation. It is flanked to the left by a three-light hopper window with a slightly projecting brick sill, set high in the wall, which swings into the building. A similar window pierces the north elevation, and two additional hopper windows with brick sills are located in the east elevation (Figures 2.2-32 and 2.2-33).

Figure 2.2-32: View of Huntersville Town Jail (MK3299), Looking East.

Figure 2.2-33: Huntersville Town Jail (MK3299), Three-Light Hopper Window.

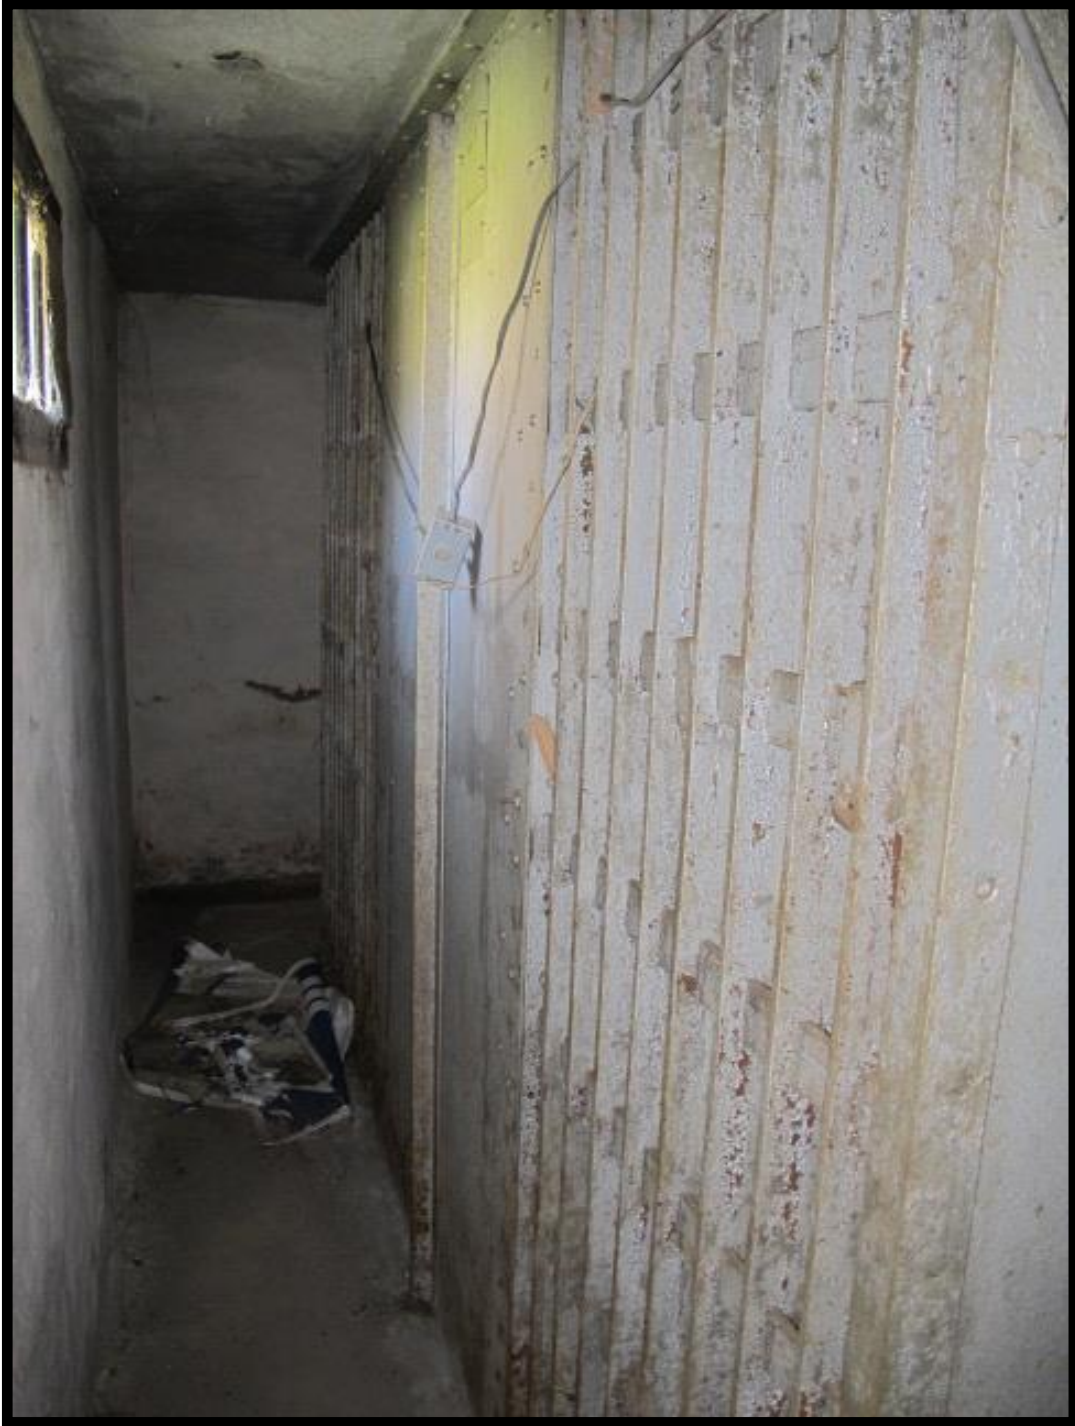
The building is divided into two spaces. The entry door opens into the office space, which is lit by the two six-over-six wooden sash windows in the south wall and a hopper window in the east wall (Figure 2.2-34 and 2.2-35). A brick partition wall with a five-panel wooden door separates the office space from the space that houses the actual cellblock (Figure 2.2-36). The interior chimney is located against the exterior east wall where it meets with the partition wall. The cellblock is a freestanding, floor-to-ceiling, steel box that contains two cells (Figure 2.2-37). The smaller of the two cells contains two iron bunks and a toilet, and the larger contains three iron bunks and a toilet (Figures 2.2-38 and 2.2-39). An additional iron bunk and toilet are located against the exterior east wall of the cellblock (Figure 2.2-40). Two steel-lattice cell doors are located in the south wall of the cellblock, and a section of the rear wall of each cell consists of steel bars, which allow for secondary light from the hopper window in the north wall of the jail to enter the cells (Figure 2.2-41).

Figure 2.2-41: Huntersville Town Jail (MK3299), View of Rear Wall of Cell Block Looking East.

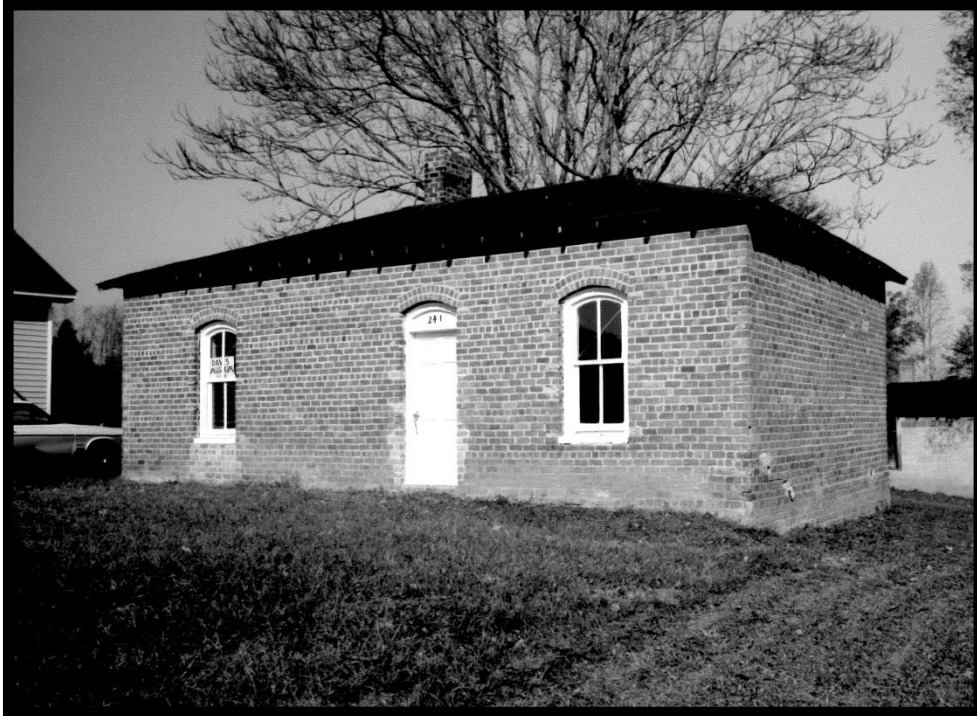
Huntersville Town Jail. It is a one-story, hip-roofed building with five-over-one common bond brick walls and a two-room plan (Figure 2.2-42).

Figure 2.2-42: View of Second Yadkin County Jail (YD0586) Circa 1892, Looking Northwest.
