RE: Addendum to Historic Structures Survey Report, Upgrade of Main Street, Huntersville,
Mecklenburg County, ER 15-2365

**ARCHITECTURAL SURVEY
ROADWAY IMPROVEMENTS, NC 115, N. MAIN STREET,
S. MAIN STREET, AND GILEAD/HUNTERSVILLE-CONCORD
ROAD, TOWN OF HUNTERSVILLE, MECKLENBURG
COUNTY, NORTH CAROLINA
TIP# U-5908; ER# 15-2365**

**ADDENDUM:
IN-DEPTH EVALUATION OF THE HUNTERSVILLE ASSOCIATE
REFORMED PRESBYTERIAN CHURCH (MK1342)**

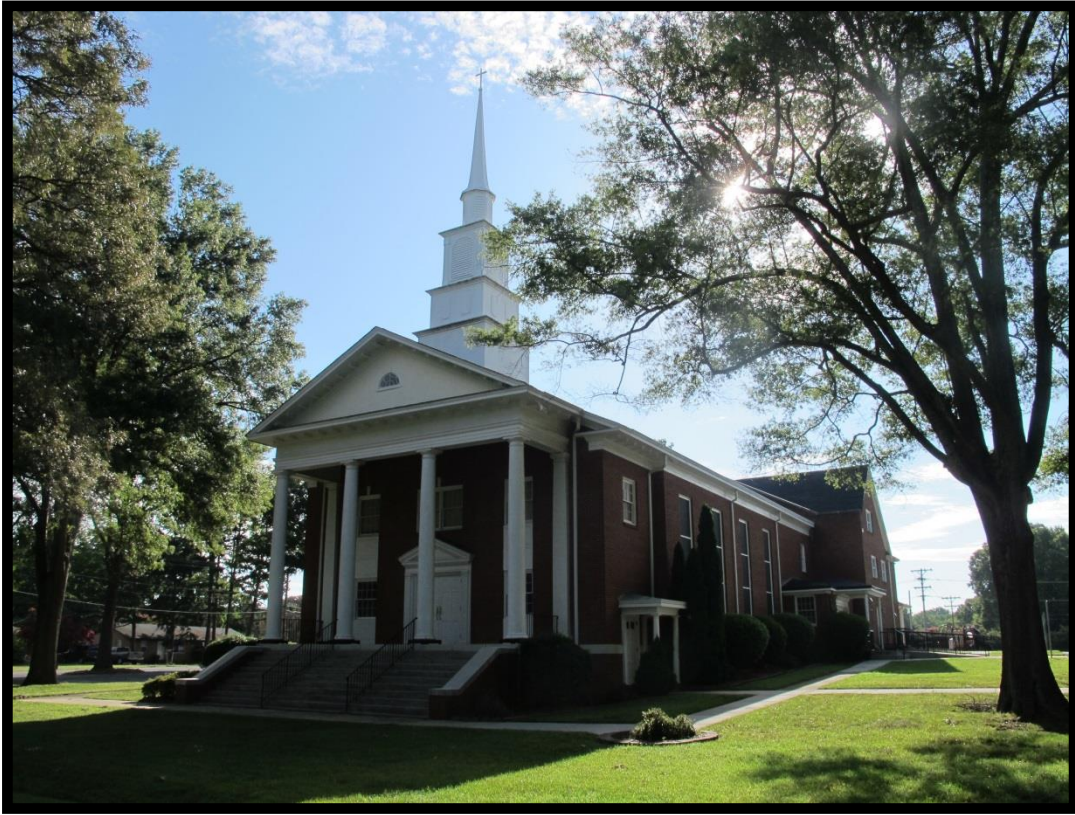
Description: The Huntersville Associate Reformed Presbyterian Church is located at the southeast corner of the intersection of Old Statesville Road (NC 115) and Bigham Street. It is a tall, front-gabled Colonial Revival-style brick church on a raised basement (Figure 2.2-1). A temple-front portico with colossal Tuscan columns shelters the main entrance on the west (front) gable end. The pediment has a small fanlight window and is modestly decorated with plain modillions. A four-tiered belfry, with three square tiers and one octagonal tier, sits just behind the portico on the roof of the sanctuary. Eight-over-eight wooden sash windows flank the double entry door on the front gable end, and fluted classical pilasters flank the entry, which is topped by a classical pediment decorated with

Figure 2.2-1: View of Huntersville Associate Reformed Presbyterian Church (MK1342), Looking Northeast.

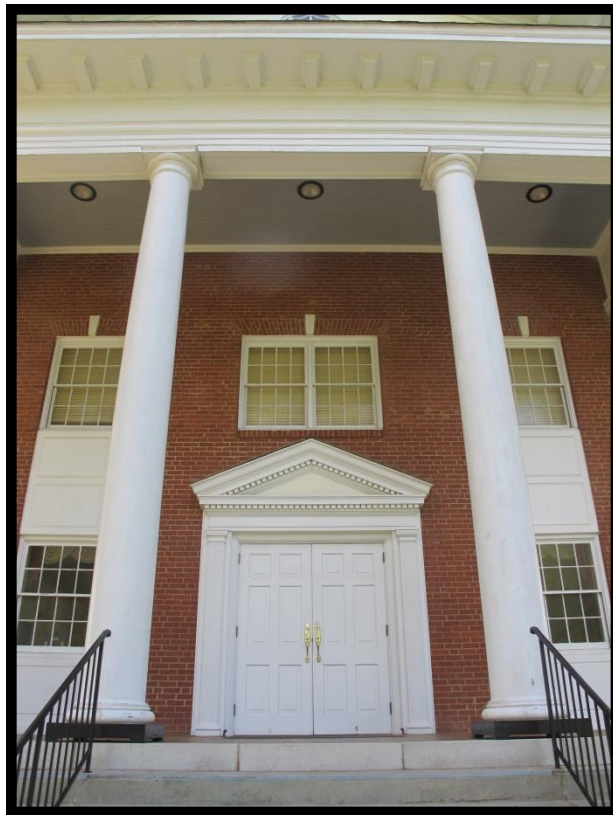
Figure 2.2-2: Detail of Entry of Church (MK1342).

dentils (see Figure 2.2-2). Tall thirty-two-over-sixteen wooden sash windows with rolled glass panes light the sanctuary. A tripartite sunscreen covers the windows on the exterior. The walls of the vestibule and the sanctuary are clad in brick with five rows of stretchers separated by a row of alternating headers and stretchers, and a stone, or concrete, water table indicates the first-floor level (Figure 2.2-3). The remaining walls are clad in plain stretcher bond brick. A two-story gable-roofed Sunday school/fellowship hall wing is located perpendicular to the east (rear) gable end of the sanctuary, and extends to either side. This section was initially extended to the north and included a narrow gable-roofed wing located against the north wall of the sanctuary (Figure 2.2-4). The addition contains a stairwell leading to the church offices on the second floor and an elevator that connects all three floors of the church, as well as smaller educational spaces. Between 2012 and 2013, the church was expanded to the east adding a two-story gable-roofed section with a double gable off the east (rear) elevation of the Sunday school/fellowship hall wing (Figure 2.2-5).

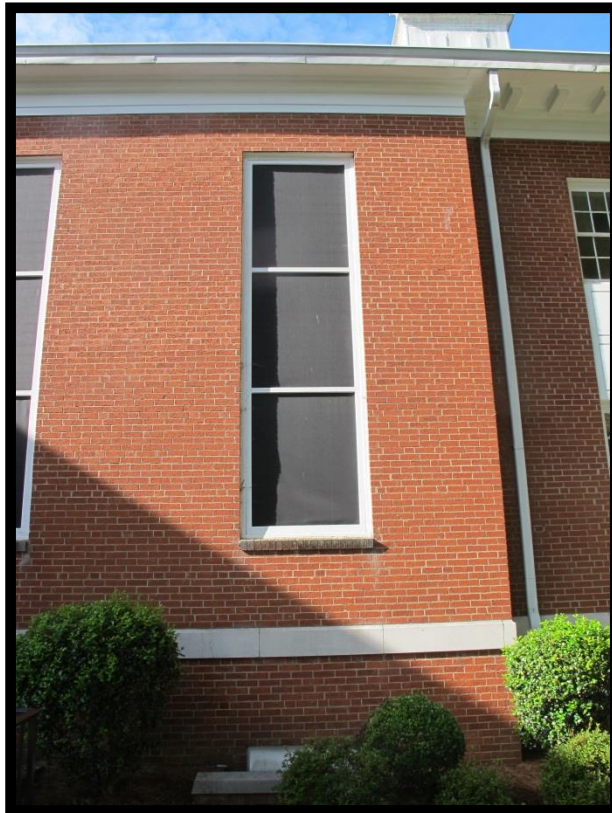
Figure 2.2-3: Detail of North Wall of Church (MK1342), Showing Window Screen and Water Table.

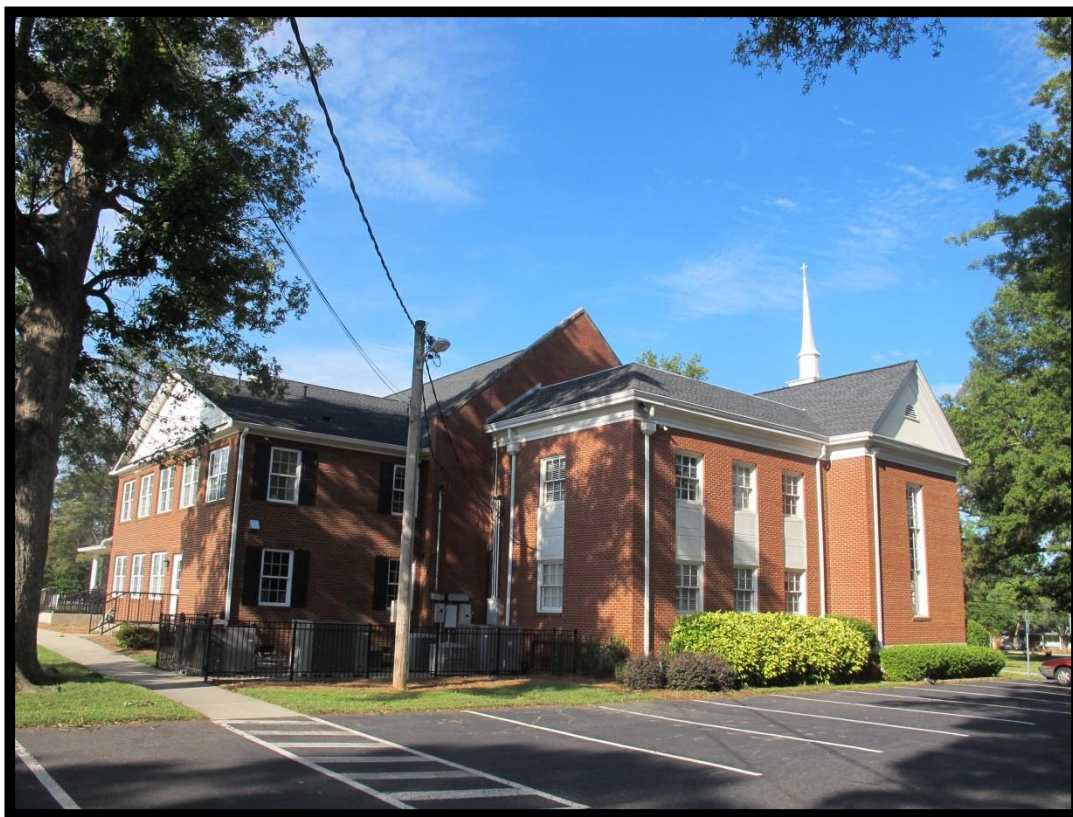
Figure 2.2-4: View of Church (MK1342), Showing First Addition to the Right and Second Addition to the Left, Looking Southwest.

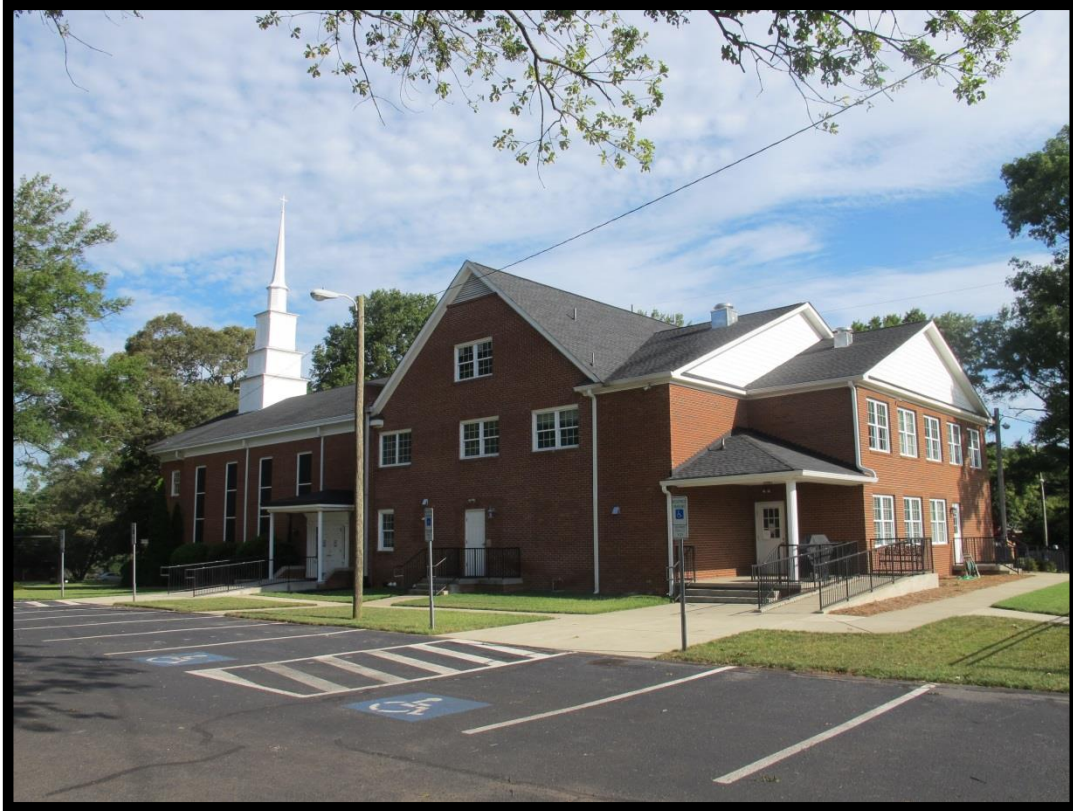
Figure 2.2-5: View of Church (MK1342), Showing Sunday School/Fellowship Hall at Center and Second Addition to the Left, Looking Northwest.

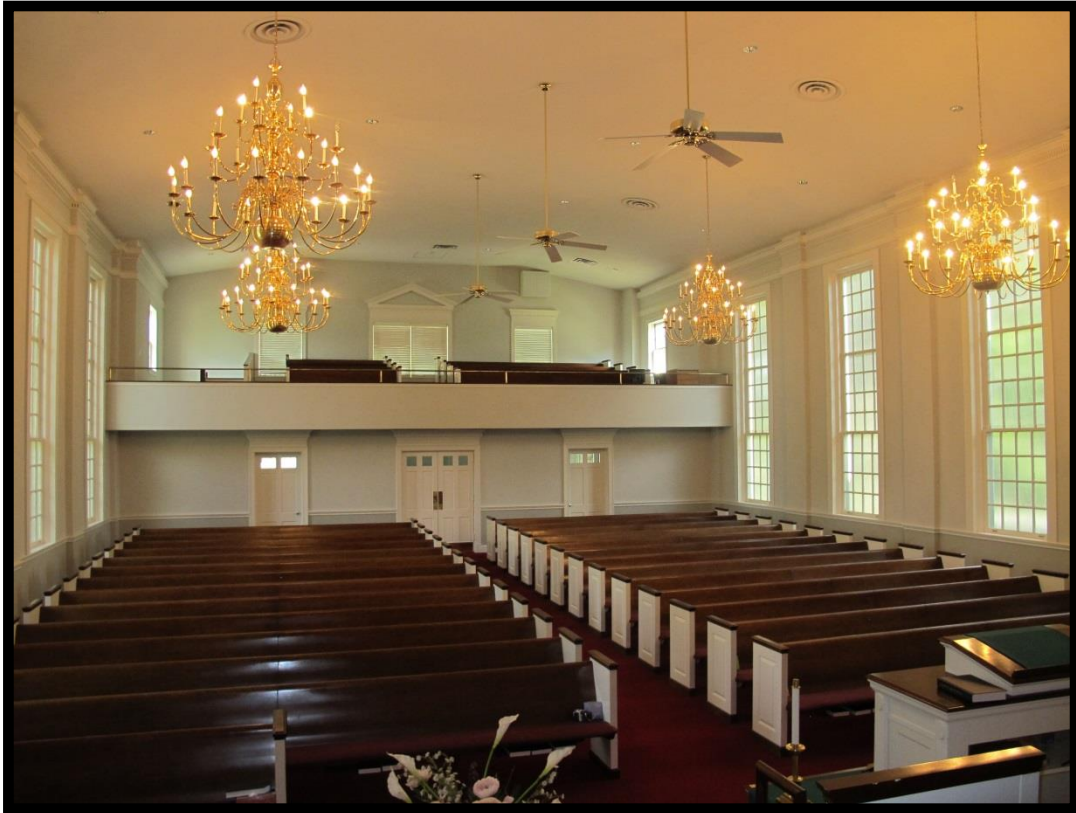
Figure 2.2-7: Church Interior (MK1342), View of Sanctuary Looking Northwest.

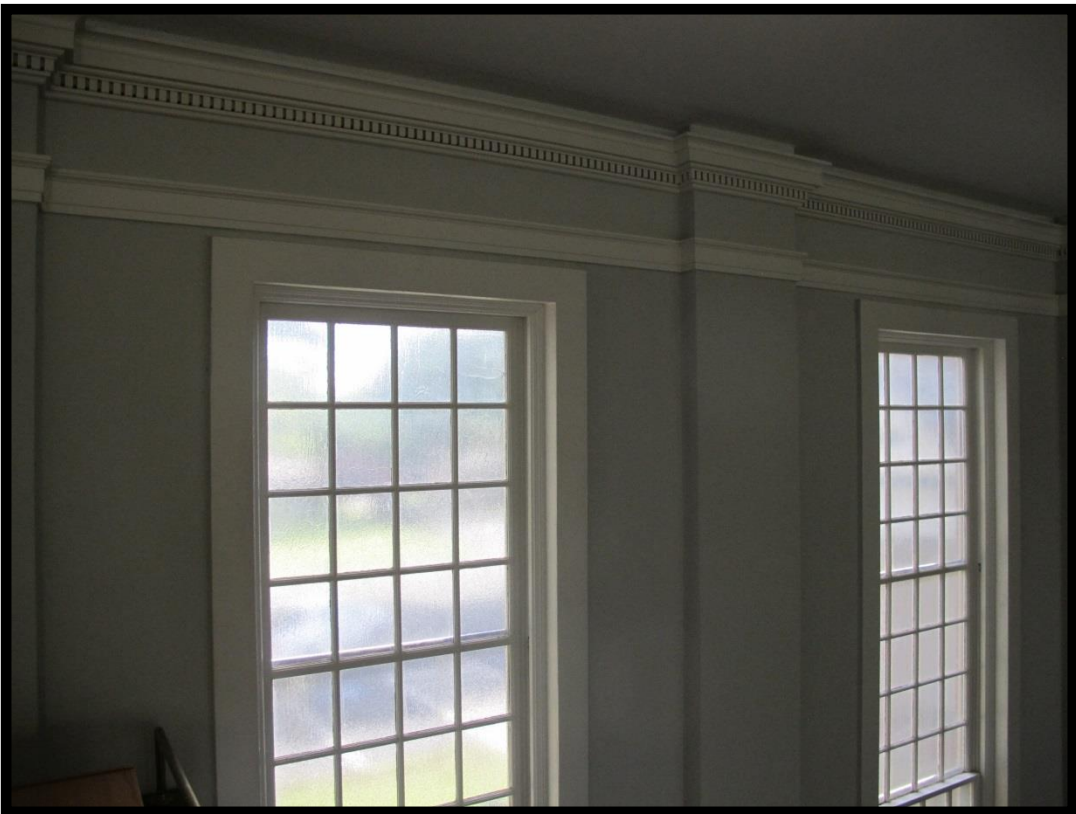
Figure 2.2-8: Church Interior (MK1342), Detail of Entablature on North Wall.

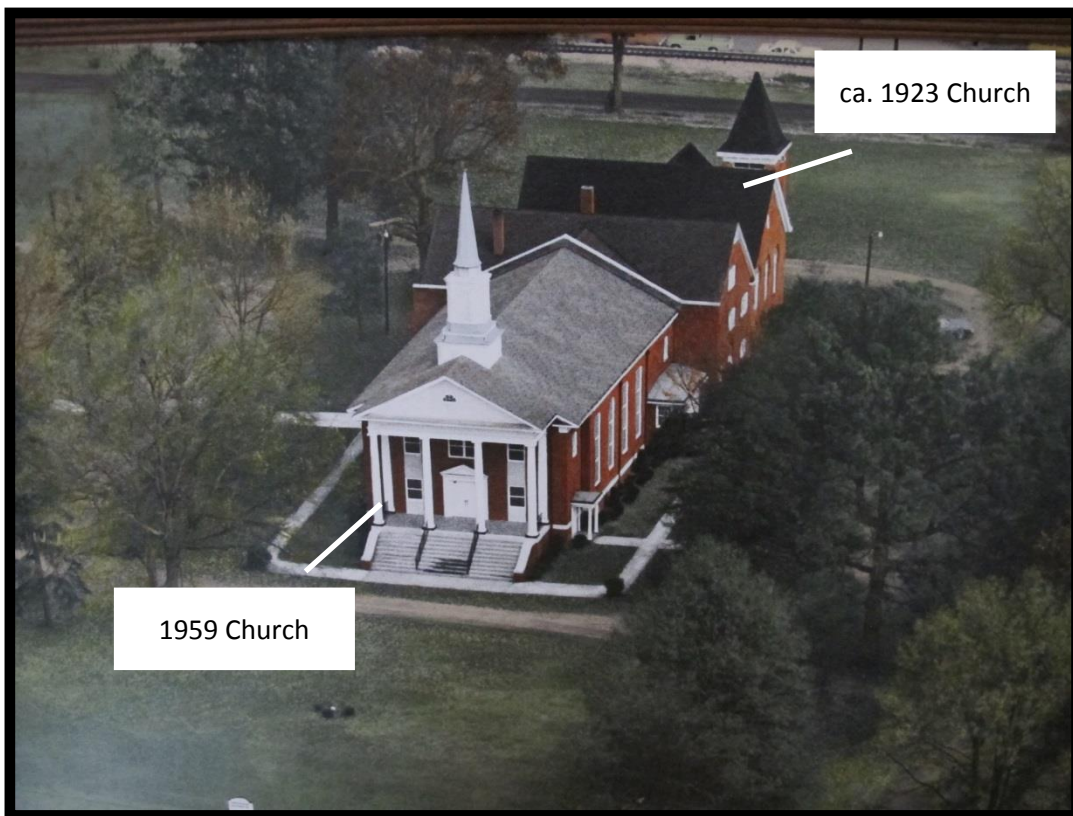
Historic Context: The land on which the church sits was conveyed to the trustees of the First Presbytery of the Associate Reformed Presbyterian Synod in 1873 by Robert Boston Hunter and his wife Rebecca W. Hunter (Mecklenburg County Register of Deeds, Charlotte, North Carolina, 1873: Deed Book 13:111). The Hunter family played an important role in the growth of Huntersville during the second half of the nineteenth century and the first half of the twentieth century. Huntersville was initially called Craighead, after Alexander Craighead, an at times controversial Presbyterian minister who had preached in Pennsylvania and Virginia before settling in Mecklenburg County, where he died in 1766 (Morgan 1979). Craighead was renamed Huntersville in 1873, after either Joseph Nicholas Hunter or his brother Robert Boston Hunter (Gray and Lunsford 2007). The Reverend Alexander Ranson established the first formal congregation of the Associate Reformed Presbyterian Church in Huntersville in 1875, of which Robert Boston Hunter was a member (Gray and Lunsford 2007). Around 1923 the congregation built a brick Gothic Revival-style church that stood to the east of the current church (Figures 2.2-11 and 2.2-12) (Mattson & Associates 2005). Aerial photographs suggest that by 1950 a separate Sunday school/fellowship hall was built to the west of the Gothic Revival church and connected via a hyphen (Figure 2.2-13). In 1959, trustees of the First Presbytery of the Associate Reformed Presbyterian Synod conveyed the property to trustees of the Huntersville Associate Reformed Presbyterian Church (Mecklenburg County Register of Deeds, Charlotte, North Carolina, 1959: Deed Book 2045:471). In 1959, a new sanctuary was completed against the west elevation of the Sunday school/fellowship hall (Figure 2.2-14; Heidi Reckard, personal communication 2016). Subsequently an addition was constructed to the north of the new sanctuary and the Sunday school/fellowship hall, and between 2006 and 2009 the Gothic Revival church was demolished (see Figure 2.2-12 and Figure 2.2-15). The last addition occurred between 2012 and 2013 (Figure 2.2-16).

Figure 2.2-12: Historic Aerial of Huntersville Associate Reformed Presbyterian Church (MK1342), Looking Northeast (n.d.).

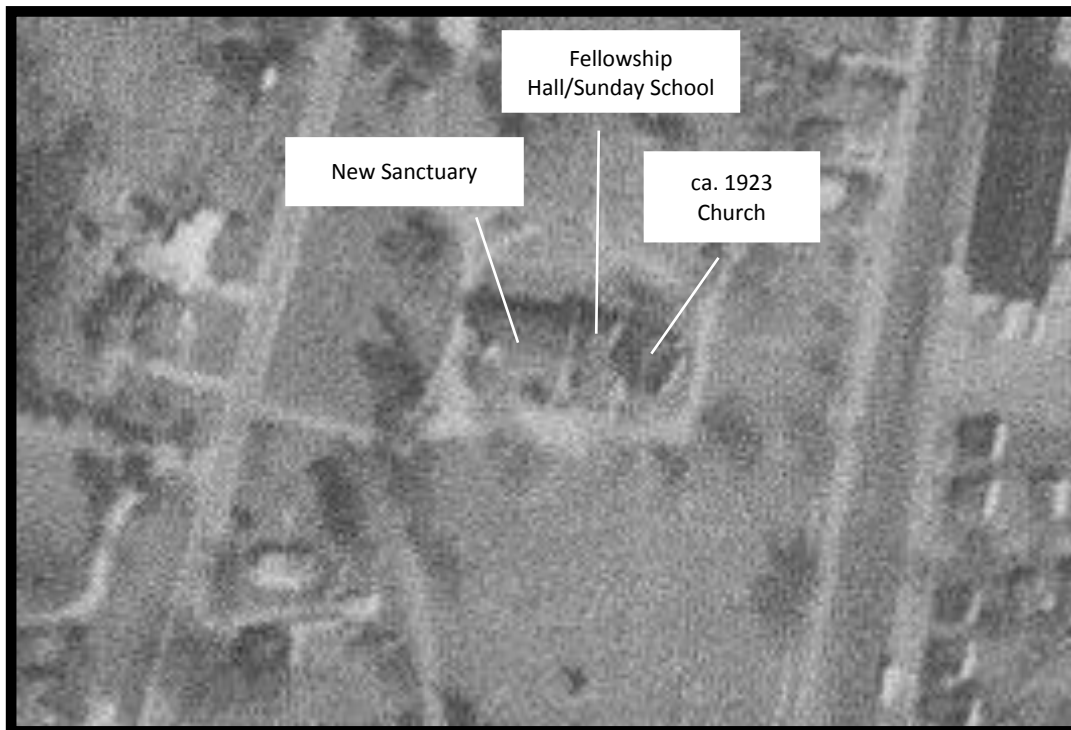
Figure 2.2-14: Detail of 1964 Aerial Showing the Huntersville Associate Reformed Presbyterian Church (MK1342) (EarthExplorer 2016b).

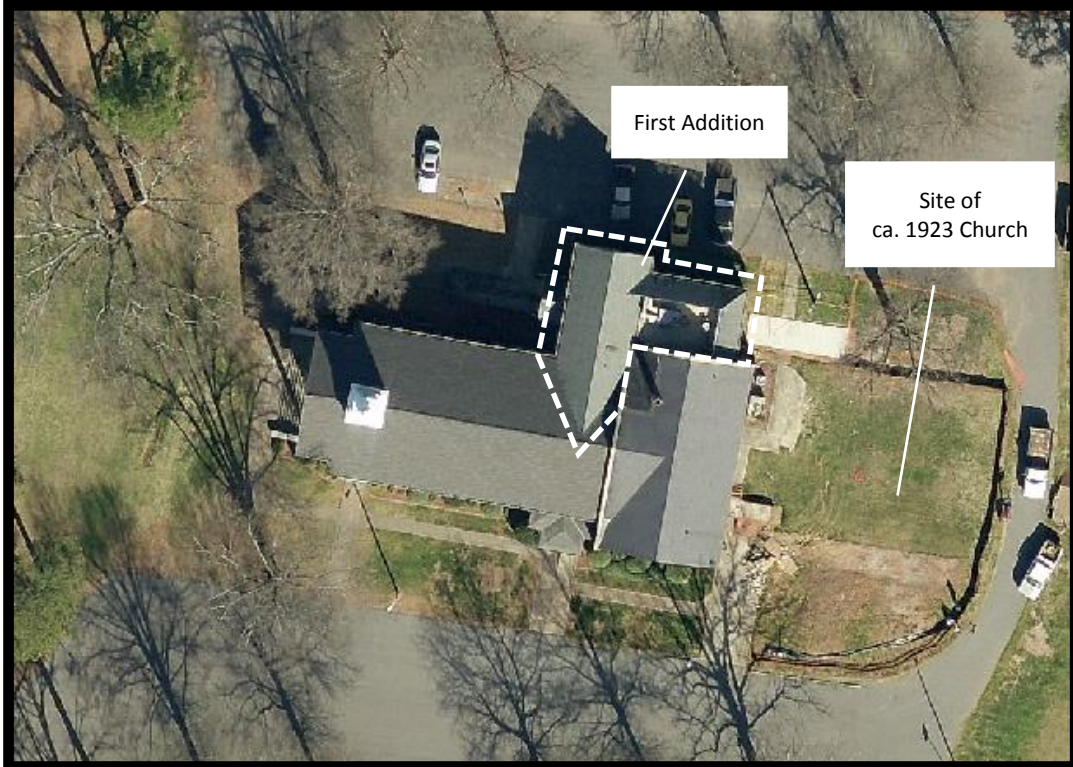
Figure 2.2-15: Detail of 2012 Aerial Showing the Huntersville Associate Reformed Presbyterian Church (MK1342) (Polaris 3G 2016).

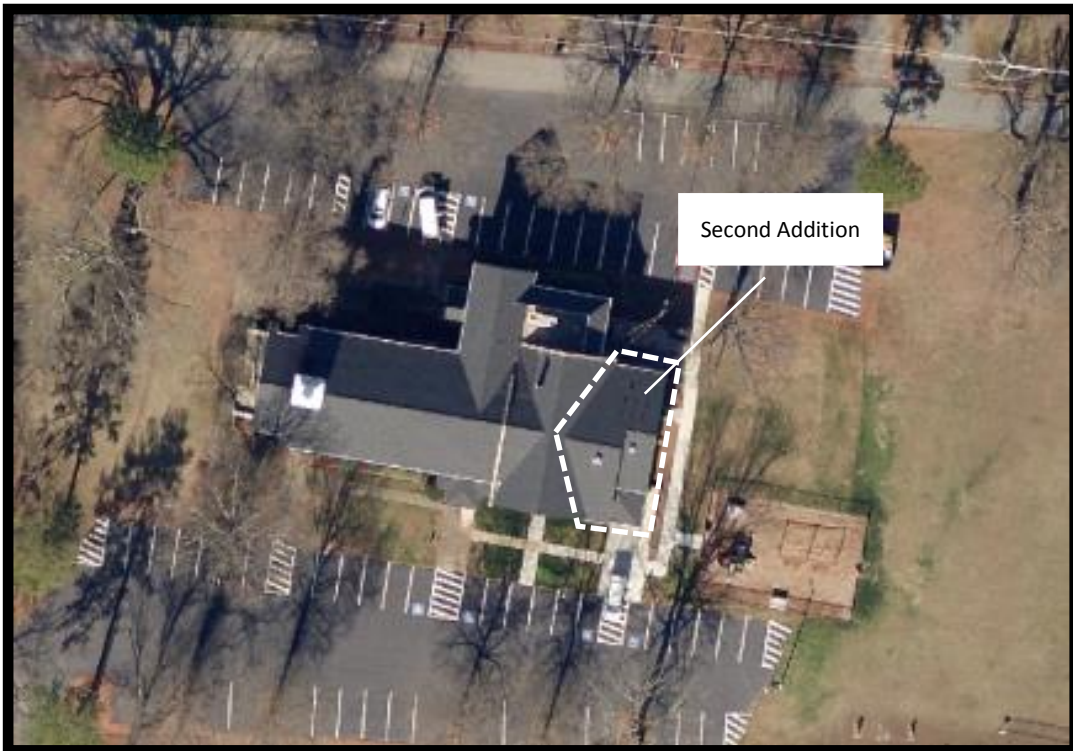
Figure 2.2-16: Detail of 2013 Aerial Showing the Huntersville Associate Reformed Presbyterian Church (MK1342) (Polaris 3G 2016).

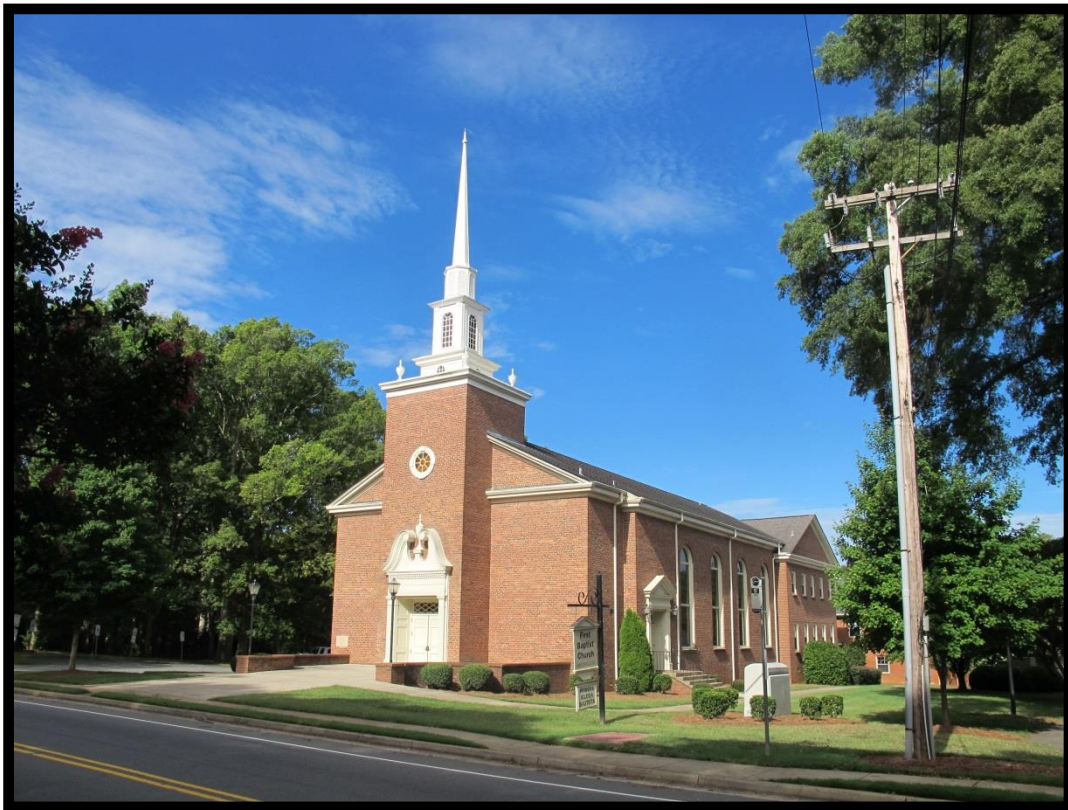
Figure 2.2-17: View of the Huntersville First Baptist Church of 1962, Looking Southwest.

Huntersville, and Mecklenburg County, appear to have been typical of the time and location, and several postwar Colonial Revival churches survive. A stone’s throw from the Huntersville Associate Reformed Presbyterian Church, on the west side of Old Statesville Road, stands the First Baptist Church of Huntersville, which dates to 1962. The church lacks the typical temple front, but has a projecting bell tower on the front gable end that boasts a grand broken swan-neck pediment with a large urn marking the main entrance. Tall round-arched windows light the sanctuary and the walls are clad in brick with four rows of stretchers separated by a row of alternating headers and stretchers (Figure 2.2-17). Other churches in Mecklenburg County combined Colonial and Gothic elements, such as the Hopewell Baptist Church near Davidson, which was built in 1948 (Figure 2.2-18). It has a modest temple-front portico and a small belfry, and pointed-arch windows with stone keystones and stone springer stones light the sanctuary. A more modest example of the Colonial Revival style is the brick Reeves Temple African Methodist Episcopal Zion Church in Davidson, which dates to 1965 (Figure 2.2-19). It has a bell tower on the front gable end and rectangular windows with opaque leaded glass light the sanctuary. Mount Zion United Methodist Church in Cornelius, which dates to 1954, is very similar to the Huntersville Associate Reformed Presbyterian Church in size although its detailing is more elaborate (Figure 2.2-20) (Mt. Zion United Methodist Church 2016). It has a five-bay front-gabled end, with a portico with colossal Tuscan columns sheltering the three bays in the middle. The double entry doors have a broken swan-neck pediment and keystones top the forty-over-twenty wooden sash windows that light the sanctuary. The walls are laid in five-over-one common bond brick with a stone, or concrete, water table, and steel-casement awning-windows light the basement level. The lowest tier of the belfry is clad in brick and has a railing with urns at the four corners. Another example of a postwar Colonial Revival church similar to the Huntersville Associate Reformed Presbyterian Church is the Back Creek Associate Reformed Presbyterian Church in Charlotte that dates to 1970 (Figure 2.2-21). It is a gable-front church with a projecting bell tower that contains the double entry door, which has a broken pediment with a large urn. A temple-front portico supported by colossal Temple of the Winds columns shelters the entry and the flanking window bays. Brick pilasters separate thirty-two-over-sixteen wooden sash windows that light the sanctuary. An unusual feature of the windows are the colored-panes of glass. The 1871 church (MK1255) survives to the southwest of the modern church and is connected via a brick arched walkway. Subsequent additions were constructed to the northeast of the 1970 sanctuary in 1982 and 1995 (BCARPC Profile 2016).
