**HISTORIC STRUCTURES SURVEY REPORT**

**Voice of America Transmitting Station Site A**

**Beaufort County, North Carolina**

**(ER 15-2838)**

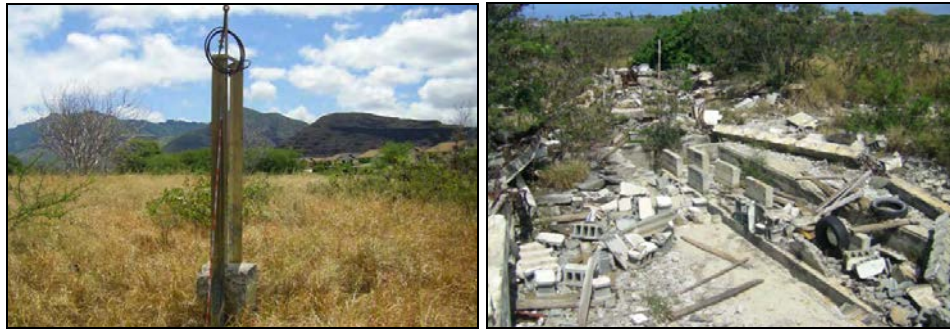
In addition to the three stations ultimately owned by the USIA, the VOA operated through various other, smaller facilities during and after World War II. During the war it broadcast from three additional high-frequency transmitting facilities on the East Coast. Two were in New Jersey—one in Bound Brook owned by NBC, the other in Wayne owned by CBS—and a third was owned by the General Electric Company in Schenectady, New York. It also supported construction of facilities at Lualualei, west of Honolulu, Hawaii, and on Saipan in the Northern Mariana Islands (Dail 2015:55-56). The Lualualei antenna foundation system at the VOA facility (Site 50-80-08-7081) was recommended as NRHP-eligible in 2009; the ruinous transmitting station was not (Reith 2009:40) (Figure 5).

**Figure 5. Lualualei antenna foundation system and ruinous station (source: Reith 2009)**

The VOA Lualualei antenna system, west of Honolulu, Hawaii, was recommended as NRHP-eligible in 2009. The ruinous transmitting station with which it was associated was not (Reith 2009:40) (Figure 5, above).

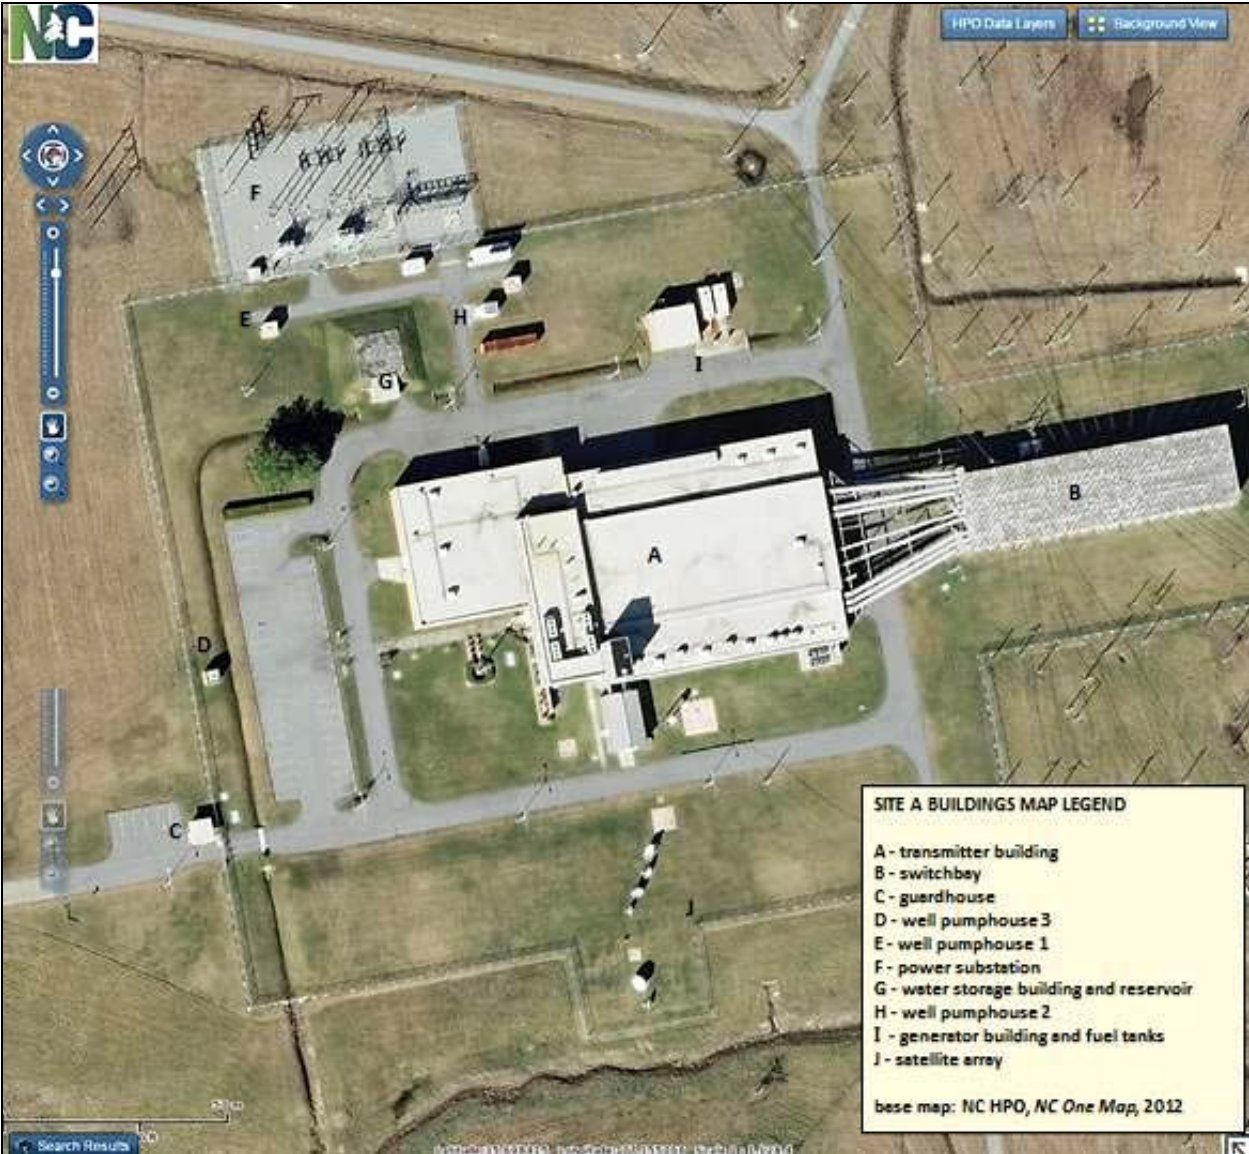
**Figure 12. Site A resources map**

Ten principal resources are located at Site A: the transmitter building [A on Figure 12], switchbay [B], guardhouse [C], well pumphouses 1, 2 and 3 [D, E and H], power substation [F], water storage building and reservoir [G], generator building and fuel tank [I], and satellite array or antenna field [J]. Extensive exterior images of the resources at Site A and interior images of the resources at Site B are included in the photographic recordation submission. Therefore, where possible historic images are included below, as the recordation submission provides a modern photographic record.

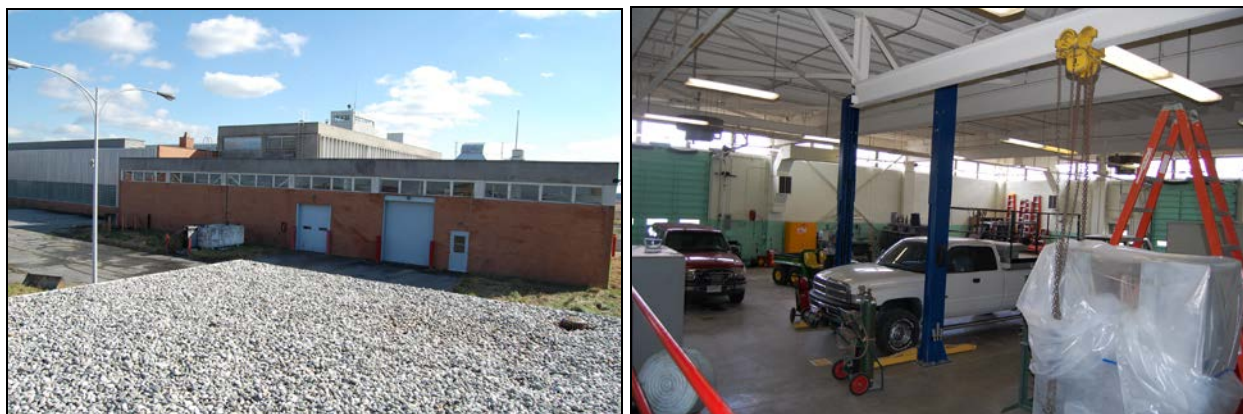
tops of the two elevations, providing natural light to the hands-on working rooms. A band of limestone panels above the windows at the roofline is its sole aesthetic treatment (Figure 15 and Figure 16).

**Figure 16. North elevation of one-story block (Site A), at left, and interior of garage with high banded windows (Site B), at right**

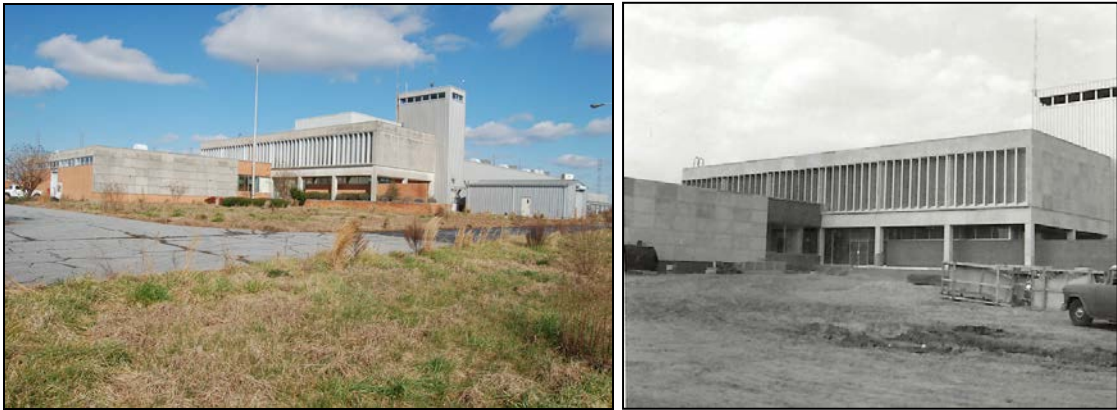
The building's public spaces—a lobby, a former library now used as an office, two small bathrooms, and associated spaces—are nestled in the front block's southwest corner (Figure 13, bottom left). The prominence of these spaces is evidenced by their location and relatively elaborate exterior finish (Figure 17 through Figure 20). A floating stair climbs up to the lobby doors, which are flanked by recessed brick walls pierced by plate-glass windows. The lobby is positioned facing the site's entry drive. A long second-story that is cantilevered over this portion of the building is carefully finished. Its side walls are sheathed in limestone panels and its west front wall is punctuated by vertical aluminum "fins," as construction photographs call them. Behind the fins are walls of louvers that expose the prosaic function of the upper story, which holds only mechanical equipment.

Figure 17. West front and south side elevations of transmitter building, at left, and same view of April 18, 1962 (both site A) (source: VOA progress photographs file)

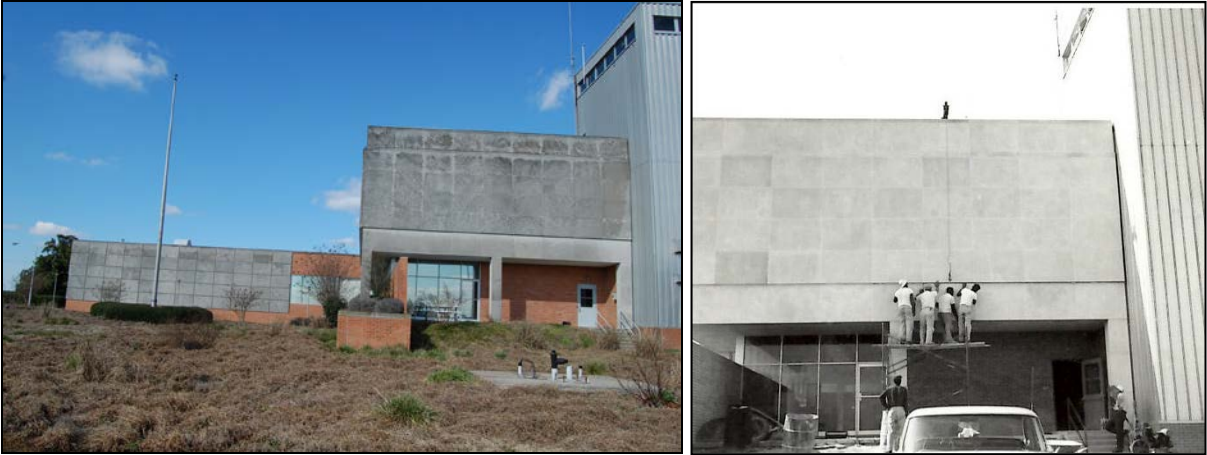
Figure 18. South side elevation of transmitter building, at left, and similar view of May 31, 1962, showing replacement of storm-damaged facing stone (both Site A) (source: VOA progress photographs file)

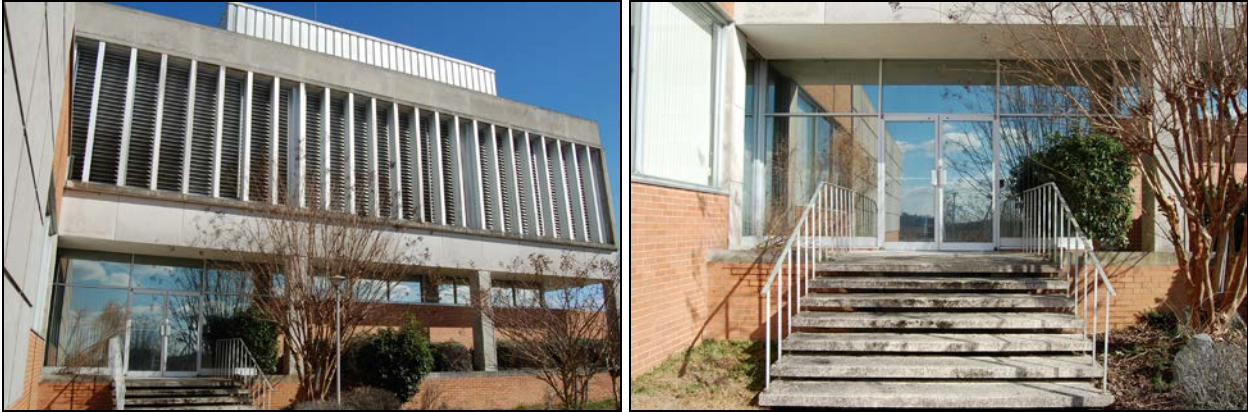
Figure 19. East front elevation of transmitter building with aluminum fins at cantilevered upper story, at left, and floating stair and lobby, at right (both Site A)

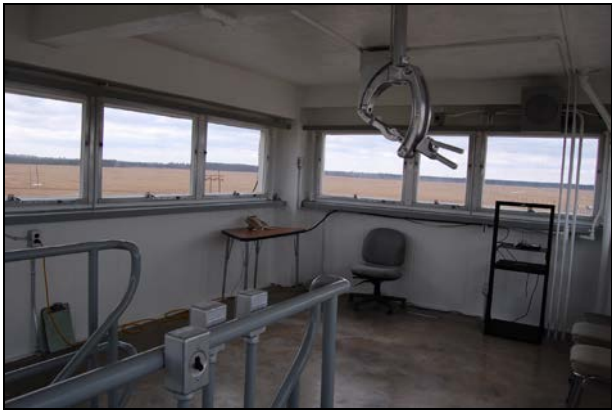
The south side elevation of the rear section holds a tall rectangular observation tower at its west front. Aluminum panels stripe the tower and bands of windows extend across the top of its four elevations (Figure 21). The observation room holds a concrete floor, wire-strengthened windows, and a grip for directing the searchlight that still remains on the roof (Figure 22). Observation was required to spot mechanical and electrical problems out in the antenna field, as well as any fires.

**Figure 22. Tower observation room with hanging grip for searchlight (Site B )**

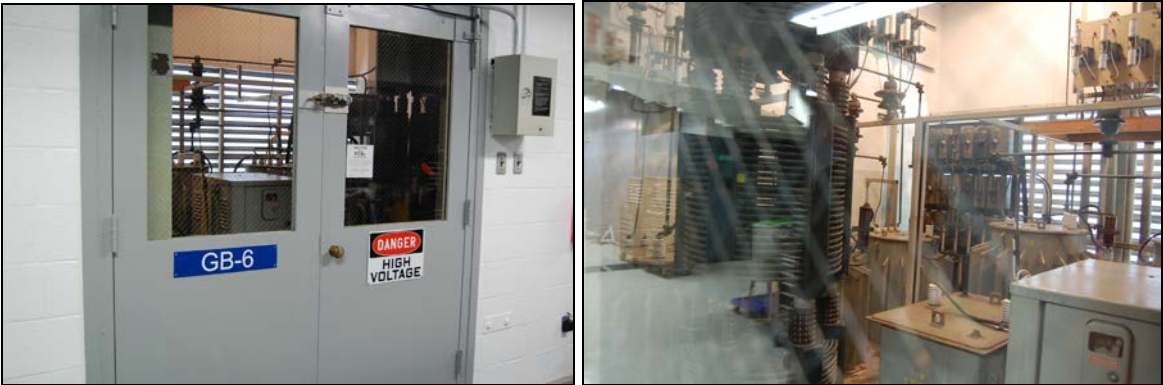
**Figure 23. Transformer power vaults along south side of building; note louvered ventilators (Site B)**

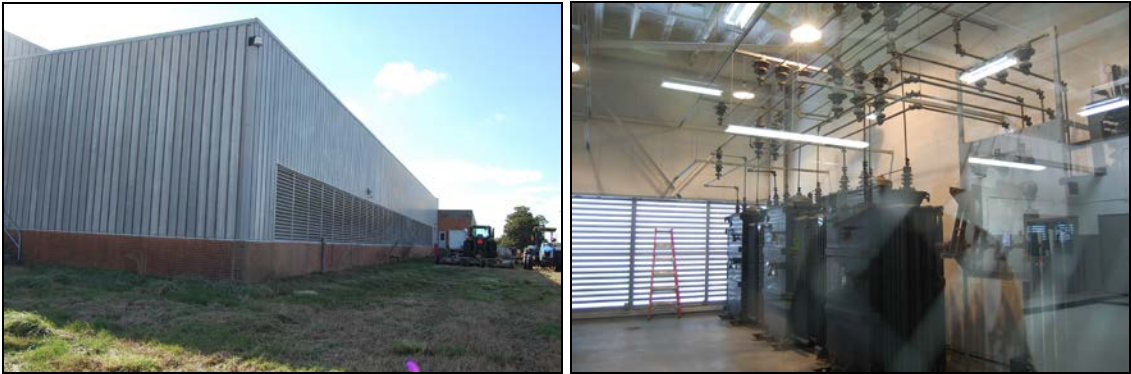
**Figure 24. Louvered north side of building (Site A), at left, and transformer power vaults with louvers opening to north (Site B), at right**

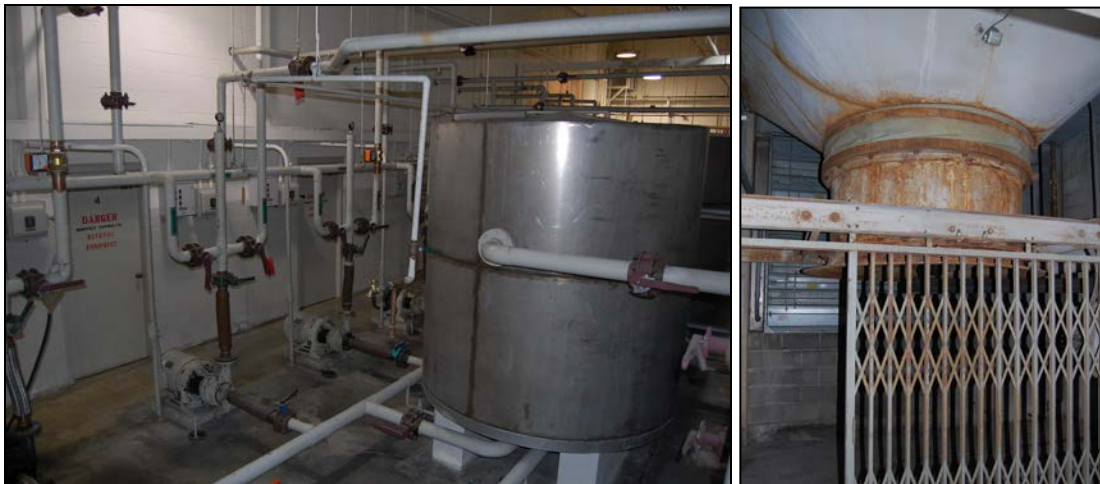
**Figure 25. Tank and pump room on north side of building, at left, with doors leading to fan rooms; fan room and fan with louvers at exterior wall, at right (both Site B)**

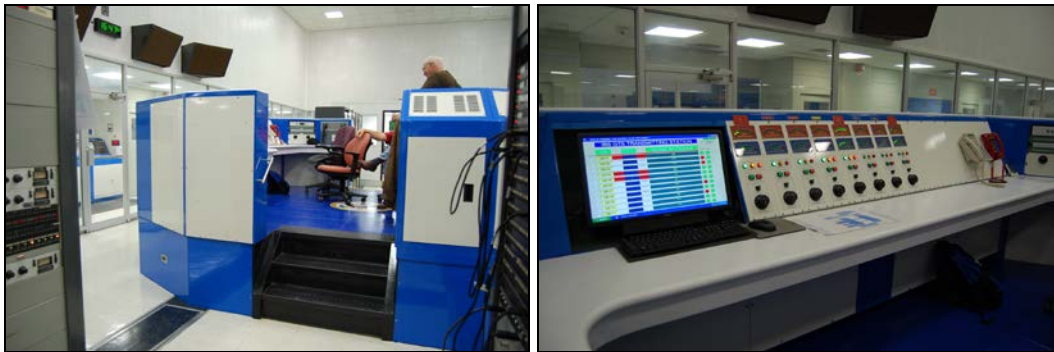
Hidden from outside view are the rooms at the center of the building's rear section. These include the control room, an office, and the north and south transmitter halls. A platform in the control room lifts the control dais and its console a few steps above floor level. This affords those working at the console views of switching equipment to the west and, through glass partition walls, a clear sightline to the transmitters and associated equipment in the north and south transmitter halls (Figure 26 and Figure 27).

**Figure 27. At left, looking east past switching equipment to control dais; at right, main console beyond which is the north transmitter hall (both Site B)**

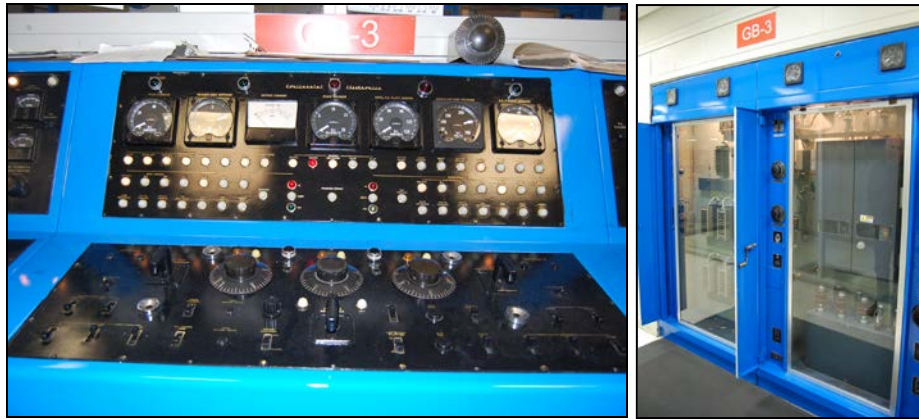
**Figure 30. South transmittal hall, console for 250kW transmitter, at left, and the transmitter, at right (both Site B)**

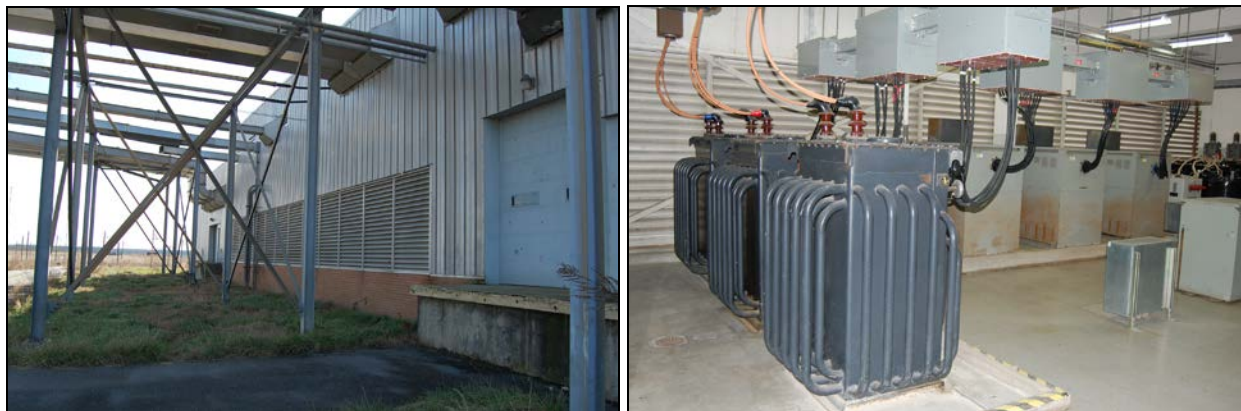
The east rear elevation of the back section of the transmitter building is also raised on a brick foundation, sided with vertical aluminum panels, pierced by aluminum louvers and plainly fitted out. The louvers provide ventilation for the power distribution room at the building's rear (Figure 29 and Figure 31).

**Figure 31. East rear elevation of transmitter building with ground-level louvers (Site A), at left, that ventilate the power distribution room (Site B), at right**

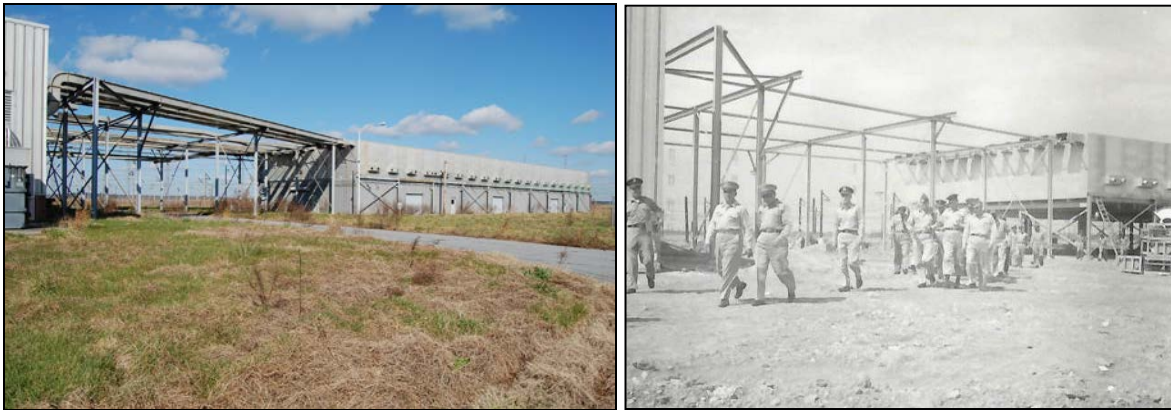
To the east rear of the transmitter building stands the switchbay building (Figure 32 and Figure 33). Freestanding, it is nonetheless closely connected by numerous input conduits, supported by X-braces, which run between the two buildings. The switchbay is a one-room metal shell, about 75' wide and 150' deep, with a dirt floor and elevated conduits. The inputs from the transmitter building are separated in the switchbay and fed out by lines to the antenna field.

**Figure 32. South side and west front elevations of switchbay connected to east rear of transmitter building by input conduits; same view, at right, including visitors from Fort Bragg War College, April 28, 1962 (both Site A) (source: VOA progress photographs file)**

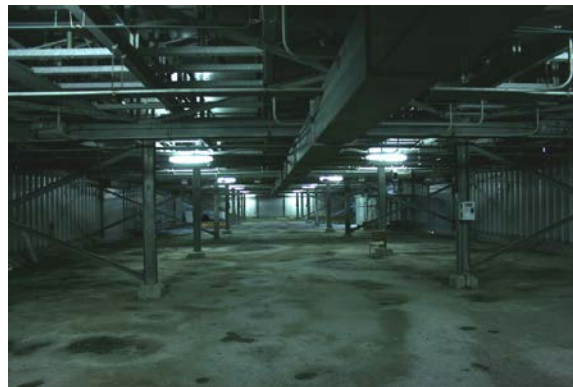
**Figure 33. Interior of switchbay in 2012 showing dirt floor, metal walls, and elevated conduits (Site B) (source: Witherspoon 2012)**

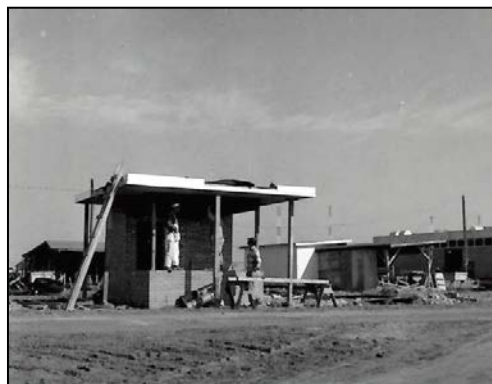
The guardhouse is a small-scale Modernist building. An unadorned box, it has a brick foundation and walls, expanses of plate glass, exposed aluminum cladding, and a widely overhanging, flat roof (Figure 34 and Figure 35).

**Figure 34. Site A guardhouse under construction, February 20, 1962 (source: VOA progress photographs file)**

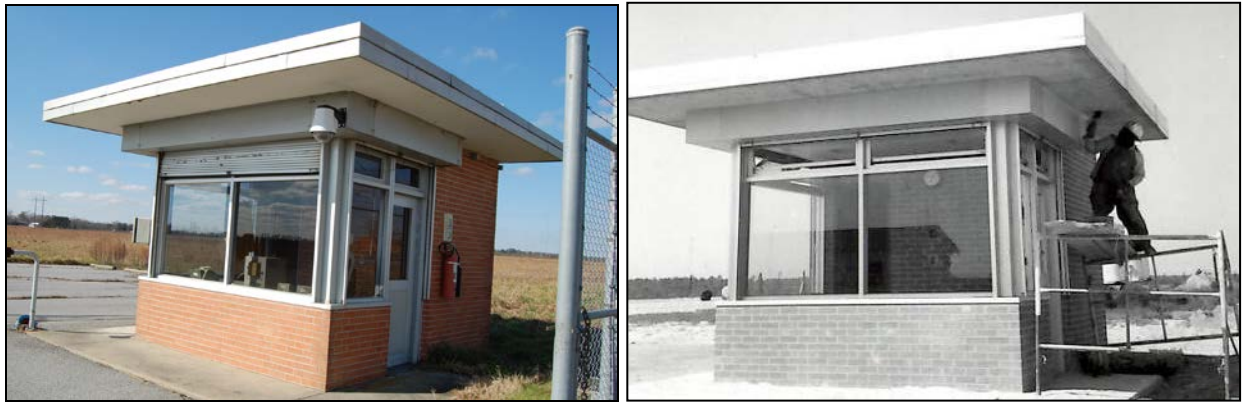
**Figure 35. Looking northwest at guardhouse, at left, and building nearing completion, September 12, 1962, at right (both Site A) (source: VOA progress photographs file)**

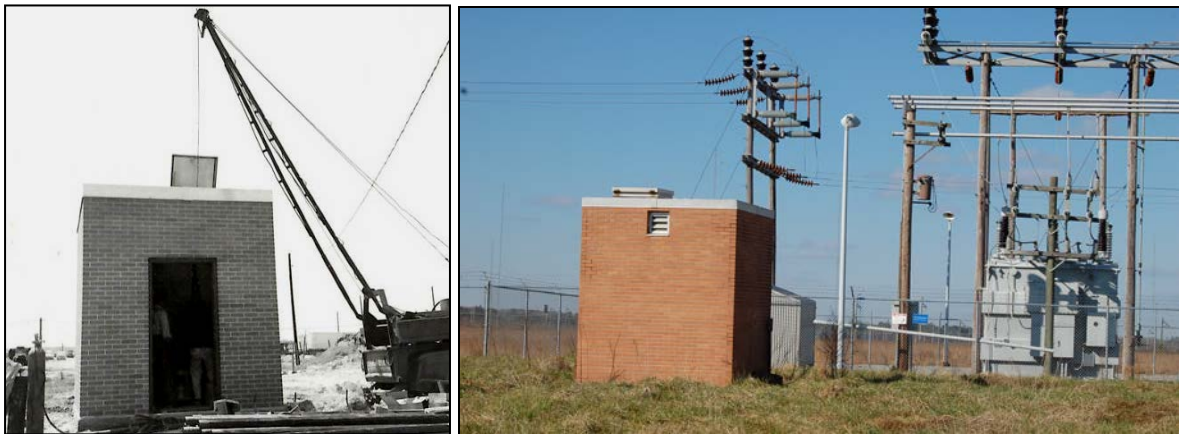
The three pumphouses are square, brick-veneered, concrete-block boxes. Aluminum coping edges their flat roofs, which are pierced by an aluminum hatch. One door opens into each; one square louver at the top of the wall opposite the door ventilates them (Figure 36 and Figure 37).

**Figure 36. Installing well pumphouse 1, May 15, 1962 (source: VOA progress photographs file), at left; well pumphouse 1 and power substation, at right (both Site A)**

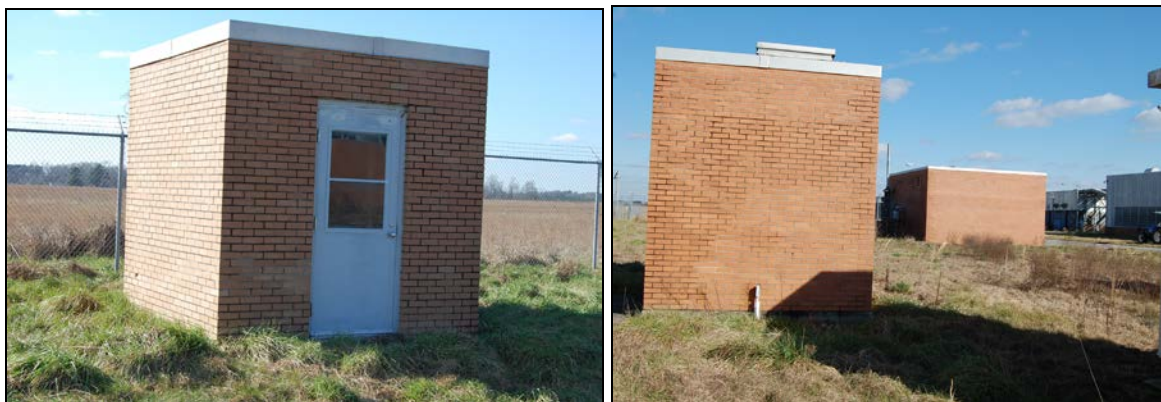
**Figure 37. At left, well pumphouse 3; at right (from left to right), well pumphouse 2, generator building, and switchbay and transmitter building (both Site A)**

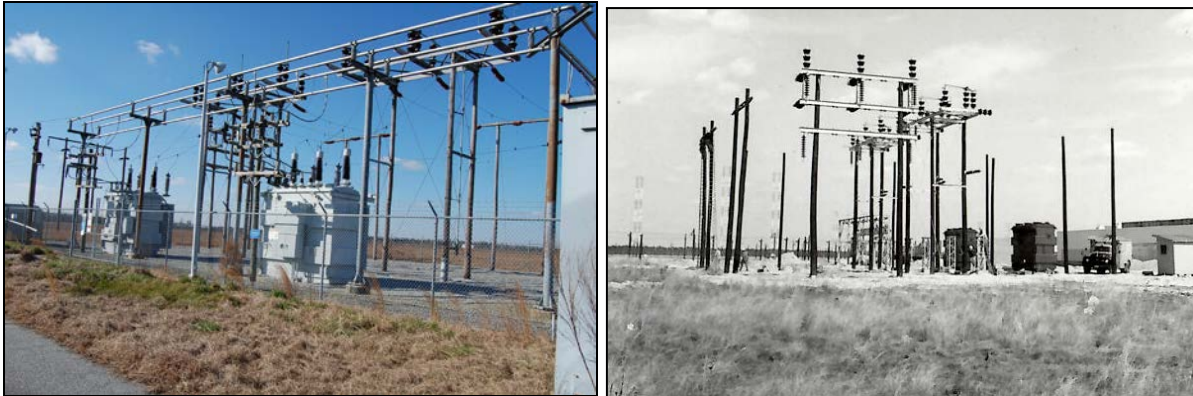
**Figure 38. Electrical power transformers, insulators, bus bars, lines, and other components at outdoor power substation, at left; substation construction, April 16, 1962 (both Site A)**

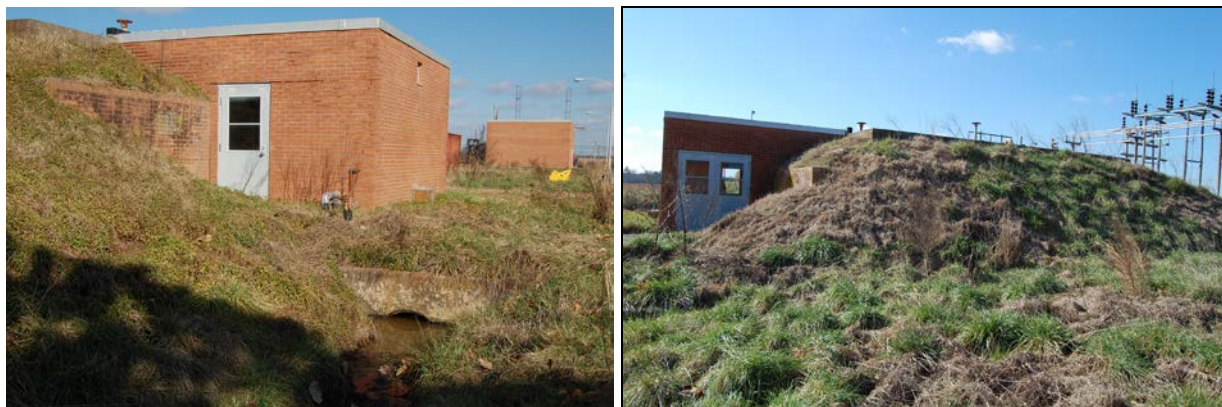
The water storage building matches the well pumphouses in design. It has brick-veneered walls and a flat roof edged by aluminum coping. Inside it has raw concrete-block walls, a concrete floor, a drinking water storage tank, and pumps. The connected concrete reservoir is largely hidden by the man-made bank into which it is built (Figure 39 and Figure 40).

**Figure 39. At left, looking northeast (from left to right) at brick retaining wall of reservoir, water storage building, and generator building; at right, looking west at generator building and reservoir set in man-made bank (both Site A)**

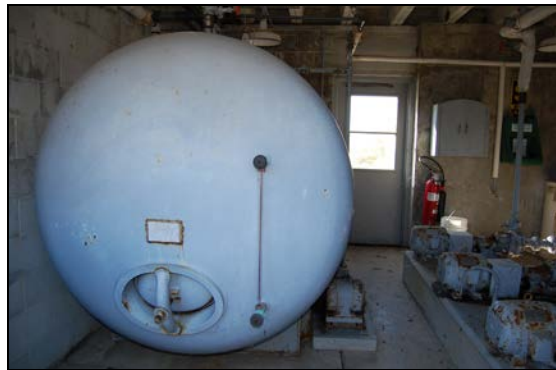
**Figure 40. Water tank and, at right, pumps in water storage building (Site A)**

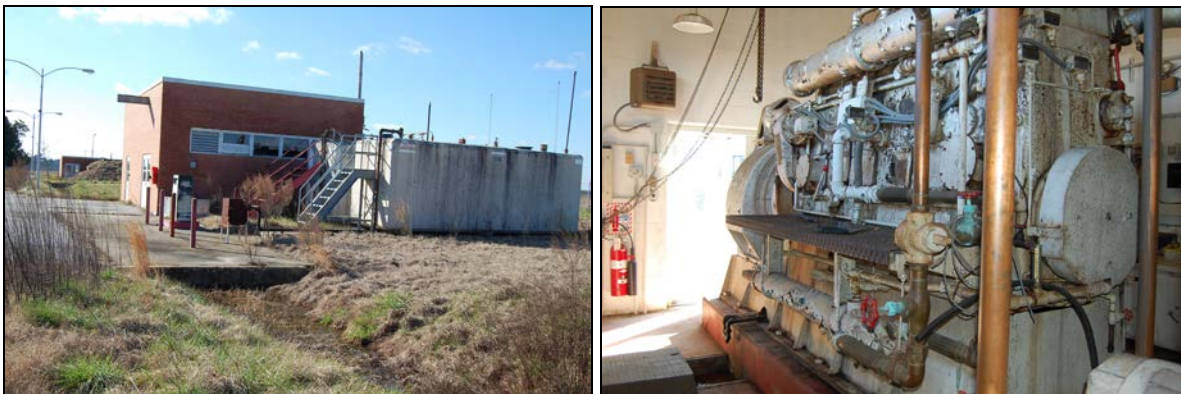
**Figure 41. At left, brick generator building and concrete fuel tank; at right, original Chicago Pneumatic Tool Company generator in building**

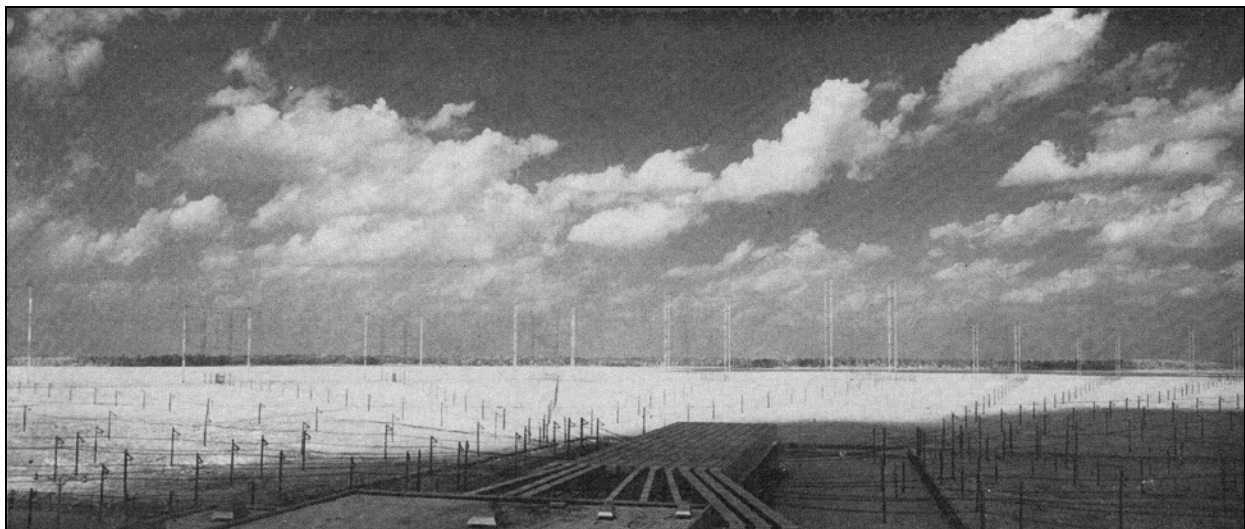
**Figure 43. Site A antenna field with transmission building and switchbay in foreground (source: Rhine 1968:53)**

Each broadcast for the transmissions the antennae made travelled a long route before reaching them out in the antenna field. The broadcast was recorded in Washington, transmitted to VOA Site C just outside of Greenville, then transmitted to Site A or B. At one of those sites the broadcast passed from the transmission building to the switchbay and then finally out to the antennae via transmission line poles (Figure 42 and Figure 43).

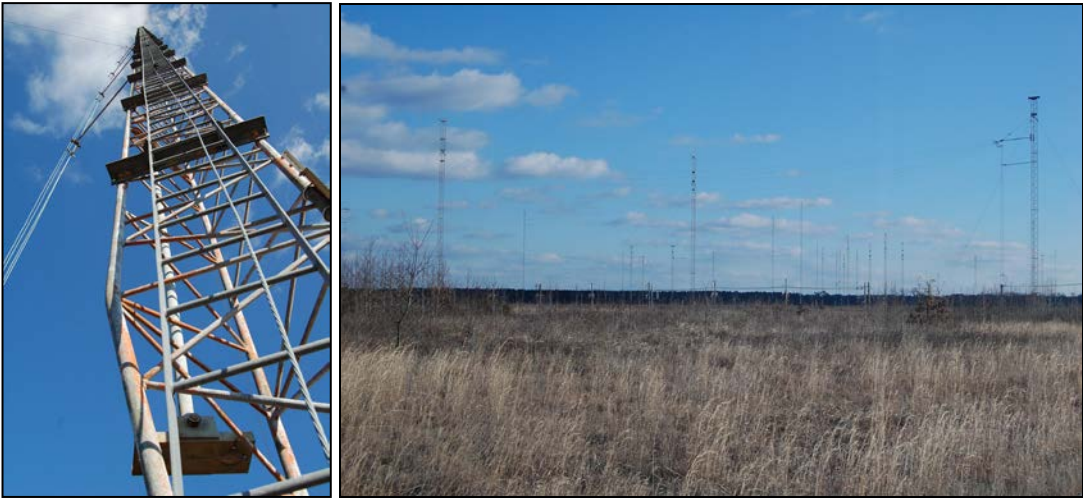
Figure 46. One of the towers of rhombic antenna A-01, at left; field of rhombic antennae along southern section of main service road south of antenna A-17, at right

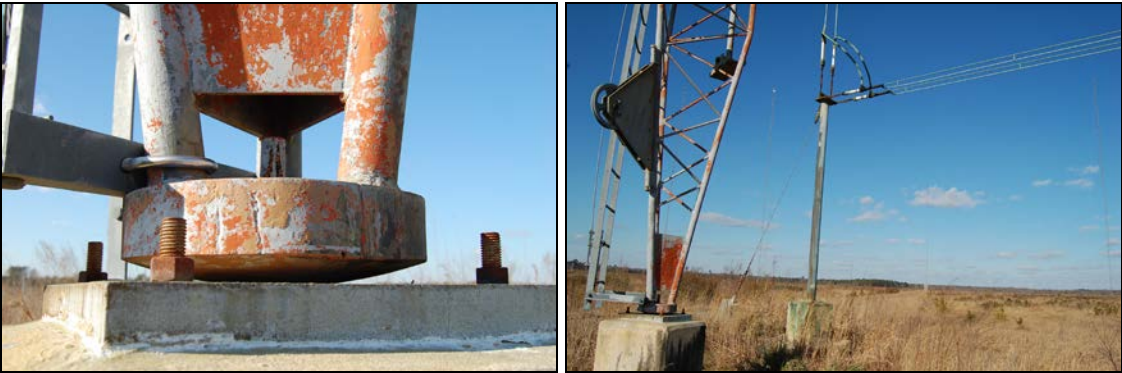
Figure 47. At left, base plate of one tower of rhombic antenna A-01 on anchor pier (note that tower is not affixed to ground); at right, concrete anchor pier and metal base plate of antenna A-01 with pulley for hauling parts

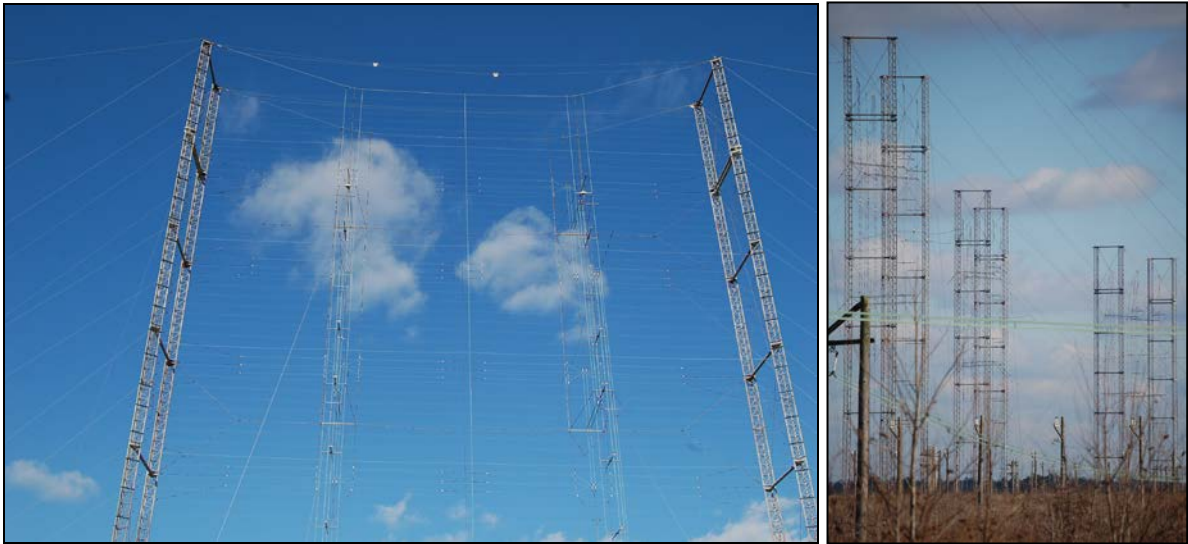
**Figure 49. Curtain antenna A-02 with “curtain” of antenna suspended between pair of towers, at left; multiple curtain antennae southeast of antenna A-02, at right**

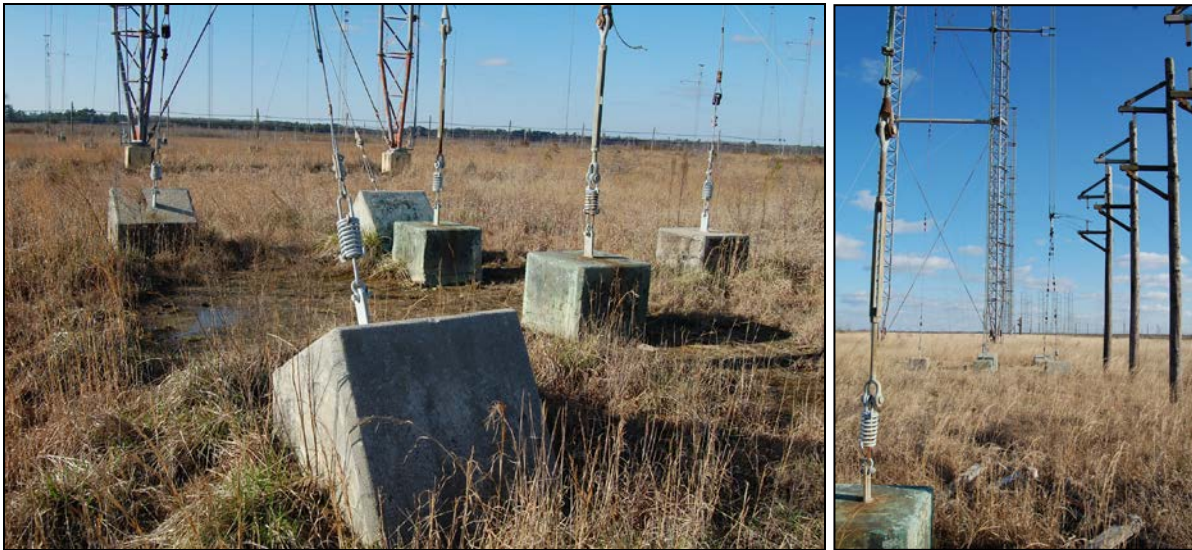
**Figure 50. Curtain antenna A-02 anchor piers and guy wires**

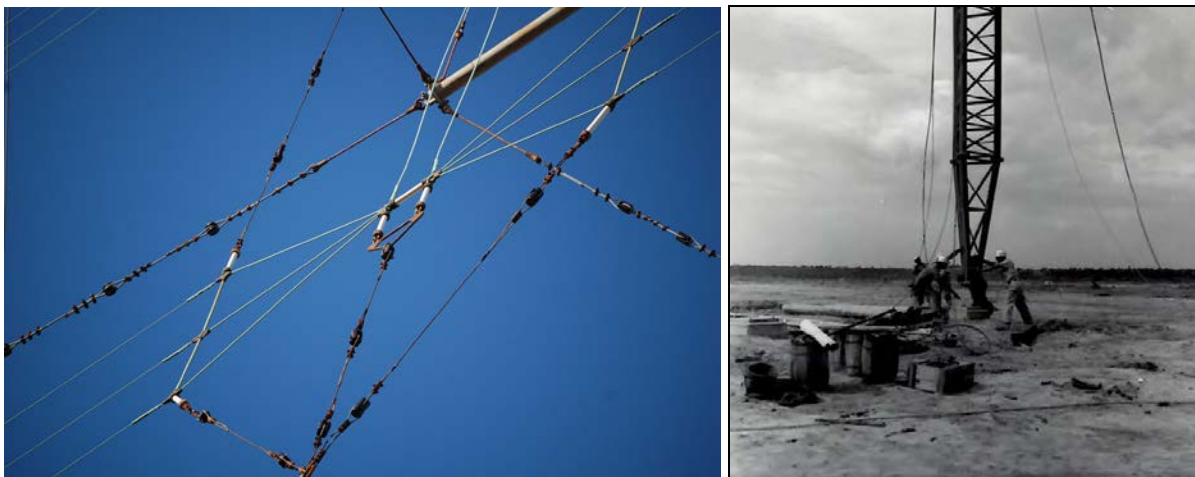
**Figure 51. Multi-wire, bowtie-like dipoles suspended between towers at curtain antenna A-02, at left; curtain antenna A-07 being set on base plate, September 13, 1961, at right (both Site A) (source: VOA progress photographs file)**

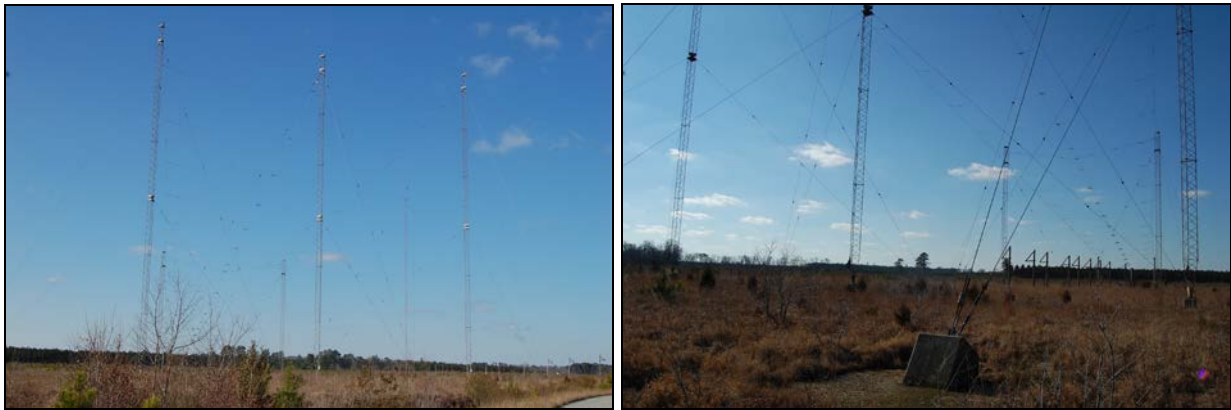
**Figure 52. Log periodic antenna A-37 with, at left, all six support towers visible, three in foreground and three in distance (Site A)**

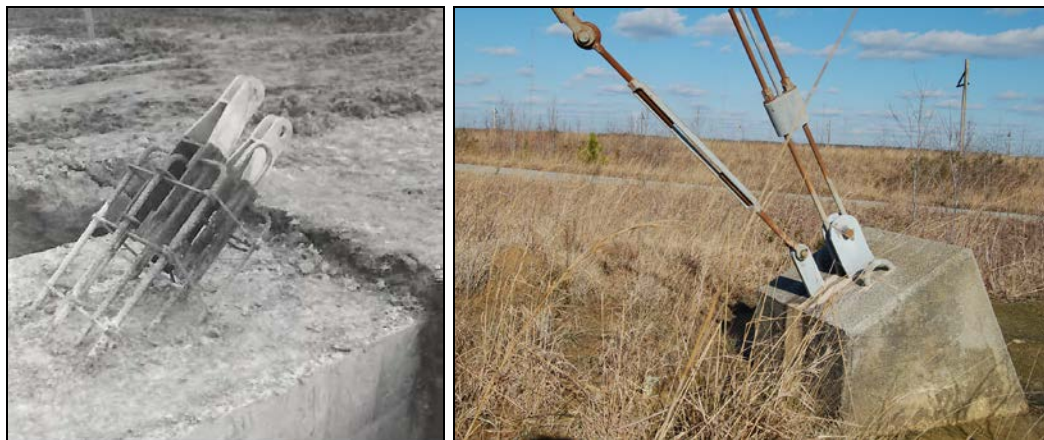
**Figure 53. Curtain antenna H-4 (old numbering system) anchor, April 15, 1961, at left (source: VOA progress photographs file); anchor pier at log periodic antenna A-37, at right (both Site A)**

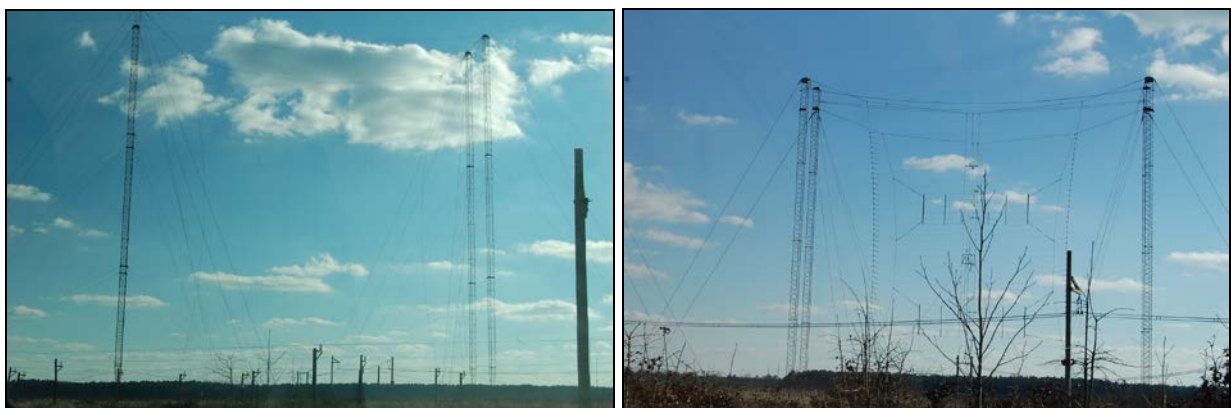
**Figure 54. Dipole antenna AD-12B, at left, and dipole antenna AD-37, at right (both Site A)**

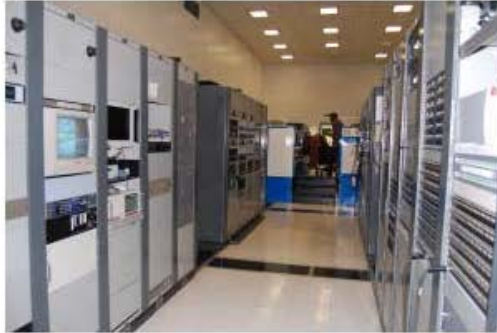
PT1726\_Murrow VOA Station\_2-16\_MAB-32.JPG

PT1726_Murrow VOA Station_2-16_MAB-32.pdf	Control room, looking E toward control dais with switching equipment at right
PT1726_Murrow VOA Station_2-16_MAB-33.pdf	Control room, switching panel with original components at bottom and replacement switches at top
PT1726_Murrow VOA Station_2-16_MAB-34.pdf	Control room, looking NE at modern main transmitter control console on control dais
PT1726_Murrow VOA Station_2-16_MAB-35.pdf	Control room, looking NE at control dais
PT1726_Murrow VOA Station_2-16_MAB-36.pdf	Control room, looking W at monitor and synthesizer racks and control dais
PT1726_Murrow VOA Station_2-16_MAB-37.pdf	South transmitter hall, looking SW at control panel of 250kw General Electric transmitter (GB-4)
PT1726_Murrow VOA Station_2-16_MAB-38.pdf	South transmitter hall, tuning coil inside 250kw General Electric transmitter (GB-6)
PT1726_Murrow VOA Station_2-16_MAB-39.pdf	South transmitter hall, back side of control panel inside transmitter GB-6
