SUBJECT: Grade, Drain, Base, & Pave SR 1527, Helton Road from End of Existing Pavement  
to the Intersection of SR 1528, Little Helton Road, PA 15-04-0032, Ashe County,  
ER 16-0009

**SUBJECT:** Historic Structures Survey Report for Grade, Drain, Base and Pave SR 1527 from  
End of Existing Pavement to SR 1528, PA 15-04-0032, Ashe County, ER 16-0009

HISTORIC ARCHITECTURAL ANALYSIS OF  
THE POINDEXTER BLEVINS HOUSE (AH 470),  
ASHE COUNTY

Grade, Drain, Base and Pave SR 1527 (Helton Road) from  
End of Existing Pavement to the Intersection of  
SR 1528 (Little Helton Road)  
Ashe County, North Carolina  
WBS No. 11C.005079

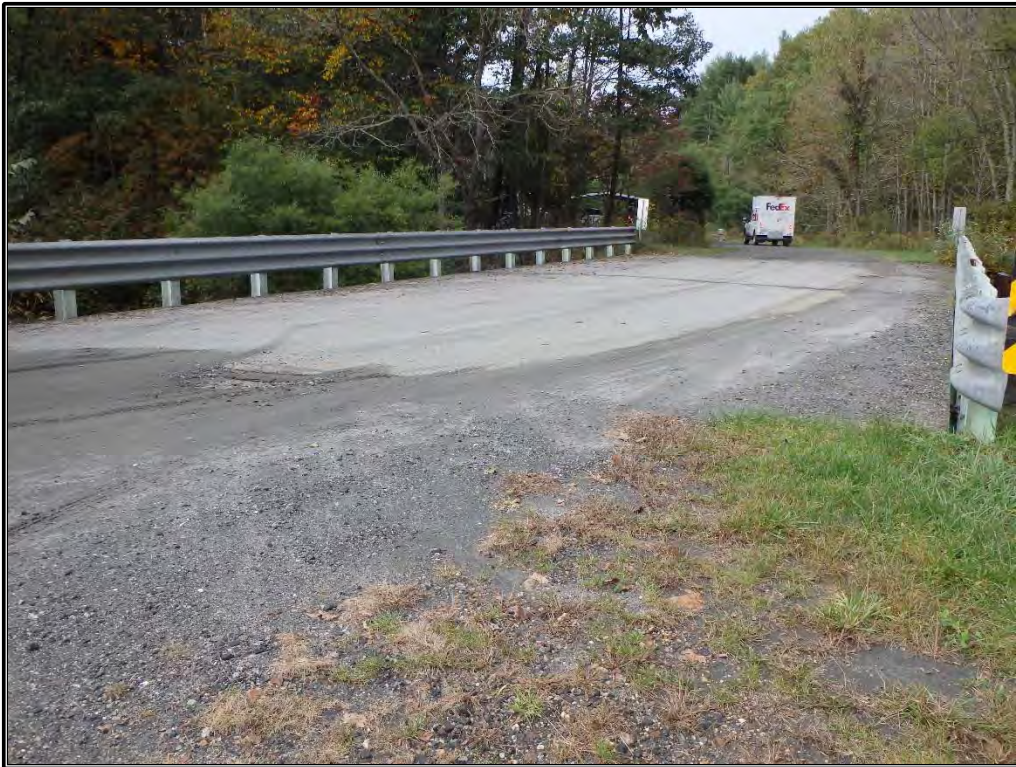
Figure 8. Overview of Bridge No. 288 over Helton Creek, facing west-northwest.

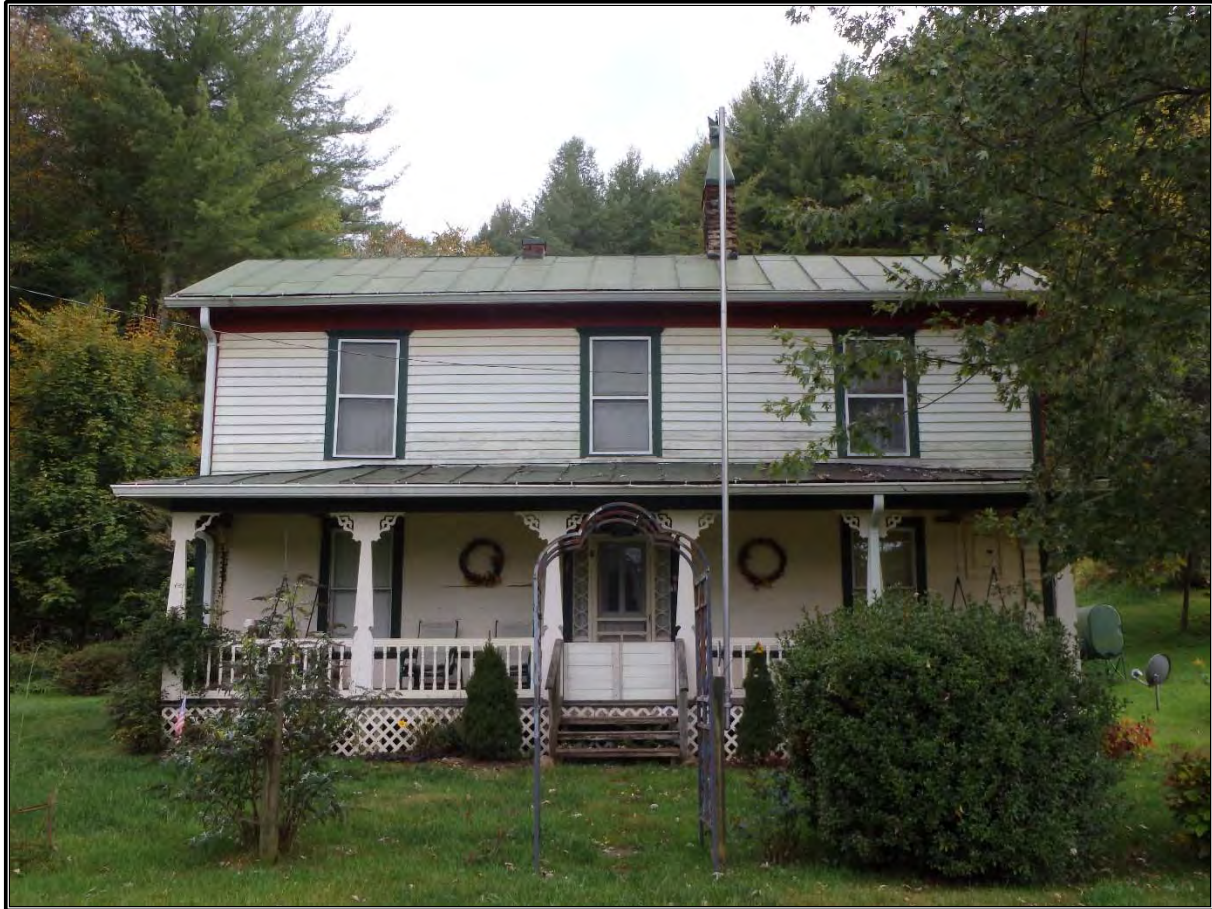
Figure 10. View of the façade of the Poindexter Blevins House (circa 1880–1900), facing southwest.

**House, exterior:** The circa 1900 side-gabled portion of the Poindexter Blevins House features a typical three-bay I-house form. The ridgeline of the roof of this portion of the house is pierced by a small interior brick chimney and a large interior brick flue that is capped by a large metal flue cap. The I-house portion of the house features windows with one-over-one-light and two-over-two-light, double-hung wood sashes. The windows on the I-house portion of the house feature simple wood surrounds topped by a coved wood trim.

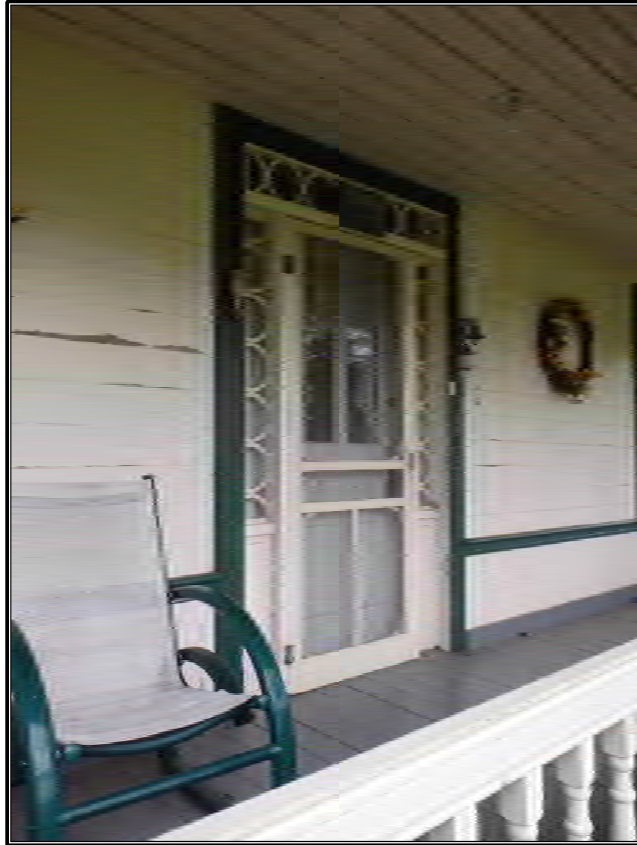
Figure 11. Entry detail.

The primary façade entry is centered on the façade and is comprised of a wood paneled door set behind a wood screen door topped with a glass transom and flanked by glass sidelights set over wooden panels (Figure 11). The transom and sidelights feature pierced wood trim with an open circle motif simulating circular lights. Flat wood trim surrounds the entire entry. The entry opens onto a full-width wood porch. The porch features a hip roof clad in standing-seam metal that is supported by scrolled posts that feature intricate designs above the balustrade and just below the roofline of the porch roof. A balustrade with turned wood balusters and a cove-molded railing runs between the posts. Three wood steps with a simple wood rail connect the porch to the front yard; a solid wood plank gate limits access to the porch. The upper portion of the walls of the façade beneath the porch feature horizontal tongue-and-groove wood siding; the lower portion, which is set beneath a chair rail molding, features vertical tongue-and-groove siding. A thick wood trim runs along the base of the lower portion of the wall under the porch. The porch also features a beaded tongue-and-groove ceiling and a tongue-and-groove wood floor.

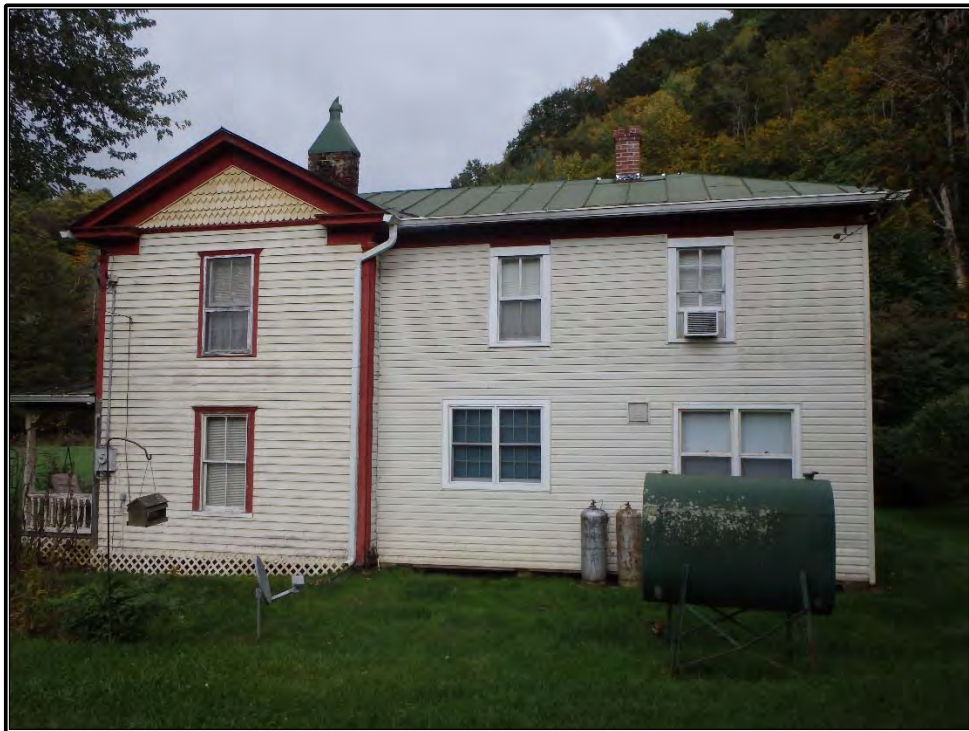
Figure 12. Northwest (side) elevation, facing southeast.

The northwest and southeast elevations of the I-house each feature single windows with two-over-two-light, double-hung wood sashes centered on each floor (Figures 12 and 13). Each of the side elevations of the I-house portion are clad in weatherboard siding. The gable ends feature cornice returns and are clad in decorative wood shingles. The rear elevation of this portion of the house is void of windows and features an enclosed one-story porch sheltered by a shed roof.

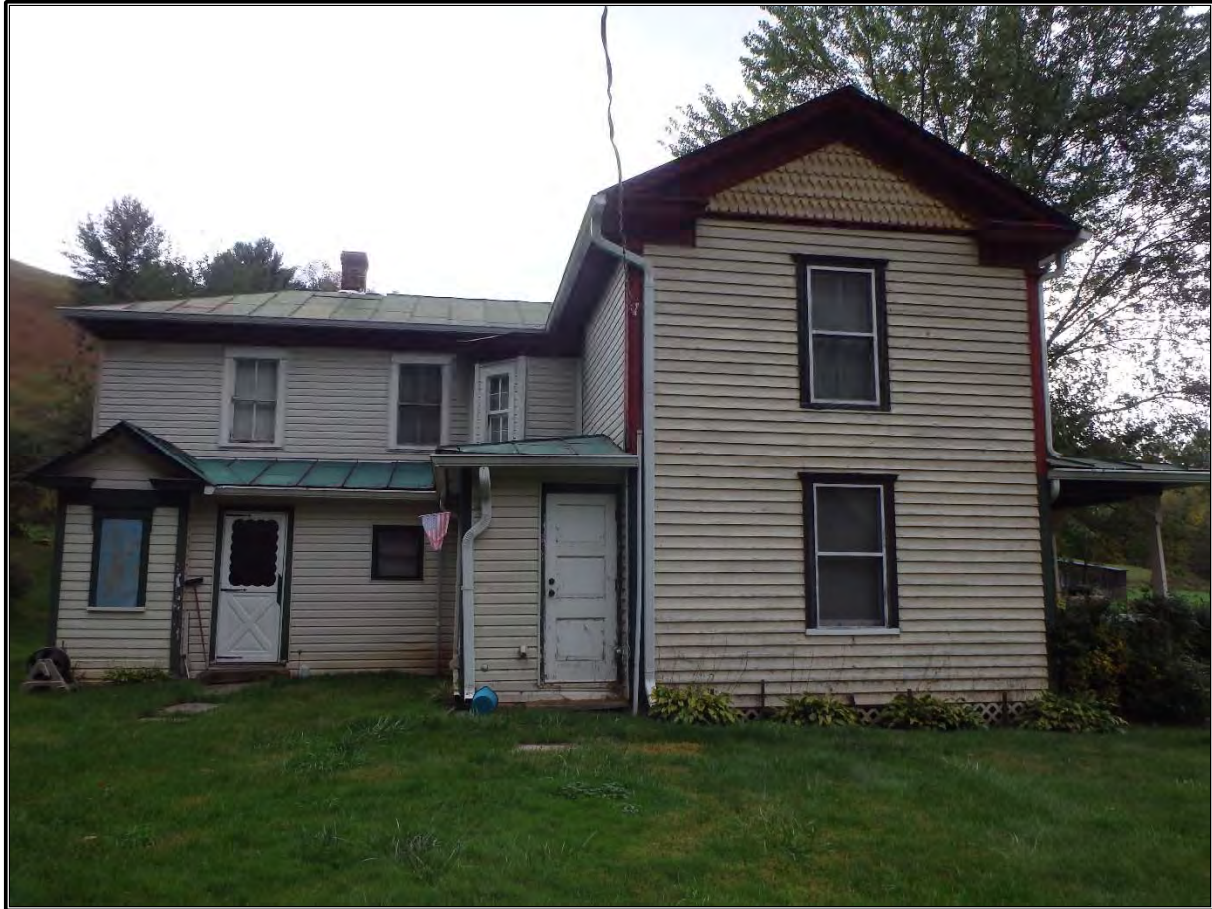
Figure 13. Southeast (side) elevation, facing northwest.

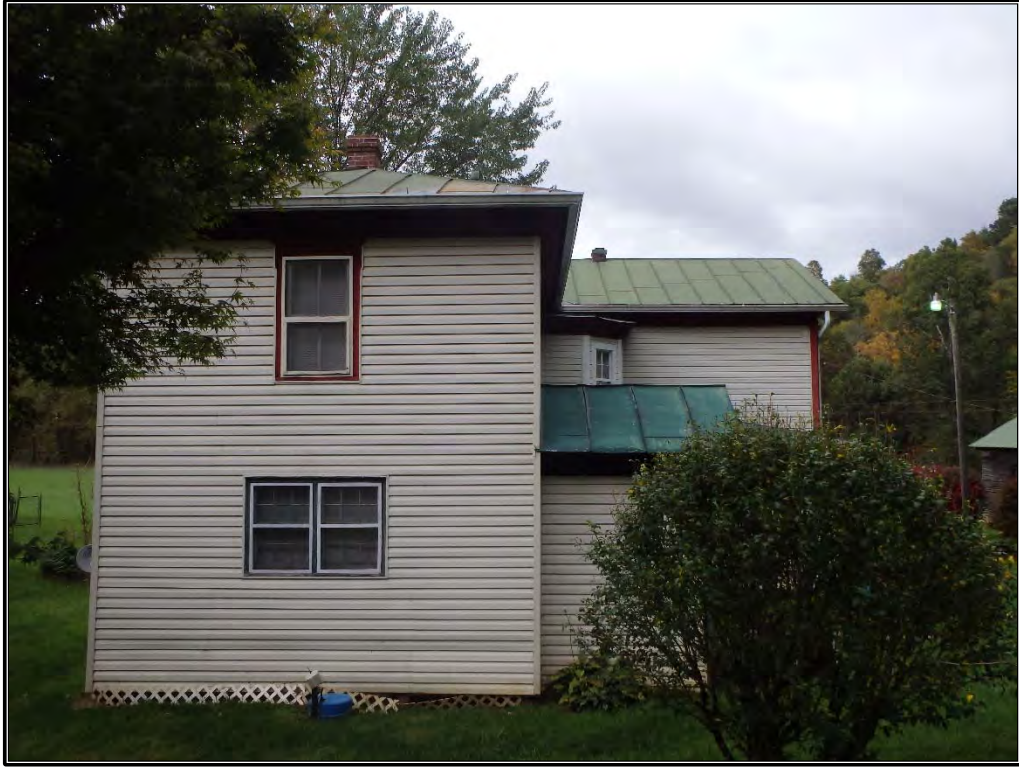
Figure 14. Rear elevation of the rear ell, facing northeast.

The rear ell, which extends from the northwest portion of the I-house portion, forms an open L-shape on the southwest portion of the I-house. The rear ell of the house features one-over-one-light, two-over-two-light, and six-over-six-light double-hung wood sashes, as well as one-over-one-light vinyl replacement sashes with muntins affixed to simulate one-over-one-light and six-over-six-light arrangement. The windows on the rear ell of the house feature simple flat wood surrounds clad in metal (Figure 14). The two-story rear ell and the only exposed portion of the rear elevation of the I-house portion of the house are clad in vinyl siding. A one-story porch sheltered by a hipped roof with a front-gable section formerly extended from the rear ell and the rear of the I-house. All of these porch segments have been enclosed and are now clad in vinyl siding (Figure 15). Two single-leaf rear entries open from the now-enclosed rear porches. A three-sided bay is centered above the enclosed porches on the second story, at the connection of the rear ell and the I-house portions of the house. This projection is sheltered by a three-part standing-seam metal roof and features a small centered single window (Figure 16).

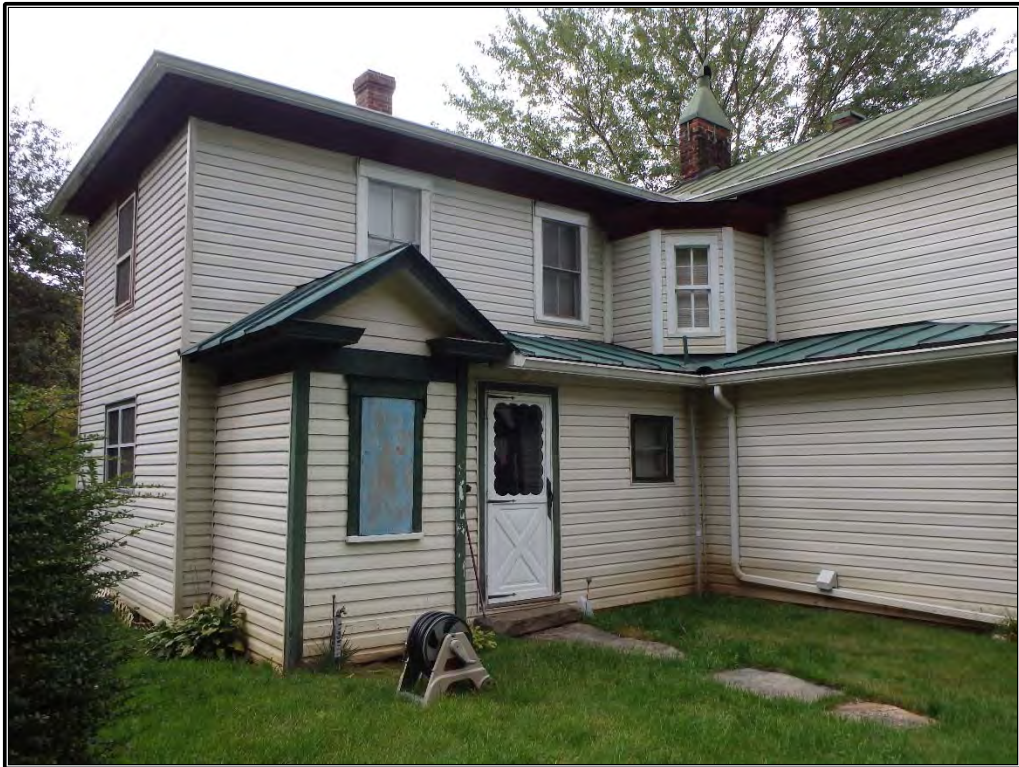
Figure 15. Rear ell and enclosed rear porches, facing northeast.

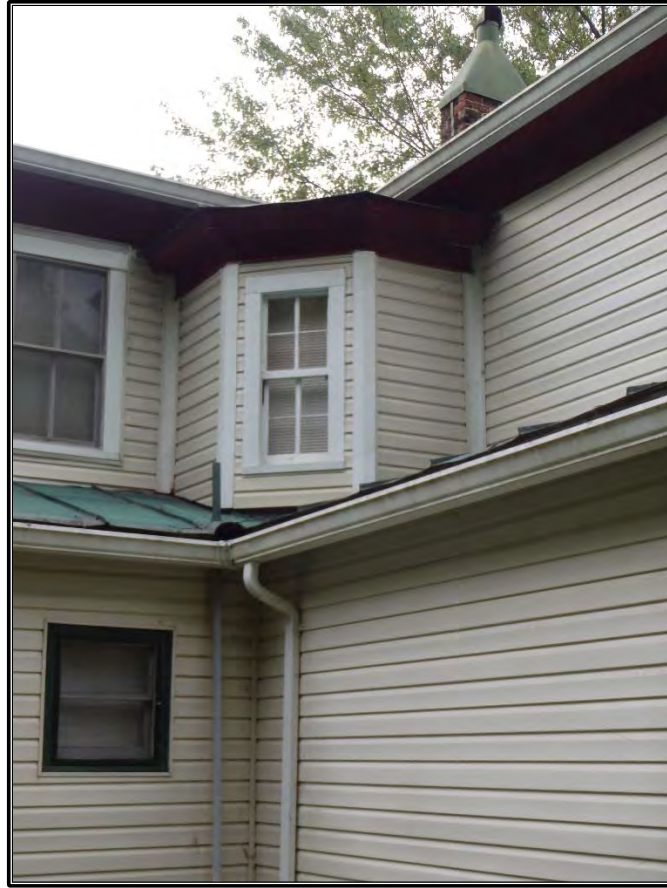
Figure 16. Rear projection above porch detail, facing northeast.

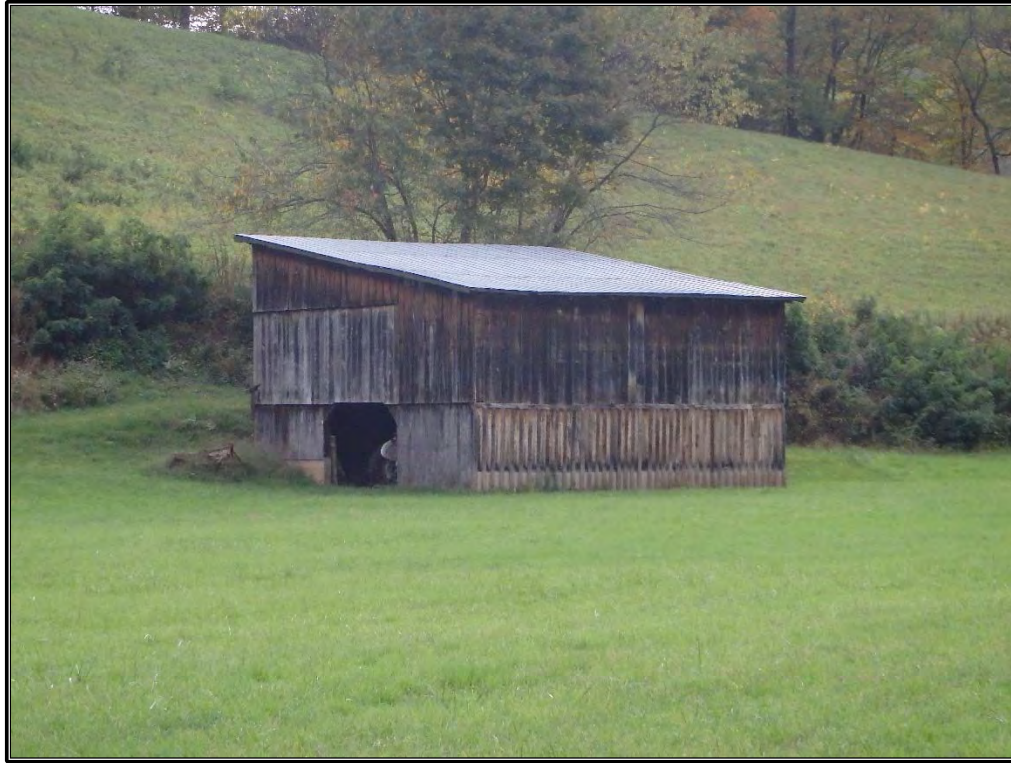
Figure 17. Barn, facing northwest.

**Barn:** The circa 1900–1956 barn is located approximately 450 feet north of the Poindexter Blevins House, within a field on the west side of Helton Creek and Helton Road (Figure 17). The two-story structure is set upon a poured concrete foundation, features frame construction clad in vertical board wood siding, and is sheltered by a shed roof clad in metal panels. The first floor of the barn features a central passage that extends between the north and south elevations of the structure. On the south elevation, the door to the loft has been enclosed with vertical-board siding. The first floor of the barn's east elevation features widely-spaced boards to create a crib.

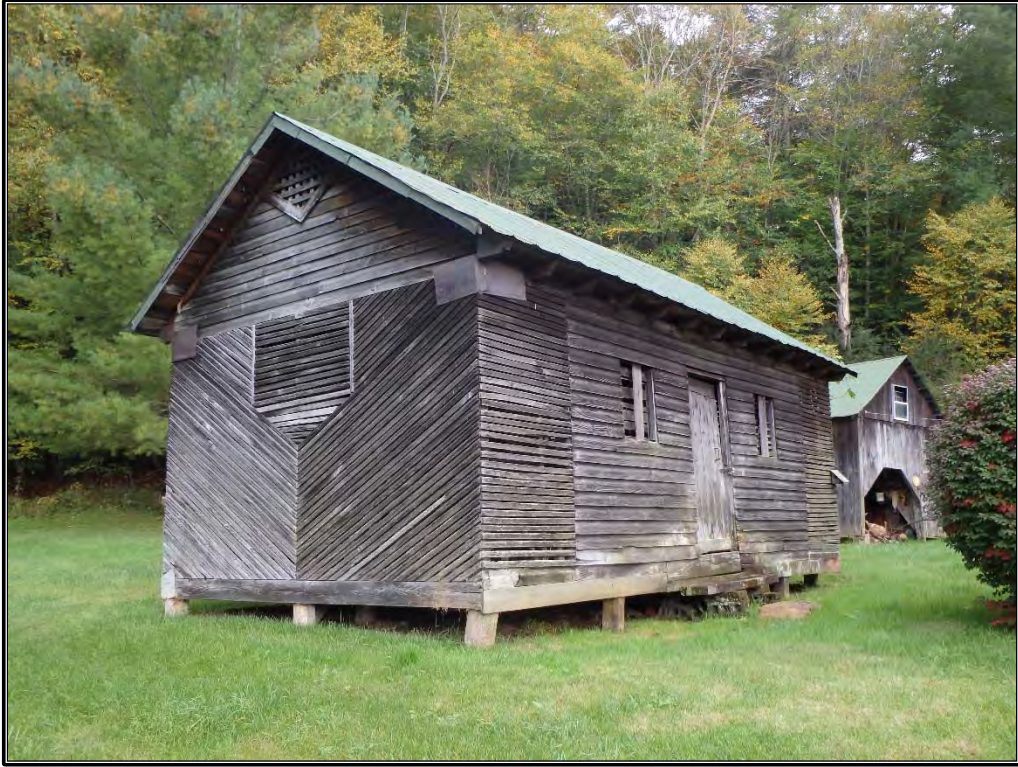
Figure 18. Granary, facing south.

**Granary:** The granary is located approximately 45 feet west-northwest of the Poindexter Blevins House (Figure 18). The one-story structure is set upon a concrete pier foundation, features frame construction clad in weatherboard and thin strips of wood siding, and is sheltered by a side-gabled roof clad in metal panels. The façade of the structure faces northwest toward the house. It features a single-leaf entry with a wood plank door that is flanked by smaller window openings that feature widely-spaced boards instead of sashes. This weatherboard-clad section is flanked by crib sections clad in thin strips of wood spaced to allow for ventilation. The crib sections of the structure comprise the northeast and southwest elevations. Each elevation features a central square vent with thin strips of wood siding that form a V-design around the vent. The gable ends of the structure are clad in weatherboard; a diamond-shaped vent is centered just under the eave and the ridgeline of the roof.

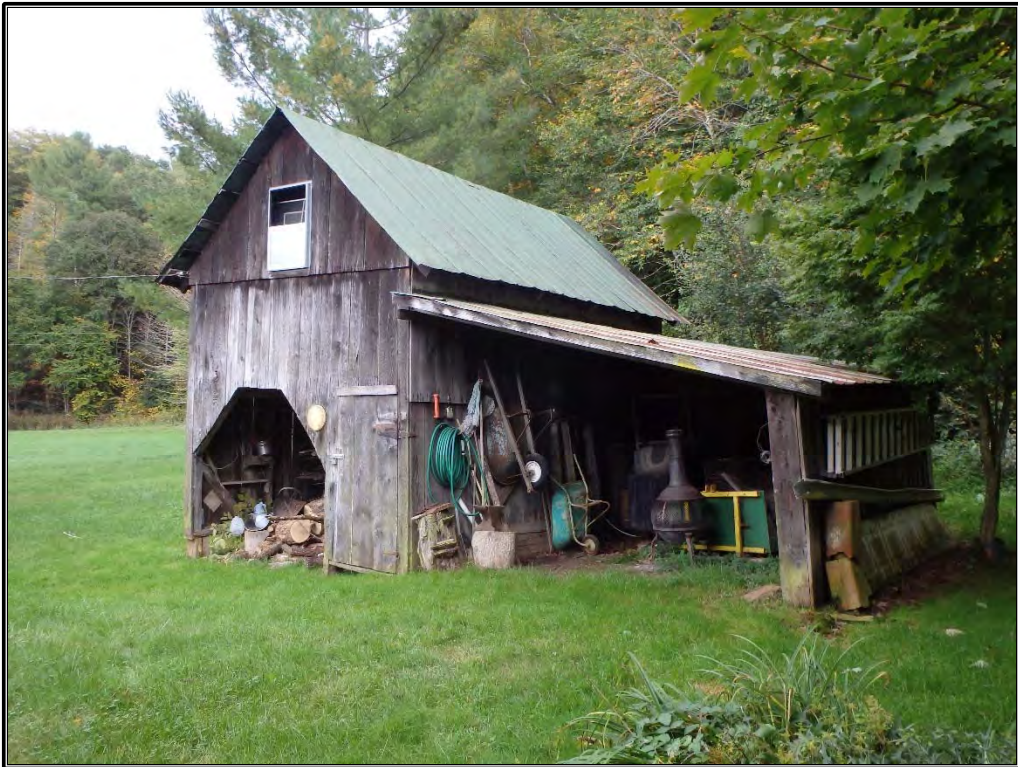
Figure 19. Wood Shed, facing south-southeast.

**Wood Shed:** The wood shed is located approximately 50 feet south of the Poindexter Blevins House (Figure 19). The two-story wood shed is situated upon a poured concrete foundation, features frame construction clad in vertical-board siding, and a front-gable roof clad in metal. Oriented to the north, the tall, narrow wood shed features an open passage and an off-center single-leaf entry with a vertical plank door. A single window is centered in the gable end and a one-story open shed addition extends from the west elevation of the wood shed.

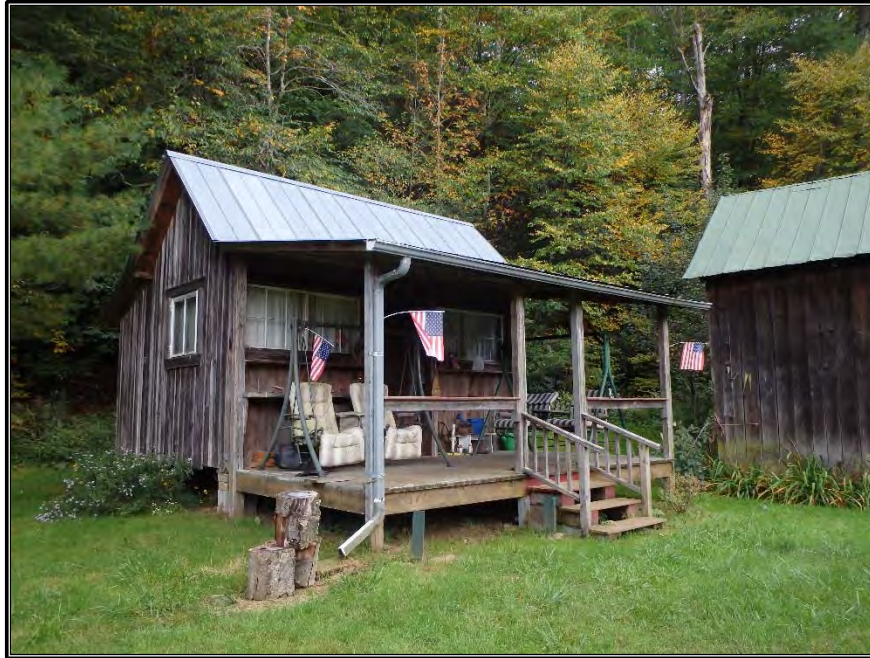
Figure 20. Modern Playhouse/Guesthouse, facing southwest.

**Modern Playhouse/Guesthouse:** A modern playhouse/guesthouse is located approximately 65 feet southeast of the Poindexter Blevins House (Figure 20), just east of the wood shed. This recently constructed building is set upon a concrete pier foundation, features frame construction clad in vertical-board siding of old wood, and a metal-clad side-gable roof. The façade features a single-leaf entry flanked by windows and a full-width porch sheltered by a shed roof.

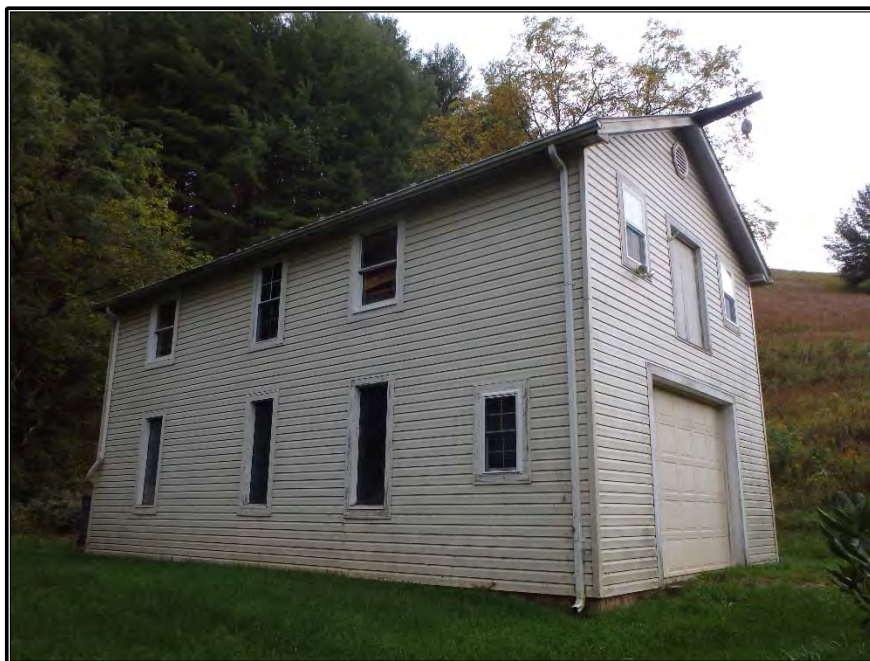
Figure 21. Modern Garage, facing west.

**Modern Garage:** A modern garage is located approximately 45 feet west-southwest of the rear of the Poindexter Blevins House (Figure 21). The two-story structure is set upon a continuous poured concrete foundation, features frame construction clad in vinyl siding, and is sheltered by a metal-clad front-gable roof. Oriented to the northeast, toward the rear of the house, the façade of the garage features a single garage bay with a paneled overhead door on the first floor; a double-leaf entry with metal doors flanked by small windows with vinyl replacement sashes occupies the second floor. The northwest and southeast elevations each feature several windows bays on the first and second floors; all windows feature replacement vinyl sashes with muntins affixed to simulate multi-pane windows.

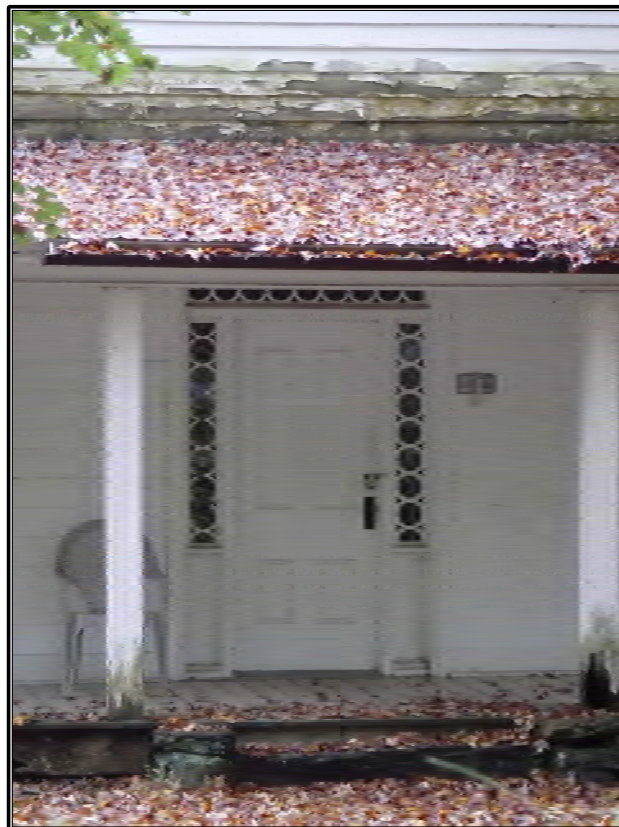
Figure 27. Detail of entry of the Frank Seagraves House (AH 191), at 1538 Little Helton Road with similar trim on sidelights and transom, facing south.

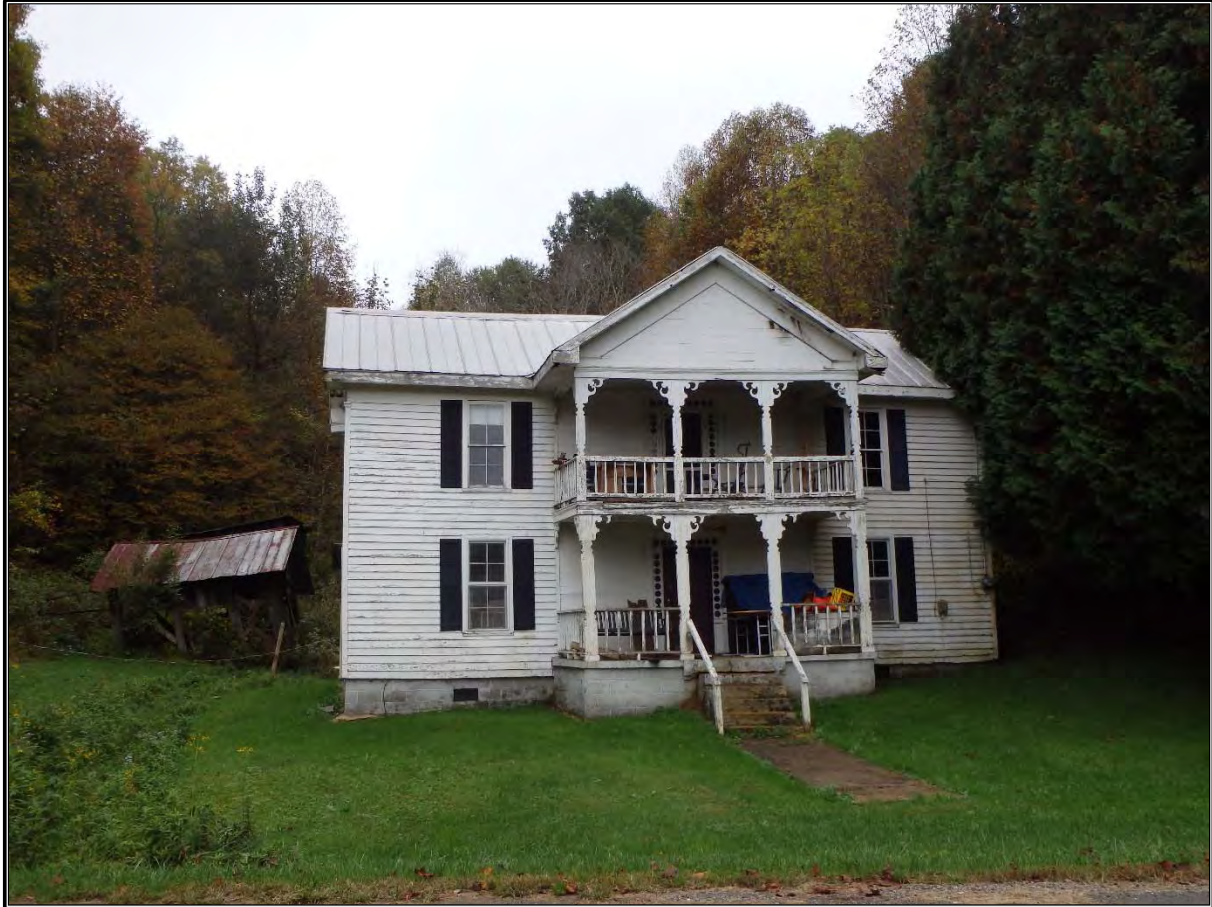
Figure 28. View of façade and porch of the Jackson Howell House (AH 402) on Silas Creek Road, with similar scroll work on the porch and similar trim at the entry, facing south.
