SUBJECT: Historic Structures Survey Report for Grade, Drain, Base and Pave SR 1560 from
SR 1549, PA 15-05-0008, Ashe County, ER 16-0010

HISTORIC ARCHITECTURAL ANALYSIS OF
THE WARD FARM (AH0202), THE STEPHEN WARD HOUSE
(AH0236), AND THE FRANK EDWARDS HOUSE (AH0237),
ASHE COUNTY

Grade, Drain, Base and Pave SR 1560 (Martin Gambill Road) from SR 1549
(Garvey Bridge Road) to Existing Pavement
Ashe County, North Carolina
WBS No. 11C.005150

Cultural Resource Analysts, Inc.
P.O. Box 71220
Richmond, Virginia 23255

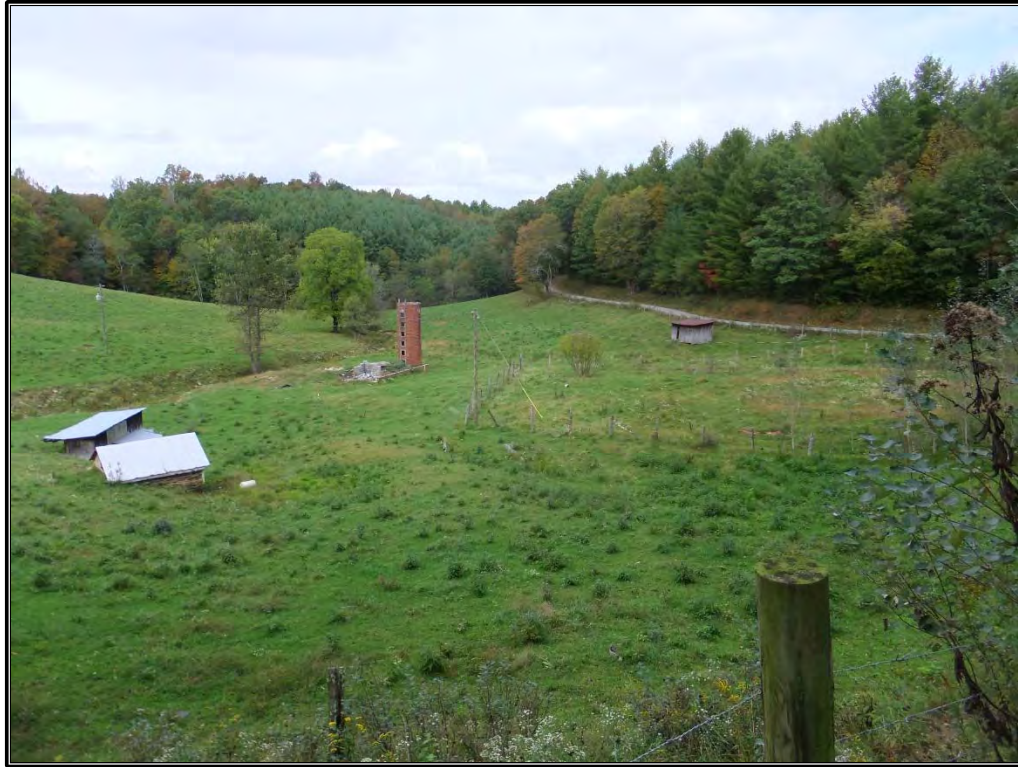
Figure 5. Overview of Ward Farm (AH0202) and woodland beyond the resource, facing north-northeast.

The barn, hunting cabin, and modern carport formerly associated with the Ward Farm are located to the east of Martin Gambill Road, on a separate parcel within dense woodland. Both properties are separated from Martin Gambill road by a barbed wire fence with metal gates (see Figures 5–8).

Barn and Silo Ruins: The foundation of a circa 1900–1960 barn and the ruins of a silo are located approximately 150 feet north of the site of the now-demolished house (see Figure 5). The foundation and ruins are set within a field on the west side of Martin Gambill Road. According to the previous survey completed in 2005, the barn featured a two-story frame form clad in vertical board siding and sheltered by a shed roof. It featured two aisles — one with a rolling door and the other with an unusual arched double-leaf entry (Wyatt and Jones 2005a). The poured concrete and concrete block foundation of the barn are all that remain. The silo, which was connected to the barn, is now in ruins. It is missing a roof, is set upon a poured concrete foundation, and features masonry construction of hollow-core glazed ceramic tile. A thin metal ladder runs along the east side of the silo structure (Figure 11).

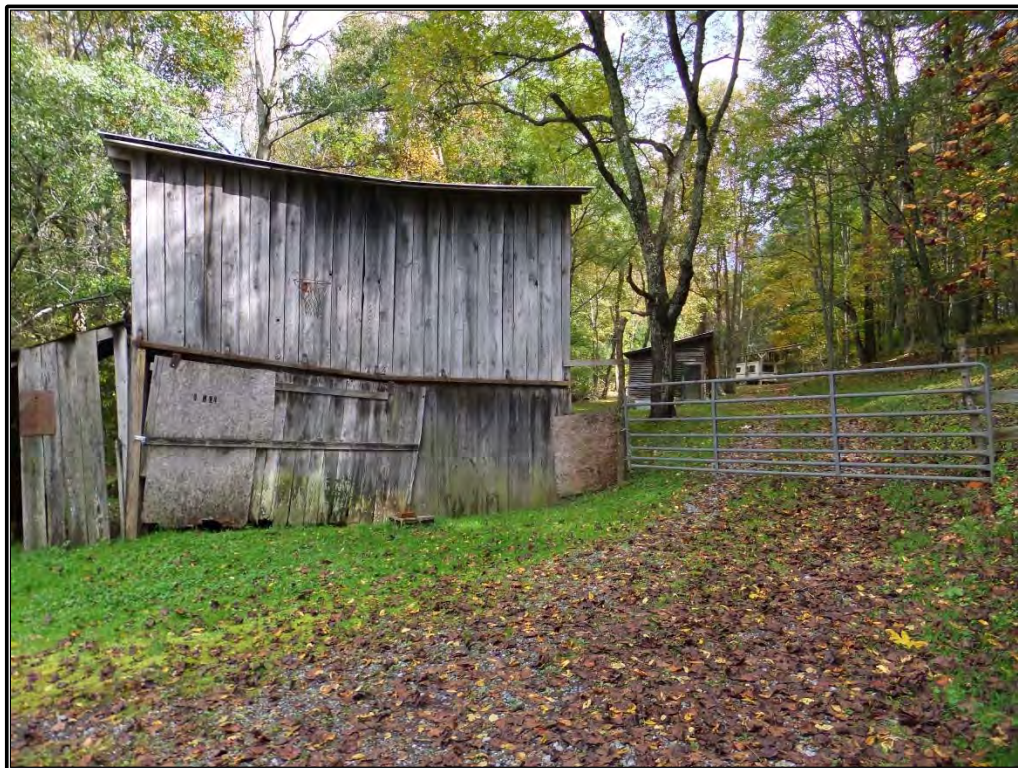
Figure 6. View of the barn, hunting cabin, and modern carport associated with the Ward Farm (AH0202), facing east.

Barn: A frame barn, hunting cabin, and modern carport are located east of Martin Gambill Road, across from the rest of the resources associated with the Ward Farm (see Figure 6). These resources are located on a separate parcel owned by the Murray family, but are historically associated with the farm. The circa 1915–1950 barn features a two-story form and frame construction clad in board-and-batten siding on the first floor and vertical-board siding on the second floor (Figure 18). The barn is situated on a poured concrete foundation and is sheltered by a metal-clad shed roof with exposed rafter tails. A single window with two single-light vinyl sashes with muntins affixed to simulate a nine-light arrangement are centered on the façade of the barn. A one-story, one-bay, open addition, sheltered by a metal-clad shed roof, extends from the northwest corner of the barn; there is no entry beneath the addition. A one-story shed addition clad in vertical-board siding and sheltered by a metal-clad shed roof, extends from the east elevation of the barn. The west elevation features a sliding vertical-plank barn door on the first floor (see Figure 6); the rear elevation features a centered single opening with a wood ramp to provide interior access to the barn.

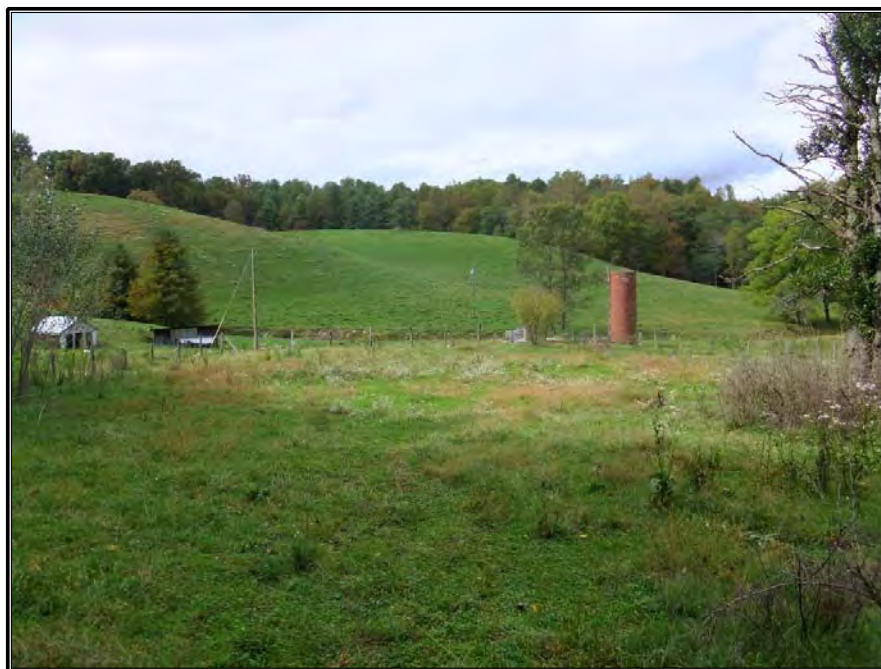
Figure 9. Overview of the site of the house associated with the Ward Farm, facing northwest.

House, overview: The house associated with the Ward Farm (AH0202) has been demolished since the time of its last survey in February of 2005 (Figure 9). According to Caroline Gamble, the trustee of the estate, the house burned. The wire fence surrounding the house remains (Figure 9). According to the text and photos included in the previous survey form for the Ward Farm, the hip-roof cottage dated to the early twentieth century. The one-and-one-half-story house featured frame construction clad in German siding with corner boards and was sheltered by a standing-seam metal roof. The roof was pierced by single front-gabled dormers on the south and east elevations and two central interior brick flues. The single-leaf entry opened to a porch that wrapped the façade and west elevation of the house. Sheltered by a hip roof clad in standing-seam metal supported by square posts, the porch featured a rounded roof on the corner. A one-story concrete block addition with a shed roof extended from the rear elevation (Wyatt and Jones 2005a).

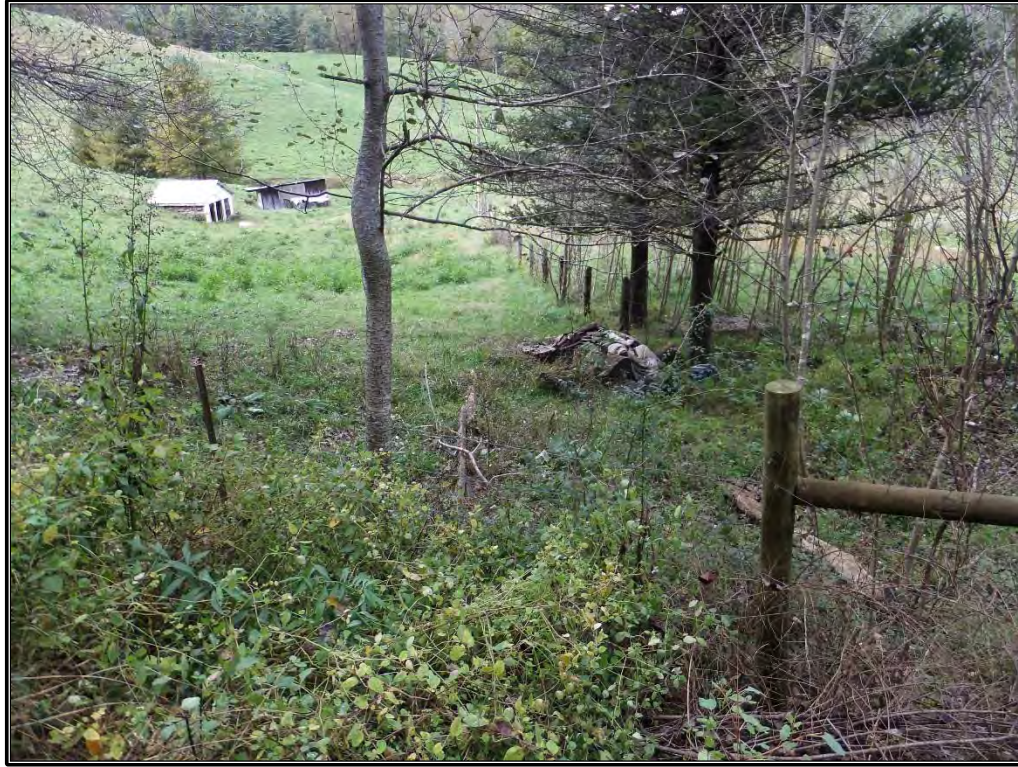
Figure 10. Site of former wood shed to the southwest of the house site, facing north-northwest.

Shed: Previous survey records indicate that a frame wood shed clad in vertical board siding and sheltered by a shed roof was located to the southwest of the house, just outside of the wire fence around the house and yard (Wyatt and Jones 2005a). This structure is no longer extant (Figure 10).

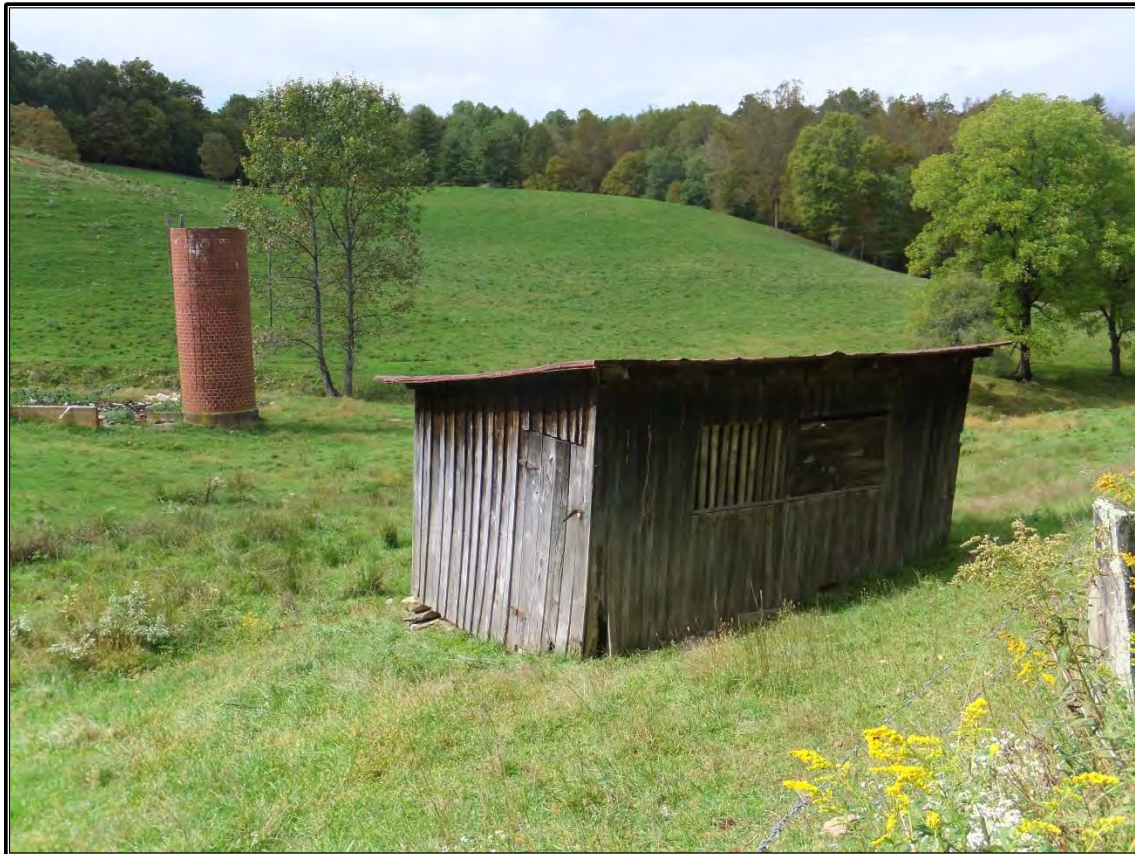
Figure 12. Shed to east of silo, facing north-northwest.

Shed: A circa 1940–1970 one-story frame shed is located approximately 100 feet east of the barn and silo ruins (Figure 12). The shed is situated on stacked fieldstone piers, features frame construction clad in board-and-batten siding, and is sheltered by a metal-clad shed roof. The south elevation of the shed features a single-leaf, off-center vertical-board plank door. The east elevation features a window opening; the southern half of the window features open narrow slats, while the northern half of the window is enclosed by a panel comprised of horizontal boards. The north elevation is void of openings and the rear, or west, elevation is not visible from the ROW.

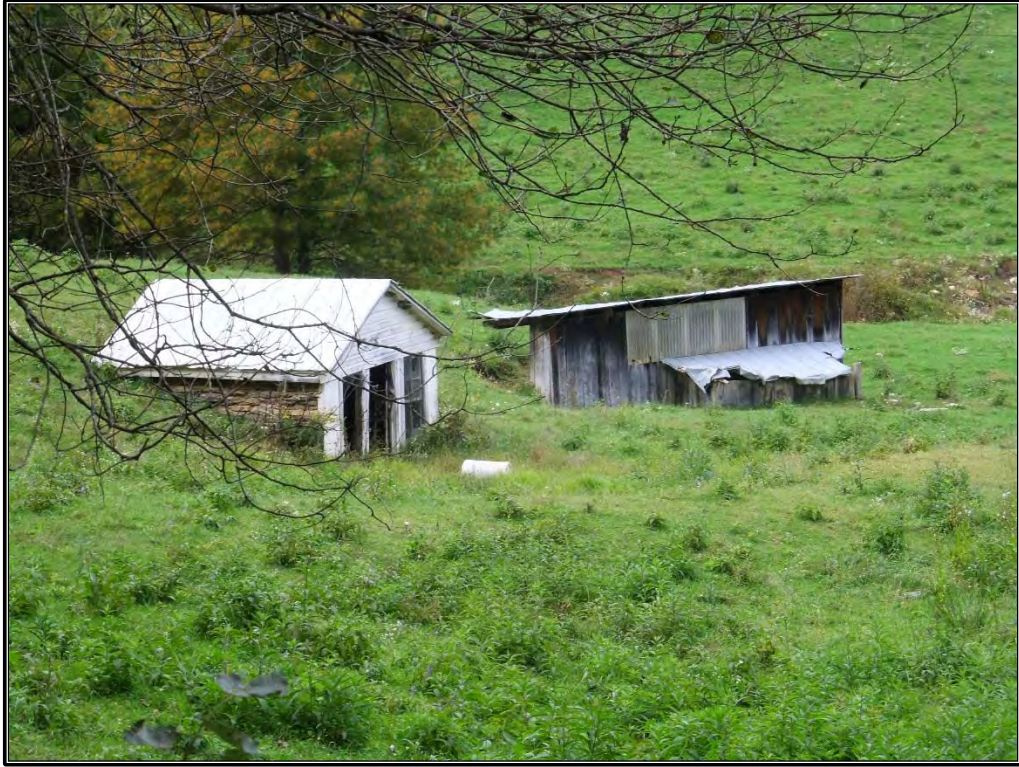
Figure 13. Overview of the second shed and cellar/canning house, facing northwest.

Shed: A second 1940–1970 shed and a cellar/canning house are located southwest of the barn and silo ruins (Figure 13). The shed is located approximately 130 feet southwest of the silo ruins. Oriented to the southeast, the one-story shed features frame construction clad in vertical-board siding and is sheltered by a metal-clad shed roof (Figure 14). An off-center vertical plank door is located on the northeast elevation. A small, half-story shed addition with a metal-clad roof extends from the southeast elevation; an opening, clad in corrugated plastic panels, is centered on the southeast elevation.

Cellar/Canning House: A circa 1890–1910 one-story cellar/canning house is located approximately 25 feet south-southeast of the second shed. Oriented to the northeast, the cellar is set into the base of a slope. The single-story structure features a metal-clad front-gable roof clad in horizontal board-and-batten wood siding on the gable end (Figure 15). The façade, which is comprised of concrete block construction, features three central single-leaf openings. The left and central openings no longer retain windows or doors, while the right bay features a single window with four-over-four-light, double-hung wood sashes. The northwest and southeast (side) and southwest (rear) elevations are void of window or door openings and feature uncoursed, mortared field stone construction.

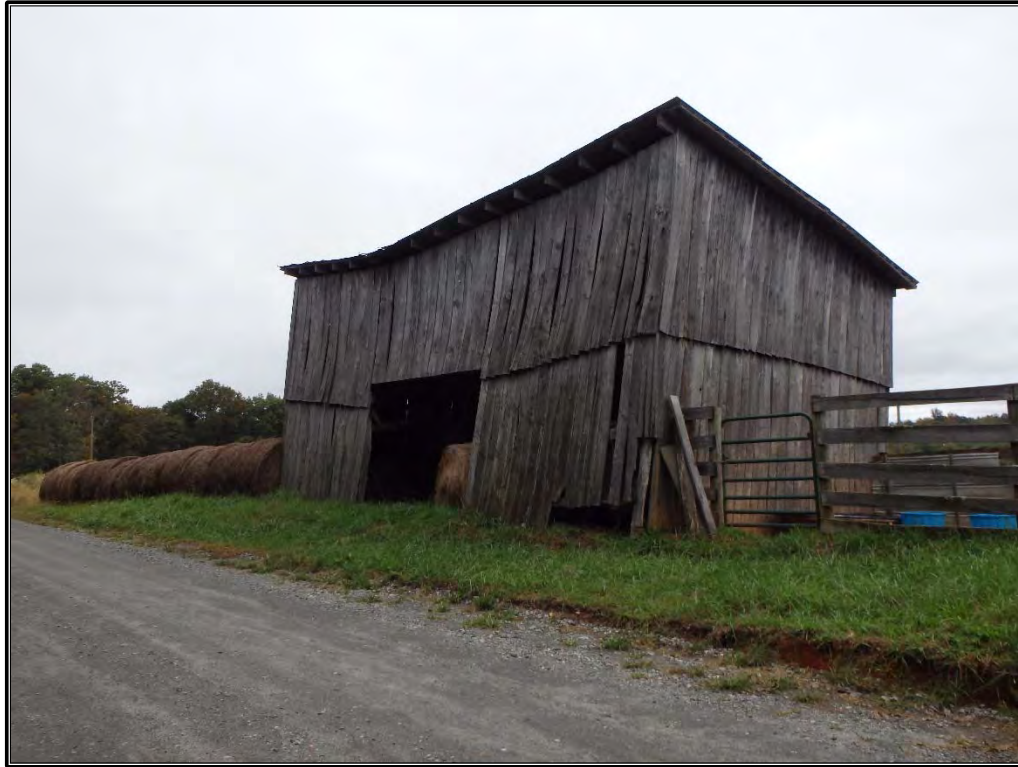
Figure 16. Modern barn, facing north.

Modern Barn: Two barns are located to the southwest and west of the previously recorded resources on the west side of Martin Gambill Road. A modern barn, constructed between 1970 and 2000 is located on the east side of a curve on Martin Gambill Road, approximately 950 ft southwest of the cellar/canning house. The two-story barn features frame construction clad in vertical-board siding and is sheltered by a metal-clad shed roof (Figure 16). The only opening on the structure is an open entry centered on the façade, facing Martin Gambill Road. Fenced pens extend from either end of the barn.

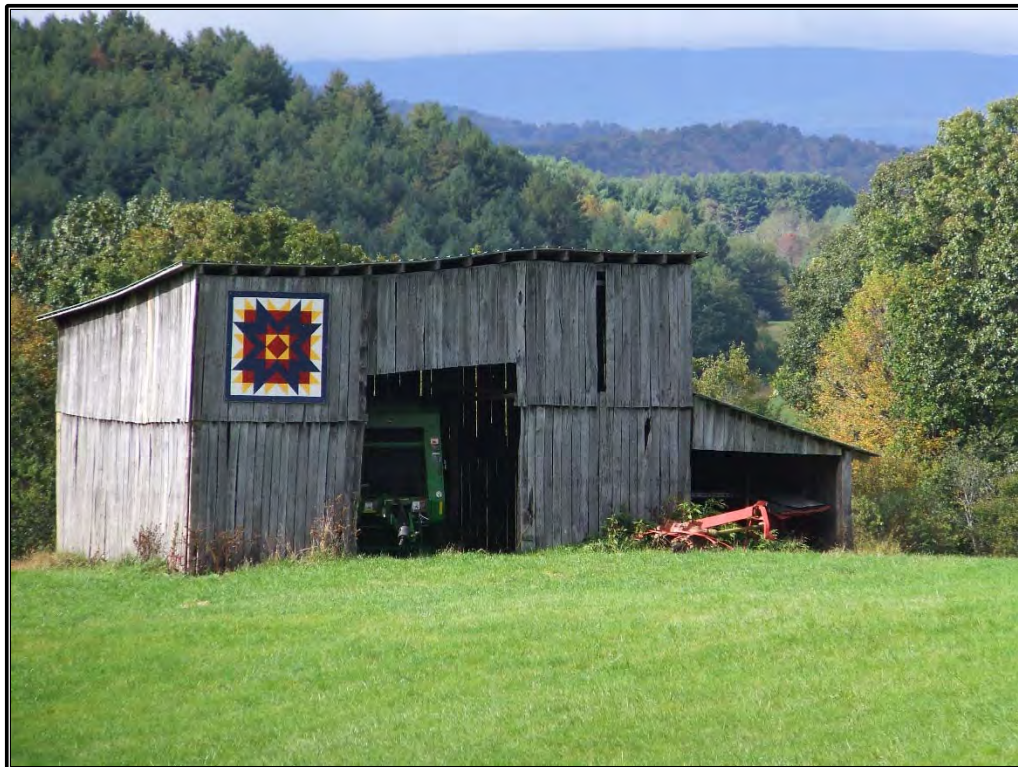
Figure 17. Barn to the far west of the Ward Farm, facing west.

Barn: A circa 1940–1970 frame barn is located approximately 2,500 feet west-southwest of the previously recorded resources associated with the Ward Farm, and approximately 1,500 feet to the west of the modern barn. Set into a grassy field, approximately 480 feet from Martin Gambill Road, the barn features frame construction clad in vertical-board siding and is sheltered by a metal-clad shed roof with exposed rafter tails. A one-story shed addition extends from the northwest elevation of the barn (Figure 17).

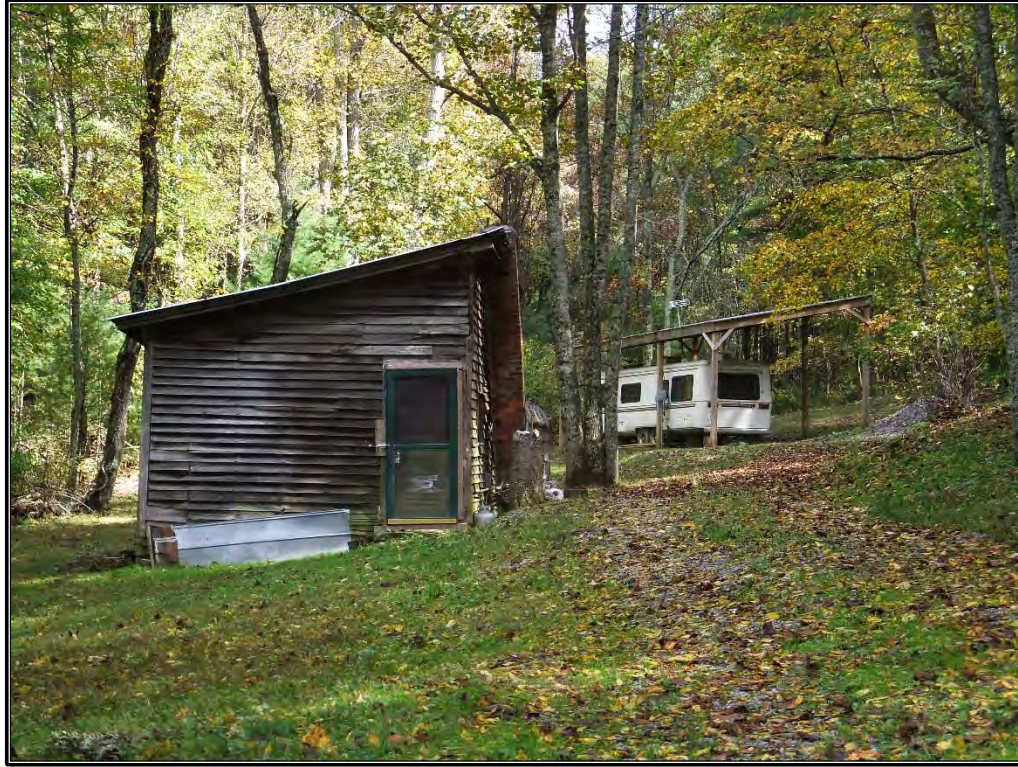
Figure 19. View of the hunting cabin on the east side of Martin Gambill Road, facing east.

Hunting Cabin: A one-story circa 1940–1970 hunting cabin/cottage is located approximately 85 feet west-southwest of the barn. Possibly converted from a frame shed, the one-story cabin features frame construction clad in weatherboard siding and is sheltered by a metal-clad shed roof (Figure 19). An exterior brick flue extends to the roofline. The west elevation of the cabin features a single-leaf off-center entry with a storm door.

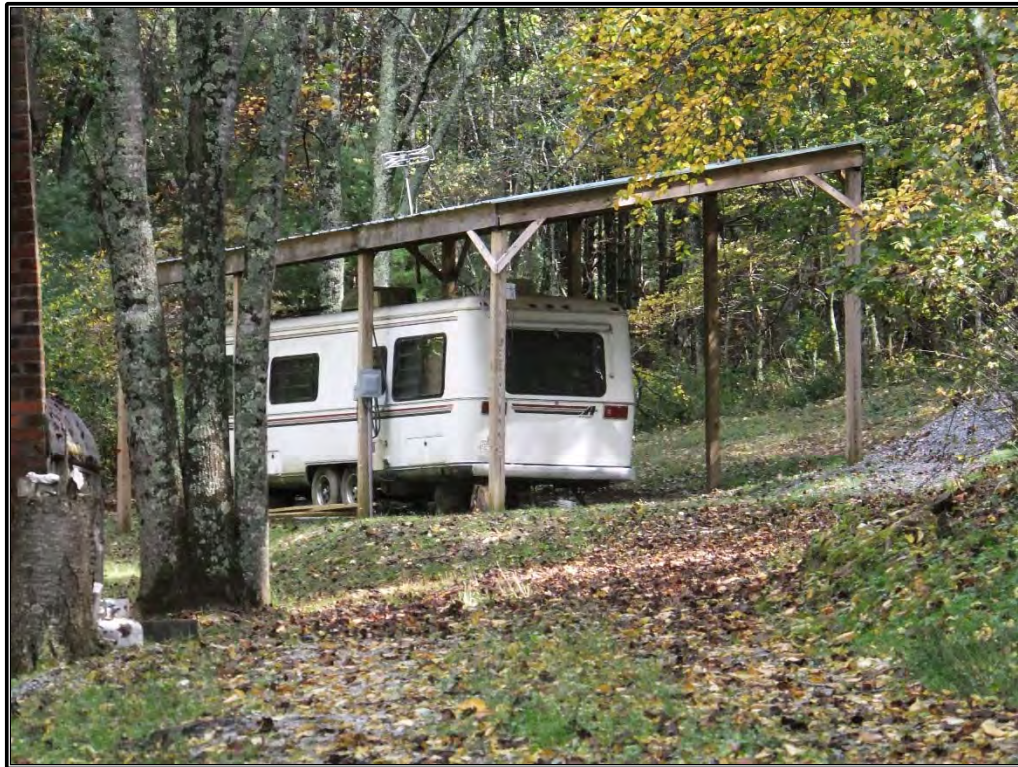
Figure 20. Modern carport, facing southeast.

Modern Carport: A one-story modern (circa 2005–2015) carport is located approximately 245 ft east-southeast of the barn on the east side of Martin Gambill Road. The tall carport, which accommodates a camping trailer, features a metal-clad shed roof supported by square posts with angled brackets at each corner (Figure 20). This resource was not previously recorded as a part of the site in 2005.

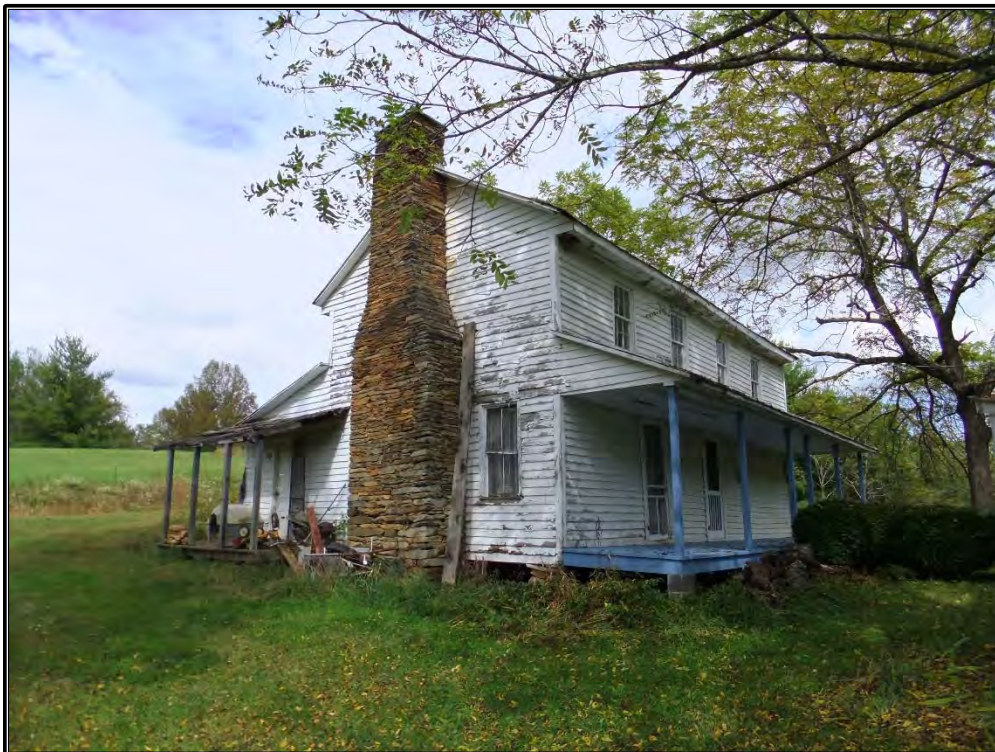
Figure 29. View of the façade and southwest elevations of the circa 1871–1935 Stephen Ward House (AH0236), facing northeast.

House, overview: The primary structure associated with the property, the Stephen Ward House, features a two-bay (d/d), side-gable I-house form with a one-story rear shed addition (Figure 29). Previous survey records indicate that the southwest (left) portion of the structure was originally a log structure built in 1872, the northeast (right) portion was added in 1893, and the kitchen rear addition was added in 1935 (Wyatt and Jones 2005b). The I-house portion of the house is sheltered by a side-gable roof clad in standing-seam metal; the front porch and rear addition are sheltered by shed roofs clad in standing-seam metal.

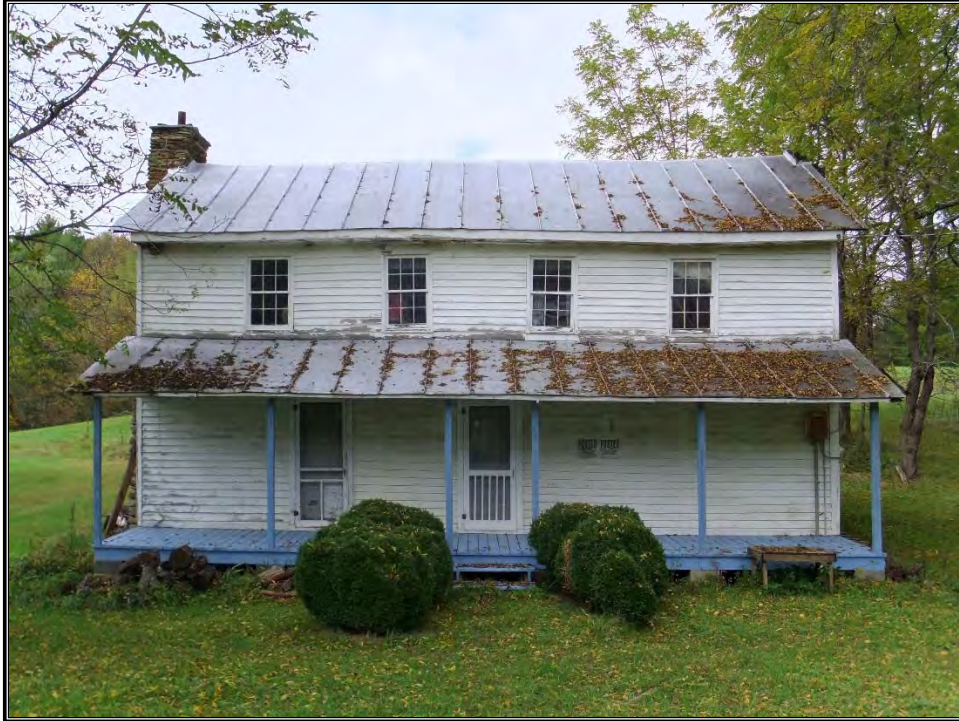
Figure 30. View of the façade of the Stephen Ward House, facing north-northwest.

The façade features two entries: the primary entry is centered; the secondary entry is off-center on the left side of the façade (Figure 30). The central entry features a single-leaf wood door with a half-light over three panels and a wood storm door (Figure 31). The secondary entry features a single-leaf five-panel wood door and a wood storm door. Simple wood trim with a single central bead surrounds both entries, which open to a wood porch that is sheltered by a shed roof clad in standing-seam metal. Six square wood posts support the porch roof; the porch features a beaded tongue-and-groove ceiling. Two wood steps connect the porch to the yard. Four single windows are centered on the second story of the façade. These windows feature six-over-six-light double-hung wood windows (see Figure 26).

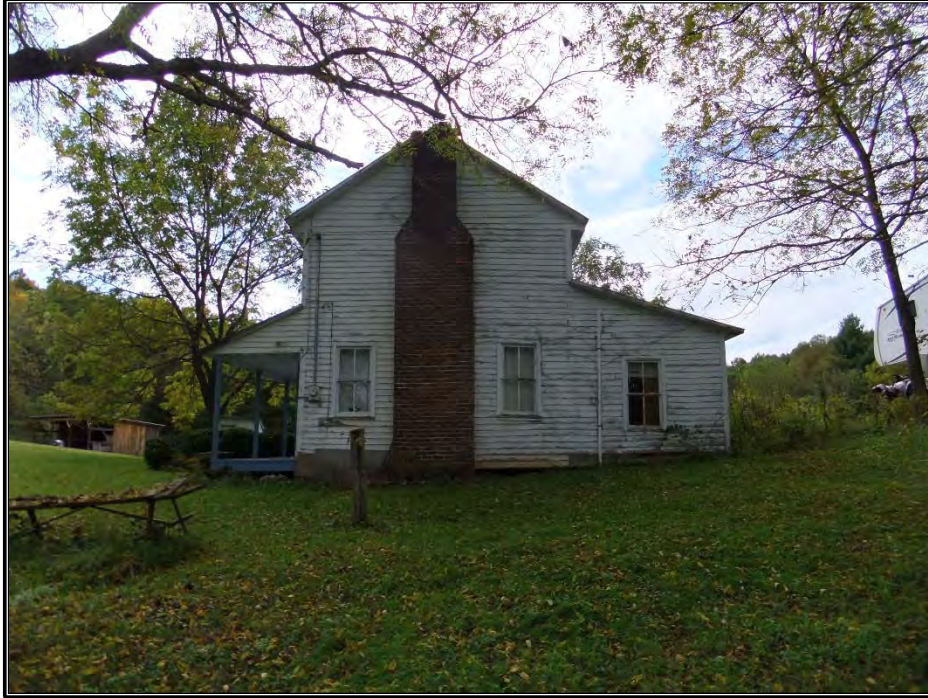
Figure 32. View of the northeast elevation of the Stephen Ward House, facing southwest.

The northeast, or side, elevation is dominated by a large brick chimney (Figure 32). The chimney features common bond brick masonry up to the shoulder; the shoulder features two angled sections that meet in the center. The stack is common-bond brick above the shoulder (Figure 33). The chimney is failing and is partially crumbled near the ridgeline of the roof. Single windows with two-over-two-light double-hung wood sashes flank either side of the chimney on the first floor; there are no windows on the second floor. A single window with two-over-two-light, double-hung wood sashes is centered on the northeast elevation of the one-story rear kitchen addition.

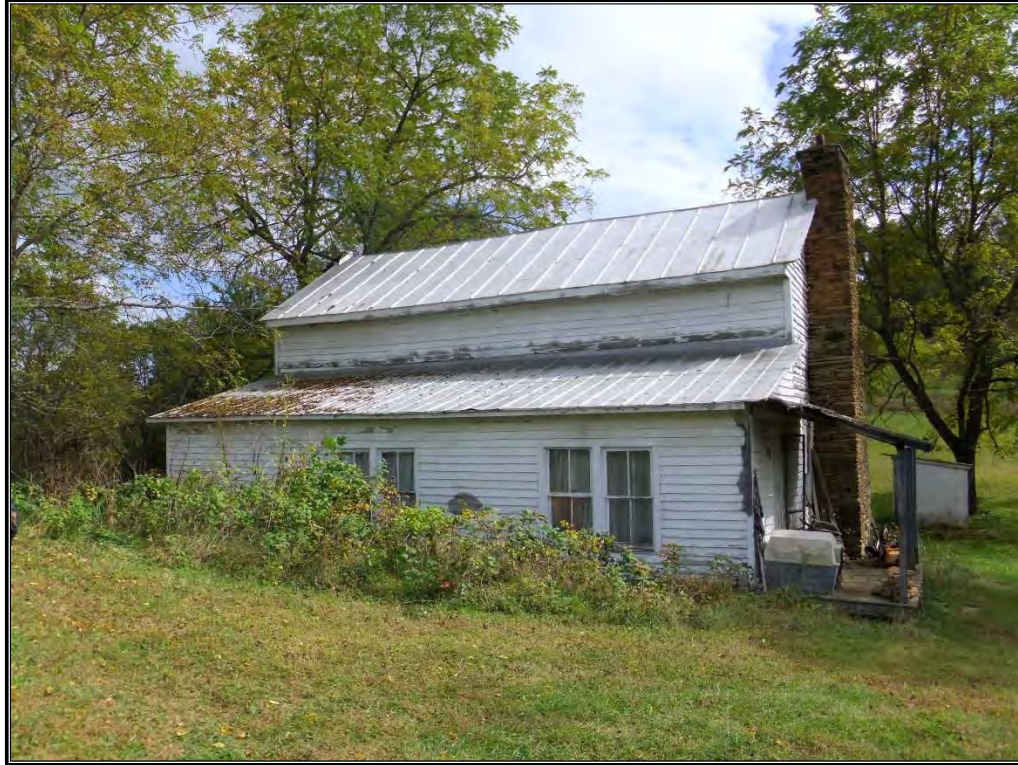
Figure 34. Detail of the rear, or northwest, elevation, facing south-southeast.

The rear elevation features two pairs of single windows with two-over-two-light, double-hung wood sash windows on the rear kitchen addition (Figure 34). There are no other openings.

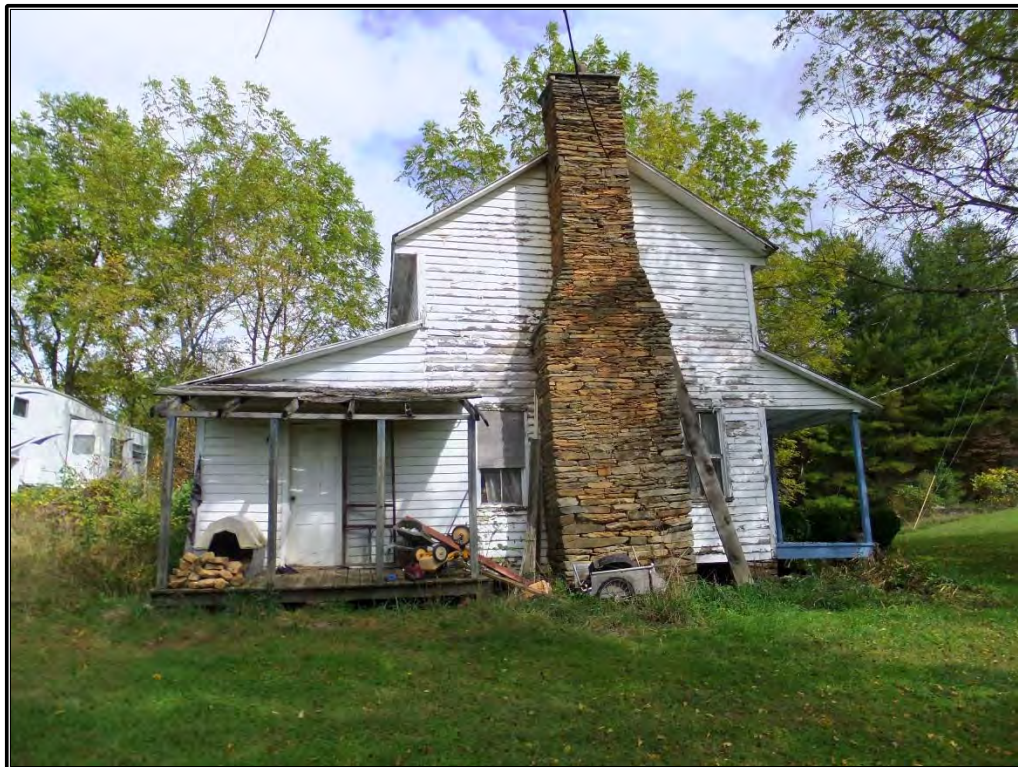
Figure 35. View of the southwest, or side, elevation, facing northeast.

The southwest, or side, elevation is dominated by a large dry-laid stone chimney (Figure 35). The shouldered chimney extends above the ridgeline of the roof, and likely dates to the original log portion of the house, circa 1872. Single windows with two-over-two-light, double-hung wood sashes flank either side of the chimney on the first floor; the second floor is devoid of windows. A single-leaf side entry with a paneled wood door and wood screen door is centered on the southwest elevation of the rear kitchen addition. This side entry opens to a wood porch that spans the depth of the rear addition. The side porch features a shed roof partially clad in standing-seam metal that is supported by four square wood posts.

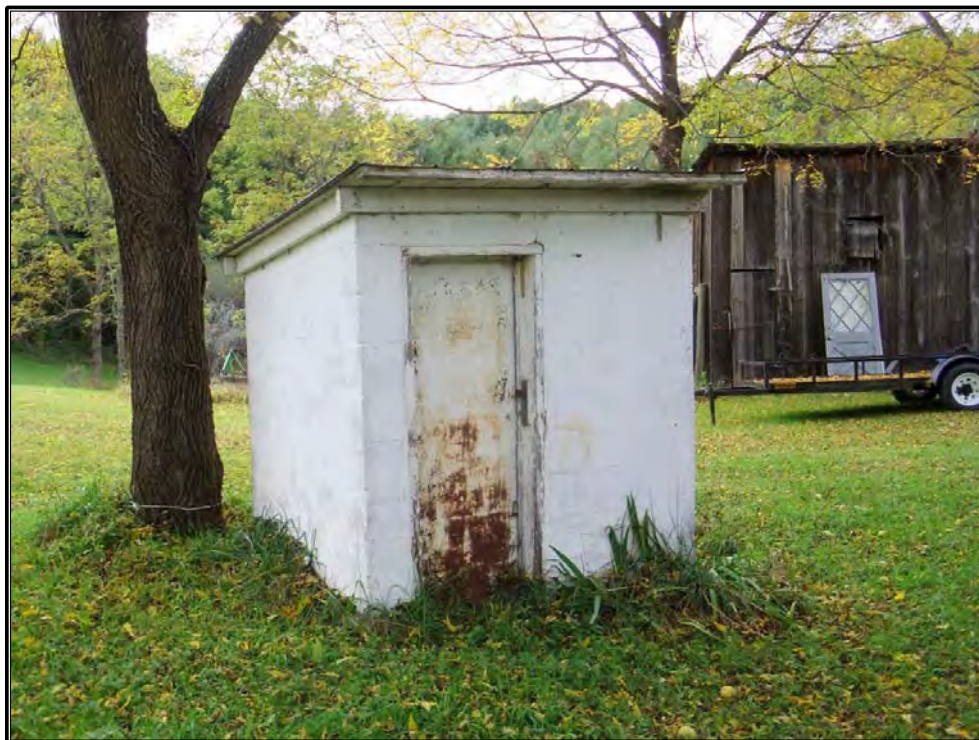
Figure 36. View of the circa 1900–1956 pump house, facing west-southwest.

Pump House: A circa 1900–1956 pump house is located approximately 15 feet south-southwest of the Stephen Ward House (Figure 36). The one-story structure features concrete block construction and is sheltered by a metal-clad shed roof. An off-center single-leaf entry with a metal door is the only opening on the structure.

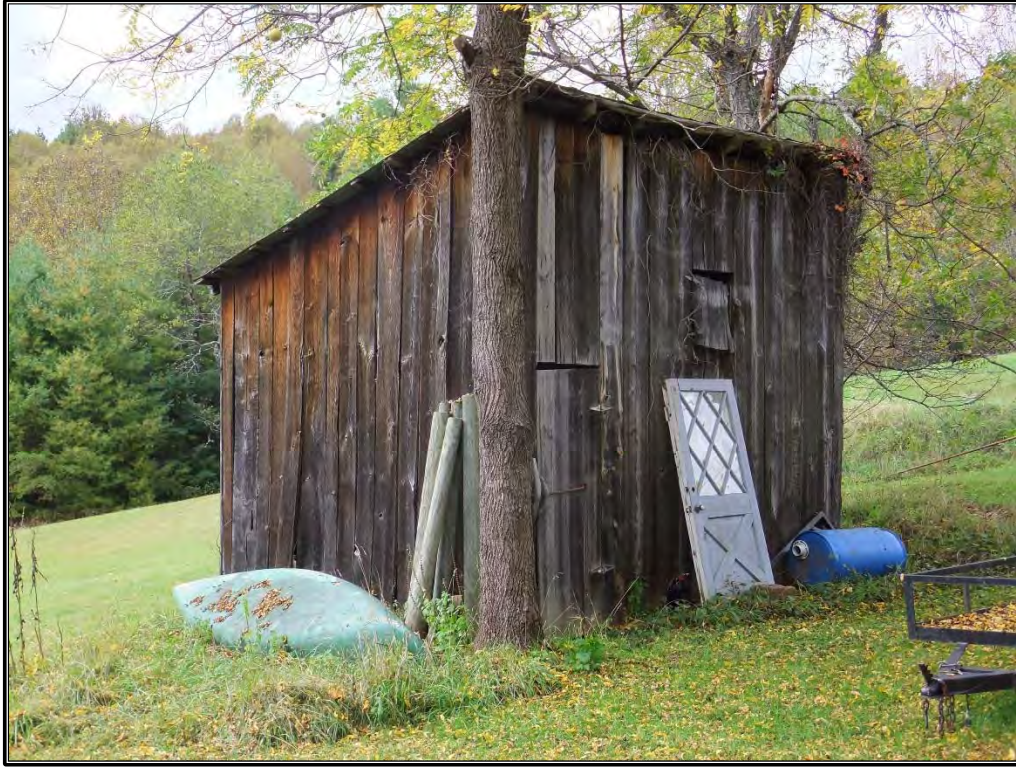
Figure 37. View of the circa 1950–1970 shed, facing northwest.

Shed: The circa 1950–1970 shed is located approximately 40 feet west-southwest of the Stephen Ward House (Figure 37). The one-story structure features frame construction clad in vertical-board siding and is sheltered by a steeply-pitched shed roof clad in metal panels. The façade features an off-center vertical-plank wood door and a small opening with a hinged door centered on the façade of the shed.

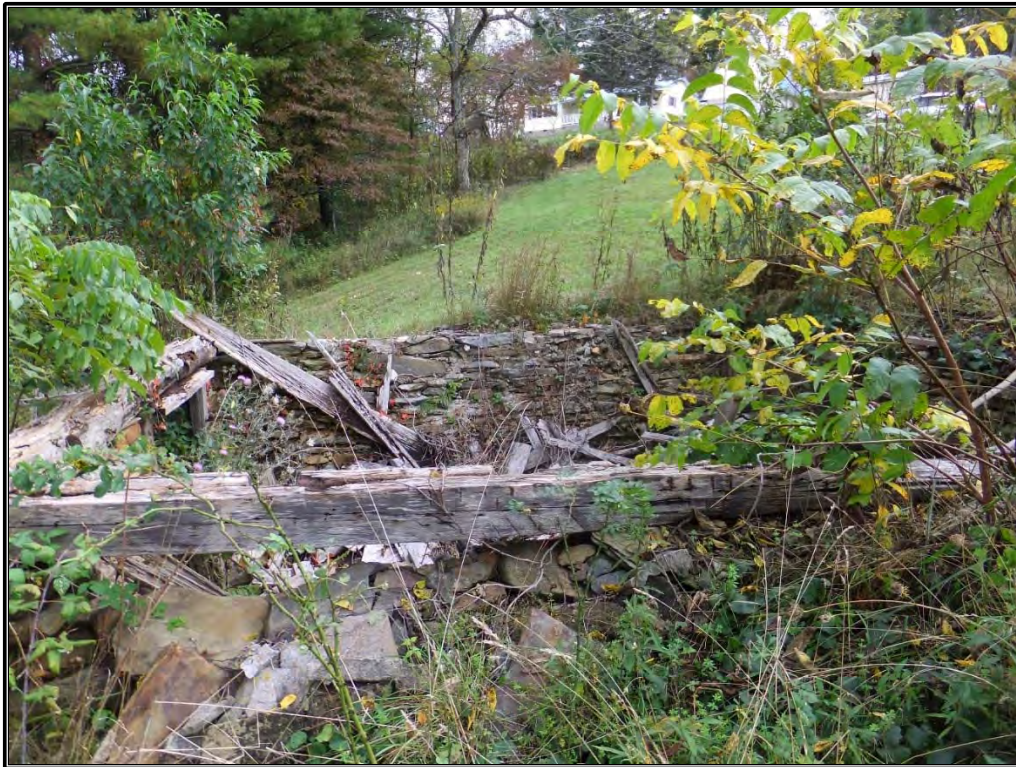
Figure 38. View of the ruins of a cellar, facing east-northeast.

Cellar Ruins: The ruins of a log canning house or barn set over a stone cellar are located approximately 70 feet southeast of the Stephen Ward House (Figure 38). Portions of the log sills and a dry-laid stone foundation are all that remain of this structure.

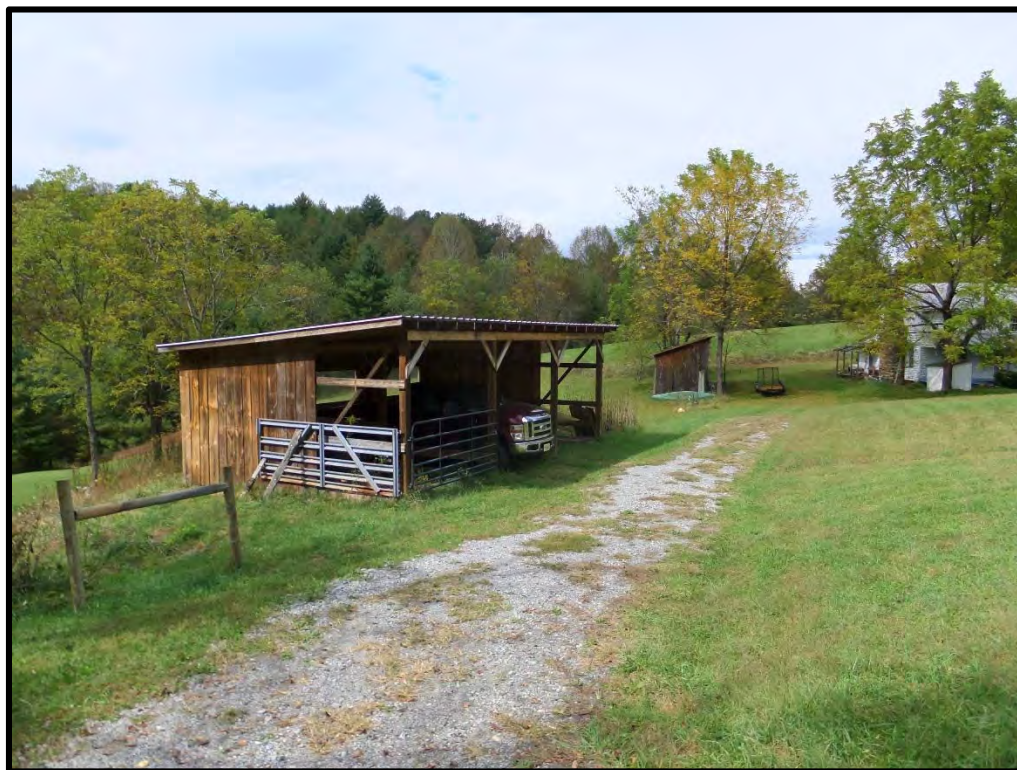
Figure 39. View of the modern shed, facing northwest.

Modern Shed: A modern shed is located approximately 120 feet south-southwest of the Stephen Ward House (Figure 39). The shed features modern frame construction, portions of which are clad in vertical-plank wood siding. The shed features a metal-clad shed roof that is supported by square wood posts. The façade is divided into three open bays.

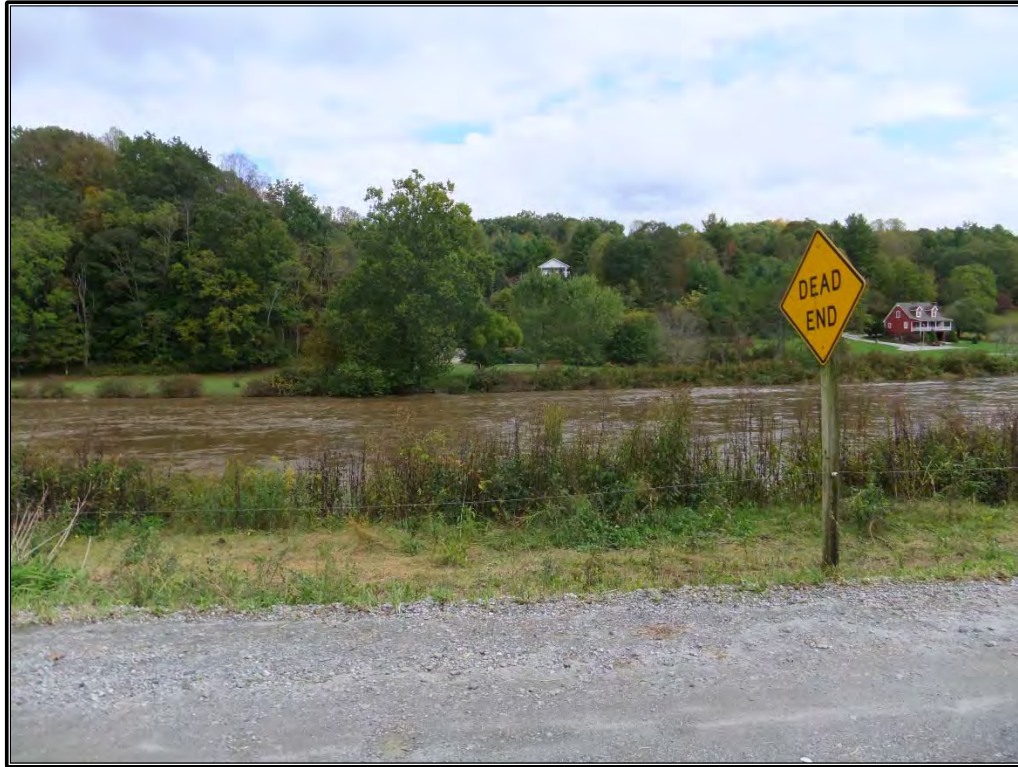
Figure 47. View of the South Fork New River from the façade of the Frank Edwards House, facing east.

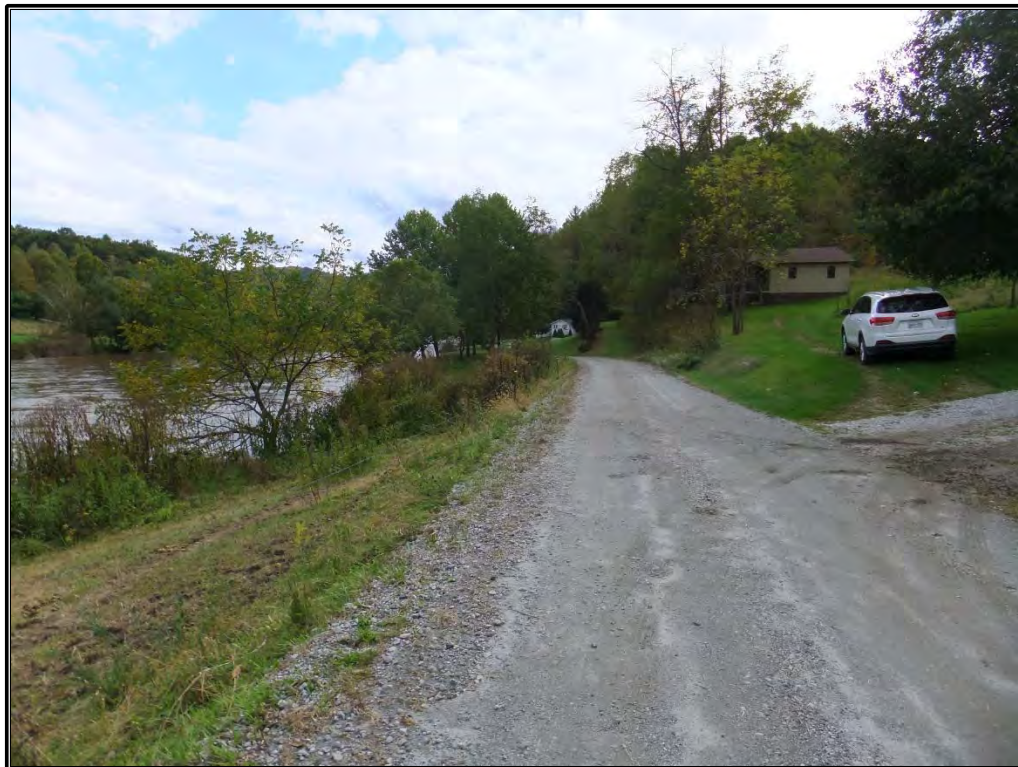
Figure 48. View of the South Fork New River and Garvey Bridge Road from the Frank Edwards House, facing south.

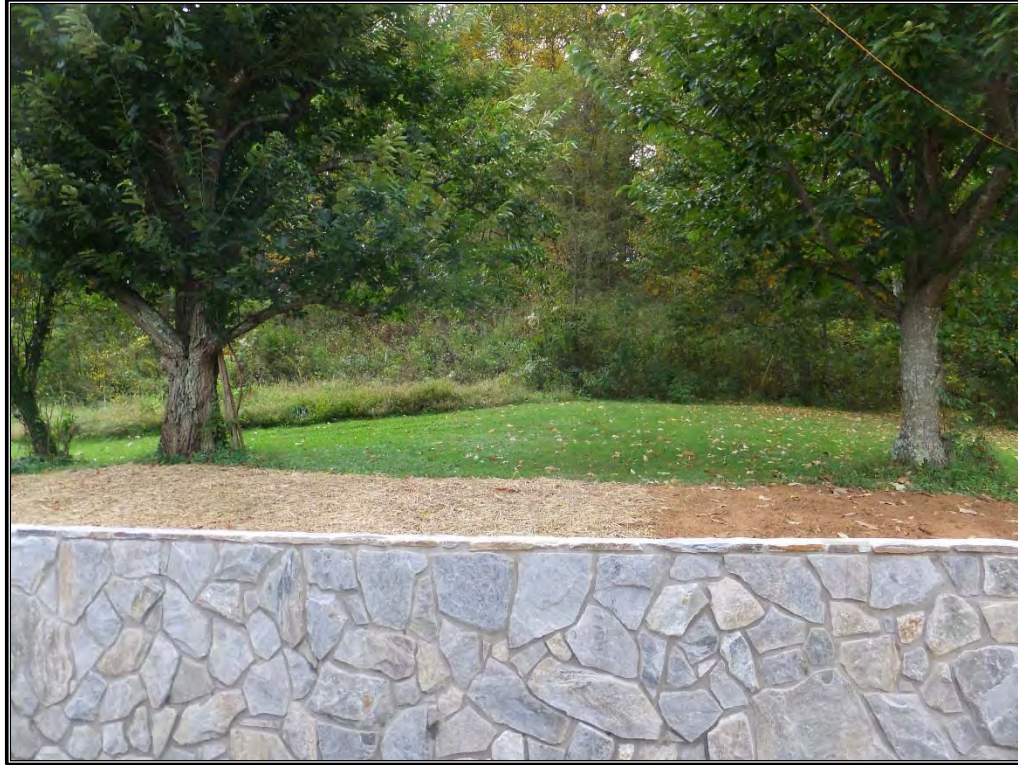
Figure 49. View of the woodland to the rear of the Frank Edwards House, facing west.

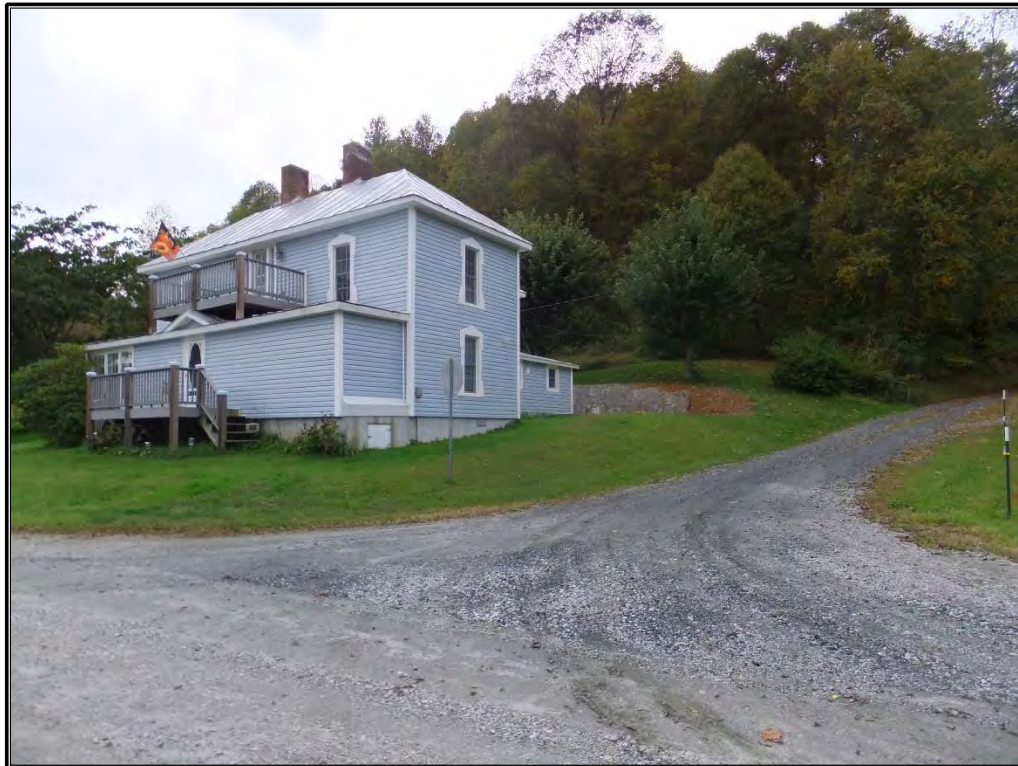
Figure 50. Overview of the circa 1900 Frank Edwards House and the terminus of Martin Gambill Road at Garvey Bridge Road, facing west-northwest.

House, overview: The Frank Edwards House is a circa 1900 T-plan house with an enclosed front porch and an enclosed side porch (Figure 50). Originally a three-bay (w/d/w) T-plan house, the core of the house is sheltered by a cross-gable hip roof clad in standing-seam metal. The house features ornate shouldered window surrounds that feature wide trim with a pointed crown and flared base; recent alterations to the home have concealed all of the window surrounds in sheet metal.
