SUBJECT: Historic Structures Survey Report for Grade, Drain, Base and Pave SR 1560 from
SR 1549, PA 15-05-0008, Ashe County, ER 16-0010

HISTORIC ARCHITECTURAL ANALYSIS OF
THE WARD FARM (AH0202), THE STEPHEN WARD HOUSE
(AH0236), AND THE FRANK EDWARDS HOUSE (AH0237),
ASHE COUNTY

Grade, Drain, Base and Pave SR 1560 (Martin Gambill Road) from SR 1549
(Garvey Bridge Road) to Existing Pavement
Ashe County, North Carolina
WBS No. 11C.005150

Cultural Resource Analysts, Inc.
P.O. Box 71220
Richmond, Virginia 23255

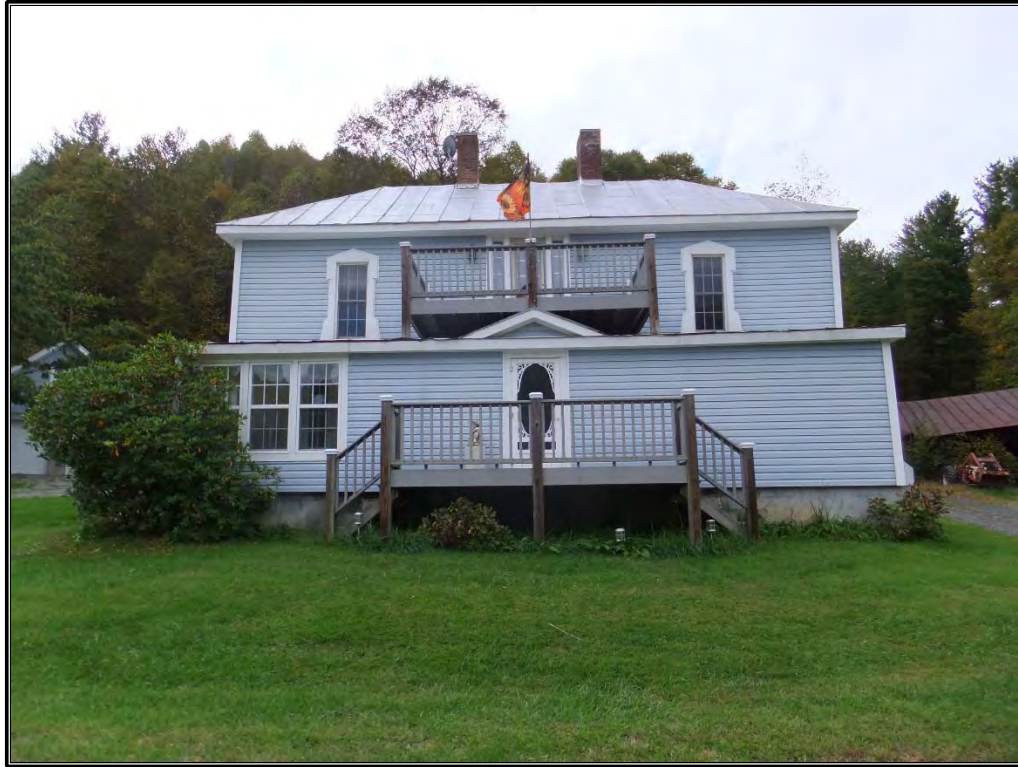
Figure 51. View of the façade of the Frank Edwards House (circa 1900), facing west.

House, exterior: The circa 1900 Frank Edwards House is comprised of two original sections: a hipped front section and a hipped rear T section. The front section features a full-width enclosed front porch and the rear T section features an enclosed side porch. The ridgeline of the front section is pierced by two central interior brick chimneys (Figure 51). An additional exterior parged concrete block flue extends from the south elevation of the rear T portion of the house. Windows throughout the house feature one-over-one-light, double-hung vinyl replacement sashes with muntins affixed to simulate six-over-six-light arrangement. All of the window surrounds, including the unique original angled surrounds on original windows, are clad in aluminum (Figure 52).

The façade is dominated by a full-width one-story front porch and two decks: one deck on the first floor and one deck above the enclosed porch on the second floor. The central façade entry is comprised of a single-leaf recessed entry with a replacement door; a decorative storm door encloses the recessed entry vestibule. A metal-clad shed roof with a small front-gable above the entry shelters the enclosed porch. The façade entry opens to a deck that features composite decking, a simple balustrade, and stairs on the north and south ends that connect the porch to the yard. A bank of three windows is located at the southern end of the enclosed porch. The second story of the façade is dominated by a raised square deck that features square posts and composite decking and balustrade. A central single-leaf door flanked by sidelights provides access to this porch. Single windows with aluminum-clad surrounds are centered on either side of the second-floor entry.

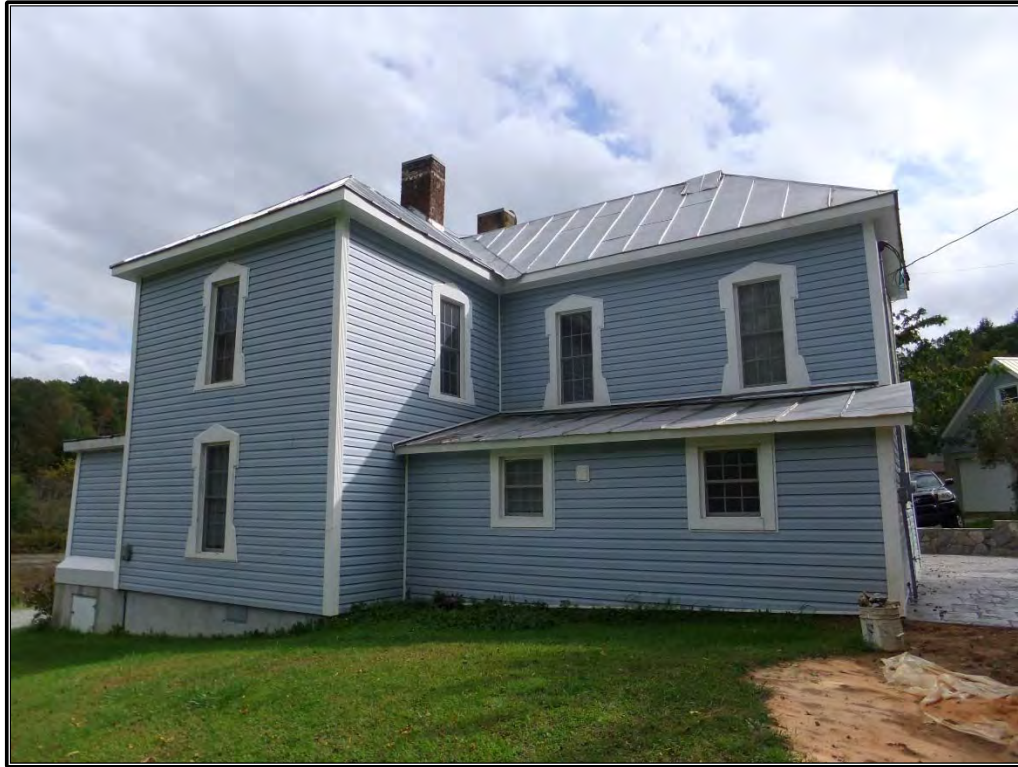
Figure 53. View of the north (side) and west (rear) elevations of the Frank Edwards House, facing southeast.

The north, or side, elevation features two windows with aluminum-clad decorative surrounds centered on the first and second floors of the front portion of the house (Figure 53). The house also features two similar windows on the second floor of the rear T portion of the house. Two smaller windows with wide aluminum surrounds are located on the north elevation of the enclosed porch that extends from the rear T portion of the house. A metal-clad shed roof shelters the one-story enclosed side porch. There are no openings on the north elevation of the front enclosed porch.

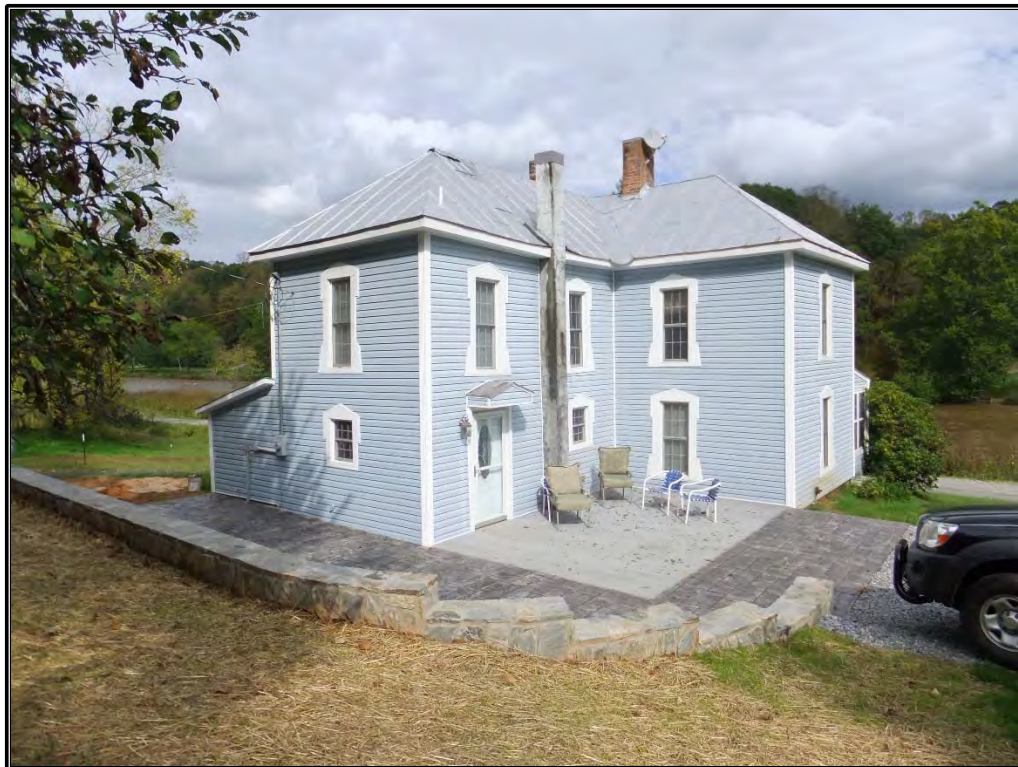
Figure 54. View of the west (rear) and south (side) elevations of the Frank Edwards House, facing northeast.

The west, or rear, elevation of the Frank Edward House features two windows centered on the first and second floors of the rear T portion (Figure 54). The first-floor window has been replaced with a smaller window than the original window, as seen in the previous survey photos. The rear elevation of the north-south portion of the house features single windows on the first and second floors to the right of the rear T portion; the rear elevation of the front portion of the house also features a single window centered on the second floor to the left of the rear T portion of the house, above the enclosed side porch (see Figure 52).

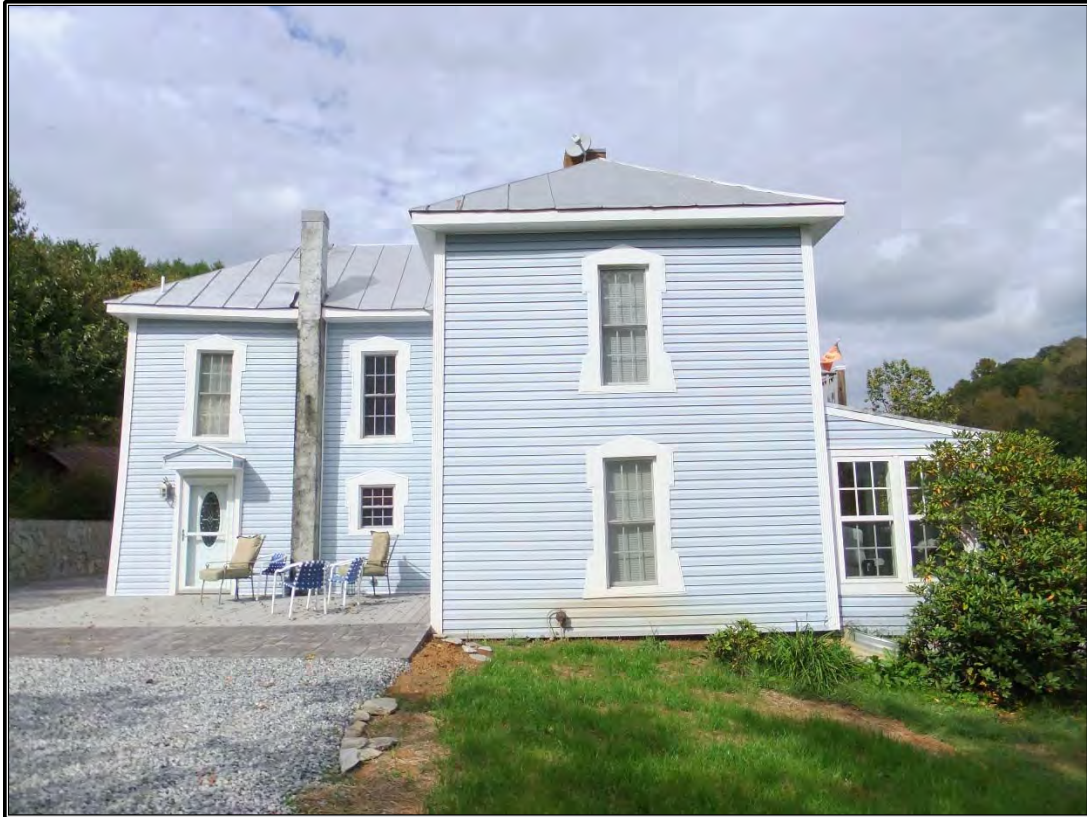
Figure 55. View of the south (side) elevation of the Frank Edwards House, facing north.

The south, or side, elevation of the Frank Edwards House is bisected by an exterior parged concrete block chimney that pierces the eave of the hipped roof (Figure 55). An off-center single-leaf rear entry with a replacement hollow-core door and storm door is located to the left of the stack. A front-gabled awning clad in metal sheeting with vinyl siding on the gable end shelters the rear entry; it opens to a composite board and stamped concrete patio that wraps the rear of the house. A small window, which has been altered from its original size, is located to the right of the chimney stack on the first floor of the rear T portion. Two windows with aluminum-clad surrounds are centered above the first-floor openings. The south elevation of the north-south portion of the house features single windows centered on the first and second floors. A pair of vinyl windows is located on the south elevation of the enclosed front porch.

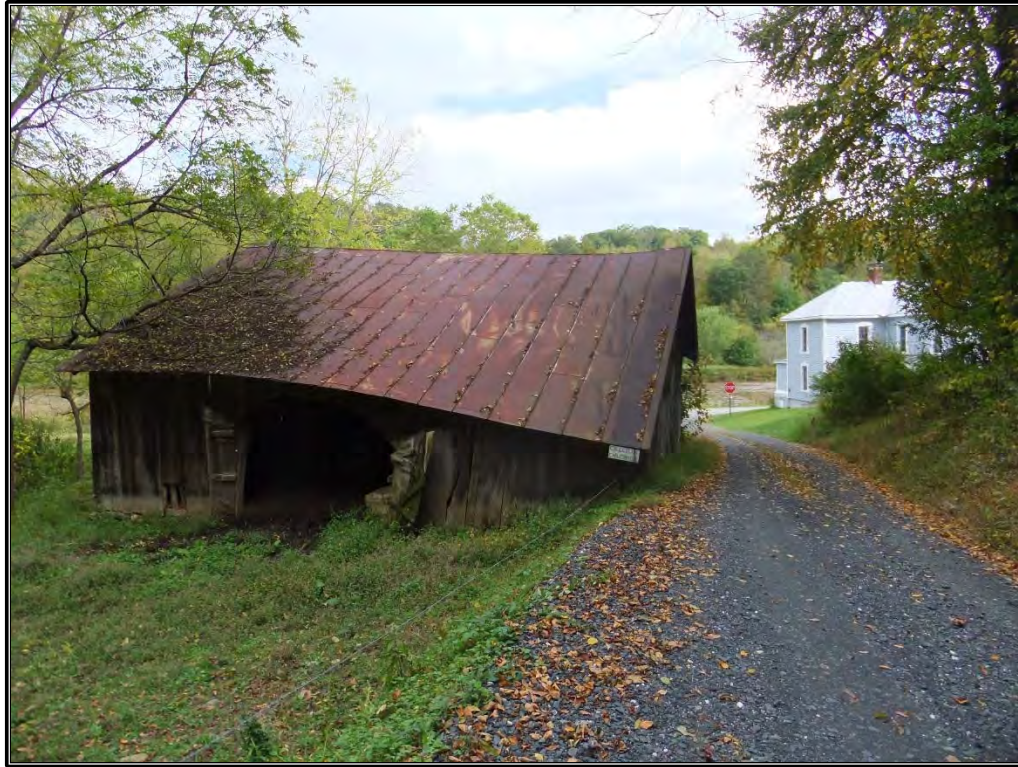
Figure 56. View of the rear of the barn and the Frank Edwards House on either side of Martin Gambill Road, facing east-southeast.

Barn: The circa 1900 side-gable barn formerly associated with the Frank Edwards House is located approximately 85 feet northwest of the rear of the house, on the north side of Martin Gambill Road (Figure 56). The one-story frame barn is set upon a concrete foundation, features frame construction clad in vertical-board siding, and is sheltered by a low-pitched, wide side-gable roof clad in metal panels (Figure 57). The interior of the barn features a central passage with a rounded arch entry flanked by pens on either side (Figure 58). The east elevation of the barn features a one-story, one-bay frame addition clad in vertical-board siding and sheltered by a metal-clad roof (see Figure 57). The southwest corner of the barn, set just off of the ROW of Martin Gambill Road, is failing and the roof does not appear to be well-supported (see Figure 56).

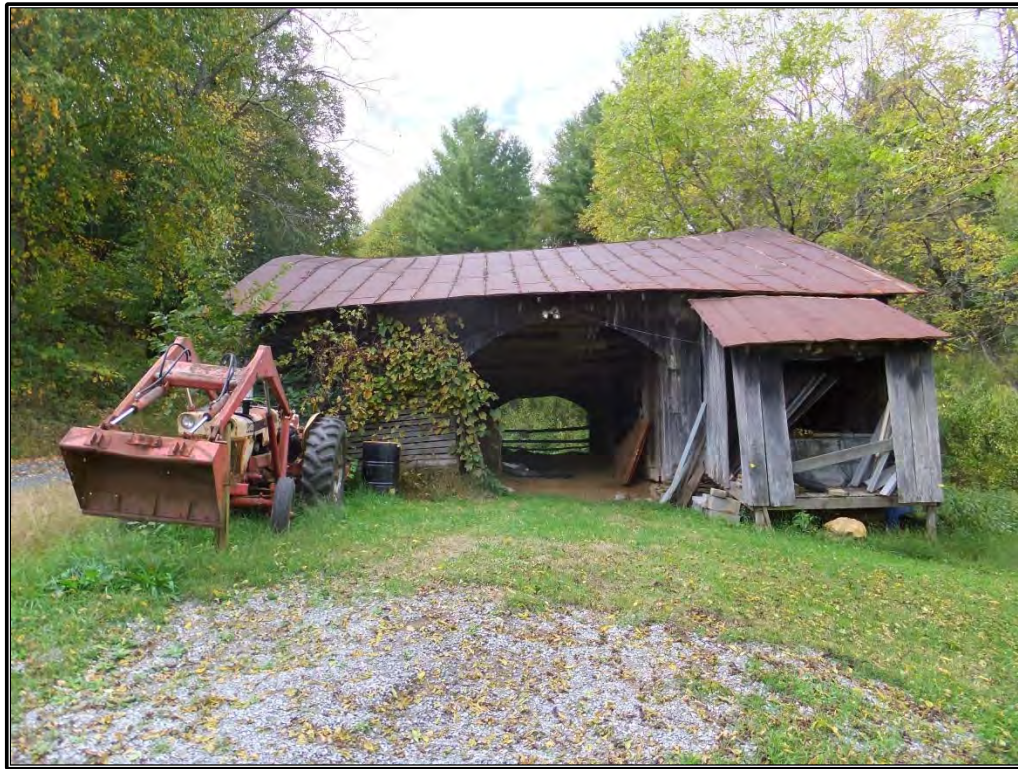
Figure 57. View of the east elevation of the barn, facing northwest.

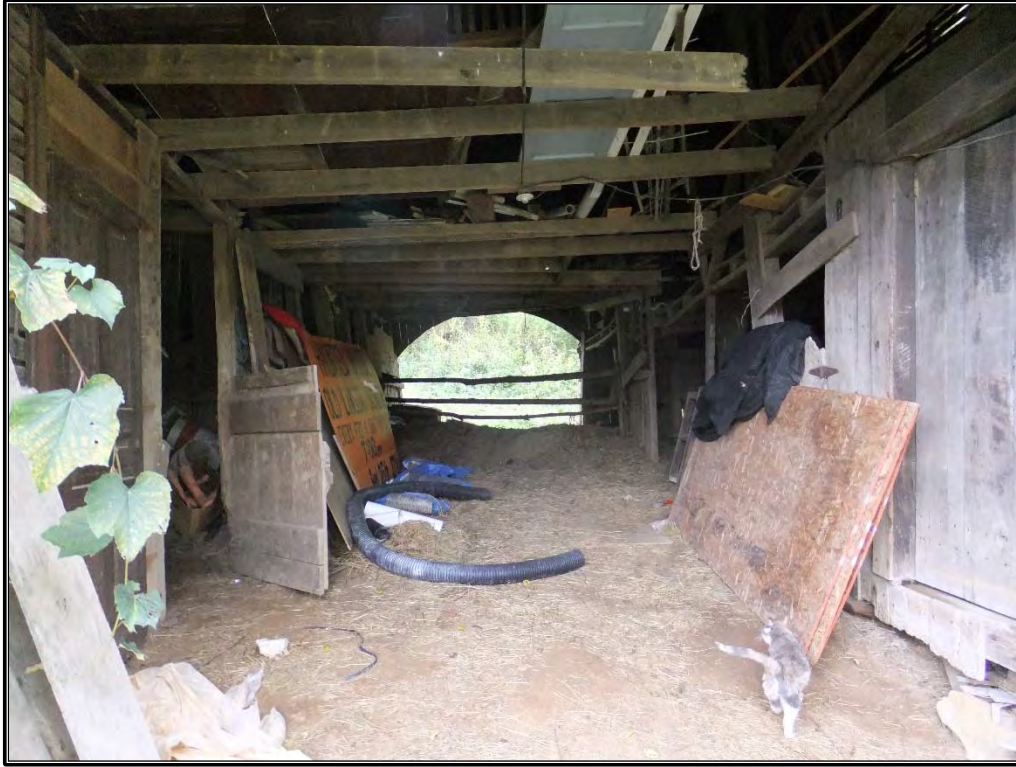
Figure 58. View of the interior of the barn, facing northwest.

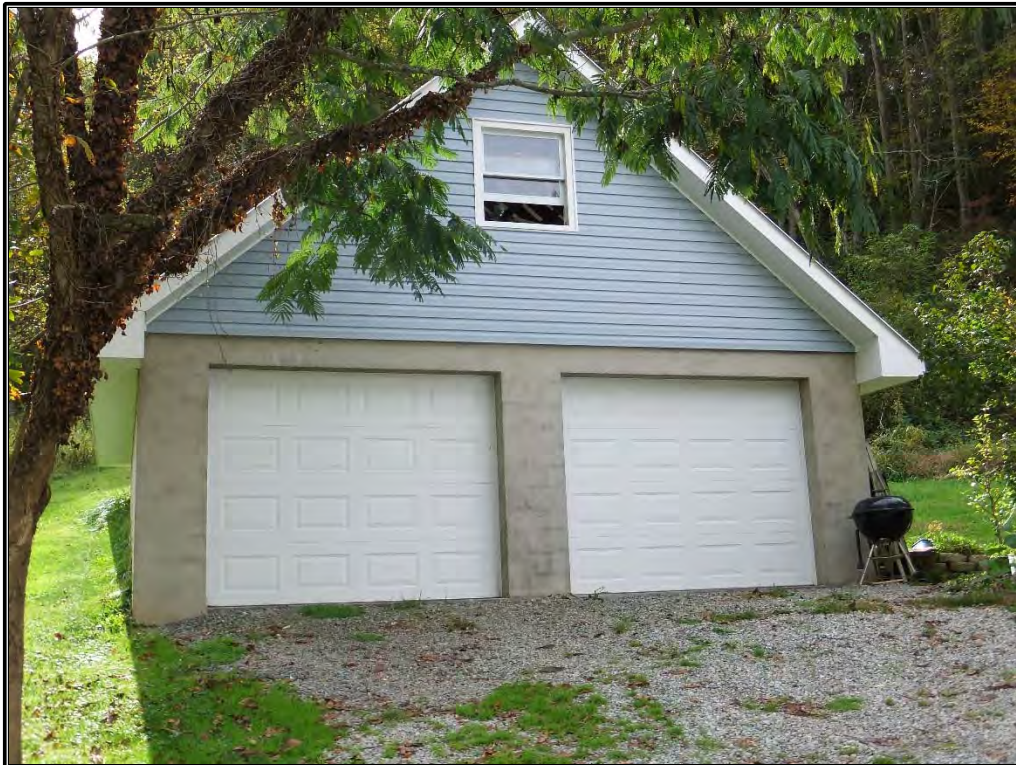
Figure 59. View of the façade of the modern barn, facing southwest.

Modern Garage: A modern, circa 2005–2010 garage is located approximately 70 feet southwest of the Frank Edwards House. A gravel driveway connects the garage to the house and Garvey Bridge Road. The one-and-one-half-story, front-gable garage is set into a slope and features parged concrete block construction on the first floor (Figure 59). Each of the two garage bays feature paneled overhead garage doors. The gable end of the metal-clad front-gable roof is clad in vinyl siding; a single window with one-over-one-light, double-hung vinyl sashes is centered on the gable end.

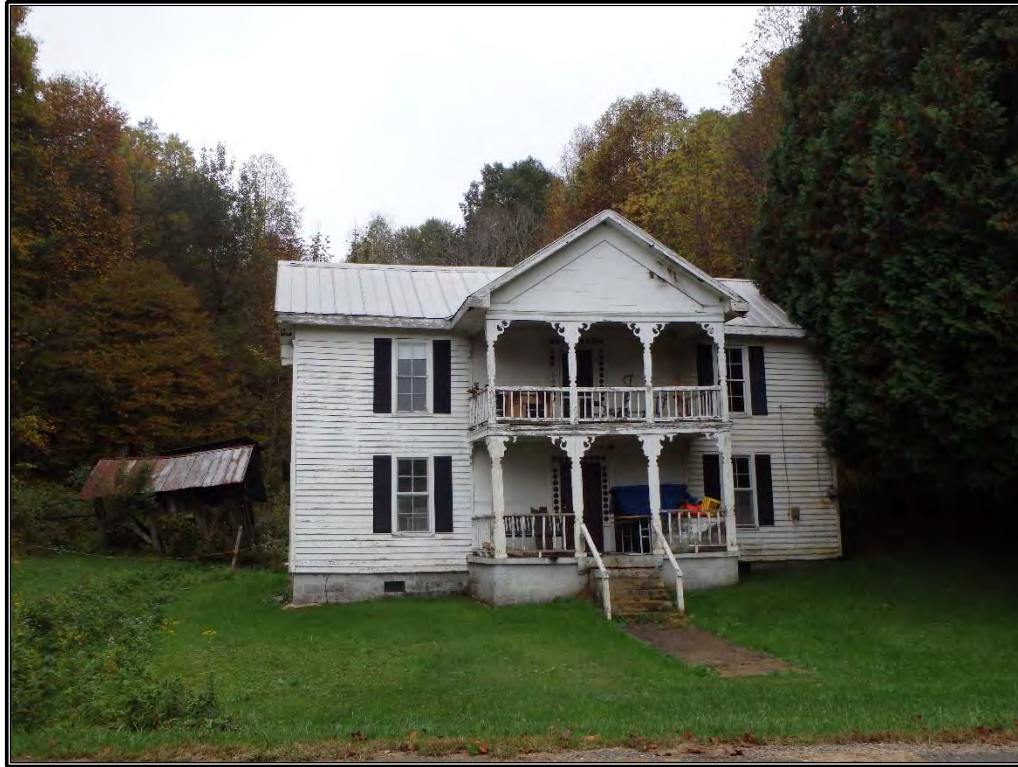
Figure 60. View of façade and porch of the Jackson Howell House (AH0402) on Silas Creek Road, facing south.

The Frank Edwards House is a T-plan vernacular housing form constructed around 1900. The house utilizes a general two-story, linear I-House form with a rear T that is original to the design of the house. The house is one of several houses dating to the turn of the twentieth century in the vicinity that reflects similar forms and details, including the Jackson Howell House (AH0402) on Silas Creek Road (Figure 60) that features façade entries on both the first and second floors and windows with four-over-four-light, double-hung sashes that the Frank Edwards House featured prior to recent renovations, and the house associated with the Study-Listed Joel Walters Farm (AH0517) at 828 Don Walters Road that features a hip roof and Queen Anne form and dates to the same period as the Frank Edwards House (Figure 61). Because there are other houses that feature similar form and trim and retain a higher degree of integrity of design, materials, and workmanship within the vicinity of the Frank Edwards House, it cannot be considered a particularly unique property type within its local setting.

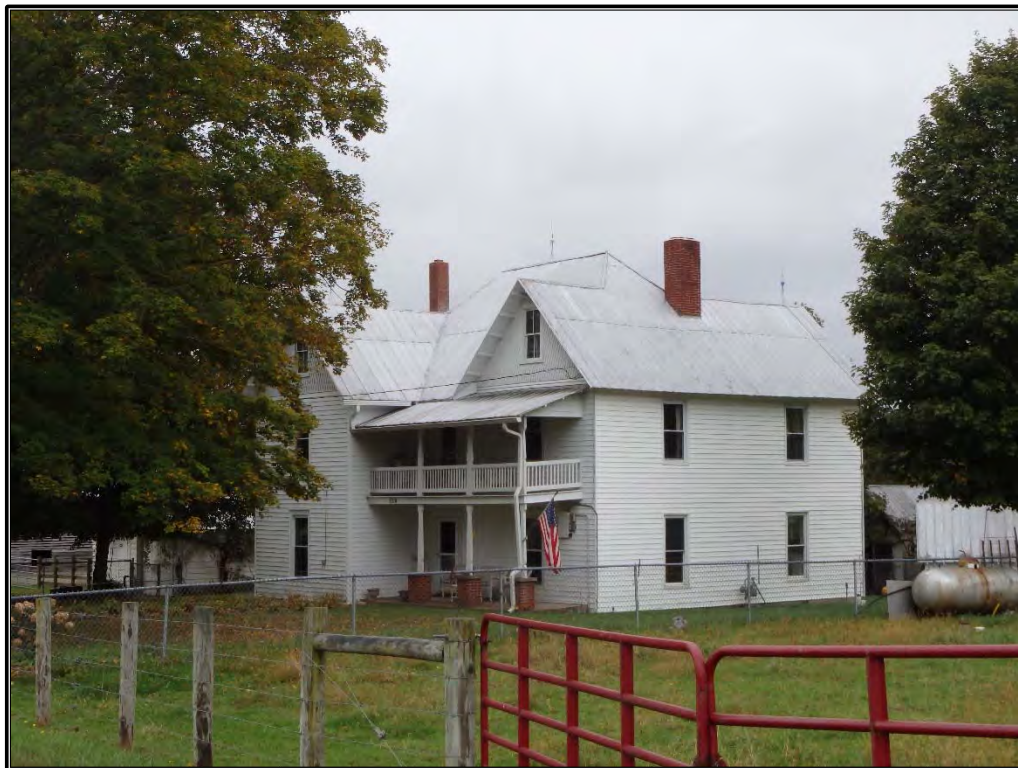
Figure 61. View of the house associated with the Joel Walters Farm (AH0517) at 828 Don Walters Road, facing southeast.
