North Carolina Department of Natural and Cultural Resources
State Historic Preservation Office

SUBJECT: C. F. Harvey Parkway Extension (NC 148), Four-Lane Divided Freeway on New Location, R-5703, NCDOT WBS No. 46375.1.1, Lenoir County, ER 16-0449

Figure 2. Area of Potential Effects, outlined in red, and property locator map

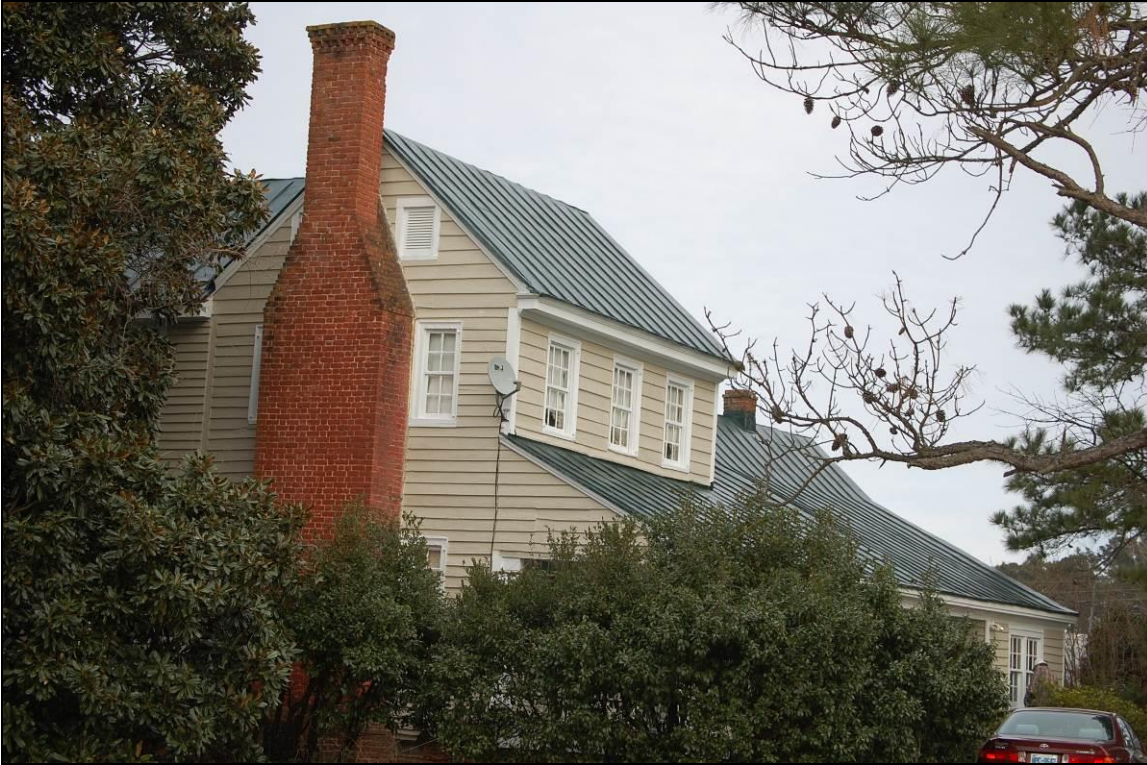
Figure 5. Rountree-Askew-Moseley House, west side and south front elevations

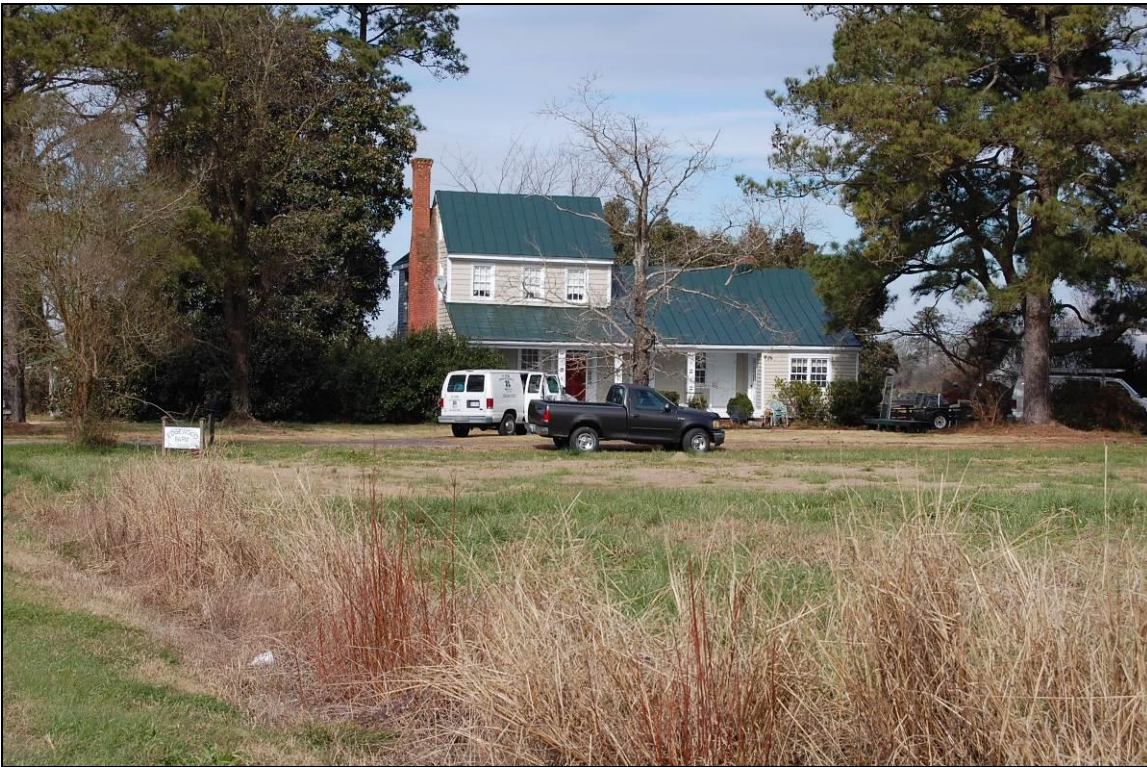
Figure 6. Rountree-Askew-Moseley House, south front elevation

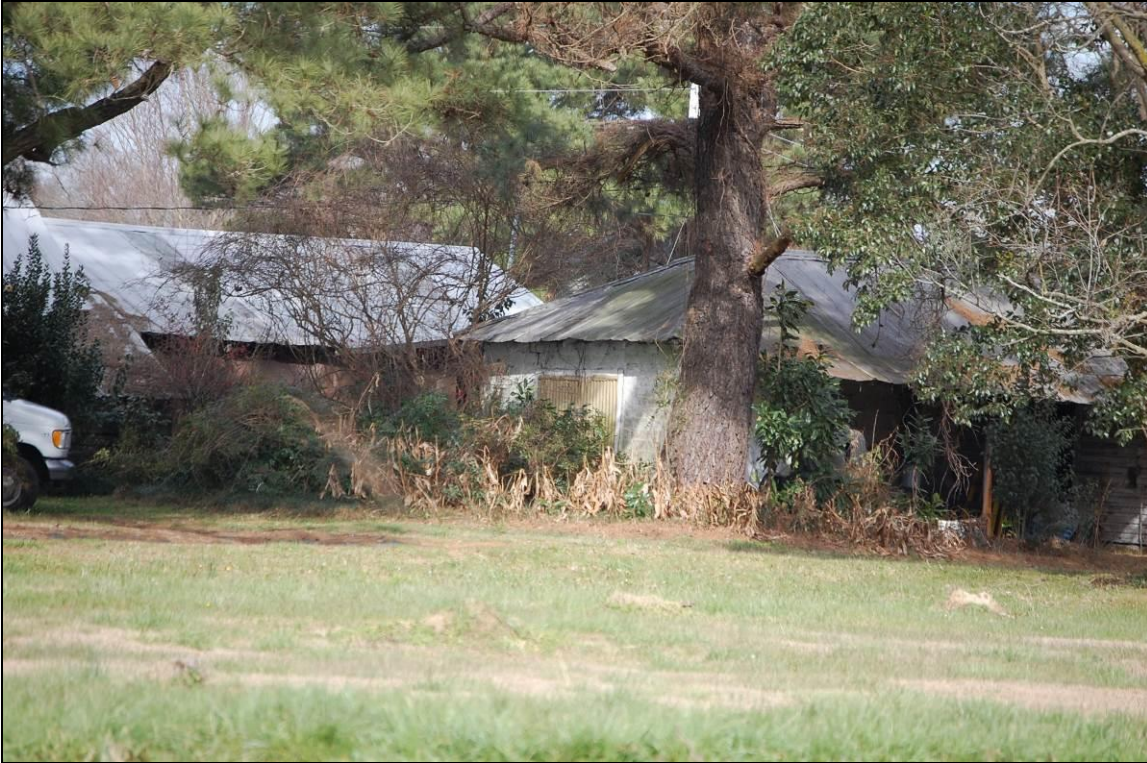
Figure 7. Looking northeast from south of house at concrete-block milkhouse

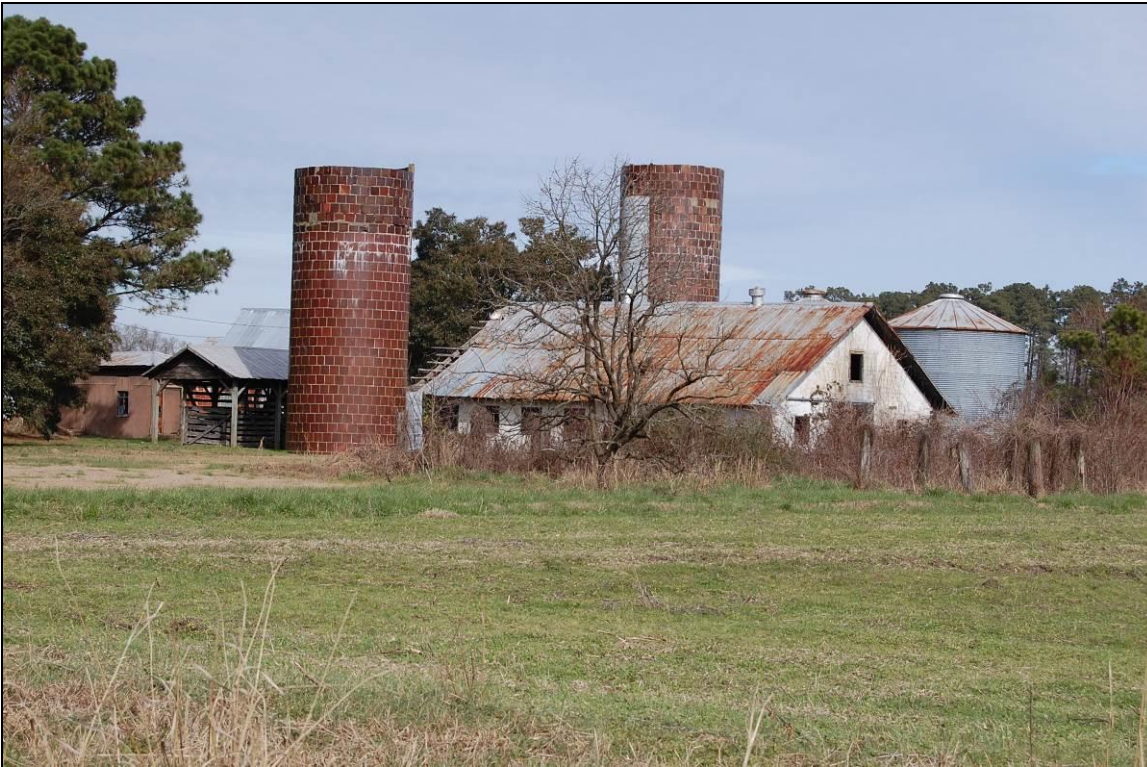
Figure 8. Looking northeast from south of house at small open shed at left, dairy barn at center, and silos at center and right

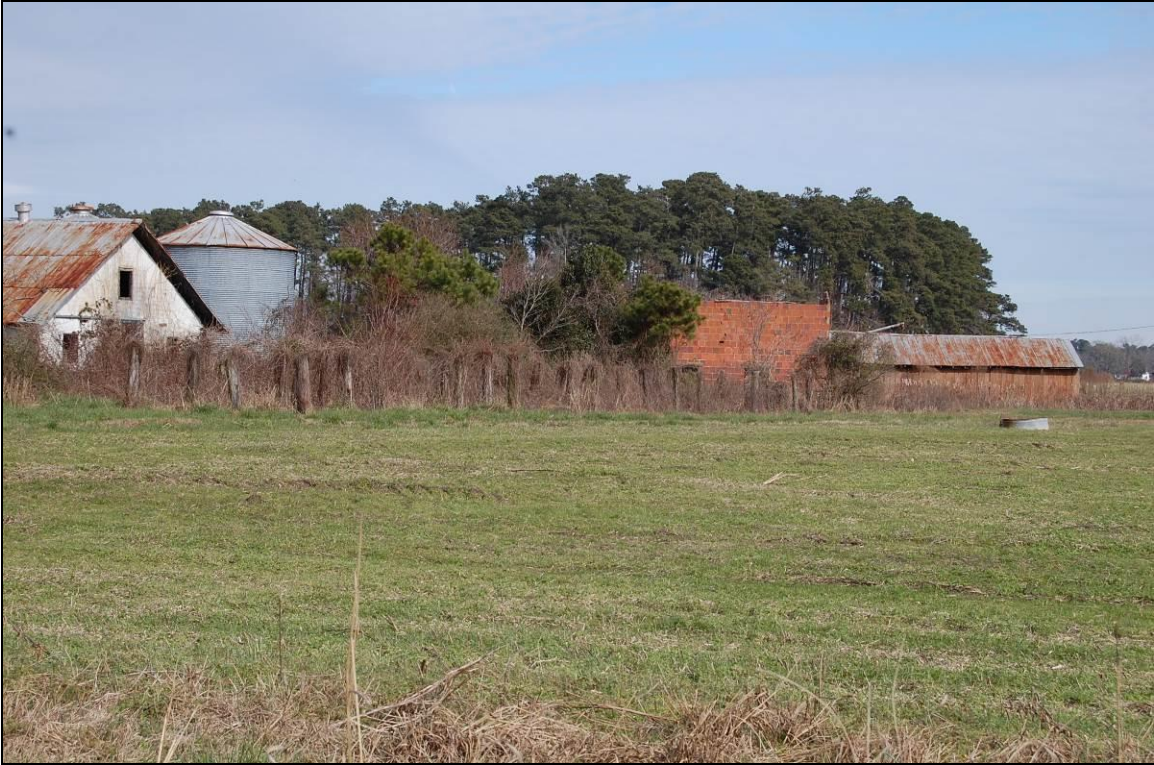
Figure 9. Looking east from south of house at dairy barn and silo at left, clay-tiled walls of roofless tobacco barn at center, and shed at far right

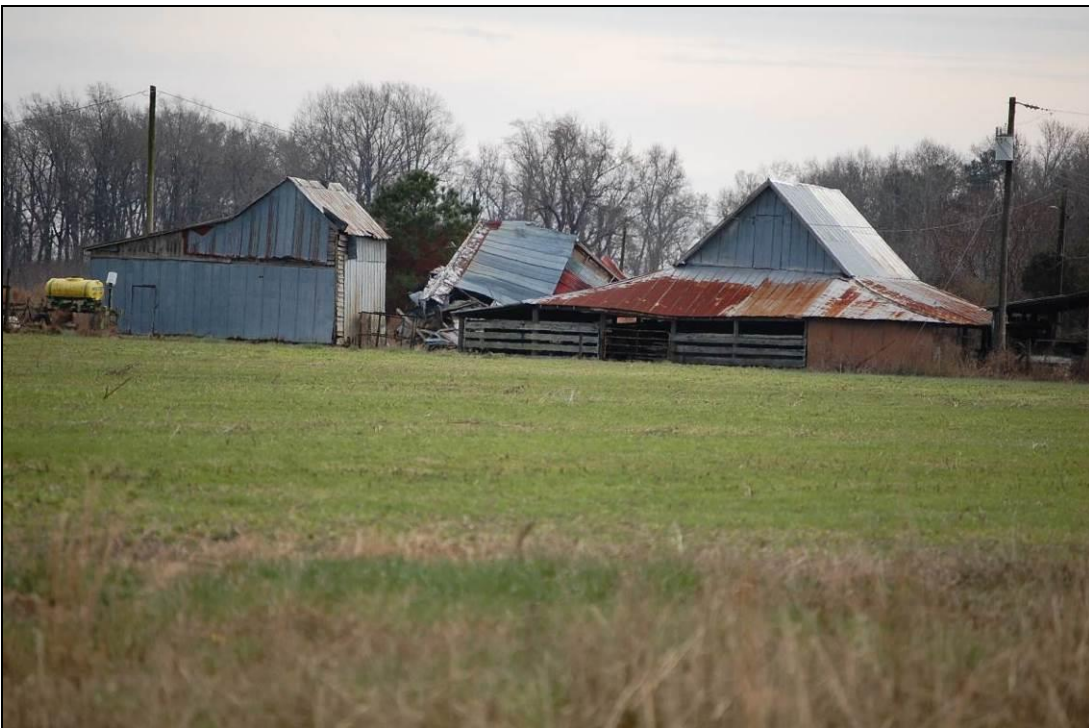
Figure 10. Looking southeast from north of house at cotton gin at left, collapsed tobacco barn at center, and mule barn at right

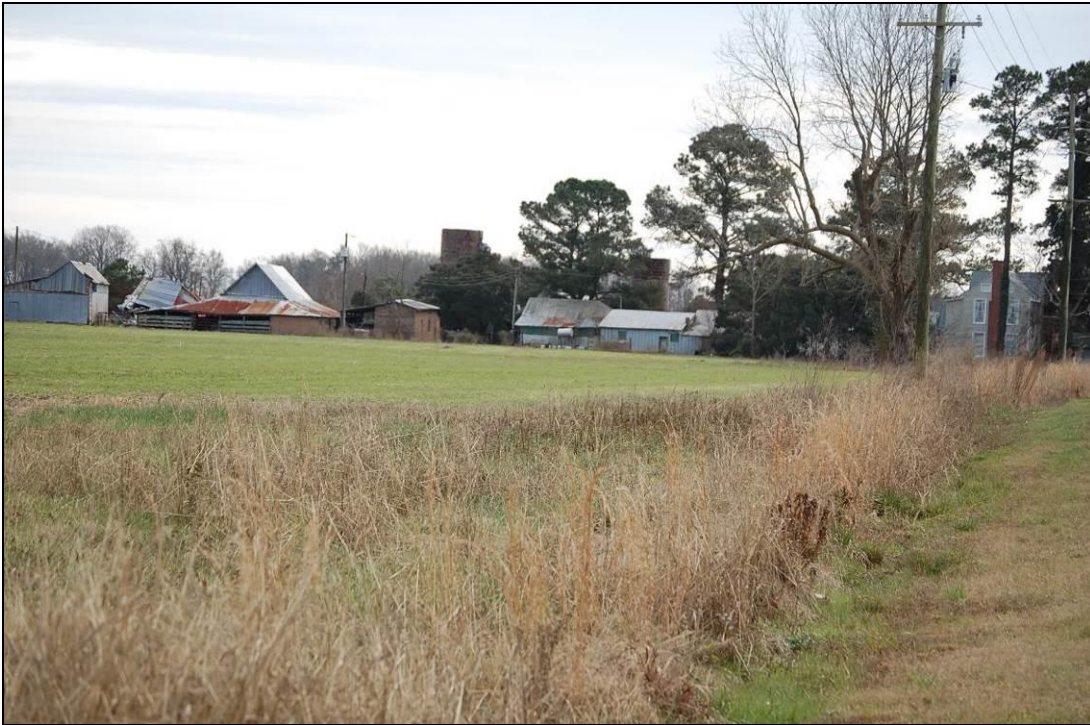
Figure 11. Looking southeast at cotton gin, tobacco barn, and mule barn at left, handyman house and smokehouse at center, and north side elevation of house at far right

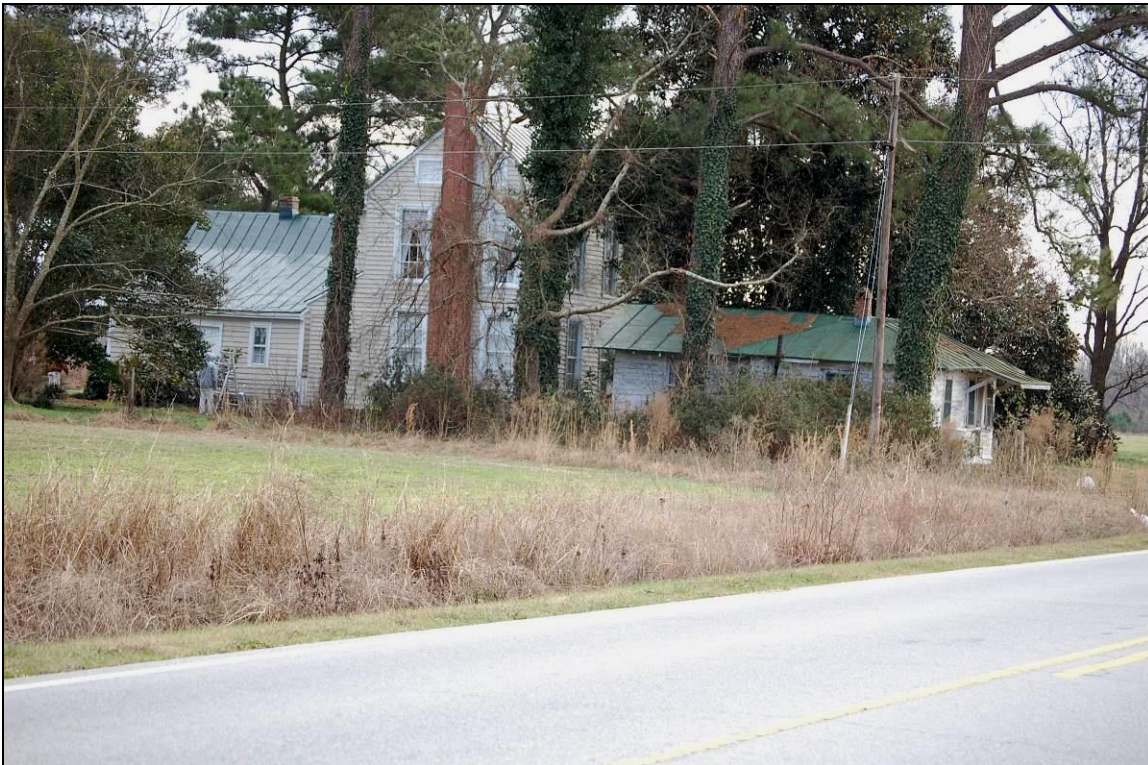
Figure 12. Looking southeast from NC 58 at house at left and tenant house at right

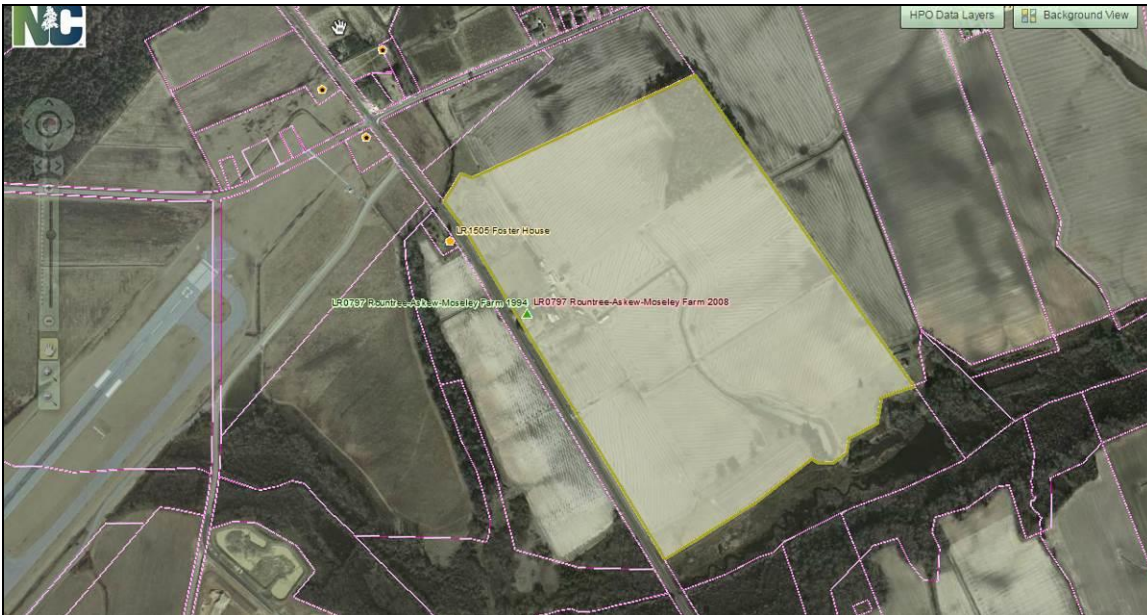
Figure 13. NRHP-eligible boundaries of Rountree-Askew-Moseley Farm at center; note Kinston Regional Jetport runway at left (source: HPOweb)

The draft National Register nomination boundaries, and the HPO website, identify the Rountree-Askew-Moseley Farm's NRHP-eligible boundaries as that of its parcel, 4528-12-9597, which encompasses 132.93 acres (Figure 13). This parcel, as marked on county tax maps, extends west up to the edge of the right-of-way of US 58. Its edge on the west is about 45 feet from the edge of pavement and excludes the NCDOT-maintained right-of-way and drainage of the road.

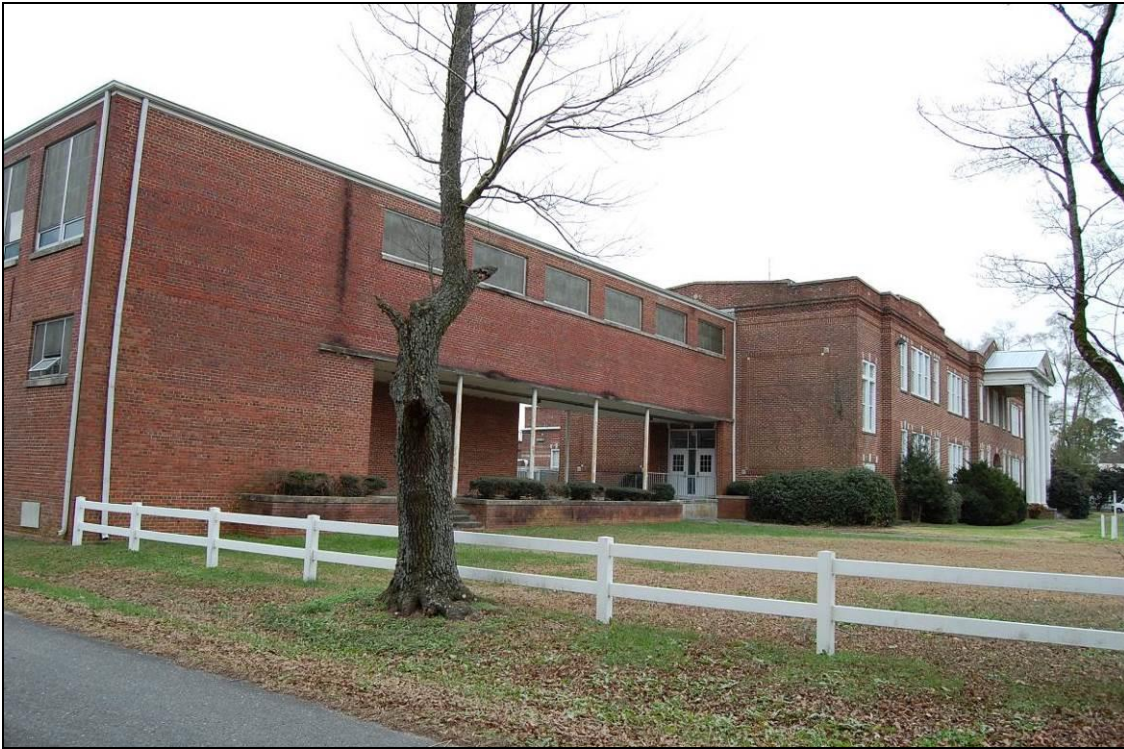
Figure 14. Southwest front and northwest side elevations of Contentnea School

In 1929 a two-story classroom wing was constructed on the south facade and attached with a two-story breezeway. Another wing, housing agricultural arts, was built in 1950 on the north facade and mirrors the size and form of the first addition. A separate cafeteria was erected to the rear of the school in 1950 and connected with covered walkways. The school was enlarged with more classrooms in 1956, and a gymnasium was built on the campus in 1957. Two other buildings, a teacherage and a shop building (originally the agriculture building), are contemporary with the school. Around 1925 a Craftsman-style dwelling was erected on the south side of the campus to serve as the teacherage and later became the principal's residence. It is now used as a private dwelling. The circa-1925 shop building, located to the rear of the school building, is a one-story hip-roof brick structure with an interior end chimney.

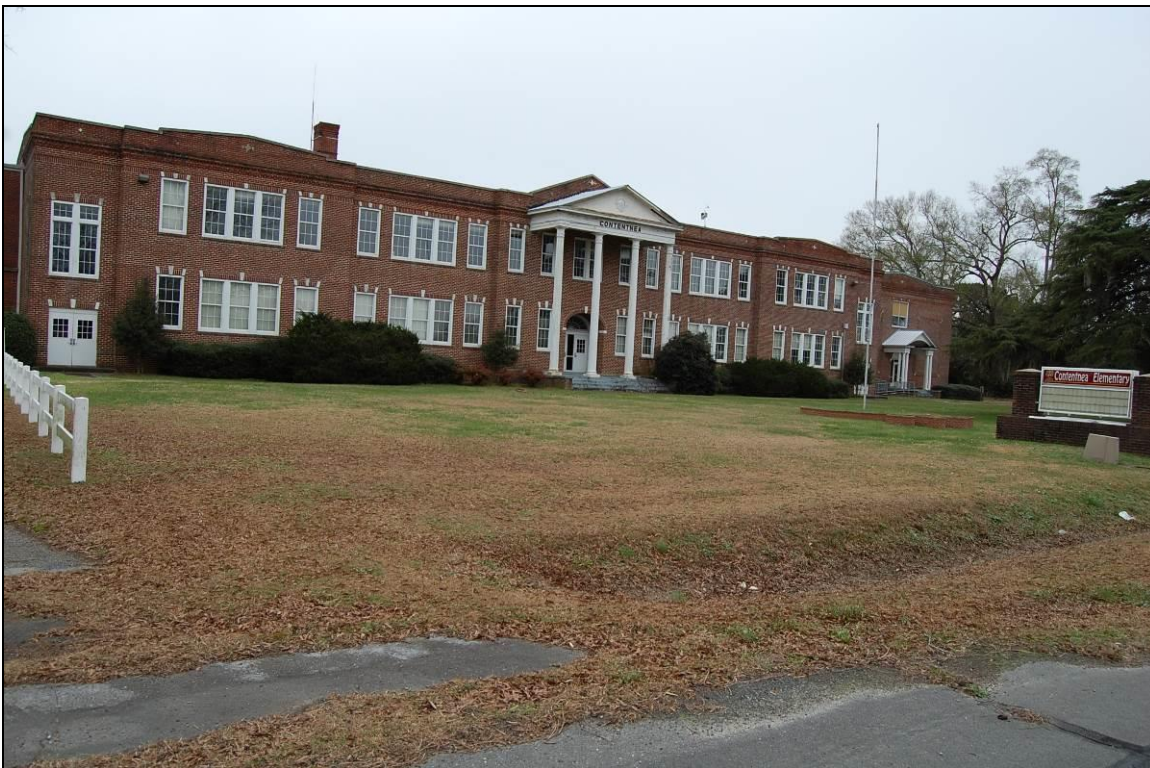
Figure 15. Southwest front elevation of original central block of Contentnea School

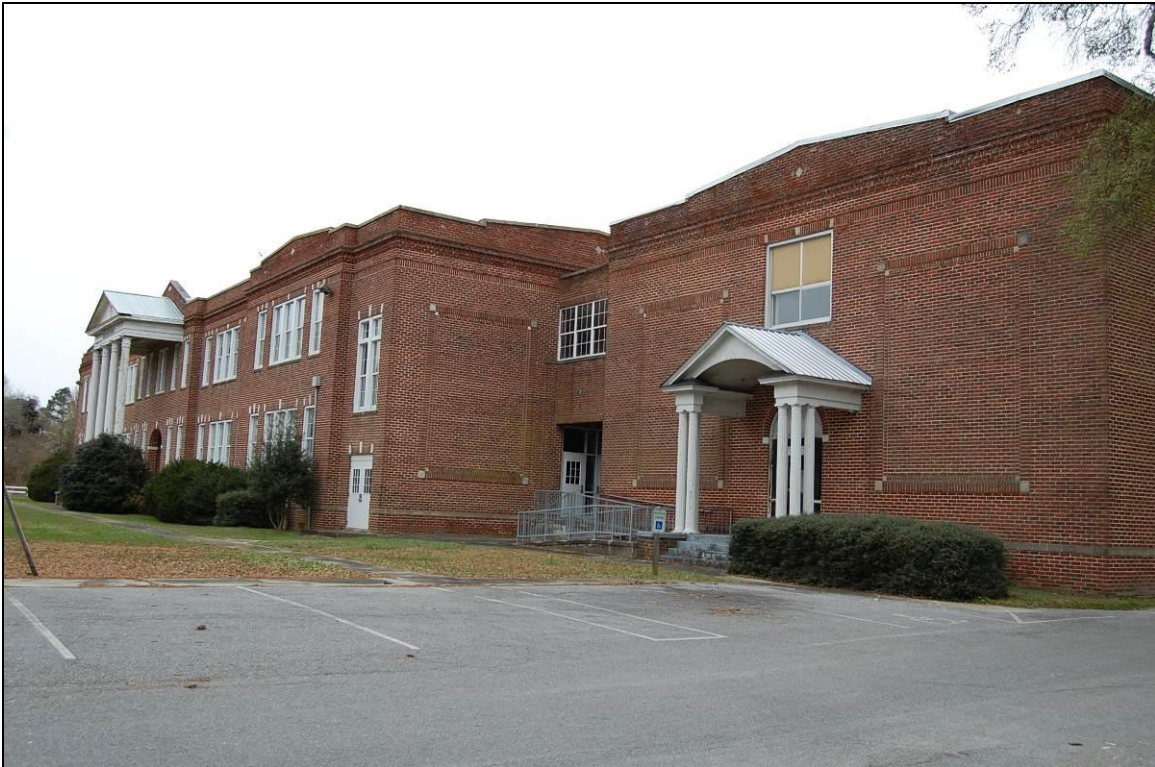
Figure 16. Southwest front and southeast side elevations of Contentnea school

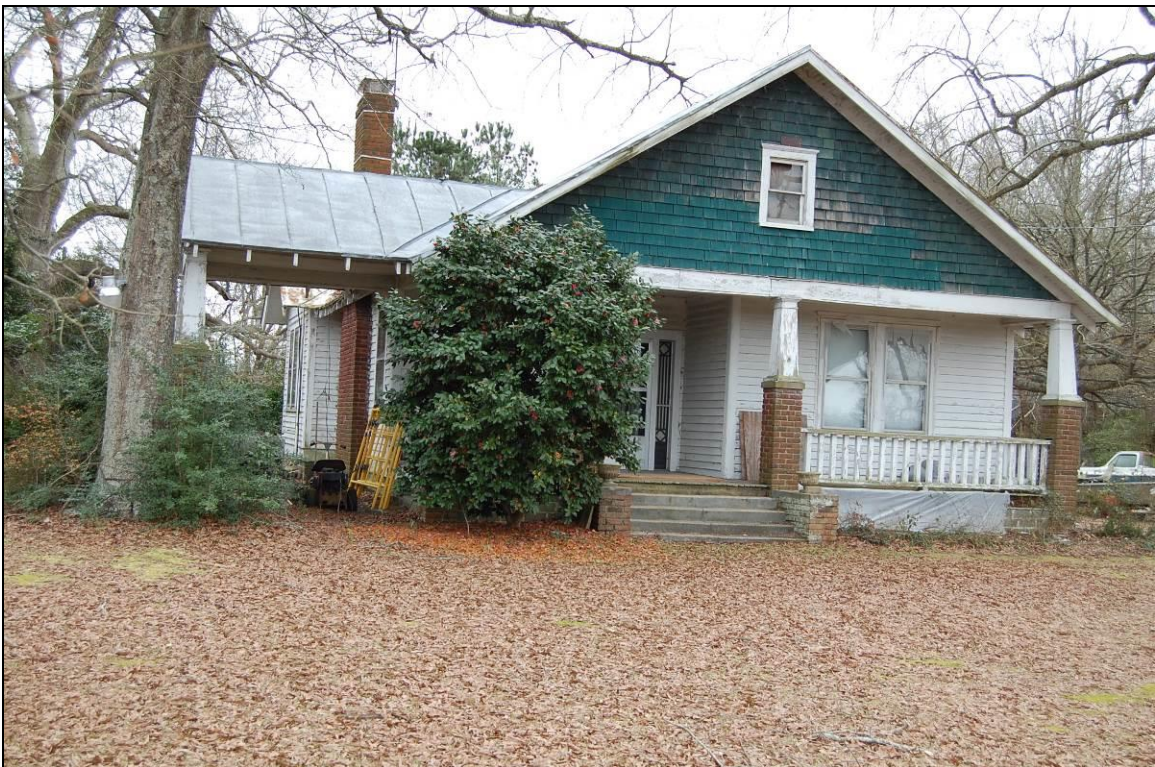
Figure 17. Southwest front and northwest side elevations of Contentnea School teacherage

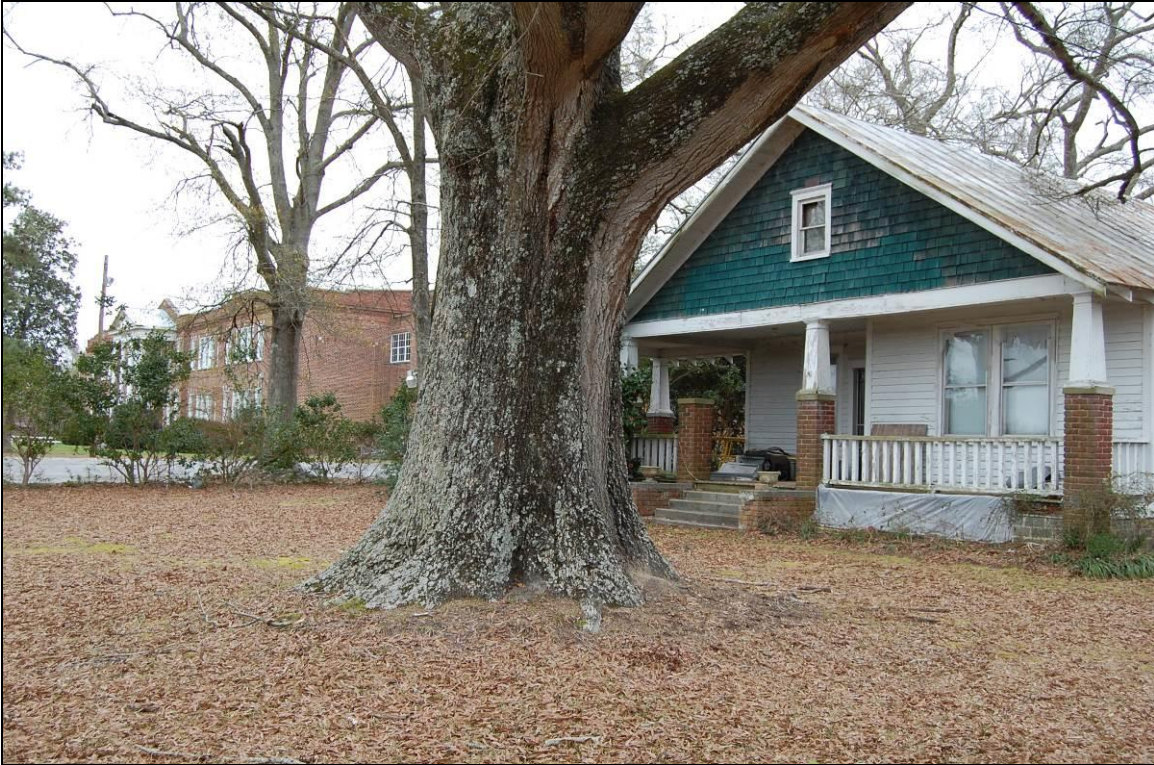
Figure 18. Looking west at southwest front elevation of teacherage, at right, and Contentnea School, at left

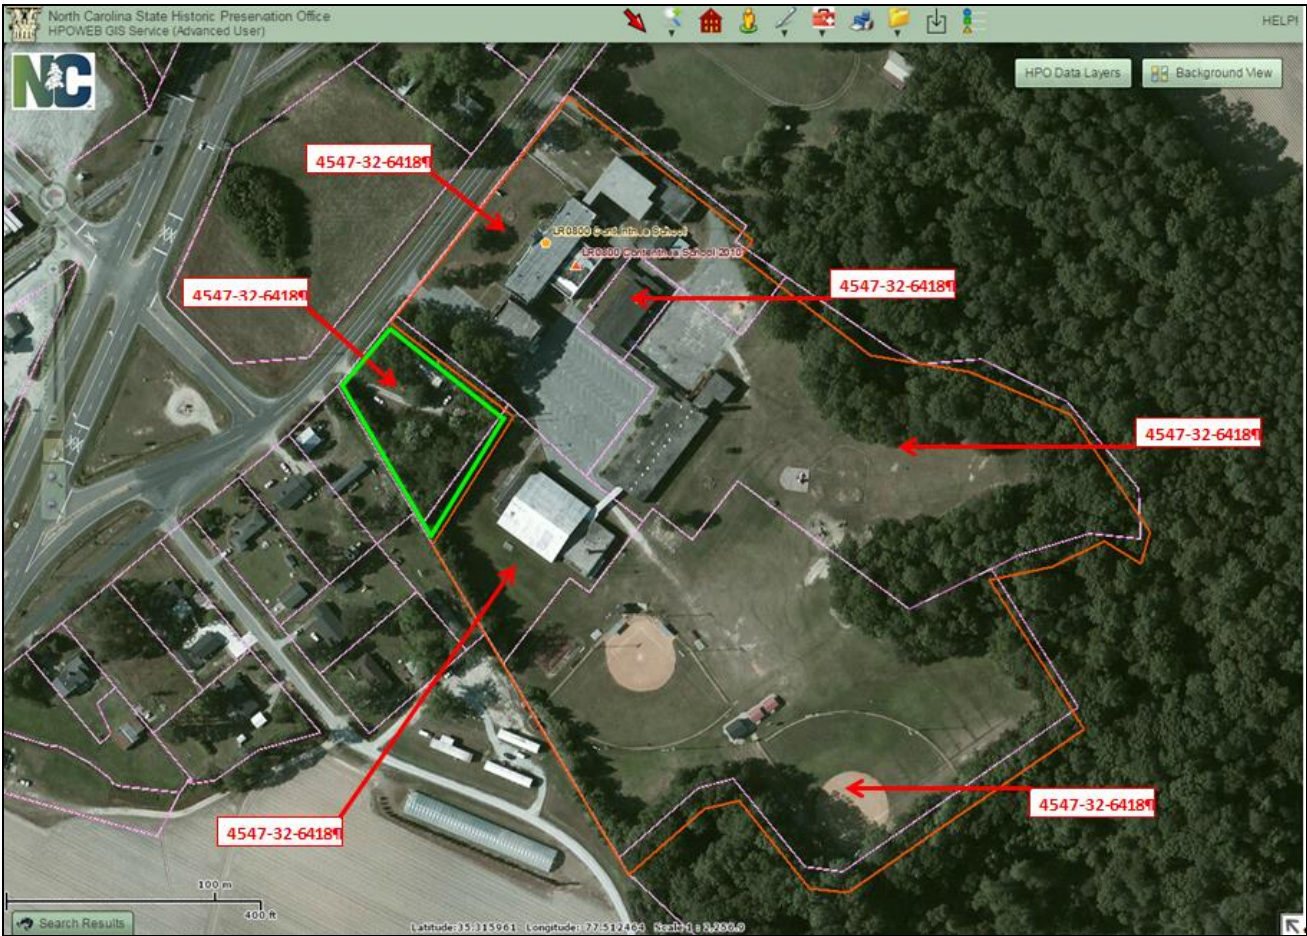
Figure 20. Contentnea School NRHP-eligible boundary as mapped by the HPO outlined in orange (with tax parcels outlined in purple); recommended extension of boundary to include teacherage outlined in green

It was not determined why the 1.0-acre teacherage parcel, #4547-32-8611, is not included on the HPO GIS website, but it is recommended that the boundaries be expanded to include this parcel, as indicated in green on Figure 20. The total boundaries of the NRHP-eligible Contentnea School would therefore encompass 19.46 acres. The two parcels that are parallel with Grainger Station Road, as marked on county tax maps, extend west up to the edge of the right-of-way of the road. Their edge on the west is about 25 feet from the edge of pavement and excludes the NCDOT-maintained right-of-way and drainage of the road.

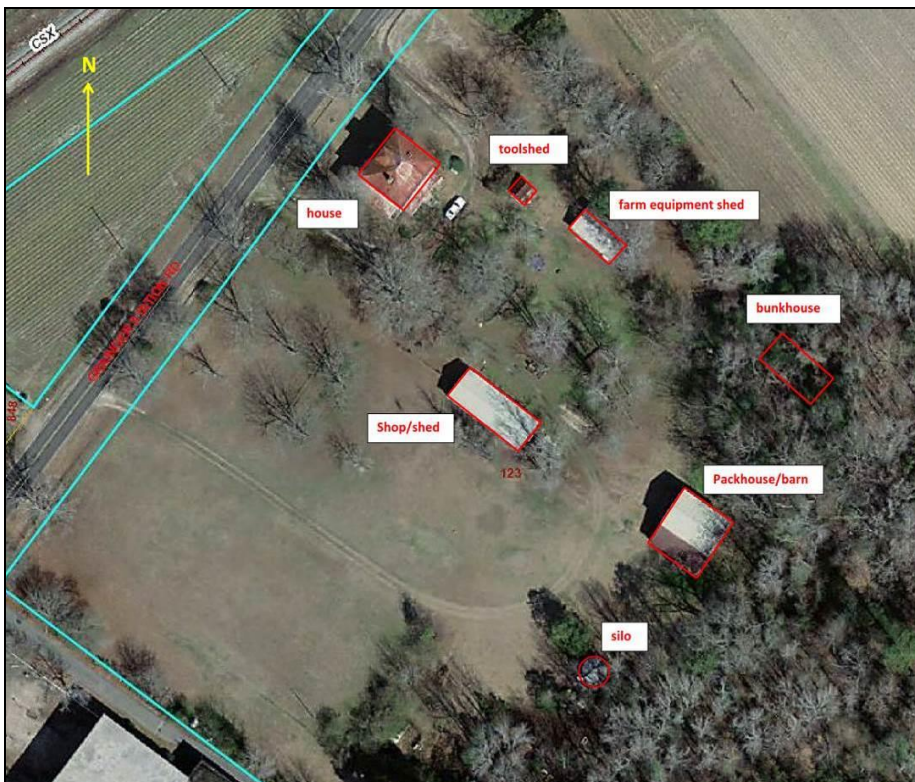
Figure 21. Charles A. Broadway House sketch map (base map: Lenoir County GIS)

The Charles A. Broadway House currently occupies a 203-acre parcel (Figure 21). The parcel was originally even larger. Broadway donated land to the southeast for the Contentnea School in the early 1920s. He also had additional landholdings in the area, some of which were likely contiguous (Broadway 2016). The current property includes extensive woodlands stretching south to Stonyton Creek. It also includes a large field at its northeast along Grainger Station Road that has been cultivated by renters for many years. (The portion of the 203-acre parcel located across Grainger Station Road contains two resources discussed later in this report, the Jesse W. Broadway House (LR0803) and the Graingers Railroad Section House (LR0804).) The Charles A. Broadway House and its six associated resources are located on the northwest corner of the parcel, adjacent to Grainger Station Road and the Contentnea School property.

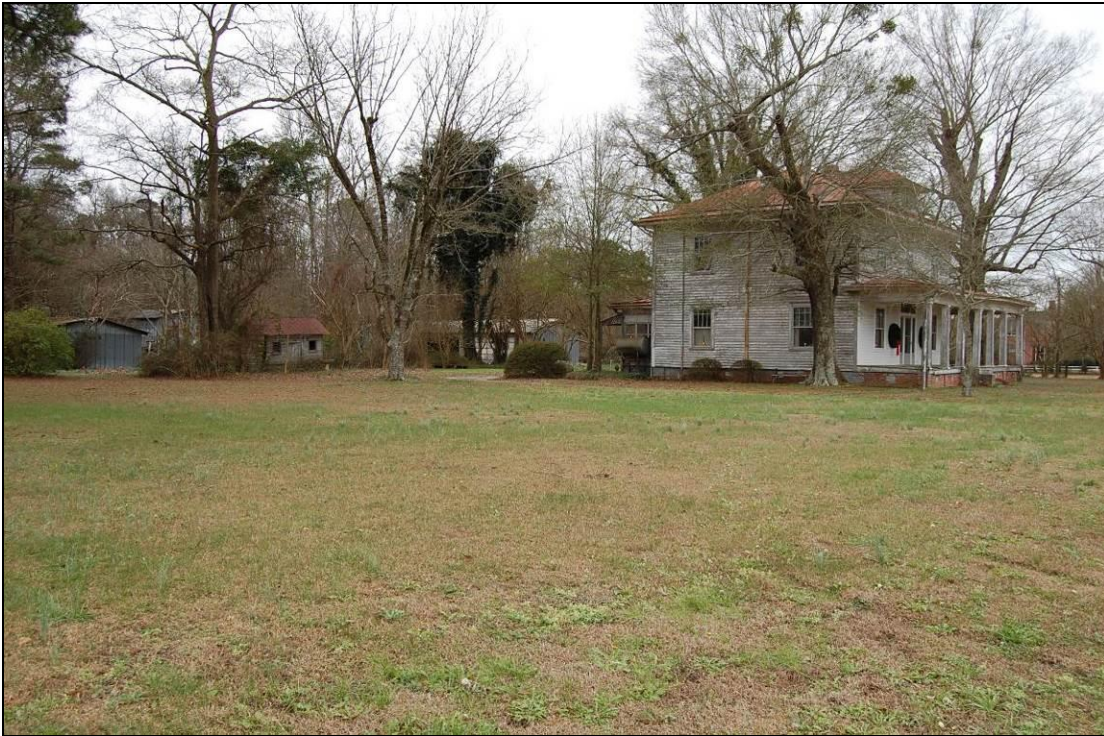
Figure 22. Looking south from Grainger Station Road at farm equipment shed and packhouse/barn, at far left; toolshed at left center; shop/shed at center; and Charles A. Broadway House at right

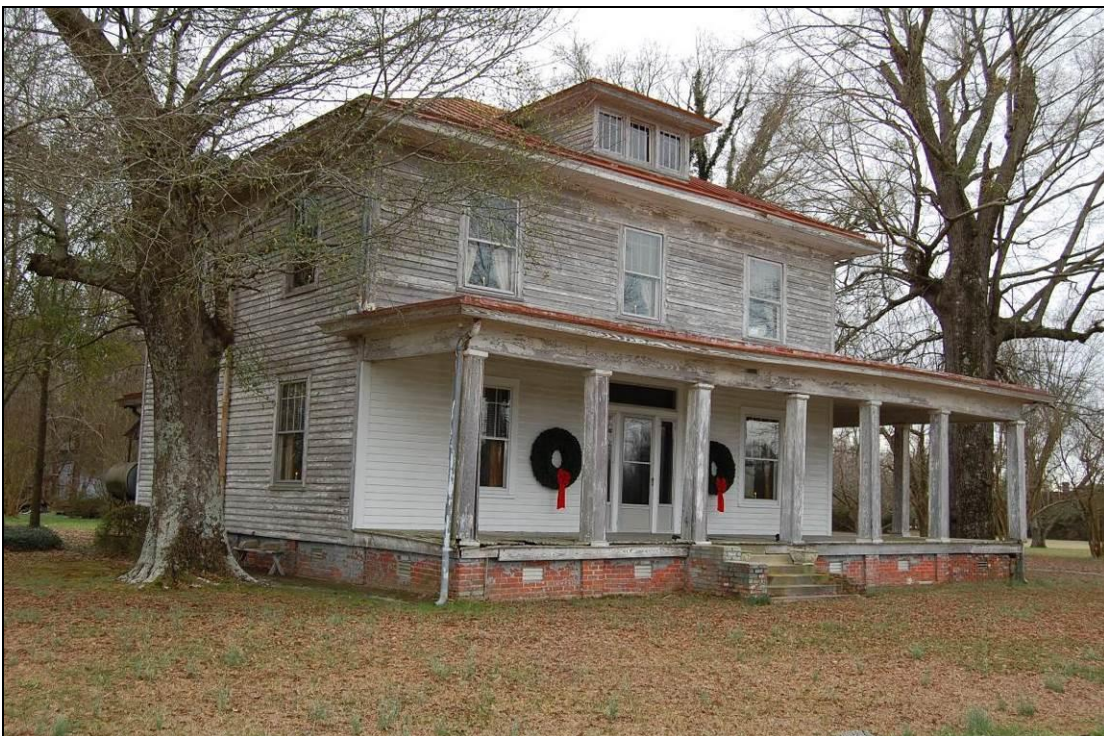
Figure 23. Charles A. Broadway House, northeast side and northwest front elevations

The house is an excellent and little-altered example in Lenoir County of an American foursquare (Figure 22 through Figure 27). It is a square, two-story, double-pile, frame building that is sided by

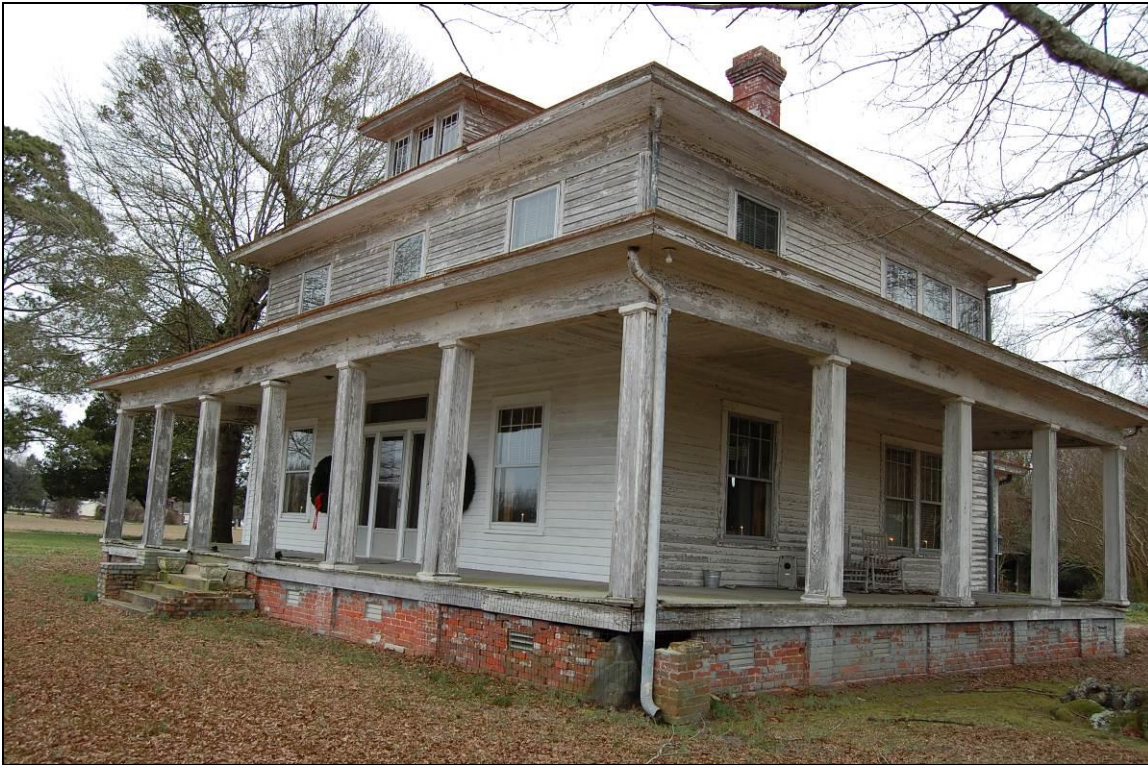
Figure 24. Charles A. Broadway House, northwest front and southwest side elevations

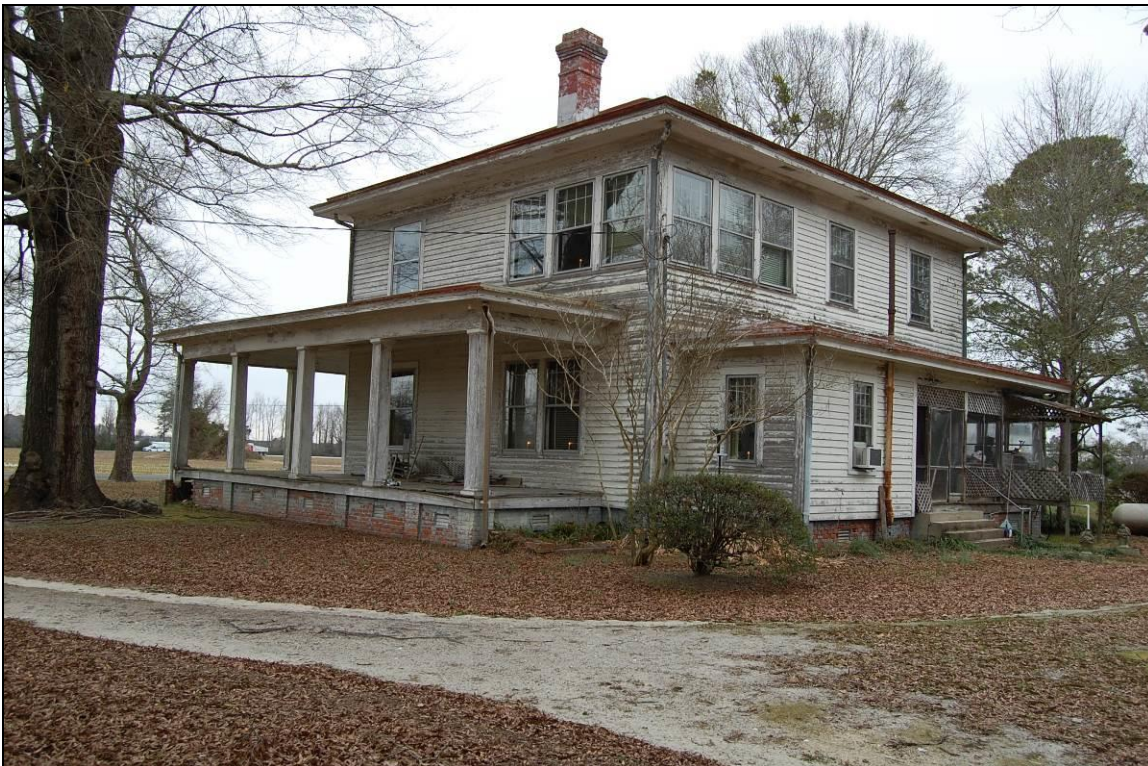
Figure 25. Charles A. Broadway House, southwest side and southeast rear elevations

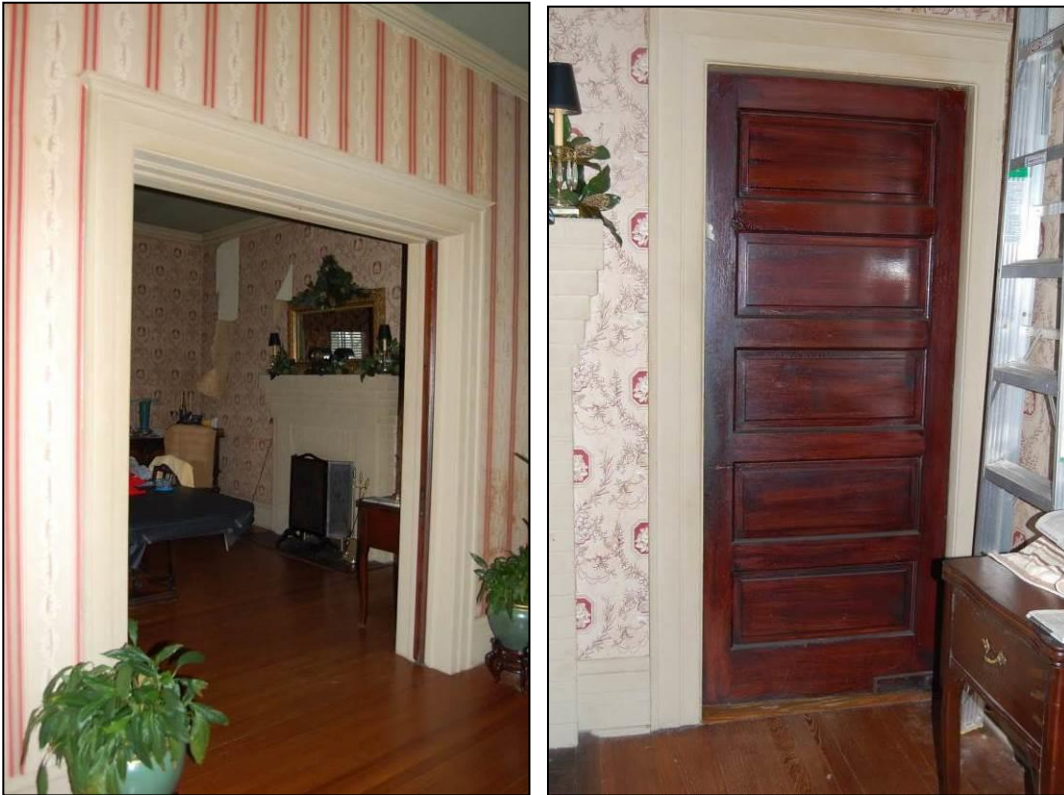
Figure 26. Charles A. Broadway House, looking from front west (right) parlor at pocket doorway into north (left) parlor; five-panel door from north parlor leading to rear rooms

The house's interior has two large rooms across its front and two rooms divided by a center hall behind. Its ceilings are 11-feet tall and its walls are plastered. The front rooms, which were available for viewing, include two brick mantels, large pocket doors, a five panel door, original push-button light switches, and molded baseboards, cornices, and surrounds. Access to the other portions of the house was not possible, but according to Little (1998:362) the finish is similar elsewhere, with an open stairway with newel post and balustrade, an original stairway leading from the second story to an attic, and three wooden mantels. Overall, both the interior and exterior of the house are remarkably intact.

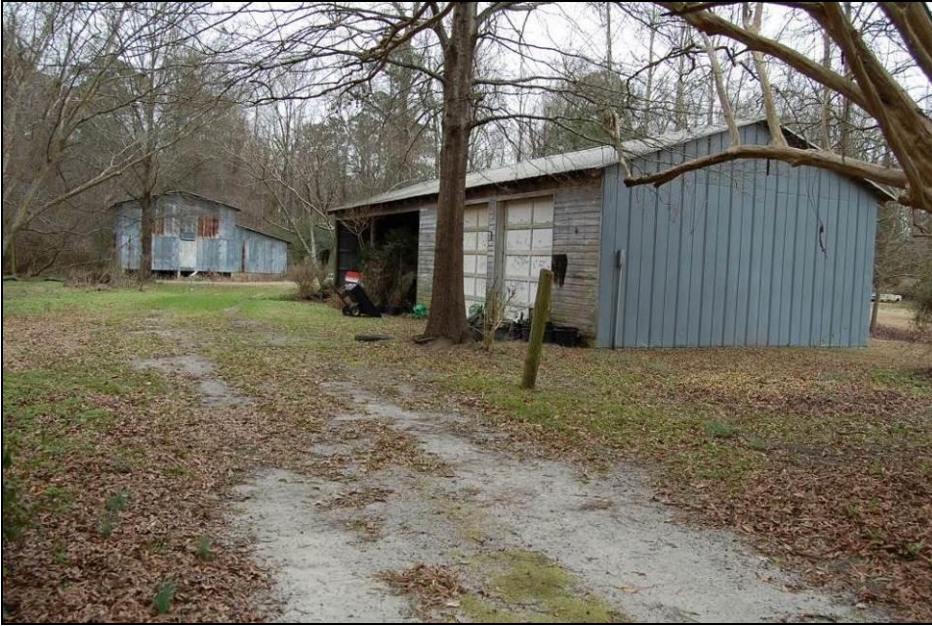
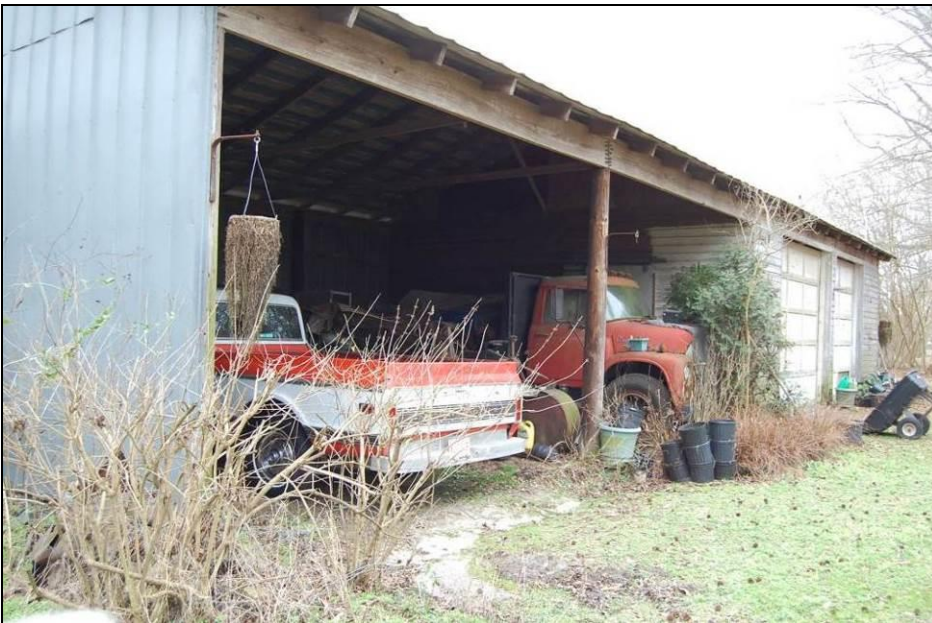
Figure 28. Shop/shed, northwest side and northeast front elevations; packhouse/barn in distance

Figure 29. Shop/shed, northeast front and southeast side elevations

South of the house stands a long, gable-end, frame outbuilding that served as a shop and shed (Figure 28 and Figure 29). It appears to date from the 1940s. The building's northwest section is enclosed for use as a shop and served by two garage doors that may be original. The southeast section, supported in part by poles, is an open shed for equipment storage. The building was originally clad with German siding, much of which has been covered with metal siding. A seam-metal roof tops it.

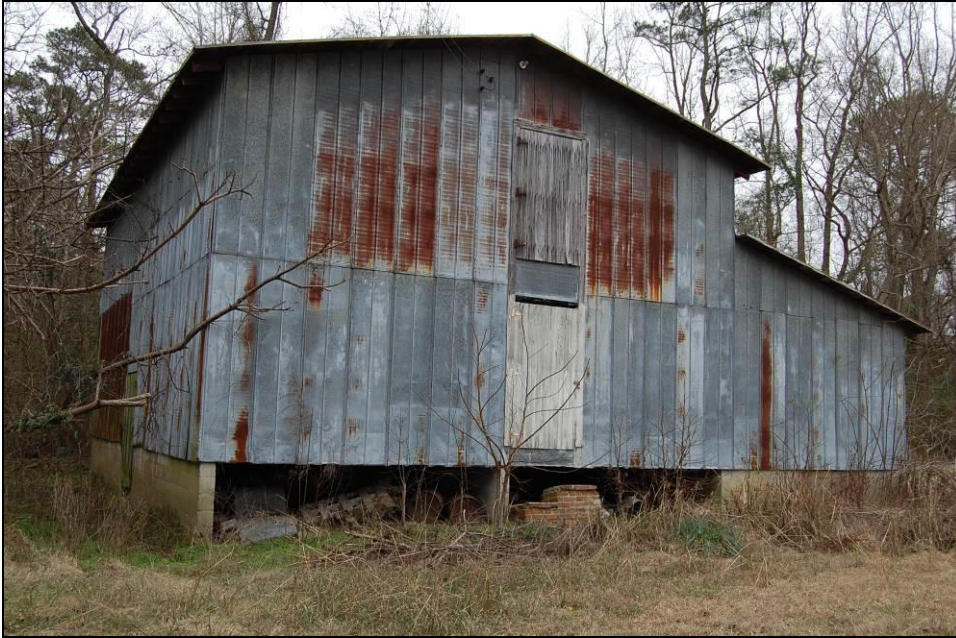
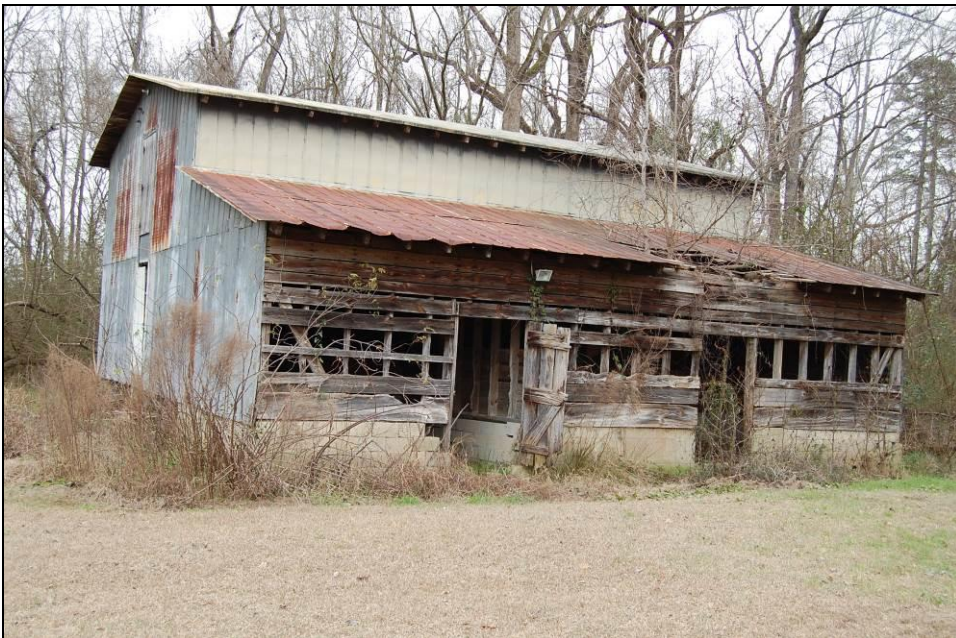
Figure 30. Packhouse/barn, northwest front and northeast side elevations

Figure 31. Packhouse/barn, southwest side and northwest front elevations

The frame packhouse/barn stands south of the shop/shed (Figure 30 and Figure 31). It appears to date from the late 1910s or 1920s. The original siding of the tall, gable-front outbuilding is hidden by metal sheathing. The placement of its northwest front doors, stacked atop each other, indicate it was used a packhouse. The shed-roofed stables affixed to the southwest side indicate it also served as a barn. Due to the irregularity of the ground, concrete-block walls support the building. Its roofs are metal.
