North Carolina Department of Natural and Cultural Resources
State Historic Preservation Office

SUBJECT: C. F. Harvey Parkway Extension (NC 148), Four-Lane Divided Freeway on New Location, R-5703, NCDOT WBS No. 46375.1.1, Lenoir County, ER 16-0449

Figure 2. Area of Potential Effects, outlined in red, and property locator map

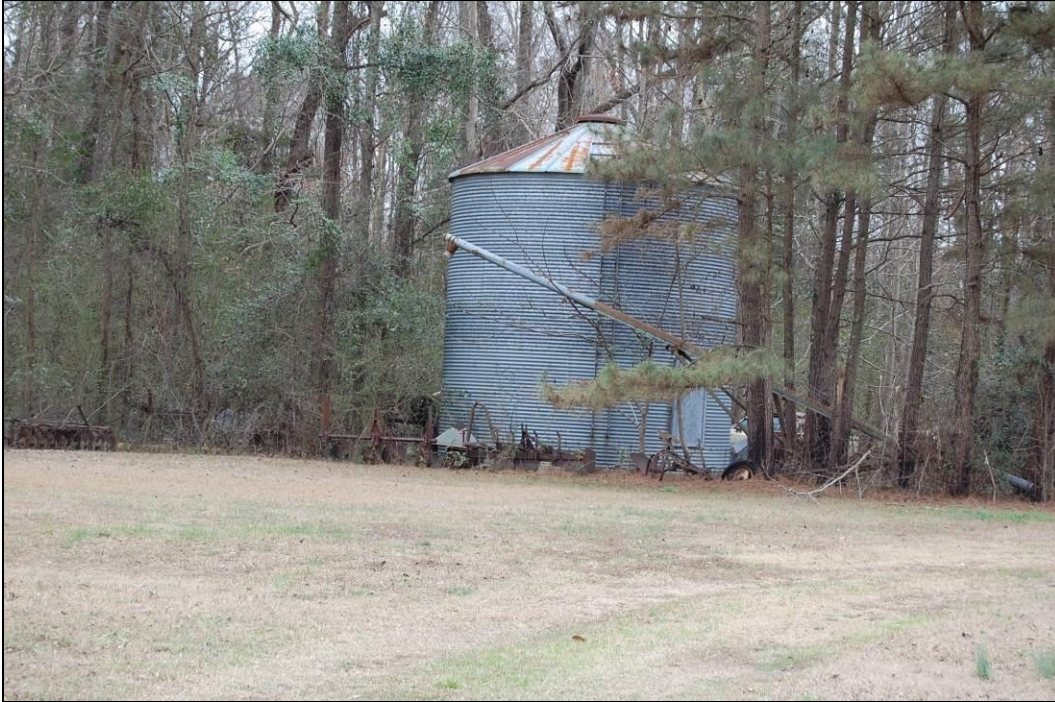
Figure 32. Silo, looking south

The silo to the southwest of the packhouse/barn may be less than 50 years old (Figure 32). It appears to date from the 1960s or later. It is a large, round structure sided in sheet metal and topped by conical seam-metal roof.

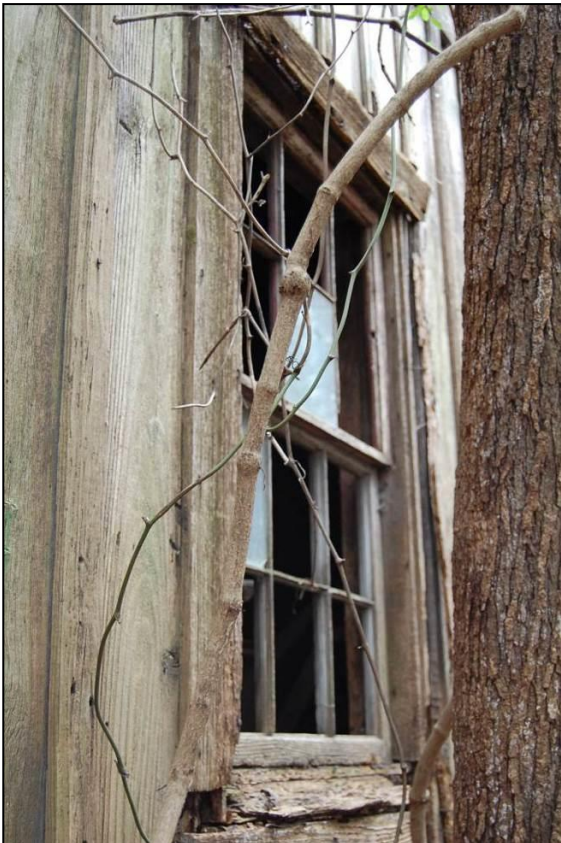
This outbuilding is one of two surviving bunkhouses, also called section houses, in Graingers. It was built in the 1890s to house employees of the Atlantic and North Carolina Railroad. Charles A. Broadway, Sr. moved the bunkhouse to this site in the early twentieth century, for use as a tenant house, after the railroad abandoned it and he acquired this tract. (The building sat on a different portion of the same parcel). It now stands in trees southeast of the farm equipment shed. The single-pile, gable-end bunkhouse, which is heavily deteriorated and overgrown, appears to hold just two rooms (Figure 33 through Figure 37). A window and door, in the four-bay southwest front elevation, serves each of the rooms. One of the doors, with panels stacked above each other, remains in place, as do some of the muntins and lights in the once six-over-sash sash. Board-and-batten siding covers the frame building. Deterioration that threatens the building with collapse includes rotten floor beams and joists, and fallen wall and ceiling sections. The bunkhouse has not been maintained for many years and was apparently last used as storage. The building is not recommended as contributing to the property, because it predates the house, is not located on its original site, and has lost much of its original fabric. Due to its move and loss of so much original fabric, it is also not believed to be individually eligible for NRHP listing.

Figure 33. Board-and-batten walls and six-over-sash window at far right of southwest front elevation of bunkhouse

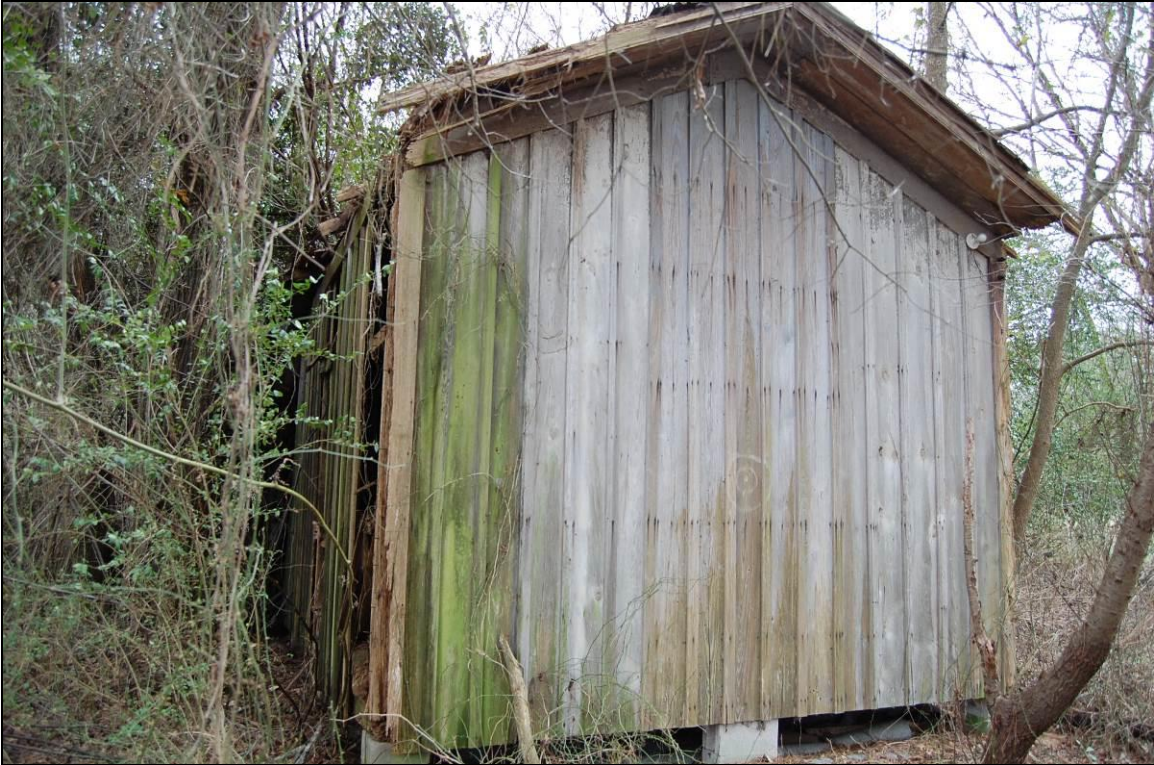
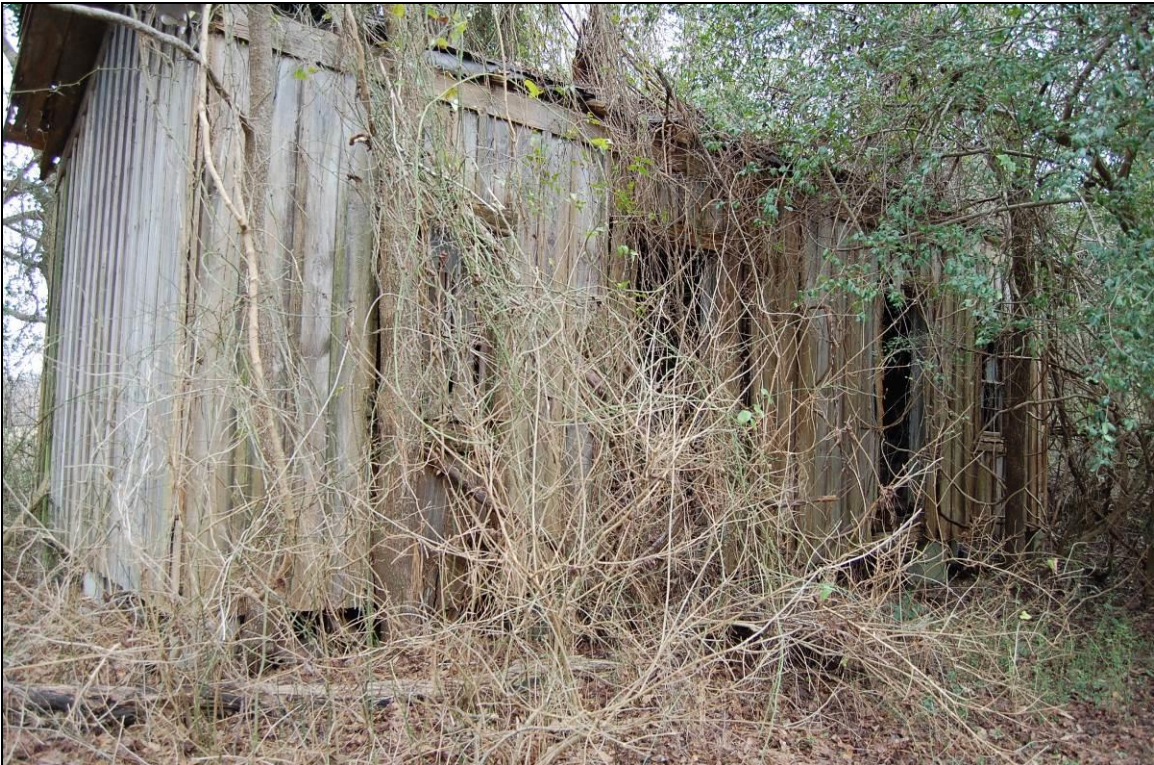
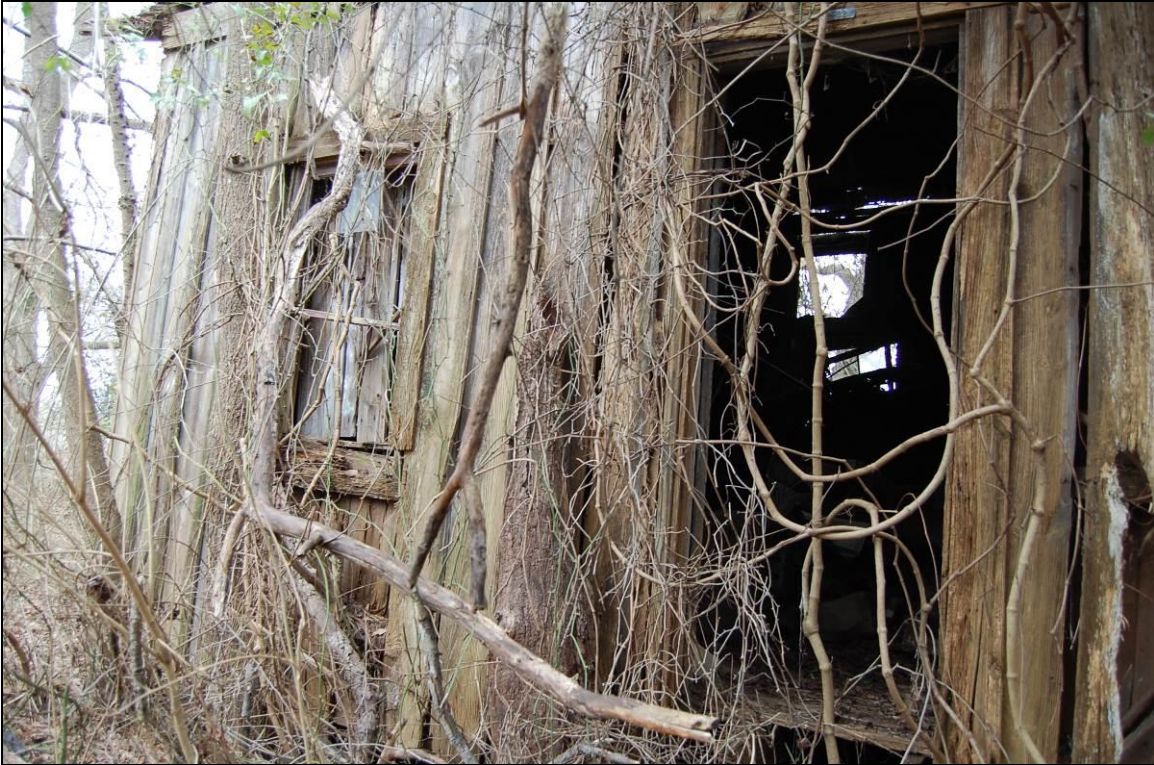
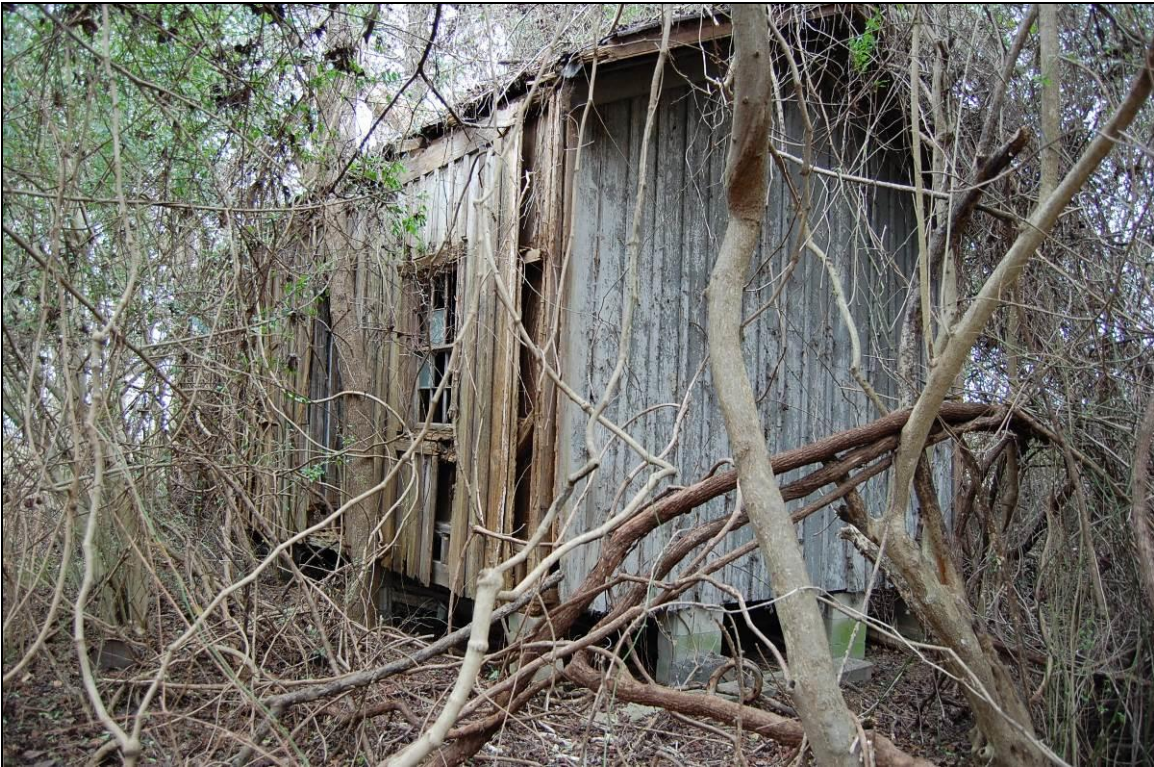
Figure 34. Northeast rear and northwest side elevations of bunkhouse,

Figure 35. Northwest side and southwest front elevations of bunkhouse

Figure 36. Two bays at left of southwest front elevation of bunkhouse

Figure 37. Southeast rear and southwest front elevations of bunkhouse,

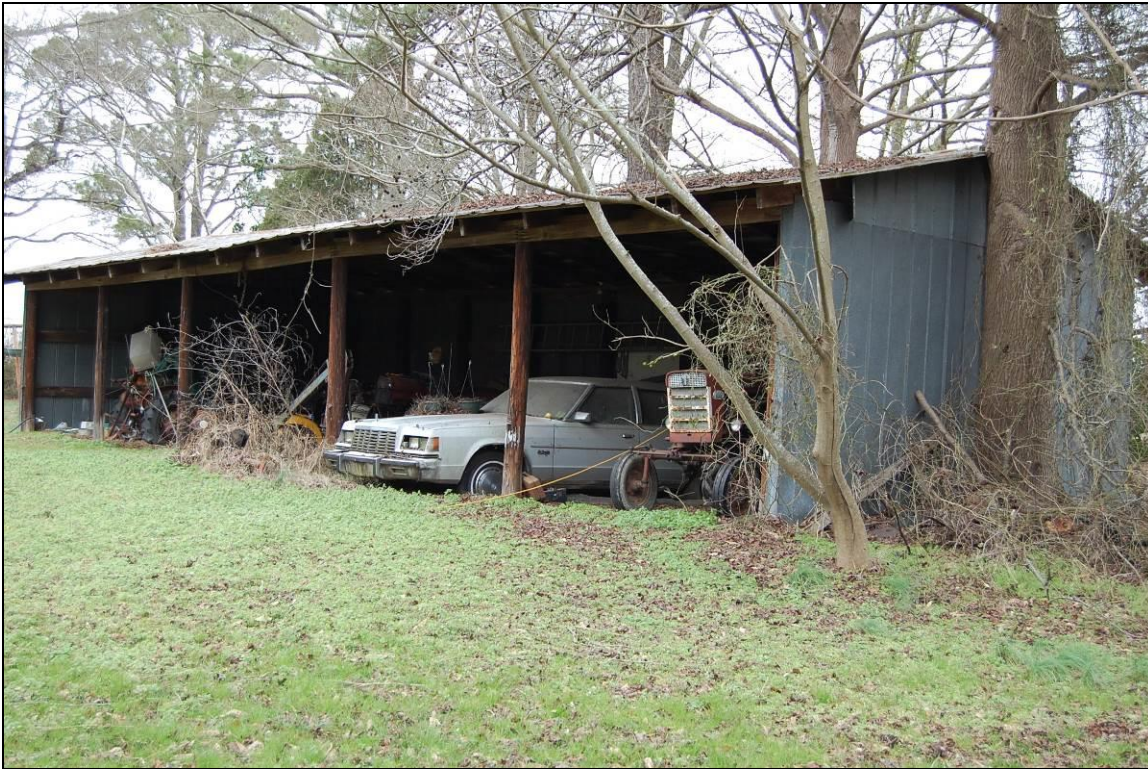
Figure 38. Farm equipment shed, southwest front and southeast side elevations

The farm equipment shed is a long, gable-end, frame building that is supported by poles, sided with metal, and topped with a seam-metal roof (Figure 38). It is located northwest of the bunkhouse. The building dates from the 1940s or 1950s. The tractor and other farm equipment it shades, along with a ca.1980 Dodge St. Regis, appears to have been long unused.

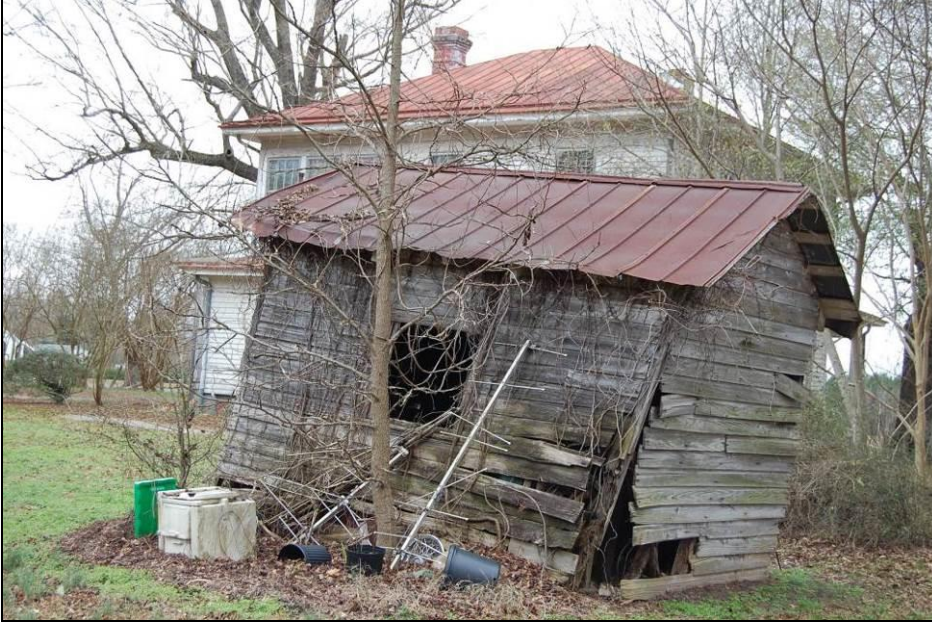
The toolshed stands just southeast of the house's rear ell. German siding covers, and seam-metal tops, the small frame building (Figure 39 and Figure 40). A window opens at the center of the southeast rear elevation. The northwest front elevation has a centered door with a window to either side. Due to rot at the ground level, the building is danger of collapsing. It is further threatened by being open to the elements at its now gaping bays.

Figure 39. Toolshed, southeast rear and northeast side elevation

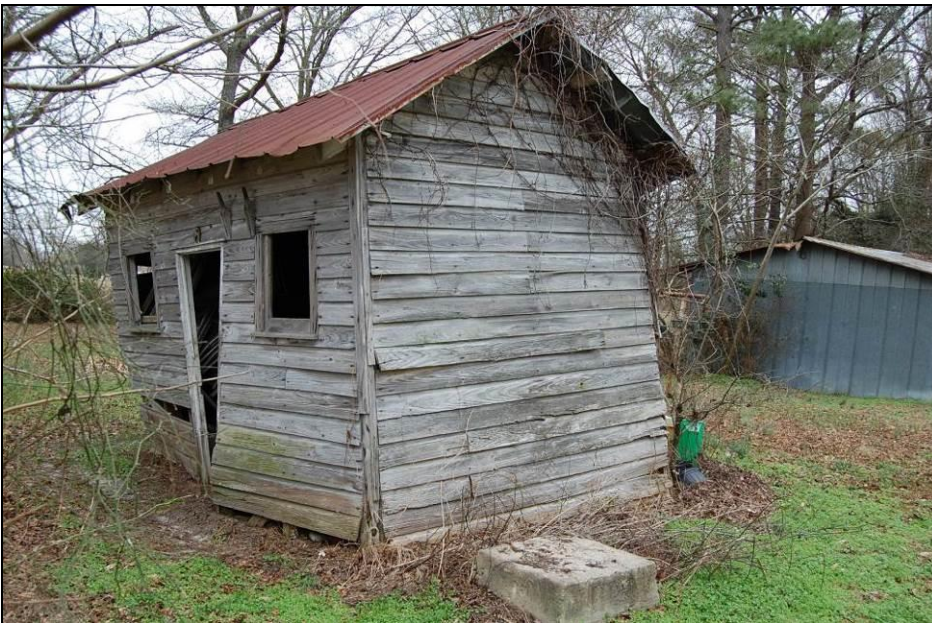
Figure 40. Toolshed, southwest side and northwest front elevations; northwest side elevation of farm equipment shed at right

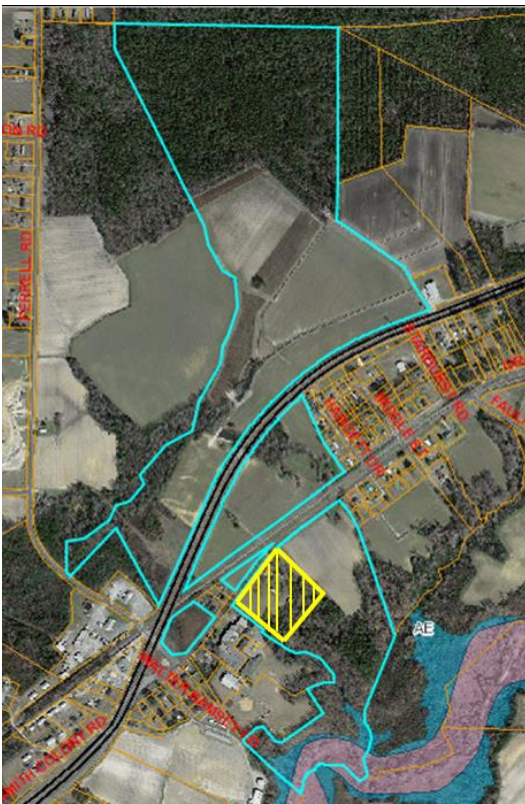
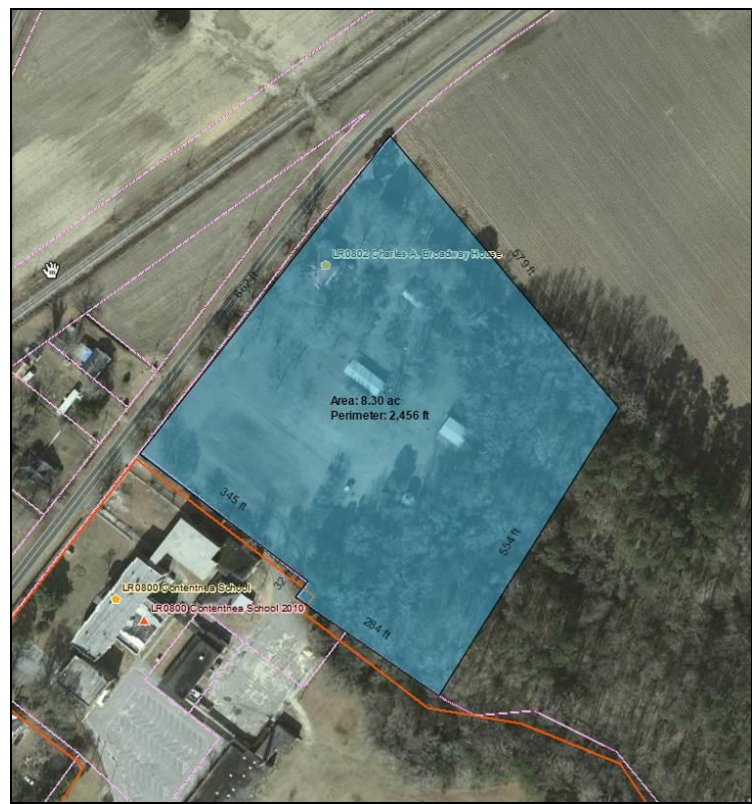
Figure 41. Charles A. Broadway House, entire 203-acre parcel outlined in teal at left on Lenoir County GIS map and proposed NRHP-eligible boundaries shaded in blue at right on HPOweb base map (and in yellow, approximately, at left)

Charles A. Broadway, Sr. was not a farmer who worked the land, but did own land worked by others. The current parcel upon which the house sites includes a large field at its northeast along Grainger Station Road, extensive woodlands that reach south to Stonyton Creek, and property across the Grainger Station Road, the railroad tracks, and NC 11 (Figure 41). Due to the limited association of this farm and woodland to the Broadway House, a smaller NRHP-eligible boundary is recommended. This boundary describes an almost square polygon that follows the northwestern property along Grainger Station Road and a portion of the southwestern boundary abutting Contentnea School. At the southeast and northeast it is truncated from the remainder of the tract in order to restrict it to a wooded boundary at the buffers the house and to include the front and rear yards, mature shade trees to either side, and the outbuildings to the house's rear. This boundary encompasses approximately 8.3 acres.

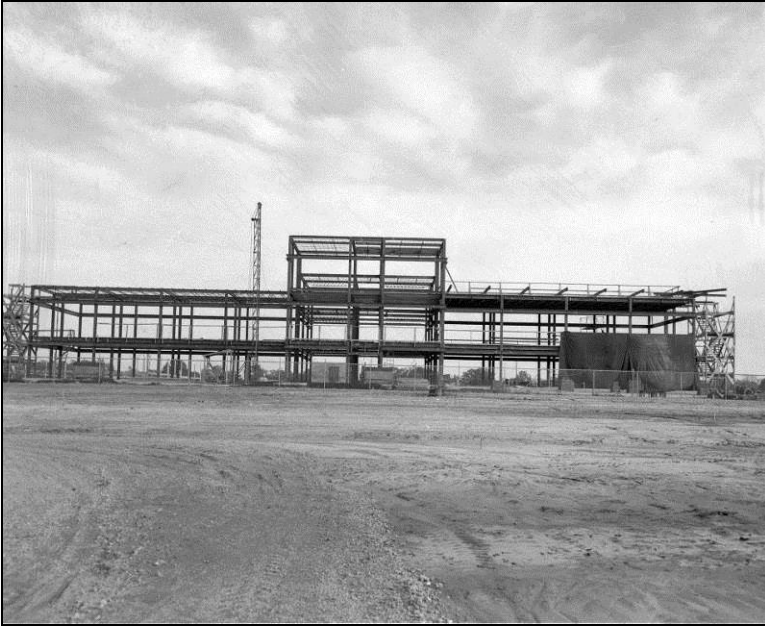
Figure 42. Plant at beginning of construction, 1951 (source: <https://digital.lib.ecu.edu/1998>)

DuPont acquired an approximately 654-acre site northeast of Kinston and Graingers in 1950 to build a two-million-square-foot plant to produce the material. In late April 1951, construction began (Figure 42 and Figure 43). The company invested \$40 million in production facilities and began the manufacture of Dacron there on March 23, 1953. DuPont added plans for a \$3 million fiber laboratory to research Dacron in late 1952. This facility, which stands at the northwest corner of the complex, was completed in late 1954.

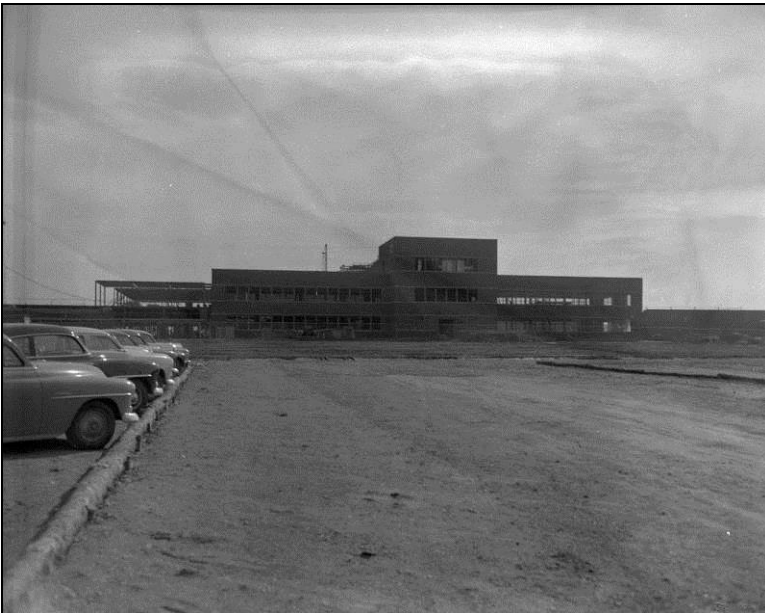
Figure 43. Plant with cladding added, 1951 (source: <https://digital.lib.ecu.edu/2003>)

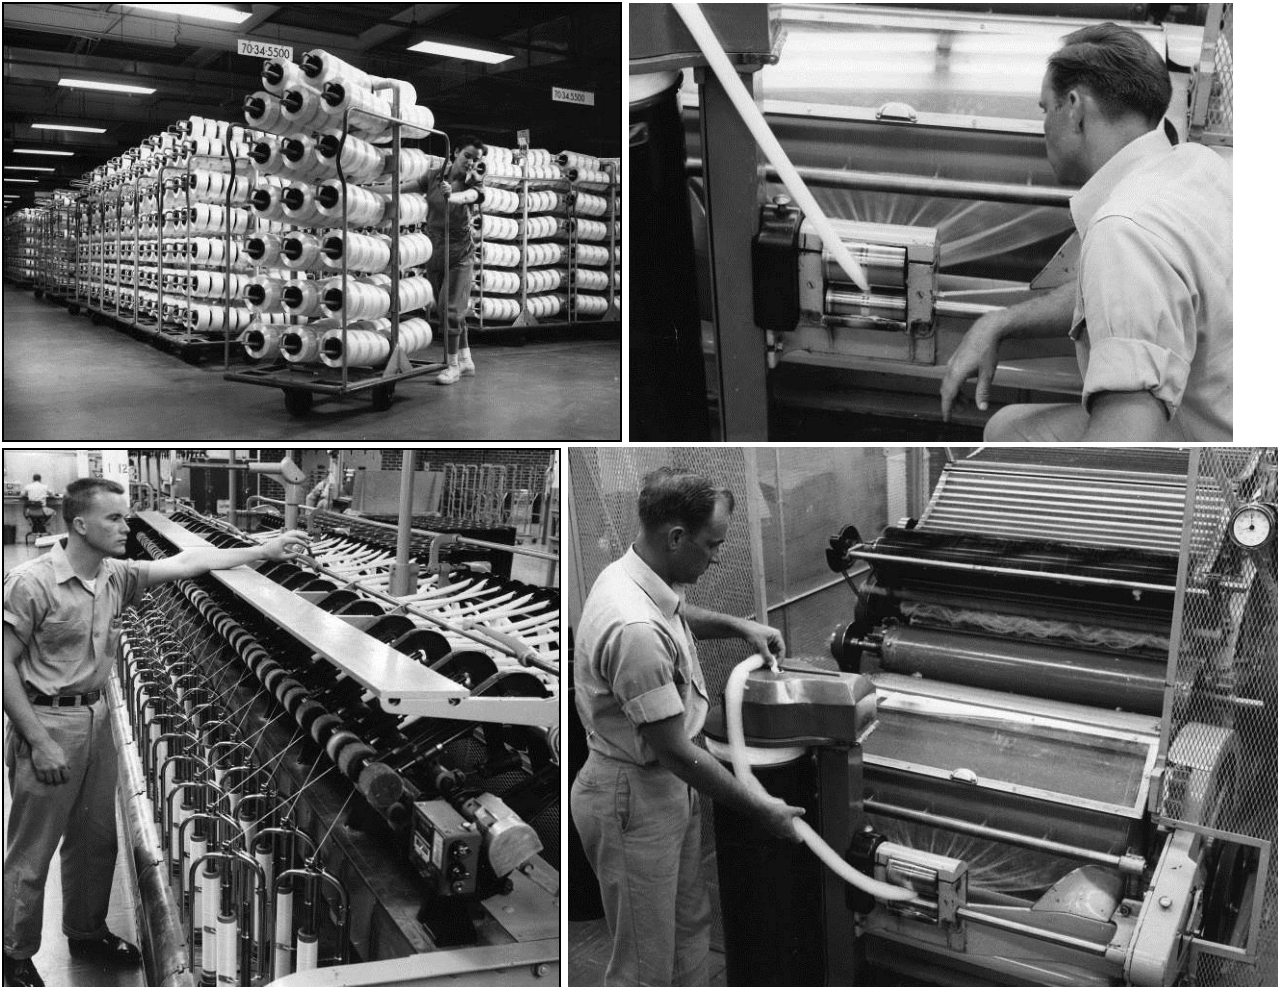
Figure 48. Workers producing Dacron at the Kinston plant (source: http://findingaids.hagley.org/xtf/view?docId=ead/1972_341.xml)

DuPont did not go into the arcana of the production process in its stories and advertisements. However, some photographs survive in the DuPont collection at the Hagley Museum and Library in Wilmington, Delaware (Figure 48).

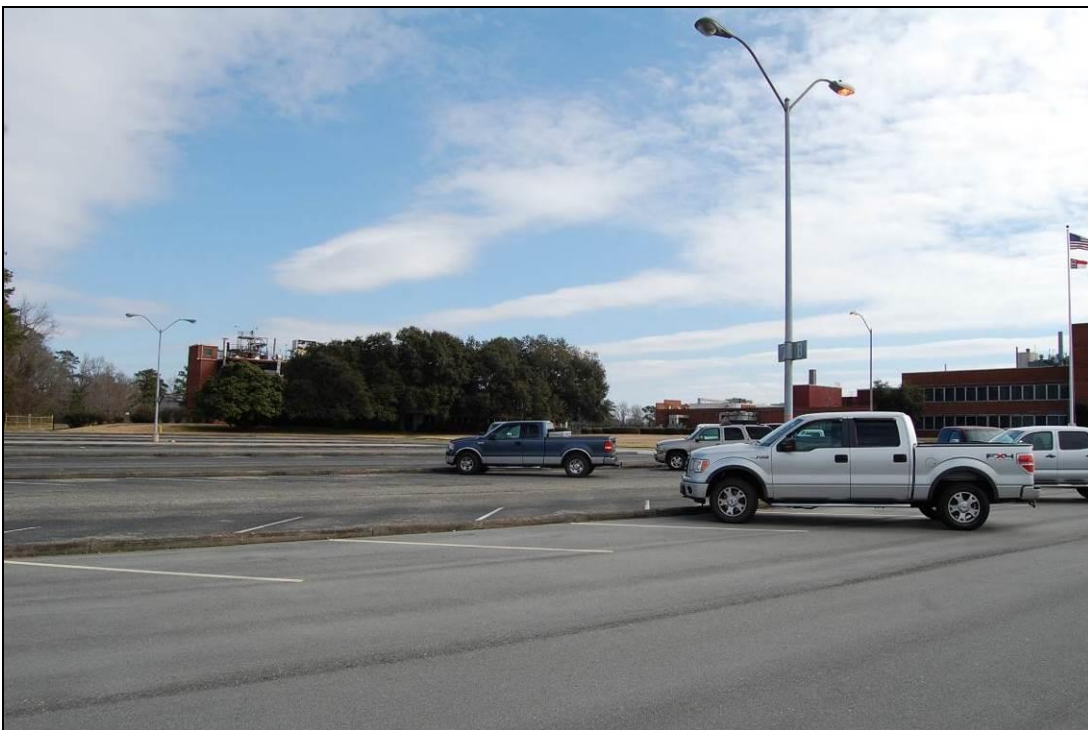
Figure 51. Looking north with office building at right at laboratory building at left

DuPont would not allow access to or photographs of the plant. Photographs taken from public thoroughfares and a careful study of aerial images and photographs, however, depict a typical industrial facility with functional masonry buildings served by chemical-processing external equipment. The only stylistically distinctive buildings are the office building at the center of the front (west) of the facility and the laboratory building just to the north. Both of these buildings have flat roofs and bands of windows influenced by the International and Mid-Century Modern styles. The office building is two and three stories tall. The laboratory building rises two stories.

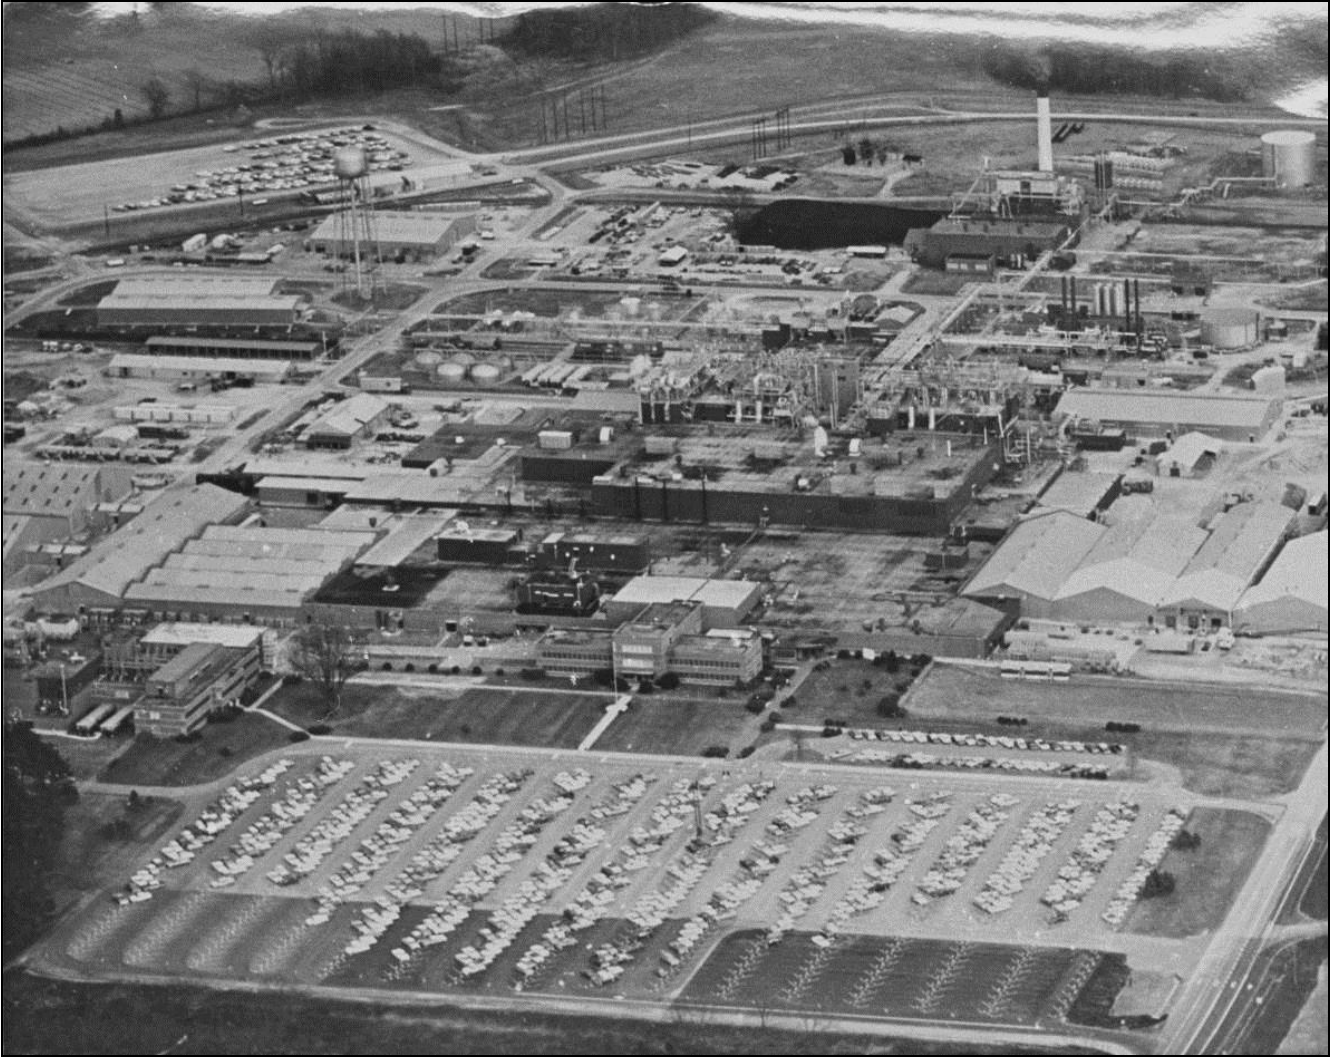
Figure 56. Bird's-eye view of facility, 1965 (source: <https://digital.lib.ecu.edu/7855>)

An early/mid-1950s photograph of the front of the facility, aerial maps of limited quality, and an excellent and informative bird’s-eye photograph from 1965 allow one to study much of the plant to determine what components survive that are more than 50 years old (Figure 49 through Figure 58). These include factory buildings, warehouses, stacks, rail lines, and rail-related buildings. As indicated on color-coded Figure 59, which follows these images, a significant percentage of the current facility was constructed as part of the initial building phase and then between 1955 and 1965.

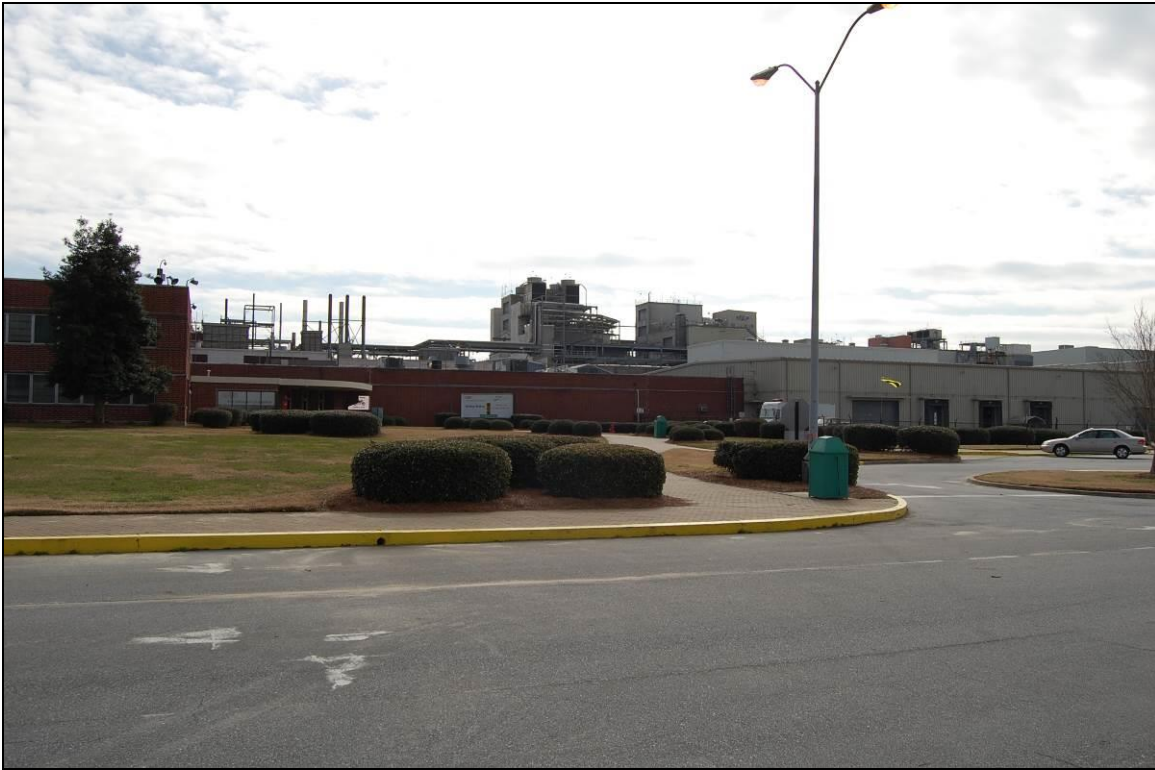
Figure 57. Looking south at facility with edge of office building at left; all buildings but for truck loading docks at right more than 50 years old

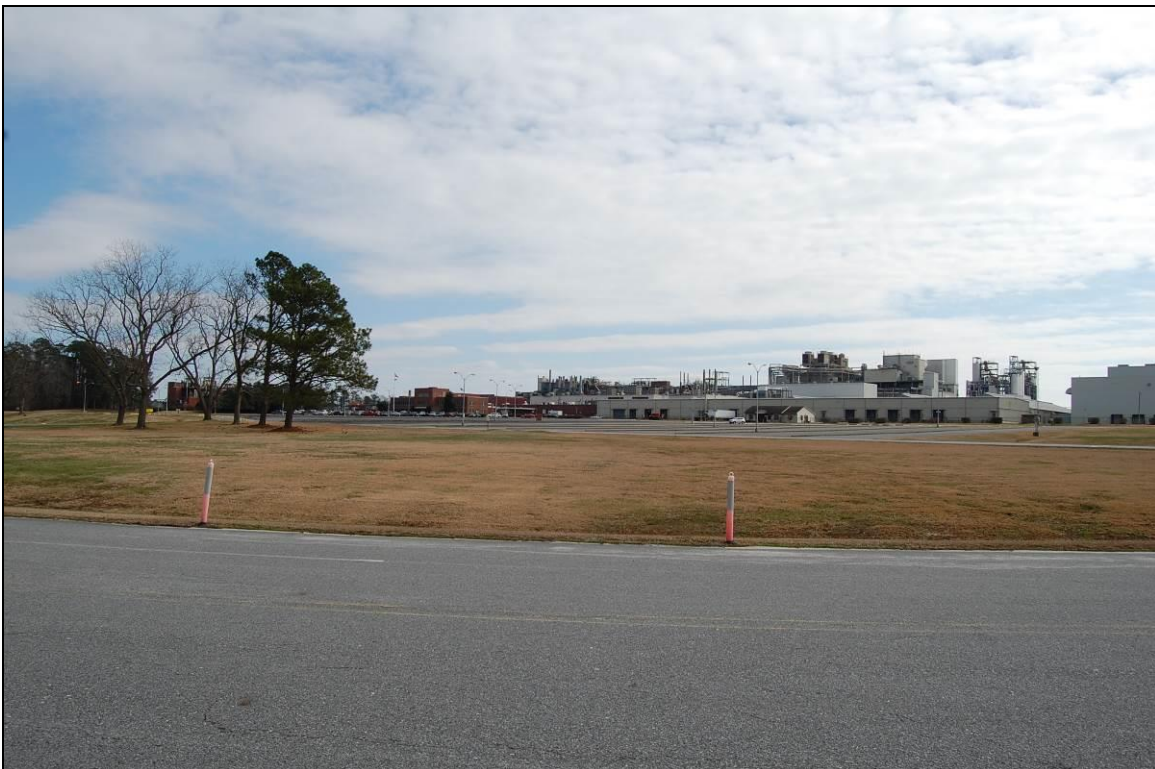
Figure 58. Looking east at facility; all buildings for one at far right more than 50 years old

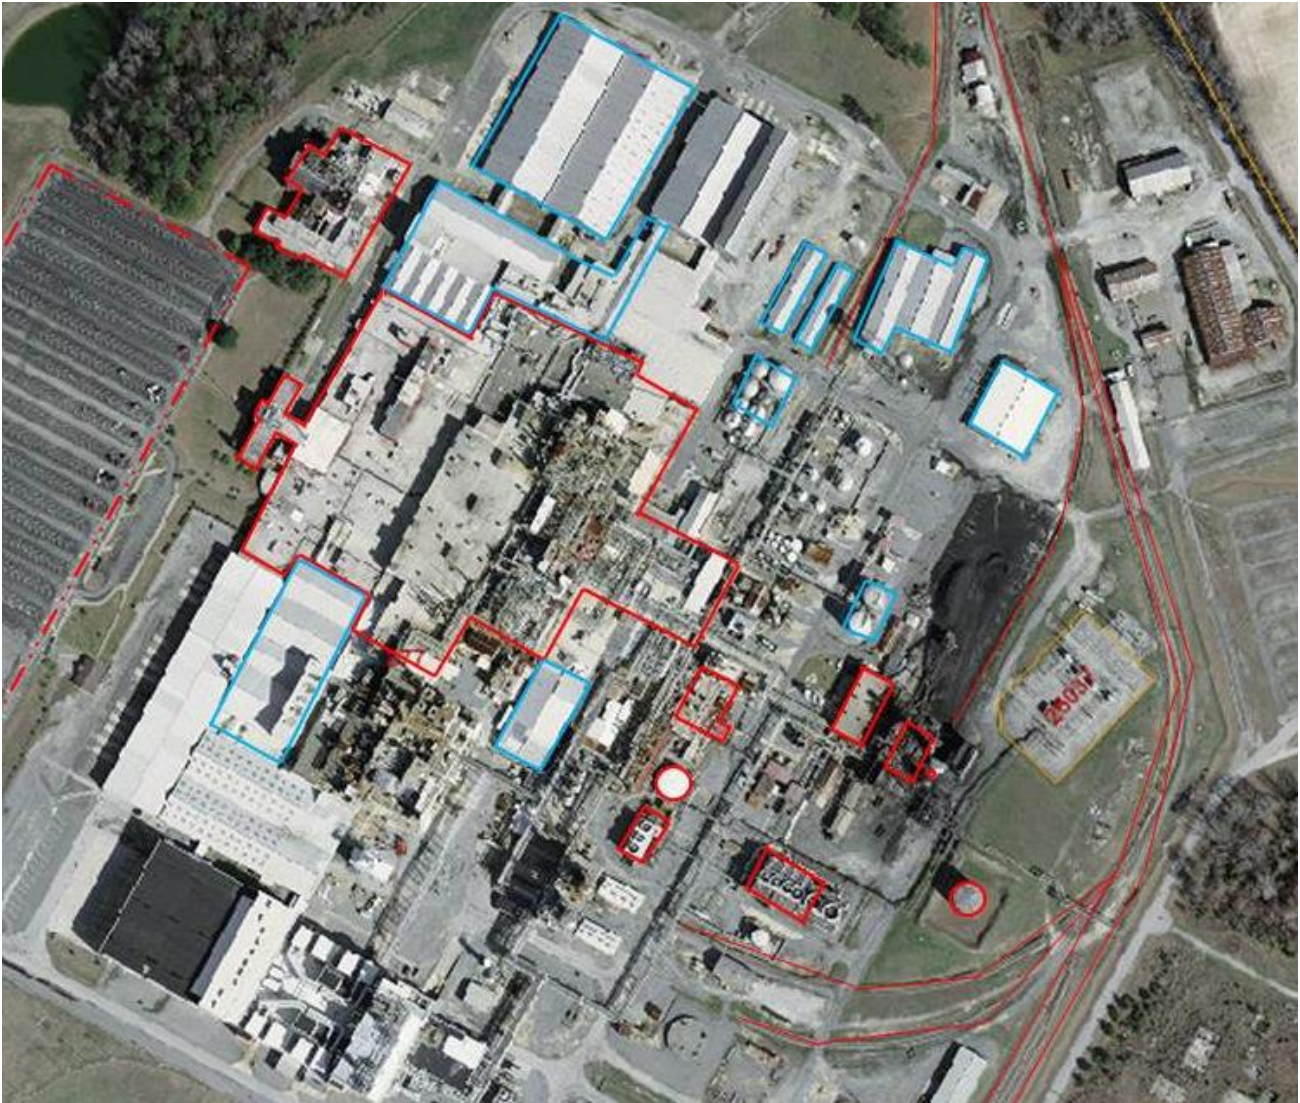
Figure 59. Modern aerial view of facility; buildings outlined in red, including rail lines and parking lot at left, in place by 1954; buildings outlined in blue in place by 1965

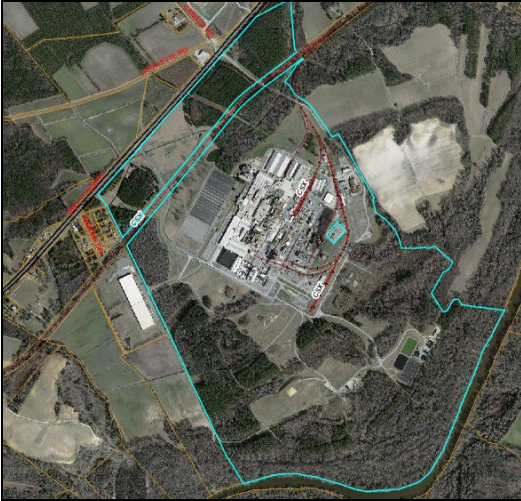
Figure 60. Entire parcel encompassing 636.98 acres, with landlocked CP&L tract near the center associated with the building complex

The DuPont Kinston Dacron Plant was built on an approximately 637-acre tract that extends east across the railroad line to NC 11 and west and south to the Neuse River (Figure 60 and Figure 61). The portion of the parcel between the rail line and the highway was never built on and most of the property to the south and east was also never developed. The boundaries are drawn to exclude all of the land on the highway and much of the remainder of the tract. The boundaries include all of the buildings, the rail lines entering the property, and a buffer of land around these facilities. They terminate at the

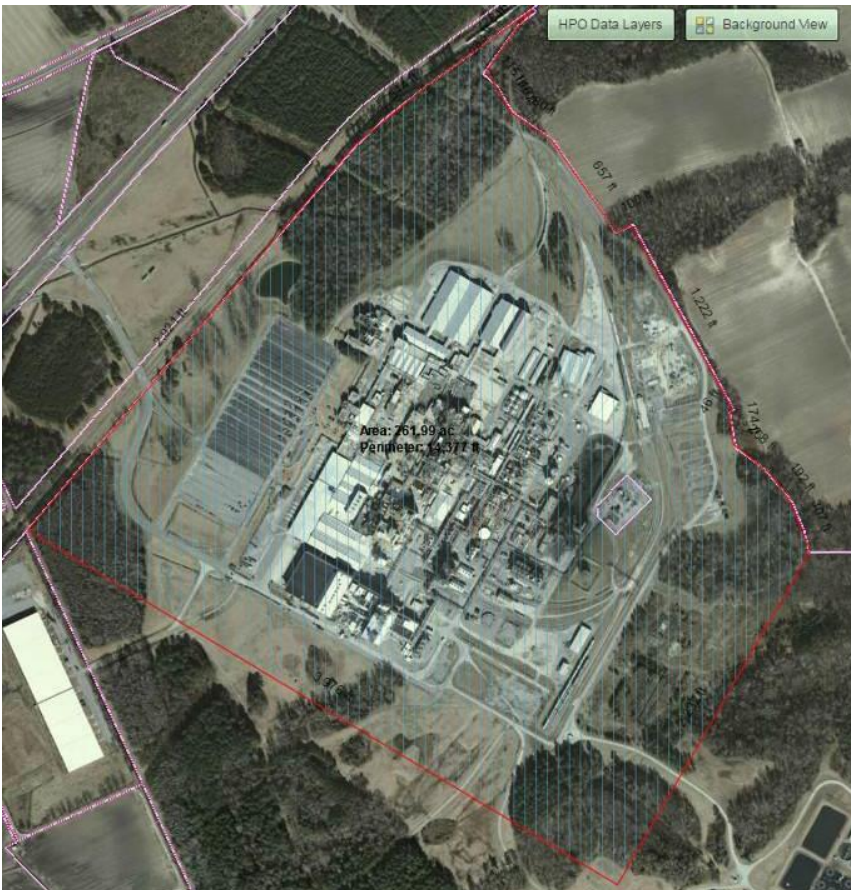
Figure 61. Recommended approximately 262-acre NRHP boundary outlined in red and cross-hatched in blue

railroad right-of-way at the west. They also include a landlocked 1.27-acre parcel owned by Carolina Power & Light. The total area within the recommended boundaries is approximately 262 acres.

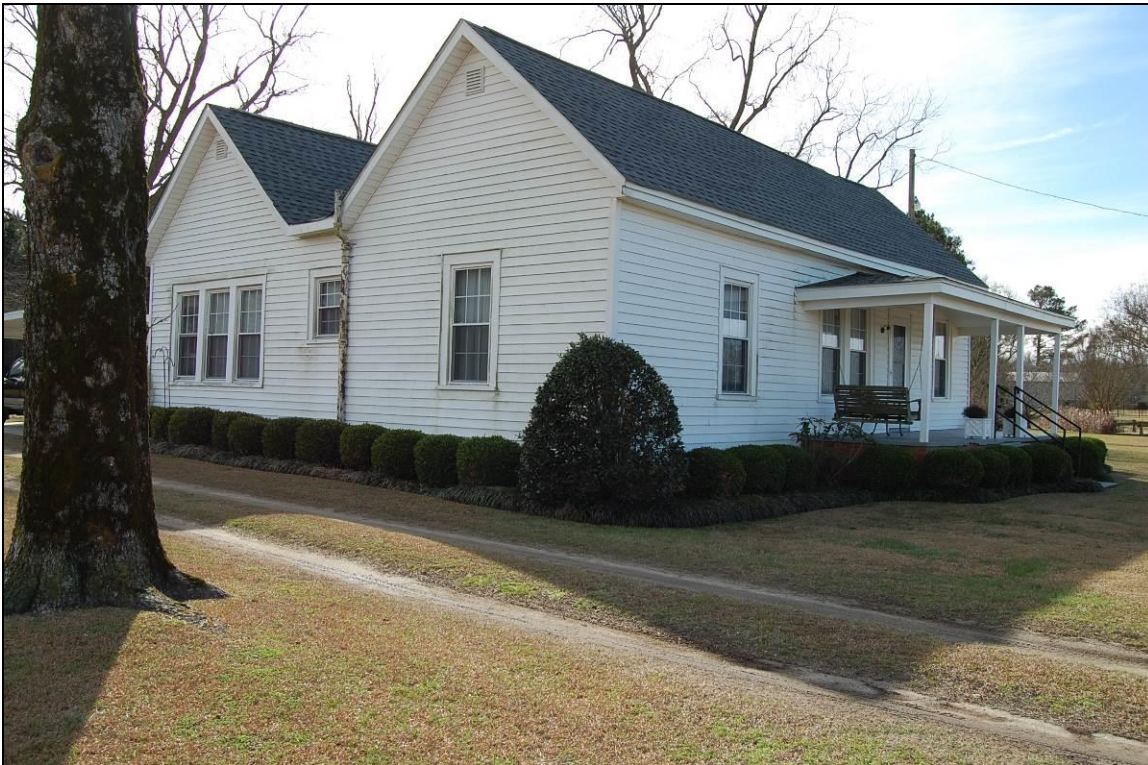
Since 1993 the integrity, if not condition, of the house has suffered further through the addition of vinyl siding and one-over-one sash with six-over-six-type snap-in muntins (Figure 67 through Figure 69). The house, an additive example of a common type, appears to have lost its integrity and is recommended as not NRHP-eligible either individually or as part of multi-resource farmstead.

Figure 67. Willie Humphrey Farm, west side and north front elevations of farmhouse

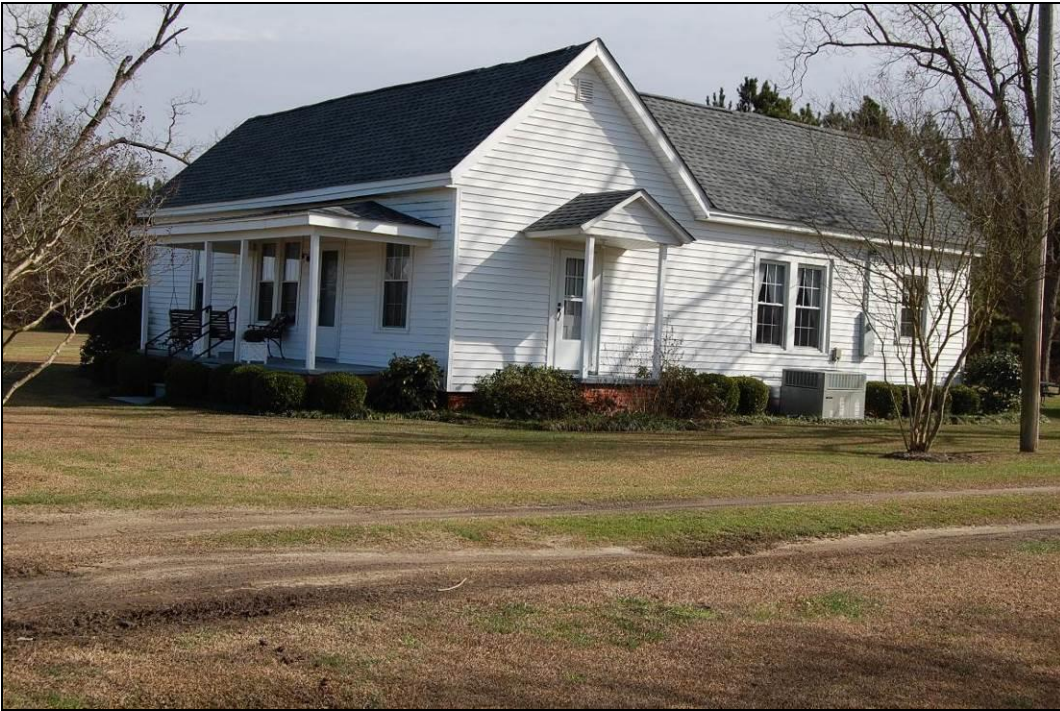
Figure 68. Willie Humphrey Farm, north front and east side elevations of farmhouse

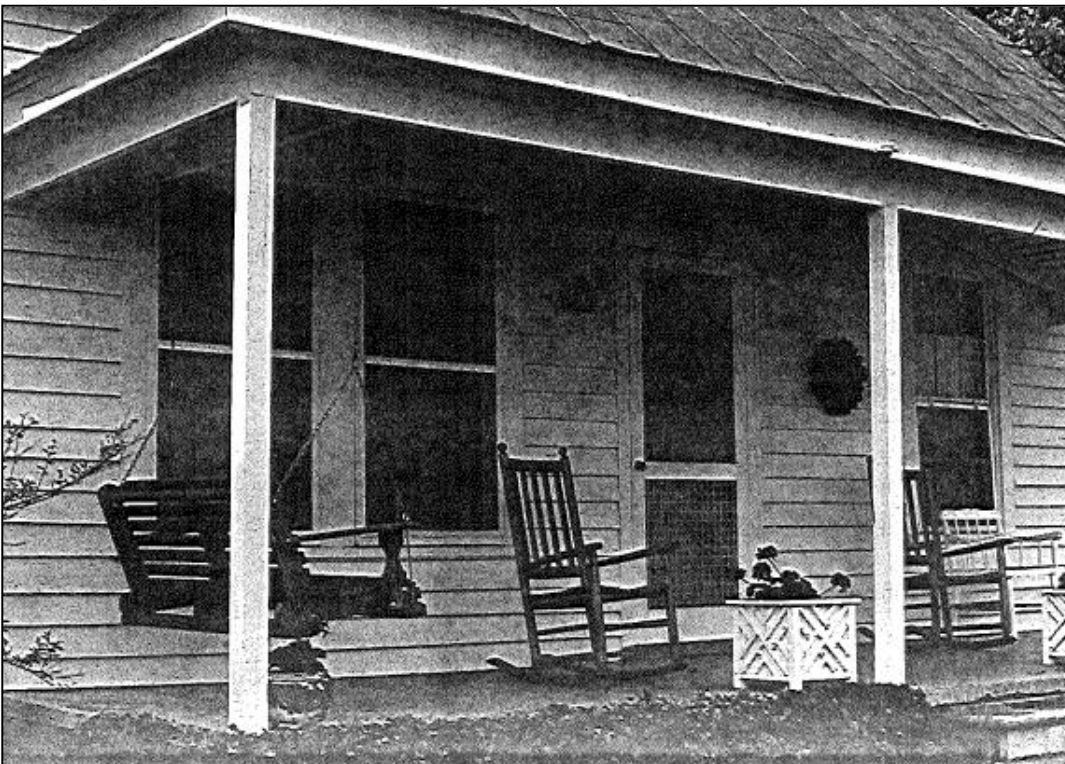
Figure 69. Willie Humphrey Farm, front elevation of farmhouse with intact weatherboards, six-over-six sash, and seam-metal roof, 1994 (photographer: Robbie Jones)

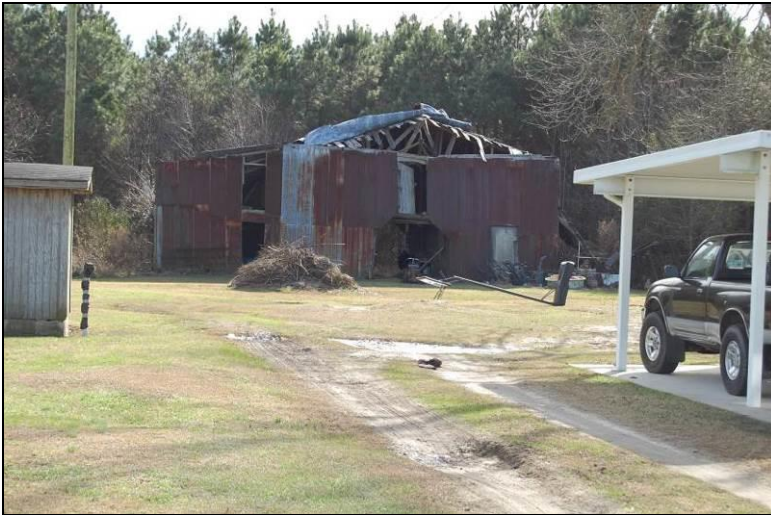
A large, frame, gable-front barn with wide sheds to either side, one of which has fallen, stands behind (south of) the farmhouse (Figure 70 and Figure 71). It appears to date from the early twentieth century. It has lost its integrity through its later cladding in metal and its advanced state of deterioration, which has taken the east shed, the roof, and much of the front gable.

Figure 70. Willie Humphrey Farm, north front of barn with farmhouse carport at right

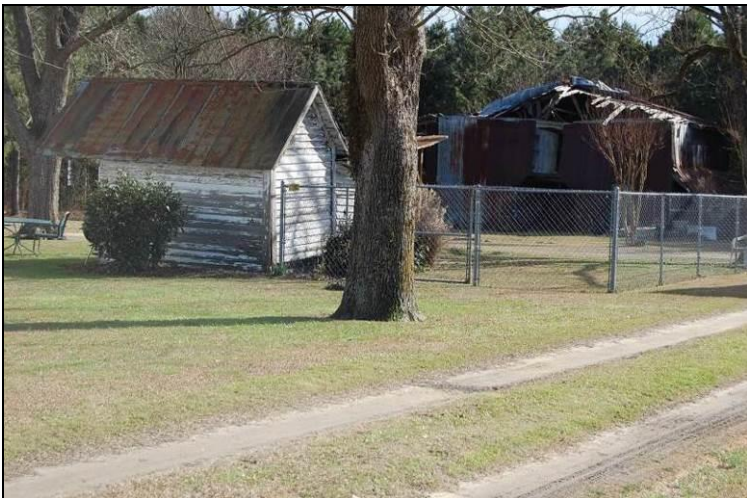
Figure 71. Willie Humphrey Farm, looking southeast at smokehouse at left, shed immediately behind partly obscured by tree, and barn at right

Two small, frame, weatherboarded outbuildings survive behind the house, both of which appear to date from the early twentieth century. One is a smokehouse with a protective overhanging gable facing east toward the farmhouse's backyard. The other is a shed covered with a shed roof that opens to the south, toward the barn. Neither building is believed to be a significant example of its type (Figure 71).

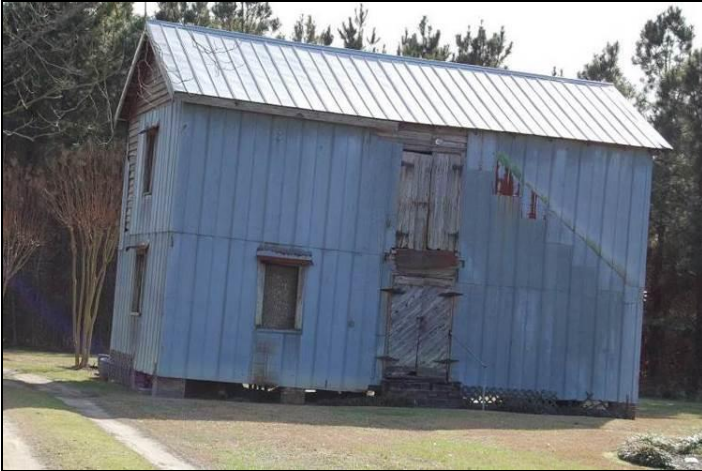
Southwest of the farmhouse, one packhouse continues to stand (Figure 72 and Figure 73). It is a rectangular, two-story, frame building with ghost marks on its long north elevation that recall a former covered stair depicted in Robbie Jones' 1993 photographs. Other alterations, which have adversely affected its integrity, include the addition of metal siding over its weatherboards, a replacement metal roof, and the addition of bays, now boarded over, inconsistent with its use as a packhouse.

Figure 72. Willie Humphrey Farm, gable-end west and long north elevations
