North Carolina Department of Natural and Cultural Resources
State Historic Preservation Office

SUBJECT: C. F. Harvey Parkway Extension (NC 148), Four-Lane Divided Freeway on New Location, R-5703, NCDOT WBS No. 46375.1.1, Lenoir County, ER 16-0449

Figure 2. Area of Potential Effects, outlined in red, and property locator map

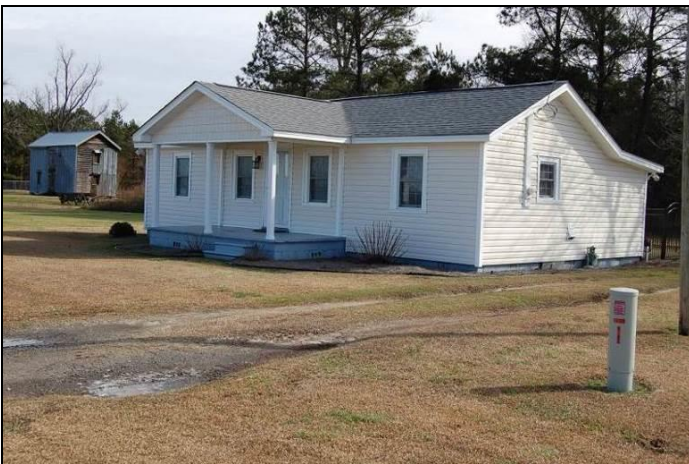
Figure 73. Willie Humphrey Farm, north front and west side elevations of former tenant house; packhouse at left distance

The one-story, single-pile, gable-end house west of the farmhouse is either a completely rebuilt former tenant house erected in the early twentieth century or a new house erected on the same site within the past five years (Figure 73). Among its many alterations, if it is an early tenant house, are its five symmetrically placed bays, artificial siding, front porch, and asphalt-shingled roof. Due to alterations and/or modernity, it is not significant and does not retain integrity.

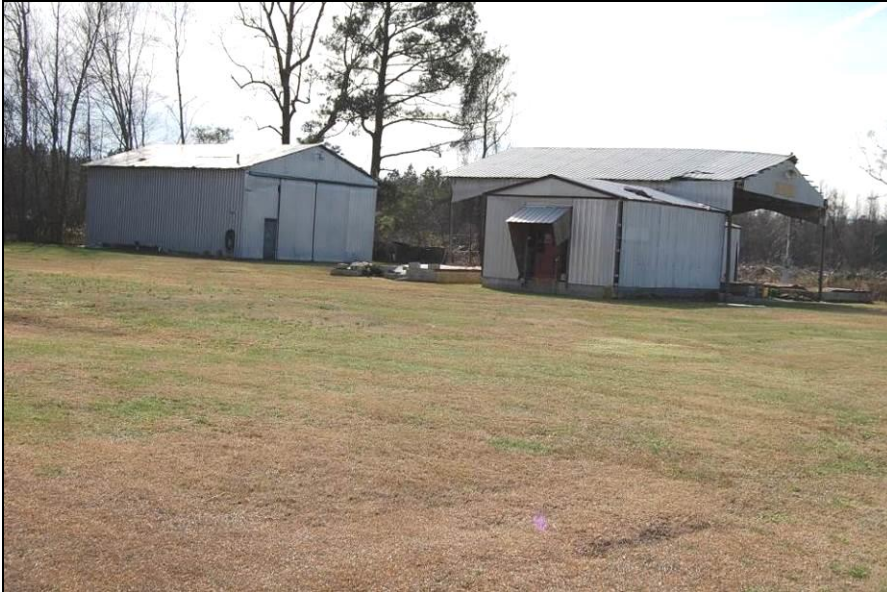
Figure 74. Willie Humphrey Farm, looking southwest at bulk barn complex at right and barn/storage building at left; note concrete pads at center and right that held additional bulk barns

East of the tenant house is a bulk tobacco barn complex that appears to be less than 50 years old (Figure 74 and Figure 75). It includes barns on either side of a tall open shed and a freestanding building to the south rear. Jones' 1993 sketch map, along with surviving concrete pads, indicate that half of the barns have been removed. The function of the tall building at the rear of the complex was not determined. It is likely a barn/storage building.

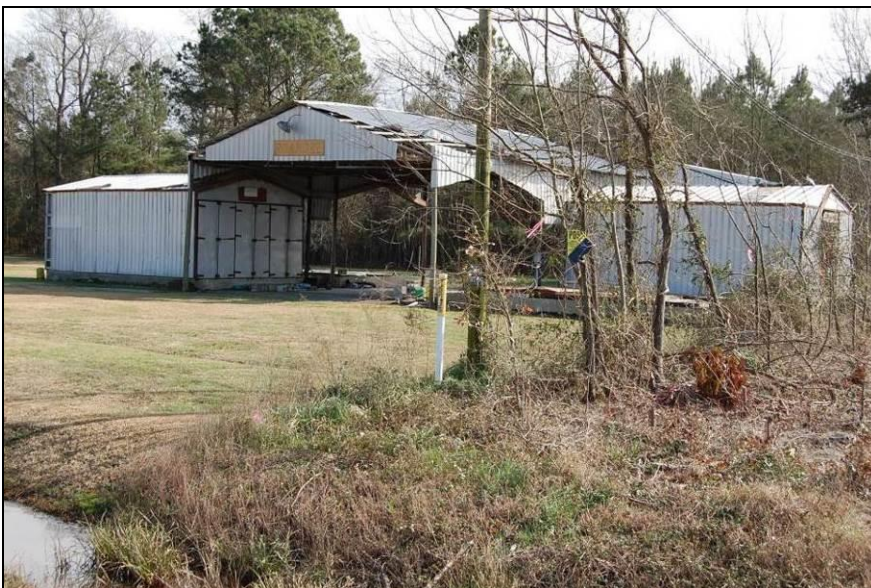
Figure 75. Willie Humphrey Farm, looking southeast at bulk barn complex

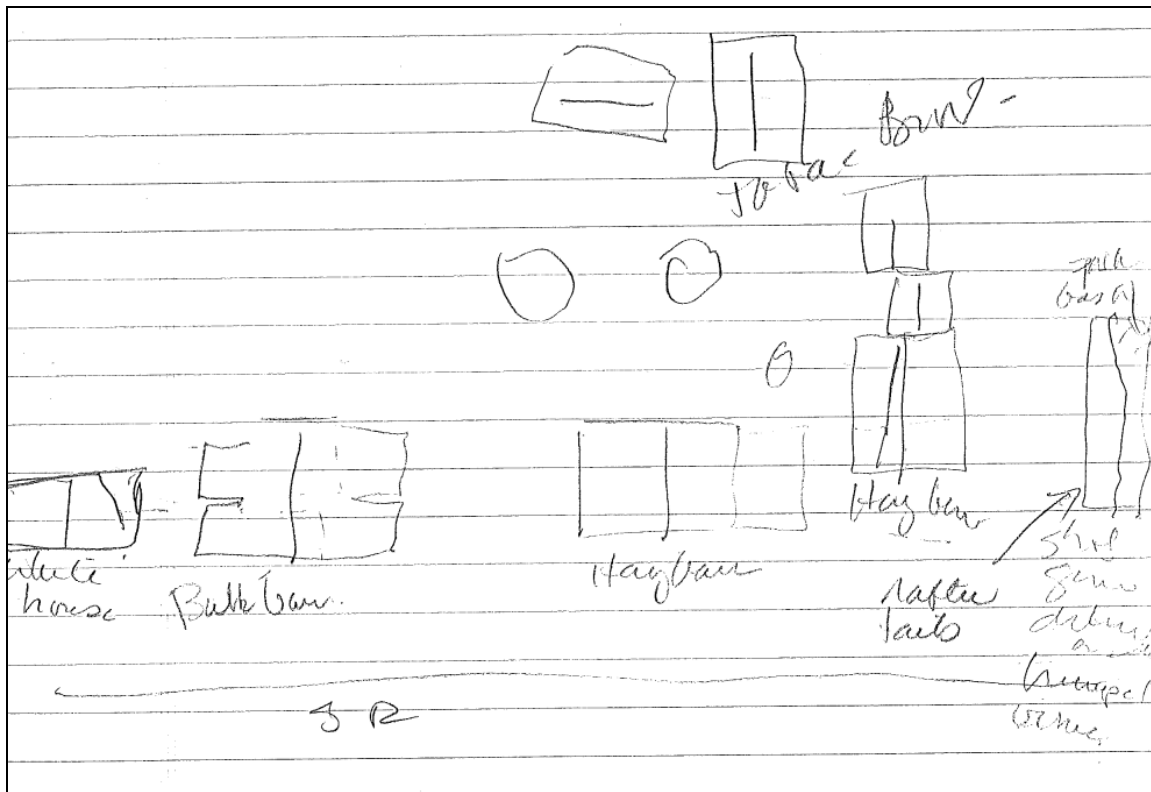
On his original sketch maps, Jones recorded a more complicated version of the farm’s eastern outbuildings that included a hay barn complex and tobacco barns (Figure 76). These resources stand, or stood, to the east of the three parcels depicted on the figure above. Their tract is no longer connected with the farmhouse and has undergone recent destruction through clear cutting. Amidst a tangle of broken trees, a portion of the frame hay barn complex survives, as do two frame tobacco barns mapped by Jones. The clay-tile walls of a third tobacco barn, not included on Jones’ map, also still stand (Figure 77 through Figure 80). The tenant house that Jones depicts at the eastern end of the property, which was heavily overgrown in 1993, but still stood when the property was resurveyed in 2010 is no longer extant. The group of surviving buildings is in poor to ruinous condition and appears to be slated for demolition in the near future.

Figure 76. Robbie Jones’ original field sketch of eastern end of Willie Humphrey Farm depicting haybarns, including one that telescopes back, and two tobacco barns

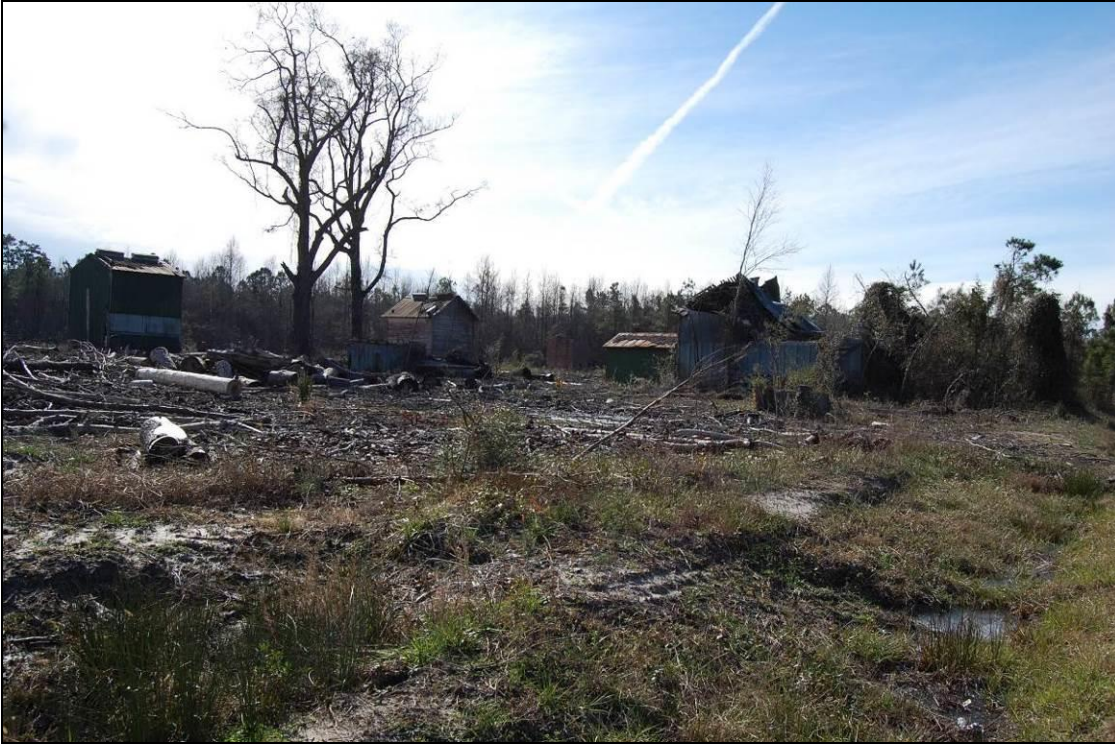
Figure 77. Willie Humphrey Farm, looking southwest from near bulk barn complex at tobacco barns and haybarn complex

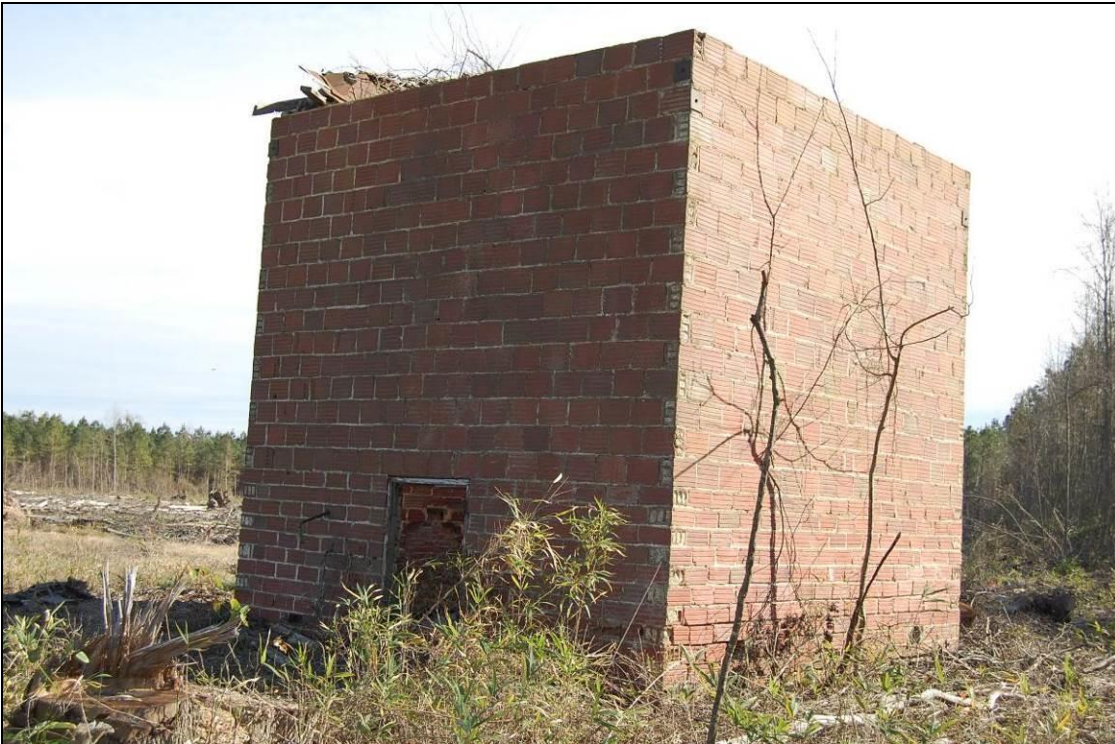
Figure 78. Willie Humphrey Farm, looking southeast at clay-tile walls of tobacco barn not depicted on Jones field map

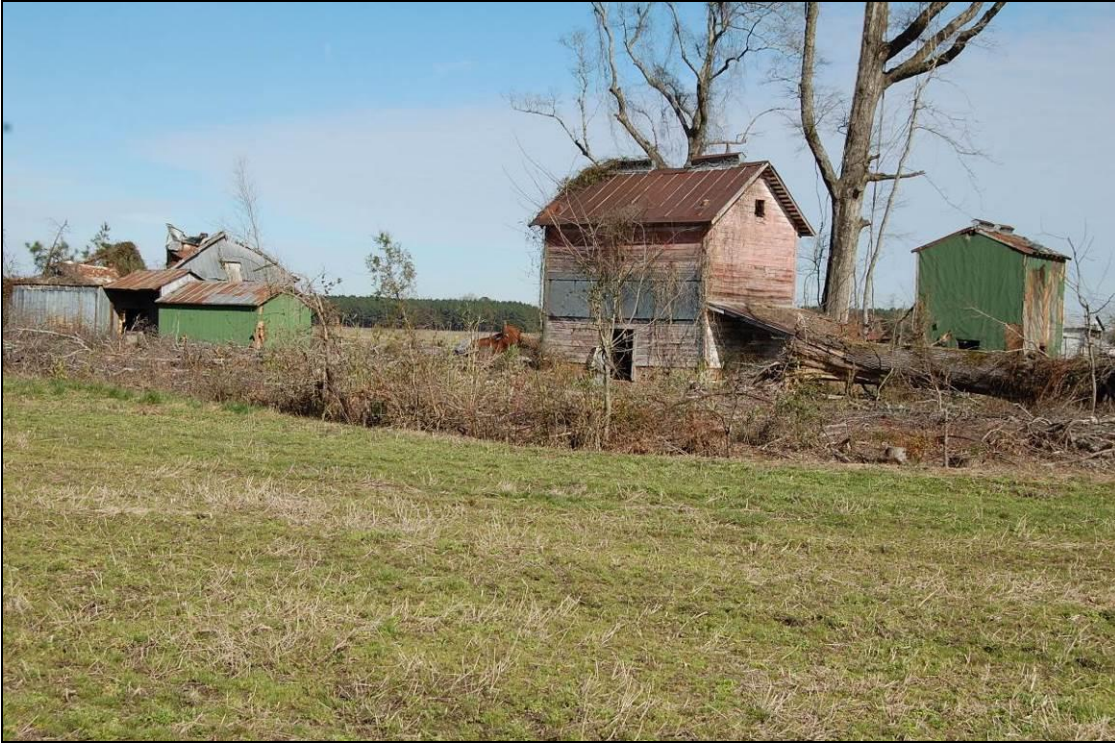
Figure 79. Willie Humphrey Farm, looking northeast at telescoping haybarns at left and frame tobacco barns at right

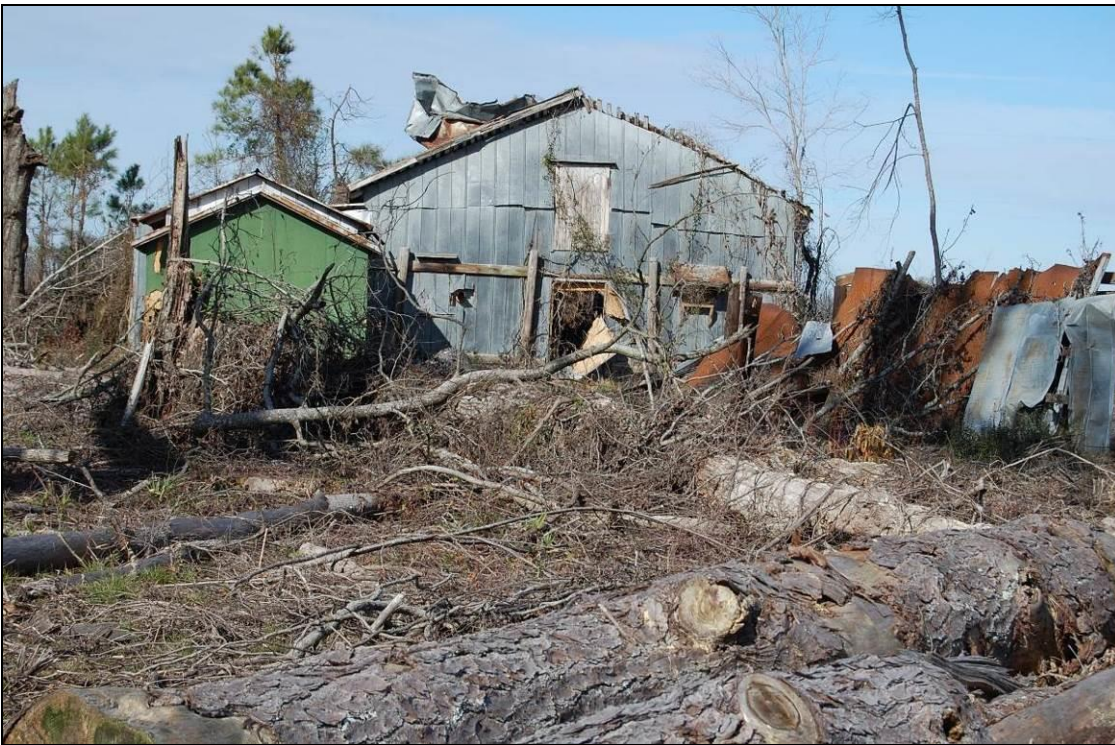
Figure 80. Willie Humphrey Farm, looking north at rear of surviving portions of telescoping haybarns

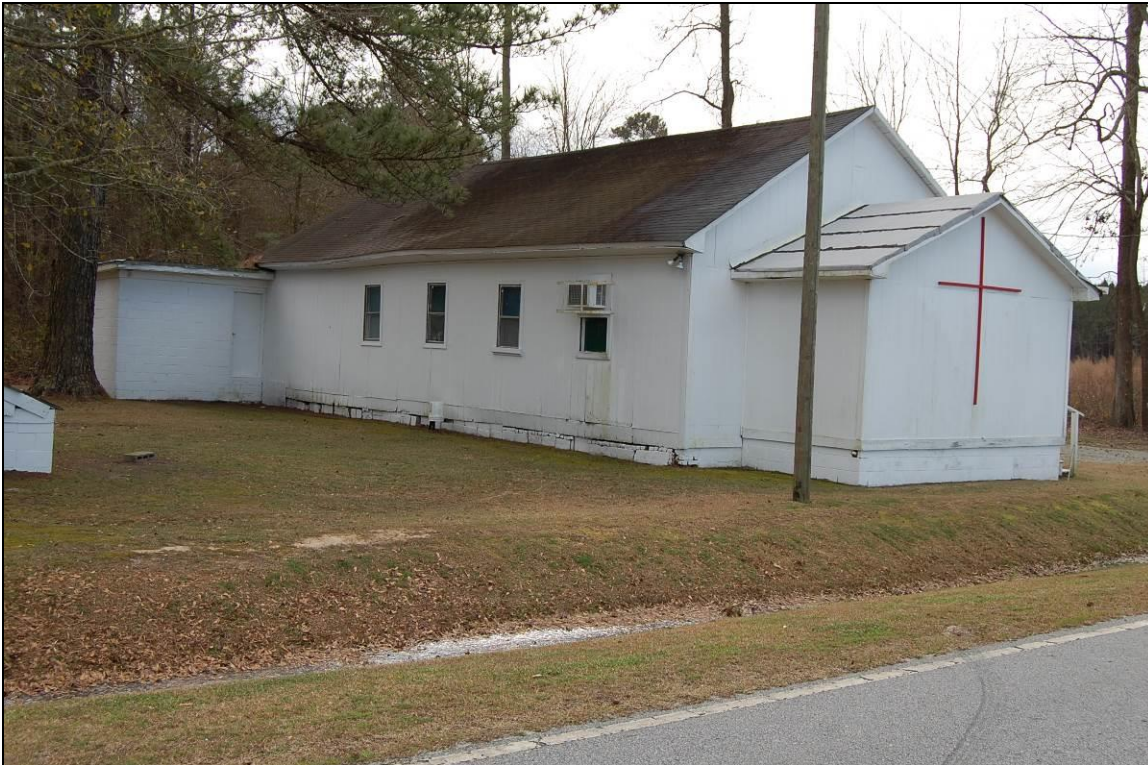
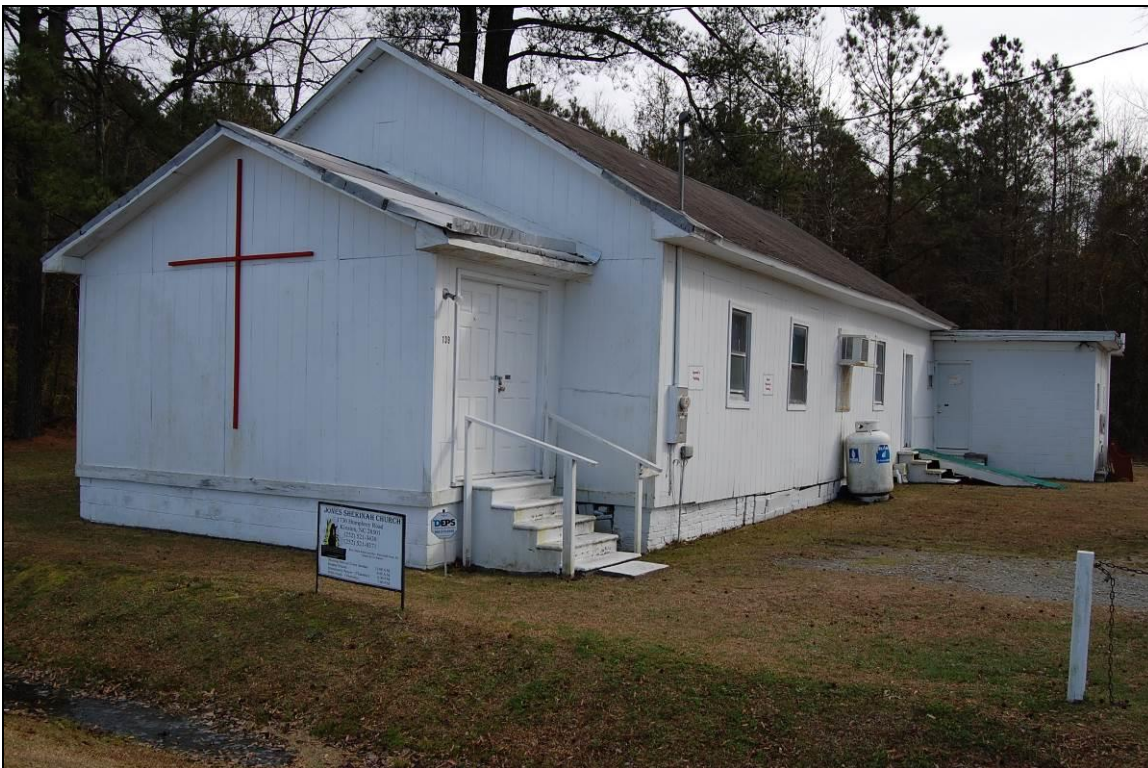
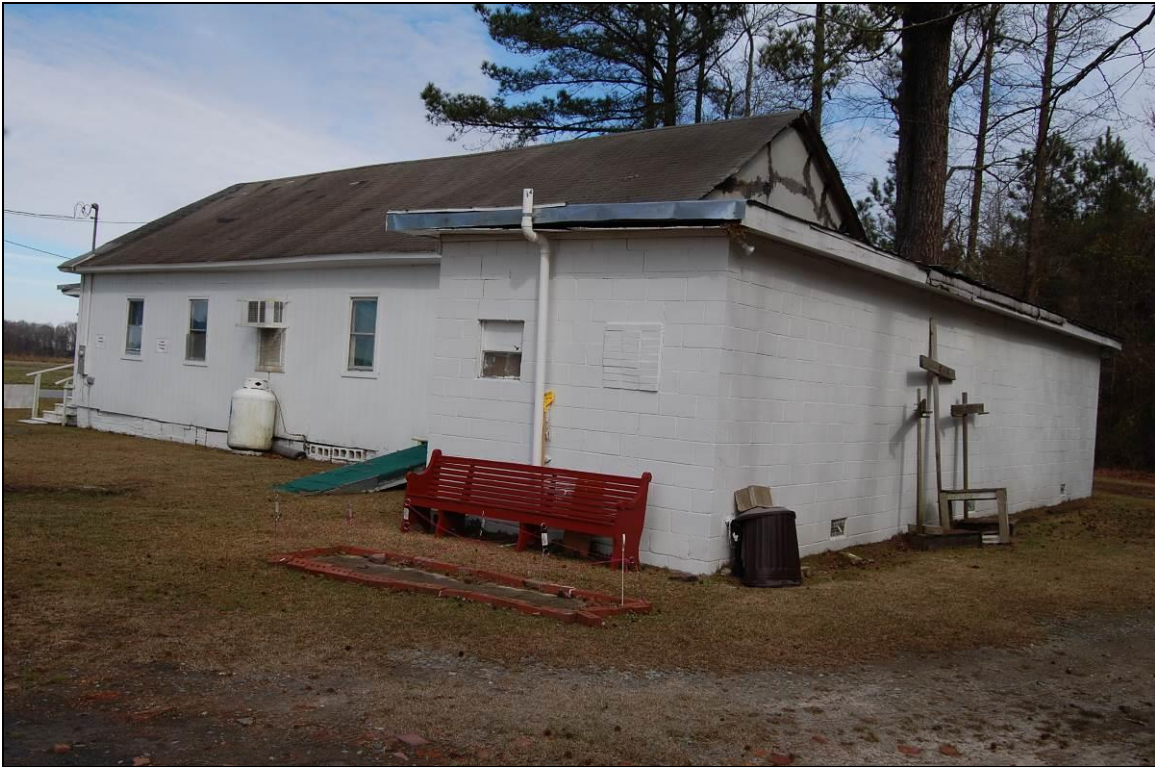
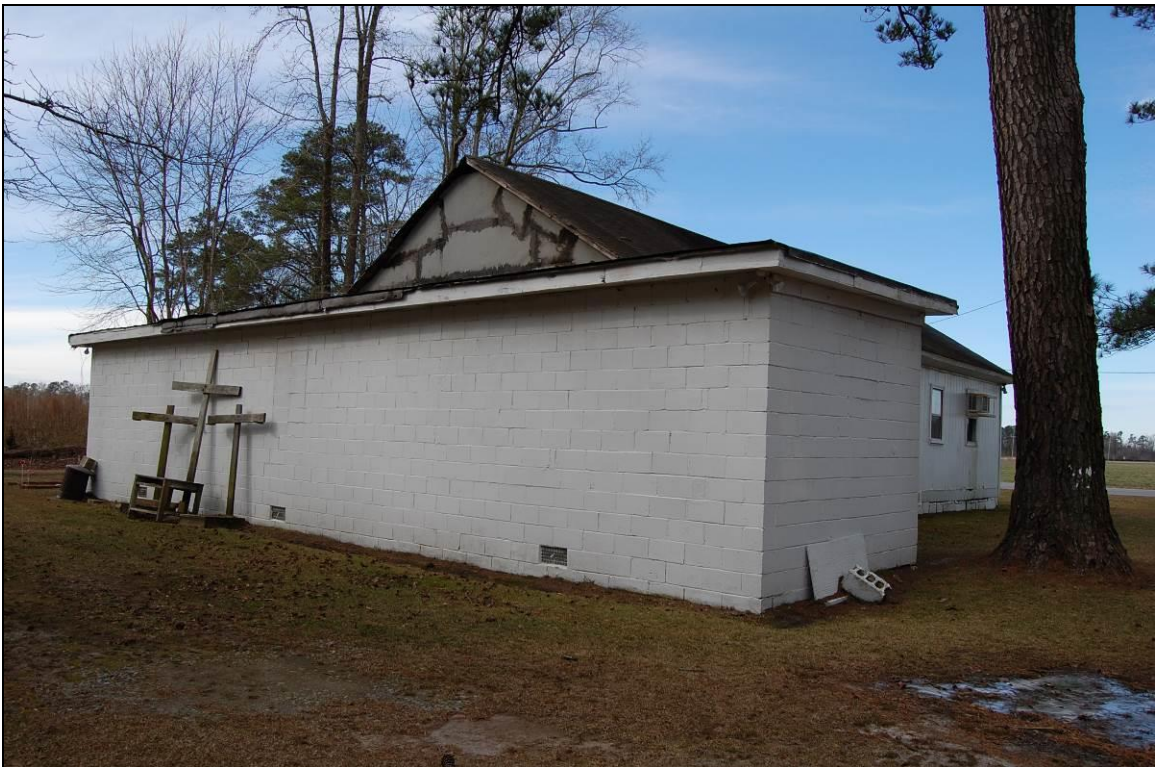
The earliest section of Foster's Chapel is likely its central sanctuary block, which is gable-fronted and one-story tall (Figure 81 through Figure 84). It has four windows bays on its east side elevation and four windows plus a rear entry on its west side. The block appears to be of frame. It is clad, likely over an earlier material, with panels of T-111-type sheathing. Brick piers later supplemented by concrete blocks form the sanctuary's foundation. The one-over sash, like the siding, appears not to be original.

The small front entry block, centered on the sanctuary's north gable end facing Humphrey Road, is clad in the same siding as the sanctuary. The double-entry doors in its west side elevation and concrete-block foundation suggest it was a later addition. The long, one-story, concrete-block rear ell, which a sign indicates contains restrooms, may date from the same time as, or postdate, the entry block.

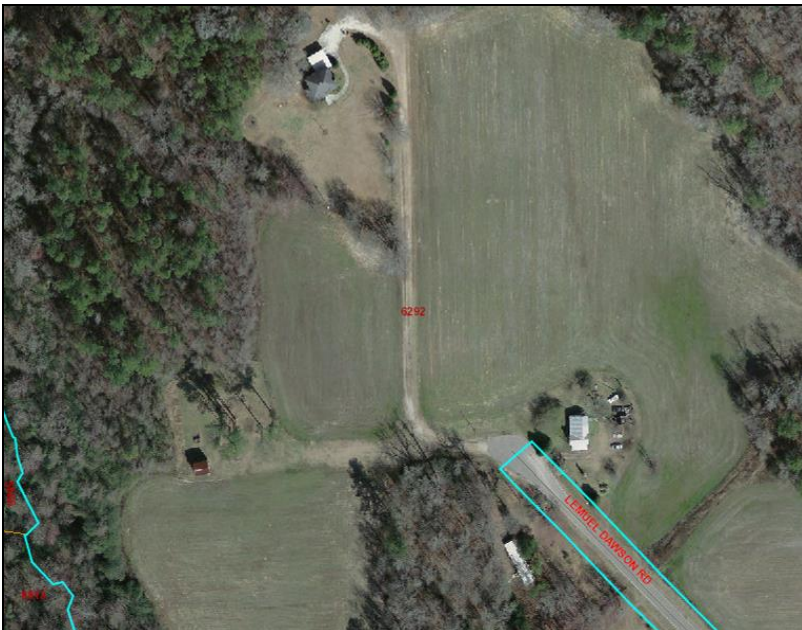
Figure 86. Eliza Dawson Farm tract, southwest section with Dawson House at lower right, trailer shell at bottom across road, tobacco barn at lower left, and modern house at top center

The 76-acre former farm is about evenly divided between woodland and farmland (Figure 85 and Figure 86). Only four resources stand on it: the 1920s Dawson House; the shell of a modern mobile home opposite the Dawson House; a modern house to the north near the center of the tract; and a ruinous tobacco barn west of the Dawson House, which was not accessible.

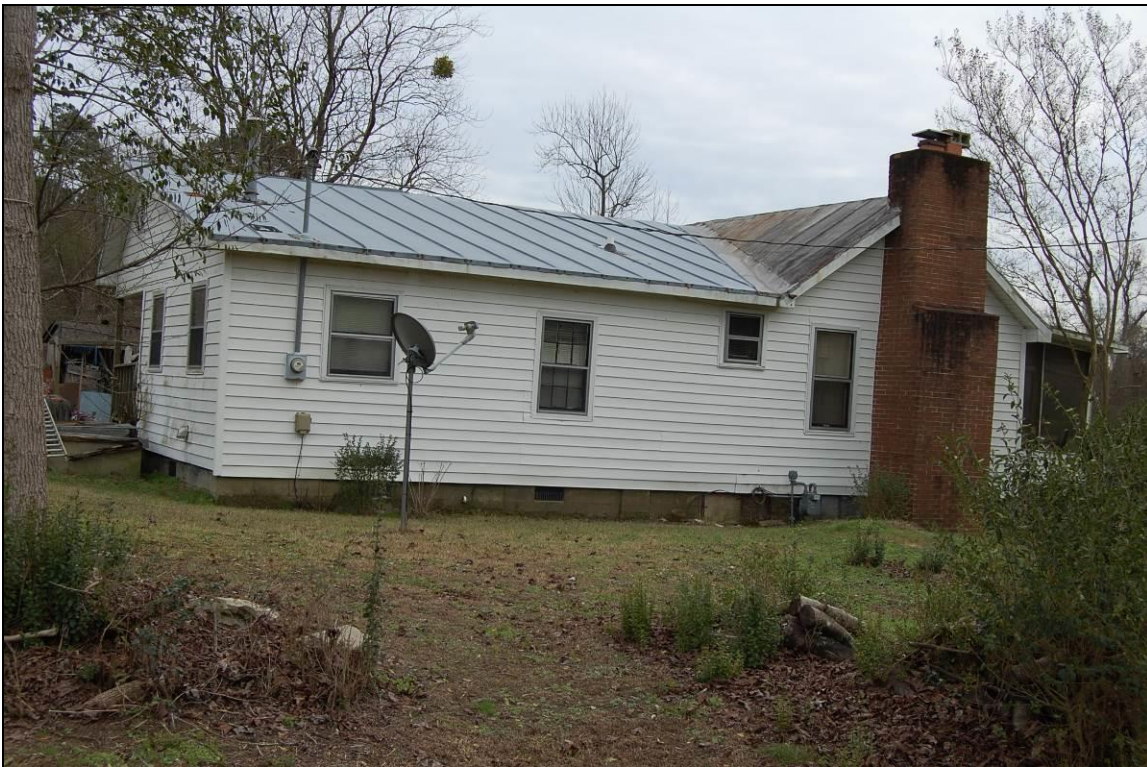
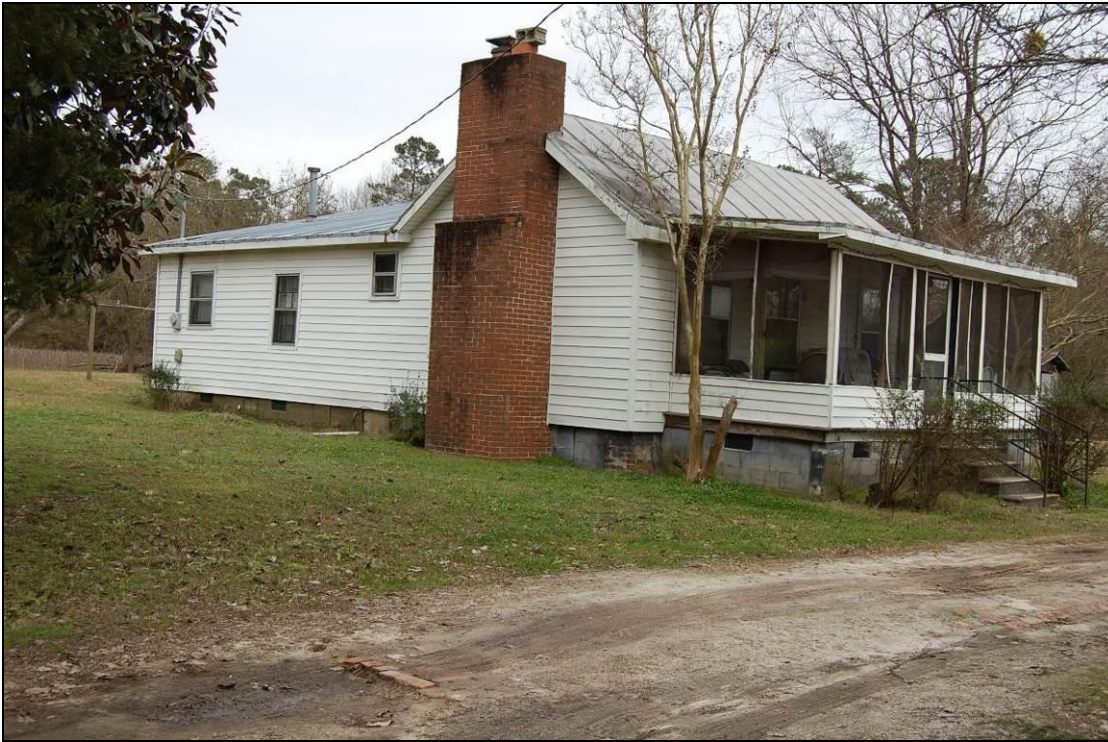
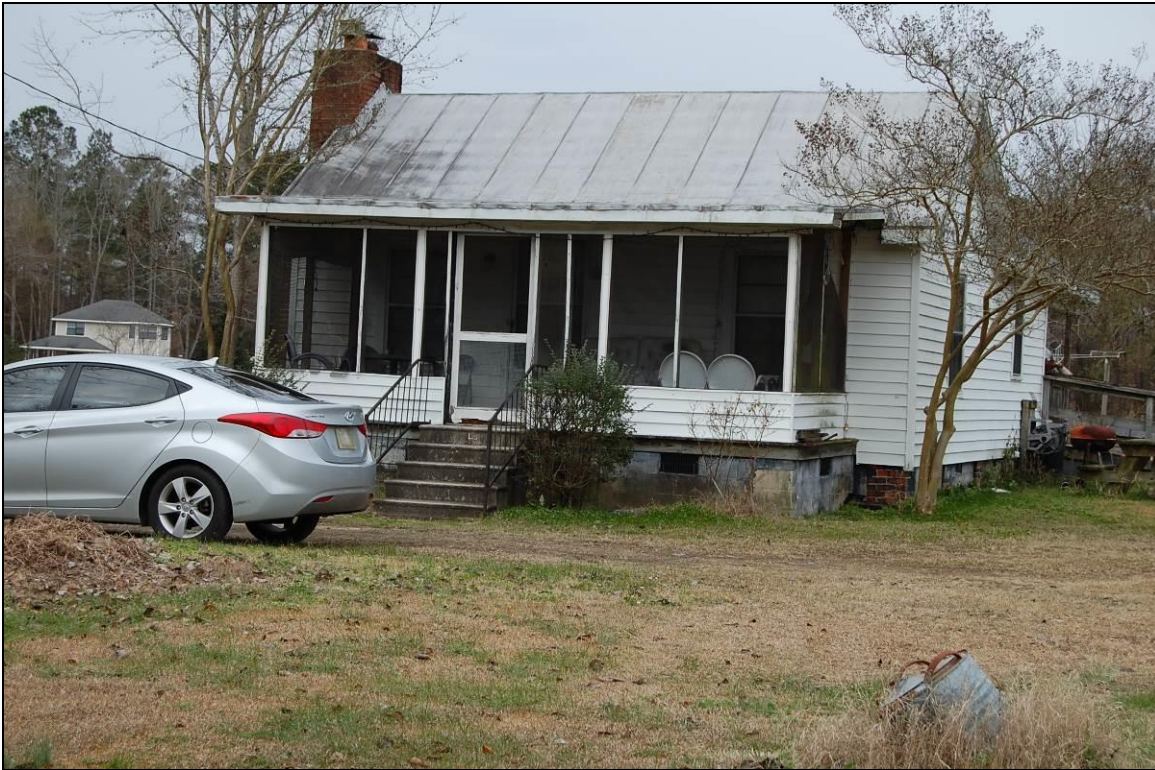
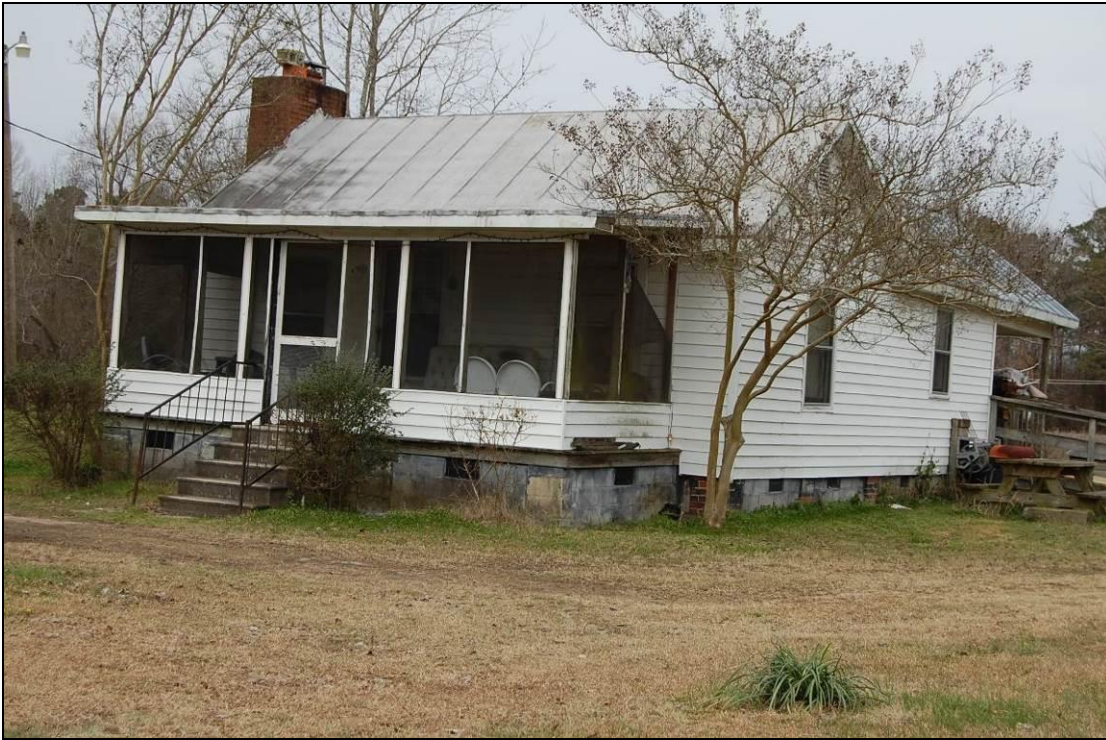
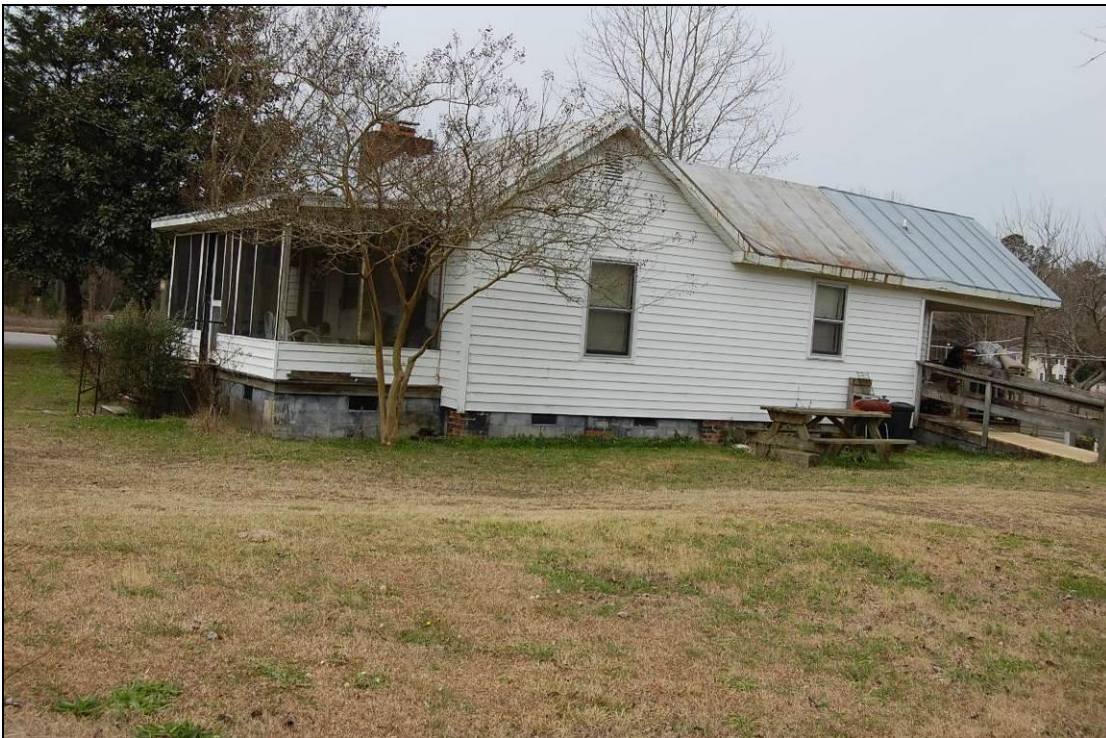
The one-story, gable-end, single-pile Dawson House has a fully screened, shed-roofed porch across its front (south) elevation, an exterior-end chimney at its west side elevation and, at its rear (north) a long, one-story, rear ell with a porch set into its corner (Figure 87 through Figure 95). Three bays cross its front elevation. Their asymmetrical placement suggests the house may have a two-room plan. Significant alterations to the house include the addition of artificial siding and one-over-one sash windows, the enclosure of the porch which appears to have included replacing the posts, the replacement of the chimney, and the addition of a wheelchair ramp up to the ell porch. Additionally, the original brick piers have been supplemented with concrete blocks. The only early photographs located in the survey file are those included with the student report that were taken in 1994. They appear to depict all of these changes in place by that time.

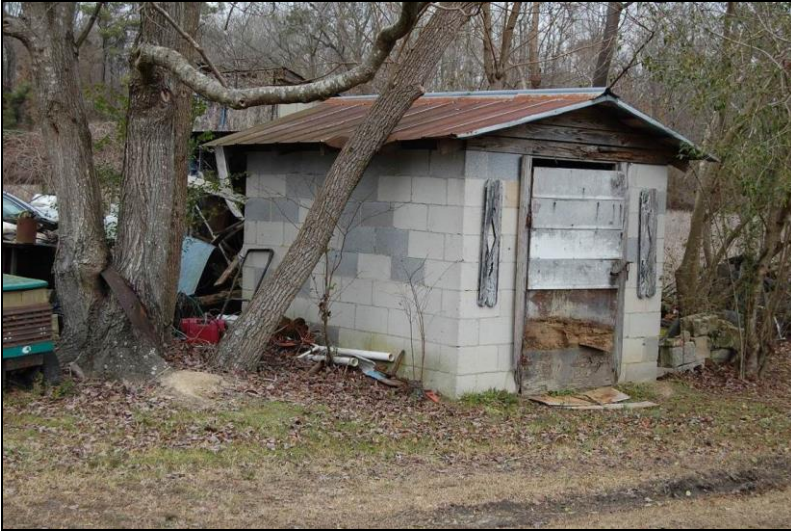
Figure 94. Eliza Dawson Farm, looking northeast from rear of house at tiny cinder-block outbuilding

The frame, shed-roofed, one-seat outhouse depicted just northeast of the house in a 1994 photograph does not appear to stand any longer. Near its location is a later small, cinder-block, seam-metal-roofed outbuilding with a sheathed-over gable-front entry. Its function was not determined. There was no access to the sole surviving farm-related outbuilding on the property. It may be one of the two included in a 1994 photograph.

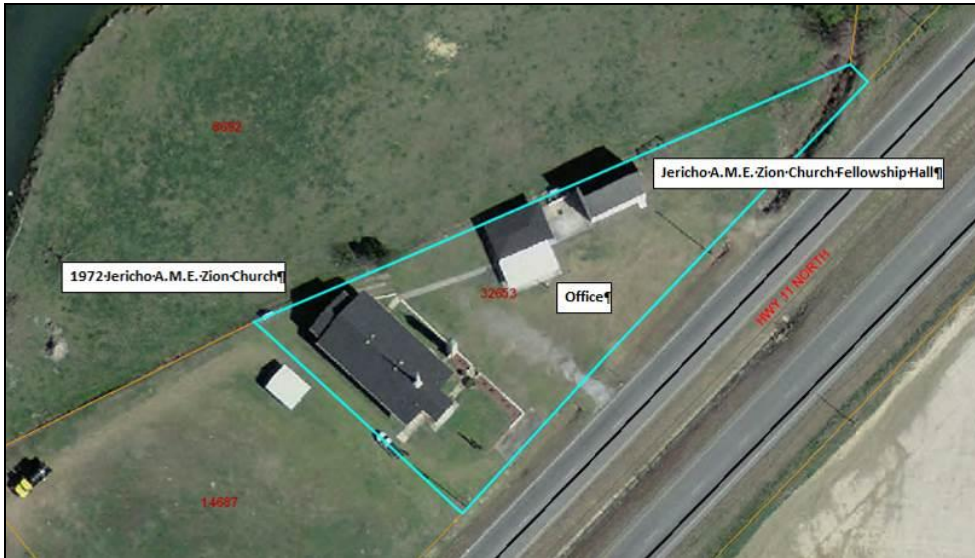
Just west of the former church (now fellowship hall) on the property are a concrete-block building that houses the church office as well as the current church building (Figure 96). As a keystone notes, the church was erected in 1972. The office likely dates from around the same time.

Figure 96. Parcel outlined in blue with original former church, now fellowship hall, at right and office and 1972 church at left (base map: Lenoir County GIS)

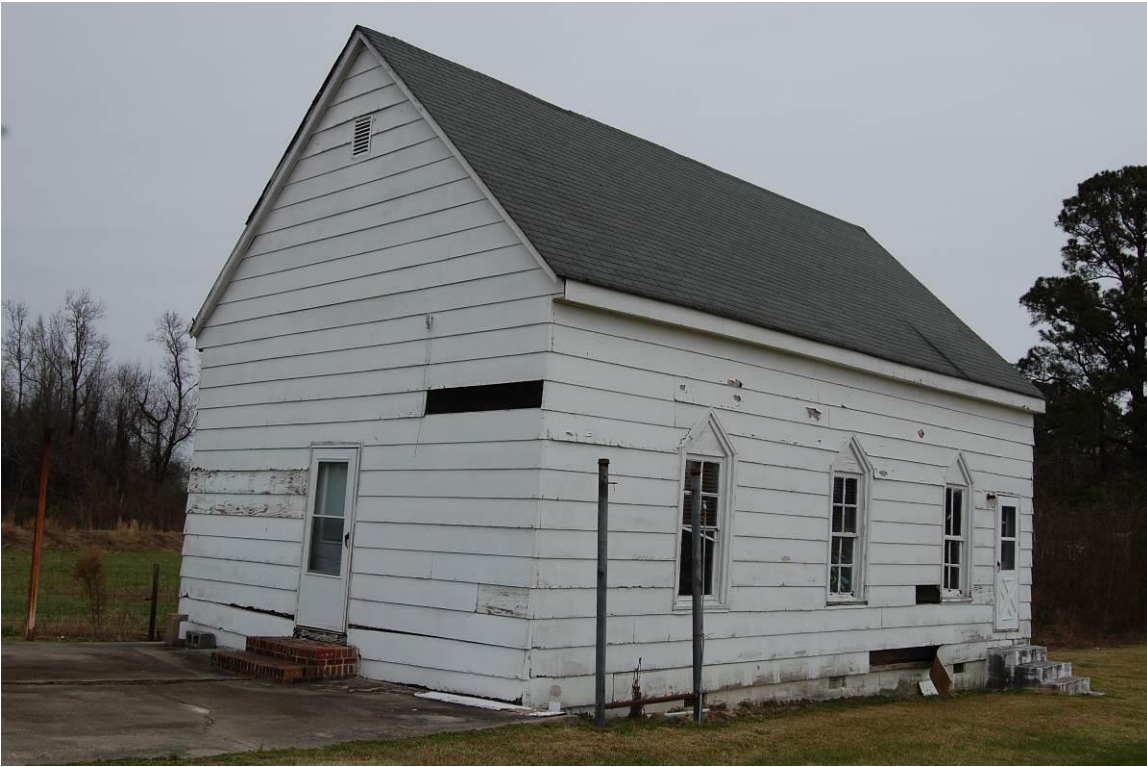
The former church is a gabled frame building that now stands parallel to NC 11 (Figure 97 through Figure 103). Its original location on the property and original orientation are not known. (It was moved when the current church building was erected.) The building's Masonite siding was added over its original weatherboards, which are visible in places where the later siding has deteriorated or pulled away. According to Jones' field notes, split wood shingles remain in place beneath the asphalt-shingled roof. The concrete-block foundation dates from the building's move in 1972. The former church's west gable end has a single modern door set in a modern surround. The long south elevation retains its original three window bays set beneath triangular-arched surrounds. The central window retains its original four-over-four sash. At the other two windows, the sash is only partially intact. An entry with a modern door was later inserted into the east end of the elevation. The east gable end continues to hold its original four-over-four window and triangular-arched surround. The three bays at the long north elevation also retain their surrounds and some of their original sash.

Figure 97. Jericho A.M.E. Zion Church Fellowship Hall, gabled west and long south elevations

The former church is also not known to be associated with any important historic events and is accordingly not believed to be significant under Criterion A. Its construction on land donated by an African-American during or shortly after Reconstruction is not believed to meet the standard of historical significance required under this Criterion. Further, as noted at the table below, it is not believed to retain sufficient integrity to support any historical significance. It has been moved, although on its original parcel, it no longer serves the congregation as a church and, most importantly, it has lost its integrity through its many alterations. For similar reasons, the church is not believed to retain sufficient integrity to support any significance under Criterion C for its architecture. The notable alterations to the building include the addition of Masonite siding and asphalt roof shingles; the covering of the floor, walls, and ceiling inside with modern materials; and the addition of modern doors at the west and south elevations. The retention of the triangular-arched surrounds and some six-over-six sash is not sufficient for the building to retain its architectural integrity.

Element of Integrity	Level of Integrity	Assessment
Location	Medium to High	The former church was moved, although it continues to stand on its original parcel.
Design	Low to Medium	The former church retains its original form and triangular-arched window surrounds, but has been covered inside and out with modern materials and has lost its original entry.
Setting	Low to Medium	The setting remains only partially rural. NC 11, now a four-lane divided highway, runs past the former church and to the north stand a car repair shop/junk yard, a modern industrial-type welding shop building, and a large Coastal AgroBusiness distribution facility.
Materials	Low	Other than the triangular-arched window surrounds, the former church's original materials are hidden from view by modern materials or gone.
Workmanship	Low	Other than the triangular-arched window surrounds, the former church's original workmanship is hidden by modern materials or gone.

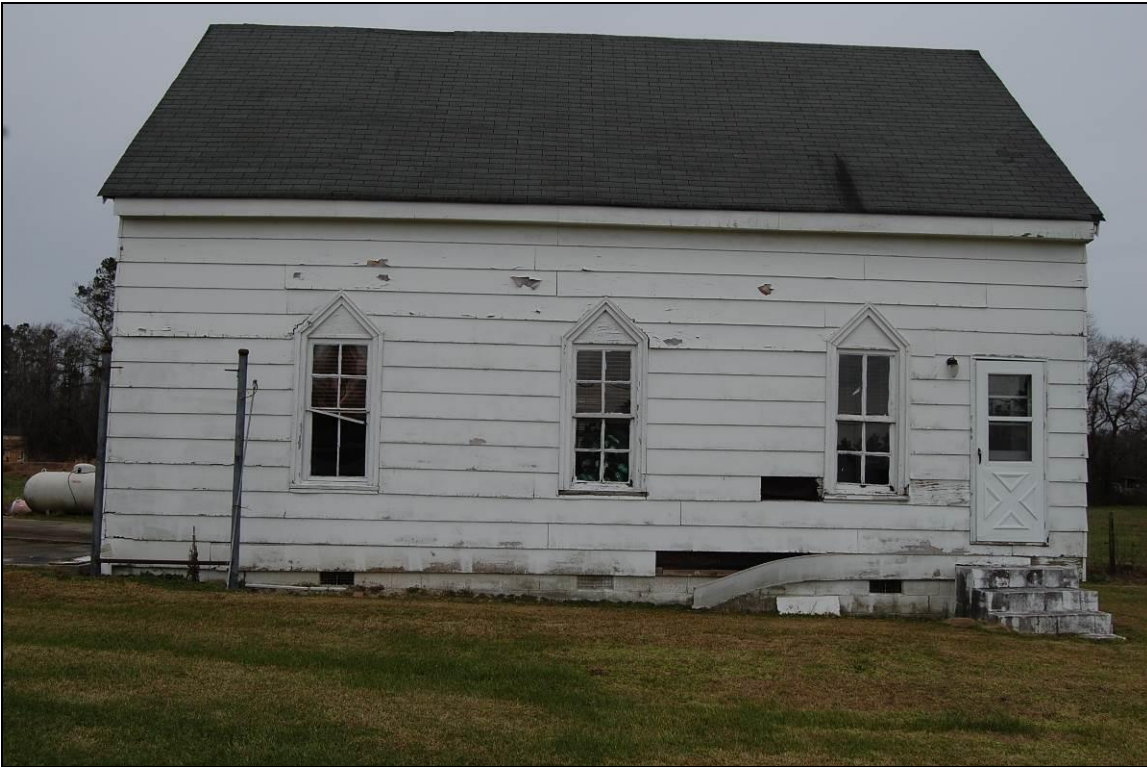
Figure 98. Jericho A.M.E. Zion Church Fellowship Hall, south elevation

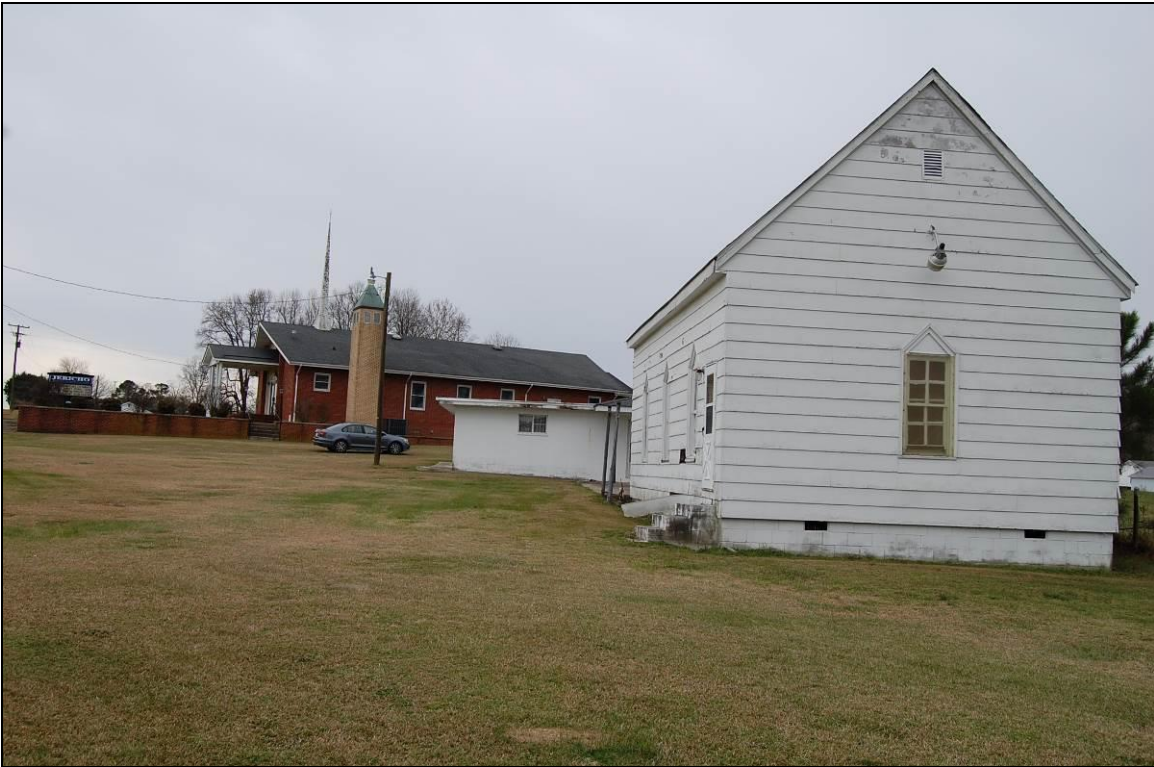
The building that holds the office is constructed of concrete block and topped by a hipped roof. The modern church is a long, brick, gable-front building with a portico, a tall narrow spire and, to its east side, a brick bell tower.

Figure 99. Looking west at Jericho A.M.E. Zion Church Fellowship Hall gabled east elevation with office at center and 1972 church and bell tower at left

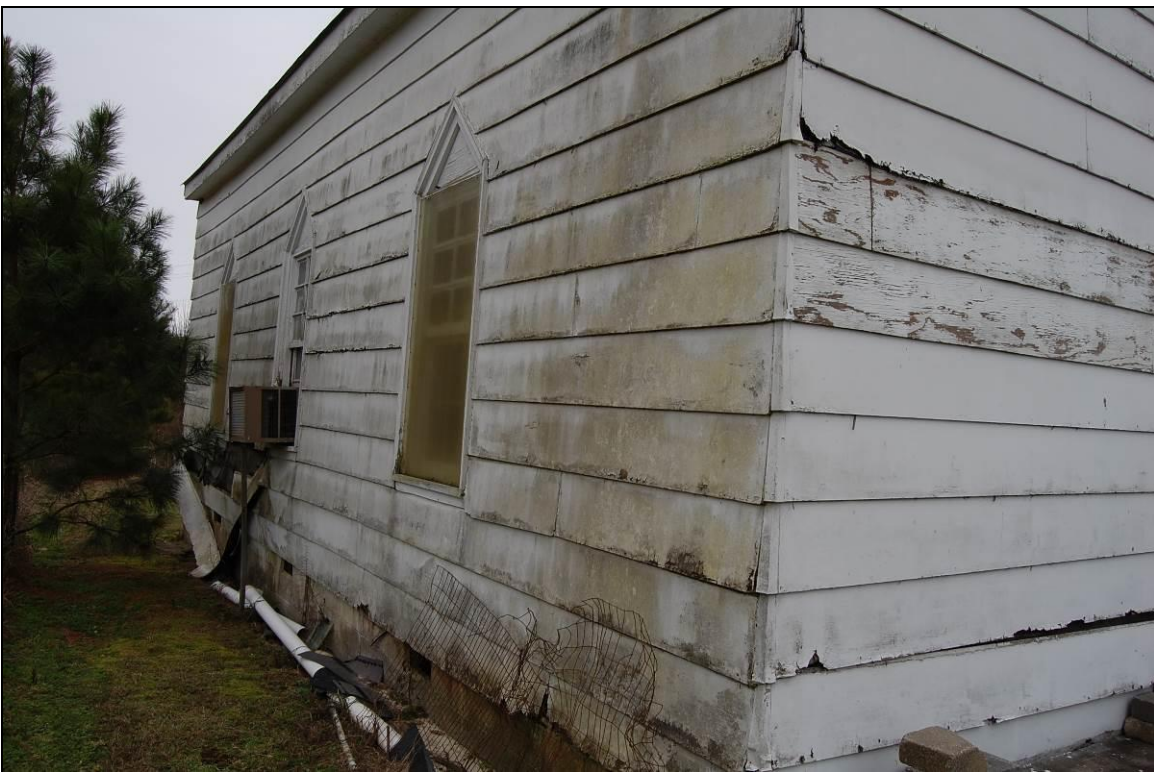
Figure 100. Jericho A.M.E. Zion Church Fellowship Hall, long north and gabled west elevations

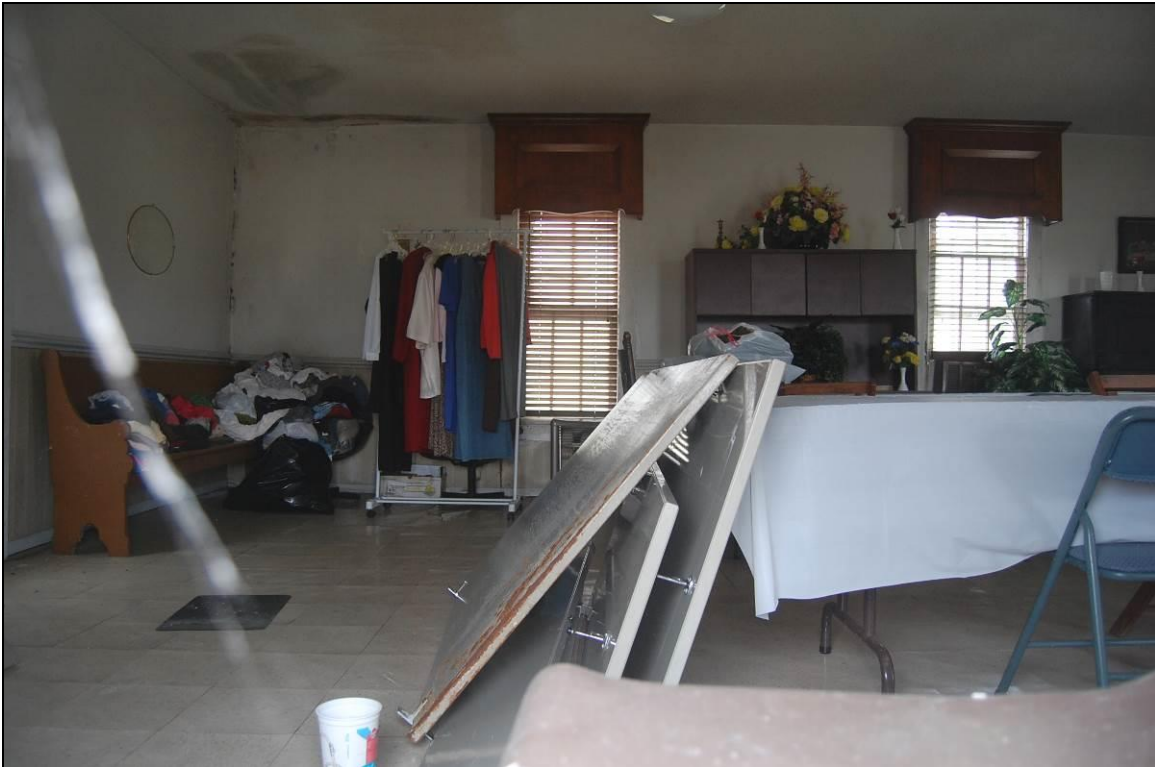
Views in through the windows of the locked building revealed ca.1972 floors, walls, and ceiling. According to Jones' field notes, the original tongue-and-groove walls and ceiling remain in place beneath the later materials. One pew that may be original to the church was visible at the west wall.

Figure 101. Interior of Jericho A.M.E. Zion Church Fellowship Hall; note modern finish and early pew at left against east wall
