North Carolina Department of Natural and Cultural Resources
State Historic Preservation Office

SUBJECT: C. F. Harvey Parkway Extension (NC 148), Four-Lane Divided Freeway on New Location, R-5703, NCDOT WBS No. 46375.1.1, Lenoir County, ER 16-0449

Figure 2. Area of Potential Effects, outlined in red, and property locator map

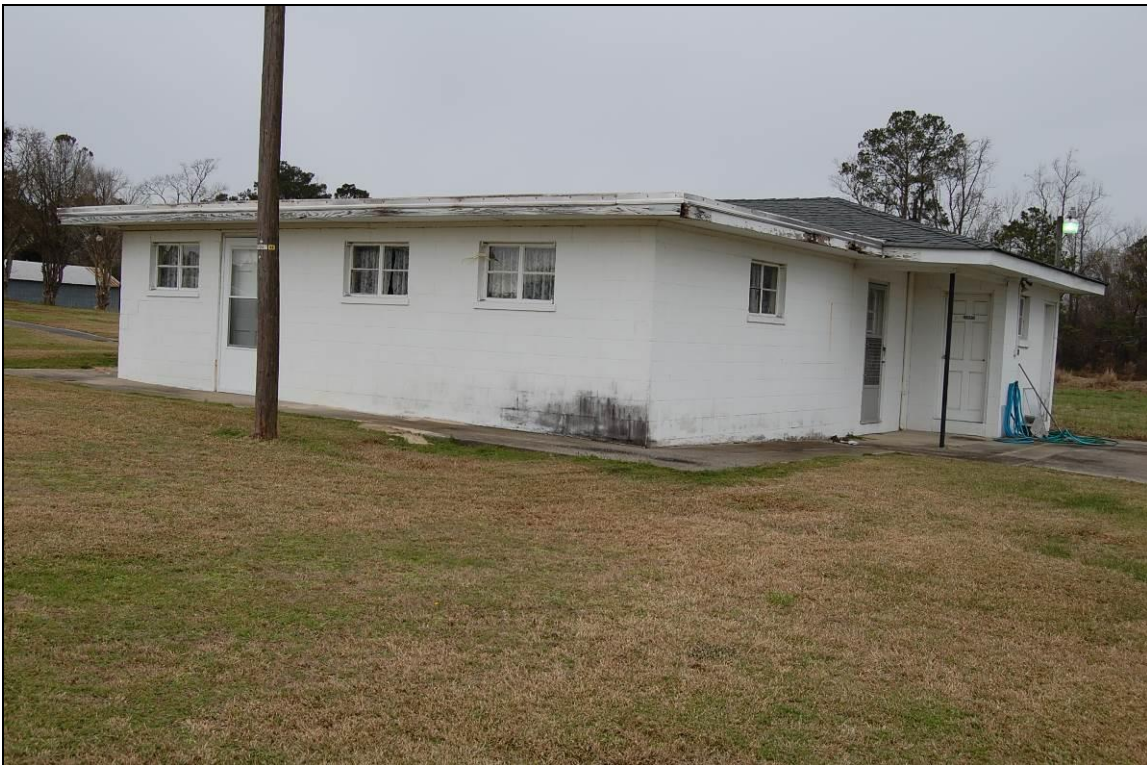
The building that holds the office is constructed of concrete block and topped by a hipped roof. The modern church is a long, brick, gable-front building with a portico, a tall narrow spire and, to its east side, a brick bell tower.

Figure 102. Looking northeast at concrete-block office

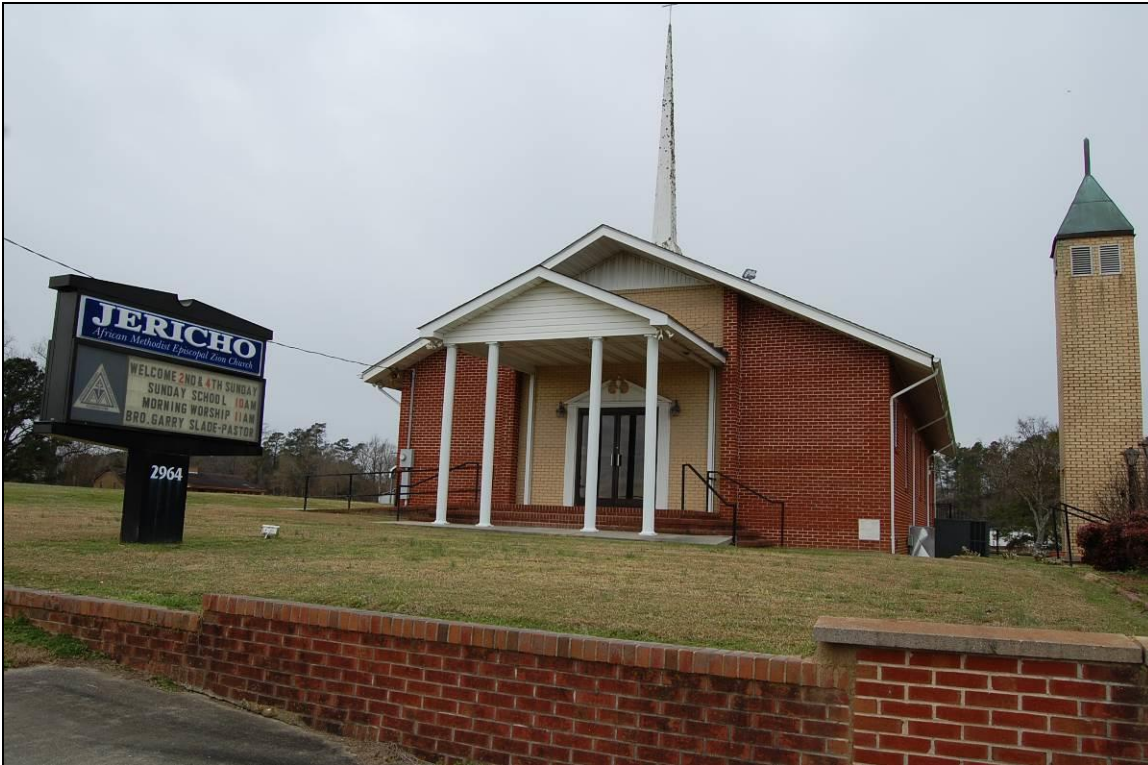
Figure 103. Looking north at 1972 church and bell tower

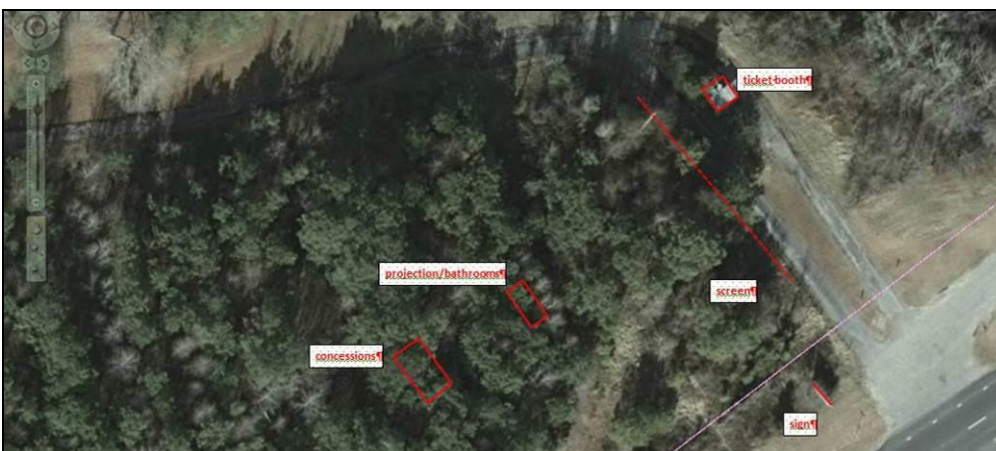
Portions of a number of the drive-in’s feature remain in place, although they are all heavily deteriorated or ruinous and largely hidden by the trees that have grown up on the site for the past 30 years. They occupy an approximately seven acres portion of a much larger 172-acre tract, which is the only part of the parcel on the north side of NC 11 (Figure 104).

Figure 104. (Former) Broadway Drive-In Theatre sketch map marked with approximate locations of screen, projection building, and concessions stand

The former drive-in is ruinous. Only pieces of its resources survive. Due to the loss of its screen, the heavy deterioration and collapse of its surviving buildings, and the growth of trees throughout its site, it is also believed to lack sufficient integrity to support its eligibility as a significant and distinguishable entity under NRHP Criterion C.

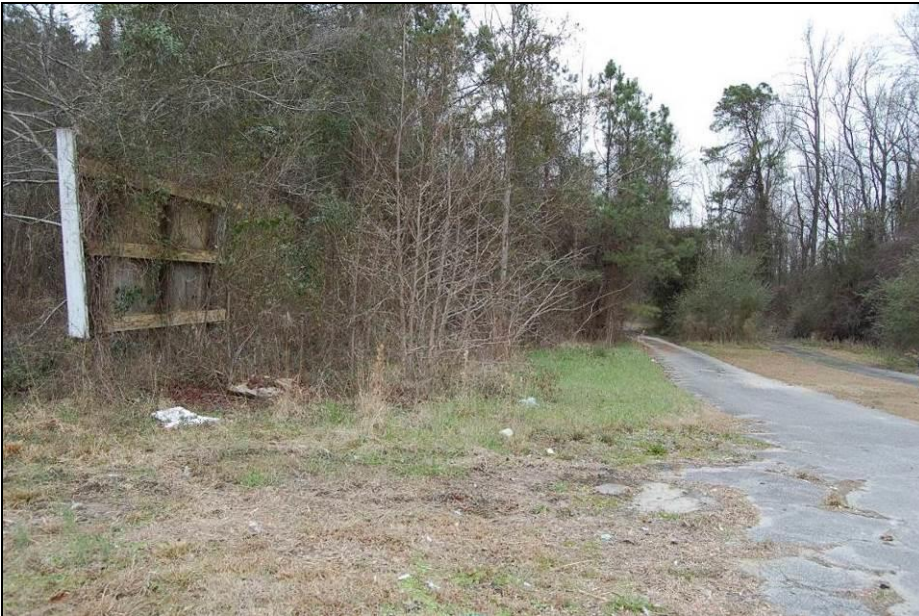
A large, wooden, polygonal sign or marquee continues to stand at the northwest corner of the junction of NC 11 and the drive-in's former driveway, which retains separate entry and exit lanes (Figure 105 and Figure 106). This sign likely announced the names and times of the shows. A separate or subsidiary entrance sign with the theatre's name is no longer extant.

Figure 105. Sign at left and drive at right, looking north from NC 11

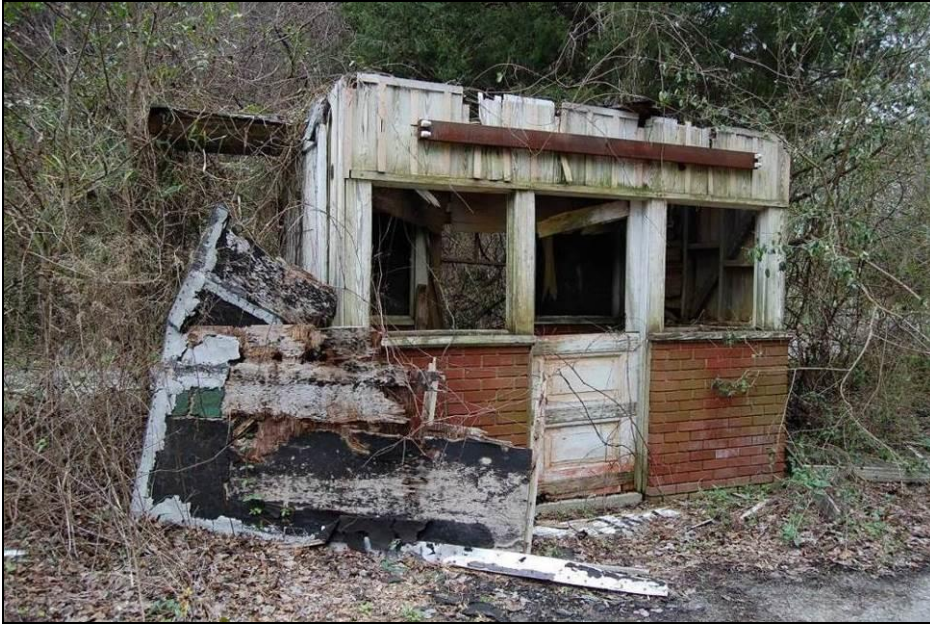
A small ticket sales building stands about 100 feet north of NC 11, between the theatre's entrance and exit lanes (Figure 107 and Figure 108). It retains a door and two sash-less window bays at its east ticket-taking elevation and a door-less entry at its west exit elevation. Brick veneer sides its lower third and broken board-and-batten siding, fallen in places, covers its upper two thirds. Its wide overhanging roof has fallen and it is ruinous.

Figure 107. West-facing, ticket-taking elevation of ticket booth

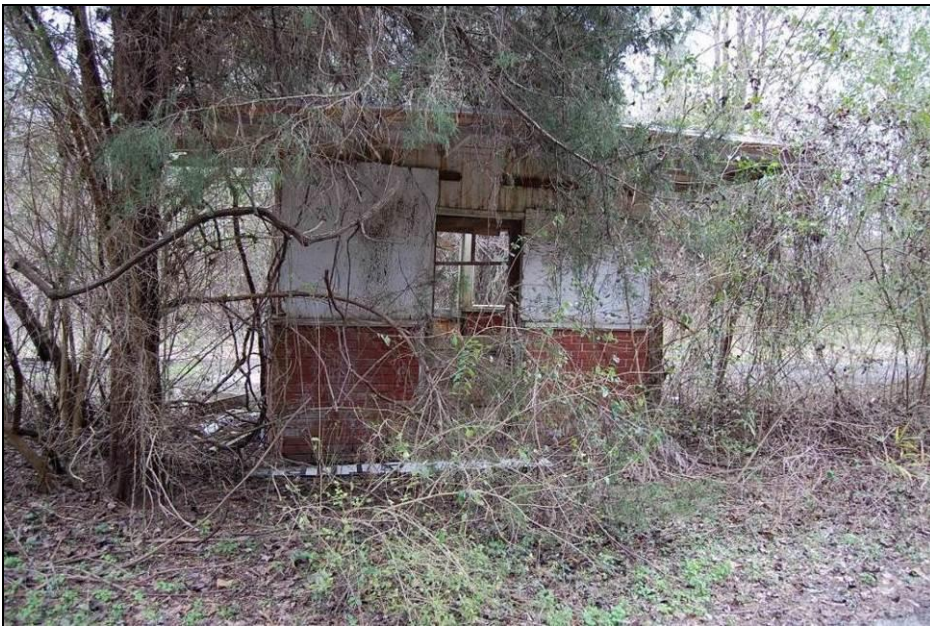
Figure 108. East-facing exit elevation of ticket booth

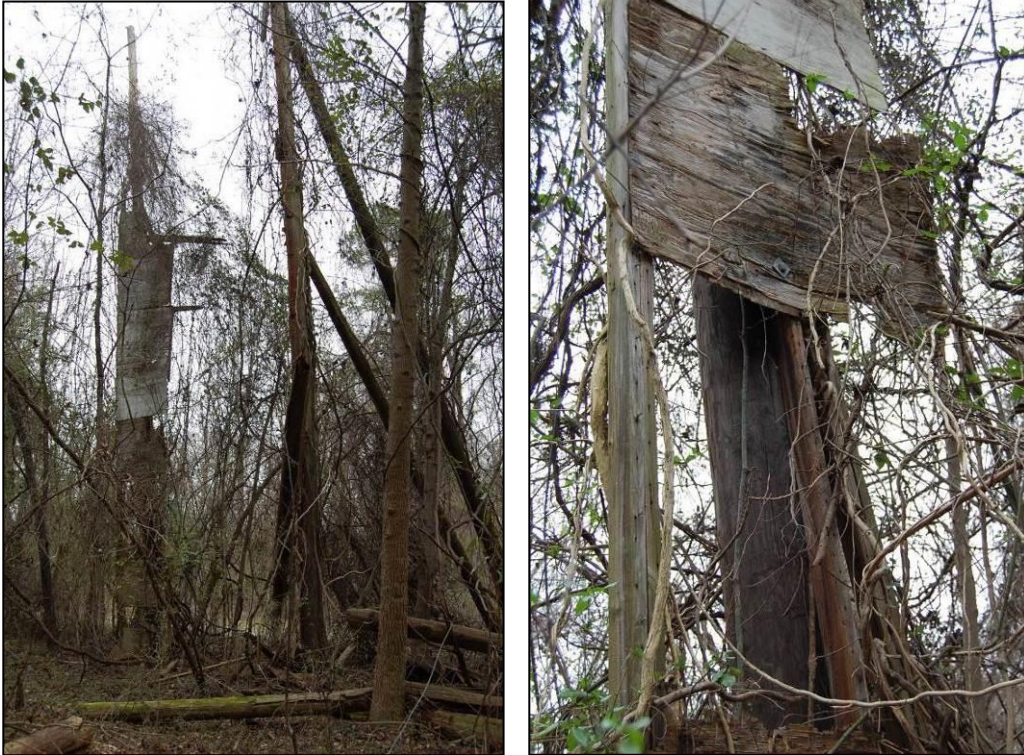
The theatre's screen has fallen, although some of its telephone-pole-like upright piers and diagonal braces still stand (Figure 109 and Figure 110). Small sections of wooden-panels that once formed the screen or its backdrop remain in spots on the uprights.

Figure 109. Surviving portions of uprights, diagonal braces, and wooden panels of screen

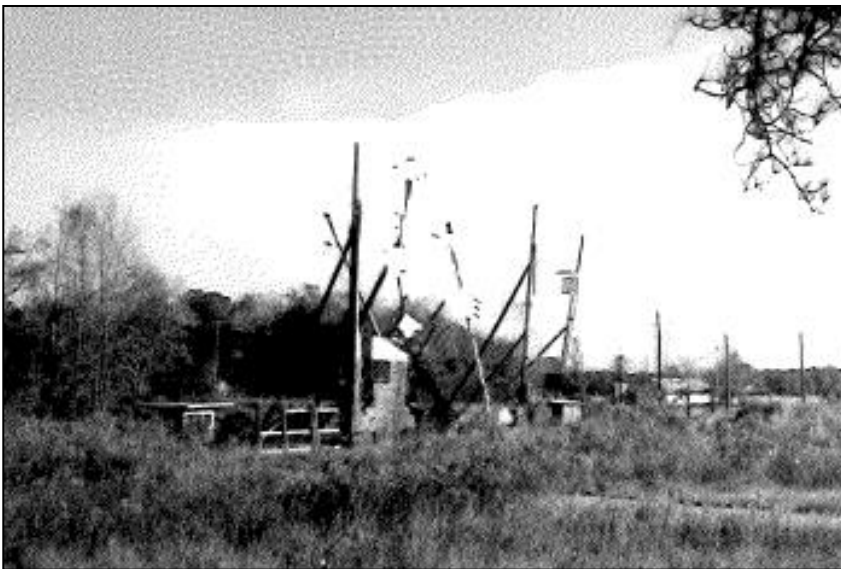
Figure 110. Screen with most uprights and bracing in place, 1993 (photographer: Robbie Jones)

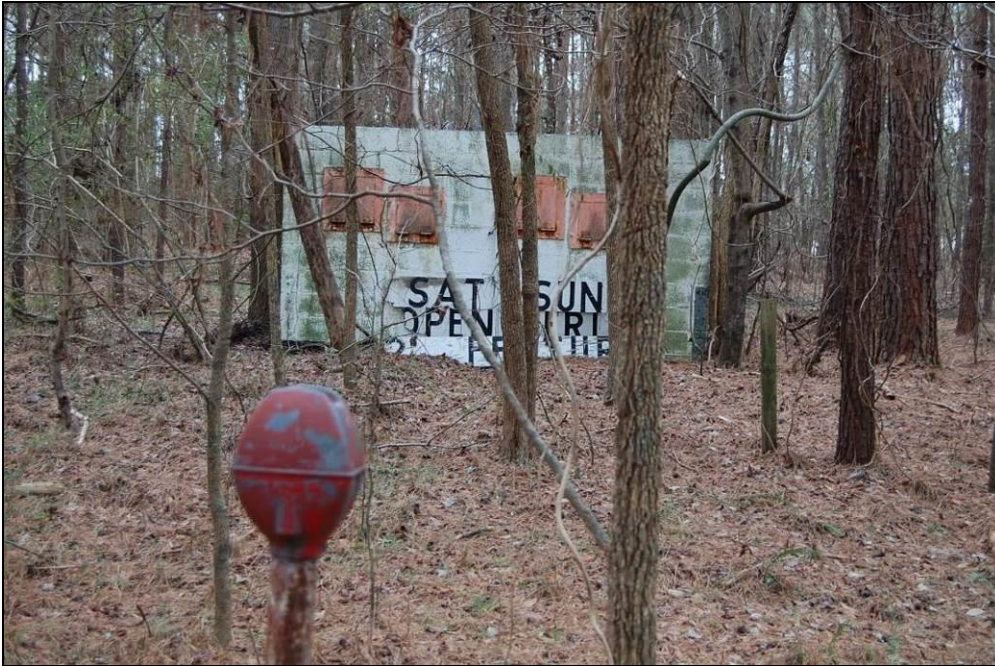
A one-story, concrete-block building to the west of the screen once held the projection equipment in its front section and bathrooms at its rear (Figure 111 and Figure 112). Its roof, doors, and windows are gone and it is ruinous.

Figure 111. Looking west past in-car speaker stanchion at front of projection building

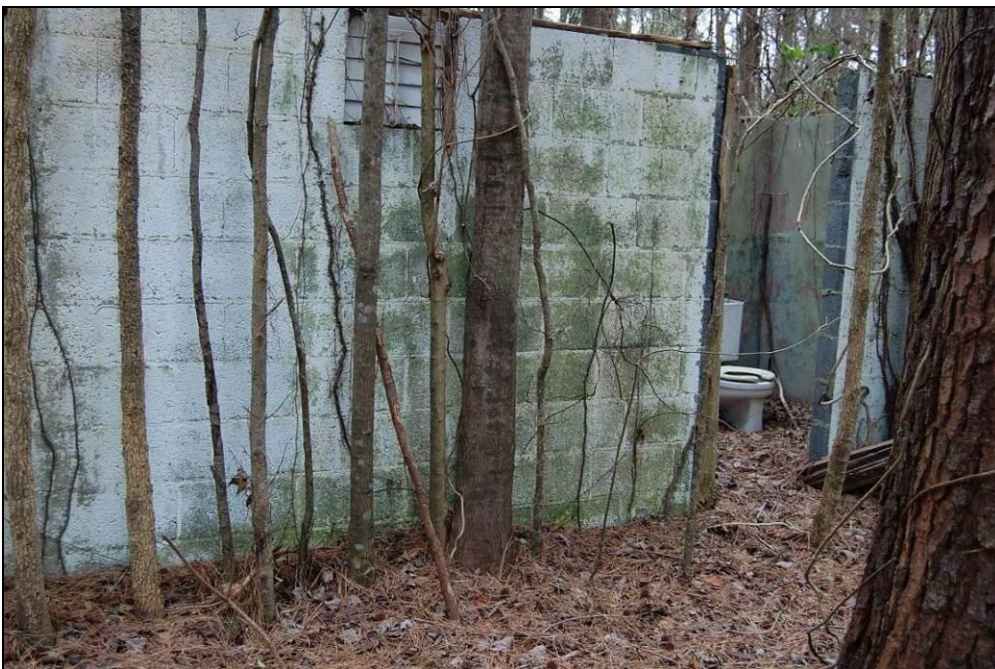
Figure 112. North side elevation of rear section of projection building, which held bathrooms

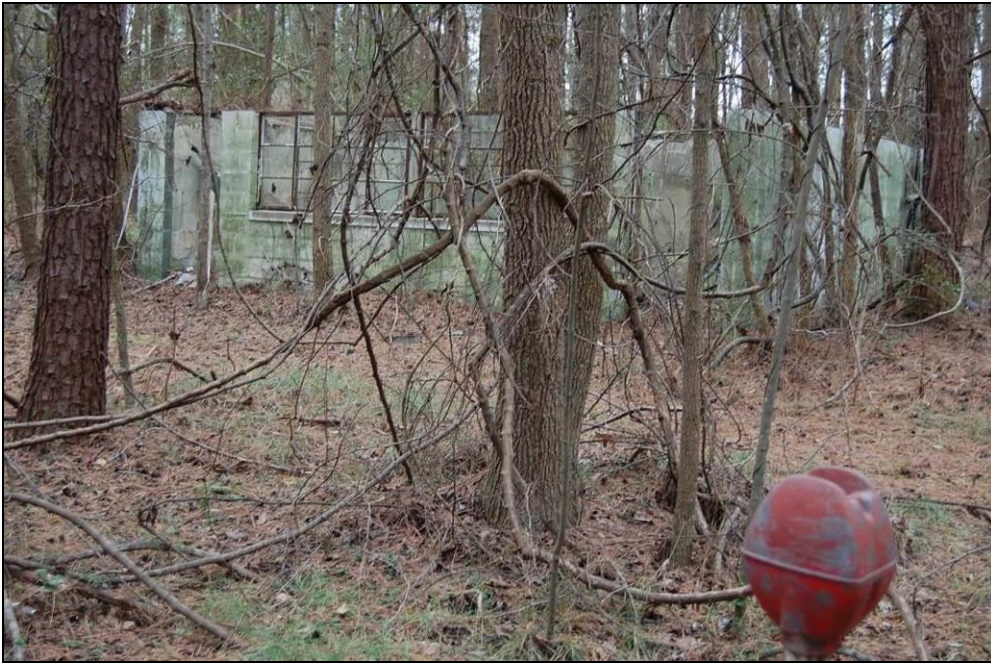
The theatre's concession stand is located west of the projection building (Figure 113 and Figure 114). It is a rectangular one-story building that once had a flat roof. The roof and doors are gone and the inside is bare. Much of the glass of its bands of metal-casement, east-facing windows remains in place, though.

Figure 113. Looking west past in-car speaker at front elevation of concession stand

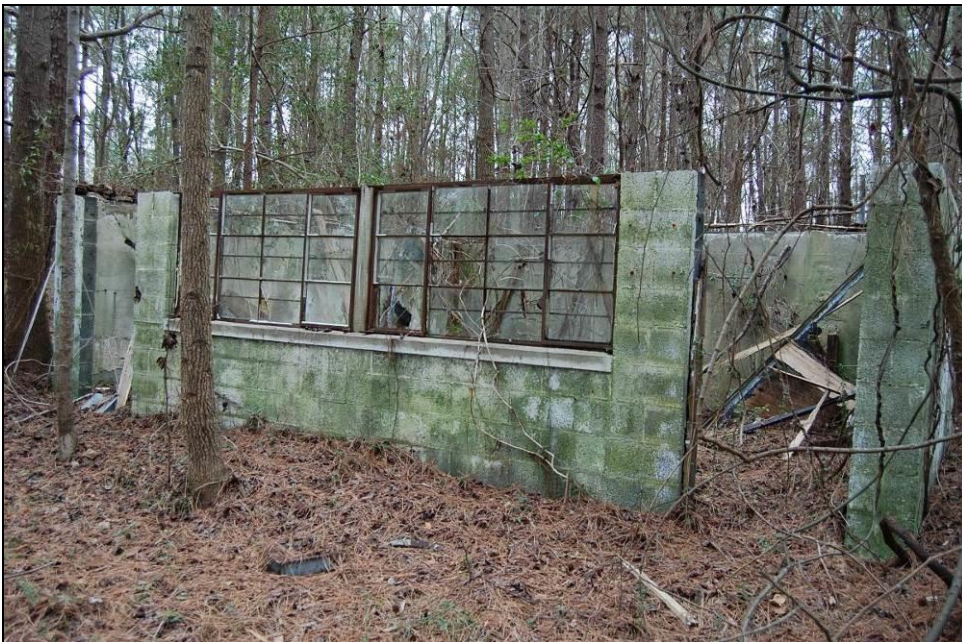
Figure 114. East-facing front elevation of concession stand

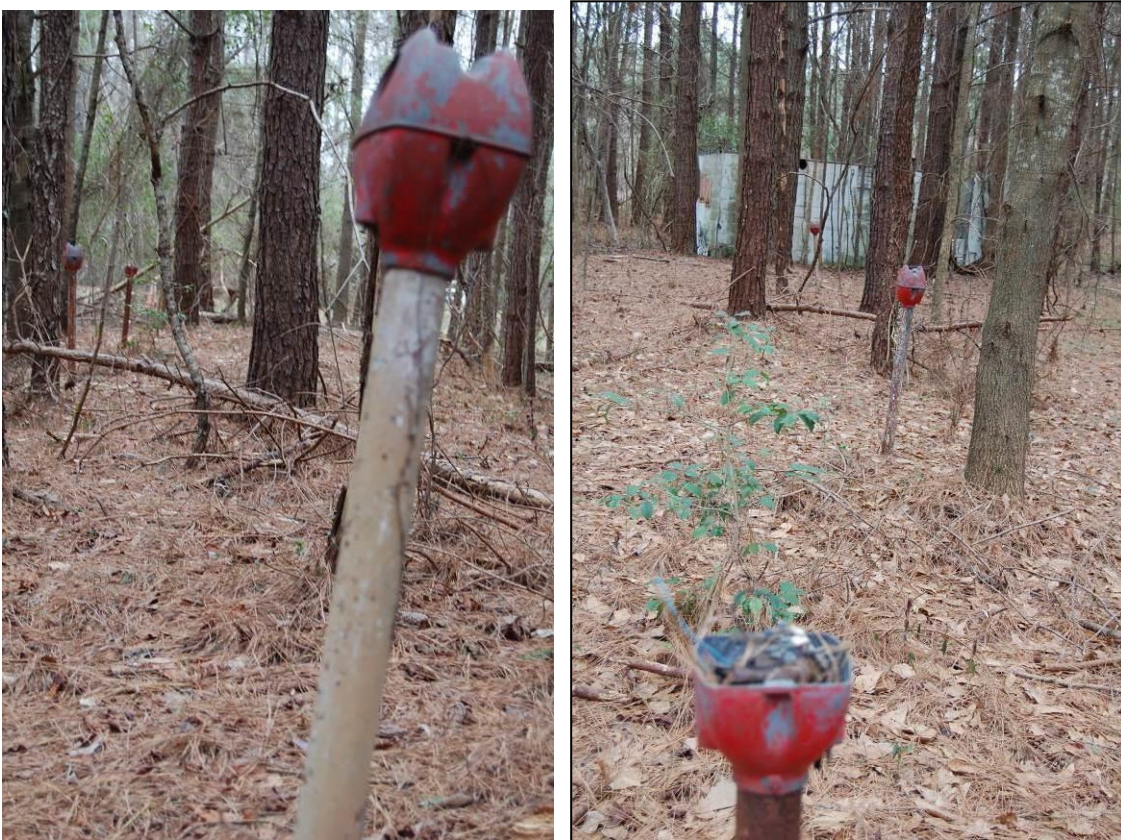
Figure 115. Rows of stanchions and in-car speakers, some with wiring still in place

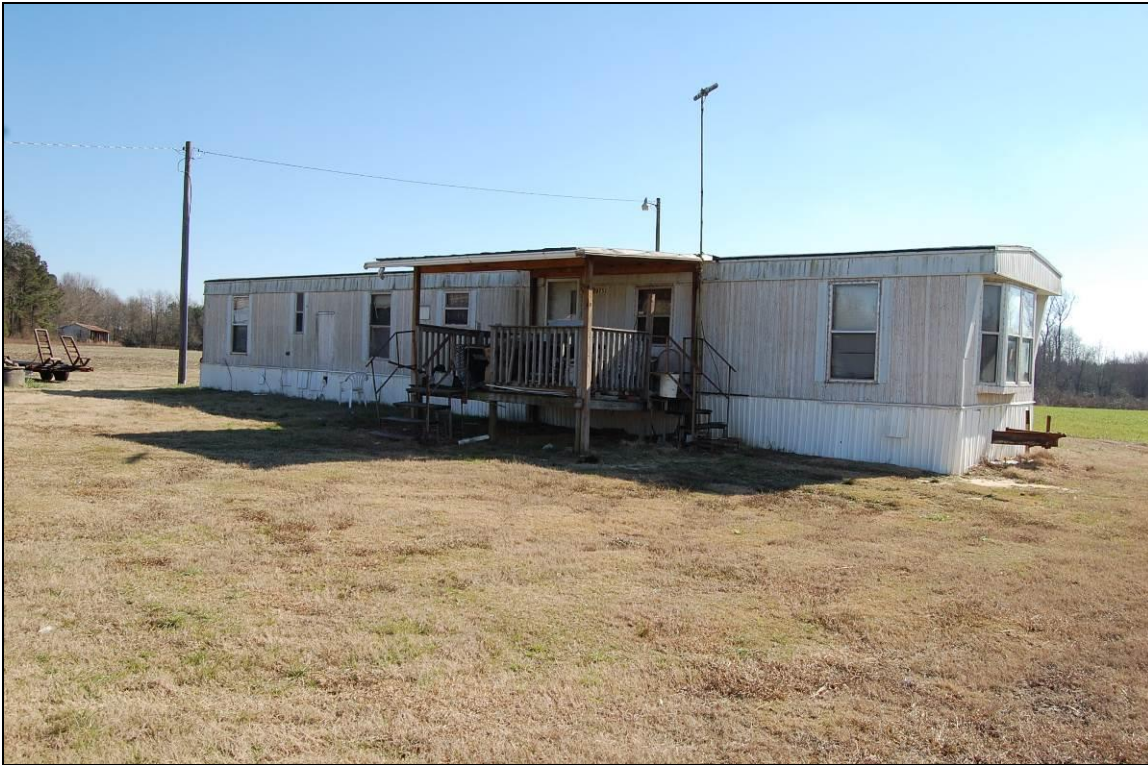
Marvin Brown found the house vacant and in good shape during his June 2010 resurvey, but no longer maintained. The house was heavily damaged between the resurvey and the shooting of the NCOne aerial image of 2012. According to a farm laborer who drove onto the parcel, it burned and the mobile home was placed on its site. All trace of the house is gone, but a packhouse recorded in 2010 continues to stand on the tract just east of the house site (Figure 116 through Figure 119).

Figure 116. Mobile home on site of former Brown House

The former Brown House no longer stands and therefore does not maintain the integrity necessary to support NRHP-eligibility under any of the NRHP's Criteria.

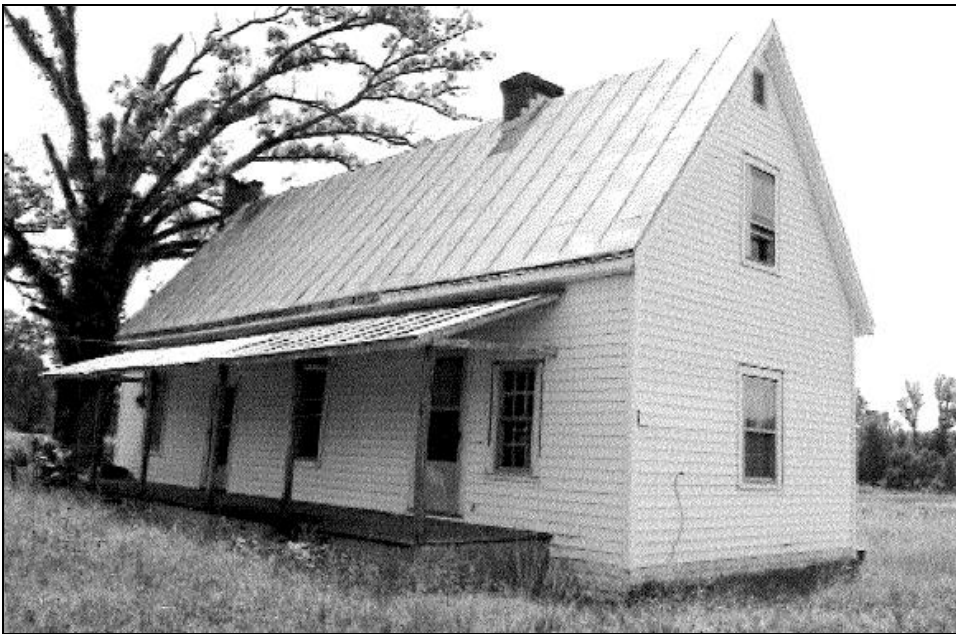
Built with a central-hall plan, the house was enlarged with a side addition and rear kitchen/dining ell in the early twentieth century. Its steeply pitched roof is unusual for houses of the era. Intact exterior details include nine-over-nine sash windows, molded window and door surrounds, flush gables, and two exterior end chimneys. The major Greek Revival expression on the exterior are the corner pilasters and eave treatment: paneled molded Doric cornerboards and a frieze band. Interior elements are five-panel doors, simple replacement mantel shelves, plaster walls, tongue and groove flooring, an open dog-leg staircase with original newel post, beaded board finish in the staircase, and loft fireplaces.

Figure 117. North front and west side elevations of Brown House in June 2010

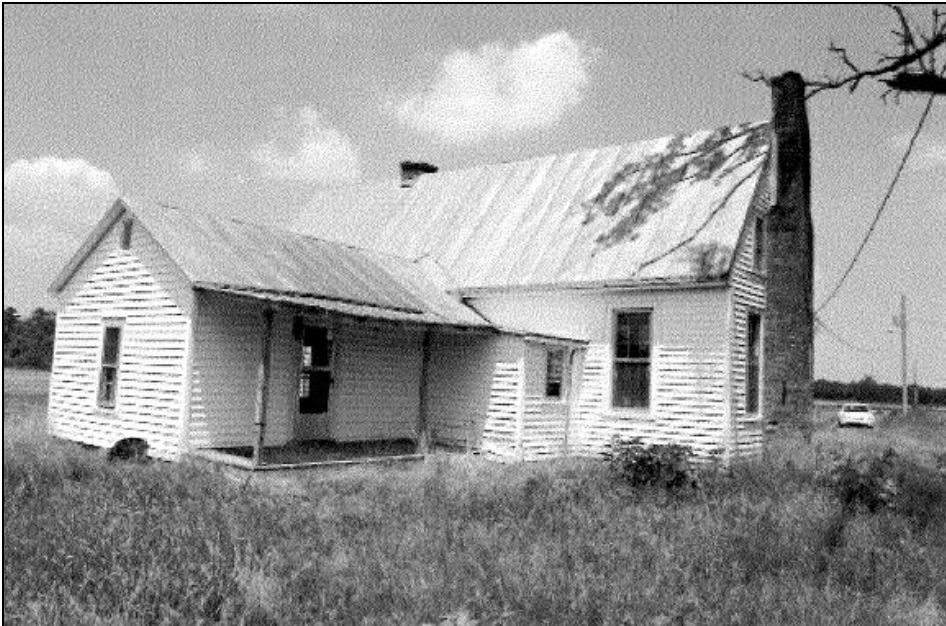
Figure 118. South rear and east side elevations of Brown House in June 2010 (photographer: Marvin Brown)

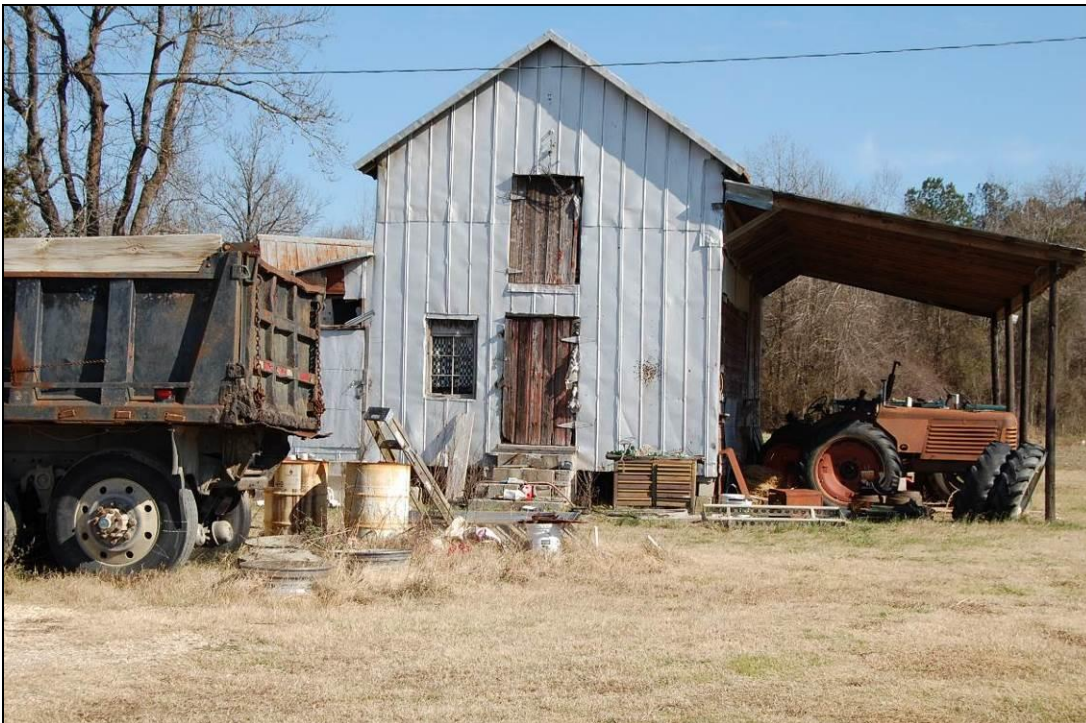
Figure 119. Looking east at packhouse at eastern edge of tract

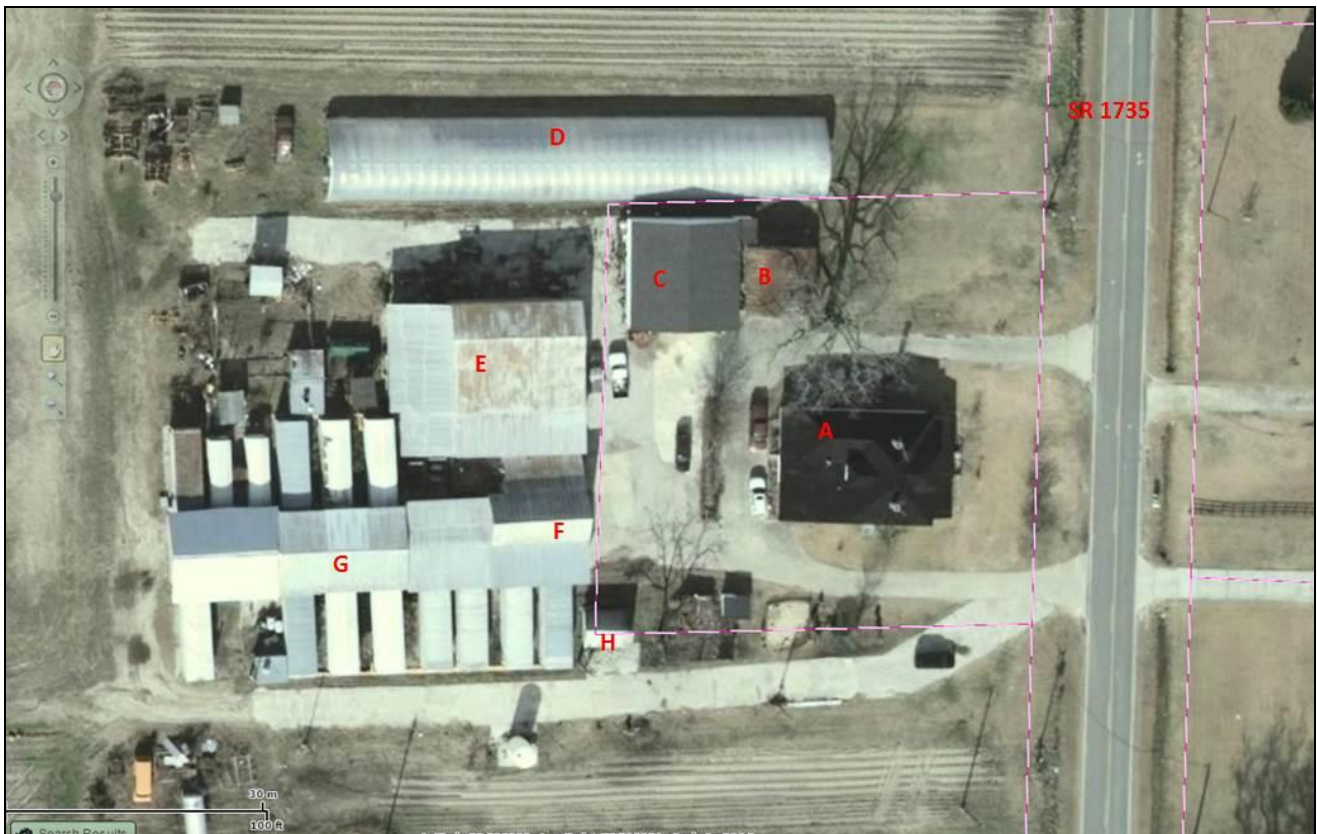
The Robert Hill Farm's resources are tightly packed into a less-than-two-acre rectangle that includes the house parcel. A packhouse is an early twentieth-century contemporary of the house. The smokehouse, shop, and part of a second packhouse appear to date from the mid-twentieth century. The other buildings are less than 50 years old (Figure 121).

Figure 121. Robert Hill Farm sketch map with red letters designating resources (base map: HPOweb)

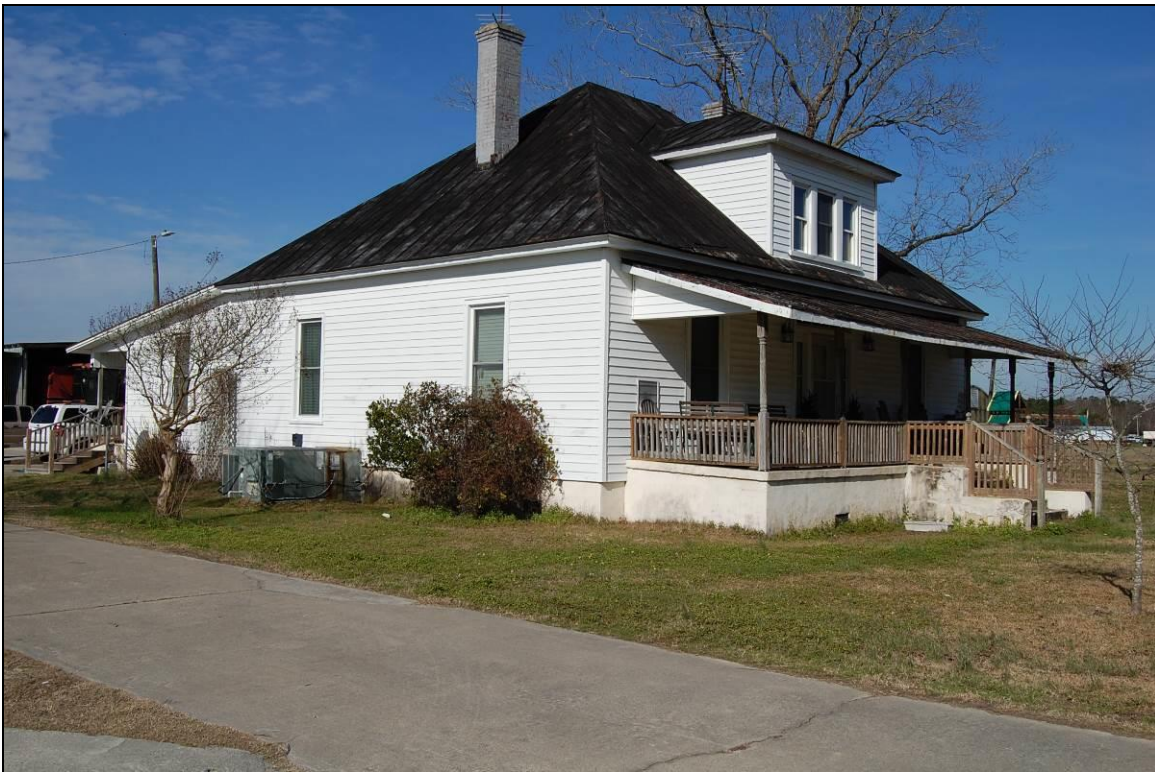
The frame house that anchors the Robert Hill Farm is one-and-a-half stories tall and boxy (Figure 122 through Figure 124). It appears to date from the first quarter of the twentieth century. The house is three bays wide and two rooms deep. A stuccoed foundation clears it off the ground and a tall, seam-metal, hipped roof tops it. Two interior, corbelled brick chimney stacks rise from the roof. A three-bay, hipped-roof dormer is centered on the front (east) elevation; a smaller two-bay dormer marks the rear (west) elevation. A shed-roofed porch shades all three of the front bays, which consist of a central doorway flanked by sidelights and a transom with a window to either side. The porch balustrade was added after Robbie Jones surveyed it in 1993 and Marvin Brown revisited it in 2010. It could not be determined whether the turned porch posts are original. The house had been recently renovated when Jones surveyed it. It retains the vinyl siding it had back then which, according to Jones, covers weatherboards. The one-over-one sash windows are also modern. A hipped-roof ell extending from the north half of the rear elevation is original. The porch that crosses the rear elevation, enclosed behind the ell, is much altered.

Figure 122. South side and east front elevations of house

Due to the many alterations to the house on the Robert Hill Farm (most notably its artificial siding, replaced windows, and altered front and rear porches), the commonness of its form, and the many surviving examples in the county with much higher degrees of integrity, it is believed that the house is clearly not NRHP-eligible under Criterion C for its architecture. As most of its outbuildings are less than 50 years old or heavily altered and do not represent a notable spectrum of outbuilding types, it is further believed that the Robert Hill Farm is clearly not NRHP-eligible under Criterion C as a significant and distinguishable entity.

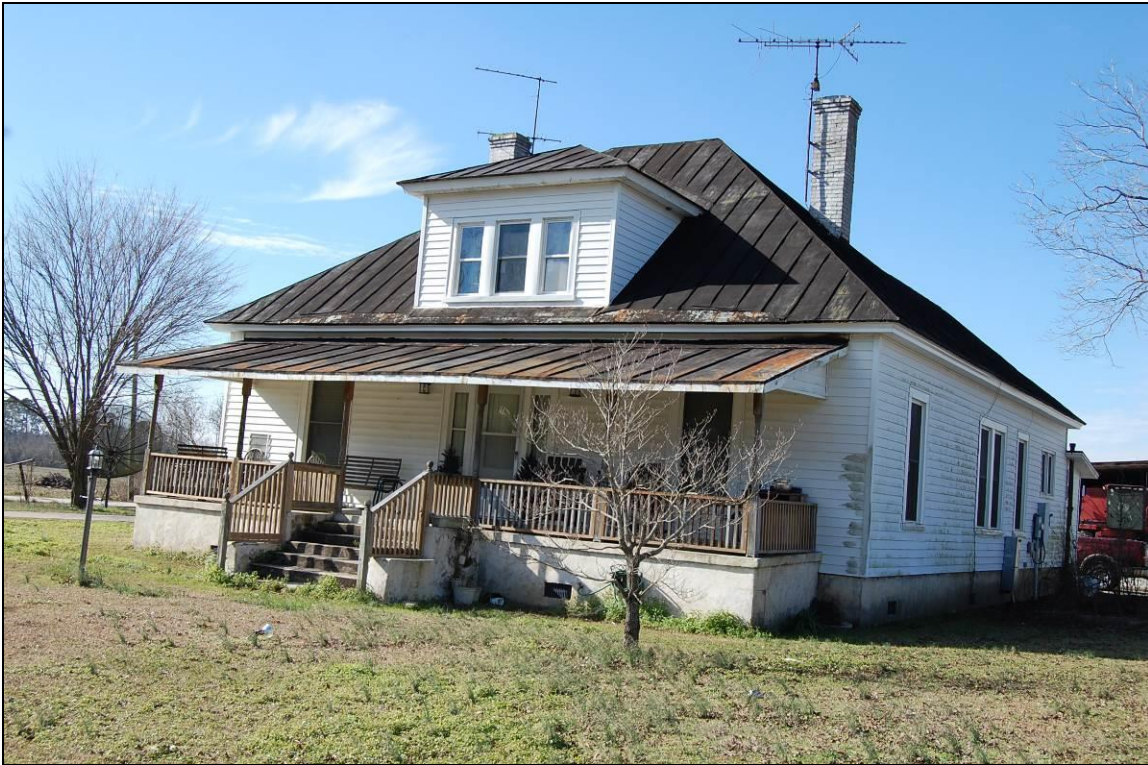
Figure 123. East front and north side elevation of house

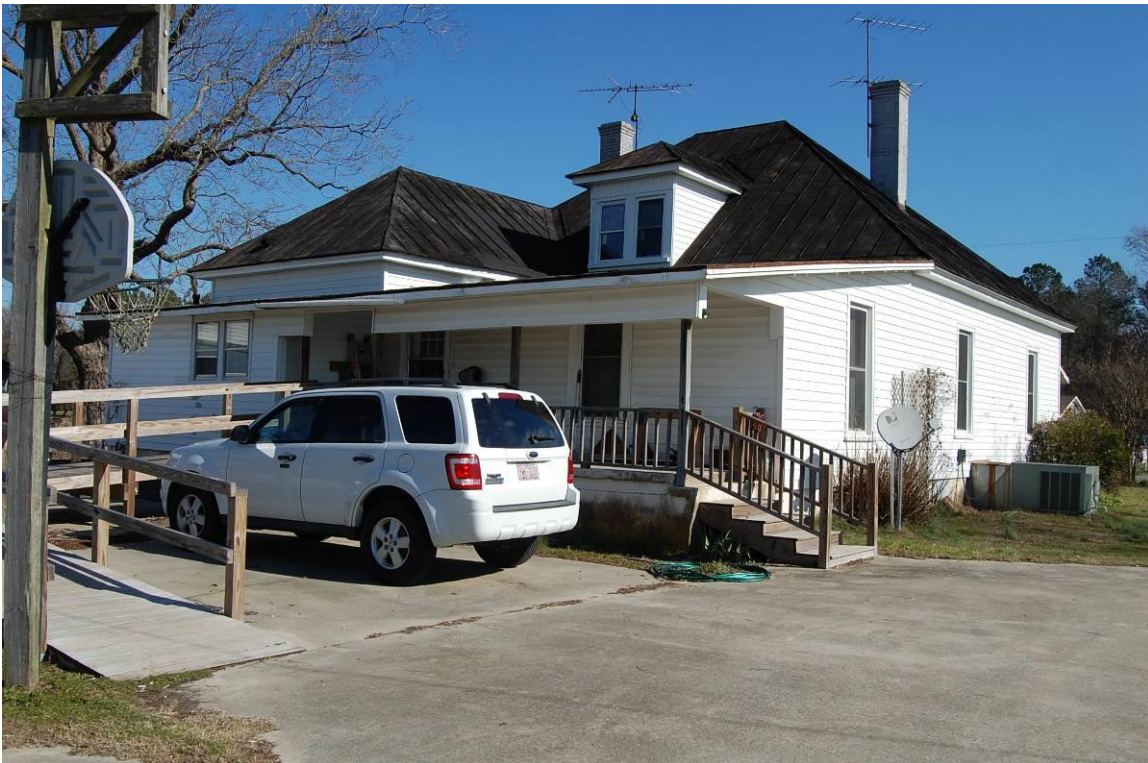
Figure 124. West rear and south side elevations of house

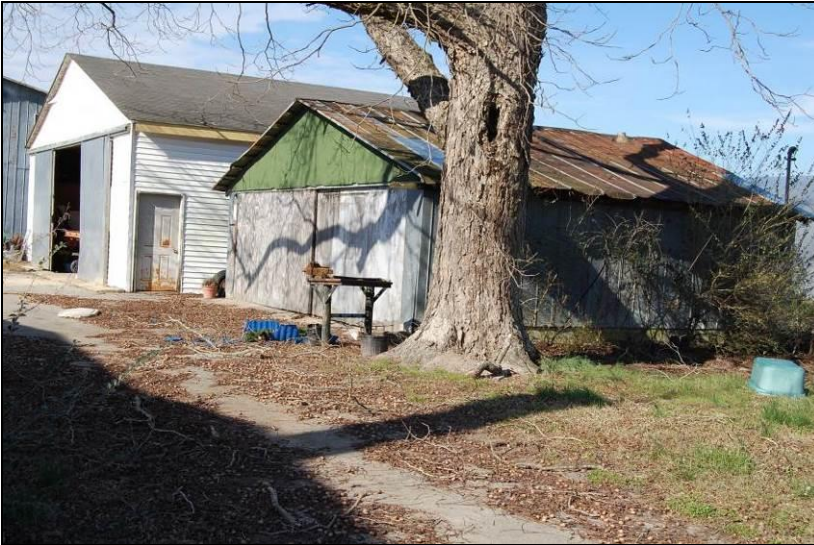
Shop [B on sketch map]

Off the northwest corner of the house stands a one-story, gable-front shop topped by a seam-metal roof (Figure 125). Sheet metal, particle board, and asphalt sheathing cover the building, which likely dates from the mid-twentieth century.

Figure 125. Looking northwest at shop at center

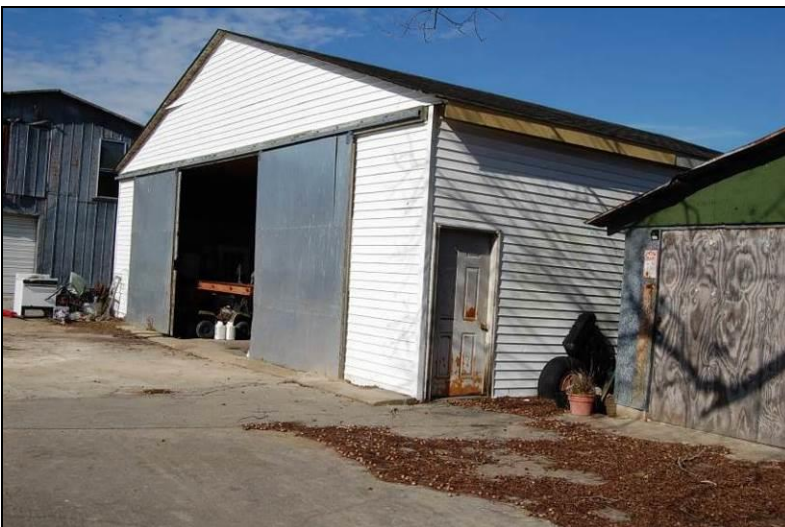
Farm equipment shed [C on sketch map]

In 1993 the site of this outbuilding held a greenhouse. By 2010 the greenhouse had been replaced by this large farm equipment shed (Figure 126). The building, standing just west of the shop, is topped by a gable-front, asphalt-shingled roof served by full-height sliding doors across its front (south) elevation. It is clad in vinyl siding.

Figure 126. Looking northwest at farm equipment shed at center

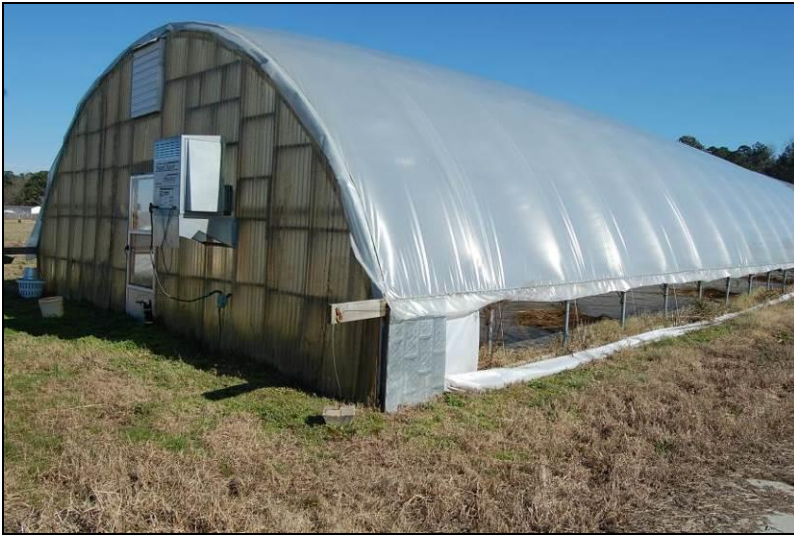
Greenhouse [D on sketch map]

This long, open, Quonset-hut-shaped greenhouse, which has heavy plastic sheeting stretched over its rounded metal frame, was standing in 1993 (Figure 127). It is likely less than 35 years old.

Figure 127. Looking northwest at greenhouse

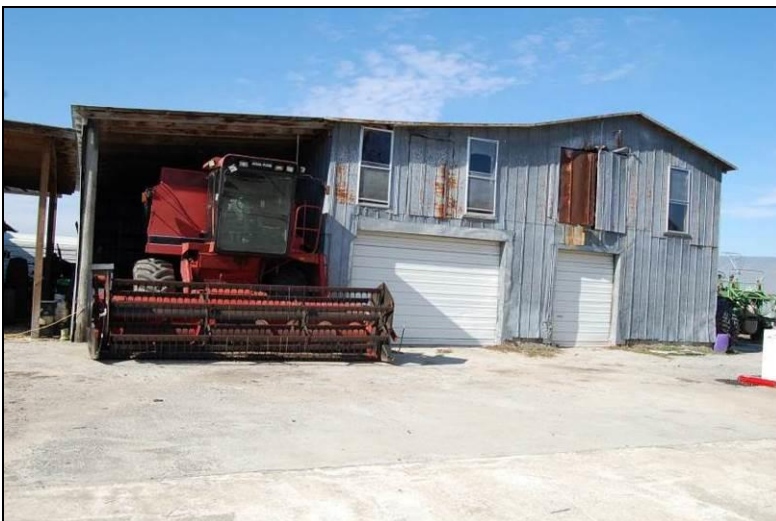
Packhouse/farm equipment shed [E on sketch map]

Jones identifies this building as a packhouse (Figure 128). Its current use, however, appears to be as a farm equipment shed. Its right-hand (north) section has the form of a packhouse, but is much altered through the modern addition of a garage door, windows, and sheet-metal siding. The tall shed addition at its center is also much altered with windows, metal siding, and a full-width garage door. At the south is an even-later-added open farm equipment shed that was in place in 1993. The building's north block may date from the early or mid-twentieth century.

Figure 128. Looking west at packhouse/farm equipment shed

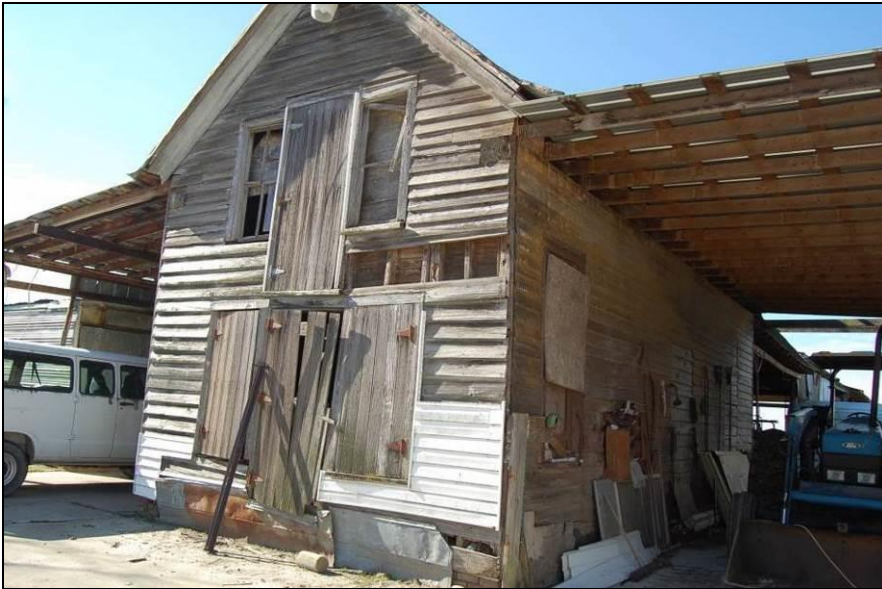
Packhouse [F on sketch map]

This frame packhouse appears to be contemporary with the house that stands just east of it (Figure 129 and Figure 130). Due to its particularly close proximity to the dwelling, it likely no longer stands on its original site and was therefore not necessarily built in association with the house. It retains its two-story, gable-front form, weatherboards, and front doorways stacked one above the other. The addition of multiple bays to all four of its elevations, including double-hung sash windows still in part in place, suggest it was converted from a packhouse to a residence. Yet later additions are the long shed roofs to either side that indicate the outbuilding's current use as an equipment shed.

Figure 129. West front and north side elevations of packhouse

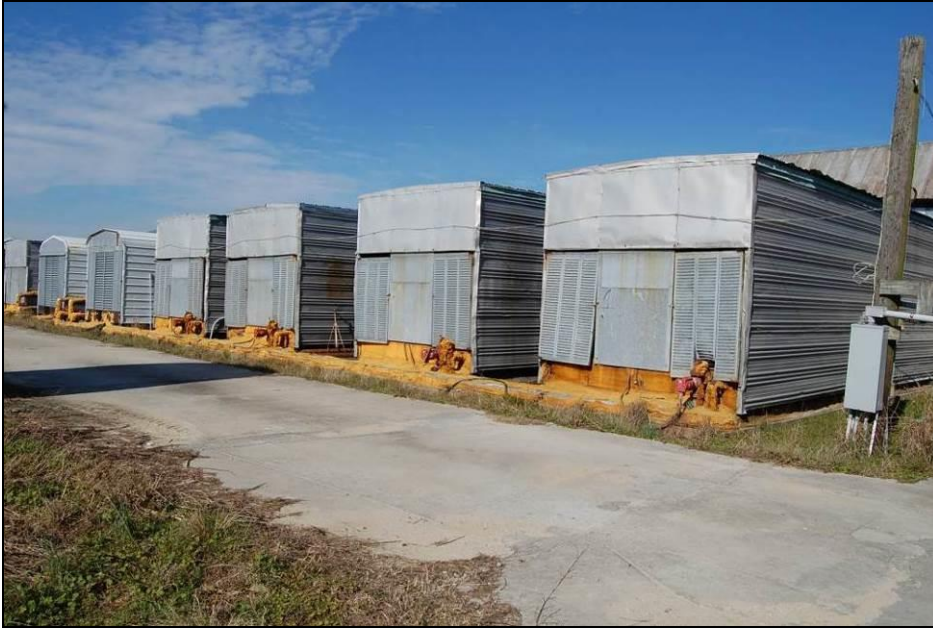
Figure 131. Looking northwest at south flank of bulk barns

A long, tall, open shed extends west of the weatherboarded packhouse. Its varied heights and construction, and the field map prepared by Jones in 1993, indicate that it has been extended at least once. Eight metal bulk barns line its south side and six hug its north side (Figure 131 through Figure 134). Their differing construction and Jones' map indicate that they are not all contemporary with each other. All of these resources likely postdate the Hills' 1980 acquisition of the farm.

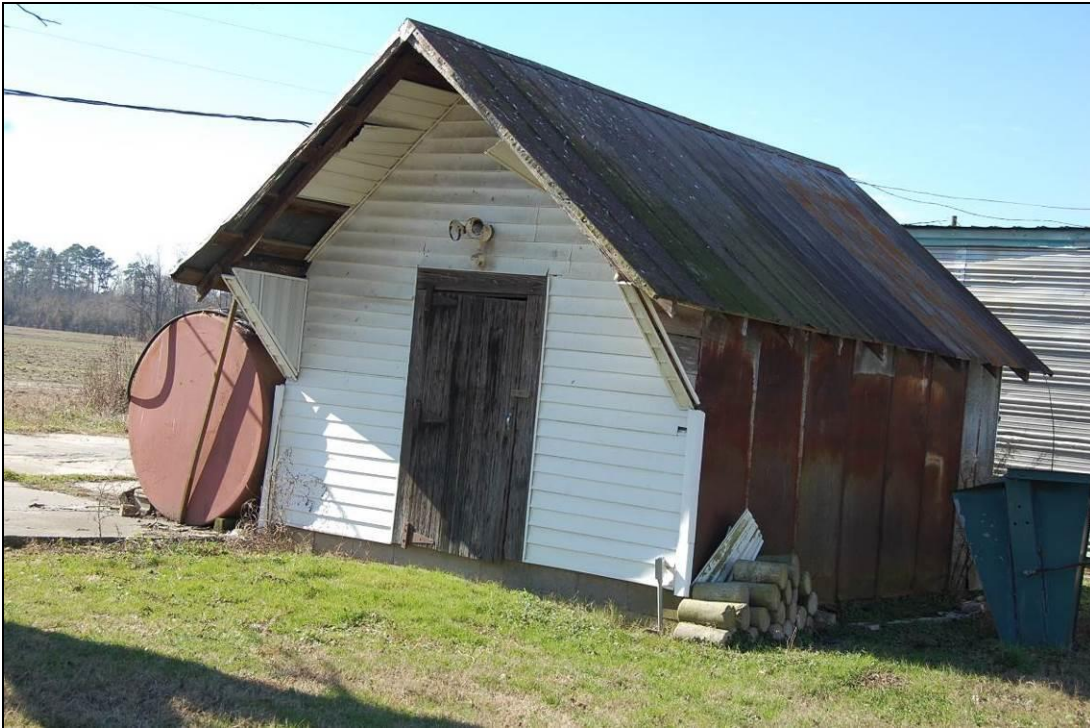
Figure 135. East front and north side elevations of smokehouse

Jones identified this one-story frame building as a smokehouse, which its size and single gable-front entry shielded by a wide overhanging roof seems to confirm (Figure 135). It is much altered through the addition of vinyl and sheet-metal siding and the closing-in of the diagonal braces that support its projecting gable. It likely dates from the early or mid-twentieth century.
