North Carolina Department of Natural and Cultural Resources
State Historic Preservation Office

SUBJECT: C. F. Harvey Parkway Extension (NC 148), Four-Lane Divided Freeway on New Location, R-5703, NCDOT WBS No. 46375.1.1, Lenoir County, ER 16-0449

Figure 2. Area of Potential Effects, outlined in red, and property locator map

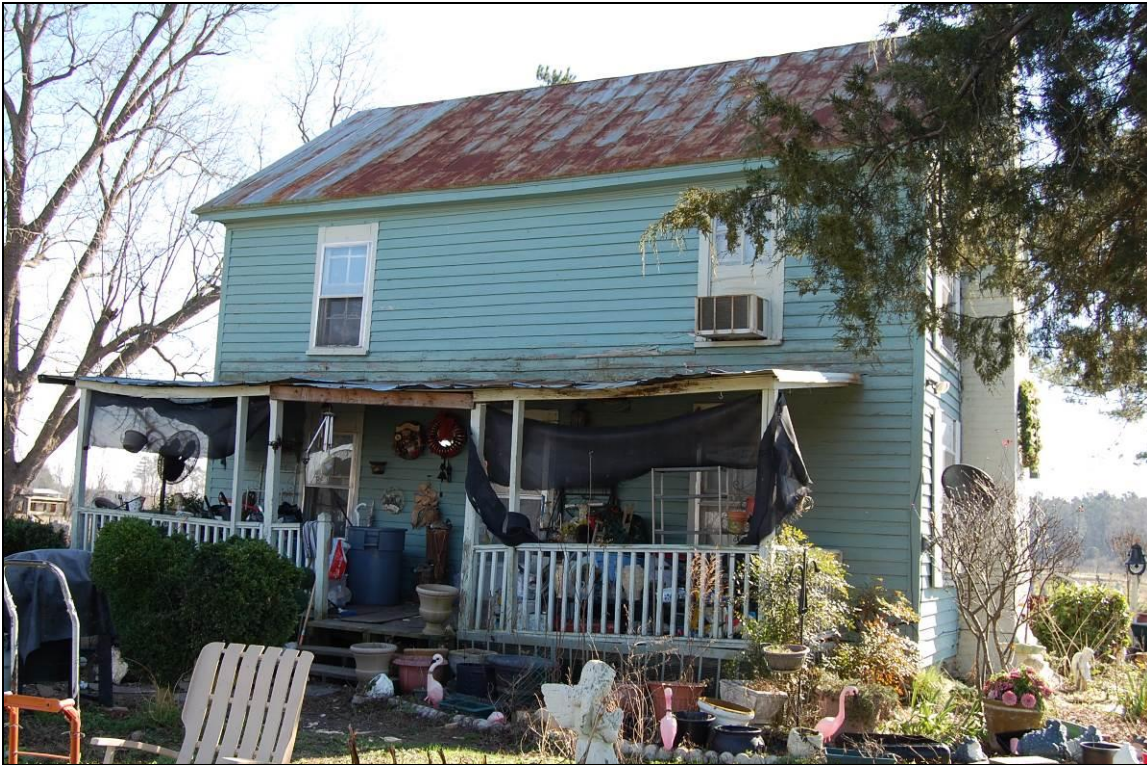
Figure 136. Northwest front and southwest side elevations of house

The frame Sherman Odham House utilizes a typical nineteenth and early twentieth-century, I-house form (Figure 136 through Figure 139). It is two stories tall, three bays wide, one room deep, and topped by a gable-end roof. The front (southwest) elevation is three bays wide at its first story and two bays wide above. This reflects its two-room, hall-parlor plan. A shed-roofed porch with a replacement balustrade and posts crosses the front elevation. A pair of windows, one above the other, marks the northeast side elevation of the main block. The same arrangement is found on either side of an exterior-end, brick chimney at the southwest side elevation. Only one upstairs window is visible at the block's southeast rear elevation, which is otherwise obscured by the frame, one-story, gabled ell. The main block retains original four-over-four sash windows, although the surrounds have been altered. Some of the ell sash is original and some has been replaced. Both the main block and ell continue to be weatherboarded and topped by standing-seam, metal roofs.

According to Jones, the ell was once a freestanding kitchen attached to the house by an open breezeway. The breezeway and the rear porch were subsequently enclosed. The breezeway's location is evidenced by the infill siding on the northeast elevation.

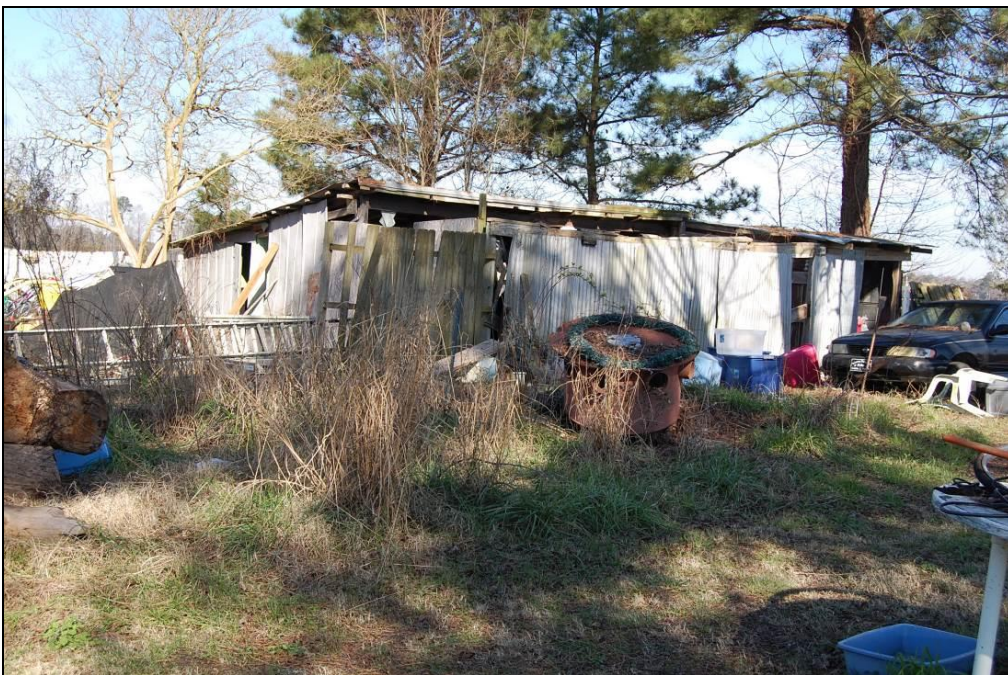
Figure 140. Looking north from side of house at shed

A large, low, frame shed topped by a shed roof and covered with sheet-metal siding stands just northeast of the house within the parcel's limited boundaries (Figure 140). In poor condition, it appears to date from the mid-twentieth century.

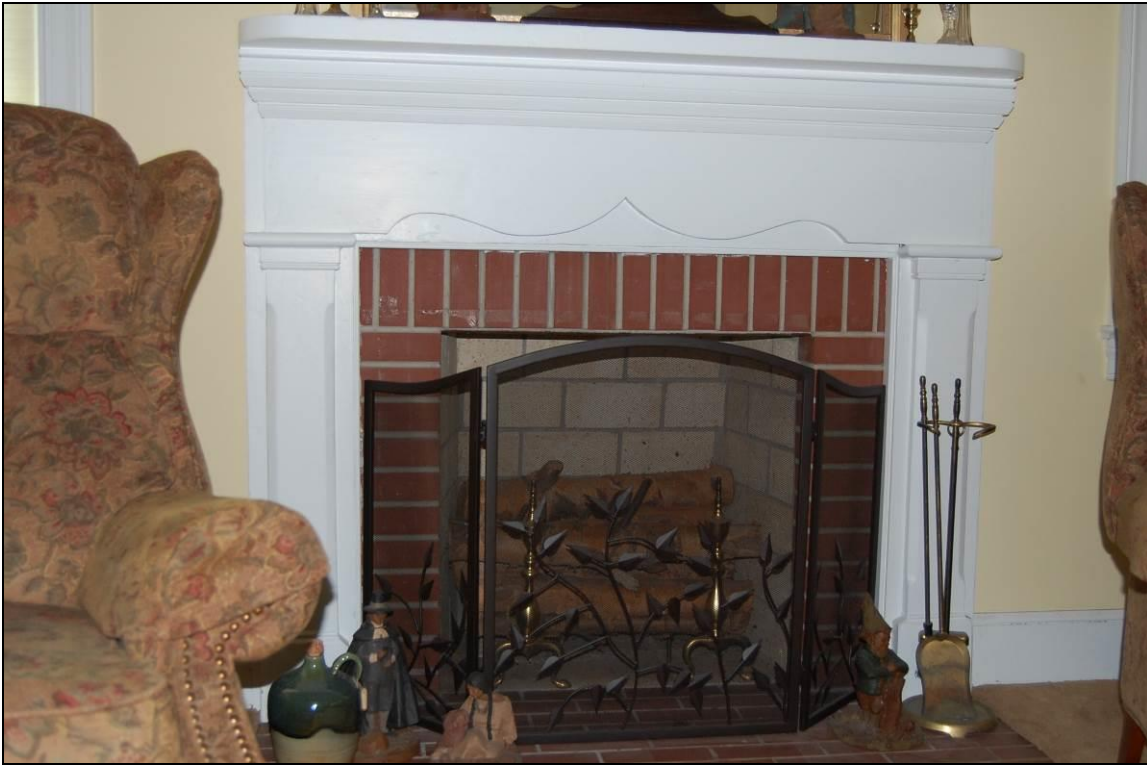
Figure 142. Post-and-lintel mantel shifted from front block of house to rear addition

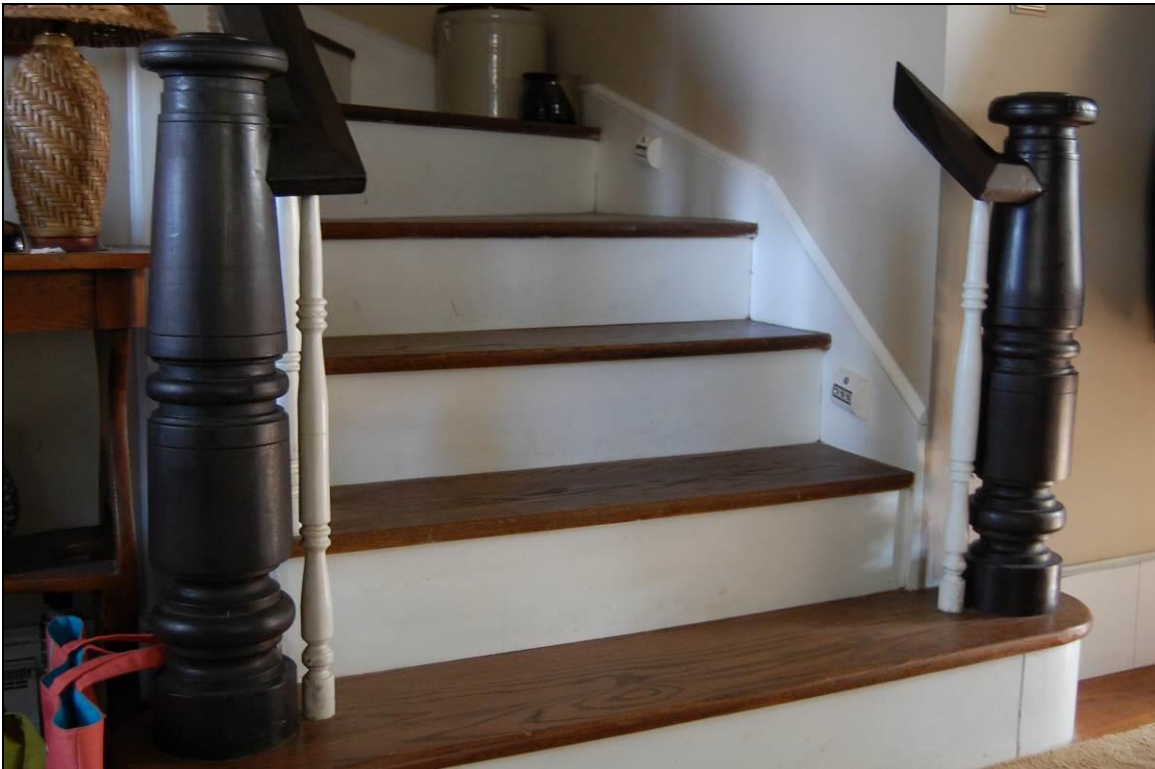
Figure 143. Altered stair in front block of house with original or early newel posts

The main block of the farmhouse appears to have been erected between about 1855 and 1875 (Figure 142 through Figure 148). It was built as a traditional I-house—two stories tall and one room deep with a center-hall plan and a gable-end roof. Its early original appearance, captured in a ca.1940 photograph and other images taken during the decade that Robbie Jones reviewed, included six-over-six sash windows; a single-shoulder, exterior-end, common-bond brick chimney; a brick pier foundation; a centered front entry framed by a transom and sidelights; weatherboards; a plain friezeboard beneath the front (west) eaves; a hipped-roof, three-quarter-width porch with square columns; and a rear shed.

Tebo and Ruby McArthur significantly and substantially altered the house in 1960. They added a full-width, two-tier porch across its front elevation; replaced its sash; removed the front entry's transom and sidelights and replaced the door; pushed forward two bays to either side of the main entry; rebuilt the foundation and added two modern, brick, exterior-end chimneys; placed vinyl siding over the weatherboards; and extended and rebuilt the rear ell. They also altered the floor plan and modernized the house's mechanical systems. This effort included rebuilding the stairway and bringing running water and bathrooms inside.

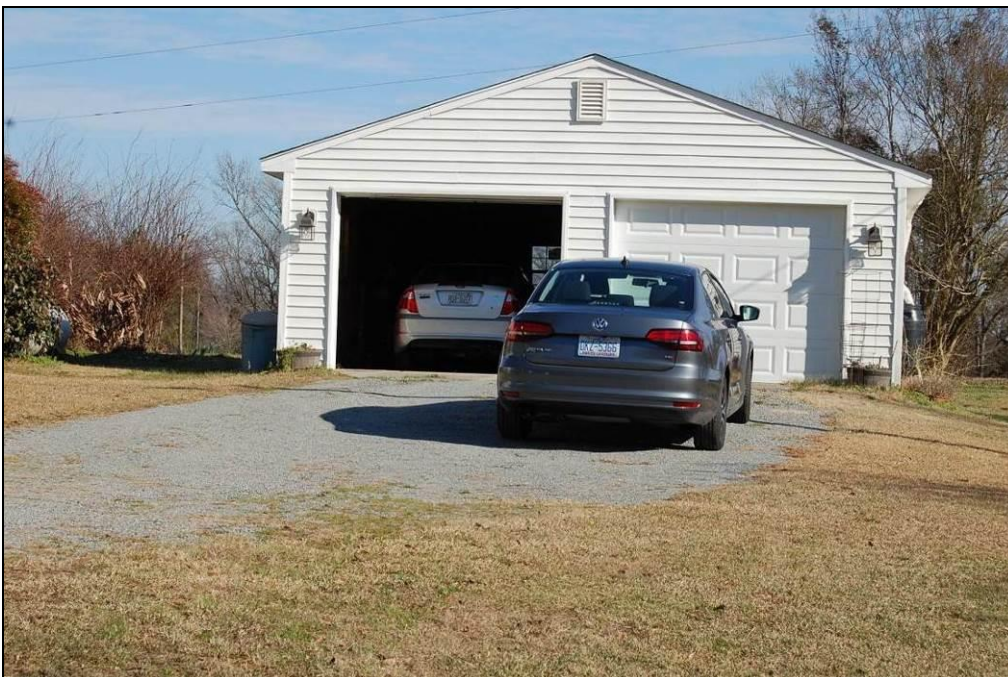
Figure 149. Looking north at garage

Off the northwest corner of the house is a frame, vinyl-sided, gable-front, two-car garage (Figure 149). It was standing in 1975 and is less than 50 years old.

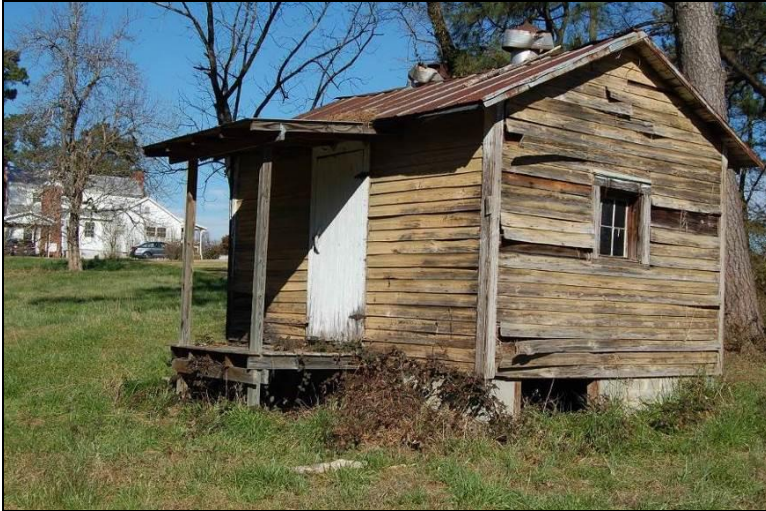
Figure 150. Looking northwest at potato house with rear of house at left

A small potato house stands east of the house and its parcel, on the edge of a tract associated with the house until Ruby McArthur's death (Figure 150). A small, frame, weatherboarded building with a seam-metal, gable-end roof topped by a pair of ventilators, it was erected about 1940. A porch shades the door at its south-facing front elevation and a small window pierces either gable end (Gaddis 2016a and 2016b).

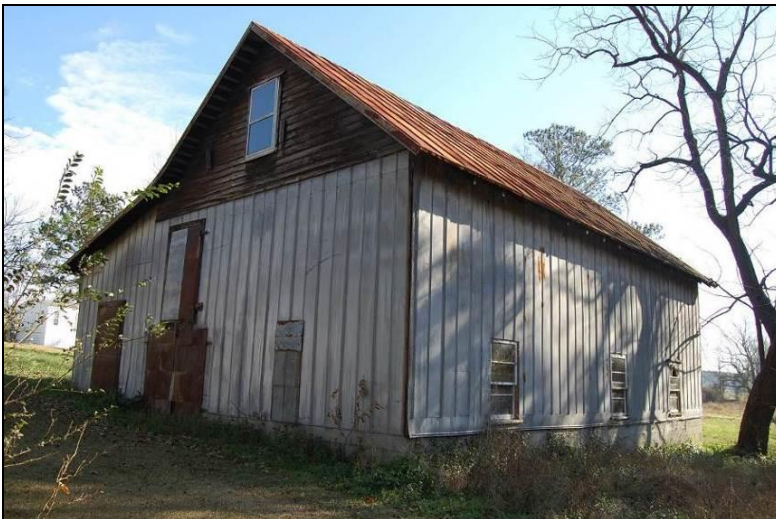
Figure 151. Looking northeast at packhouse

This packhouse was moved to the farm from the DuPont Dacron Plant property about 1952 (Figure 151). Typical of the packhouse form, it is two stories tall and gable-ended with a shed affixed to one side. It retains a seam-metal roof and some of its original weatherboards, but is largely clad in metal.

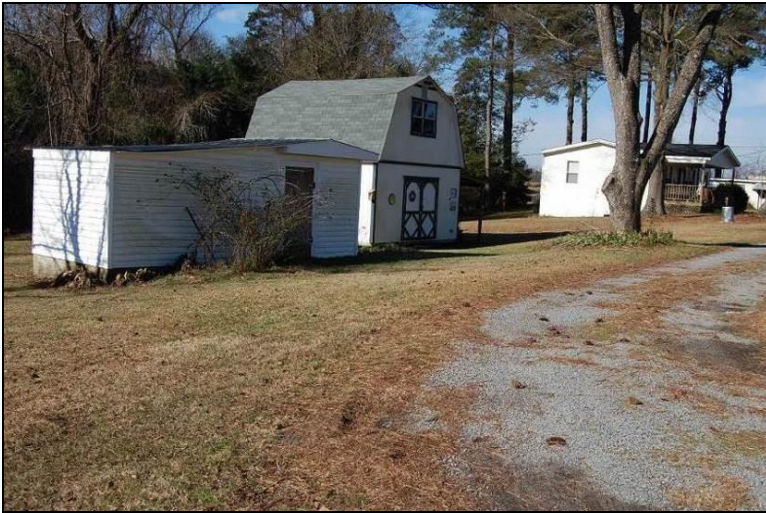
Figure 152. Looking southeast at pumphouse at left, manufactured shed at center, and manufactured house at right

These three buildings stand in a row on the south side of the entry drive opposite the house. The mid-twentieth-century pumphouse, at the left of the image, is a small rectangular building topped by an almost flat roof and sided with vinyl (Figure 152). To its north stands a modern manufactured shed. North of the shed, at the right of the image, is a modern manufactured house.

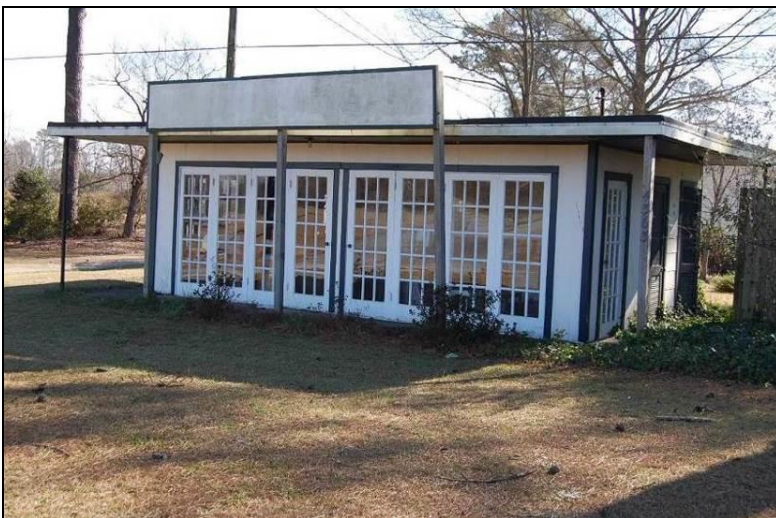
Figure 153. Looking northeast at produce stand

This former produce stand is located at the southeast corner of the house's entry drive and NC 11 (Figure 153). An overhanging flat roof tops the building, which is crossed at its front elevation by glass doors that could open it to the air. It appears to be less than 50 years old.

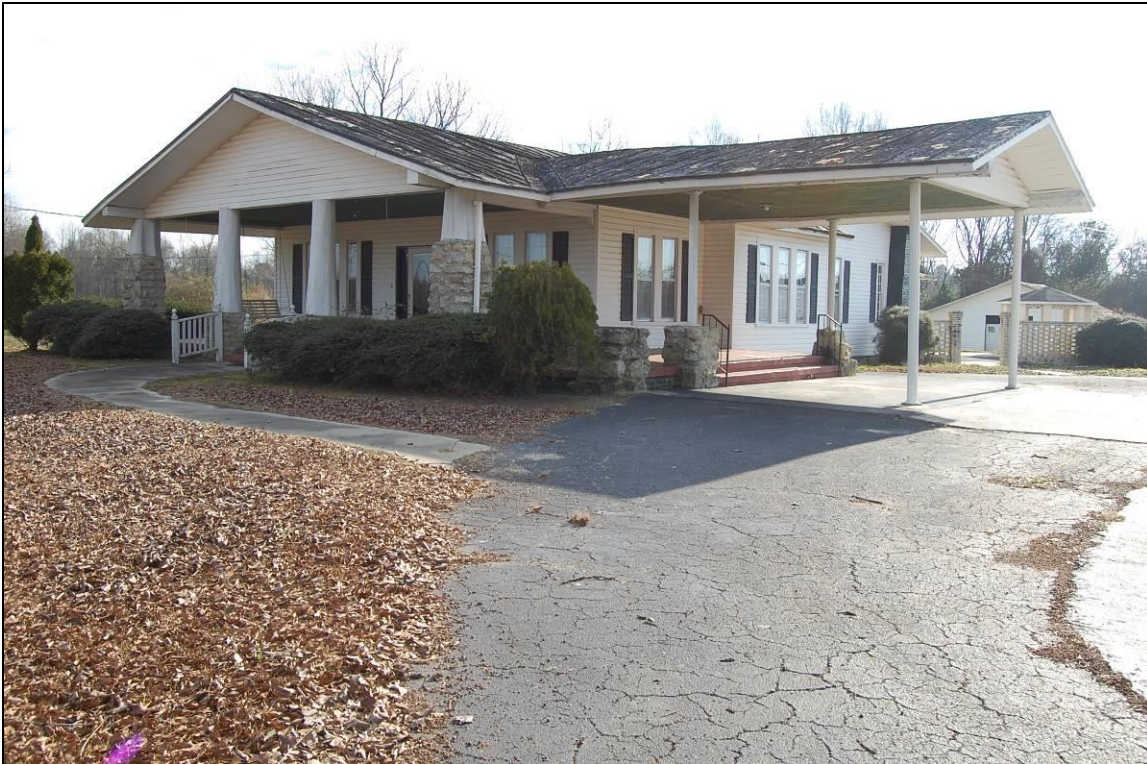
Figure 156. North front and west side elevations of house

This house, according to Jones and Little, originally had a traditional form (Figure 156 through Figure 159). It was one-story tall, topped by a gable-end roof, and extended to the rear (south) by a one-story ell. In the 1930s it was renovated in Craftsman style. The changes included the addition of the porch, which features cypress-tree posts on stone marl piers. The principal entry sidelights at the front (north) elevation and the long, grouped windows likely date from the 1930s as well. The interior may still contain some of its original 1930s features, including wainscoting, crown molding, a two-room floor plan, a built-in china cabinet, and mantels (Little 1998:362). The house is vacant and access was not possible. Prior to 1984, the front porch was altered to remove the section that wrapped part way around the west side elevation up to a shallow projecting bay. This section had been replaced by a porte cochere supported on attenuated posts. At the east side elevation a brick, exterior-end chimney was truncated at an undetermined date. Changes between 1984 and 1993 include the construction of the drive up to the house and the extension of the rear ell. By 2010, when the house was revisited, its weatherboards had been covered with vinyl siding.

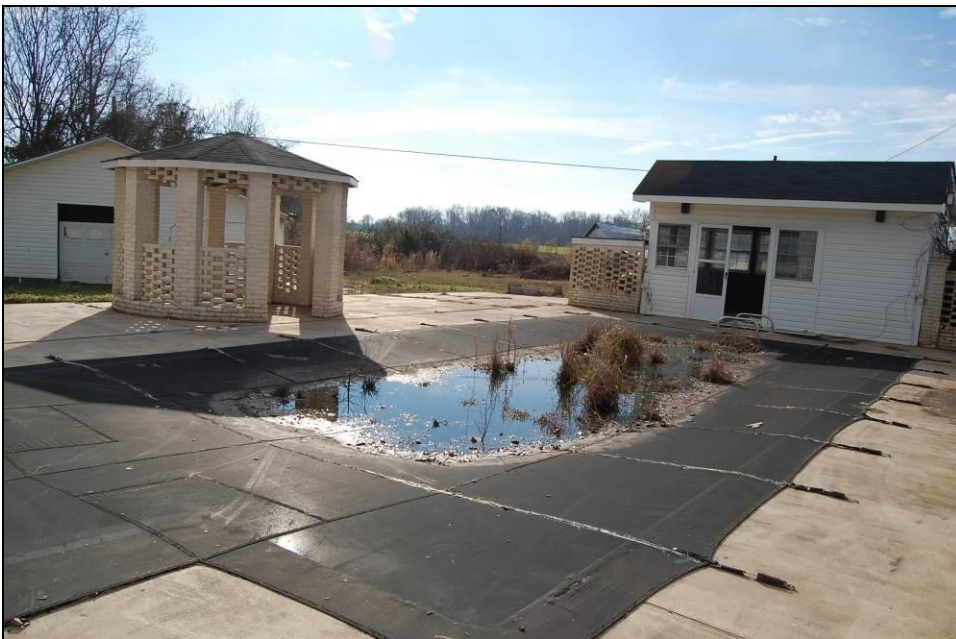
Figure 160. Looking south at pool deck with pool house at right, gazebo at left center, and storage building at far left

Between 1984 and 1993 a concrete pad and pool were added to the rear of the house, along with a frame, gable-end pool house at the south edge of the pad (Figure 160). After 2010 a masonry gazebo rose on the deck behind the ell, at the east side of the pool, and walls of similar rusticated bricks were added to either side of the pool house.

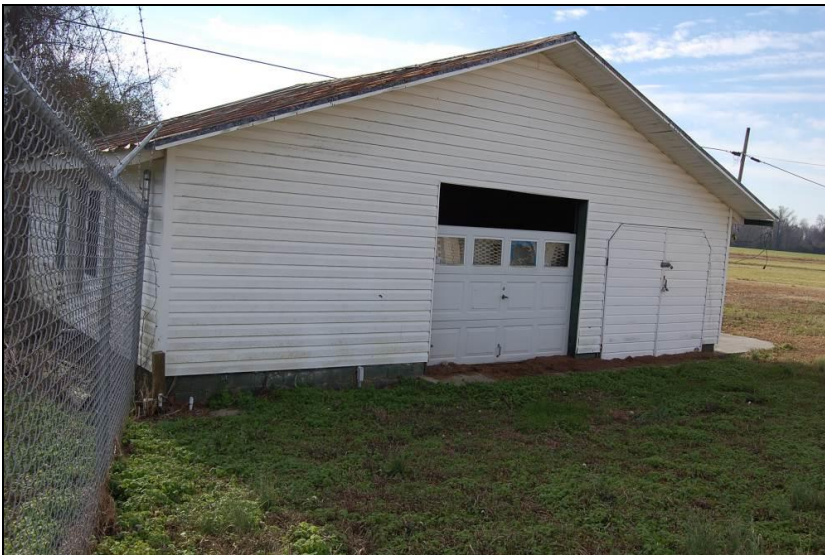
Figure 162. Looking south at storage building

A vinyl-sided, gable-front storage building to the rear of the pool deck is depicted on the 1984 plat map (Figure 161 and Figure 162). The building is vinyl-sided and appears to be modern, but according to Jones, in 1993 it contained a frame smokehouse smaller than its footprint. Access to it was not possible and it is not known whether it is the same building and still contains the smokehouse. If it is the same, it has lost side and rear sheds and had a (detached) undersized garage door added since 1993.

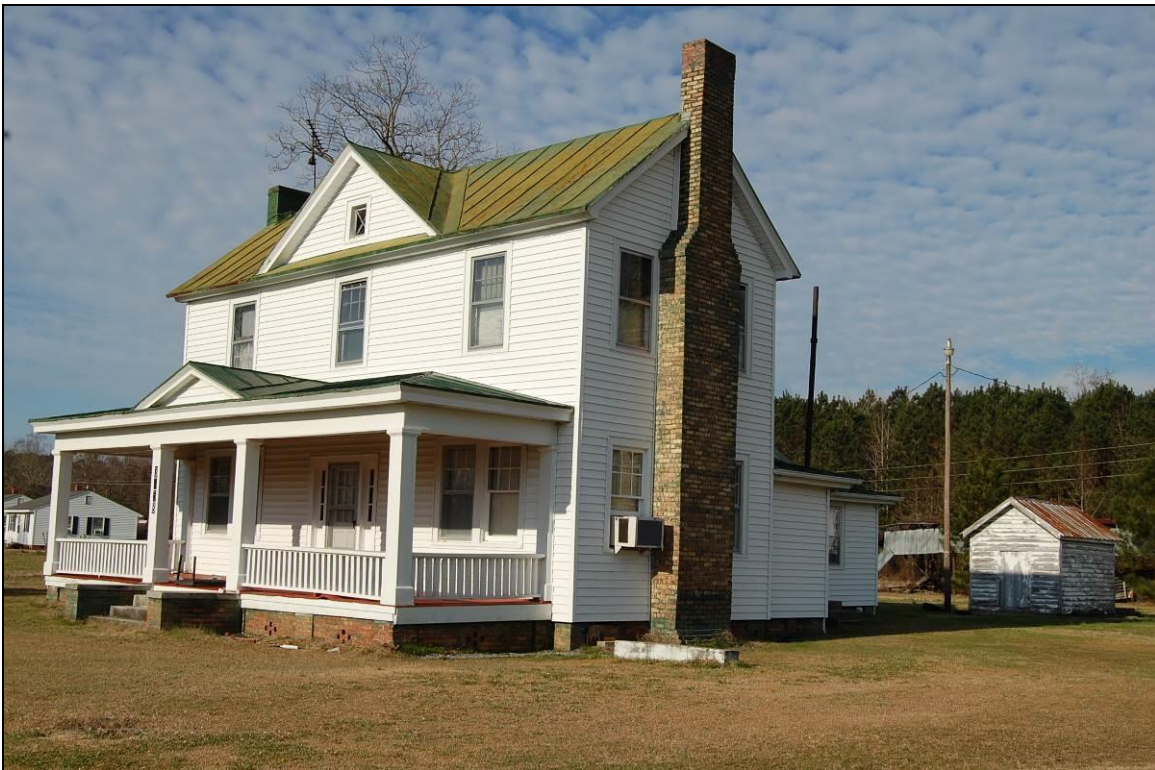
Figure 165: South front and east elevations of house

The Hunt-Blow House is typical of an early twentieth-century I-house (Figure 165 though Figure 168). It is two stories tall and one-room deep with a center-hall plan. It stands on a brick foundation and the same brick forms its single-shoulder, exterior-end chimneys. A gable-end, seam-metal roof tops the house. A façade gable at its center remains in place. Three bays cross the front (south) elevation. At the first story, paired windows flank the centered entry, which is set off with sidelights. The bays are shaded by a full-façade porch supported by square columns and topped by a shallow façade-gable. The three bays at the second story hold one window each. All of the house's windows are double-hung, six-over-one sash. Both side elevations have window bays to either side of their relatively narrow chimney stacks. Vinyl siding sheaths the main block and the ell. Access to the house was not available.

A one-story gable ell projects to the rear (north) of the main block. Its brick foundation and six-over-one windows indicate it was built at the same time as the house. In addition to its vinyl siding, the ell has been altered by the enclosure of its former east-facing porch.

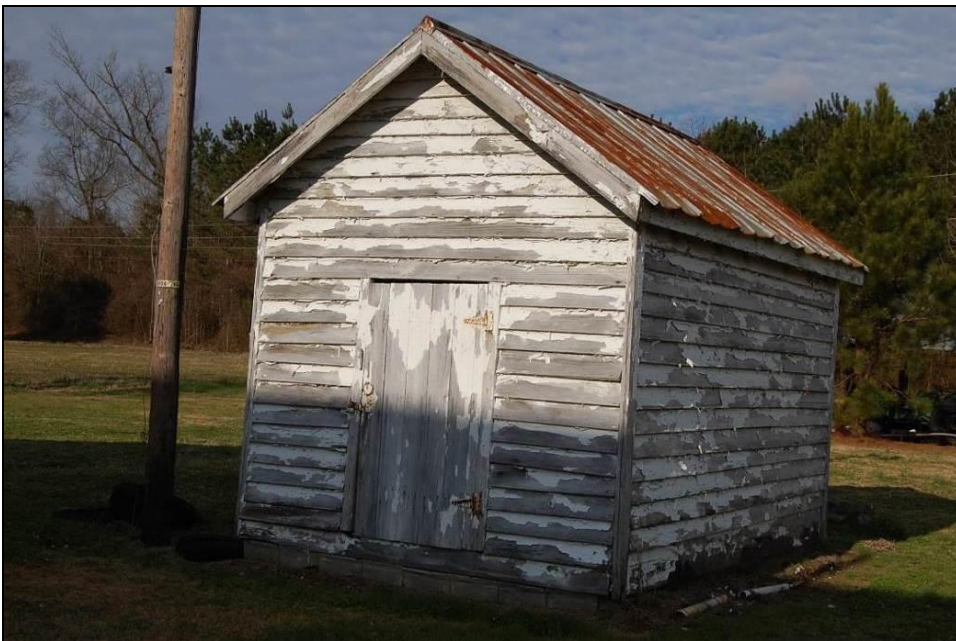
Figure 169. Looking northwest at smokehouse

The smokehouse is its only surviving early outbuilding on the tract on its original site (Figure 169 and Figure 170). It is a rectangular, frame, weatherboarded building topped by a seam-metal, gable-front roof. A vertical-board door opens at its front (south) gable. The smokehouse appears to date from the first third of the twentieth century.

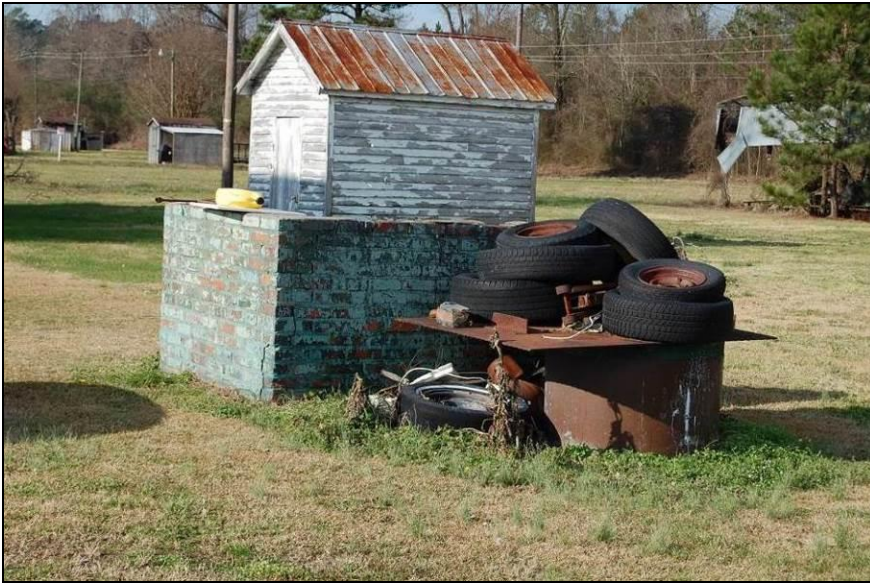
Figure 170. Looking northwest at covered shaft of well and walls of pumphouse

A well and the brick walls of a pumphouse stand to the house's east (Figure 170). The surviving portions of the pumphouse may date from the 1930s.

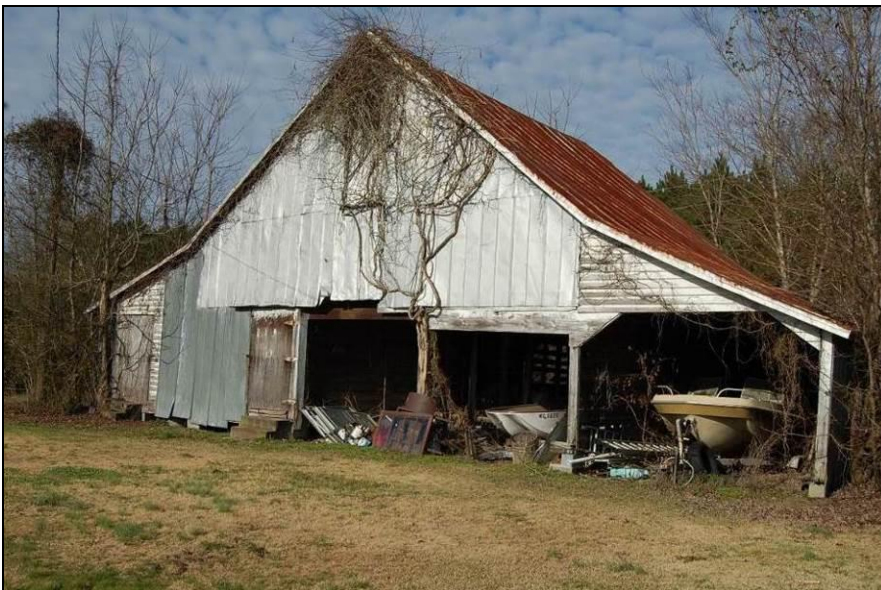
Figure 171. Looking northwest at barn

A deteriorated gable-front barn with side sheds stands north of the house (Figure 171). According to William Hunt (2016), it was moved here from elsewhere on the former farm. Various materials, including weatherboards and metal sheeting, cover its wooden frame. A seam-metal roof tops it.

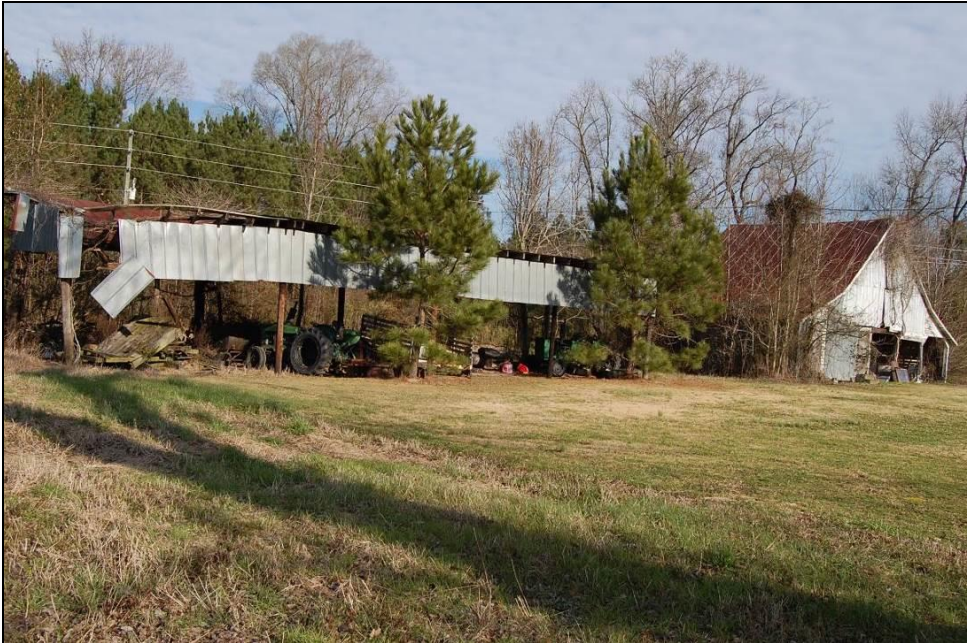
Figure 172. Looking northeast at pole barn/farm equipment shed at left and barn at right

A heavily deteriorated, open pole barn/farm equipment shed stands at the woods line north of the house and west of the barn (Figure 172). It retain large pole supports and sections of a seam-metal shed roof and sheet-metal siding. It appears to date from between 1945 and 1965.

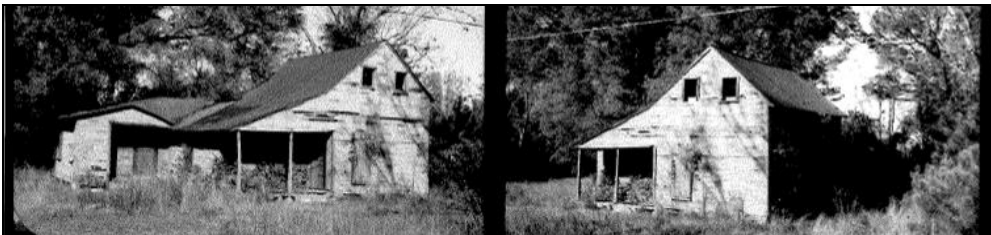
Figure 173. House in 1993 (photographer: Robbie Jones)

In 1993 Robbie Jones inventoried the house that stood at this site (Figure 173). He wrote:

Located adjacent to the railroad tracks, this abandoned, one-and-a-half story house features the common hall and parlor floor plan. A ladder located in the hall corner leads to a loft. Architectural details include a stone pier foundation, six-over-six sash windows, and a simple mantel shelf. The house was enlarged with a side addition, a front kitchen ell and by partially enclosing the large, engaged front porch. Remaining outbuildings include a smokehouse and an outhouse.

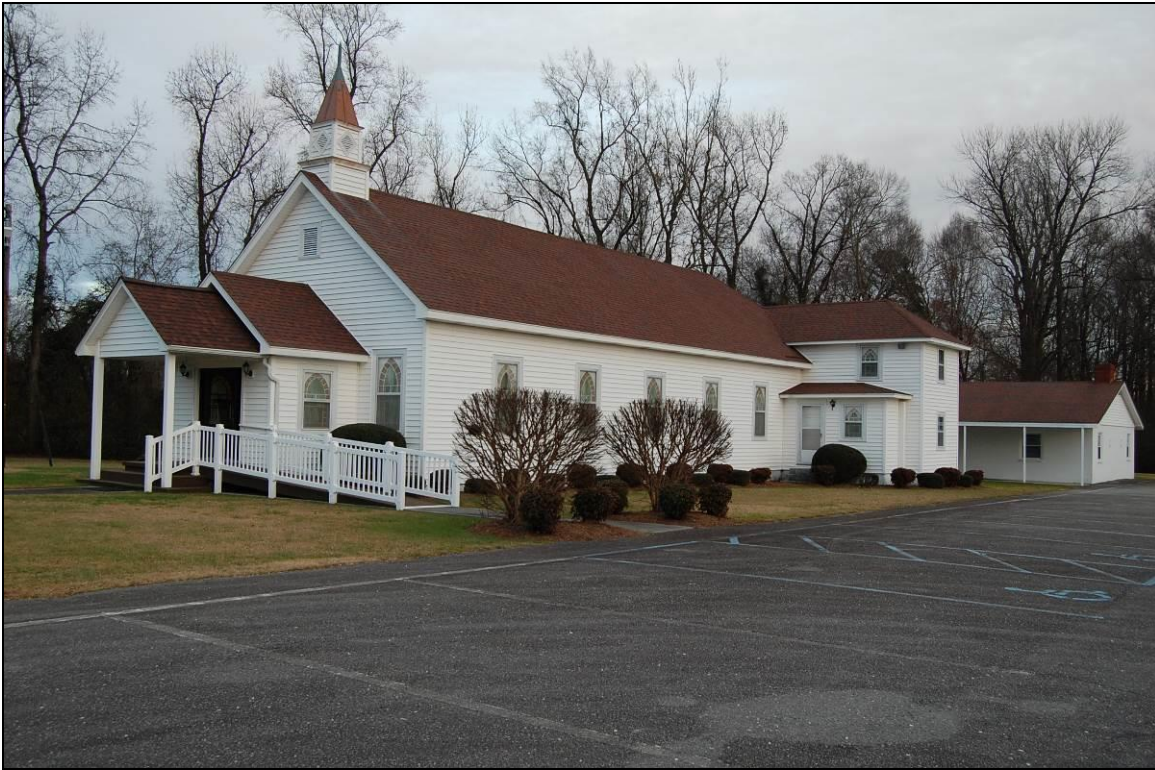
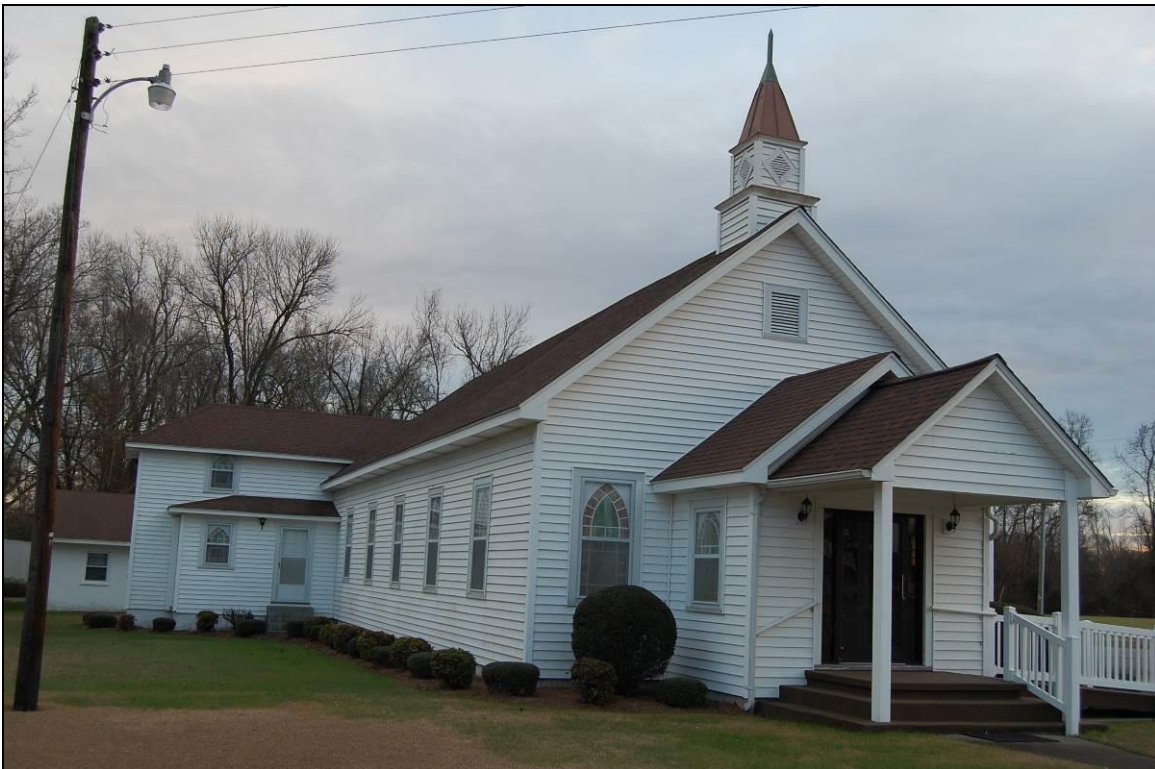
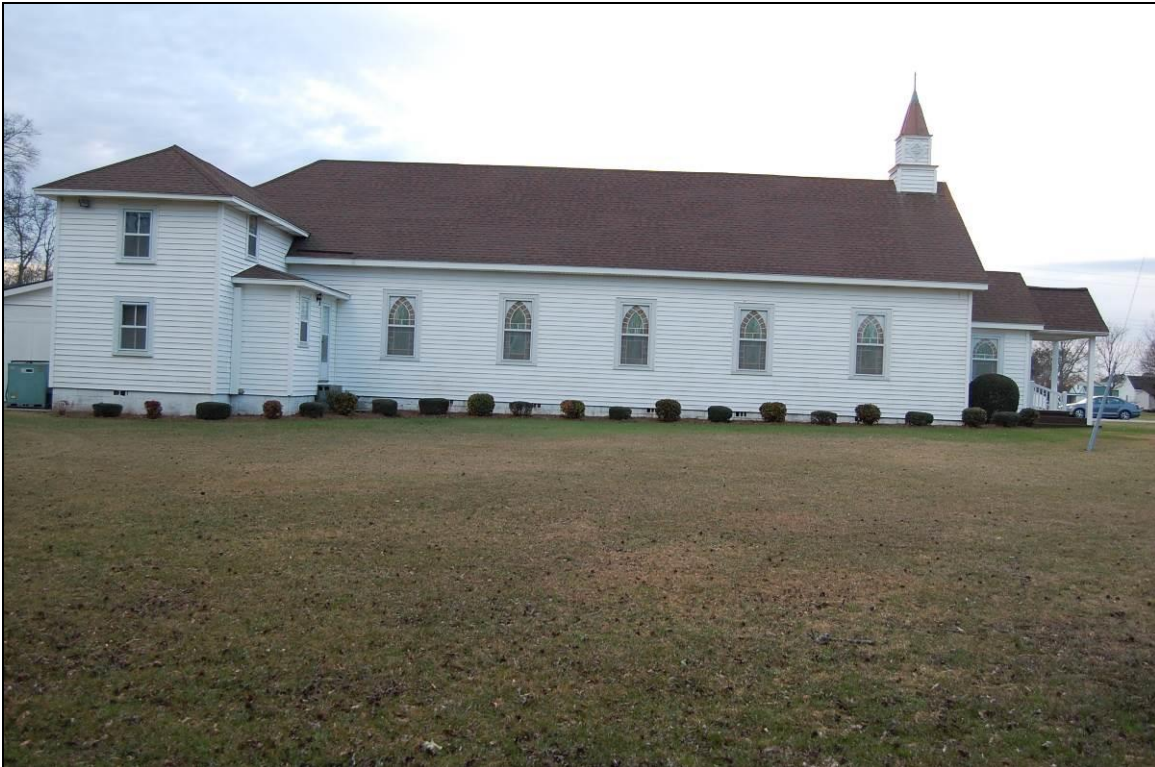
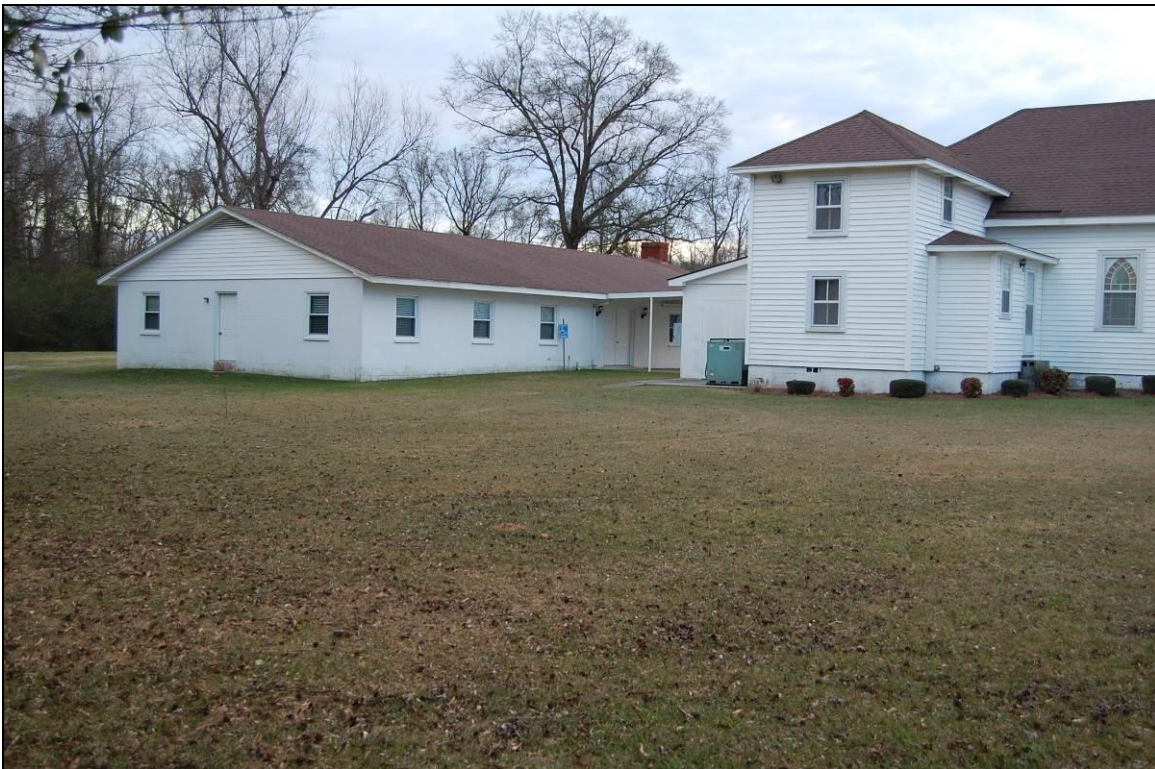
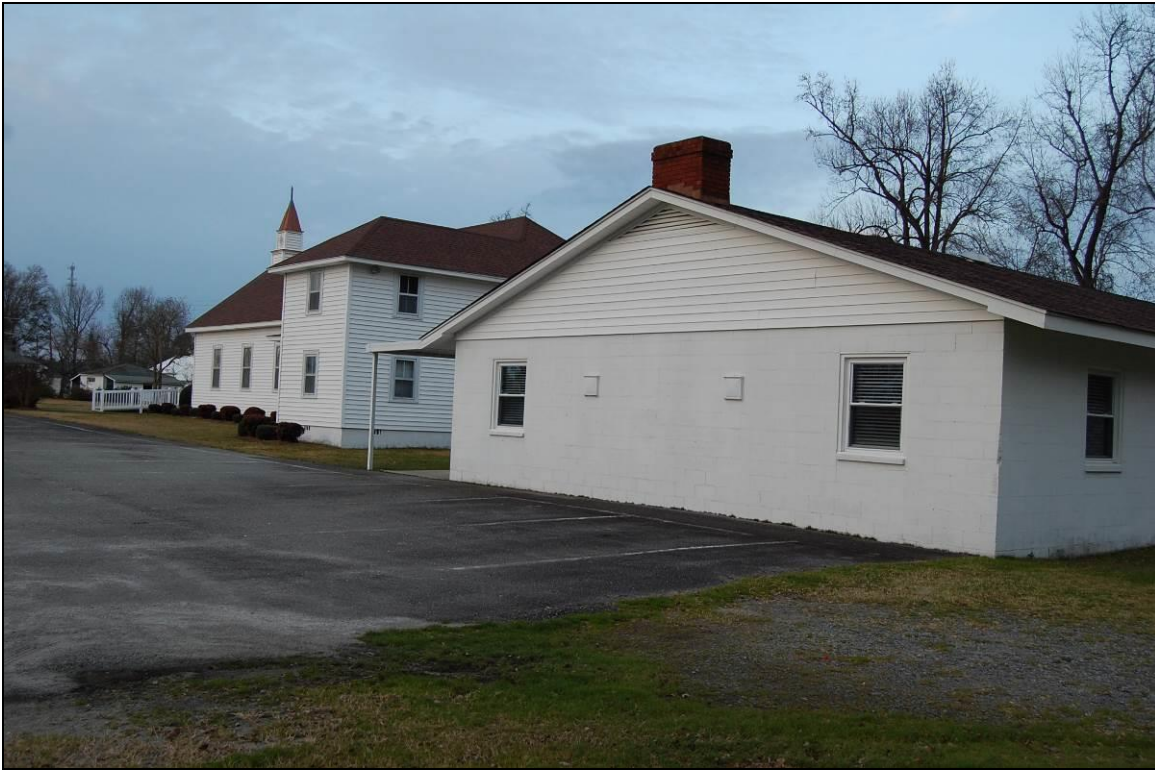
Three bays, a portico, and a short steeple—all part of the 1954 enlargement—mark the gable-front (north-facing) principal elevation of the sanctuary block (Figure 174 through Figure 180). The frame block is five bays deep and clad in vinyl. Although it was rotated and much enlarged, the sanctuary block, according to Jones and Little, retains original stained-glass windows. The single-pile, two-story, hipped-roof block perpendicular to the sanctuary's rear is the Sunday school wing added in 1938. It retains some its original four-over-four sash windows. Its current hipped roof, however, is a replacement for its original gable-end roof. The long, one-story, gable-roofed, concrete-block building just behind the church is the 1973 fellowship hall.

Figure 176. North front and west side elevations of sanctuary

Figure 177. North front and east side elevations of sanctuary

Figure 178. East side elevation of sanctuary with hip-roofed Sunday school wing at left

Figure 179. Looking southwest at Sunday school wing at right center and fellowship hall at left

Figure 180. Looking northeast at sanctuary at left, Sunday school wing at center, and fellowship hall at right

Element of Integrity	Level of Integrity	Assessment
Location	High	The church stands where it was constructed, although it was rotated on its site.
Design	Low	The church has been substantially altered through multiple additions, expansions, and modernization.
Setting	Medium to High	The setting remains small town, but many houses and other buildings have been erected in the past 30 years in Graingers.
Materials	Low	The church has been substantially altered through multiple additions, expansions, and modernization.
Workmanship	Low	The church has been substantially altered through multiple additions, expansions, and modernization.
Feeling	Low	Losses to the church's integrity of design, materials, and workmanship due to additions, expansions, and modernization have led to a loss of integrity of feeling.
Association	Low to Medium	Losses to the church's integrity of design, materials, and workmanship due to additions, expansions, and modernization have led to a loss of integrity of association.
