North Carolina Department of Natural and Cultural Resources
State Historic Preservation Office

SUBJECT: C. F. Harvey Parkway Extension (NC 148), Four-Lane Divided Freeway on New Location, R-5703, NCDOT WBS No. 46375.1.1, Lenoir County, ER 16-0449

Figure 2. Area of Potential Effects, outlined in red, and property locator map

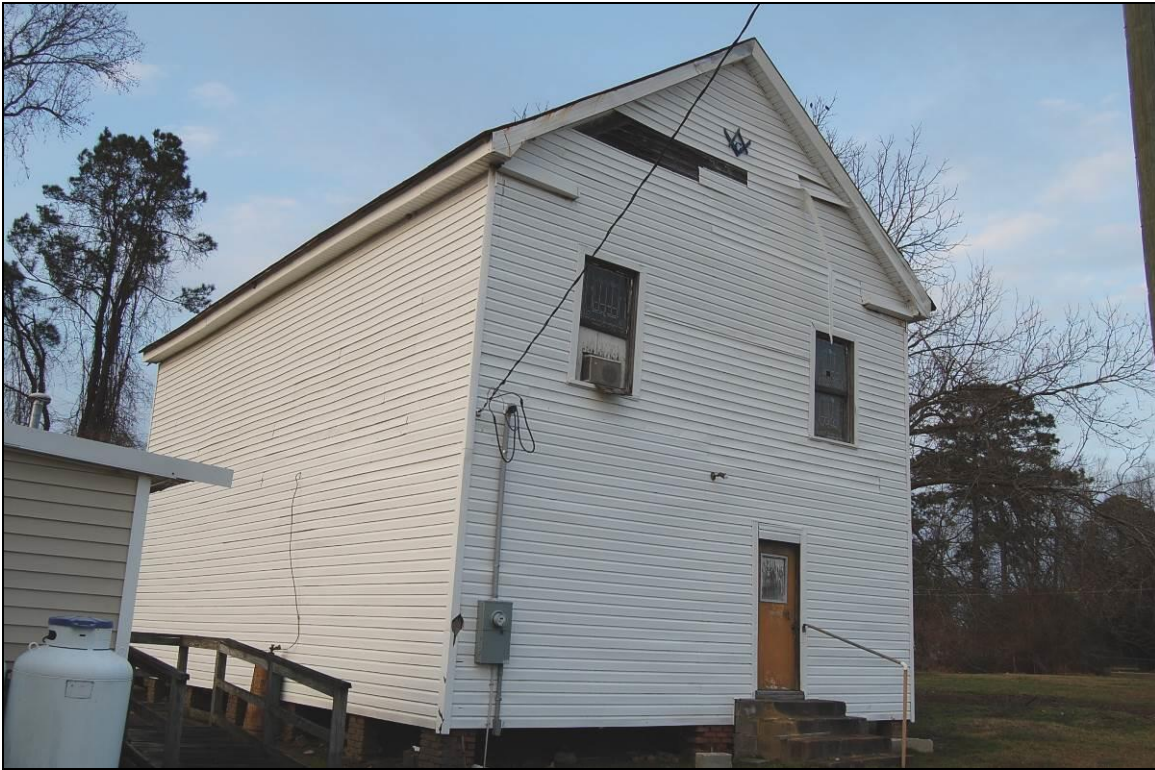
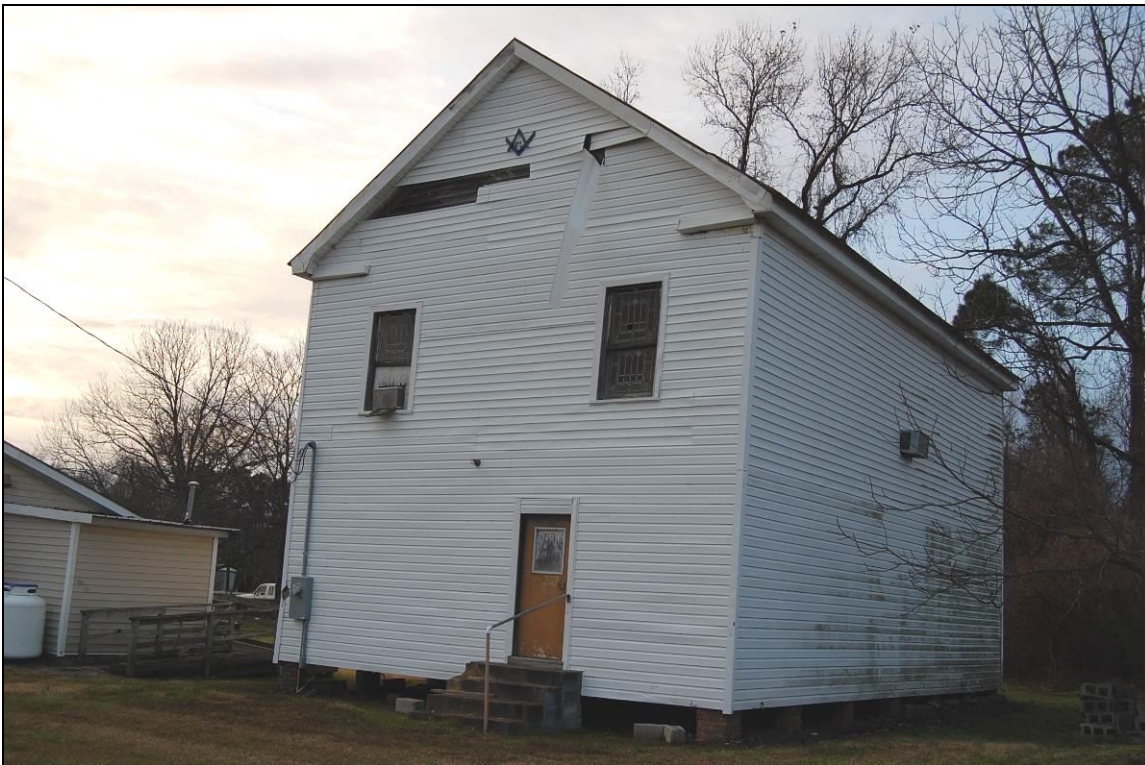
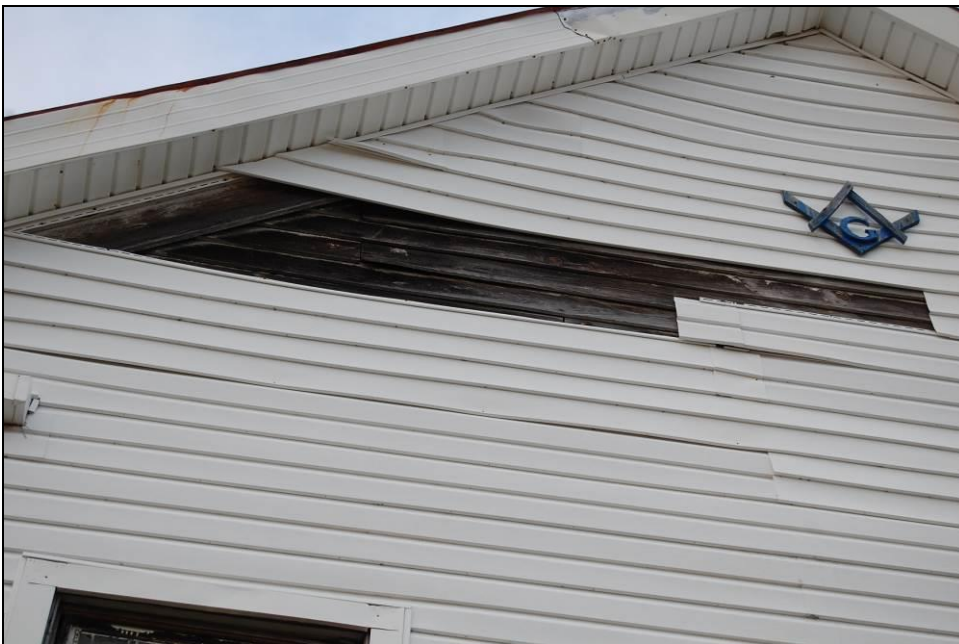
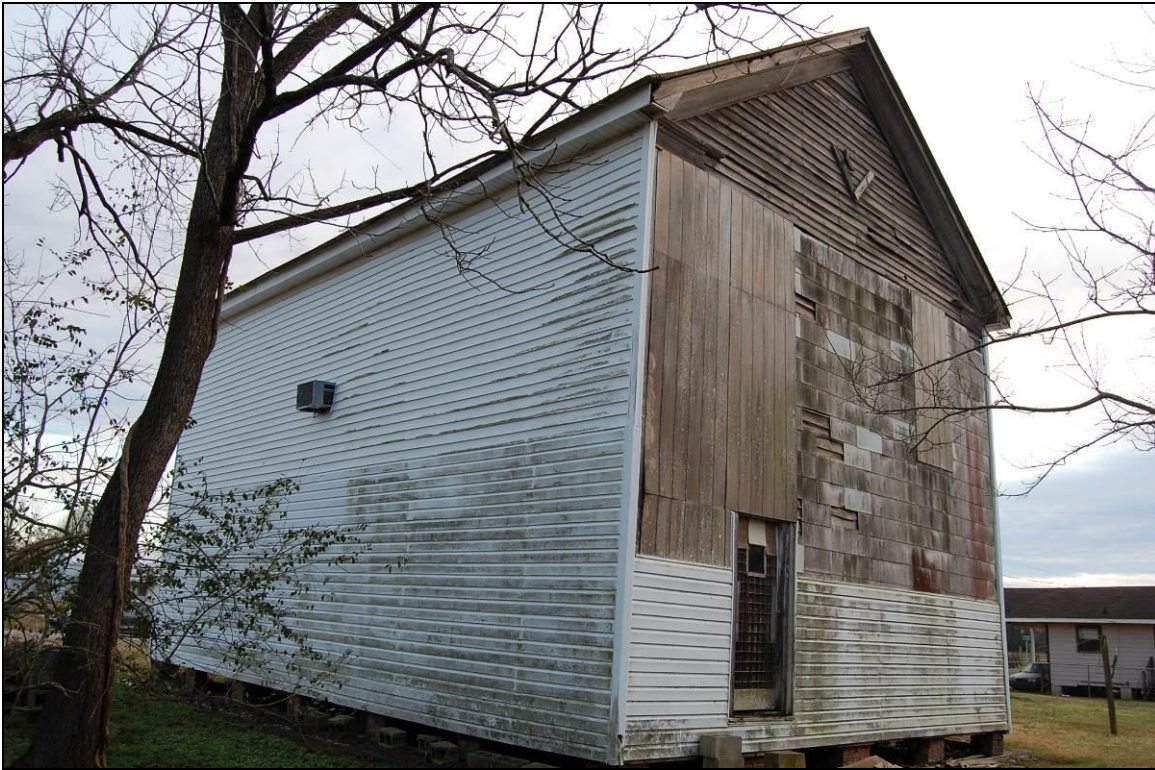
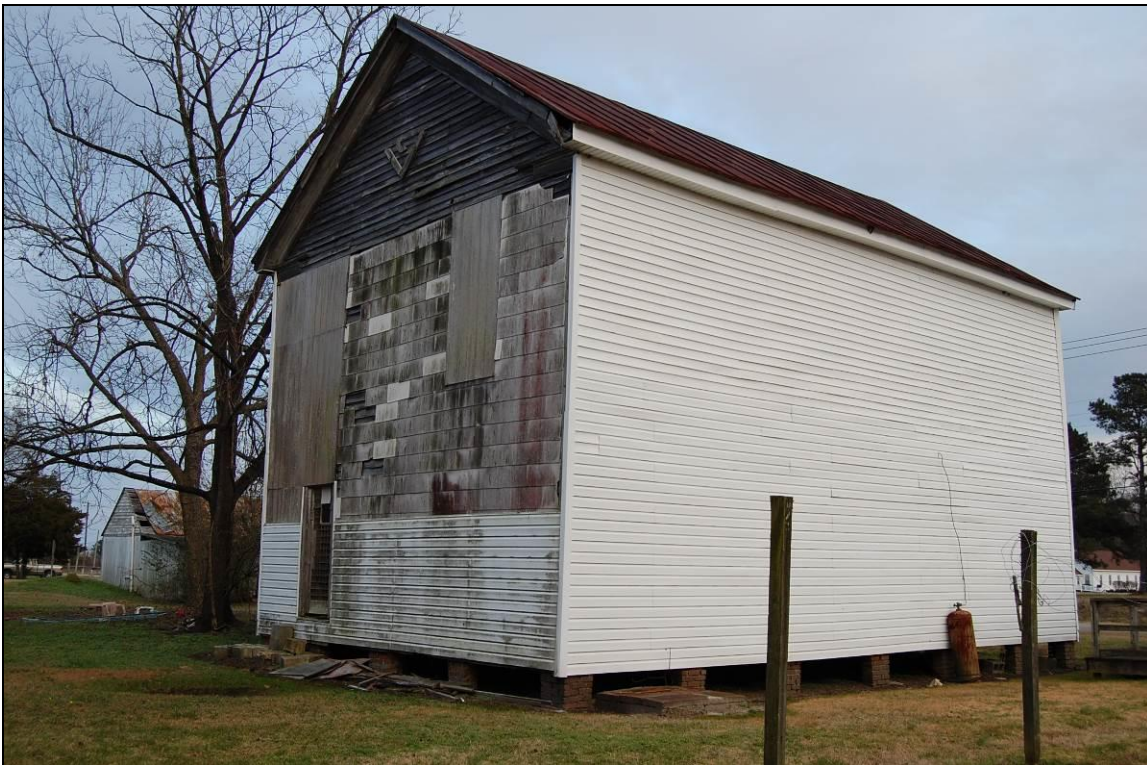
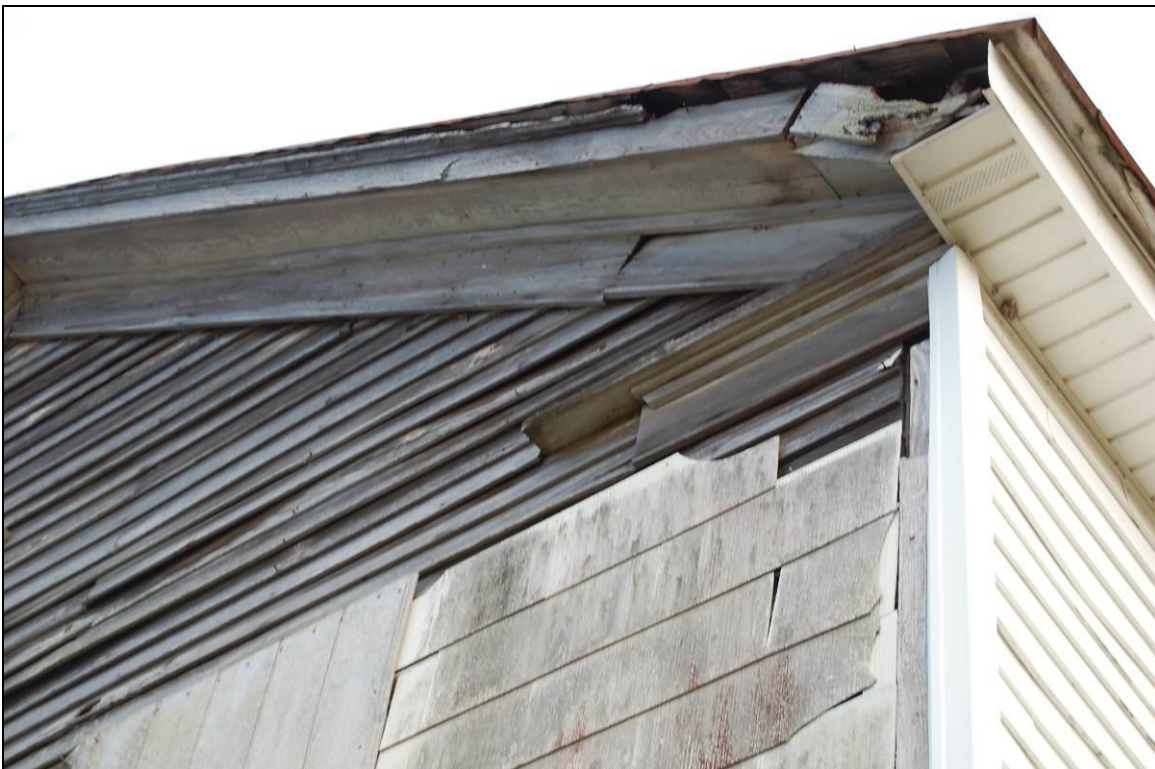
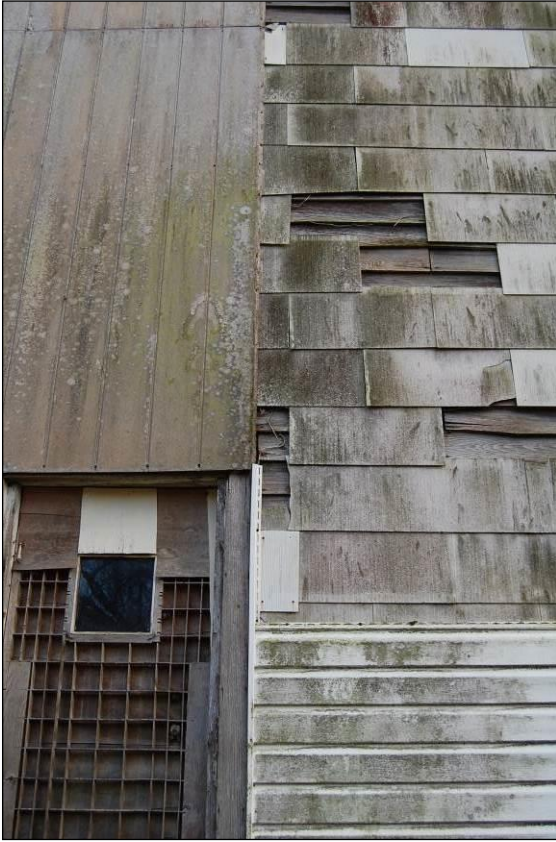
The Capstone Lodge is a frame, two-story, gable-front building (Figure 181 though Figure 190). When Robbie Jones recorded it in 1993, it had two front (southeast) entrances with leaded stained-glass, double-hung windows at the second-story above. Clear glass filled the sash that lit the first and second stories of its side elevations. An additional door opened at the rear (northwest) gable end and at the back of the southwest side elevation (see HPO file and Little 1998:360). Weatherboards, cornice returns, and an intact square-and-compass Masonic symbol marked the front and rear gables; the remainder of the building was sided with asbestos shingles. Brick piers raised it off the ground and it was topped by a standing-seam metal roof pierced at the northeast side elevation by a brick flue stack.

Marvin Brown found it much further altered in 2009, to the state in which it remains at present. The building is clad in vinyl at the front and sides. At the front elevation the vinyl covers over the left-hand entry and the cornice and returns. The right-hand entry remains, narrowed and served by a modern door. The lower sash of the front elevation's left-hand window had been removed and the Masonic symbol in the front gable had been shifted onto the vinyl siding. Where the vinyl has pulled away at the gable, however, weatherboards are still visible.

At the lodge's rear elevation, the vinyl only extends about a third of the way up the façade. Above it are asbestos shingles, composition board, and a few spots of exposed weatherboards. The honeycomb interior of the modern door is exposed. Only at the rear gable is the original finish visible. The gable retains weatherboard cladding, an exposed wooden cornice with returns, and a wooden square-and-compass symbol. The symbol retains the downward-pointed compass and much of the letter "G" above. In 2009 it retained one leg of its upper compass. Both legs have now fallen.

Figure 181. Southeast front and southwest side elevations

Figure 182. Northeast side and southeast front elevations

Figure 184. Southeast front elevation weatherboards and square-and-compass Masonic symbol

Figure 185. Northwest rear and northeast side elevations

Figure 186. Southwest side and northeast rear elevations

Figure 188. Northwest rear elevation cornice and cornice return

Figure 189. Northwest rear elevation detail of door and composition board, vinyl, asbestos, and weatherboard siding

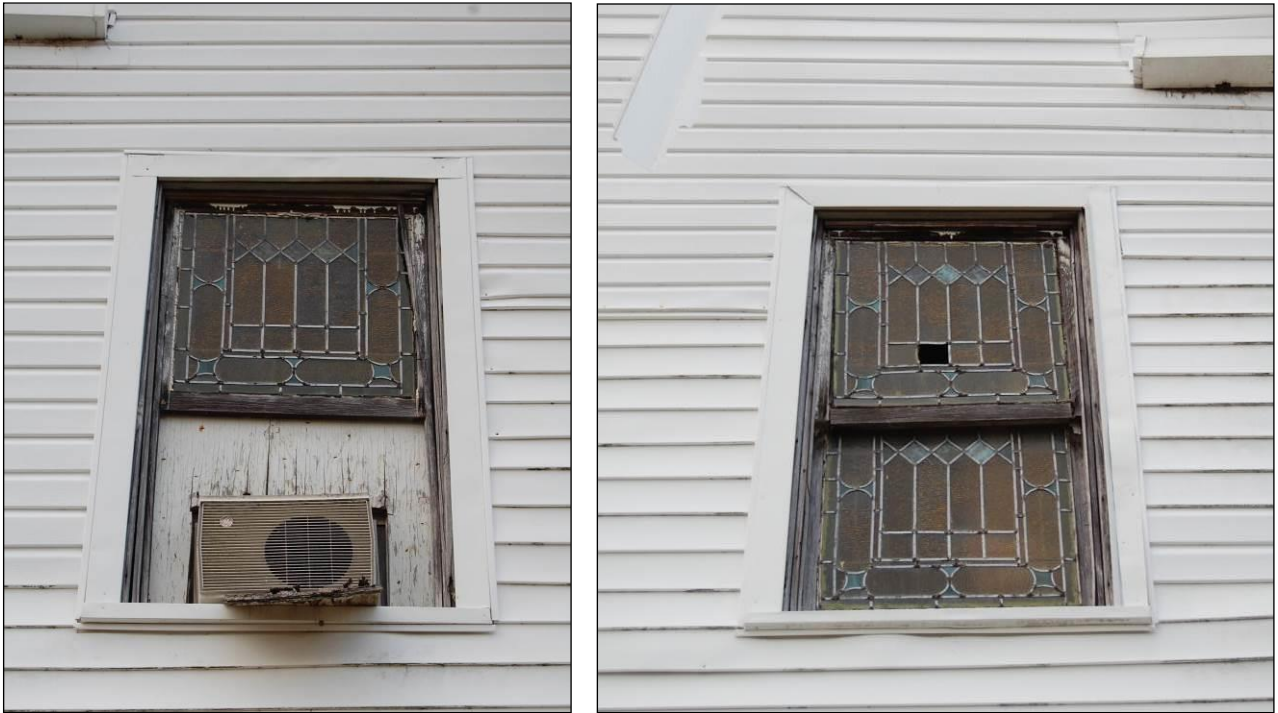
Figure 183. Southeast front elevation windows

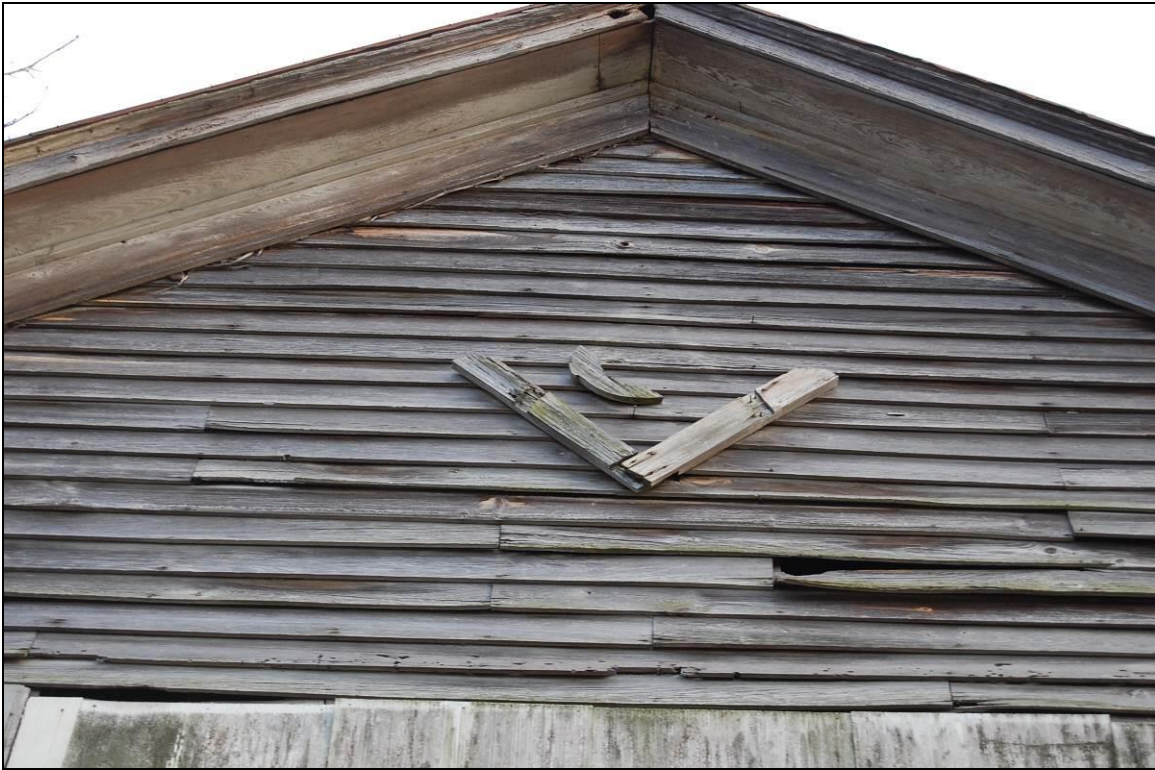
Figure 187. Northwest rear elevation weatherboards, cornice, and remnant of square-and-compass Masonic symbol

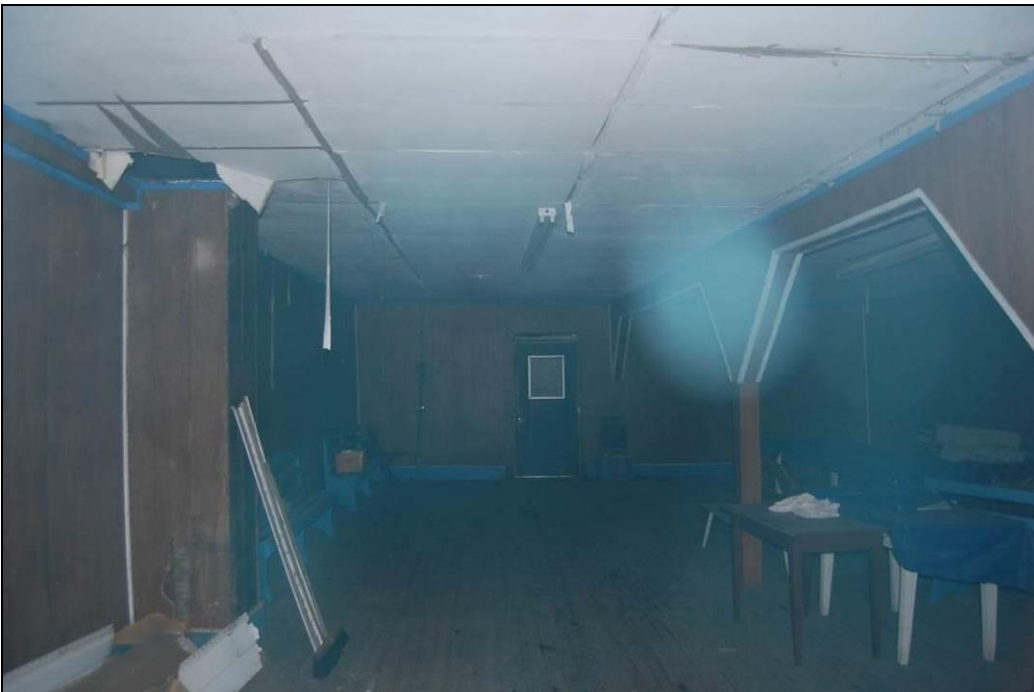
Figure 190. View through rear door window into downstairs room

There was no access to the interior. However, a flash photograph shot through the window of the rear door reveals an apparently completely altered interior, but for the wooden floor. The walls are covered with composition paneling, the ceiling is faced with acoustic tile, and a double archway of sorts crosses the center of the room from front to rear.

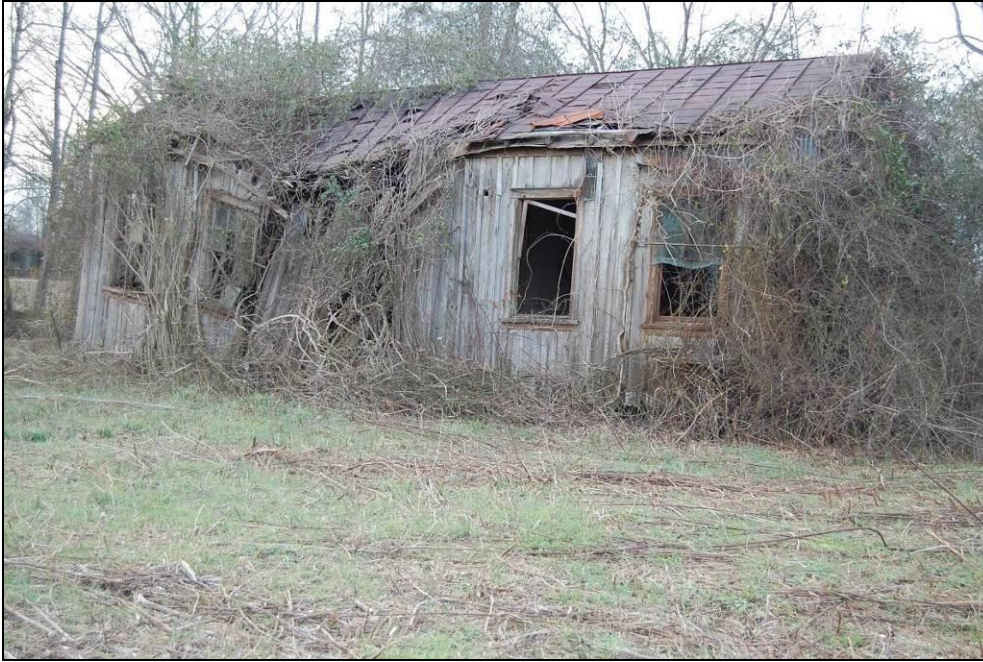
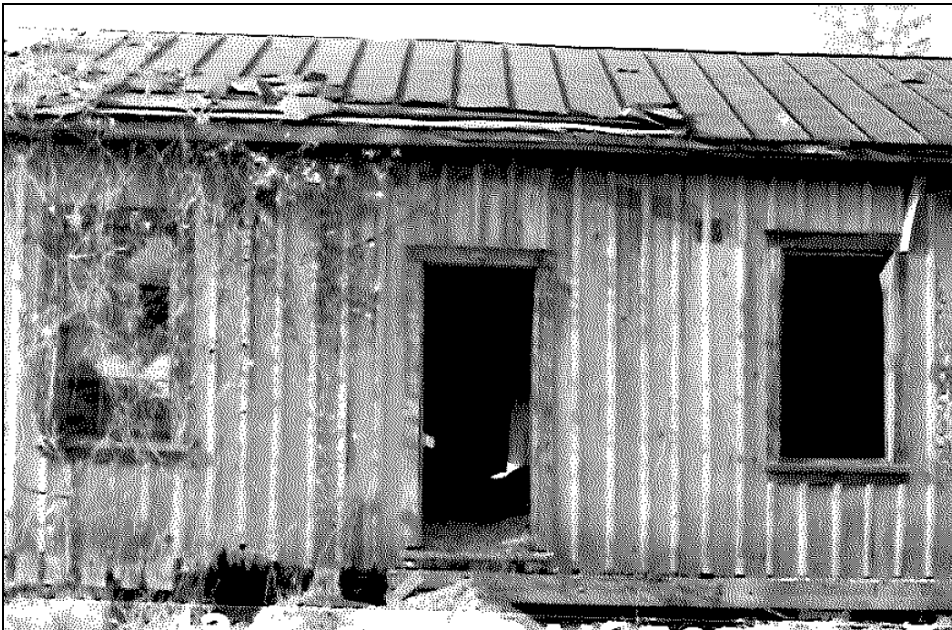
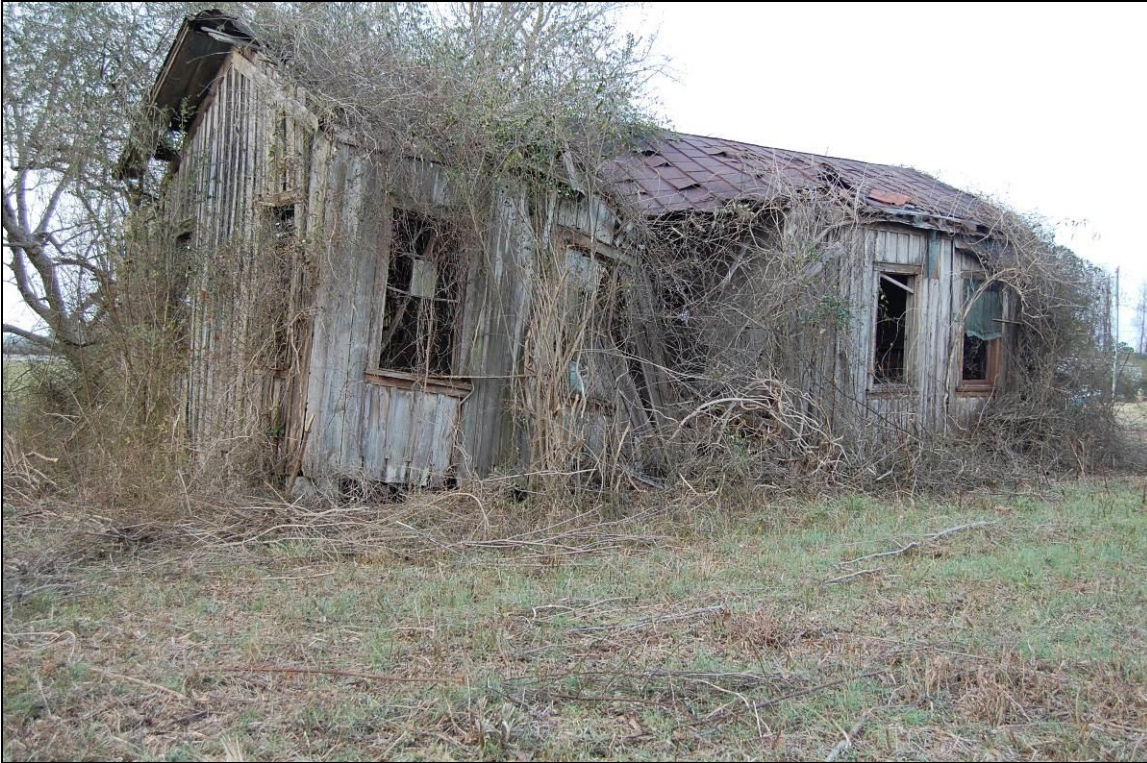
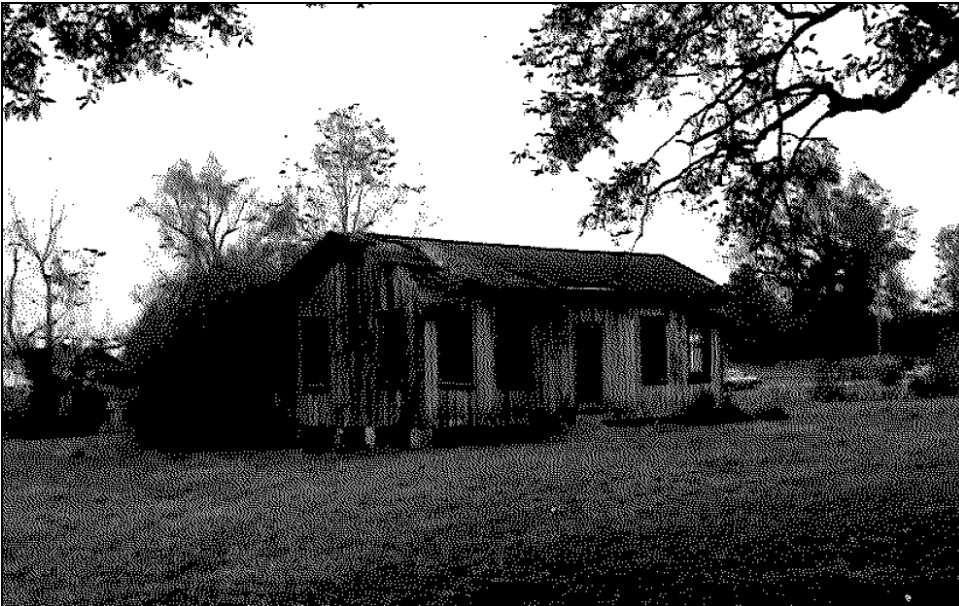
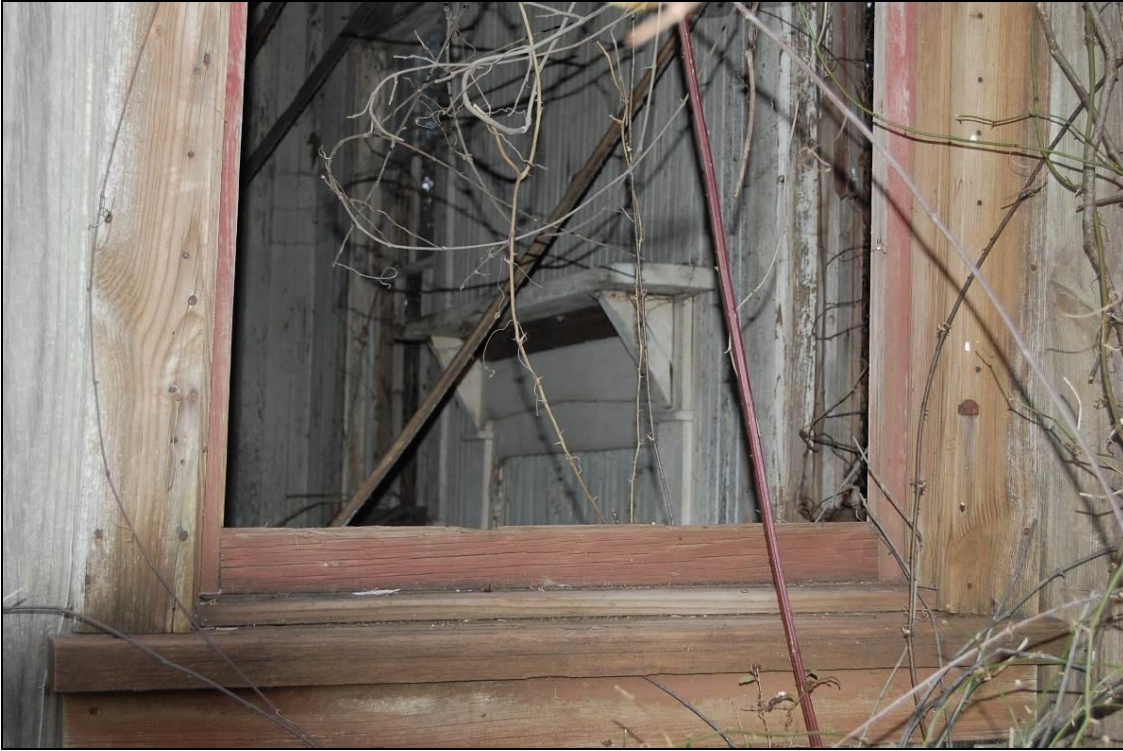
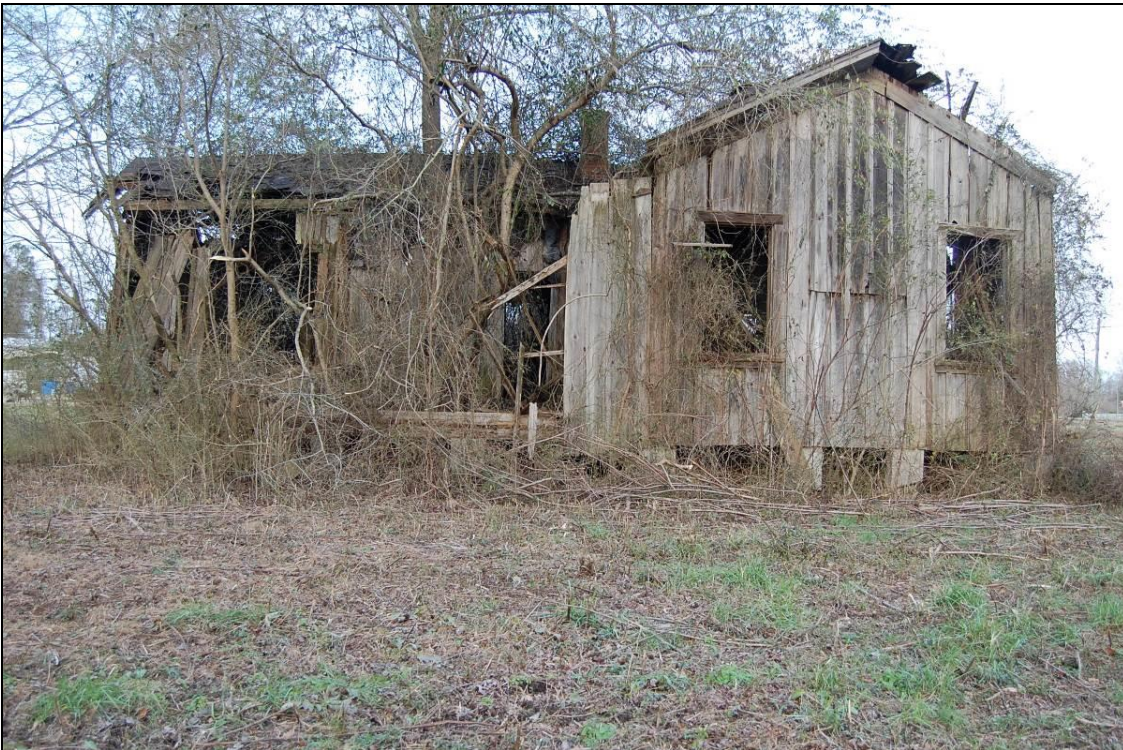
The heavy overgrowth and ruinous condition of the Graingers Railroad Section House make it difficult to view some of its features today (Figure 191 through Figure 197). Jones’ 1993 description best captures the building’s appearance, although it has only continued to deteriorate over the past 23 years:

The section house appears to retain all or almost all of these features. However, since 1993 the roof of its front (south) main block has partly collapsed, the siding has largely fallen from main block's rear (north) elevation and the west-facing side of the ell, and almost all of the glass has fallen from the few windows that retain muntins.

Figure 191. Graingers Railroad Section House, looking northwest

Figure 192. Graingers Railroad Section House, looking north in 1993 (photographer: Robbie Jones)

Figure 193. Graingers Railroad Section House, looking northwest

Figure 194. Graingers Railroad Section House, looking northwest in 1993 (photographer: Robbie Jones)

Figure 195. Graingers Railroad Section House, mantel and tongue-and-groove wall boards in front block's east room

Figure 196. Graingers Railroad Section House, looking east at front block at right and ell at left

Element of Integrity	Level of Integrity	Assessment
Location	High	The former section house stands very close to where it was constructed, in close proximity to the railroad tracks that prompted its constructed..
Design	Low	The building retains its original form, but it has lost its integrity of design because of its ruinous condition, which includes the collapse of part of its front roof, the loss of almost all its sash, and the falling of large sections of siding at its rear and ell.
Setting	Medium to High	The setting remains small town, but many houses and other buildings have been erected in the past 30 years in Graingers.
Materials	Low	The building has lost its integrity of materials because of its ruinous condition, which includes the collapse of part of its front roof, the loss of almost all its sash, and the falling of large sections of siding at its rear and ell.
Workmanship	Low	The building has lost its integrity of workmanship because of its ruinous condition, which includes the collapse of part of its front roof, the loss of almost all its sash, and the falling of large sections of siding at its rear and ell.

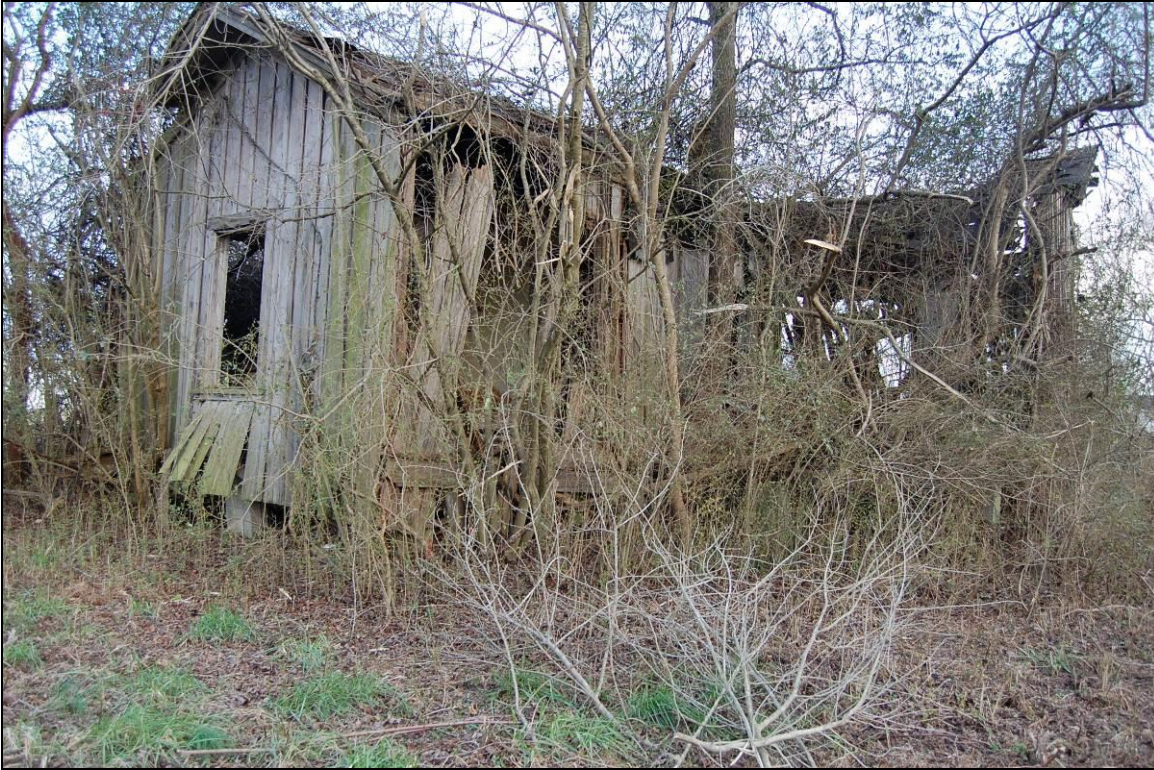
Figure 197. Graingers Railroad Section House, looking southeast at collapsed walls of front block at right and ell at left

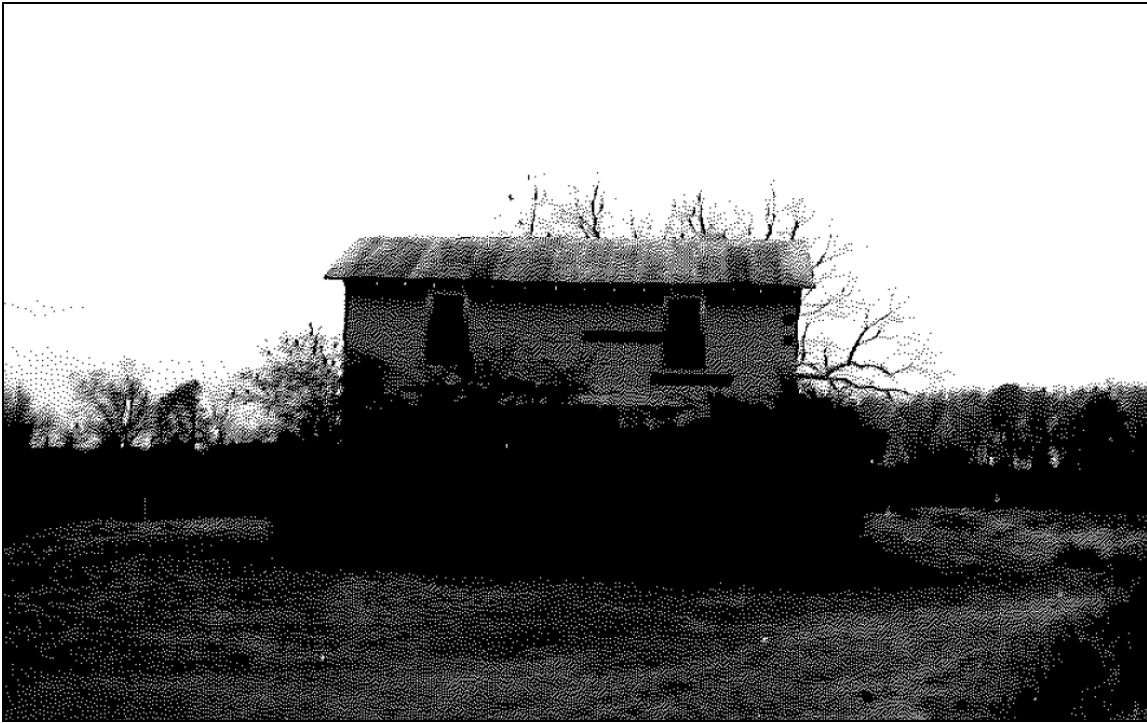
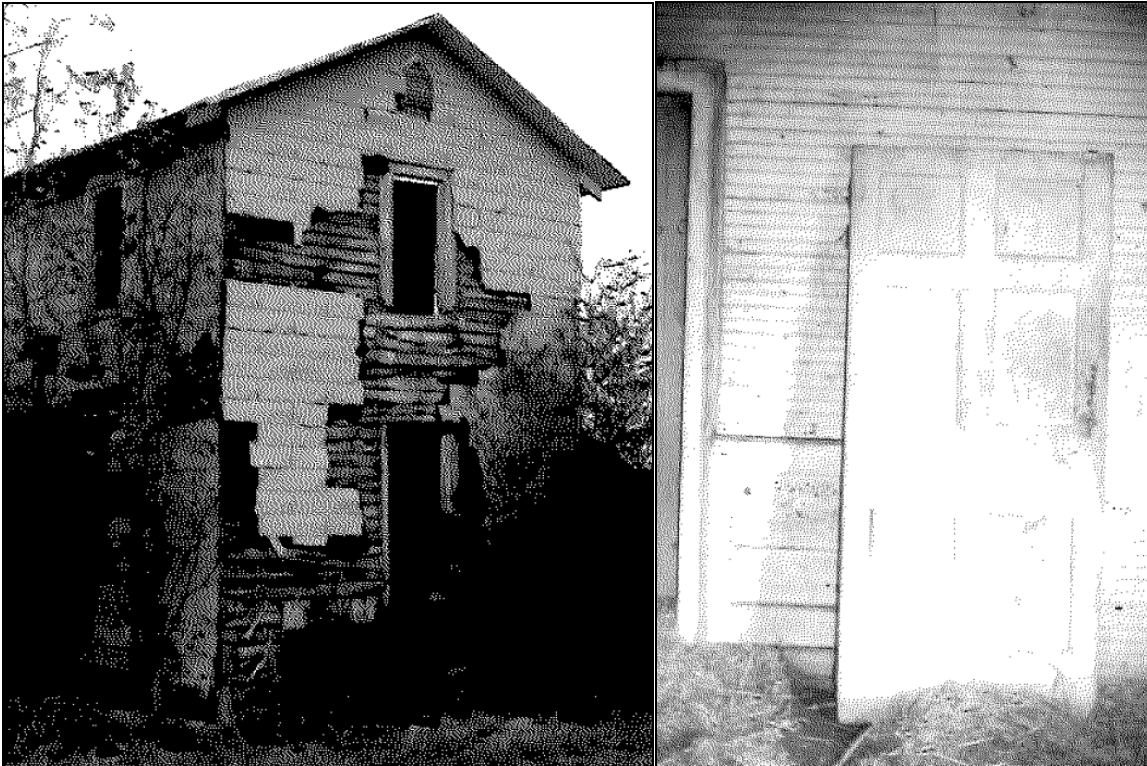
Figure 225. Jesse W. Broadway House, 1993 (photographer: Robbie Jones)

By the time Robbie Jones recorded the Jesse W. Broadway House, it was already heavily deteriorated and used as a hay barn (Figure 225 through Figure 227). He described its appearance and history as follows:

The Jesse W. Broadway House is now little more than a pile of timbers, which were not visible due to overgrowth when Marvin Brown re-visited it in June 2010.
