SUBJECT: Historic Structures Survey Report for Replacement of Bridge 224 on SR 1562
Over Big Creek, PA 15-11-0038, Montgomery County, ER 16-0669

**Evaluation of Eligibility Report
McCallum Mill
Bridge No. 224 over Big Creek on SR 1562
(McCallum Pond Road) Replacement Project
Area
Montgomery County, North Carolina**

EVALUATION OF ELIGIBILITY REPORT
MCCALLUM MILL
BRIDGE NO. 224 OVER BIG CREEK ON SR 1562 (MCCALLUM
POND ROAD) REPLACEMENT PROJECT AREA
MONTGOMERY COUNTY, NORTH CAROLINA
FINAL REPORT
WBS No. 17BP.8.R.102

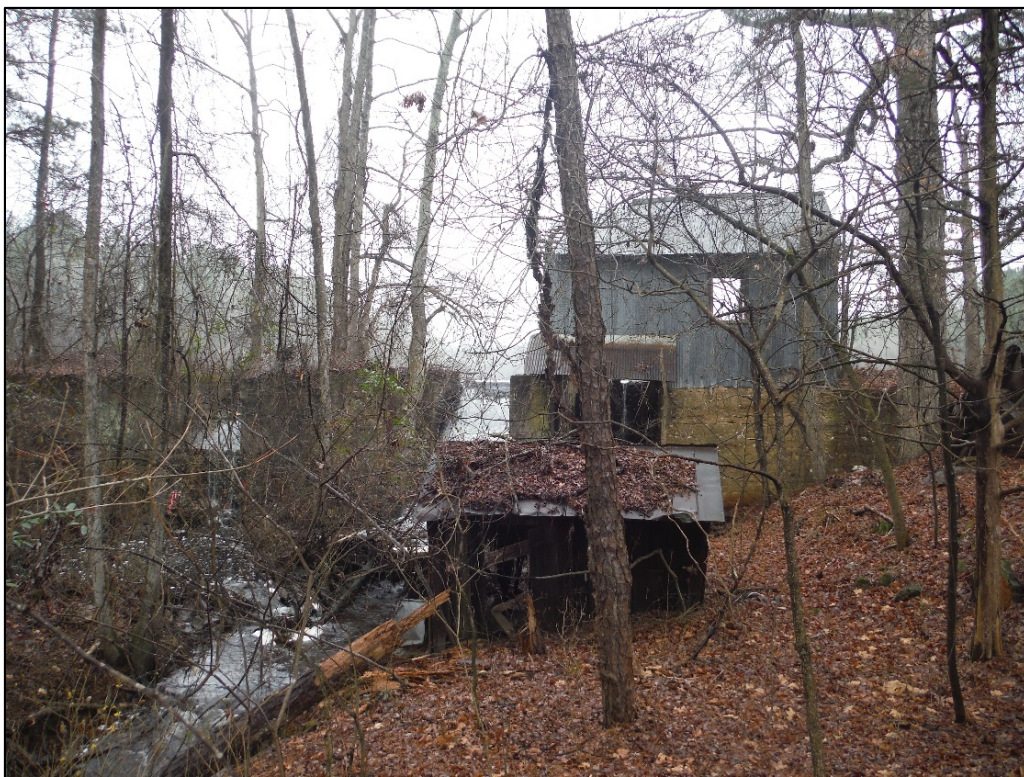
Figure 3. View of McCallum Mill (MG0153) (PIN 757500081325), facing east.

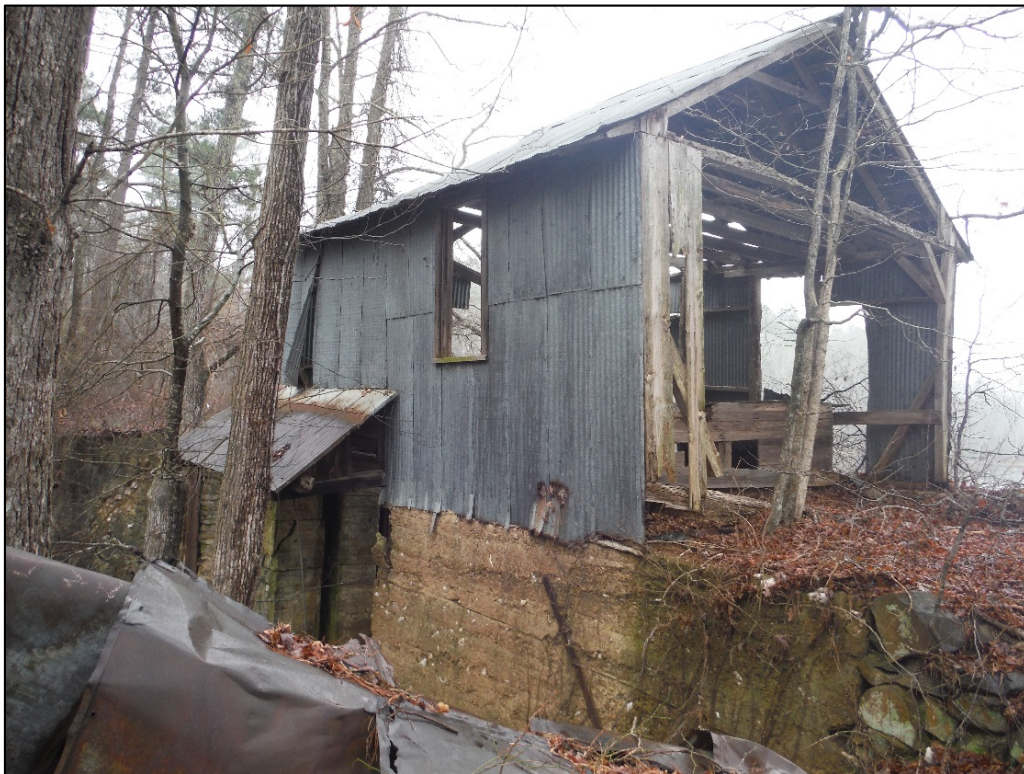
The mill structure is a single story, frame building with a lateral gabled roof, sitting on a concrete covered stone foundation, along the south side of the dam (Figure 5). The frame building has fallen into disrepair and much of the underlying structural framework is visible; the exposed wall studs and roof rafters are constructed of dimensional lumber and wire nails (Figures 6–8). There are remains of vertical wooden sheathing on the southern elevation of the structure, but the remainder of the building, including the roof, is covered with corrugated metal sheeting, with large sections missing. On the west elevation, a single window opening is visible, although there is no window within it. There is also a corrugated metal awning, located above the large opening in the foundation that once housed the waterwheel (Figures 5 and 7).

Figure 5. View of the McCallum Mill building (MG0153), facing northeast.

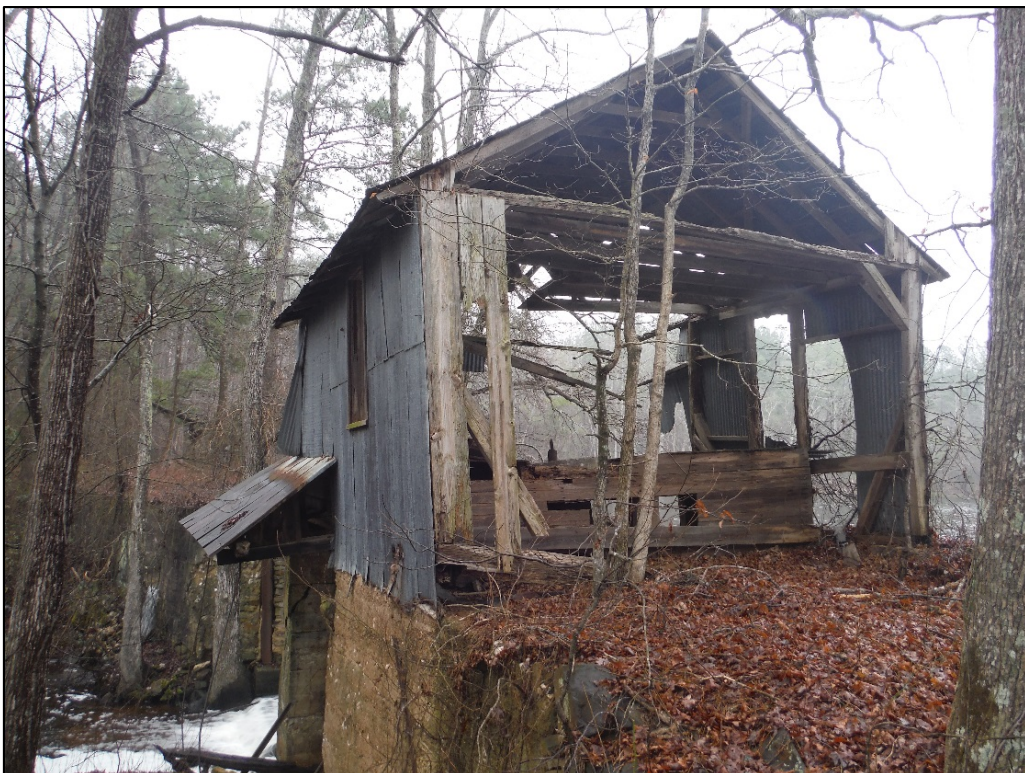
Figure 7. View of the McCallum Mill building (MG0153), facing north.

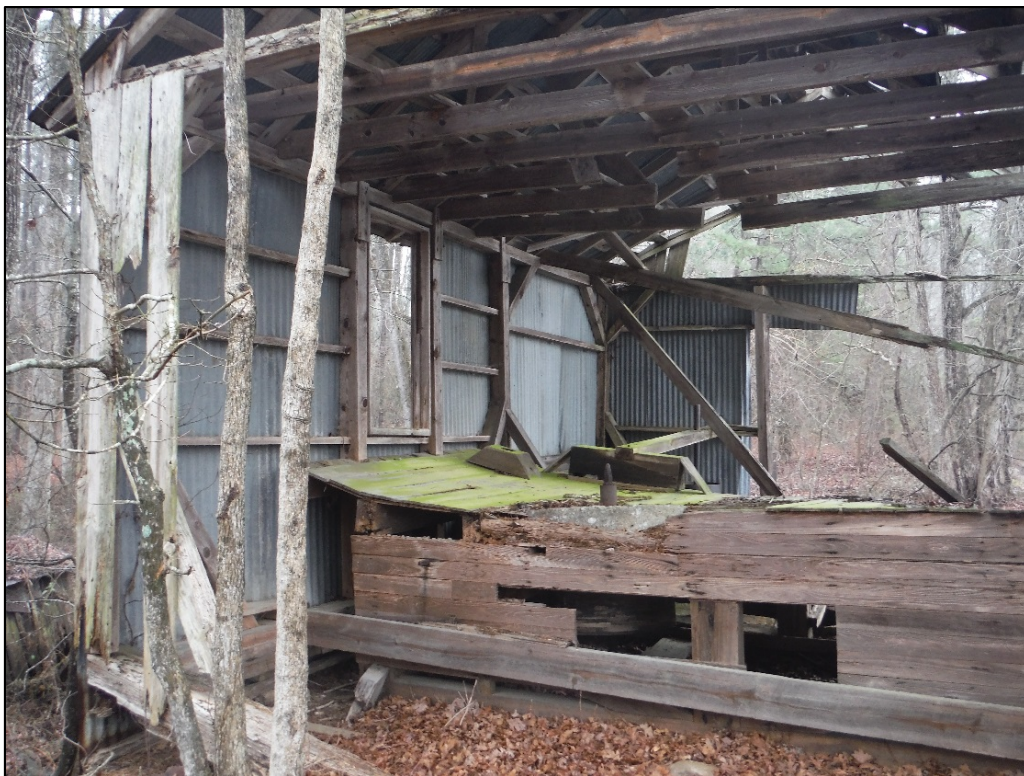
The interior of the mill contains the remnants of a platform, which formerly housed the mill mechanics (Figure 9). The metal spindle and bedstone (stationary stone) remain embedded in the platform, while the runner (rotating) stone is located on the ground, south of the mill building (Figure 10). A large rectangular opening in the mill foundation is located beneath the northern half of the structure; this is where an overshot waterwheel would have been located. The interior of the opening has engaged columns of grooved concrete, while the rear wall appears to be stone. Water from the pond would flow over this rear wall, likely through a wooden penstock or sluiceway, to power the waterwheel. The remnants of mill mechanics are also visible here, with a pair of metal shafts that held the gears that would be turned by the waterwheel to move the millstones (Figure 11). Additional components of the mill building, including broken wood and corrugated metal, have fallen into the waterwheel opening.

Figure 9. View of the McCallum Mill building (MG0153), interior, facing northwest.

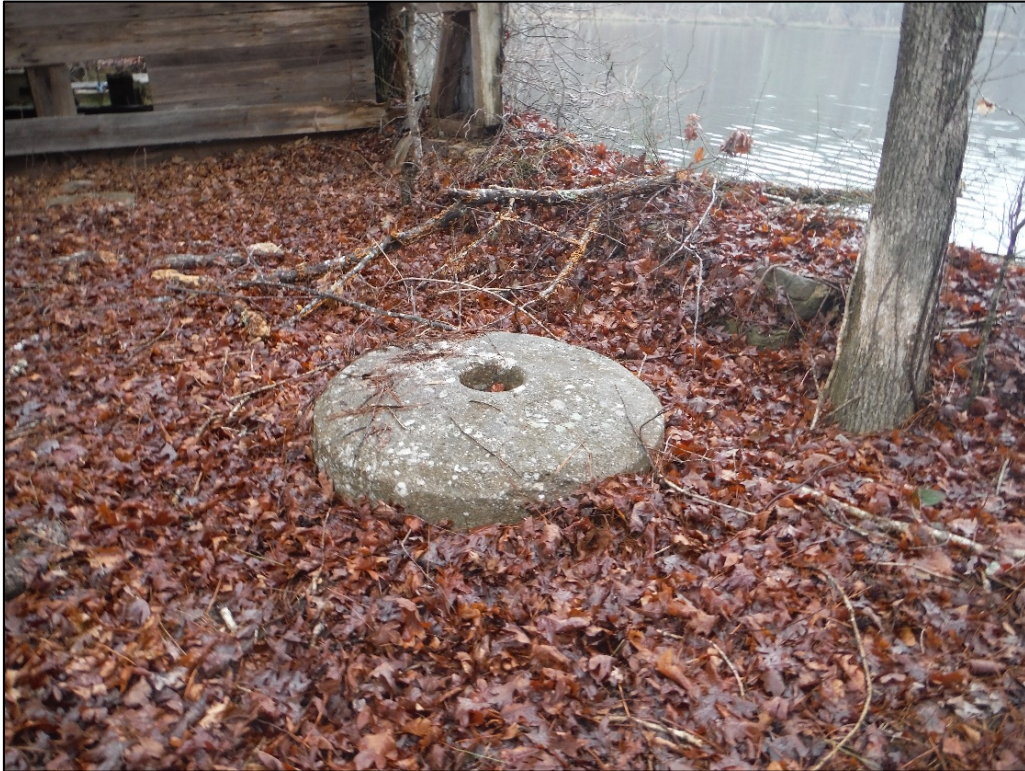
Figure 10. Millstone at McCallum Mill building (MG0153).

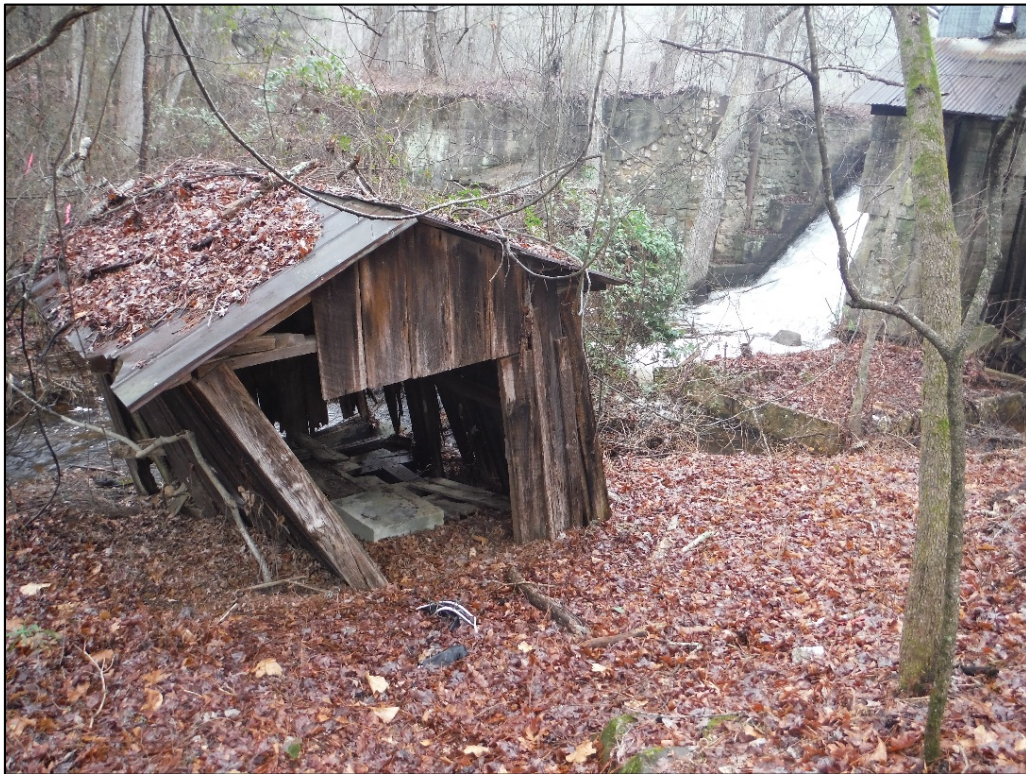
West of the mill building, there is a square concrete foundation, and west of the foundation is the remains of a small, gable roofed, frame structure that may have served as an office for the mill operator or a shelter structure, sometimes called a warming or waiting hut (Figures 4 and 12). The building and foundation appear to be the same size, and it is possible that the building remains were knocked from the foundation during flooding (Figure 13). The wooden structure had vertical wooden sheathing and a large opening on its south elevation. The roof was covered with standing seam metal. The north elevation has a smaller, window like opening, which appears to be covered with metal (Figure 14). Although removed from the foundation and severely leaning, the wooden structure remains standing and its form is recognizable.

Figure 12. View of building ruins and concrete foundation at the McCallum Mill (MG0153) property, facing northeast.

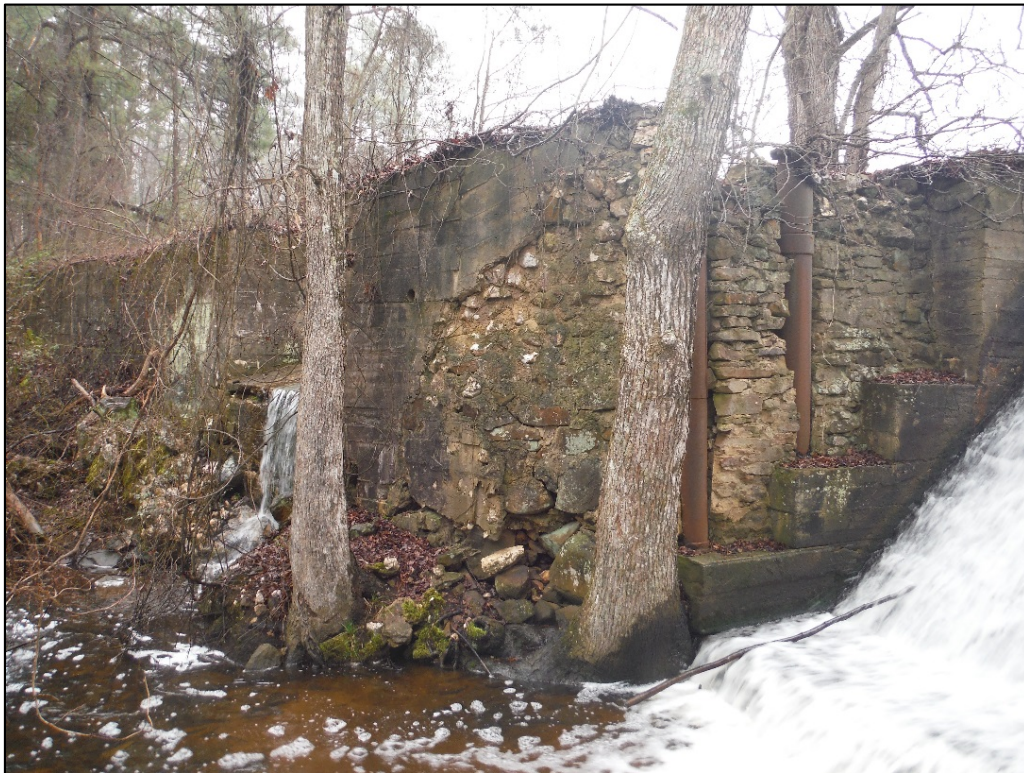
The dam, which spans the creek bed and includes extensions along the shoreline, appears to have originally been constructed of dry stacked stone, although it was covered with concrete, likely during the early-twentieth-century when the mill structure was built (Figure 13). It has a head of approximately twelve feet above the lower creek bed and contains two spillways and single millrace, which would flow under the north side of the mill building (Figure 14). The central section of the dam is located between the two spillways, and it is here where the deterioration of the concrete covering shows the original stacked stone construction; two vertical metal shafts or pipes are also visible in this section, along the northern wall of the south spillway. The southern spillway, which is closer to the mill, has visible stepdowns along its edge (Figure 15). The piping and stone found on the central portion of the dam, along with the two separate spillways, and cut foundation stones scattered around the site and on the center portion of the dam, could indicate that an older mill was located in a different point on the dam. A rebuilding and/or expansion of the dam, along with the relocation/reconstruction of the mill, may have occurred in the early-twentieth-century, corresponding to the construction date of the current mill structure.

Figure 13. View of central portion of dam at the McCallum Mill (MG0153) property, facing northeast; south spillway is in the foreground (right) and north spillway is in the background (left); metal piping is built into the stone dam on the north wall of the south spillway.

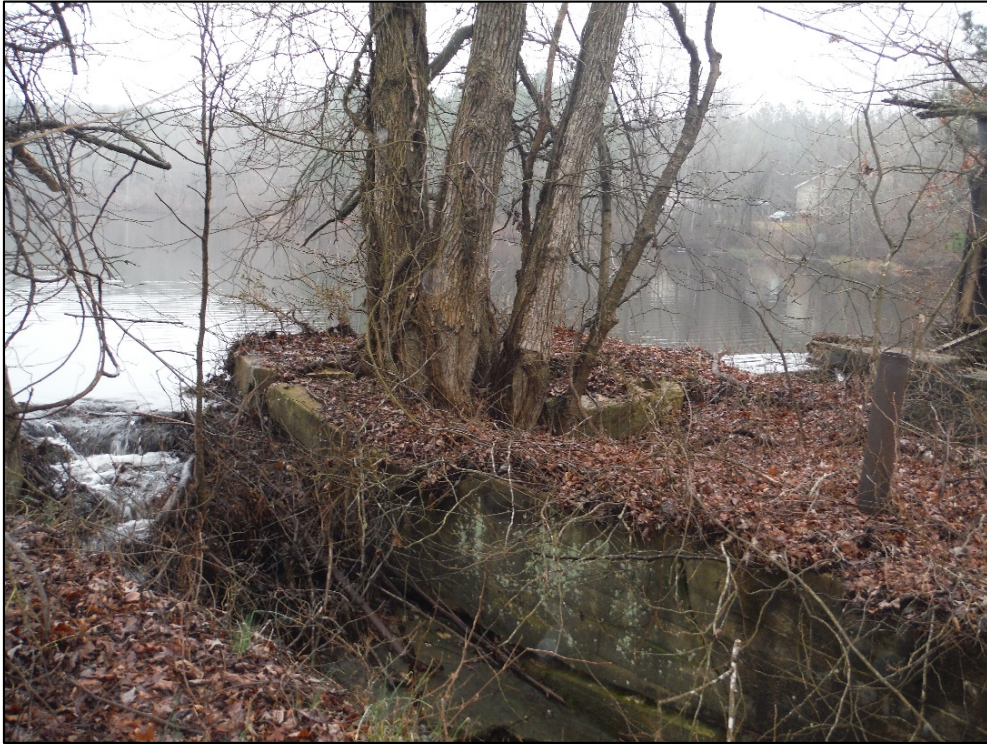
Figure 14. Central portion of top of dam at the McCallum Mill (MG0153), facing east; north spillway is in the foreground (left) and south spillway is in the background (right); a metal pipe extends out of the central portion of the dam and cut stones are beneath the leaves.

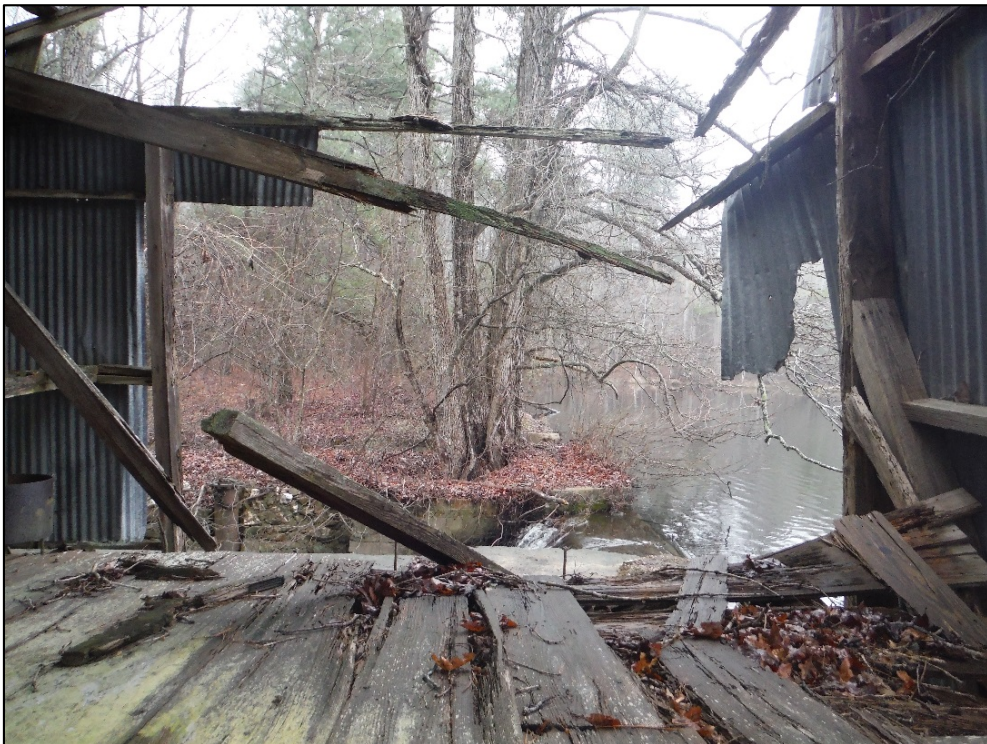
Figure 15. View of south spillway at top of dam at the McCallum Mill (MG0153) property, from mill building, facing north.

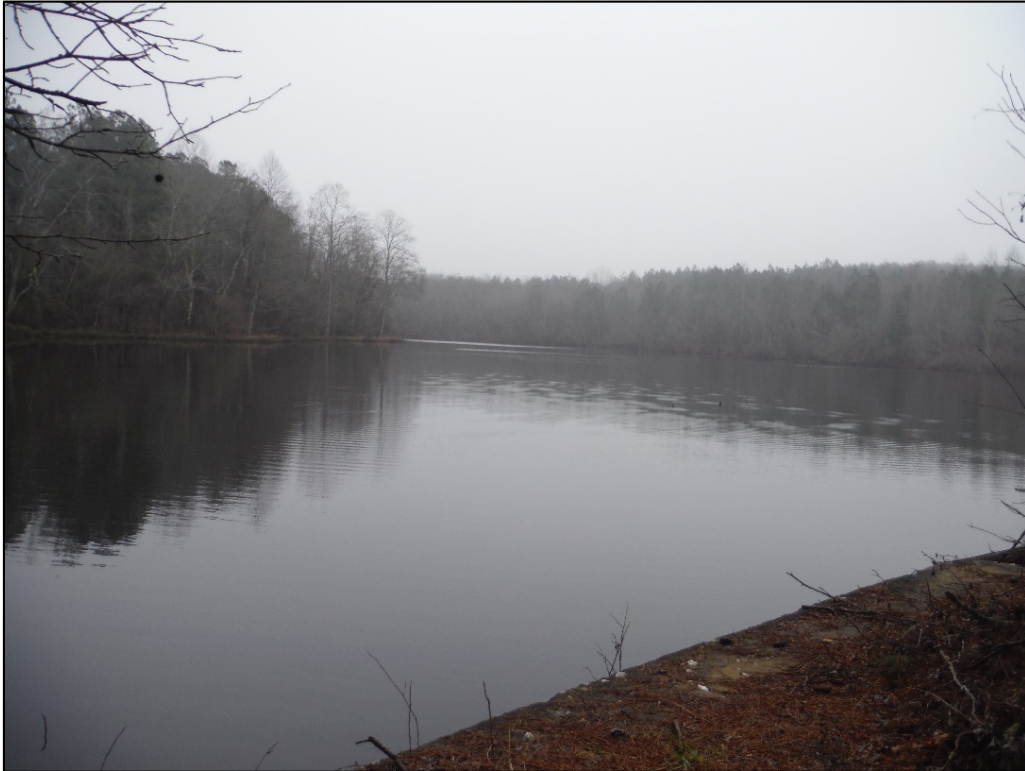
The millpond created by the dam is approximately seven acres in size (Figure 16). The concrete also extends north and south of the dam, along the shoreline of the western edge of the pond (Figure 17). Metal bracing on the northern portion of the dam appears to have some association with recreational activities at the pond, and may have been a mount for a diving board (Figure 18).

Figure 16. View of McCallum Pond at the McCallum Mill (MG0153) property, facing east.

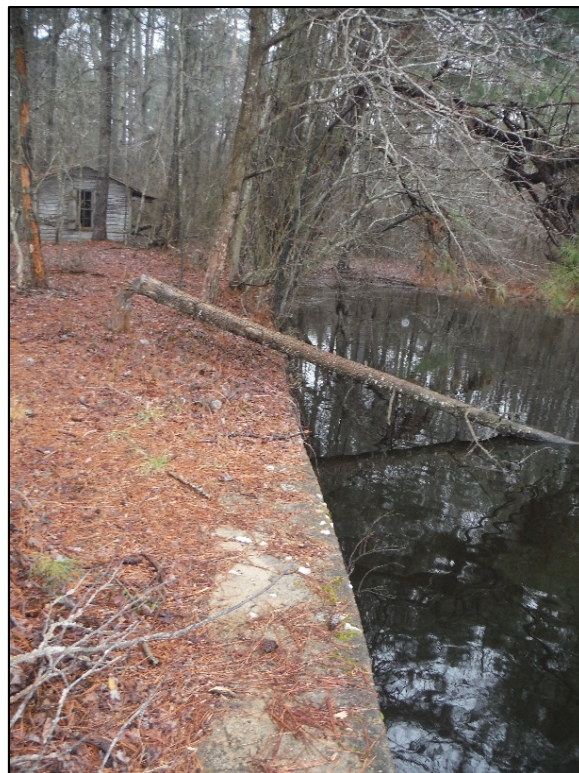
Figure 17. View of dam at the McCallum Mill (MG0153) property, north of spillways, facing north.

The McCallum Mill retains early-to-mid-twentieth-century form and design, as does the bathing house. However, it appears that the mill dam has been expanded from its original form, with the addition of concrete shoreline shoring. Additionally, the office structure has lost integrity of design, as it has been removed from its foundation and undergone significant deterioration.

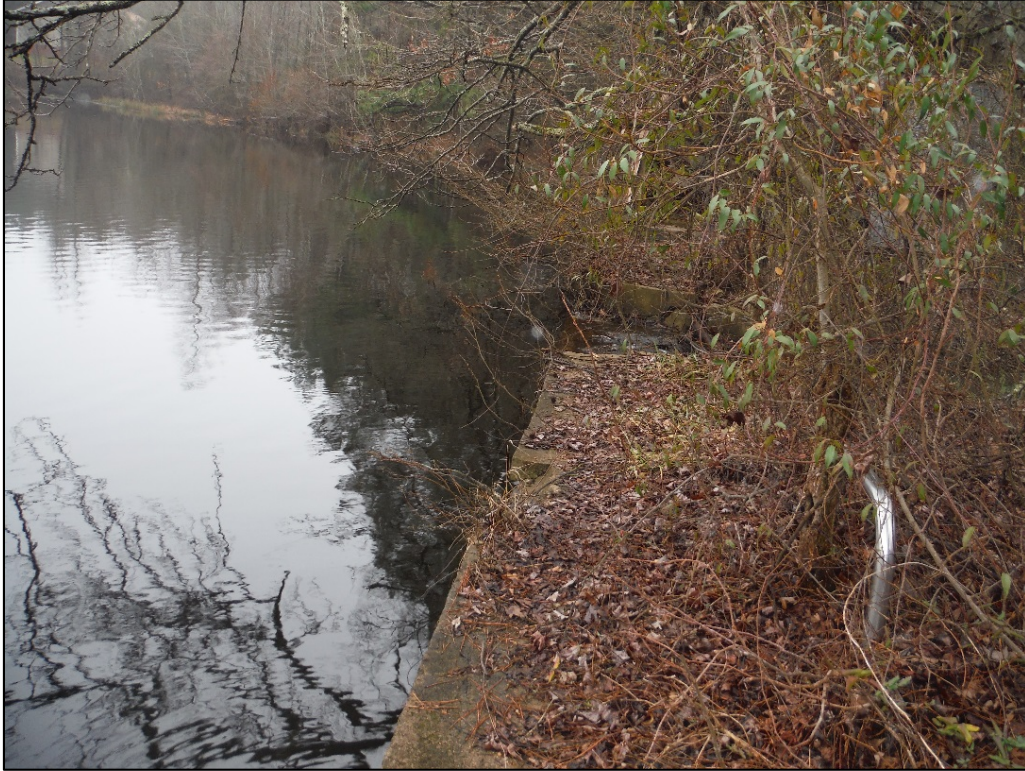
Figure 18. View of upper portion of dam and millpond at the McCallum Mill (MG0153) property, facing southeast.

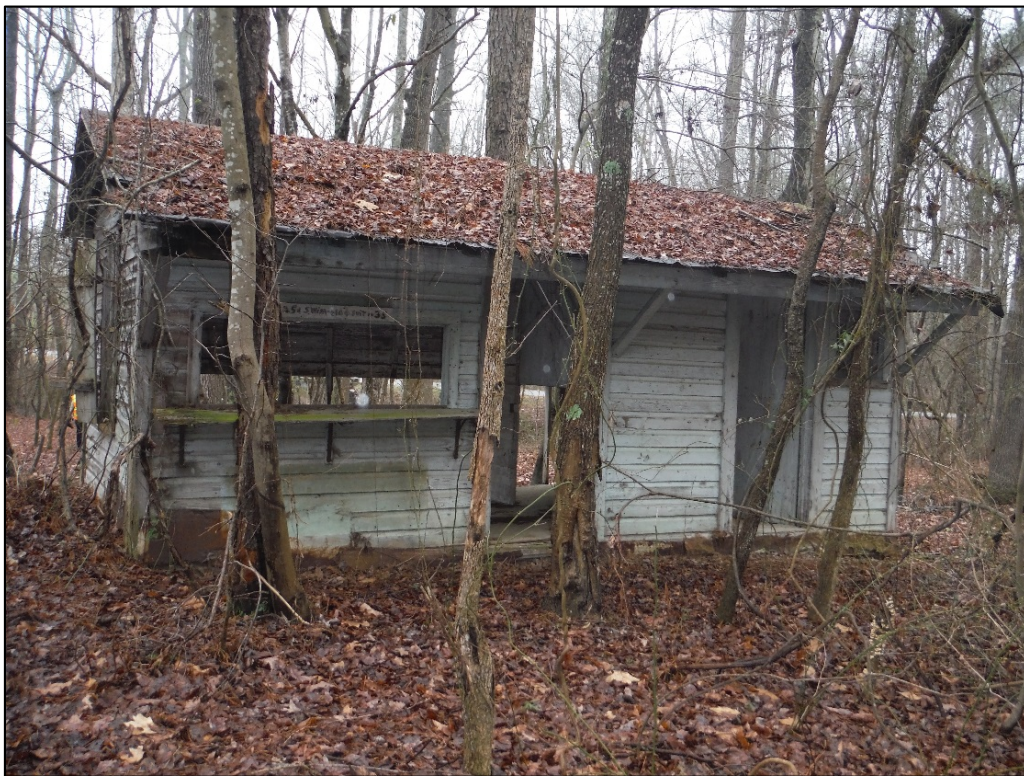
North of the mill complex and dam, there is an early-twentieth-century, wooden framed building that appears to have been used as a bathing house (Figures 17 and 19). This two room wooden building is set on a log pier foundation and is sheathed in wooden weatherboard. It has a side gabled roof, covered with standing seam metal, and a wide eave overhang, supported by triangular brackets. Both the northern and southern elevations had a small window that could be closed with shutters; the northern section is closed, but the southern section's window remains and is a four-over-four wooden sash (Figures 20 and 21). The rear of the structure has open spots where the siding has been removed (Figure 22). The front of the building faces east, toward the pond, and contains two doors and a large window. The northern door leads to a small room, which was originally separated by a wall and doorway from the larger southern section (Figure 23). The southern section contains the other door and a large, horizontally oriented window, with a bar top along its length. The window resembles a concession stand and a sign above the window reads "25¢ swim and 10¢ suit = 35¢"; this seems to indicate that the pond was utilized as a recreational facility and the building was associated with that use.

Figure 19. View of the bathing house at the McCallum Mill property (MG0153), facing northwest.

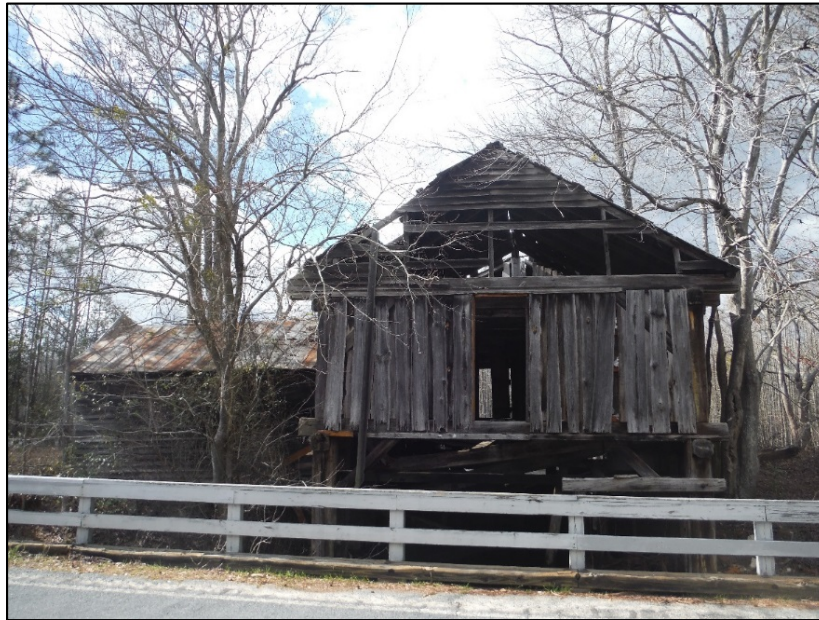
Figure 27. McNeill's Mill (HK0016), facing northwest.

McNeil's Mill (HK0016), which has not been evaluated for NRHP eligibility, is a late-nineteenth-century frame gristmill that is constructed of hewn lumber and wooden pegs, indicating an older structure than the McCallum Mill. It has vertical wooden siding on the main portion and wooden weatherboard siding on the adjacent office section (Figure 27). Like the McCallum Mill, McNeil's Mill sits on a dam, although the McNeil Mill dam is stone with a bank shored up with concrete block and the mill itself sits on wooden piers on a bank of the dam, instead of directly on top of the solid dam wall. Although the mill itself is in disrepair, some of the mechanical elements remain in the structure and along the dam, where the run of the stream would have powered the equipment (Figure 28).

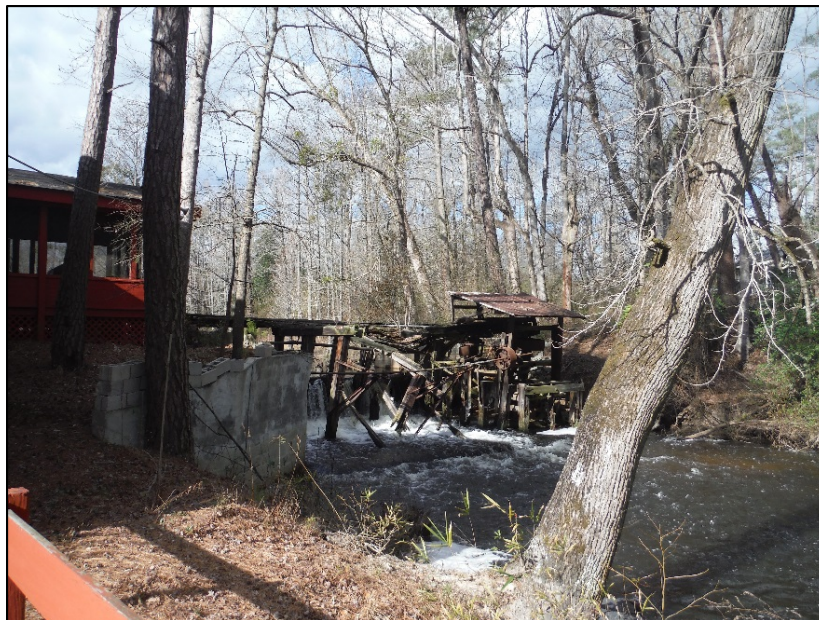
Figure 28. McNeill's Mill (HK0016) dam and mechanical equipment, facing west.

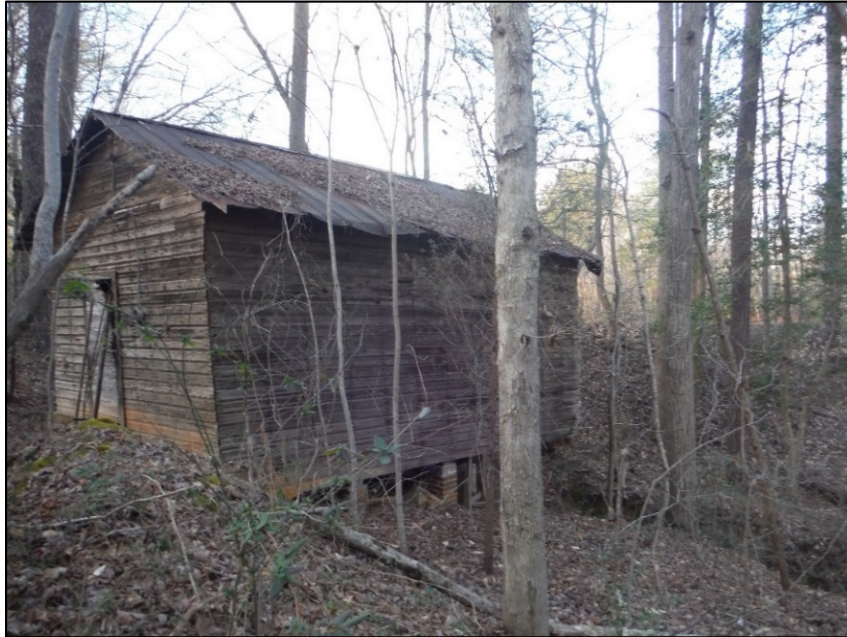
Figure 29. Joe Kelly Mill (LE0265), facing north.

The Joe Kelly Mill and Millpond (LE0265) is a circa-1925 frame gristmill that contains its original machinery. The Joe Kelly Mill is turbine powered and water is supplied through a concrete and brick shaft and the millpond is created by an earthen dam. The mill structure has horizontal weatherboard siding that dates from the 1950s and a standing seam metal roof (Figures 29 and 30). The Joe Kelly Mill and Millpond were surveyed and placed on the North Carolina Study List in 1992. The dam and mill structure are of different construction from the McCallum Mill, although they date to the same time period. In contrast to the McCallum Mill, the Joe Kelly Mill retains its original mill workings and equipment.

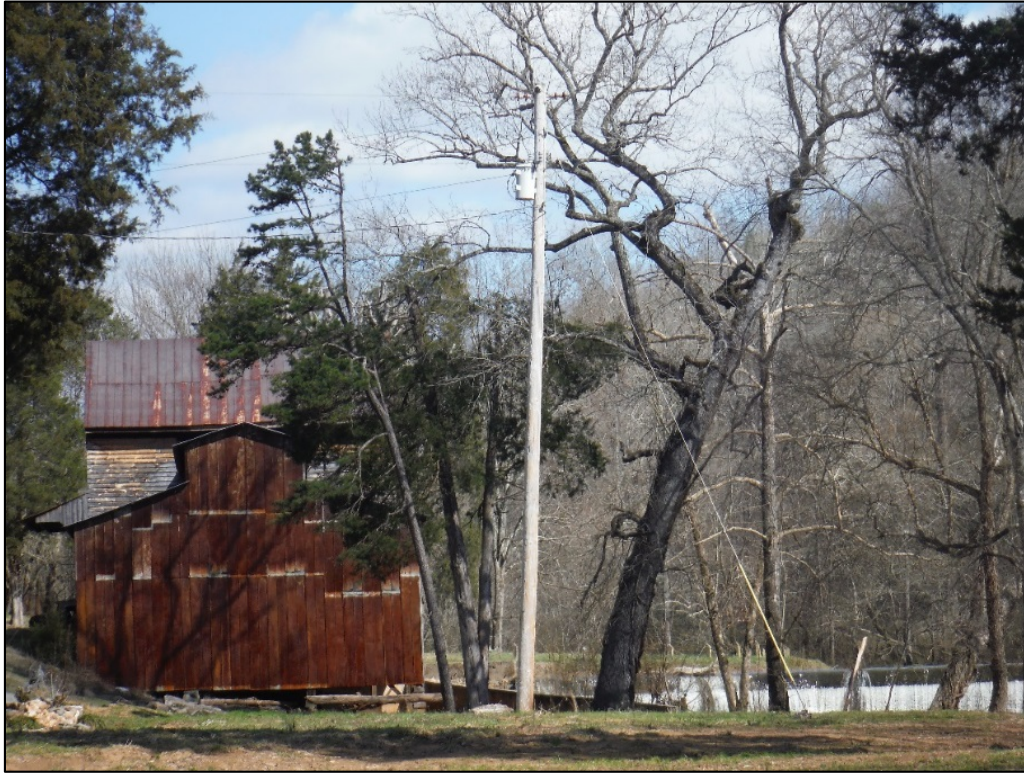
Figure 31. Whitley Mill (ST0432), facing northeast.

The Whitley Mill (ST0432) was the only mill in the adjacent counties that could be photographed during the survey. The mill is a circa-1875 grist mill, located on the bank of Big Bear Creek, southwest of a later concrete dam (Figure 31). The two-and-one-half-story frame structure, built using timber framing techniques, is significantly larger than the McCallum Mill. The Whitley Mill was surveyed and placed on the North Carolina Study list in 1990; it was determined eligible for the NRHP in 2002 (Brook to Gilmore 2002). In contrast to the McCallum Mill, the Whitley Mill retains much of its original form and material, including mill machinery and a horizontal waterwheel.
