#### HISTORIC STRUCTURES SURVEY REPORT

# HENDERSON GROVE CHURCH ROAD RAIL CROSSING CLOSURE AND NEW ACCESS ROAD CITY OF SALISBURY AND ROWAN COUNTY, NORTH CAROLINA

TIP No. Y-5500IA WBS No. 45533.1.4 ER 16-0955

**20 December 2016**

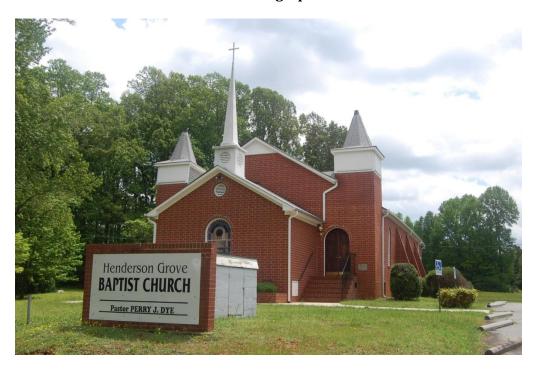
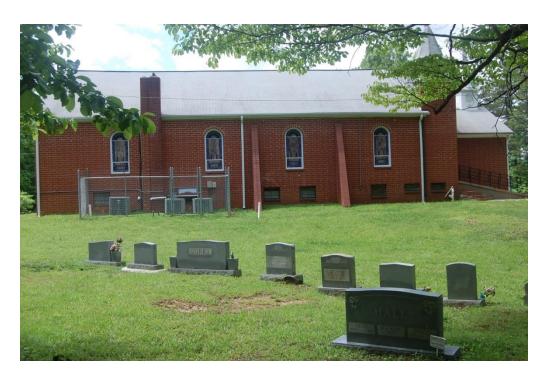
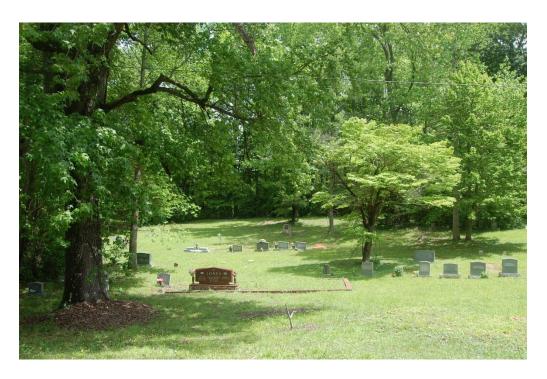
The inscription in the concrete corner block of this African American church states that the church was organized in 1812, and the church building was rebuilt in 1961. However, published studies of Rowan County's cemeteries and African American historic sites record the establishment of this congregation as 1912 which is evidently the correct date.

The original church was probably built initially with the organization of the congregation in 1912 but was rebuilt (or heavily remodeled and expanded) in 1961. The present church has a gablefront main block, veneered in jumbo brick, with flanking, conical-roofed entrance towers and a gable-front wing that projects from the center of the façade. The front wing is capped by a tall steeple. The wing is probably used for additional seating as well as for a Sunday School classroom. The two entrances have round-arched openings with double-leaf, paneled doors. Stylized, brick buttresses define the window bays on the side elevations. The round-arched windows in the sanctuary have stained glass while the basement and rear elevation have steel-sash windows that appear to date to the 1961 remodeling. The principal investigators did not gain access to the interior. However, an online video revealing a portion of the church interior shows pews and other furniture that date to circa 1961. A small, tree-shaded cemetery is located on the north side of the church. Reflecting the organization of this church in 1912, the cemetery primarily contains twentieth-century markers. An overgrown section of the cemetery at the north side of the cemetery may contain additional unmarked graves, but this has not been confirmed. A small, concrete-block pump house and brick sign stand in front church (www.youtube.com/HendersonGrove/PraiseSingers, March 11, 2010; Brown Interview 2016).

Because of a loss of architectural integrity, Henderson Grove Baptist Church is not recommended for National Register eligibility.

No. 1 Henderson Grove Baptist Church, circa 1912, rebuilt circa 1961

No. 1 Henderson Grove Baptist Church, circa 1912, rebuilt circa 1961, Church and Cemetery.

No. 1 Henderson Grove Baptist Church, circa 1912, rebuilt circa 1961, Cemetery.

- 1. The African American church (1) raises questions about whether the residential resources in the southern area of the APE are associated with an African American community. The church was veneered in brick within the historic time period and the report does not address the question of whether the church is an important institution or the building is architecturally significant.

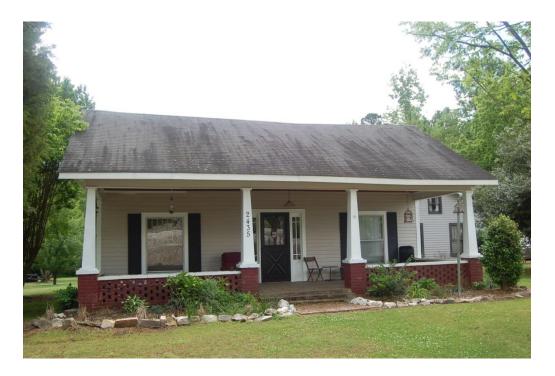
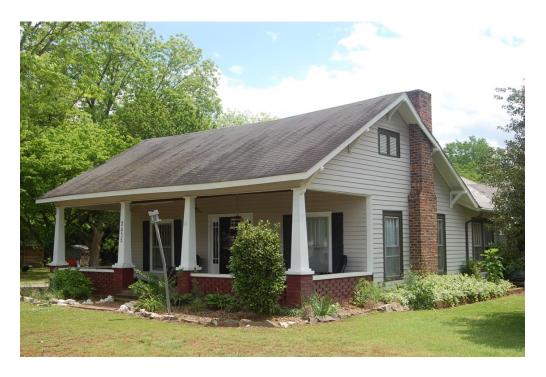
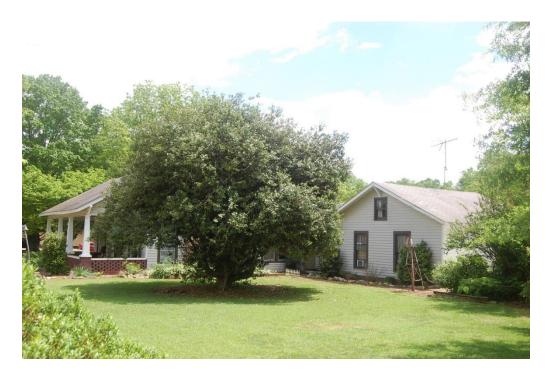
Remodeled and expanded in recent years, this 1920s, frame bungalow has a side-gable roof with broad, bracketed eaves. The three-bay façade is sheltered by an engaged porch supported by battered piers on brick pedestals. An open-work, brick apron spans the pedestals. The house retains its weatherboard siding, a Craftsman-style door with sidelights, and seven-over-one sash windows on the facade. All the other windows are four-over-one sash. The side elevations and rear ell have been vinyl sided, and the variegated brick chimneys are later. The house has a large wing that is attached by an enclosed breezeway to the rear of the side (south) elevation. The wing may have originally been another bungalow that was moved to the site and remodeled as the side addition. Now also vinyl siding, this gable-roofed wing has the characteristic four-over-one sash windows, deep eaves, and a knee-bracket in the gable. The house does not have the integrity to merit National Register eligibility.

No. 2 House, circa 1925.

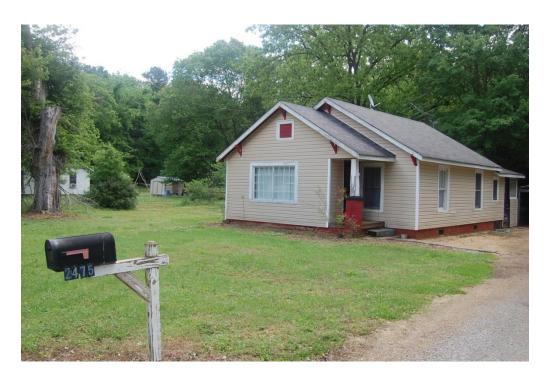
Vinyl siding covers this simple one-story, gable-front bungalow. The 1920s house retains its original inset porch supported by a battered pier set on a brick pedestal as well as some three-overone sash windows and deep eaves with knee brackets. The fixed-light window on the façade is a later replacement. The house lacks the significance and integrity for National Register eligibility.

No. 3 House, circa 1925.

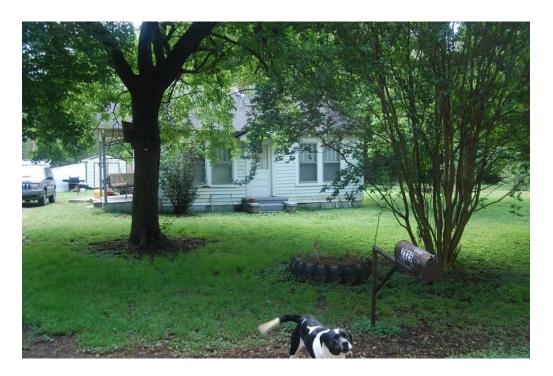
This 1920s, side-gable, double-pile cottage has original German siding and paired, four-over-one sash windows flanking the center entrance. The glazed and horizontal-paneled door is sheltered by a bracketed, gable-front canopy. The side porch is supported by later metal posts. The dwelling lacks architectural and historical significance and is not recommended for National Register eligibility.

No. 4 House, circa 1925.

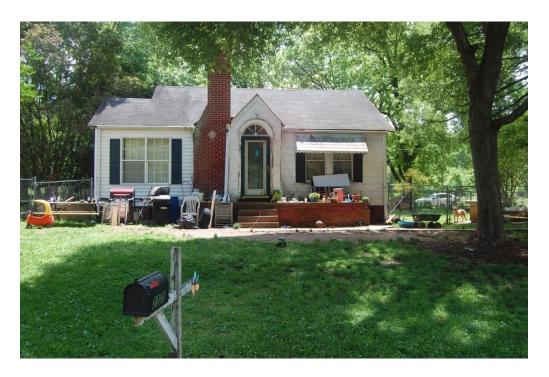
Asbestos shingles and later vinyl siding cover this 1940s, Minimal Traditional dwelling. The one-story, side-gable house has a projecting, gabled entry bay and a brick, front-exterior chimney with a single, stepped shoulder and concrete ornamentation. A fanlight caps the entrance which is flanked by paired windows. Only the six-over-six sash windows in the north bay of the façade are original. Now in deteriorated condition, the house lacks the integrity for National Register eligibility.

No. 5 House, circa 1945.

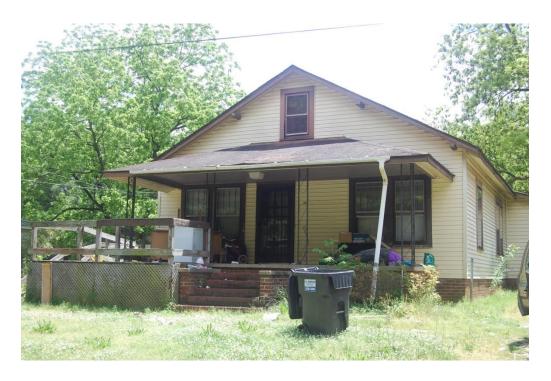
This gable-front, frame, vinyl-sided bungalow has exposed purlins in the eaves and a hip-roofed porch with later metal supports. A later shed-roofed appendage is found at the rear of the south elevation. The four-over-one sash windows are original. The house no longer retains sufficient integrity for National Register eligibility.

No. 6 House, circa 1925.

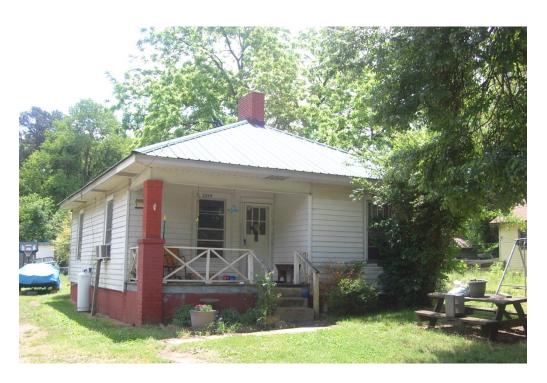
Built in the 1920s, this one-story, hip-roofed, vinyl-sided bungalow has an inset front porch supported by a brick pier set on a brick pedestal. The four-over-one sash windows are original, but the horizontal-sash window next to the entrance is a postwar alteration. There is one interior, brick chimney, and the standing-seam, metal roof is modern. The house lacks the significance and integrity needed for National Register eligibility.

No. 7 House, circa 1925.

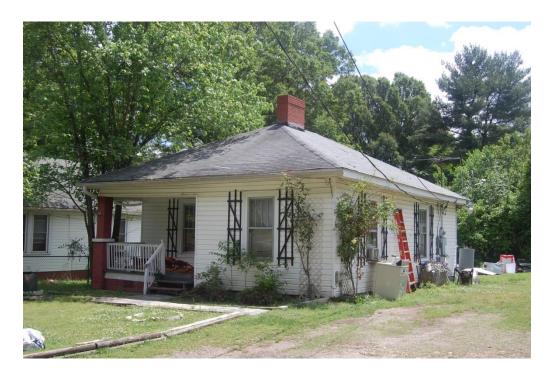
Nearly identical to the neighboring house at 2245 Jacob Bost Road, this hip-roofed, vinyl-sided bungalow has an inset front porch supported by a brick pier set on a brick pedestal, four-over-one windows, and an interior, brick chimney. The house lacks architectural or historical significance and is not recommended for National Register eligibility.

No. 8 House, circa 1925.

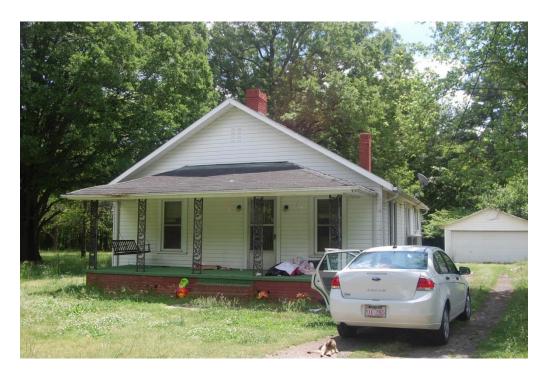
Replacement one-over-one sash windows are found on this 1920s, vinyl-sided, gable-front bungalow. The hip-roofed front porch has later metal supports. The house no longer has the architectural integrity for National Register eligibility.

No. 9 House, circa 1925.

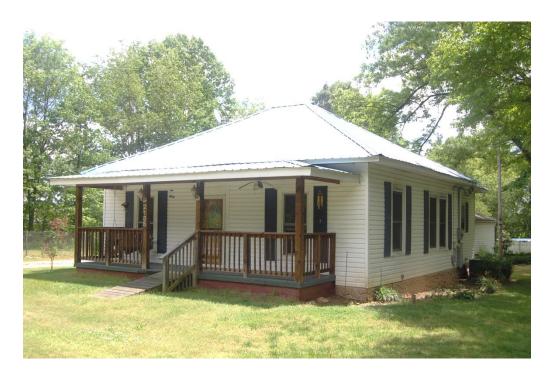
Heavily remodeled, this 1920s, one-story, hip-roofed, double-pile dwelling has replacement oneover-one sash windows and vinyl-siding. The rebuilt, hip-roofed porch has replacement square posts and balustrade. The roofs of the house and porch are covered recently in standing-seam metal. The house no longer has sufficient integrity for National Register eligibility.

No. 10 House, circa 1925.

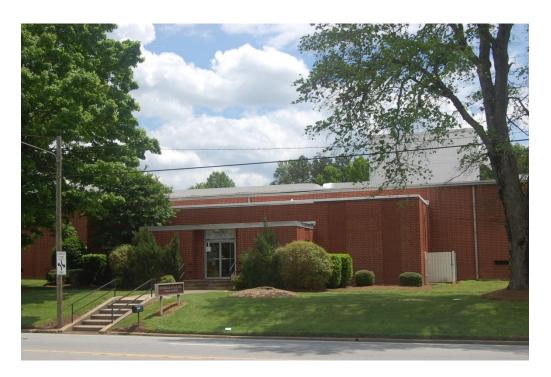
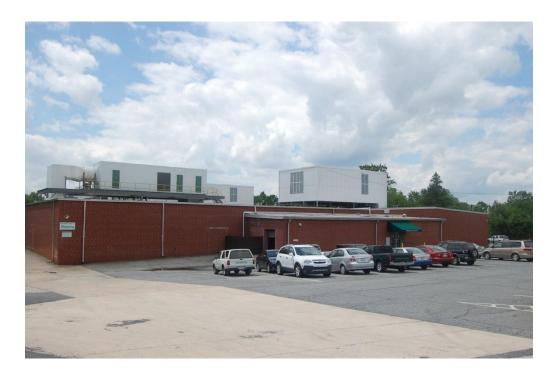
In 1919, the Rowan Cotton Mills Company constructed the core of this long, rectangular, one-story textile manufacturing plant along the southeast side of South Main Street (US 29). The associated mill village, now largely gone, was constructed across the street on the northwest side of South Main, beyond the APE for this project (see RW0737). The plant has undergone a series of renovations and expansions, notably by Parkdale Mills of Gastonia, North Carolina, which acquired the property in the 1950s. The current building largely reflects Parkdale's extensive changes in the postwar period. The long, main elevation facing South Main Street is composed of a windowless, brick façade with slender piers of raised brick defining the bays and a projecting, flat-roofed entrance bay near the center. Veneered with Jumbo brick offset by vertical brick bands, this entry features a recessed doorway with glazed, steel-framed double doors. The postwar changes to the complex were comprehensive, and there is no visible evidence of the original 1919 mill on the exterior. Because of the major renovations, Parkdale Mills, Plant 11 is not recommended for National Register eligibility.

No. 11 Parkdale Mills, Plant 11, 1919, circa 1960.

- 2. The textile mill building (11) was remodeled in the 1960s, within the historic time period. Is this an important mill through the 1960s in Salisbury? Are the nearby houses associated with the mill?

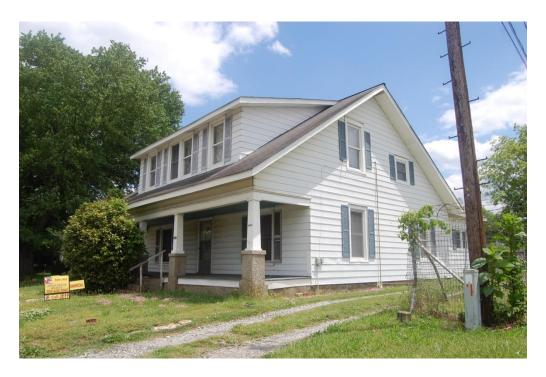
Now covered with aluminum siding, this 1920s, story-and-a-half dwelling reflects a common bungalow design. The side-gable house has broad eaves, an engaged front with battered piers resting on brick pedestals (now stuccoed), and a prominent, shed-roofed dormer. The one-over-one sash windows are replacements. The house no longer has the integrity needed for National Register eligibility.

No. 12 House, circa 1925.

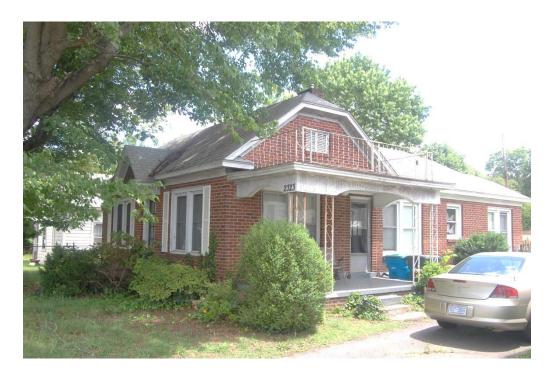
This 1930s, brick-veneered, one-story dwelling has a Jerkinhead roof and gabled entry bay in the center of the three-bay façade. The windows are mainly one-over-one replacements although paired six-over-six sash windows on the side elevations of the main block are original. A flat-roofed porch, with metal supports and roof balustrade, extends from the side (south) elevation. The house has only marginal integrity and lacks the significance needed for National Register eligibility.

No. 13 House, circa 1935.

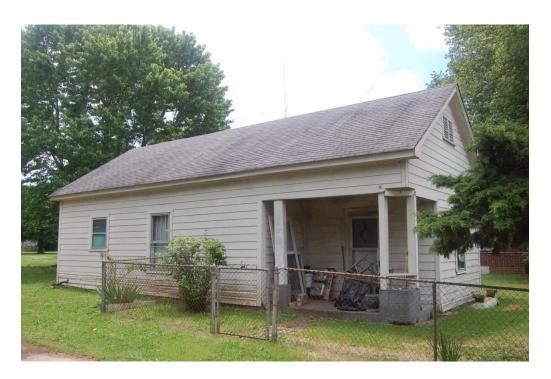
Altered and deteriorated, this 1930s, frame, one-story, gable-front bungalow has an original three-over-one sash window on the north elevation and an inset front porch. The house has later aluminum siding, replacement porch posts, and replacement one-over-one sash windows. The house does not have the integrity needed for National Register eligibility.

No. 14 House, circa 1935.

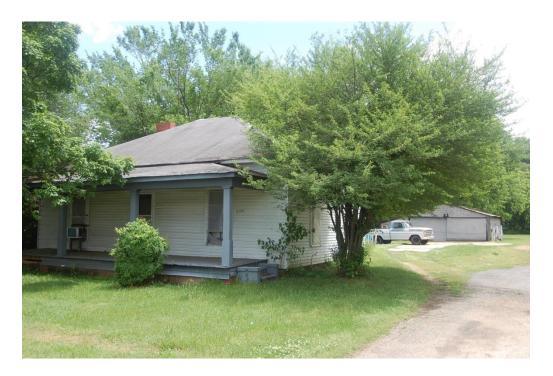
Built in the 1920s, this one-story, hip-roofed, double-pile dwelling has weatherboard siding and six-over-six sash windows. The hip-roofed front porch is supported by box piers. An asbestos-shingled, two-car garage stands behind the dwelling. The property does not have the architectural or historical significance needed for National Register eligibility.

No. 15 House, circa 1925.

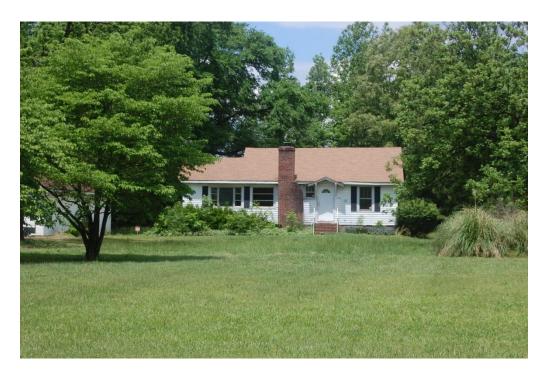
Probably originally built in the 1940s and expanded in the 1960s, this one-story, weatherboarded dwelling consists of a Minimal Traditional main block and what appears to be a later wing on the west elevation. The original block includes a front-exterior, brick chimney, a gabled entry, a three-over-one sash window, and later horizontal-sash windows. The wing has a picture window. The property no longer has the integrity needed for National Register eligibility.

No. 16 House, circa 1925.

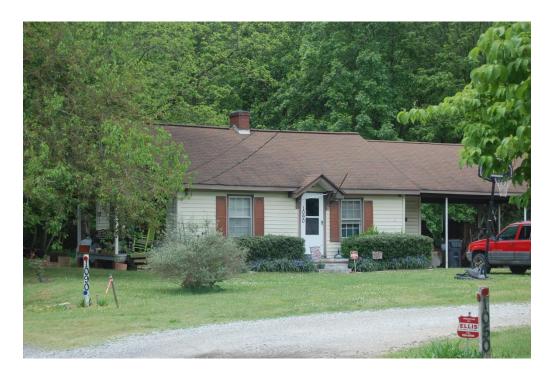
Now vinyl-sided, this one-story, side-gable, three-bay dwelling has a center chimney, six-over-six sash windows, and a carport on the side (north) elevation. On the opposite side is a gable-roofed porch. Built circa 1950, the house lacks the significance and integrity needed for National Register eligibility.

No. 17 House, circa 1950.

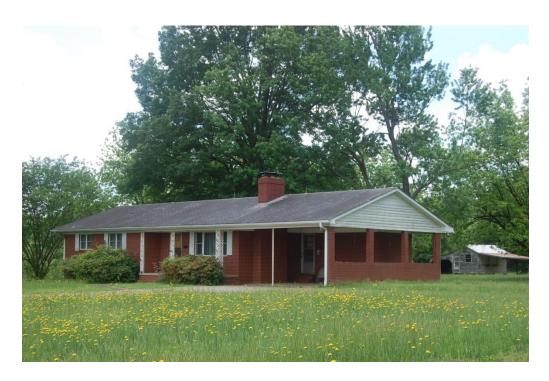
This circa 1960, brick-veneered, side-gable ranch house now has replacement windows. The dwelling has an engaged carport on the side (north) elevation and decorative metal supports that support the engaged porch. A small, weatherboarded, gable-front shed stands behind the house. The property does not have the significance or integrity needed for National Register eligibility.

No. 18 House, circa 1960.

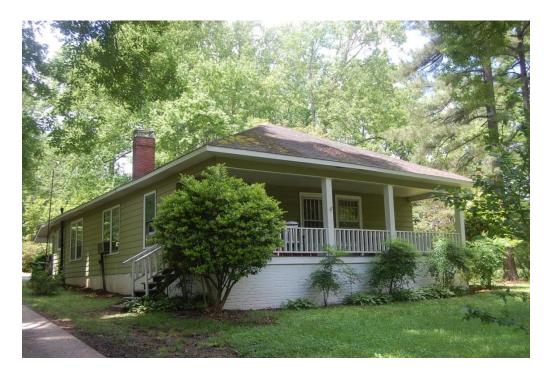
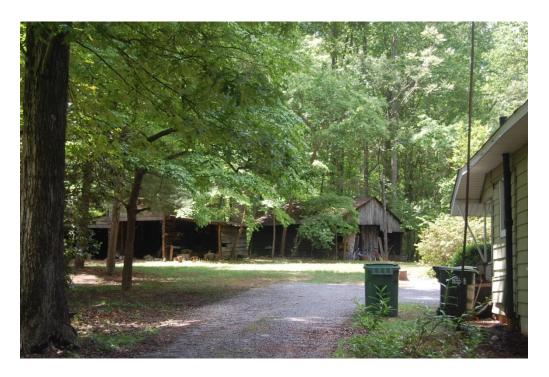
Built in the 1920s, the one-story, hip-roofed bungalow has an engaged porch supported by box piers with a replacement balustrade. Now aluminum sided, the house has original Craftsman-style six-over-one sash windows. Two deteriorated, frame outbuildings stand in woodland behind the house. The property lacks the integrity needed for National Register eligibility.

No. 19 House, circa 1925.

No. 19 House, circa 1925, Outbuildings.

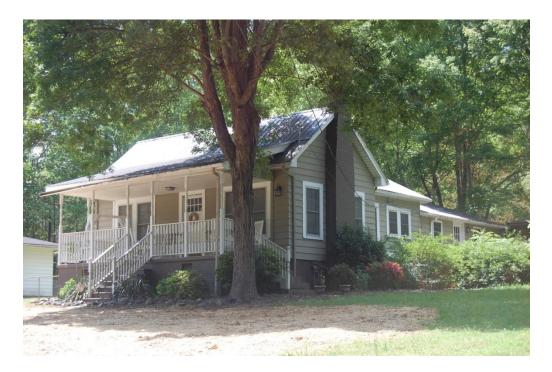
Displaying a traditional form, this one-story, single-pile, three-bay, weatherboarded dwelling has a side-gable roof and a rear ell. There are both single and paired, six-over-six sash windows. The shed-roofed porch has replacement turned posts and balustrade. Built circa 1945, the property does not have the significance needed National Register eligibility.

No. 20 House, circa 1945.

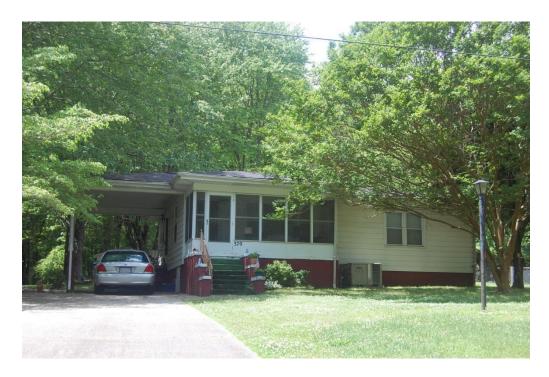
Now heavily remodeled, this frame, one-story, hip-roofed cottage (1920s) has replacement oneover-one sash windows and aluminum siding. Other alterations include an inset porch that has been enclosed and a later, attached carport. Because of this loss of integrity, the house is not recommended for National Register eligibility.

No. 21 House, circa 1925.

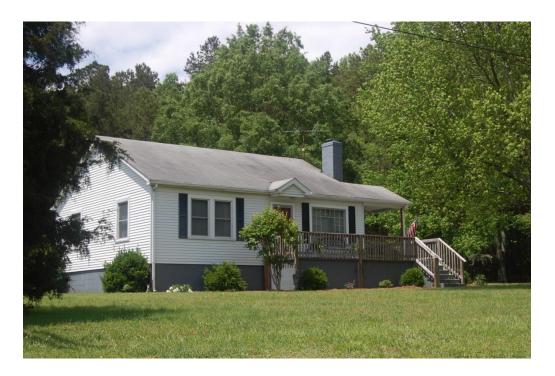
Built in the early 1950s, this one-story, frame, Minimal Traditional dwelling has been heavily altered with replacement windows and vinyl siding. In addition, a deck has been added to the front. There is a gabled canopy over the center entrance, a brick, exterior-end chimney, and an engaged side porch on the north elevation. The house is not recommended for National Register eligibility because of its loss of integrity.

No. 22 House, circa 1950.

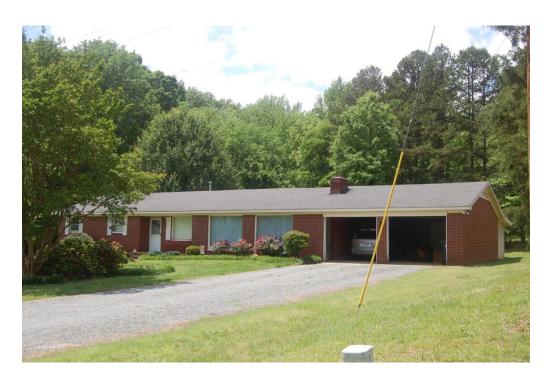
Built circa 1960, this brick-veneered ranch house has a long, side-gable form that includes an engaged, two-car garage on the north side. There are horizontal-sash windows in the south bays, and three fixed-light picture windows in the bays between the recessed entrance and the garage. The two especially large picture windows are later replacements. The house does not have the historical or architectural significance needed for National Register eligibility.

No. 23 House, circa 1960.

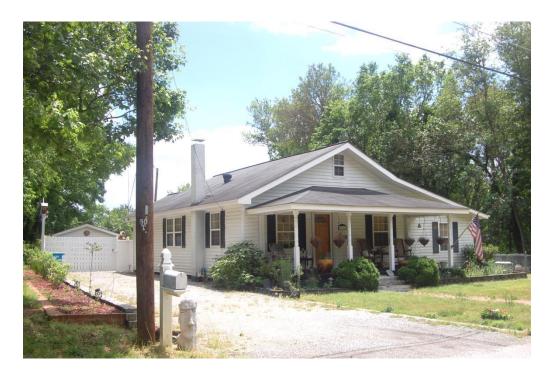
Probably built in the 1920s, this altered, gable-front bungalow now has vinyl siding, modern six-over-six sash windows, a concrete-block chimney flue, and a replacement hip-roofed porch with turned posts. The property includes a gable-front garage. Because of its loss of integrity, the house is not recommended for National Register eligibility.

No. 24 House, circa 1925.

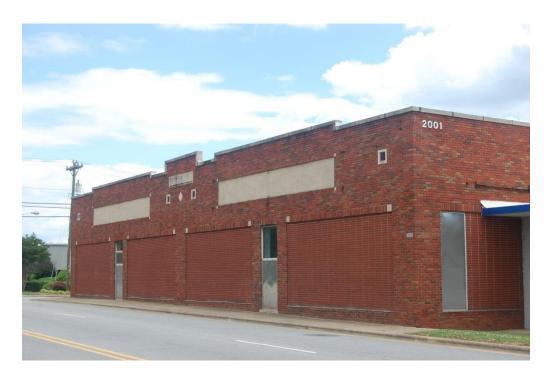
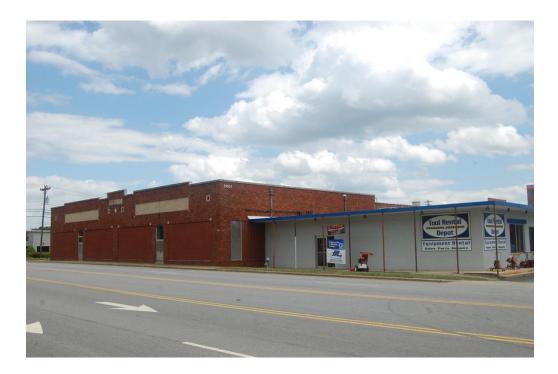
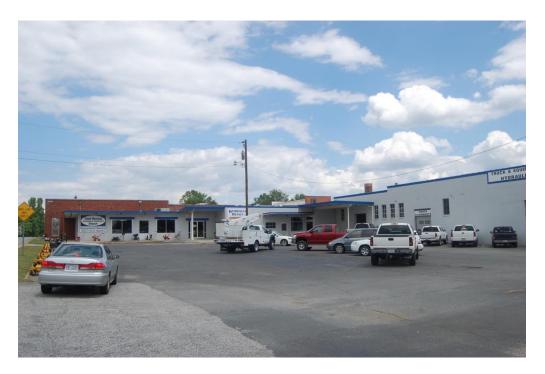
This now sprawling commercial/industrial building is comprised of an original brick building (1929) and an abutting masonry commercial building, with a roughly L-shaped plan, that was erected during the postwar period. As inscribed in the cast-stone name block in the parapet, the original brick factory was constructed as the Brown Building. The Brown Company manufactured industrial and commercial cooling systems. The building is now devoted largely to truck repair and the sale and rental of tools. The one-story, flat-roofed, brick, concrete-block, and metal-sheathed building has been expanded and remodeled over time. The original, 1929 section facing South Main Street retains its variegated-brick exterior, stepped parapet, and cast-stone trim. The large, display windows have been bricked in, and the doorways in the two storefronts have been enclosed. According to the present owner, the building was subsequently expanded in the 1930s, the mid-1950s, the 1960s, and the 1970s. The postwar construction includes a flat-roofed, brick office wing (1966) that is set tangential to South Main Street and abuts the south elevation of the original Brown Building. The roof of the office wing extends out to shelter sidewalks on the west and south sides. The large, brick and concrete-block service building, set back from South Main Street, was built in 1953. This building was subsequently expanded to the rear in the 1960s and to the south with a metal veneer in the 1970s. The interior has been modified in recent years for various offices

and sales and service departments. Because of its alterations and additions, the property no longer has the integrity needed for National Register eligibility.

No. 25 Commercial/Industrial Building, 1929.

No. 25 Commercial/Industrial Building, 1929, 1953-1970s.

No. 25 Commercial/Industrial Building, 1953-1970s.

- 3. Much of the commercial/industrial building (25) also appears to date to the historic time period. If it was a manufacturing building, then the bricked-up windows are not a major loss of integrity. Many mills have been listed in the National Register with bricked-windows. Also, the later addition dating to the 1960s appears to be intact. More contextual information about the 1950-1967 industrial development in Salisbury is needed to evaluate whether this company is of historic significance.
