**Historic Structure Survey Report for the Replacement of Bridge No. 127 on SR 1387  
(Upper Burningtown Road) over Burningtown Creek**

**TIP No. B-5908  
Macon County**

**Mount Sinai Church (MA0334)  
5869 Upper Burningtown Road**

**April 2016**

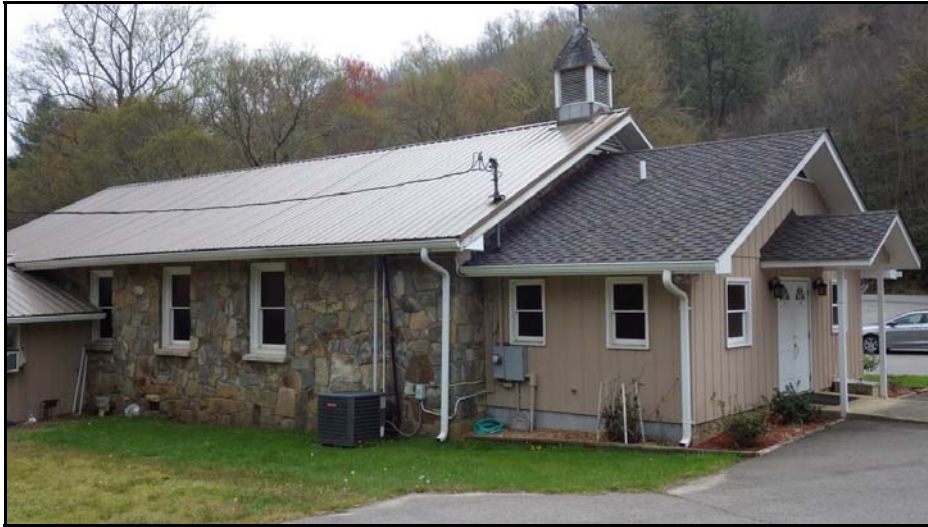
Mount Sinai Church (MA0334), Northwest Oblique

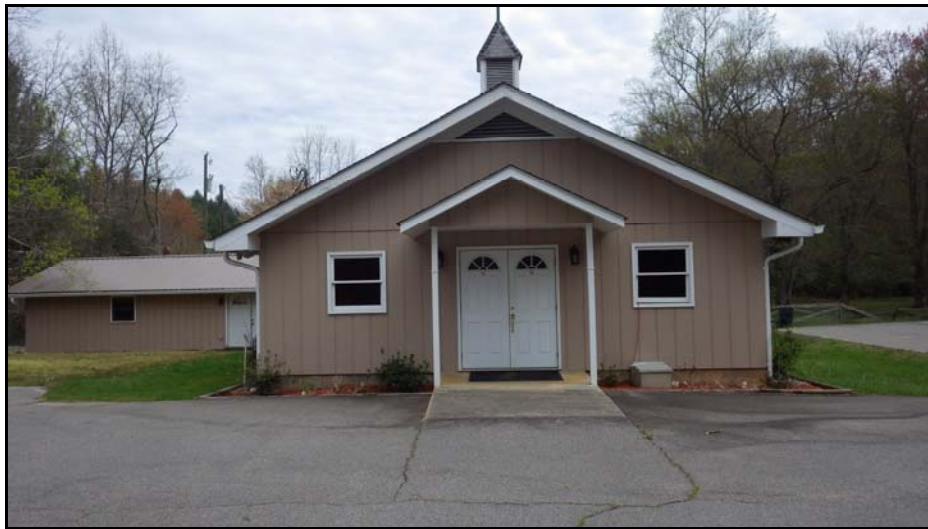
Mount Sinai Church, Façade (West Elevation)

The Mount Sinai Church (MA0334) is a rural, single-nave church with an exterior of uncoursed stone. The front-gable roof is clad in corrugated metal with overhanging, boxed eaves, and triangular wood vents in the gable ends. A c.1970 one-story, gabled addition conceals the original facade (west elevation). The addition is lower than the original building and is covered in vertical fiber board paneling. It sits on a concrete block foundation. Its roof is clad in asphalt shingles. The addition's symmetrical façade is three bays and features a central, double-leaf entry door and one-over-one, double-hung wood sash windows. A small gabled roof supported by square wood posts extends above the door and a concrete slab path. A concrete entry ramp leads to the stoop. A triangular wood vent is located in the gable end of the addition.

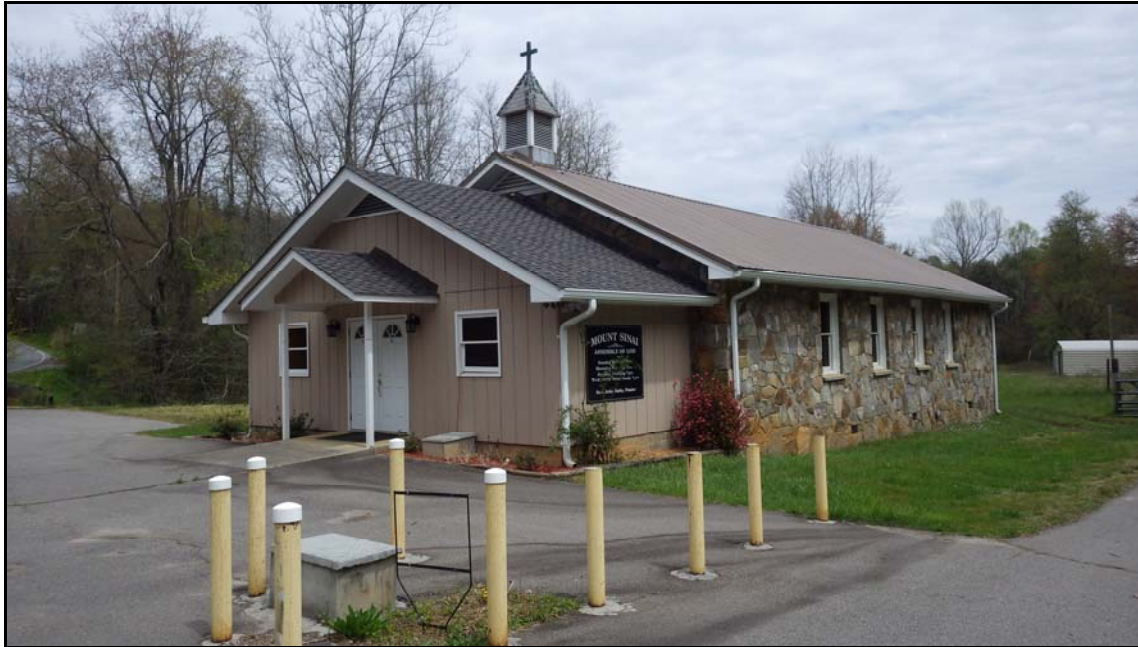
Mount Sinai Church, Southwest Oblique

The original church features four windows on the south elevation and three on the north. The original fourth window on the north elevation is replaced by an interior door leading into a c.1970 wing addition. Windows appear to be original, one-over-one, double-hung wood sash with textured panes. The two windows on the rear of the original massing are recent replacements. A small square cupola with a pyramidal roof straddles the ridgeline of the original massing, includes wood-louvered vents on all sides, and is topped by a small cross. Structural cracking is identified on the exterior of the east elevation.

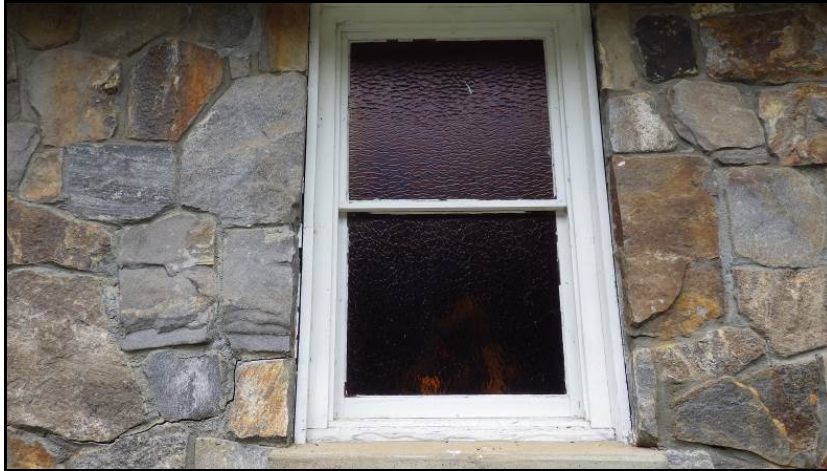
Original, one-over-one, double-hung wood sash window with textured pane

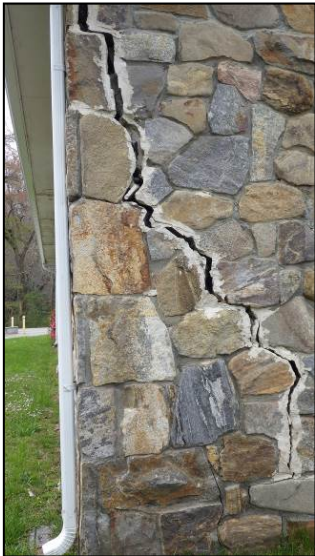
Structural Cracking

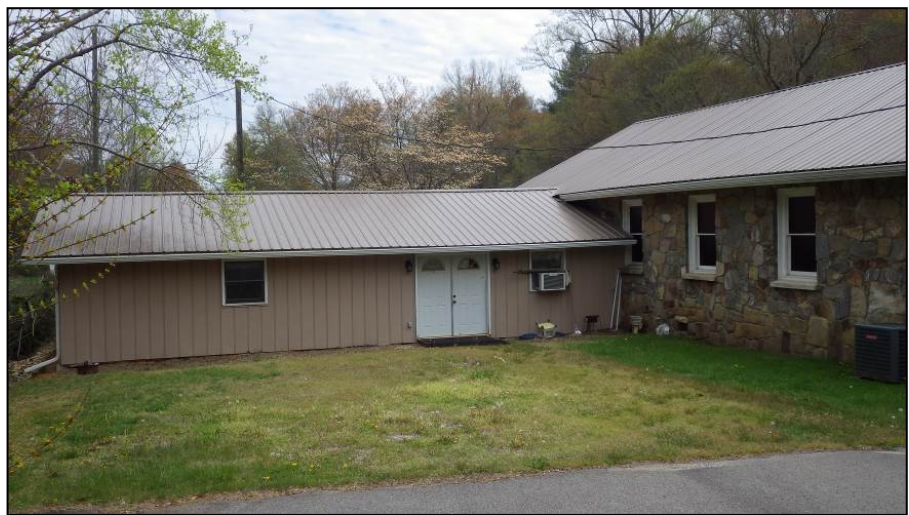
A c.1970 one-story, gabled wing is located at the northwest corner of the building and sits on a concrete block foundation (Photograph 9). The addition creates the present L-shape of the church. Its exterior is clad in vertical paneling and its roof is covered with corrugated metal. Windows are one-over-one, double-hung vinyl sash. A double-leaf, entry door with fanlights is located on the west elevation of the addition. A rectangular wood vent is located in the gable end of the north elevation. Figure 6 provides a general floor plan of the church, including window and door placements, and the c.1970 additions. The interior of the church was not available for inspection. Further, due to the colored, textured glass of the windows, interior visibility was not possible. The following floor plan is based on exterior observations only. However, it is not likely that the single nave interior of the original building is substantially remodeled.

Northeast Addition (c.1970)

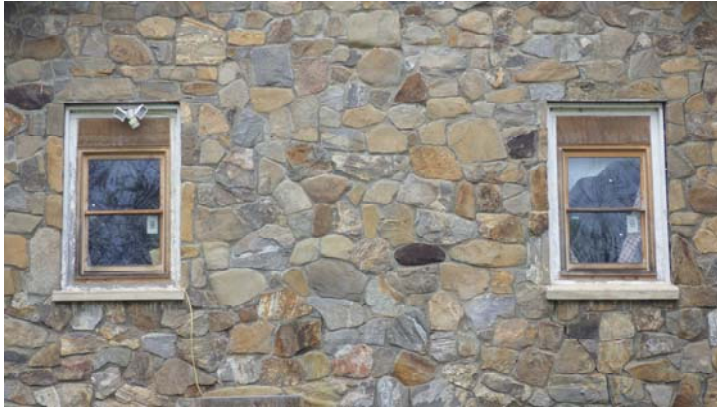
Replacement Windows on the Rear

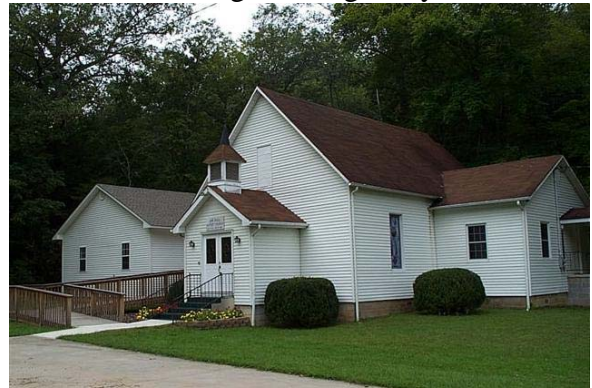
Oakdale Baptist Church (MA0328)

The Oakdale Baptist Church (MA0328) is an early-20<sup>th</sup> century frame, single-nave building with a front gable roof. Small, transept additions extend from the side elevations. Oakdale Baptist Church is located only a half mile east of Mount Sinai Church along Upper Burningtown Road. Characteristic of small, rural churches is a lower, enclosed entry lobby centered on the façade. This particular example features a cupola similar to the one on the Mount Sinai Church. The Oakdale Baptist Church also features stained glass windows. A large, non-historic addition is on the west elevation. Unlike the Mount Sinai Church addition, this large addition does not compromise character-defining elements of an early-20<sup>th</sup> century rural community

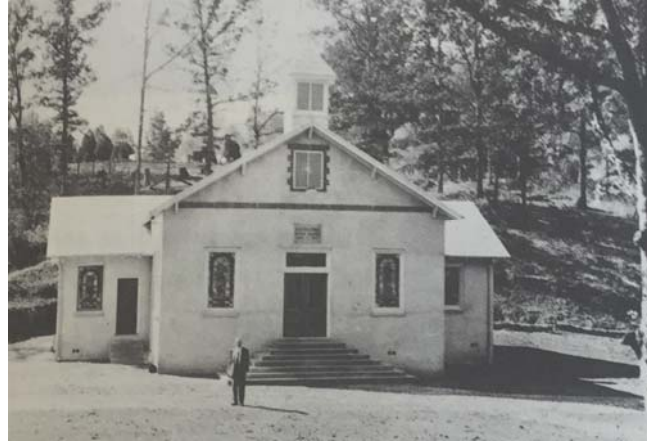
Photograph 1. Burningtown Baptist Church, c.1950  
Source: *Heritage of Macon County*

Burningtown Baptist Church (MA0243) was formed in 1839. Its third, and present church building, was completed in 1949. This stucco-over-concrete block church is a single nave with east and west transepts. The building features a front gable roof topped with a square cupola similar to the one on the Mount Sinai Church. Also featured are decorative stained glass windows. For the most part, the Burningtown Baptist Church retains good integrity with minimal alterations including the front-gabled entry porch and concrete steps. The following photographs reflect the alterations since its construction in 1949. It does not appear to be eligible for listing in the National Register.

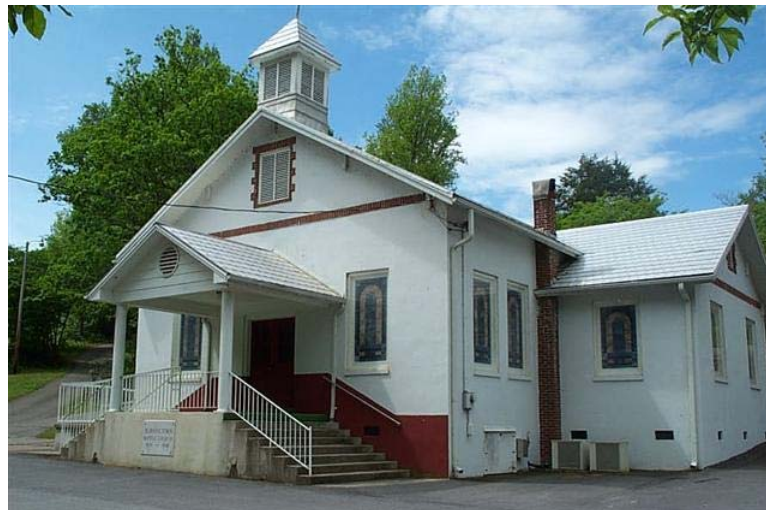
Photograph 2. Burningtown Baptist Church, c.2010  
Source: Macon County Tax Assessor

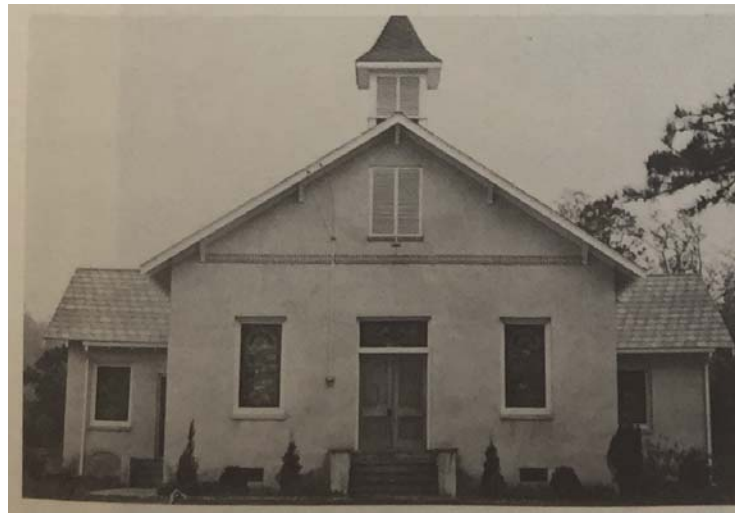
Iotla Methodist Church, c.1950  
Source: *Heritage of Macon County*

c.1895. Its second church building was constructed in 1922 of concrete and brick. Unfortunately, it was destroyed by fire in 1943. The present church building was built in 1947 in a very similar design as the Burningtown Baptist Church, constructed two years later (Photograph 13). The original church was a single nave, front-gabled building with side transepts and an exterior of stucco-over-masonry. In 1963, a vestibule was added to the façade (Photograph 14). That same year, carpeting was applied to the interior, and in 1984, the foundation was laid for a Fellowship Building.<sup>6</sup> Due to additions and alterations, the church does not appear to possess historic or architectural distinction.

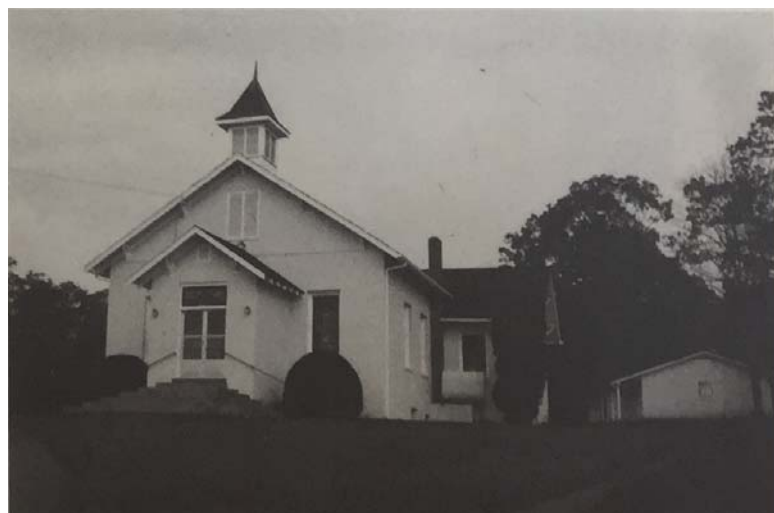
Iotla Methodist Church, c.1985  
Source: *Heritage of Macon County*
