SUBJECT: Historic Structures Survey Report, Replace Bridge 25 on SR 2033 over Buffalo Road,
B-5845, PA 16-01-0066, Cleveland County, ER 16-1423

**Historic Structures Report
Replace Bridge No. 25 on SR 2033 (Oak
Grove Road) over Buffalo Creek
TIP# B-5845
Cleveland County, North Carolina**

S&ME Project No. 4213-16-143

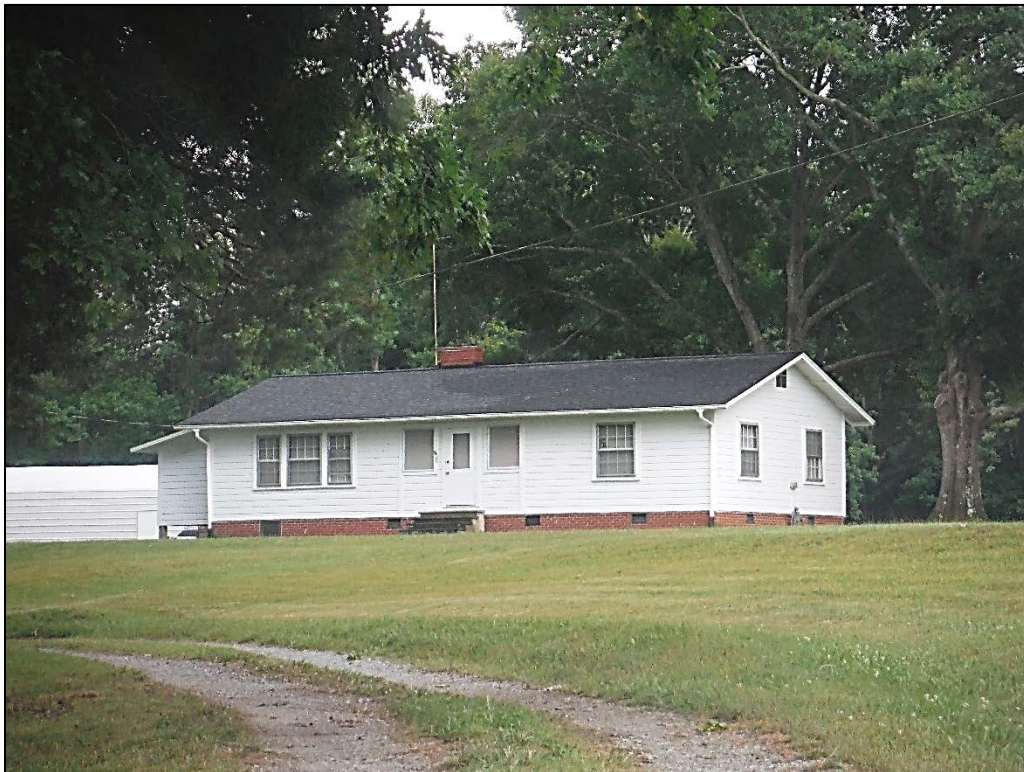
Figure 8. View of the Freemon & Marie Cash House, facing south.

The Freemon & Marie Cash House is a single story, frame structure with a side gabled roof (Figure 8). The building rests on a brick foundation that has evenly spaced vents and a crawlspace access. The front elevation is three bays wide, with a central entry door; the central bay is outlined with square molding and has a single pane casement window on either side of the door, suggesting that an original inset porch may have been altered to create a flush entrance. West of the central entrance is a single eight-over-eight double-hung sash window and east of the entrance is a triple window, consisting of an eight-over-eight double-hung sash flanked by a six-over-six double-hung sash on either side (Figure 10). The house is two bays deep and the west elevation has symmetrical six-over-six double-hung sash windows and an attic vent centered within the gable (Figures 10 and 11). The rear elevation has a mixture of fenestration; from west to east it consists of a six-over-six double-hung sash window, an eight-over-eight double-hung sash window, a small six-over-six double-hung sash window, and a pair of small six-over-six double-hung sash windows (Figures 12 and 13). The east elevation has a shed-roofed porch, which has been enclosed, that has a rear entry door and six single-pane casement windows; the porch sits on a concrete and brick pier foundation (Figure 13–15). The house is covered with horizontal wooden siding. The roof, which has a wide eave overhang and visible ribs along the gable ends, is covered with composition shingles. A central brick chimney is visible above the roofline. Interior access to the structure was not possible, as attempts to contact the owners went without response; however, the 1998 survey file indicates that the house had been extensively remodeled at that time.

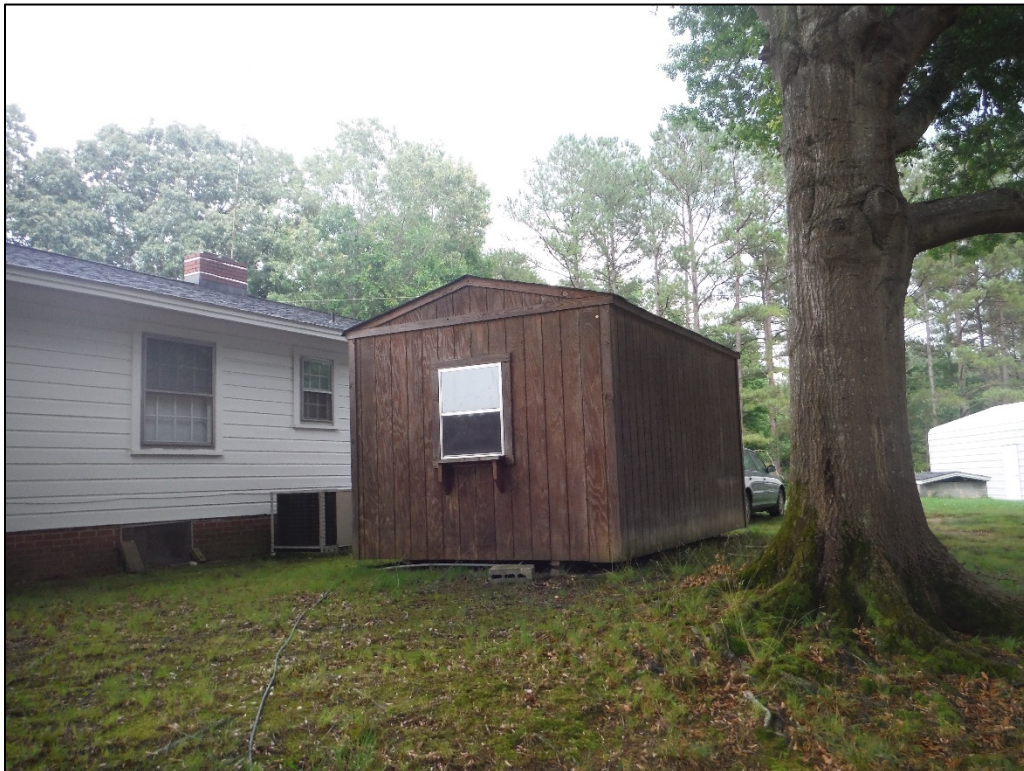
Located southwest of the Freemon & Marie Cash House is a small, wooden, gable-roofed shed that dates to the late twentieth century (Figure 16). Southeast of the house is a collection of outbuildings that range in date from around 1953 through the twenty-first century. At the southern terminus of the driveway, near the house, there is a low-profile, gable-roofed concrete wellhouse from the late-twentieth century and a gable-roofed metal carport from the twenty-first century (Figure 17). Southwest of the carport is a wooden-frame chicken house, built in 1953, which sits on a concrete pier foundation (Figure 18). The chicken house has a shed roof, which is covered with standing seam metal, and horizontal wooden siding; the north elevation has an entry door with six-pane glass on the upper half, while the south elevation has a six-over-six, double-hung sash window and the east elevation has a two-pane horizontal sliding window. South of the carport is a circa-1953 granary, which is currently being used as storage and a garage (Figure 19). It is a gable-roofed, wooden frame structure with horizontal wooden siding. There is a central entry door, which is reached via concrete steps. Either side of the main structure has a shed-roofed extension; the roof of the entire structure is covered with composition shingles. South of the granary, within a grove of trees, is a circa-1965 tractor shed and circa-1953 mule barn (Figure 20). The tractor shed is a wood-framed structure, with vertical seam metal panels covering it; it has a shed roof that is covered with standing-seam metal (Figure 21). The mule barn is a large, front-gabled wooden structure that sits on a concrete pier foundation (Figure 22). It has a large, central clipped gable opening, which spans the entire length of the barn. The mule barn is covered with horizontal wooden siding and has a standing seam metal roof, with visible rafter tails (Figure 23).

Figure 16. View of the late-twentieth century shed on the Freemon & Marie Cash House property, facing east.

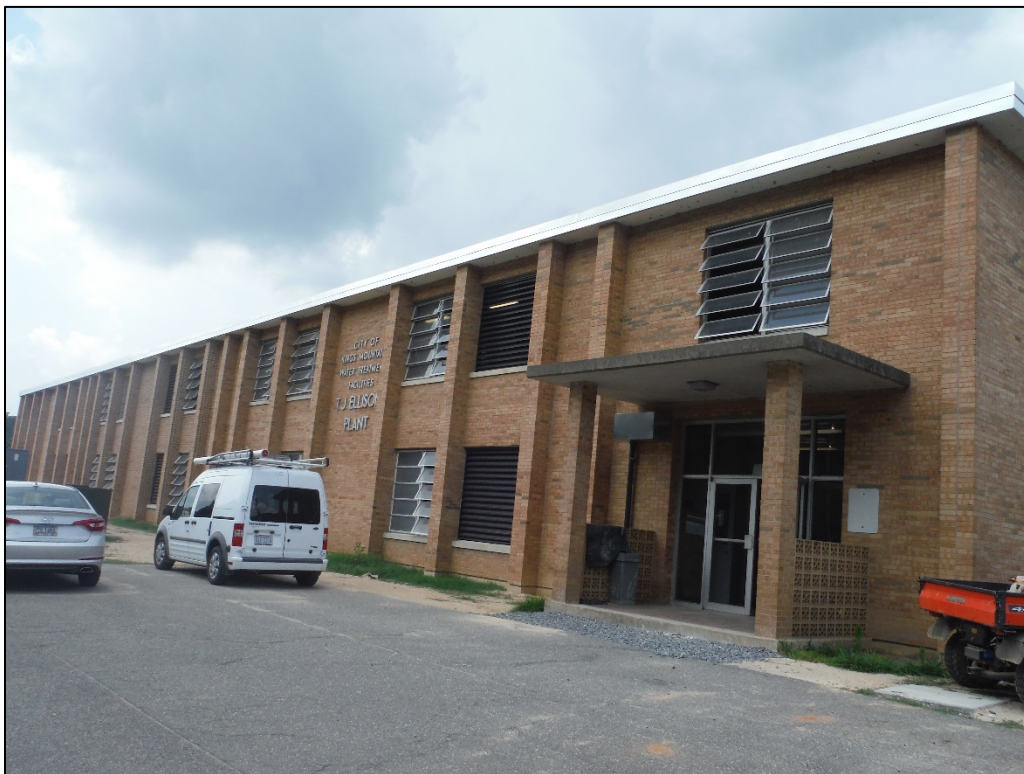
Figure 27. View of the T. J. Ellison Water Treatment Facility, facing northwest.

The T. J. Ellison Water Treatment Facility (PIN 2566741313) is located north of SR 2033, east of Buffalo Creek, between Shelby and Kings Mountain. The facility consists of a large two-story treatment plant and office building with attached treatment and settlement basins, raw water pumps, a sludge building, a pump building, four storage tanks, a storage building, a carport, and an electrical building (Figures 27 and 28).

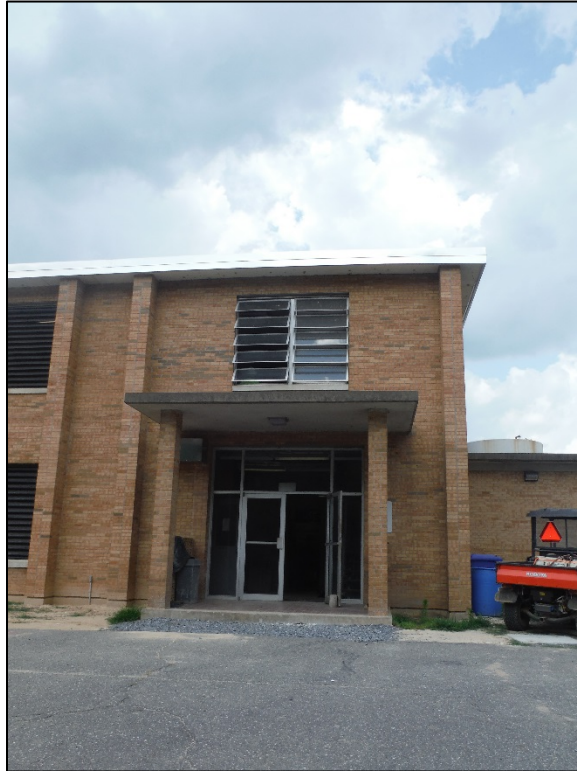
The east elevation of the office and treatment building has a single-story, brick extension which has a garage-door entry way and a flat roof. Fenestration on this elevation are three-pane, tilting windows arranged in groups of three (Figure 33). The west elevation of the structure is currently under construction, but appears to have a single large window opening on the second story (Figure 34). The north elevation has a large, raised, concrete pad that contains the settlement basins; there are 24 rectangular basins, consisting of four columns of six basins, located behind both 1970s portions of the plant. The new portion of the plant has a concrete walkway that connects to the bank of basins (Figures 35–38). Each portion of the building that corresponds to a unique building episode (1971, 1978, and current) has a central door, flanked by large glass-block windows.

Figure 29. View of the entry bay of the T. J. Ellison Water Treatment Facility, facing north.

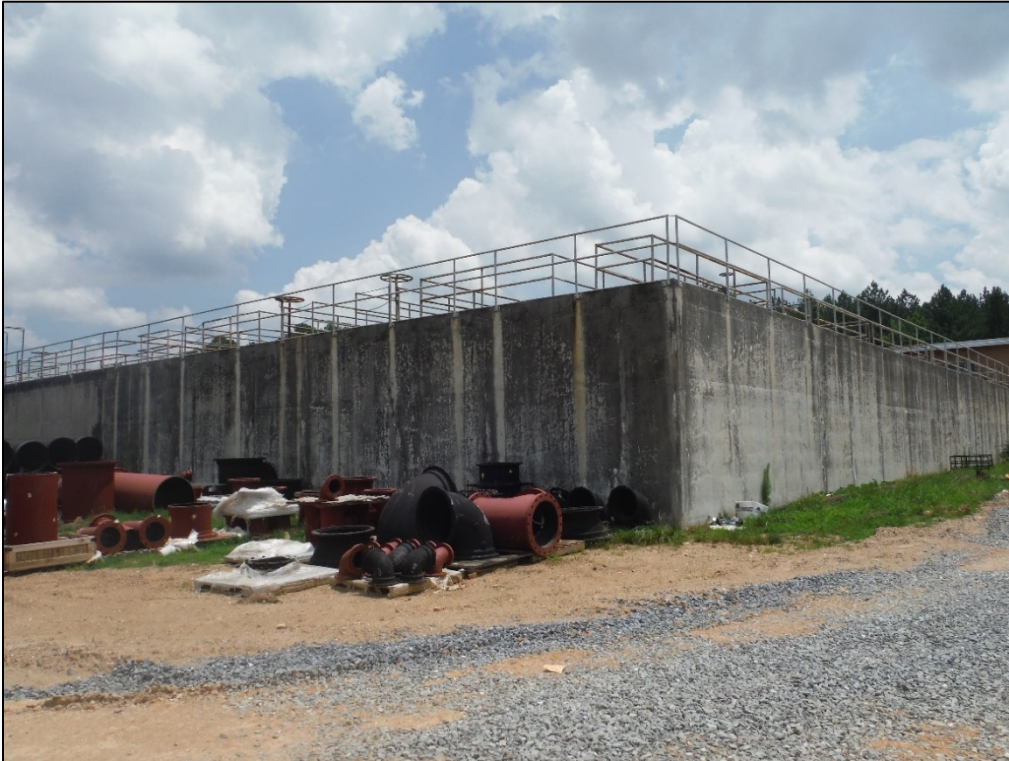
Figure 36. View of the office and treatment building at the T. J. Ellison Water Treatment Facility, basins on rear elevation, facing southeast

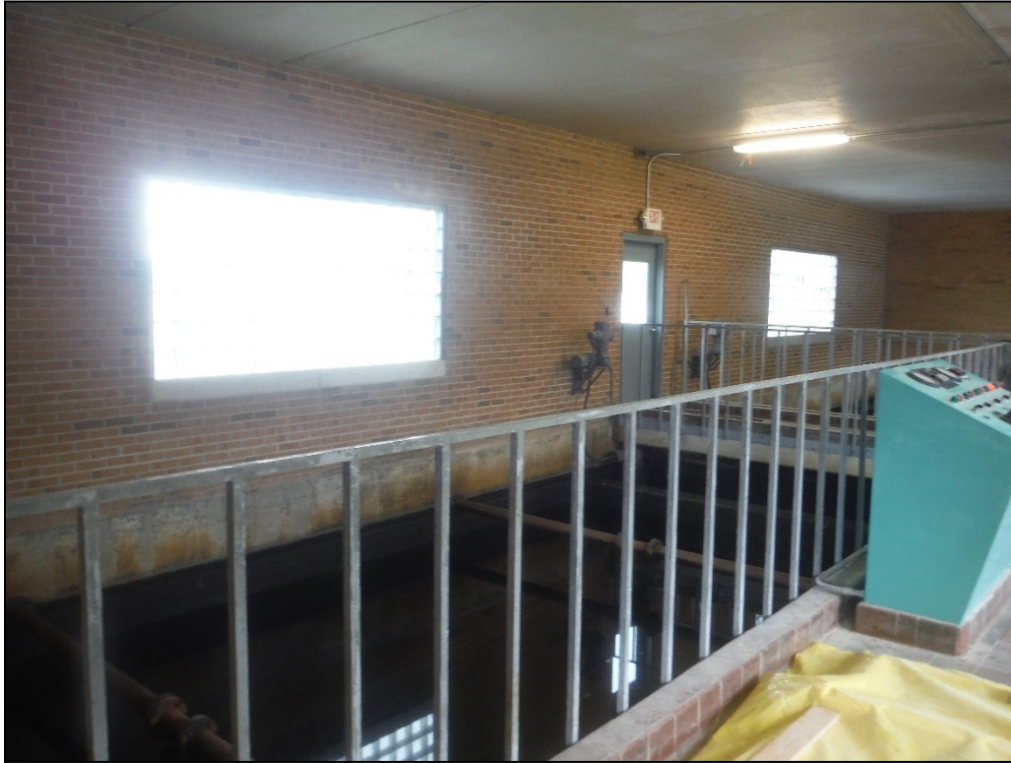
Figure 42. View of the interior basins, second story of the office and treatment building at the T. J. Ellison Water Treatment Facility.

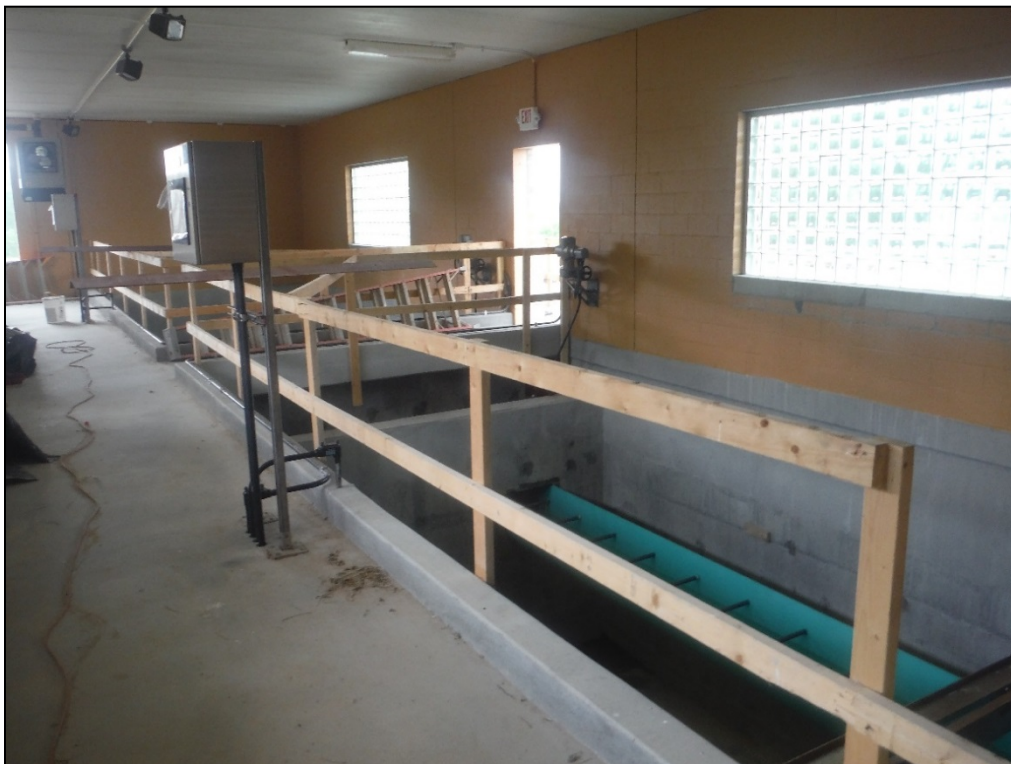
Figure 43. View of the interior basins, second story of the office and treatment building at the T. J. Ellison Water Treatment Facility.

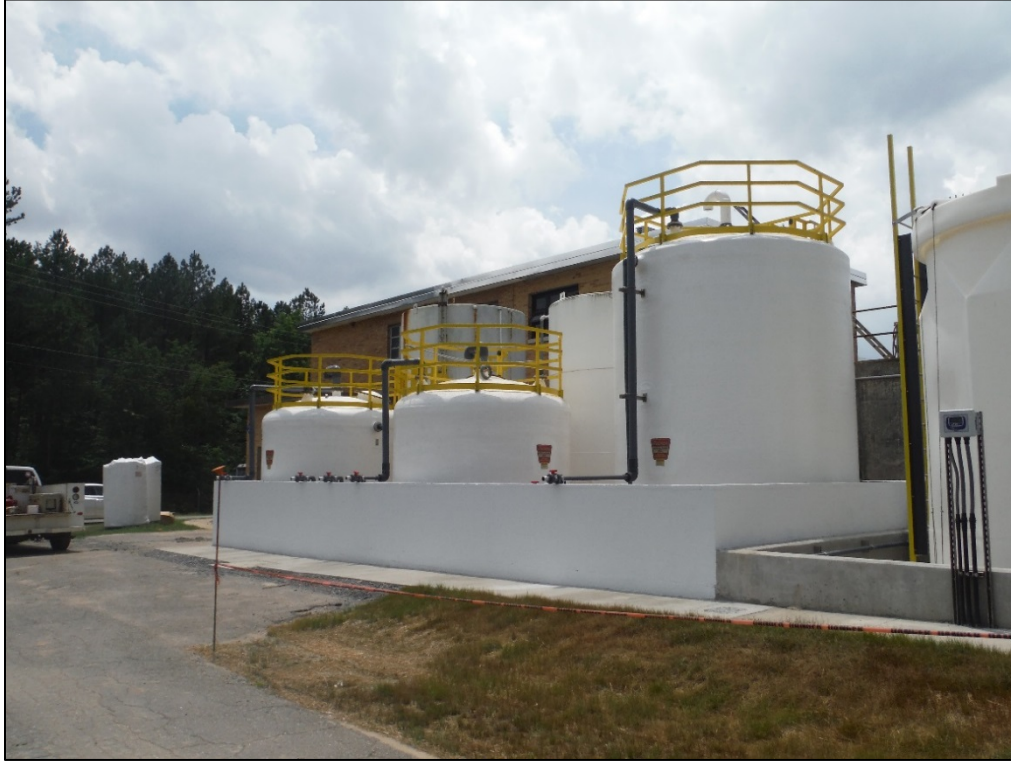
East of the office and treatment building is a series of modern plastic tanks, which hold a variety of substances and chemicals used at the plant (Figure 47). North of the building, protruding into the John H. Moss Lake, is a metal pier that holds the raw water pumps (Figure 48). West of the office and treatment building are two metal structures – a storage shed and a carport – both dating to the late-twentieth century. The construction at the site has brought a number of construction and supply trailers onto the facility land, which take up much of the land and parking lot behind the main building (Figures 37 and 49). At the western edge of the parcel, down a hill from the office and treatment building, are four water storage tanks, two of which are open and two of which are enclosed (Figures 50–52). The southwest corner of the parcel has a single-story, flat-roofed pump building which is covered with brick veneer; the pump building has two entry doors on its front elevation, a single door and a double door, and a five-pane tilting window and exhaust system on the north elevation (Figure 53). Part of the current construction is adding new pumps to the facility, which are located east of the pump building, along with a compression tank; these new pumps will make the current pump building obsolete (Figure 54). Between the tanks and the main building is a small, single-story brick building with a flat roof. This building, which is known as the sludge building, is where the sediment that is filtered out of the water is loaded onto trucks. It has a double front entry door on the east elevation and a metal chute system to deposit the sludge onto trucks on the north elevation (Figure 55). In front of the office and treatment building is a small, brick electrical building (Figure 56). The John H. Moss Lake, to the north and east, was formed by the damming of Buffalo Creek with a concrete dam to the west of the T. J. Ellison Water Treatment Facility. Although not officially part of the water treatment facility property, the reservoir formed by the dam is where the raw water that is pumped to the plant originates from (Figure 57).

Figure 47. View of the modern plastic tanks at the T. J. Ellison Water Treatment Facility, facing southwest.

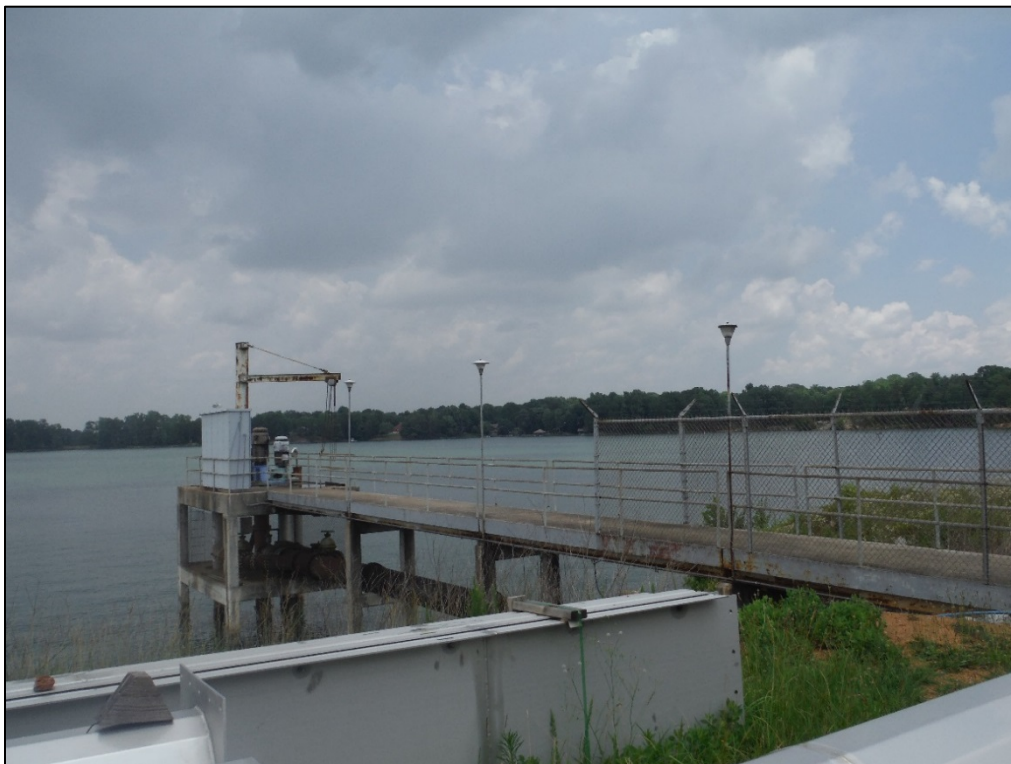
Figure 48. View of the raw water pumps at the T. J. Ellison Water Treatment Facility, facing north.

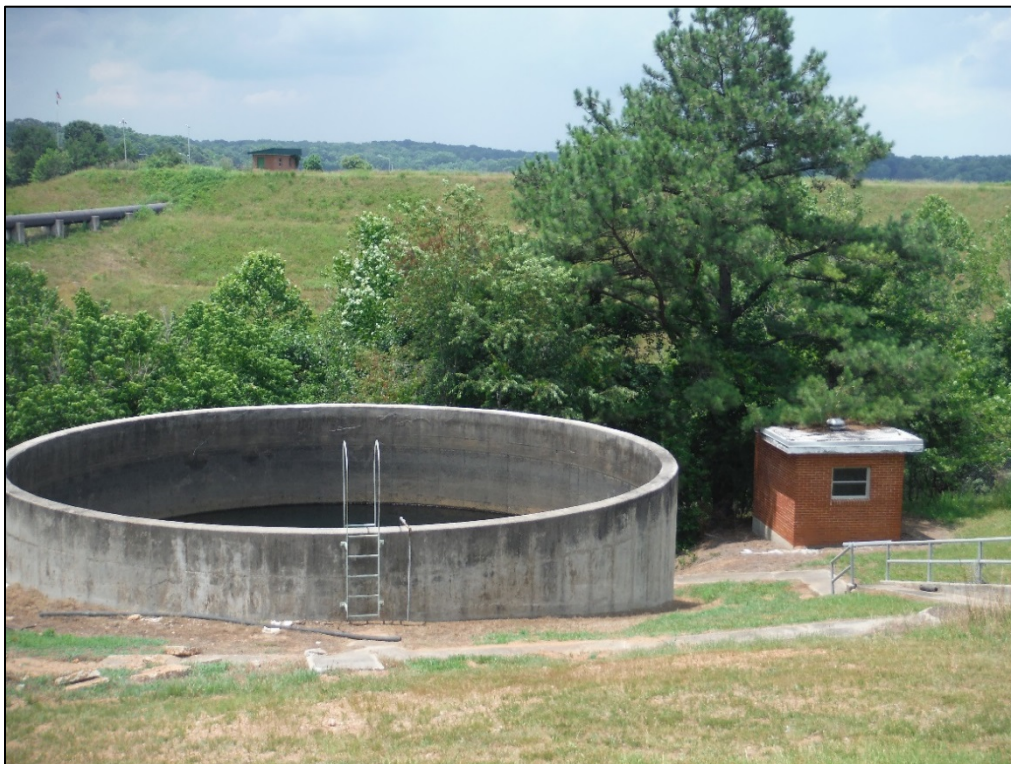
Figure 50. View of one holding tank at the T. J. Ellison Water Treatment Facility, facing west.

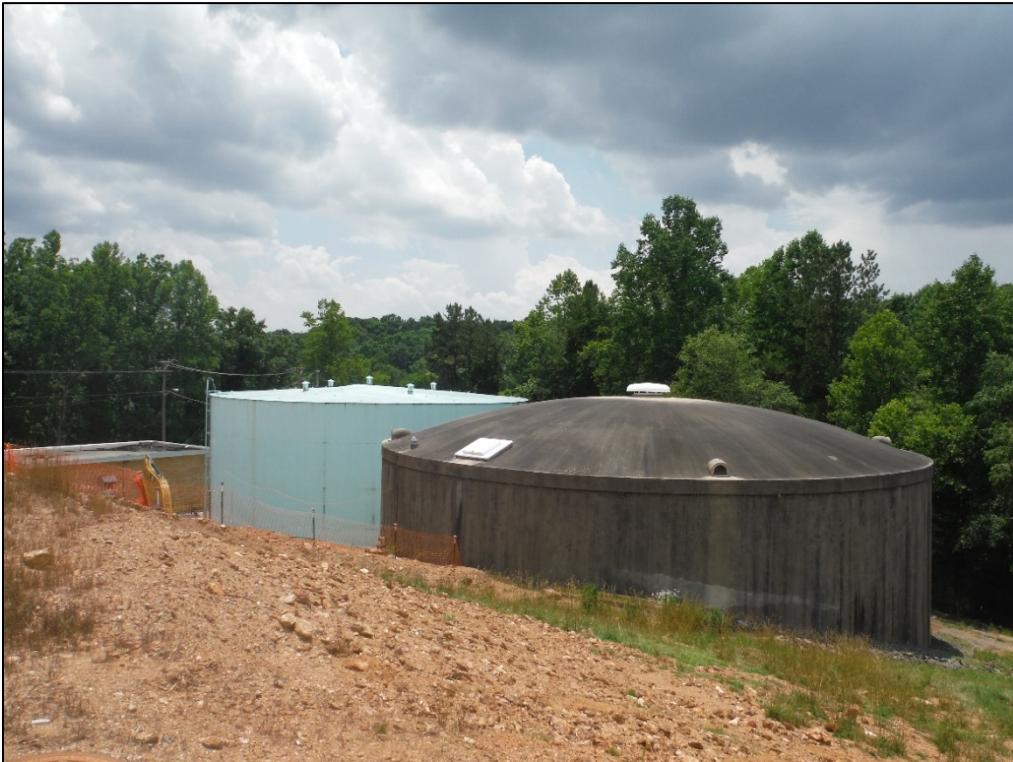
Figure 52. View of two holding tanks at the T. J. Ellison Water Treatment Facility, facing southwest.

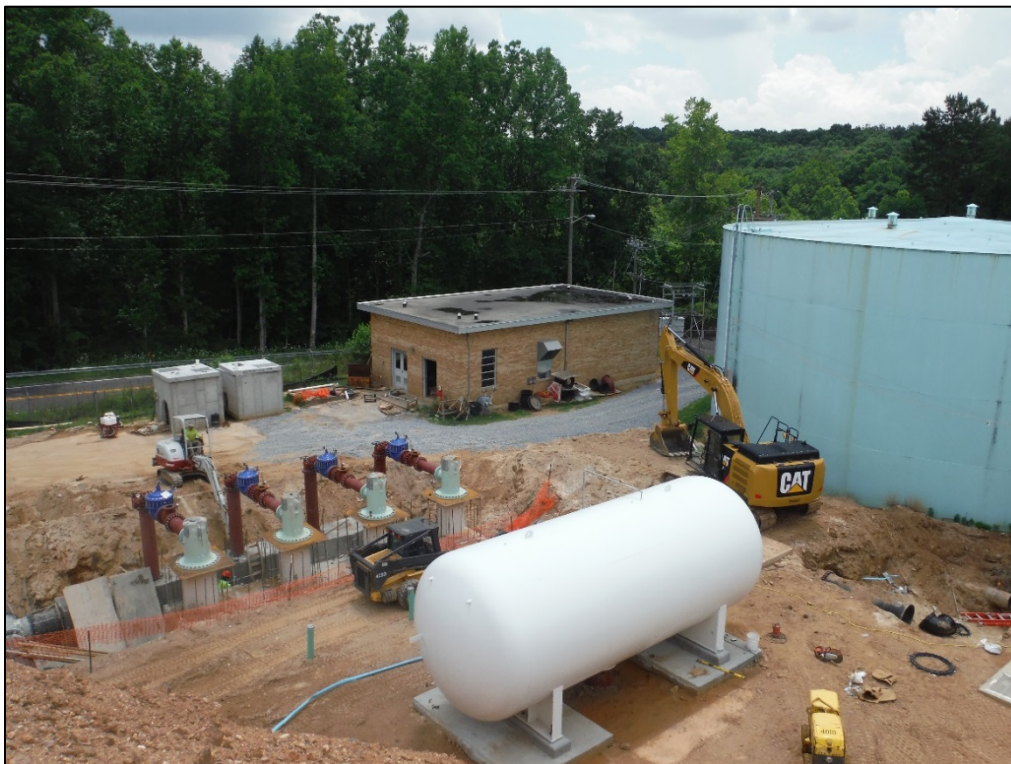
Figure 54. View of the pump building and new pumps at the T. J. Ellison Water Treatment Facility, facing southwest.

The T. J. Ellison Water Treatment Facility retains much of the original exterior workmanship. Finishes and details, both interior and exterior, remain the same as when the facility was built in the 1970s. Modern additions to the plant have altered some of the workmanship on the office and treatment building and the pump building, as original equipment is being replaced with modern equivalents.

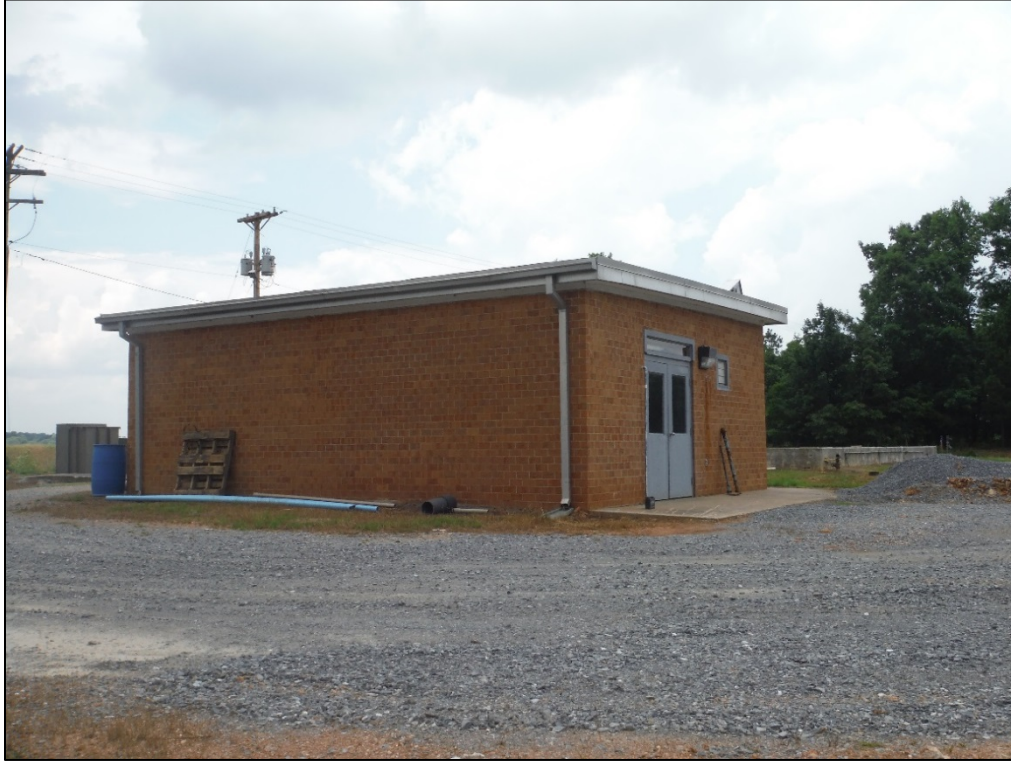
Figure 55. View of the sludge building at the T. J. Ellison Water Treatment Facility, facing northwest.

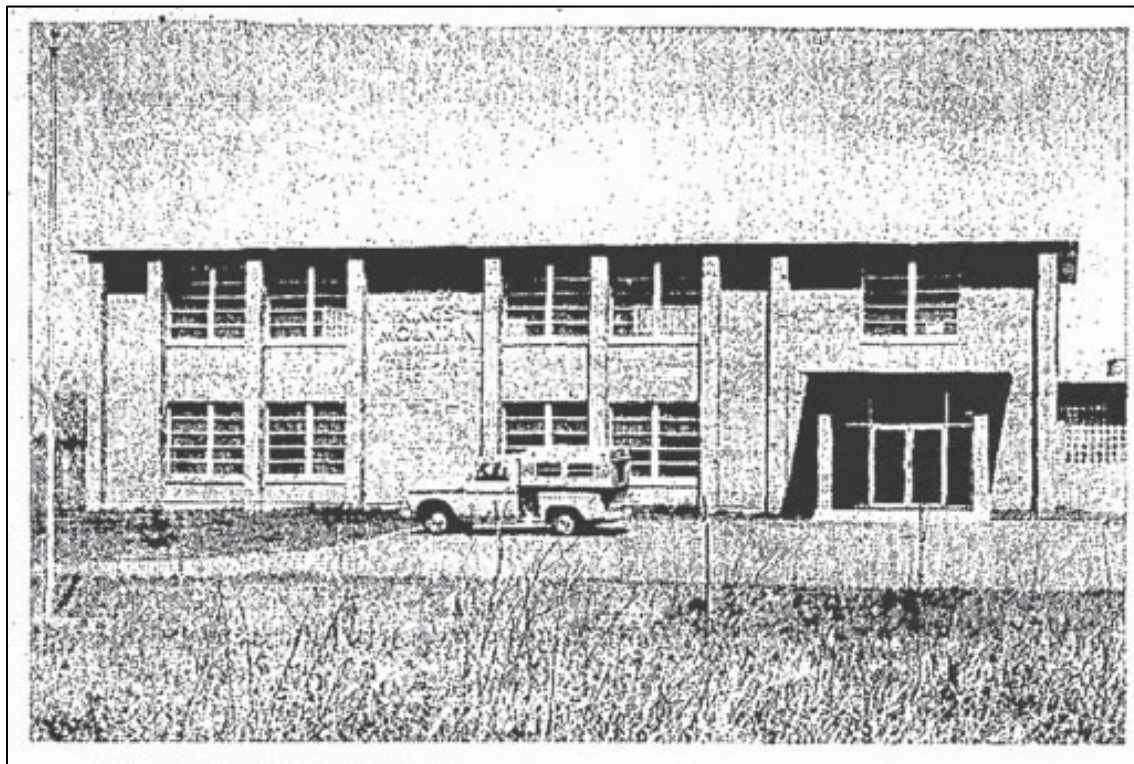
Construction on the project began on March 19, 1969, as clearing of the land commenced (*Kings Mountain Herald* 20 March 1969). The priority for construction was to complete the water treatment facility first, even if the dam and reservoir could not be completed until later in the project timeline; construction on the plant itself began in July 1969 and construction on the dam began in March 1970 (*Kings Mountain Herald* 20 March 1969; 17 July 1969; 12 March 1970). Initial estimates had the completion of the plant slated for March 1970 and, despite the dam and reservoir not being completed, the engineers planned to pump raw water from Buffalo Creek to the plant (*Kings Mountain Herald* 11 September 1969; 1 January 1970; 12 March 1970). Heavy rains and the potential for flooding along Buffalo Creek in August 1970 threatened the uncompleted dam, but the plant was unharmed (*Kings Mountain Herald* 13 August 1970). A trial run of the plant was set for September 1970 and the official planned opening was October 1, 1970 (*Kings Mountain Herald* 3 September 1970; 10 September 1970). Ultimately, the facility was completed and ready for state and federal inspections by April 1971 (*Kings Mountain Herald* 8 April 1971), more than a full year after the original expected completion date (Figure 58).

Figure 58. Photograph of the original portion of the T. J. Ellison Water Treatment Facility building (*Gastonia Gazette* 1 April 1973).
