SUBJECT: Historic Structures Survey Report, Replacement Bridge 140 on SR 1138 over the
Dan River, B-5716, PA 16-01-0087, Rockingham County, ER 16-1529

HISTORIC ARCHITECTURAL RESOURCE REPORT INTENSIVE EVALUATION FOR THE PINE HALL BRICK PLANT

Replace Bridge No.140 over Dan River on SR 1138 (Lindsay Bridge Road)
Rockingham County
WBS# 45672.1.1
B-5716

AUGUST 2016

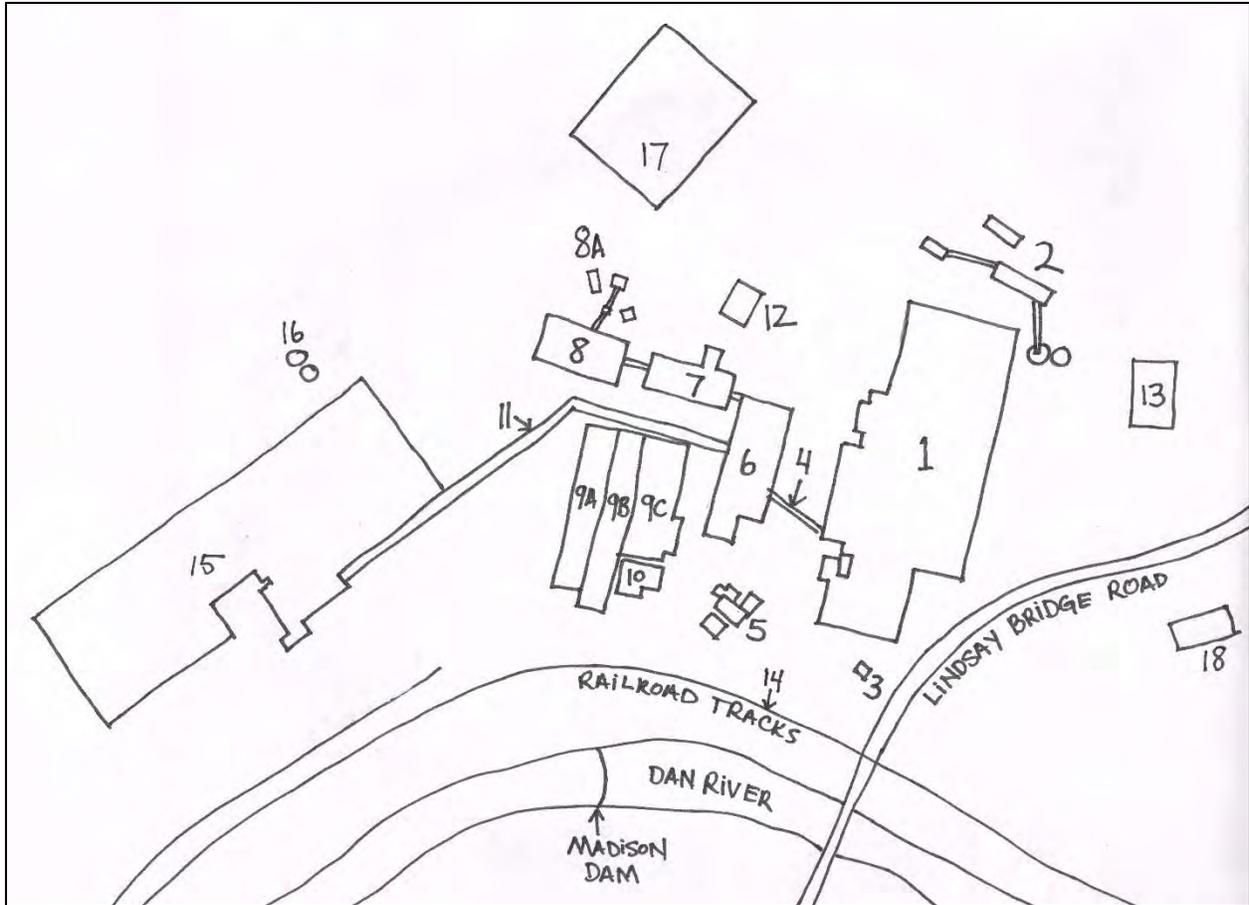
Figure 1: Pine Hall Brick Plant Site Plan

At the highest point on the property, a large yard is used for storing finished bricks. Just to the southwest is a large, open pavilion with a shallow gable roof where raw clay is stored (noted as 17 on Figure 1). Immediately south of the storage yard and east of the raw materials shed is a paved lot with brick and metal buildings that housed machinery to sort and prepare sawdust used to fire the kilns (noted as 2 on Figure 1). The sawdust for Plant 3A was stored in two silos situated immediately downhill from the sawdust preparation area.

South of the sawdust preparation area is Plant 3A (noted as 1 on Figure 1). This group of buildings was shuttered in 2008, at which time it still housed all the operations for brick-making: mixing (where water and clay are mixed), extruding (where the mud is compacted into a long snake-like brick and then cut to size with wire cutters), a holding room (where brick dries for about 24 hours), a drying room which is warmed at a controlled rate up to about 425 degrees Fahrenheit, a long tunnel kiln that reaches a top temperature of 1,980 degrees Fahrenheit, and a cooling room where the bricks are cooled at a controlled rate. Today, the buildings are mostly empty with sections used for sand storage and sifting.

A conveyor belt (noted as 4 on Figure 1) connects Plant 3A to a storage building where ground and sifted clay was stored. This storage building appears to be contemporary with Plant 3A. Additions have been made to both the north and south ends. Another conveyor belt extends from this building's west elevation to the east end of another large, prefabricated storage building (noted as 7 on Figure 1) built in the 1960s or possibly the 1970s.

South of these larger buildings are a collection of smaller buildings: a small brick gate house (noted as 3 on Figure 1) near the Lindsay Bridge Road entrance; a brick office (noted as 10 on Figure 1) and a group of small brick and metal buildings (noted as 5 on Figure 1). The office can be seen on the 1950s aerial photograph, but it was expanded significantly before the 1970s.

To the immediate west and north of the above are a cluster of long sheds (noted as 9A-C on Figure 1). These predate 1957, and they may be remnants of the 1947 Plant 3 complex. All are currently used for parts storage. One is an open pavilion while the other two have brick knee walls and corrugated metal walls above the brick.

In 1974, Pine Hall added Plant 4 (noted as 15 on Figure 1) to this property. This is a significantly larger facility composed of standard modern metal buildings. It is connected to one of the oldest storage buildings used for storing ground and sifted clay by a long L-shaped conveyor belt (noted as 11 on Figure 1) housed in corrugated metal on stilts. A parallel conveyor belt formerly connected Plant 3's sawdust sorting facility to two silos at Plant 4, but this belt has been removed.

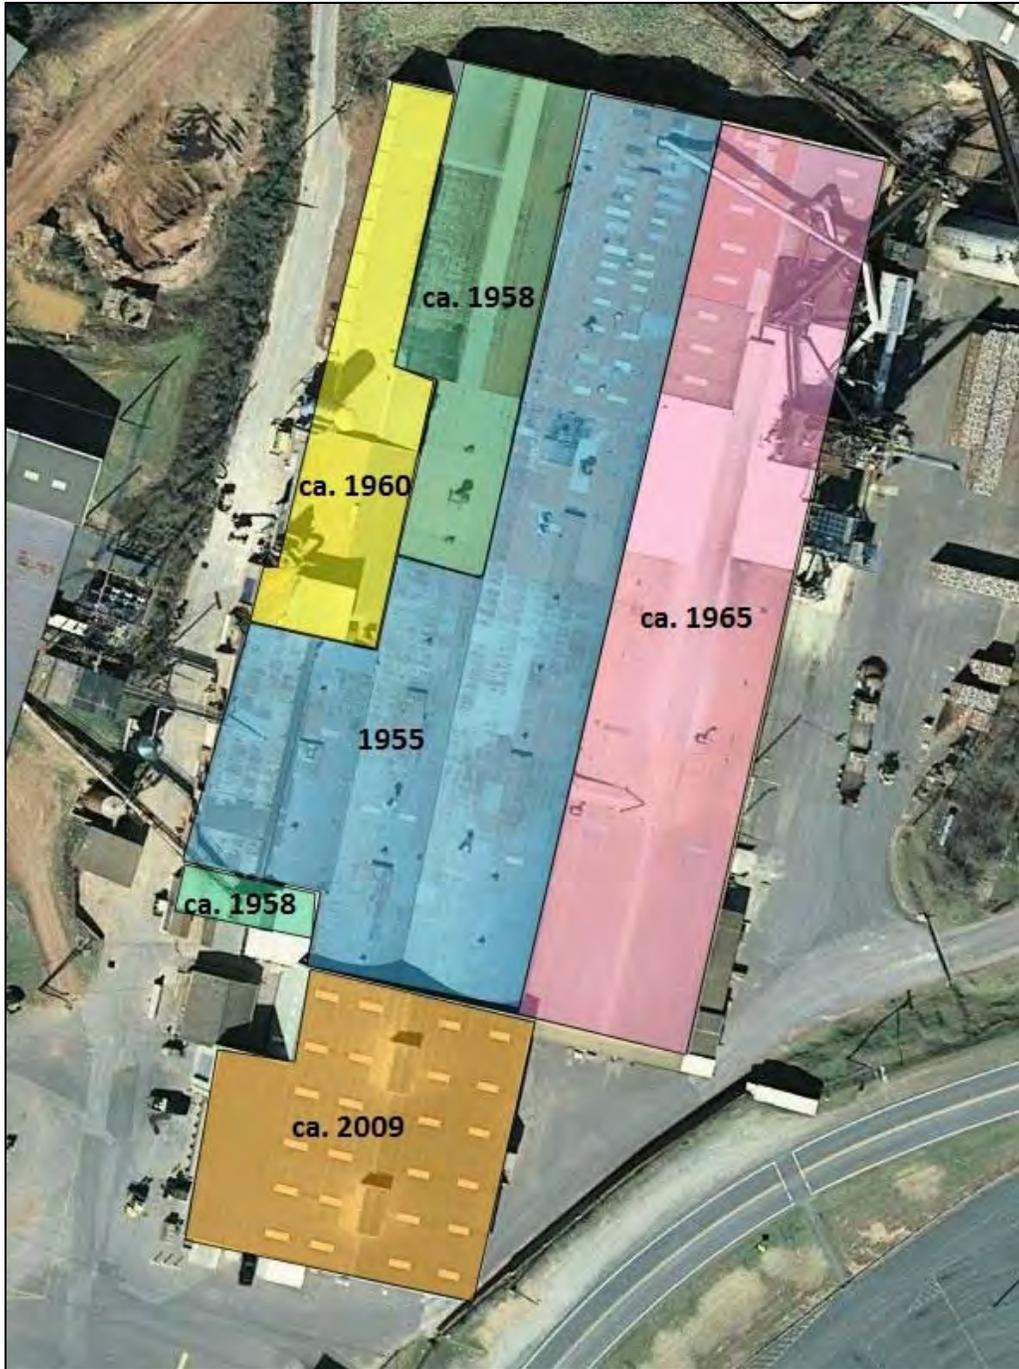
Figure 2: Plant 3A with phases of construction shaded

Plant 3A was built in 1955.¹ The original section consists of a group of three arched-roofed buildings with brick knee-walls up to a height of about four feet. Above the knee-walls, the walls are constructed of corrugated metal. Plant 3A has been expanded and modified several times. A relatively early addition lengthened the middle section of the building so that it was as long as the eastern section. Before 1959, a square tower was added to the south end of Plant 3A's western section along with a new conveyor belt (noted as 4 on Figure 1) connecting this tower to the storage building immediately to the west. Other late 1950s or early 1960s additions are located along the west elevation. The plant was significantly expanded in the 1960s with an addition that runs along the east side of Plant 3A. Another section was attached to Plant 3A's south elevation in 2009. Figure 2 is a plan of the building indicating its evolution and labeled with dates.

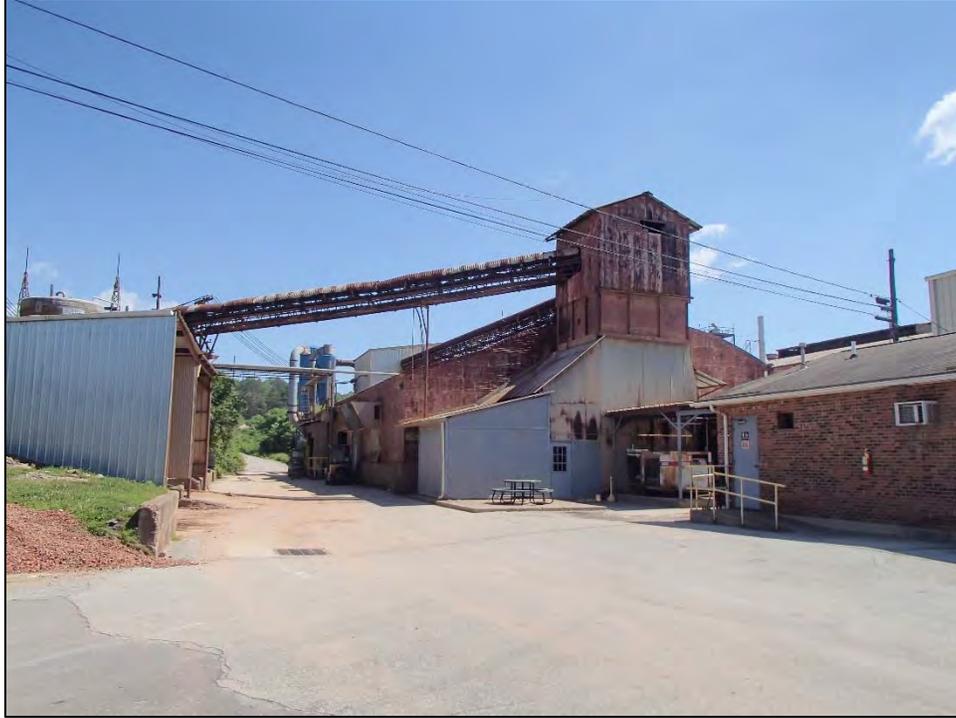
Figure 3: Plant 3A, south elevation with newer section to the right or east

Three one-story buildings abutting one another date from 1955 (Figure 2-5). The buildings have brick knee walls approximately four feet in height from which rise corrugated metal walls. All three roofs are slightly arched barrel vaults. This plant was expanded early in its life with an addition to the middle section and via other small additions on the west elevation. In the mid-1960s, a long, metal-clad addition (Figures 6 and 7) was added to the east elevation, and in 2009, another expansion (Figure 8) was made to the south.

A braced, metal-framed structure supporting a conveyor belt sheltered by half-round, corrugated metal piping. (Visible in Figure 3)

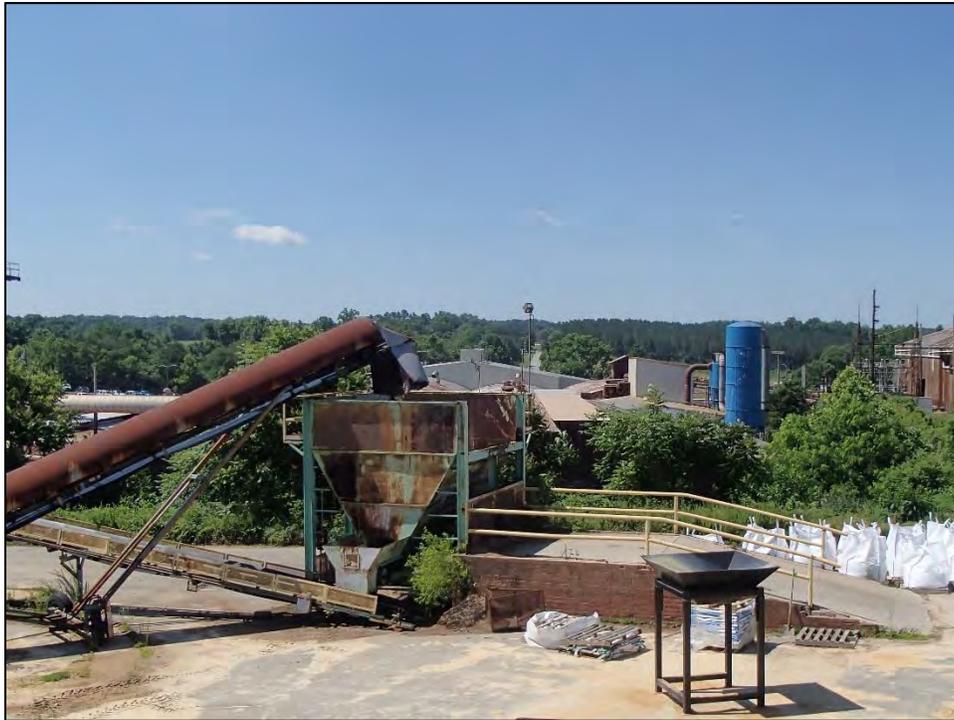
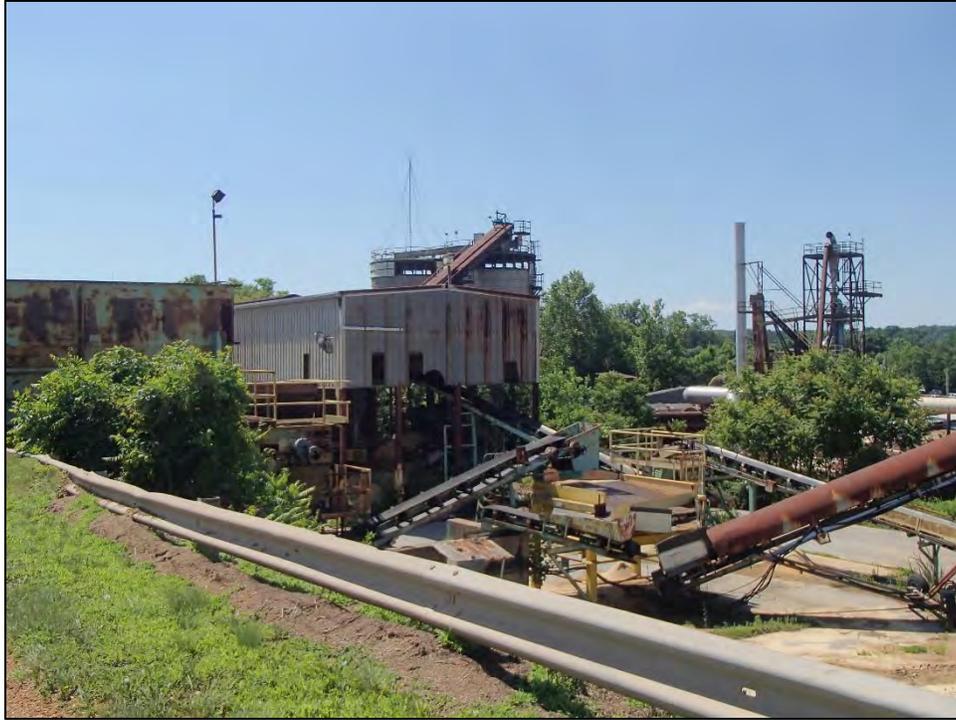
Small brick and metal buildings (Figures 9 and 10) that house machinery to sift and prepare sawdust for use in firing the kilns. The kilns were originally coal-fired, but the plant switched to sawdust from logging operations in the 1960s. The factory still uses sawdust, but a more refined sawdust that is waste from flooring manufacturing. Two corrugated metal silos (Figure 11) store the sawdust.

Figure 9: Sawdust sorting area, facing south

Figure 10: Sawdust sorting area, facing southeast

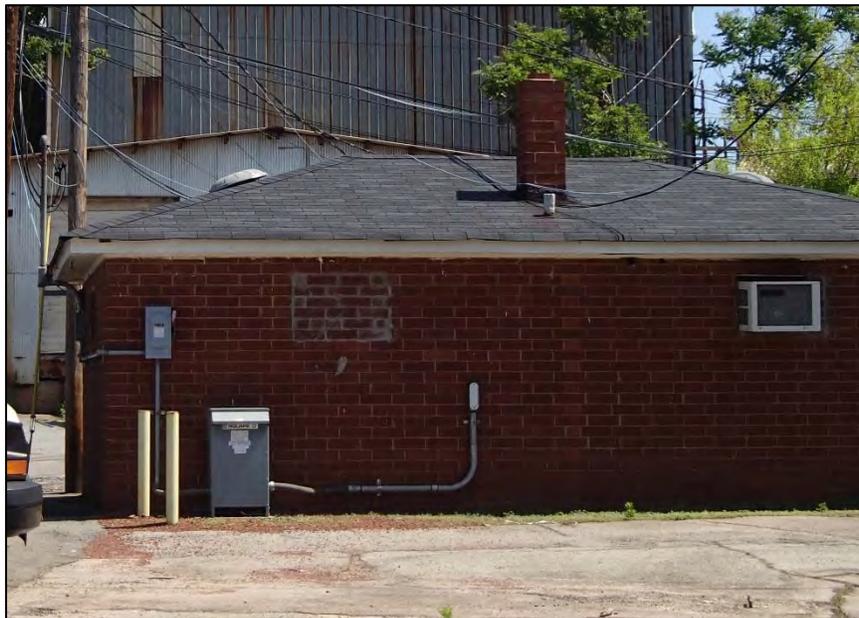
Figure 12: Largest and most substantial of a group of 1950s and 1960s storage buildings

A group of small, plain, gable-roofed, rectangular-plan, metal and brick storage buildings. The largest and most substantial is the hip-roof building in Figure 12. The other buildings are prefabricated metal structures.

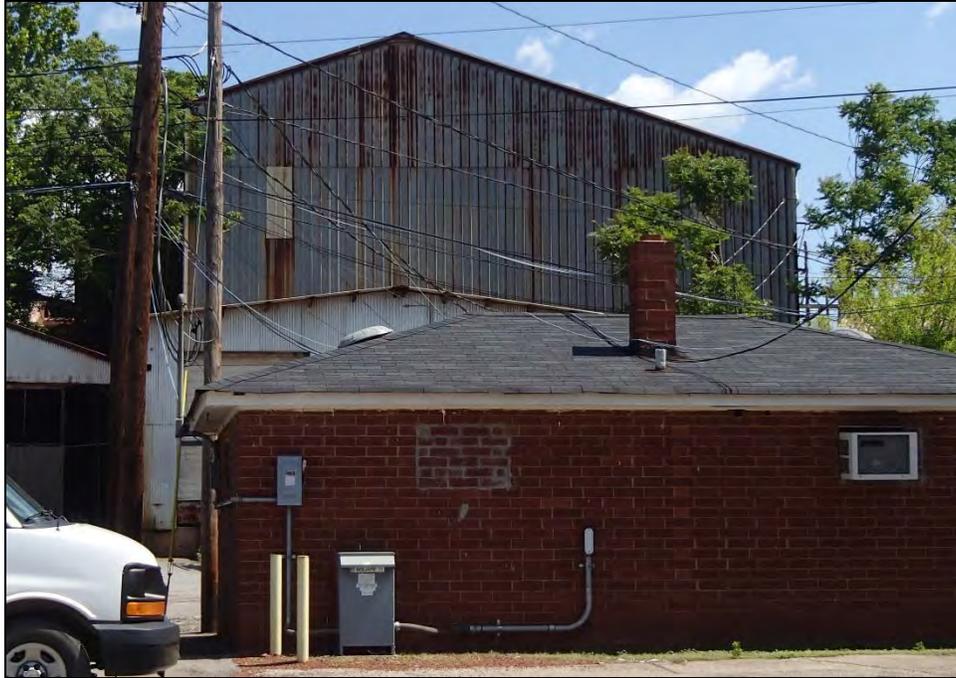
An imposing corrugated metal building with a gabled roof on a brick foundation that appears to have been built at the same time as Plant 3A. (Figures 13 and 14)

Figure 13: After-Grinding Storage 1, south elevation behind smaller brick building; the white building between these two is a lower-level addition to After-Grinding Storage 1.

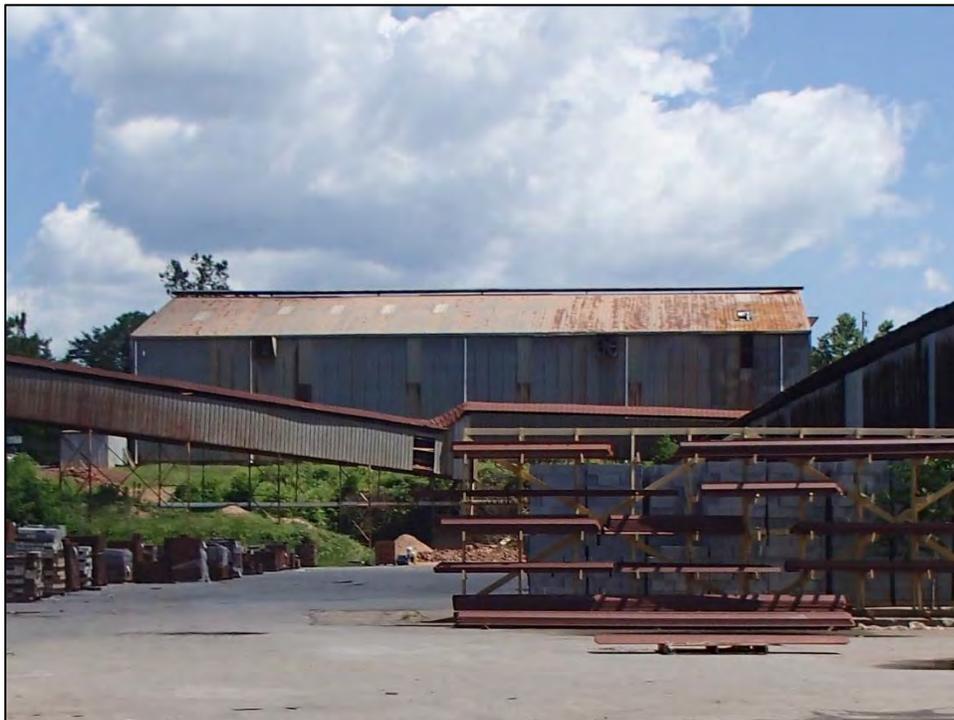
A prefabricated, metal-clad storage building with a gable roof. (Figure 15)

Figure 15: Grinding Room, south elevation, in background with conveyor belt to Plant 4 in the mid-ground

This conveyor belt is enclosed in a metal, gable-roof structure, and it connects one of the after-grinding buildings to Plant 4. (Figure 15)

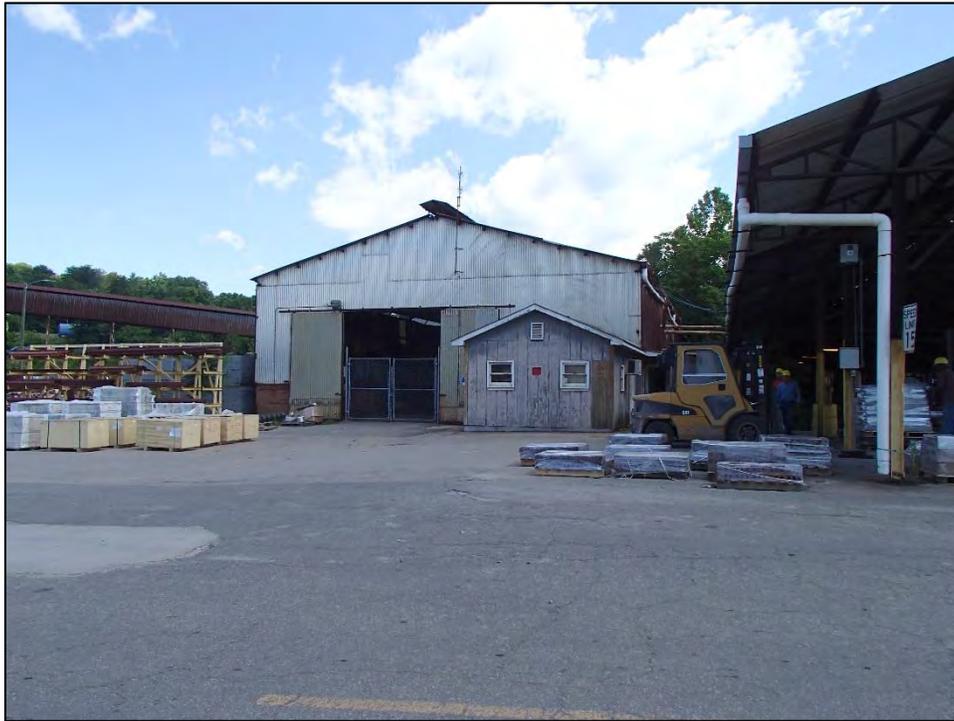
Figure 16: South elevation of Parts Storage Building 9A

A group of connected, gable-roofed buildings and structures. The two outer buildings (9A, Figure 16, and 9C, Figure 17) are clad with corrugated metal, while the structure in the middle

(9B) is an open-sided pavilion. Buildings 9A and 9B occupy a similar footprint to buildings that were here by 1955 suggesting that they may be older, contemporary with the 1947 Plant 3, which stood immediately west of 9A. However, the comparisons of aerial photographs suggest that the current buildings are slightly wider than the ca. 1947 structures. Thus, the more conservative estimate of 1955 is more safely applied to 9A and 9B. Based on the same aerial photos, 9C was built after 1960.

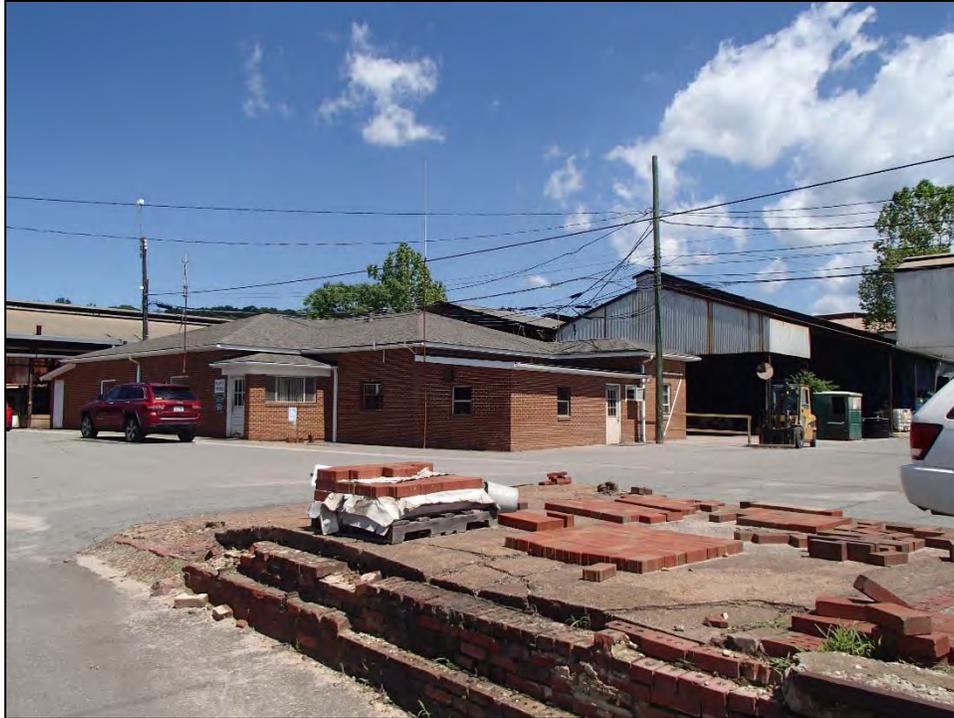
Figure 17: Parts Storage Buildings 9B and 9C behind (to the north and west) the brick office building

A one-story, brick, hip-roof building with plate glass windows. The office started as a small, square, flat-roofed building, but was expanded in the 1960s and possibly again in the 1970s. (Figure 17)

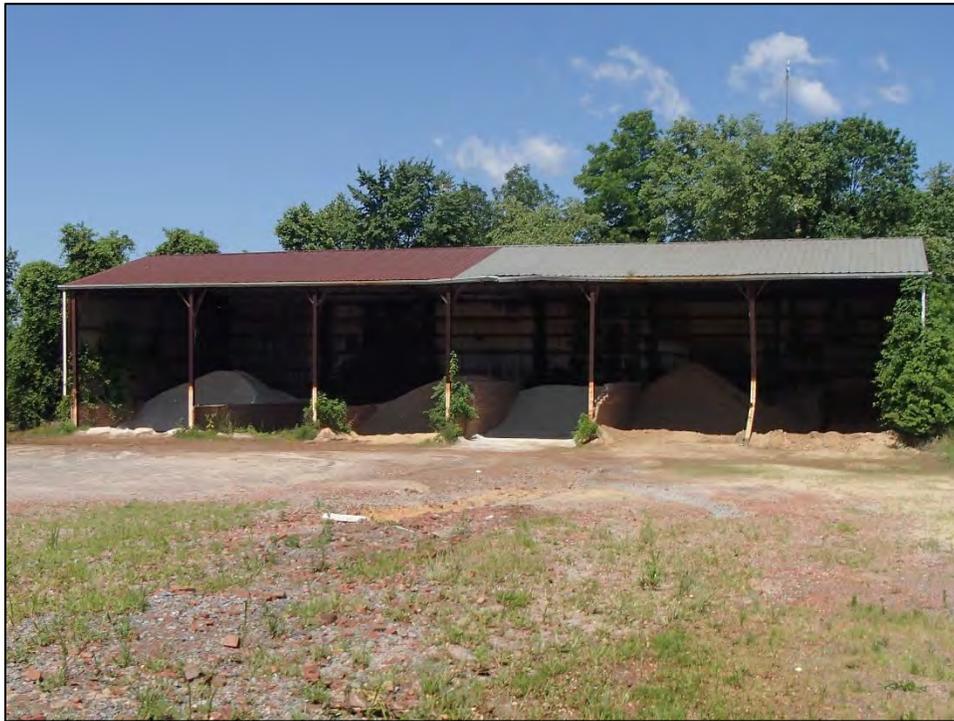
Figure 18: Sand Storage, east elevation

One-story, gable-roof building enclosed on three sides, open to divided storage areas on the east elevation. (Figure 18)

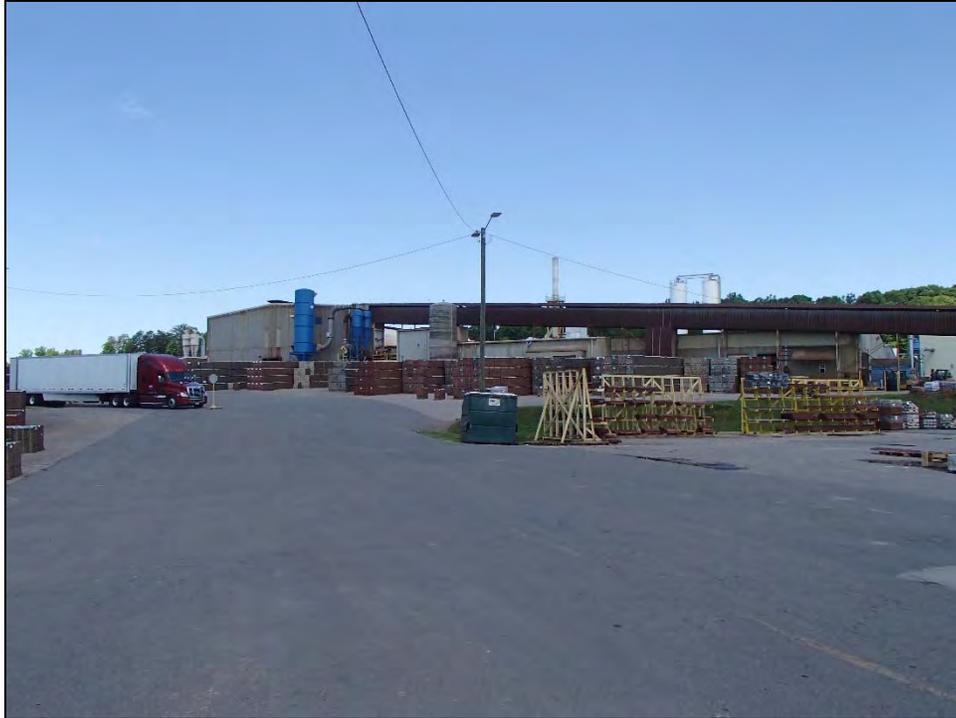
Figure 19: Plant 4, facing west from National Register eligible area

A large, metal factory building with several additions. (Figure 19)

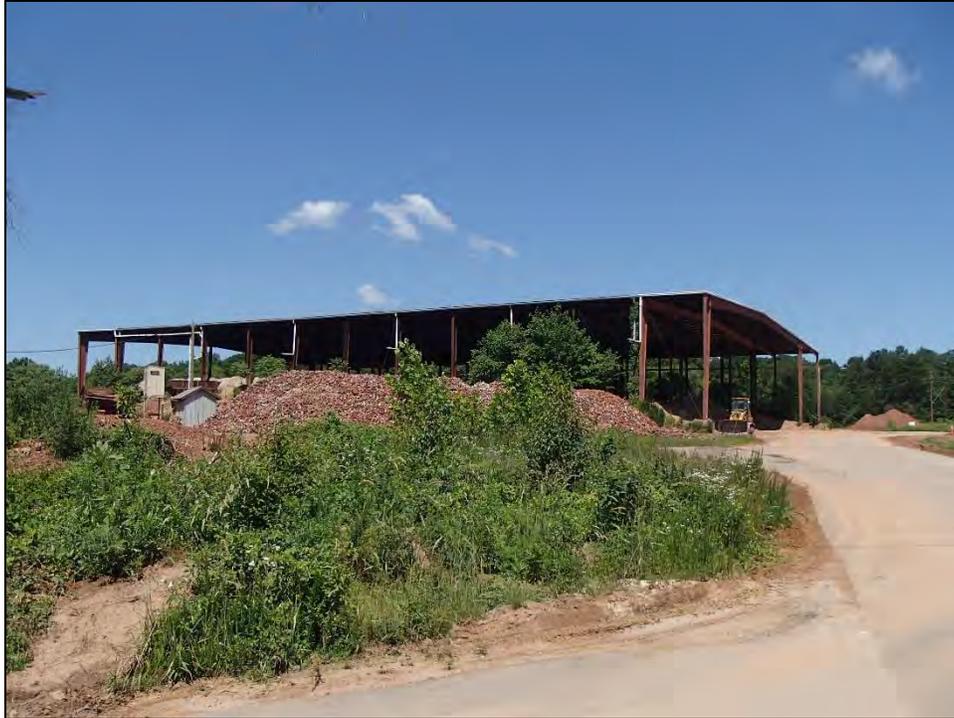
Figure 20: Raw Materials Storage Shed, northeast elevation

Large, open pavilion with metal pipe poles and a shed roof. (Figure 20)

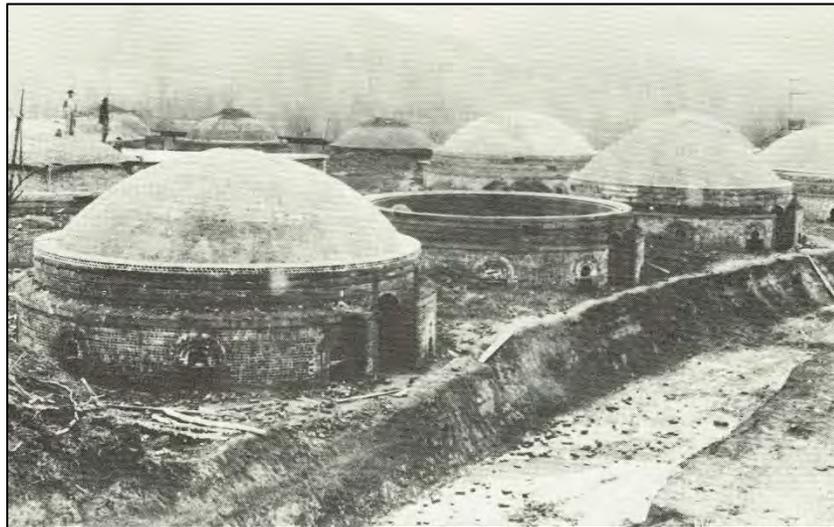
Figure 21: Beehive kilns at Pine Hall Brick Plant 1 in Stokes County; Photo from *The Heritage of Stokes County*.

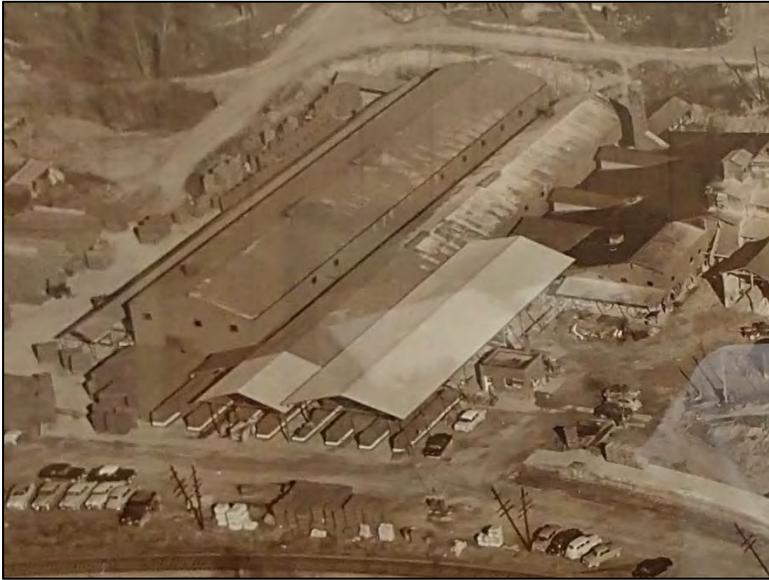
Figure 22: Ca. 1955 photo showing a large building that has been torn down. This seems to be Plant 3. The sheds to the right may be the storage buildings labeled on the site plan as 9A and 9B

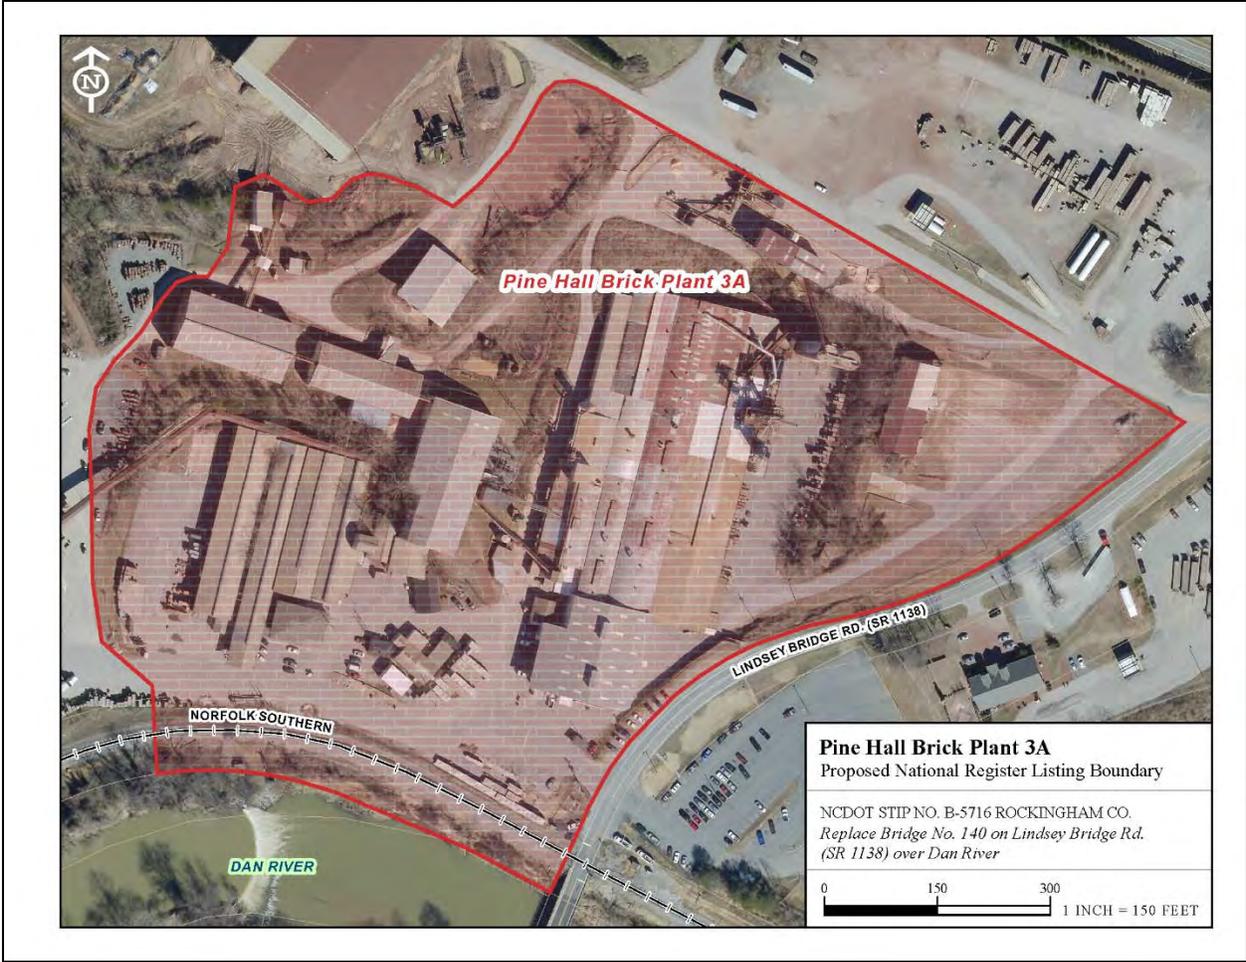
Figure 25: Pine Hall Brick Plant 3A Proposed Boundary

The boundary for Pine Hall Brick Plant 3A incorporates all remaining historic buildings at the factory (see Figure 25). On the south, the boundary follows the southern edge of the railroad right-of-way. On the east, it follows the parcel line along Lindsay Bridge Road. At the intersection of Lindsay Bridge Road and an unnamed road that is part of the plant, the boundary turns west and follows the southern edge of the unnamed road. From that road, the boundary turns south to follow a dirt road and then a pavement edge to the east of Plant 4 until it rejoins the southern boundary. This incorporates all the historic buildings associated with Plant 3A and the railroad, which was integral to the plant's success. The river is excluded because it was an indicator of good clay and forms the corridor the rail line follows, but it does not have an actual role in the factory's function.
