SUBJECT: Historic Structures Survey Report, Replace Bridge 173 on SR 1709 Over I-40, B-5847,
Catawba County, ER 16-1725

**EVALUATION OF HEFFNER FARM (CT1574)
1503 ROCK BARN ROAD
BRIDGE REPLACEMENT (No. 173) ON SR 1709 (ROCK BARN ROAD) OVER I-40
CATAWBA COUNTY, NORTH CAROLINA**

**TIP# B-5847
WBS# 45800.1.1**

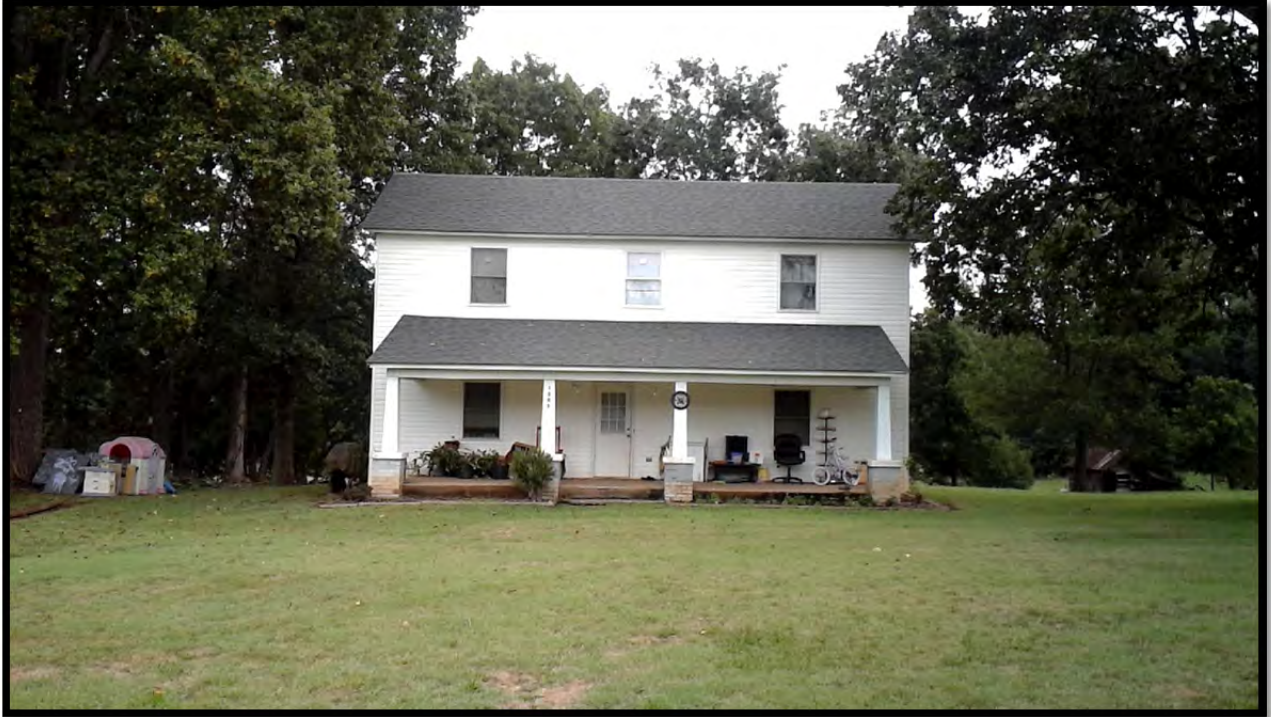
Main house at Heffner Farm, (CT1574) façade and front yard

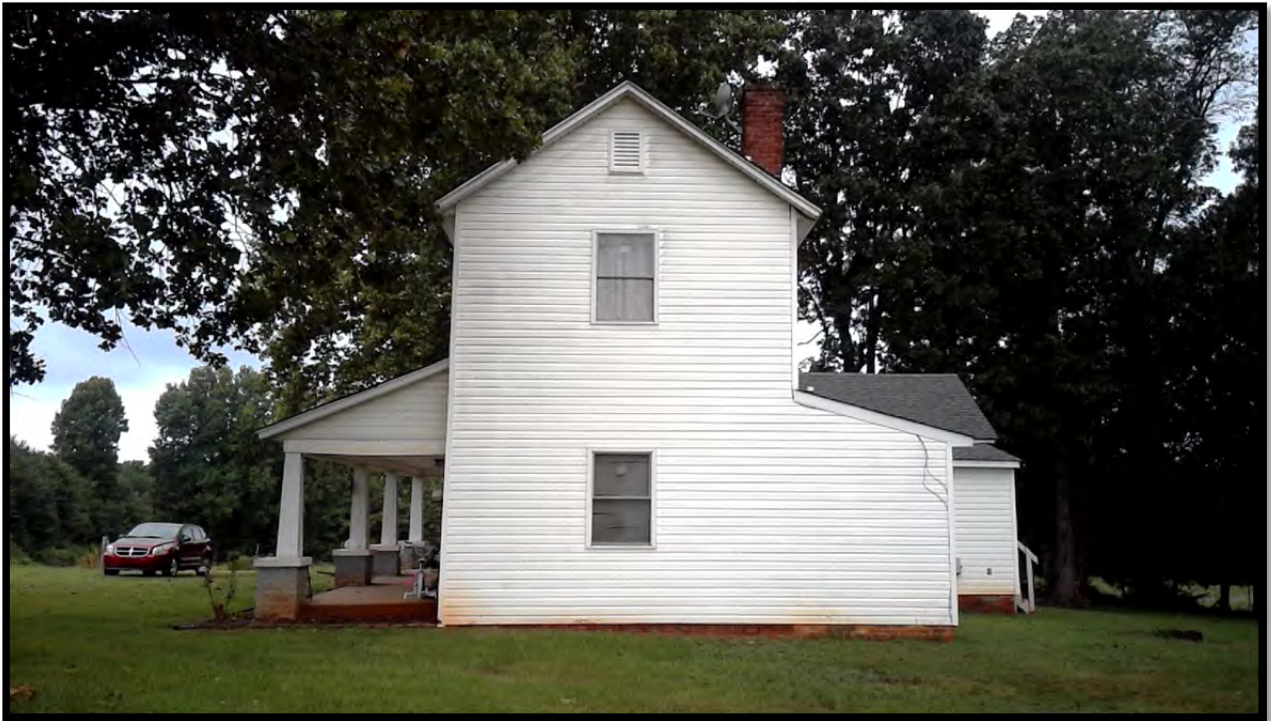
East elevation of main house

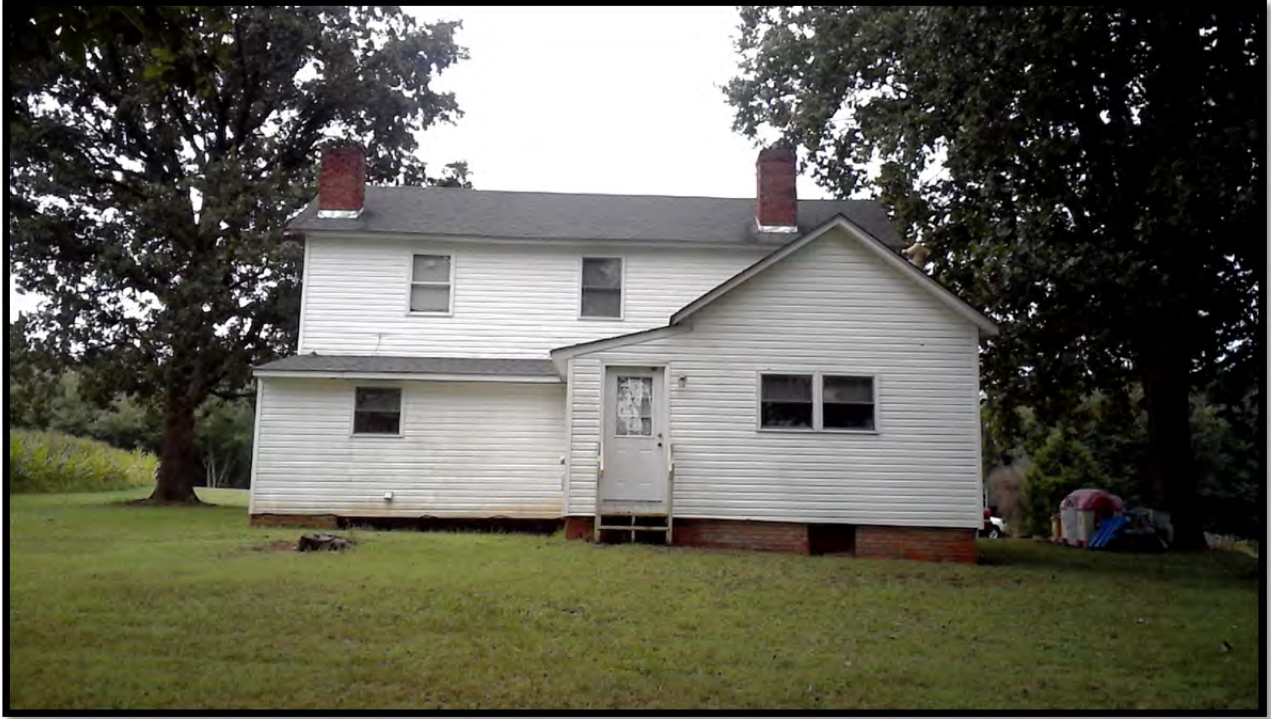
Rear (north) elevation of main house

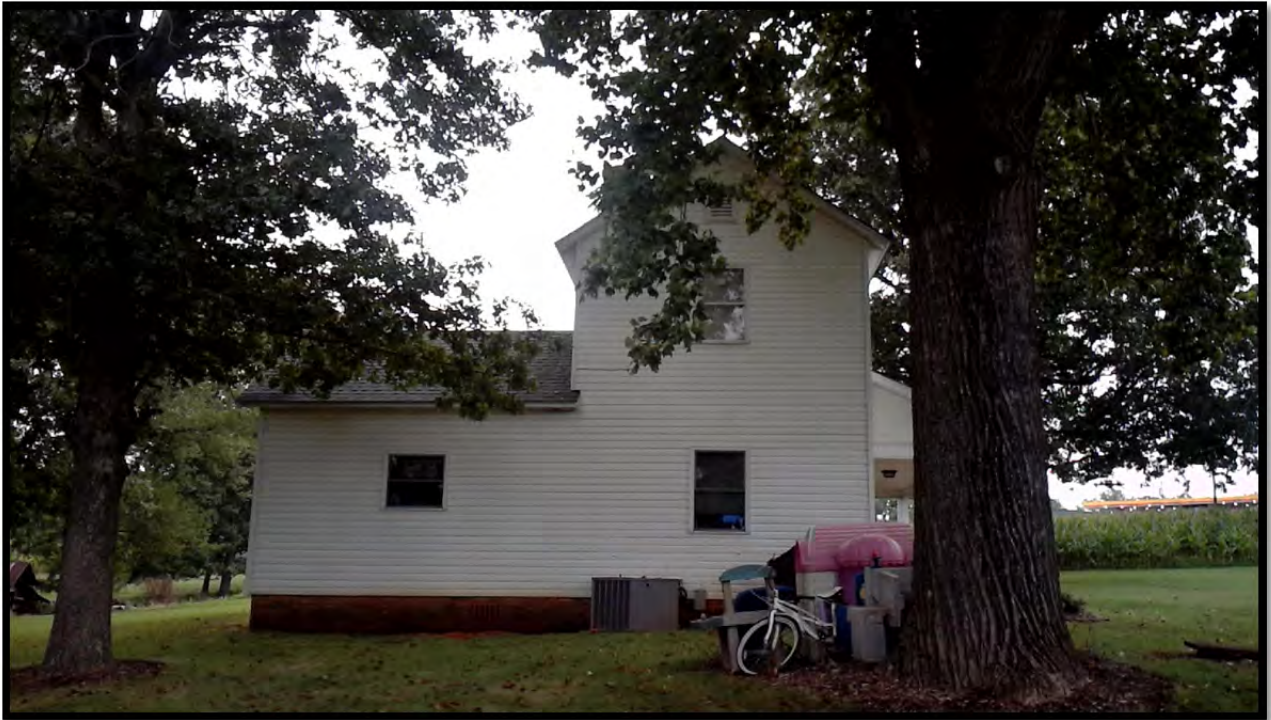
West elevation of main house

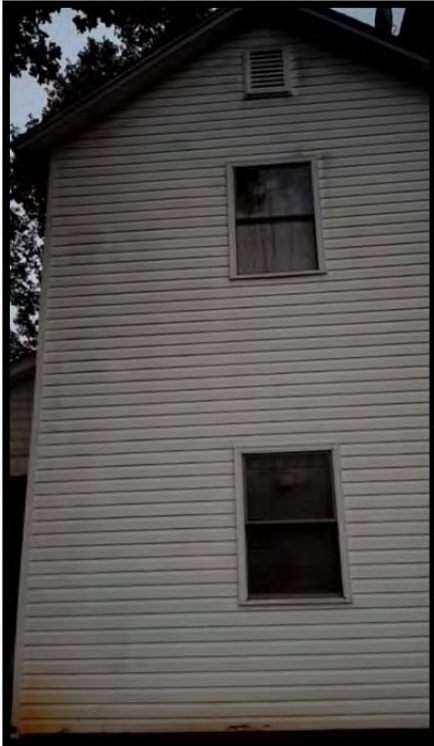
1/1 replacement windows

The original c1910 structure with its rectangular plan and rear ell is still present. The original windows have been replaced with new one-over-one vinyl double hung sashes and the front entry with single wood panel door, side lights and transom were removed and partially enclosed in favor of a single hollow core front door. The rear ell was altered slightly to accommodate a laundry room adjacent to the rear kitchen. Original wood siding has been covered with vinyl siding; however, the overall appearance is relatively similar to the original.

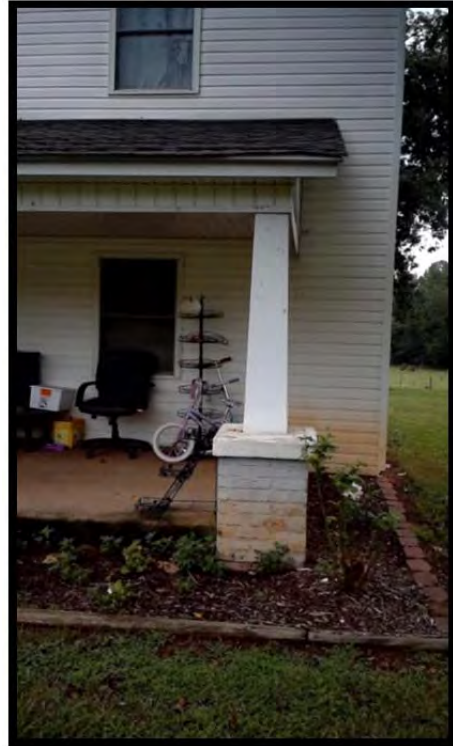
Vinyl over wood columns with brick piers

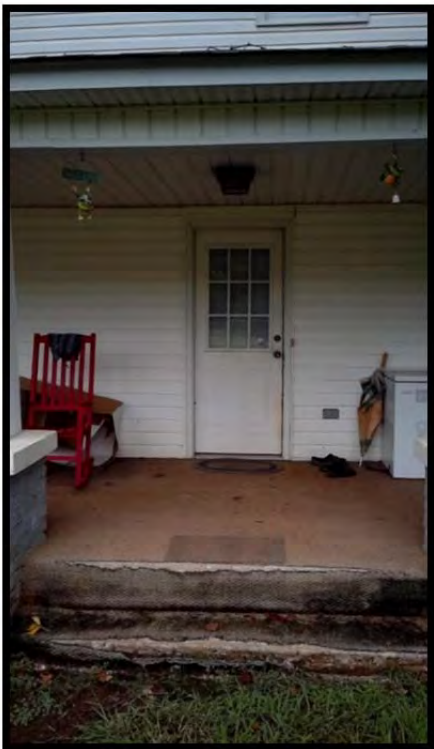
Replaced front door

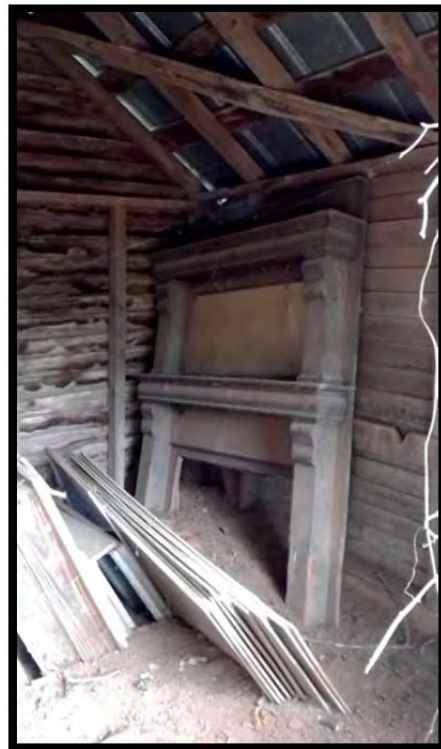
**Over-mantle removed from home;
stored in hog barn**

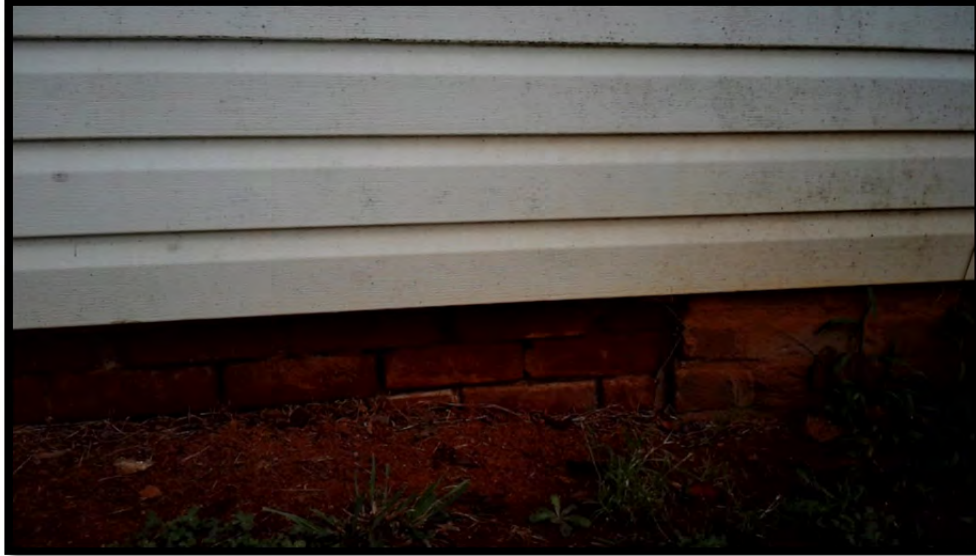
Vinyl siding over wood; disintegrated mortar joints in foundation

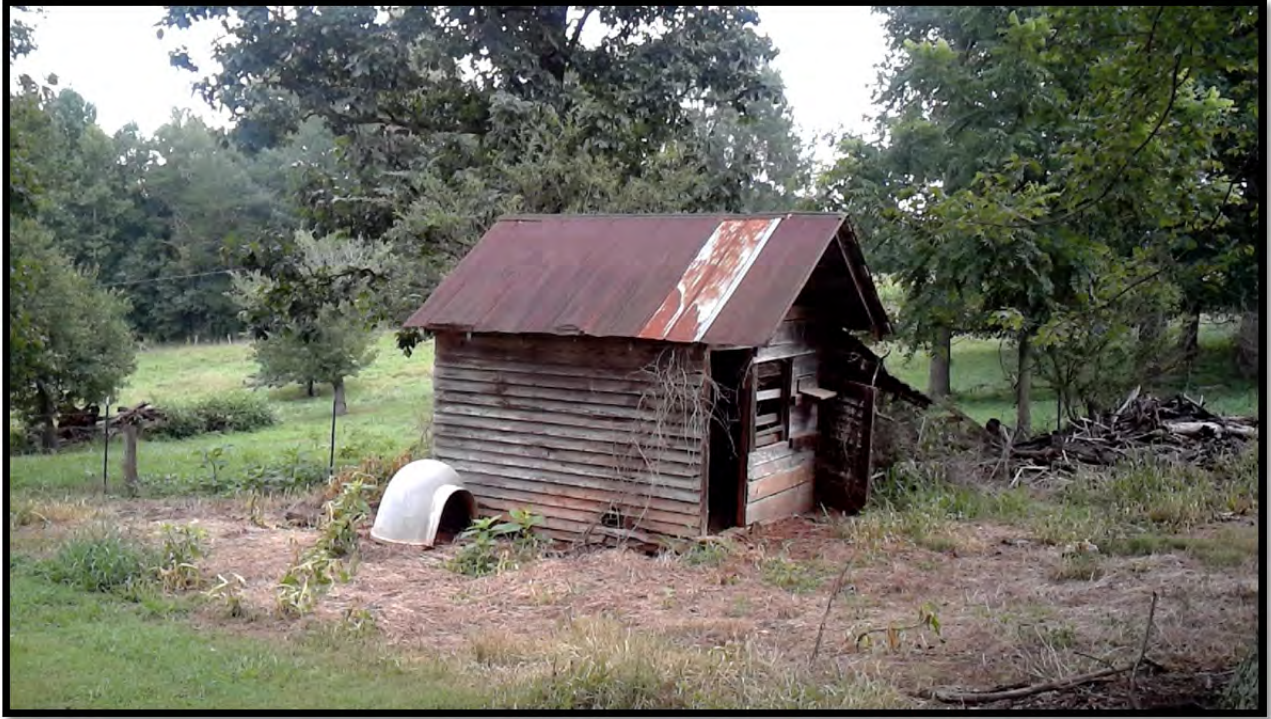
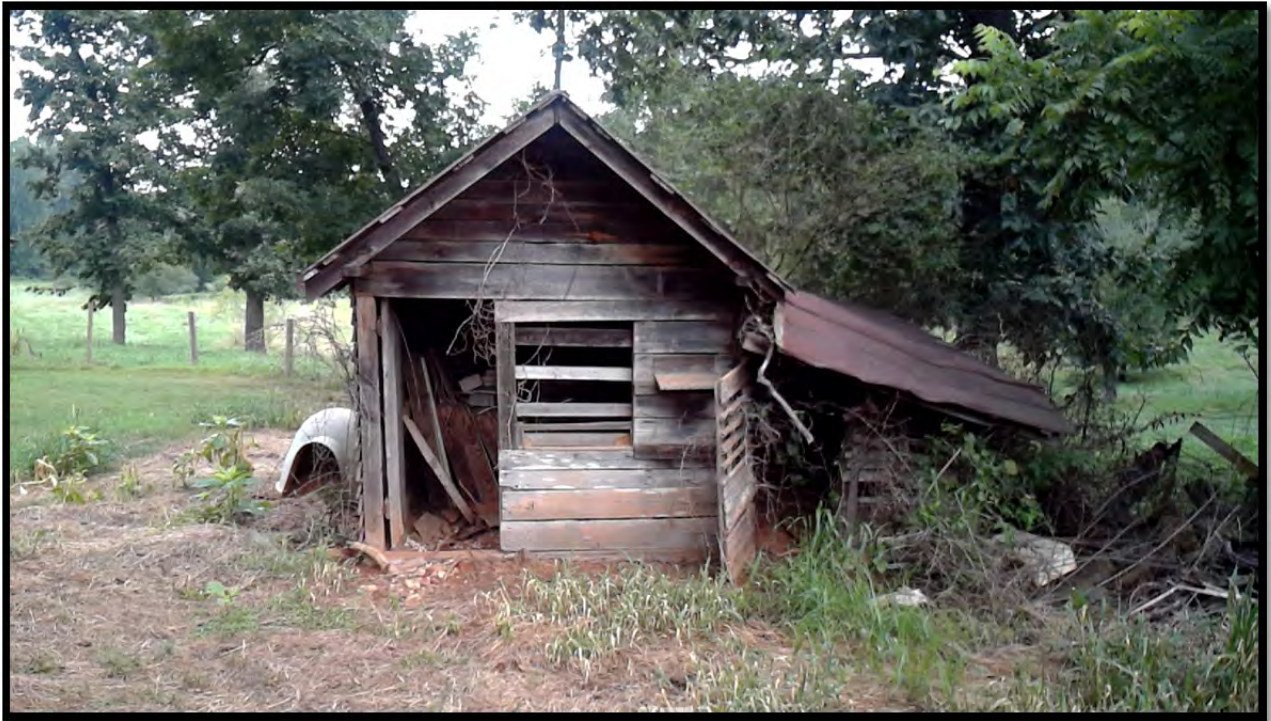
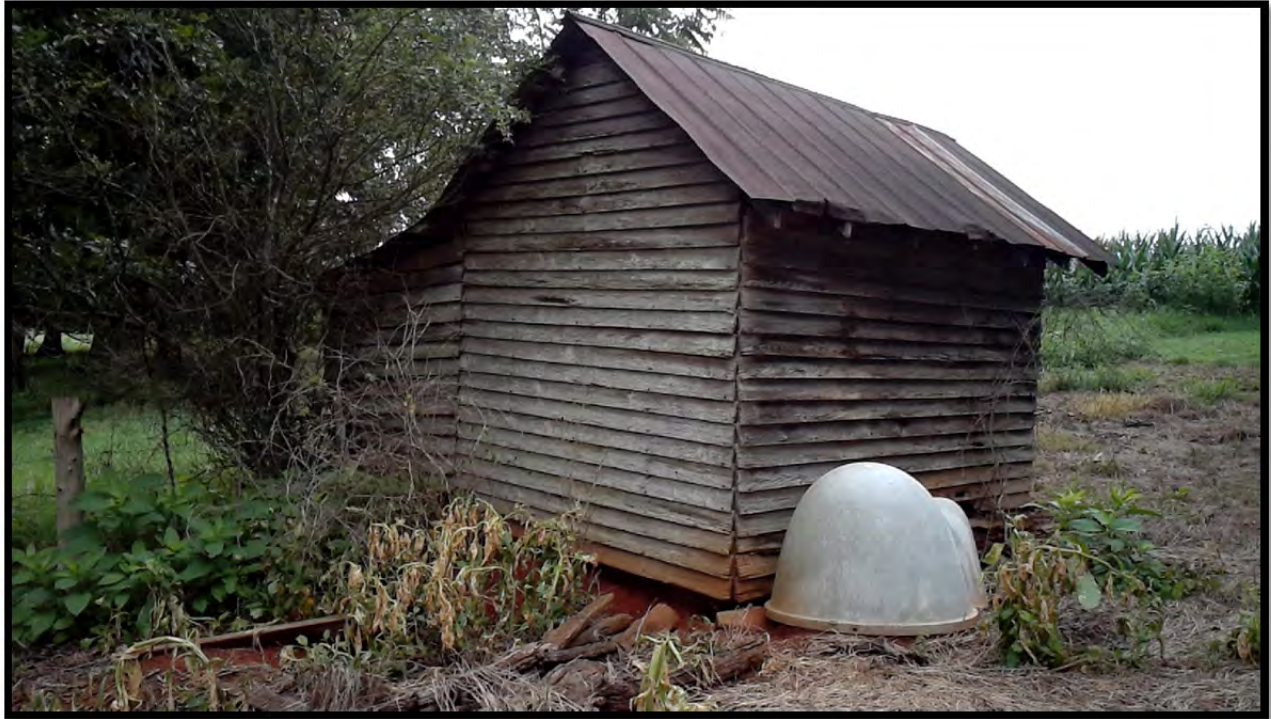
Typical of many outbuildings during this time period, the hog barn located on the property is a small rectangular wood frame building with front gable roof covered in five-V crimp sheet metal. There is a small closed side shed addition to the right of the main form. Exposed rafters extend slightly creating a narrow eave and the exterior is clad with beveled wood lap siding. Inspection of the interior revealed a nicely carved over-mantel as well as single weight and pulley window frames. This outbuilding is not actively used and is in poor condition.

Hog barn looking northeast

Front of hog barn; looking north

Northwest corner of hog barn looking southeast

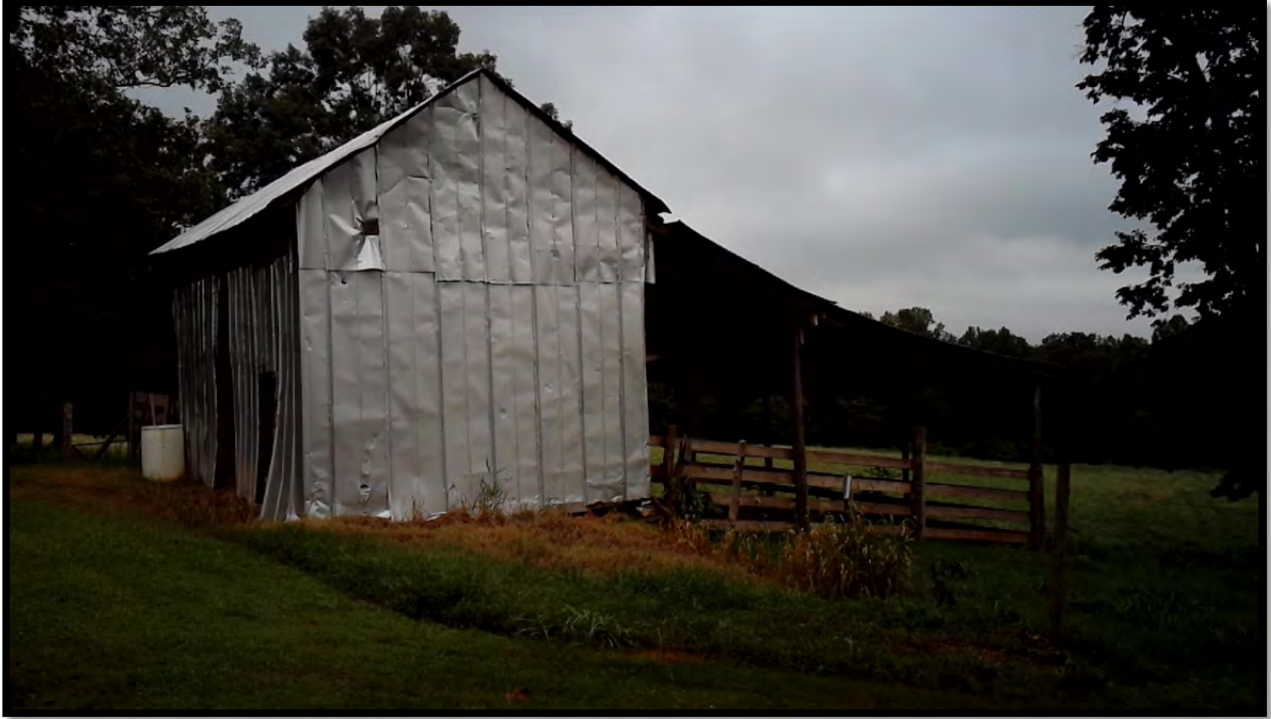
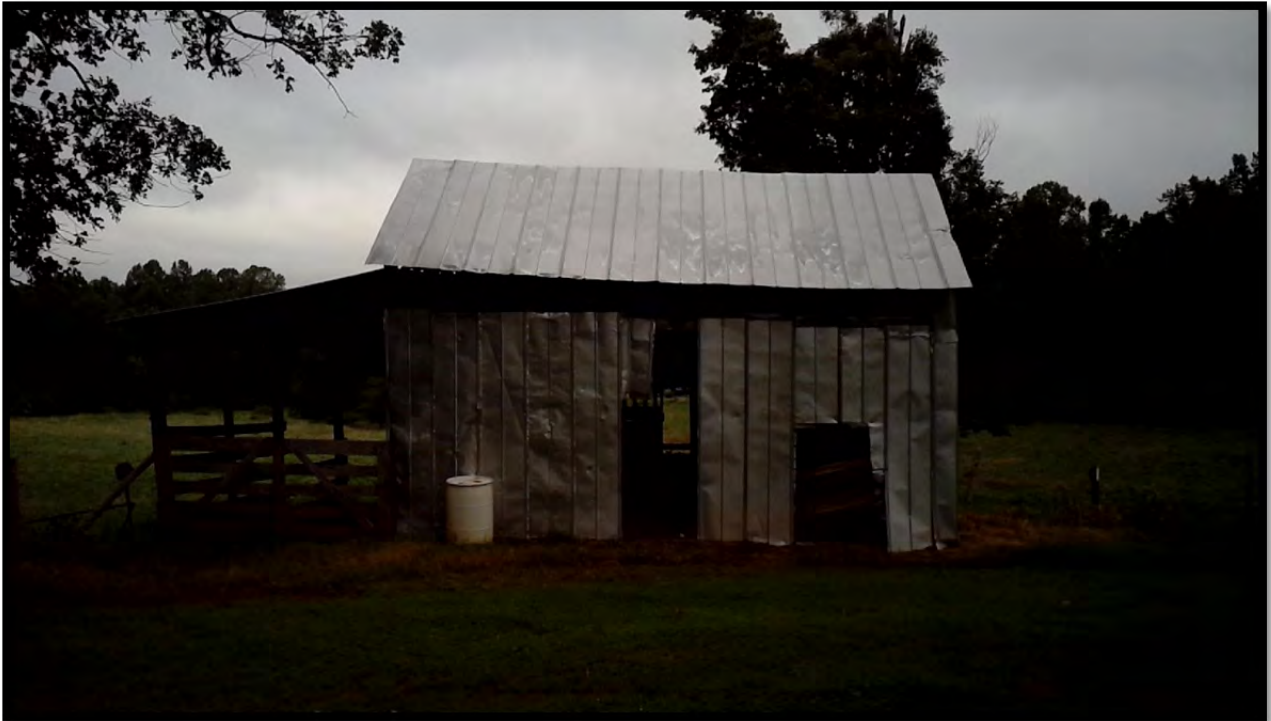
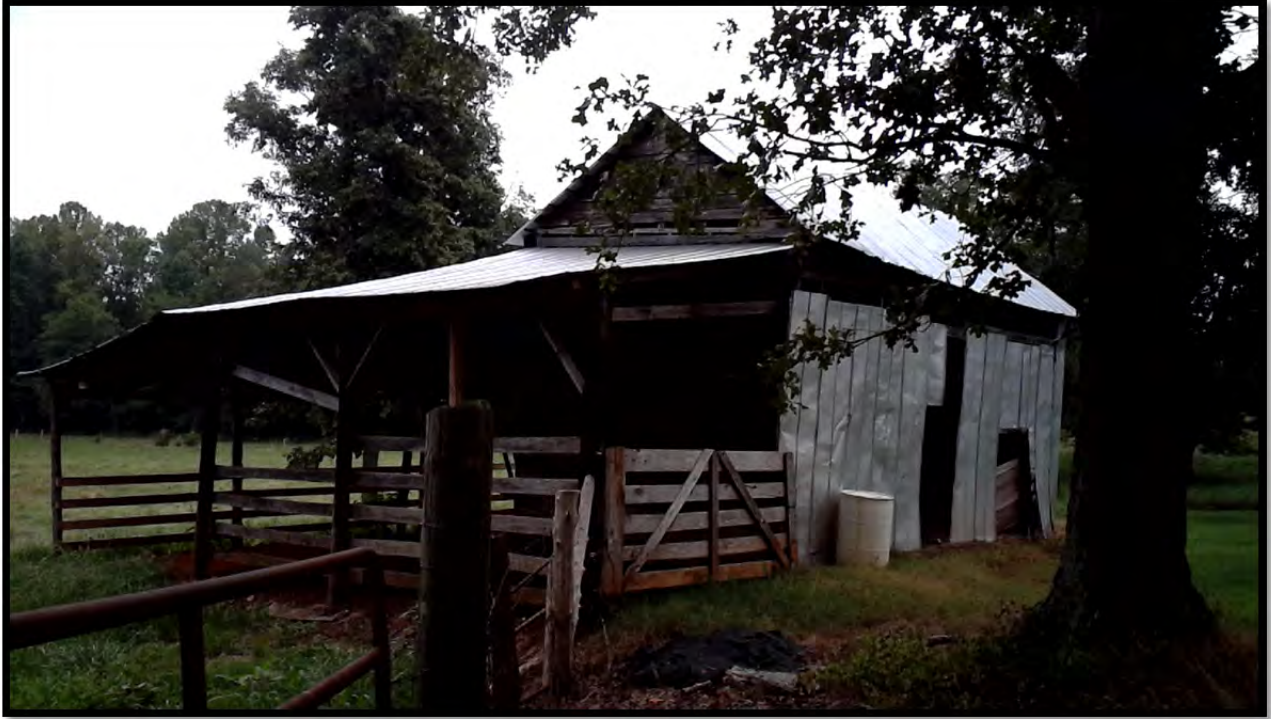
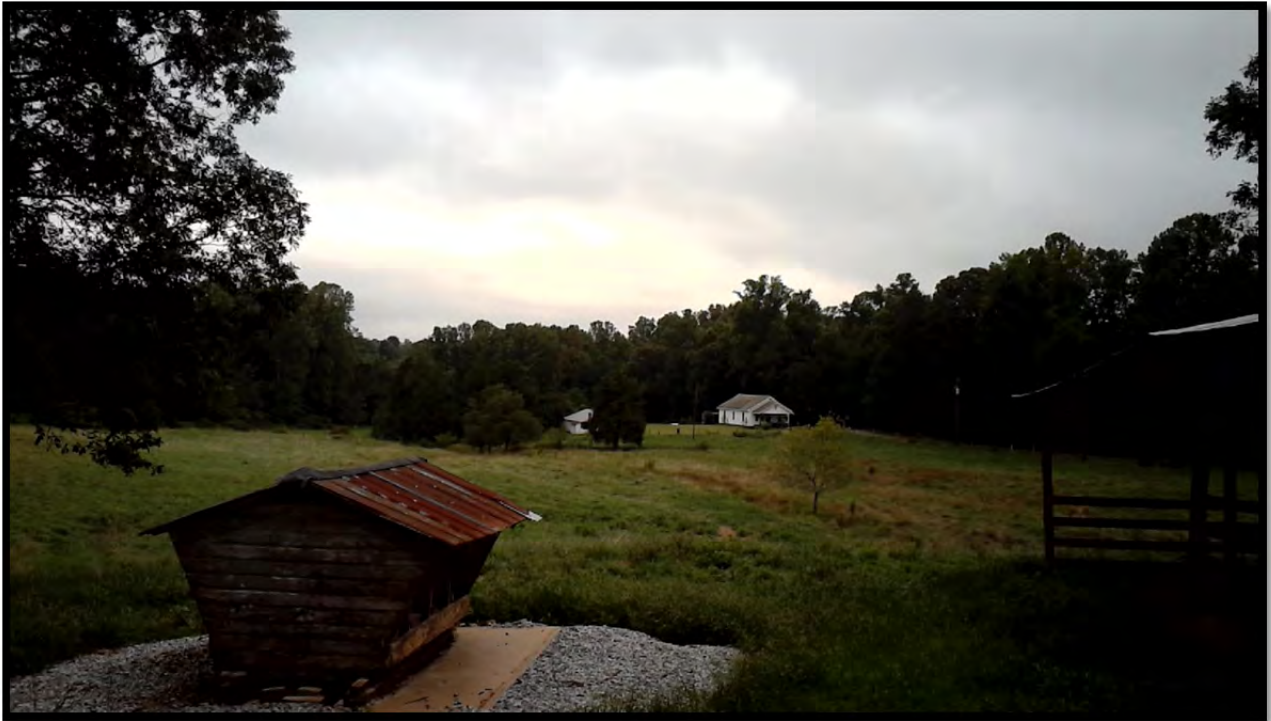
The construction date for this barn is unknown; however the current owner of the property recalls the structure being present as long as he can remember and speculates the barn would have been constructed at the same time or shortly after the home. The barn is one and a half stories, rectangular in plan with a side gable roof and open shed additions on the north and west elevation. Shed additions are for livestock pens and the interior of the main portion of the barn is used for storing hay. The roof, as well as north, south and east elevations is covered with five-V crimp sheet metal. There are two pedestrian openings on the south façade. Due to the lack of use, this outbuilding is in fair to poor condition. There is a small feed trough constructed of wood and capped with a metal roof adjacent to the barn which was recently placed on a new concrete foundation.

West elevation of livestock and hay barn looking east

Front (south) elevation of livestock barn, looking north

Livestock shed/stables on west side of barn

Feeding trough located west of the livestock barn looking north toward House 2

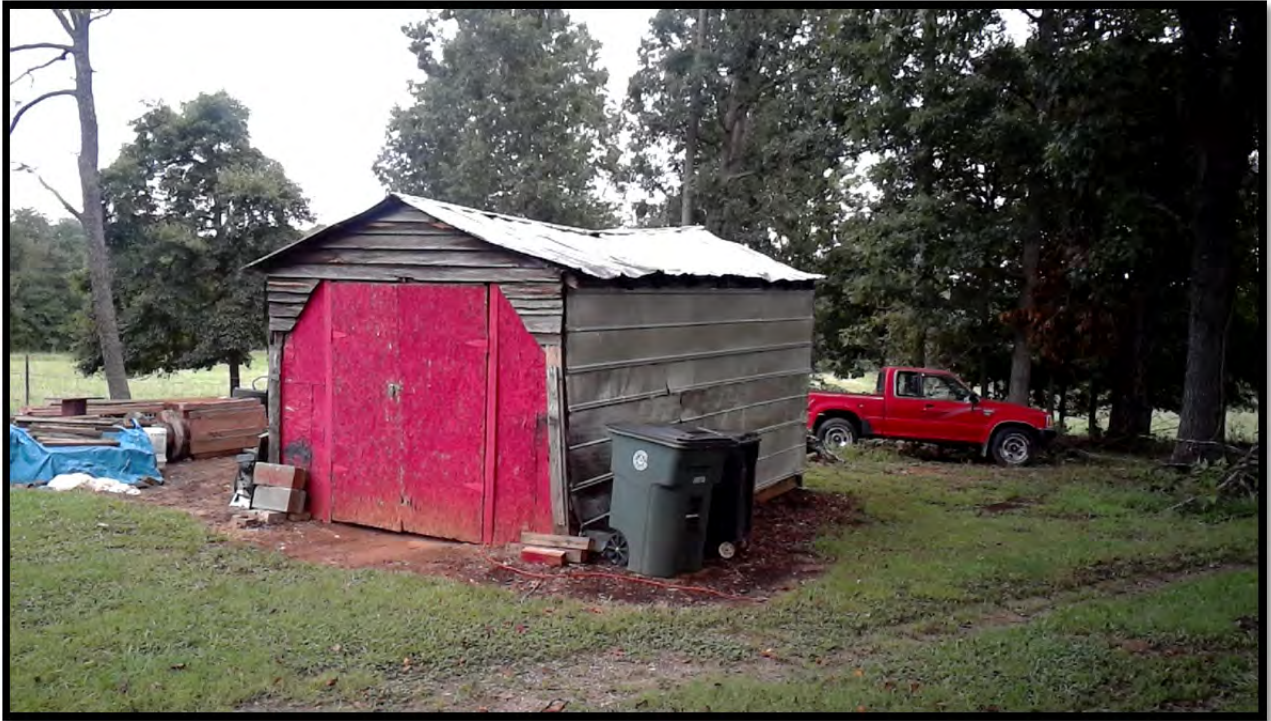
A wood frame single-car shed is located to the west of the main house and has a low pitched front gable roof covered with sheet metal. The entry to the shed has been enclosed with rough finish MDF board hinged doors painted red. Original horizontal planks are still present on the north, south and west elevations. The east side of the structure is covered with five-V crimp sheet metal. The shed is used for storage and is in fair to poor condition.

c.1930-40s car shed looking northwest

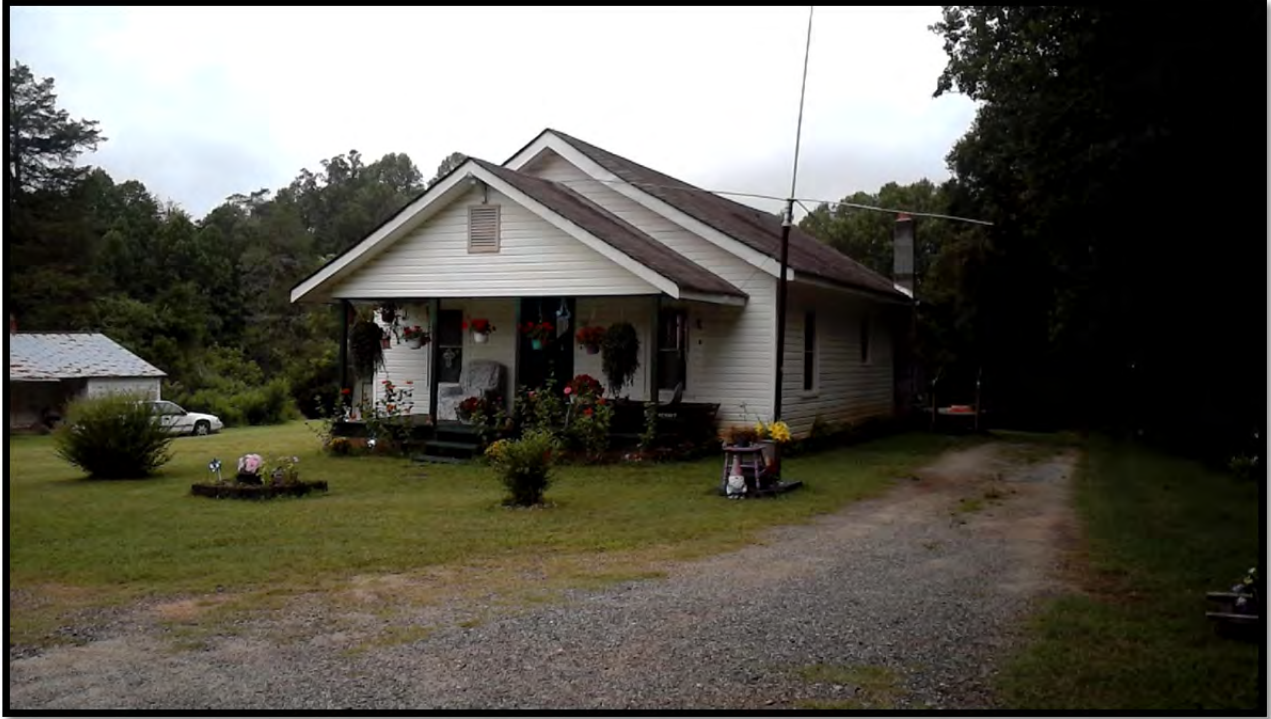
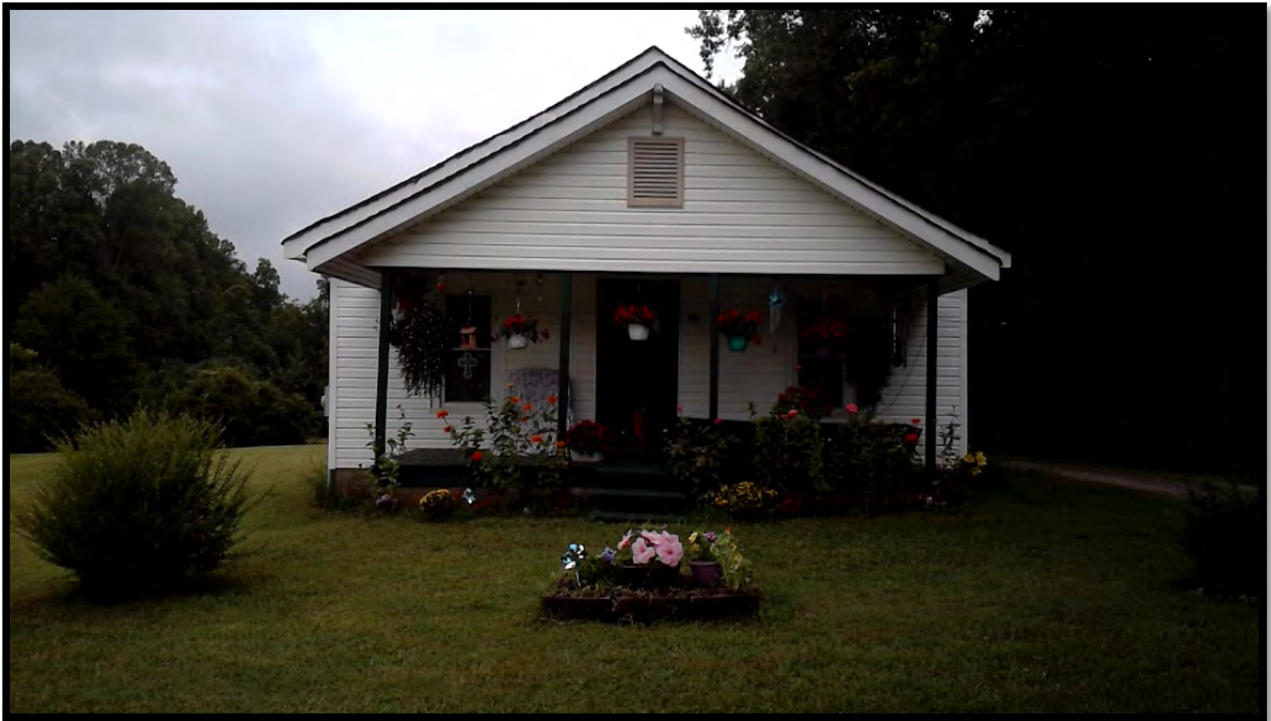
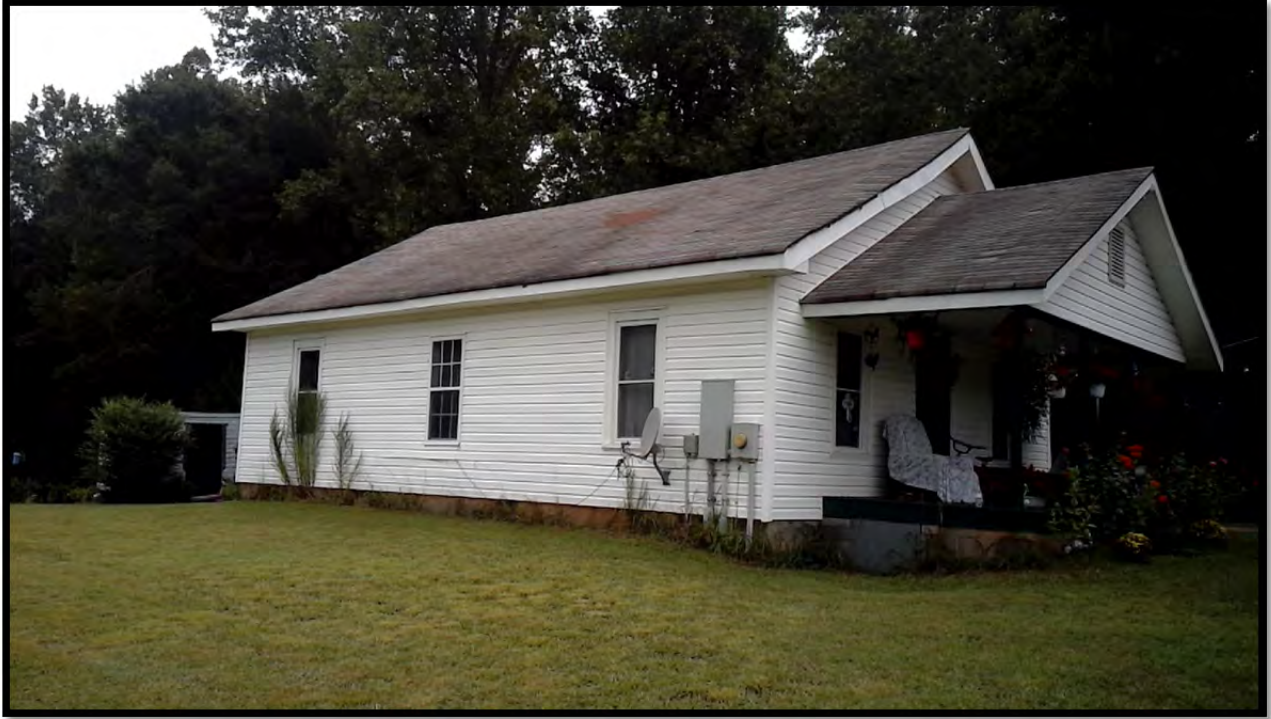
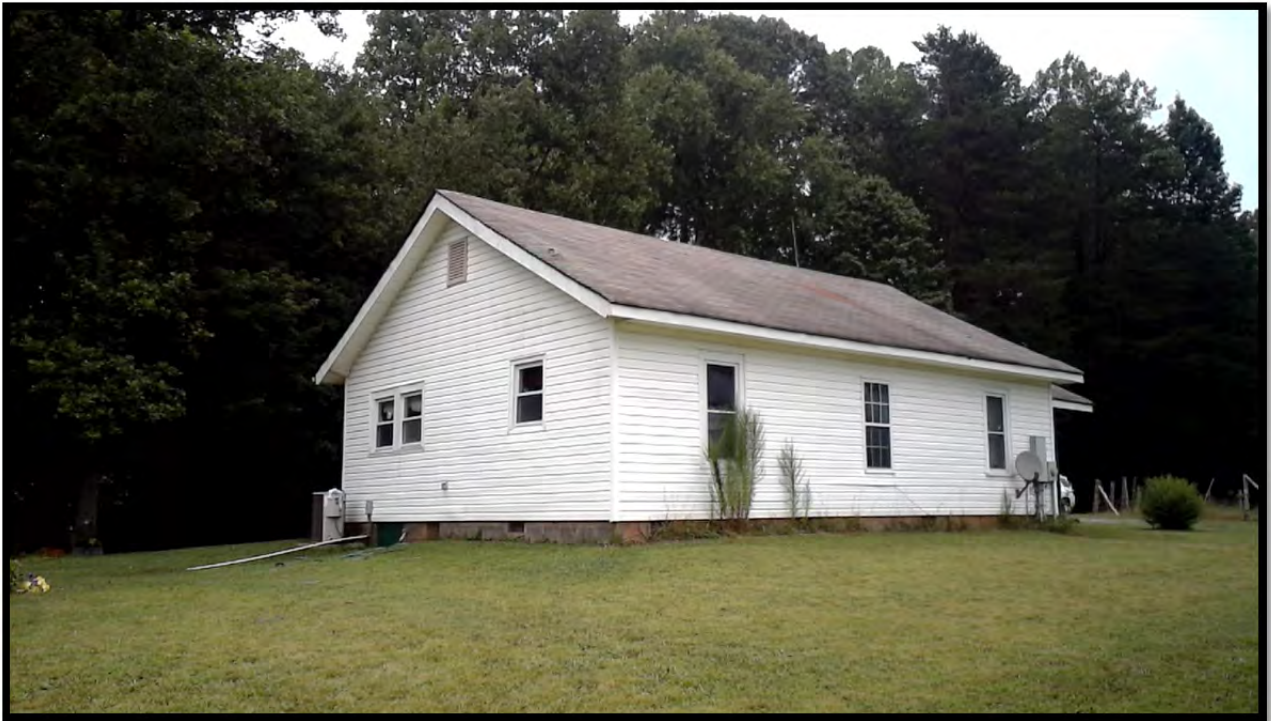
The single story rectangular frame vernacular home located near the extreme northern boundary of the parcel was moved to the property in the 1980s. The structure is currently used as a rental property. It has a three bay façade with centrally located single wood panel door flanked by single one-over-one vinyl windows set under the front porch that extends the majority of the façade with an asphalt shingle covered gable roof supported by square wood posts. Single one-over-one windows are set in a regular fenestration pattern around the home. The house sits on a continuous concrete block foundation and the exterior has been covered in vinyl siding with corner boards. Access to the interior was not available. Overall the home seems to be in good condition and well kept.

Lloyd Canipe House (House 2) looking north

Façade and front porch of Lloyd Canipe house; moved to property in mid-1980s

Southwest corner of House 2 looking northeast

Northwest corner and rear elevation of House 2

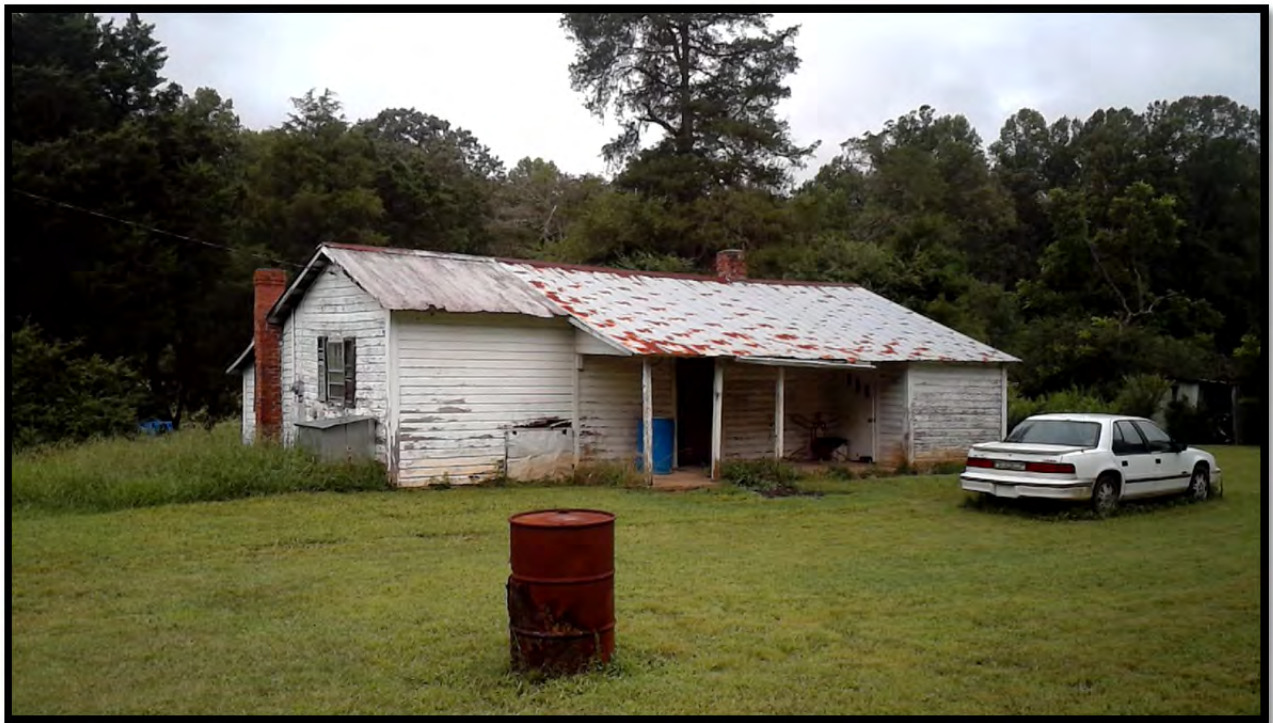
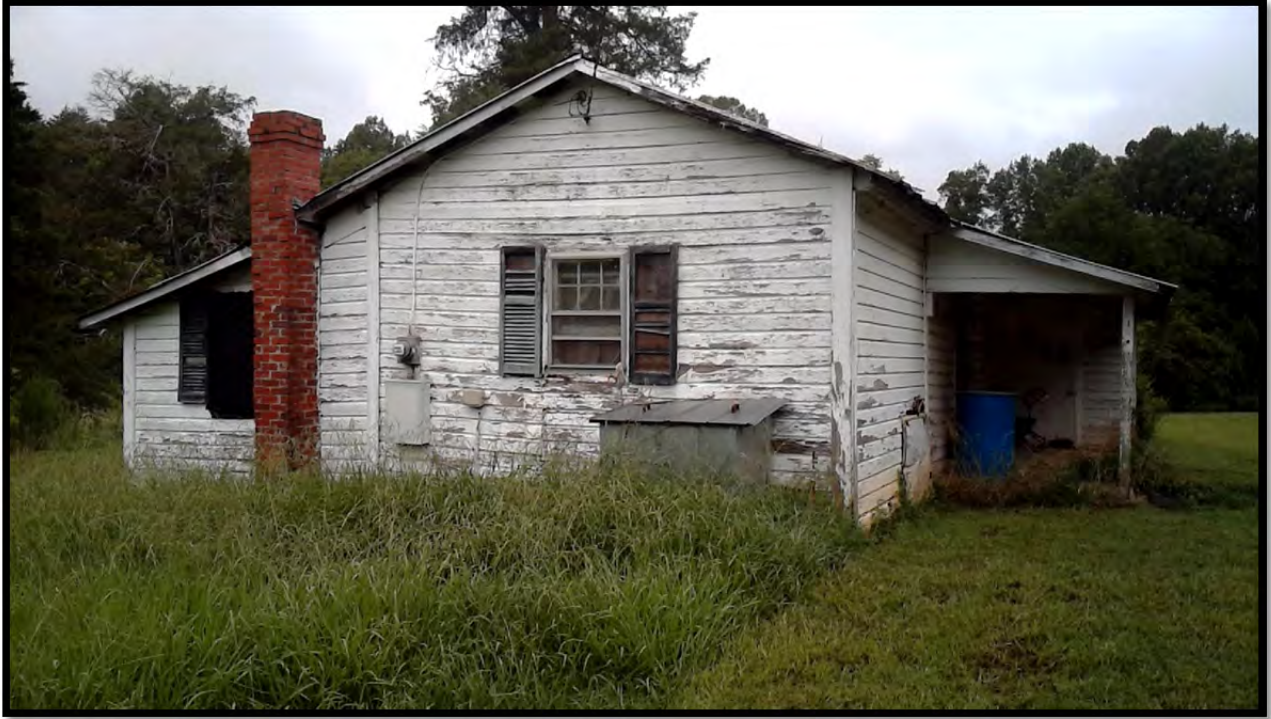
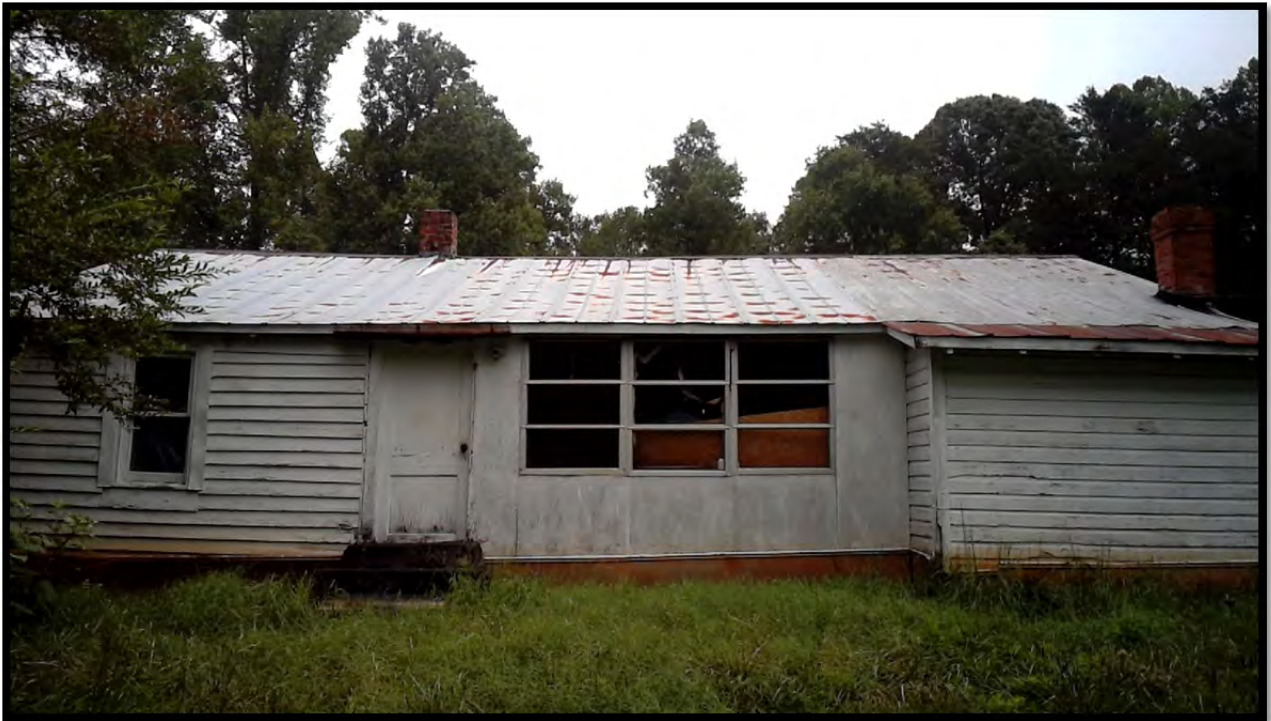
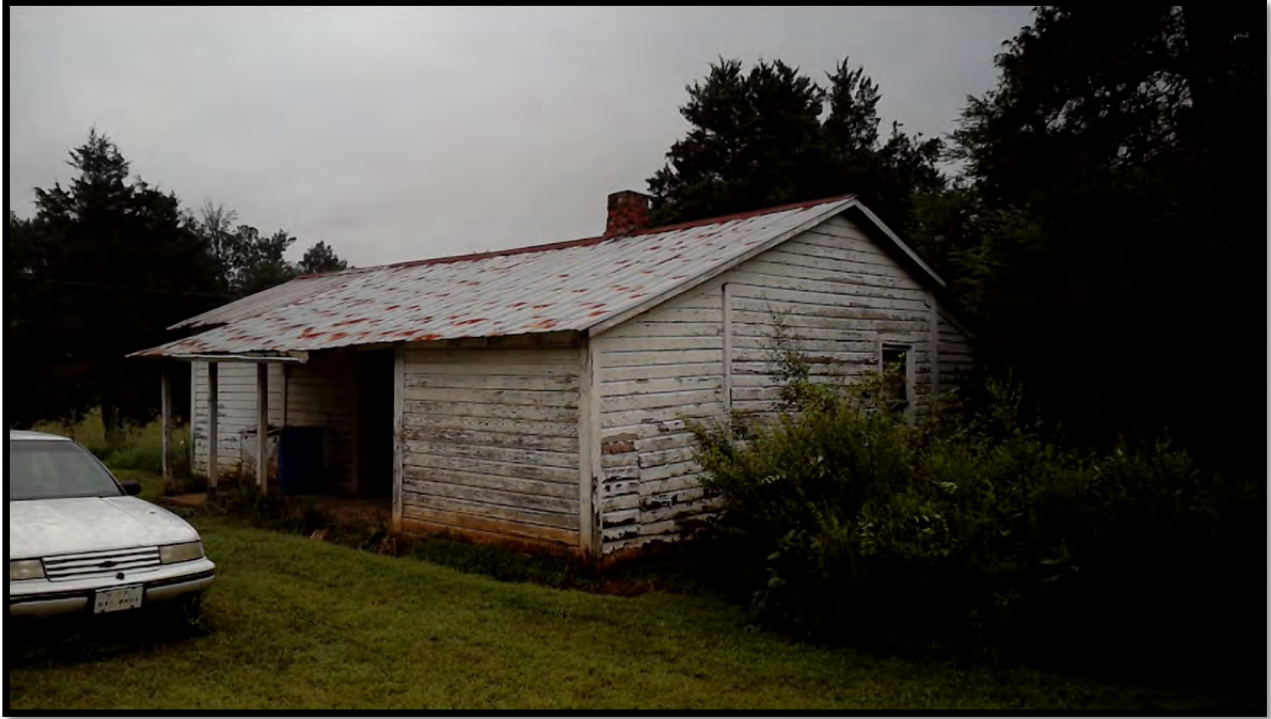
This simple L-shaped vernacular home is of wood frame construction and clad with German cove drop wood siding, lap siding and corner boards. The front (east side) of the house appears to rest on grade; the rear of the home rests on piers that have been filled in with underpinning. There have been small room additions to the floor plan over time, and the rear porch was enclosed by Dewey Hunsucker.² The façade contains no window openings. A central single door entry is located behind a small front porch under the extended main roof supported by square wood posts. Single one-over-one and six-over-six window openings pierce the north, south and west elevations. The side gable roof is clad in five-V crimp sheet metal with two brick chimneys, one on the ridgeline in the main portion of the home and the second on the south elevation. The home is vacant and in a deteriorated state. The interior of the home was unavailable for inspection.

c. 1880s J. P. Heffner home looking northwest

South elevation and possible addition

Rear (west) elevation; enclosed rear porch

Northeast corner of J.P. Heffner house looking southwest
