SUBJECT: Historic Structures Survey Report, Widen SR 1523 (Wilson Ridge Road) from SR 1522 to US 421/US221, PA 16-11-0001, U-5810, Watauga County, ER 16-1985

**Historic Architectural Resources Eligibility Report
Widen SR 1514 (Bamboo Road) and SR 1523 (Wilson Ridge Road) from SR 1522
(Deerfield Road) to US 421/US 221
Watauga County, North Carolina
PA# 16-11-0001
TIP# U-5180
WBS# 44383.1.1**

Resource Name: 5544 Bamboo Road, Bamboo Quarry and 5605-5665 Bamboo Road, Bamboo Quarry

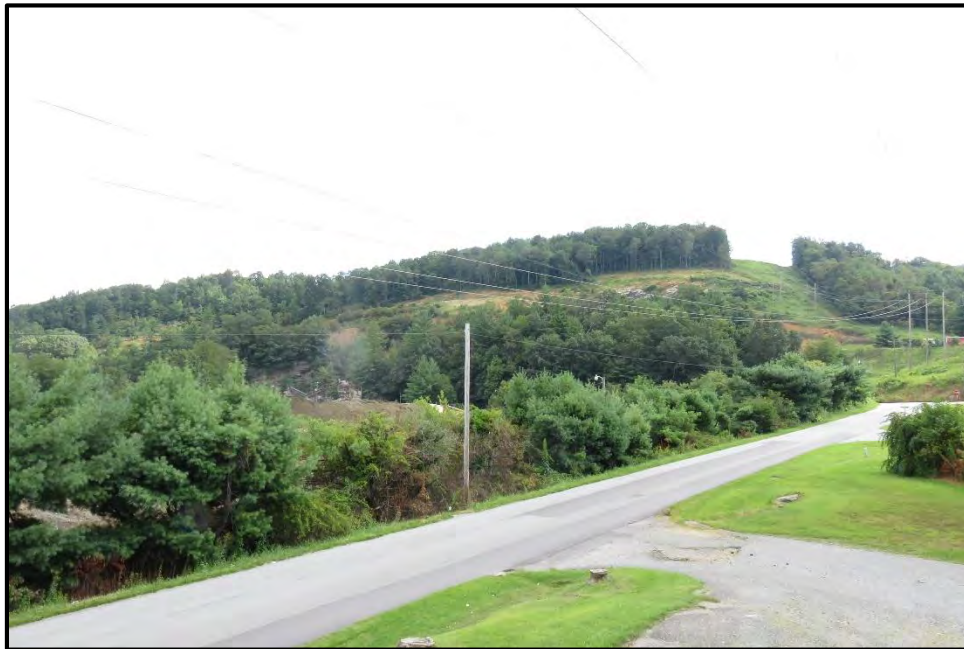
Figure 2: Overview of WT951 (mid-ground) and WT950 (background) with Rocky Knob in the distance.

Quarry: The quarry occupies 14.72 acres at the center of the parcel. The north-south axis is approximately two-tenths of a mile and the east-west axis is approximately one-tenth of a mile with both measurements taken at the longest section of each axis. The quarry is roughly oval in shape and elongated at the north-south axis. Equipment located within the quarry was not visible from the road. However, the location of crushing equipment along SR 1514 indicates that there is a system of conveyor belts or dump truck access roads supporting the excavation activities within the quarry which transfer rock to crushers along SR 1514. USGS topographical maps indicate that the quarry transitions rapidly from nearly 3400 ft to 3200 ft in elevation east to west, respectively. As a result, excavation walls visible from the road are between 150 ft and 200 ft above SR 1514, with the quarry likely excavated below the roughly 3200 ft elevation of SR 1514. There are access roads encircling the quarry with a single gravel road connecting the quarry to SR 1514 and the rear of the crushing equipment and operator observation shed. Other details of the quarry, including additional equipment and any other access roads, were not visible from the ROW (Figures 2, 4, and 5).

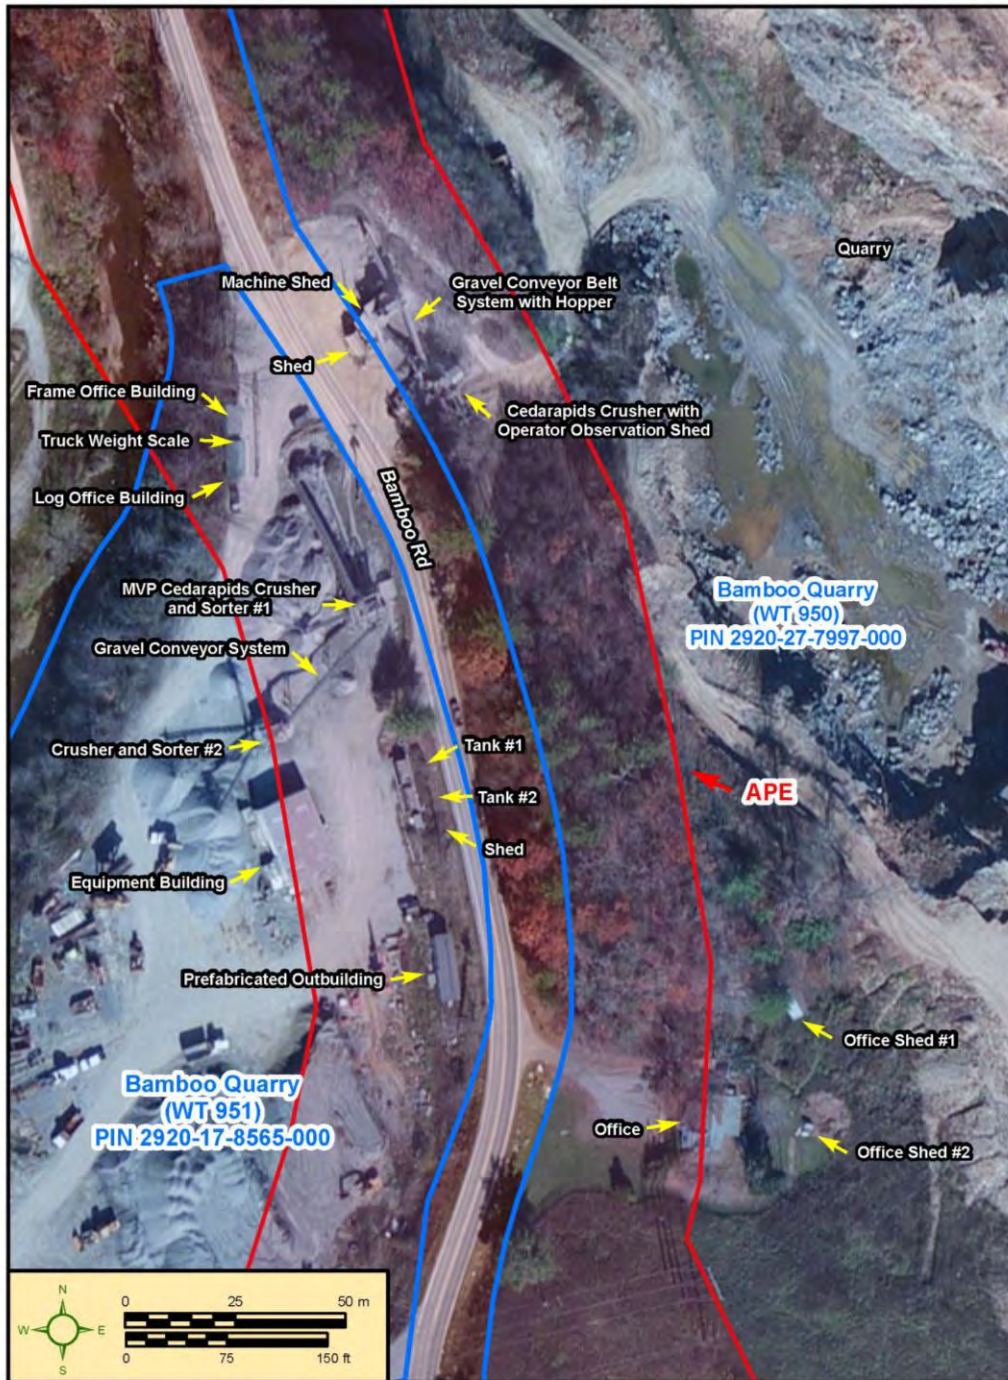
Figure 3b: Site plans for both 5544 Bamboo Road, Bamboo Quarry (WT 950) and 5605-5665 Bamboo Road, Bamboo Quarry (WT 951).

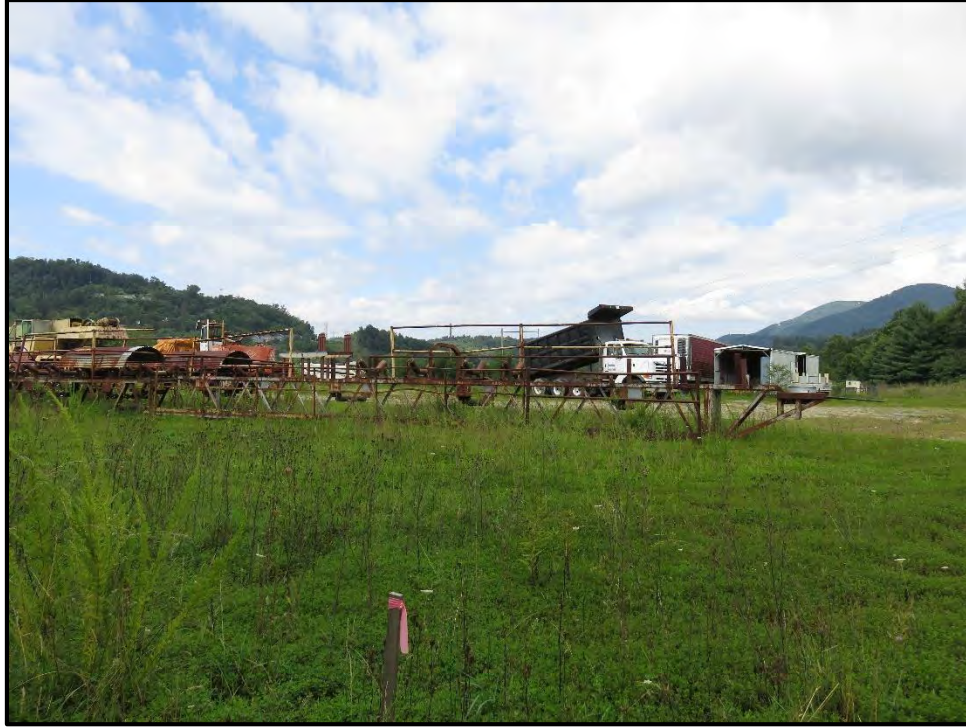
Figure 4: Overview of the storage area on the southern portion of the parcel, looking north.

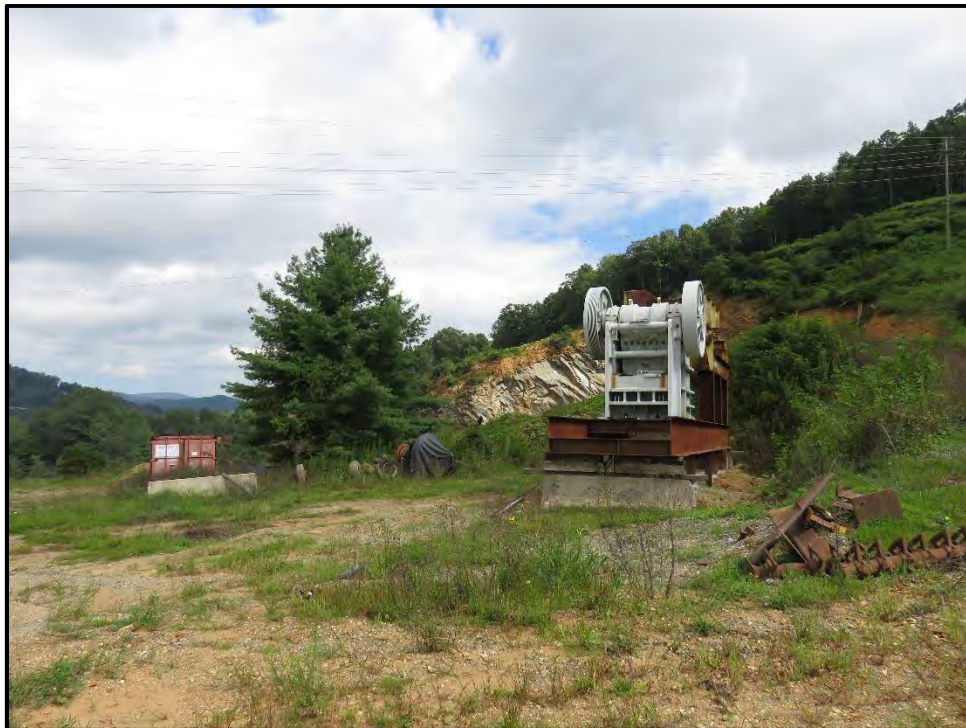
Figure 5: Overview of the storage area on the southern portion of the parcel, looking northwest towards Rocky Knob.

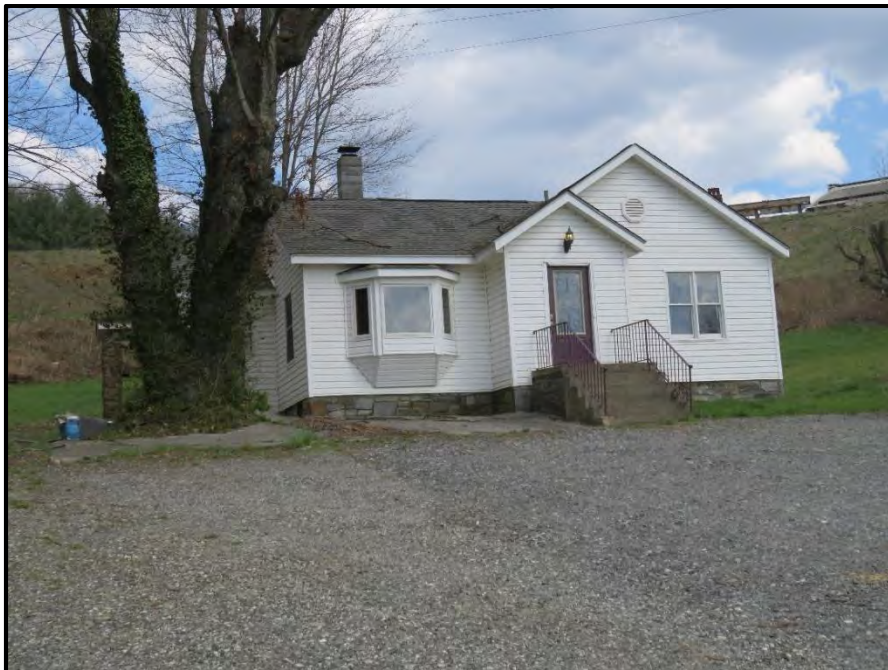
Office: This c. 1935 one-story, frame residence, now converted into an office, has three bays (www/d/ww) and sits on an uncoursed stone foundation (Figure 6). The house features a projecting cross gable with the main entrance accessible by a stone stair with metal railings. The cross-gable roof is clad in asphalt shingles and the house is wrapped in vinyl siding. The roof is pierced by an interior-ridge, concrete block chimney. The north (side) elevation features a one-story, one-bay portico over a poured concrete pad, with the gabled hood supported by uncoursed random rubble masonry columns with raked joints (Figure 7). Windows throughout the house are one-over-one, double-hung vinyl replacement windows. The front (west) elevation has a large, modern bay window toward the northern end. The south (side) elevation features a single projecting bay, octagonal vinyl louvered vents, and basement windows puncturing the foundation. The elevation has three windows. There is a large, one-story shed roof addition situated on parged concrete at the rear (east) elevation (Figure 8).

Figure 6: Façade of the former residence, looking east.

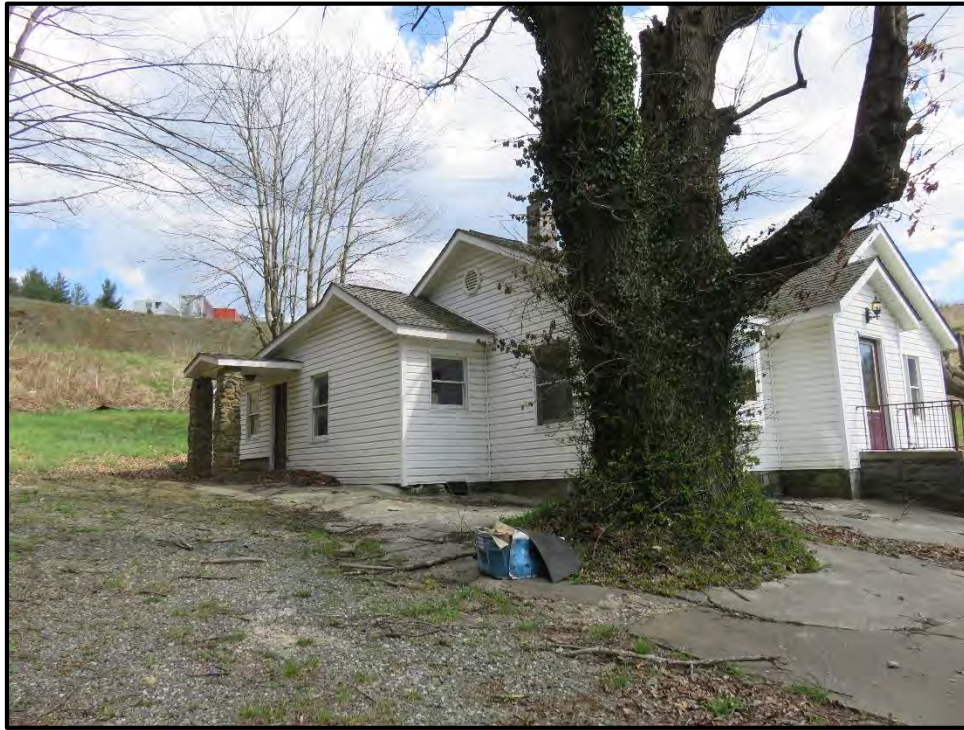
Figure 7: Corner view of the former residence, looking southeast.

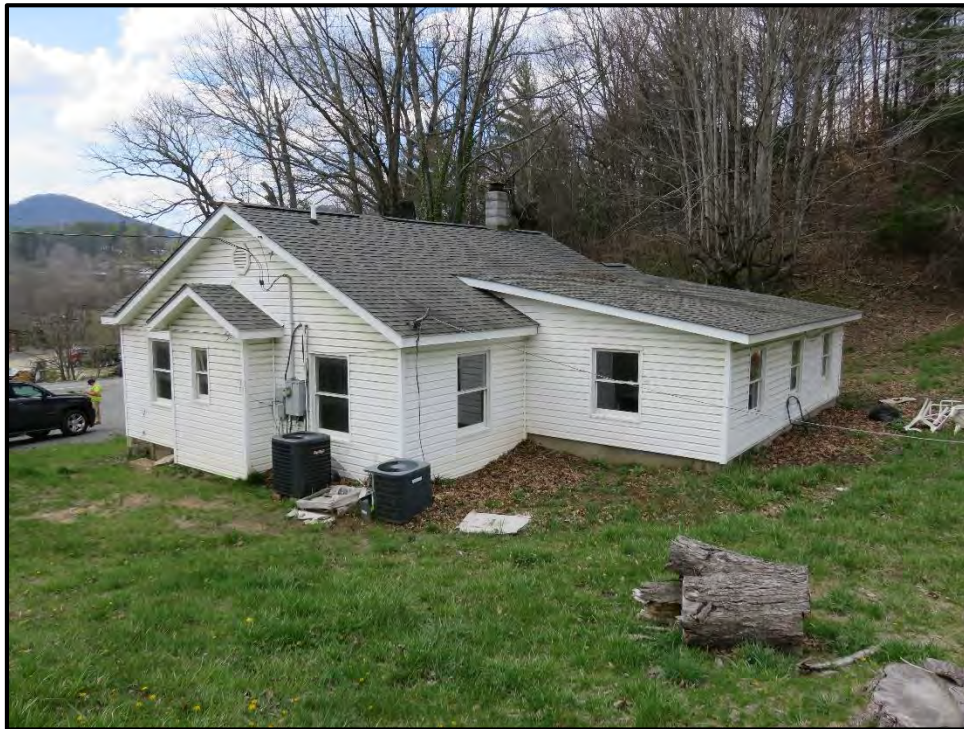
Figure 8: Rear view of the former residence, looking northwest.

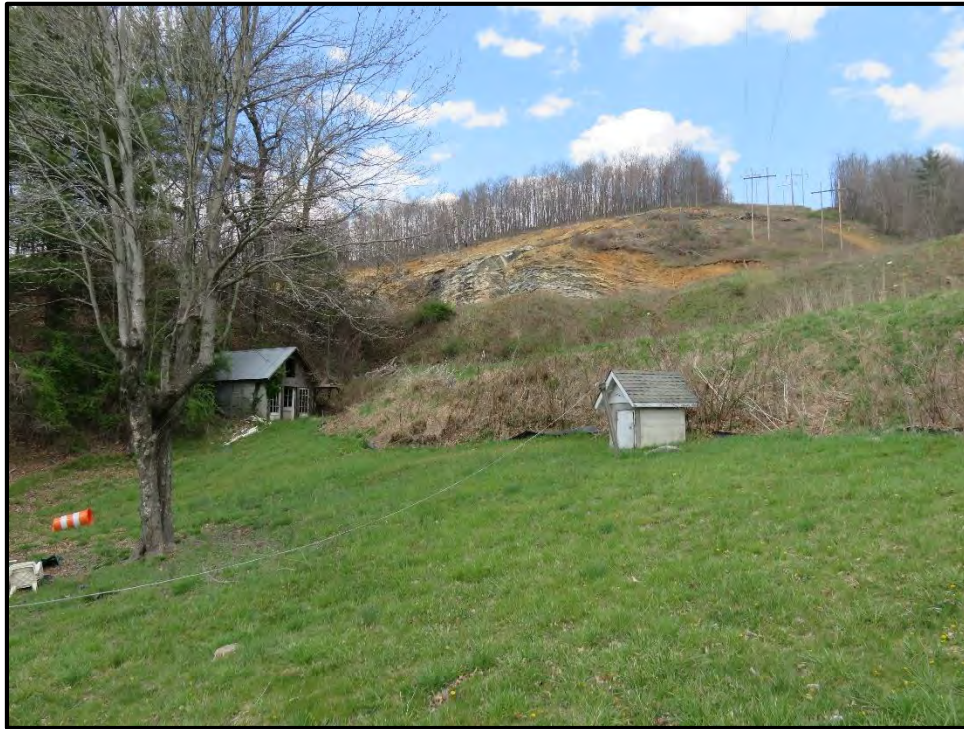
Office Shed #1: A c. 1950-1970 frame, front-gable shed is located approximately 57 ft northeast of the residence's northeastern corner. The concrete block structure has a v-crimp metal roof and central single-leaf door with six lights and a single wood panel. The door is flanked by fixed, twelve-light windows over a narrow, rectangular wood panel. There is an opening in the gable-end that likely accommodated a window or door at one time (Figure 9).

Office Shed #2: Approximately 42 ft east of the residence is a one-story, front-gable c.1950-1970 shed that may be a pump house or storage shed. The concrete block structure has a single latched entry and the roof is clad in asphalt shingles (Figure 9).

Figure 9: View of sheds associated with the former residence, looking northeast.

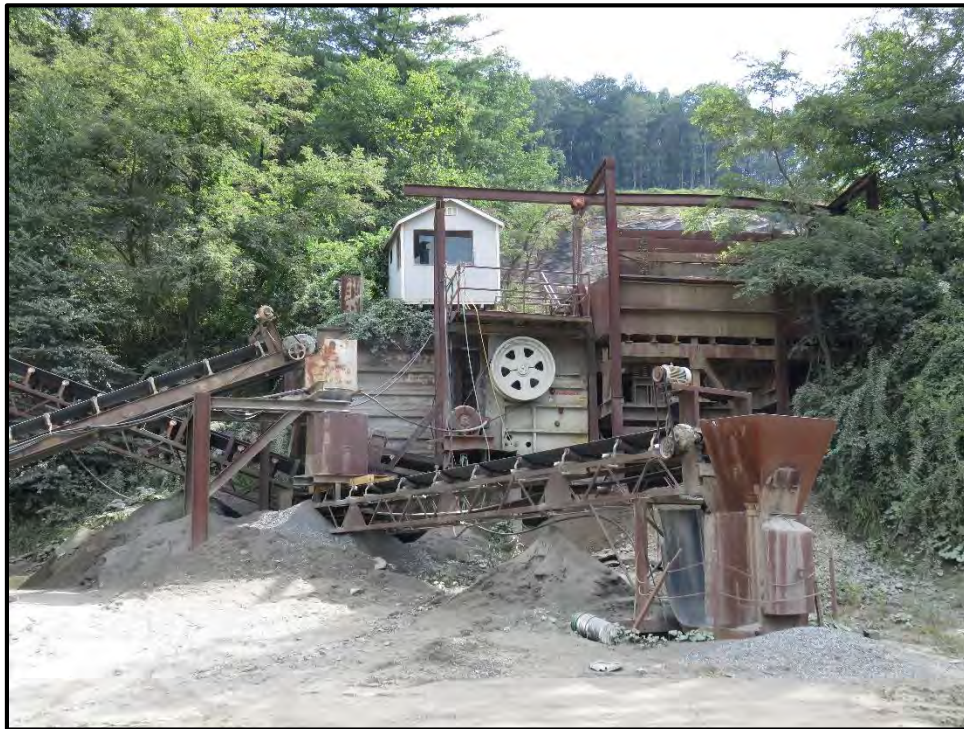
Gravel Conveyor Belt System with Hopper: Four large conveyor belts transfer various sizes of crushed rock from the quarry (not visible from the ROW) to the crushers located on this site. The belt system ultimately dumps rock to form a gravel pile to the north that is then used to load dump trucks. Meanwhile, another conveyor belt transfers gravel to a hopper serving the conveyor belt that passes underneath SR 1514 to a gravel pile on the WT951 parcel. The conveyors feature heavy rubber belts with supporting rollers spaced approximately every two feet at the apex of the truss support running along each steel beam. The beams are held by vertical steel posts that are often modular in design. The gears and motor that generate the power for the belt are mounted above these posts, which often form an H- or U-shaped pattern. The hopper appears to date from the same period as the conveyor belts. While it is difficult to date equipment that has no maker marks or other identifying features, these belts likely date from c. 1970 to c.1990 (Figure 10).

Figure 10: View of quarry machinery with Cedarapids jaw crusher, hopper, conveyor belts, and operator observation shed, looking east.

Cedarapids Crusher with Operator Observation Shed: This gravel crusher with steel I-beam super structure is manufactured by Terex Mineral Processing Systems under the Cedarapids brand (Terex Corporation 2017). This jaw crusher appears to be a relatively recent replacement. However, the steel support structure pre-dates the crusher and is likely from c. 1970 to c. 1980. Jaw crushers function by rapidly lifting a ridged die near a fixed, ridged steel plate. The plates create a wedge with a small opening at the bottom allowing crushed stone to fall to conveyor belts below. Stones are dropped in the opening and the vertical action of the die lifts the stone repeatedly, forcing it against the ridged steel plate, cracking the stone to the desired size until falls through the bottom opening. Large gears on either side of the crusher are belt-driven to provide power to the die (Figures 10 and 11).

Sitting on a steel frame above the jaw crusher, and accessible by a steel platform with metal railing, there is a one-story, pre-fabricated c. 1990 shed with plate glass windows and slightly overhanging eaves. The structure is wrapped in T1-11 siding and has an asphalt shingle roof. The structure appears to sit

partially on a steel retaining wall and partially on stone. The joists are not supported on the corners visible from the ROW.

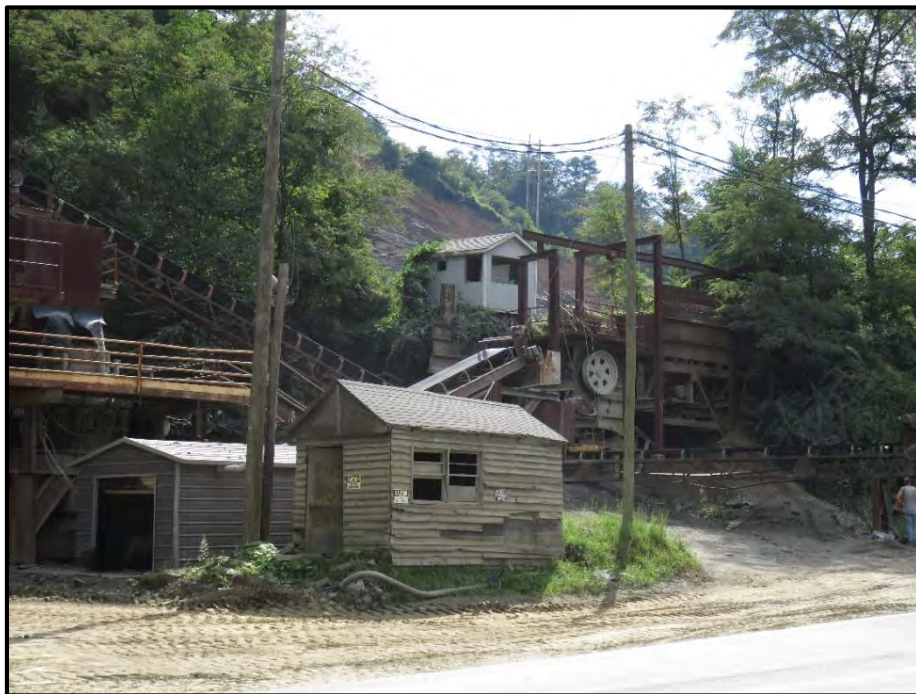
Shed: This one-story, front-gable shed faces north towards the gravel pile and loading area just off SR 1514. The shed is approximately 20 ft east of SR 1514 and forms the first of three main structures within this section of the quarry. The shed is wrapped in weatherboard siding that has significantly deteriorated, revealing plywood sheathing underneath. The building is set on a pier foundation of either stone or concrete block, which is obscured by grass and fallen siding. The building is marked with high voltage signs indicating that it could house electrical service for the large crushing equipment and conveyor belts. The gable roof is clad in asphalt shingles and has exposed rafter ends that are further exposed by deterioration along the roof's eaves. The gable ends are filled with plywood and there is a single-leaf entry door. The windows, largely missing their glass panes, were originally two-over-two, double-hung wood sashes (Figures 11 and 12).

Figure 11: Detail view of sheds, looking southeast.

Machine Shed: A c. 2000, front-gable prefabricated shed is located immediately to the east of the quarry shed. The roof and sides are clad in v-crimp metal and there is a single entry on the façade (north). The foundation is not visible from the ROW (Figures 11 and 12).

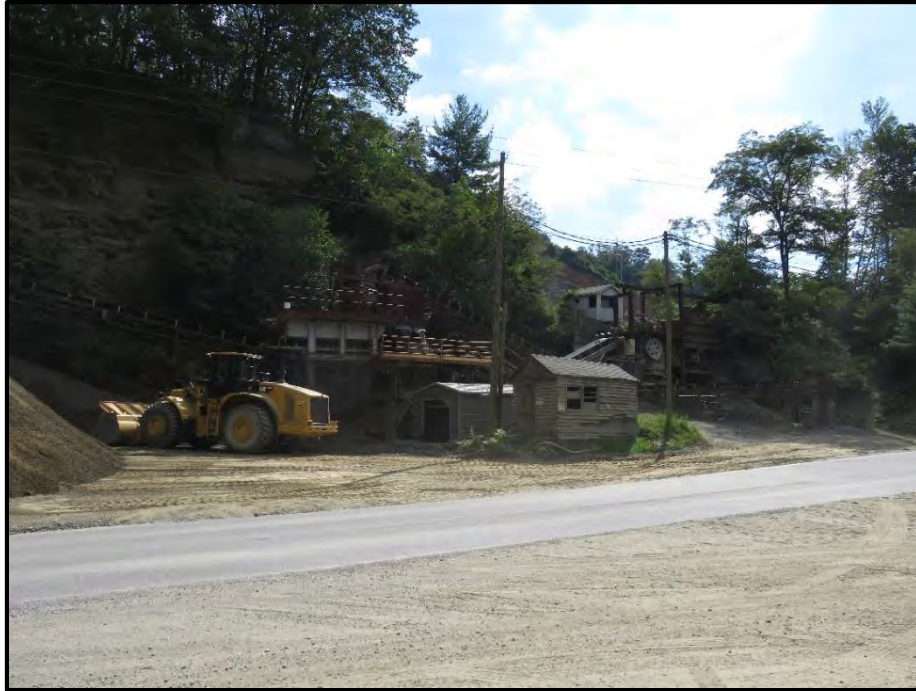
Figure 12: Overview of WT950 quarry machinery as visible from the ROW, looking southeast.

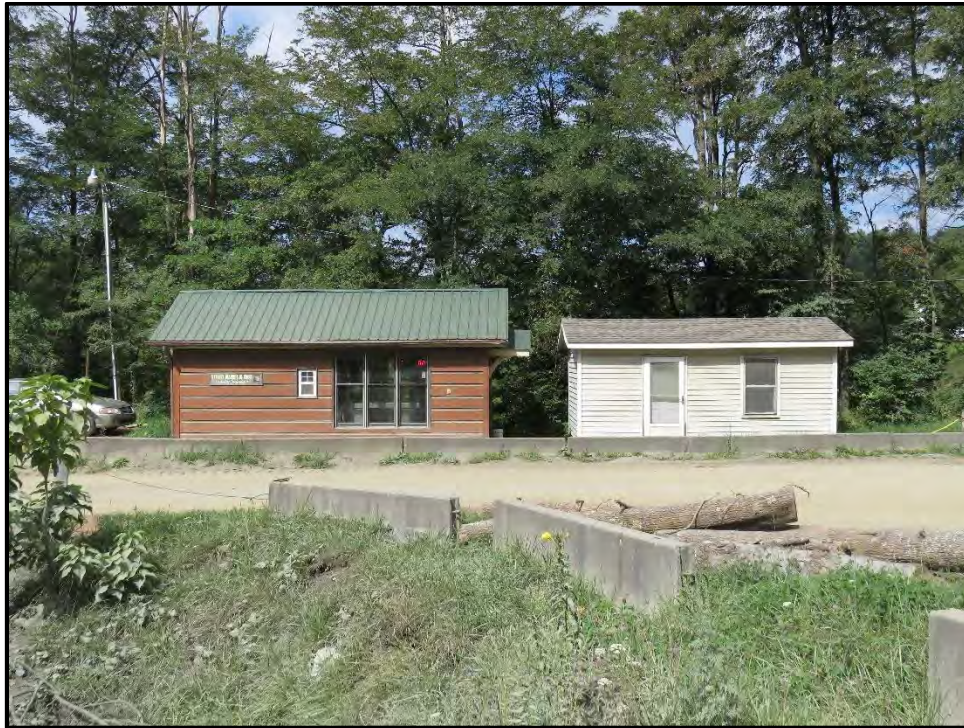
Log Office Building: This c. 2010 prefabricated log building sits approximately 77 ft southwest of SR 1514 between the primary gravel drive and the South Fork of the New River. This one-story, front-gable building has machined-flat logs set into corner posts over a poured concrete slab foundation. The gable roof with overhanging eaves is clad in v-crimp metal. There is a pedimented entrance with oversized brackets on the east elevation. The building features bands of three one-over-one, double-hung vinyl windows and several smaller one-over-one windows with snap-in grids mimicking four lights (Figure 13).

Figure 13: Log and frame offices located at the principal driveway to WT951, looking north.

Frame Office Building: The c. 1990-2000 side-gable, frame structure houses a second office on the property. The two-bay (d/w) building sits on a poured concrete foundation and is wrapped in vinyl siding. The gable roof is clad in asphalt shingles and has overhanging eaves. There is a single-leaf door on the south elevation. Windows throughout the structure are one-over-one, double-hung vinyl sashes with screens. This building likely monitors the weight scale immediately to the south (Figure 13).

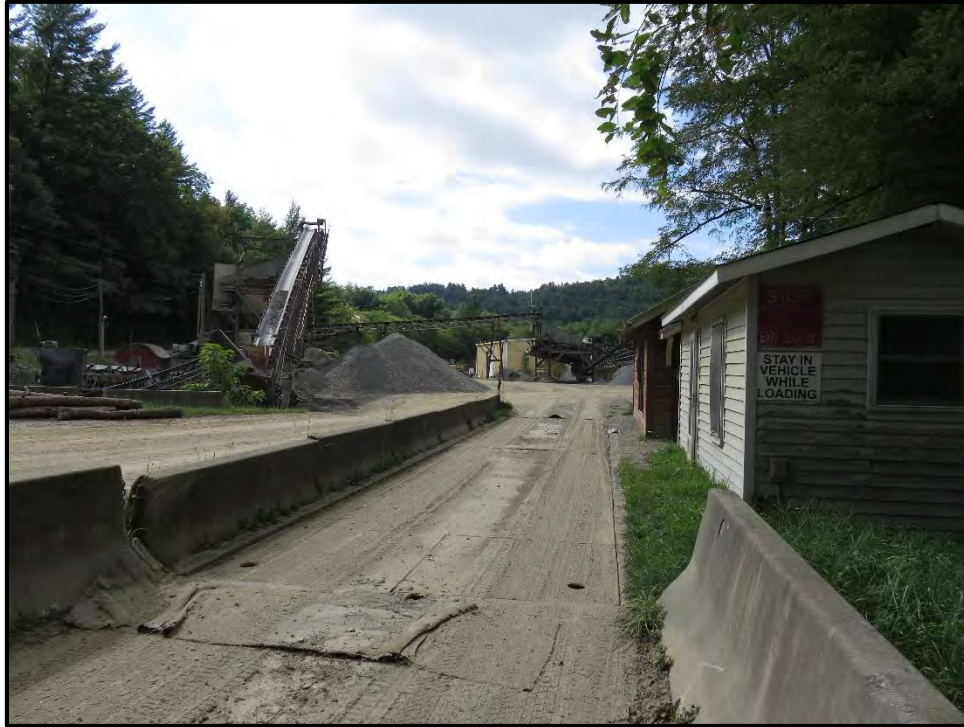
Truck Weight Scale: The truck weight scale consists of two pressure-sensitive plates that assist in measuring the weight of trucks both entering and exiting the facility. The two office buildings sit to the north of these plates, and large concrete barriers sit to the south and define the scale area from the rest of the driveway. The rest of the scale mechanism is below ground and not visible from the ROW (Figure 14).

Figure 14: View of truck weight scale and offices, looking west.

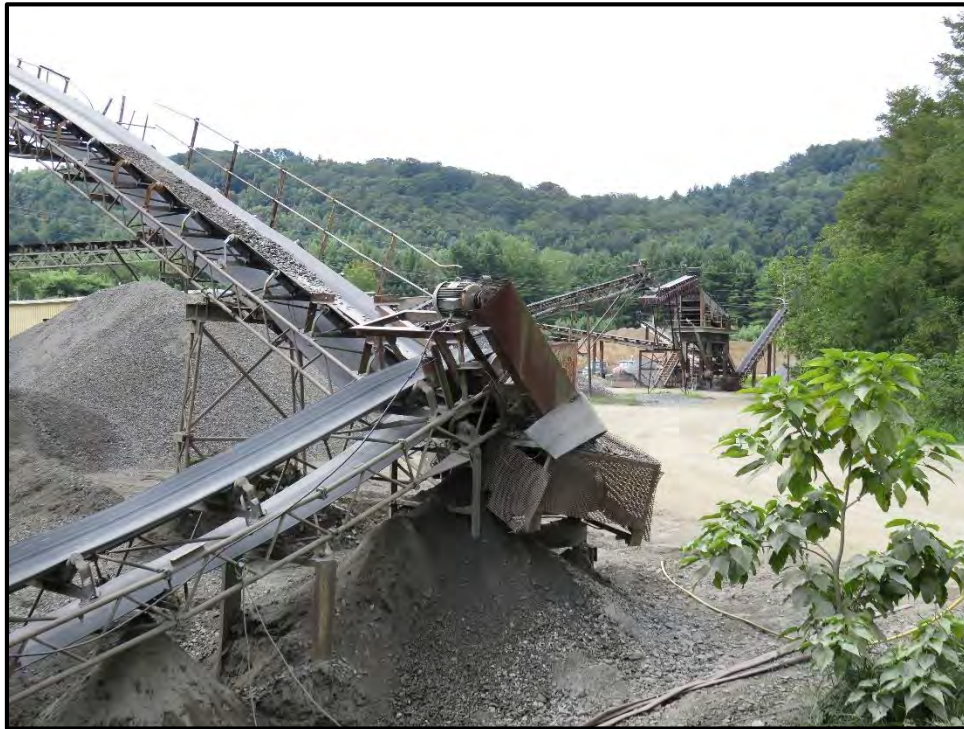
Gravel Conveyor System: A series of rubber conveyor belts supported by steel beams create a network connecting WT950 and WT951 underneath SR 1514. Belts then connect from the crusher immediately adjacent to SR 1514 to a second crusher and sorter. From there, sorted crushed rock is deposited into separate piles for transport. These belts appear to date from c.1970 to c.1990 and feature steel I-beam posts supporting trussed beams with rollers that allow the belt to carry the weight of the crushed rock and sand (Figure 15).

Figure 15: View of the belts connecting both crushers, looking west.

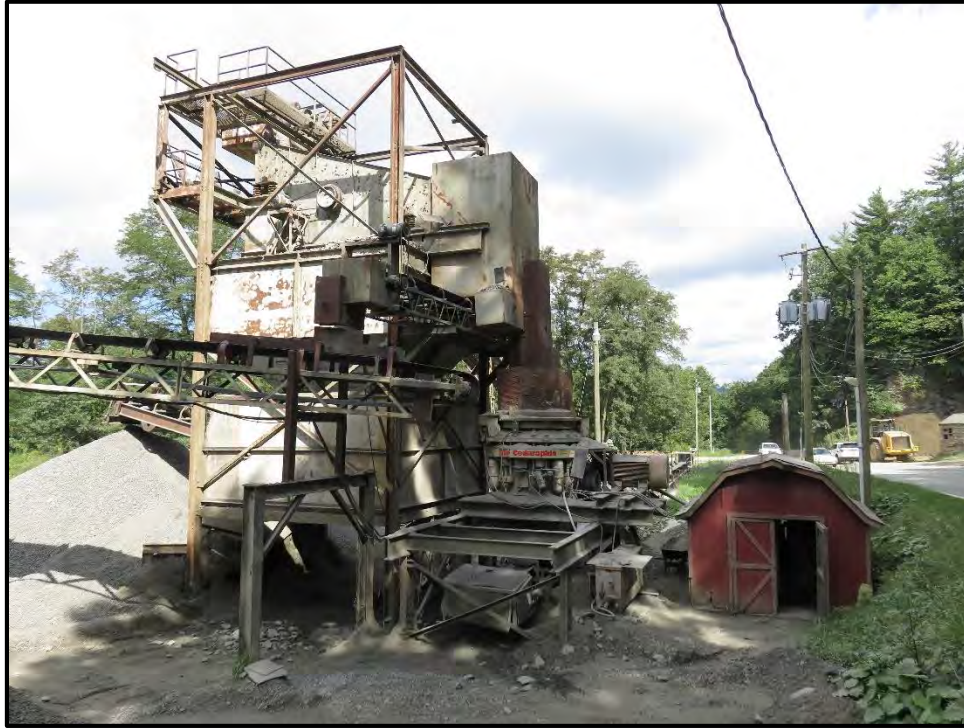
Prefabricated Shed: A c. 2005 prefabricated shed sits immediately to the south of the principal driveway between SR 1514 and the large crusher. This one-story, gambrel shed has flared overhanging eaves, T1-11 siding, and an asphalt shingle-clad roof. Windows throughout are one-over-one, double-hung vinyl sashes. The foundation is not visible from the ROW (Figure 16).

Figure 16: View of the prefabricated shed and crusher, looking north.

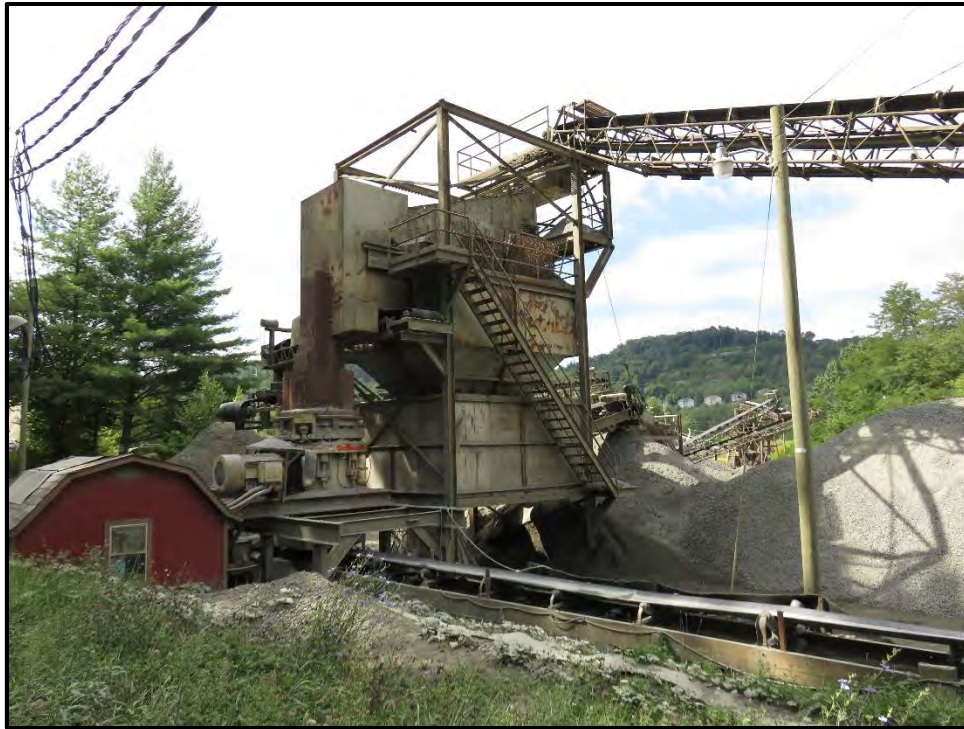
MVP Cedarapids Crusher and Sorter #1: While much of the machinery may pre-date the crusher, the MPV Cedarapids cone crusher likely dates from 2005-2010 and replaced an earlier crusher. Cone crushers typically feature a central steel cone wrapped by a second steel plate with a small opening at the bottom of each piece to allow sized crushed stone to fall to screens or conveyor belts below. The top of the machine has an opening to feed larger rocks into the crusher. The cone typically rotates along the plate (although the plate can be rotating in some models), crushing stone by impact while opening the opposite side so crushed stone can fall below the machine. This machine also contains a sorter for sizing rock that has been crushed (Figures 16 and 17).

Figure 17: View of the crusher, looking southwest. The red lettering in the image is the Cedarapids logo.

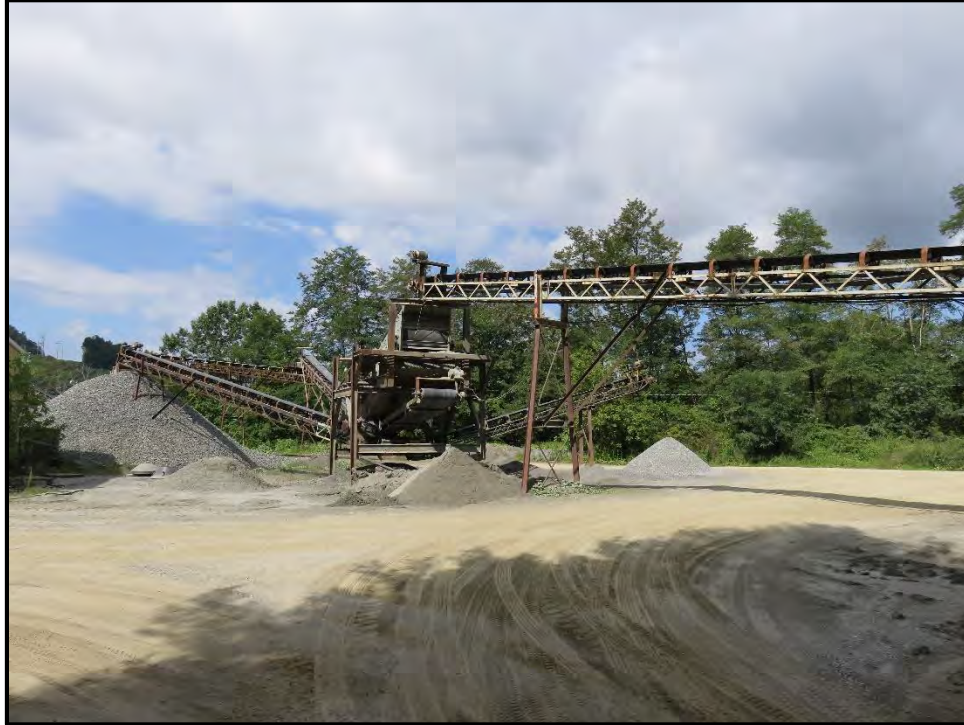
Crusher and Sorter #2: A second crusher and sorter are located approximately 300 ft southwest of SR 1514 with supporting steel I-beams and an accompanying system of conveyor belts. The model of the crusher and other details are not visible from the ROW (Figure 18).

Figure 18: Northwestern view of second crusher, looking northwest.

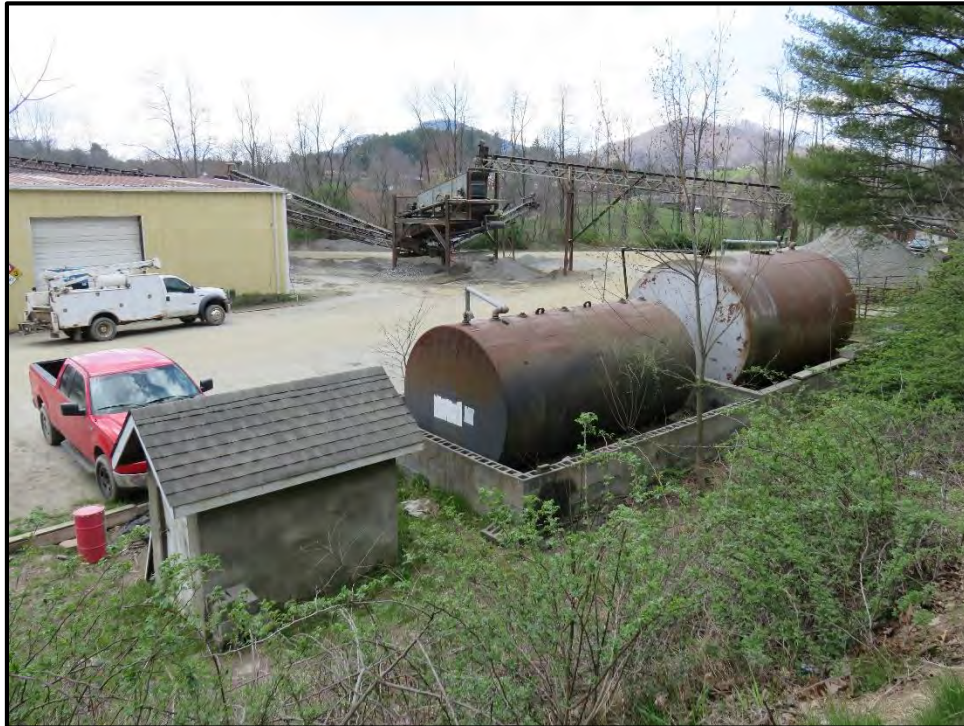
Tank #1: South of the main crusher and immediately adjacent to SR 1514, there is a c. 1980 large steel tank, approximately 14 ft in length, surrounded by a low concrete block wall (Figure 19).

Tank #2: Immediately south of Tank #1, this c.1980 steel tank is similarly enclosed by a low concrete wall and is approximately 14 ft in length (Figure 19).

Shed: Approximately 3 ft southeast of the tanks is a c. 1990 one-story, front-gable parged concrete block shed. The roof has overhanging eaves and is clad in asphalt shingles. There is a single-leaf entry on the south elevation (Figure 19).

Figure 19: Northwestern view of both tanks and the concrete block shed, looking northwest.

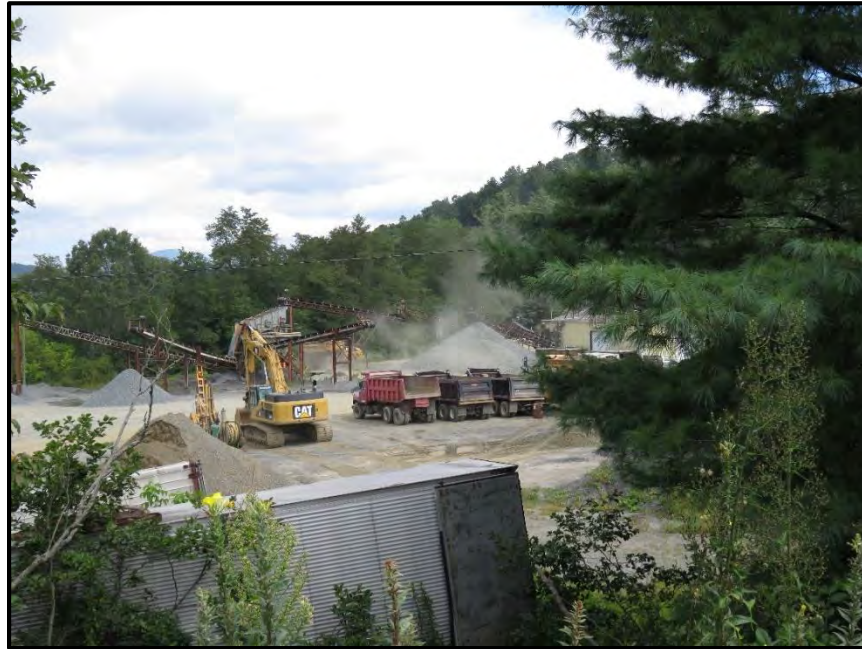
Equipment Building: Approximately 100 ft west of SR 1514 and 260 ft south of the South Fork of the New River, there is a one-story c.2010 prefabricated building. This metal panel building features a v-crimp metal roof, metal panel siding, and large metal garage doors on the south and east elevations. There is a single-leaf entry door on the north elevation. The west elevation and foundation are not visible from the ROW (Figures 20 and 21).

Figure 20: Overview of the western section of the property with dump trucks alongside the equipment building, looking northeast.

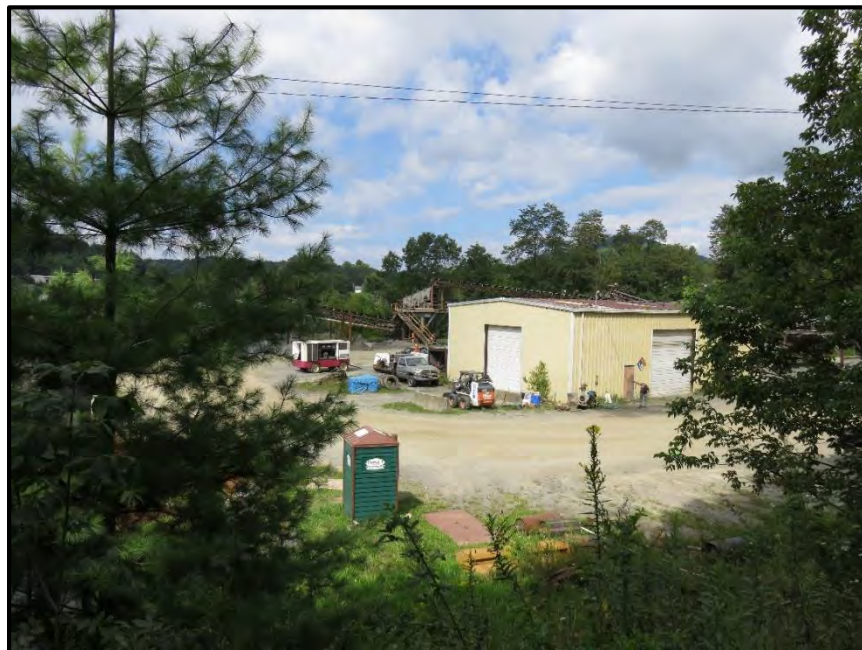
Figure 21: Western view of the equipment building, looking northeast.

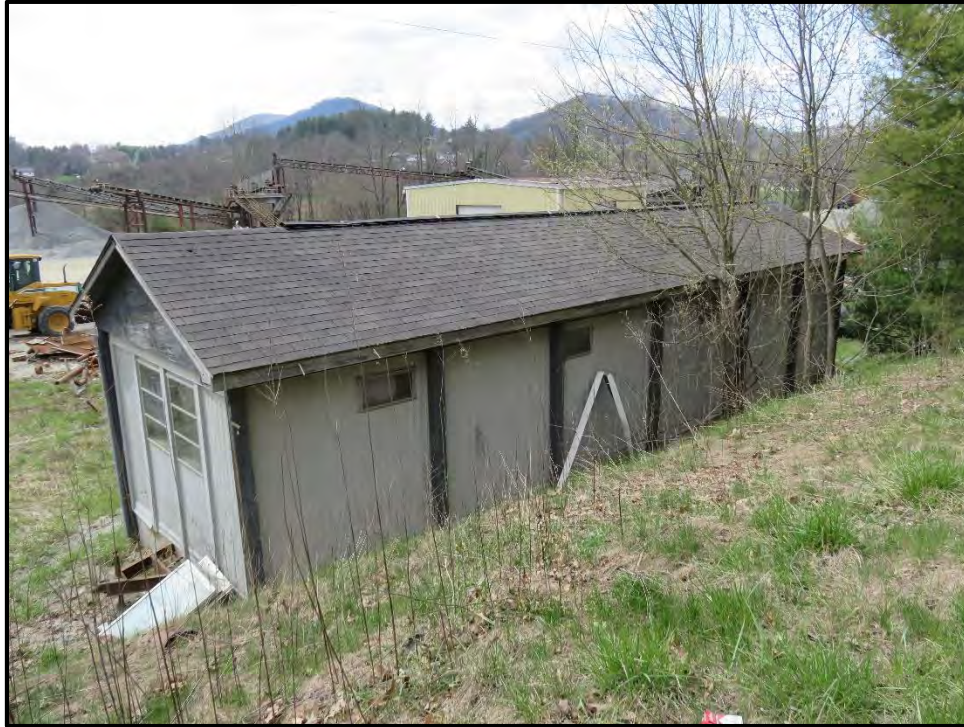
Prefabricated Outbuilding: Approximately 80 ft south of the concrete block shed, there is a one-story, front-gable outbuilding wrapped in T1-11 siding. The side bays are articulated by vertical boards and the north elevation has a single-leaf entry. The gable roof is clad in asphalt shingles with a central roof cap and plywood in the gable ends. Windows throughout the building are single-light fixed aluminum windows or three-light, fixed aluminum windows. The foundation is not visible from the ROW (Figure 22).

Figure 22: Northwestern view of the prefabricated outbuilding, looking northwest.

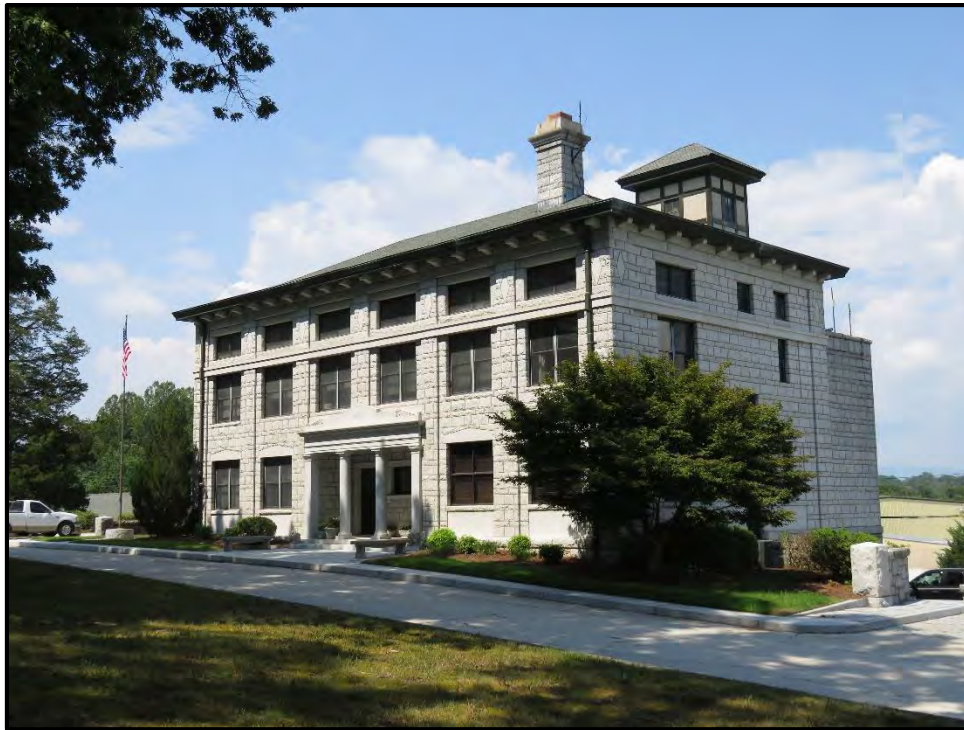
Figure 23: North Carolina Granite Corporation quarry office building constructed in 1928, looking west.

The architectural historian visited four of the six quarries: North Carolina Granite Corporation (Figures 23 and 24), Grove Stone and Sand Quarry (Figures 25 and 26), Glendale Springs Quarry, and Table Rock

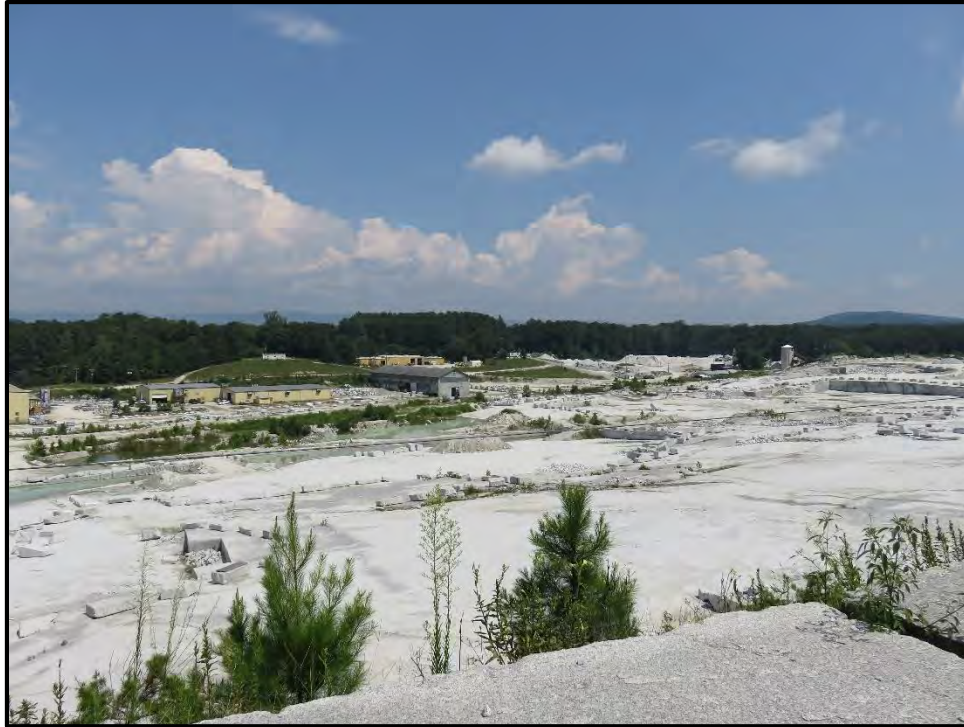
Figure 24: Overview of North Carolina Granite Corporation quarry, looking north.

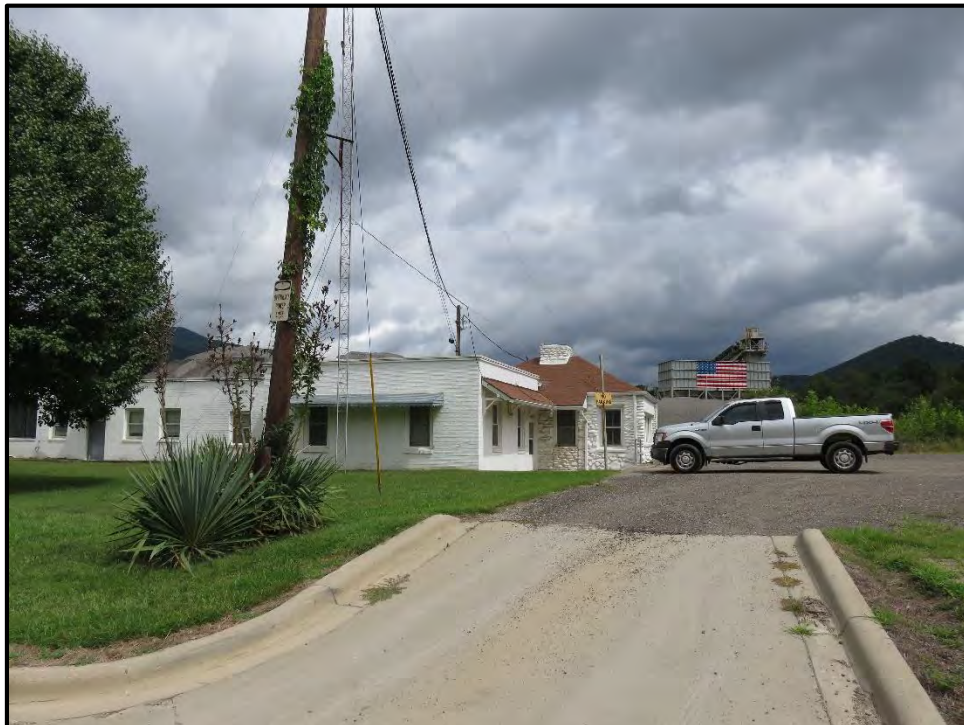
Figure 25: View of Grove Sand and Stone Quarry office building with stone masonry former residence in the rear, looking north.

In contrast to the architectural stone quarries, Grove Stone and Sand Quarry, Glendale Springs Quarry, and Table Rock Quarries, Inc., are crushed stone and sand quarries with products similar to those of Bamboo Quarry. These quarries all feature stone crushers and sorters with conveyor belt systems. Grove Sand and Stone Quarry in Black Mountain, Buncombe County, appears to show a similar progression in land use as a c. 1930-1950 residence has been converted to office space (Figure 25). Meanwhile, Glendale Springs Quarry only has one visible pre-fabricated shed serving as an office building next to the truck weight scales,

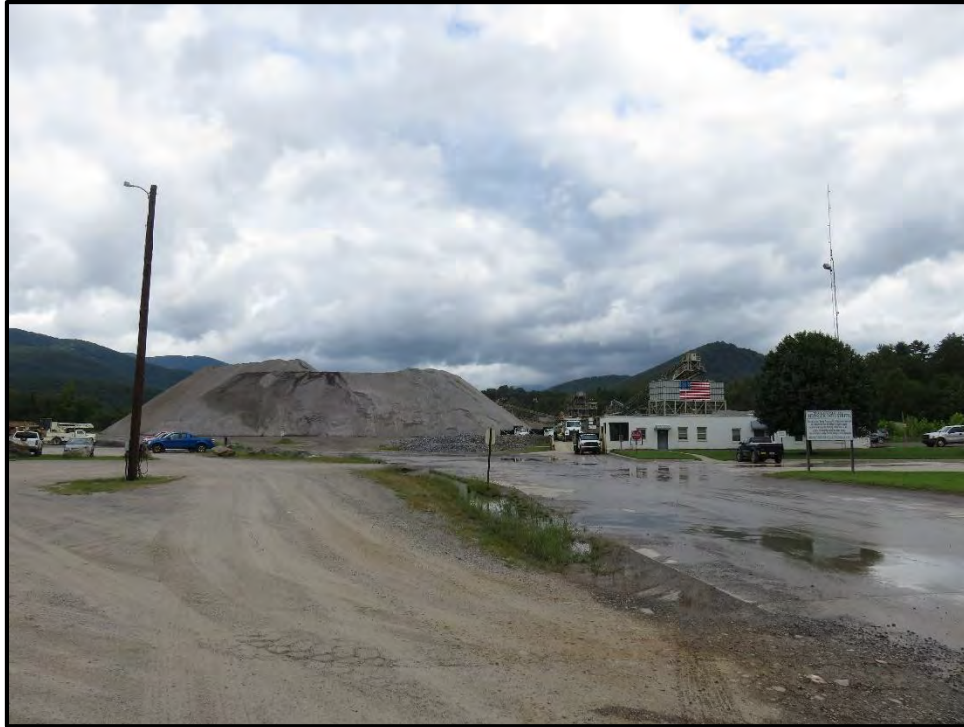
Figure 26: Northwestern view of Grove Stand and Stone Quarry and office building from the main entrance.
