Subject: Historic Structures Survey Report for Balfour Parkway from NC 191 to US 64,
PA 16-08-0004, R-5744, Henderson County, ER 16-2007

(#3) Corn-Rhodes House

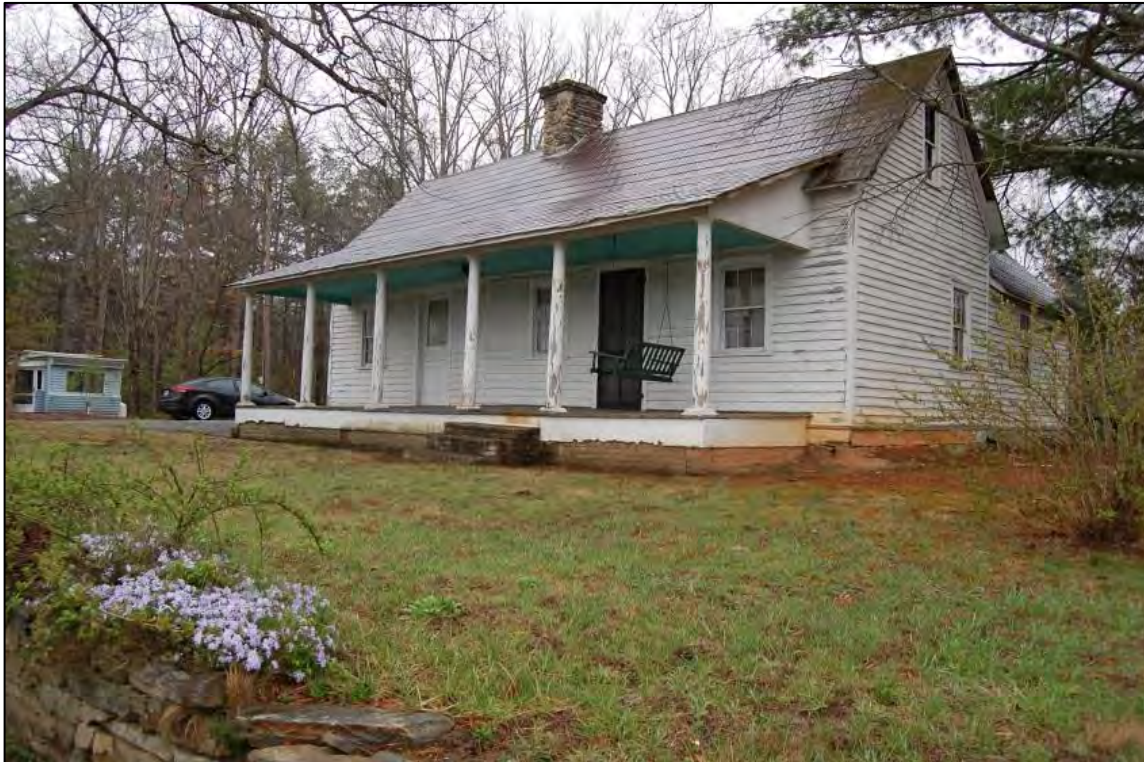
The one-story, single-pile, wood-frame Corn-Rhodes House is clad in weatherboard siding and features simple cornerboards. Plain surrounds frame its double-hung, six-over-six windows and multi-panel doors (Figure 4 through Figure 9). Overall, the five-bay-wide house is simply finished. The house's three western bays, likely dating from ca. 1875-1885, comprise its original hall-parlor-plan block. They sit on a stone foundation hidden by a wooden skirtboard (most likely added to create a more cohesive look when the house was extended) and are topped by a pressed-metal-shingle, gable-end roof. When looking at the front (north) elevation, the original section of the house is clearly differentiated from the later, two-bay, west wing addition by a thin piece of white molding to the left of the original three bays. The interior placement of a once-exterior-end fieldstone chimney on the ridge of the gable further indicates that the house was later extended to the east. The addition sits atop a brick foundation that is largely masked by the wooden skirtboard. Its proportions and finish, which match those of the original section, suggest it was added in the late nineteenth century. A one-story, shed-roofed porch supported by wooden Tuscan columns shades all five bays of the house's front elevation. Its beadboard ceiling is painted "haint blue." The porch stands on a brick foundation like that of the east wing and was likely added along with the addition.

Figure 4. North front and west side elevations of house; retaining wall in foreground and mobile home at far left

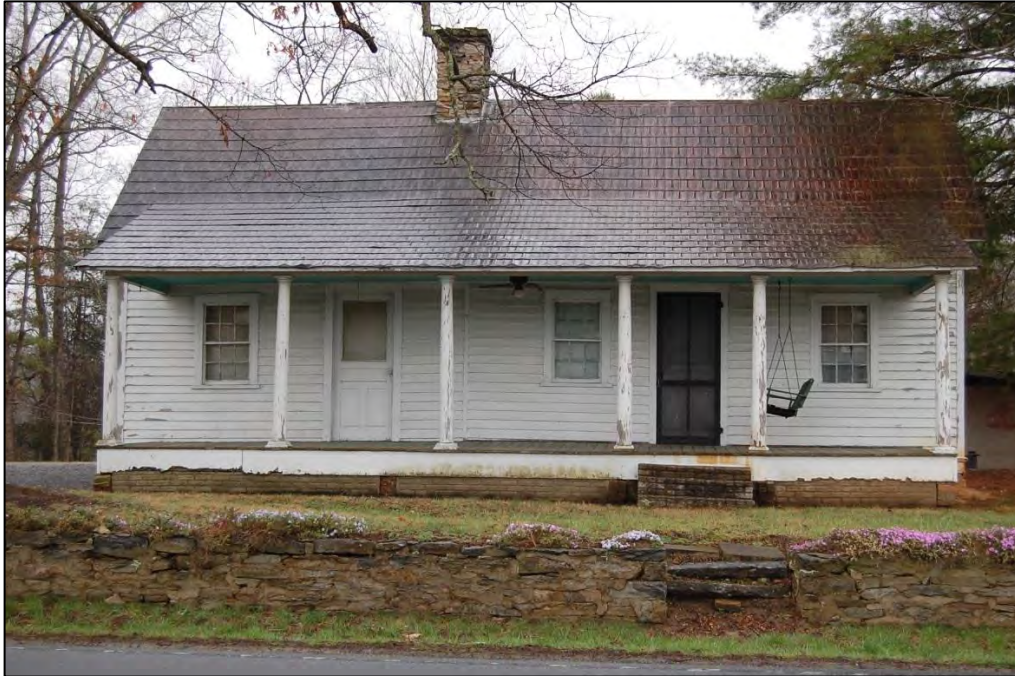
The stone retaining wall between the front of the house and Chimney Rock Road marks the current edge of the house's parcel (Figure 11). Immediately beyond (south of) it is NCDOT right-of-way and then a narrow grassy verge at the edge of pavement. The wall is constructed of fieldstone laid with mortar. Two large stones serve as steps, which are placed opposite the house's original entrance. It appears to date from the late nineteenth century. Although weathered and disrupted in part by tree roots, the wall is believed to retain its integrity and is therefore recommended as a structure that contributes to the historic property.

Figure 11. Looking south from road at wall and north elevation of house

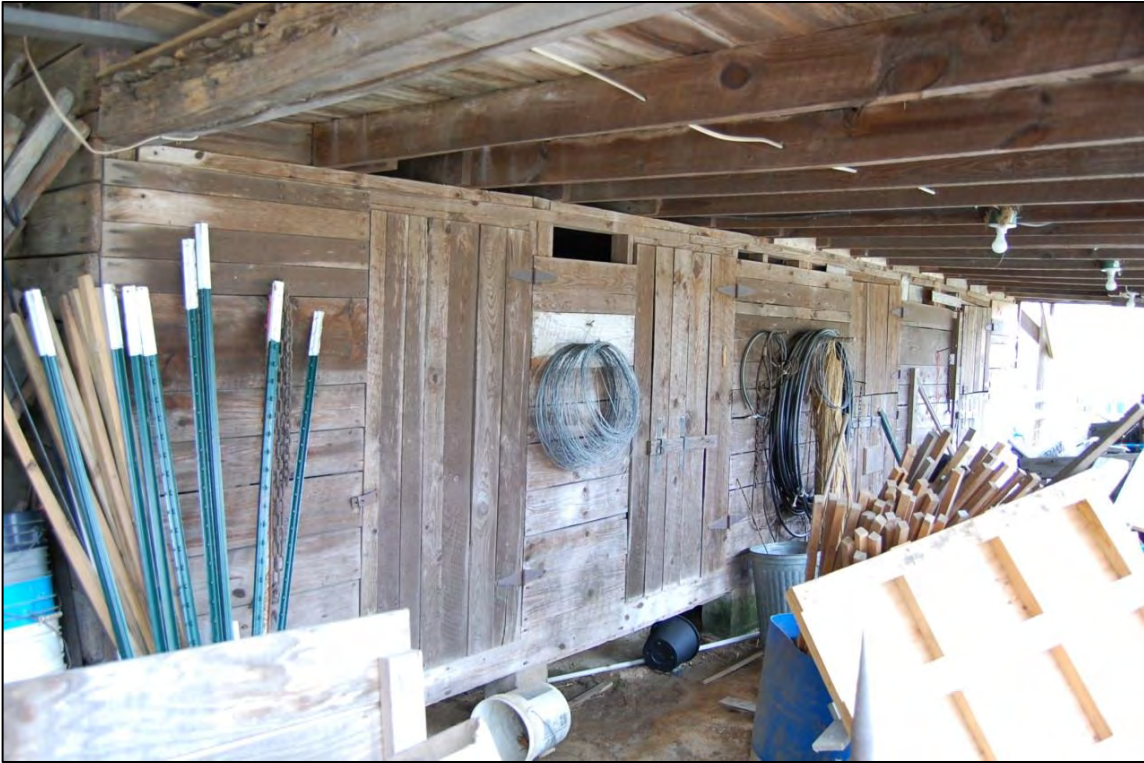
Located south of the house is a twentieth-century barn currently utilized for horses (Figure 12 and Figure 13). It is comprised of three distinct sections: the main barn, the east shed, and the west shed. Built first, probably in the early/mid-twentieth century, is the one-and-a-half-story enclosed barn, which sits atop a stone pier foundation and is of wood frame construction. It has a side-gabled, standing-seam-metal roof and is clad in horizontal-board siding. It is three bays wide and two piles deep, with the first pile arranged as an open-air bay and the second enclosed for housing livestock. The enclosed area of the bottom floor has four doors opening into converted horse stalls. A half-story loft is situated above. The east addition is an open-air pole barn of post-in-ground construction that is three bays wide and used for tractor/machine storage. The west addition, also of pole-barn construction, is only one bay wide and is used as a horse run-in. Both additions feature corrugated metal roofing. Attached to the rear of the barn complex is a small fenced-in paddock accessible from the barn through a rear door. The pole barns and paddock appear to be later additions dating from the mid-/late twentieth century. The main body of the barn is roughly contemporary with the house and supported its rural function. .

Figure 12. Looking southeast at front elevation of barn with stall doors

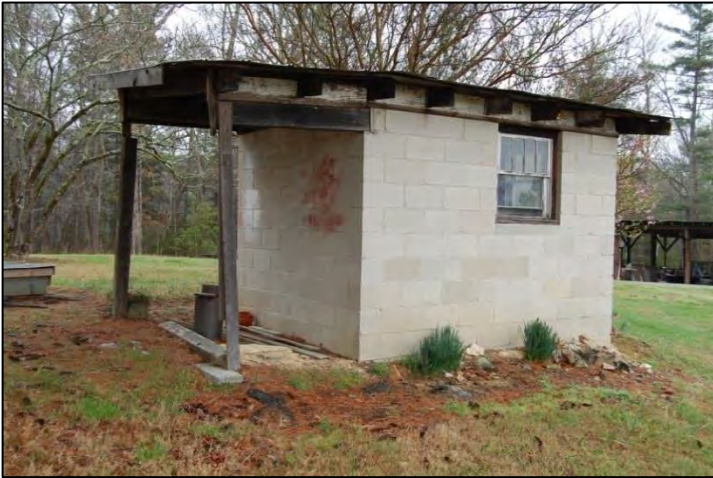
Located south of the house, this outbuilding is a small, square, single-room shed constructed of concrete masonry unit (CMU) blocks (Figure 14). A later twentieth-century addition to the site, the building features one door on its east side and one four-over-one, double-hung window on the west. A small porch is created by a roof overhang supported by wooden posts. The interior of the building is lined with shelves and appears to have been used for canning. Due to its late twentieth-century construction date, the canning shed is recommended as a noncontributing building.

Figure 14. Looking southeast at canning shed with well cover at left and barn at right

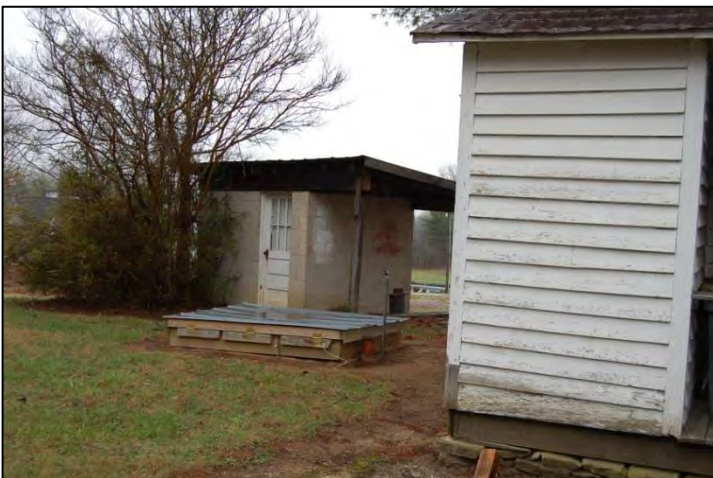
Situated in between the canning shed and the house, this structure is a wooden box standing approximately two feet off the ground with a hinged, standing-seam-metal roof/trapdoor (Figure 15). A metal pipe and tap at one end suggest it covers a well. A wire leading into the box likely powers an electric pump. The large dimensions of the door suggest that it covers a wide early well. As the original aboveground portion of the well has been removed, and the box and cover are modern, the well is recommended as a noncontributing structure.

Figure 15. Looking southwest at house at right, well at center, and canning shed to rear

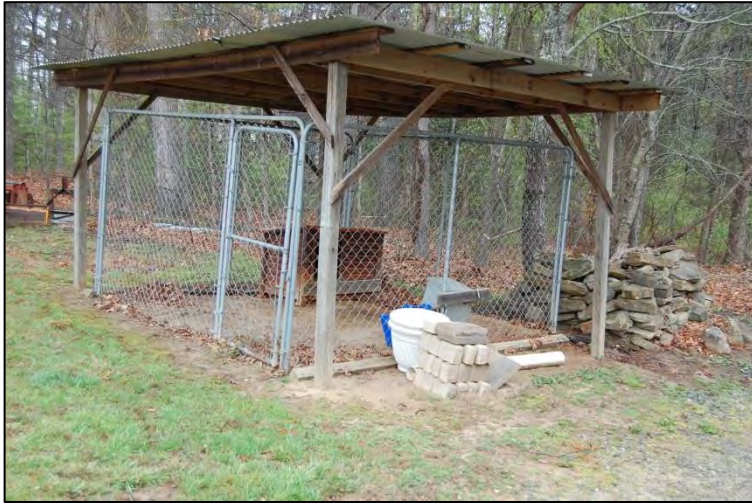
Of wooden post-in-ground construction, the open dog kennel is topped by a corrugated metal roof under which is a chain-link fence (Figure 16). The structure is located to the south of the house. Due to its modern construction date, the dog kennel is recommended as a noncontributing structure.

Figure 16. Looking northeast at dog kennel from barn

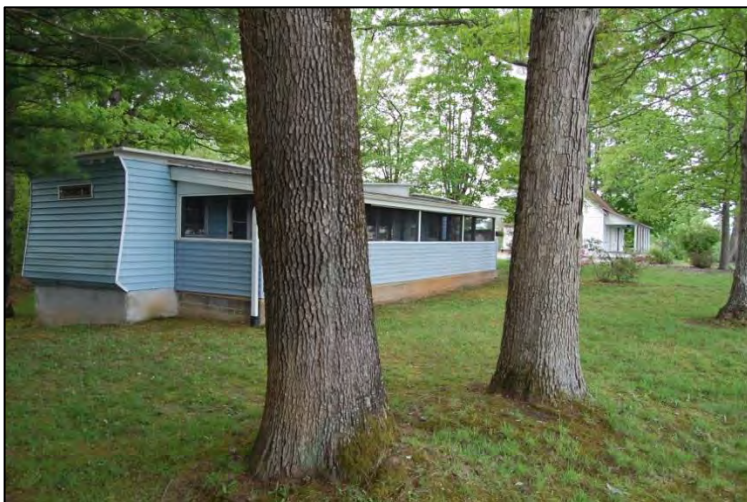
A late twentieth-century addition to the parcel is the house trailer that sits on the road directly east of the house (Figure 17). A double-wide mobile home, its square footage is divided into two usable spaces—an enclosed living space with a large screened-in porch attached to its north. The trailer is clad in blue vinyl siding and immobilized on a concrete foundation. The building stands at the northeast edge of the house parcel and would not contribute to the historic property. As described below, it has therefore been excluded from the property’s recommended NRHP-eligible boundaries.

Figure 17. Looking southwest at mobile home at left and house at right

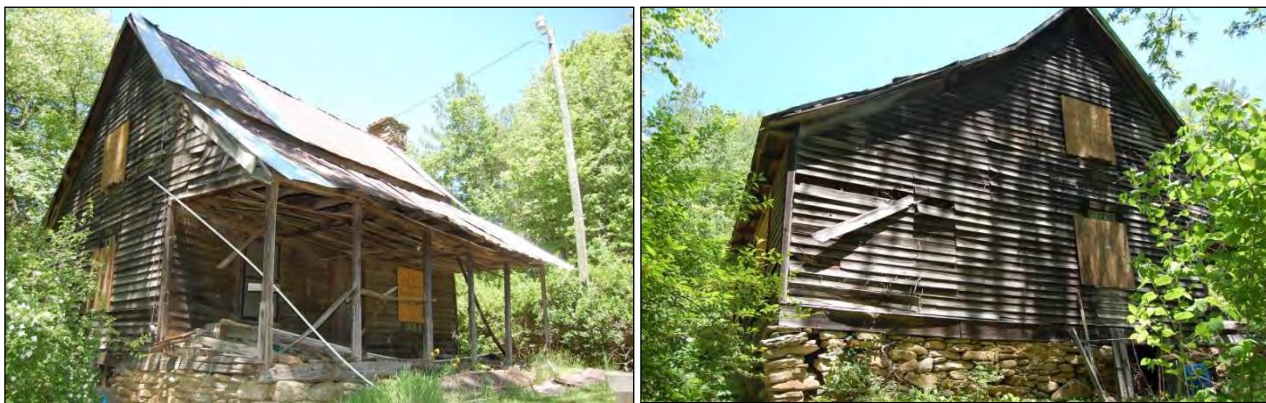
The Riley Wall House is believed to date from the late nineteenth century and its construction is attributed its original owner, Riley H. Wall (1840-1940). Resting on a stone foundation, the one-and-a-half-story heavy timber frame dwelling is covered with weatherboards and capped by a standing-seam metal, side-gable roof. An engaged full-width porch carries across the façade and a shed-roof kitchen addition extends across the rear elevation. An exterior stone chimney rises against the north side elevation. The porch, which is supported on chamfered wood posts, shelters a single-leaf wood door. Windows are typically nine-over-six double-hung sash on the first story and six-over-six sash on the upper story. The house is vacant and deteriorating with sections of the roofing material missing, broken weatherboards, and a collapsing porch floor.

Figure 18. Riley Wall House (HN-1274): east front and south side elevations, left; south side and west rear elevations, right

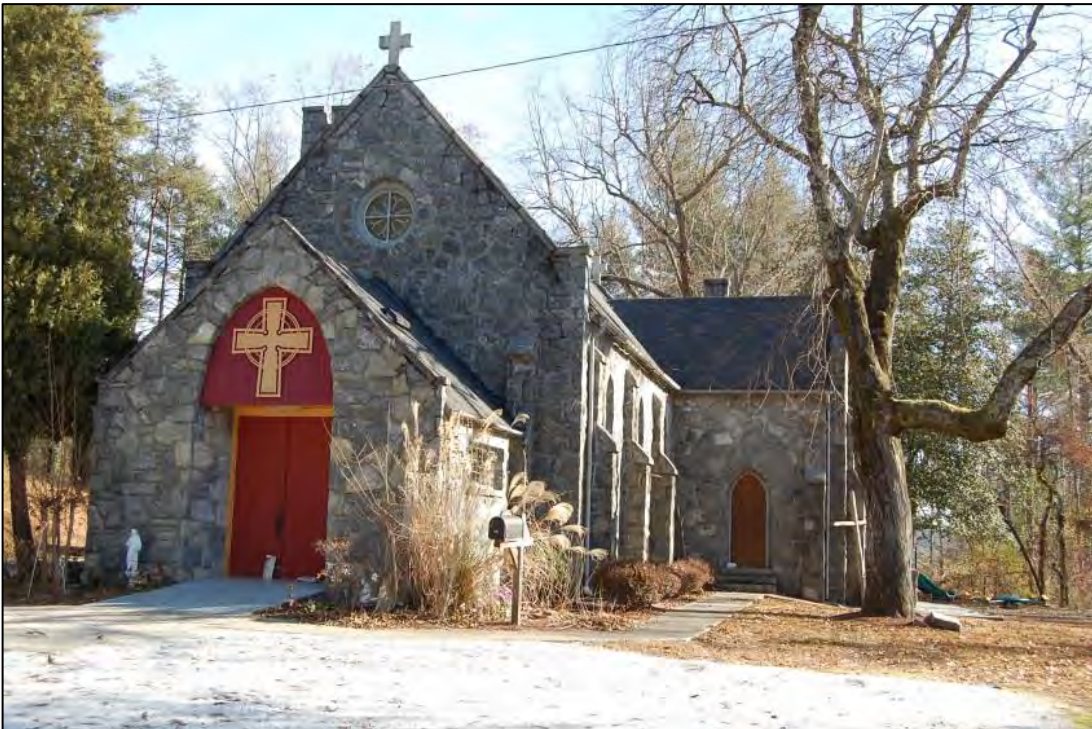
The granite stones serve as visual markers of the building's lengthy construction period, which spanned over 14 years (delays were caused by World War II). Variances in both the color of the mortar and the stones—visible from the interior and exterior of the building—clearly show the various building phases. Unlike many buildings affected by this situation, the chapel's main footprint was constructed all at once. The differences in materials are visible throughout the height of the walls rather than from one space to another: the walls were built of a dark-gray stone to about the tops of the windows, construction halted, and then they were completed with a lighter-colored stone and mortar. The exception to this construction pattern is the small narthex attached to the west side of the building. This space was added sometime post-1954, as it does not appear in a photo dating from that time. Additionally, the coloration of the narthex's stone and mortar is lighter in composition than the rest of the building.

The building retains its original windows. Fixed, ten-light, arched windows are found on the north, east, and south sides of the chapel. The windows are clear, but for stained glass at the chancel. The narthex features rectangular multi-light windows. A small rose window appropriately lights the west gable of the nave. The building's primary access is through double doors on the narthex's west gable end. Secondary doors, designed in a pointed-arch shape, are located at the base of the north tower and south transept. All doors are painted red; the secondary doors have stone steps at their base. Stone flying buttresses rise at all sides of the original building, but are absent from the narthex addition. Battlements top the north tower. A short stone wall connected to the south wall of the south transept features a small iron gate in front of steps that lead down to basement access. A small, interior, stone chimney protrudes from the roof of the south transept.

Figure 27. West front and south side elevations of St. Mary's Chapel

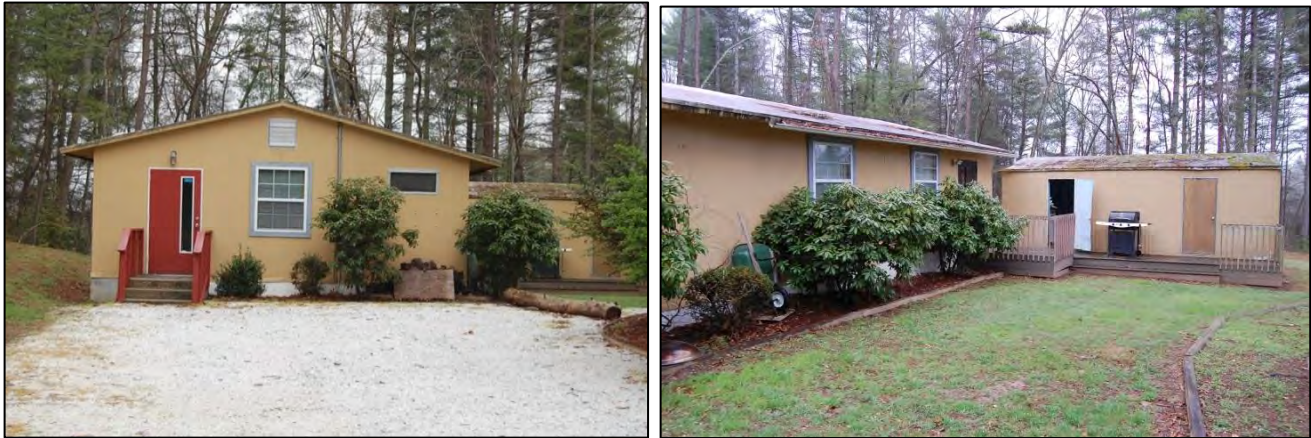
Located to the northeast of the church is a small modern office building. Rectangular in plan, it stands on a continuous concrete masonry unit (CMU) foundation and is clad in yellow vertical siding. Standing seam metal covers its low-slope gabled roof. A small shed building of similar construction is located adjacent to the office building, to which it is connected by a wooden deck (Figure 36). Due to its late twentieth/early twenty-first-century construction date, the office/shed is recommended as a noncontributing building.

Figure 36. Looking east at office and shed, at left, and northeast, at right

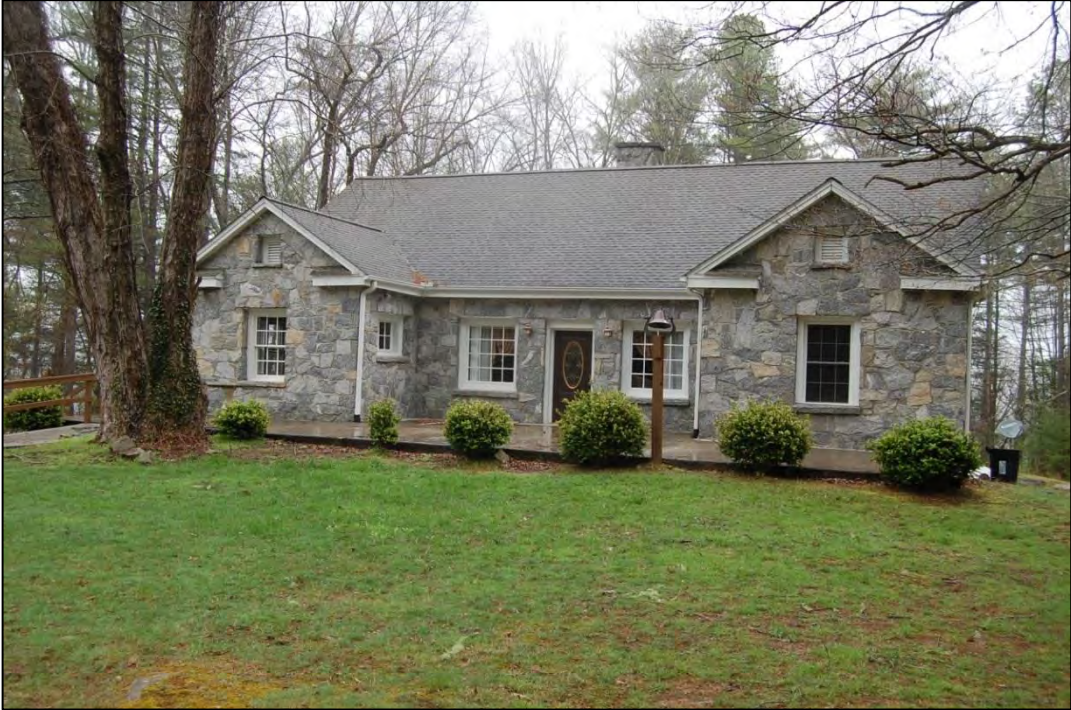
Constructed of a local, rough-cut, granite stone, the Seagle House stands one story tall, on a continuous stone foundation with a basement level accessible from the house's southwest side (Figure 37 through Figure 40). The house is U-shaped in plan with two small wings on its primary (southwest) façade and features a low-pitched, cross-gable roof clad in asphalt shingles. Slightly overhanging eaves extend around all sides of the house, with the front-facing gabled wings marked by a heavy wood cornice and cornice returns. The primary façade features original, fixed, 16-light windows flanking either side of the modern main door. Double-hung, six-over-six windows on the gable ends of the wings, in addition to those at the rear (northeast) elevation, also appear to be original. Other sash has been altered. All of the windows feature stone window sills and deep-set openings that reflect the house's masonry construction. Basement windows are visible on the north, west, and east sides of the house. A central, interior, stone chimney rises on the east slope of the roof. A rough stone retaining wall extends out from the southeast side of the house, to the left of a double-door basement access originally faced with a garage door. Stone stairs lead from a secondary first-floor door at the rear (east side) of the house onto the open lawn.

Figure 37. Southwest front elevation of house

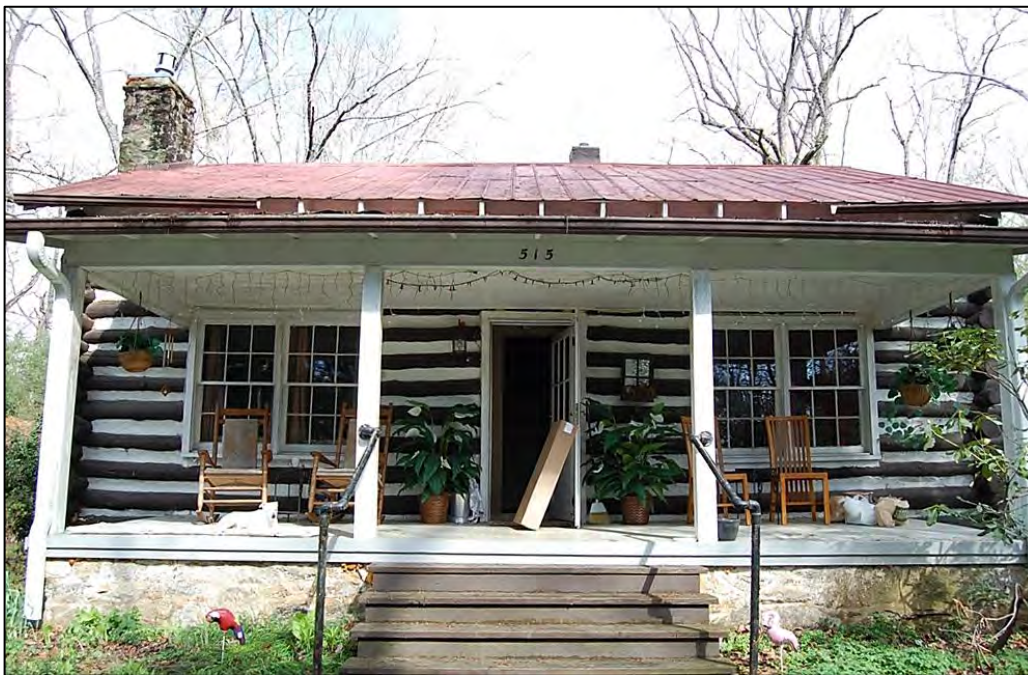
The one-story-and-loft Robert and Emily Johnson Log House is built of saddle-notched, pole-log walls heavily chinked with concrete that rest on a continuous stone foundation (Figure 54 through Figure 58). It is two piles deep and extended on the north side by a low-sloped, frame, shed ell. The roofs of the original gable-end block and the shed are clad in standing-seam metal. A dropped-roof porch supported by four square posts spans the house’s three-bay-wide front elevation. Its shed roof is also standing-seam metal. Beadboards form its ceiling. An exterior-end stone chimney is offset at the house’s west gable end. A small, concrete-block flue stacks rises from the roof ridge. Most of the house’s window bays, which are doubled at the front, contain original six-over-six, double-hung sash.

Figure 54. South front elevation of log house

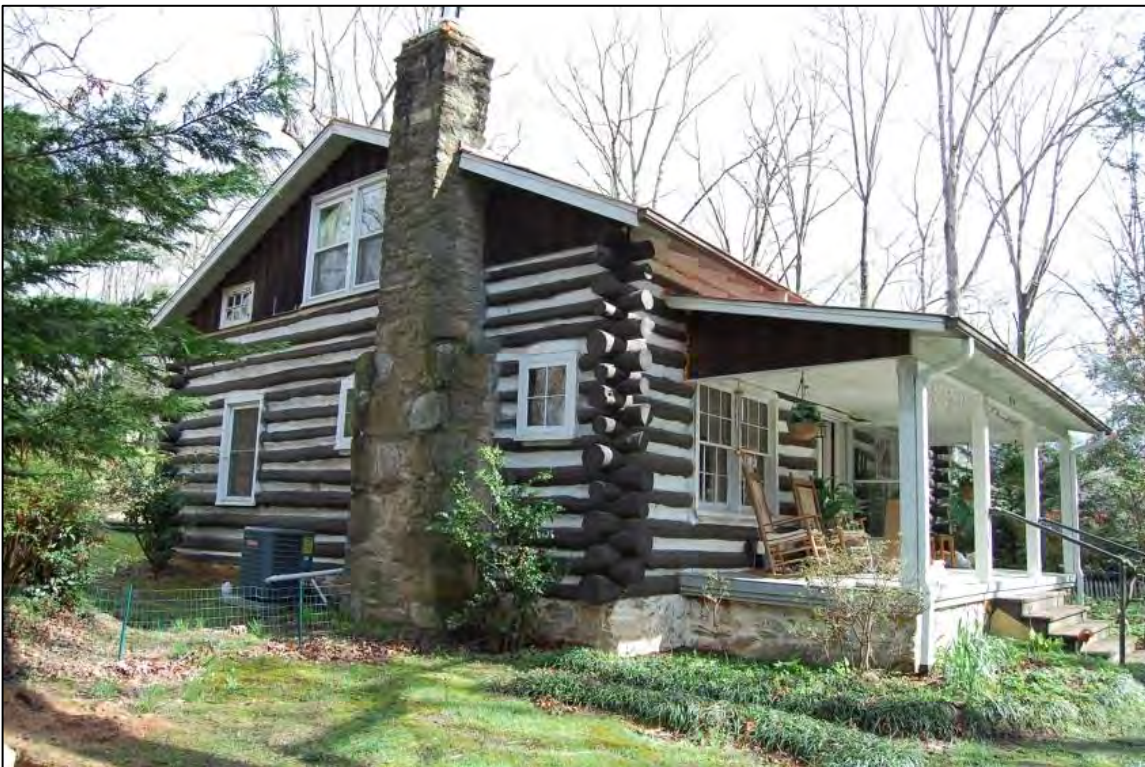
Figure 58. West side and south front elevation of log house; note stone chimney and foundation, thick concrete chinking, and saddle-notching extending well beyond wall planes

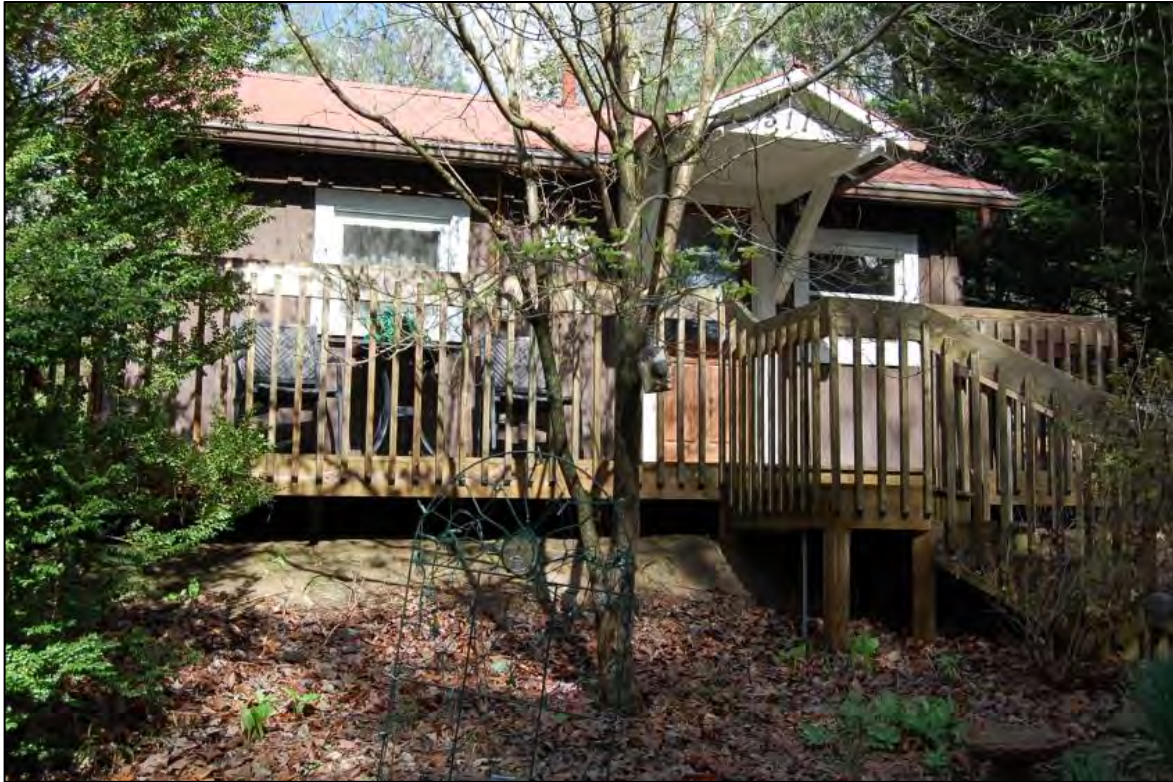
Robert and Emily Johnson built this gable-end, frame, Rustic-Revival-style cabin 40 feet southwest of their log house around 1950. Smaller than its neighbor, the house is one-story tall and contains two rooms, with an additional shed room at its rear (northwest) elevation (Figure 60 through Figure 63). Board-and-batten siding covers the walls of the main block and shed, both of which are covered by a standing-seam metal roof. A concrete slab supports the house. A wooden deck serves the three-bay wide front (southeast) elevation. It is extended to the southwest side by a brick patio. Both appear to be later additions. A wooden overhang supported by oversized triangular kneebraces shields the front entry. Each elevation is marked by a pair of window bays set in plain surrounds; the sash does not appear to be original.

Figure 60. Southeast front elevation of frame cabin

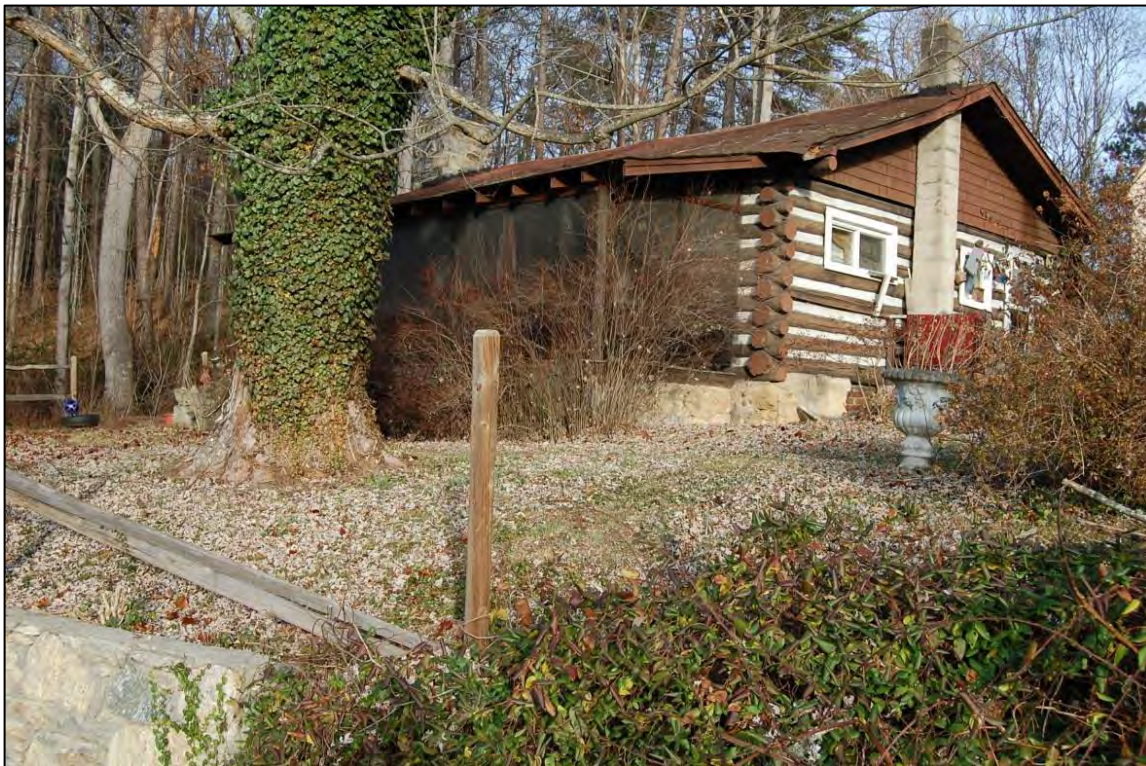
Figure 76. West front and south side elevations of house; note retaining wall along road at left foreground

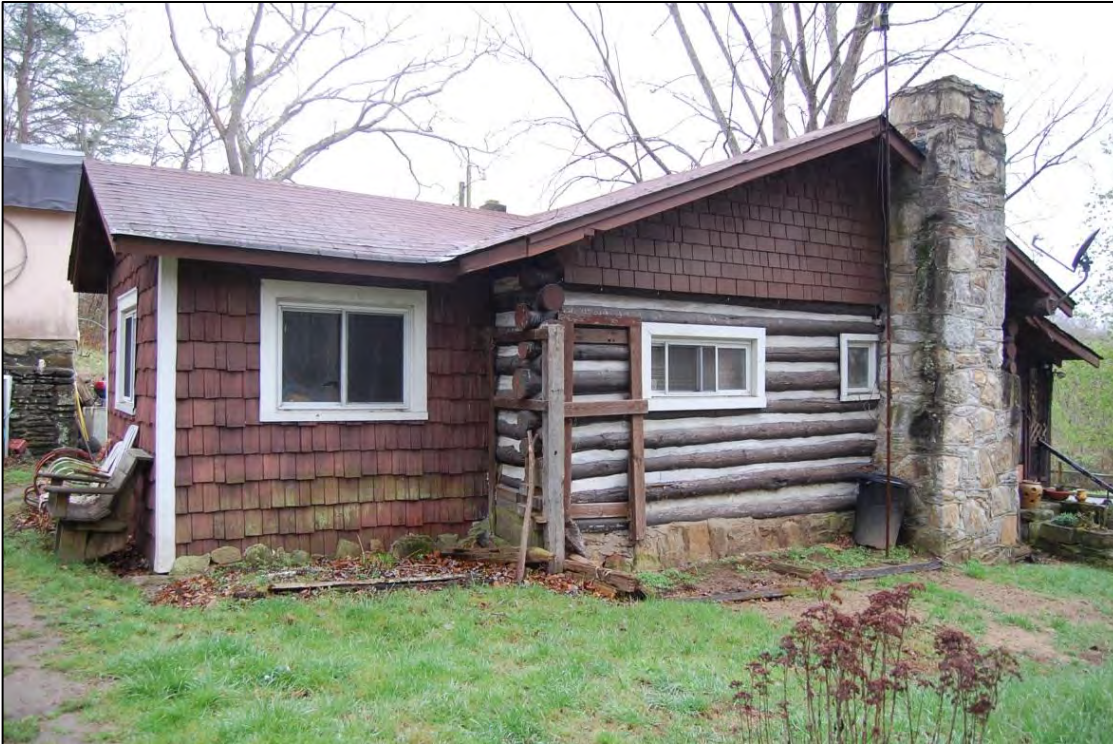
Figure 79. North side elevation of house with ell extending to east rear; gambrel-roofed shed on tall stone foundation at far left

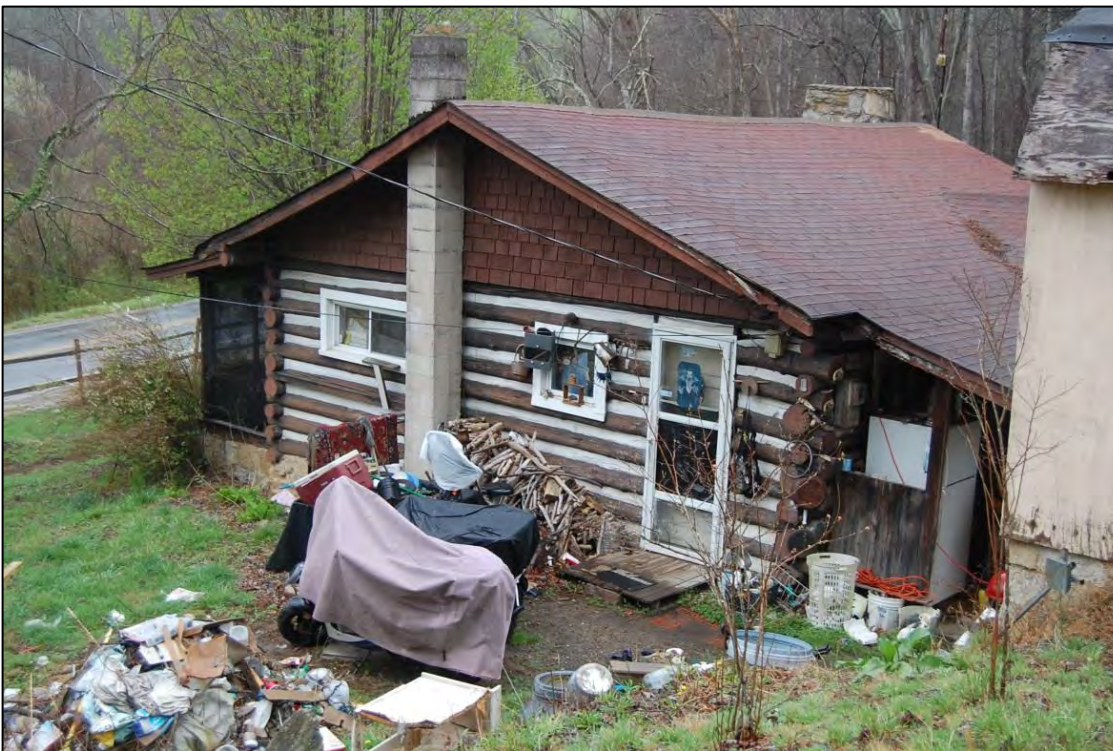
Figure 80. South side and east rear elevations of house; gambrel-roofed shed at right

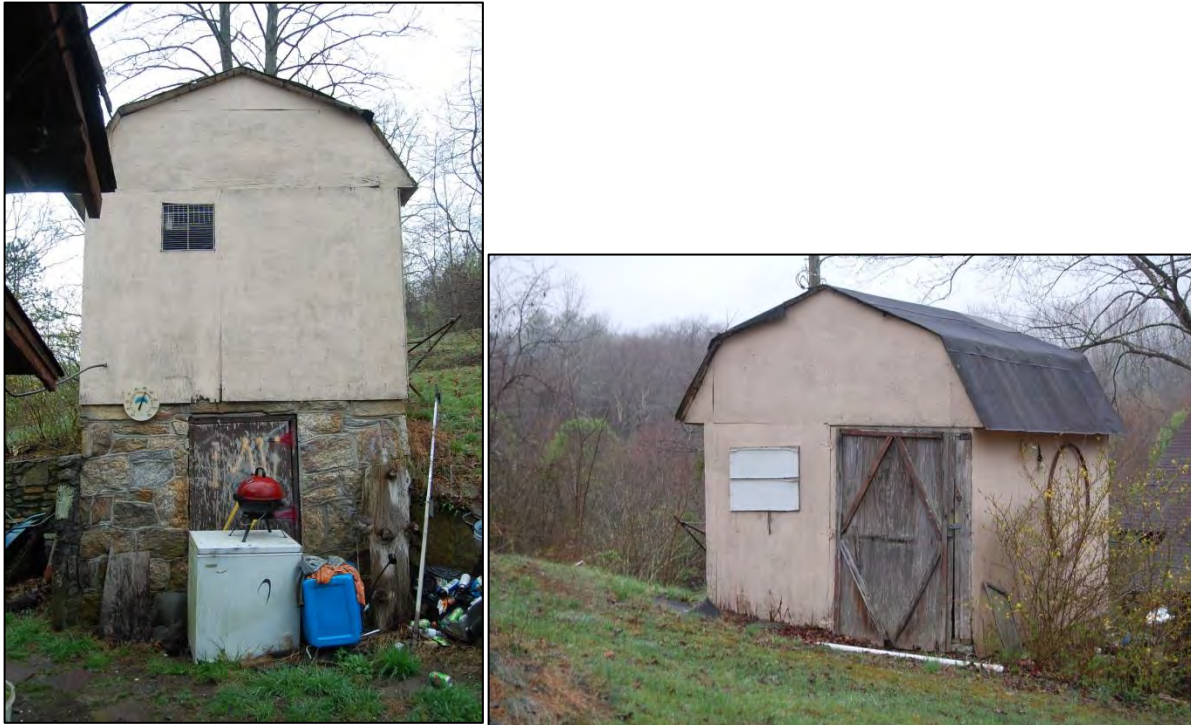
Figure 81. West elevation of gambrel-roofed shed, at left; looking southeast at shed, at right

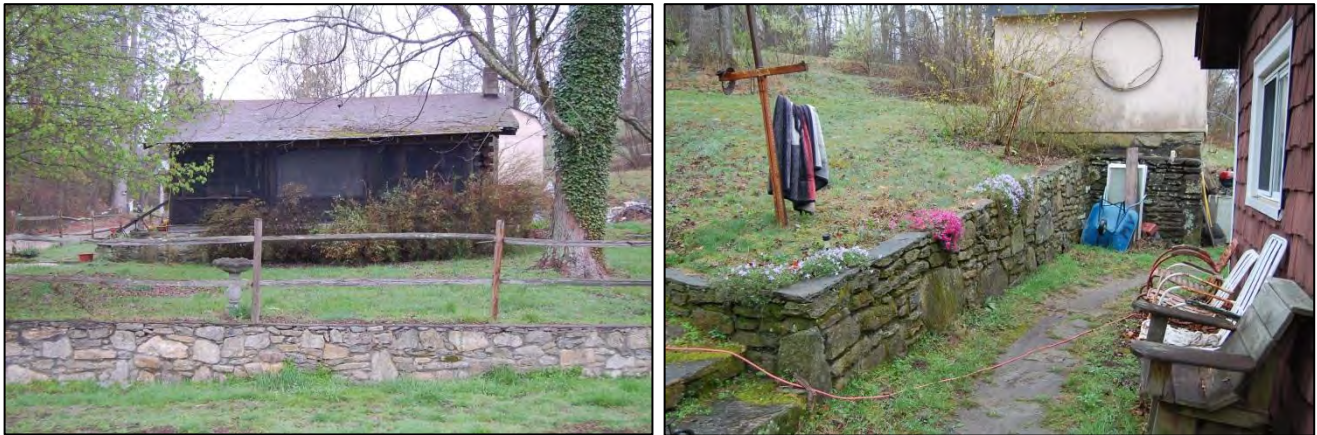
Figure 83. Retaining wall facing Balfour Road, at left; retaining wall behind house, at right

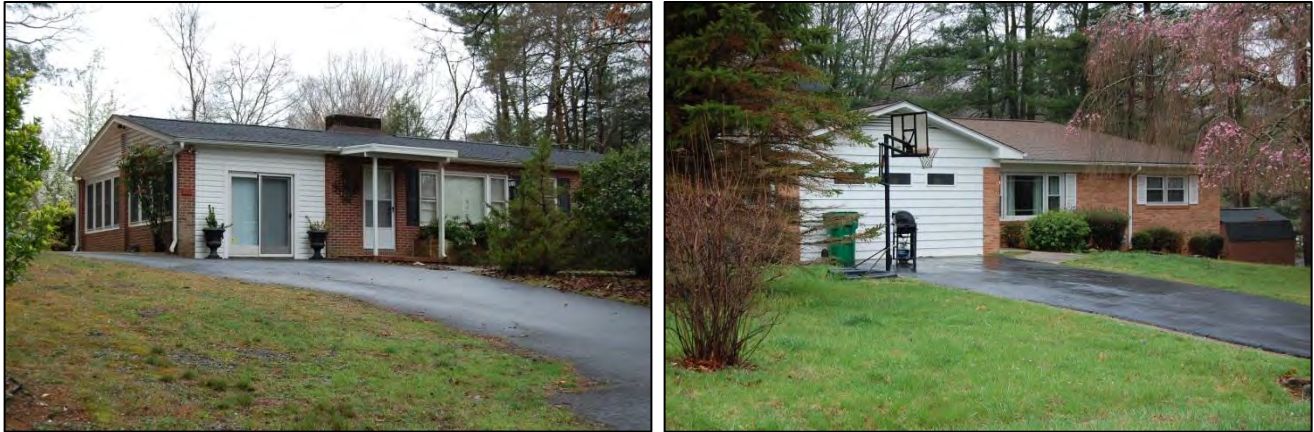
Figure 92. 3119 Cardinal Lane (left) and 3231 Magnolia Drive (right), which both feature enclosed carports, a common alteration found among houses in Grimesdale

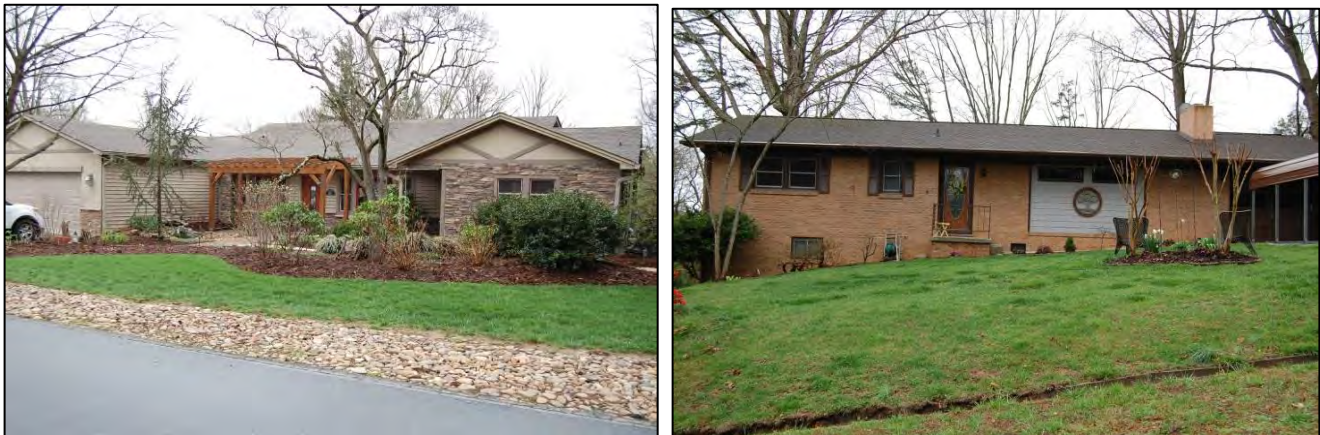
Figure 93. 3218 Florida Drive (left) and 3079 Napier Drive (right) display significant alterations to material and fenestration at their front elevations

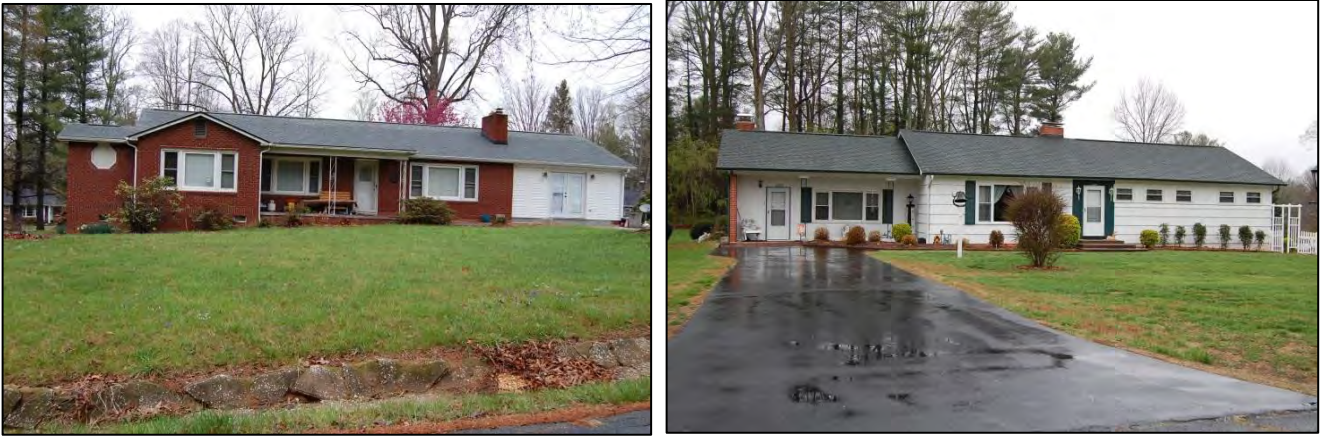
A small number of structural additions are found throughout the subdivision, as is visible at 3228 Florida Drive (traditional Ranch; ca. 1959) and 3159 Cheryl Drive (Raised Ranch; ca. 1960) (Figure 94). However, this is relatively uncommon in Grimesdale.

Figure 94. 3228 Florida Drive (left) and 3159 Cheryl Drive (right) with side additions

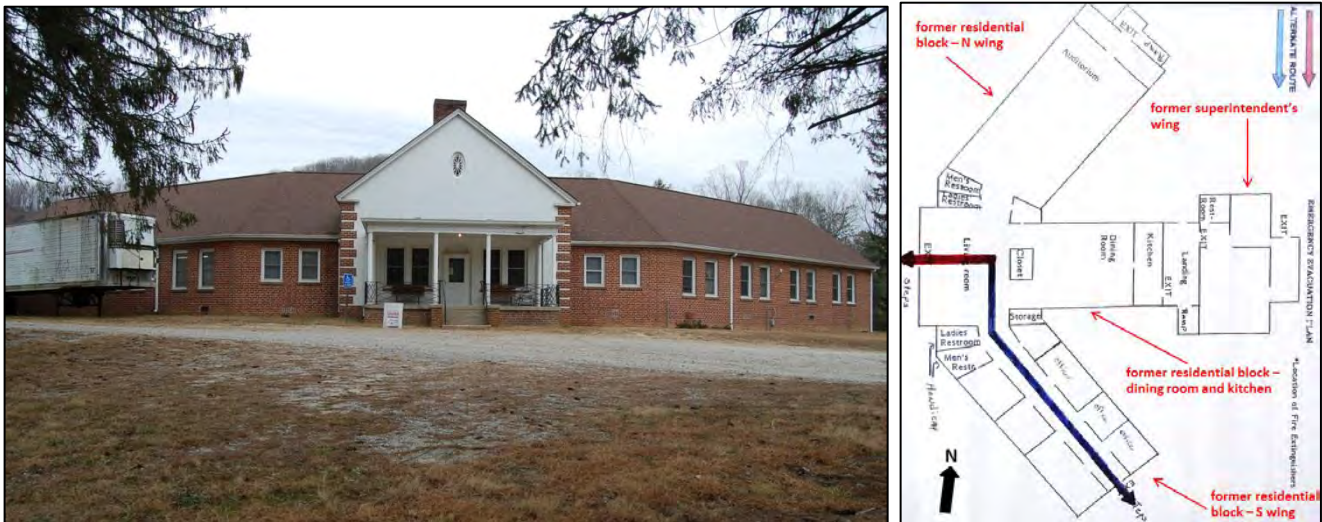
Figure 163. Looking west at front elevation of County Home’s former residential block, left; annotated plan and building footprint, right (source: County Engineering Solid Waste Division)

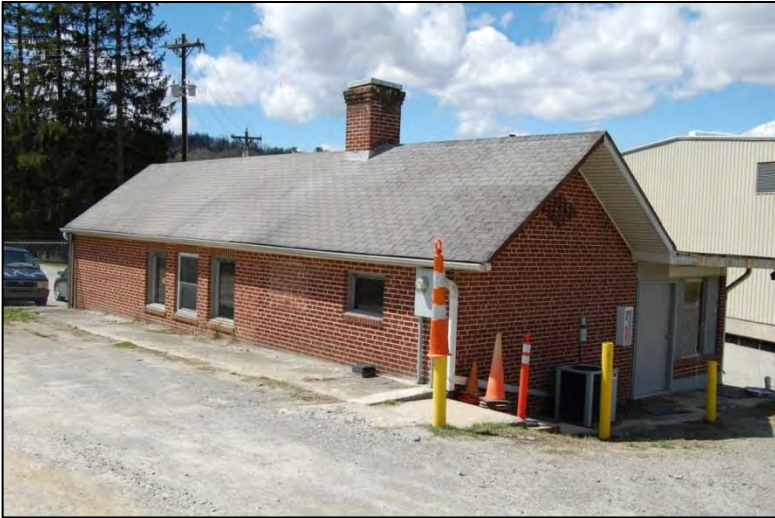
Figure 170. East side and north gable end of former washhouse

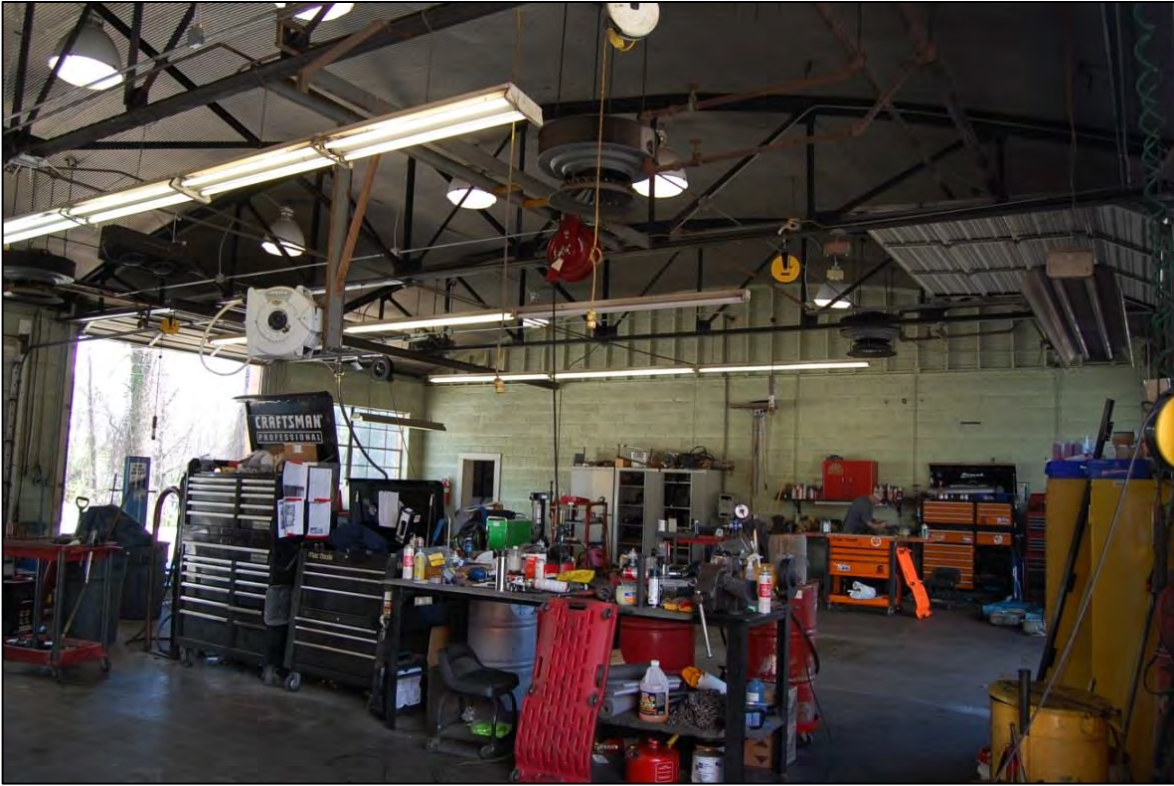
Figure 184. Garage interior with north wall, beyond which is later-added painting bay

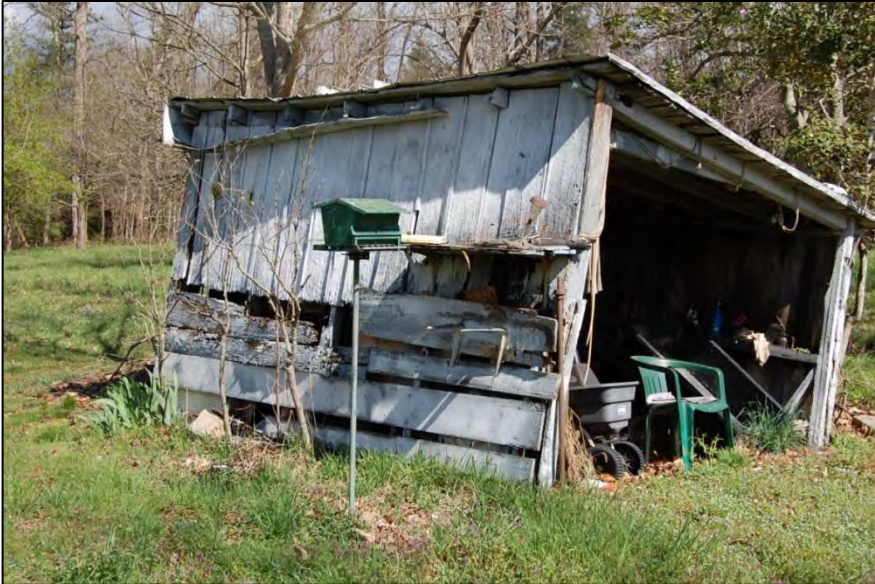
Figure 216. Southwest and southeast (open) elevations of tool house
