SUBJECT: Upgrade US 64 from SR 1317 to US 421, U-5737, Chatham County, ER 16-2119

HISTORIC STRUCTURE SURVEY REPORT

TIP# U-5737 UPGRADE US 64 (EAST 11TH STREET) FROM SR1317 (GREENSBORO AVENUE) TO US 421 IN SILER CITY, CHATHAM COUNTY

1005 East 11th Street WBS# 54027.1.1

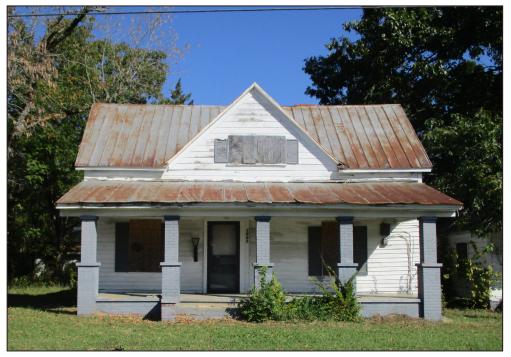
Photograph 1: Facade (south elevation) of 1005 E. 11th St.; looking north. (2016)

The façade (south elevation) features an off-center main entrance (west of center) flanked by two individual windows, all of which are protected by the one-story porch. The entrance is a replacement storm door. A pair of windows are located on the centered dormer above the porch (Photograph 1). The side, west elevation has one window centered on the first story of the main block, a smaller window centered under the gable end of the main block (vertically aligned above the first floor window), and three evenly spaced windows on the rear ell (Photographs 4 & 5). The side, east elevation is a mirror image of the west elevation. The rear, north elevation is not visible from the public right of way.

Constructed c. 1900, the dwelling is a one-and-a-half story, triple-A structure clad in weatherboard with a side gable roof clad in standing seam metal. A one-story front-gable rear ell is located off the north elevation, and a one-story porch runs the length of the façade and can be reached by a set of concrete steps. The porch, which was most likely added c. 1910, is supported by five brick piers and is capped by a shed roof clad in corrugated metal. All window openings visible from the public right of way have been covered with plywood. It is not known if any original glazing is extant. The window openings are surrounded by fixed wood shutters. These shutters remain mostly intact, but are likely not original. The dwelling sits on a brick foundation (Photographs 1, 2 & 3).

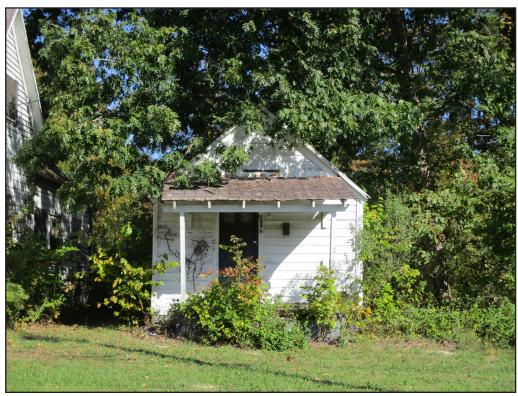
Photograph 6: South elevation of 1007 E. 11th St.; looking north. (2016)

An additional, one-story, dwelling is located east of 1005 E. 11th St. This smaller dwelling is clad in weatherboard and marked with the address "1007 E. 11th St." It is capped by a front-gable roof clad in standing seam metal. A wood framed porch with a shed roof clad with standing seam metal runs between the gable and is supported by two wood posts. The front entrance is located west of center on the façade. The window openings on the east elevation are visible from the public right of way and have been covered with plywood (Photographs 6 & 7).

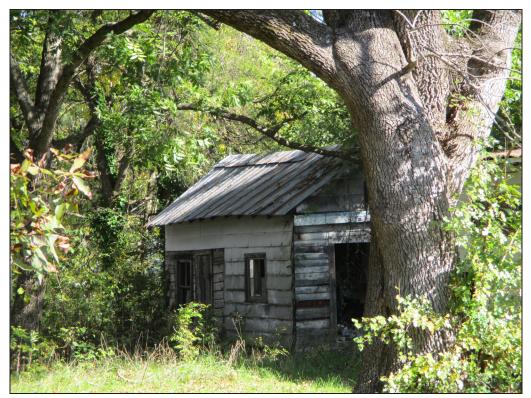
Photograph 8: Southwest elevation of rear shed. (2016)

A one-story shed is located to the rear (north) of the main dwelling and is only partially visible from the public right of way. The structure is clad in weatherboard and capped by a front-gable standing seam metal roof (Photograph 8).

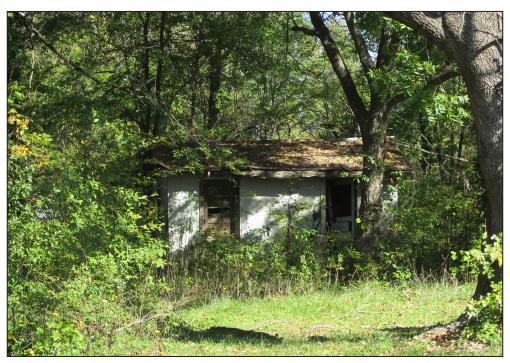
Photograph 9: South elevation of the shed in the northwest corner of the property, looking north. (2016)

A one-story, two-bay shed, is located northwest of the main dwelling and is partially obstructed by tree cover. The structure is clad in vertical wood siding and capped by a side gable standing seam metal roof. Two door openings are located evenly spaced on the façade. (Photograph 9).
