SUBJECT: Historic Structures Survey Report for the Replacement of Bridge 183 on SR 1313 Over Brummett Creek, PA 16-1-117, B-5874, Mitchell County, ER 16-2161

Historic Structure Report Replace Bridge No. 183 on SR 1313 (Miller Road) over Brummett Creek, Mitchell County, North Carolina PA # 16-01-0117 TIP# B-5874 WBS # 48068.1.1

HISTORIC STRUCTURE REPORT Replace Bridge No. 183 on SR 1313 (Miller Road) over Brummett Creek, Mitchell County, North Carolina,

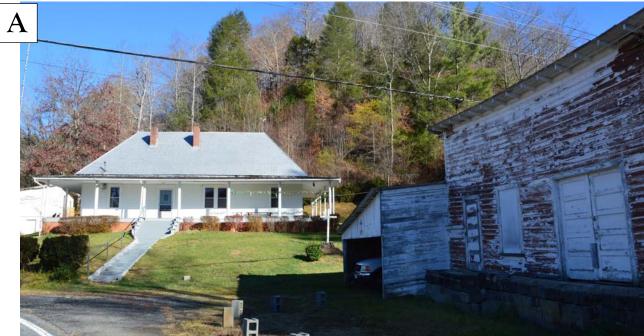
PIN 0835-00-00-2649 Owner: Matilda McPeters Address : 48 Brummett Creek Road

House, store, and outbuildings dating from circa 1890 to 1920

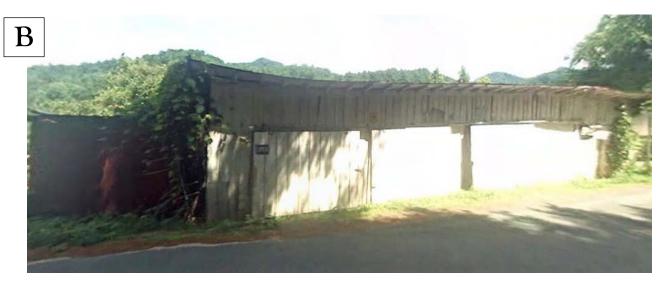
PIN 0825-00-91-8606 Owner: Frank & Faye Griffith Address: Miller Road

Circa 1910-1950 shed/garage historically associated with and on the parcel containing the J.W. Webb Farm

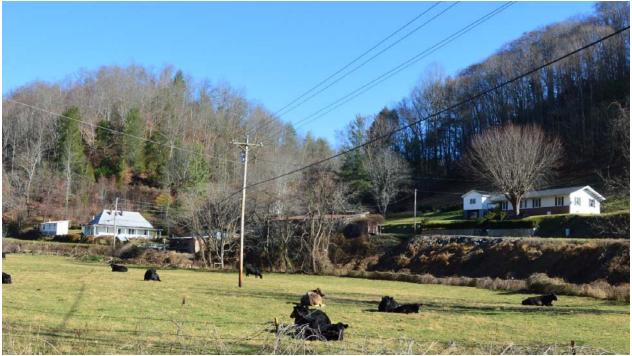
The image above depicts the dwelling at 48 Brummett Creek Road, at the intersection of Brummetts Creek Road and State Route 197. With the house at the left of the image, at the center, and behind the utility pole, is the shed/garage associated with the J.W. Webb Farm, as viewed from Miller Road. At the right is the modern J.W. Webb House.

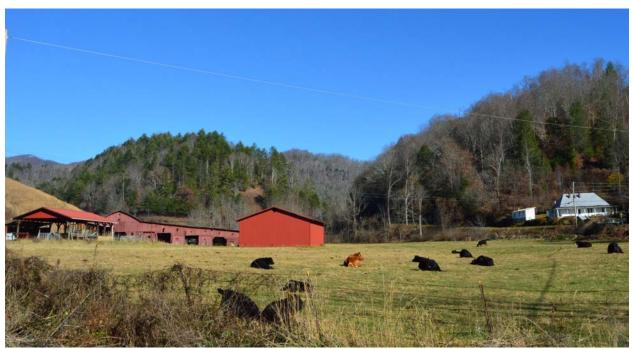
The image above depicts the house at 48 Brummett Creek Road, which sits just east of and across Brummett Creek Road From the J.W. Webb Farm, the outbuildings of which are shown to the left.

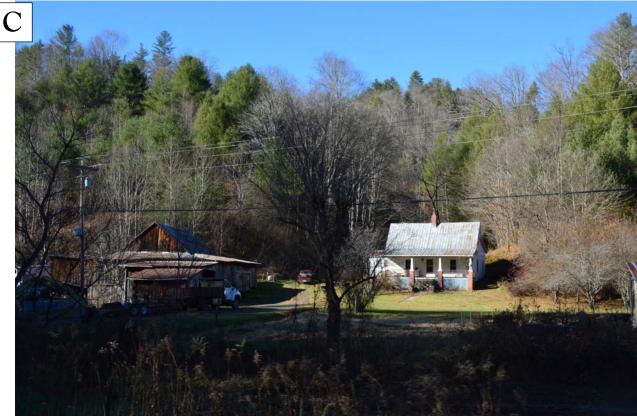
PIN 0825-00-81-2087 Owner: Anita Worley & Debra L. Bowling Address: 5748 Highway 197

House and agricultural outbuildings dating from circa 1890-1920, located immediately west of the Whitson-Tipton Farm

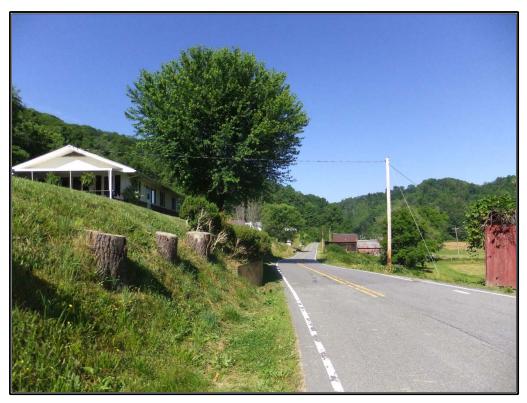
House: The primary structure associated with the property, the circa 1935–1938 J.W. Webb House, is a single-story side gable dwelling that is sheltered by a metal gable roof and covered in brick veneer and vinyl siding, is situated on a concrete block foundation, and features replacement windows and doors (Figure 5). No interior access was granted. According to the occupant and former owner, Gail Phillips, the house was a very small front-gable dwelling when she and her husband purchased it and they expanded it in the 1960s to its current Ranch form.

Figure 3. Overview of the J.W. Webb House (ML0128), facing south-southwest.

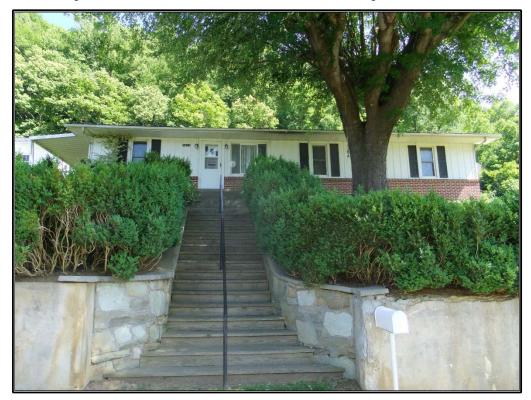
Figure 4. View of the retaining wall and steps that connect the J.W. Webb House (ML0128) from NC 197, facing south-southwest.

Setting: Located approximately 1.2 miles northwest of the small community of Tipton Hill and 1.5 miles northeast of the small community of Relief in the vicinity of the former community of Webb in northwest Mitchell County, the J.W. Webb House (ML0128) is situated on the south side of NC 197, approximately 100 feet southwest of its intersection with SR 1312 (see Figure 1; Figure 2). The parcel is comprised of two sections: a 2.0-acre section on the south side of NC 197 and a 0.03-acre section on the north side of NC 197, on the south bank of Brummett Creek. The house and garage associated with the J.W. Webb House are situated along a flat clearing on a hill that rises above NC 197 (Figure 3). An uncoursed mortared stone retaining wall with a concrete ledge and wood steps connect the house to NC 197 (Figure 4). The wall curves at the base of the steps and extends on either side along NC 197; the straight extensions are parged with concrete. A gravel driveway also connects the property to NC 197.

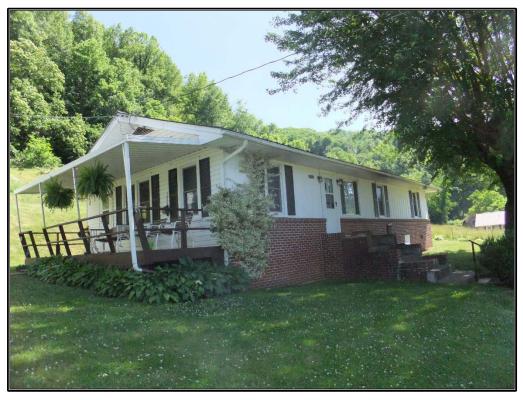
Figure 5. Façade and northeast (side) elevations of the J.W. Webb House (ML0128), facing southwest.

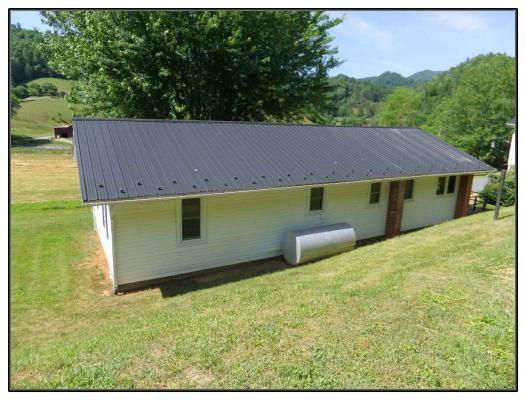
Figure 7. Rear, or southeast, elevation of the J.W. Webb House (ML0128), facing north.

The rear, or southeast, elevation, is clad in vinyl siding and features no shutters (Figure 7). Two former brick exterior chimneys extend to the eave on the right half of the rear elevation; however,

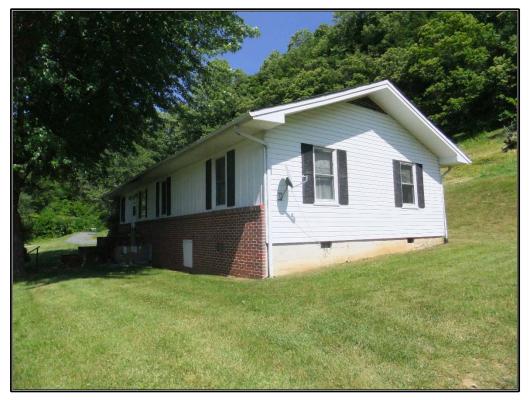
The southwest, or side, elevation features two single windows, each flanked by shutters (Figure 8). Vinyl louvered shutters flank each window and the entire elevation is clad in vinyl siding. The concrete block foundation is painted.

Figure 8. Façade and side, or southwest, elevation of the J.W. Webb House (ML0128), facing east.

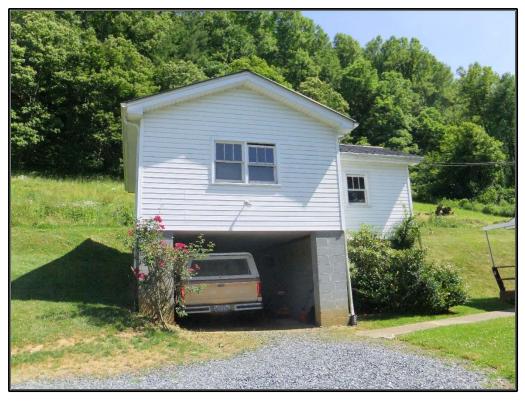
Garage: A circa 1935–1951 garage is located approximately 20 feet east-northeast of the J.W. Webb House (Figure 9). Situated upon a concrete block foundation, the two-story, cross-gable, L-shaped structure is set into the steep slope that runs behind the house. The outbuilding is sheltered by a metal replacement roof and windows throughout feature three-over-one-light, double-hung wood sashes. The first floor features a single, open garage bay with no door and walls constructed of concrete block. The second floor is clad in vinyl siding and features a pair of single and paired windows. An off-center single-leaf entry with a paneled wood door provides access to the upper floor from the rear elevation of the outbuilding (Figure 10). A single window with one-over-one-light, double-hung vinyl replacement sashes is located to the left of the rear entry.

Figure 9. Façade of the garage associated with the J.W. Webb House (ML0128), facing south-southeast.

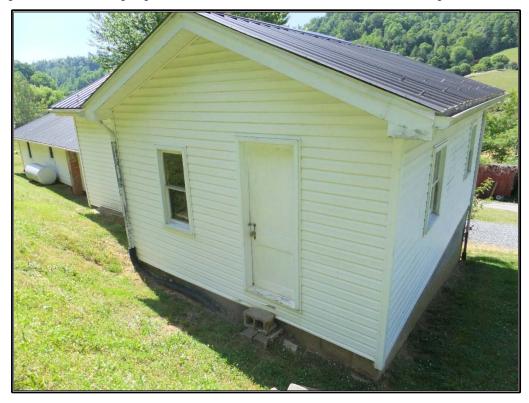
Figure 10. Rear of the garage associated with the J.W. Webb House (ML0128), facing northwest.

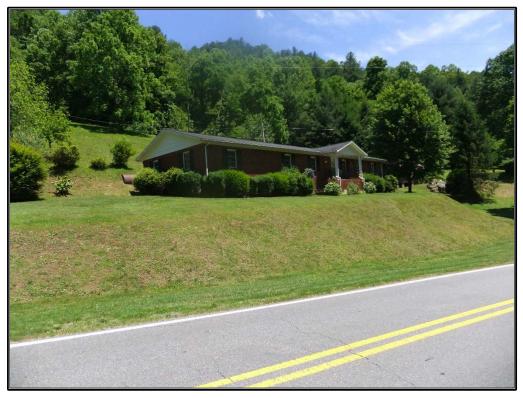
Similar to the rest of the American landscape, Ranch houses are a common residential form and style found in Mitchell County. Several comparable examples are located within the vicinity of the J.W. Webb House (ML0128) (Figures 12 and 13). The Ranch house at 8104 NC 197 also features a comparable garage.

Figure 12. Comparable Ranch house located at 12160 NC197, facing southeast.

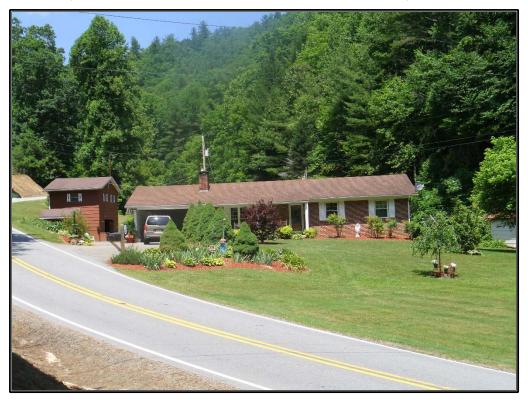
Figure 13. Comparable Ranch house and garage at 8104 NC 197, facing north-northwest.

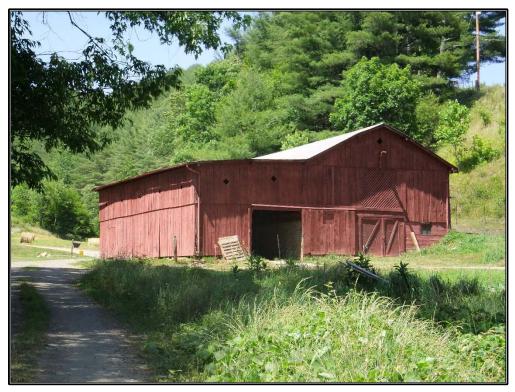
Figure 19. View of the circa 1900 Historic Barn #1 located east of Miller Road, part of the J.W. Webb Farm (ML0127), facing north-northeast.

Historic Barn #1: The primary structure associated with the J.W. Webb Farm (ML0127) is a circa 1900 two-story, frame livestock barn with a one-and-one-half-story shed addition located immediately east of Miller Road (Figure 19). The barn is slightly set into a slope and rests upon a poured concrete and concrete block foundation. The barn features frame construction clad in vertical-board siding. The low-pitched gable roof of the core of the barn and the shed roof of the addition are both clad in metal panels. The gable end of the barn and the top of the walls of the shed addition below the eave feature diamond cut-outs. A concrete block wall separates the core from the side addition.

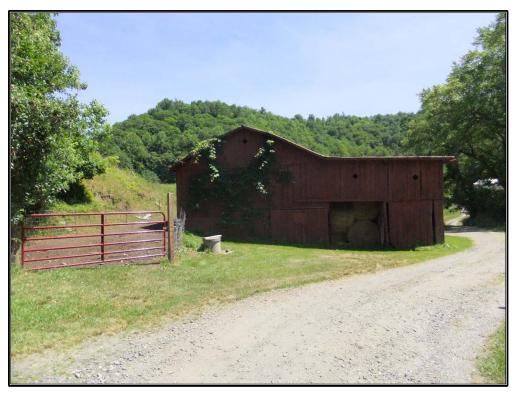
Figure 20. View of the rear of Historic Barn #1 just east of Miller Road associated with the J.W. Webb Farm (ML0127), facing south-southeast.

The north and south elevations of the barn each feature a double-leaf entry centered on the first floor of the core of the barn (Figure 20); the opening centered above the entry is enclosed with wood lattice. The side addition exhibits a transverse passage that features sliding vertical plank barn doors on each end. The east and west elevations do not feature any windows or doors.

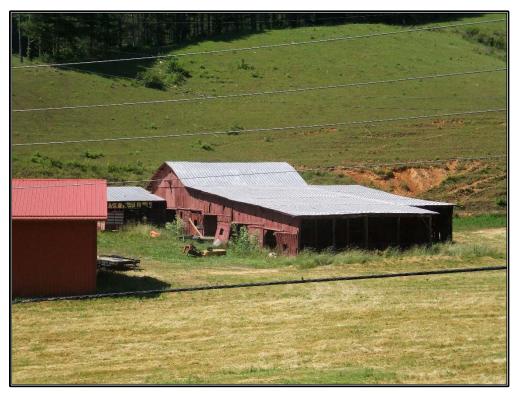
Figure 21. View of the circa 1900 Historic Barn #2 located 200 feet east of Miller Road, associated with the J.W. Webb Farm (ML0127), facing north-northeast.

Historic Barn #2: A second circa 1900 livestock barn associated with the J.W. Webb Farm (ML0127) is located approximately 200 feet west of the primary barn (Figure 21). This structure features a twostory core with a long shed addition with three transverse bays, a rear shed addition, and a connected open shed on the façade. This barn features the same detailing as the other barn with diamond cutouts in the gable end and below the eave on the additions. Each of the entries on the first floor of the barn feature sliding vertical-plank doors. Much like the other barn, the second story of the core of the barn features an opening enclosed with wood lattice. The entire barn and its additions are sheltered by a metal panel roof. The attached open shed that extends from the northwest corner of the façade features a shed roof clad in metal panels (Figure 22).

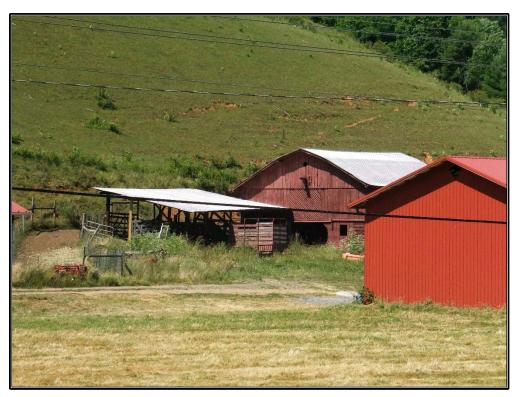
Figure 22. View of the façade and attached open shed of Historic Barn #2 on the J.W. Webb Farm (ML0127), facing northeast.

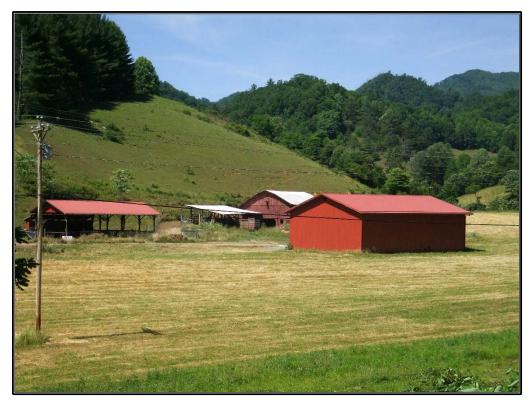
Modern Pole Barn 2: A second circa 1970–2000 tall, open, one-story frame cattle barn with a gable roof and a one-story shed extension is located approximately 100 feet southeast of the primary historic barn (see Figure 24). The modern barn features a metal-clad gable roof supported by wood posts with large angled wood braces. The gable end of the roof is also clad in metal panel siding. The one-story shed extension is open to the barn on the southeast elevation and clad entirely in metal panel siding (see Figure 23).

Figure 23. View of Modern Pole Barns #1 and #2 and Historic Barn #2 associated with the J.W. Webb Farm (ML0127), facing north-northeast.

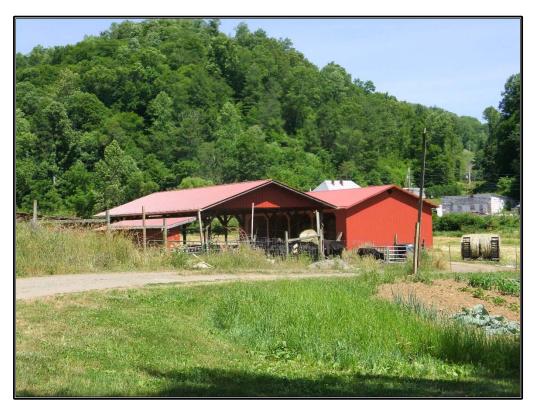
Figure 24. View of Modern Pole Barns #1 and #2 associated with the J.W. Webb Farm (ML0127), facing east.

Modern Pole Barn 1: A circa 1970–2000 frame pole barn for crop storage is located approximately 215 feet east-southeast of the primary barn and 90 feet south of the secondary historic barn (Figure 23). This one-story, side-gable metal-clad pole barn features frame construction and is clad entirely in metal panels (Figure 24). Oriented to the northwest, the façade of the barn features four open bays, and is currently used for hay storage. The rear and side elevations feature no windows or doors.

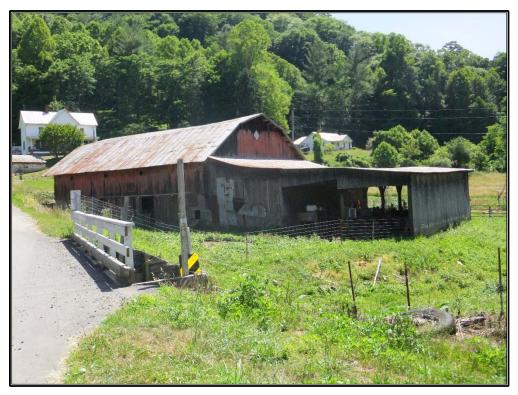
Figure 25. View of the barn associated with the Whitson-Tipton Farmstead (ML0130) that features the same diamond cut-out detailing, facing southeast.

Gambrel-roofed barns reflect a typical barn form found throughout Mitchell County and western North Carolina (Figures 25–29). This barn type generally features frame construction clad in vertical board siding and a metal-clad gambrel roof. In Mitchell County, most gambrel-roofed barns feature concrete block foundations and walls on the first floor with frame construction on the second floor.

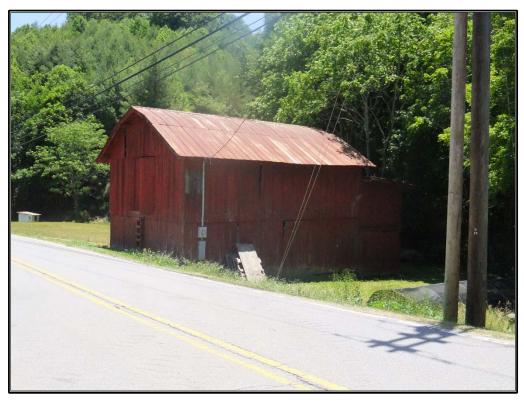
Figure 26. View of gambrel-roof barn on NC 197 in Tipton Hill, facing southwest.

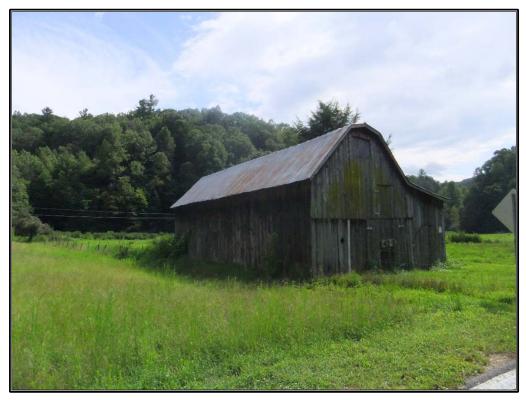
Figure 27. View of a gambrel-roof barn on NC 197 southeast of the community of Poplar in Mitchell County.

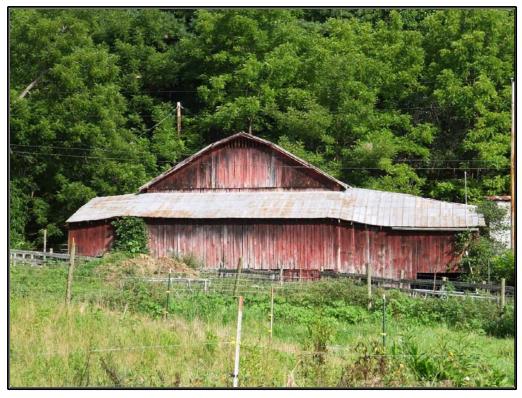
Figure 29. View of a gambrel-roof barn on NC 197 near the community of Tipton Hill in Mitchell County.

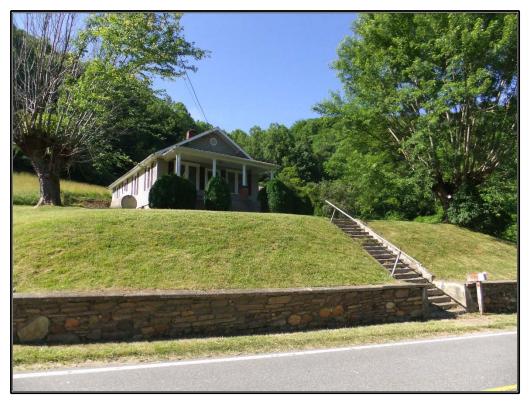
Figure 37. View of the façade of the D.W. Tipton House (ML0129), facing south-southwest.

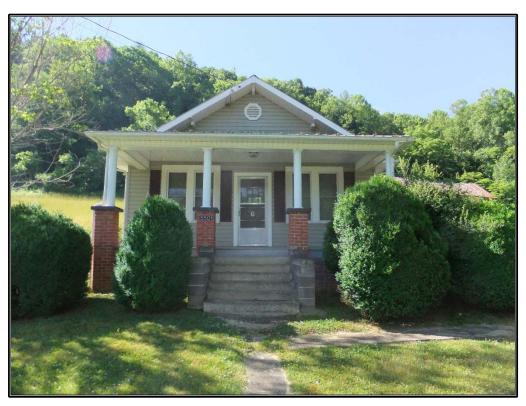
Figure 38. View of the porch details of the D.W. Tipton House (ML0129), facing southwest.

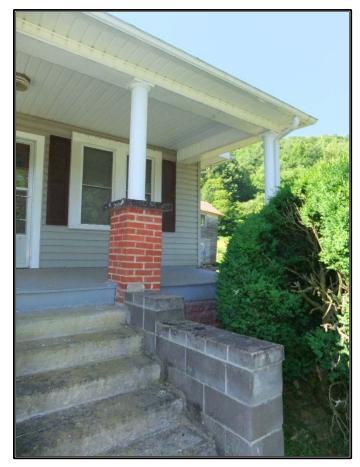
Figure 39. Southwest elevation of the D.W. Tipton House (ML0129), facing east-northeast.

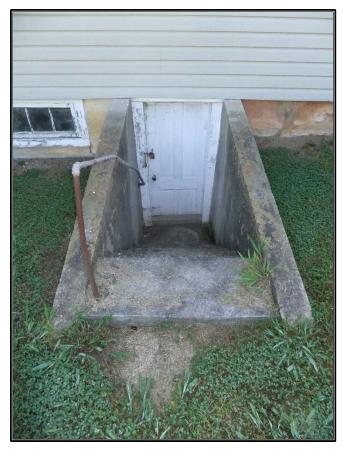
Figure 41. Rear elevation of the D.W. Tipton House (ML0129), facing north-northeast.

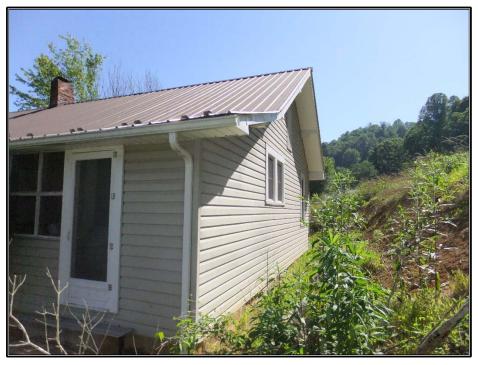
Figure 42. Northeast elevation and façade of the D.W. Tipton House (ML0129), facing southwest.

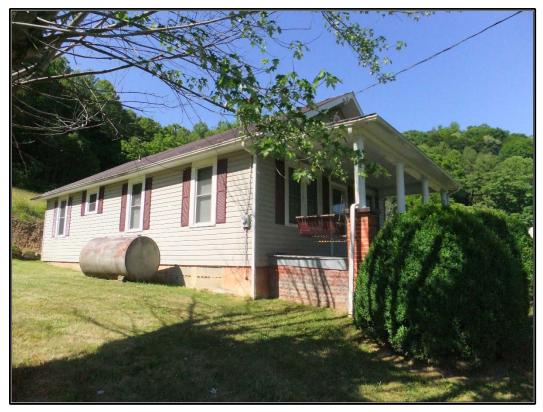
Figure 43. Northeast and façade elevations of the moved structure associated with the D.W. Tipton House (ML0129), facing south.

The two-story side-gabled vernacular building, located immediately west of the D.W. Tipton House, which appears to be moved, reflects an interesting property type that is not directly comparable to other resources in the vicinity. The type of this vernacular structure could not be determined, even following discussion with Annie McDonald in the Western Office of the NC HPO. Given its form and materials, it likely dates to the turn of the twentieth century. Several nineteenth-century residences and outbuildings remain in Mitchell County, including those located immediately to the west that are associated with the Whitson-Tipton Farmstead (ML0130).

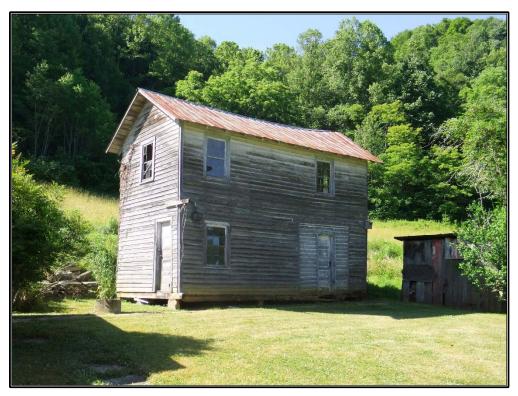
Figure 44. Southwest and rear elevations of the moved structure associated with the D.W. Tipton House (ML0129), facing northeast.

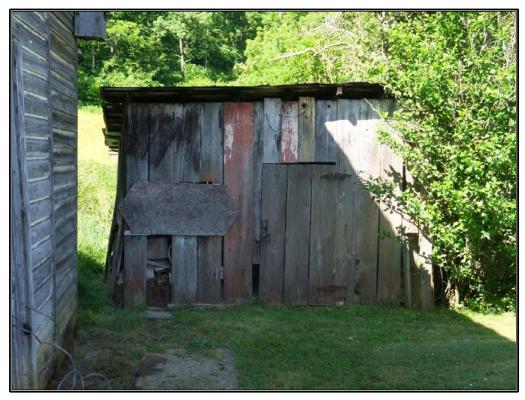
Shed: A circa 1938 one-story frame shed is located approximately 50 feet southwest of the D.W. Tipton House (Figure 45). This shed features frame construction clad in a patchwork of vertical board siding, is sheltered by a metal-clad shed roof and features a small single-leaf vertical plank door.

Figure 45. View of the shed associated with the D.W. Tipton House (ML0129), facing west-southwest.

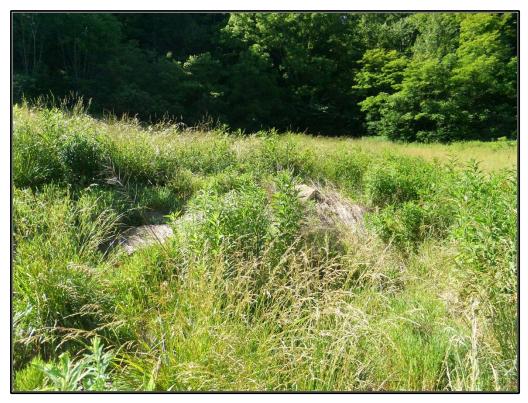
Foundation: A small stone foundation, located behind the shed, is partially visible through overgrown vegetation (Figure 46). Aerial photography since 1992, available through GoogleEarth, indicates that the structure, likely a structure for drying burley tobacco, was located here until 2010. The 2010 aerial view also illustrates that the slopes beside and behind the residence were planted with burley tobacco at that time. These fields are no longer cultivated.

Figure 46. Foundation remnants located immediately behind the shed, facing southwest.

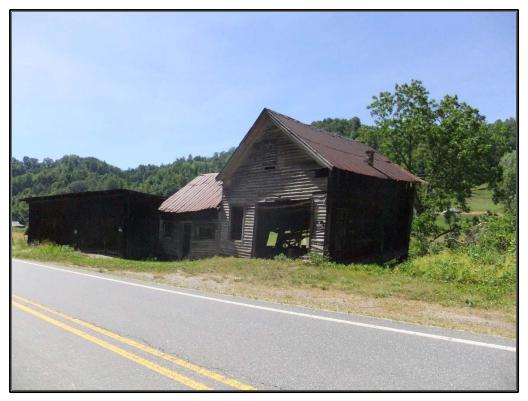
Shed: A circa 1950–1980 frame shed is located immediately west of the service station/store associated with the D.W. Tipton House (Figure 49). The one-story shed rests upon a concrete block pier foundation, features frame construction clad in vertical-board siding, and is sheltered by a metal-clad shed roof. The façade of the shed features two double-leaf entries with vertical plank wood doors (see Figure 47).

Figure 47. Façade and east elevation of the service station/store associated with the D.W. Tipton House (ML0129), facing northwest.

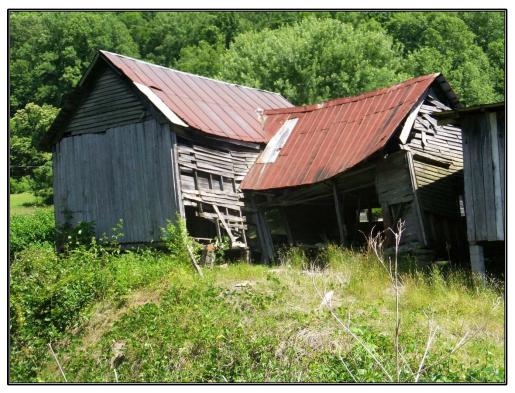
Figure 48. Rear elevation of the service station/store associated with the D.W. Tipton House (ML0129), facing southeast.

Discussion with Annie McDonald also confirmed the property type of the service station/store. Throughout the twentieth century, country stores and service stations served as a lifeline for those who lived in the rural and rugged mountains of western North Carolina and Mitchell County (Grisham and Koran 2011:85). In addition to selling food, dry goods, and supplies for the operation of small farms in the area, the stores also offered gasoline as the popularity and affordability of automobiles increased. The service station/store associated with the D.W. Tipton House (ML0129) was likely one of those small locally-based stores and gas stations that served the former community of Webb. While deed research indicates that J.W. Webb owned the D.W. Tipton House from 1943 to 1951, no local histories indicate that Mr. Webb owned a store at this location; however, they do indicate that his largest store, which also operated as a funeral home, was located at the mouth of Brummett Creek at Relief (Hunter 2011:55; 65). Country stores and service stations in the area near the D.W. Tipton House in Mitchell County include Griffith's General Store in Tipton Hill and the Phin Peterson Store in Huntdale. The Phin Peterson Store (noted in the HPOWeb Database) is comprised of two components-an early-twentieth-century one-and-one-half-story front-gable frame store and service station (Figures 54-55). The circa 1925 Relief Post Office and Store (ML0064), which was added to the study list in 1987, is also an example of a country store, though it is no longer in operation (Figure 56) (Bishir, Southern, and Martin 1999:238).

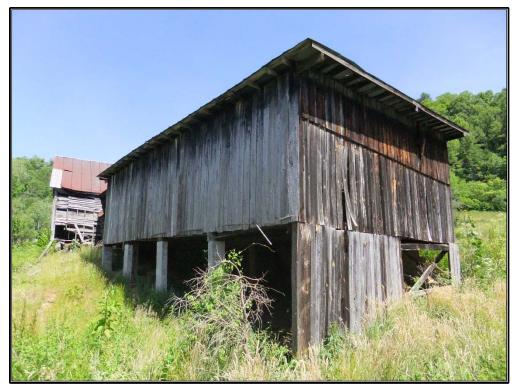
Figure 49. Rear and west elevations of the shed associated with the D.W. Tipton House (ML0129), facing eastsoutheast.

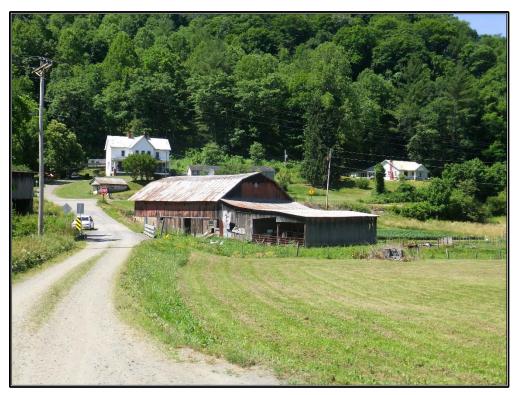
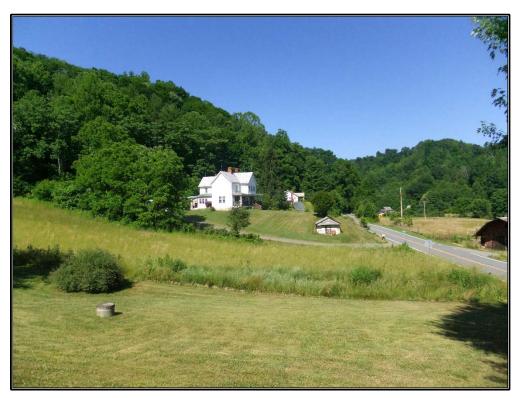
Setting: Located approximately 1.2 miles northwest of the small community of Tipton Hill and 1.5 miles northeast of the small community of Relief near the former community of Webb in northwest Mitchell County, the Whitson-Tipton Farmstead (ML0130) is situated on the south side of NC 197, immediately south of its intersection with Miller Road (SR 1313) (see Figures 1; Figure 57). The 36.69-acre parcel on which the Whitson-Tipton Farmstead is situated is comprised of two sections: a large section on the south side of NC 197 containing a circa 1885 residence, a pump house, a cold storage cellar, three sheds, three modern carports, and a chicken coop; and a small section containing a barn, outbuilding, and foundation (Figures 58 and 59). Concrete steps and a gravel driveway connect the Whitson-Tipton Farmstead to NC 197.

Figure 58. Overview of the house, barn, and outbuildings associated with the Whitson-Tipton Farmstead (ML0130) and Bridge No. 183 over Brummett Creek, facing south-southwest.

Figure 59. Overview of the Whitson-Tipton Farmstead (ML0130) and outbuildings, facing southwest.

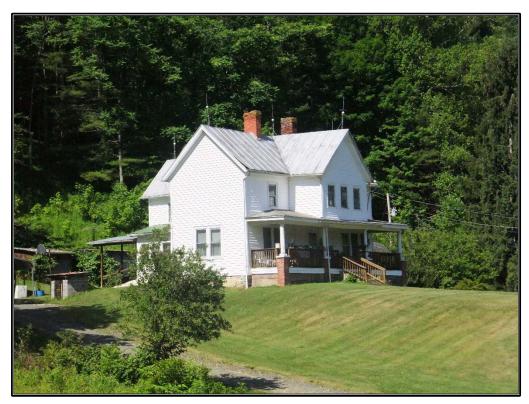
Figure 60. View of the façade and east elevations of the Whitson-Tipton Farmstead (ML0130), facing southwest.

House: The primary resource associated with this property, the circa 1885 Whitson-Tipton Farmstead (ML0130), features a two-story, single-pile, cross-gable form with a second-floor cross-gable extension, a rear ell addition, and a rear porch addition (Figure 60). While the property owner, Thelma Tipton, granted permission for photography and documentation of the exterior of the property, she did not grant access to the interior. As such, details regarding the framing of the house are unconfirmed; however, given the building's age, form, and appearance, the house likely features frame construction. The roof is clad in metal panels and is pierced by two interior brick chimneys on the side-gable core and a third on the rear ell. The house is situated on an uncoursed, mortared continuous stone foundation. Windows throughout the house feature a combination of one-over-one-light vinyl replacement and six-over-six-light wood sashes. The entire exterior of the house is clad in vinyl siding.

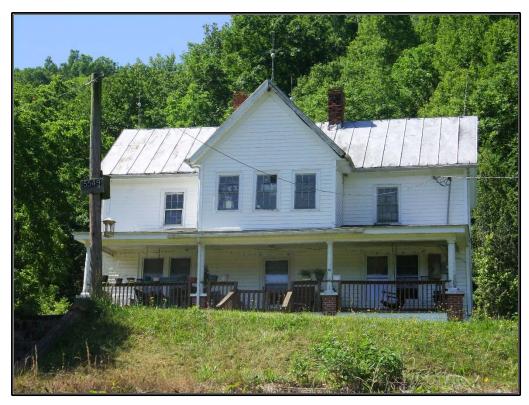
Figure 61. Façade of the Whitson-Tipton Farmstead (ML0130), facing south.

The façade features a single central entry with a storm door that opens to a full width porch (Figure 61). Wood Doric columns on brick piers support the hip roof of the porch. The porch also features a modern wood balustrade and gate. Pairs of one-over-one-light, double-hung replacement windows flank the entry on the first floor. The second floor of the façade is dominated by a three-bay, front-gable projection that extends over the one-story porch. Single windows flank the central projection on the façade. Second-story windows of the façade feature six-over-six-light, double-hung wood sashes.

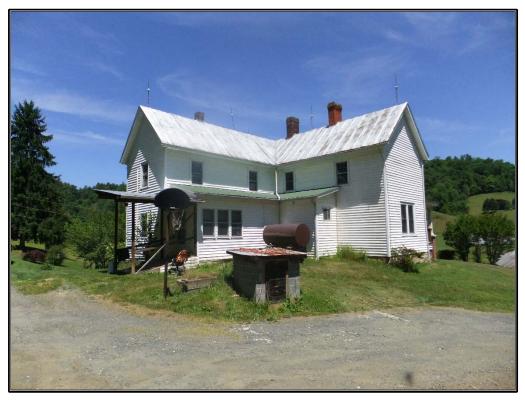
Figure 62. Rear and east elevation of the Whitson-Tipton Farmstead (ML0130), facing northwest.

The east, or side, elevation features a pair of single windows on the first floor of the core and no windows on the second floor (Figure 62). A bank of three windows is located on the enclosed porch on first floor of the east elevation. The enclosed porch features a bank of three replacement vinyl windows on the first floor. Two windows are located on the second story of the east elevation of the rear ell above the porch. An additional small sliding window is located on a one-story rear enclosed porch that extends from the rear of the core of the house.

Pump House: A circa 1950–1990 concrete block pump house with a flat metal roof and a single small wood door is located approximately 14 feet southeast of the Whitson-Tipton Farmstead (see Figure 62).

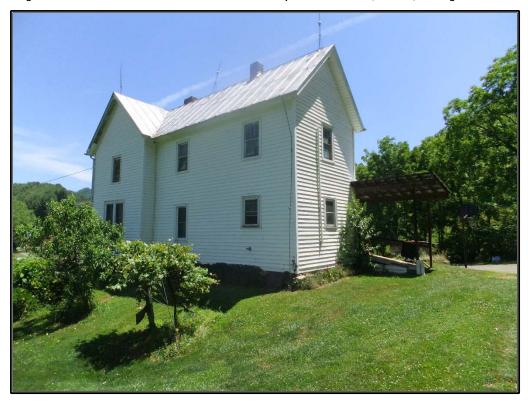
Figure 63. Rear and west elevation of the Whitson-Tipton Farmstead (ML0130), facing northeast.

The rear elevation features two windows with six-over-six-light, double-hung wood sashes on the second floor and no windows and doors on the first floor. Two single windows are centered on the first and second floors of the rear ell of the Whitson-Tipton Farmstead (Figure 63). A shed roof supported by wood posts shelters a wheelchair ramp that extends from the enclosed porch.

centered on the second floor of the core of the side-gabled Whitson-Tipton Farmstead (see Figure 63). Two windows are located on each floor of the west elevation of the rear ell.

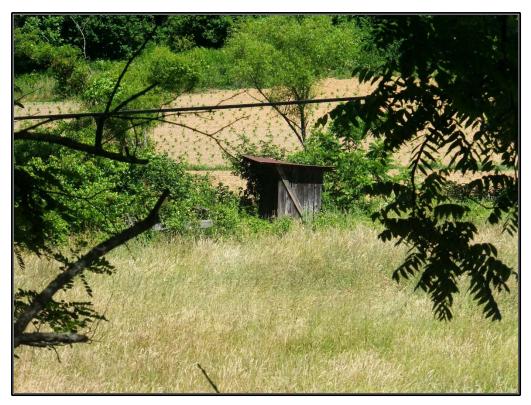
Outbuilding and Foundation: A small, circa 1920–1950 one-story frame outbuilding clad in vertical siding with a metal-clad shed roof – possibly an outhouse – is located approximately 660 feet west of the barn. The remnants of a foundation are also visible immediately west of the small outbuilding (Figure 69).

Figure 69. Outbuilding and foundation, facing northwest.

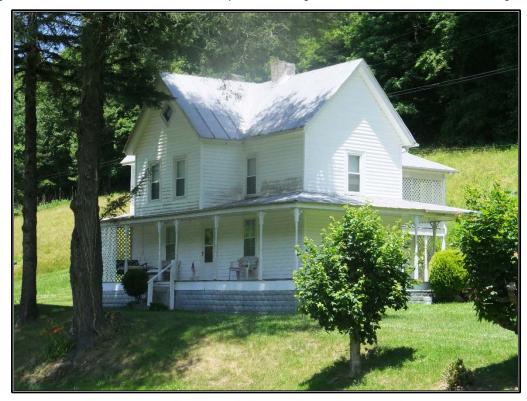
This assessment is misleading. To begin, only one of the comparable properties, depicted in figures 72-73, appears to retain a higher degree of integrity than the Whitson-Tipton Farmstead. Yet even this building appears to have vinyl siding and replacement vinyl windows. In addition, the domestic outbuilding shown in figure 74 appears to be of later construction (cement) than the older stone masonry cellar of at the Whitson-Tipton Farmstead. Interestingly, the farmstead depicted in figure 76 is located northwest of and adjacent to the Whitson-Tipton Farmstead retains a number of outbuildings and may have historically been associated with the subject property. However, like the other properties presented as comparables, it is simply described as "Farmstead with overgrown fields located just west of the Whitson-Tipton Farmstead on the north side of NC 197," with no analysis of how the two properties compare in terms of integrity and eligibility.

Figure 73. Detail of the cross-gable residence associated with the farmstead at 11842 NC 197, facing north.

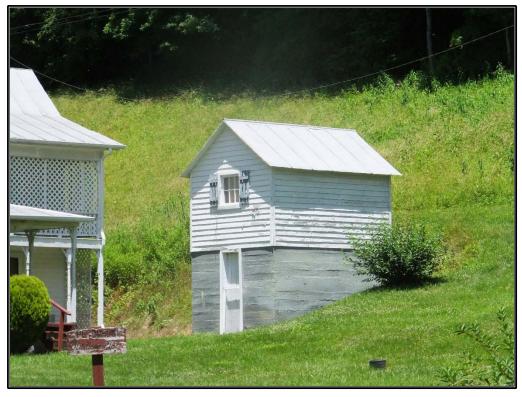
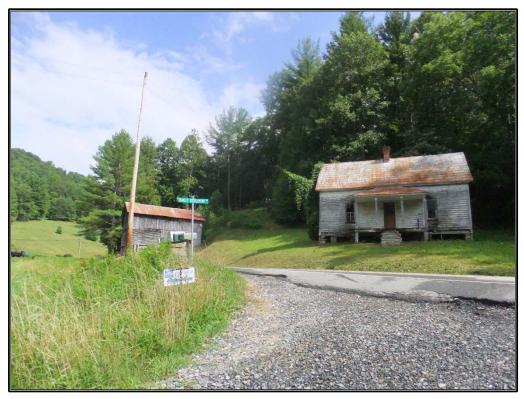
The house associated with the Whitson-Tipton Farmstead reflects a typical late-nineteenthcentury frame two-story form. Only one directly comparable example was noted in the vicinity of the Whitson-Tipton Farmstead (see Figures 72–74), the house features a very similar form and style as well as a cold storage cellar. Other houses that reflect the same age and similar style and materials were located in the vicinity (see Figures 75 and 76).

Figure 74. Detail of the cellar associated with the farmstead t 11842 NC 197, facing north.

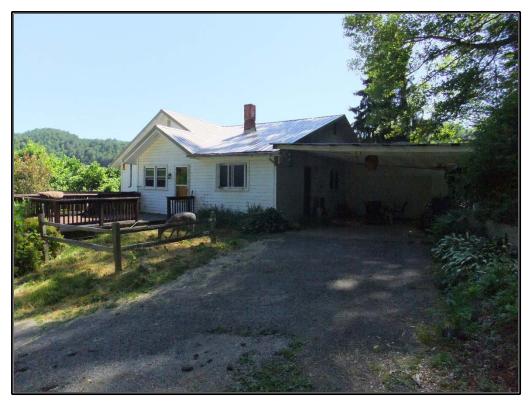
Figure 85. Detail of the porch of the Eston Pate House (ML0131), facing southwest.

The façade features a single central entry with a storm door that opens to a one-bay porch (Figure 85). Battered wood columns on piers support the front-gable roof that extends over the porch. A delicate wood trim extends around the eave of the front porch roof. Single one-over-one-light double-hung replacement windows flank the entry on the first floor.

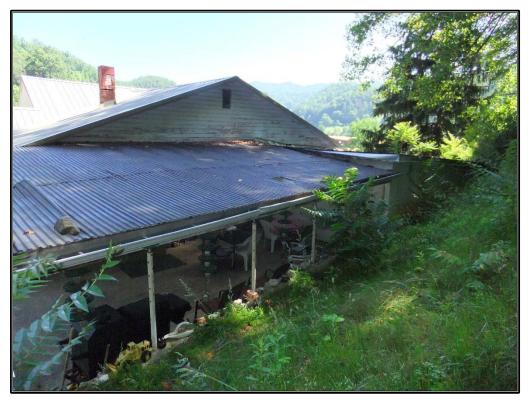
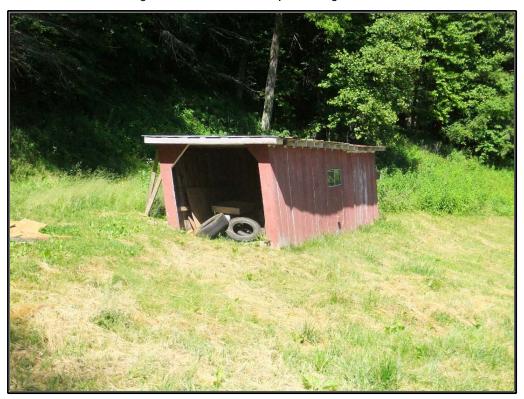
a one-by-one-light vinyl replacement window that open to an attached carport. A corrugated metal shed roof shelters the carport (Figures 88 and 89).

Figure 88. Interior view of the carport on the rear of the Eston Pate House (ML0131), facing east.

Figure 89. Exterior of the carport, facing northeast.
