Re: Architectural Survey and Evaluation, Harvey Point Testing Area, Hertford,
Perquimans County, ER 17-0160

October 2016

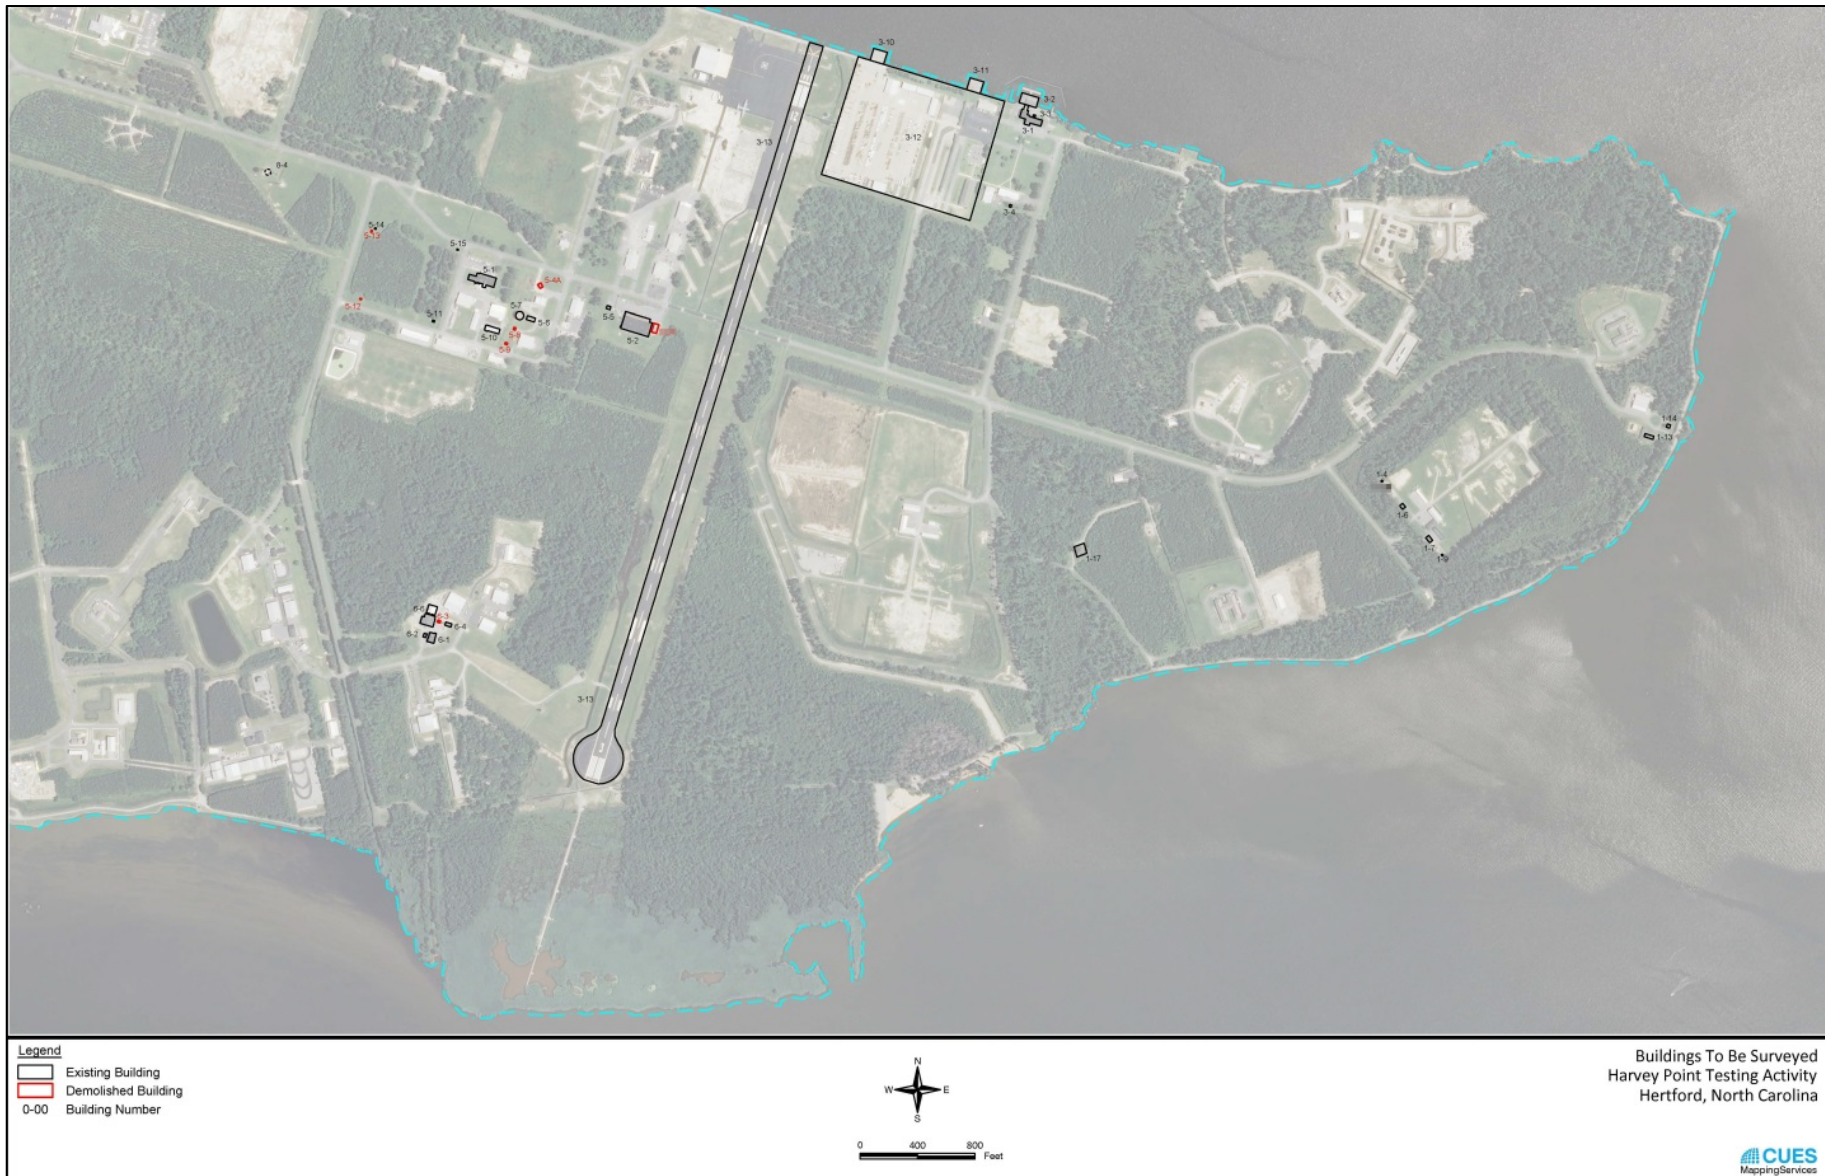
Figure 1. HPDTA architectural resources surveyed and location of demolished resources. (Source: HPDTA).

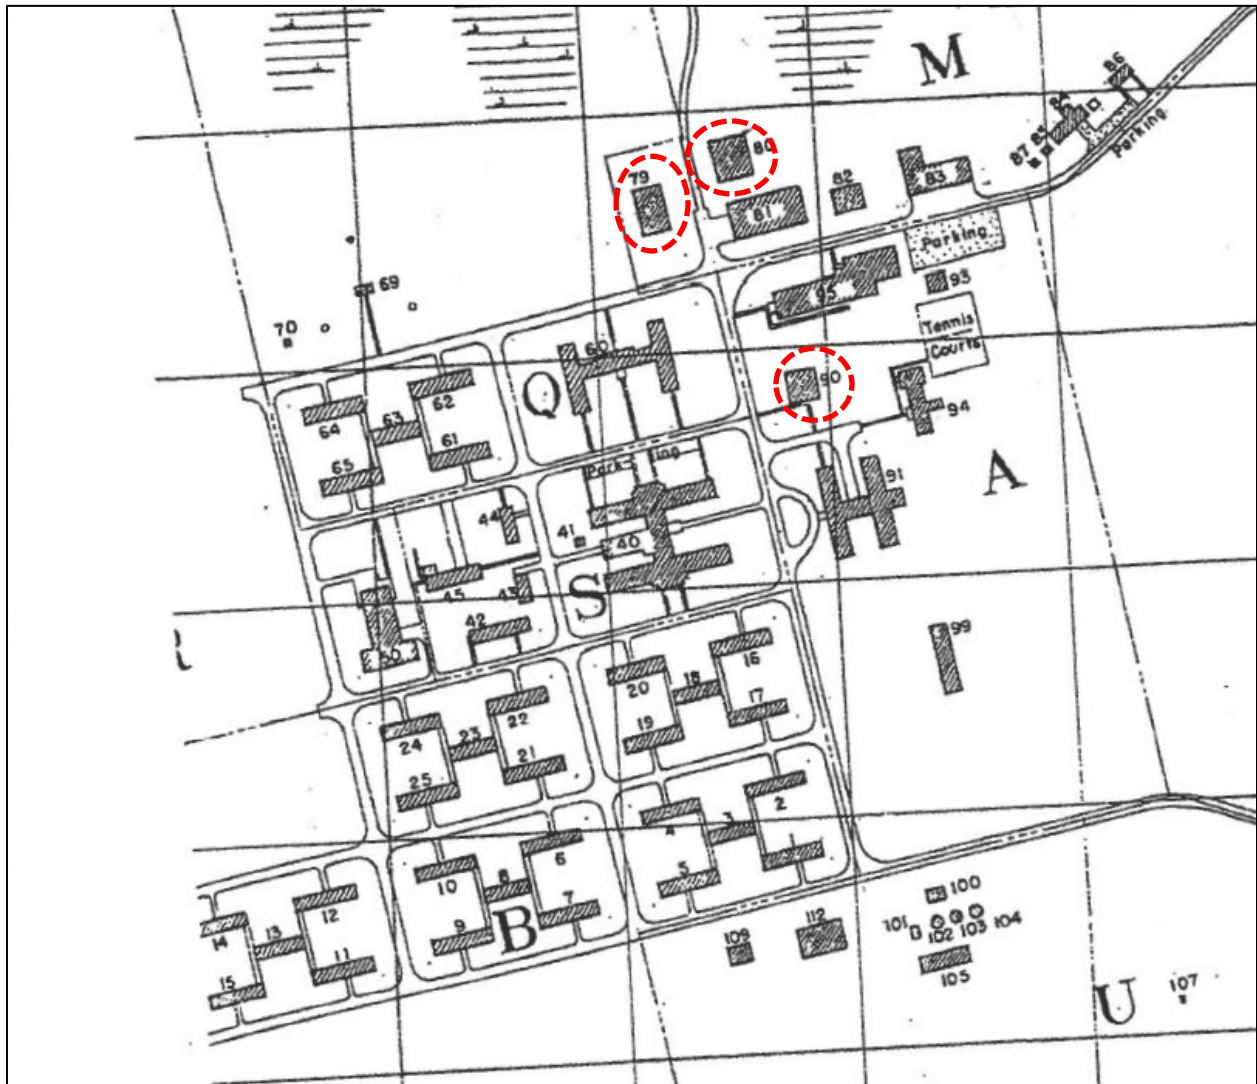
Figure 5: Map of Auxiliary Air Station, Harvey Point, North Carolina, showing conditions on January 1, 1945, detail. Shows the administrative area of the seaplane base during WWII, with Ashland (Building 90, upper right) and its outbuildings (Buildings 79 and 80, upper center) circled in red. (Source: Davis, 2001)

Ashland (Figure 3), a c.1775 wood-framed house associated with John Skinner's plantation, provided space for the base's commander from 1942 to 1946 (Davis 2001:33). The WWII housing and administrative cantonment, likely consisting of temporary, frame buildings, surrounded Ashland (Map of Auxiliary Air Station, Harvey Point, North Carolina, showing conditions on January 1, 1945 (Figure 5)). In addition to the cantonment and the operational seaplane area, the ammunition storage area supported the operations, but developed physically separate (southeast of the seaplane area), presumably for safety purposes.

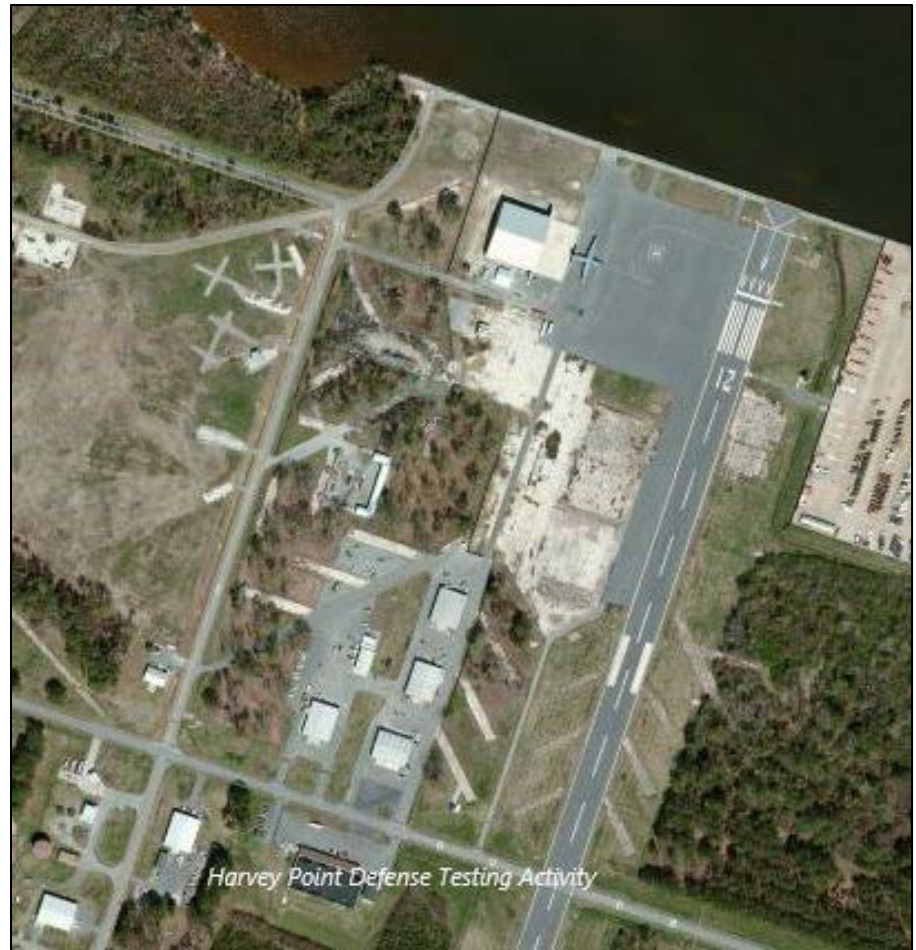
Figure 6. Historic map showing conditions in 1945 (left) and current aerial showing conditions in 2016 (right). (Source: McClintock and Sara, 2006 & Bing Maps, 2016)

roads and fields of Ashland Plantation and other agricultural endeavors, left an indelible mark on the road patterns, air-related infrastructure and the placement of later facilities. However, no extant resource surveyed in this report originated, or remained mostly as constructed, from the WWII period. Evidence of the eastern seaplane taxiway associated with the WWII seaplane operations is present, but the taxiway has lost integrity with the expansion of the runway (Facility 3-13; PQ857) in the 1960s. The expansion of the apron and runway, and other alterations in this area obliterated much of the paved, tree-like revetments that once provided parking space for the WWII seaplanes. There are small portions of the revetments that appear in current aerial photographs (Figure 6). Based on historic maps, two WWII seaplane ramps entered the Perquimans River shoreline immediately north of the two ramps constructed circa 1959 for the SeaMaster program (Facility 3-10 and Facility 3-11; PQ854 and PQ855). The WWII-era ammunition storage area, southeast of the seaplane parking and hangars, evolved into Range C in recent years, and as a result, the storage facilities no longer exist.

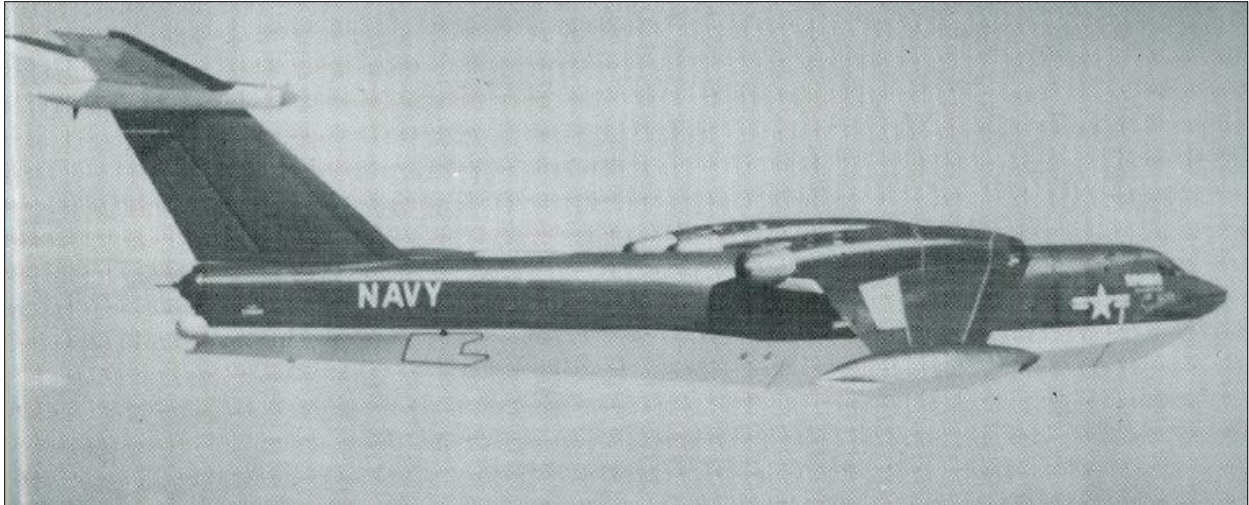
Figure 8: Image of P6M (SeaMaster) jet seaplane in flight. (Source: Town of Hertford Bi-Centennial, p. 63, 1958).

The P6M SeaMaster, one of the largest seaplanes ever constructed, appeared deceptively streamlined and graceful. “The SeaMaster weighed 160,000 pounds on takeoff, and was 134 feet long, with a wingspan of 102 feet,” almost the size of a B-52 Stratofortress (Dorr). The plane, powered by four jets mounted on top of its wings, maintained a maximum capacity for 30,000 pounds of droppable stores, dispersed through Martin’s distinct rotating mine door, at speeds of up to 600 miles-per-hour (Murphy 1981:31 and Dorr). Most importantly, as a seaplane, the P6M took flight and landed without a land-based runway, and did not need the costly and cumbersome support of an aircraft carrier for long-range missions.

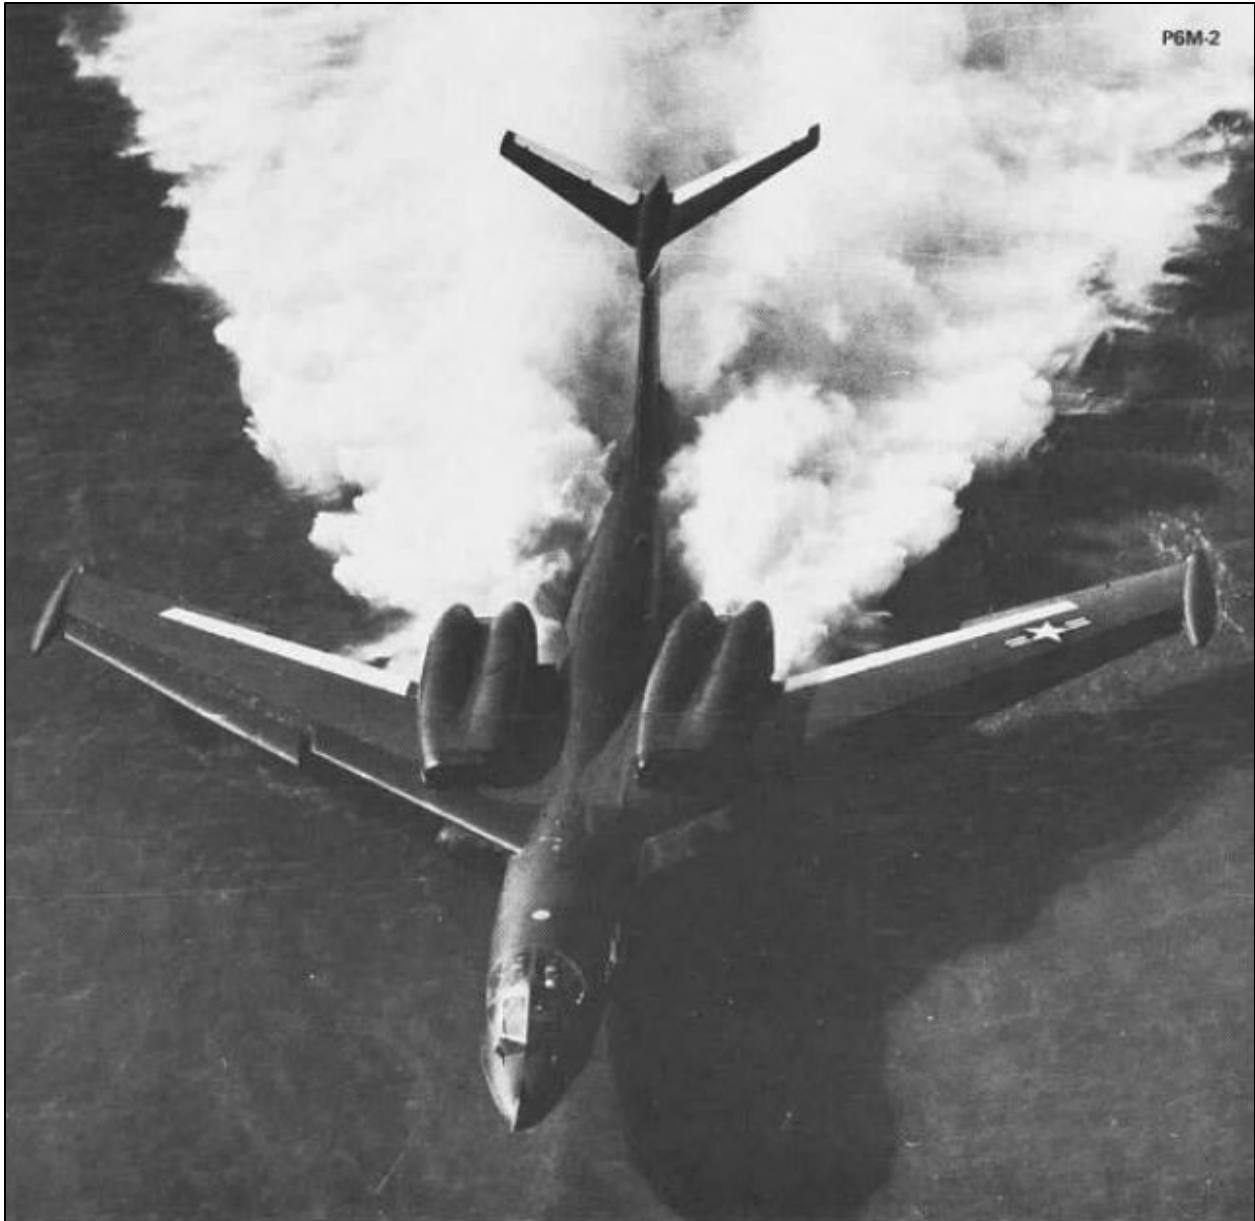
Figure 9: P6M-2 on water. (Source: *SeaMaster Remembered*).

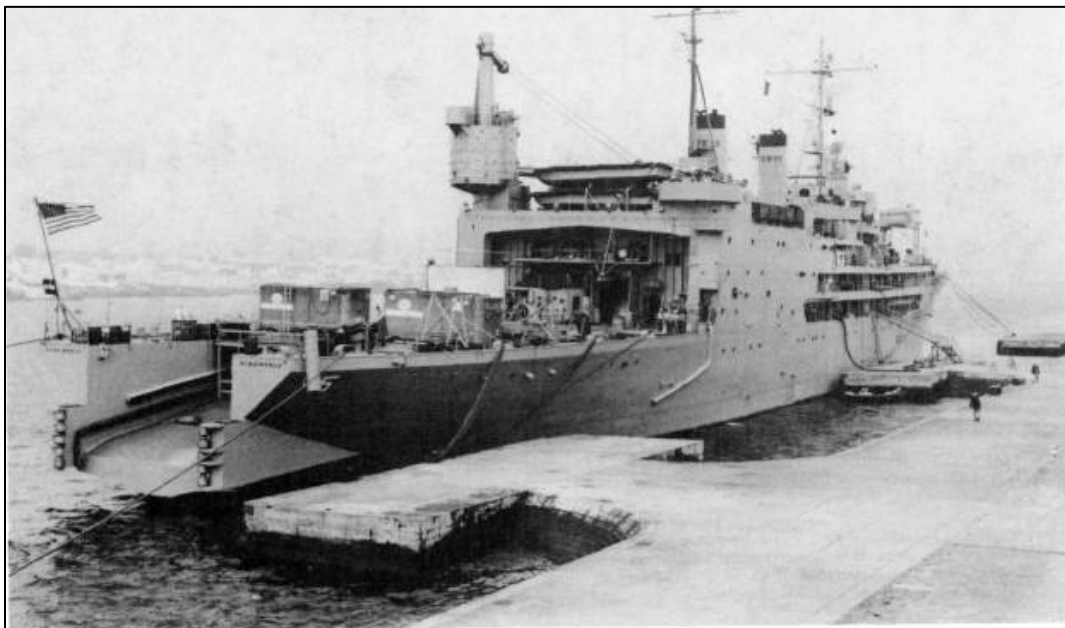
Figure 10: *USS Albemarle* on August 21, 1958, after extensive modifications to handle the SeaMaster. (Source: NHHHC).

While the identity of AVD-1 remains inconclusive at the time of this report, literature conclusively identifies AV-5 as the *USS Albemarle*. The aptly named seaplane tender, and the third ship named *Albemarle*, constructed in 1939, saw continuous service throughout WWII and in the immediate years after. After decommissioning in 1950, the vessel moved to the Philadelphia Naval Shipyard in February 1956, to begin its transformation to serve the SeaMaster. As the only seaplane tender converted to service jet seaplanes, *Albemarle* featured stern ramps and servicing booms, negating the need for cranes, a semi-sheltered area and service drydock. (NHHHC and <http://www.combatreform.org/p6mseamaster.htm>). The Bureau of Aeronautics 1959 directive seems to contradict the ramp construction details of the *Albemarle*, when it states that, “The AV-5 will not have a ramp installed, therefore, hull bottom inspections and repairs will not be performed on that vessel” (National Archives). Seaplanes could also be serviced alongside the vessel. Re-commissioned at Philadelphia on October 21, 1957, the *Albemarle* participated in exercises with traditional seaplanes across the globe, awaiting its eventual placement with the SeaMaster; an assignment that never arrived.

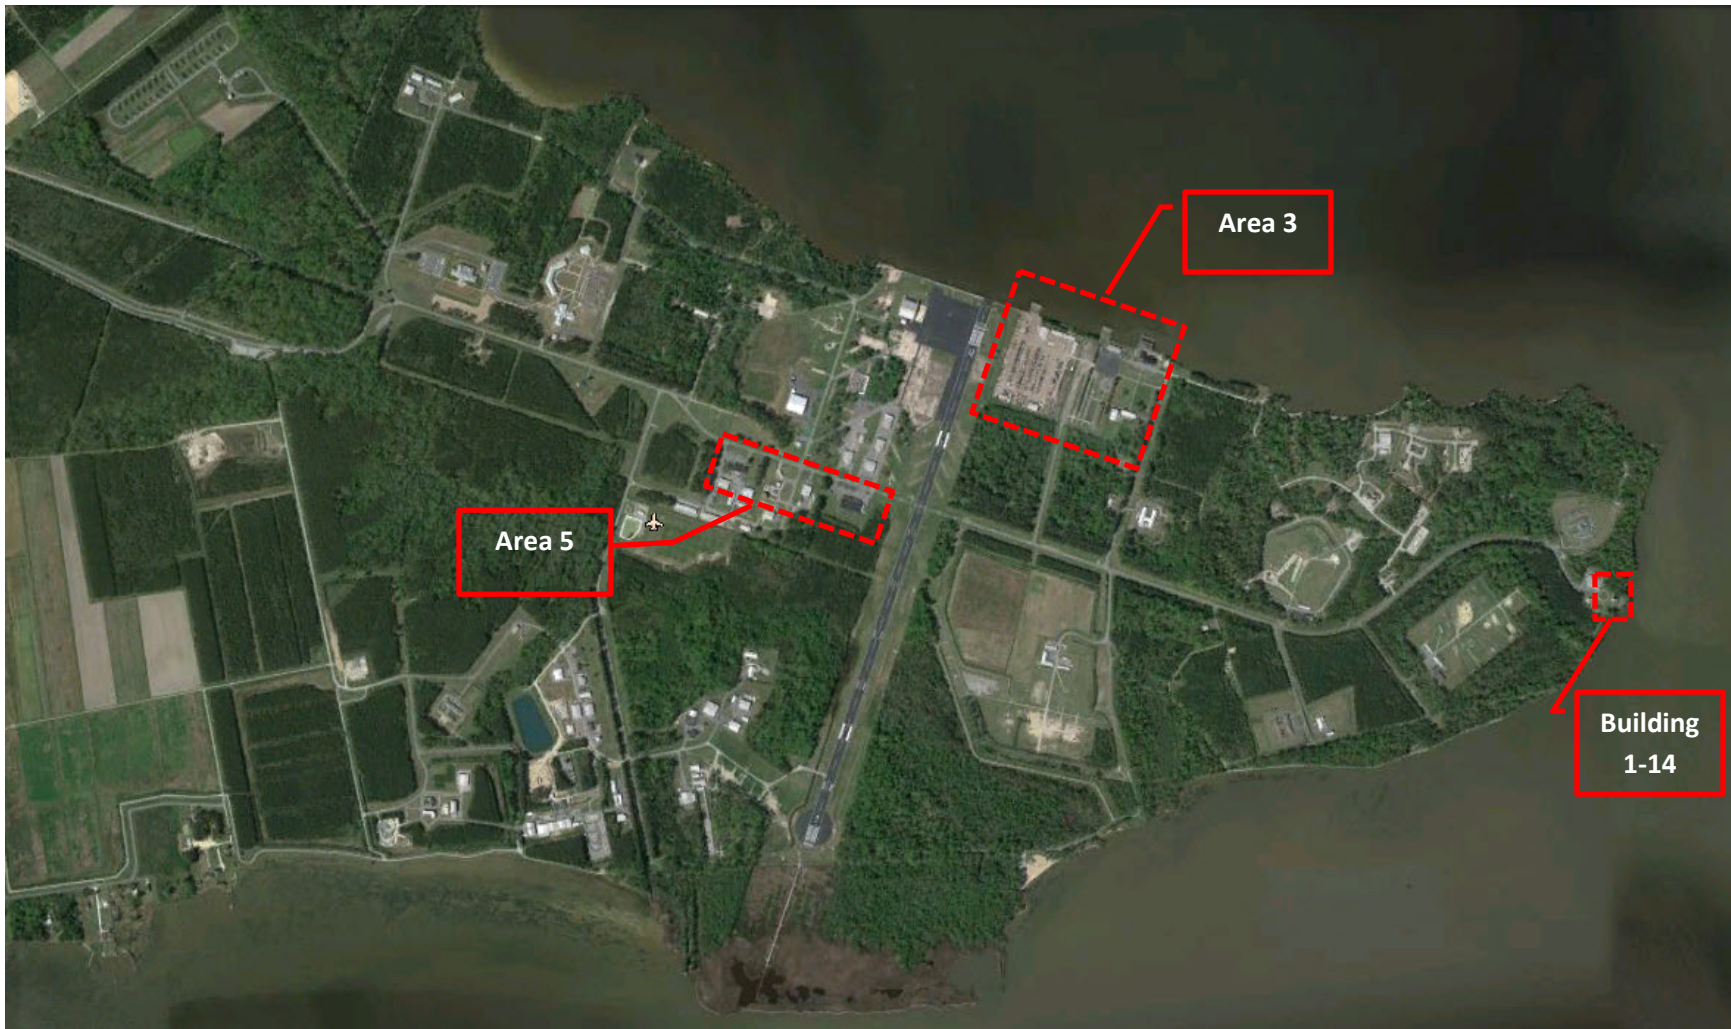
Figure 13. 2016 Aerial of HPDTA depicting Area 3, Area 5, and Building 1-4. (Source: Google Earth)

As it relates to a linkage or collective grouping of the resources constructed in support of the SeaMaster program, the resources are spread out across the installation, with two small groupings of the buildings and structures: Building 3-1, Building 3-2, Building 3-3, Facility 3-10, Facility 3-11, and Facility 3-12 located to the northeast of the current runway; and, Facility 5-1 and Facility 5-2 located to the southwest of the current runway. Building 1-4 was constructed as the control tower and is located on the far, east side of the installation. Even though there are complexes of buildings, the overall setting and context from the SeaMaster Program period of significance is obscured with the development of the installation from the 1960s to the present. The relationship of the buildings to significant features of the SeaMaster program is not evident, as the master plan associated with building the SeaMaster installation was never completed. The buildings that were constructed and still remain only portray a small part of the buildings necessary to support the SeaMaster program, and do not present a complete picture.

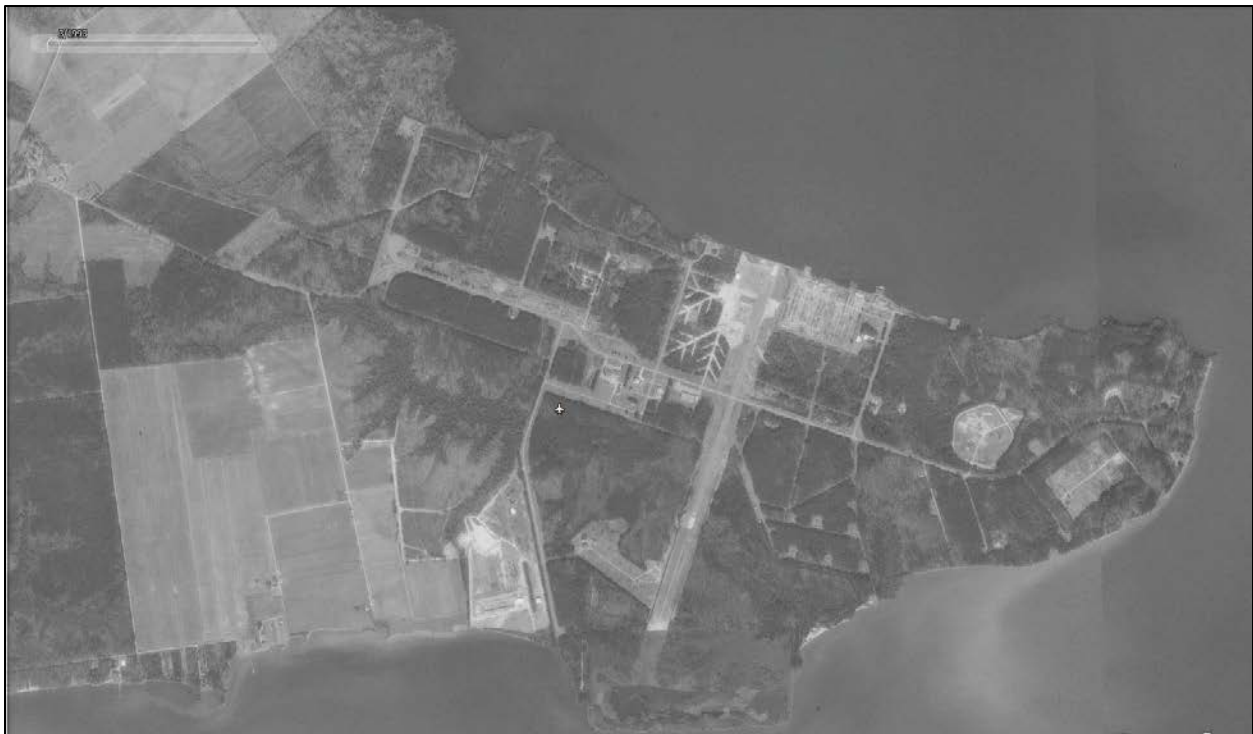
Figure 15: 1993 aerial view, HPDTA. (Source: Google Earth).

Recent base construction activities have focused on providing additional range space, and moving administrative functions away from the range areas. HPDTA likely converted the former pentagon-shaped tank farm into Range B soon after it started operations in 1960, and later expanded its activities, with the demolition of the tank farm’s remaining tanks. Range C, the former location of ammunition storage facilities, became a testing range in the early 2000s. Building 3-1, the administration and operations center since 1960, was replaced with Building 750, located farther from the testing ranges, around 2006.

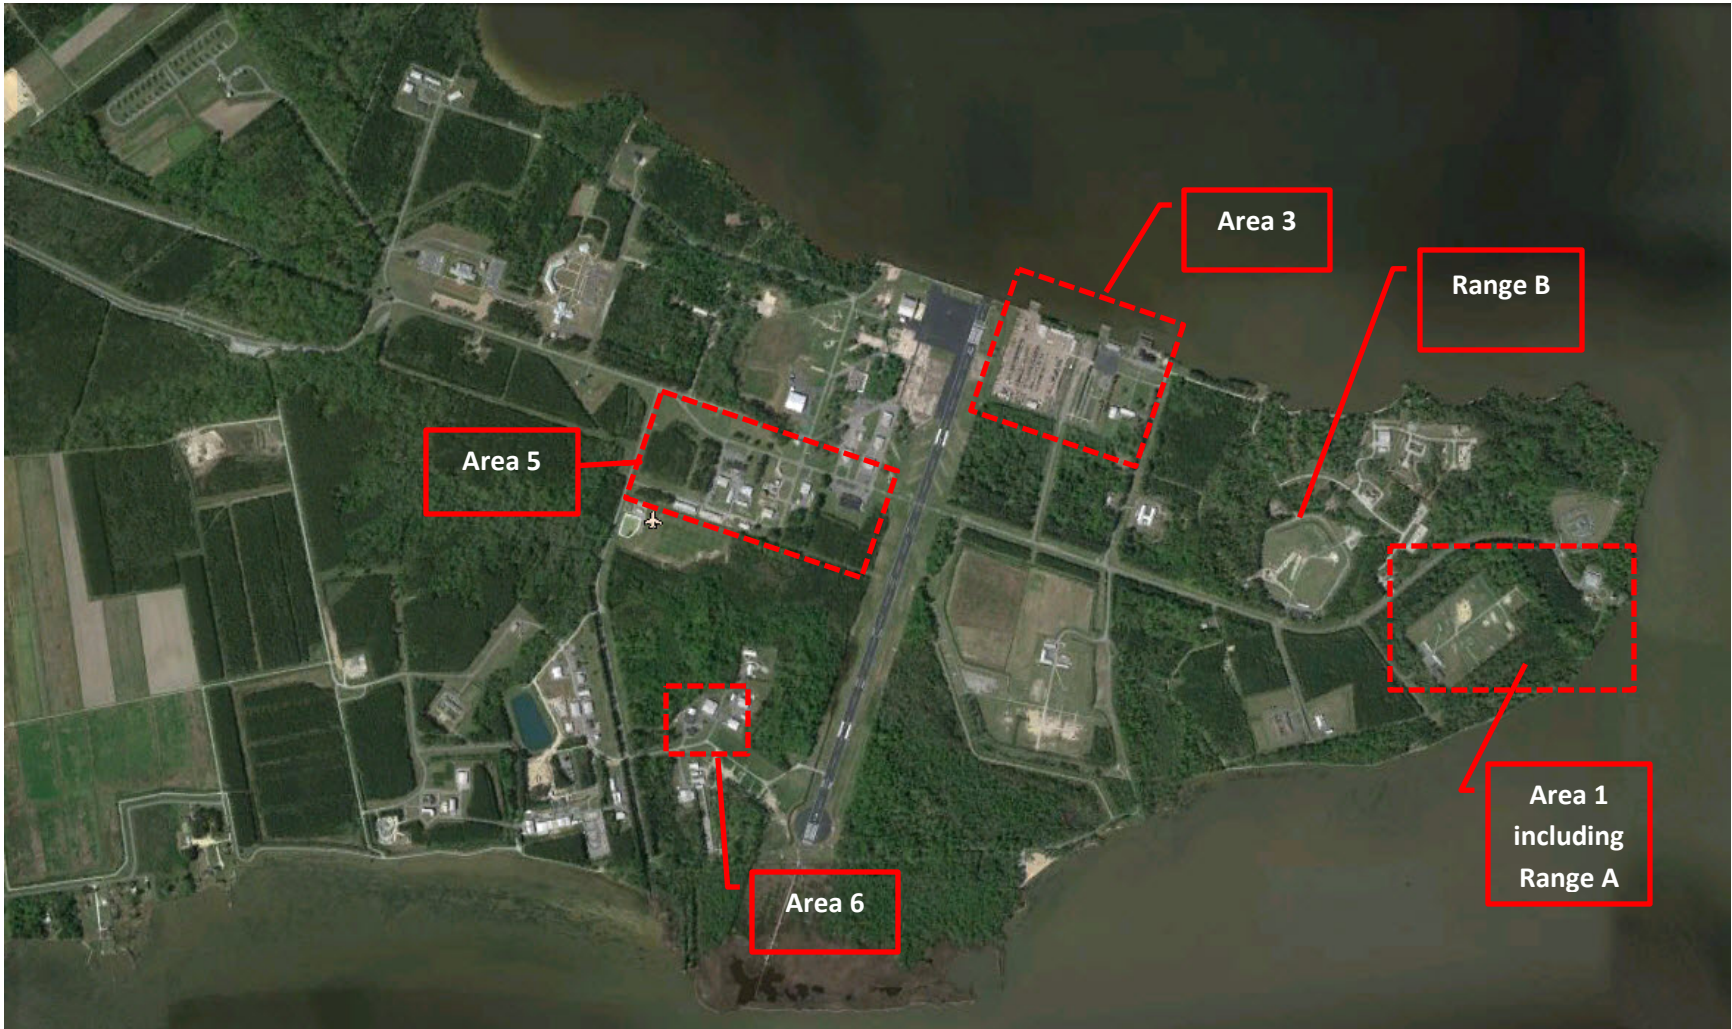
Figure 16. 2016 Aerial of HPDTA depicting areas of development between 1960-1965. (Source: Google Earth).

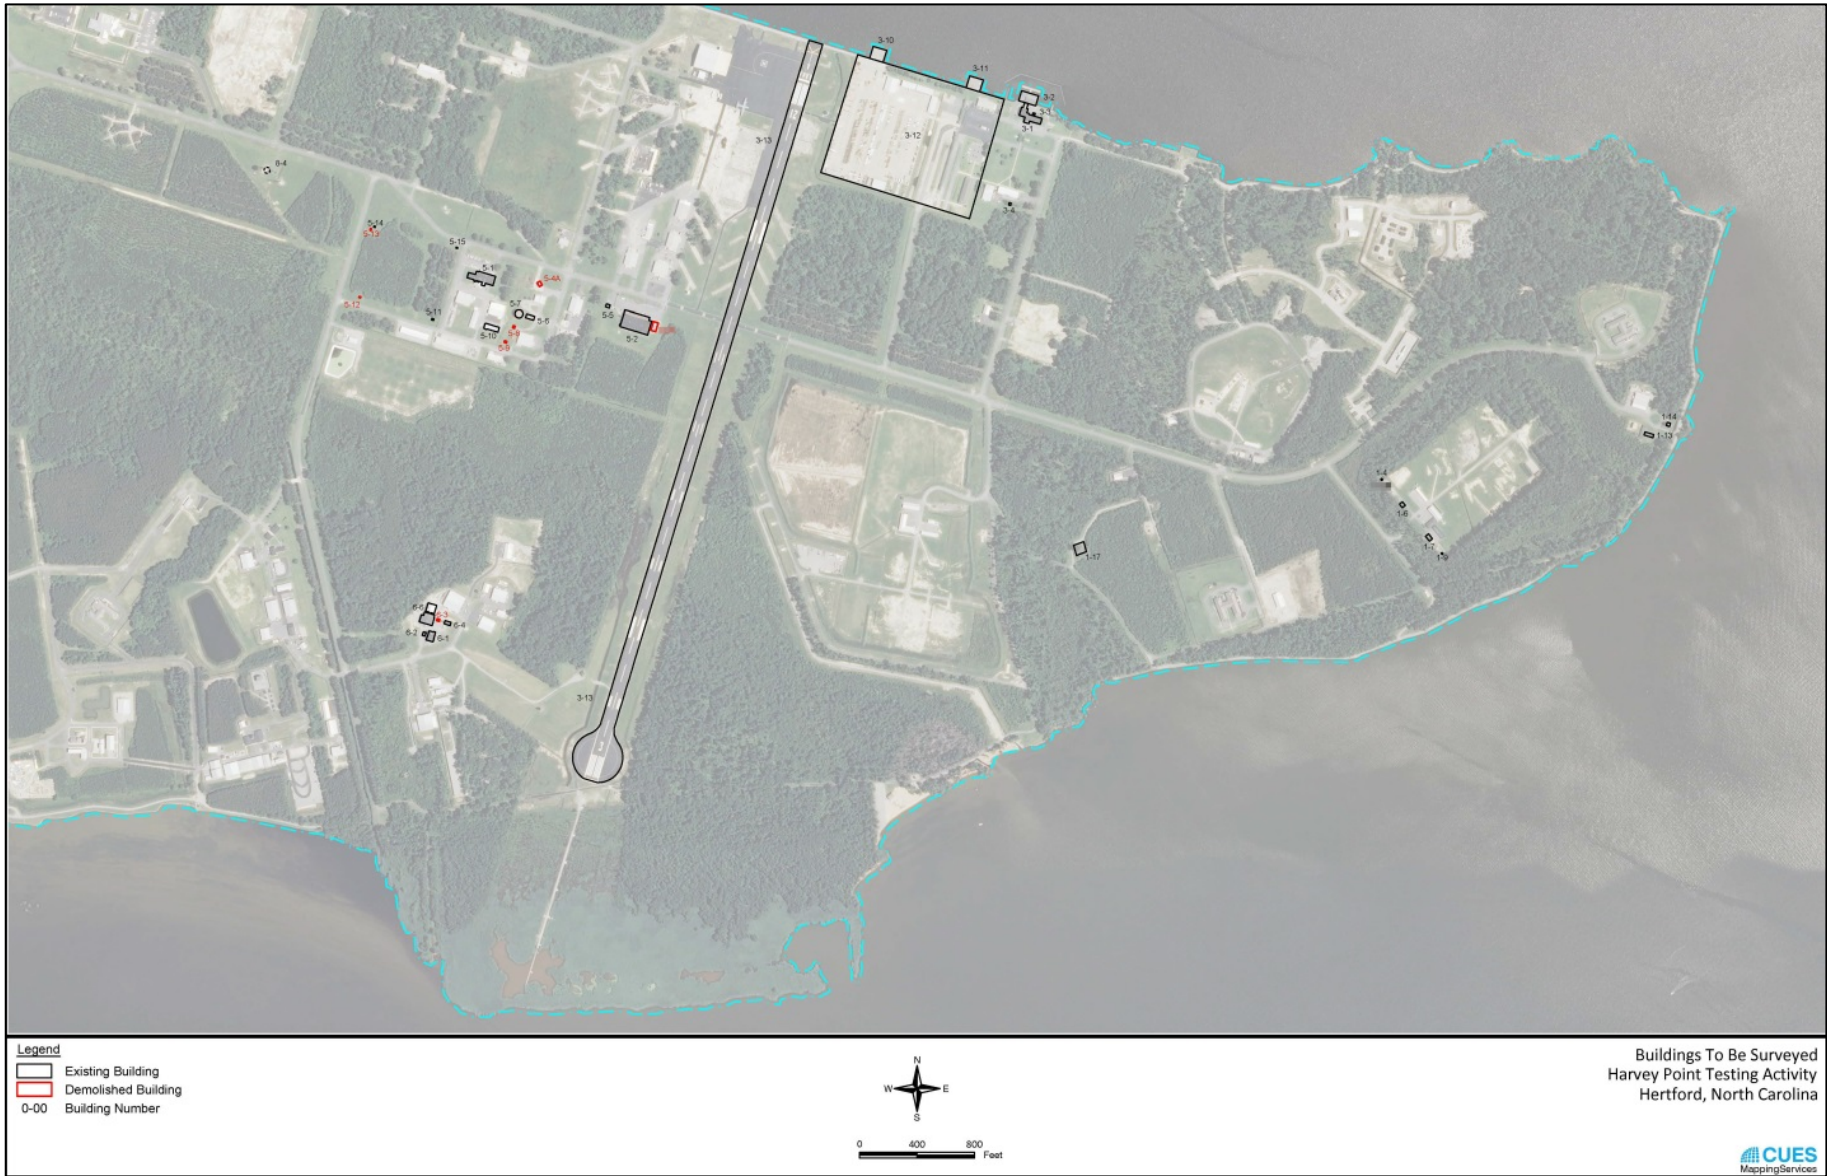
Figure 17: HPDTA architectural resources surveyed and those that were previously demolished. (Source: HPDTA).

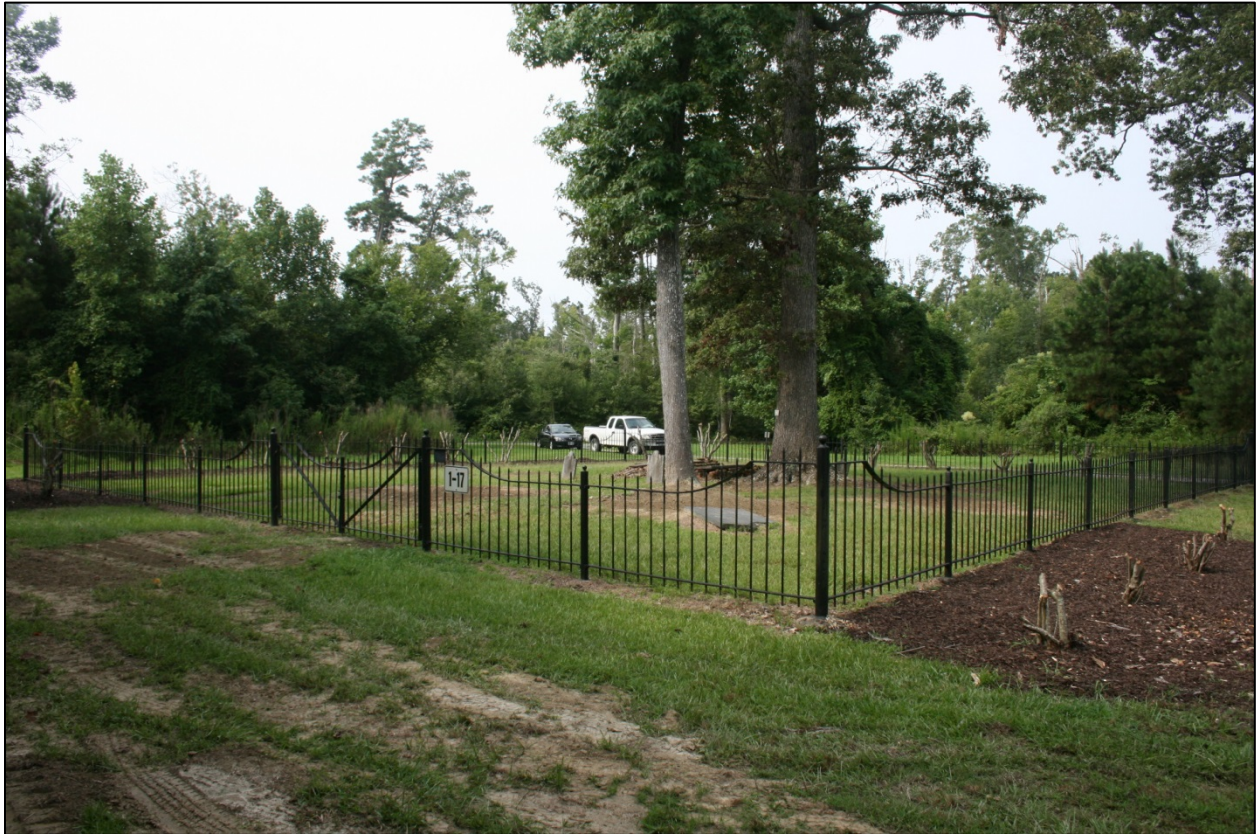
Figure 18: Harvey Cemetery

Survey work completed in 2014 verified previously recorded information and noted the existing conditions of Harvey Cemetery. An ornamental black iron fence, with a double swing gate, surrounds the cemetery, and features a plaque that states, "TIDEWATER MACHINE & BOILER CO, AIRLINE TURNPIKE, PORTSMOUTH VIRGINIA, MAY 1959." Headstones, footstones,

and brick outlines mark eighteen possible grave locations. Cemetery inscriptions note death dates from the eighteenth and nineteenth centuries, starting in 1761.

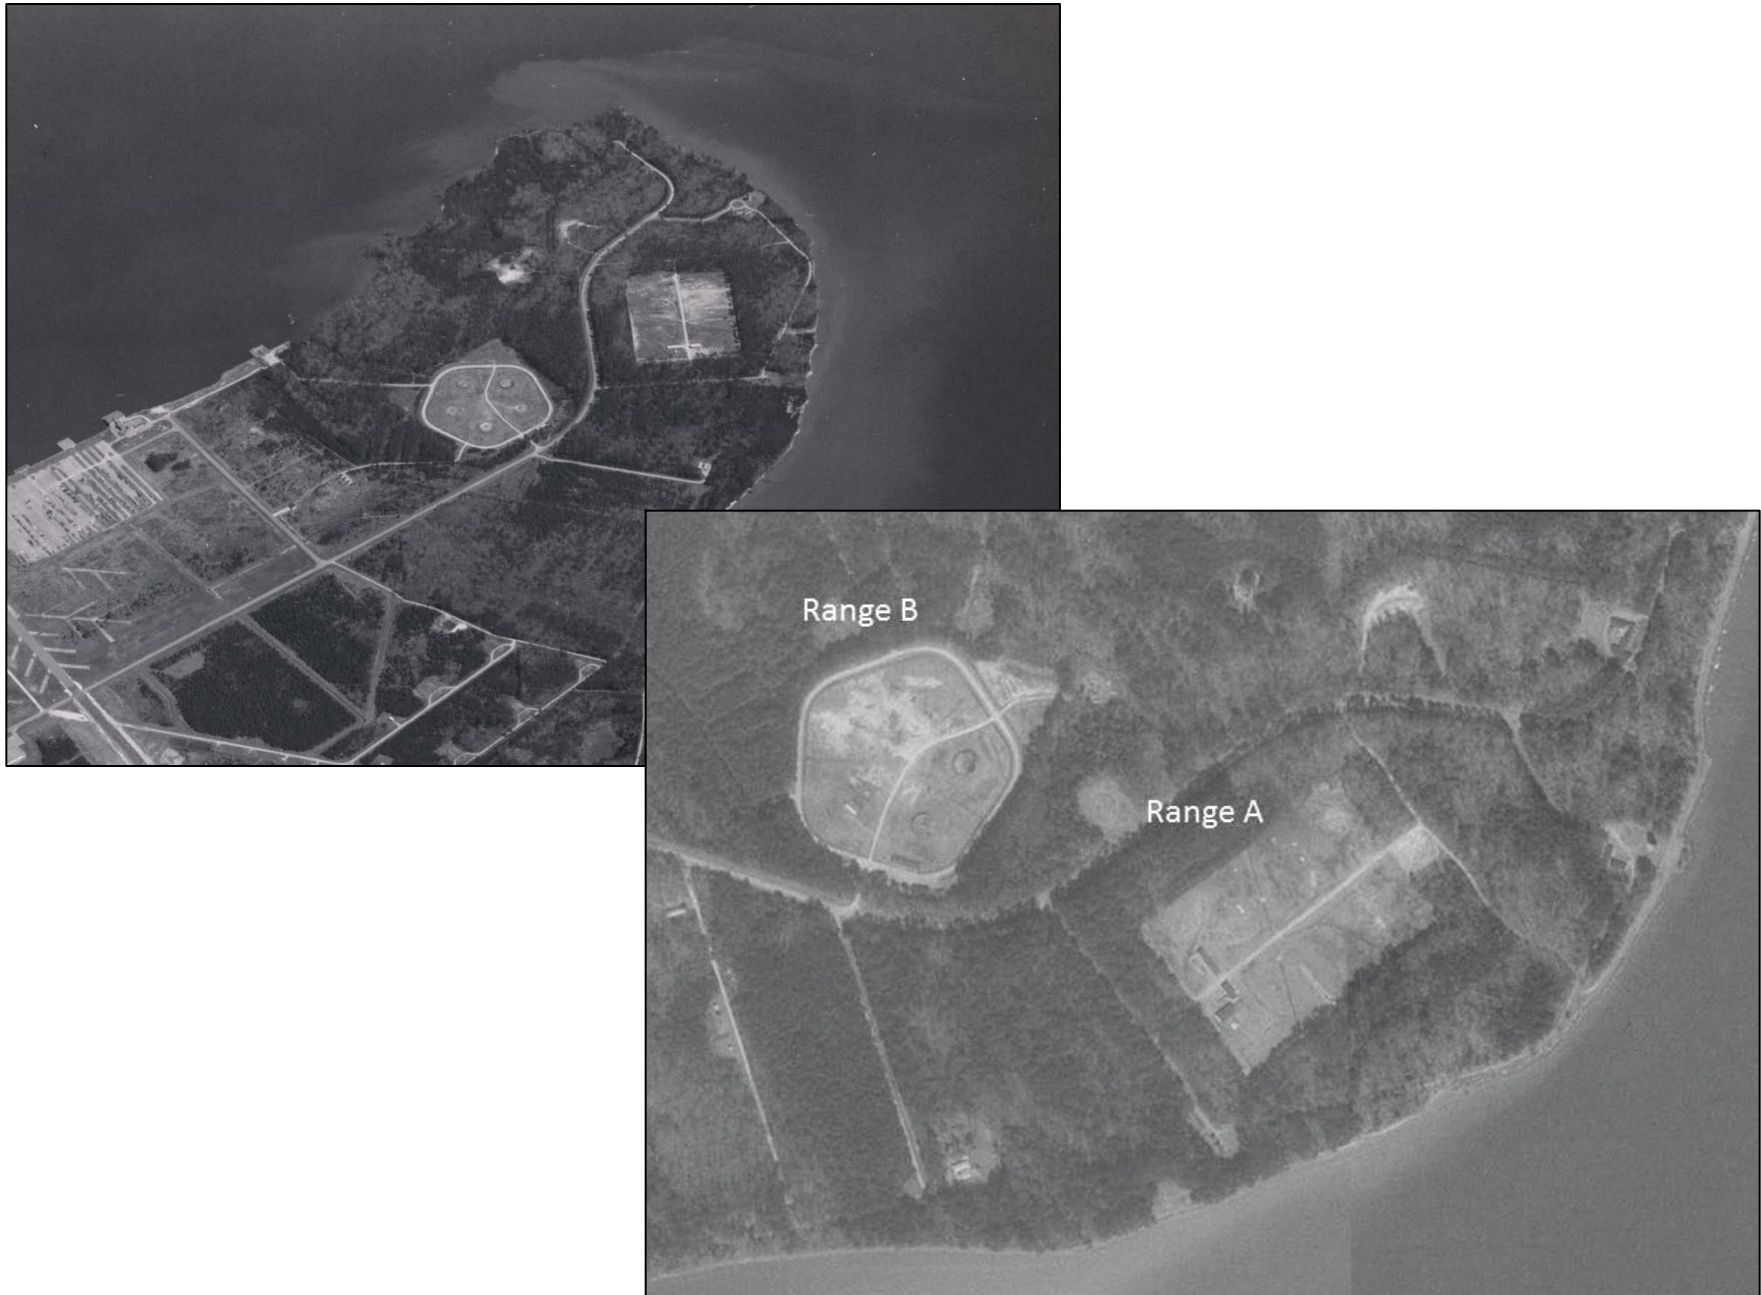
Figure 21. Post-1960 aerial view of HPDTA (left) and 1993 aerial view (right) showing configuration of Range A and B. (Source: HPDTA and Google Earth)

Range B was planned and constructed as a fuel farm for the SeaMaster program. HPDTA removed the last of the fuel tanks by 2013, although the pentagon-shaped area transitioned to use as Range B prior to this date. There are no structures or buildings constructed between 1959 and 1965 associated with Range B.

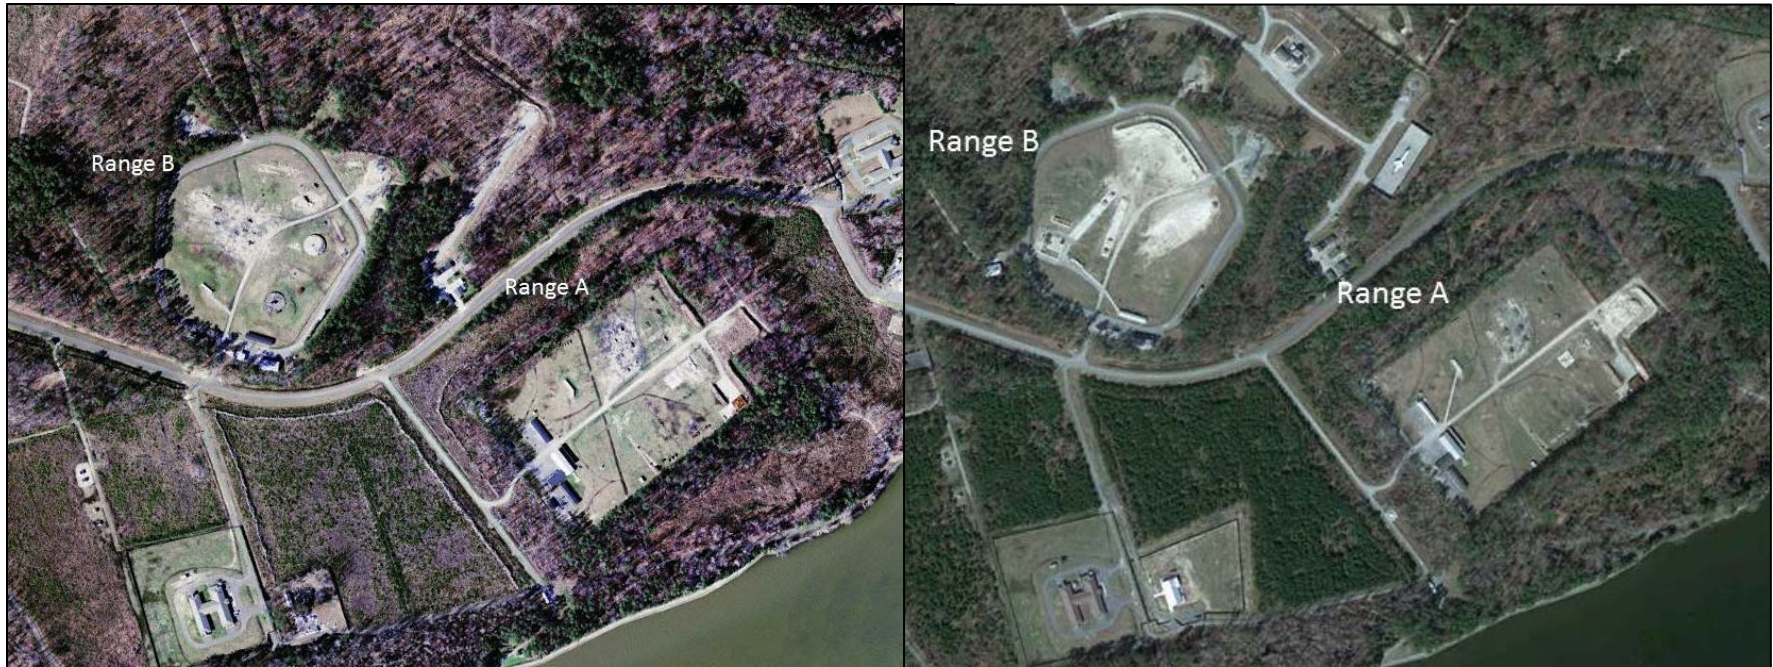
Figure 22. 2008 aerial view of HPDTA (left) and 2013 aerial view showing changes to Range A and B after 1965. (Source: Google Earth)

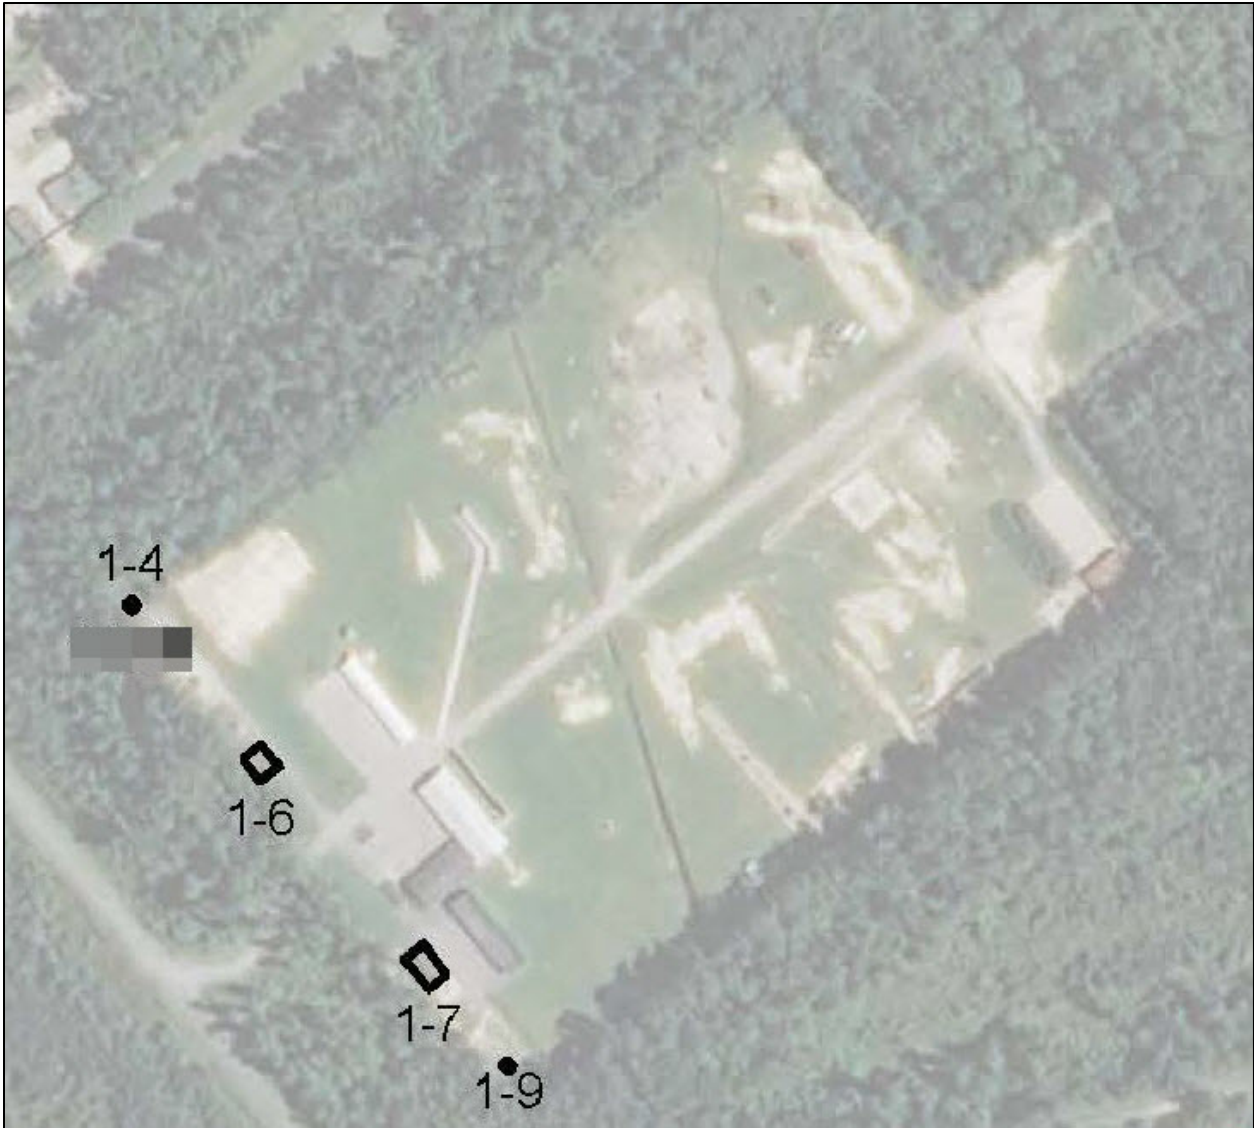
Figure 23: Surveyed resources associated with Range A. (Source: HPDTA).

Testing Range A sits at the southeastern edge of Harvey Point, south of Harvey Point Road, and north of the Albemarle Sound. The rectangular-shaped range includes the surveyed Buildings 1-4, 1-6, 1-7, and 1-9, in addition to more modern buildings and structures, and temporary objects used for testing. HPDTA did not allow photography of the range itself during fieldwork. The construction dates of buildings on Testing Range A and maps suggest that the range was constructed in 1961. It appears to be the first purpose-built range located at HPDTA, for the Defense Testing Activity mission (1960+). The general shape and configuration of resources on the range has remained constant, although, as with most ranges, change is likely constant with the actual test objects. While the resources surveyed as part of this report on Range A maintain integrity, the blast house and other buildings on the range do not.
