Re: Architectural Survey and Evaluation, Harvey Point Testing Area, Hertford,
Perquimans County, ER 17-0160

October 2016

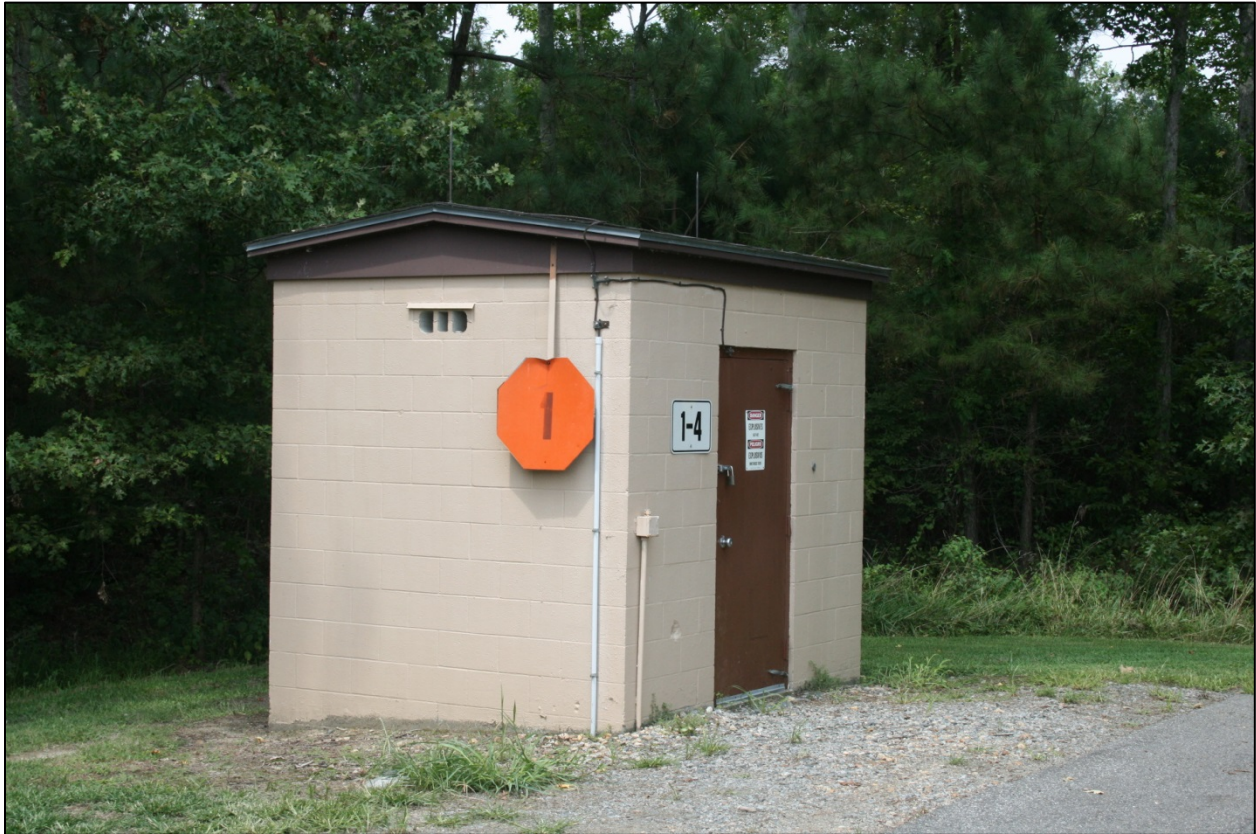
Figure 24: Building 1-4, south and east elevations

Building 1-4 sits south of Harvey Point Road, in Range A, the complex on the east side of the installation. Installation property records indicate this storage building, constructed in 1961, retains its original use. The one-story, one-bay, concrete block building rests on a reinforced concrete slab. A wood-framed, side-gabled roof covered in asphalt shingles tops the building. A hollow metal exterior door set in a metal frame opens in the center of the front elevation. The building includes no additional fenestration. A hollowed-out block near the side gable appears to provide ventilation. The interior floor, walls, and ceiling remain unfinished. This building is identical to Building 1-9, and no alterations were observed.

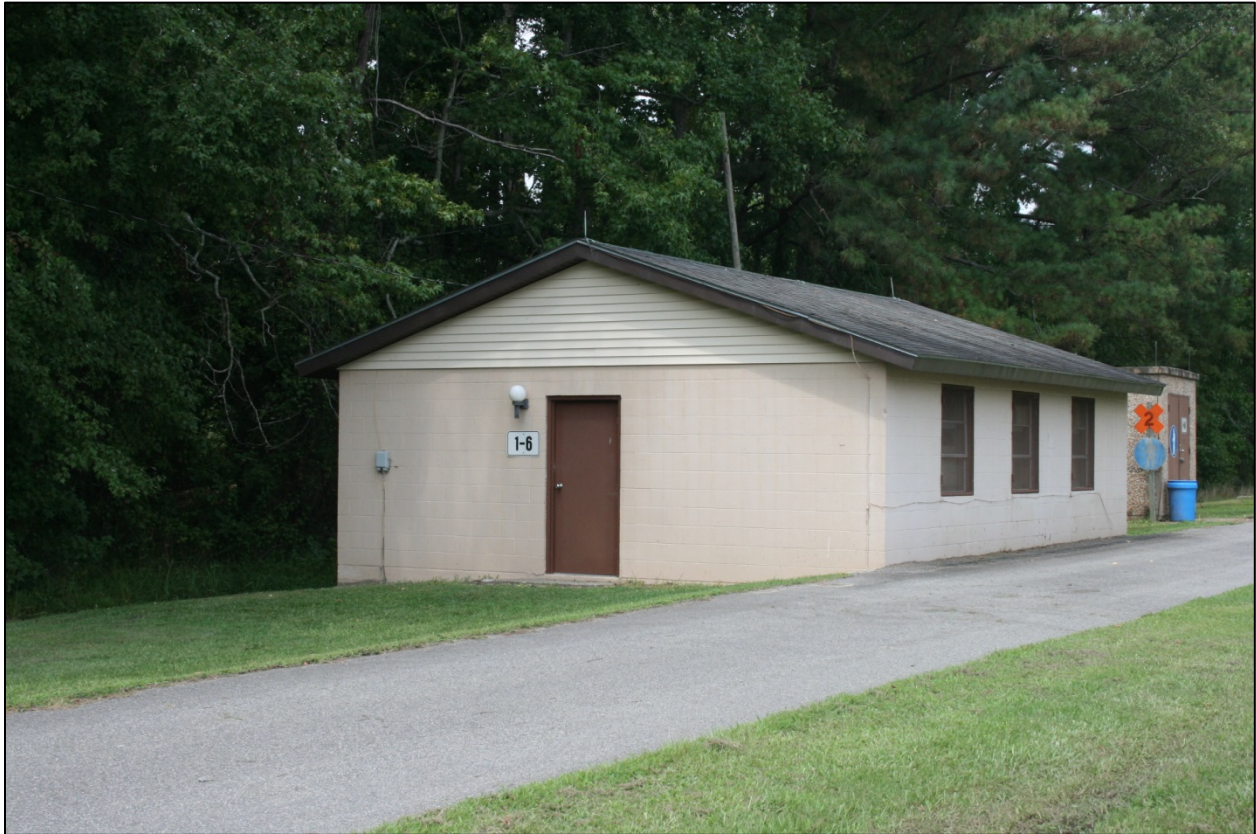
Figure 25: Building 1-6, south and east elevations

Building 1-6 sits south of Harvey Point Road, in Range A, the complex on the east side of the installation. Installation property records indicate this classroom building, constructed in 1962, has also been used for storage. The one-story, concrete block building features vinyl siding on the gable ends. The front-gabled, asphalt-shingled roof includes a vinyl fascia board. A central, hollow metal door, set in a metal frame, opens on the one-bay front and rear elevations. Three, original two-over-one, horizontal, metal windows with wireglass, light the side elevations. The open bay interior of the building features painted concrete block walls, vinyl composite tile covering a concrete slab floor, and ceiling of painted plywood sheathing mounted to the roof superstructure with wood furring strips. Alterations, including door replacements, the addition of vinyl sheathing, and interior changes, such as the addition of vinyl composite tile and plywood sheathing are evident. Property records note that a renovation occurred in 2000. Building 1-6 is similar to Building 1-7.

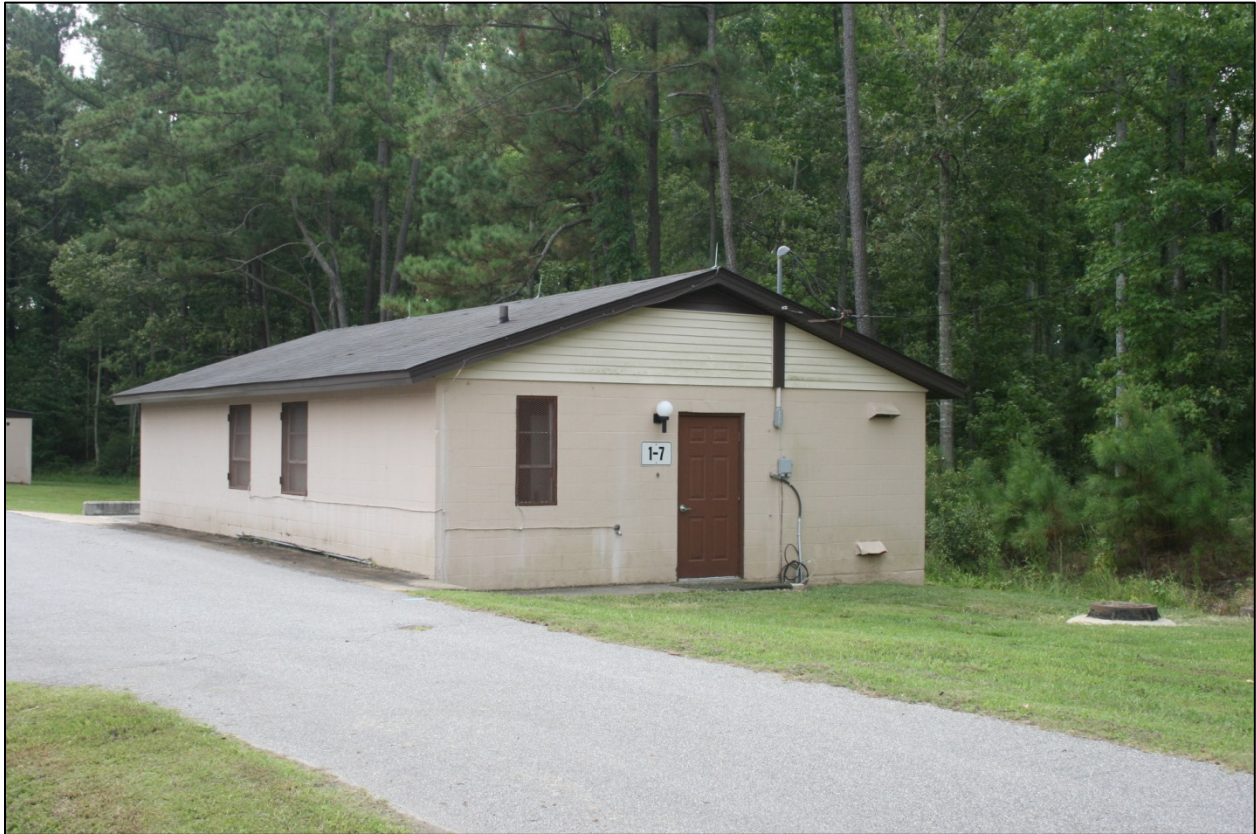
Figure 26: Building 1-7, north and east elevations

Building 1-7 sits south of Harvey Point Road, in Range A, the complex on the east side of the installation. Property records note a 1962 construction date for this clinic building, but do not shed light on its original use. Building 1-7 is similar to the neighboring Building 1-6, which originally provided storage. An asphalt shingle, front-gabled roof tops the building and includes a vinyl fascia board. The one-story, concrete block building, with vinyl siding in the gable ends, rests on a reinforced concrete slab. The two-bay, front elevation consists of a central, metal, replacement door, with six panels, and an original, two-over-one, horizontal, metal window, with wireglass, on the east end. Small vents also appear on the front elevation. The side elevations each have two, original, two-over-one, horizontal, metal windows with wireglass. On the south elevation, a center, replacement double door leads to a rectangular, exterior storage area, consisting of a poured concrete slab with a low, concrete wall edge on two sides. Renovations on the interior of the building include the installation of dry wall, a popcorn ceiling, tile floors, and fluorescent lights.

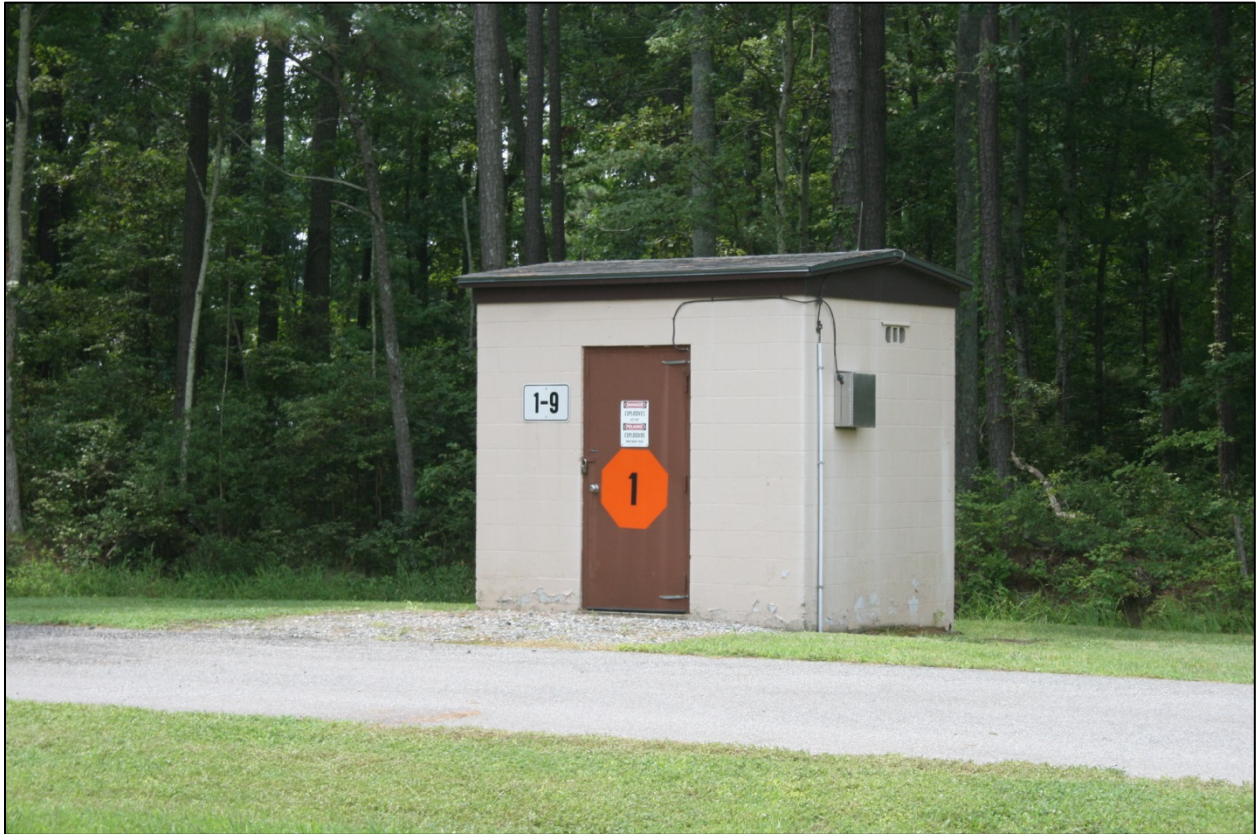
Figure 28: Building 1-9, north and east elevations

Building 1-9 sits south of Harvey Point Road, in Range A, the complex on the east side of the installation. Installation property records indicate this storage building, constructed in 1961, retains its original use. The one-story, one-bay, concrete block building rests on a reinforced concrete slab. A wood-framed, side-gabled roof covered in asphalt shingles tops the building. A hollow metal, exterior door, set in a metal frame, opens in the center of the front elevation. The building includes no additional fenestration. A hollowed-out block near the side gable appears to provide ventilation. The interior floor, walls, and ceiling remain unfinished. This building is identical to Building 1-4, and no alterations were observed.

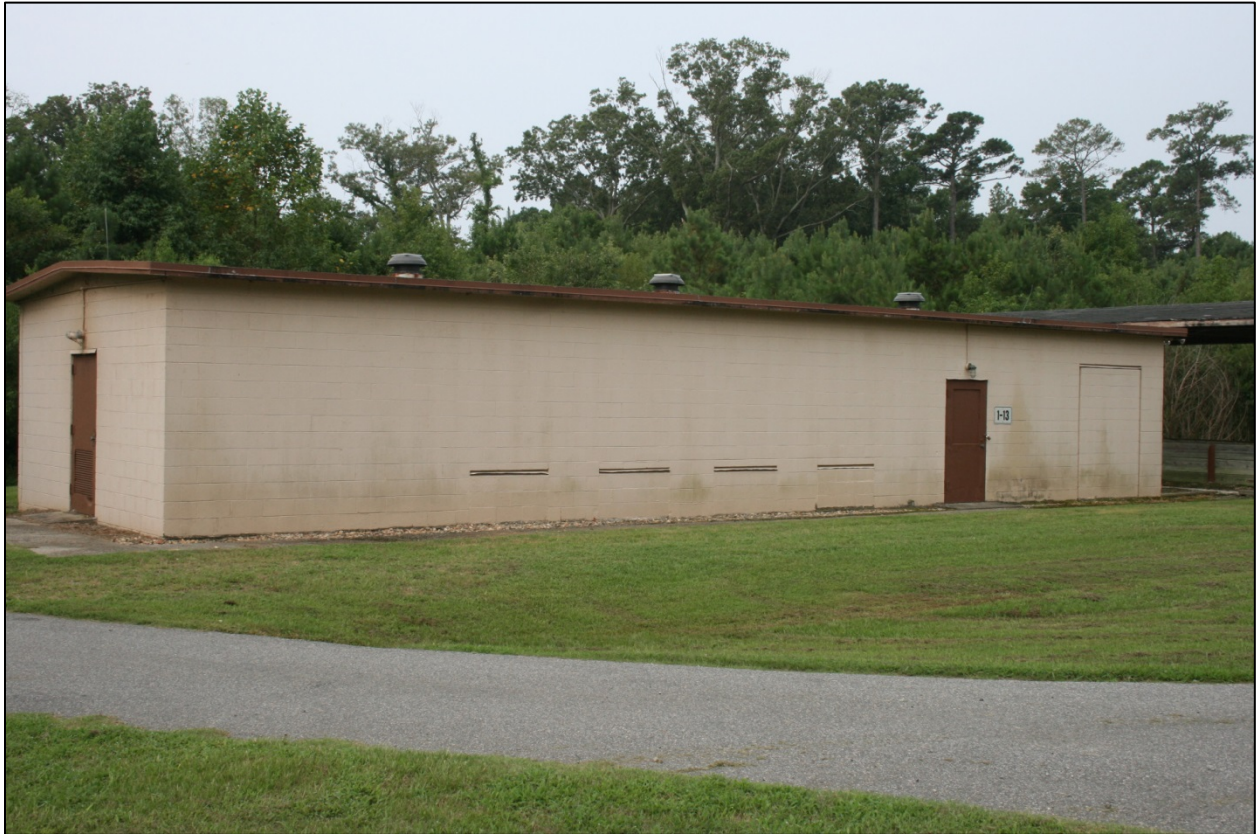
Figure 29: Building 1-13, front (north) and east elevations

Located on the eastern edge of the installation, at the end of Harvey Point Road, Building 1-13 sits near the control tower (Building 1-14). Constructed in 1961, the one-story, painted concrete block storage building rests on a reinforced concrete slab. A side-gabled, built-up roof, with three metal roof vents, tops the building. The front elevation (north façade) consists of the original, six-light, metal panel door on the northwest corner (note: metal covers the glazing on the exterior); four partially infilled louver vents; and an infilled larger door opening on the northwest corner. The rear elevation consists of four partially infilled louver vents in the same position as those on the front elevation, and a larger opening infilled with concrete block. The west elevation consists of a four-light, fixed pane, steel window, with a two-light awning window on the bottom. A solid, metal door with a louver vent in the bottom panel opens on the east elevation. Overall, the building's simple form consists of a utilitarian style, with minimal ornamentation.

On the interior, concrete block walls divide a rectangular floor plan into three rooms. The door on the north elevation provides access to the west room. The door on the east elevation provides access to the two rooms on the east side of the building. The two eastern rooms include a smaller entrance area that opens into a larger space that corresponds with the louver vents on the exterior. The two eastern rooms connect via a replacement, solid, metal door in the middle of the concrete block dividing wall. Interior surfaces remain unfinished, with concrete floors and ceilings, and hanging, metal, industrial lights. A number of alterations to the building, including the aforementioned concrete block infills on exterior vents and doors, the metal cover on the north elevation door panels, and the replacement door on the interior were evident.

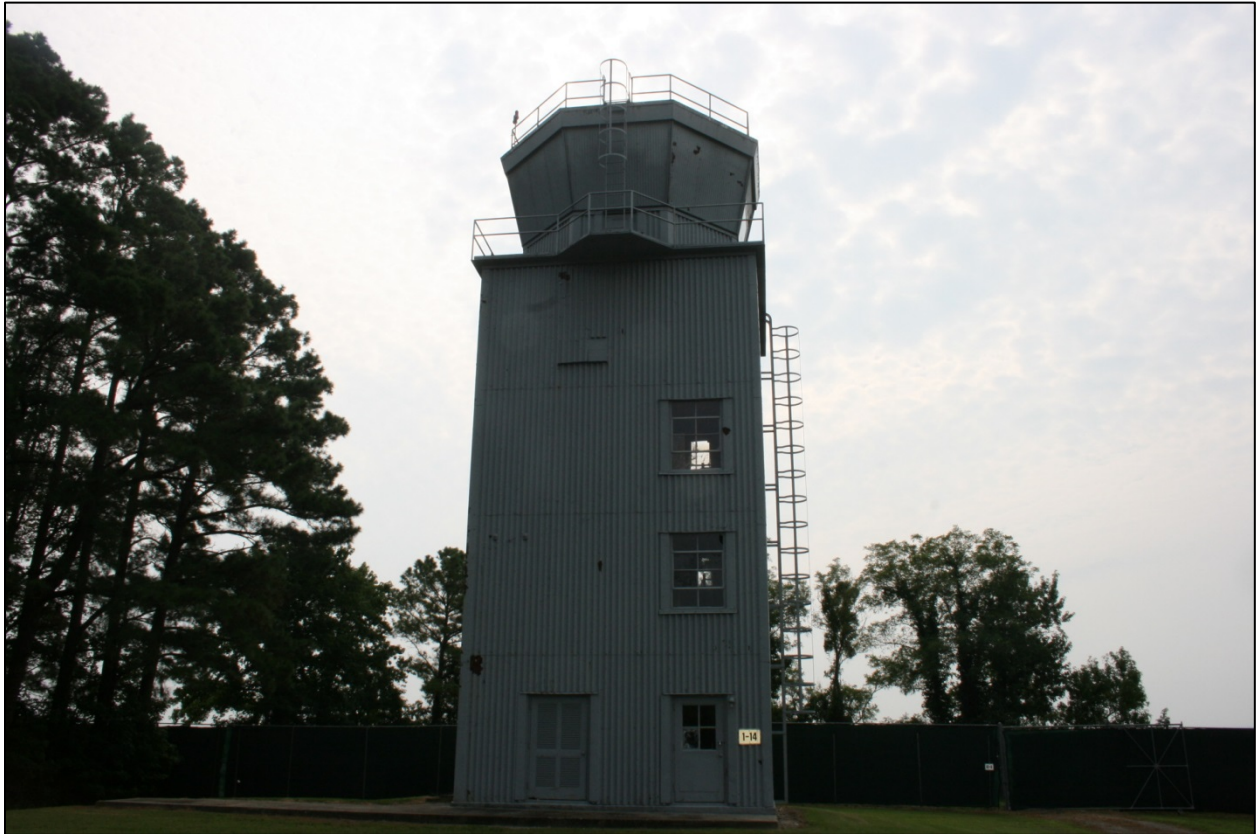
Figure 32: Building 1-14, west elevation

Located on the eastern edge of the installation, at the end of Harvey Point Road, the control tower (Building 1-14) sits near Building 1-13. A July 2006 evaluation of the control tower recommended the building not eligible for listing in the National Register, but did not include the completion of a survey form. Sources indicate that construction of the tower pre-dated the current Defense Testing Activity, and likely occurred at the outset of the build-up for the SeaMaster jet seaplane program c.1959. The tower, likely used for a number of months in its original function, currently sits unoccupied, and is used on occasion for training maneuvers. The Winston Salem architectural firm of Lashmit, James, Brown & Pollock and the engineering firm of Thomas B. Bourne Associates designed the building for the Department of the Navy.

The five-story control tower exhibits simple geometry, plain finishes, and no architectural embellishment. An octagonal control room on the fifth story sits on a square four-story tower. A piled foundation supports the structural steel frame of the building. The exterior

is clad with painted corrugated metal panels, joined at the corners by pieces of flat, metal trim. Steel pipe railing surrounds both levels of the built-up roof, which consists of asphalt and gravel. A caged, metal stair provides access on the exterior of the south elevation, and on the exterior of the west elevation, to the control room. The four sides of the control room facing land do not have windows, while the four sides of the control room facing water do. Three of the four windows in the control room are fixed glass, single light steel windows. The fourth window is a one-by-one metal window. Multiple-light steel windows illuminate the four lower floors. Eight-light, steel windows, with the four middle panes set within an operable awning sash, light the interior stairway. Steel doors consist of either four-light doors or louvered doors.

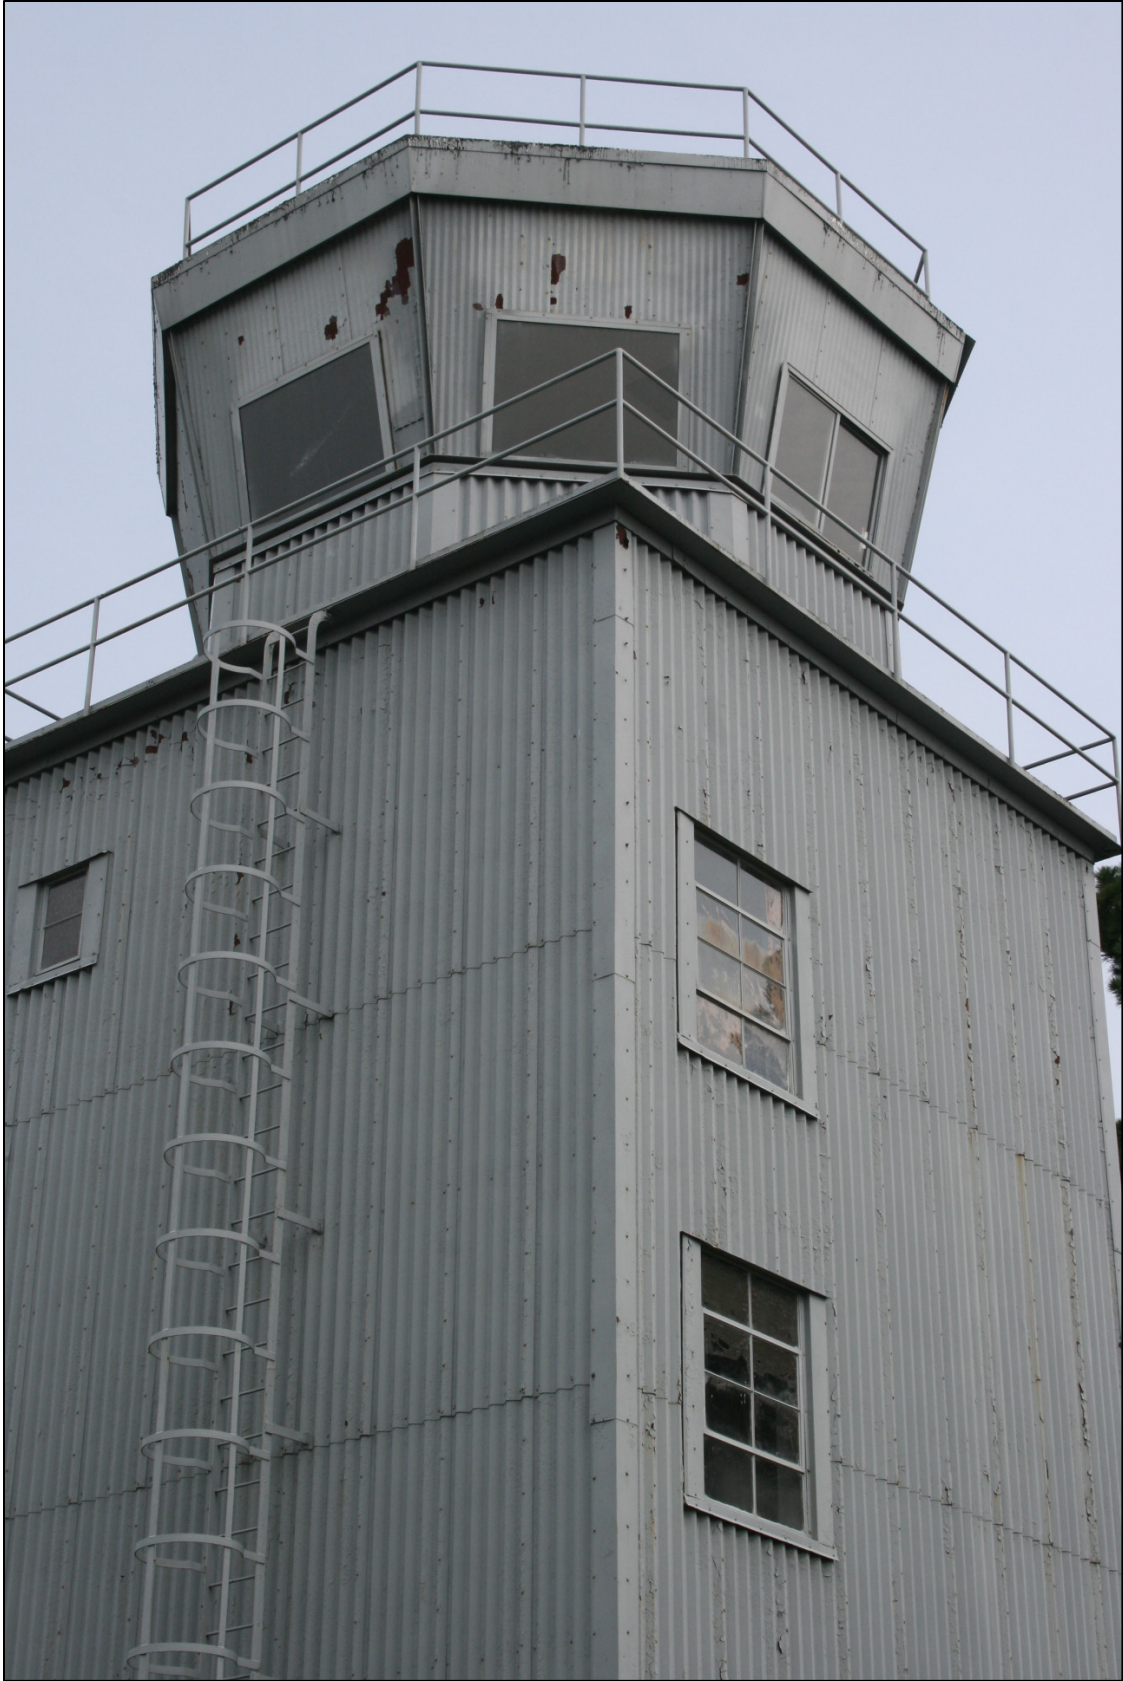
Figure 34: Building 1-14, exterior top floor detail

The finished first floor elevation is 13 feet and the control room floor is approximately 56 feet. The fifth floor octagonal walls of the control room slope at an outward angle from the windowsill line to the roofline. The four lower floors provide space for the transformer vault, and telephone and communications rooms (first floor); an air-conditioning equipment room (second floor), electrical equipment rooms (third and fourth floors), and a small bathroom (fourth floor). Most equipment no longer remained in the building at the time of the site visit in August 2014. The interior wall finishes are composite panels applied to the steel structure and secondary metal framing. The panels consist of a fibrous insulation board faced with sheets of smooth cement asbestos. The concrete slab floors rest on the steel frame. While cement asbestos tiles cover the control room floor, the other floors remain unfinished, with exposed concrete. Perforated, metal, acoustical ceiling tiles are located in the control room and other spaces. Stairs occupy a large percentage of the floor space on the first four floors. A very narrow and steep stair provides access from the fourth floor to the control room. Framed with steel, the stairs have diamond-patterned steel plate treads and steel pipe handrails.

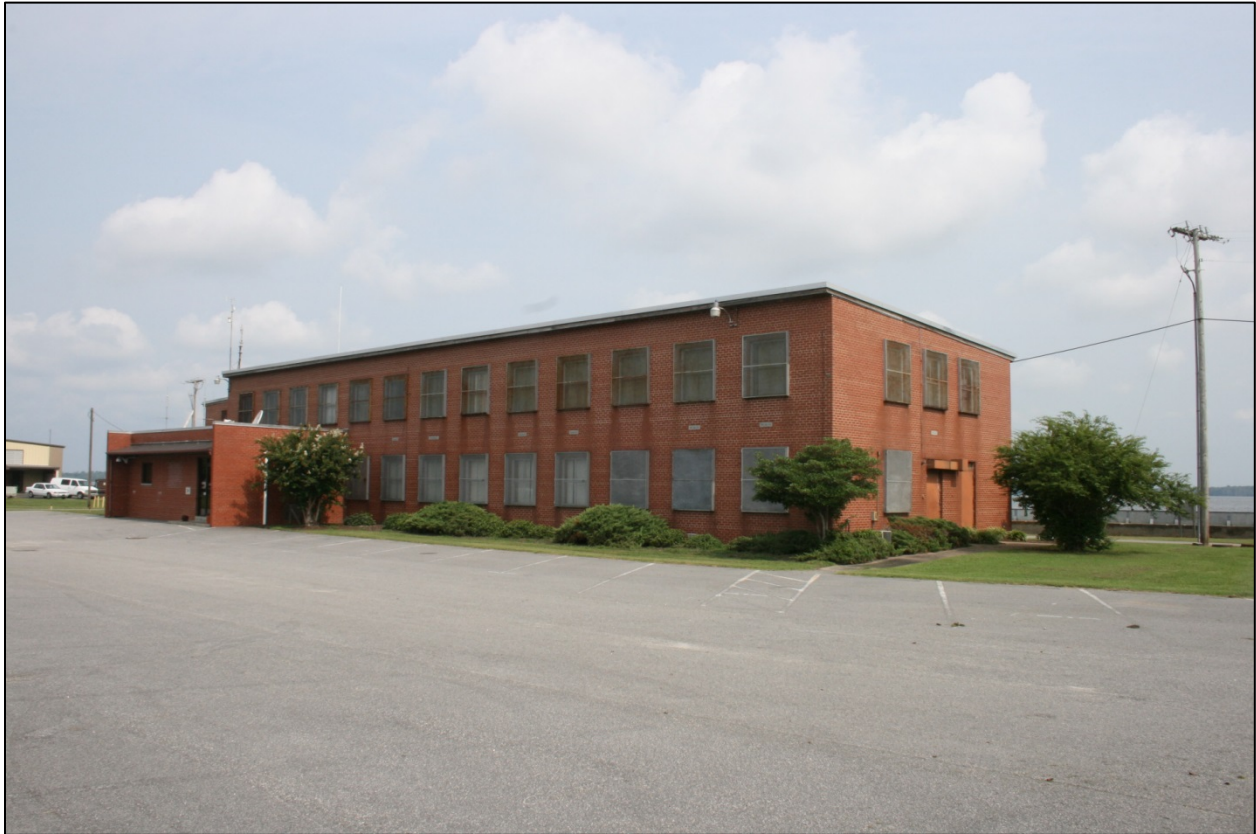
Figure 39: Building 3-1, front (south) and east elevations

Located on the northern edge of the installation, along the Perquimans River shoreline, the former administration/operations building (Building 3-1) sits in close proximity, south of the boathouse (Building 3-2). Sources indicate that construction of Building 3-1 pre-dated the current Defense Testing Activity, and likely occurred at the outset of the build-up for the SeaMaster jet seaplane program c.1959. The building, likely used for a number of months in its affiliation with the SeaMaster program, currently sits unoccupied, after a new headquarters building replaced it in 2006, located in the new administrative compound closer to the installation's entrance to the west. The Winston Salem architectural firm of Lashmit, James, Brown & Pollock and the engineering firm of Thomas B. Bourne Associates designed the building for the Department of the Navy.

The two-story, L-shaped, brick Building 3-1 includes 17 bays across the front (south) elevation, with 13 bays on the main block. The 1958 construction plans shows banks of three windows, while the actual construction appears to have been the current line of single windows. Concrete columns, beams, and bearing walls support a low-pitched concrete and steel roof, with a single-ply membrane covering. The wall structure consists of concrete block with a five-over-one, common bond, brick veneer. A one-story, three-bay, flat roof entrance vestibule is located on the west side of the south elevation, on the main block. This entrance does not appear to match the plans, but may have been an alteration made prior to the original construction. The entrance vestibule consists of a replacement aluminum storefront door, a two-light, aluminum window, and a bricked-in window bay. The exterior windows on the building consist of a combination of the original two-over-two, steel-framed, double-hung windows, and vinyl-framed windows. Security screens attached to the exterior brick walls protect a number of the windows. A variety of exterior doors open on the east, north, and west elevations, including original, painted, hollow metal, louvered doors, and two-light, metal doors.

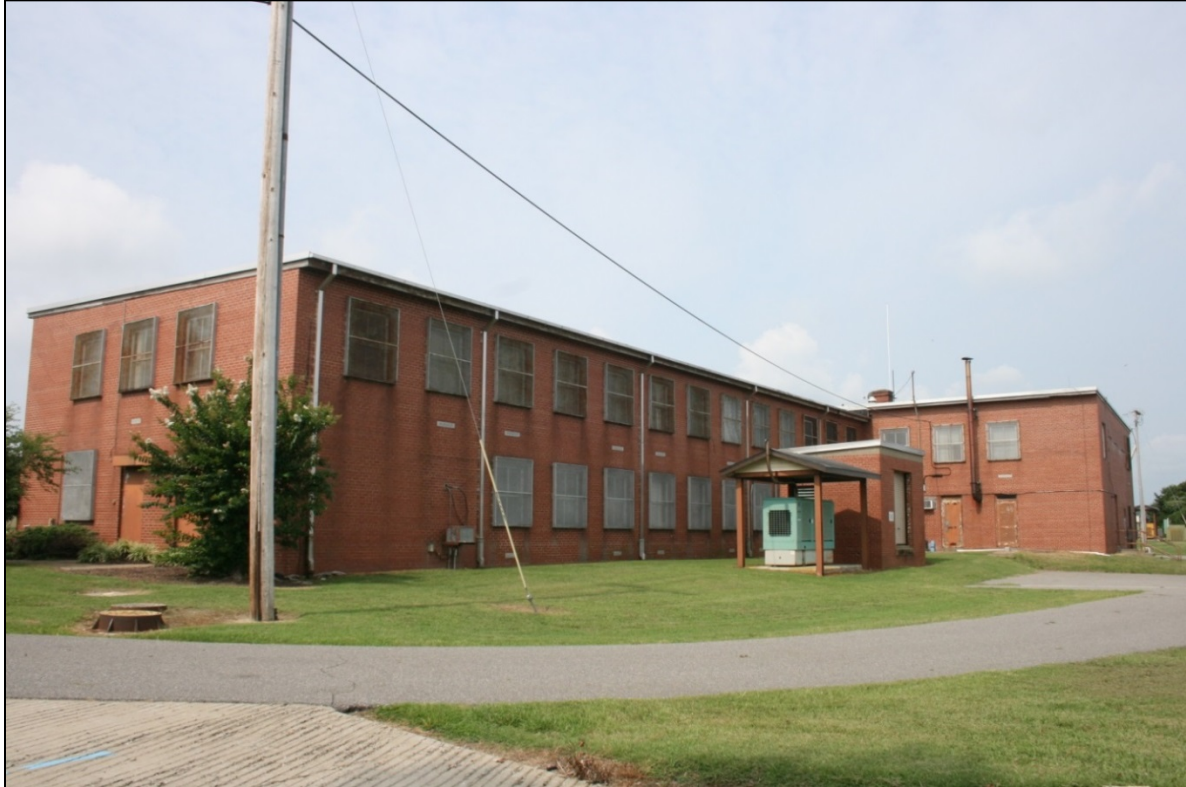
Figure 43: Building 3-1, north (rear) and east elevations

The ell of the building, oriented north-to-south, consists of an open, two-story, concrete-block and concrete floor space that provided the garage space for an ambulance. A set of concrete steps lead from the first floor down into the bay.

Numerous alterations, including replacement windows and doors, and the infill of openings are evident as well as interior alterations. Plans indicate that the final construction details changed, including alterations to the window massing and fenestration, the entrance vestibule, and the west elevation wing. Plans confirm that a canopy connecting Building 3-1 to 3-2, now evidenced only by ghost marks, was an original feature.

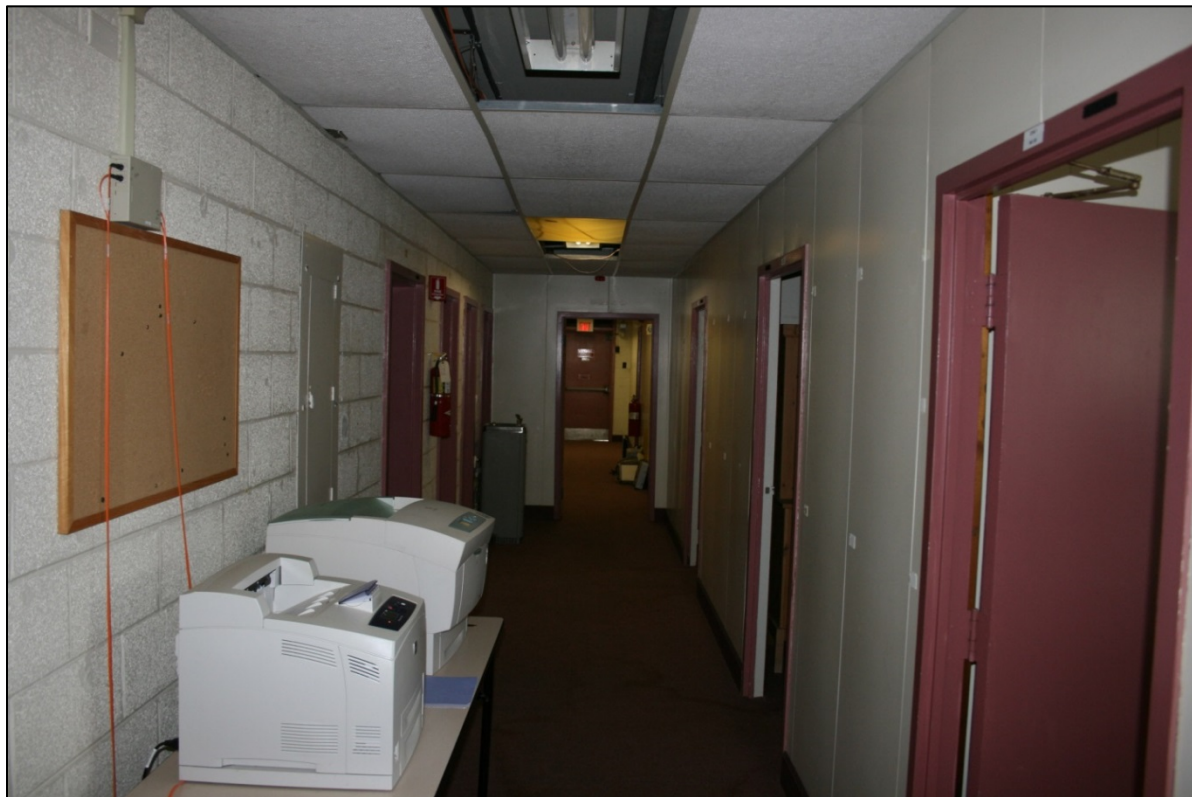
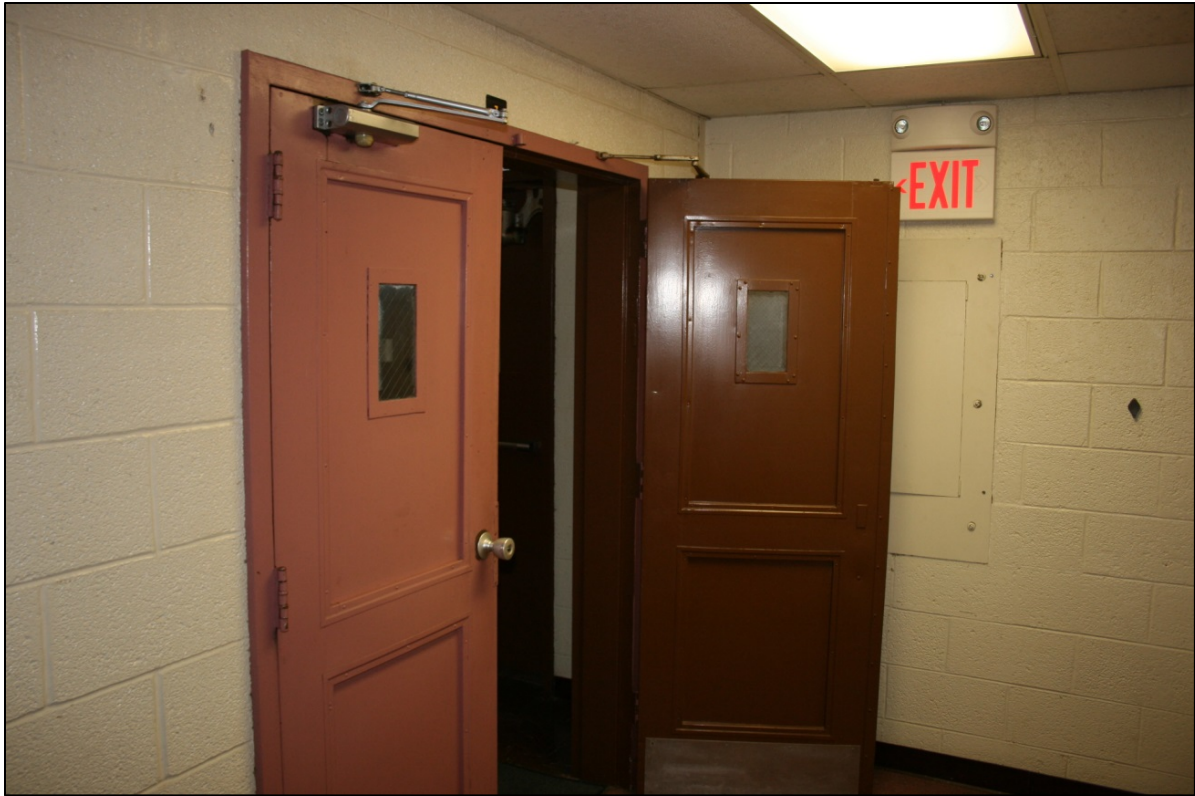
Figure 46: Building 3-1, interior hallway

The east-west-oriented main block of the building consists of office space. The altered office space features a combination of concrete block walls (primarily in the stairways and utility rooms) and drywall partition walls. Carpet primarily covers the floors in the corridors and office spaces, and vinyl tile appears in the utility rooms and stair landings. Suspended acoustic panels, with flush, fluorescent lights, cover the original plaster ceiling. The interior doors are a combination of replacement, stained or painted, solid-core, flush, wood doors; original, metal, double-leaf doors, with a single pane of corrugated wireglass (leading to stairs); and original, solid, vault doors (provides entry into office spaces). According to construction plans, Building 3-1 originally held a mix of administrative and operations functions, related to the SeaMaster program, including the following rooms: radio, crypto, teletype, wing staff officers, wing communications, electronic repair, clearance, map, and aerology. Due to the cancellation of the SeaMaster program, Building 3-1 probably never reached full operation. During the Defense Testing Activity period, until 2006, the building served in a similar capacity, for operations and administration.

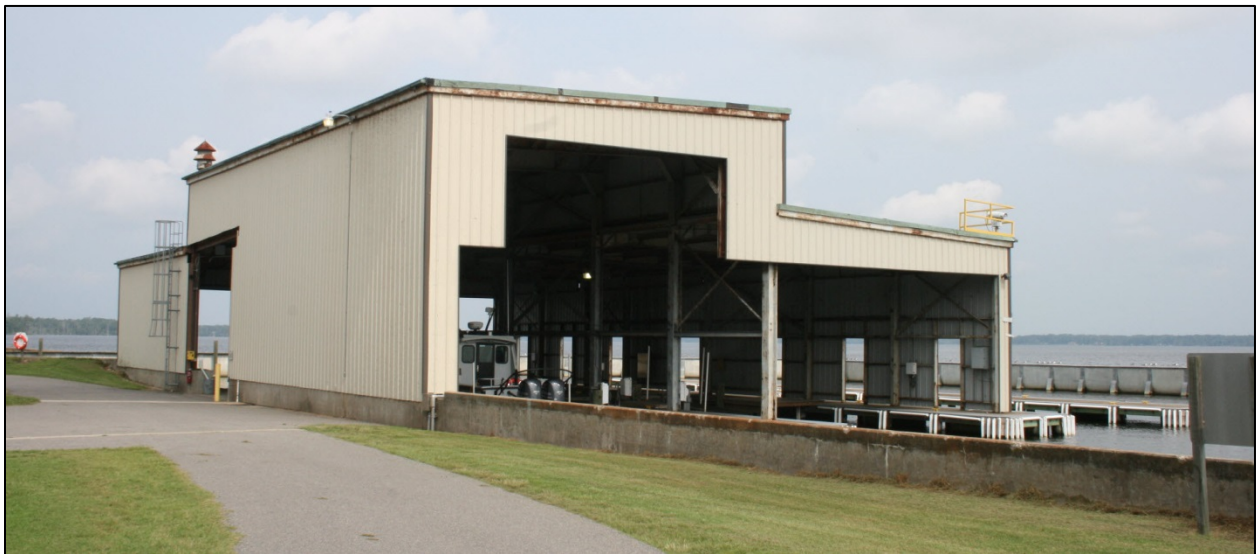
Figure 51: Building 3-2, south and east elevations

The open-air, steel-framed boathouse rests above a boat dock and piers, and features two sections: 1) a one-story, two-bay structure, with a front-gabled roof; and, 2) a two-story, large one-bay structure, with a low-pitched, shed roof. Replacement, corrugated metal panels cover the exterior on much of the north and south elevations. A series of seven open door bays line the dock on the structure's north elevation, providing access to the outside boat slips. A wide, one-story bay provides access to the central aisle way between the boat slips on the south elevation. Large openings provide access to varying sizes of boats on the east and west elevations. No windows or doors enclose the openings on the structure. The roof structure consists of precast concrete panels supported by eight steel roof trusses resting on interior and exterior steel columns. Copper gutters and downspouts provide drainage from the roofs. The boat dock and piers are concrete with concrete pilings. Steel ladders provide access to each of the six boat slips within the structure. An additional pier sits outside the structure. Recent modifications to the concrete piers included the installation of metal plates with a textured abrasive finish bolted to the edge of each pier, to prevent slipping, and the addition of modern lighting in the building.

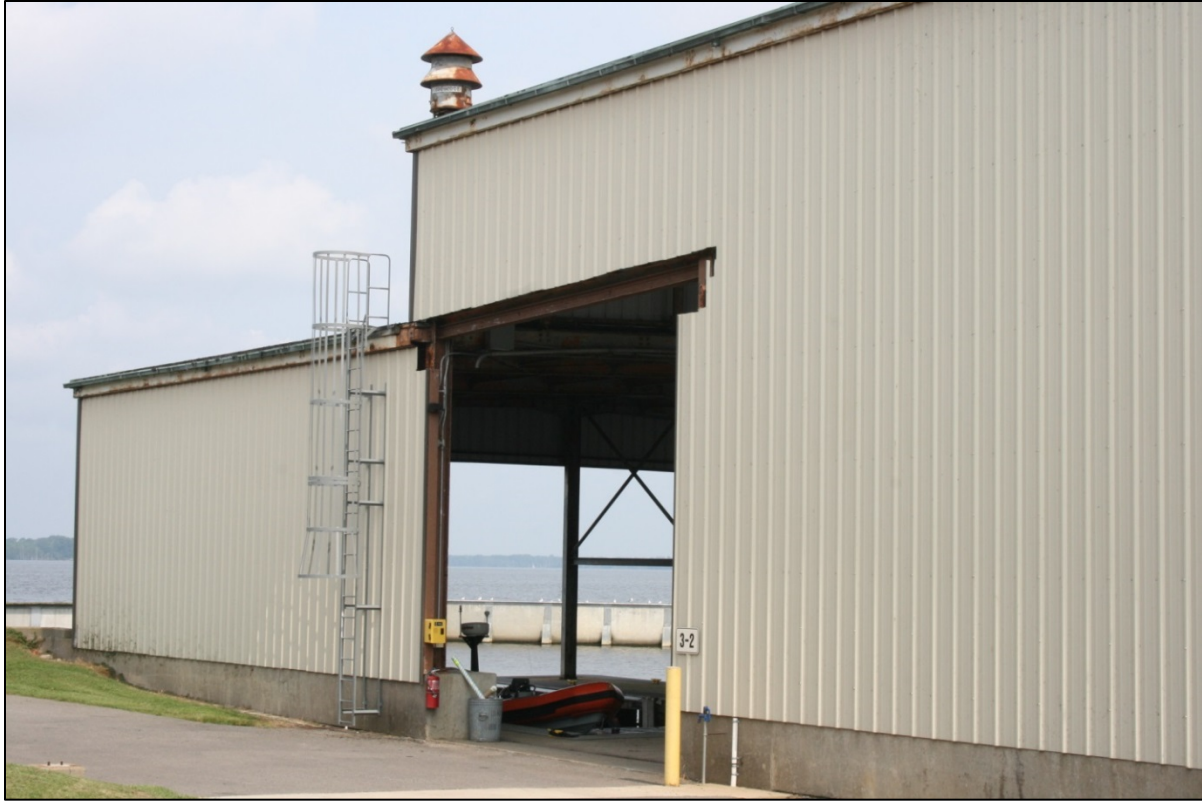
Figure 52: Building 3-2, exterior door detail, south elevation

A one-story, two-bay, pre-fabricated wood building rests on a wood palette foundation in the middle of the central aisle, and provides office space. The building features a six-panel door and a four-over-four, vinyl window, with an asphalt-shingled, front gable roof.

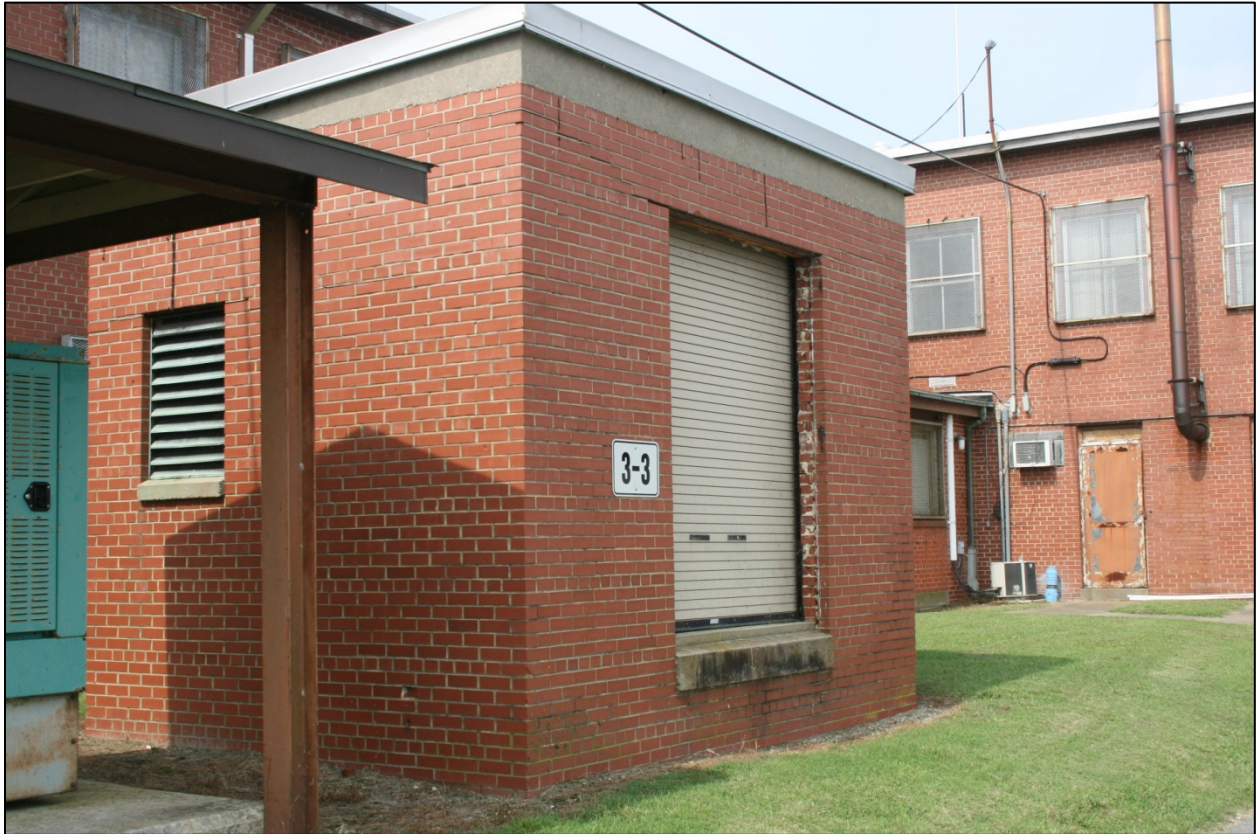
Figure 61: Building 3-3, front (north) and east elevations.

Building 3-3 sits in the space provided by the ell of Building 3-1, south of the boathouse (Building 3-2), near the Perquimans River shoreline. Plans indicate that Building 3-3 was planned for construction in tandem with Building 3-1 and Building 3-2, likely to support those buildings. The one-story, one-bay building continues its original function by housing transformer equipment. Concrete caps the building's five-over-one, common bond, brick walls. The flat, precast concrete and single-ply, membrane roof features metal trim at the roof-wall juncture. A replacement garage door, with a concrete sill, dominates the north façade and is recessed into the wall farther than the original door. The east and west elevations consist of one metal-louvered vent, with concrete sills. The rear contains no fenestration and has a copper gutter and downspout. The one-room interior consists of exposed brick walls, a concrete floor, and two hanging, metal, industrial lights.

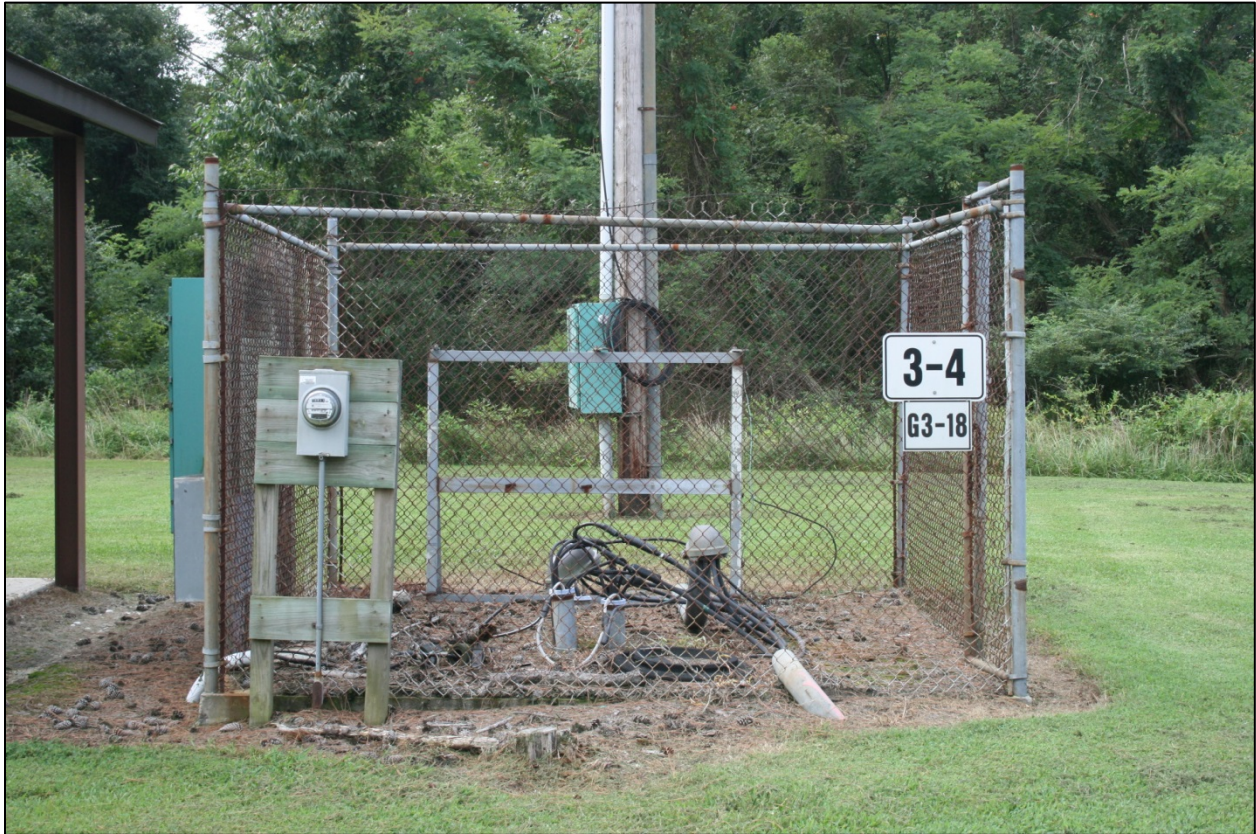
Figure 64: Building 3-4 looking south

Facility 3-4, a concrete pad with utilities, surrounded by a chain link fence, sits south of the administration/operations building (Building 3-1) and east of the seaplane apron constructed for the SeaMaster. Originally constructed to hold a transformer, the equipment has been removed.
