Re: Architectural Survey and Evaluation, Harvey Point Testing Area, Hertford,
Perquimans County, ER 17-0160

October 2016

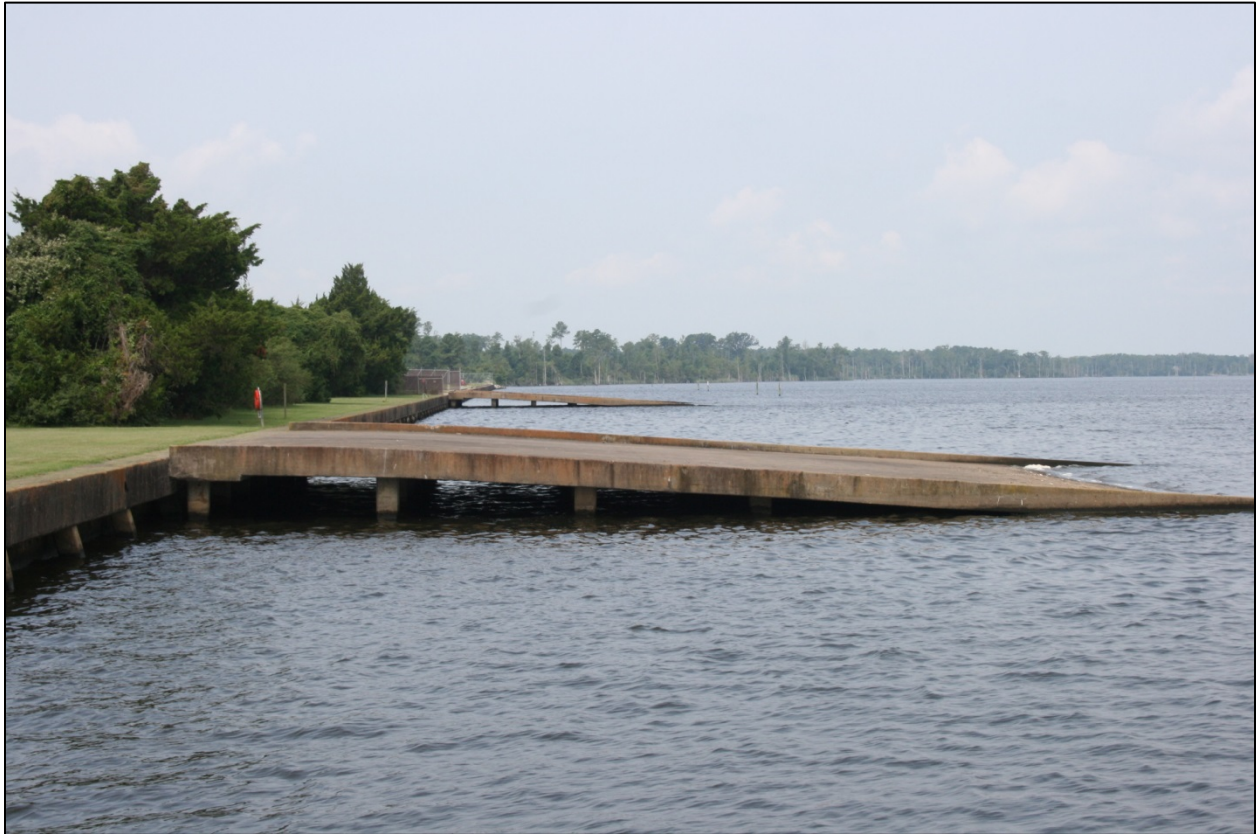
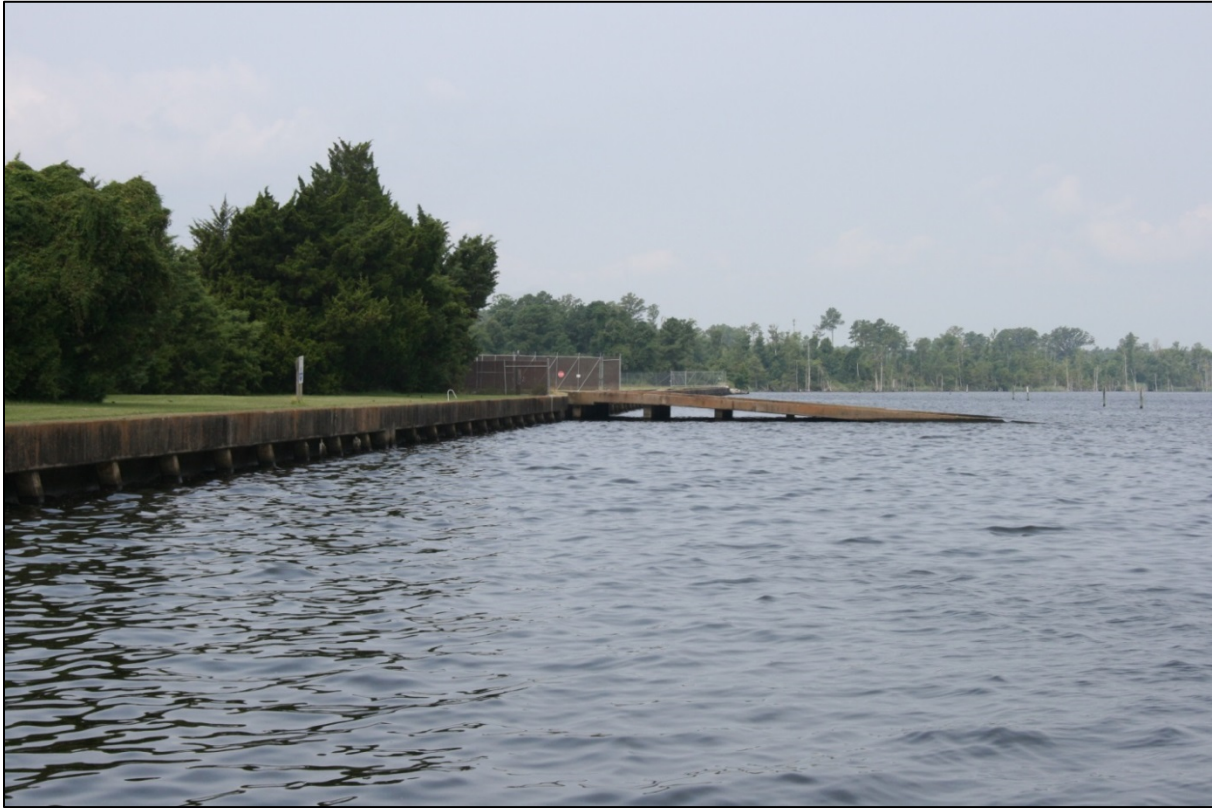
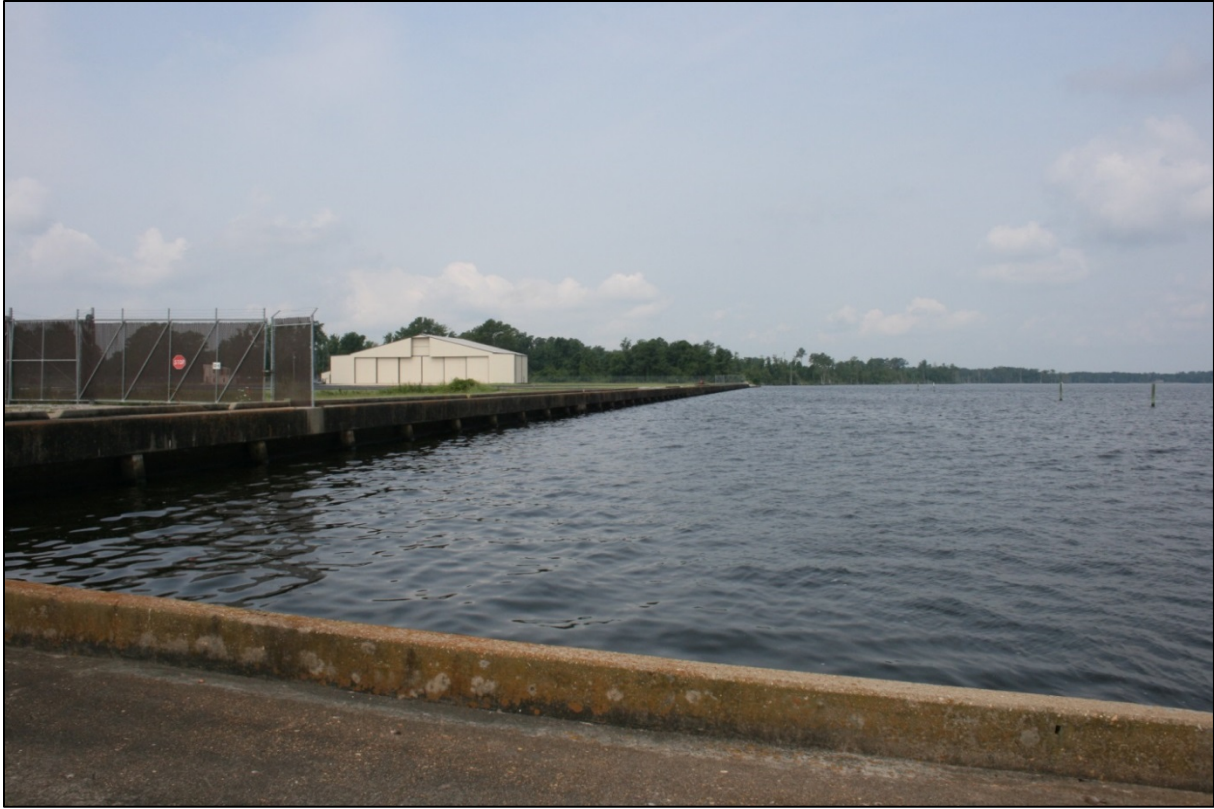
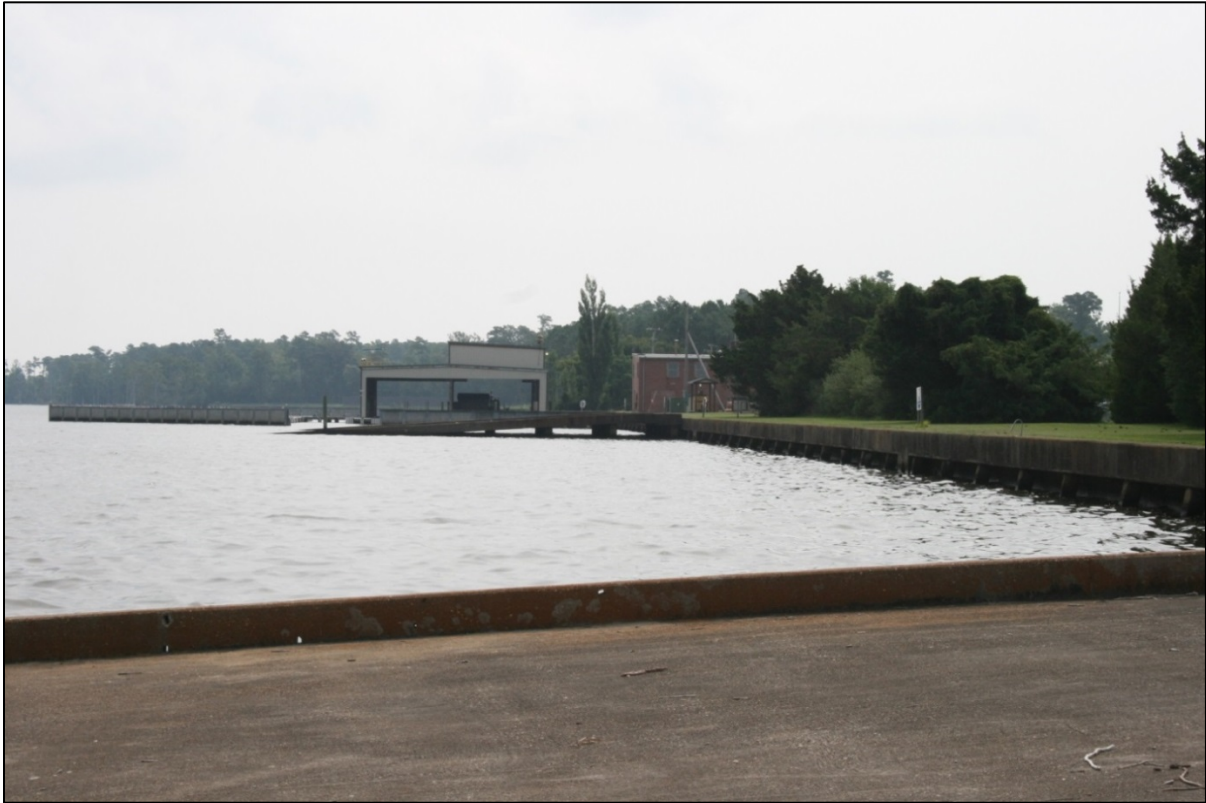
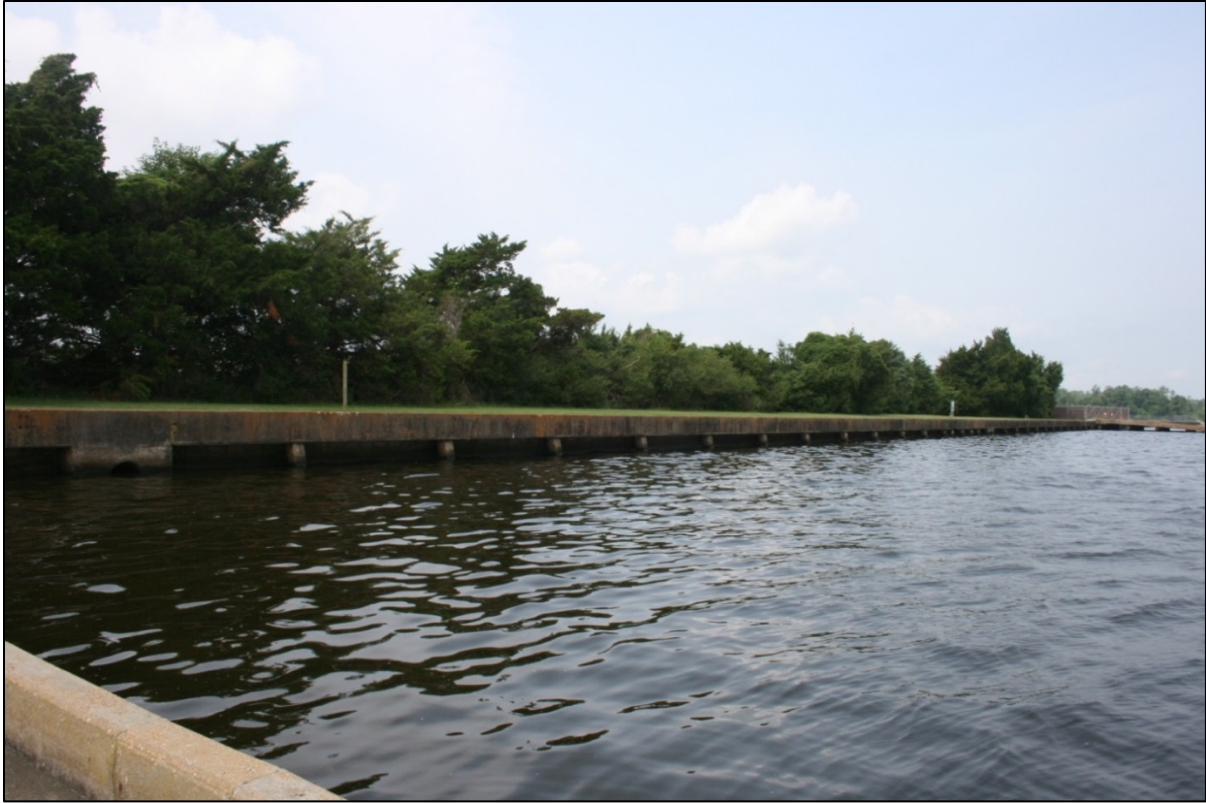
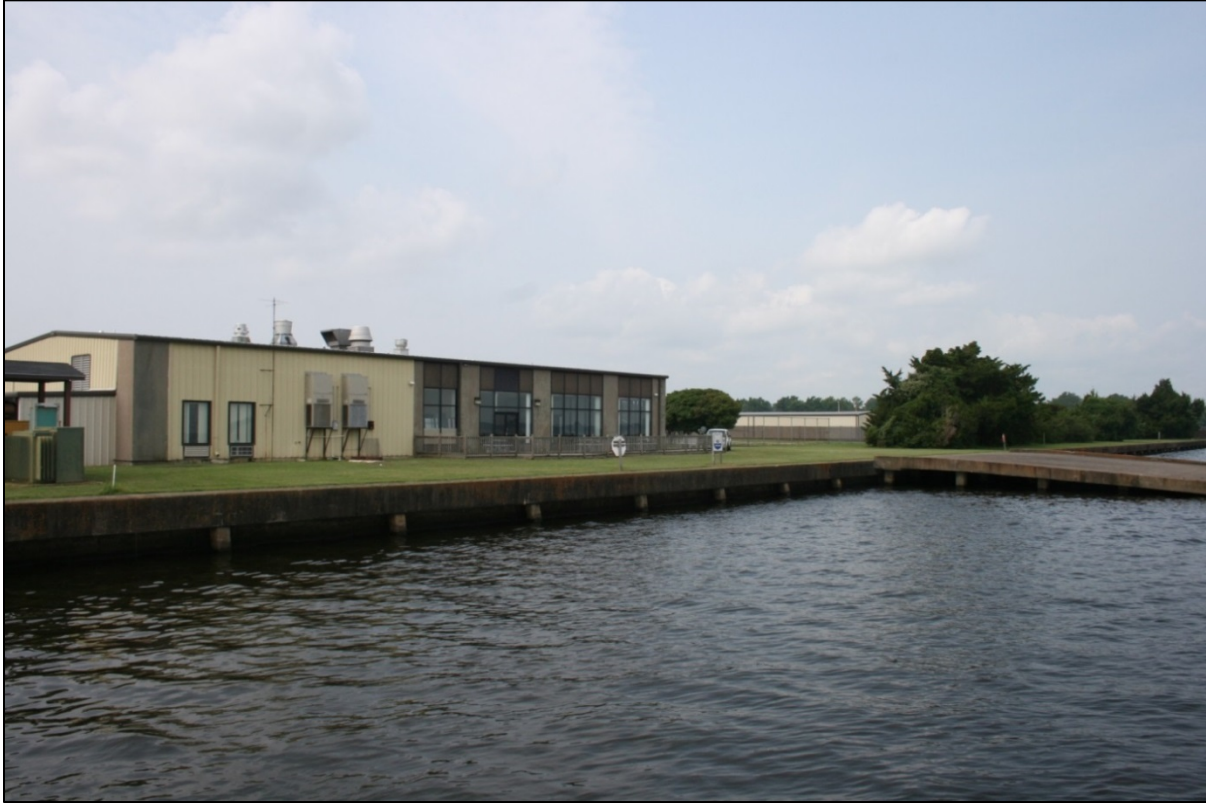
Figure 65: Facility 3-10, in foreground, Facility 3-11, in background looking west

Facilities 3-10 and 3-11 are seaplane ramps constructed to support the SeaMaster jet seaplane program c.1959. Maps indicate that the two ramps sit east of the former location of the original WWII seaplane ramps, along the Perquimans River. Supported by concrete buttresses, the concrete ramps extend from the concrete bulkhead into the Perquimans River. A raised concrete lip marks each side of both ramps. The ramps lead to the aircraft apron (Facility 3-12) south of the shoreline, which was also newly constructed to store jet seaplanes.

The Navy likely used the ramps and apron for a number of months, prior to the termination of the SeaMaster program.

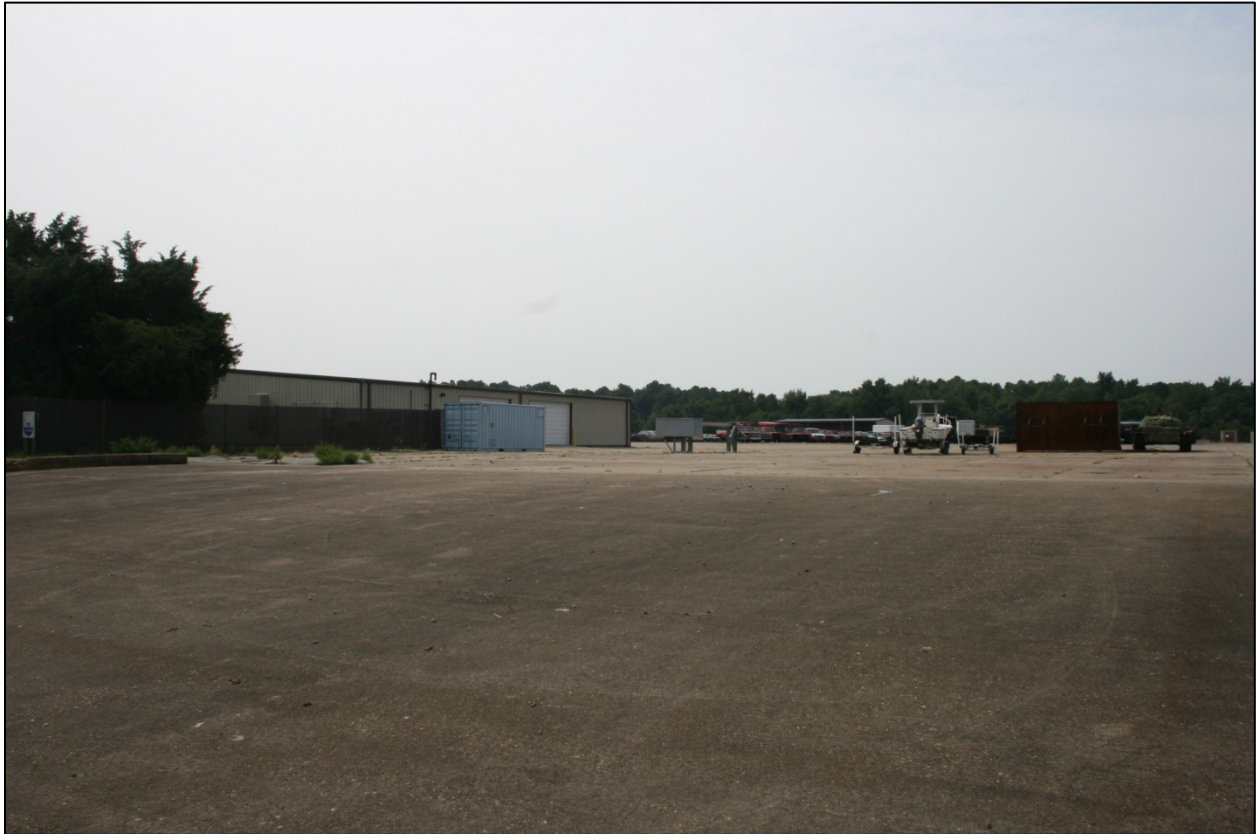
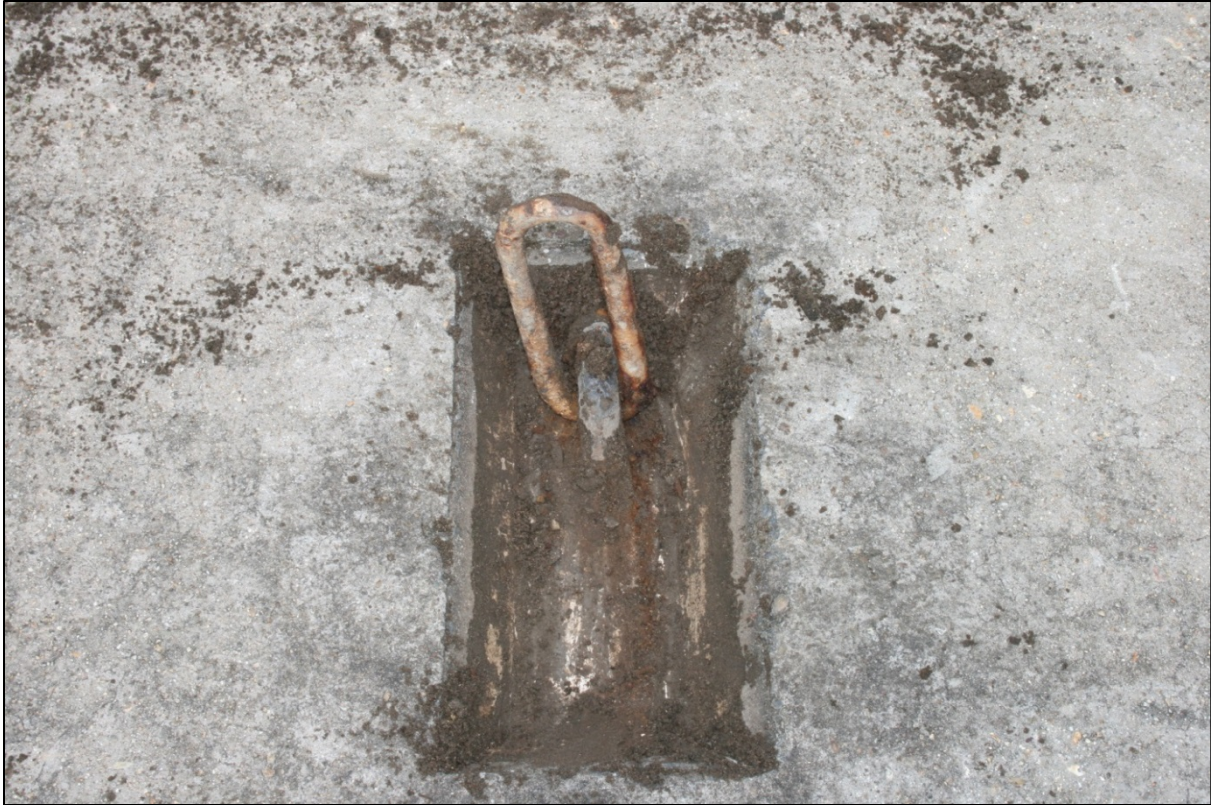
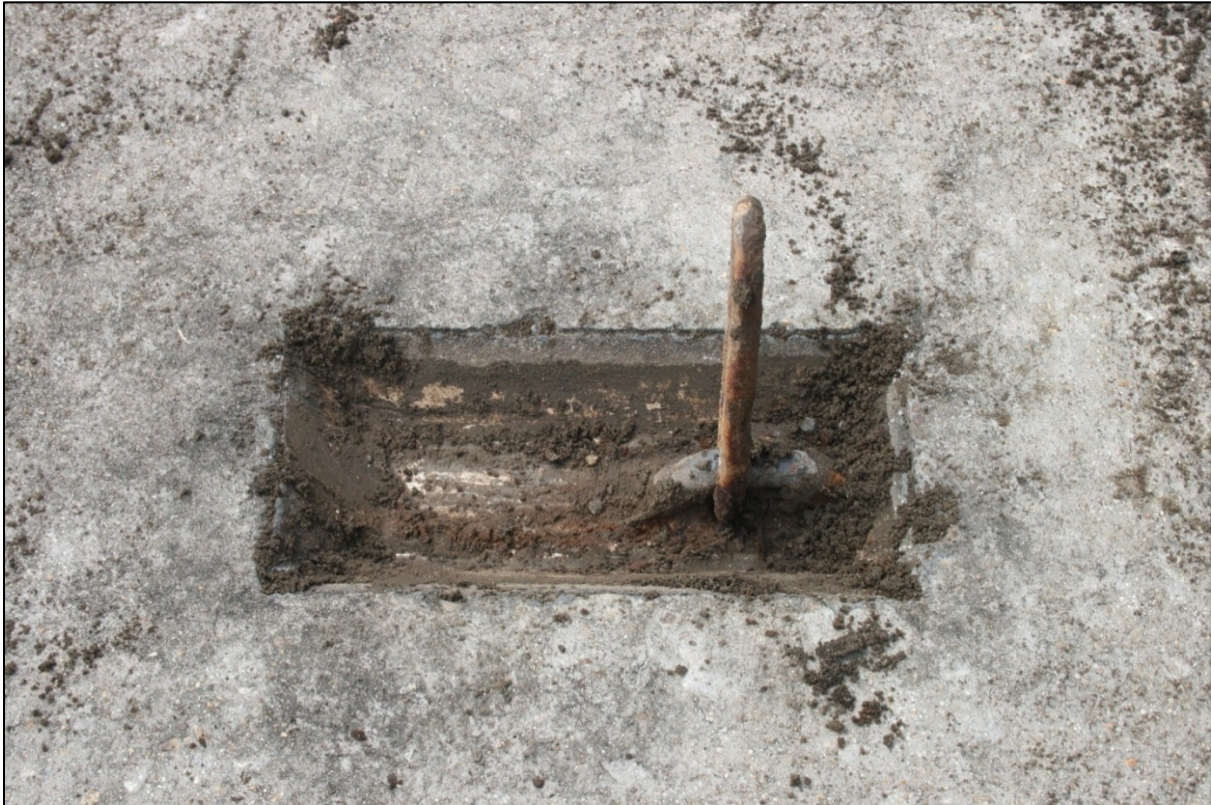
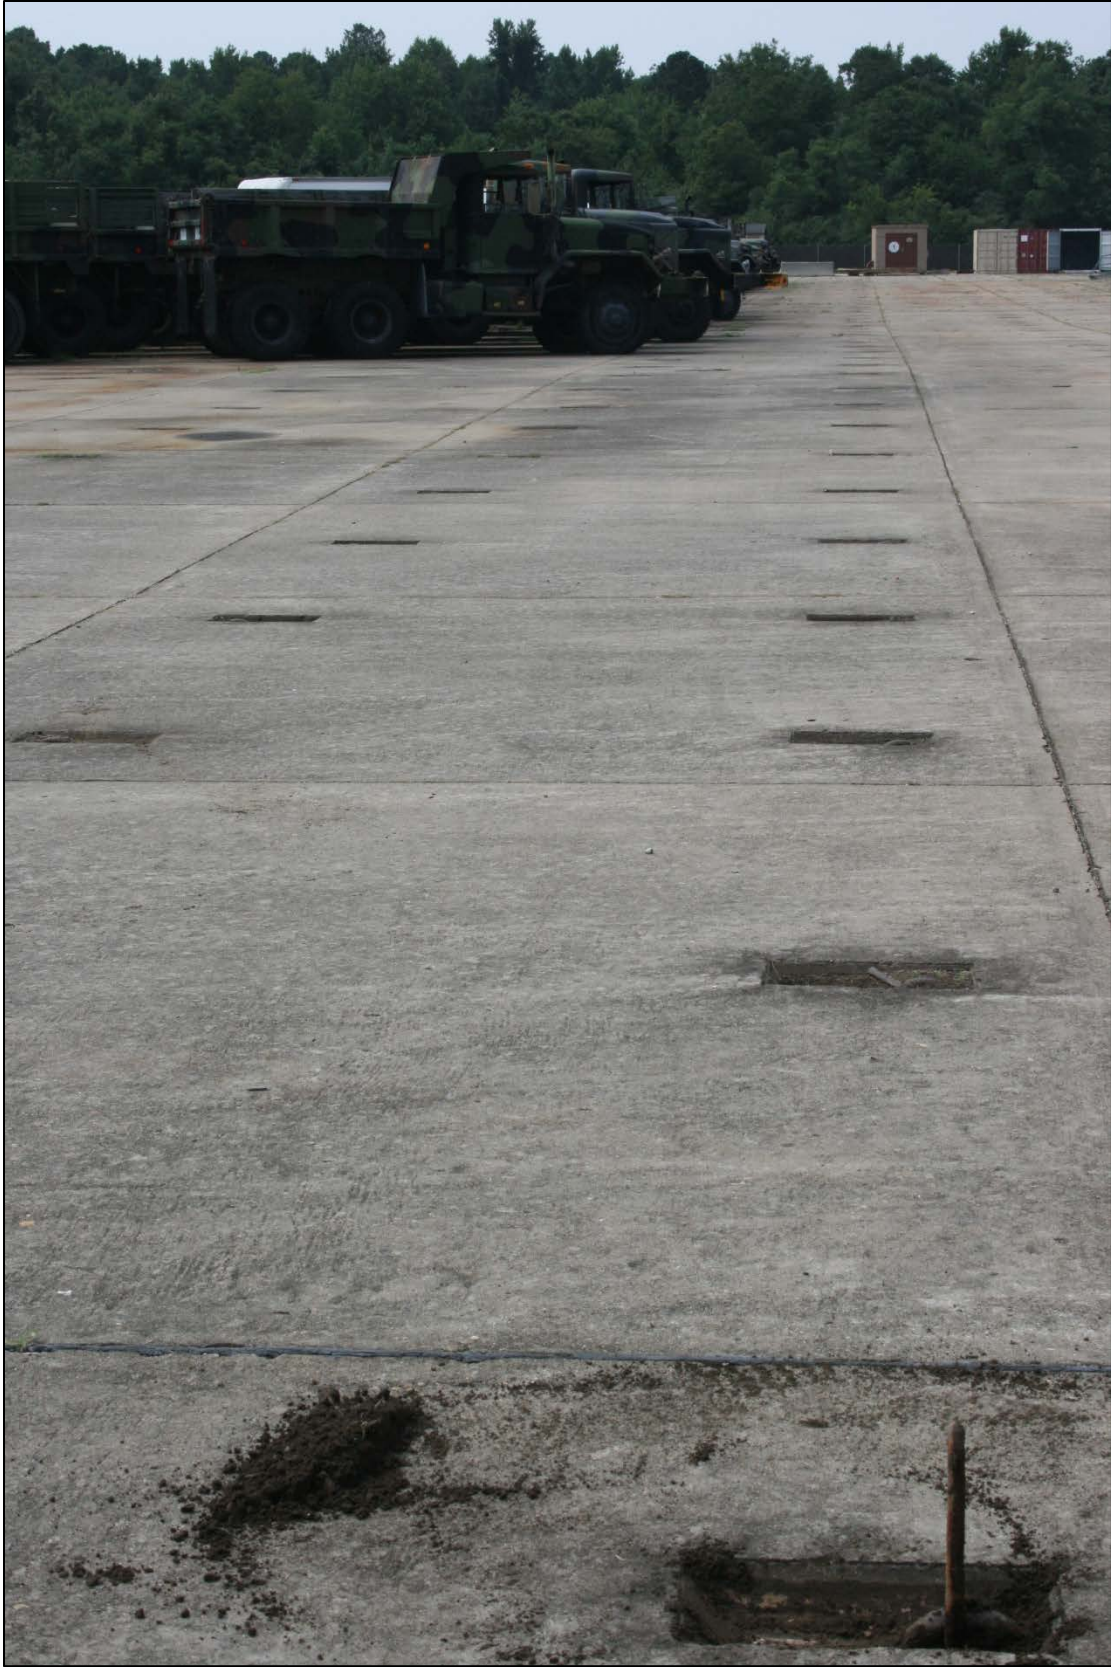
Figure 73: Facility 3-12, general view looking south

Facility 3-12, a seaplane apron, sits east of the WWII seaplane apron and parking area. The concrete-paved structure, constructed with two seaplane ramps (Facilities 3-10 and 3-11), supported the SeaMaster jet seaplane program for a brief time, prior to its termination in 1959. Rows of metal tie downs line the apron in a grid pattern. Originally constructed as a parking lot for seaplanes, the structure now functions as a laydown area and vehicle parking lot.

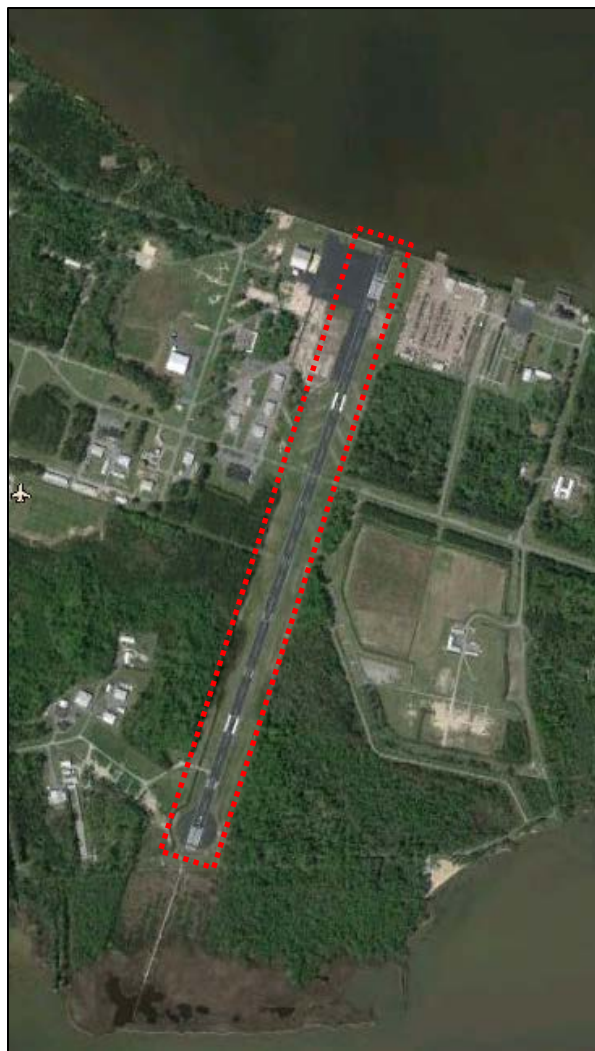
**Figure 77: Facility 3-13, 2016 aerial view (within red-dotted line)
(Source: Google Earth)**

Facility 3-13 follows the path of one of several former WWII seaplane parking lanes, west of the seaplane apron (Facility 3-12) constructed for the SeaMaster. The asphalt-paved, active runway roughly runs in a south to north direction, from the Albemarle Sound to the Perquimans River. The current runway includes a footprint lengthened on multiple occasions, and replacement surfacing.

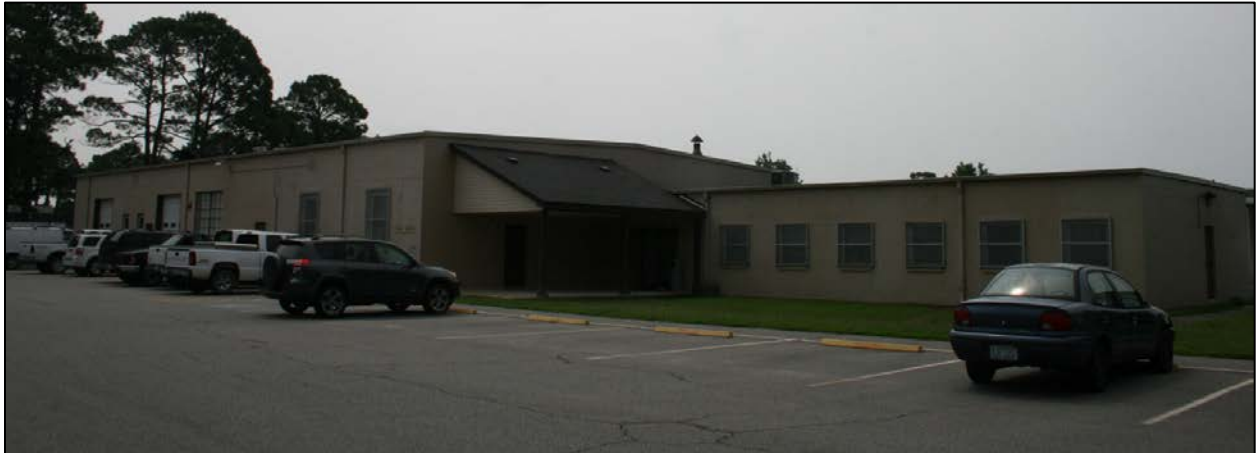
Figure 78: Building 5-1, front (north) elevation

Building 5-1 sits on the south side of Harvey Point Road, west of the seaplane area and testing ranges. Sources indicate that construction of the public works building pre-dated the current Defense Testing Activity, and likely occurred at the outset of the build-up for the SeaMaster jet seaplane program c.1959.

The concrete block building consists of two rectangular sections: a one-and-a-half story shop area, and a one-story office section. The juncture of the shop and office areas on the front (north elevation) serves as the main entrance, with an asphalt-shingled, shed-roofed canopy, sheathed in vinyl siding and supported by wood piers. The shed roof extends from the shops section, and the main entrance doors, located on the office section, consist of aluminum storefront doors. Six replacement, eight-over-eight windows, with security screens line the remaining portion of the office section. The one-bay, west elevation includes one pedestrian door. Six windows light the rear elevation; four match the front windows, and two are smaller. A flat roof covered in a single ply membrane tops the office section. The recently renovated office space interior includes vinyl flooring and carpet, dry wall, and a suspended acoustic ceiling.

The front elevation of the shops section of the building consists of seven bays, with one original, 36-light, steel industrial window; two replacement, garage doors; two single-light, replacement metal doors; and, two replacement, one-over-one, vinyl windows. The east elevation includes one original, 36-light, steel industrial window, three pedestrian doors, and three vent openings. Two of the wood-paneled doors are two-light, and the third features no lights. Two of the vents are louvered, while the third is covered. The rear elevation of the shop section consists of a double-leaf pedestrian door, a pedestrian door sheltered by a long shed roof, a 36-light, steel industrial window, a modern, metal garage door, and a 24-light, metal industrial window. A shallow-sloped, side-gabled roof covered with single ply membrane tops the shops section. The interior of the shops section features good integrity, with painted CMU walls, and an exposed concrete floor and ceiling. The paneled, interior doors are a combination of original and replacement doors.

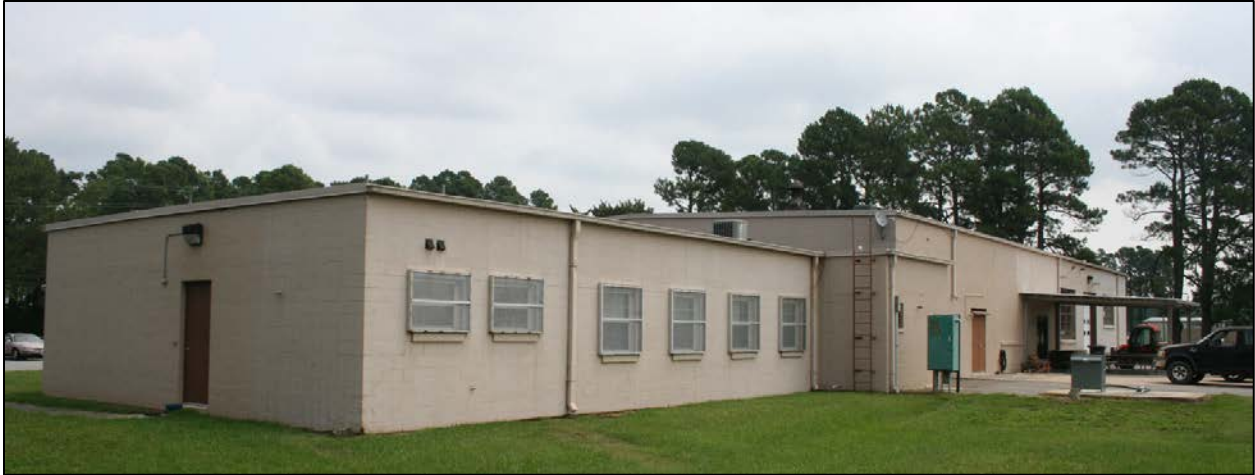
Figure 80: Building 5-1, south and west elevations

Constructed to serve as the public works building, Building 5-1 continues that function. Alterations to the building include the aforementioned interior renovations, the addition of partition walls in the shops section, replacement of windows and doors, and the infilling of openings with CMU.

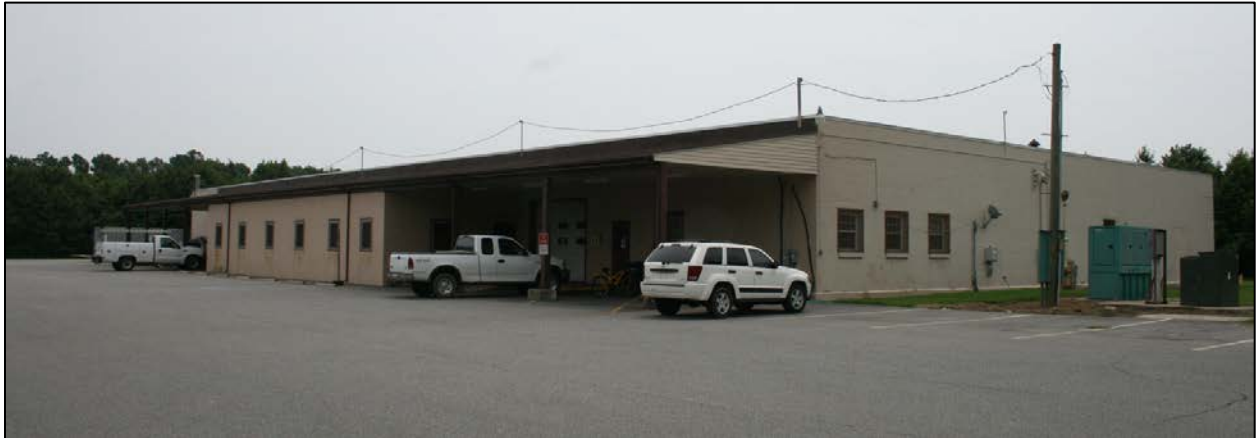
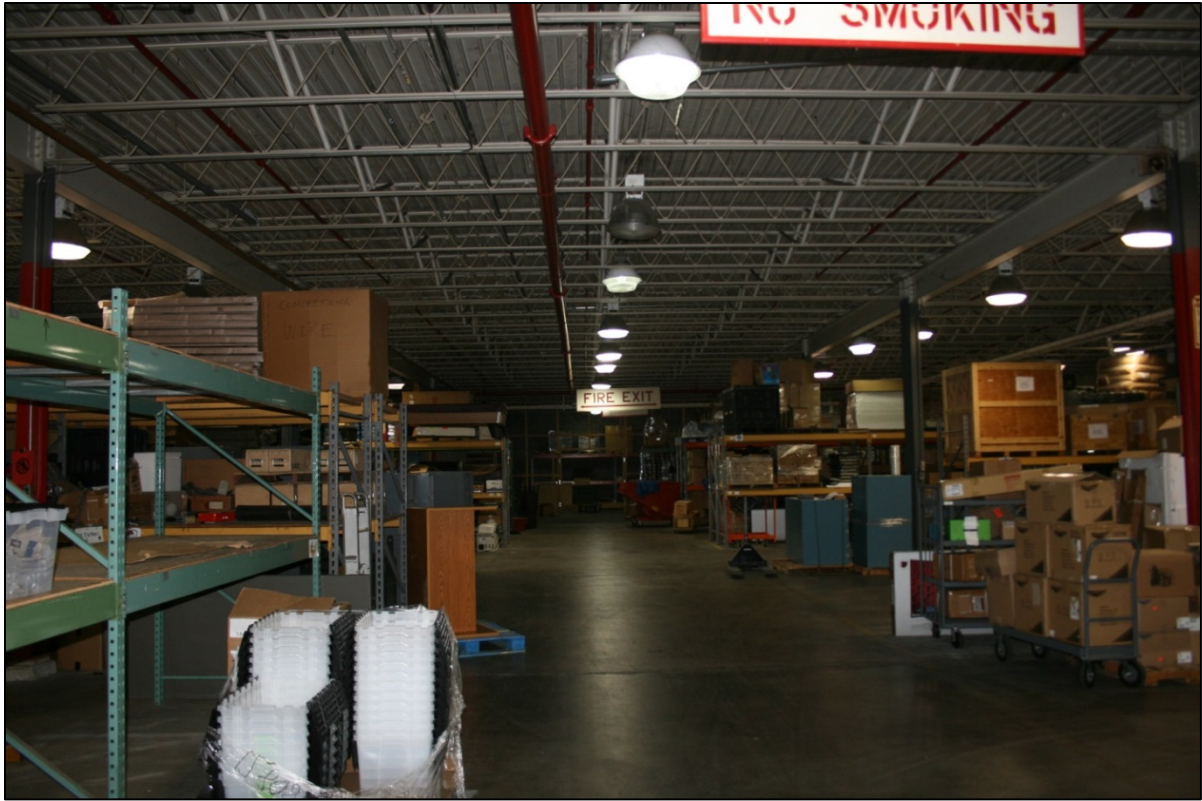
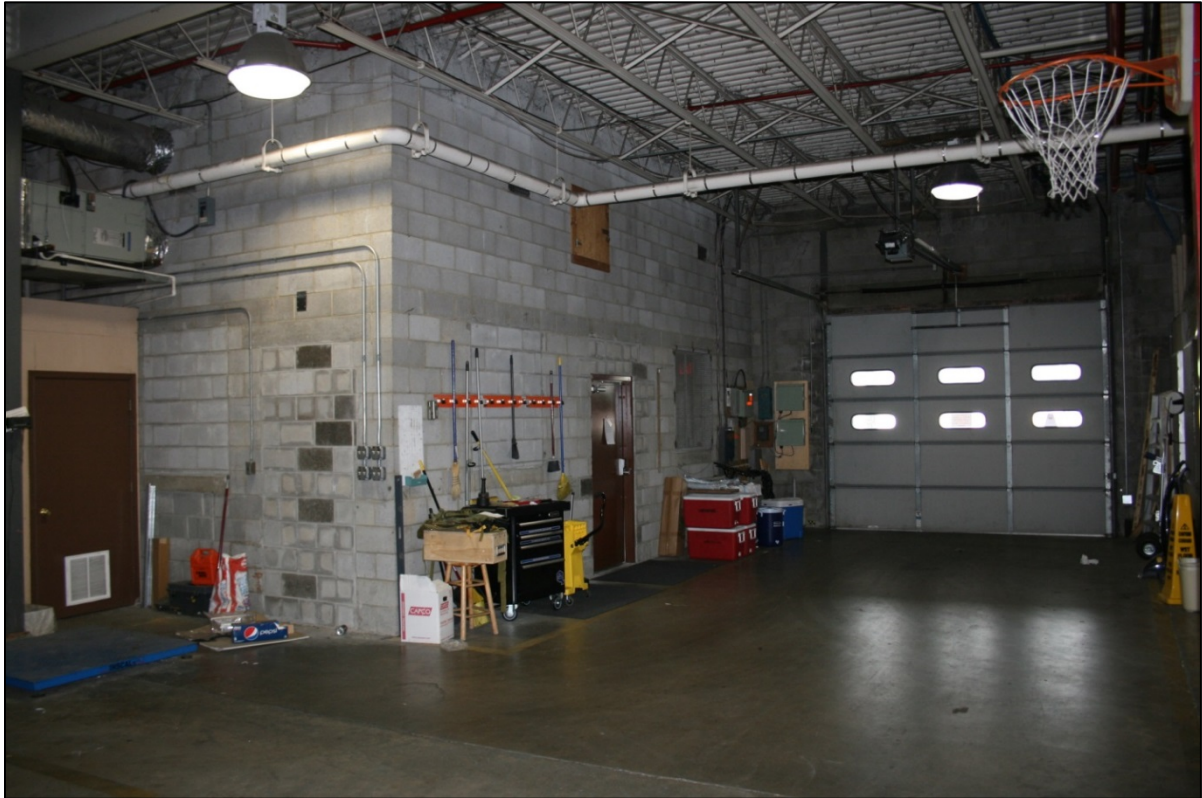
Figure 85: Building 5-2, north and west elevations

Building 5-2 sits on the south side of Harvey Point Road, immediately south of the WWII seaplane area, and west of the active runway. Sources indicate that construction of the warehouse building pre-dated the current Defense Testing Activity, and likely occurred at the outset of the build-up for the SeaMaster jet seaplane program c.1959. The warehouse retains its original function.

A combination of original, steel windows and replacement, vinyl-framed windows light the building. The exterior doors include hollow metal, painted louver doors and steel overhead replacement doors. A flat, single ply membrane roof covers the main block, and an asphalt-shingled, shed roof covers the front overhang.

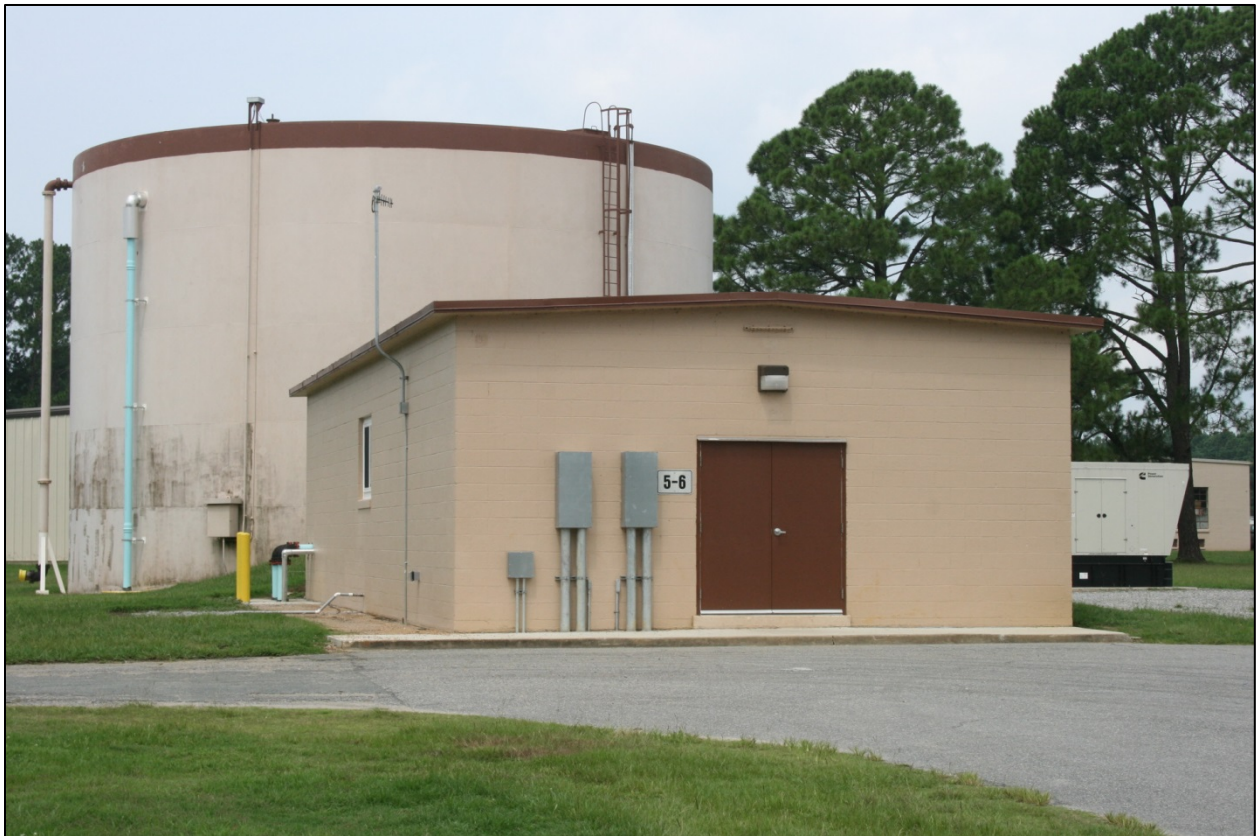
Figure 89: Building 5-6, south and east elevations

Building 5-6 sits on the south side of Harvey Point Road, west of the active runway, and adjacent to a water reservoir (Building 5-7). The one-story, concrete block building features a shallow, front-gabled, concrete roof, with a gravel-topped asphalt roof covering. The east and west elevations consist of one bay, a double, solid metal door, located in the middle of the wall.

The north and south elevations have a two-light, sliding, replacement window in the middle of the elevation.

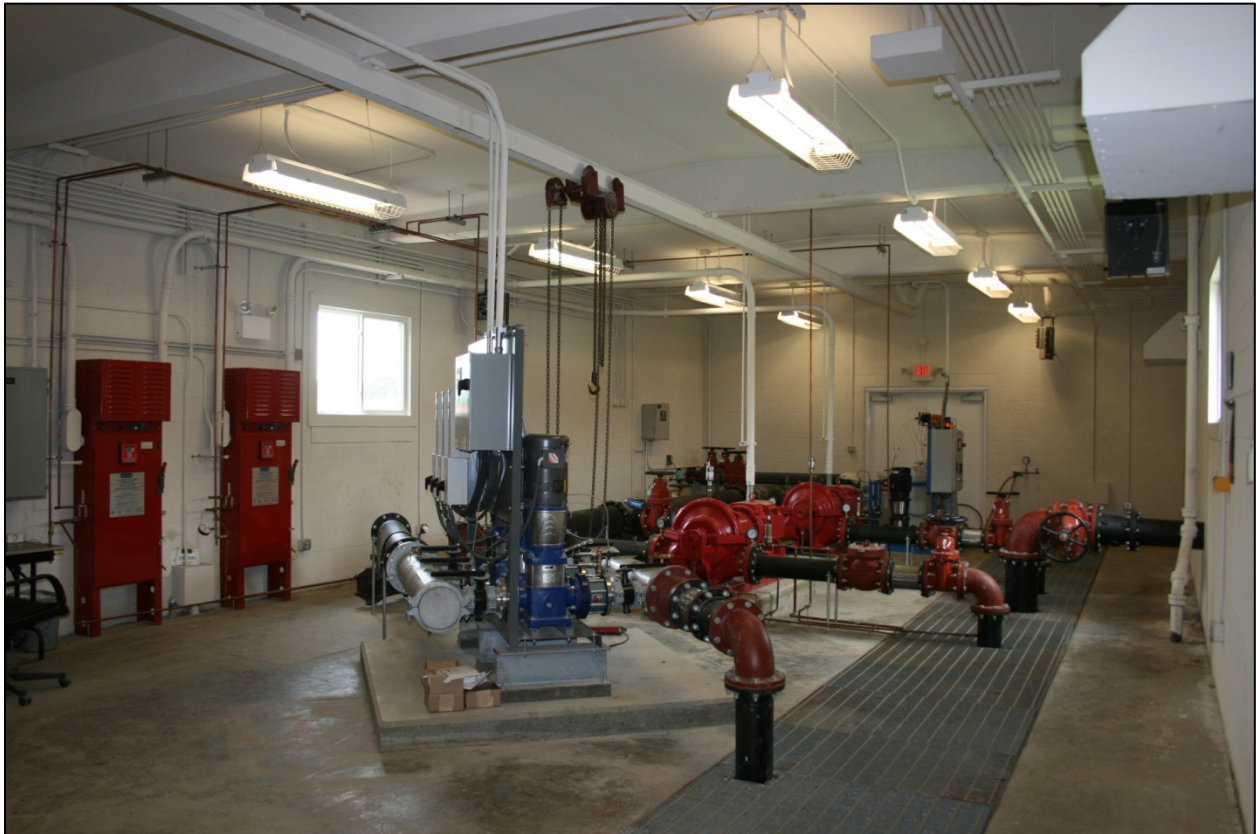
Figure 90: Building 5-6, interior view, looking southwest

The industrial interior consists of an open floor plan with a concrete floor and ceiling, with three concrete trusses spanning the width of the building. There are two vents located on the north elevation. A metal beam runs the length of the building, in the middle of the room, to support a pulley system. Two rows of four fluorescent light fixtures hang from the ceiling. The pumping equipment sits in the middle of the open floor, and feeds into a linear metal-grated area. The pumping equipment and electrical gear dates to a renovation in 2011.

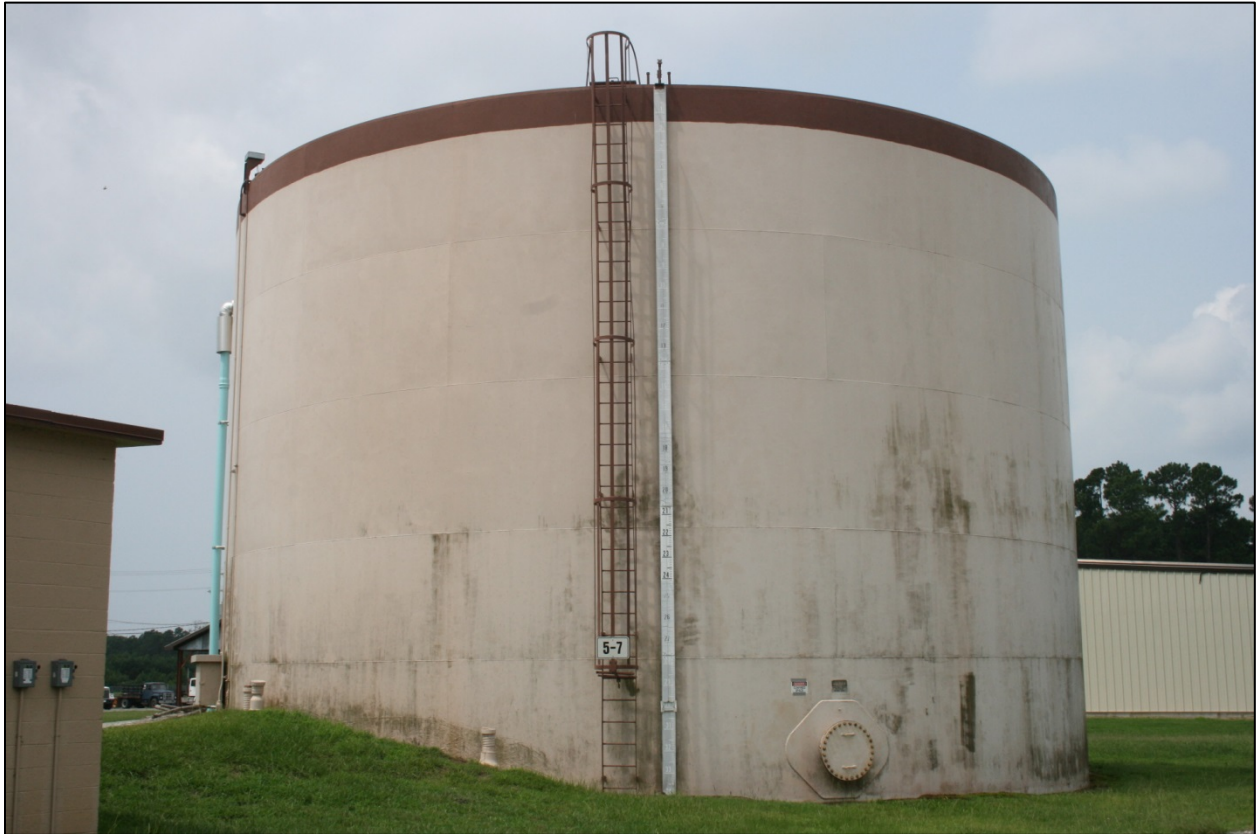
Figure 91: Facility 5-7, looking southwest

Facility 5-7 sits on the south side of Harvey Point Road, west of the active runway, and adjacent to Building 5-6. The above-ground, cylindrical water reservoir holds 600,000 gallons of water. The steel reservoir features a metal, caged ladder, which provides access to the roof. No alterations were evident.

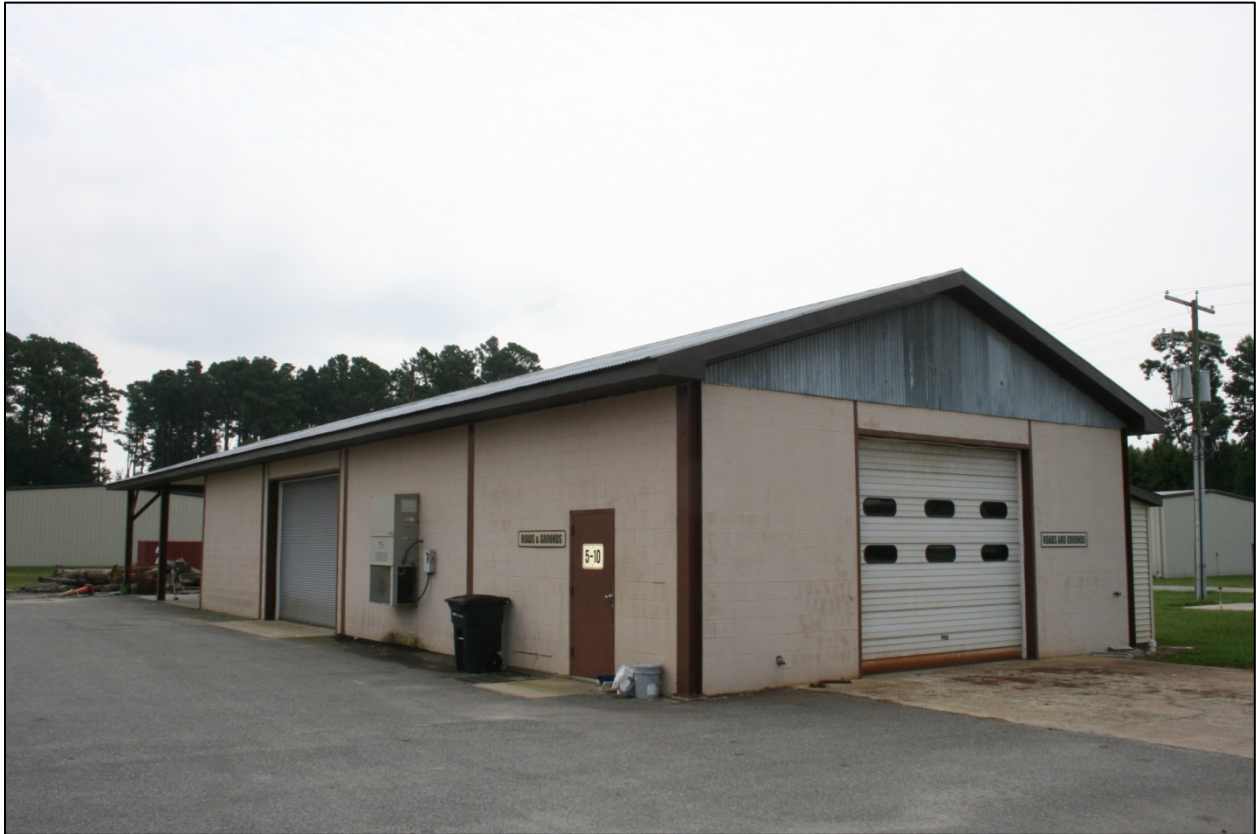
Figure 92: Building 5-10, south and west elevations

Located south of Harvey Point Road, and west of the active runway, Building 5-10 once served as a welder's shop, but now houses a roads and grounds maintenance facility. The surveyors selected the resource in the field based on construction methods and materials, since installation property records date the building to 1992. The front elevation of this side-gabled, concrete block building includes a replacement garage door, and a metal pedestrian door. An open, equipment storage area, covered by the roof, extends from one end of the building. The other gable end includes a replacement, metal, roll-up garage door, and corrugated metal siding in the gable. The open plan interior features exposed concrete walls, with a brick row on top, a concrete floor, fluorescent lights suspended from a drywall ceiling, and a bathroom with modern fixtures.

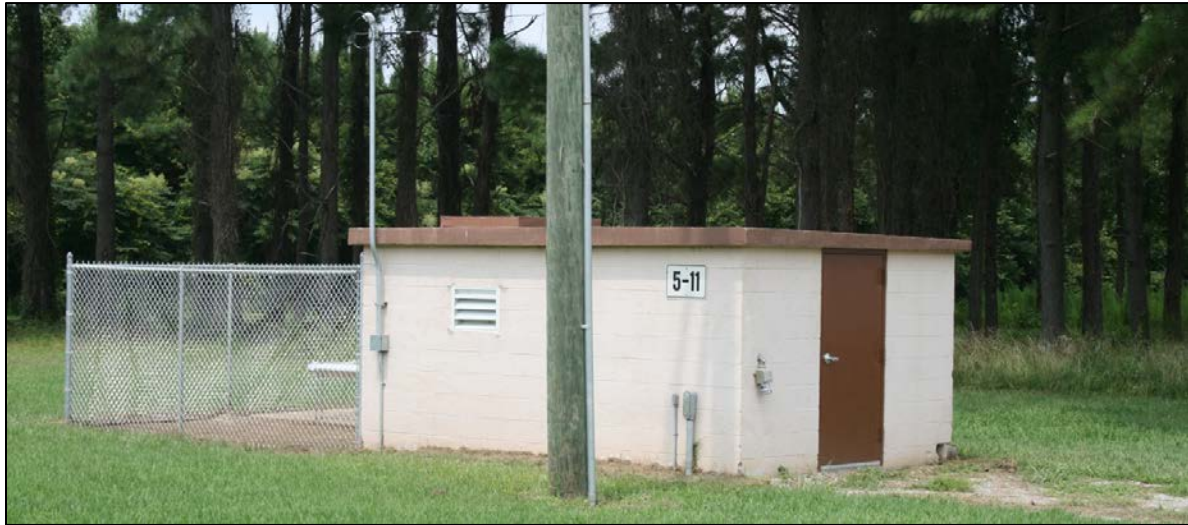
Figure 94: Building 5-11, south and east elevations

Building 5-11, located south of Harvey Point Road and west of the active runway, is a one-story, one-bay, concrete block pumphouse. Tar and gravel cover the flat, concrete roof. A solid, metal door opens on the east elevation. The west elevation features a four-light, metal window, and galvanized metal piping extends from the wall to the well. A chain link fence installed in 2014 surrounds the galvanized piping and well. The interior walls, floor, and ceiling remain exposed and unfinished. Alterations include replacement pump equipment and controllers and electrical upgrades completed in 2013 to 2014.
