Re: Architectural Survey and Evaluation, Harvey Point Testing Area, Hertford,
Perquimans County, ER 17-0160

October 2016

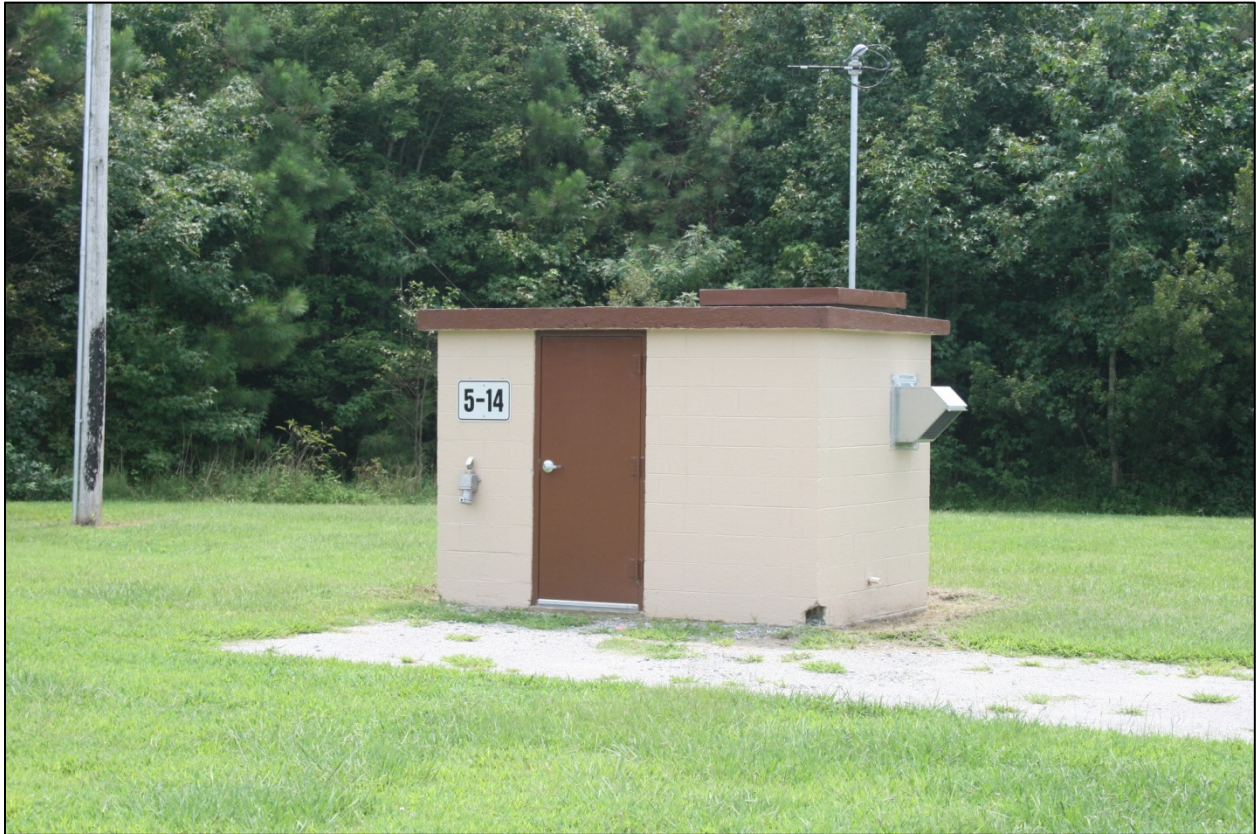
Figure 96: Building 5-14, south and east elevations

Located south of Harvey Point Road and west of the active runway, Building 5-14 is a one-story, one-bay, concrete block pumphouse. Tar and gravel cover the concrete, flat roof. A solid, metal door opens on the north elevation. The interior walls, floor, and ceiling remain exposed and unfinished. Alterations include replacement pump equipment and controllers and electrical upgrades completed in 2013 to 2014.

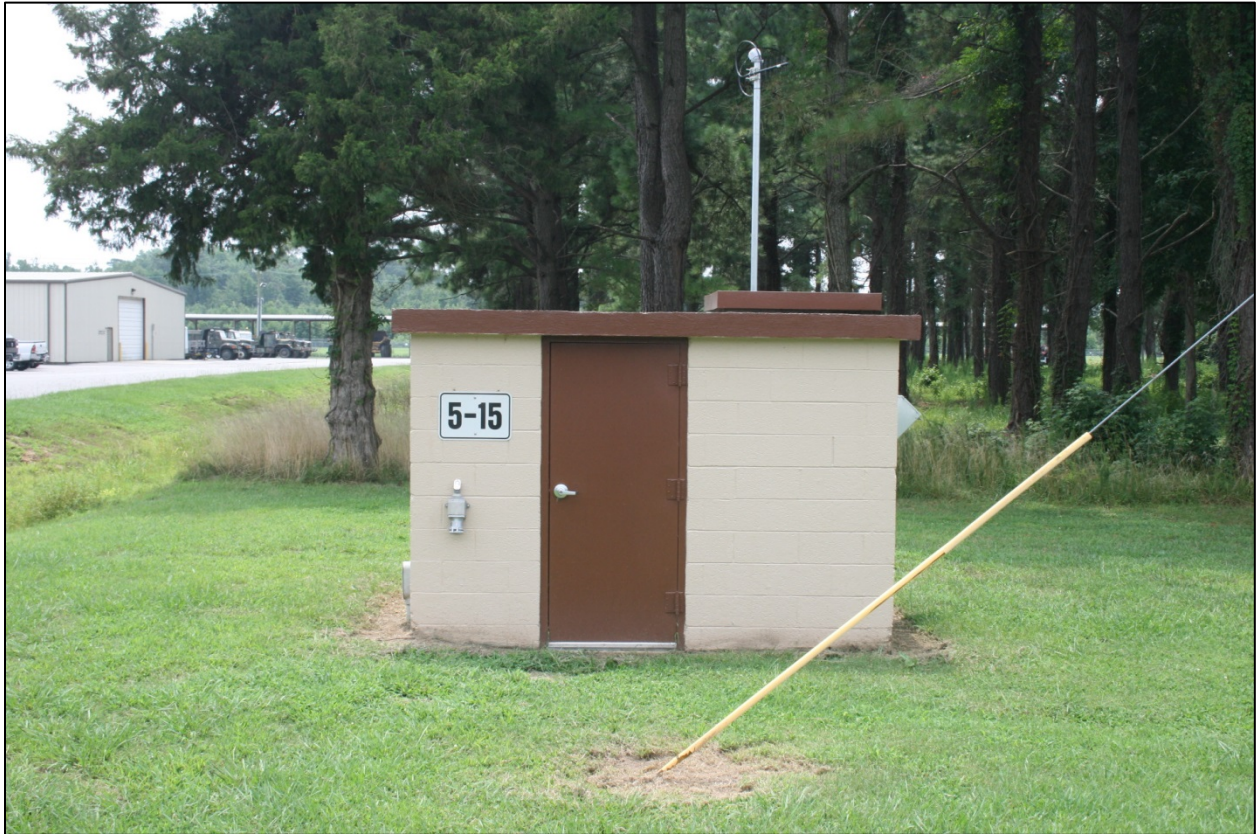
Figure 97: Building 5-15, north elevation

Building 5-15 sits south of Harvey Point Road, west of the active runway. The one-story, one-bay, concrete block pumphouse has concrete slab, flat roof, covered in tar and gravel. A solid, metal door opens on the front elevation. The interior walls, floor, and ceiling remain exposed and unfinished. Alterations include replacement pump equipment and controllers and electrical upgrades completed in 2013 to 2014.

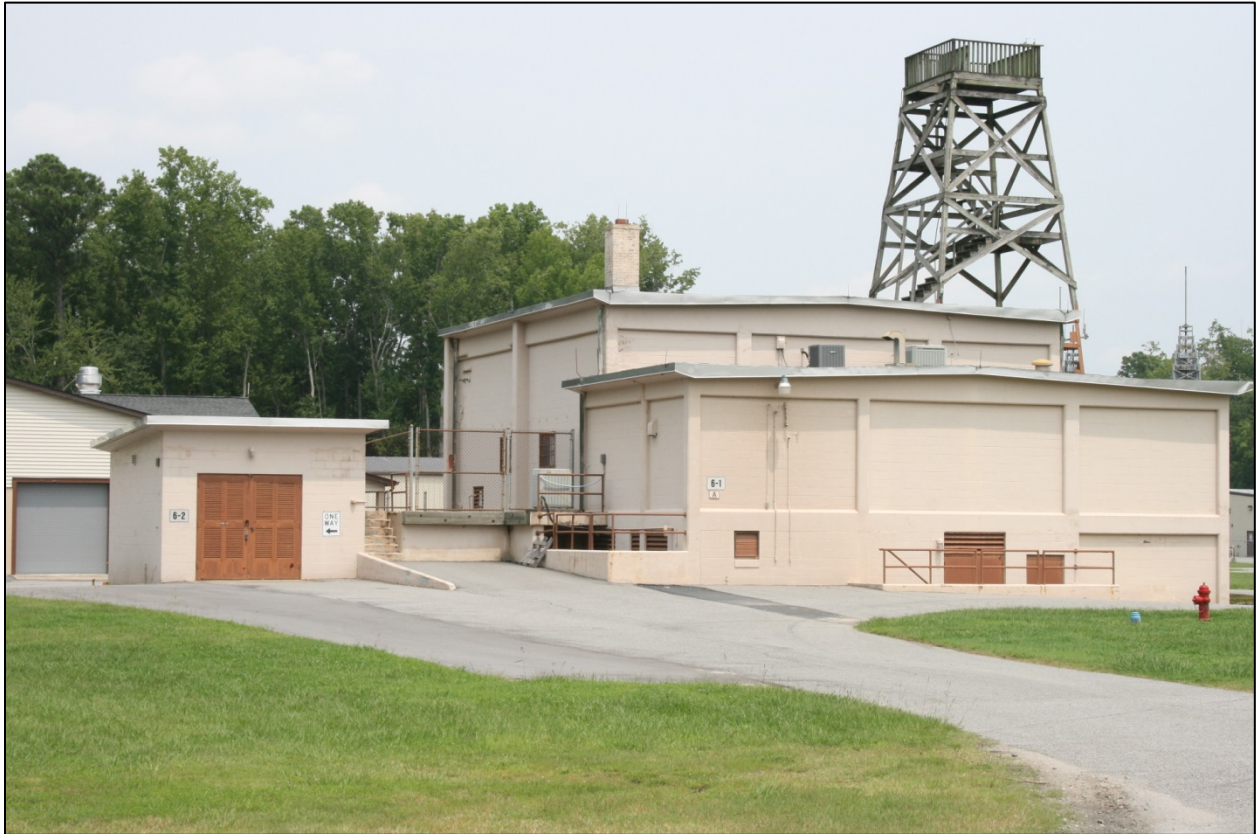
Figure 98: Building 6-1, south (front) and west elevations

Located at the south end of the installation, Building 6-1 sits south of Harvey Point Road, west of the active runway. The building currently sits vacant. The exterior wood tower, since removed, provided occasional training. The building previously housed a photographic laboratory and communications equipment. Radar has been removed from the roof, and adjacent radar towers have been removed. The building appears to have been completed in the early 1960s, during the Defense Testing Activity period, although communications facilities were planned for the SeaMaster base as well.

The second section, three stories in height, sits behind the first section. A set of concrete steps on the northeast corner of the north elevation provides access to the first floor. Additionally, a metal stair continues up from the first floor to provide roof access to the steel and wood structure that may have held the radar. A double door opens at the first floor level on the south end of the west elevation. Two four-light, steel windows, with security bars, light the west elevation. The east elevation of the second section features a fixed, single-pane, aluminum window; a portion of the metal tower that supports the wood tower on the roof; and, two metal structures rising from the ground that likely serve a communications function.

The interior consists of a combination of painted CMU walls and gypsum board on metal or wood studs with a painted finish. Interior doors are a combination of painted, solid-core, wood and hollow-core, metal doors, both set in metal frames. Ceramic tiles cover the restroom floors, vinyl composite tiles cover the administrative and common areas, and painted flooring exists in the support areas. A suspended acoustic ceiling appears throughout the interior spaces. Noted alterations include the removal of radar and associated communication equipment, and the installation of interior partition walls and drop ceilings.

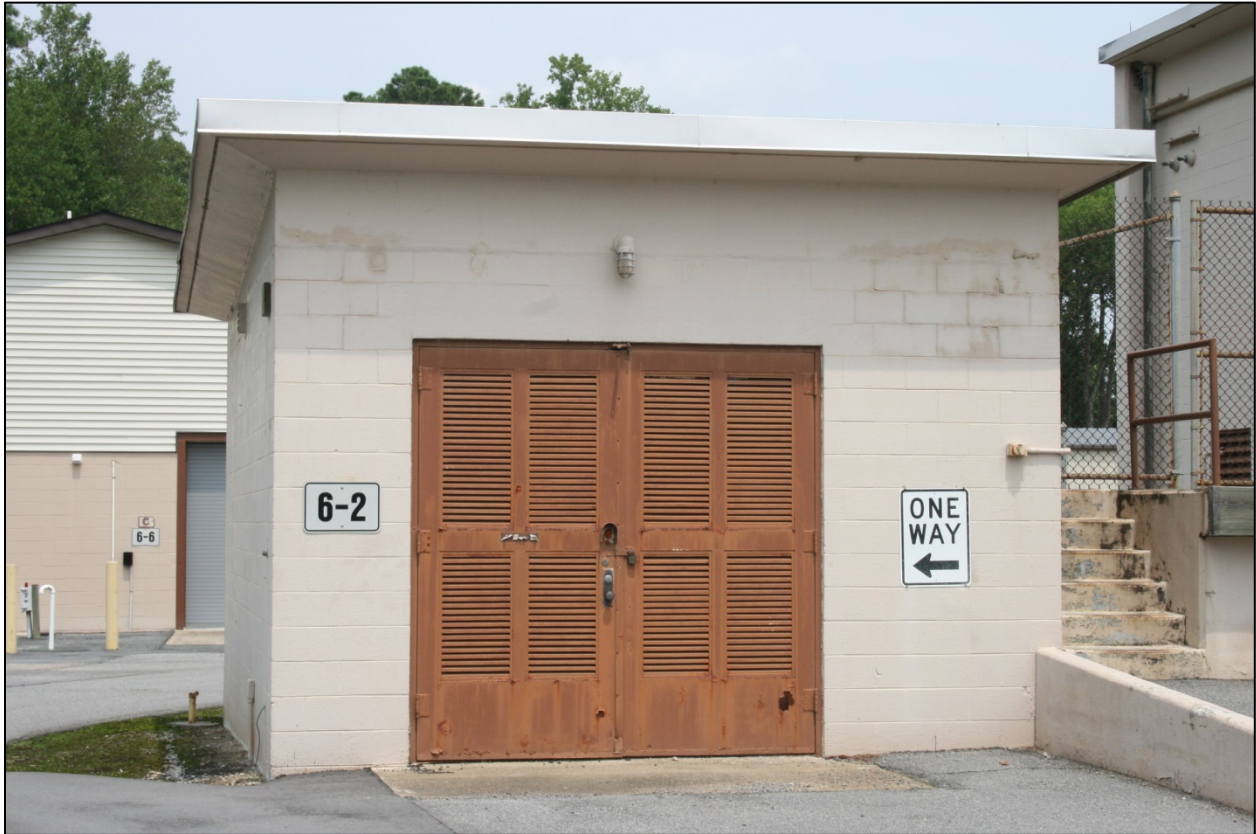
Figure 102: Building 6-2, front (south) elevation

Building 6-2 sits south of Harvey Point Road and west of the active runway, adjacent to Building 6-1. The surveyor observed no alterations to this storage building. The original function is unknown. The one-story, one-bay, concrete block building is topped with a shed roof, covered in EPDM membrane. A double-leaf, louvered, metal door, with a flush, concrete slab entrance, dominates the front elevation. An eight-light, steel window, with metal security bars, is on the rear elevation. No fenestration adorns the side elevations. The interior consists of painted CMU walls with a concrete floor.

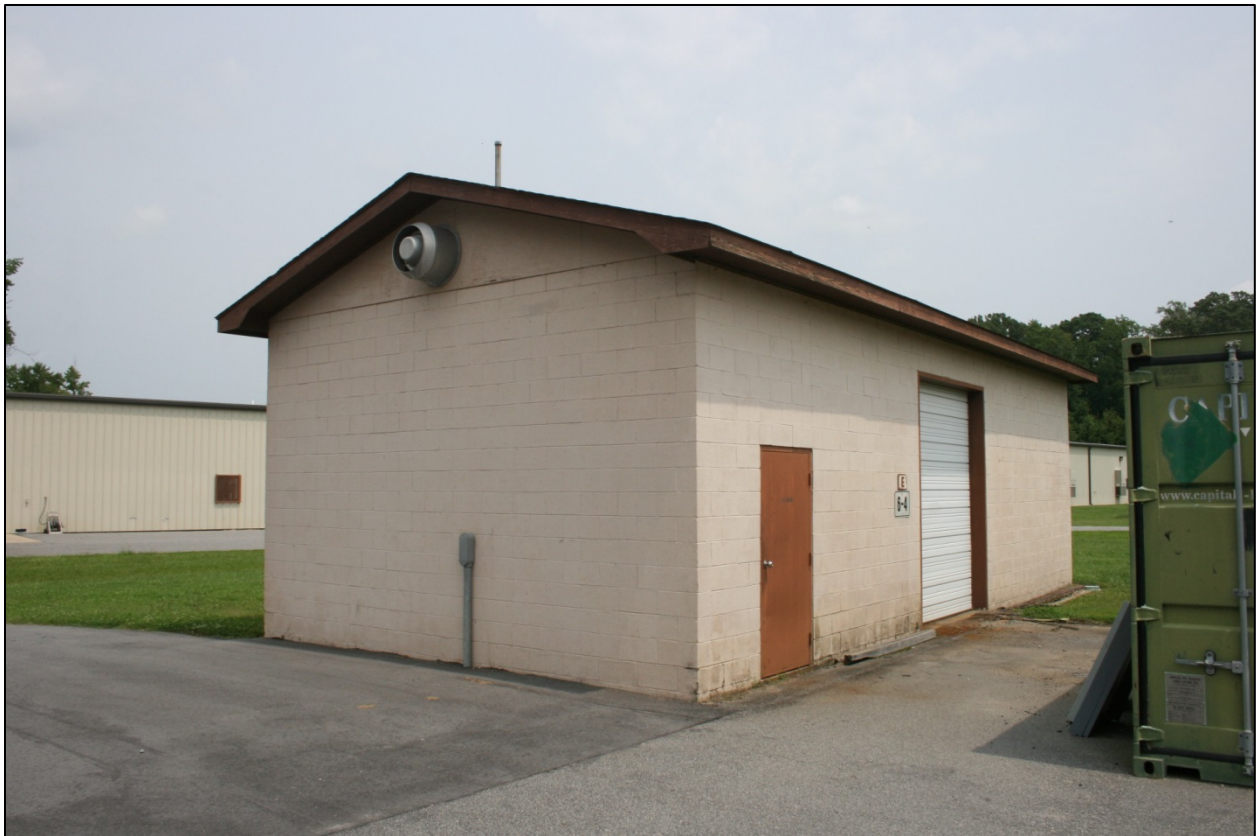
Figure 104: Building 6-4, south and west elevations

Building 6-4 sits at the south end of the installation, west of the active runway, near Building 6-1. The one-story, concrete block building features an asphalt-shingled, overhanging side-gabled roof with wood fascia and plywood gable ends. The two-bay façade consists of a replacement, roll-up garage door and a single, solid, metal door, set in a metal frame. The building's other elevations remain without fenestration. Interior finishes include painted CMU

walls, an exposed concrete floor, and painted plywood ceiling attached to the roof superstructure.

The building currently serves as a maintenance shop. The original function of the building is unknown; however, due to the presence of a garage door and no windows, the building may have served as storage or a shop building.

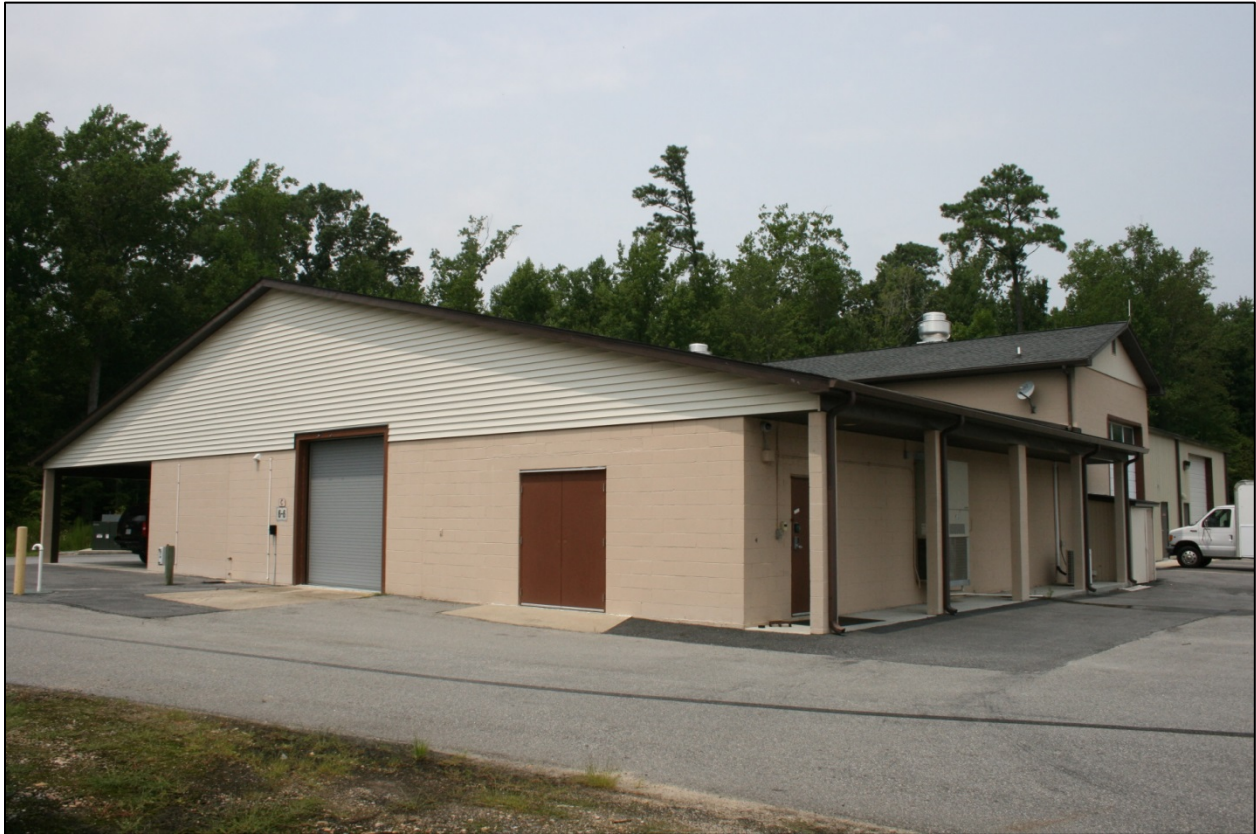
Figure 106: Building 6-6, south and east elevations

Building 6-6 sits south of Harvey Point Road and west of the active runway, north of Building 6-2. The surveyors chose this building for survey in the field based on its period construction methods and materials. The concrete block building features a one-story main block, with a two-story, concrete block, garage addition to the north. The main block, topped with a side-gabled roof, covered in asphalt shingles, features vinyl siding in the gable ends and sheltered spaces on each side elevation, provided by the overhanging roof. Five wood piers support the roof overhang on the side elevations. The front (south) elevation consists of two bays: a roll-up garage door located near the center, and a double-leaf, solid, metal door to the east. A solid metal door is the only fenestration on the side elevations. The one-bay garage addition sits perpendicular to the main block, with its front-gabled, asphalt-shingled roof. The east elevation of the garage includes a centrally located garage door bay.

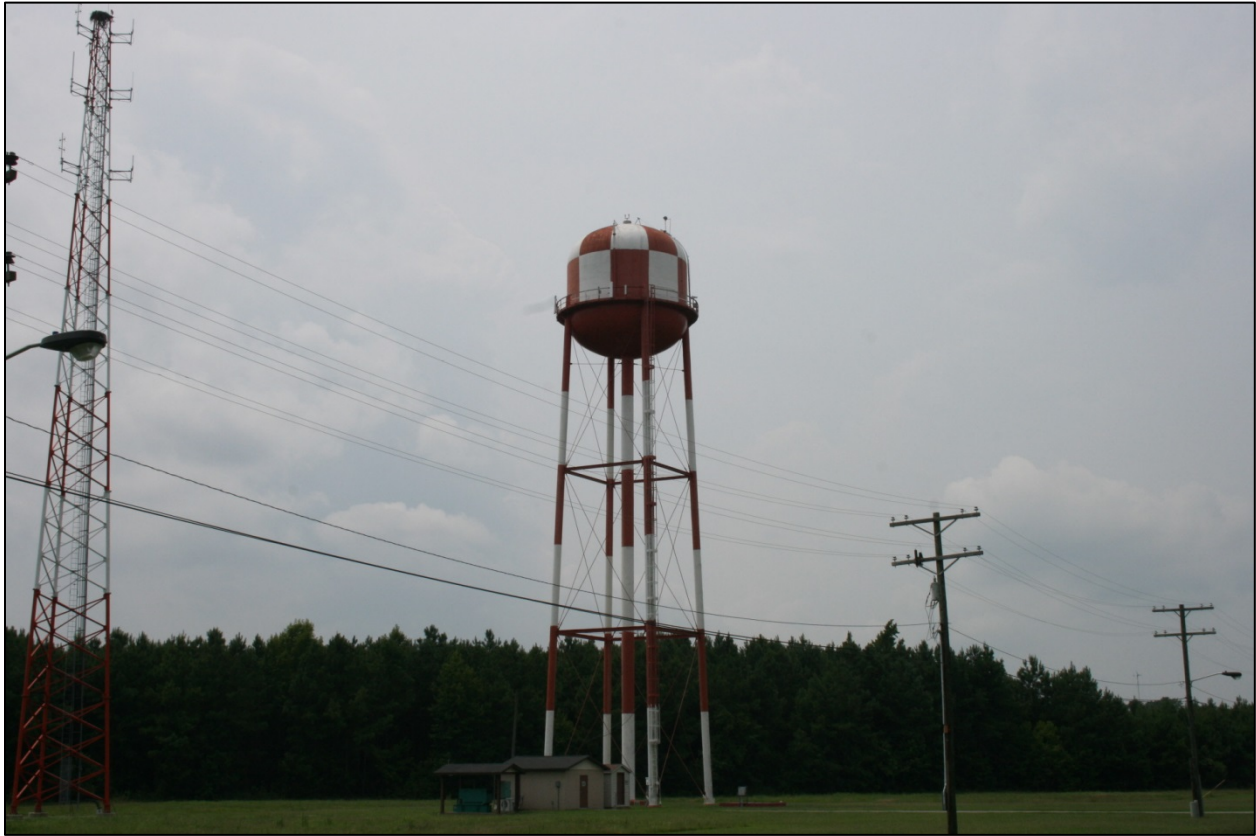
Figure 107: Building 8-4, looking west

Building 8-4 rises from the south side of Harvey Point Road, on the west side of the installation. Painted in a checkerboard pattern of white and orange colors, the elevated, metal water tower rests on a steel frame, consisting of a central post, with four smaller posts on the outside. A cylindrical storage tank sits atop the posts. A metal ladder attached to one of the smaller, exterior posts provides access to the top of the tower, and a walkway with steel pipe railings surrounds the water tank. The tank holds 125,000 gallons of water. No alterations were evident.
