**SUBJECT:** Historic Structures Survey Report for the Replacement of Bridge 121 on SR 1113 over Tanyard Creek, PA 16-11-0010, Lincoln County, ER 17-0570

## HISTORIC STRUCTURE SURVEY REPORT

# TIP# N/A REPLACE BRIDGE NO. 121 ON SR 1113 (REEPSVILLE ROAD) OVER TANYARD CREEK, LINCOLN COUNTY

**David C. Warlick Farmstead (LN0155)**  
**WBS# 17BP.12.R.104**

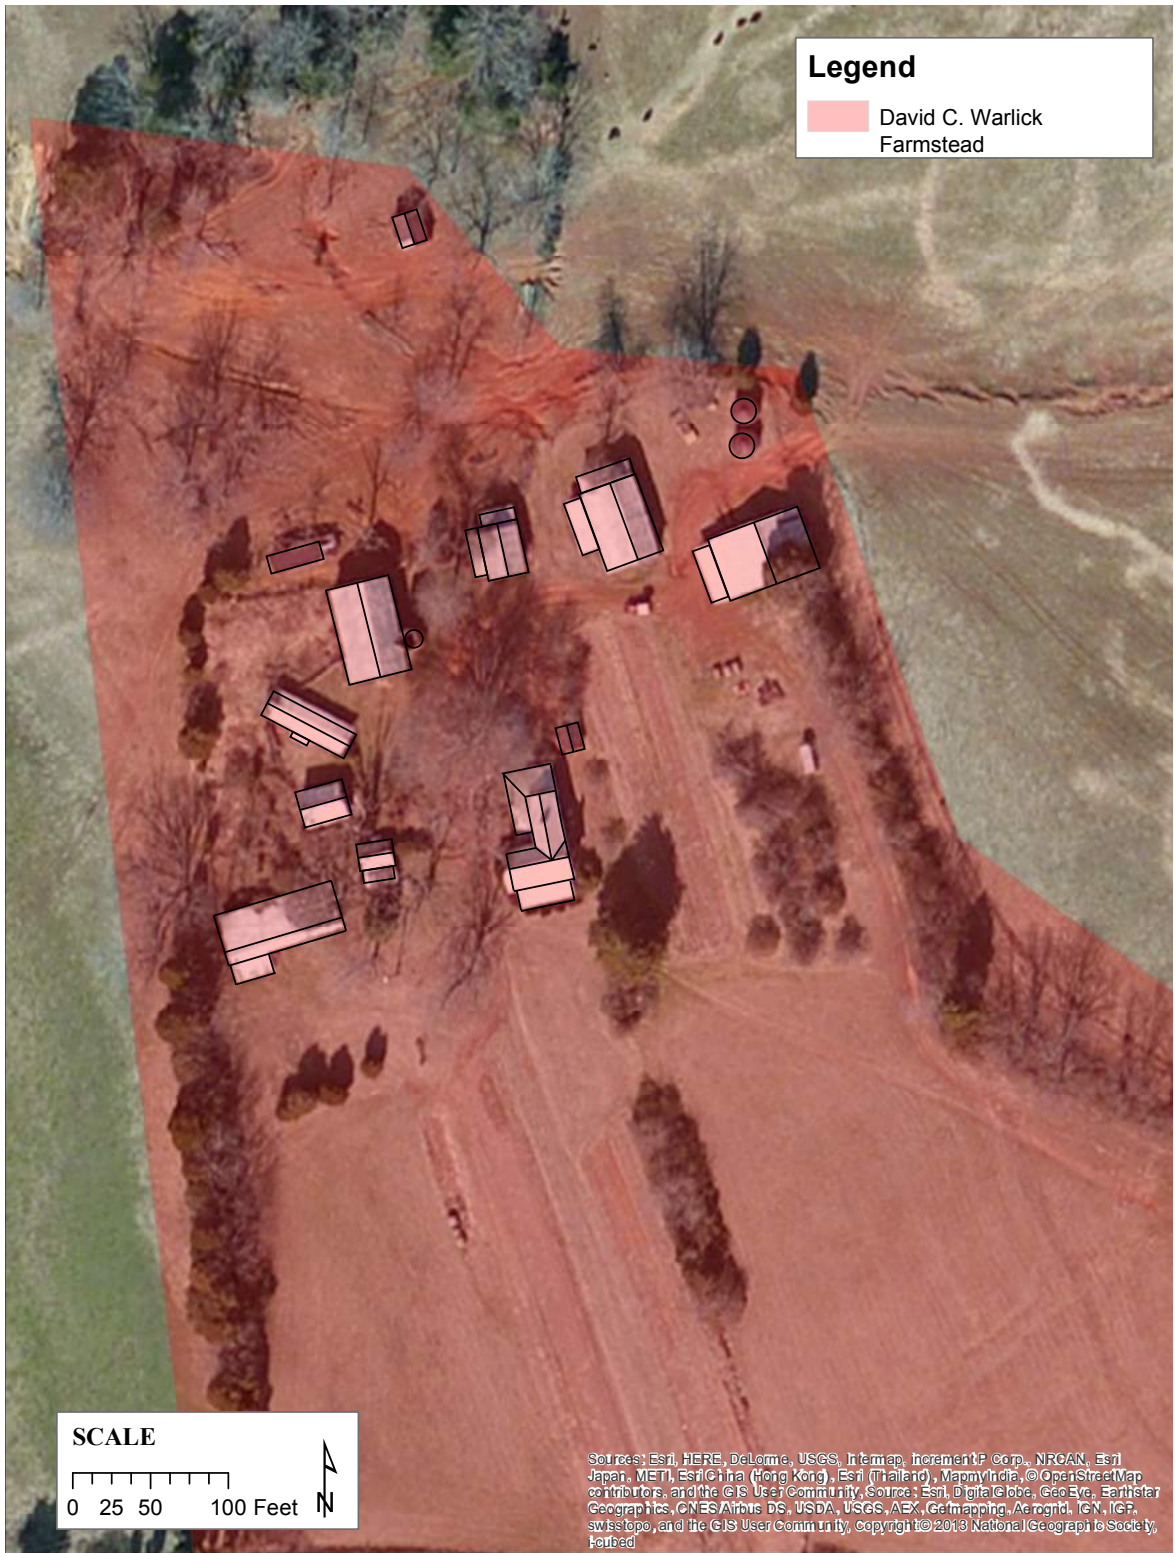
Figure 3: David C. Warlick Farmstead (Source: ESRI)

The façade (south elevation) is three bays wide and features a centered entrance flanked by four-light side lights. An original wood screen door protects the entrance. The entrance is flanked on both sides by two, evenly spaced windows, each with a pair of fixed wood shutters. These shutters are likely original. The first story fenestration is sheltered by the one-story porch. The second story features three evenly spaced windows aligned above the first story fenestration (Photographs 2-3). The side (east and west) and rear (north) elevations are not visible from the public right-of-way. However, aerial photographs show that the house contains a large, rear ell and rear porch. This ell is likely a later, but still historic addition (Figure 3).

Seven additional outbuildings/structures are located on the property, but are not visible from the public right-of-way. Outlines of these buildings are visible in aerial photographs (Figures 3-4) .

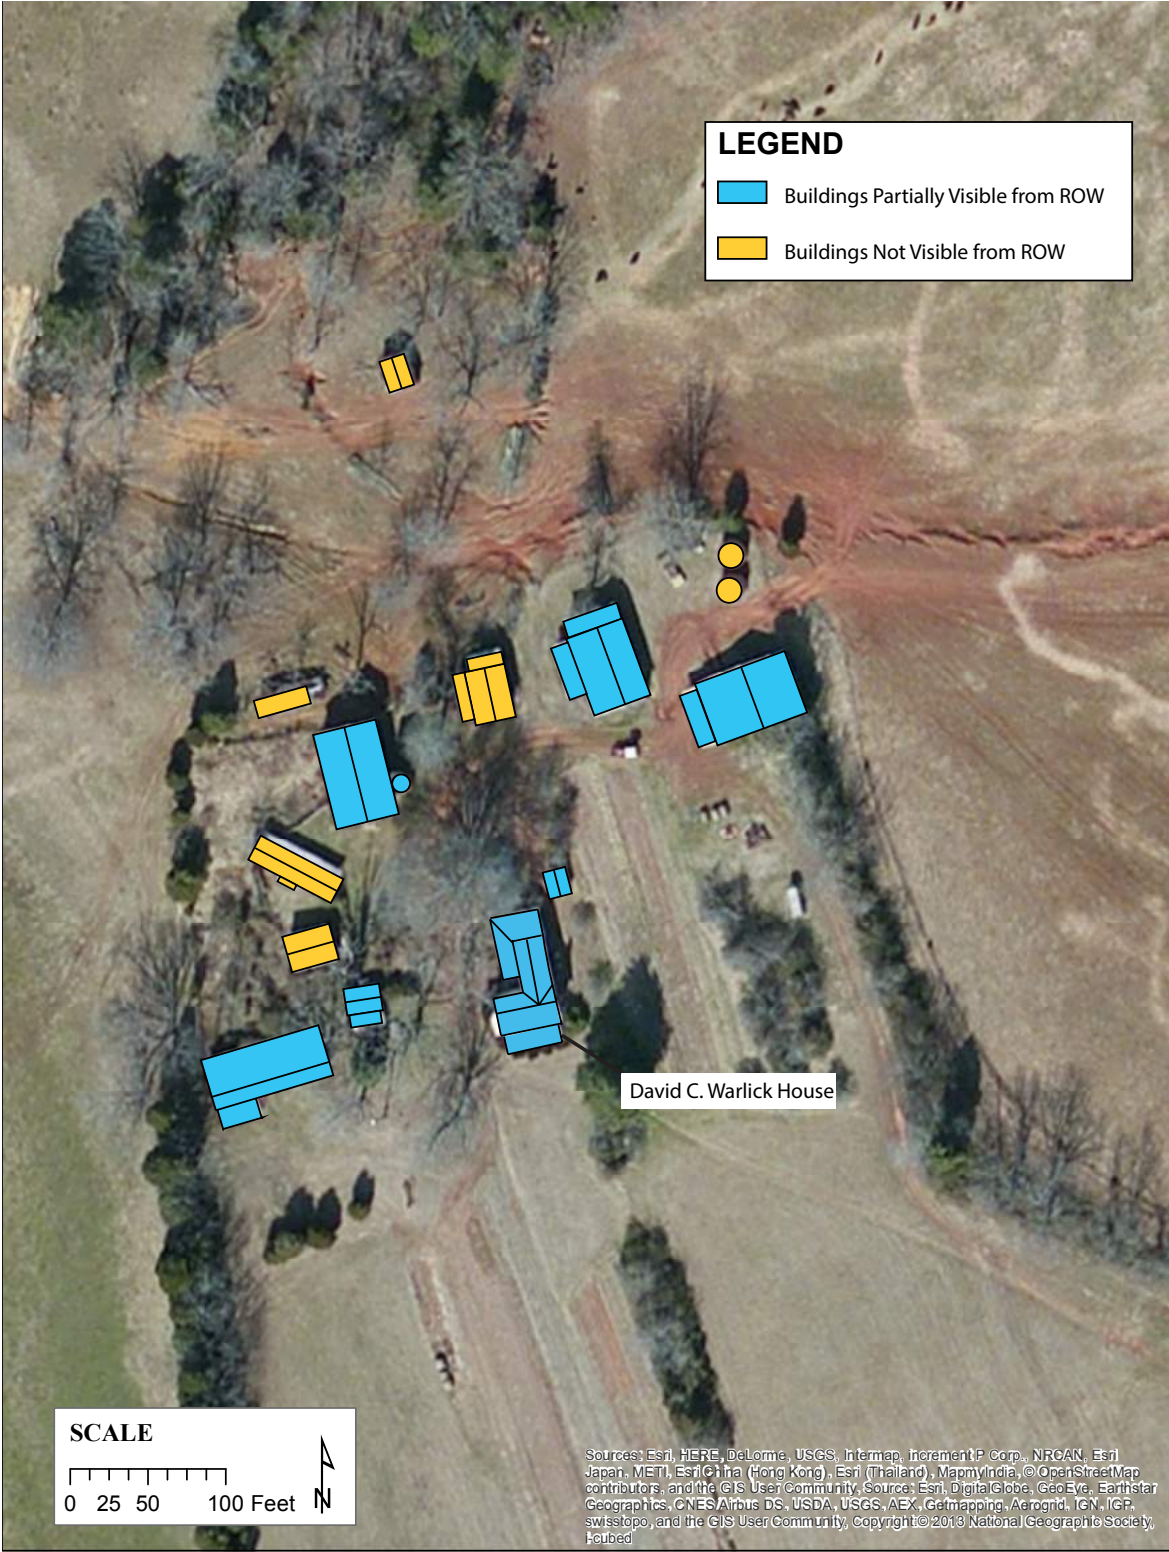
Figure 4: Buildings Visible from the Public Right-of-Way on the David C. Warlick Farmstead (Source: ESRI)

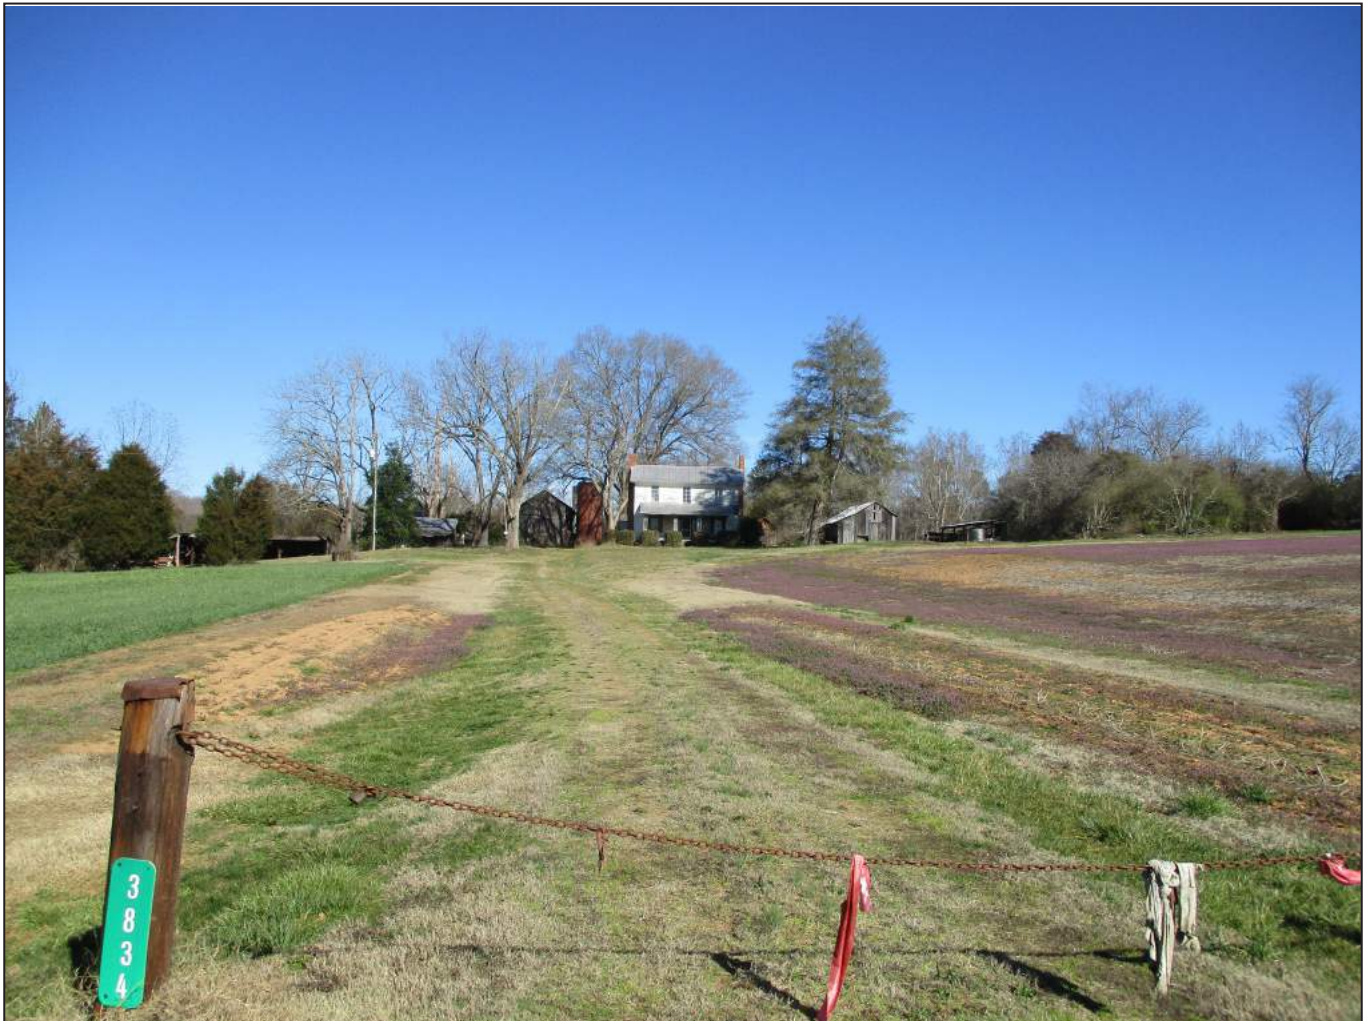
Fieldwork was completed on February 17, 2017. The interior of the property, which serves as a private residence, was not accessed. Attempts to gain access to the property were unsuccessful. Therefore, all photos of the property were taken from the public right-of-way. The dwelling and outbuildings were not completely visible from the public right-of-way due to a dense line of trees on the property. The driveway was gated and the dwelling was set back approximately 350 feet from Reepsville Road. The associated outbuildings were set back approximately 350 to 700 feet from the road behind dense tree cover. Six outbuildings were partially visible from the right-of-way (Photograph 1).

Photograph 1: David Warlick House and outbuildings; looking north. (2017)

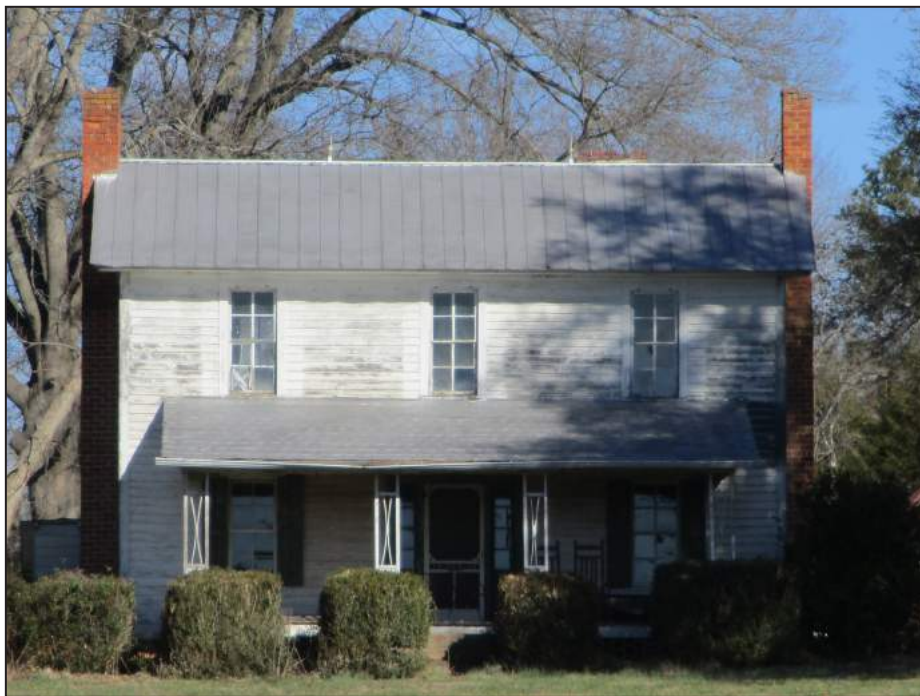
Photograph 2: Facade (south elevation) of David C. Warlick House; looking north. (2017)

intact. The structure sits on a brick foundation. Two exterior end chimneys pierce the gable ends on the east and west elevations. A third brick chimney located on the rear ell is just visible at the roof ridge near the east end of the dwelling (Photograph 2).

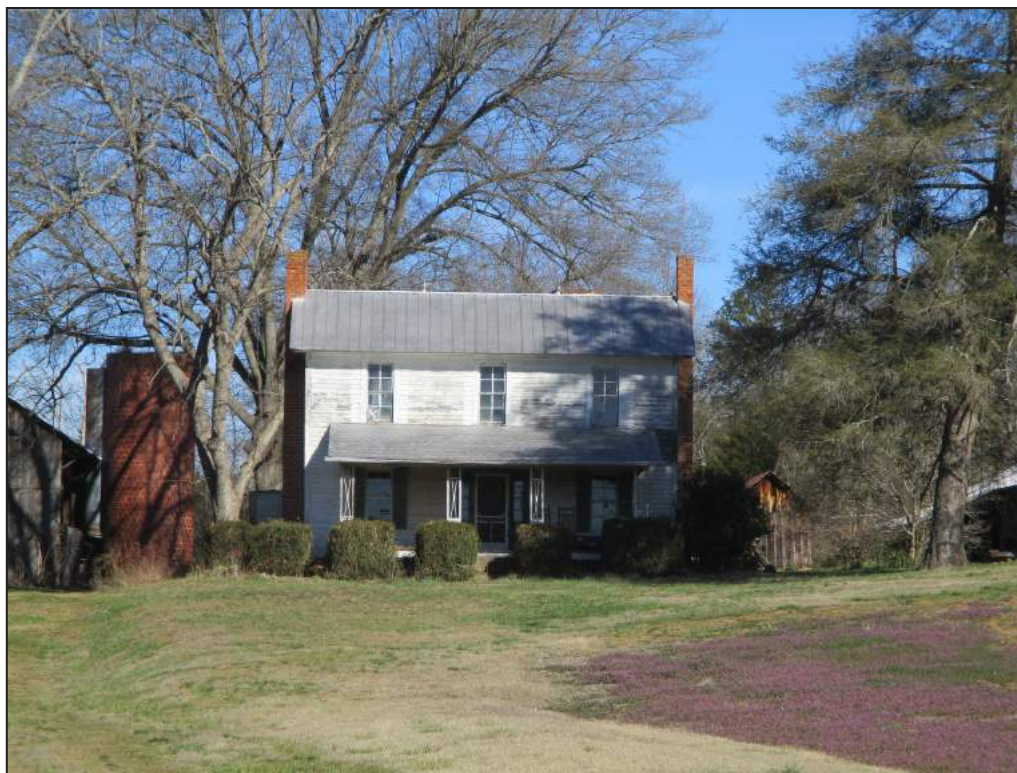
Photograph 3: Facade of David C. Warlick House; looking north. (2017)

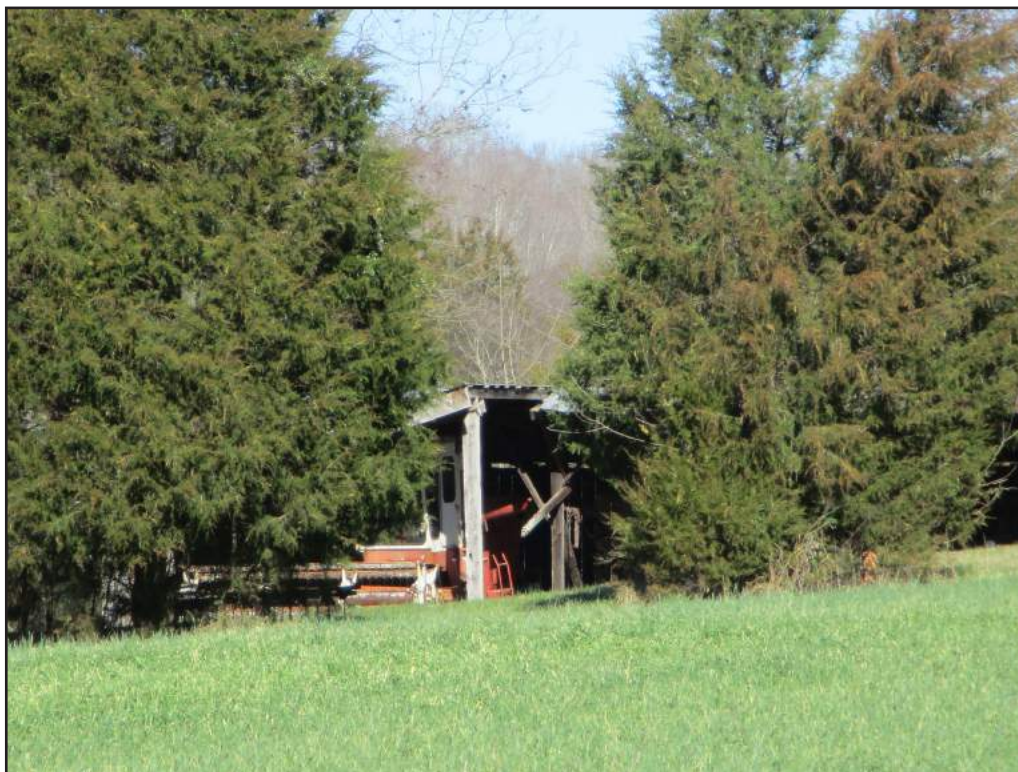
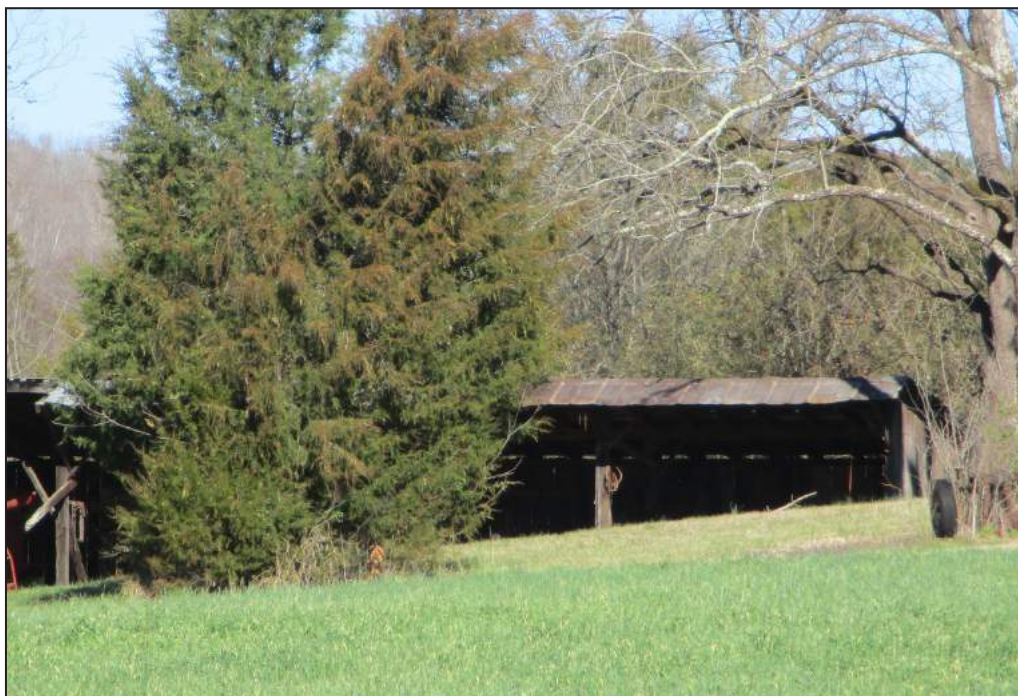
Photograph 4: Three-sided pole barn.; looking northwest. (2017)

Photograph 5: Three-sided pole barn.; looking northwest. (2017)

A late nineteenth, early twentieth-century one-story, three-sided pole barn is located farthest west of the main dwelling and is mostly obstructed by tree cover. The structure is partially constructed of logs and is capped by a side-gable standing seam metal roof. The south elevation does not have a wall. Walls are visible on the north and east elevations (Photographs 4-5).

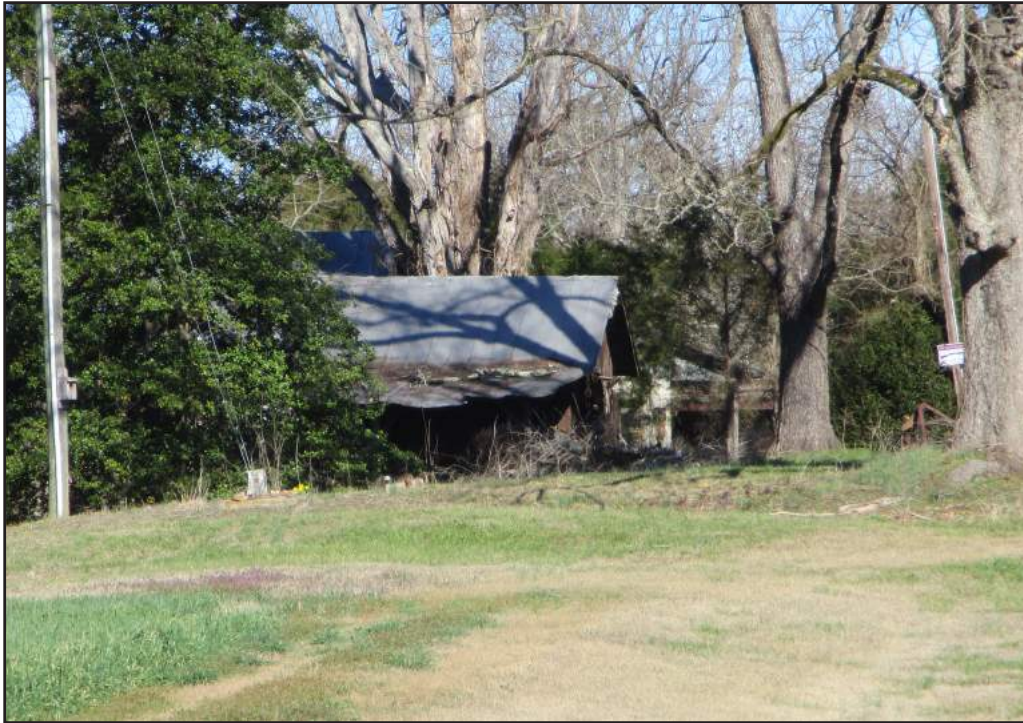
Photograph 6: One-story shed located east of the main dwelling ; looking northwest. (2017)

A late nineteenth, early twentieth-century one-story shed is located west of the main dwelling and is only partially visible from the public right-of-way. The structure is clad in vertical wood siding and capped by a side-gable standing seam metal roof. (Photograph 6).

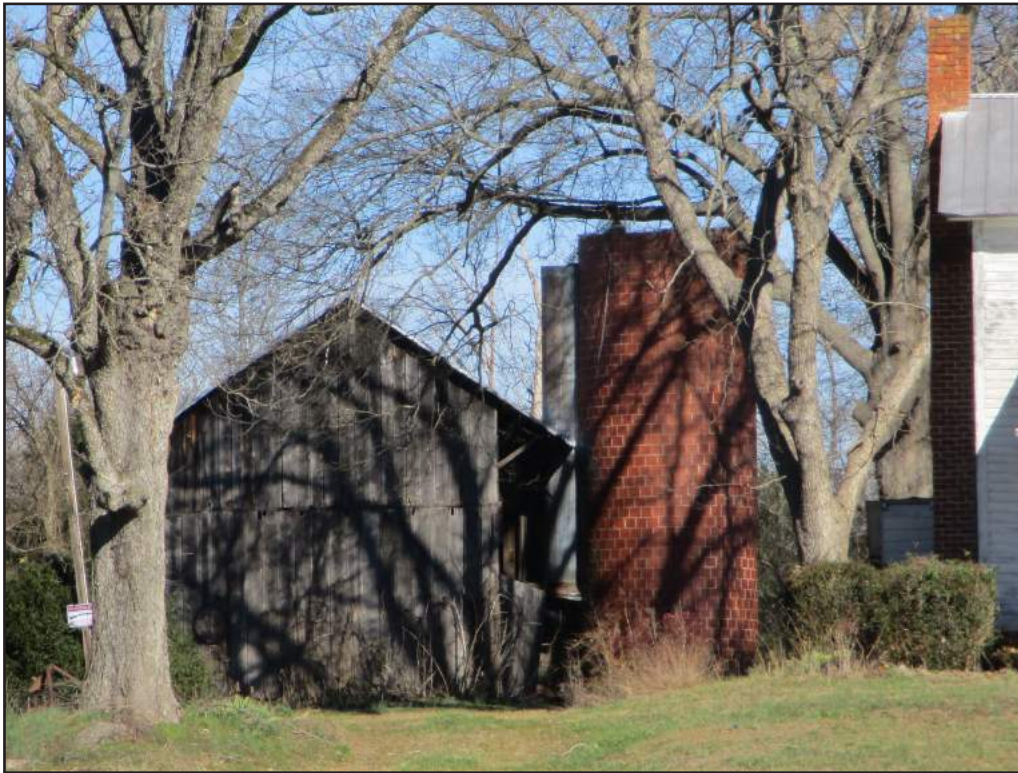
Photograph 7: One-and-a-half-story frame barn and glazed tile grain sile located northwest of the main dwelling.; looking north. (2017)

A one-and-a-half-story early twentieth-century barn is located northwest of the main dwelling and is only partially visible from the public right-of-way. The structure is clad in unfinished vertical wood siding and capped by a front-gable standing seam metal roof. A glazed tile grain silo is located directly to the west of the main dwelling and is partially attached to the one-and-a-half-story barn (Photograph 7).

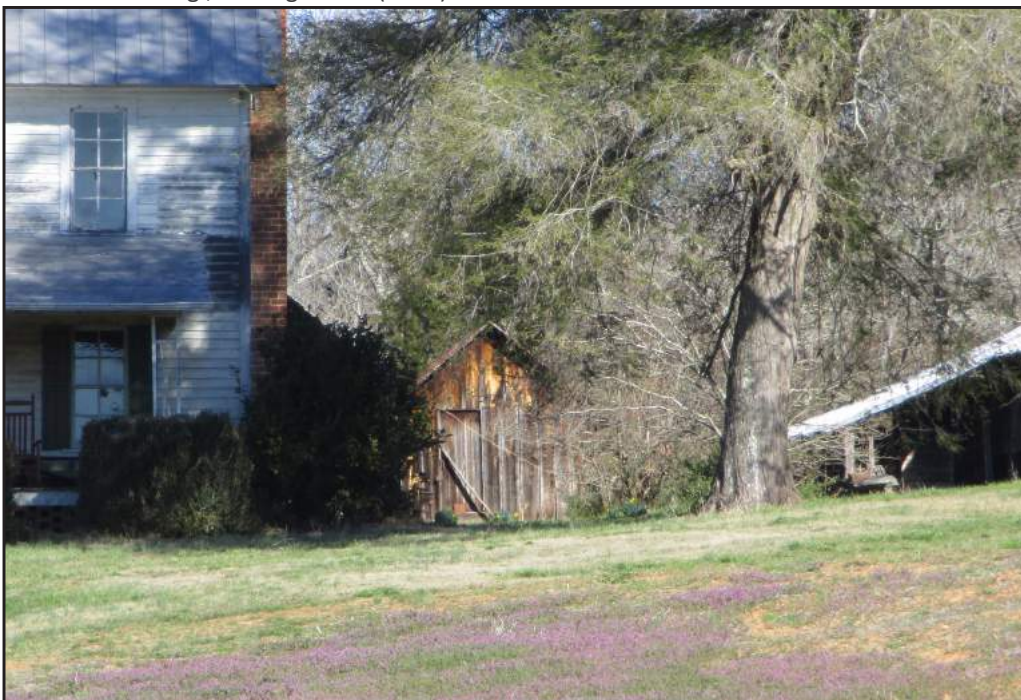
Photograph 8: Small, one-story frame shed located northeast of the house; looking north. (2017)

A one-story early to mid-twentieth-century shed is located directly northeast of the main dwelling and is only partially visible from the public right-of-way. The structure is clad in stained vertical wood siding and capped by a front-gable roof. The front entrance is located on the south-facing façade west of center (Photograph 8).

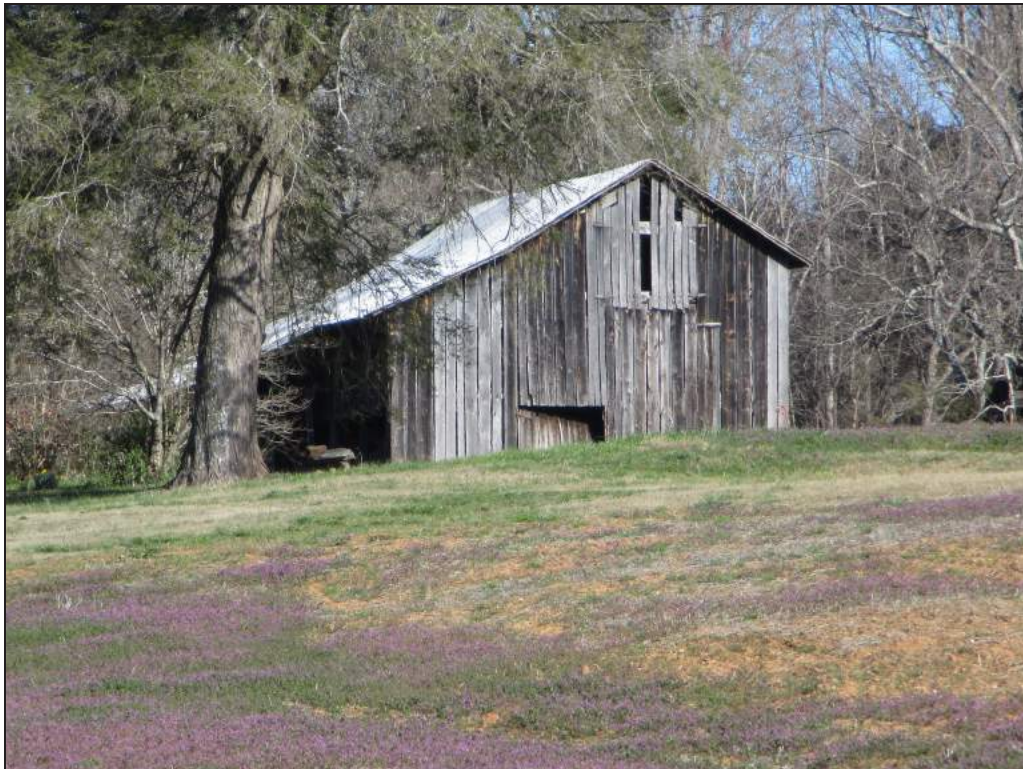
A one-and-a-half-story, early twentieth-century barn is located northeast of the main dwelling and is only partially visible from the public right-of-way. The structure is clad in vertical wood siding and is capped by a front-gable standing seam metal roof. A shed overhang is located off the west elevation (Photograph 9).

Photograph 9: One-and-a-half-story frame barn located northeast of the David C. Warlick House; looking northeast. (2017)

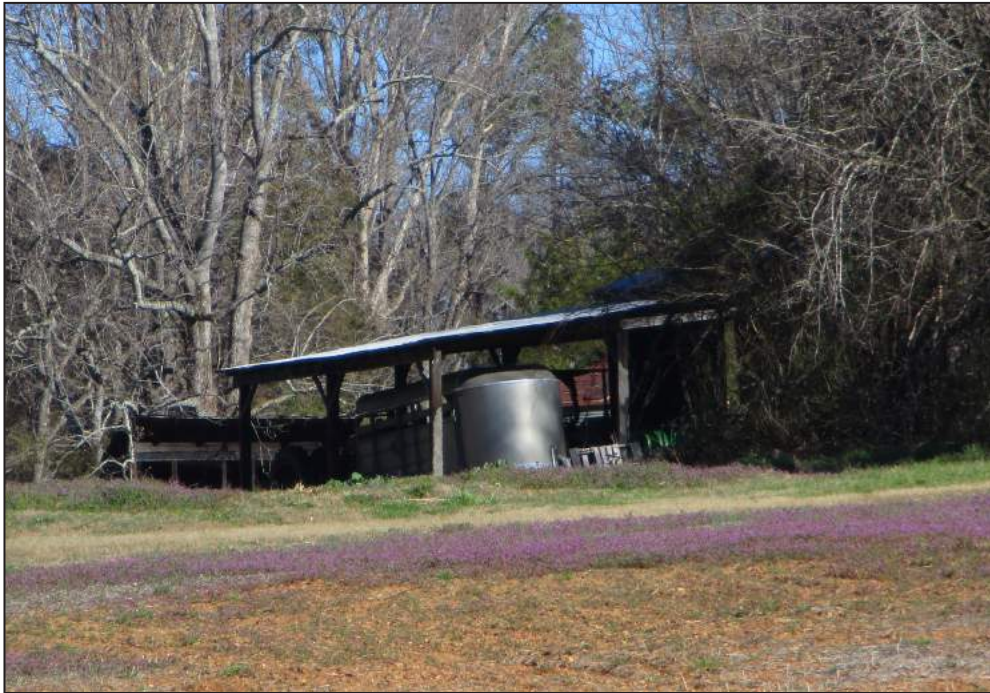
An early to mid-twentieth-century, one-story front-gable outbuilding is located northeast of the main dwelling and is almost completely obstructed by tree cover. A standing seam metal shed-roof overhang is located off of the east elevation. The overhang is supported by wood posts (Photograph 10).

Photograph 10: Shed-roof overhang of the one-story front-gable outbuilding located northeast of the David C. Warlick House; looking northeast. (2017)

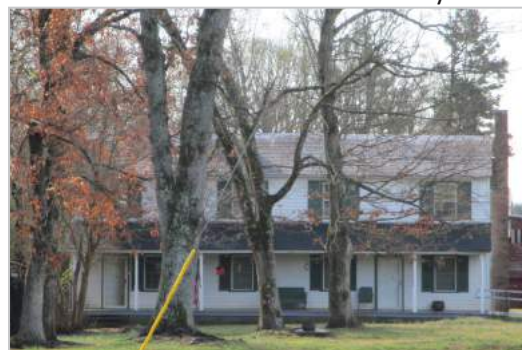
The National Register listed Andrew Seagle Farm, serves as an example of a mid to late nineteenth-century family farm in Lincoln County (Photograph 11). The property consists of a group of several farm buildings of simple, functional design, which was characteristic of many Lincoln County farms at the time.

Photograph 11: Andrew Seagle Farm. (2017)

Located 0.65 miles from the David C. Warlick Farmstead, the Seagle Farm complex features a mid-nineteenth century frame dwelling. The building was constructed in two sections a few years apart. Both sections were three bays wide, one room deep, and two-stories high. “The house and entire complex speaks of a no-nonsense approach to building with an eye to utility, independence and function.” All of this was accomplished in a neat and well-crafted manner characteristic of German design. (Thopkins and Suttlemyre 1975: 7-2). As described in the National Register Nomination for the Andrew Seagle Farm:

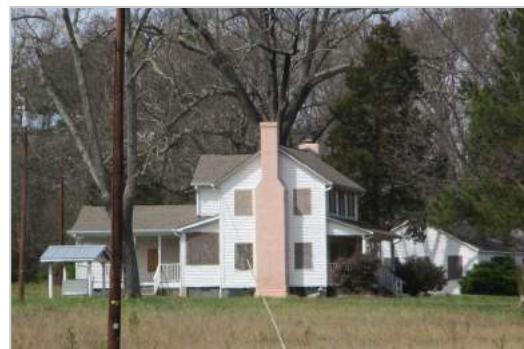
The National Register Listed Edward M. Rozzell House, constructed c. 1880, serves as a relatively unaltered example of a traditional postbellum farmhouse (Photograph 12). Located in northwest Mecklenburg County, approximately 30 miles from the David C. Warlick Farmstead, the Edward M. Rozzell House is a well-preserved example of the two-story, I-house form that is representative of the late nineteenth-century lives of rural residents of the Piedmont region. As described in the National Register Nomination for the Edward M. Rozzell House,

With its symmetrical three-bay wide façade, brick end chimneys, and rear kitchen ell, the side-gabled Edward M. Rozzell House exhibits many of the characteristics associated with nineteenth-century I-houses in Mecklenburg County. It is noteworthy among the county's dwindling stock of late nineteenth-century farmhouses due to its rural setting and the integrity of its distinctive architectural features (Gray 2003: 8-5).

Photograph 12: Edward M. Rozzell House. (2017)

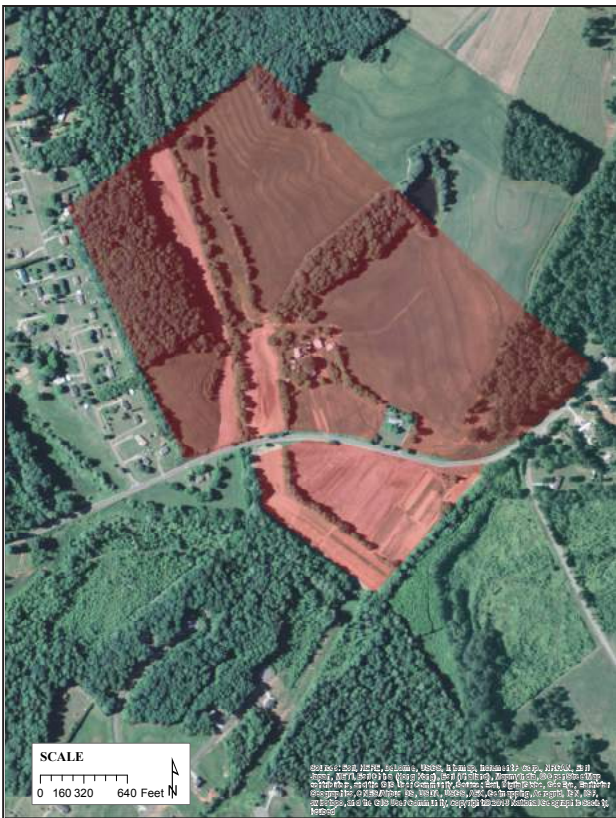
Figure 5: Existing Boundaries of the David C. Warlick Property (Source: ESRI and Lincoln County GIS)

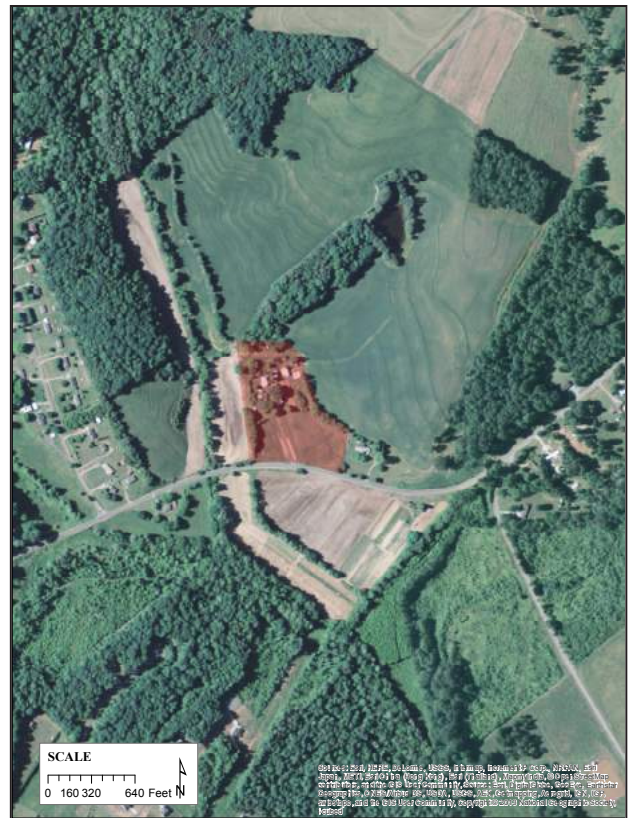
The proposed National Register Boundary for the David C. Warlick Farmstead encompasses the approximately 12 acre area around the dwelling as well as its associated outbuildings and is smaller than the legal parcel boundaries, which encompasses 111 acres. The proposed southeastern boundary follows the legal parcel boundary. The proposed southern boundary is Reepsville Road and the proposed western boundary is Tanyard Creek. The proposed northern and northeastern boundaries correspond with the northernmost outbuilding where the land changes to forest and agricultural fields.

Figure 6: Proposed boundaries of the David C. Warlick Property (Source: ESRI)
