SUBJECT: Historic Structures Survey Report for the Replacement of Bridge 186 over Unnamed Creek on SR 2568 (Rimertown Road), Rowan County, ER 17-0766

**EVALUATION OF YOST-KETNER FARM (RW2172)
640 RIMERTOWN ROAD
REPLACEMENT OF BRIDGE NO.186 ON SR 2568 (RIMERTOWN ROAD)
ROWAN COUNTY, NORTH CAROLINA**

WBS# 17BP.9.R.14

ESI Project Number AR15030.03

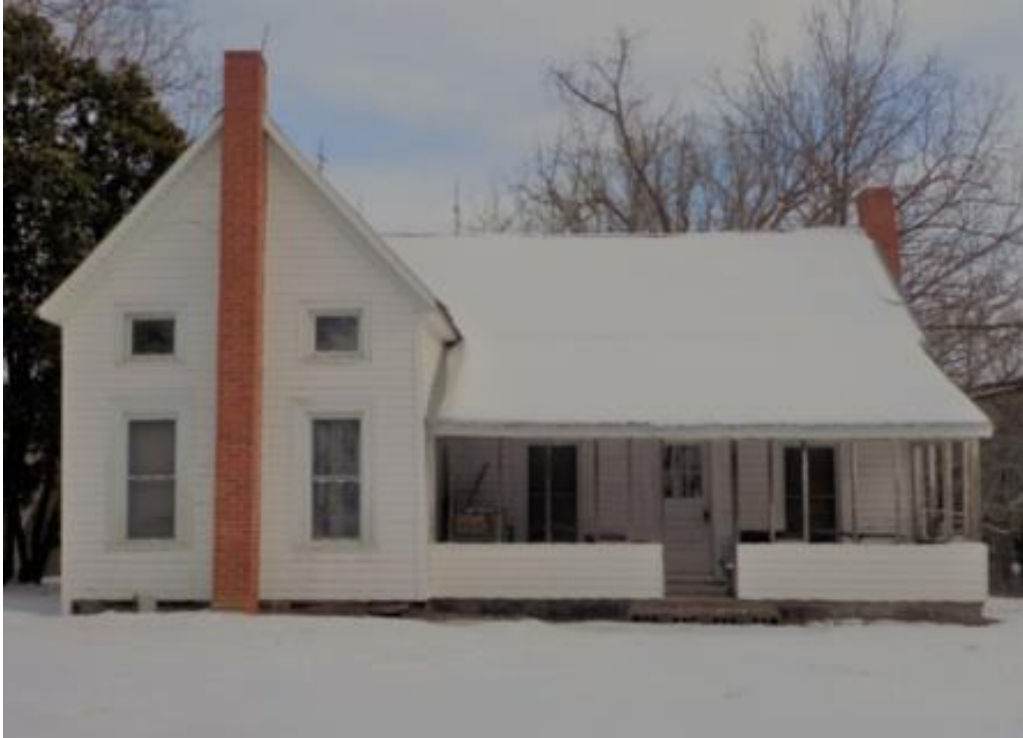
c.1890s house at Yost-Ketner Farm, (RW2172) façade and front yard, looking east

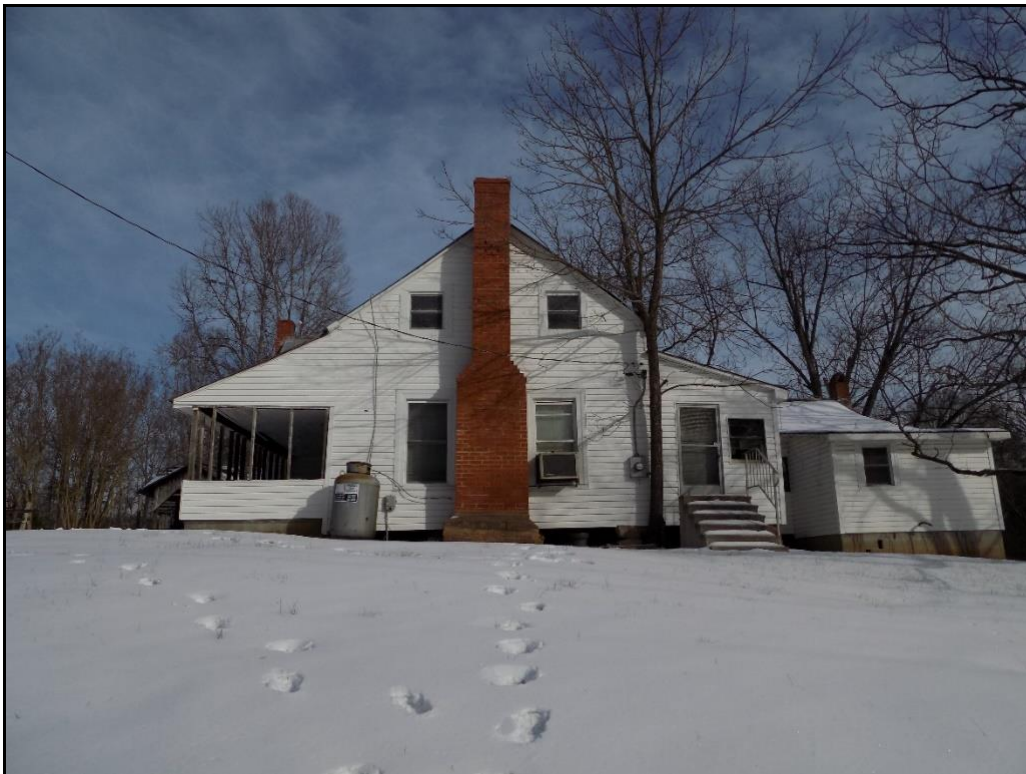
South elevation of main house

The one-and-a-half story with unfinished attic frame farm house was constructed c. late 1890s and rests on granite piers and a stacked rock foundation with deteriorated heavy wood sill and floor joists. The exterior of the home has been covered with vinyl siding with a similar profile (German/drop cove siding) to the original wood siding on the facade. The partially enclosed front porch runs half the length of the façade and has a shed roof with modern 2x4 wood supports and screening atop brick piers with a concrete floor and step. A moderately pitched cross gabled roof with 5-v crimp metal tops the building with three brick chimneys interrupting the front (west), side (south) and rear (east) gabled elevations. The ridgeline of the roof hosts five connecting metal lightning rods with milk-glass balls. Joints below the shoulder of the chimney on the south elevation have been pointed with a cement mortar and are in good condition; however, portions of the neck look as if to have a higher lime content and need repointing. The other chimneys appear to have all cement mortar.

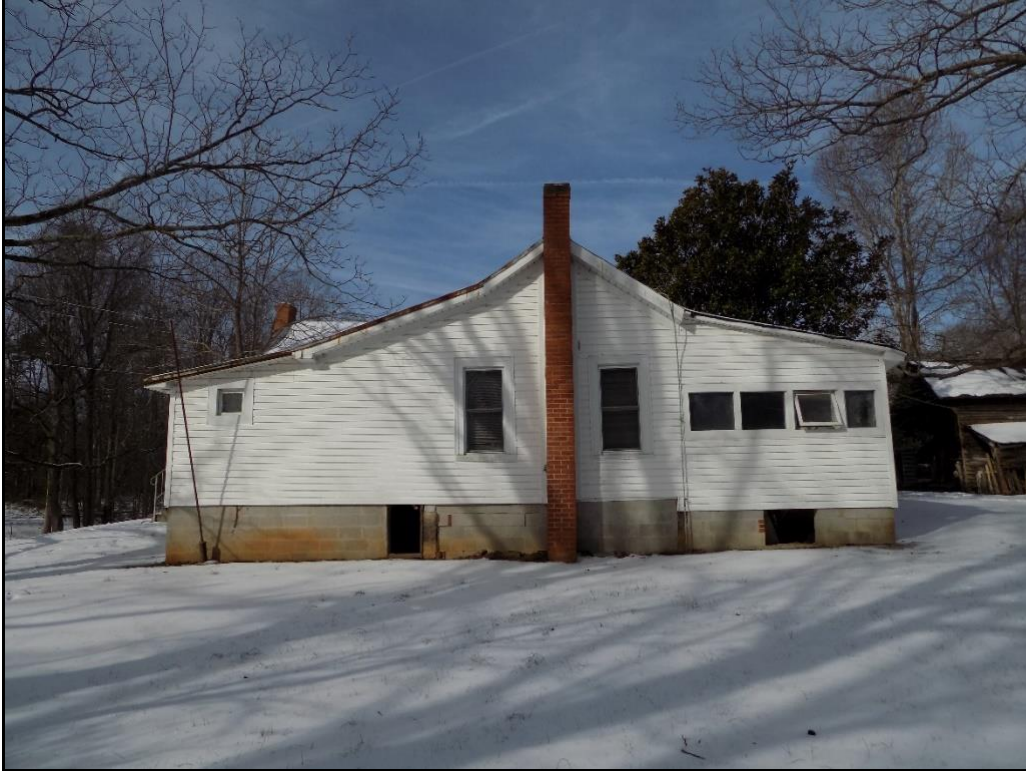
Rear (east) elevation of main house

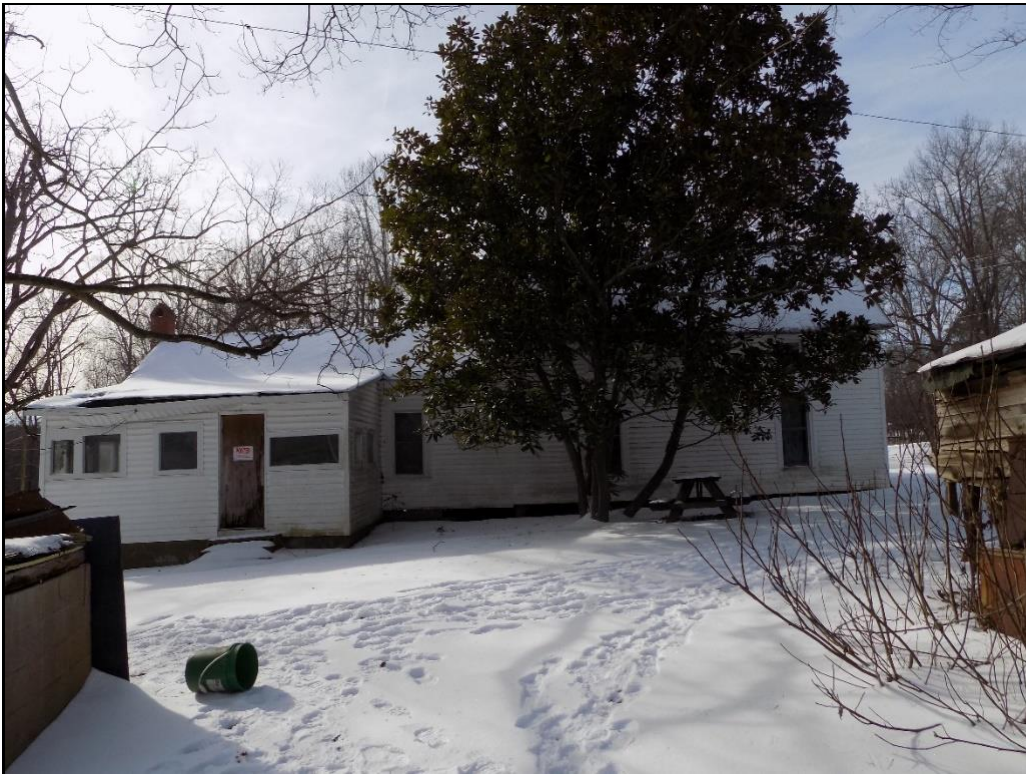
North elevation of main house

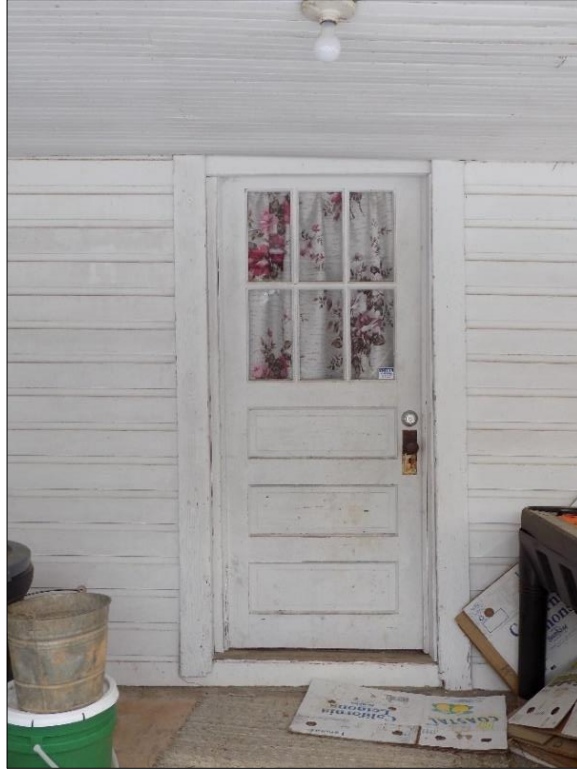
Single 3/panel, 6/light wood door main entry with drop siding and bead board ceiling

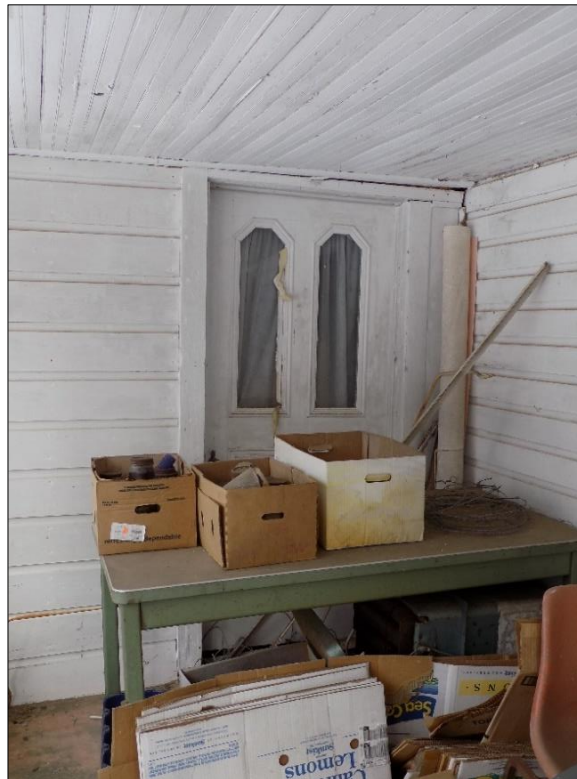
3/panel, 2/light wood door with molded trim; mix-matched drop siding

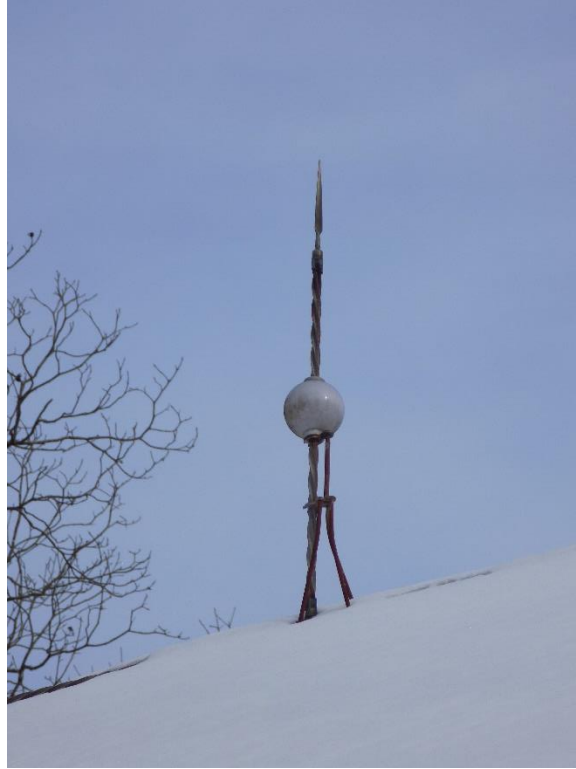
Lightning rod with glass ball located on top of Yost-Ketner home and log barn

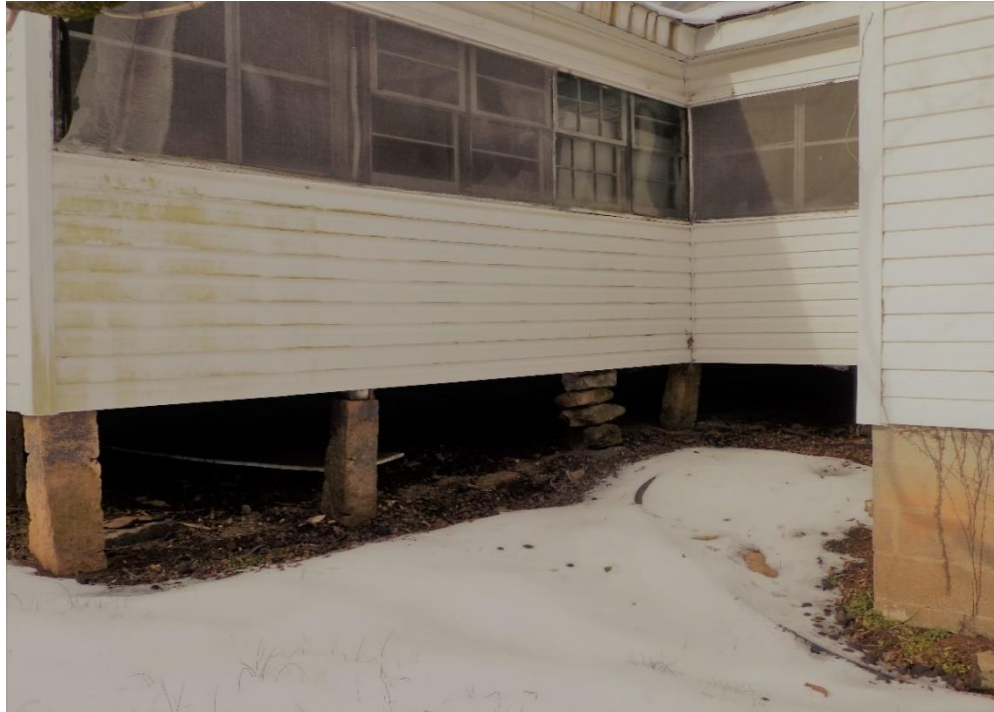
Granite pier foundation; rear shed porch

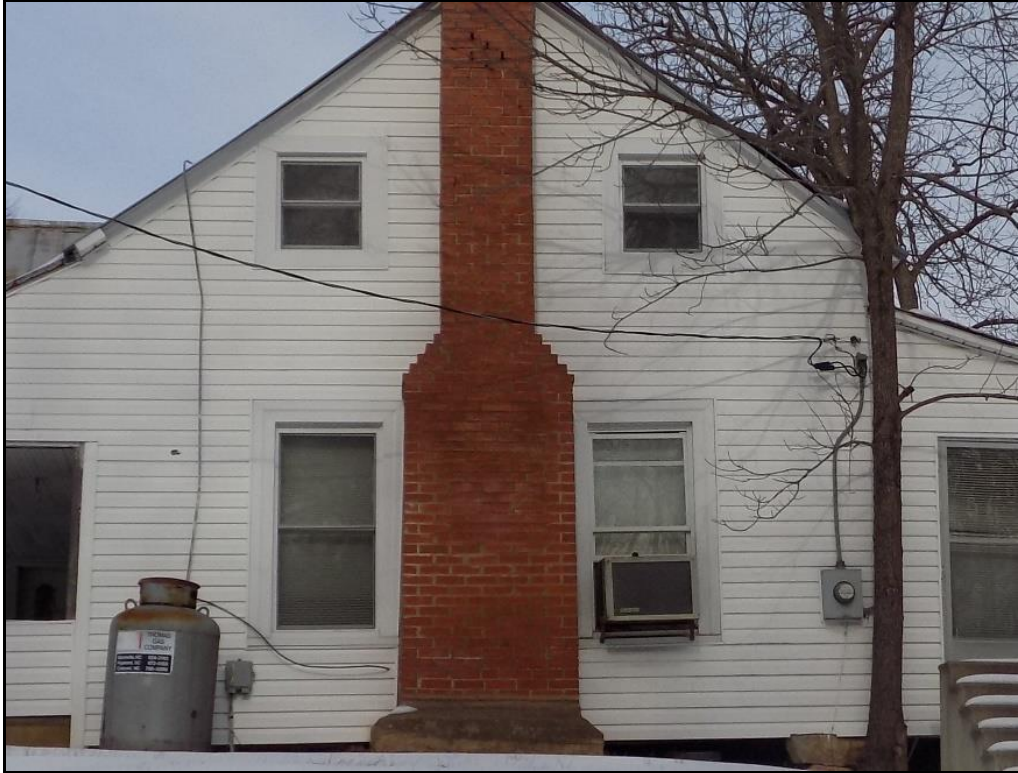
One-over-one replacement sash windows

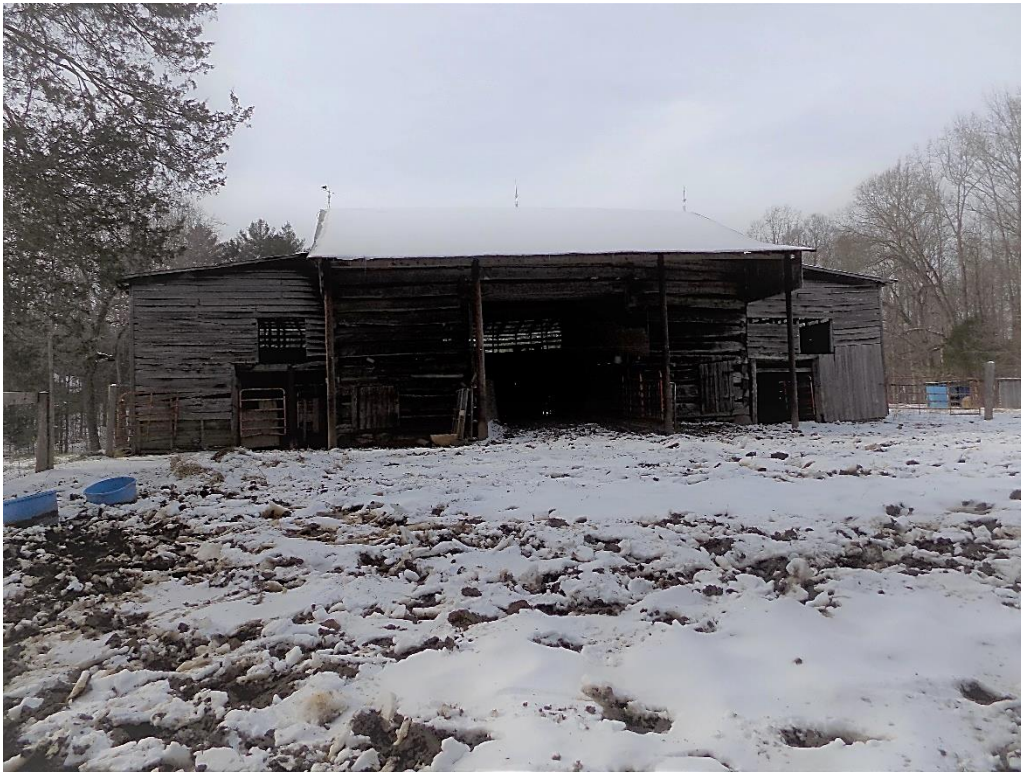
The robust double-crib log barn is the largest structure on the property and is typical of the dominant form found in the Piedmont during the nineteenth century. Two cribs flank a central passageway and a U-shaped addition wraps around the south, west and north sides. A side-gabled roof tops the central portion of the barn extending out over the front of the barn and is supported by round wood posts; the U-shaped addition has a shed roof, and the exterior is clad in wide plank horizontal wood siding and corner boards. The barn is still being used to house cattle and store hay and feed; its large wood logs lack chinking and are joined at the corners with half dovetail joinery. It is deteriorating but in fair condition.

Front of the double-crib barn looking west

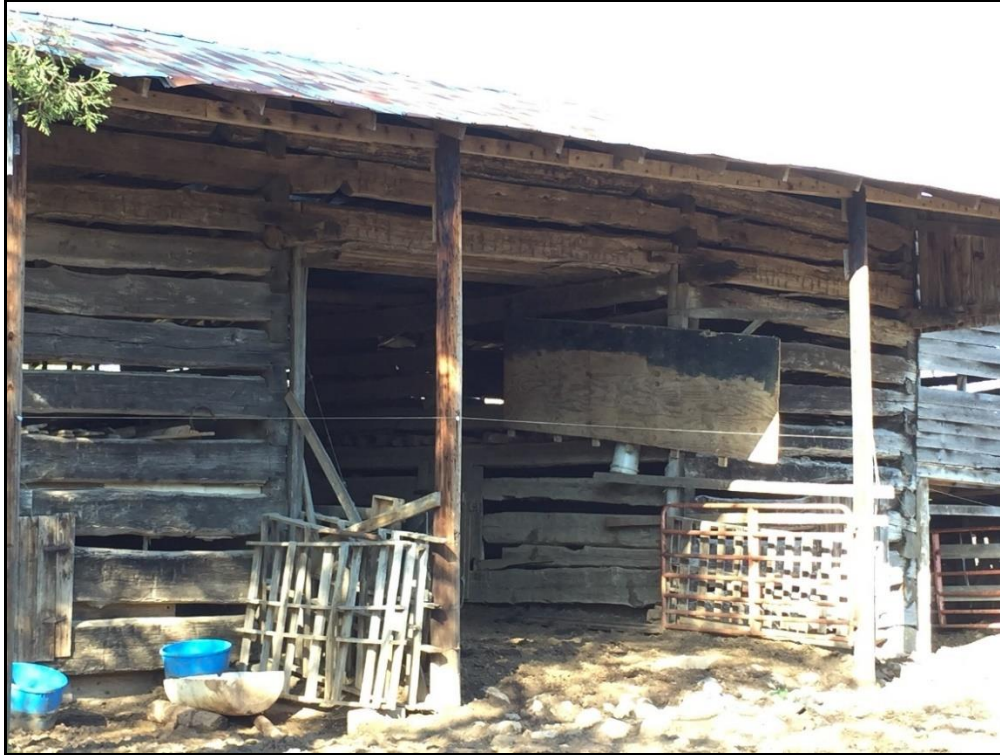
Central section of original portion of barn

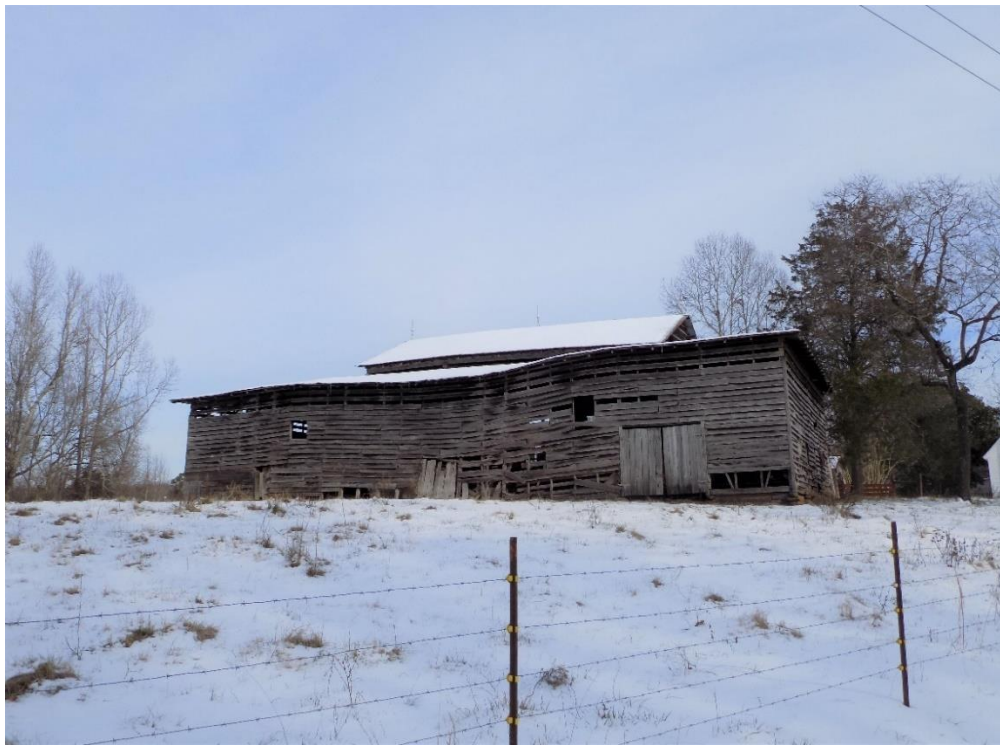
Rear (west) elevation of double-crib log barn

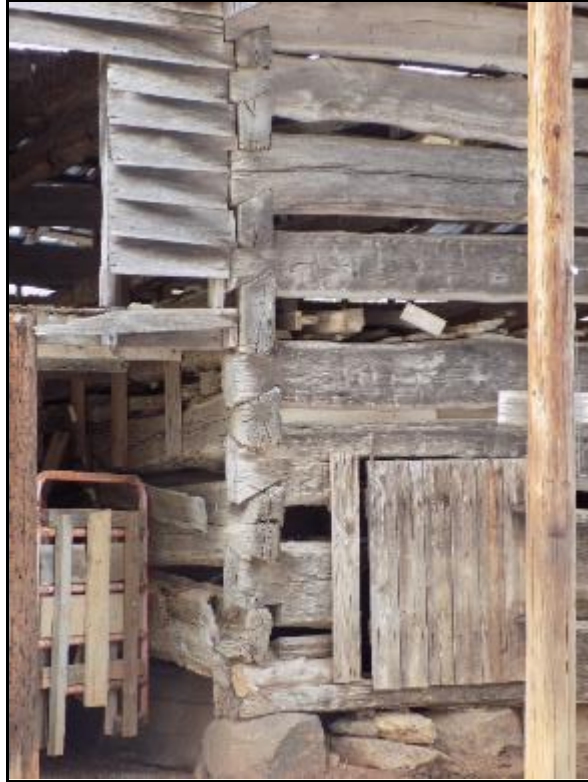
Half dovetail joint detail on double-crib log barn

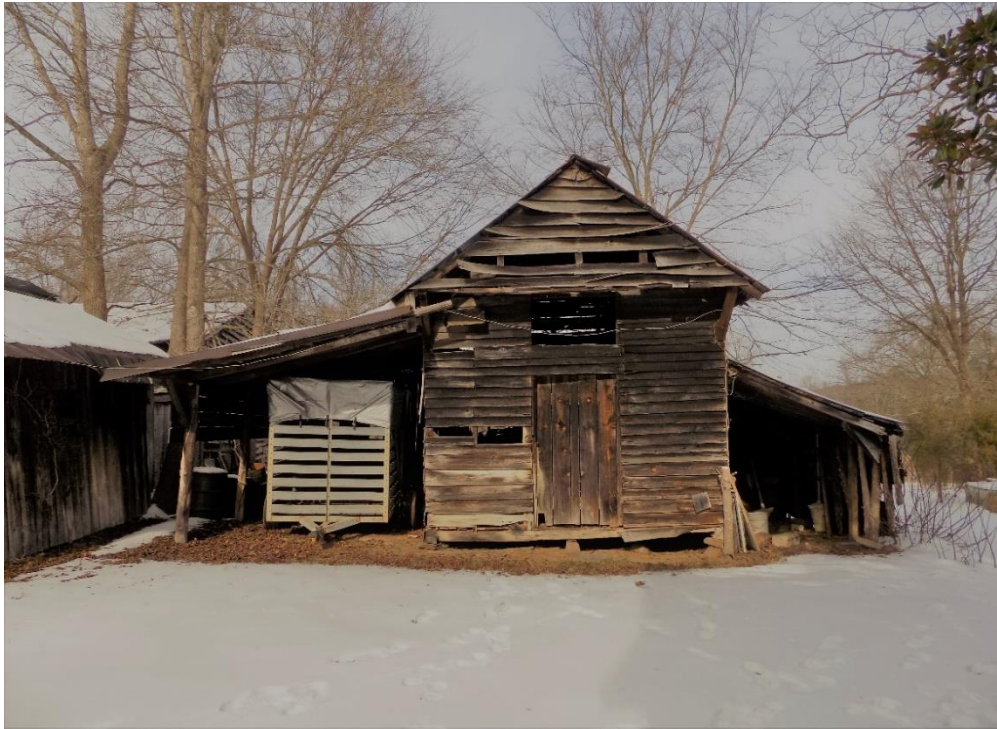
The construction date for this shed is unknown; however, the current owner of the property recalls the structure being present as long as she can remember and speculates the shed would have been constructed at the same time or shortly after the home. The shed is a gabled front single story with loft structure flanked by sheds for buggy or trailer. The loft extends over the single entry; the exterior is clad with wood siding and roof is topped with 5-v crimp sheet metal. It is deteriorating and in poor condition.

Tool shed looking north

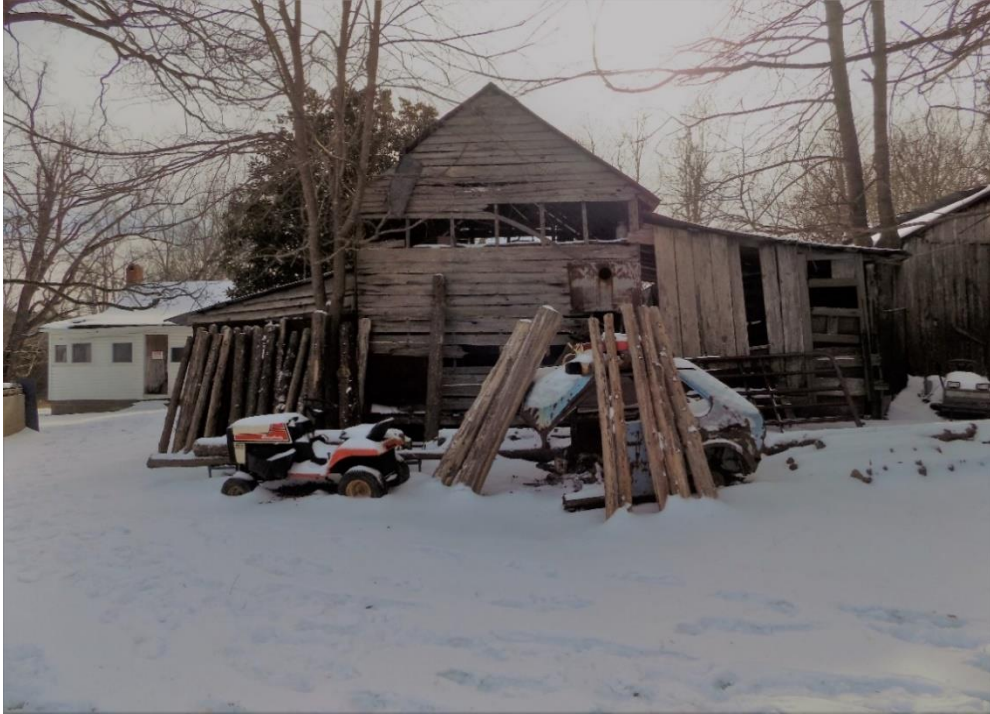
Rear elevation of tool shed, looking south

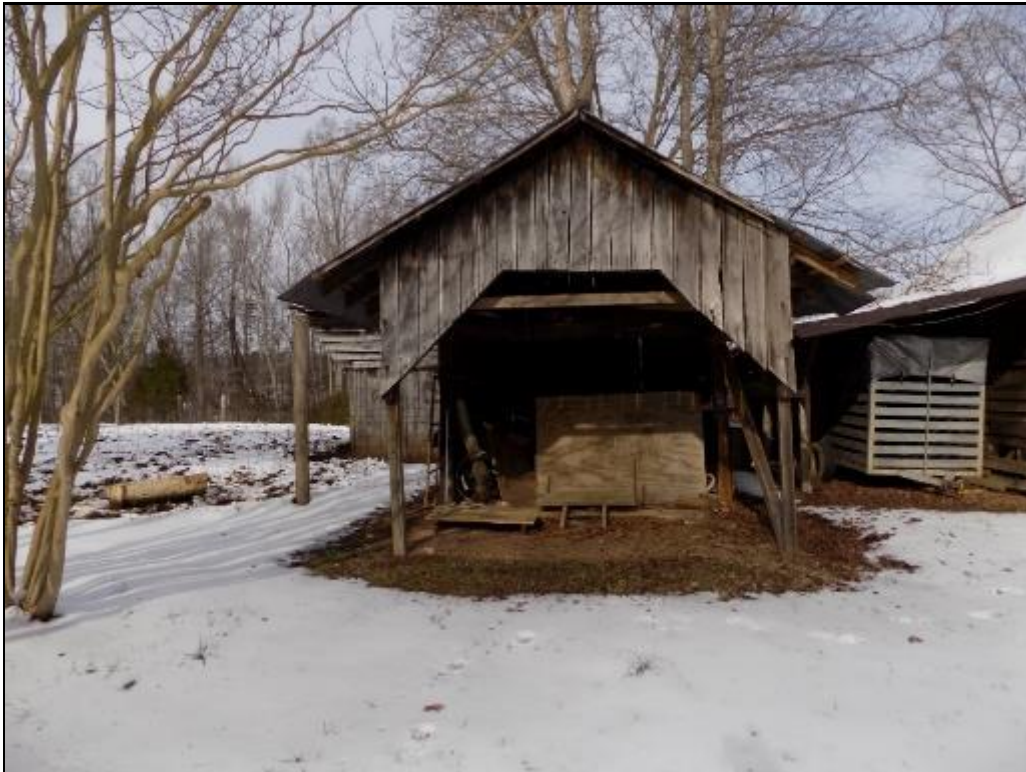
A wood frame single-car shed is located to the north of the main house and has a low pitched front gable roof covered with sheet metal. The construction date for this shed is unknown; however, board and batten detailing and the general appearance suggests 1920s or 1930s construction. There is an enclosed section at the rear of the shed that is clad in board-and-batten on three sides and contains two single six-light windows; the front portion of the shed is open. The car shed is in fair condition.

Car shed looking north with tool shed to the right (east)

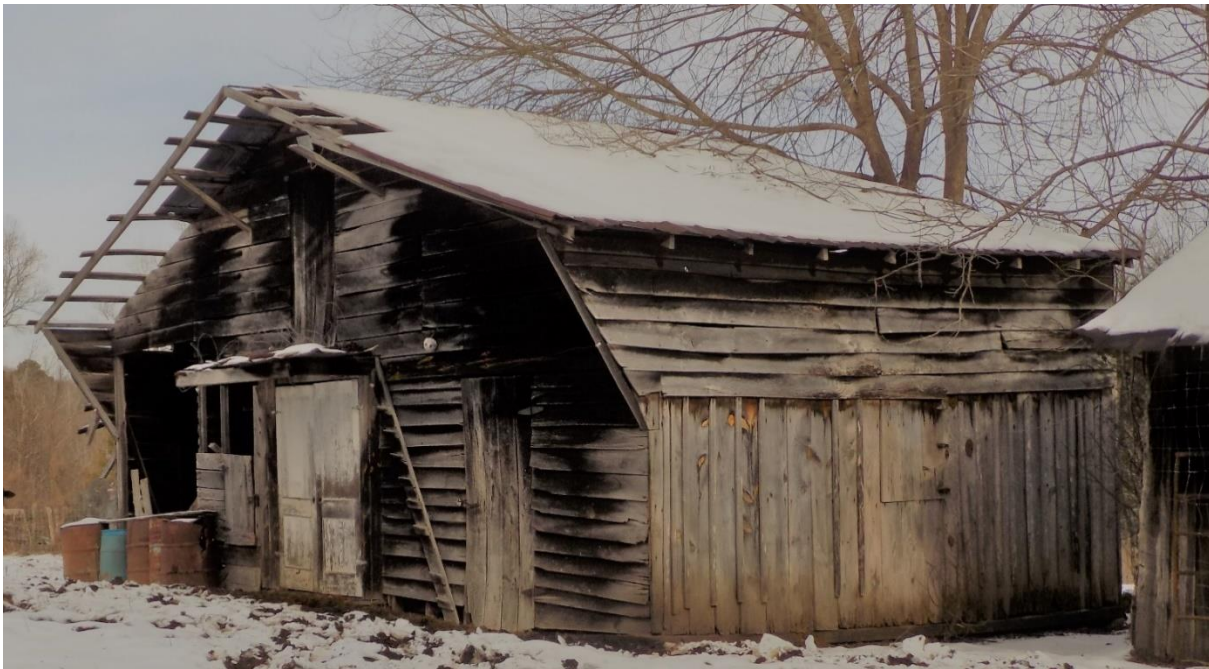
The date of construction for the granary is unknown; however, it contains the same board-and-batten detailing as the car shed and could have been built in the 1920s or 1930s. According to the current owner, the previous owners stored potatoes in the barn as well grain and corn for the livestock. The two story, wood frame structure has a rectangular footprint, is clad with a variety of wood siding (wide plank weather board and board-and-batten) and has a low pitch gabled roof covered with 5-v crimp sheet metal that extends over the facade. A set of paneled wood doors has been added to the centrally located entrance; other single door entrances maintain the original vertical wood-plank doors on metal strap hinges. The granary is still in use but is in fair to poor condition.

Granary located to the north of the car shed, looking north

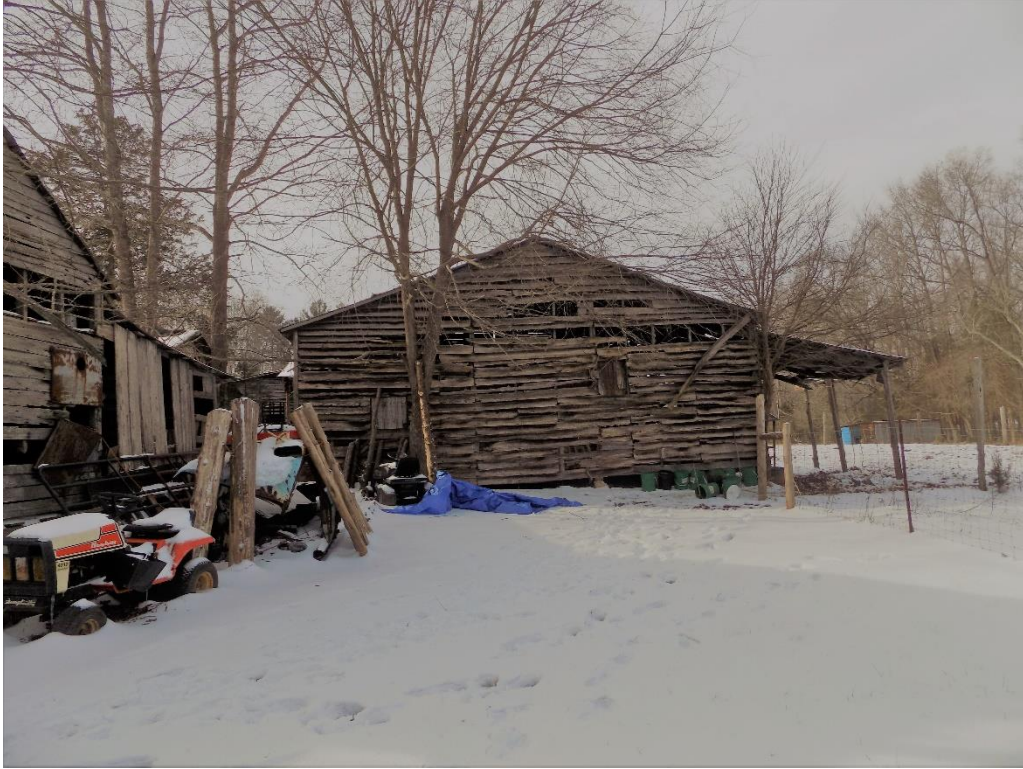
Rear elevation of the granary, looking west

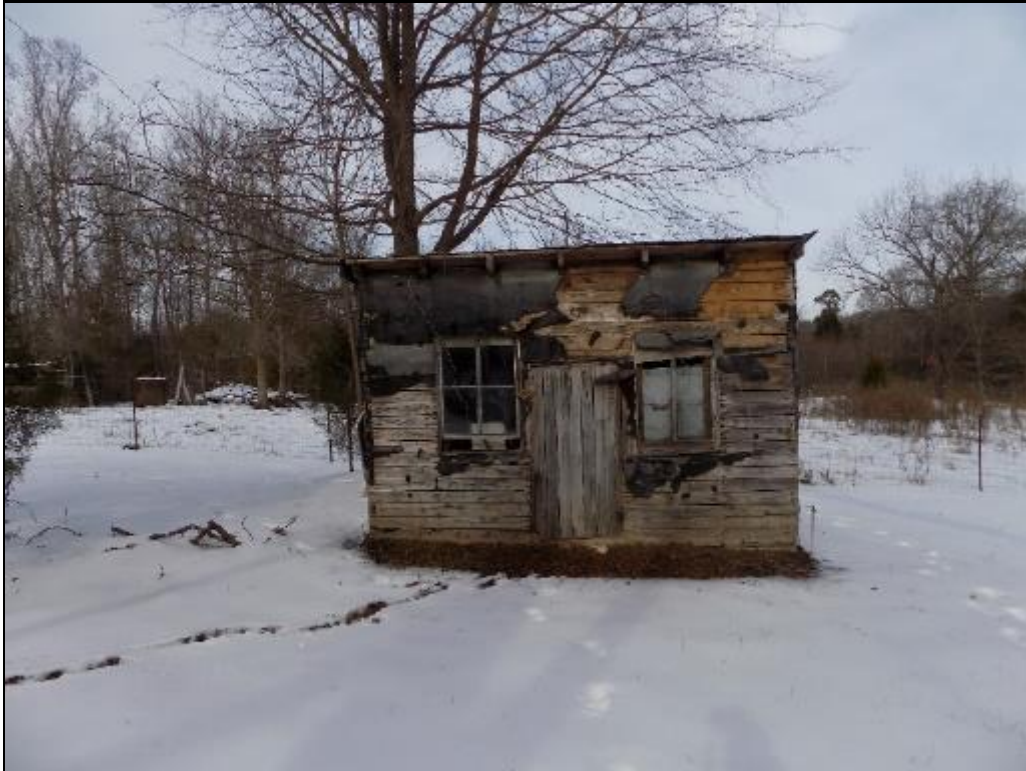
The chicken coop is located to the north of the house and appears to be newer construction. It is slightly rectangular in plan, with a shed roof and horizontal shiplap siding that was once covered with tar paper or asphalt shingle. A symmetrical façade has a small vertical wood plank door flanked by square openings: one has chicken wire and a two-light wood window sash, the other has a fixed four-light wood window. The building is currently used for storing multiple six-over-six wood sashes among other random objects. There is a large hole in the west wall of the building and it is in very poor to a ruinous state.

Chicken coop located north of the house, looking north

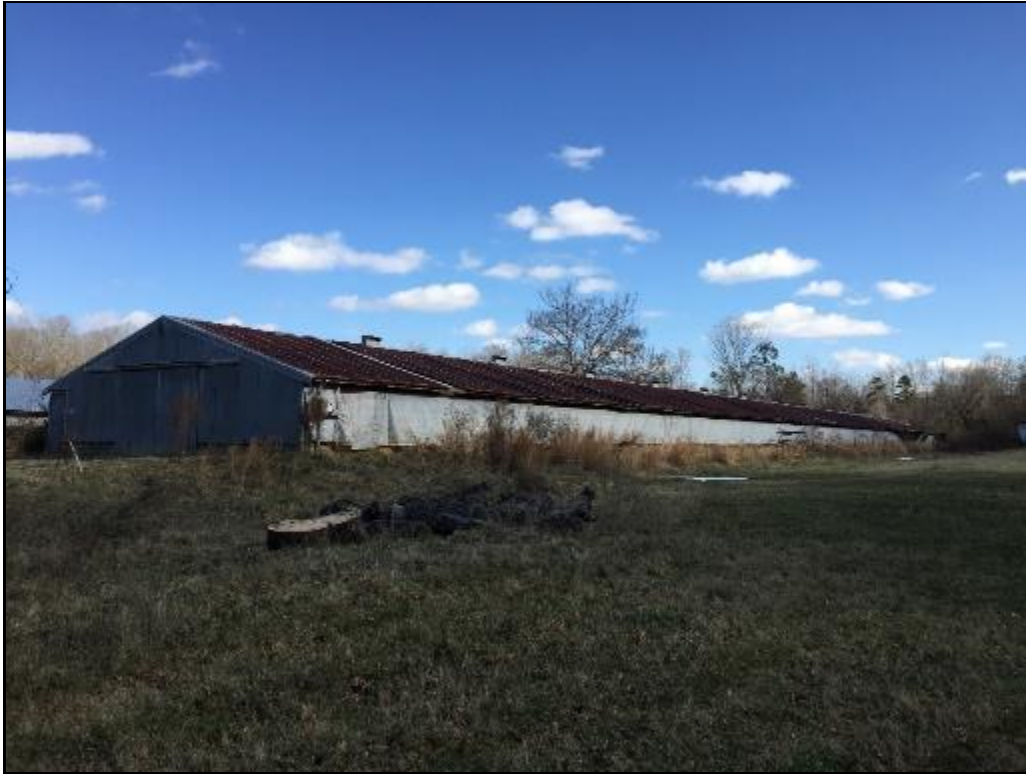
There are two metal frame, partially enclosed chicken houses measuring approximately 50' x 400' situated on the northeast portion of the property. Each building has a gabled roof topped with corrugated sheet metal and is enclosed at each end with vertical sheet metal; large metal clad track sliding doors and a single pedestrian door allow access to the interior. The north and south elevations of the buildings are only partially enclosed with horizontal wood plank knee walls and fabric sheeting. The buildings were utilized for poultry farming by the Faggart Family from the 1980s through the early 2000s and are currently used for storing firewood and equipment.

1980s chicken houses, looking east

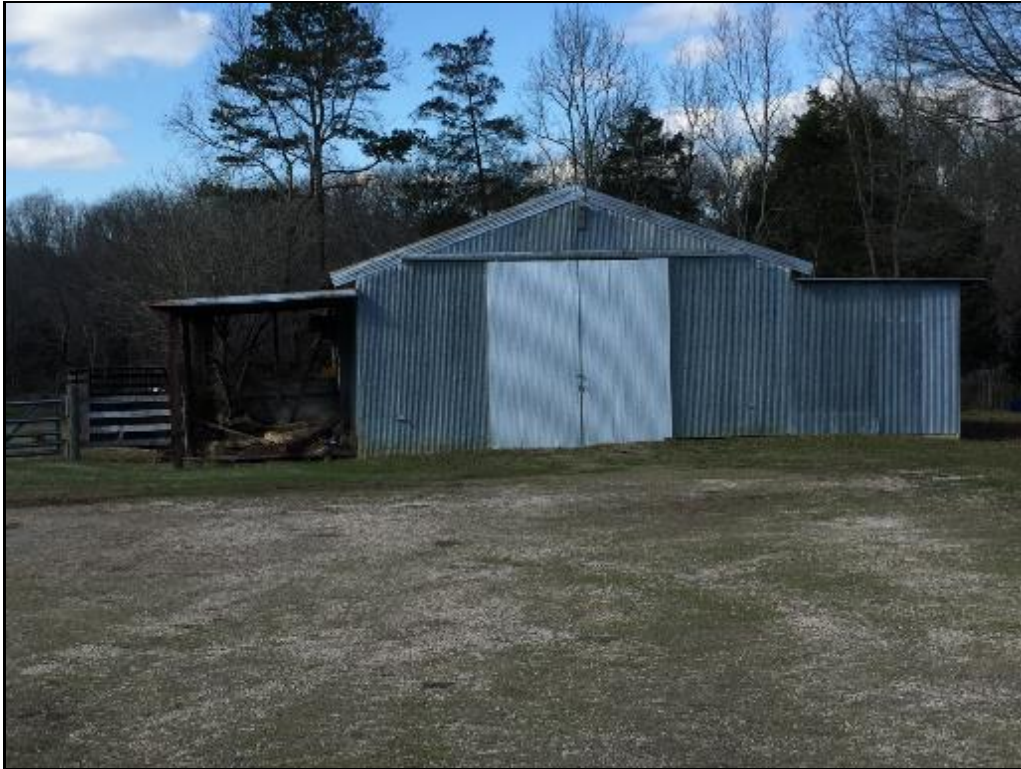
The owner's son recalled that this sheet metal clad shed was constructed around the same time as the two chicken houses and was used primarily for keeping shavings that they would put down on the floors for the chickens. The building is roughly 40' x 40' with a gabled roof covered with corrugated sheet metal; it has large sliding doors and one-over-one wood sash windows. The main structure has been supplemented by shed additions to the north, south and west elevations. Currently, the shed is used for storage of wood and farm-related equipment.

Shavings and tool shed used to support chicken houses, looking west

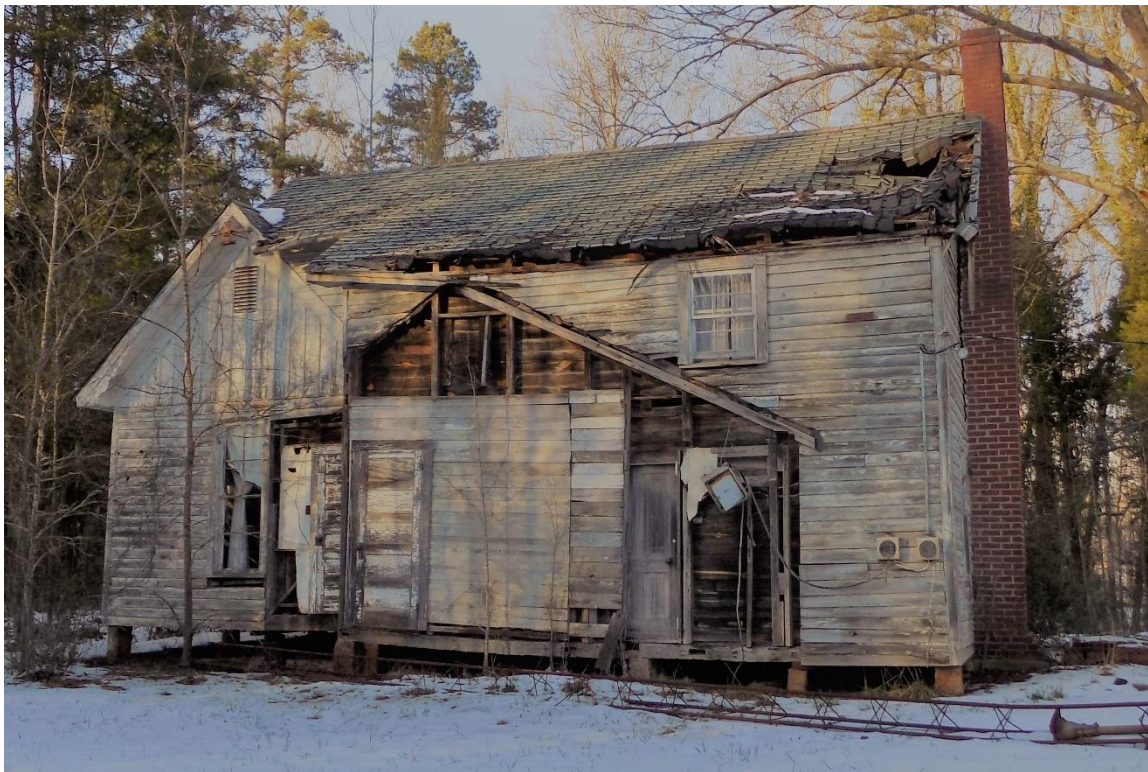
Mr. Yost served as the Post Master from 1892 to 1906 and the building that served as the post office is now located on the property approximately 20 yards in front of the home. The home is in fair to poor condition due to water infiltration from roof damage; however, it is relatively structurally sound and retains much of the original detailing. The home is situated on top of a slight hill in a wooded lot. While scrub oaks and brambles have been allowed to grow up around the old post office, landscaping around the house has been kept intact.

T. M. Yost house, rear elevation, looking north

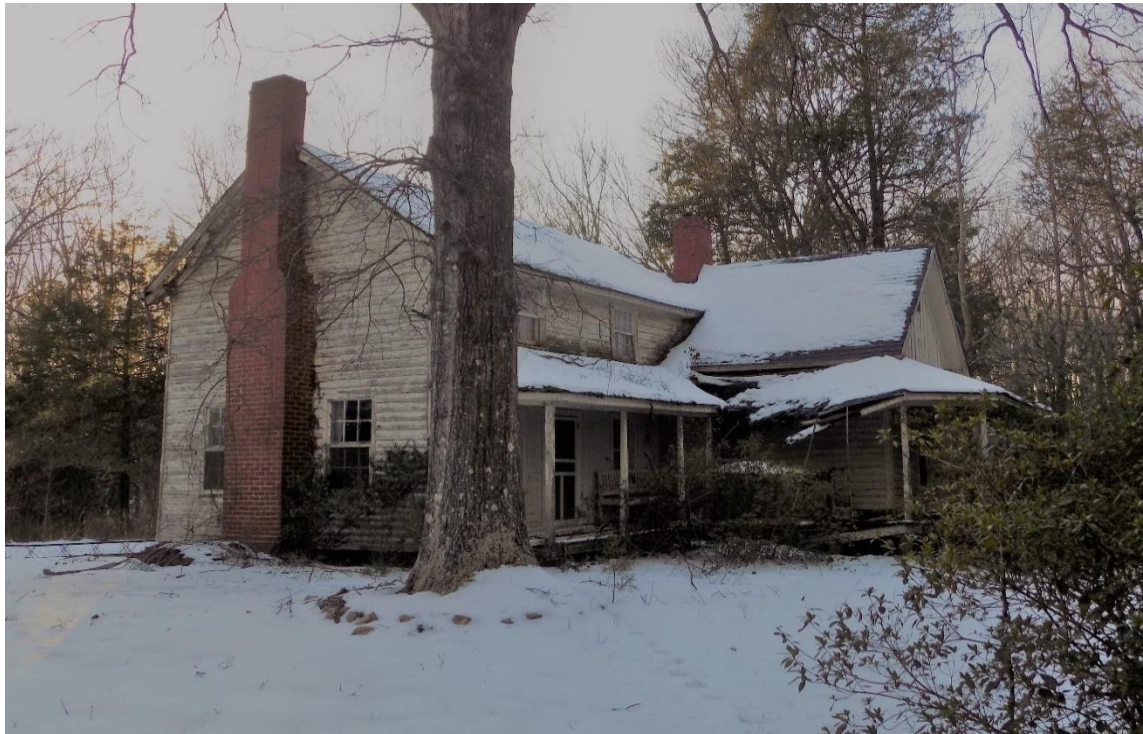
The Thornton Manles “Manly” Yost house was constructed between 1880 and 1890 as a single room framed house with a sleeping loft. Interior walls were added later. The original portion of the home was a symmetrical three bay wood frame house with centrally located single entry, moderately pitched side gable roofline with a single shoulder brick chimney on the south elevation and single six-over-six wood sash windows. The home is covered in wood lap siding with butt-joined corner boards which are created by turning one strip of wood on its side and extending perpendicularly away from the structure. The home rests on a stone pier foundation and exhibits an assortment of wood trim detailing, including corner boards, fascia boards, and board and batten in the gabled ends. Information provided by the current property owner reveals that the front gabled addition was once a doctor’s office in Concord and was moved to the property and connected to the original portion of the home. This portion of the home is clad with the same lap siding on its first story and board-and-batten siding in the half-story gabled ends, with narrow single four-over-four wood sash windows and centrally located brick chimney. A second addition on the rear of the house has since been taken down. An L-shaped porch with hipped roof frames the front of the house; it sits on a stacked rock foundation and has both square and slightly tapered round wood supports.

T. M. Yost house c.1880-1890, looking west

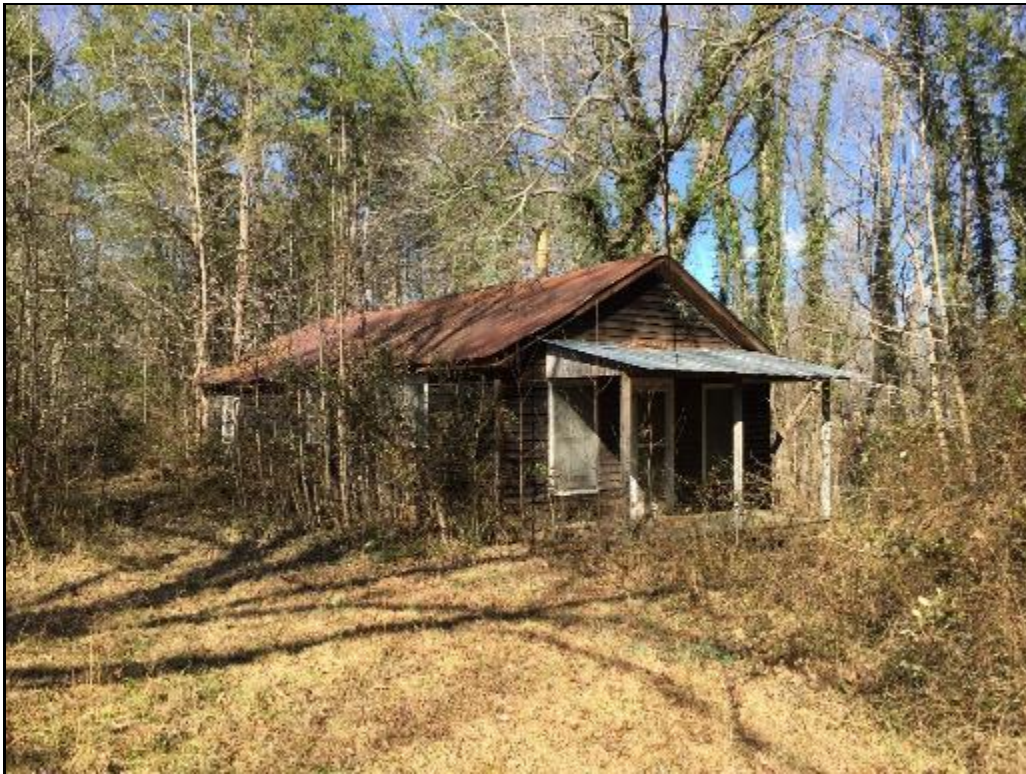
The Yost Post Office located on Annie Faggart's property is a modest one-story wood frame building with gabled roof and shed porch. The rectangular building has a single wood door centrally located on the façade, flanked by two-over-two wood sash windows. The exterior finish is wood weatherboard and the rear elevation has been replaced with pressboard-plywood. Per the current owner the post office/store was altered for use as a summer home for visiting relatives who would come to see T. M. Yost or the Ketner family. The building is currently vacant. Overall the building is in fair condition.

c.1892 Yost Post Office and Store, looking northwest

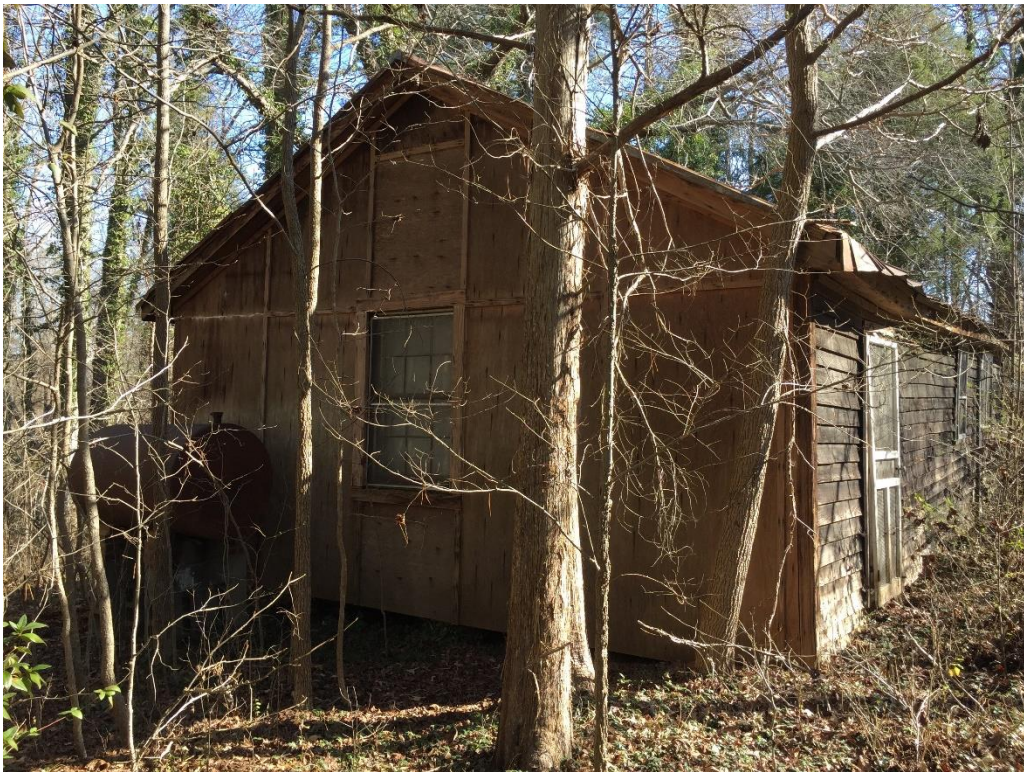
Rear elevation of post office with replacement siding, looking east

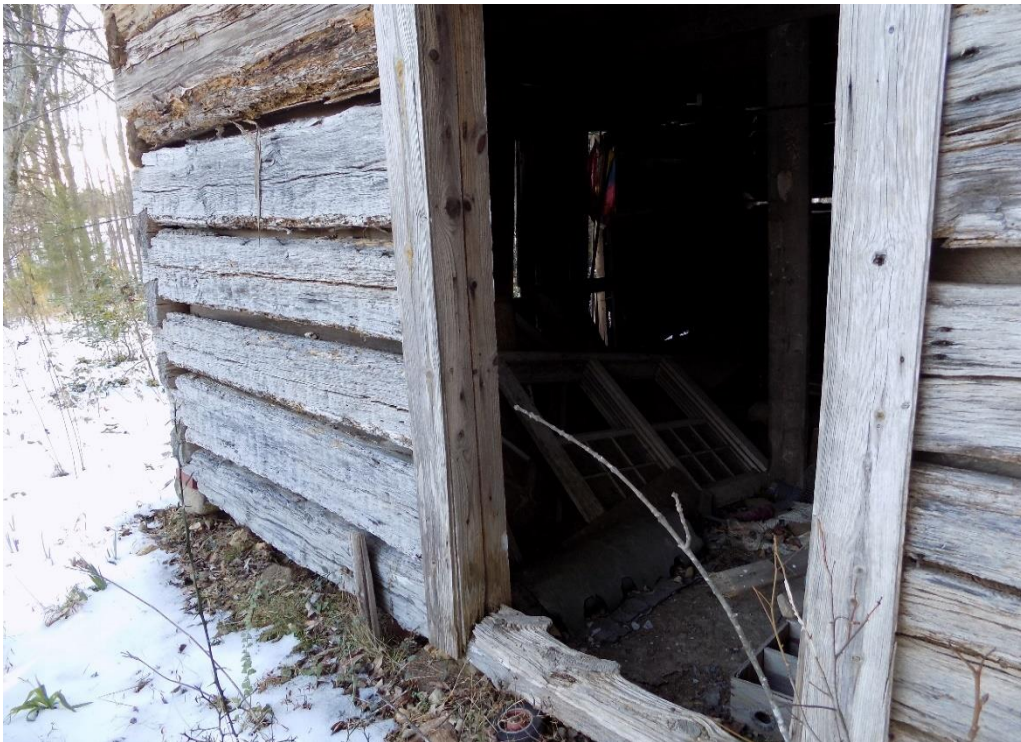
Front entry of Sloop School

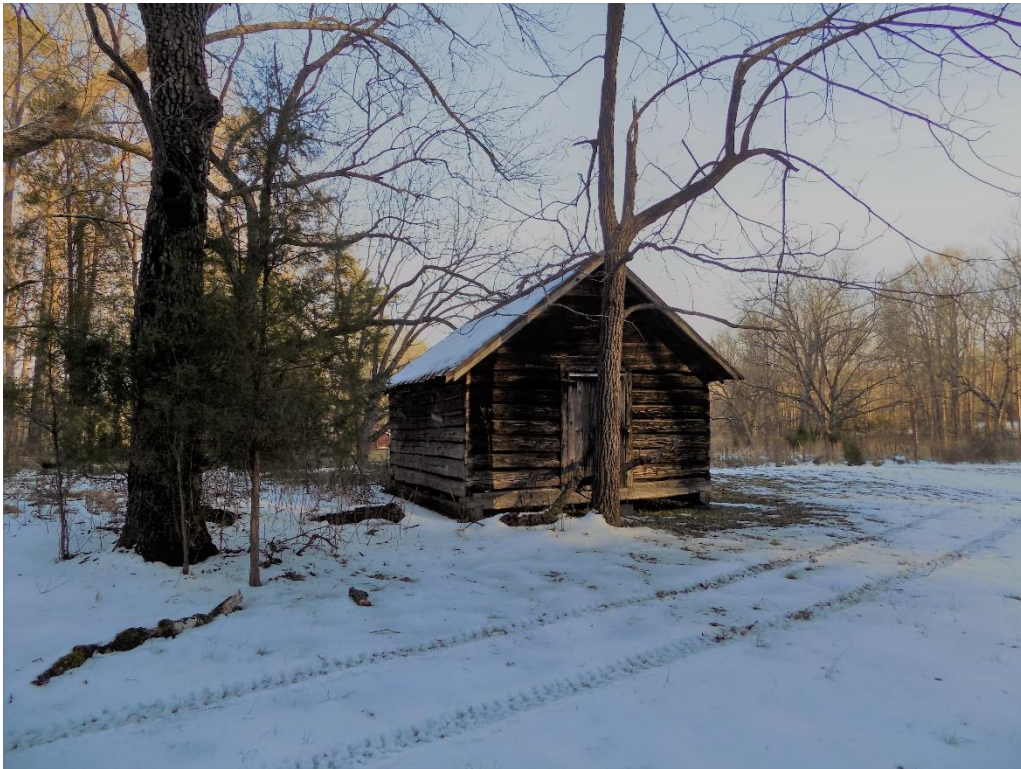
According to the owner, this small log shed was used for canning and storing canned goods by the previous owner. The exact year of construction is unknown; however, it is thought to have been constructed around the same time as the T. M. Yost home. The small log building is located behind the T. M. Yost house and west of Annie Faggart's home. The building rests on a stone foundation and its logs are united at each corner by half-dovetail joints; there is a single wood door entry and the building is capped by a gabled roof with a slight overhang.

Log canning shed on southern parcel, looking east
