SUBJECT: Historic Structures Survey Report for the Replacement of Bridge 186 over Unnamed Creek on SR 2568 (Rimertown Road), Rowan County, ER 17-0766

**EVALUATION OF YOST-KETNER FARM (RW2172)
640 RIMERTOWN ROAD
REPLACEMENT OF BRIDGE NO.186 ON SR 2568 (RIMERTOWN ROAD)
ROWAN COUNTY, NORTH CAROLINA**

WBS# 17BP.9.R.14

ESI Project Number AR15030.03

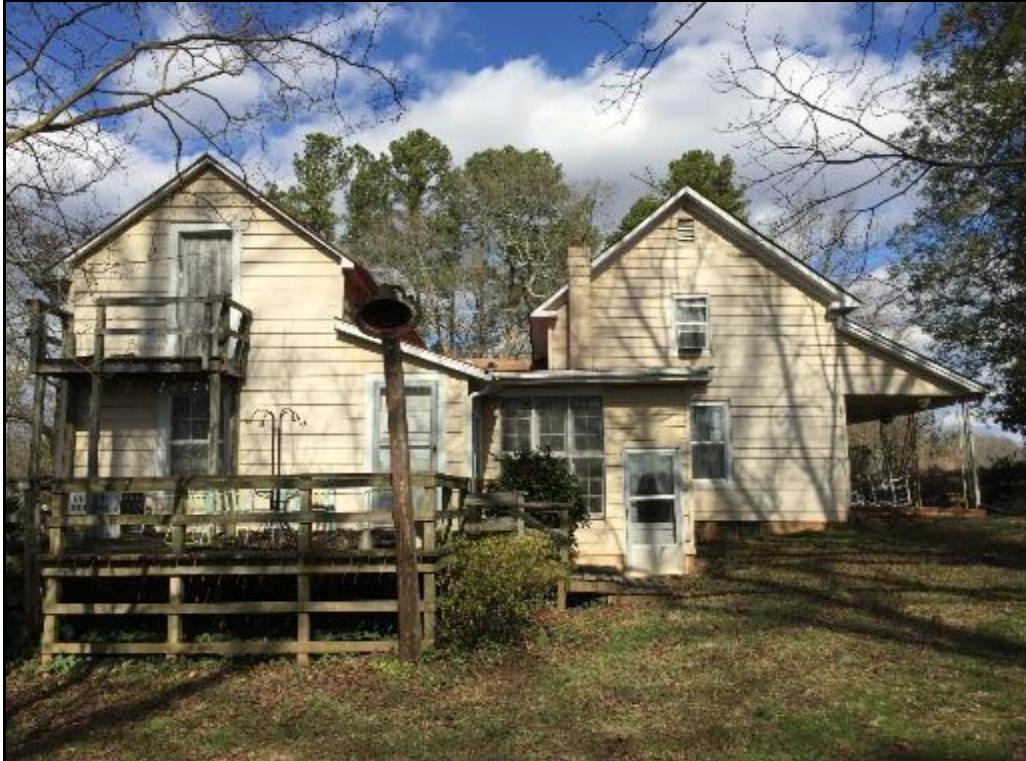
According to the owner, the home has rough-hewn-log floor joists that were originally set on a stacked rock foundation; concrete blocks were added during a later renovation. The carport was added in 1978 as was the rear addition and a c.1840s wood frame home previously located down Phaniel Church Road was moved to the property and joined with the house at that time as well.

Rear additions to the Sides-Carter House, looking north

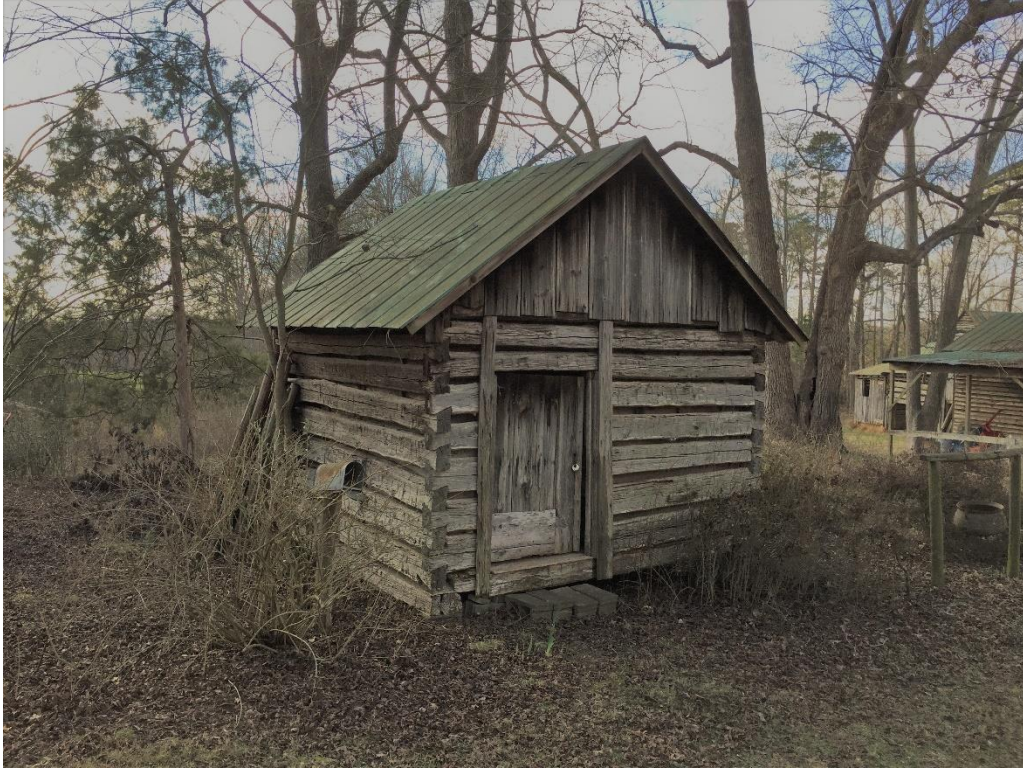
Corn crib at Sides-Carter House, looking southwest

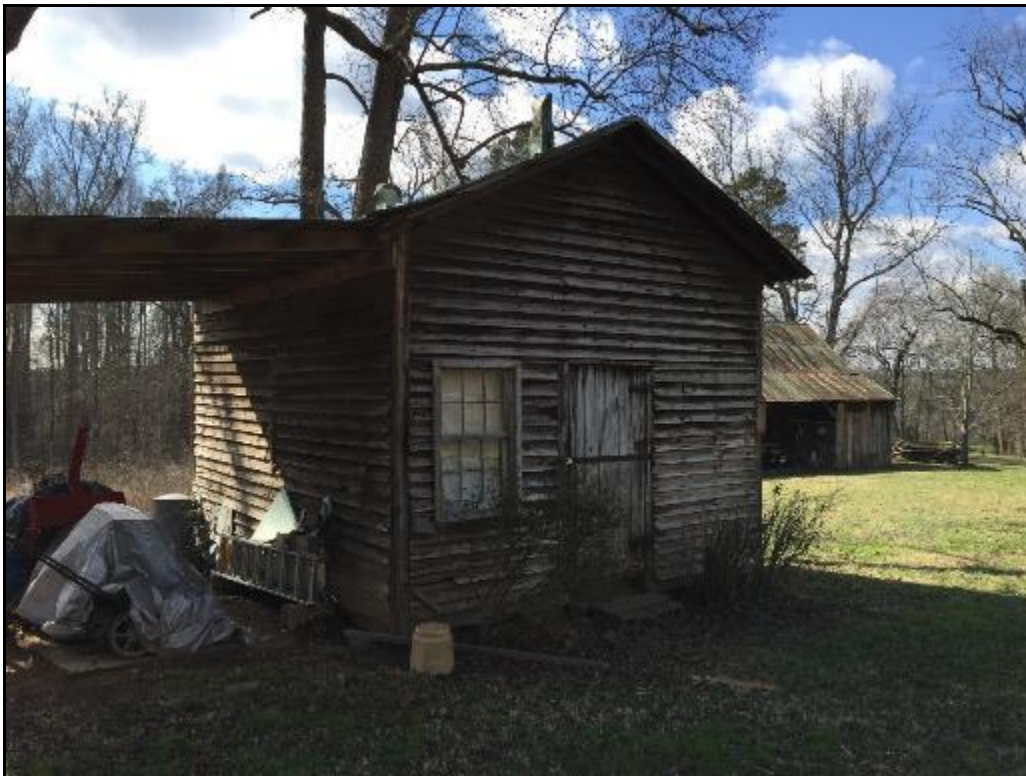
Granary at Sides-Carter House, looking southwest

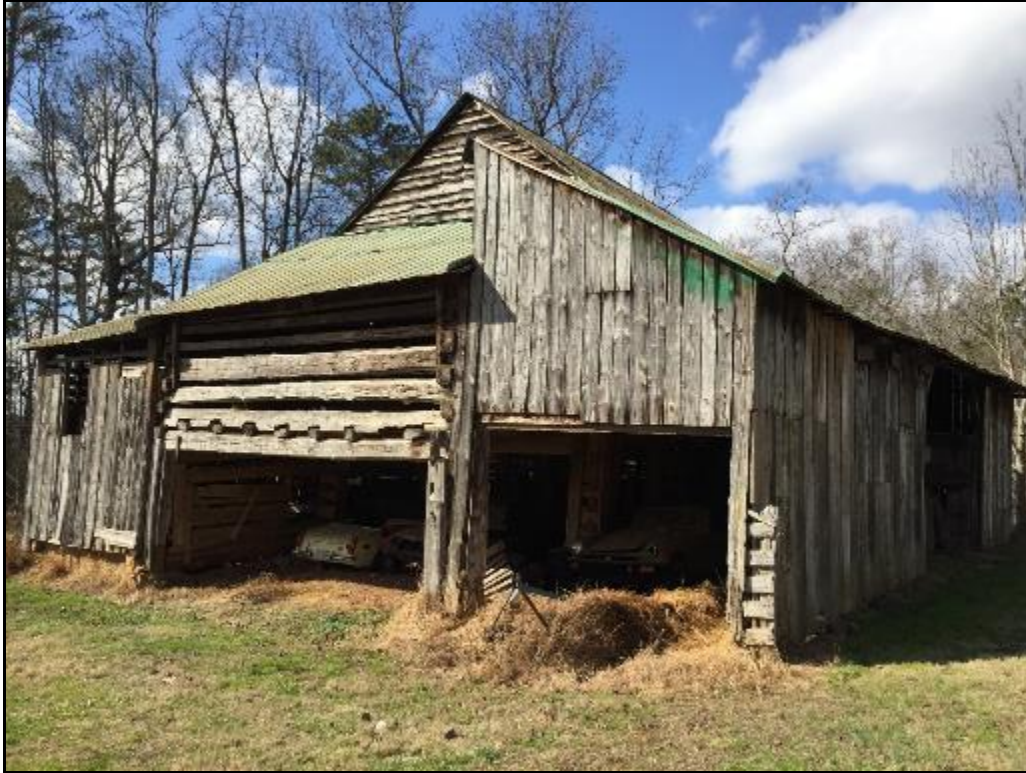
The log barn appears to have had many additions and alterations making it difficult to determine the original configuration. Horizontal weatherboards cover the upper story gabled ends of the original portion of the barn, while the shed additions are clad in vertical wood planks. The barn is currently used for storage and appears to be in fair condition.

Log barn with frame additions; looking southwest
