SUBJECT: Historic Structures Survey Report for Replacement of Bridge 237 on SR 1120  
Over Sorrel Creek, PA 16-02-0082, Haywood County, ER 17-0880

**HISTORIC ARCHITECTURE  
ELIGIBILITY EVALUATION REPORT**

**Replace Bridge No. 237 over Sorrell Creek  
on SR 1129 (Little East Fork Road),  
Haywood County, North Carolina**

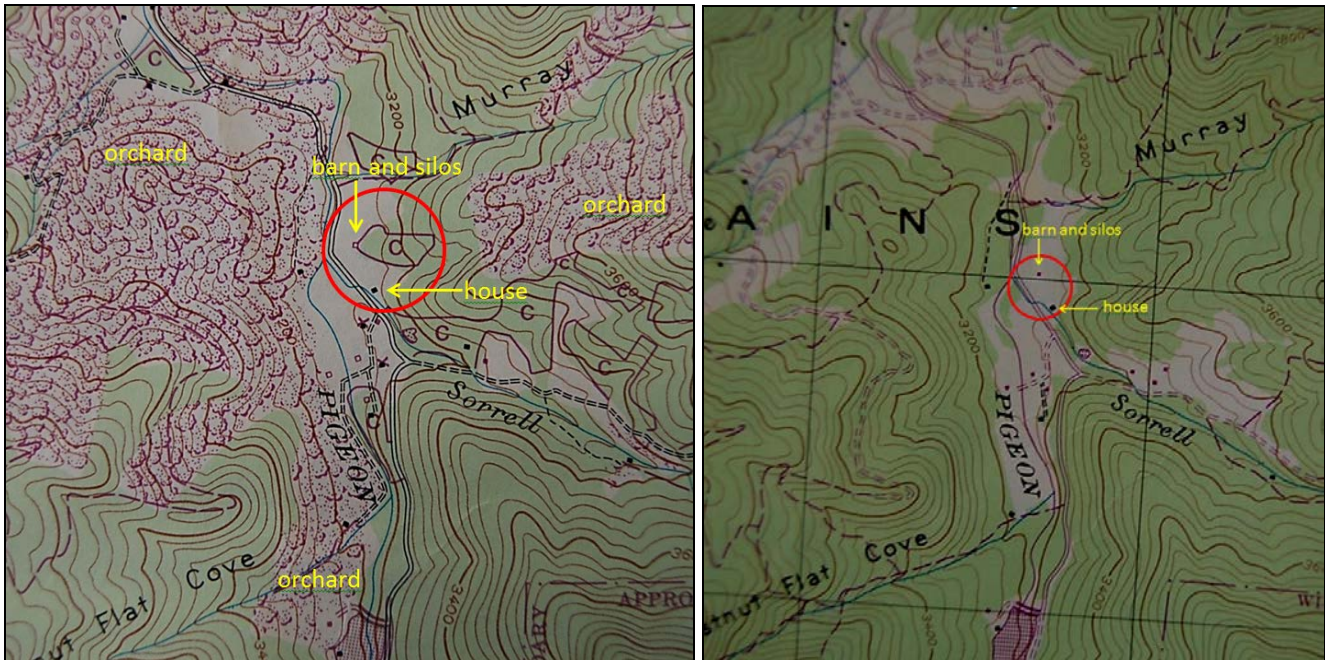
**Figure 8. Waynesville, N.C. U.S. Geological Survey 1941 topographical map photorevised in 1967, at left, and 1979, at right (annotated)**

The 1967 and 1979 updates of the 1941 Waynesville, N.C. topographical map sheet bring the history of the project area and APE almost completely up to the present. The 1967 map includes building symbols that in all likelihood are the current house and barn site/silos (Figure 8, left). Around the project area it also locates apple orchards. These orchards were removed sometime between 1967 and 1979 (Figure 8, right). (The inventory below addresses the role of apples within the APE.)

The association of crabapple cultivation with the farm also failed to provide any fruitful leads on its history. The 1967 photorevision of the 1941 topo map does show apple orchards to each side of the property (Figure 8, at left). However, the silos would not have been connected with crabapple production or storage. Silos (as discussed below) were for the storage of silage, almost 90% of which was composed of chopped up corn stalks and cobs in the country in 1940 (Wiegand 1989:1). Apples

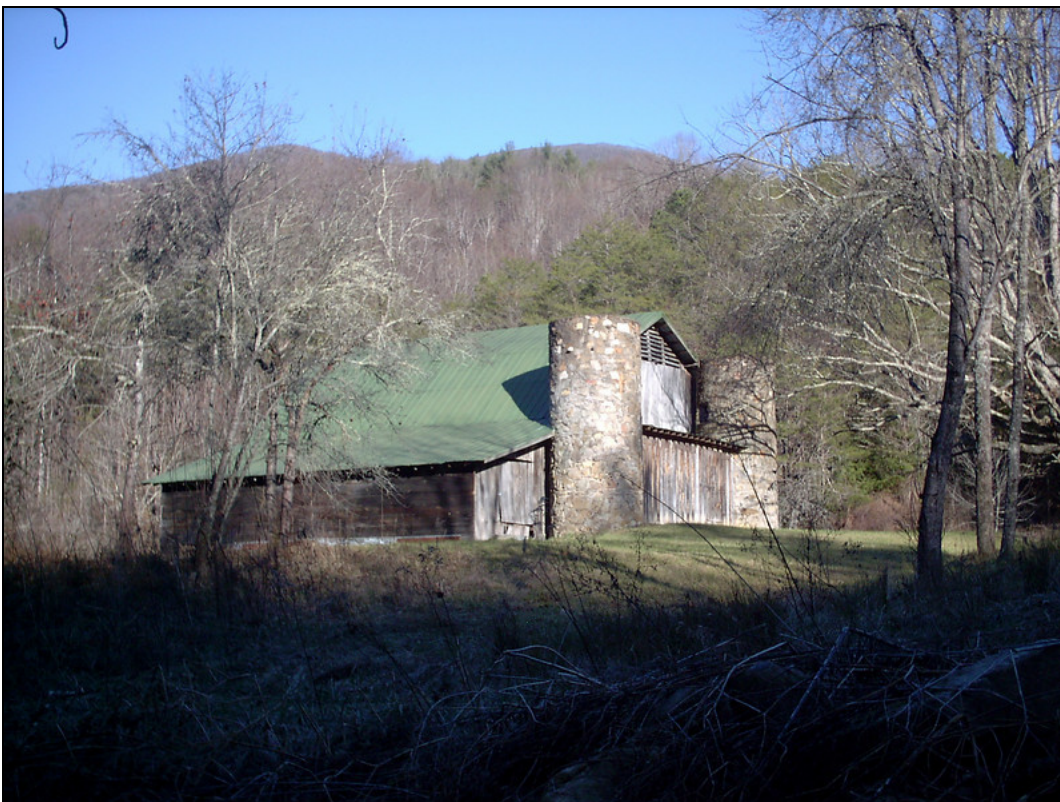
**Figure 11. Looking northeast at barn, sheds, and silos, December 10, 2005 (photographer: ‘DW Hike’; source: <http://www.dwhite.com/Hikes-in-the-South/North-Carolina-Hikes/South-Beyond-6000-Hikes/Cold-Mountain-NC-12-10-05/i-T8Zk5kC/A>)**

Before addressing the site’s intact resources—the silos, the former house, and the shower facility—it is important to address the remnant foundation walls and lost barn. Following review of aerial images and two photographs of the standing barn and silos, and a somewhat cursory examination of the walls, it was initially assumed that the silos and barn were structurally integrated (Figure 10 through Figure 12). A closer examination reveals otherwise.

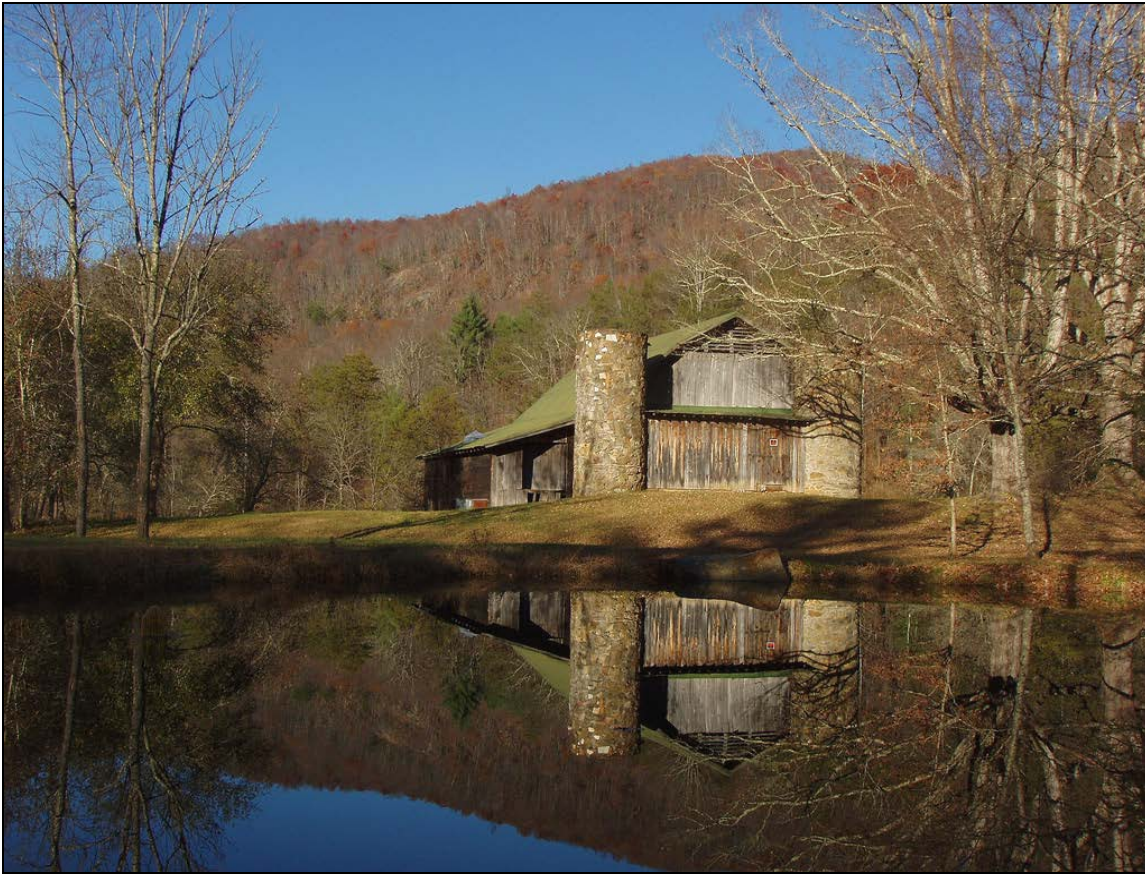
**Figure 12. Looking northeast at barn, sheds, silos, November 11, 2010 (photographer: ‘Internet Brothers’; source: [www.flickr.com/photos/netbros/5167673823/in/album-72157623912582454/](http://www.flickr.com/photos/netbros/5167673823/in/album-72157623912582454/))**

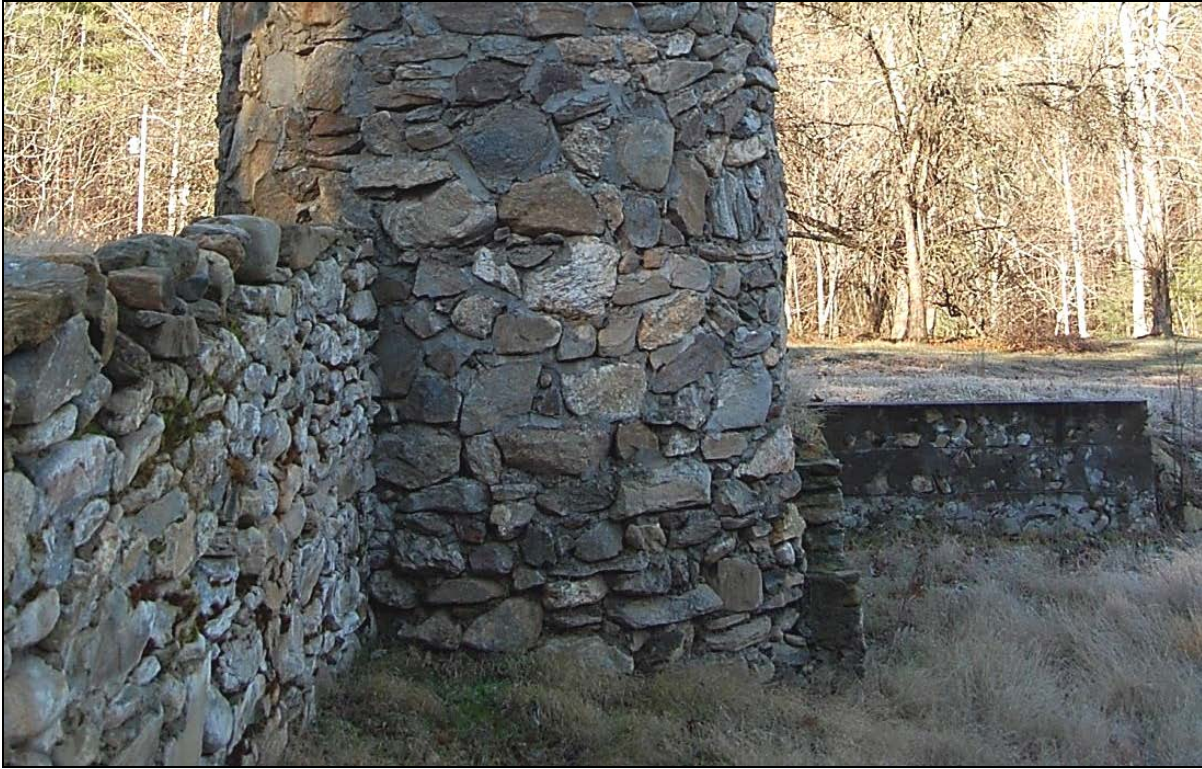
**Figure 13. Looking west along south barn shed foundation wall, at left, to its abutting of west silo**

The fieldstone foundation of the south barn shed extends, on an east-west axis, about 25 feet between the silos. A second fieldstone foundation at a lower elevation, which underpinned the south end of the barn’s long western shed, extends about 12 feet west of the west silo. A small section of concrete foundation wall is set at a right angle to this wall. This too underpinned the barn’s western shed. A careful look at the points where the stone foundations meet the stone silos reveals the abutting rather integration of the walls (Figure 13 through Figure 18).

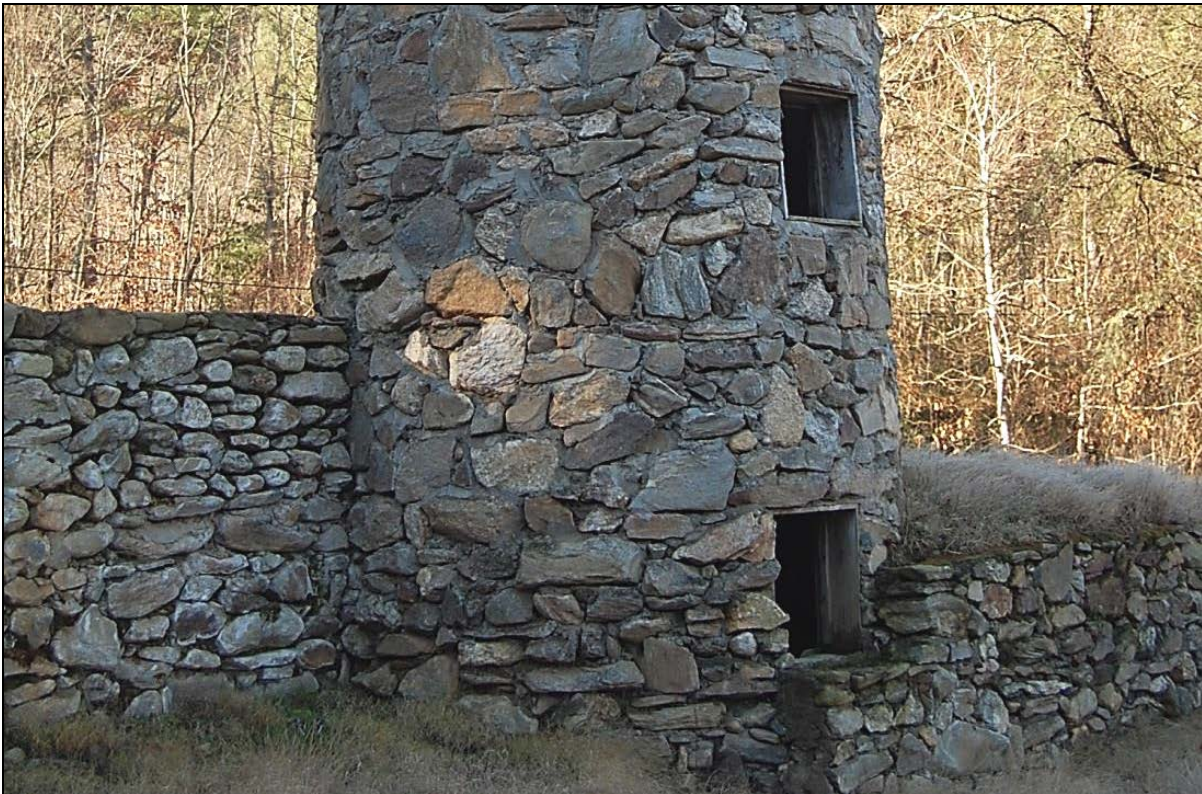
**Figure 14. Looking southwest at south shed foundation wall, at left, and west shed foundation wall, at right, abutting west silo**

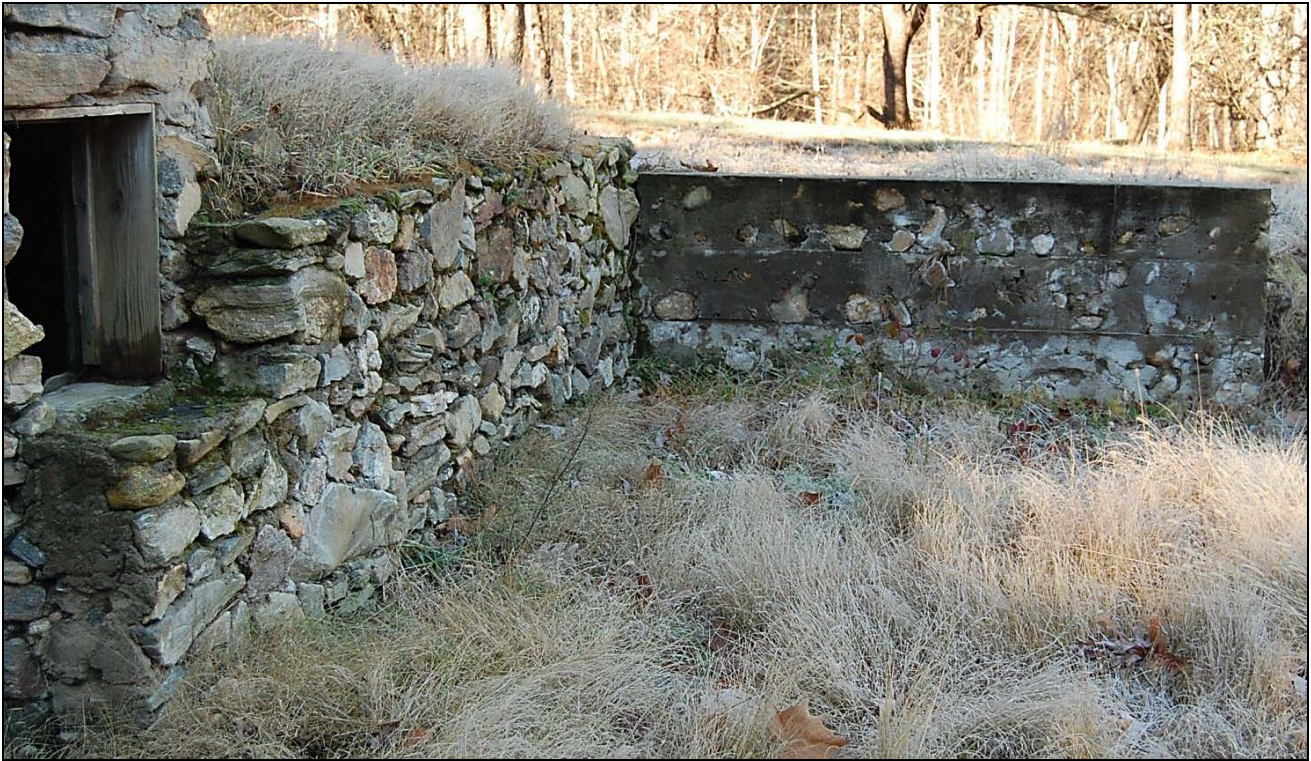
**Figure 15. Looking west along west barn shed foundation wall, at left, showing where it abuts west silo and concrete foundation wall**

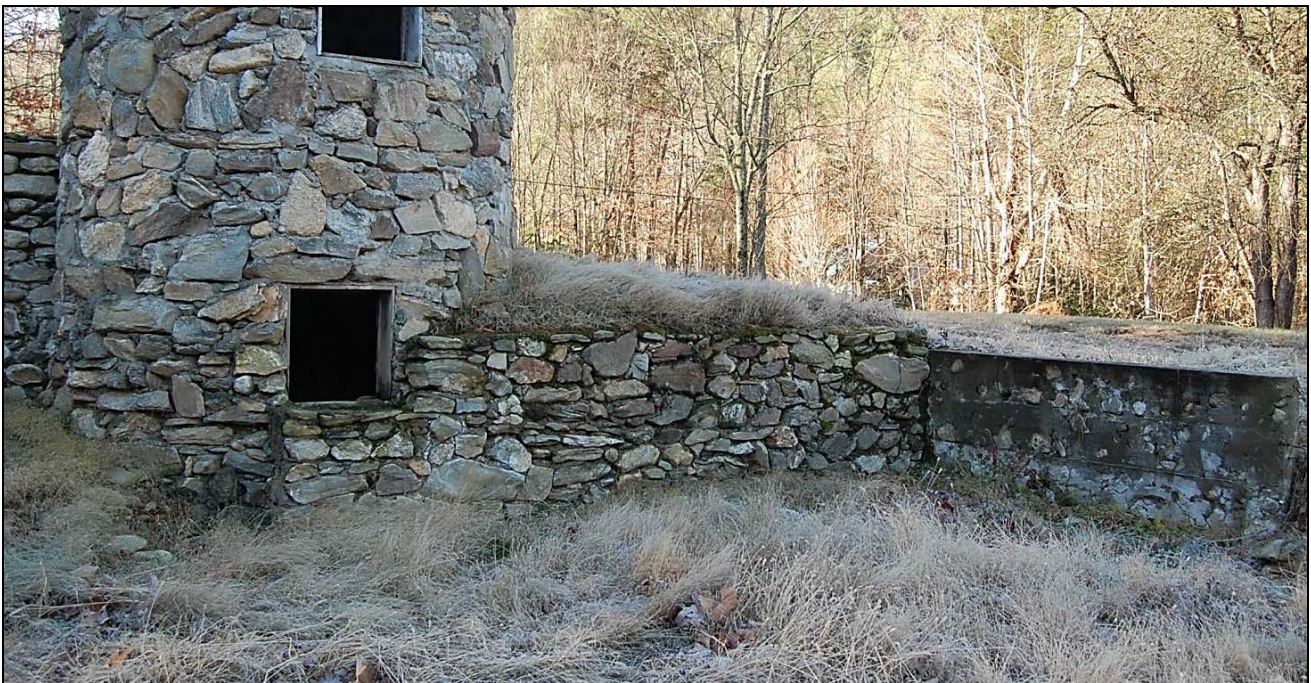
**Figure 16. Looking southwest at three sections of foundation wall and west silo**

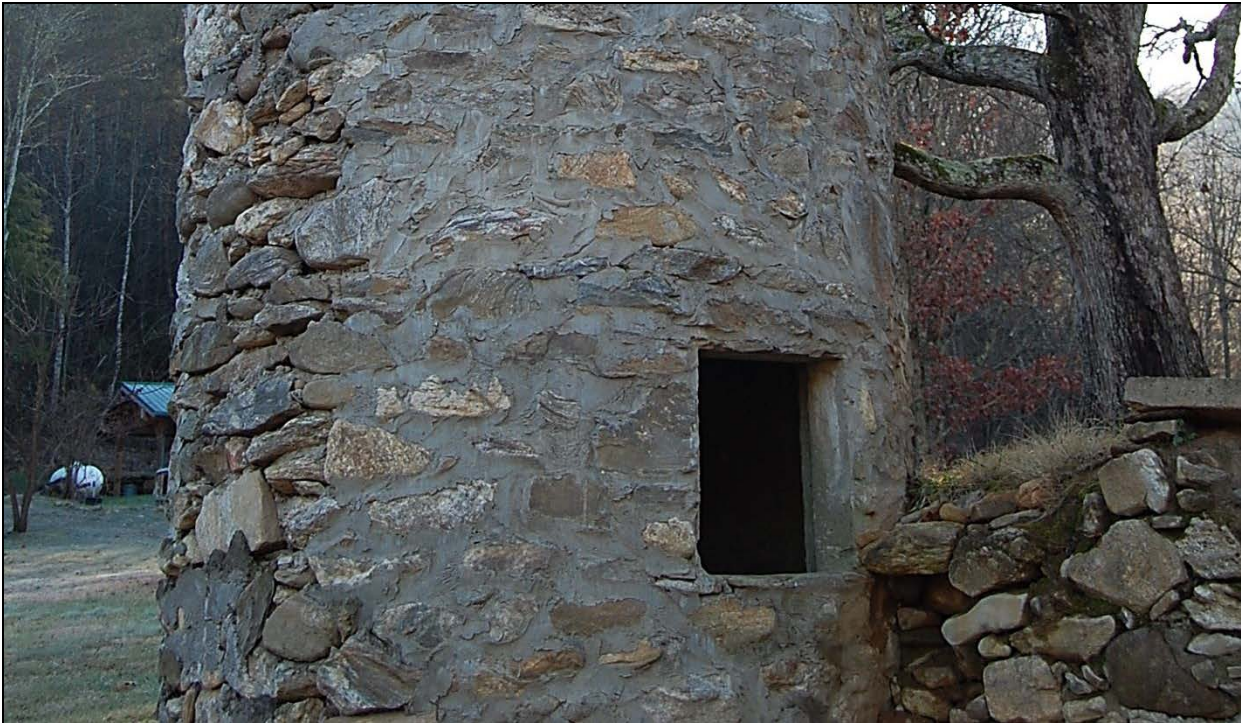
**Figure 17. Looking southeast at point where south shed foundation wall abuts east silo**

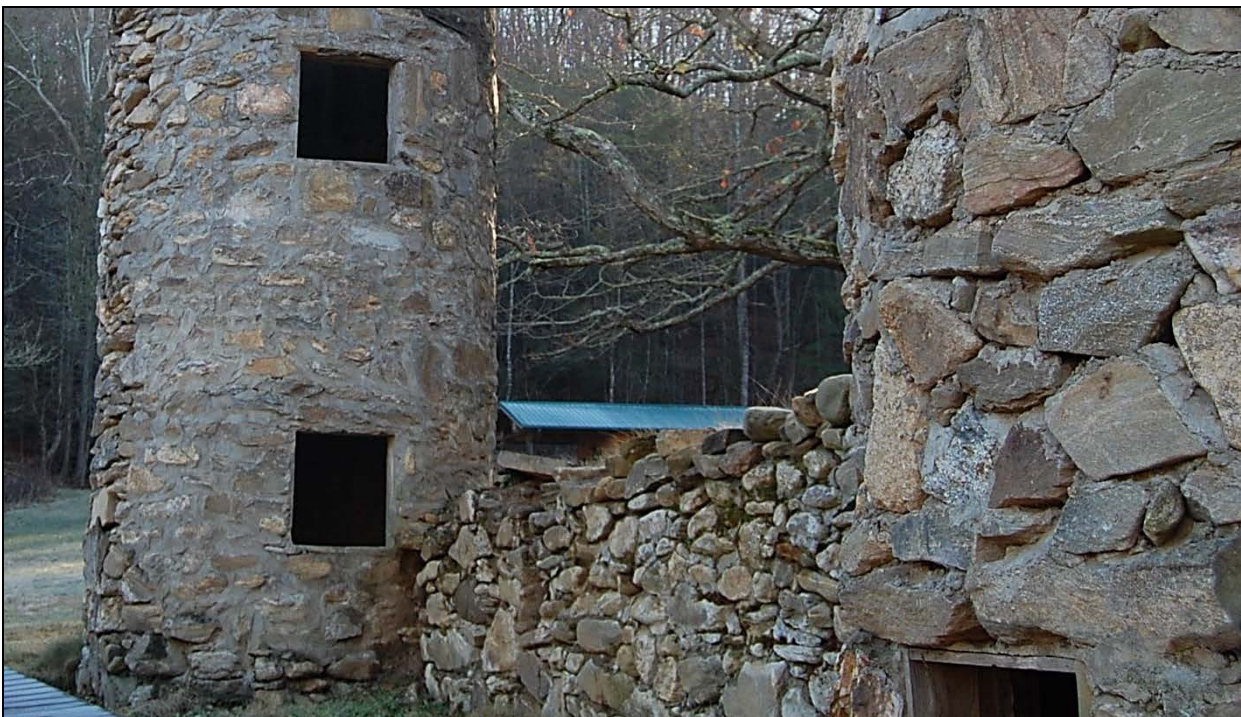
**Figure 18. Looking southeast along length of south shed foundation wall between west silo, at right, and east silo, at left**

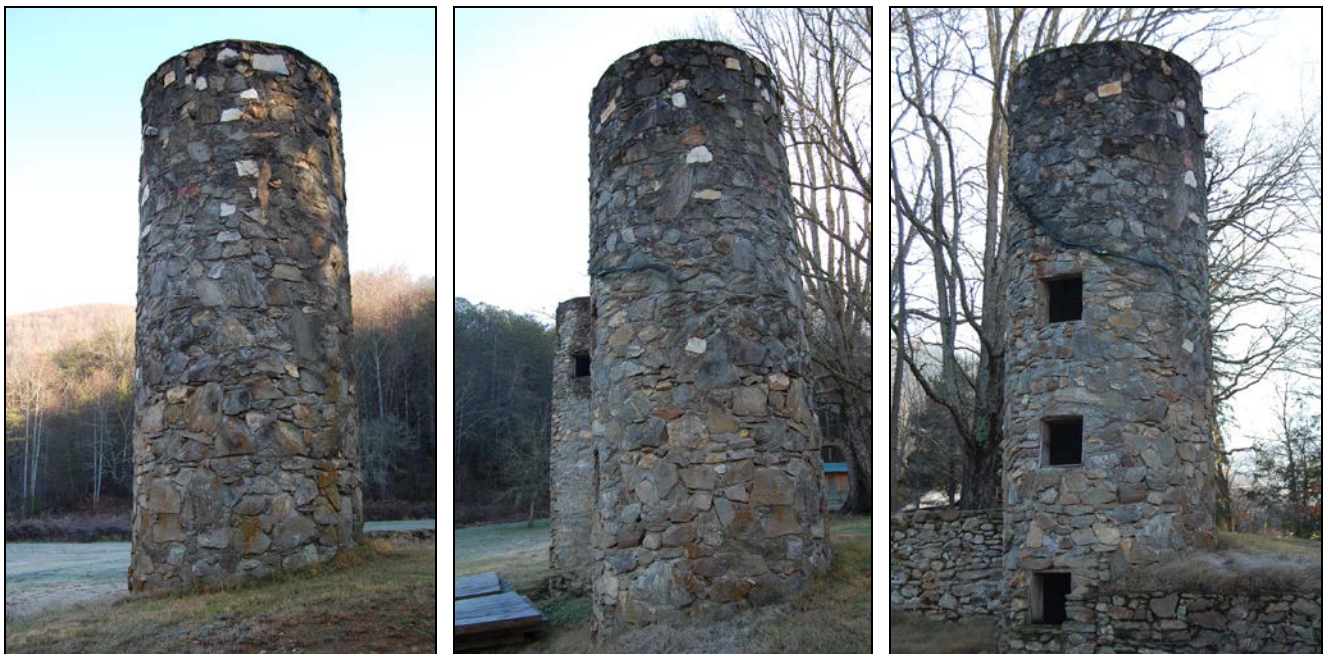
The west silo is constructed of variegated local fieldstones of the same material as, if in many instances larger than, the surviving barn shed foundation. Three regularly spaced almost-square openings, set one above the other starting at ground level, penetrate the silo's north face. A fourth opens above them on the silo's northeast face. Building ghost marks indicate that the lower three opened directly into the main body of the barn, while the uppermost faced outside (Figure 19 and Figure 20). Early literature called for openings to be placed one above the other (see for example Shaw 1900:305; Silver Manufacturing Co. 1913:72). Why both of the Little East Fork silos have their uppermost openings skewed to the side is not known. It is also not known why their openings face in different directions, although this likely had to do with when and how the barn and its north shed were constructed. The differing directions of the openings suggest that the silos were built at least a few years apart.

**Figure 19. West Silo: south face at left; west face and edge of east silo at center; north face at right**

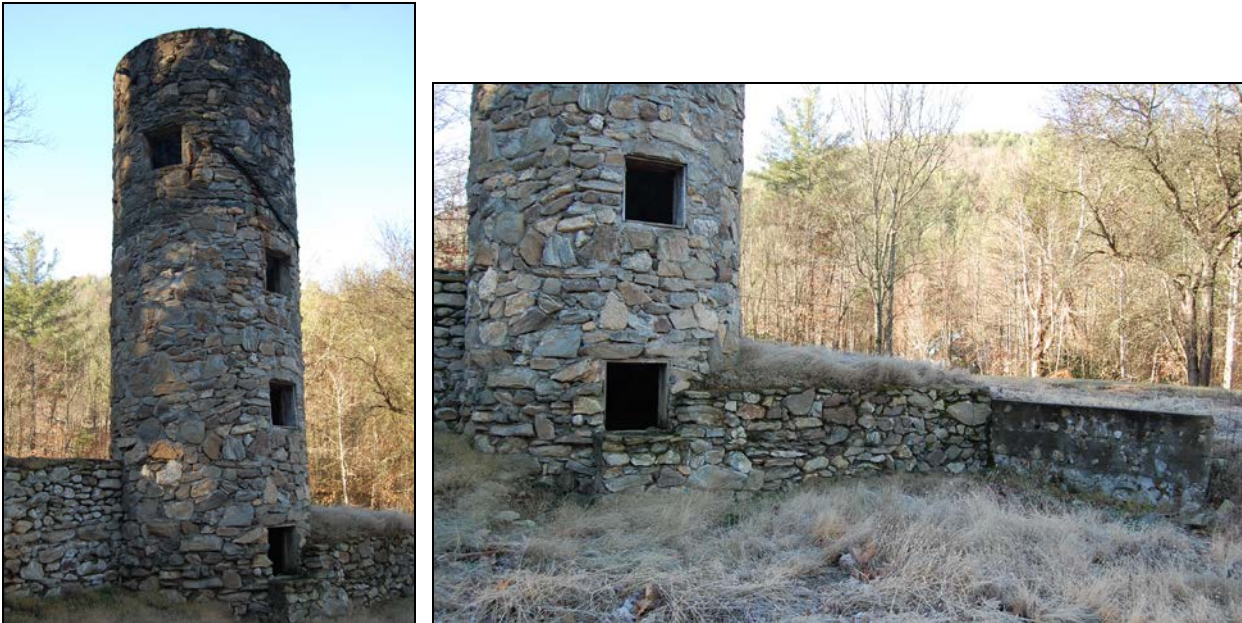
**Figure 20. West Silo: looking southwest, at left, with opening at top that did not face into barn; looking south at bottom of silo and surviving fieldstone and concrete barn foundation walls**

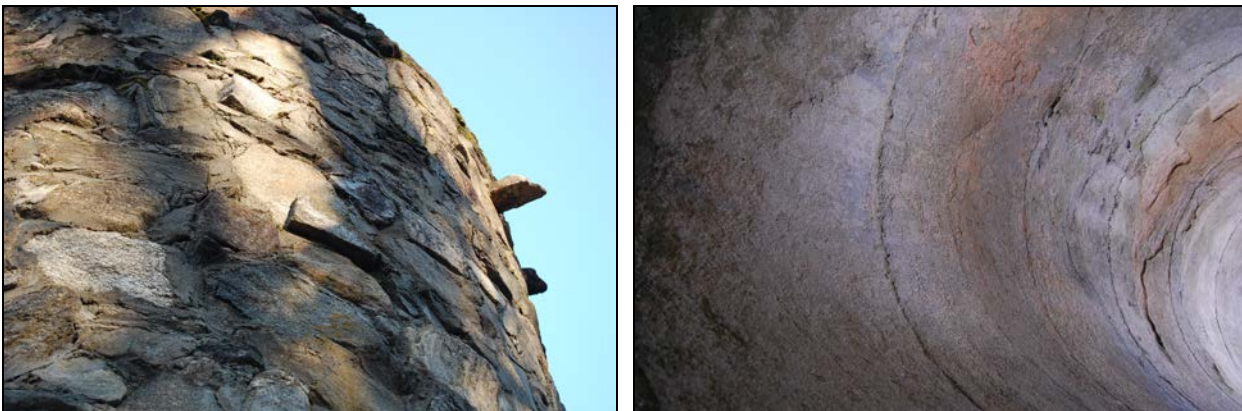
A coat of cement lines the silo's interior (Figure 21, at right). Likely once smooth, it has deteriorated somewhat over time, but continues to cover the interior stone face. Concrete and wood boards frame the bottom three silo-filling openings; only concrete faces the uppermost. Two apparently largely intact doors that once sealed the openings (which are also called "doors") lie on the silo's floor. Among the floor's additional detritus are boards that were likely portions of the other two doors and the top opening's frame. A triangular section of standing-seam metal may once have formed part of a roof or it may have come from the barn (Figure 22).

**Figure 21. West Silo: top of silo with some integral projecting stones at left; plastered interior at right**

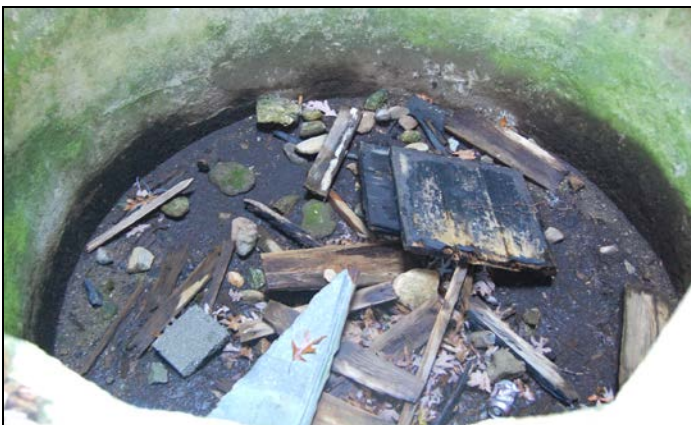
**Figure 22. West Silo: silo floor with doors and other detritus**

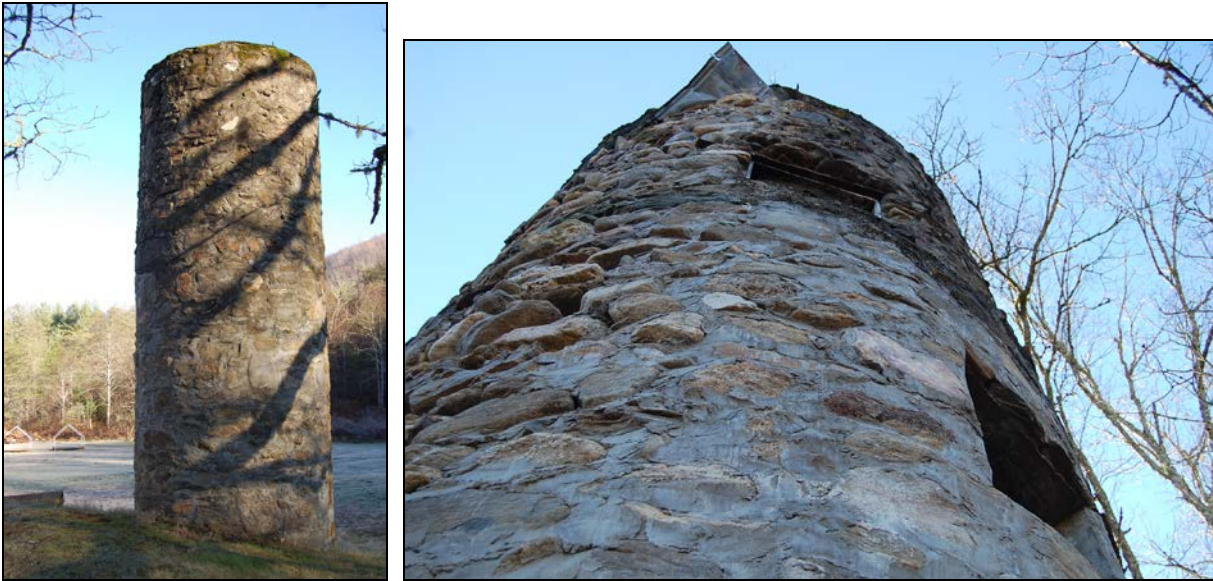
As is its mate, the east silo is round with concrete mortar laid roughly but evenly between its stones. Much of the mortar is original, but the lower two-thirds of the east elevation, which opened into the shed that connected the barns, have been re-mortared. This effort likely included rebuilding the openings, which may have been slightly enlarged and reduced in number from three to two (Figure 24, at right). Only the uppermost opening appears to be untouched. The rebuilding suggests a failure at this lower portion of the silo: the bottoms of silos were at greater risk due to the increased pressure of the silage upon their walls. From ground level or looking up through the silo there is no evidence of a roof. (A piece of standing-seam metal projecting out near the silo's top was a portion of the barn roof, not the silo's.) No stones project out from the silo's top and its walls retain no evidence of a ladder, filling tube, or any support braces.

**Figure 24. East Silo: south face at left; west/northwest face at right with re-mortaring evident, original uppermost opening at top center, and piece of barn roof sandwiched into stonework near the top**

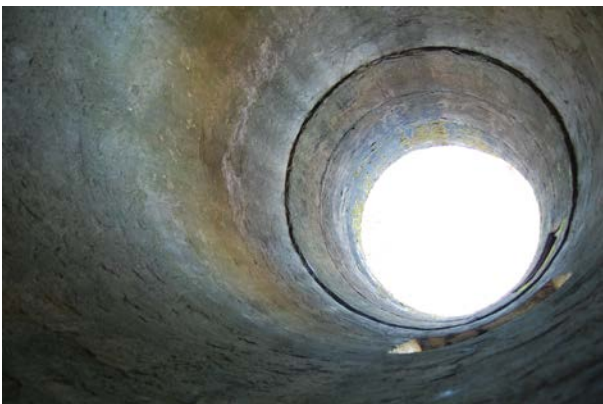
Cement lines the silo's interior (Figure 25). Although deteriorated, it continues to shield the interior stonework. The uppermost opening retains its original concrete enframement, bolstered by wood boards that would have held the no-longer-extant door. The silo's floor retains no pieces of its doors or any possible roofing materials.

**Figure 25. East Silo: interior cement surface**

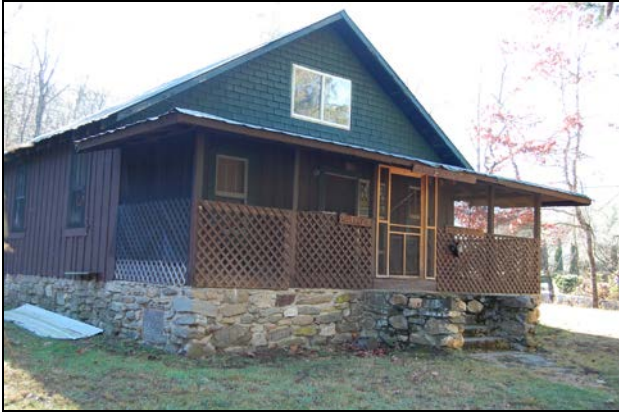
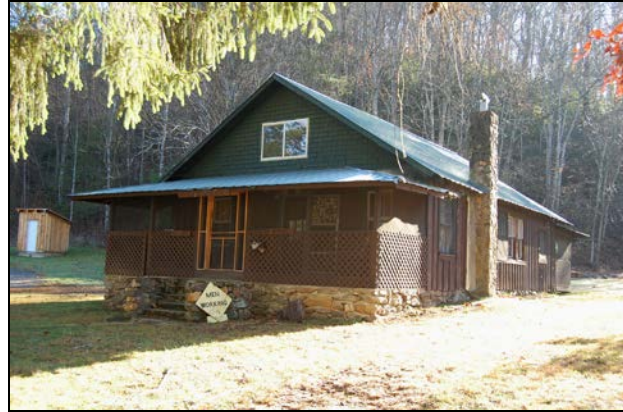
The house on the property was built as a single-family dwelling or perhaps a hunting lodge. Since the Boy Scouts have owned the property, it has been used as the office/support building for Camp Daniel Boone's High Adventure Camp. It is built of frame and clad in board-and-batten siding. Three bays cross the house's front (northwest) elevation and it is three piles deep. Rafter ends are visible beneath the gabled roof, which is filled at its front and rear (southeast) peaks with asphalt shingles. Fieldstones support the house and its full-façade front and rear porches. Both porches have been altered through the addition of screens and wooden lattices. The framing of the front porch's hipped roof, however, may be original. The 3/1 sash that fills most of the window bays also appears to be original. The interior was visible through doors and windows. It now holds offices, but retains wooden floors and plain wooden surrounds. At least one original, vertically stacked, five-panel door remains in place inside (Figure 26 through Figure 28).

**Figure 26. House: northeast side and northwest front elevations at left; northwest front and southwest side elevations at right**

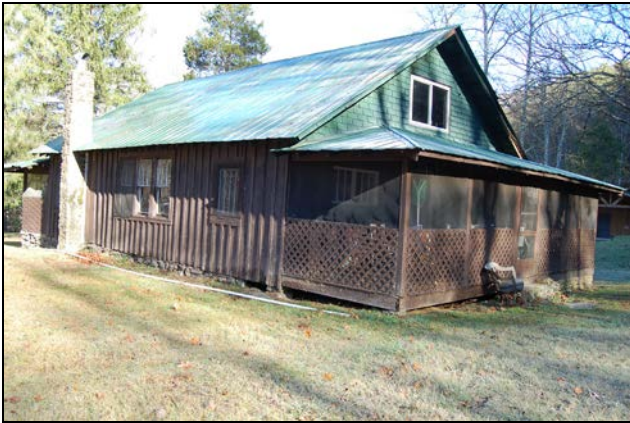
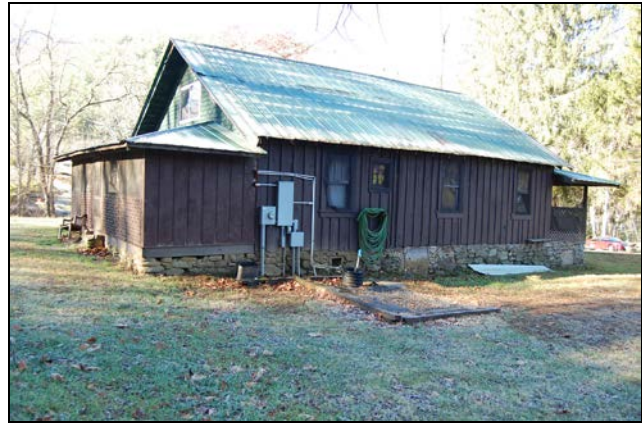
**Figure 27. House: southwest side and southeast rear elevations at left; southeast rear and northeast side elevations at right**

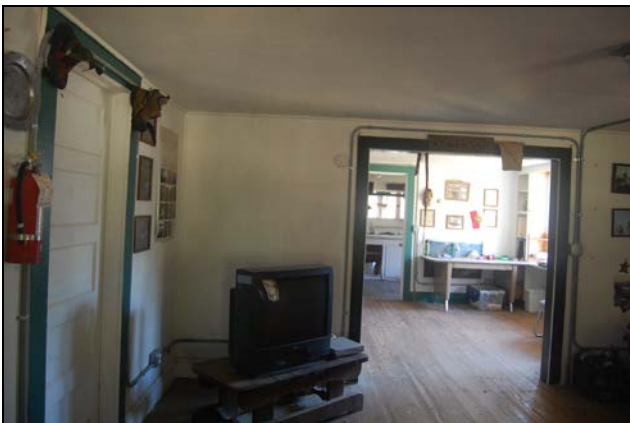
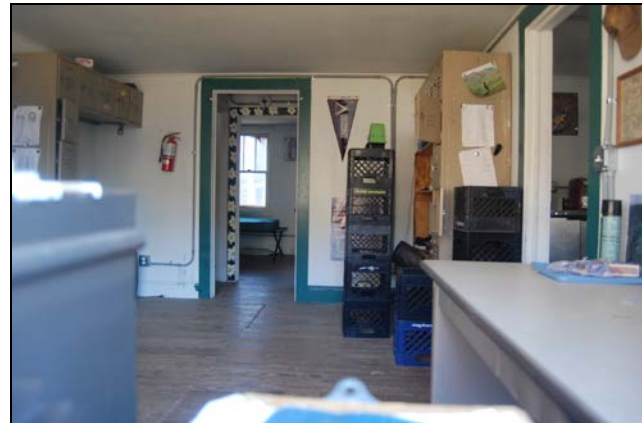
**Figure 28. House: view looking through front door toward rear room at left; view looking from rear window toward front room at right**

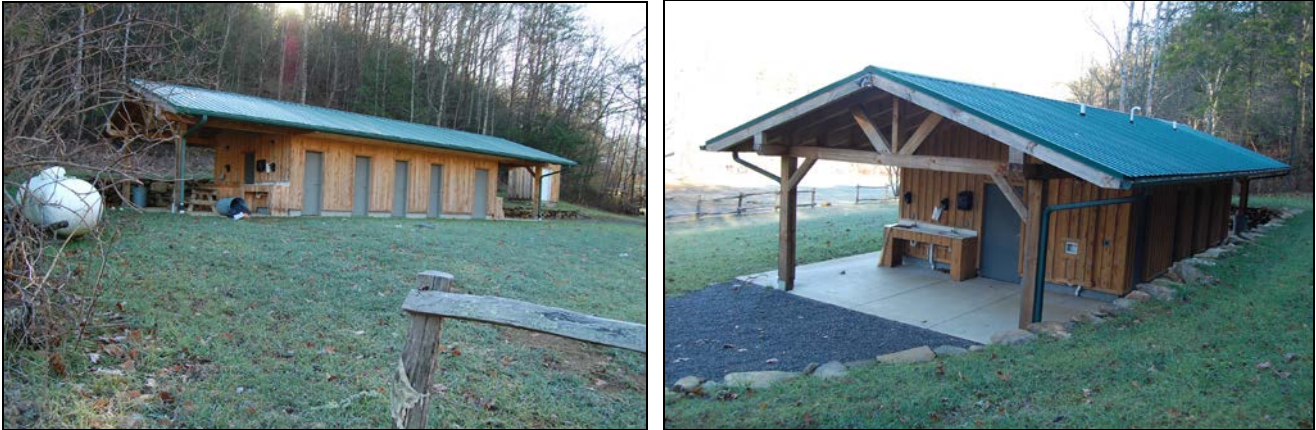
The modern shower house is a long board-and-batten siding building that houses multiple showers behind doors on its long side elevations. The gables of its seam-metal roof extend out over its short north and south elevations to shade outdoor sinks and concrete-floored patios. A tiny, modern, board-and-batten sided building off its southeast gable likely holds pumping mechanisms (Figure 29).

**Figure 29. Shower House: north short and west long elevations at left; south short and east long elevations at right**

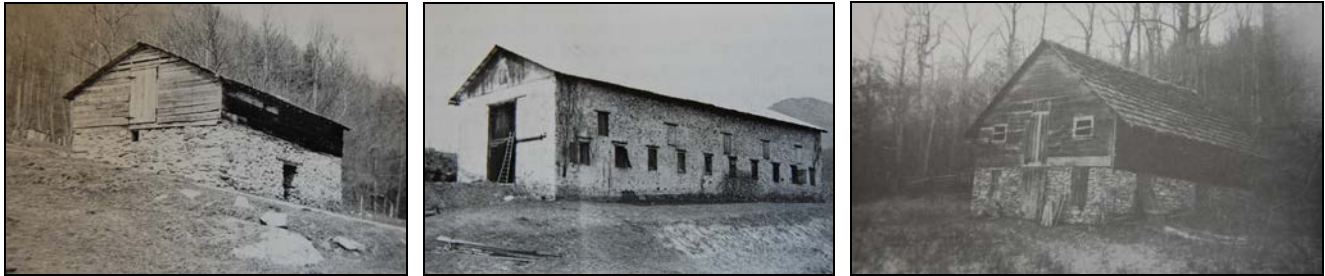
**Figure 30. O’Neil applehouse, built in the 1890s, at left; Barber’s Orchard applehouse, built in the early twentieth century, at center (source: Oliver and Farlow, *Mountain Gables*); Cook Place applehouse in December 1937, at right (source: Carroll and Pulley, *Historic Structures Report*)**

cannot be made into silage. In the North Carolina mountains, apples in the late nineteenth and early/mid-twentieth centuries were stored in purpose-built, rectangular, stone buildings often erected partially into a hillside. Examples of these in Haywood County include ones at the O’Neil and Barber orchards and at the Dan Cook Cabin (Oliver and Farlow 2001:38; Cotton 1993:18; Carroll and Pulley 1976:74-78, 108-115; North Carolina Department of Agriculture 1910) (Figure 30). Alternatively, they were stored in similarly fashioned frame buildings.

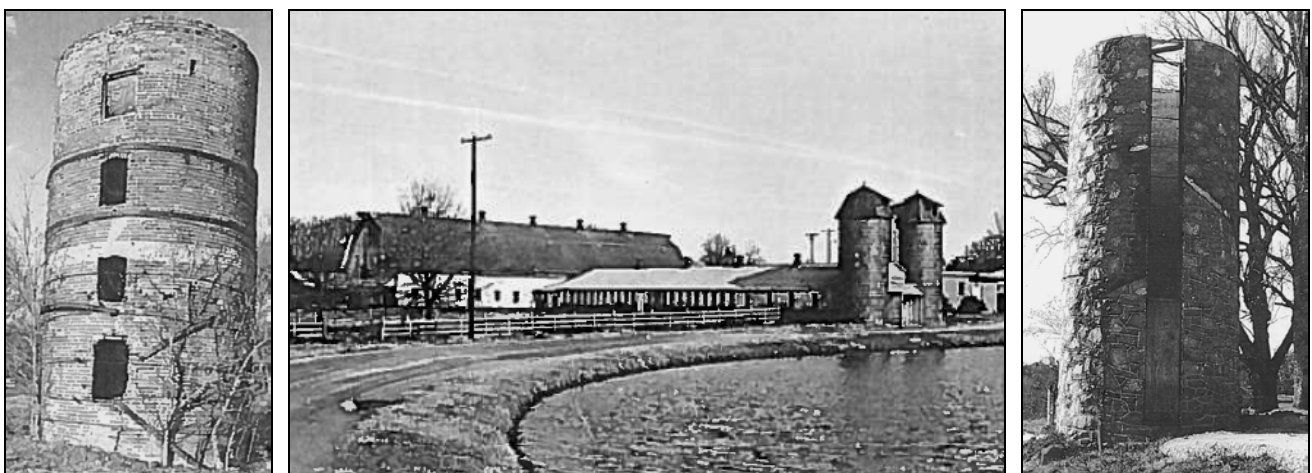
**Figure 33. Smith Silo at left; Jackson Training School brick-tile silos at center; Mary’s Grove silo at right (source: North Carolina Historic Preservation Offices files)**

Recorded evidence of the types, materials, and date ranges of early silos constructed in Haywood County and elsewhere in the state is as limited as the documentary record. Presumably few of the silos built in the late nineteenth and early twentieth centuries survive and those that do are difficult or impossible to date. The files of the North Carolina HPO, however, include examples of silos made out of various materials, including stone, even if those structures often cannot be dated with any precision. Examples of those silos—located east of the mountains—include the Smith Silo (HX0519), built of brick in Halifax County (Taves 1988); the paired brick-tile silos that contribute to the NRHP-listed Stonewall Jackson Training School (CA0045) in Caldwell County, which may date from 1918, along with a contributing concrete silo also on the property that likely predates 1940 (Kaplan and Brown 1984); and the early 1930s, stonemason-laid silo that contributes to the NRHP-listed Mary’s Grove property (CW0052) in Caldwell County (Hood 2000) (Figure 33).

In their general refinement, these silos may typify ones built on estate-type properties (although the nature of the Smith property is not known). Finely built stone silos and paired stone or brick silos seem to be found more often at the farms of the well-to-do, and to date later into the twentieth century, in North Carolina and elsewhere.

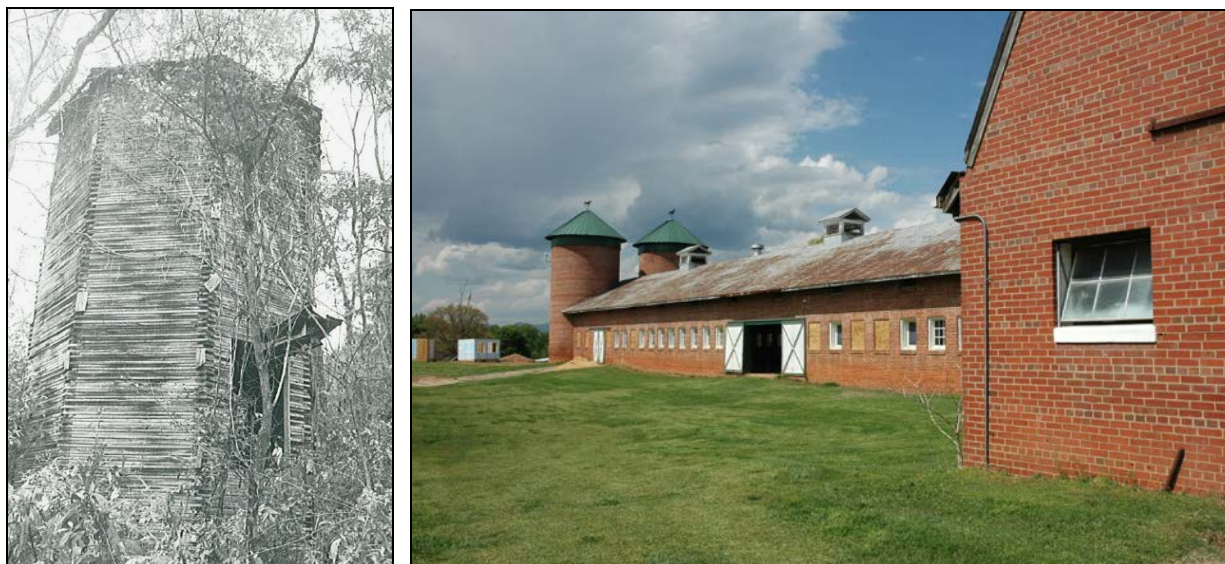
**Figure 34. “The Pines” Silo at left; the carefully constructed twin brick silos within the Broughton Hospital Historic District at right (source: North Carolina Historic Preservation Offices files)**

The HPO files also include silos built in the mountain counties. Among these is the octagonal silo at “The Pines” in Jackson County, surprisingly built of stacked wood (JK0299). Probably erected between about 1915 and 1930, in association with a no-longer-extant boarding house, the silo is believed to be lost (Humphries 1991). Paired brick silos that contribute to the NRHP-listed Broughton Hospital Historic District in Burke County, still extant, date to the 1920s or 1930s (Wylie 1986) (Figure 34).

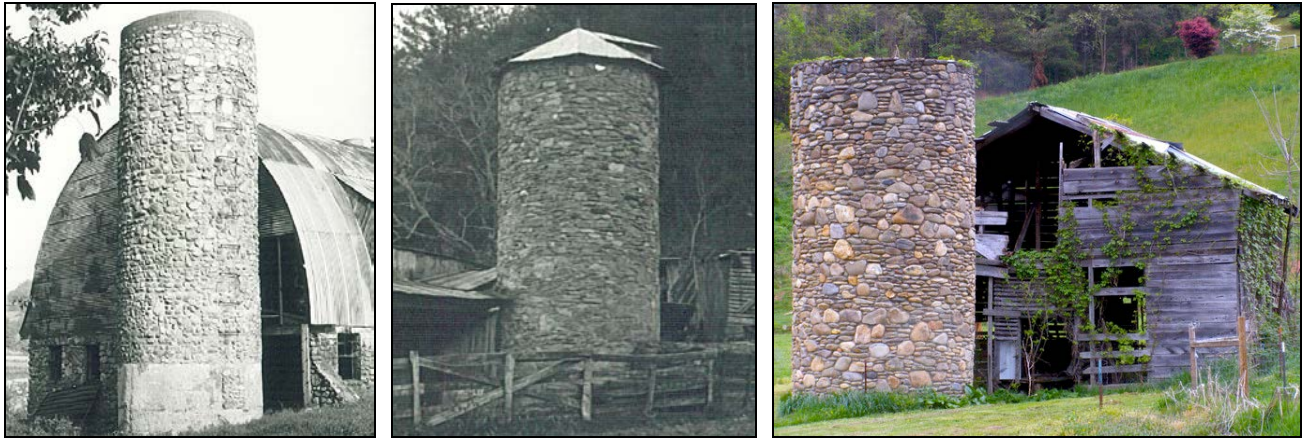
**Figure 35.** Bennett Silo at left and the Stradley House silo at center (source: North Carolina Historic Preservation Offices files); Moss Rock Silo in April 2010 at right (photographer: Melinda Stewart at <https://www.flickr.com/photos/melvstu/albums/72157627517259758>)

At least five western silos included in the files are of stone. These are the early 1920s coursed, squared-off, granite-block silo, clearly professionally laid, at Carl Sandburg’s National Historic Landmark Connemara estate in Henderson County (HN0001) (Gay 1976) and four more workmanlike silos closer in appearance to those on the Little East Fork: the ca.1935 Bennett Rock Barn and Silo (BN0253) near Candler in Buncombe County (Swaim 1981:136 and survey form); the undated stone silo at the Joseph A. Stradley House (BN0687) near Asheville (Swaim 1981:158 and survey form); the 1946 (?) Moss Rock Silo (BN0533) near Barnardsville in Buncombe County (Swaim 1981:110 and survey form); and a stone silo in the Sunburst community in Haywood County near the Little East Fork, about 3.5 miles northwest of the twin silos (Gardner Log House/HW0391) (Oliver and Farlow 2001:14).<sup>1</sup> Aerial and other images suggest that all five of these stone silos still stand, along with at least one more in Buncombe’s Barnardsville community (Figure 35 through Figure 37).

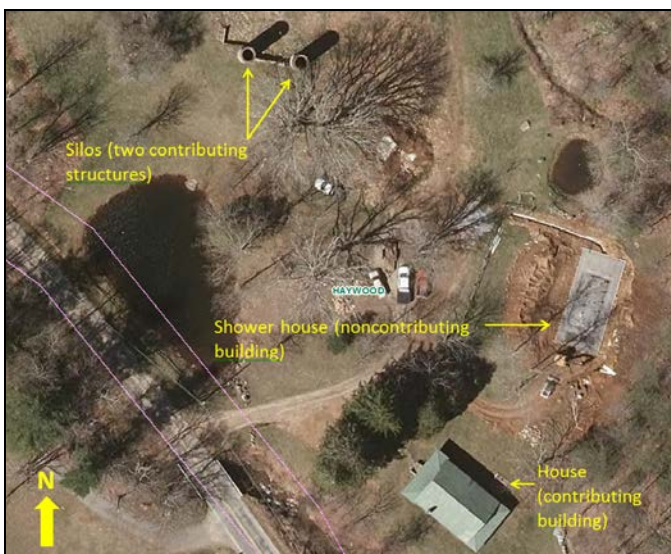
**Figure 38. Contributing/noncontributing resource locator map (source of ca.2015 base map: <http://gis.ncdcr.gov/hpweb/>)**

The ca.1935 house on the property is an unremarkable example of an early/mid-20<sup>th</sup>-century dwelling. There are numerous similarly fashioned houses found throughout Haywood County, many with higher degrees of integrity, and the house is not believed to be individually significant under any of the NRHP Criteria. However, the house was standing on the farm property when the silos were in operation and is recommended as a contributing building. The shower house erected by the Boy Scouts on the property within the past few years is a noncontributing building.

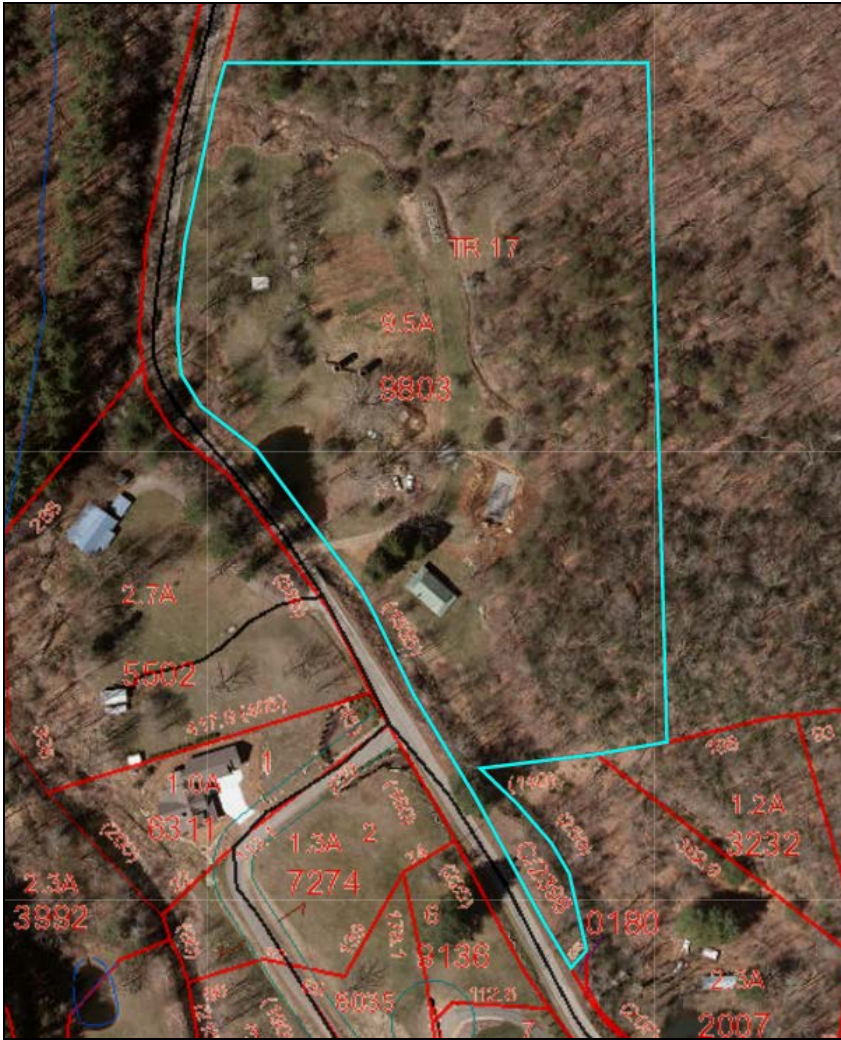
**Figure 39. Proposed National Register of Historic Places boundary (light blue outline) of Little East Fork Creek Stone Silos property (source: <http://maps.haywoodnc.net/gisweb/default.htm>)**

The recommended NRHP boundary of the Little East Fork Creek Stone Silos property is that of Haywood County parcel number 8632-83-9803, which encompasses approximately 9.5 acres (Figure 39). The western portion of the parcel is largely cleared open land. The remainder is wooded. The open relatively flat portion of the property, now used as temporary tent sites by Camp Daniel Boone, would have supported corn and cattle, which prompted the silos' construction. The woodland would have provided building material and fuel for those who farmed the land and tended the cattle and silos. Although the historic extent of the property is not known, the inclusion of open land and woods provides a setting that reflects its historic use. On the west, the boundary of parcel 8632-83-9803 appears to not extend into the NCDOT right-of-way along SR 1129 (Little East Fork Road). The recommended NRHP boundary on the west is limited by and does not extend into that right-of-way.
