SUBJECT: Historic Structures Survey Report for Replacement of Bridge 219 on SR 1354 over Bear Swamp, PA 16-12-0022, Duplin County, ER 17-0998

**Historic Structures Survey Report
Replace Bridge No. 219 on SR 1354 (Taylor Town Road) over Bear Swamp
Duplin County, North Carolina**

The North Carolina Department of Transportation (NCDOT) proposes to replace Bridge No. 219 on State Road (SR) 1354 (Taylor Town Road) over Bear Swamp in Duplin County (WBS# 17BP.3.R.60). In February 2017, NCDOT requested that Cardno, Inc., complete an assessment of the National Register of Historic Places (NRHP) eligibility of certain structures within the Area of Potential Effects (APE) and provide this report.

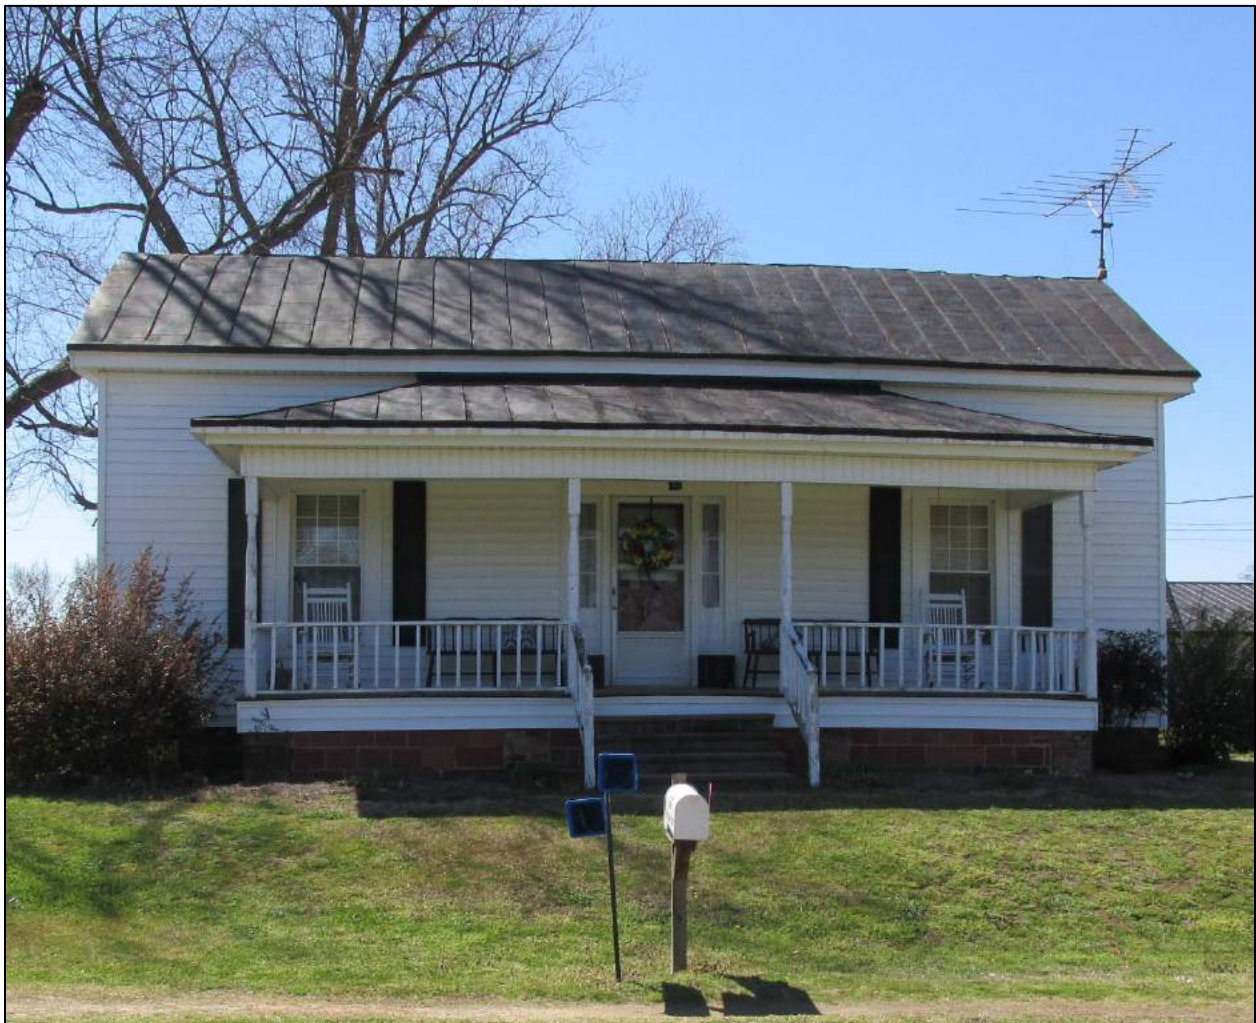
Figure 3. Ceness Taylor Farm House (597 Taylor Town Road). Main (northeast) elevation.

The main entrance faces Taylor Town Road and is through a half-light door with three-pane sidelights centered under a hip-roofed porch with a wood floor (see Figure 3). Ornamentation includes turned posts with a symmetrical, plain balustrade and matching stair railings. Secondary entrances are found on the south and west elevations, all served by concrete steps. While the side entrance is unsheltered, the rear stoop is shaded by a cantilevered gabled roof with braces (see Figure 8).

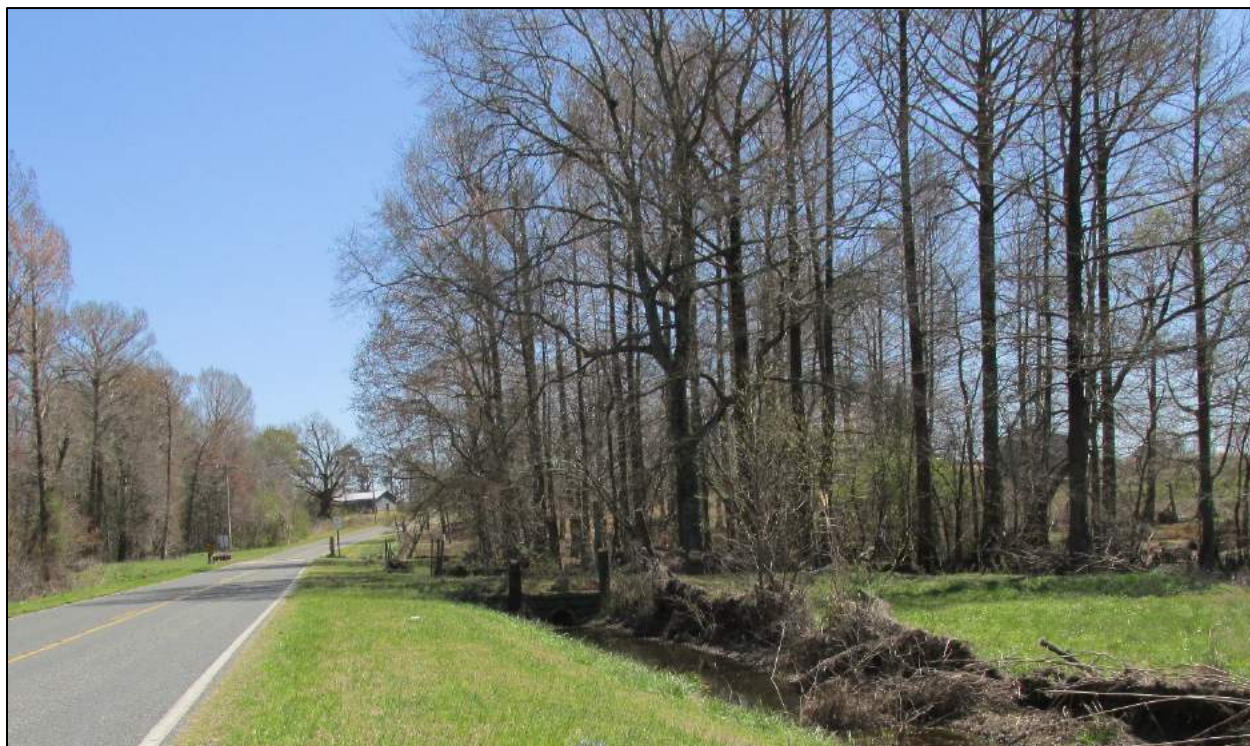
Figure 4. Northern boundary of Ceness Taylor Farm along Taylor Town Road, view of Bear Swamp with barn roofs partially visible through trees.

The Ceness Taylor Farm is located south of Faison on the southwest side of SR 1354 (Taylor Town Road) on a parcel bisected by Bear Swamp (Figure 4). Today, the surroundings are rural, including pasture, fields, and other farmsteads. To the east and southeast are the historic Hill Family Cemetery, a modern house and older barn at 556 Taylor Town Road, and the NRHP-listed Buckner Hill Plantation. Bridge No. 219 carries Taylor Town Road over the main flow of Bear Swamp (Figure 5). The House Branch of this waterway runs behind the main cluster of buildings on the farm.

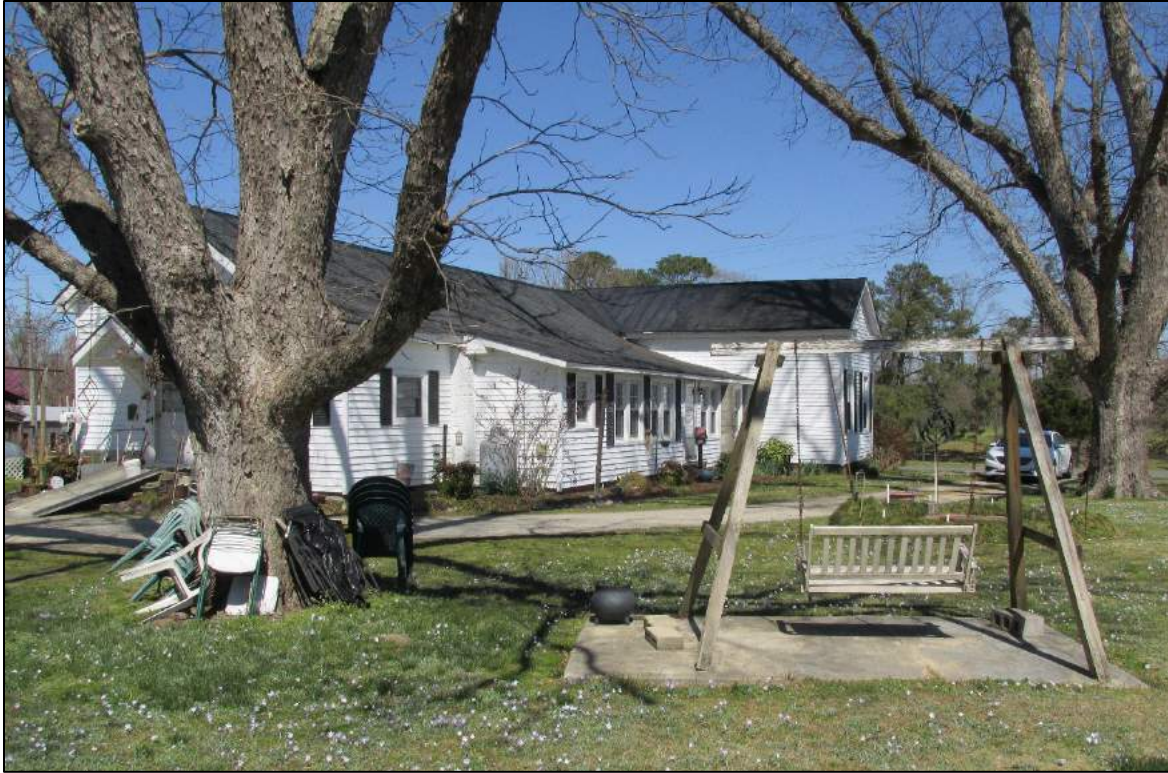
Figure 7. Rear and south elevations of house.

This is a central-passage-plan house, one-room deep, with a rear ell and at least two subsequent additions: a side shed-roofed room dating to the 1930s and a rear space built by Samuel Taylor in the 1950s (Figure 7 and Figure 8). According to Taylor, this is the building's original location. It rests on brick piers with hollow tile infill, except for the back room, which has a continuous concrete foundation. The exterior is currently covered with vinyl siding, and the eaves have been enclosed. The original siding would have been wood, and the 1993 structure form indicates that there was asbestos siding on the westernmost portion. The false shutters were added along with the vinyl siding. Three-quarters of the gabled roof is covered with metal sheets, with some wooden shakes remaining underneath. The rear quarter of the roof is clad with asphalt or composite shingles (Figure 9).

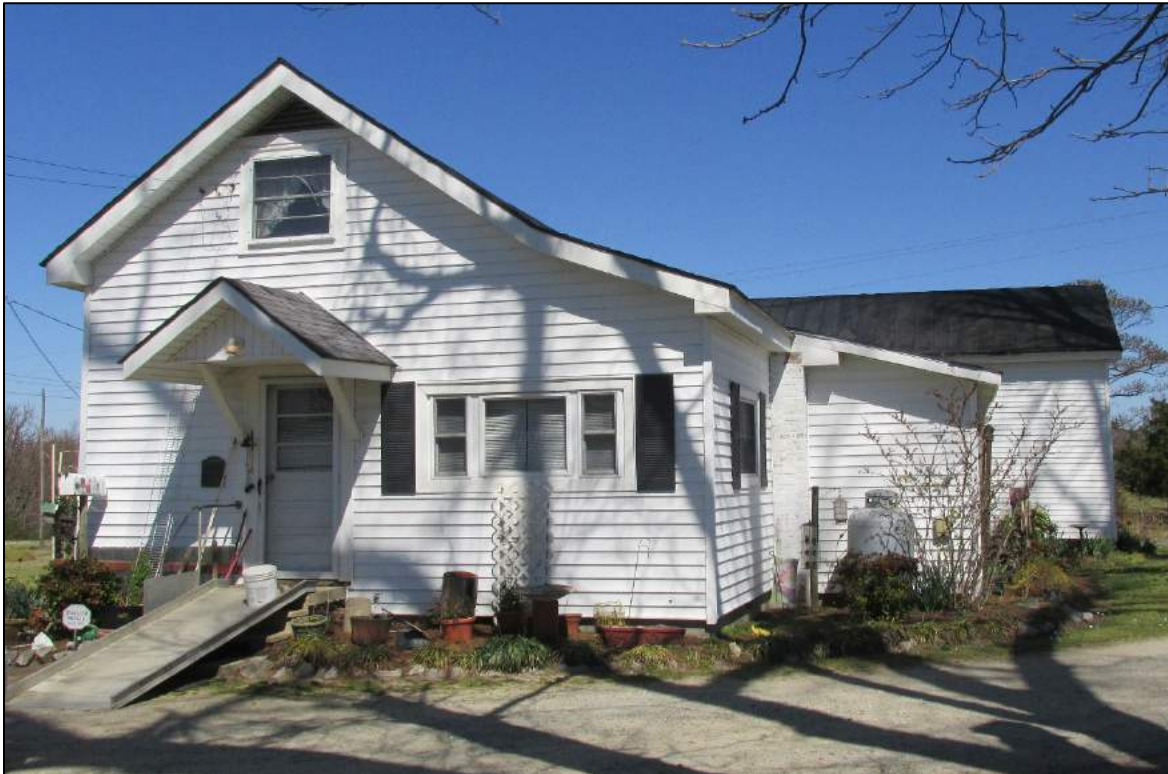
Figure 8. Rear elevation of house.

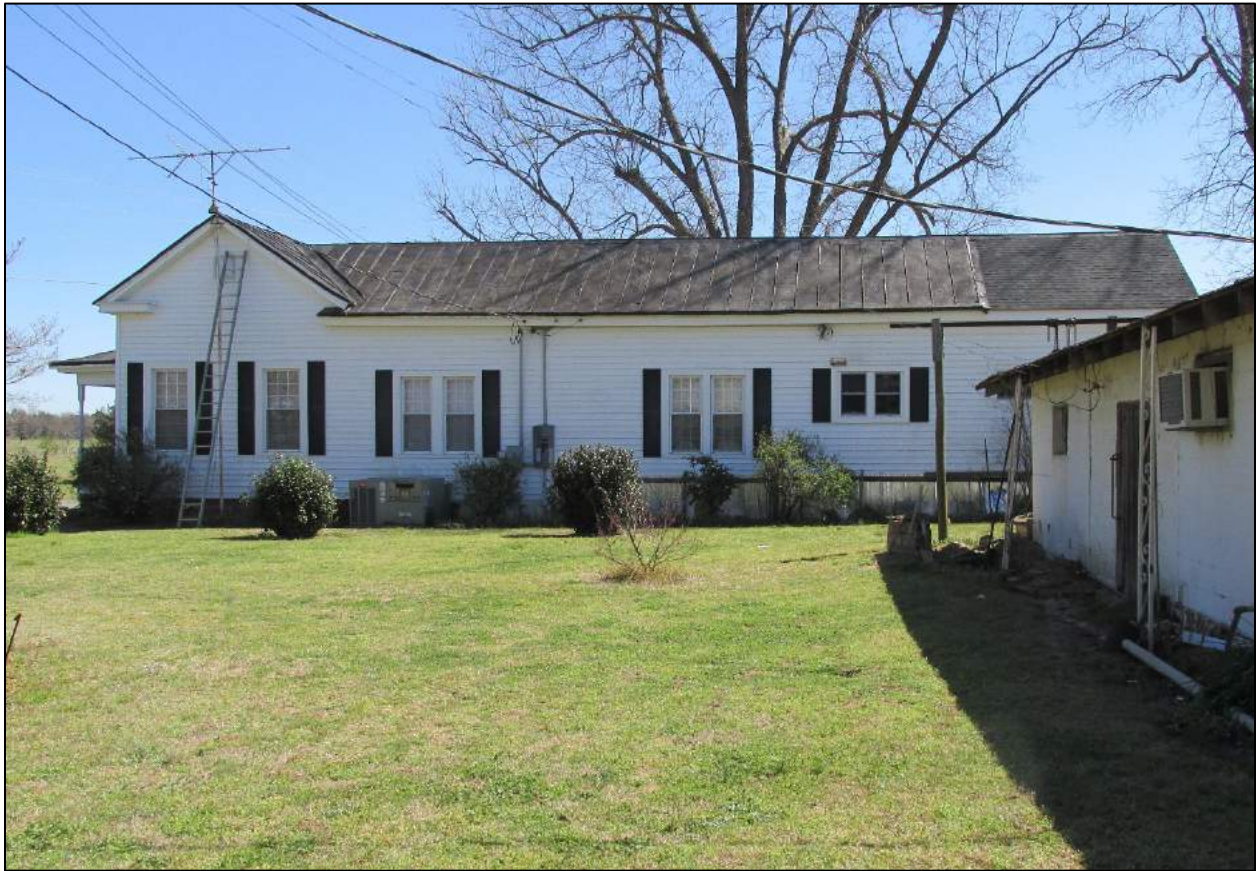
Figure 9. North elevation of house.

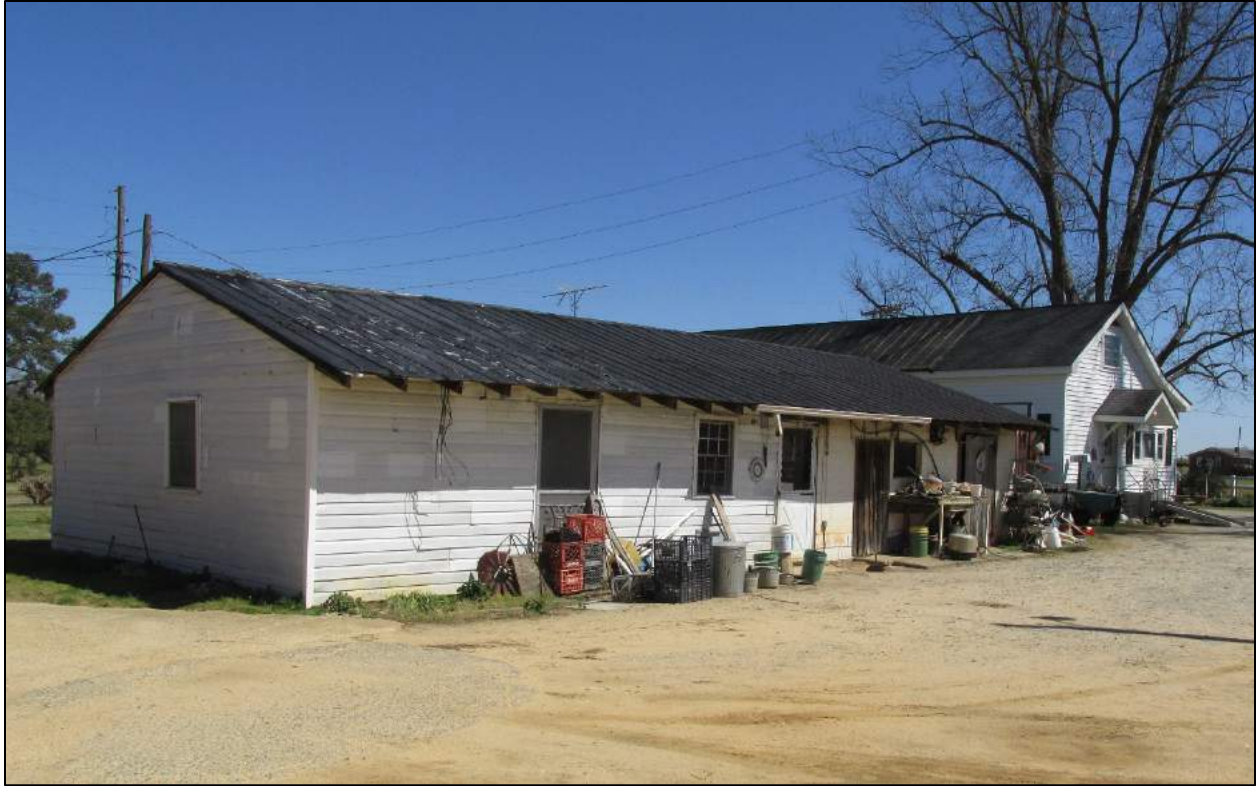
To the immediate north of the residence is a workshop also used as offices for Bear Swamp Taxidermy (Figure 10). The floor plan is three rooms in a row, beginning with the southern bay (originally the farm's pump house), which dates to the early twentieth century. The second room was added in the 1950s as a concrete-block carport on a concrete slab, but is now enclosed. Taylor built the final room in the 1960s for his taxidermy work resulting in a simple rectangular plan building with a side-gabled roof covered with 5V metal sheets. The southern gable is also covered with metal. The shop's exterior fabric is painted block and vinyl siding, with aluminum slider windows and six-over-six wood sashes. One vertical wood door is located on the east elevation where the eaves are wide enough that with wrought-iron supports it forms a porch over the entry. Each room has at least one door opening on the west elevation. The original pump house doors are wooden sliding doors hung from the top. The other two rooms have half-light panel doors with screens. There are small concrete pads along this elevation at the doorways, but no actual porch.

Figure 10. Workshop and house, looking southeast.

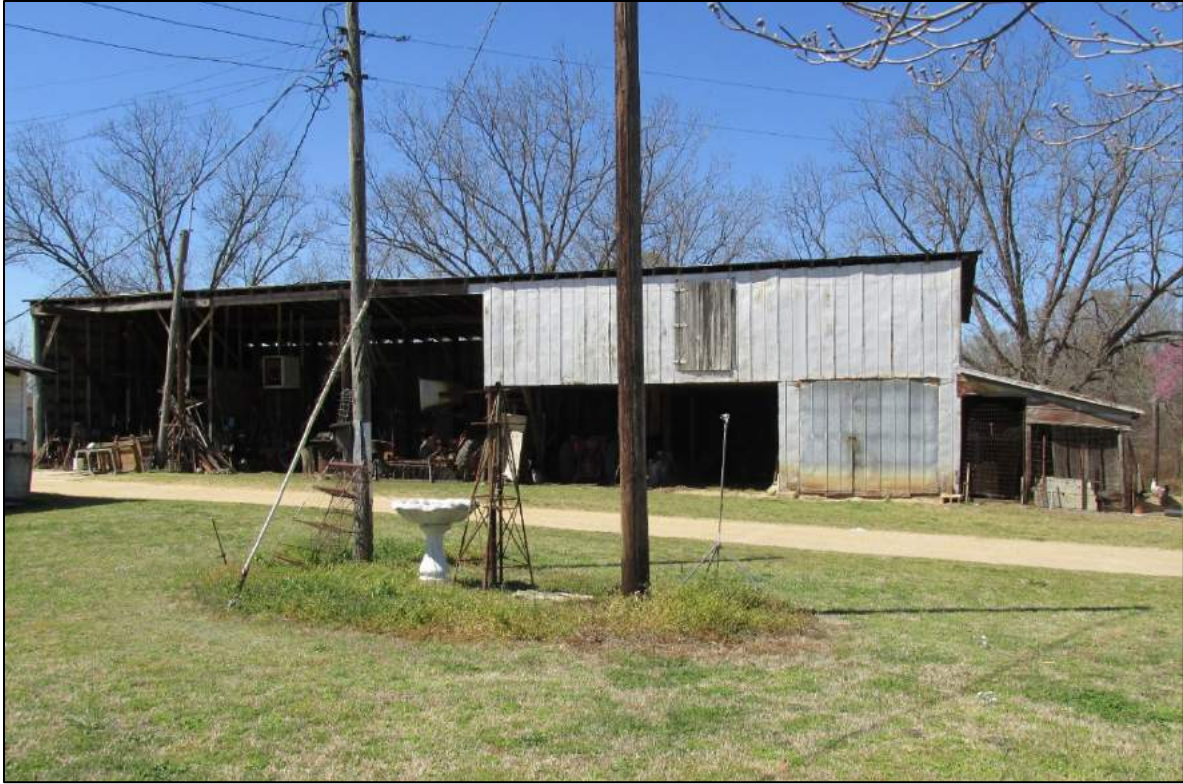
To the north of the workshop is a large rectangular six-bay pole barn built in the late-nineteenth or early-twentieth century (Figure 11). Three western bays are open to their full height on the south elevation, but the top half of the three eastern bays is enclosed as a loft. The bottom of the easternmost bay is enclosed as well, with a horizontal wood-plank wall. The exterior fabric, including that of the asymmetrical-gable roof, is 5V metal sheeting. The loft, which is accessed up wooden steps without risers, has a hinged wooden door with narrow vertical planks. The enclosed room on the lower level has a hinged double door covered with the same metal exterior fabric. On the eastern elevation is a shed addition, fenced, and currently used by Samuel Taylor to raise peacocks. To the immediate north of the barn is a fenced yard for the birds (Figure 12).

Figure 11. Barn to north of workshop.

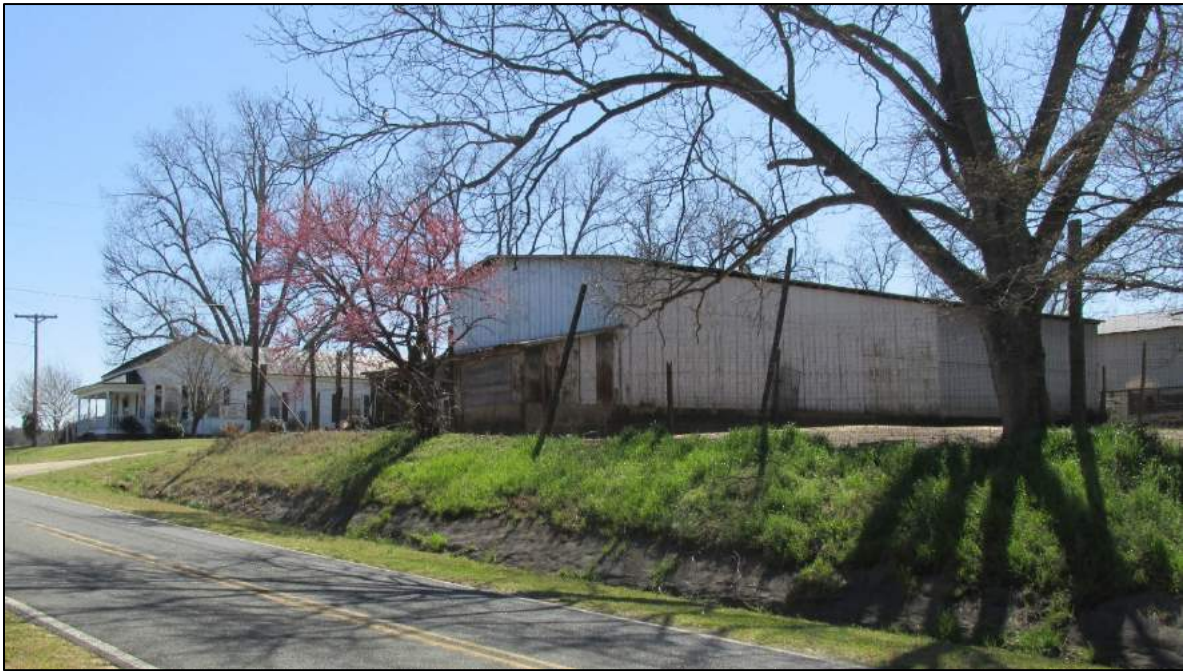
Figure 12. Barn and house on west side of Taylor Town Road.

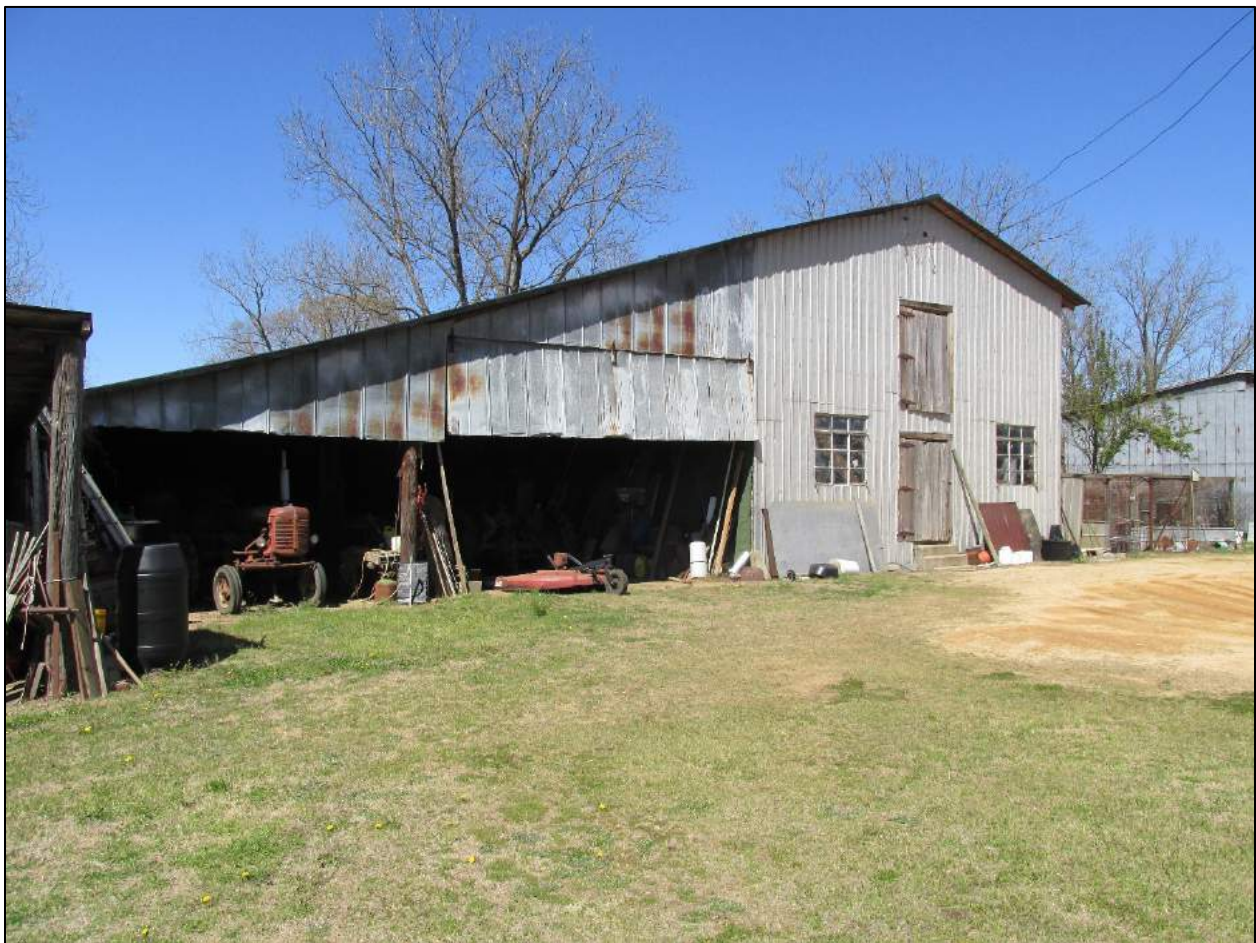
To the west of this large barn is another (Figure 13). Over the course of a century farm buildings come and go. According to Samuel Taylor, the original structure at this location was destroyed by Hurricane Hazel in 1954. The replacement was used as a pack house, but now for storage. A long shed addition to the west provides equipment shelter. The main body of the building has two levels, and twelve-light metal casement windows allow light into the lower floor. Concrete steps lead to a vertical-plank hinged door, with a similar opening for the loft above, centered under the gable. At the southwest corner of this barn is a flat-roofed open pole shed that appears to postdate the pack house and currently is used for storage (Figure 14).

Figure 13. Pack house with shed extension. Southeast elevation.

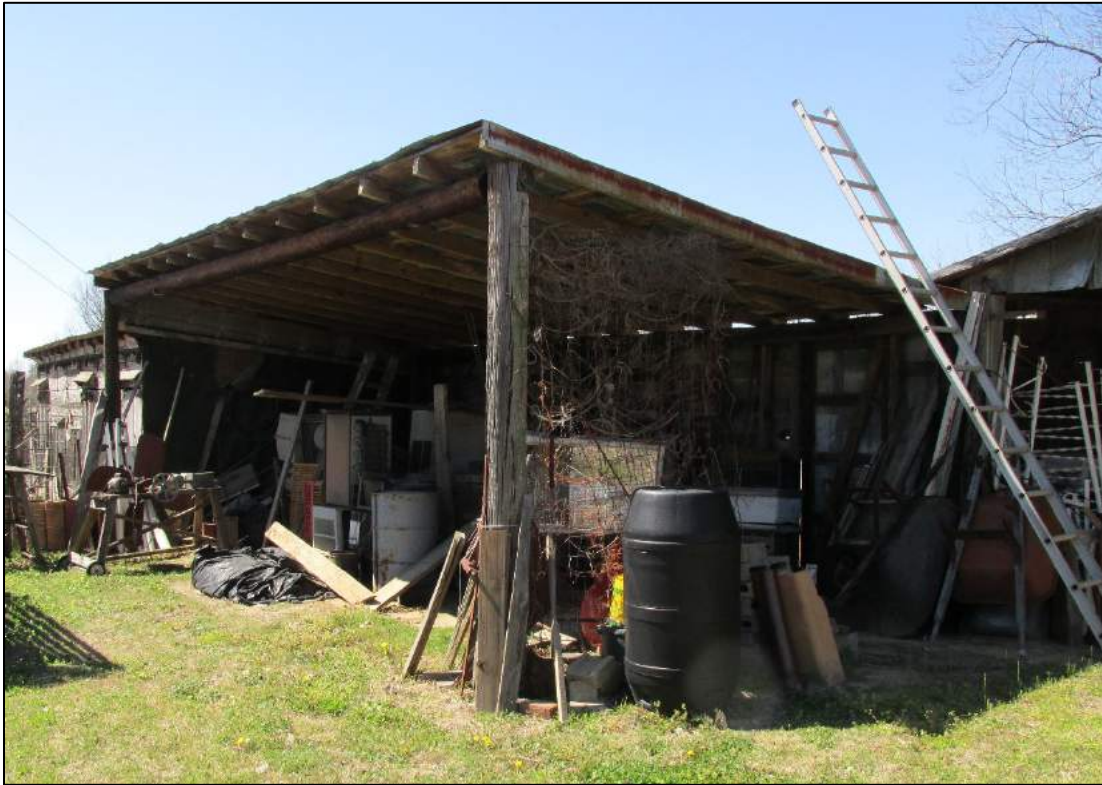
Figure 14. Pole shed. Southeast and northeast elevations.

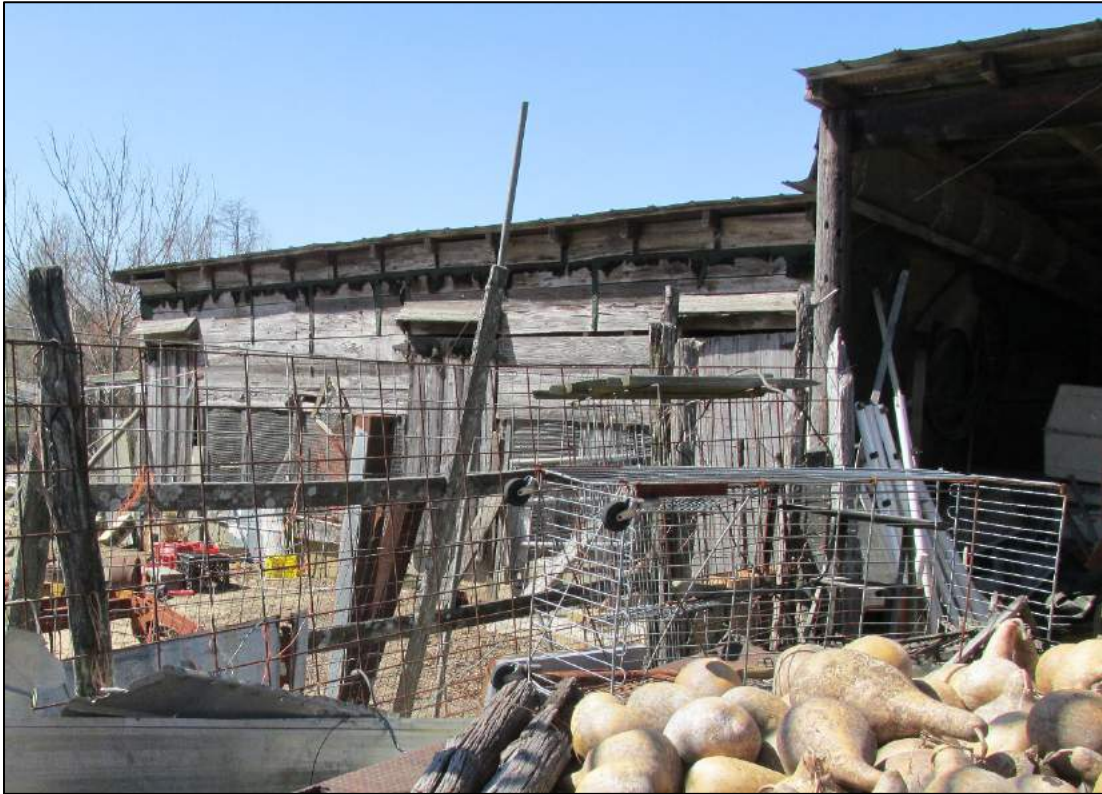
Adjacent to the west side of the pole shed but on the other side of a fence is a poultry house likely dating to the 1930s, a wooden framed structure with exterior horizontal-plank siding (Figure 15). Small wooden awnings are placed over each of three vertical-plank hinged doors on the south elevation; the lower half of this wall is screened for ventilation and there is a screened sun parlor to the west. The shed roof has exposed rafter tails. While not currently in use, the structure stands within a large poultry yard. The poultry yard is also used to store equipment. On the fence line between the open pole shed and the maintenance shed is a metal pole holding several gourd bird houses (Figure 16).

Figure 15. Poultry house. Southeast elevation.

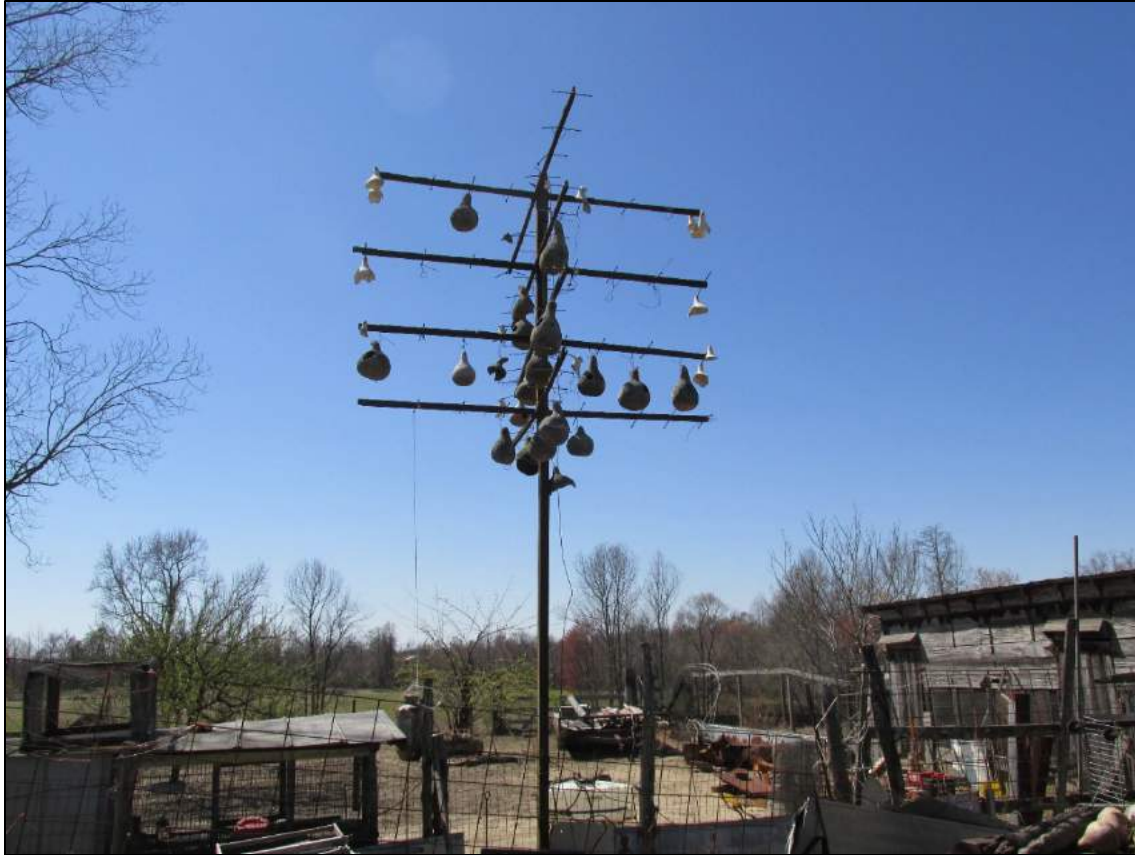
Figure 16. Poultry yard and bird houses. Looking west.

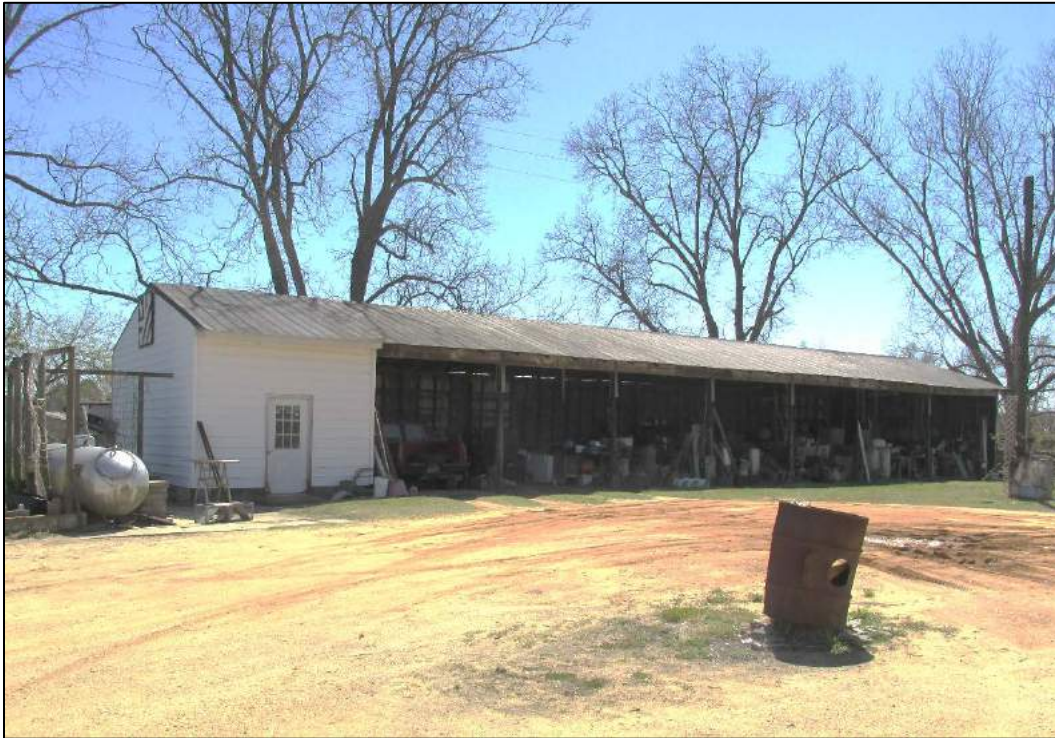
Across a dirt yard from the pack house is a long one-story maintenance or tractor shed dating to the early or mid-twentieth century (Figure 17). This is a seven-bay pole barn with an enclosed room on the eastern end that has a half-panel entrance on its north elevation and is covered with vinyl siding. The shed has a concrete floor, three sides covered with metal sheets, and the northern elevation left open. A brick furnace or cooker was built into one of the open bays (Figure 18). Metal sheets cover the gabled roof, leaving the rafter tails exposed. In the open yard between buildings are a pump and a burn barrel (Figure 19). The fenced poultry yard wraps around the back of the maintenance shed (Figure 20).

Figure 17. Maintenance shed. Northwest elevation.

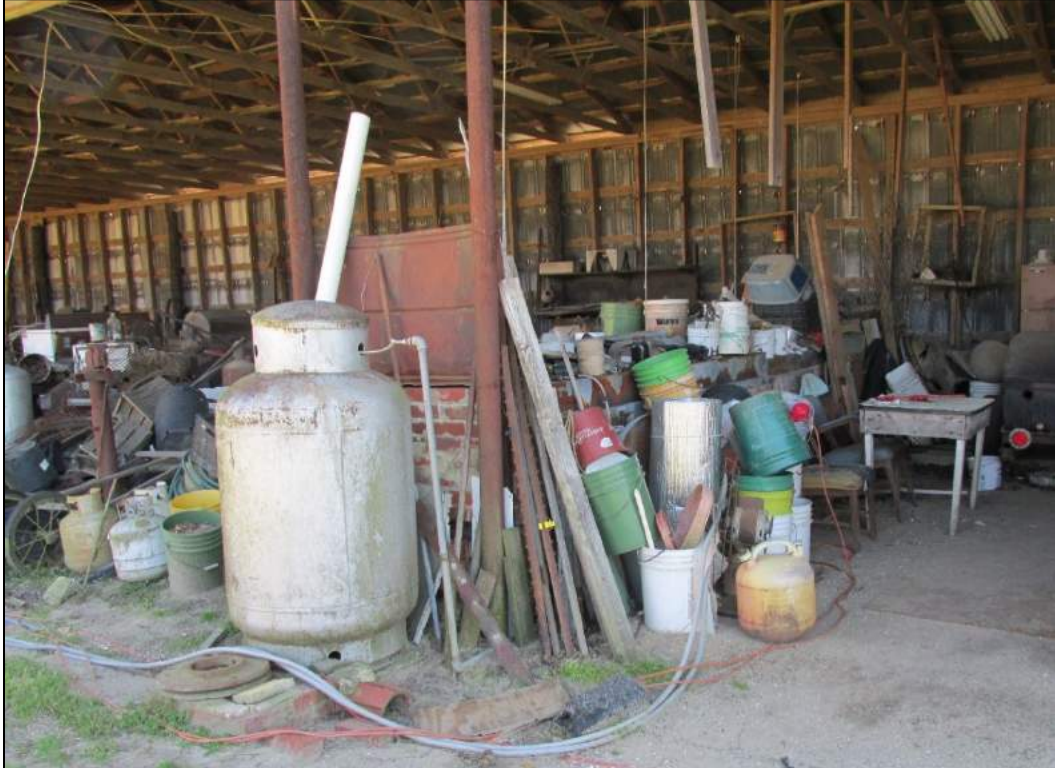
Figure 18. Interior of maintenance shed.

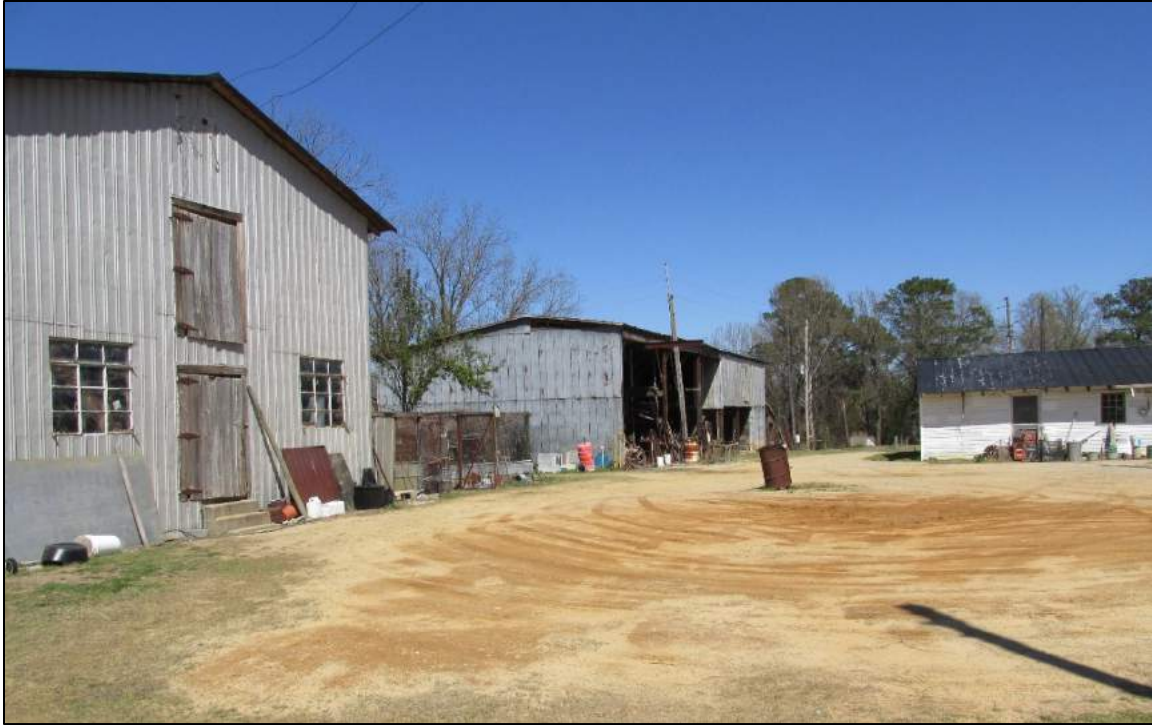
Figure 19. Yard and burn barrel between outbuildings. Looking northeast.

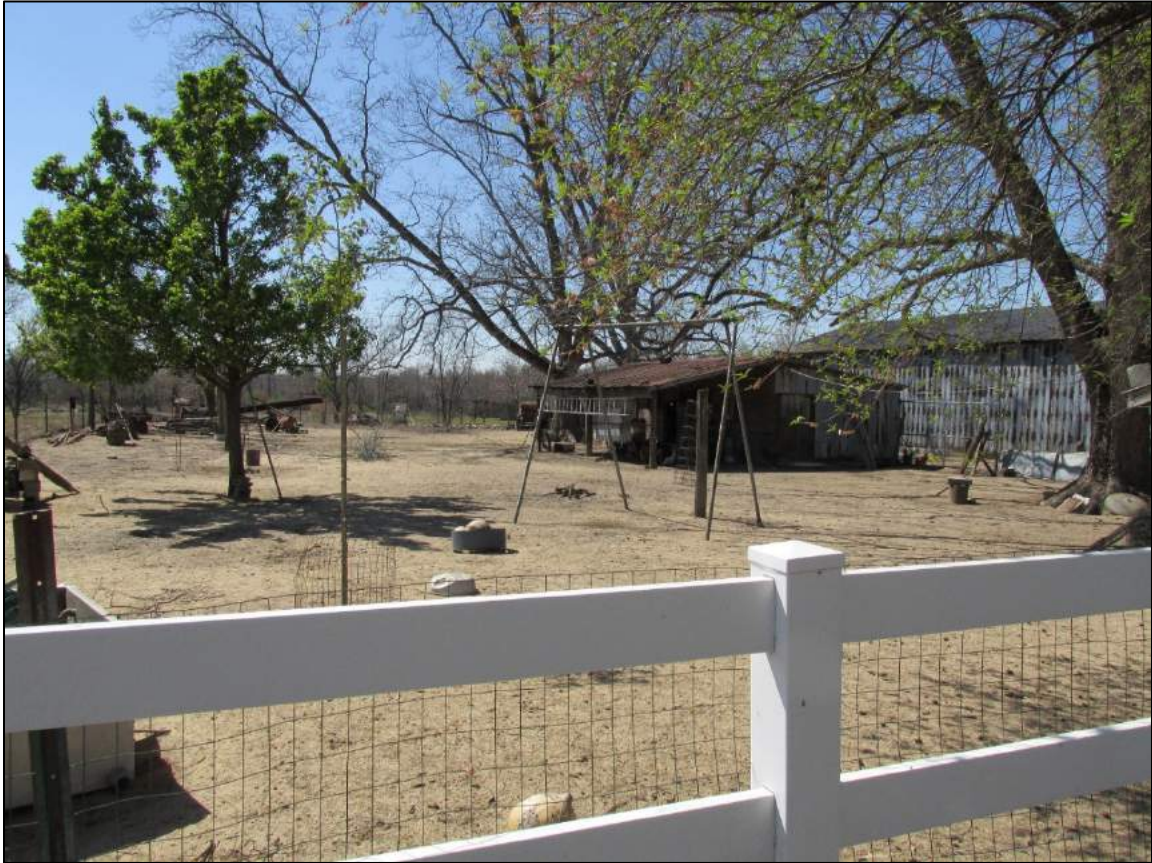
In the poultry yard to the north of the maintenance shed are two circa-1930s poultry houses. The chicken house is still in use (see Figure 20 and Figure 21), while the turkey house has been repurposed as a storage shed covered with vinyl siding and the windows and door replaced (Figure 22). In the 1920s, the state's Extension Service encouraged farmers to build poultry houses using standard plans distributed by their office, and laying houses were often placed near a farm's main residence for the convenience of the person caring for the chickens (Jull 1930; Oliver and Parrish 1925). Wood was a commonly used material as it was inexpensive. Part or all of the front wall of the structure would be left open depending on the need for ventilation, lighting, or warmth in winter. This chicken house is typical of shed-roofed laying houses with a human-sized doorway on the corner side, although a shed-roofed porch creates the appearance of a gable roofline.

Figure 20. Poultry yard and rear elevation of maintenance shed. Looking west.

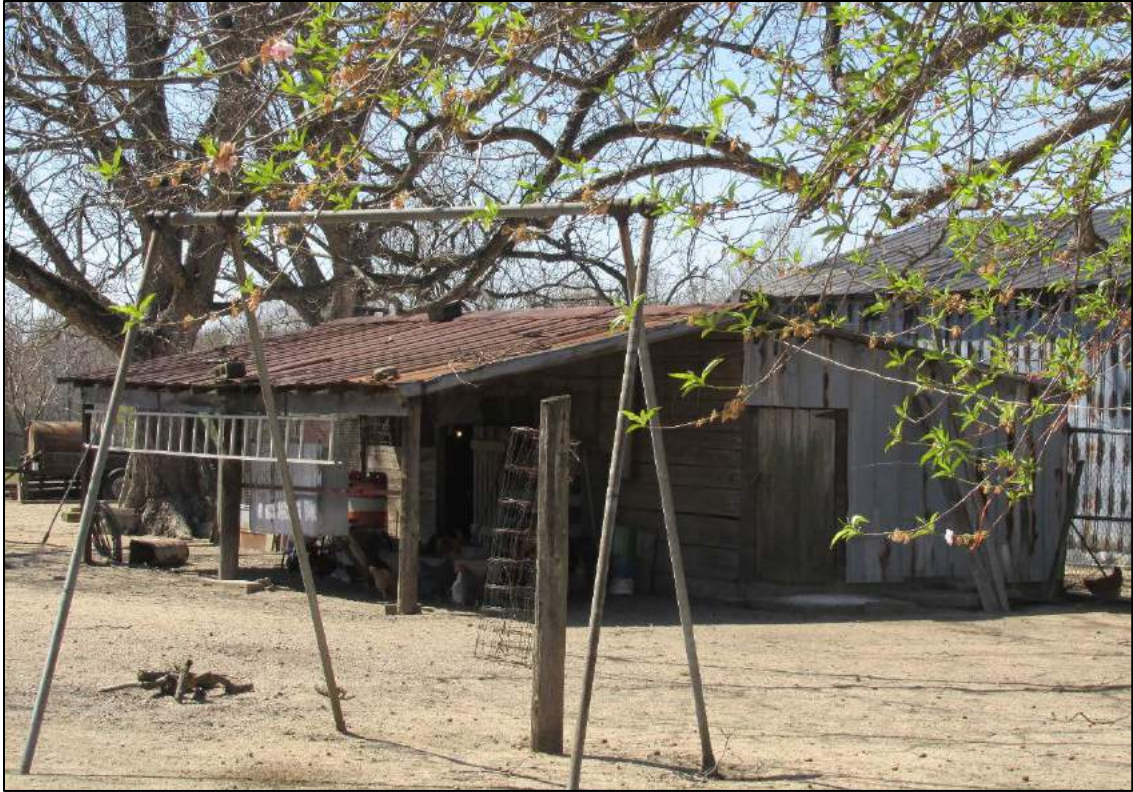
Figure 21. Poultry house. Southeast and northeast elevations.

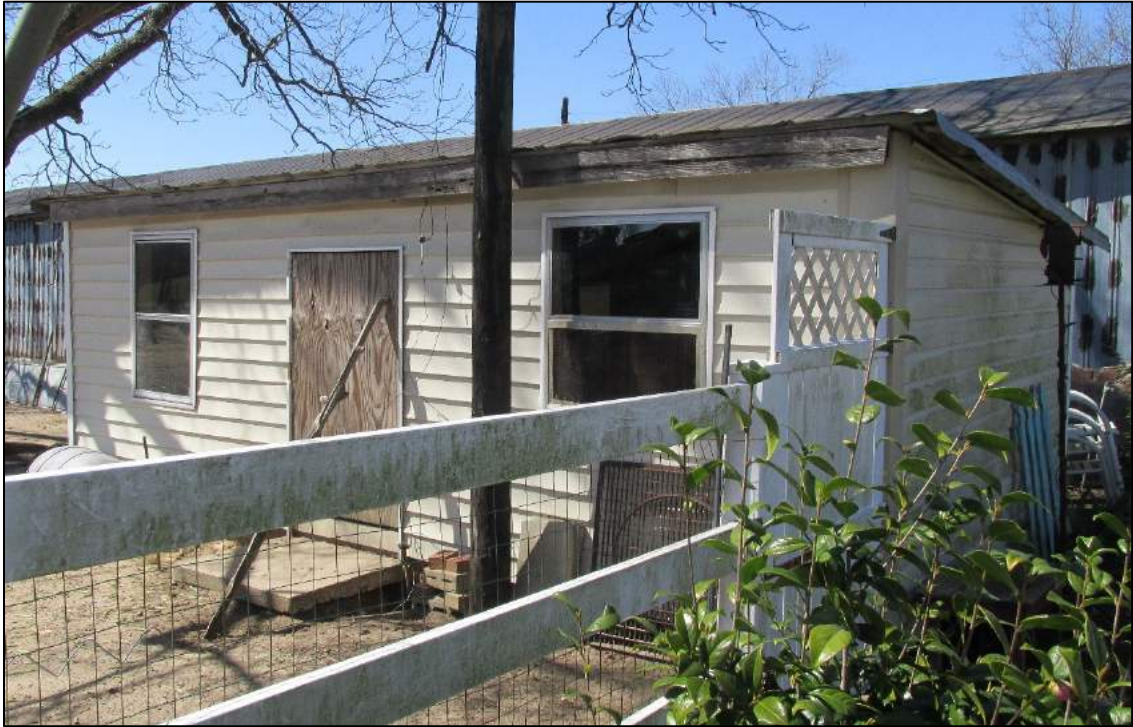
Figure 22. Former poultry house now used for storage. Southeast and northeast elevations.

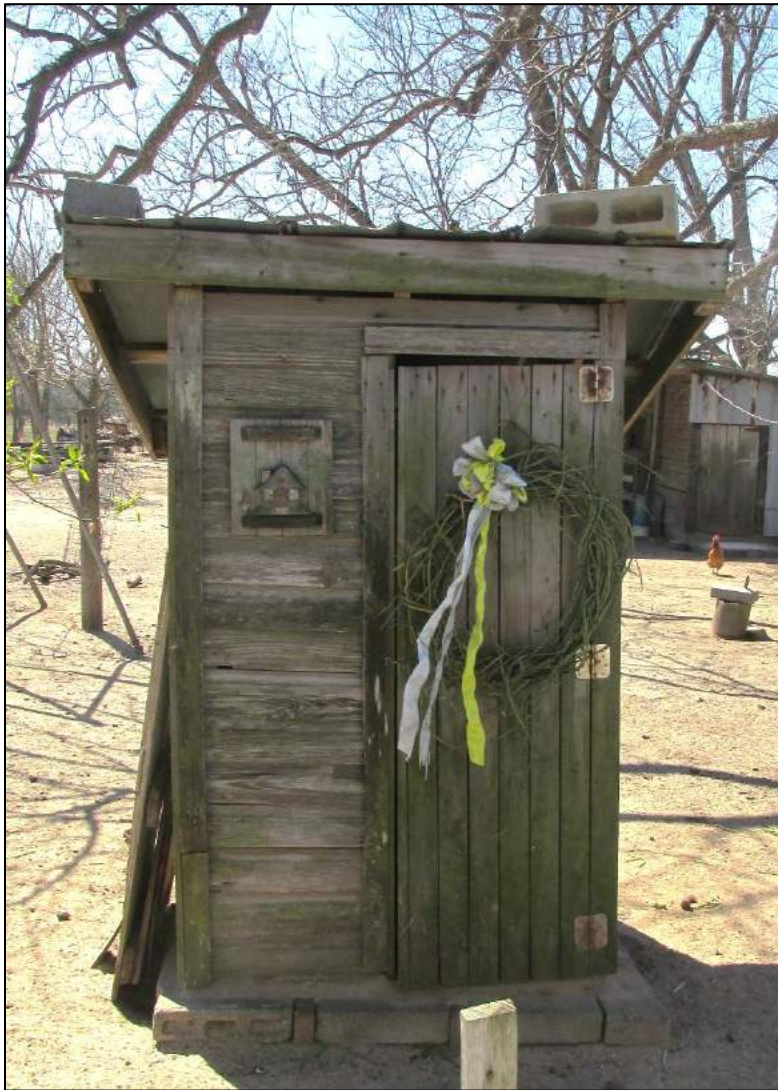
Also in the yard is the farm's privy (Figure 23). According to Taylor, the privy was moved from place to place when a new pit was needed. Now that it is no longer used for its original purpose, he has fixed it up to store garden tools. Based on a review of HPO records (Carnes-McNaughton and Harper 2000), this outbuilding is typical of North Carolina's early-twentieth-century rural privies, 91 percent of which were of frame construction and 40 percent had metal-covered shed roofs. The horizontal flush-plank walls of this example are less common than the more frequently found vertical-plank or weatherboard siding.

Figure 23. Former privy now used as garden tool shed. Northeast elevation.

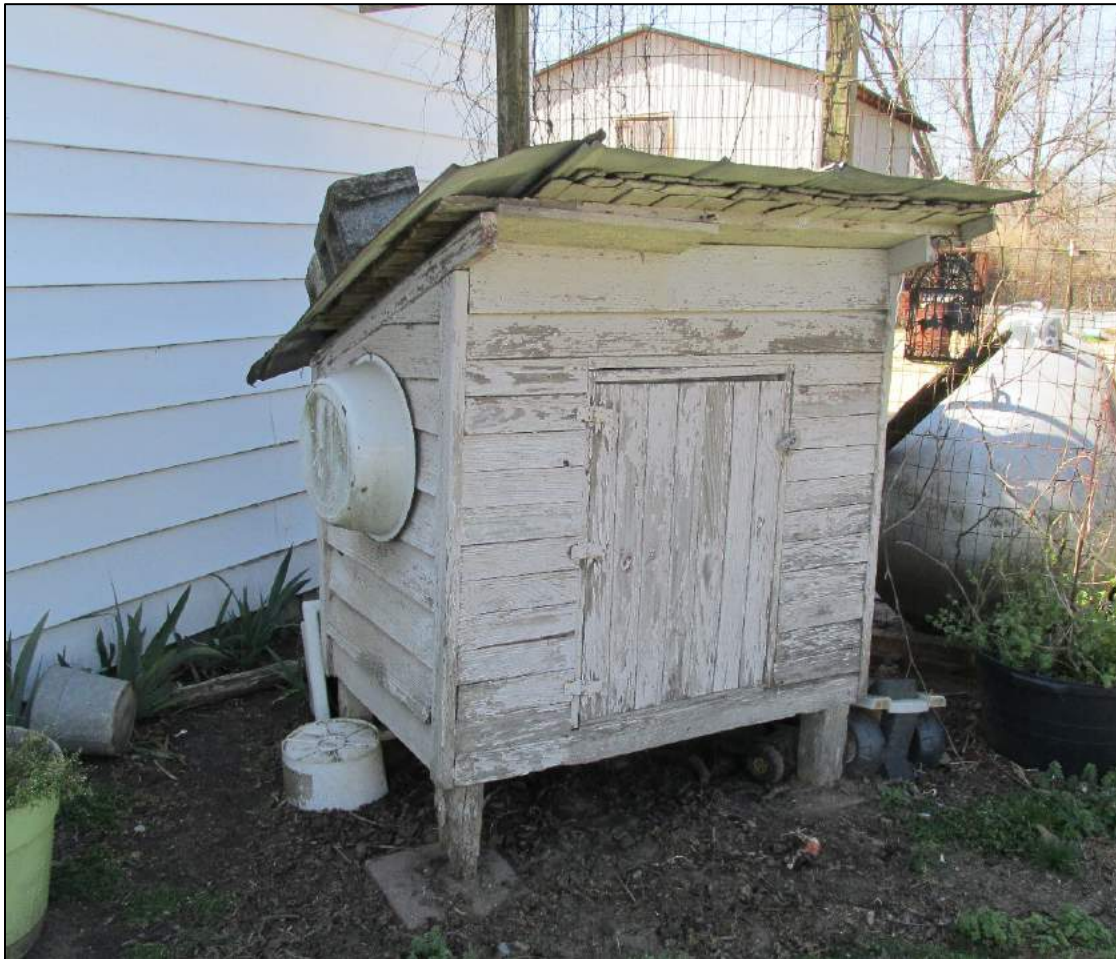
At the east end of the maintenance shed is found a small milk house, also known as a cool house or screen house (Figure 24). This structure is not original to this farm and was moved here from elsewhere by Taylor and repurposed as additional garden storage. Nonetheless, it does display a good degree of historic fabric, including wood shingles under a newer covering of 5V metal sheeting. This type of milk house is a small construction raised off the ground and used to keep food cool before refrigeration was widely available. This particular example resembles those at Portsmouth Village on the Outer Banks (Village Craftsmen 2014).

Figure 24. Milk house. Looking northwest.

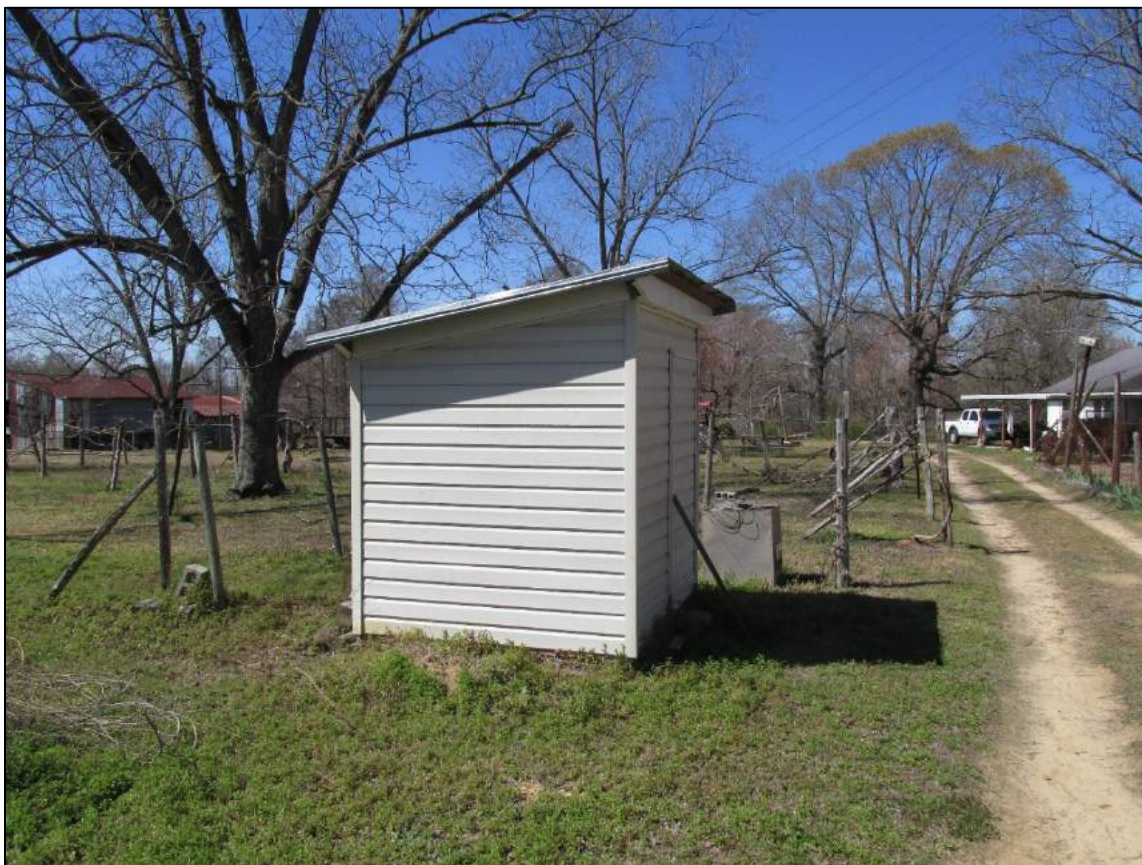
Continuing east from the milk house across the dirt yard and behind the former pack house stands a pump house and grape arbor (Figure 25 and Figure 26). The pump house is a frame structure on a concrete slab with a metal-covered shed roof. It appears newer than the nearby barns, but the exact date of construction is unknown.

Figure 25. Pump house. Looking northwest.
