SUBJECT: Historic Structures Survey Report for Replacement of Bridge 219 on SR 1354 over Bear Swamp, PA 16-12-0022, Duplin County, ER 17-0998

**Historic Structures Survey Report
Replace Bridge No. 219 on SR 1354 (Taylor Town Road) over Bear Swamp
Duplin County, North Carolina**

The North Carolina Department of Transportation (NCDOT) proposes to replace Bridge No. 219 on State Road (SR) 1354 (Taylor Town Road) over Bear Swamp in Duplin County (WBS# 17BP.3.R.60). In February 2017, NCDOT requested that Cardno, Inc., complete an assessment of the National Register of Historic Places (NRHP) eligibility of certain structures within the Area of Potential Effects (APE) and provide this report.

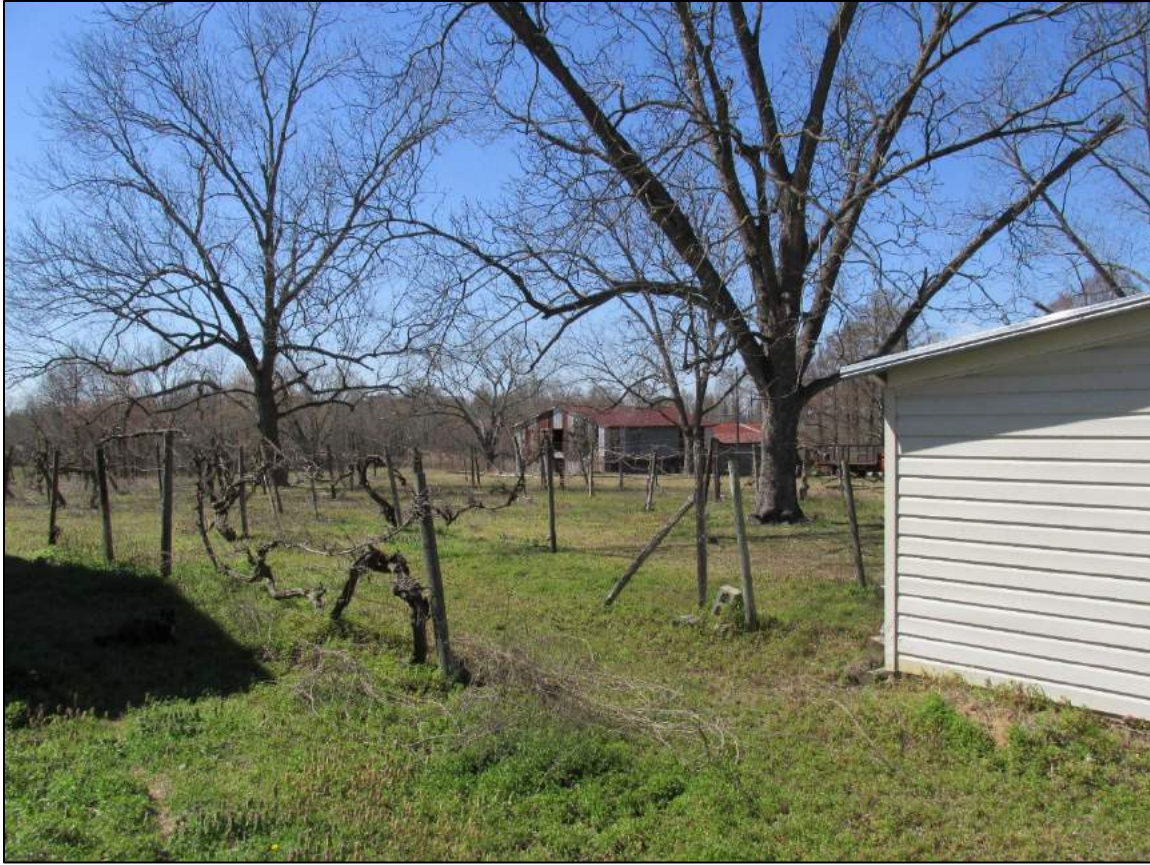
Figure 26. Grape trellises. Looking west.

Muscadine wine has a long history in North Carolina. Locally, Louis Froelich produced scuppernong wine in Kenansville during the 1870s. When, in 1909, North Carolina declared a statewide prohibition on the production or consumption of alcohol, farmers lost a market for their fruit. Later, grapes were seen as a cash crop alternative to tobacco or cotton, with a resurgence in the 1960s and 1970s. Several Duplin County grape growers came together in the late 1970s to form what is now the Duplin Winery, the state's largest (Helsey 2010; Pinney 2005). The grape trellises on the Taylor farm are composed of wires stretched between unmilled wood posts, the end posts braced by additional timbers in a manner illustrated in the 1919 *A Manual of American Grape-Growing* (Figure 27). This is an older style seldom used today. While it is possible that grapevines have been cultivated here for 100 years with the trellis repaired with in-kind materials, this may be a mid- to late-twentieth-century expression of an older farming technique.

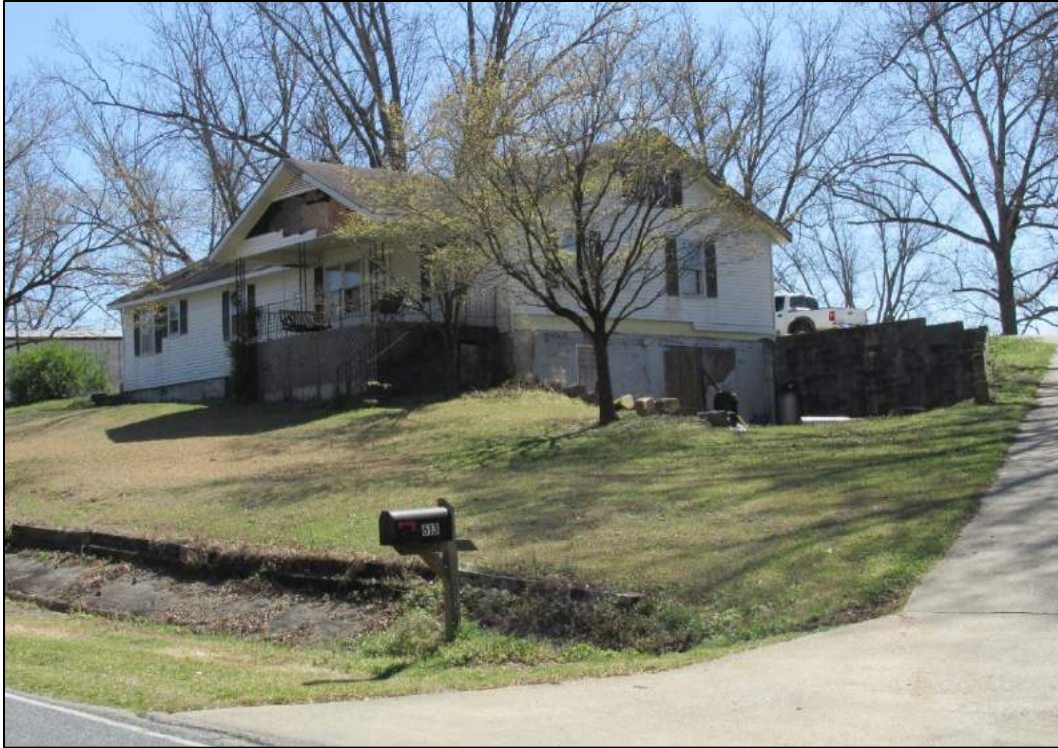
This is a side-gabled, one-and-a-half-story linear ranch house with a protruding gabled front porch. Ornamentation on the porch includes wrought iron columns and rails, with wooden lattice covering the porch foundation. Concrete steps with wrought iron handrails on the side of this porch provide access to the main entrance. The exterior is covered with white vinyl siding, part of which peeled off in a recent storm. Windows are single and paired two-over-two, double-hung sashes accented with false shutters. The building rests on a continuous concrete-block foundation. The roof is covered with composite shingles, and vents are located under the gable ends. The flat-roof open patio on the rear elevation has a view of the grapes (Figure 29).

Figure 28. Front and northeast elevations of 613 Taylor Town Road.

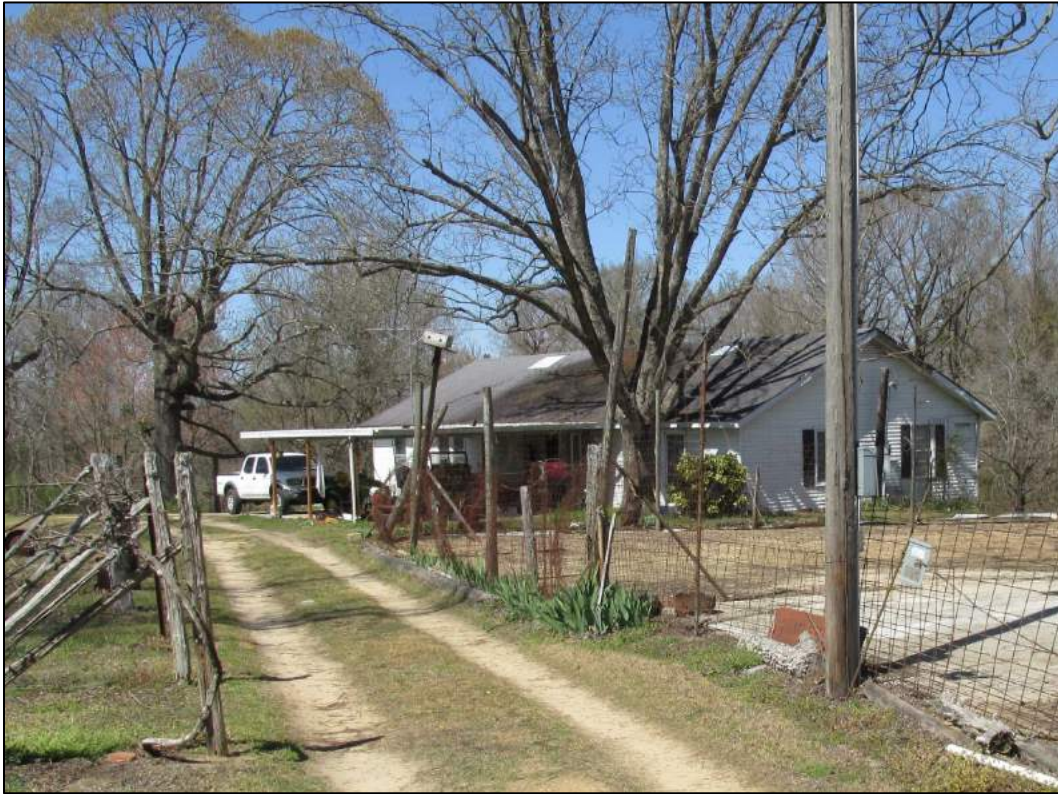
Figure 29. Rear and southeast elevations of 613 Taylor Town Road.

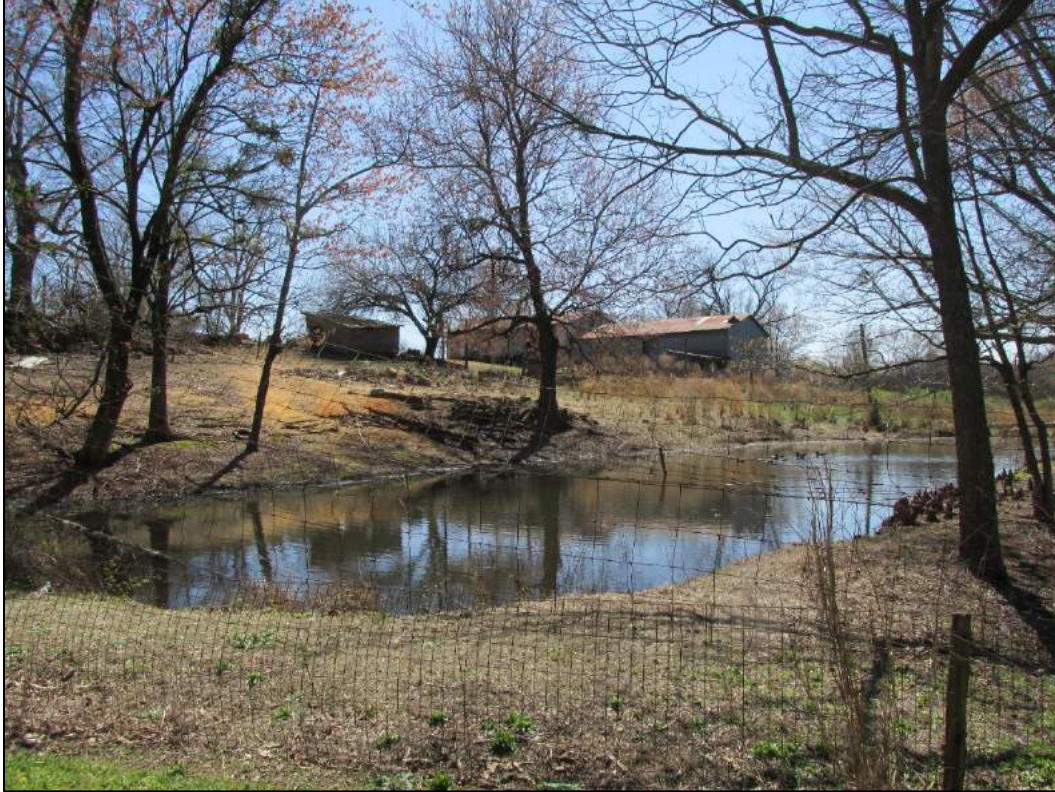
North of this house is a pond excavated by Taylor and his brother; Taylor now keeps ducks here (Figure 30). Nearby are an unused poultry house and a pair of gabled barns. The property card lists two swine houses on the parcel, one built in 1952 (1536 square feet) and one built in 1960 (1600 square feet), which may be these two barns, although they more resemble corn cribs. Both barns are built on a slope and are elevated on concrete piers (Figure 31). The poultry house has a sloping roof, weatherboard siding, and a corner entrance, similar to the example nearer the main house. This structure, however, has partially collapsed at one corner, possibly due to its location on a slope (Figure 32).

Figure 30. Pond. Looking southwest.

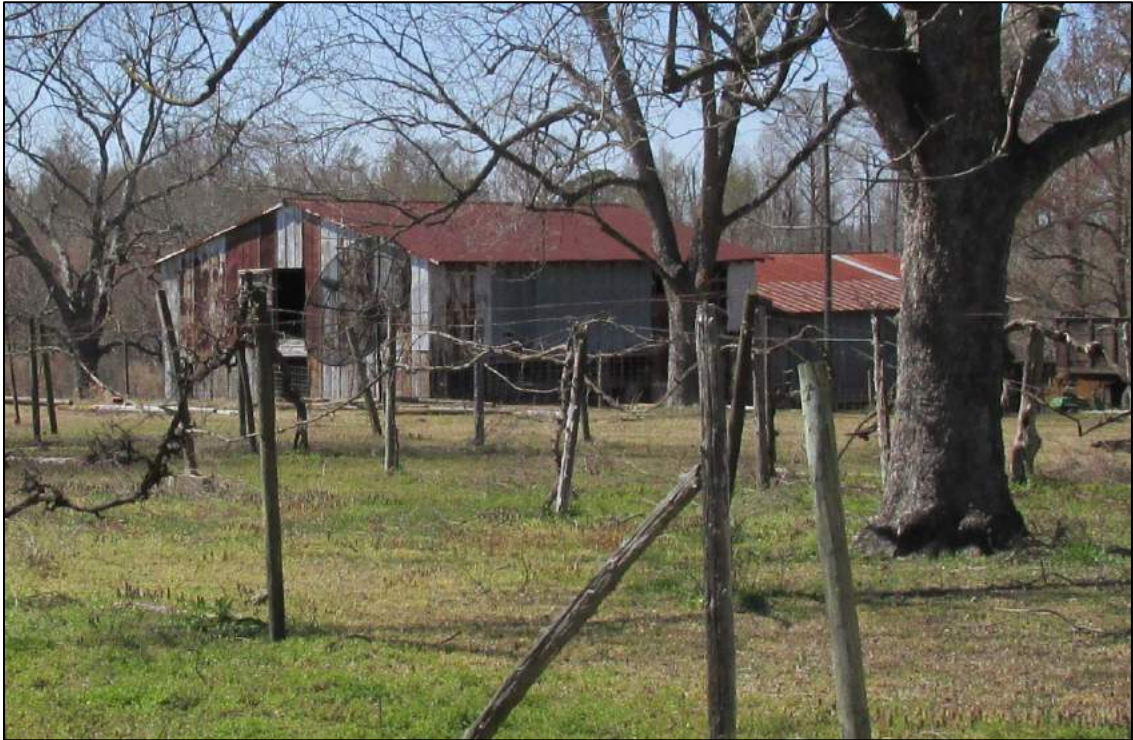
Figure 31. Pair of barns west of 613 Taylor Town Road. Looking northwest.

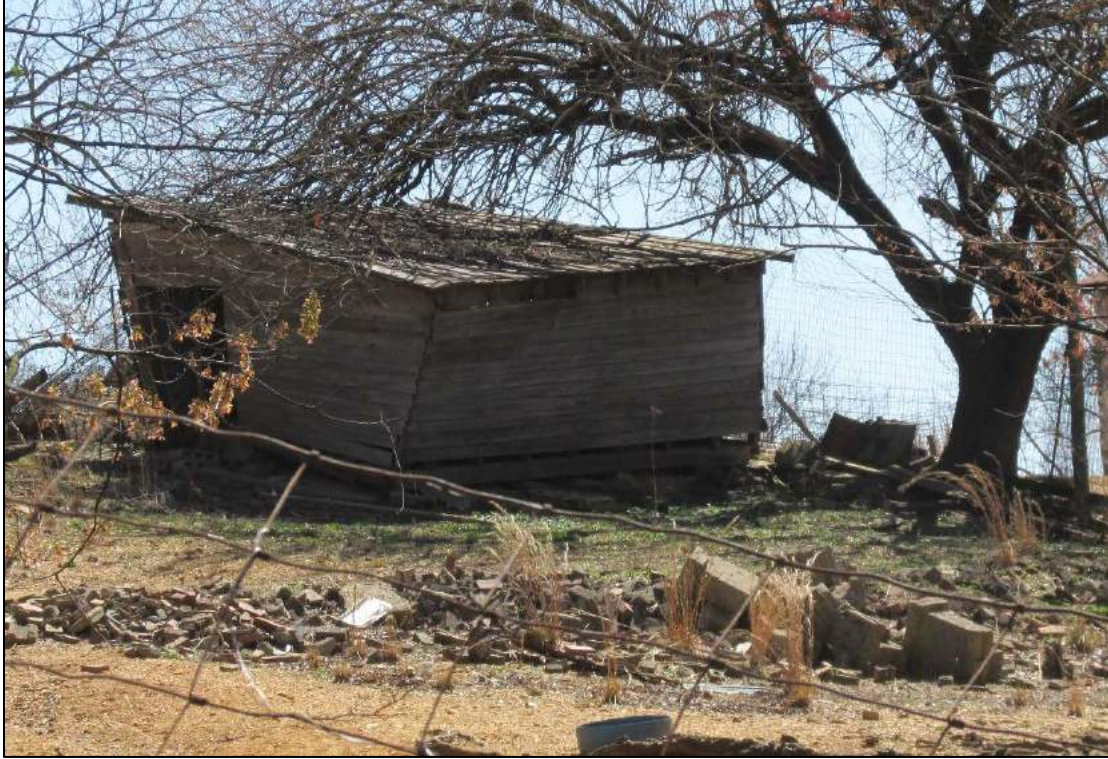
Figure 32. Poultry house by pond. North and east elevations.

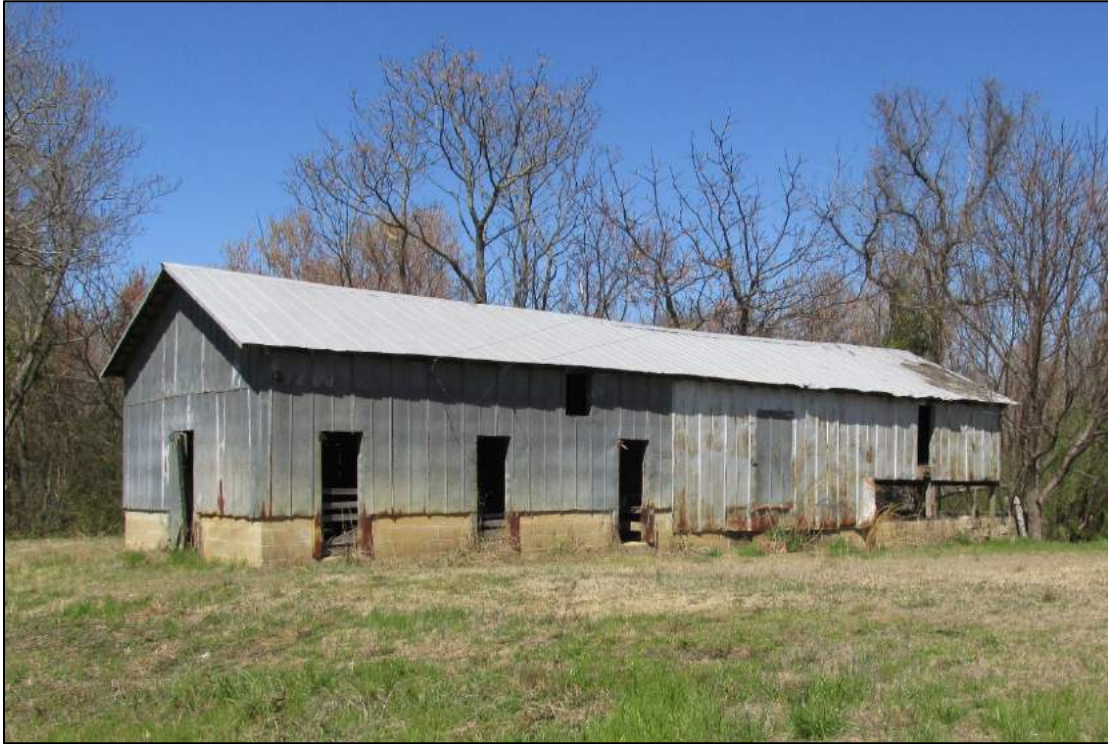
Just across Taylor Town Road from the ranch house is a barn formerly used by the Taylor family to raise hogs, 100 or so at a time (Figure 33). It does not stand on Samuel Taylor's property, although the land was originally part of the Bear Swamp Plantation and is still family owned. To the immediate south of the hog barn are foundations where other farm buildings once stood. Despite the proximity of the hog barn to the Ceness Taylor Farm (Figure 34), it is not part of this resource.

Figure 33. Hog barn. Southwest and southeast elevations.

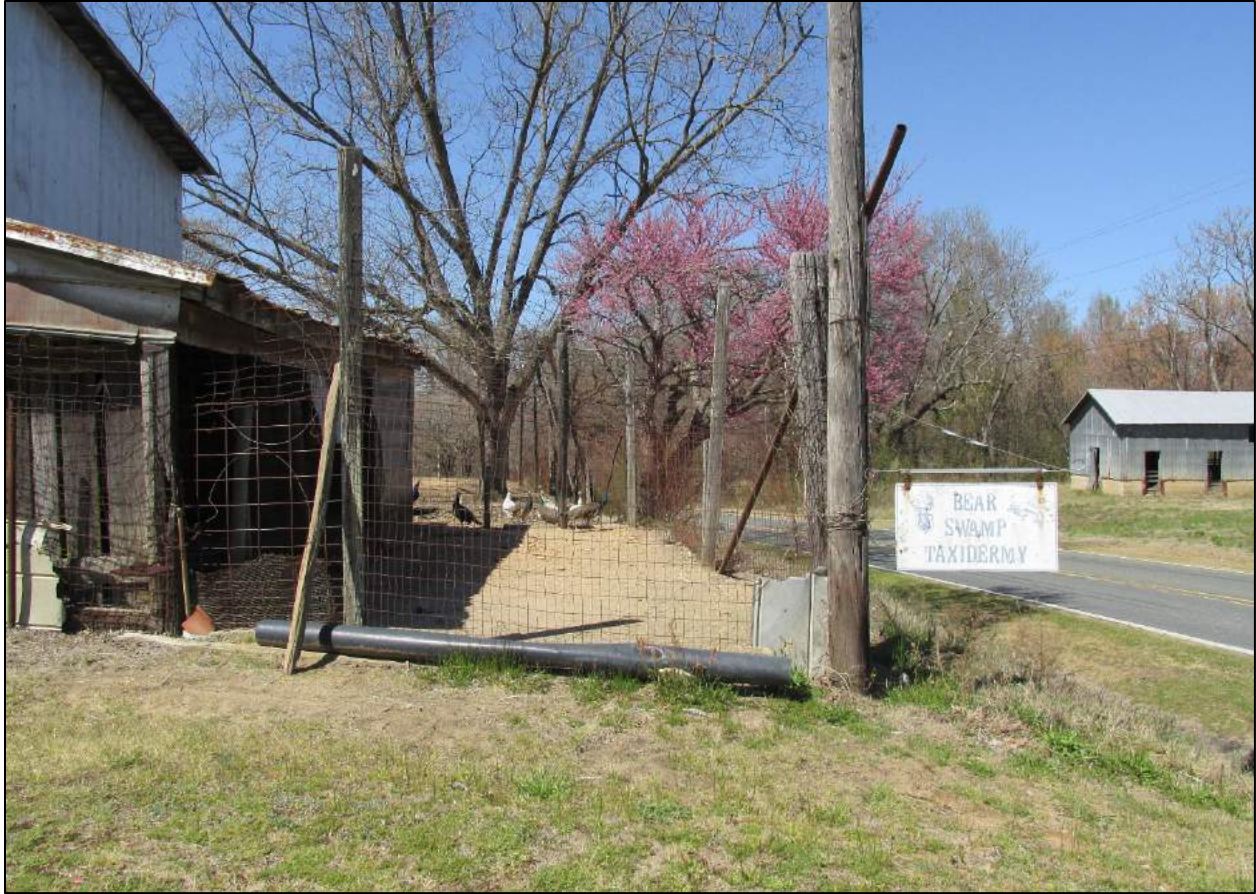
Figure 34. View looking north from the peacocks' sun parlor toward hog barn.

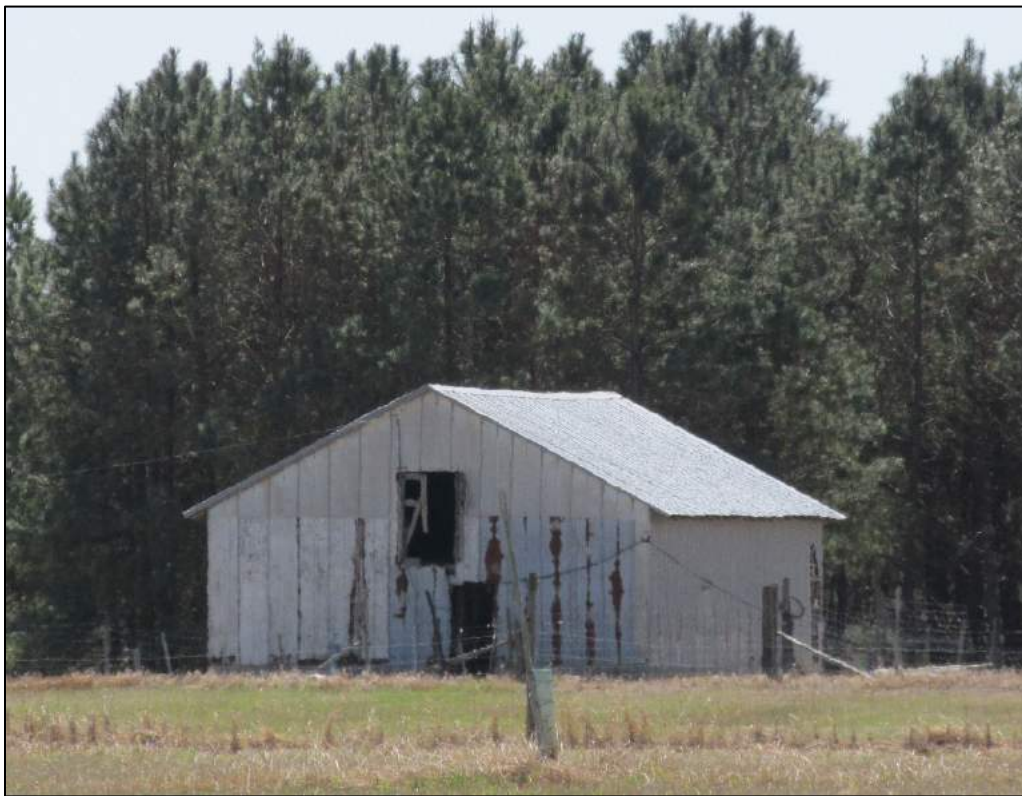
The larger of the buildings located to the north of the main farm complex is a transverse frame crib barn (Figure 38). Given the history of the area, it may have originally been built as a tobacco barn and moved here when no longer serving that purpose. Door openings are on the east and north elevations, with an opening into the loft centered under the eastern gable end. The land immediately around the barn is fenced.

Figure 38. Barn to north of Bear Swamp. Northeast and northwest elevations.

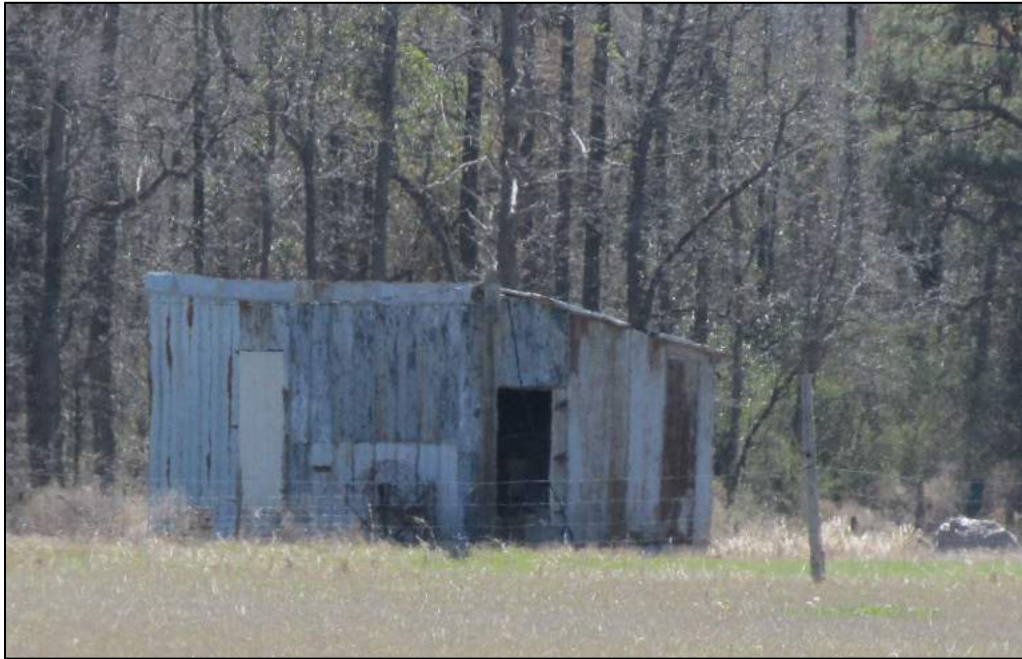
The smaller of the two buildings has square plan and a back-sloping shed roof, with a side door configuration that usually signifies a poultry house (Figure 39). Metal sheets clad the exterior walls and the roof. This building is also fenced to contain livestock.

Figure 39. Former poultry house north of Bear Swamp. Northeast and northwest elevations.

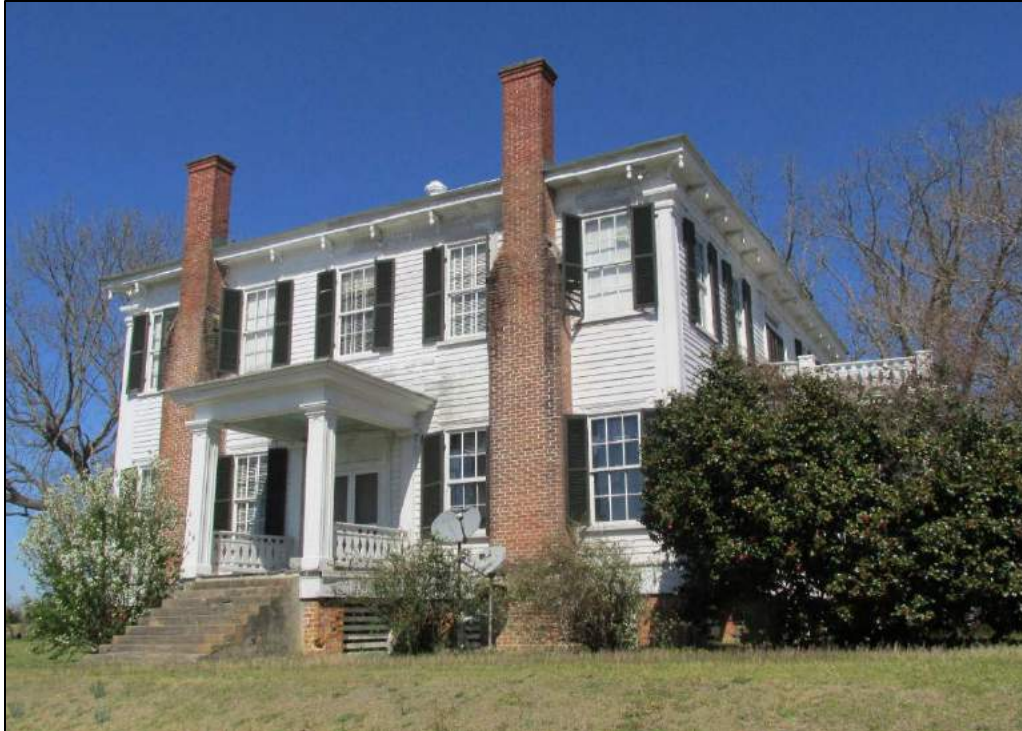
Thomas Hill was the first owner of Bear Swamp Plantation, subsequently inherited by his son Dr. Buckner L. Hill. Dr. Hill built a large Italianate house here in the 1850s (Buckner Hill Plantation, DP0001, NRHP Listed; Figure 40). He owned nearly 3,000 acres of land in Duplin County and was a stockholder in the Wilmington and Weldon Railroad, which provided him a means to transport goods to and from the plantation. Upon his death in 1860, Dr. Hill left “unto Isaac Wright and Halstead Bowden and to the survivors of them to the heirs executors administrators and assigns my piece of land in Duplin County on the south side of Bear Swamp, where my new dwelling house is with the tenements hereditaments & appurtenances, And also my piece of land Known as the Mill tract on the north side of Bear Swamp (said tract having been bought by me from W.D. Pearsall...). To Have and To Hold The said negroes and lands upon the confidence and in Trust for the use benefit and behalf of my son Thomas B. Hill, sometimes called Thomas B. Stephens, and his wife Betsy" (Little-Stokes 1975; Martin 1994; Scott 2001). Family lore has it that Thomas B. was the illegitimate, but recognized, son of Dr. Hill and Jakey Wilkins Stephens, who worked for him as a maid (Scott 2001).

Figure 40. West elevation of Buckner Hill Plantation.

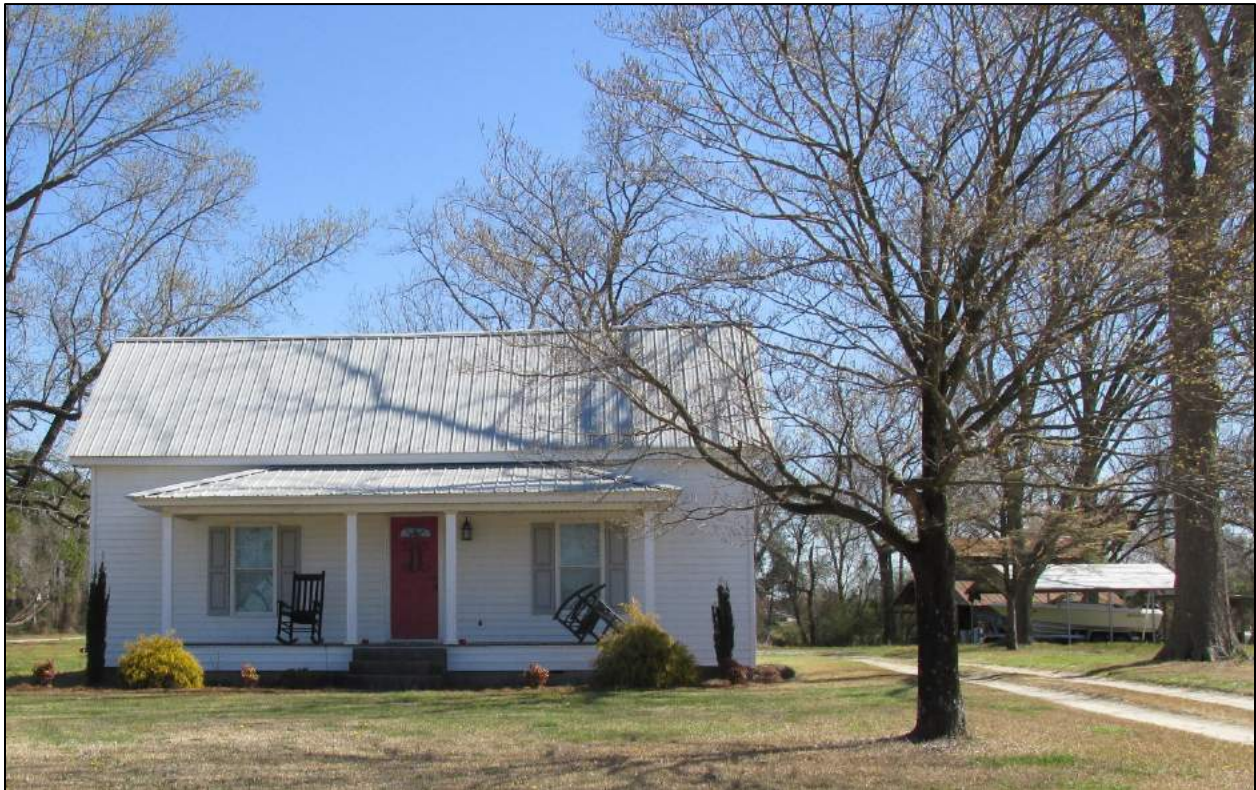
The Chester Houston Farm (DP0232) stands along SR 1701 near Sarecta in Smith Township east of Kenansville (Figure 44). This one-story, one-room deep house gains additional living space from an ell extending from the rear. Alterations since this circa 1918 structure was recorded in the early 1990s include replacement of the pressed-metal roof with standing seam metal, removal of the two end chimneys, and loss of the porch balusters (Martin 1999:199). Vinyl false shutters have been added to all the windows. One historic outbuilding remains, a pack house (Figure 45).

Figure 44. Chester Houston Farm. West elevation.

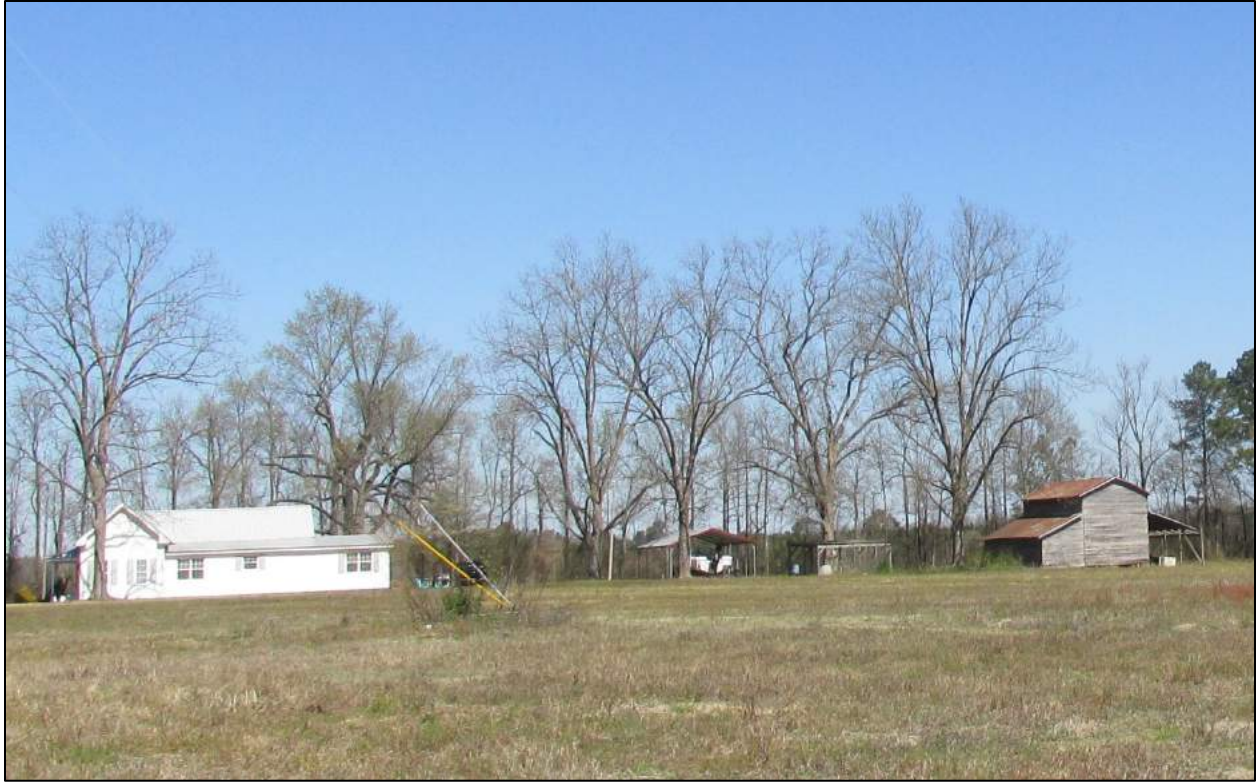
Figure 45. Overview of Chester Houston Farm, including remaining pack house. Looking northeast.

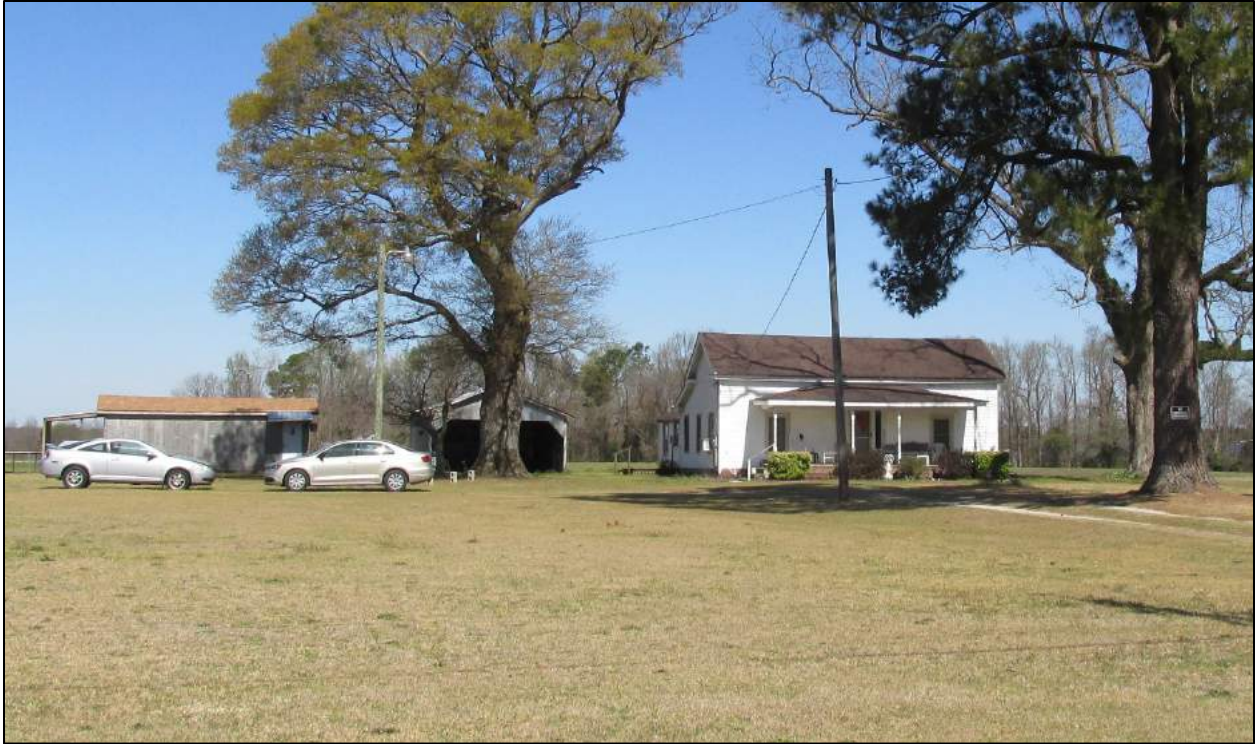
The Ben Williams House (DP0276), also on SR 1701 near Sarecta, is a slightly earlier example of this type, built contemporaneously with Ceness Taylor's house (Figure 46). Although the circa 1884 structure was well-preserved when recorded in the early 1990s, it has since suffered the loss of two gable-end chimneys and replacement of the metal roof with composite shingles (Martin 1999:201). Like the Ceness Taylor house, it displays turned posts under a hipped porch with sidelights flanking a centered doorway.

Figure 46. Ben Williams House and outbuildings. Looking west.

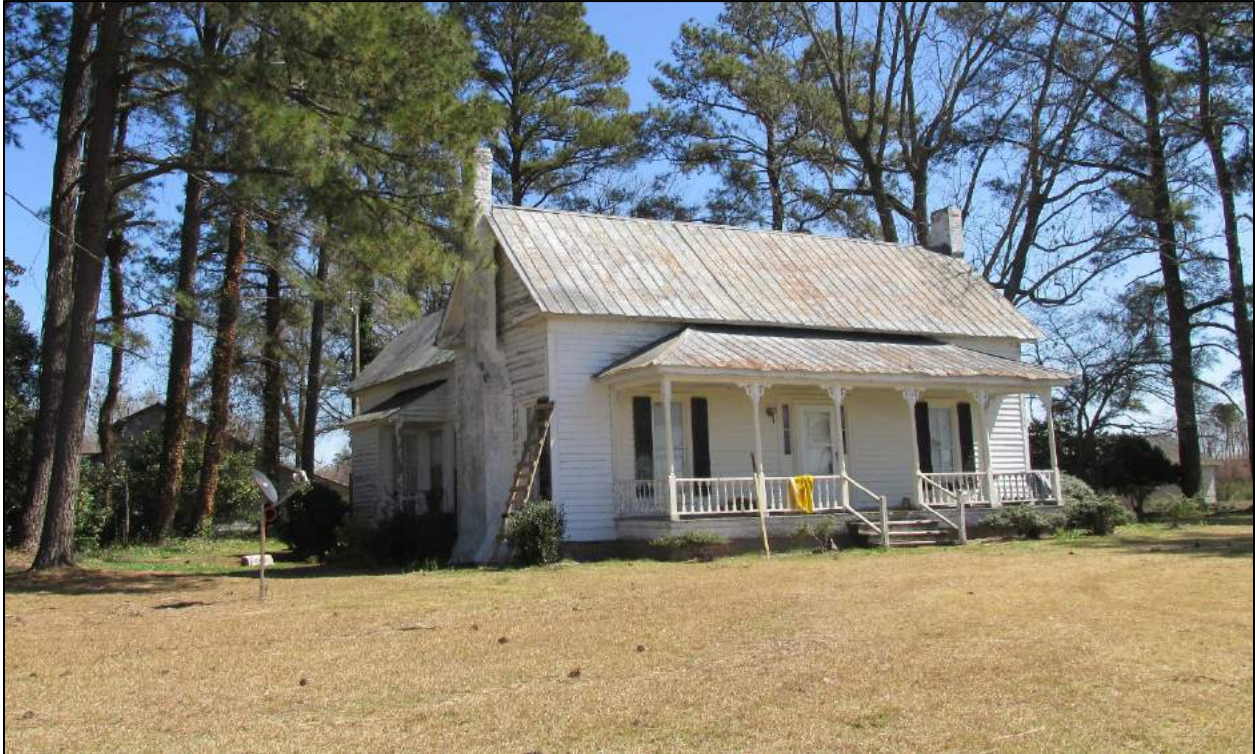
The Robert Wells Farm (DP0402) on Cornwallis Road near Corinth Church in Rose Hill Township is a more intact and elaborate example of the house form than the examples mentioned above (Figure 47). The exterior fabric is wooden siding with a metal roof, and the turned posts, balustrades, and sawn ornaments remain as does the original chimney on the north gable end. Again, a rear-extending ell provides additional living space. Robert Wells built this residence in 1902 as part of a farmstead on which the family produced strawberries and tobacco (Martin 1999:178-179). Some historic outbuildings stand near the house.

Figure 47. Robert Wells Farm. Looking southeast.

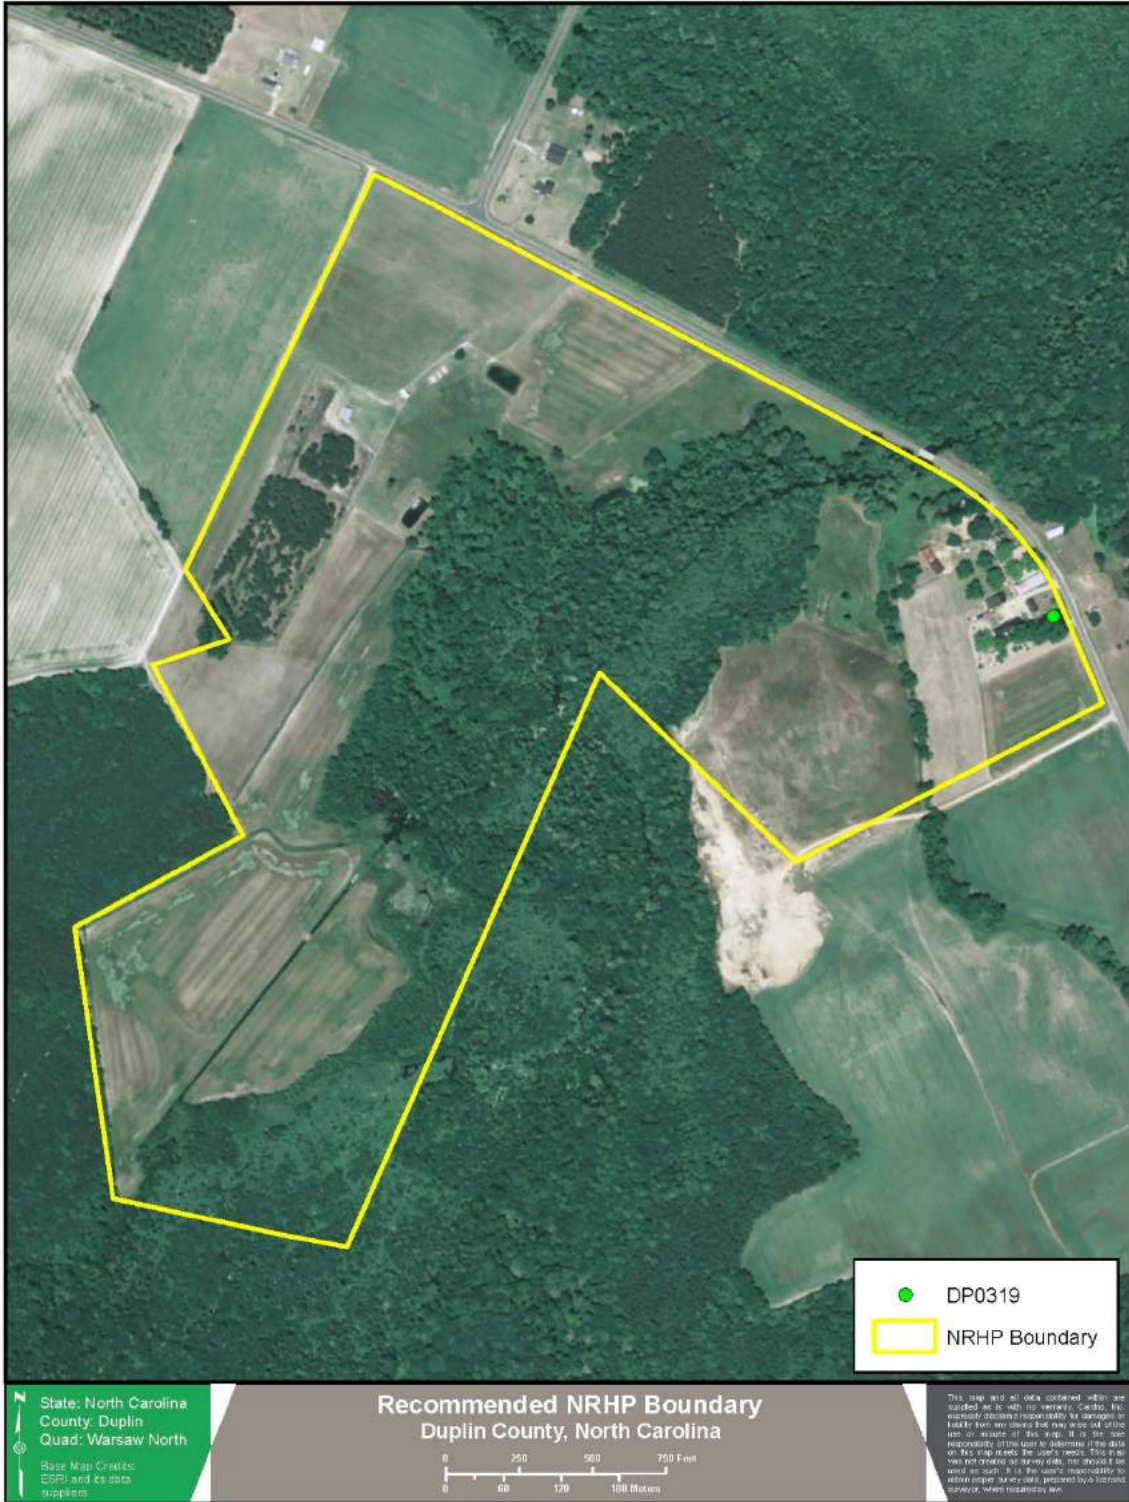
The recommended NRHP boundaries include that land within both the current Duplin County tax parcel 247800054516 owned by Samuel Taylor and within that property shown on a 2002 plat of the farm (Map Book 17, Page 148), and excludes those portions within only one or the other of those maps (Figure 49).

Figure 49. Proposed NRHP boundaries.

While Taylor Town Road and Bridge No. 219 define the northeastern edge of the property and are part of the general historic setting, these features' locations predate the Ceness Taylor Farm and were not owned by Ceness, Leon, and Samuel; therefore, the road right-of-way and the Bear Swamp crossing are excluded from the proposed NRHP boundaries.
