Re: Widen NC 211 from SR 1241 (Holly Grove School Road) to NC 73 in West End,
R-5726, Moore County, ER 17-1302

RE: R-5726—Widen NC 211 from SR 1241 (Holy Grove Rd) to NC 73 in West End,
Moore County, ER 17-1302

NCR-0748

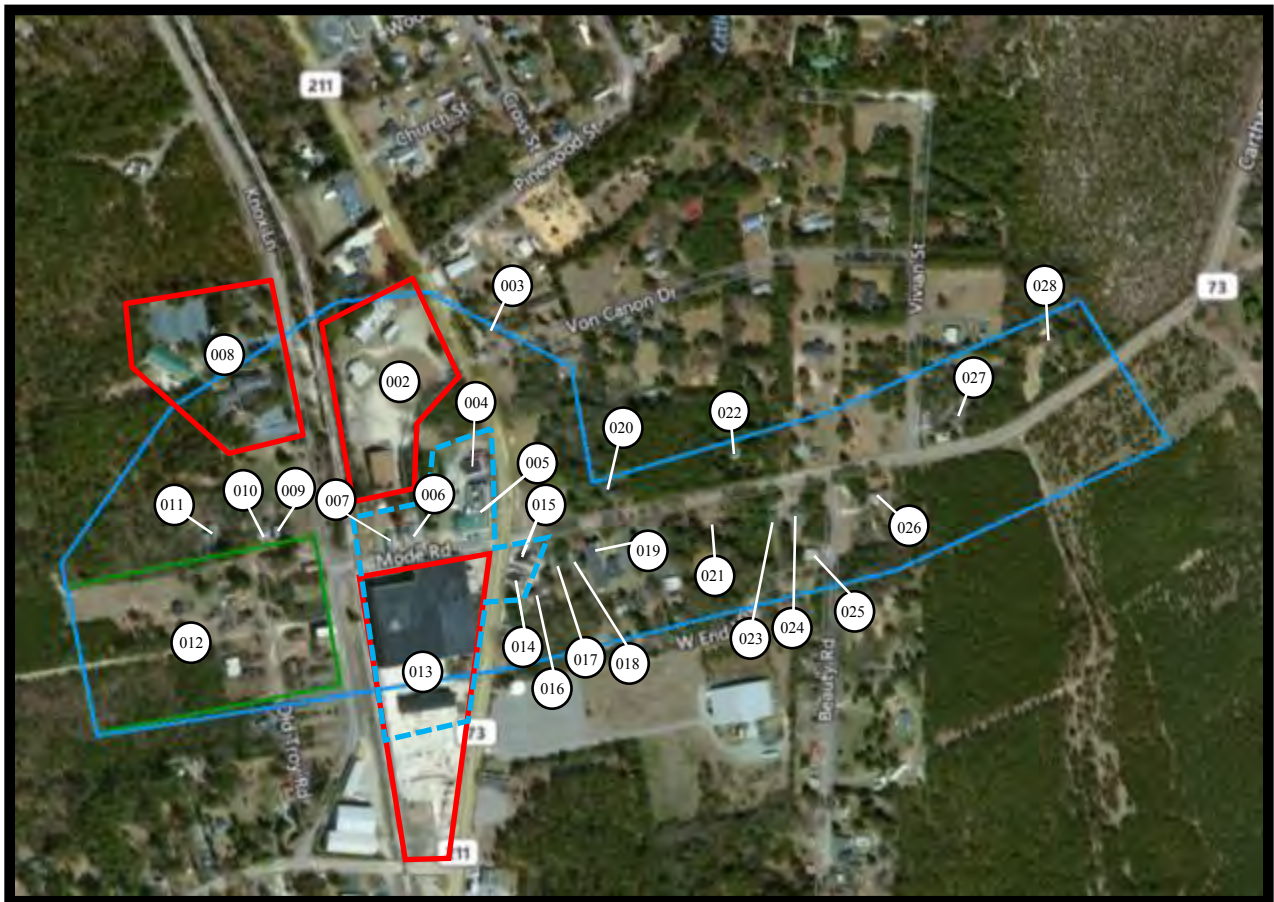
Figure 4: Resources in the West End Historic District. Note that resources 012 and 019 were evaluated separately from the historic district, and the dashed blue outline indicates commercial core area.

West End is a small unincorporated community located at the intersection of NC 73 and NC 211. The oldest section is located to the west of the Norfolk & Southern Railroad at the intersection of Mode Road and Knox Lane, with the early twentieth-century expansion occurring east along NC 73. The layout of the community does not follow a specific design, but occurred more organically along established roadways (Figures 4 and 5). The twentieth-century commercial

development is centered around the intersection of NC 73 and NC 211 (see Figure 4). The building stock reflects the establishment of the community at the end of the nineteenth century and its growth during the first half of the twentieth century. More recent modern development has occurred north along NC 211 towards Seven Lakes.

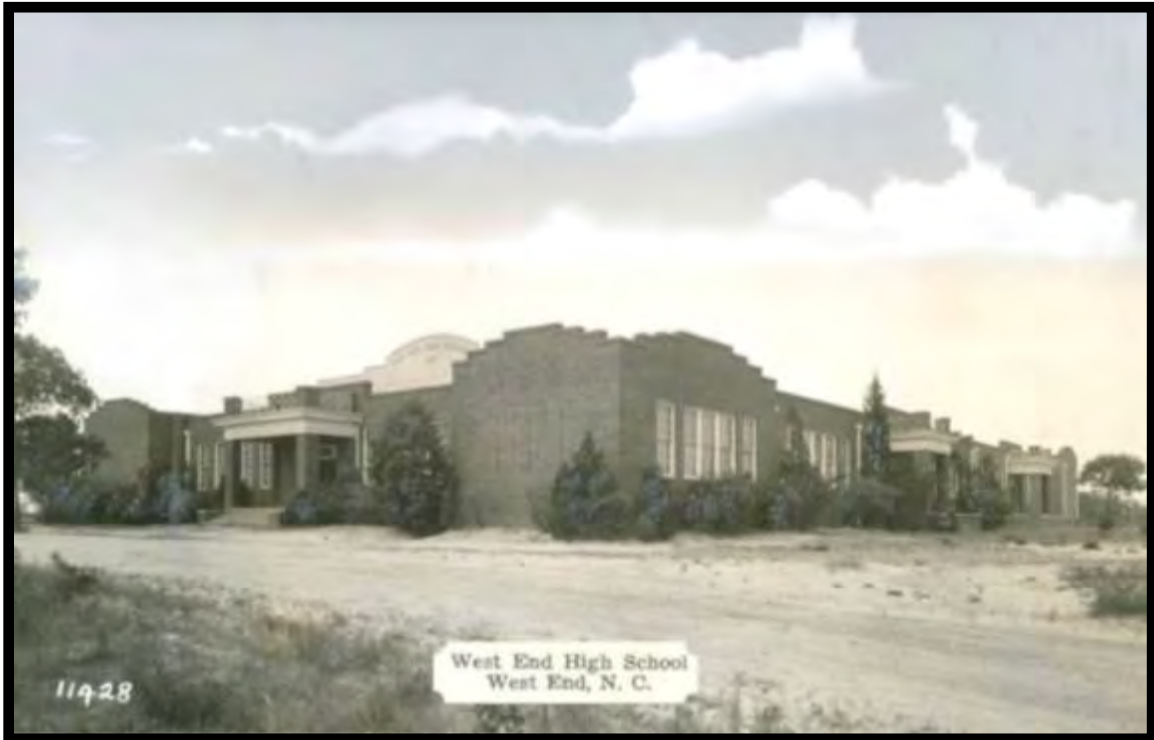
West End High was in operation from ca. 1927 until 1969. The original one-story, brick high school building was a modest example of the Mission, or Spanish Revival, style with its stepped parapet walls, and not uncommon for schools built during the first decades of the twentieth century (Figure 6). The main building was demolished in 1986, but three of the ancillary structures survive (Figure 7). The oldest of the surviving structure is the large front-gabled brick gymnasium, which is located to the southwest of where the high school used to be and

Figure 6: Historic Photograph of West End High School (Moore County History 2016).

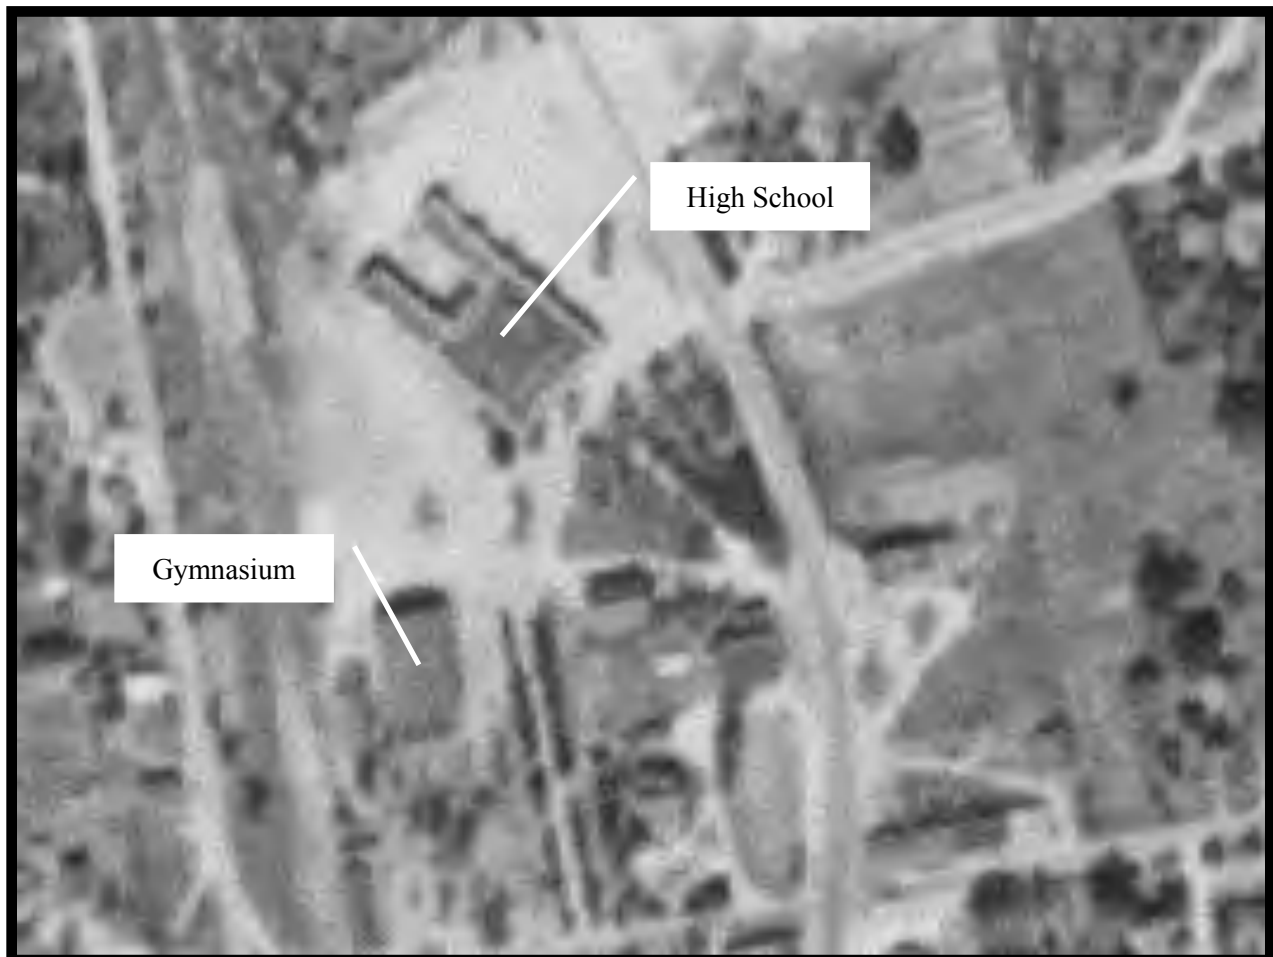
predates 1950 (Figure 8 and 9). By 1964, a one-story, flat-roofed free standing classroom building was constructed behind the original high school, and a smaller one-story, flat-roofed ancillary building, was built to the west (Figures 10 through 12). The latter was later used as a senior center. The property is still owned by Moore County, who in more recent years placed a modular office structure in front of the surviving classroom wing (Figure 13).

Figure 8: Detail of 1950 Aerial Showing West End High School (EarthExplorer 2017a).

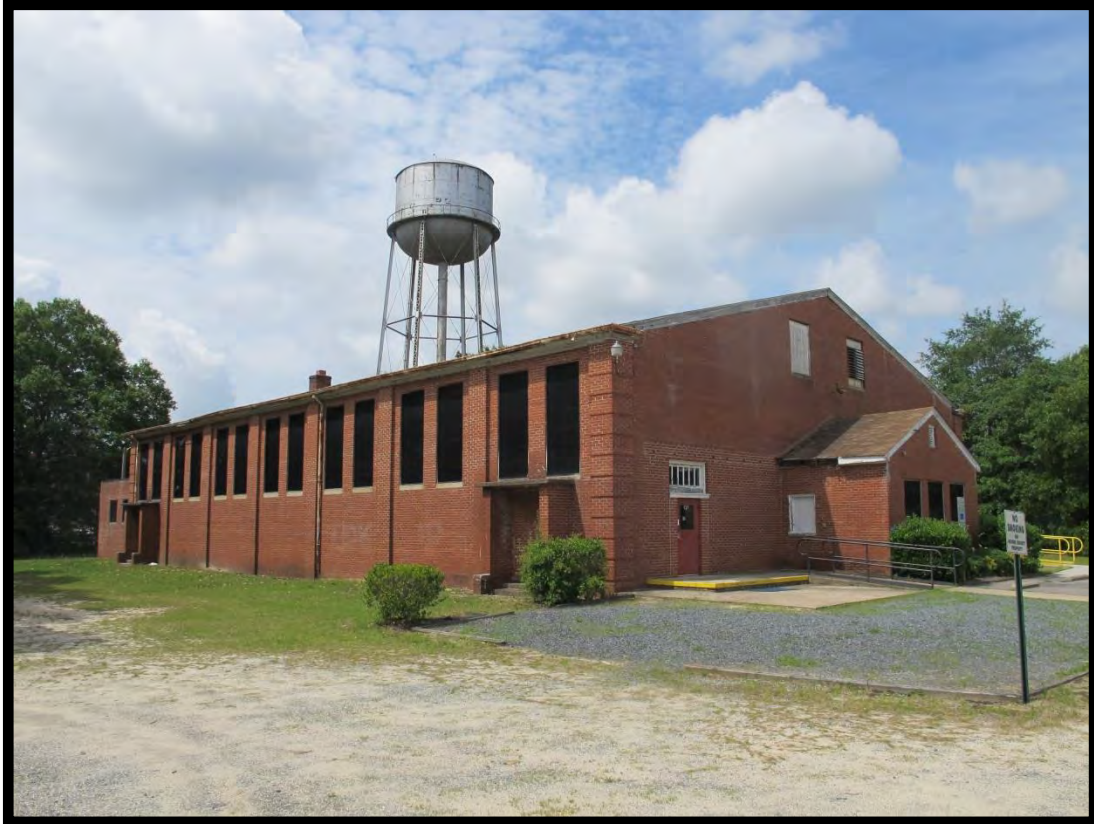
Figure 9: West End High School, Gymnasium Looking Southwest.

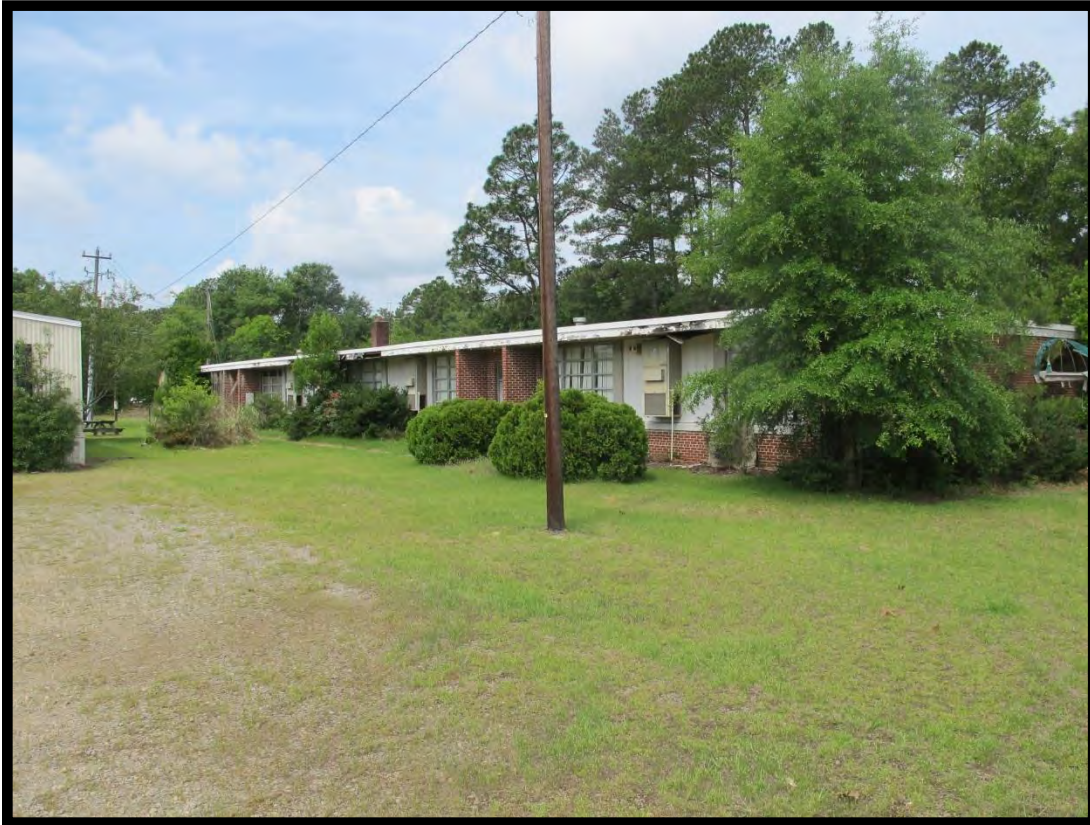
Figure 11: West End High School, Classroom Building Looking Northwest.

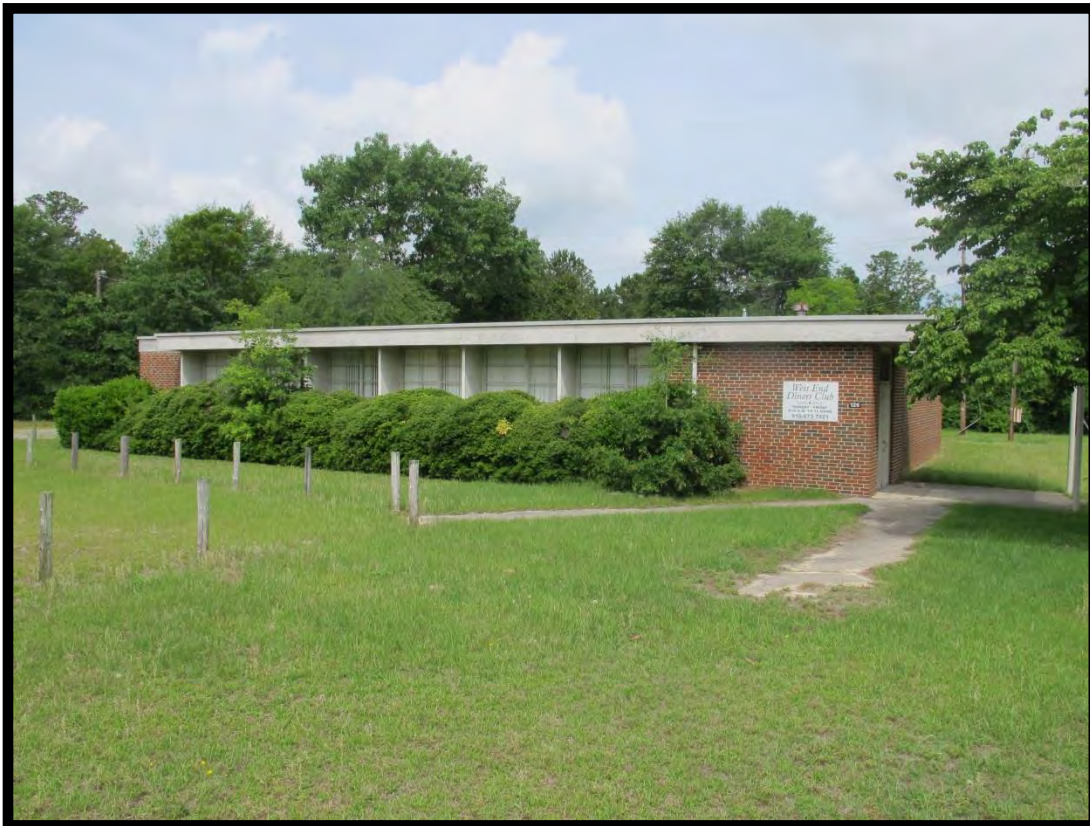
Figure 12: West End High School, Ancillary Building Looking Northwest.

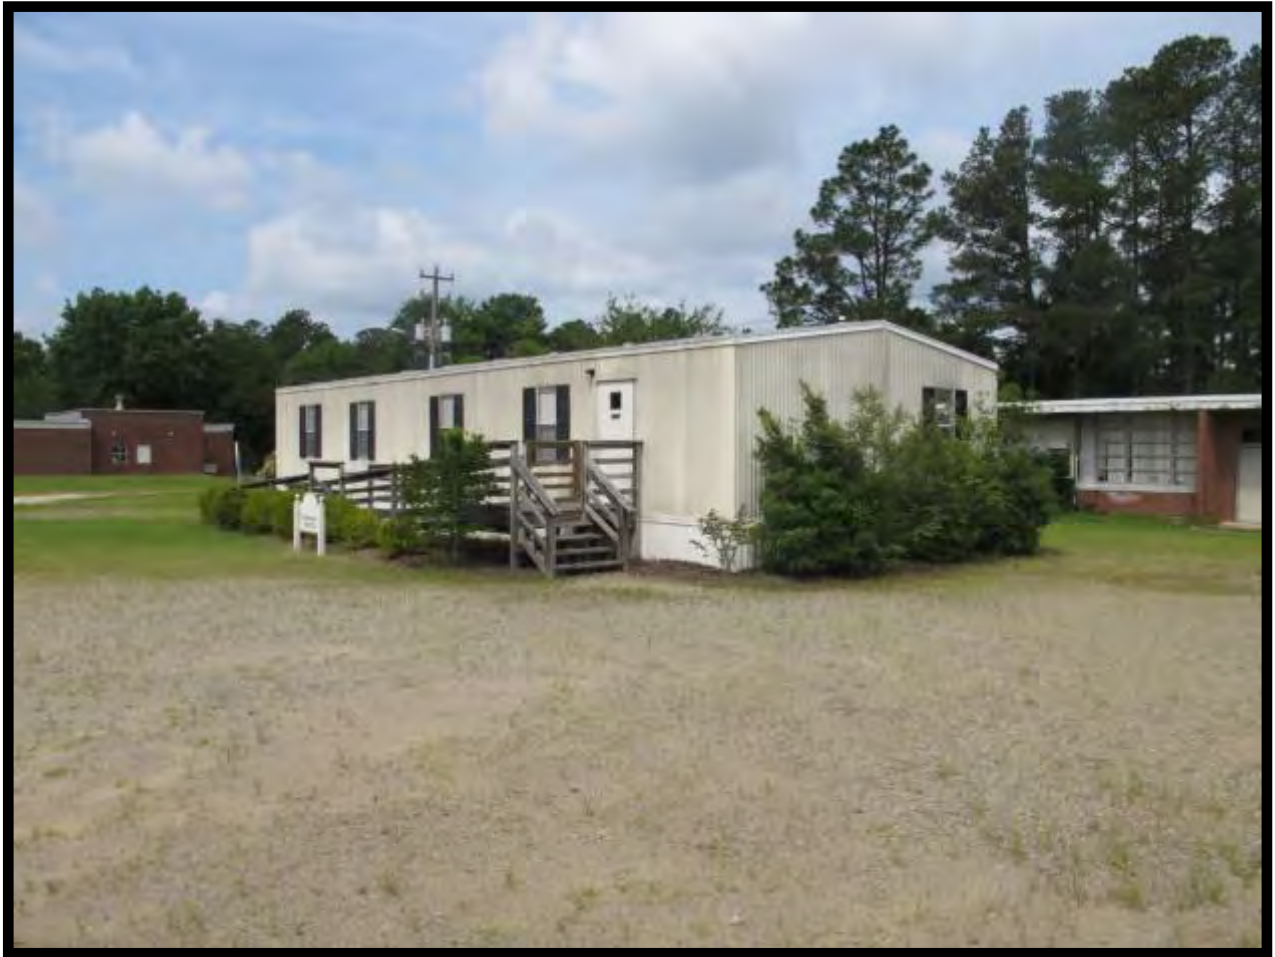
Figure 13: West End High School, Modular Office Looking Northwest.

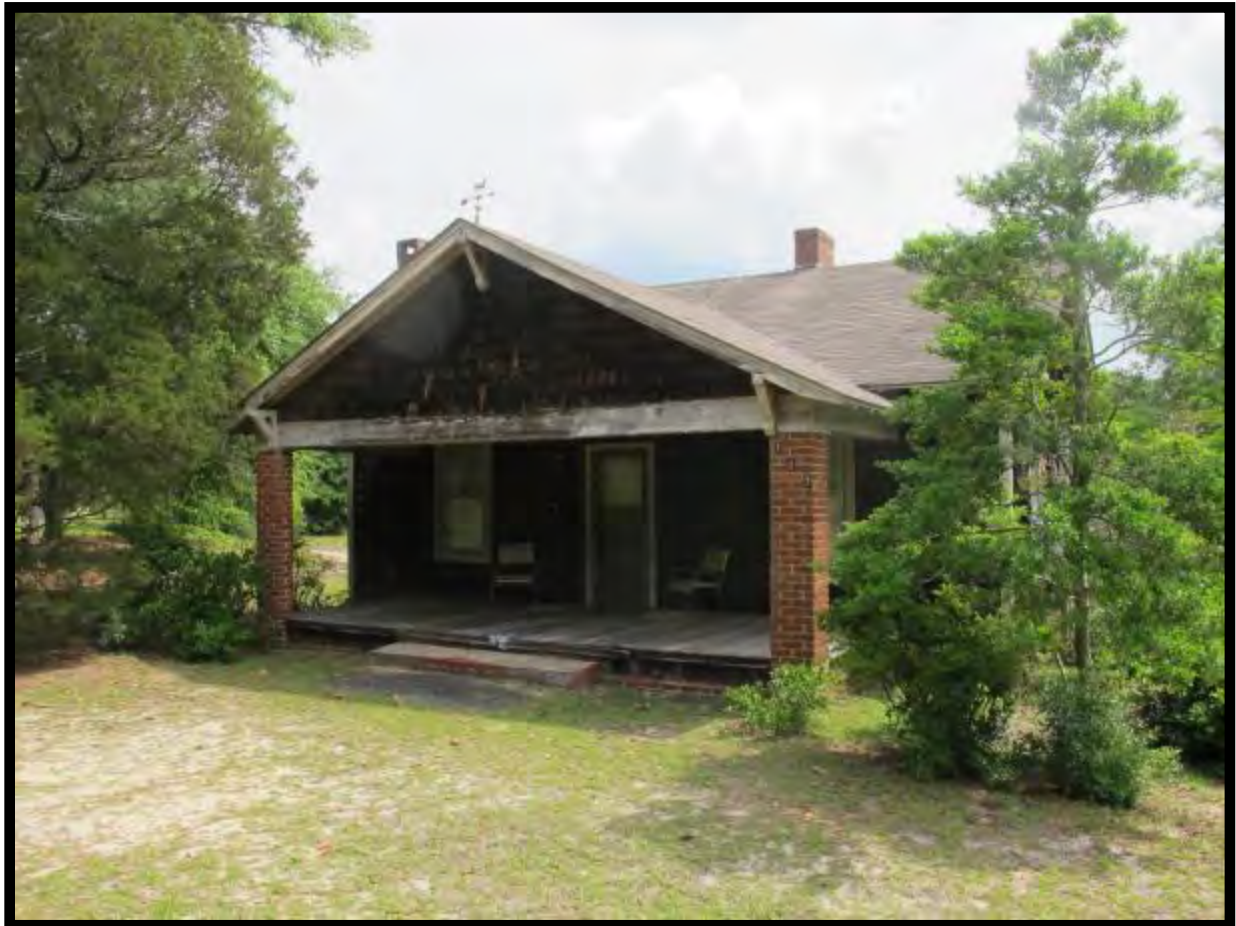
Figure 15: Sinclair House, Looking Northeast.

The Sinclair House is a modest one-story, side-gabled, Craftsman-style dwelling with a large front-gabled porch, supported by brick columns, which shelters the three bays on the southwest (front) elevation of the dwelling. A gable-roofed wing, with a screened in porch along its southeast (side) elevation, extends off the northeast (rear) elevation of the main block. A brick chimney pierces the roof just below the ridge on the rear slope of the main block, and an exterior brick chimney is located against the northwest gable end. The dwelling sits on a continuous brick foundation, is clad in cedar shingles, has six-over-one wooden sash windows, and gallows brackets that support the overhang of the roof on the gable ends (Figures 15 through 17).

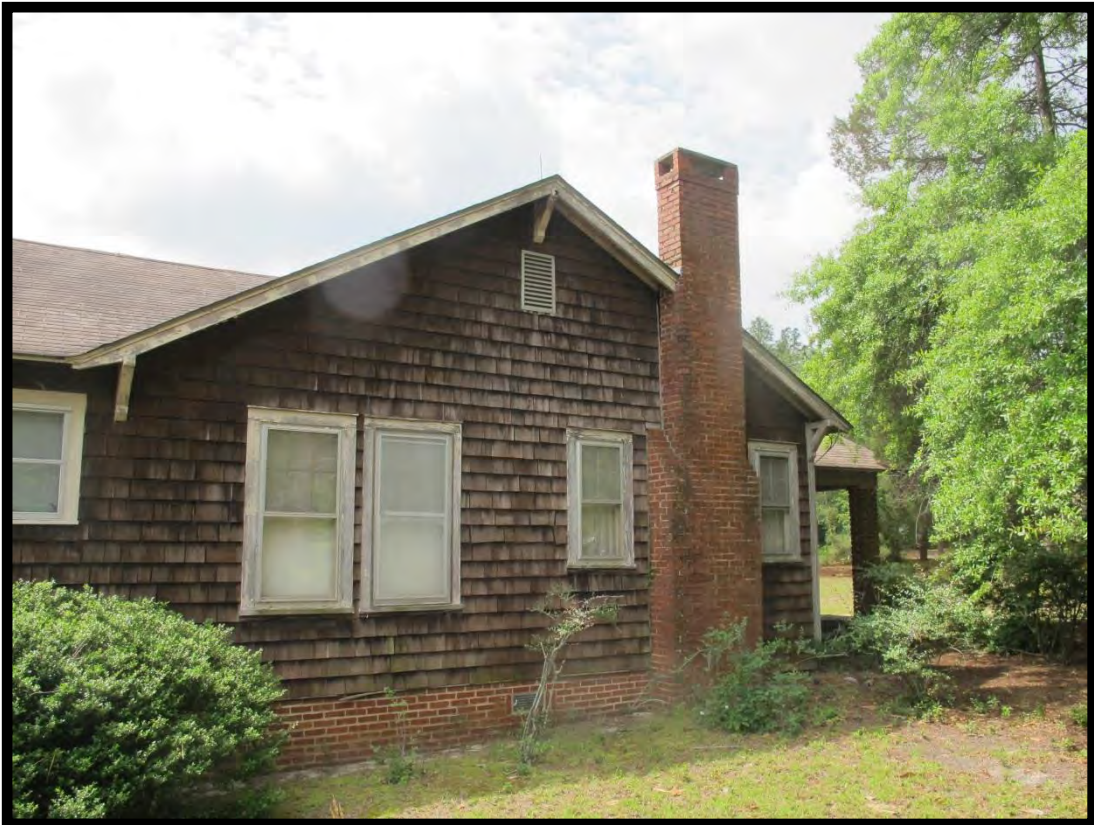
Figure 17: Sinclair House, Looking Southwest.

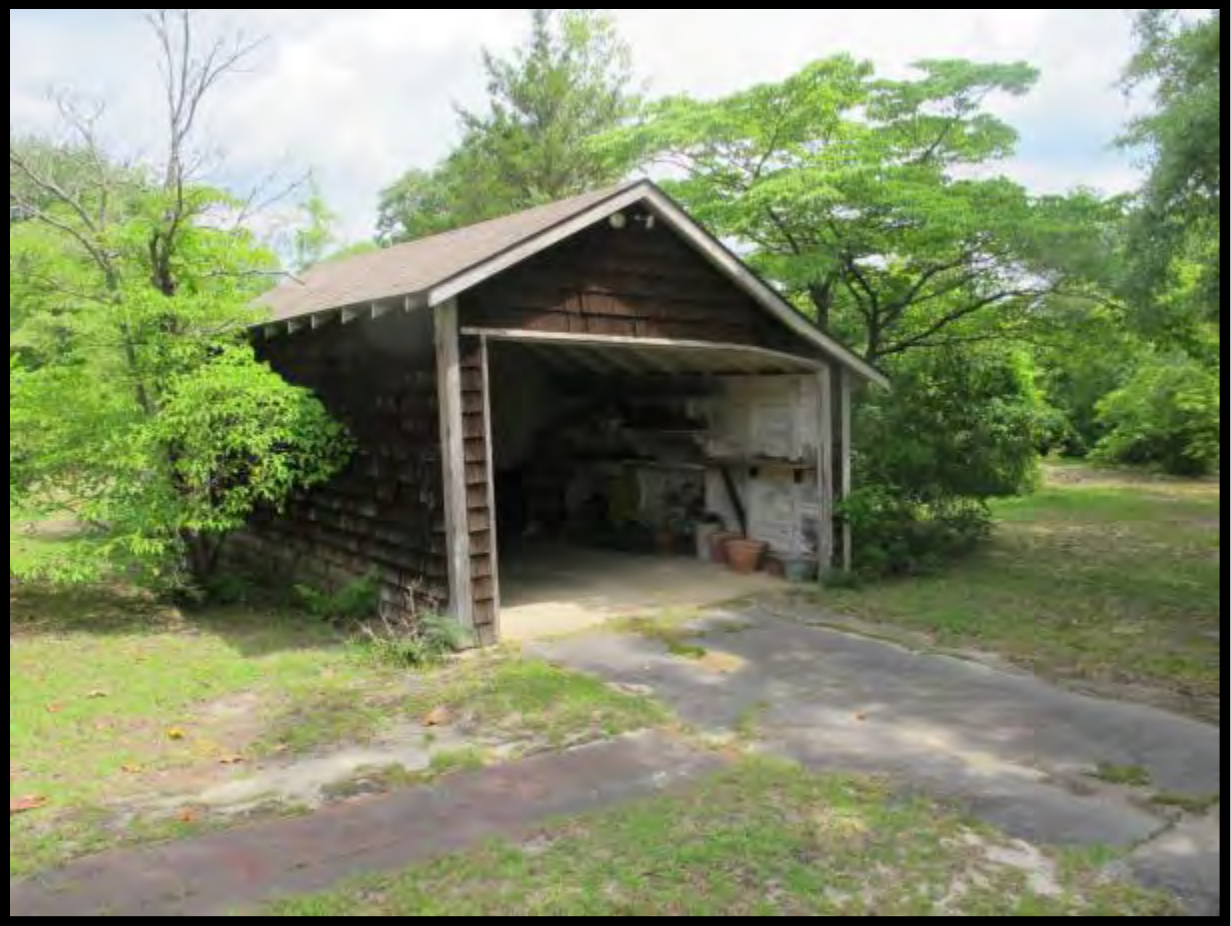
Figure 18: Sinclair House, Garage, Looking Northeast.

Located behind the dwelling is a small front-gabled frame garage also clad in cedar shingles (Figure 18).

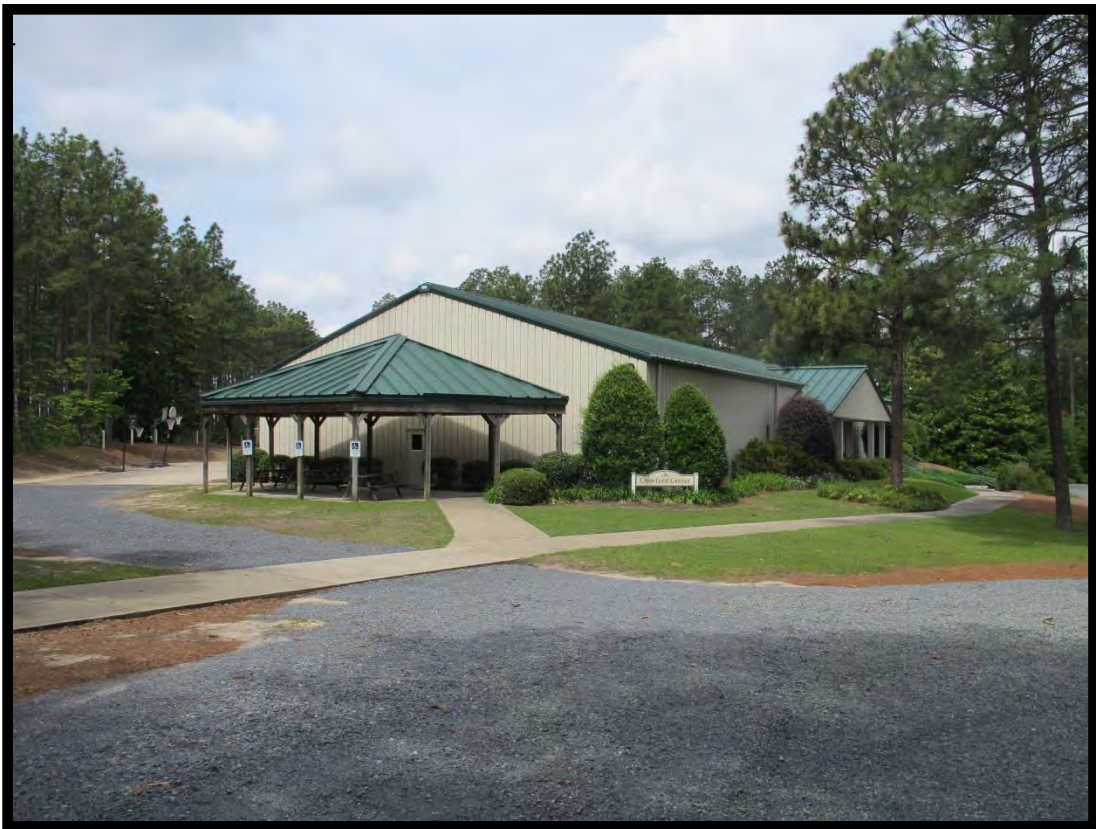
Figure 28: West End Presbyterian Church, Activity Center, Looking Northwest.

Located to the north of the sanctuary is a manse, which the church constructed in 1952. It is a one-story, side-gabled Ranch-style dwelling with an exterior brick chimney on the east (front) elevation of the building. The building is partially banked on the north gable end, were there is an integral one-car garage. The building is clad in stretcher-bond brick and has horizontal two-over-two wooden sash windows (Figures 26 and 27). A large, one-story, side-gabled activities center was constructed northwest of the church around 2000 (Figure 28).

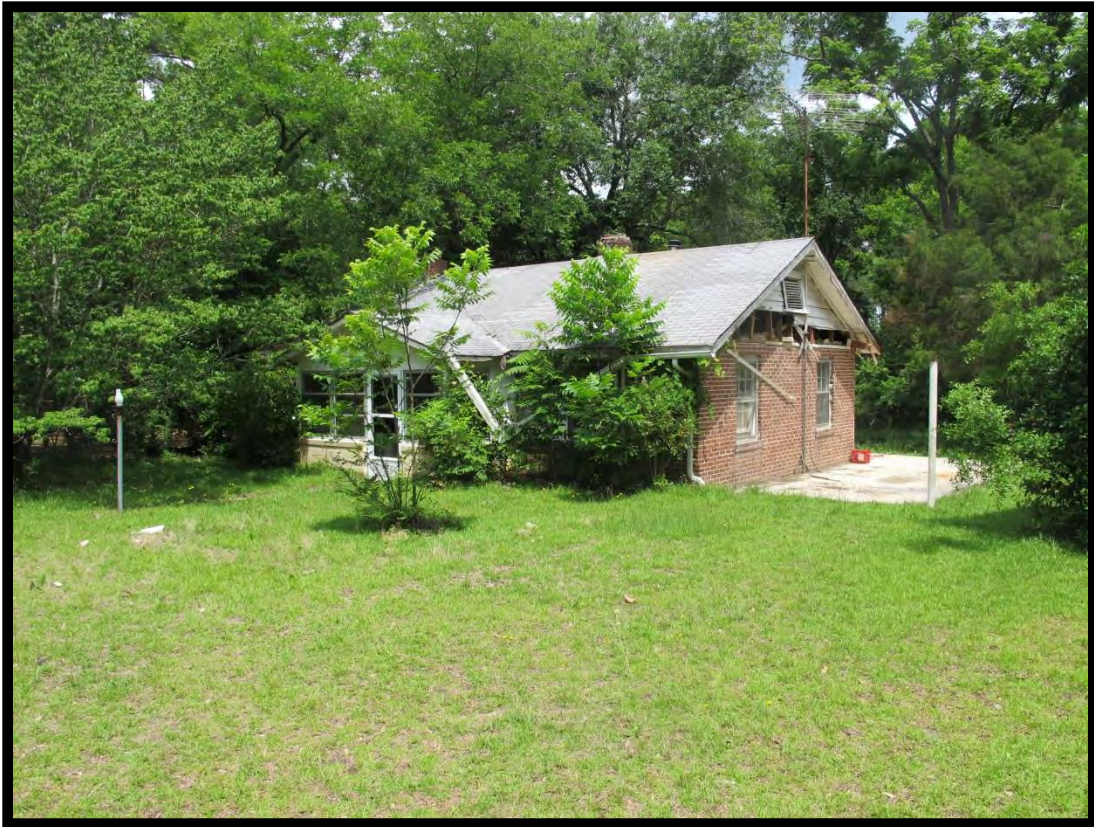
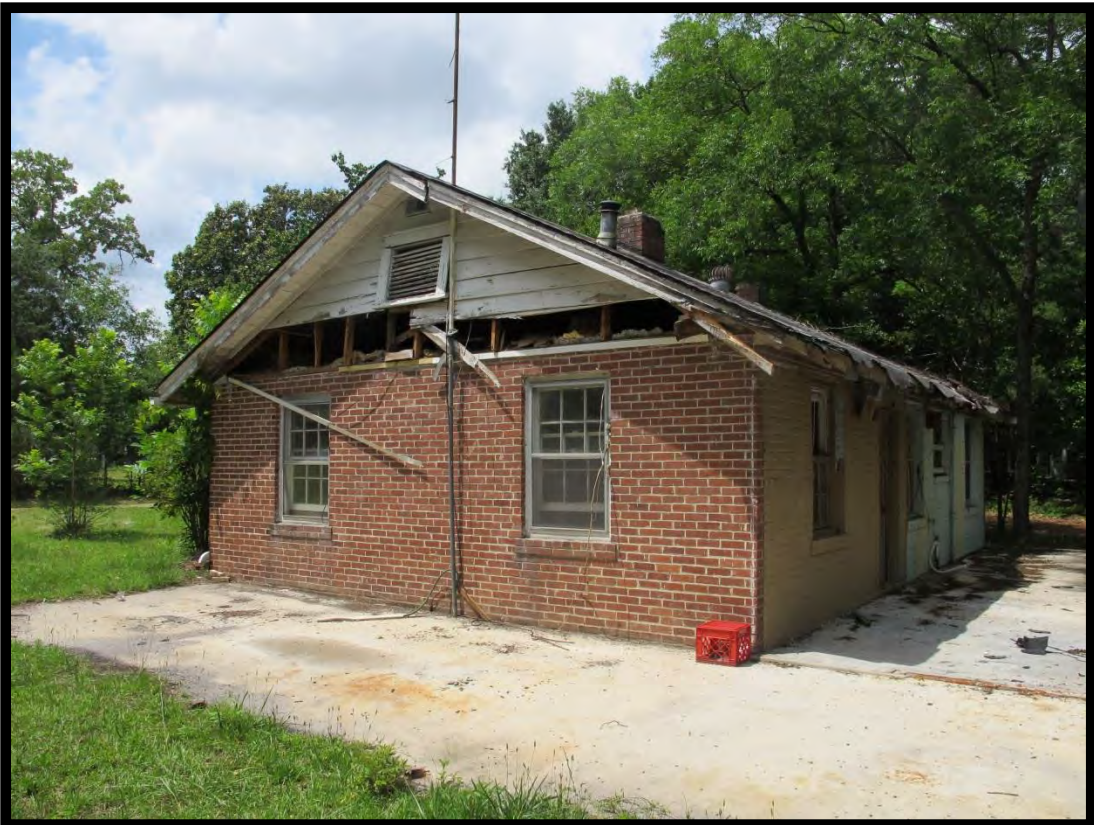
One-story, side-gabled dwelling with an enclosed front-gabled porch that partially covers the south (front) elevation of the dwelling. The building is clad in stretcher-bond brick and has six-over-six wooden sash windows (Figures 33 and 34).

Figure 33: House, Looking Northwest.

Figure 34: House, Looking Southwest.

The building remains in its original location. Its design is reminiscent of the Minimal Traditional style popular around World War II. The property is currently not occupied and deteriorated, and as such no longer conveys its historic character and feeling. The building is associated with the development of communities during the middle of the twentieth century.

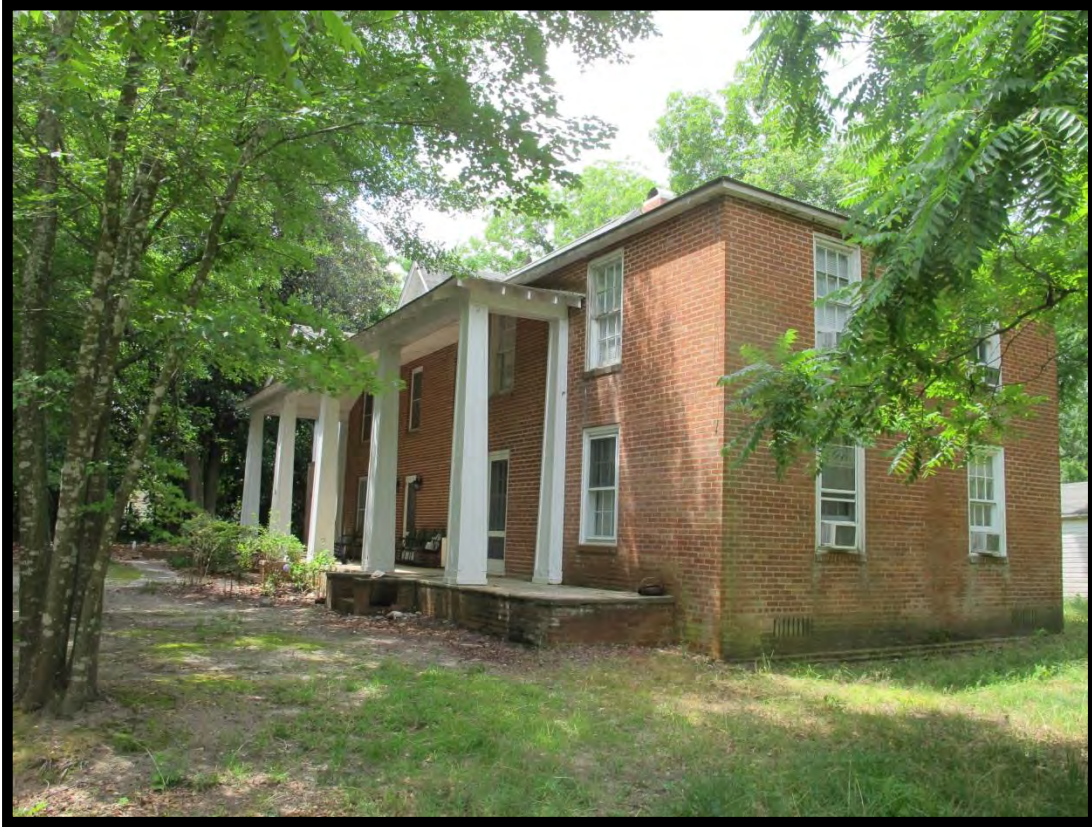
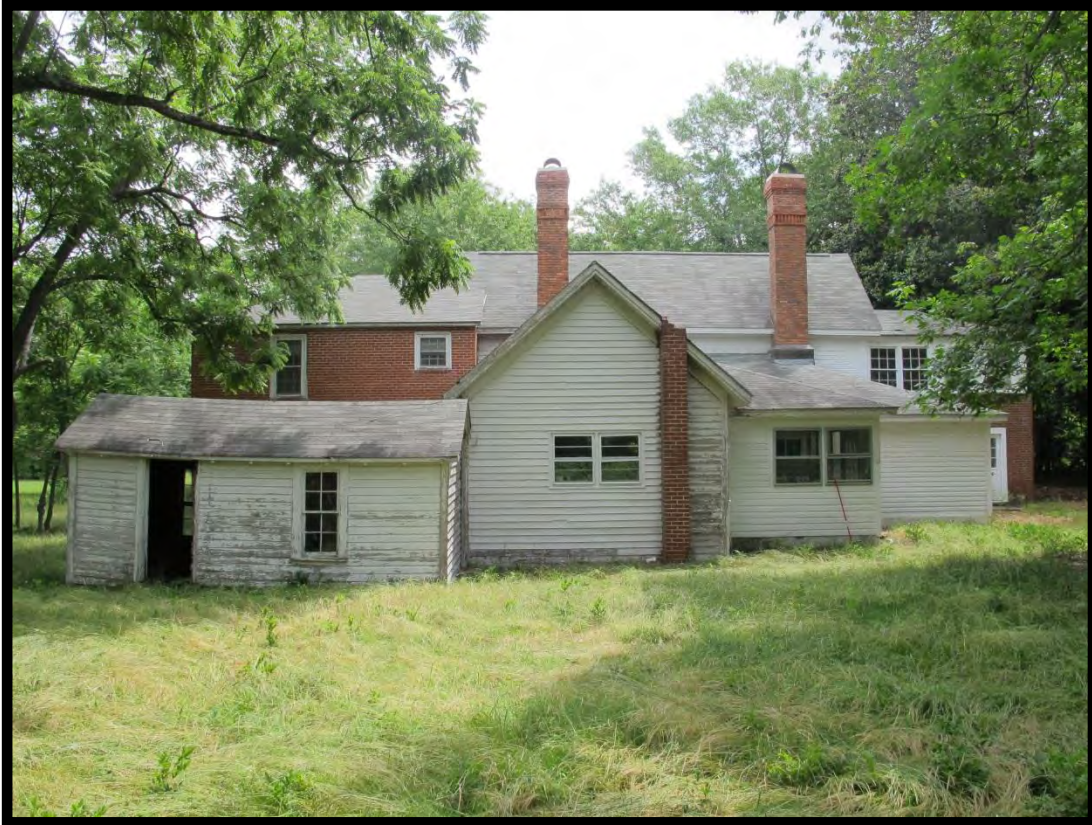
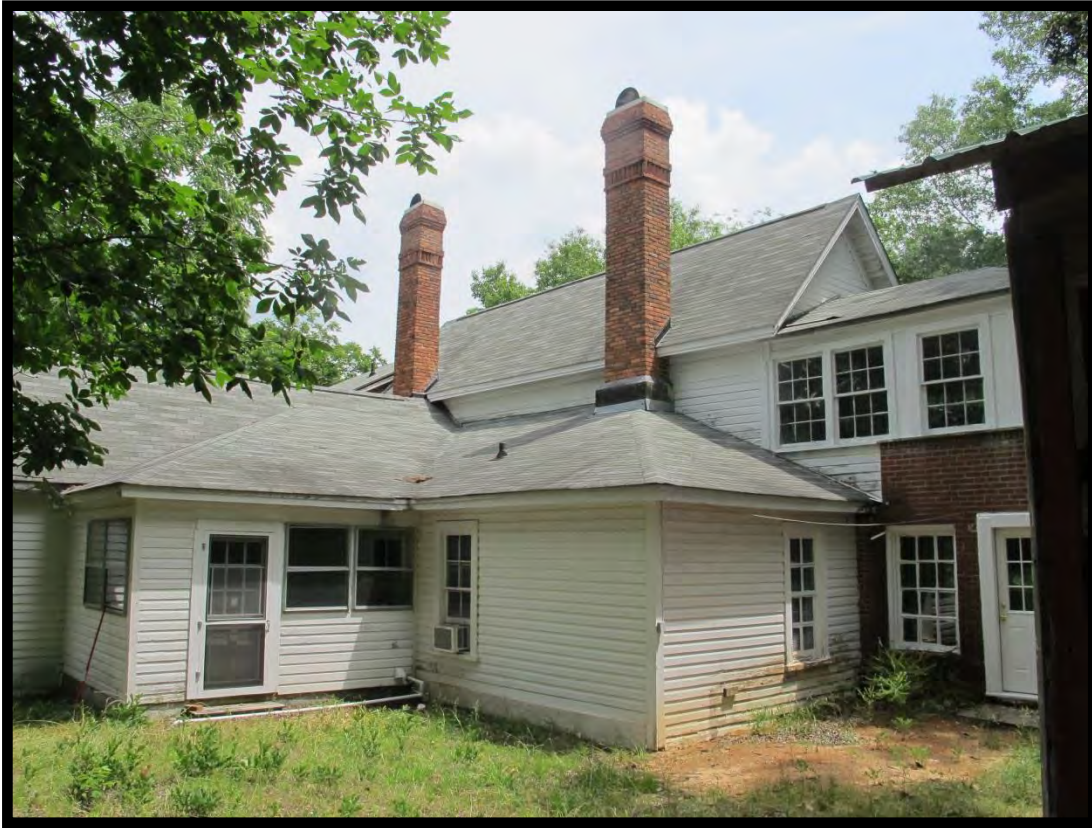
Two-story dwelling with a triple-A roof, and later additions on the north and south gable ends. A one-story, gable-roofed wing extends off the west (rear) elevation of the main block and originally gave the dwelling an L-shaped footprint. Located off the northwest corner of the rear wing is a one-story, side gabled wing. An enclosed, hip-roofed porch, runs along the south (side) elevation of the rear wing, and continues along the rear elevation of the main block. The dwelling has two corbelled brick chimneys against the rear elevation of the main block and was originally clad in German, or drop, siding. The front of the dwelling was clad in brick veneer, when a two-story, hip-roofed addition was constructed against the north gable end of the main block. The two-story, hip-roofed sunroom/sleeping porch against the south gable end may predate the brick addition, but was clad in brick veneer at the same time. At the same time a full height portico was added on the front elevation, which partially extends across the brick addition. The hip-roofed portico has a decorative cross gable and is supported by colossal battered-box columns (Figures 35 through 37).

Figure 35: J. B. Von Canon House, Looking Southwest.

Figure 36: J. B. Von Canon House, Looking East.

Figure 37: J. B. Von Canon House, Looking Northeast.

application of brick veneer can longer convey its historic feeling. The building is associated with J. B. Von Canon, the head of one of the leading families in West End during the first half or the twentieth century, and the development of small crossroads communities during the same period.

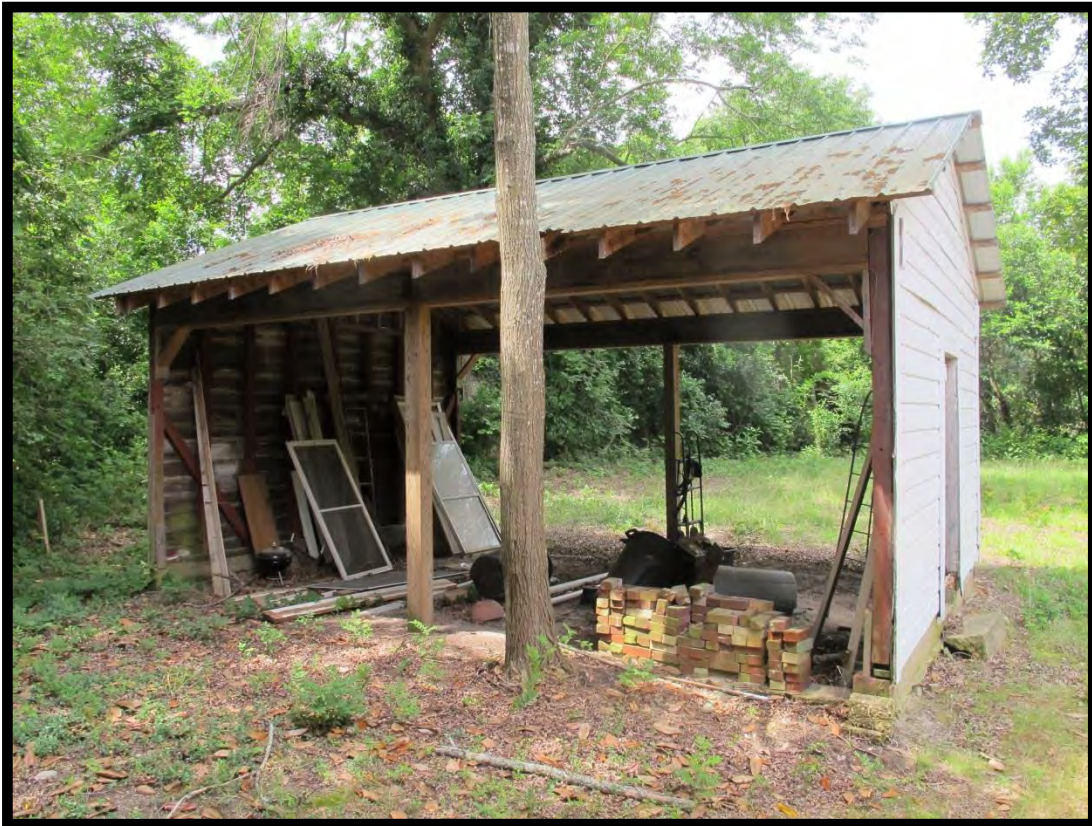
Located behind the dwelling is a front-gabled frame building. It appears the framing and siding on the side elevations may have been removed at some point (Figure 38).

Figure 38: J. B. Von Canon House, Outbuilding, Looking Southwest.

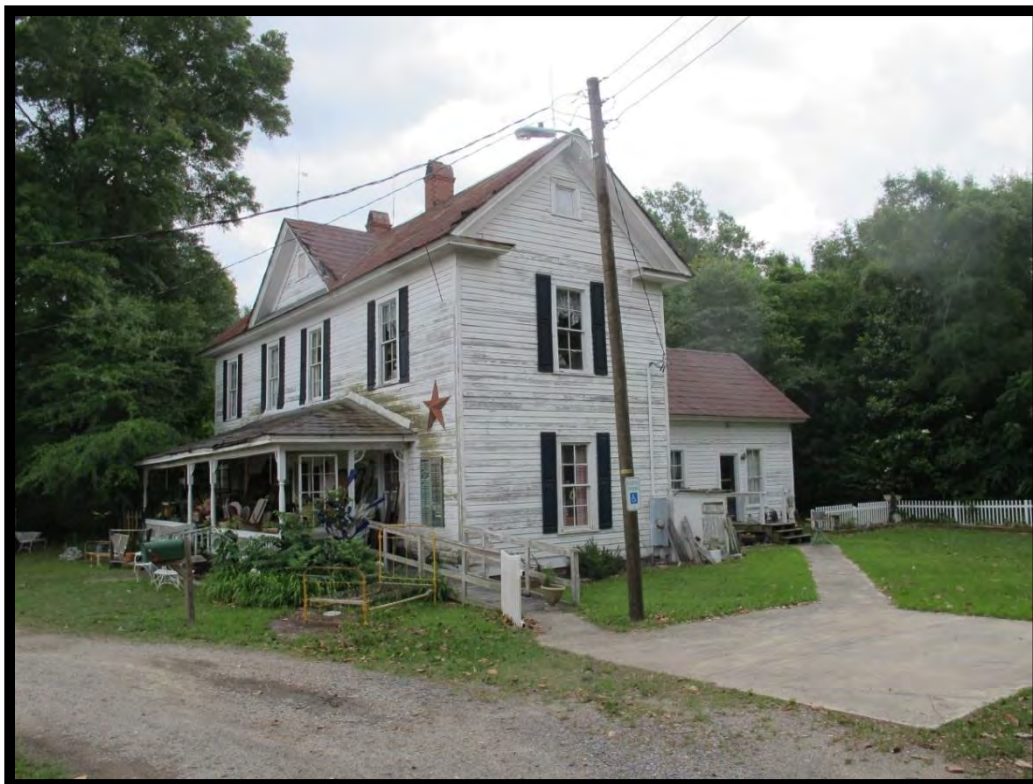
Figure 39: Morris House, Looking Southeast.

The Morris House is an I-house with a triple-A roof, and a hip-roofed porch, supported by turned posts, which shelters three bays on the north (front) elevation of the dwelling. A one-story, gable-roofed wing extends off the south (rear) elevation of the dwelling, and has a one-story gable-roofed wing, of its east (side) elevation creating an L-shaped rear section. The building sits on a brick foundation, is clad in plain weatherboard siding, has four-over-four wooden sash windows, and a pressed-metal roof. Two brick flues pierce the roof on the two-story section, and single brick flues pierce the ridge of each of the sections of the wing (Figures 39 and 40).

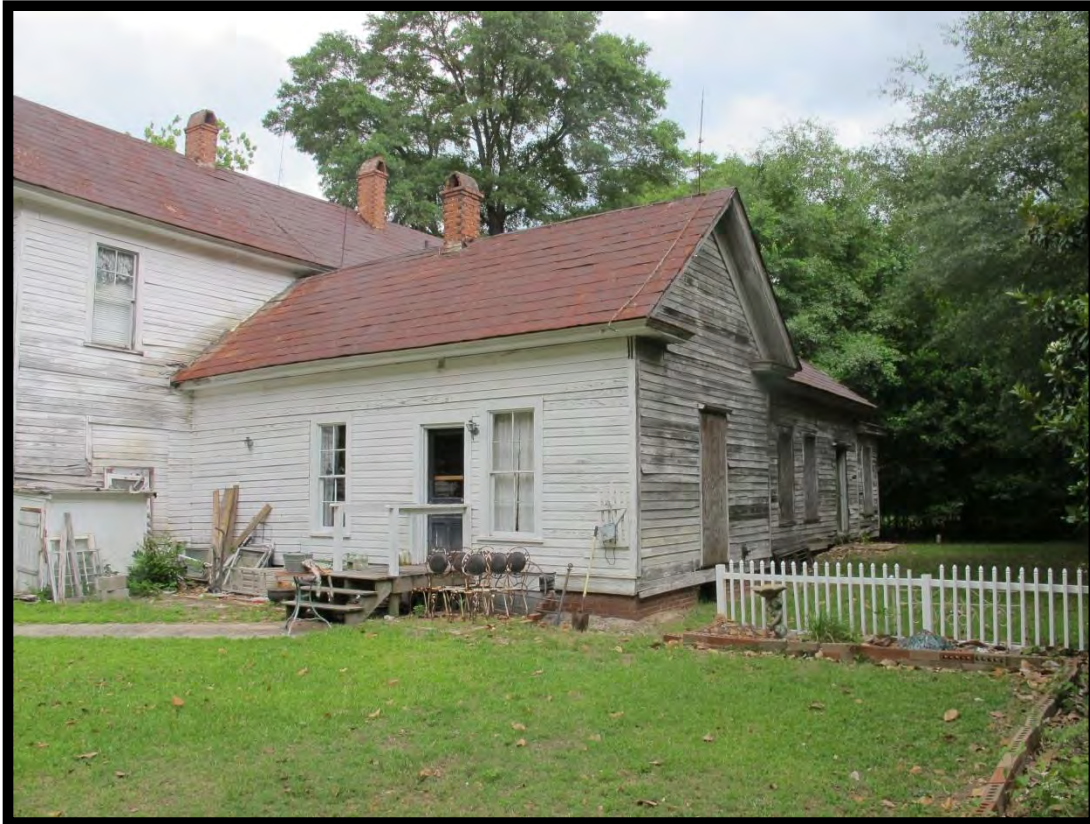
Figure 40: Morris House, Rear Wings, Looking Northeast.

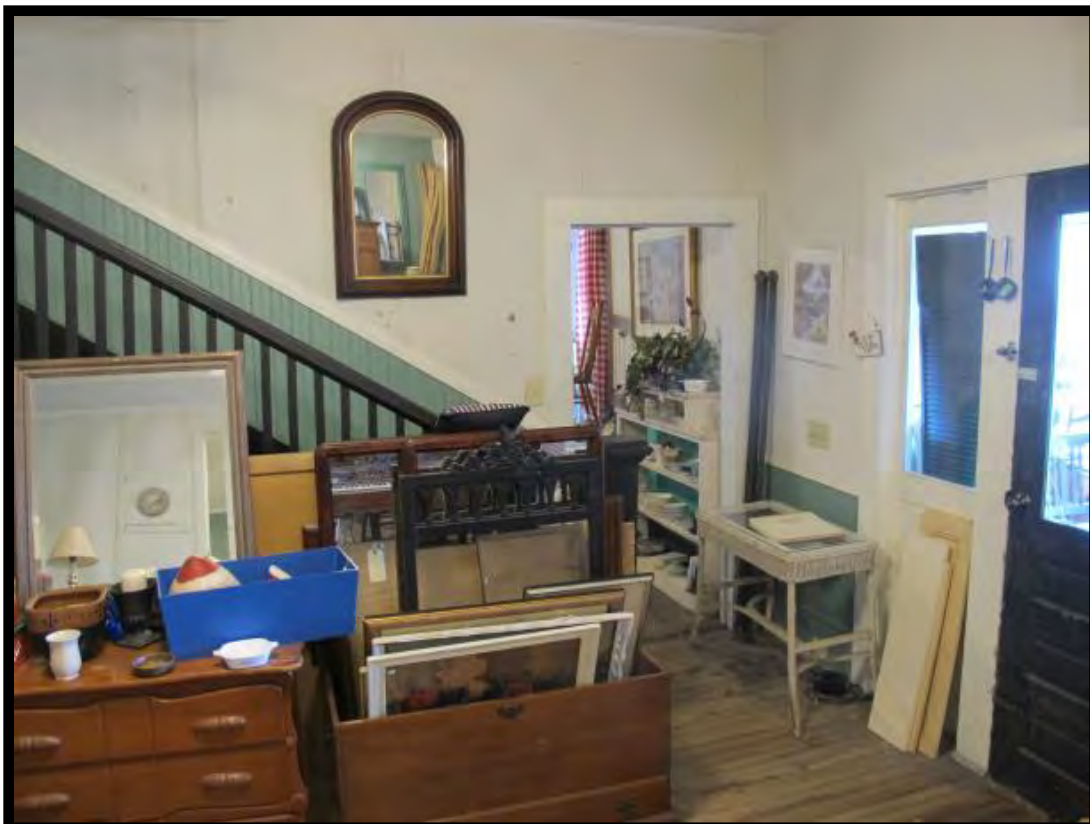
The building is currently used as an antique store, and appears to retain some of its original features. The main part of the dwelling has a two-room plan. It may originally have had a center passage. The walls have narrow beaded-board wainscot and panels with battens above. The latter may have replaced the original lath-and-plaster walls. The doors have plain surrounds, which also may be a later addition. An open flight of stairs, with a square newel post and simple square balusters, gives access to the second floor. The stair makes a turn at a small landing, about two-thirds up (Figure 41).

Figure 41: Morris House, Interior.
