Re: Widen NC 211 from SR 1241 (Holly Grove School Road) to NC 73 in West End,
R-5726, Moore County, ER 17-1302

RE: R-5726—Widen NC 211 from SR 1241 (Holy Grove Rd) to NC 73 in West End,
Moore County, ER 17-1302

NCR-0748

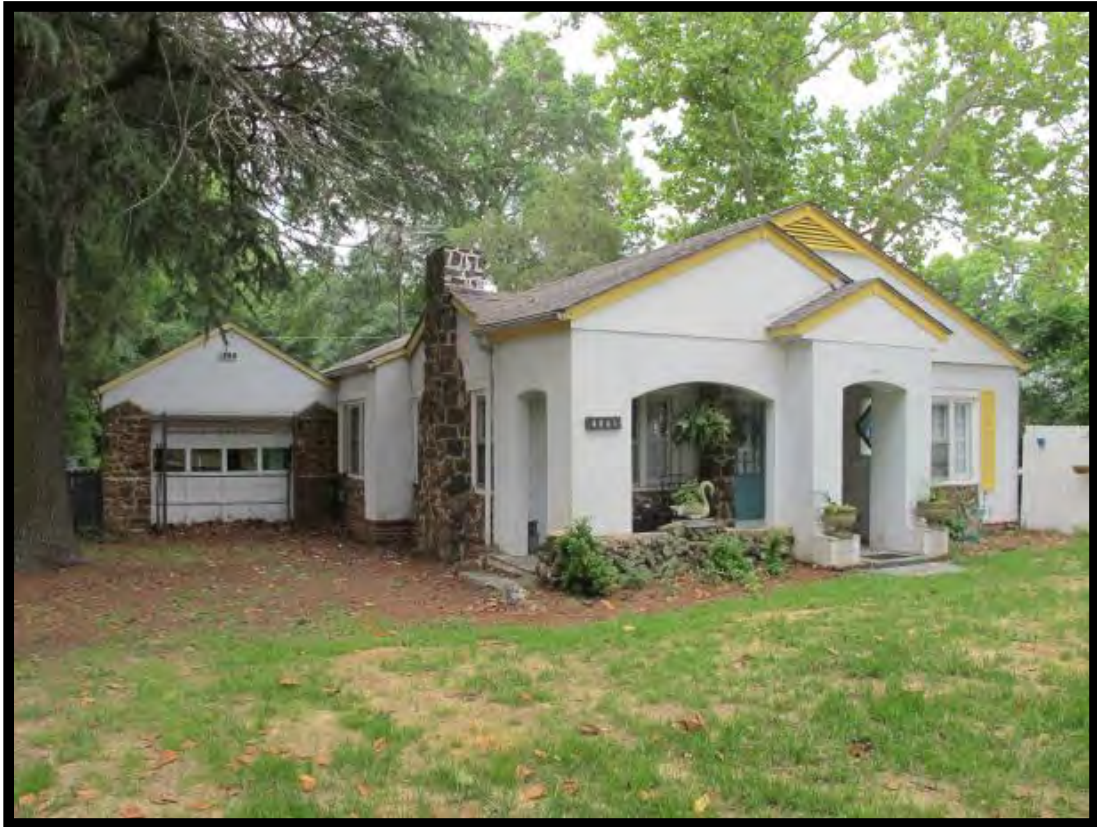
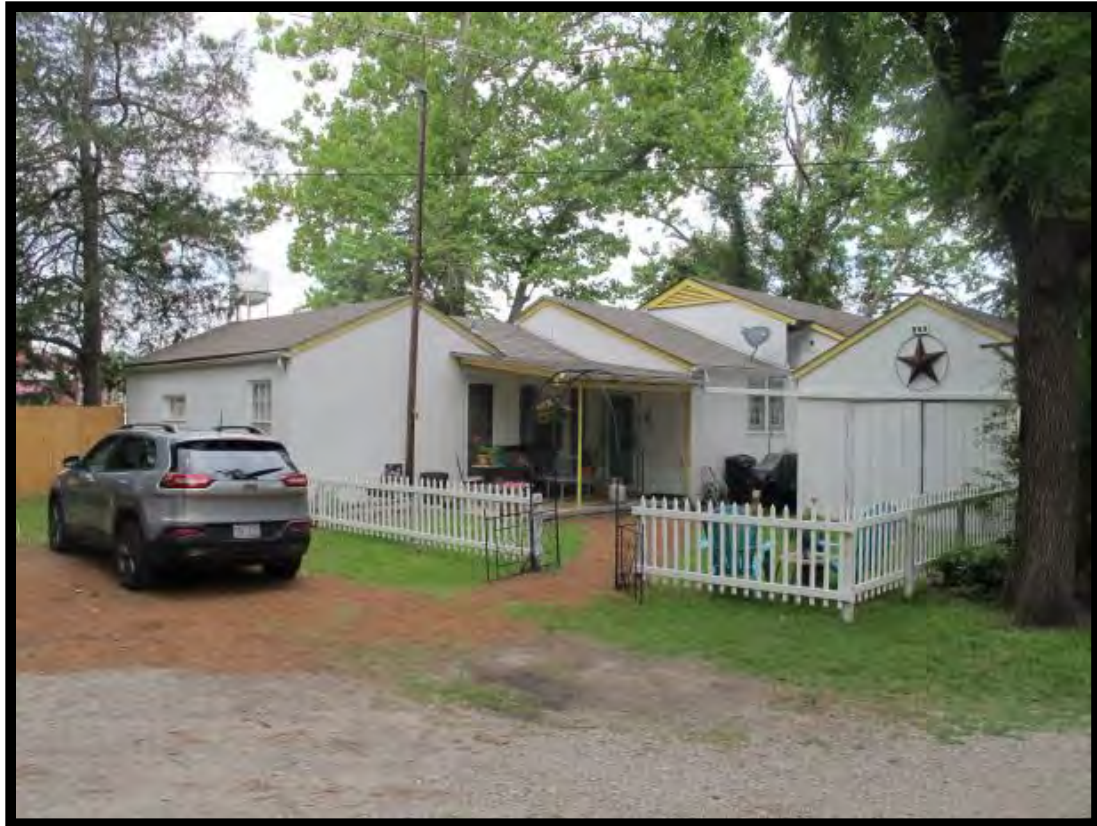
The Tucker House is a modest example of a Spanish Revival-style dwelling. The small, one-story, front-gabled dwelling has a partially enclosed integral front-gabled porch, with arched openings, that shelters the entry door and a tripartite picture window, on the north (front) gable end. A second tripartite picture window flanks the porch to the right. Located against the east (side) elevation is a partially exterior fieldstone chimney, flanked by six-over-six wooden sash windows. Located against the south (rear) gable end of the dwelling is a slightly narrower gable-roofed wing. A small gable-roofed hyphen connects the wing to a gable-roofed section, which is placed perpendicular to the dwelling. A simple shed-roofed porch, connects the wing, the hyphen and the gable-roofed section on the east side. A one-car garage is attached to the southeast corner of the main block. The dwelling sits on a brick foundation and the walls are stuccoed with stone-veneer detailing, below the windows and flanking the entry door and the garage door (Figures 42 and 43).

Figure 42: Tucker House, Looking Southwest.

Figure 43: Tucker House, Looking Northwest.

The building remains in its original location and retains much of its original setting. The design is a modest example of the Spanish Revival style, which was part of a national trend between ca. 1915 and 1940. It may have been inspired by a design from a Montgomery-Ward's mail-order homes catalog or *Sears Modern Homes* catalog (Figure 44). The building retains a modest level of integrity with respect to materials and workmanship. The building is associated with changing architectural sensibilities during the first half of the twentieth century and with the growth of small rural crossroads communities.

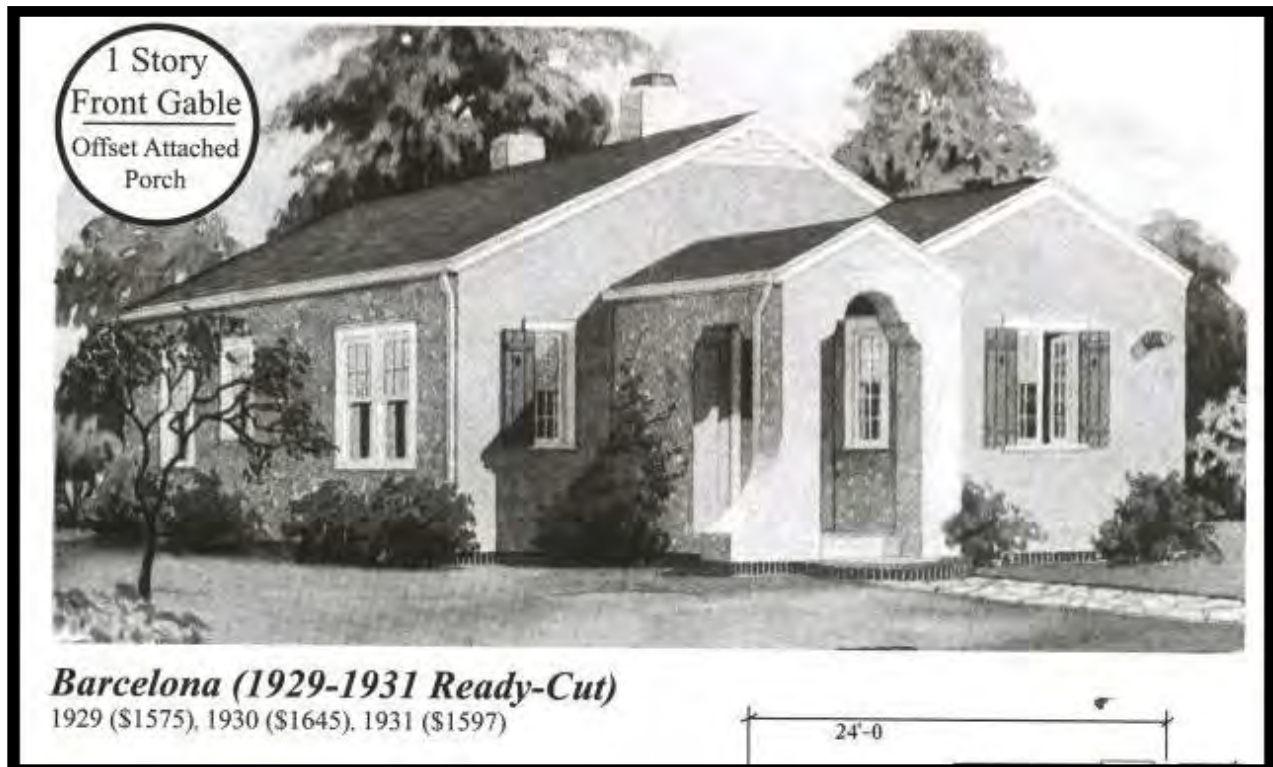
Figure 44: Spanish Bungalow, *Barcelona*, from Montgomery-Ward's Mail-Order Homes Catalog (Sears Modern Homes 2017).

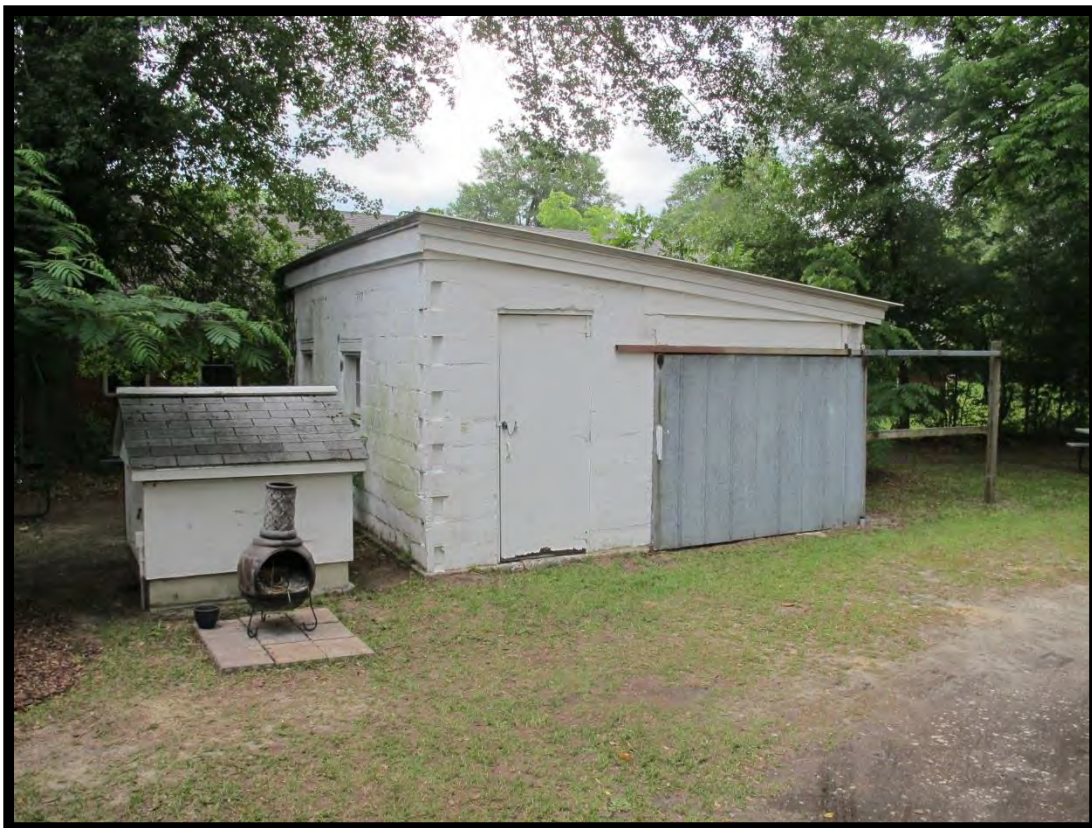
Figure 47: House, Outbuildings, Looking Southeast.

Located behind the dwelling is a gable-roofed well house, and a shed-roofed outbuilding, with windows in the north elevation and an entry door, and sliding garage door in the west elevation (Figure 47).

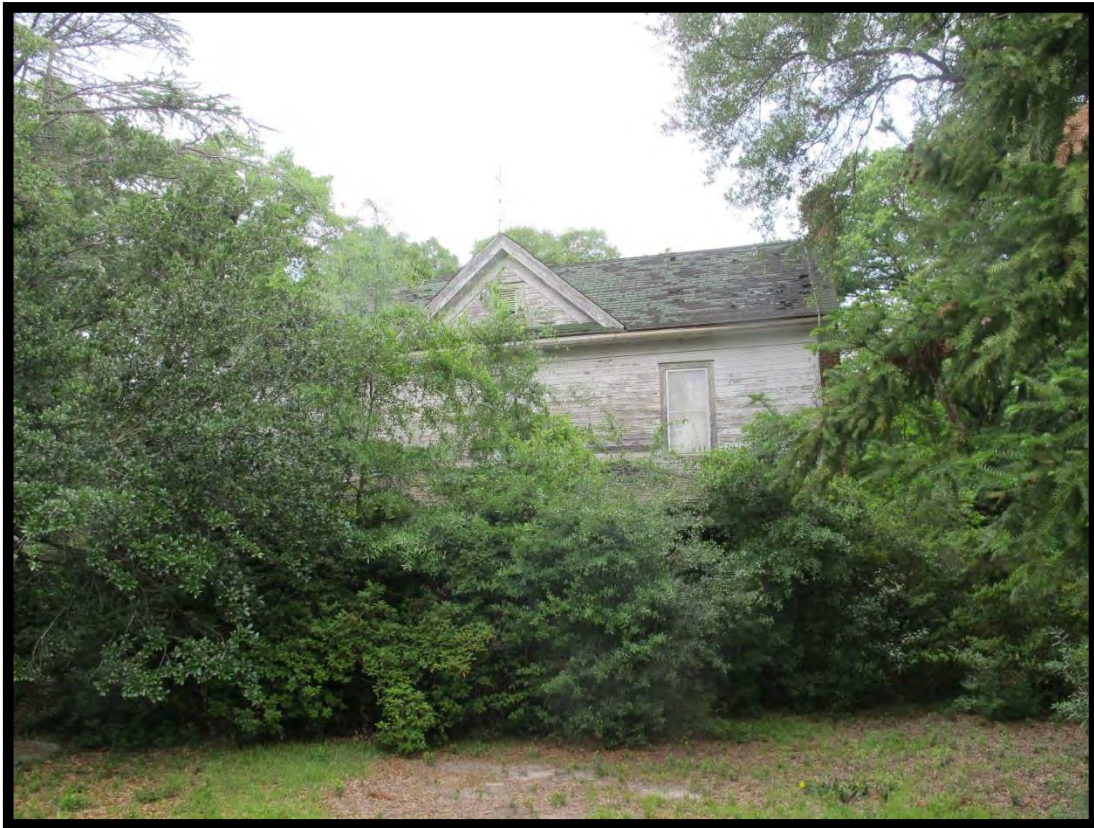
Figure 48: Ritter House, Looking Northwest.

The Ritter House is an I-house with a triple-A roof. A hip-roofed porch, supported by heavy chamfered posts, shelters three bays on the south (front) elevation of the building. A short, two-story gable-roofed wing extends off the north (rear) elevation of the main block, and has a one-story gable-roofed section against its north (rear) gable end. An enclosed shed-roofed porch runs along the east (side) elevation of the two sections of the rear wing and extends into a hip-roofed section against the rear elevation of the main block. The dwelling sits on a brick pier foundation with rusticated concrete block infill, is clad in German, or drop, siding, and has six-over-one wooden sash windows. Located against the east gable end of the main block is a single-shouldered brick chimney with a corbelled top. An interior brick chimney with a corbelled top pierces the ridge of the two-story rear wing (Figures 48 and 49).

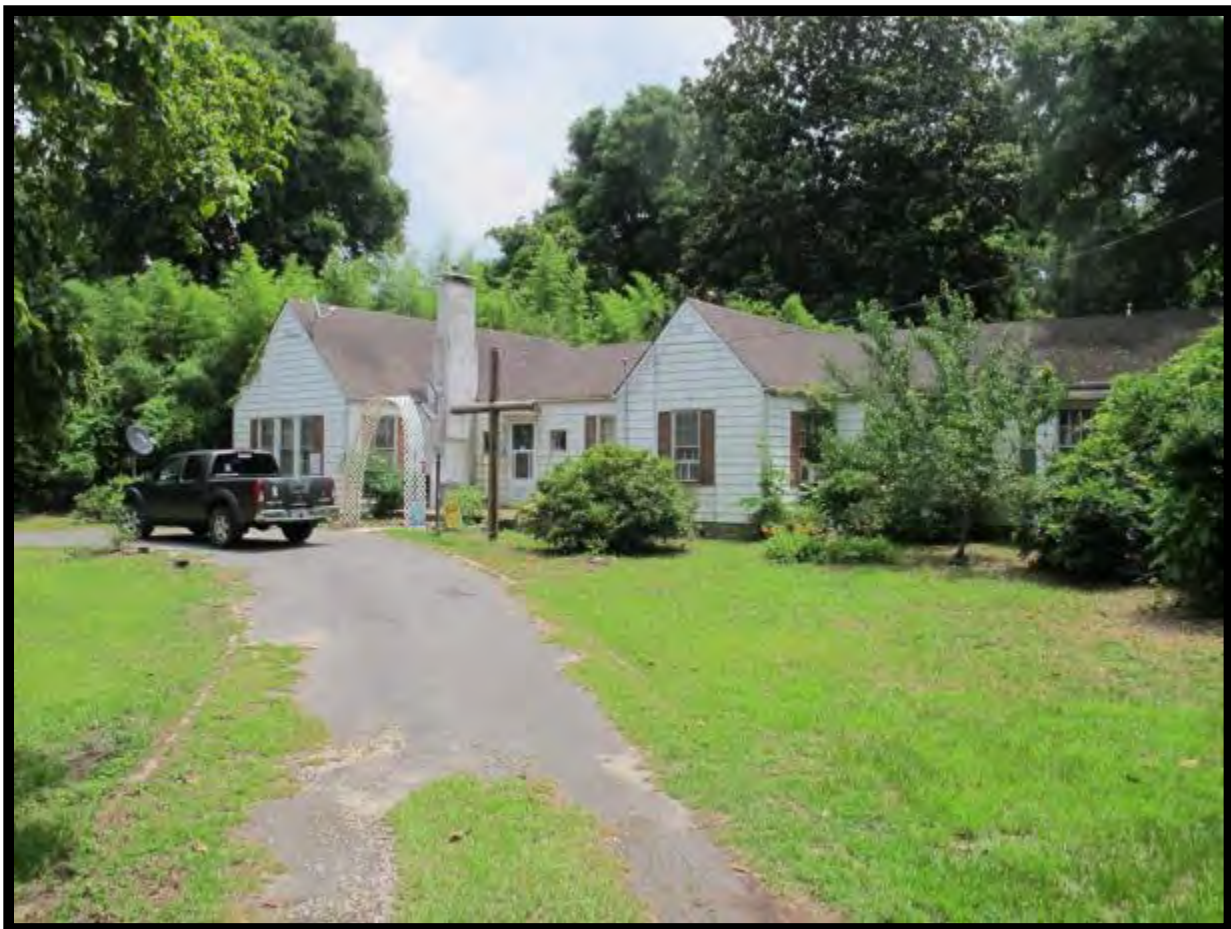
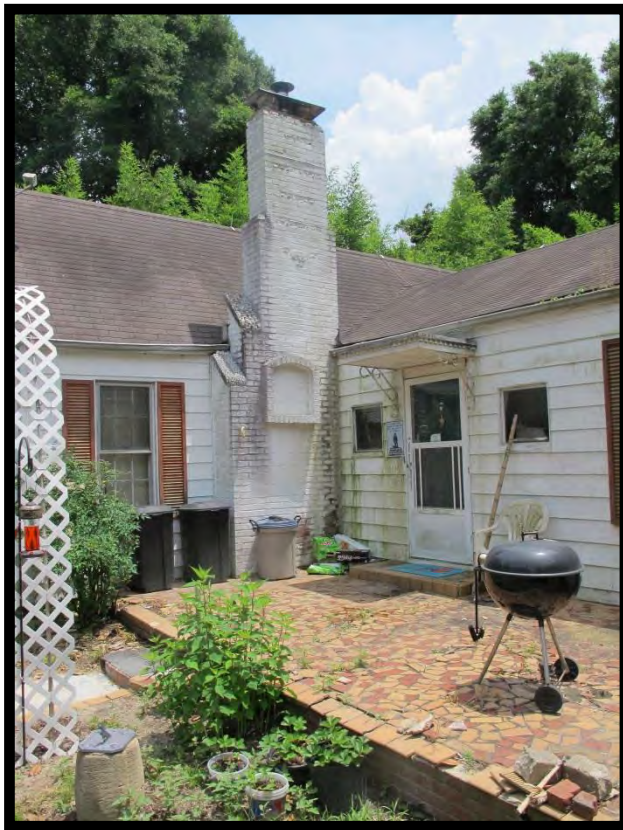
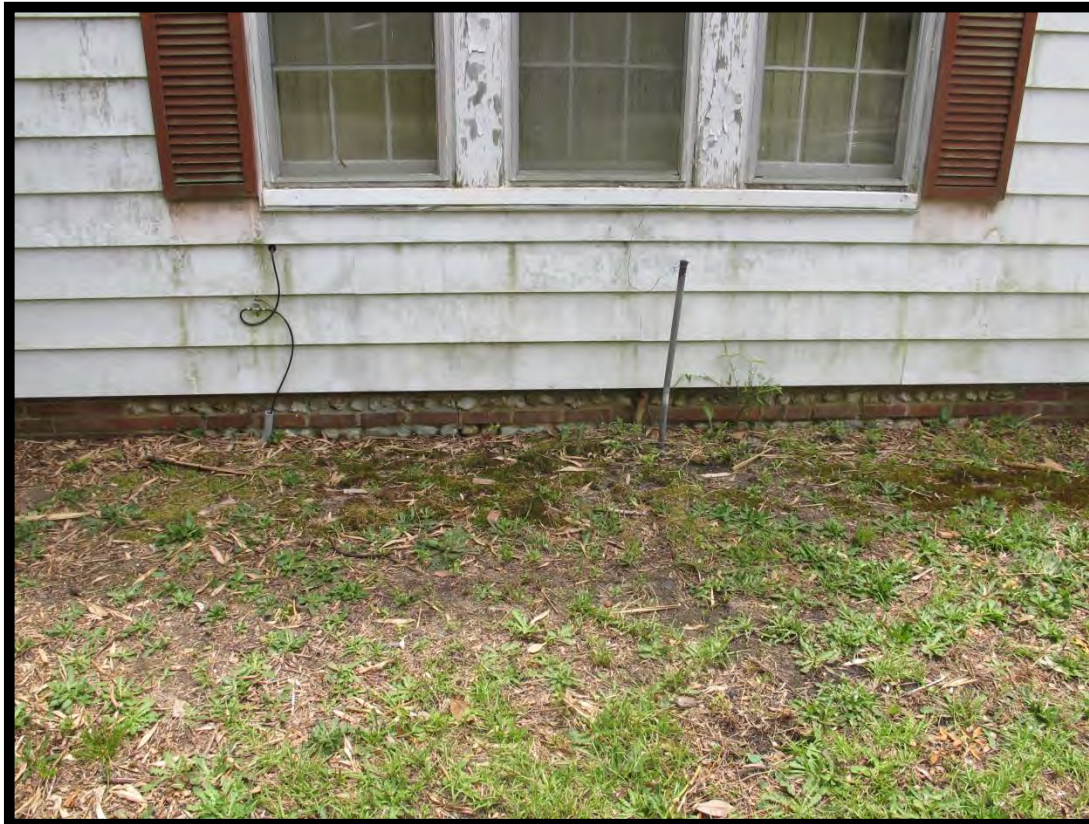
Known as the Sutphin House, the dwelling has a rambling footprint. The one-story, side-gabled dwelling has two projecting front-gabled bays on the north (front) elevation of the building. The larger of the two bays flanks the entry door to the left and has a triple window in the north (front) gable end. Located against its west (side) elevation, where it meets with the main block, is an exterior brick chimney with stone detailing. A shorter bay is located to the right of the entry, and has a single window. The main dwelling continues west past the shorter bay and has a polygonal bay window on its front elevation. Located against its west gable end is an exterior brick chimney with stone detailing, and a small front gabled portico shelters an entry door. The dwelling sits on an unusual foundation consisting of alternating courses of brick and rocks, is clad in aluminum siding, and has six-over-six wooden sash windows (Figures 51 through 53).³⁵

Figure 51: Sutphin House, Looking Northeast.

Figure 52: Sutphin House, Detail of Chimney.

Figure 53: Sutphin House, Detail of Foundation.

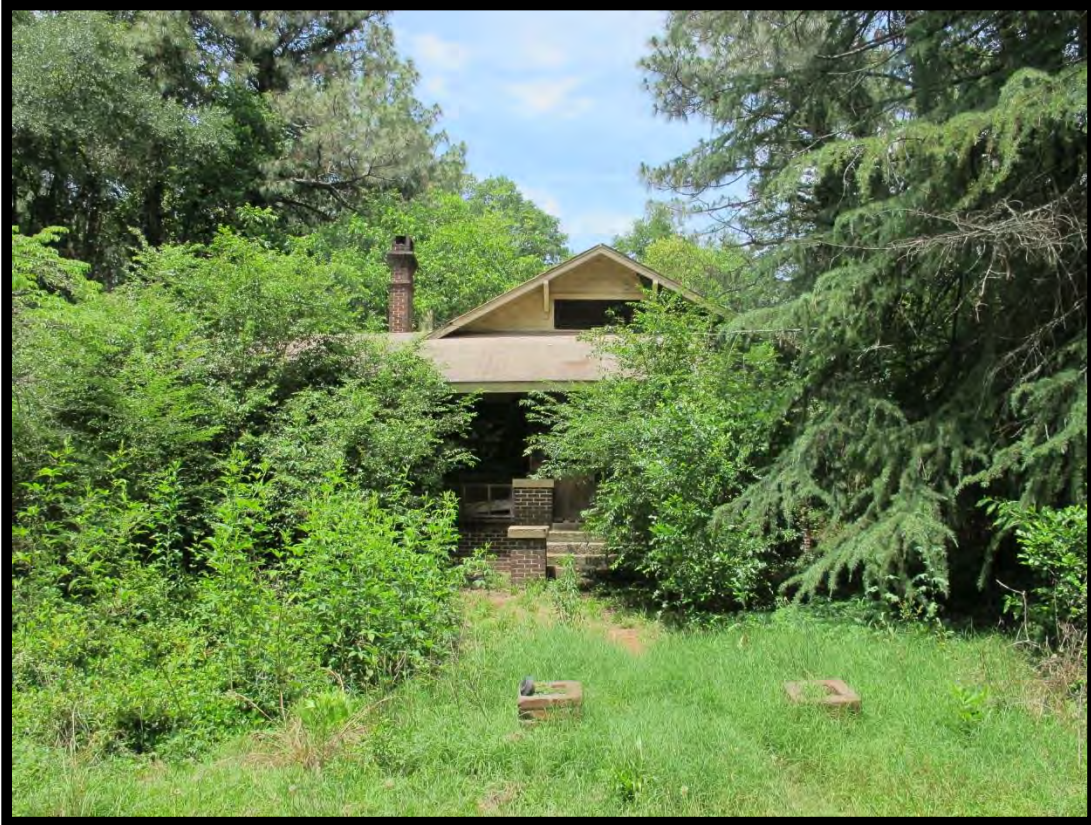
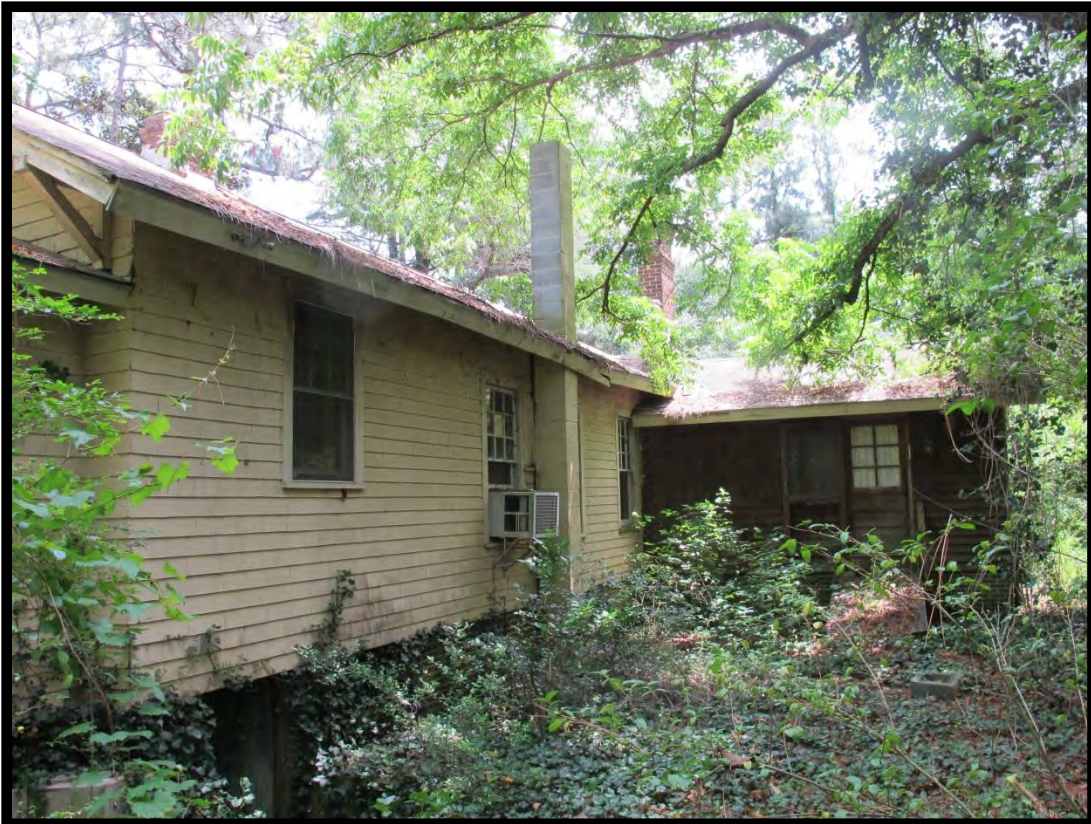
One-story, front-gabled Craftsman-style dwelling with a shed-roofed porch, supported by square shingled columns on brick pedestals, which shelters the two of the three bays on the south (front) gable end. The porch extends into a gable-roofed wing off the west (side) elevation. A shallow hip-roofed section runs across the north (rear) gable end of the dwelling. The dwelling sits on a continuous brick foundation and is clad in wood singles, which have been painted on the main block. It has nine-over-one wooden sash windows and a large window with a leaded-glass transom flanks the entry door to the left on the front gable end. Gallows brackets support the overhang of the roof on the gable ends and a brick chimney with a corbelled top pierces the rear slope of the side wing where it meets with the main block. A concrete block flue was later constructed against the west (side) elevation of the dwelling (Figures 54 and 55).

Figure 54: House, Looking North.

Figure 55: House, Looking Southeast.

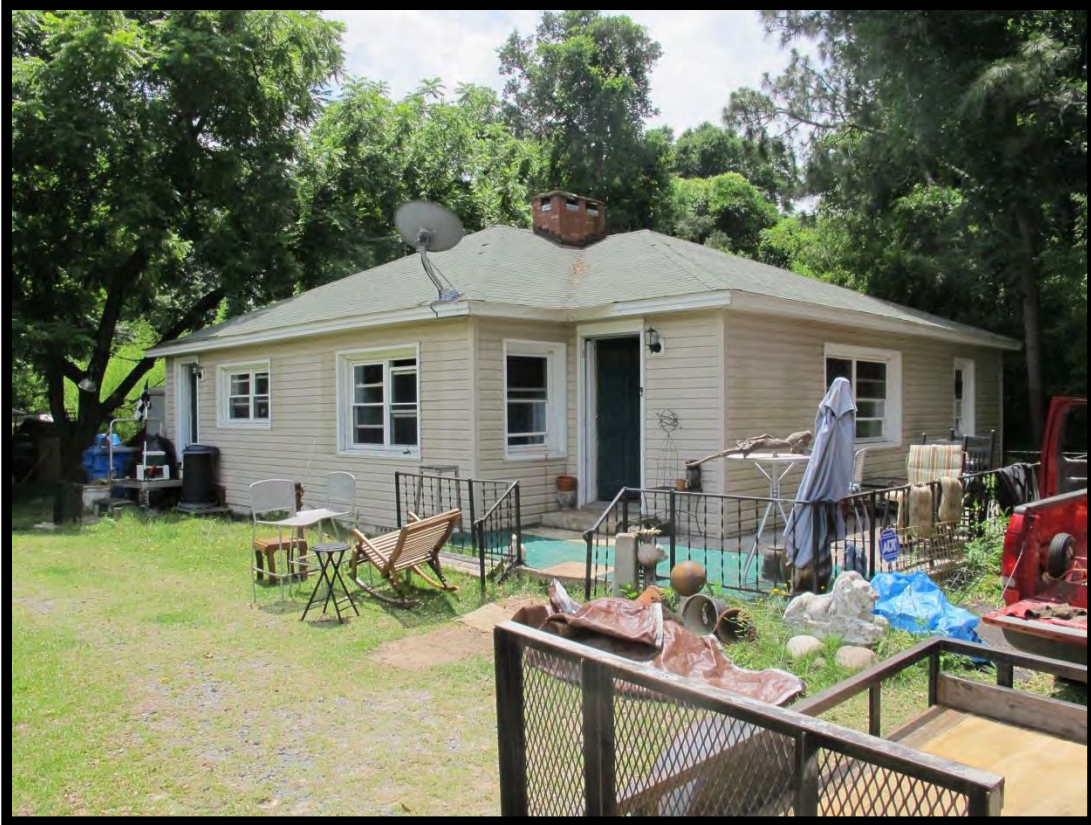
Figure 56: House, Looking Southwest.

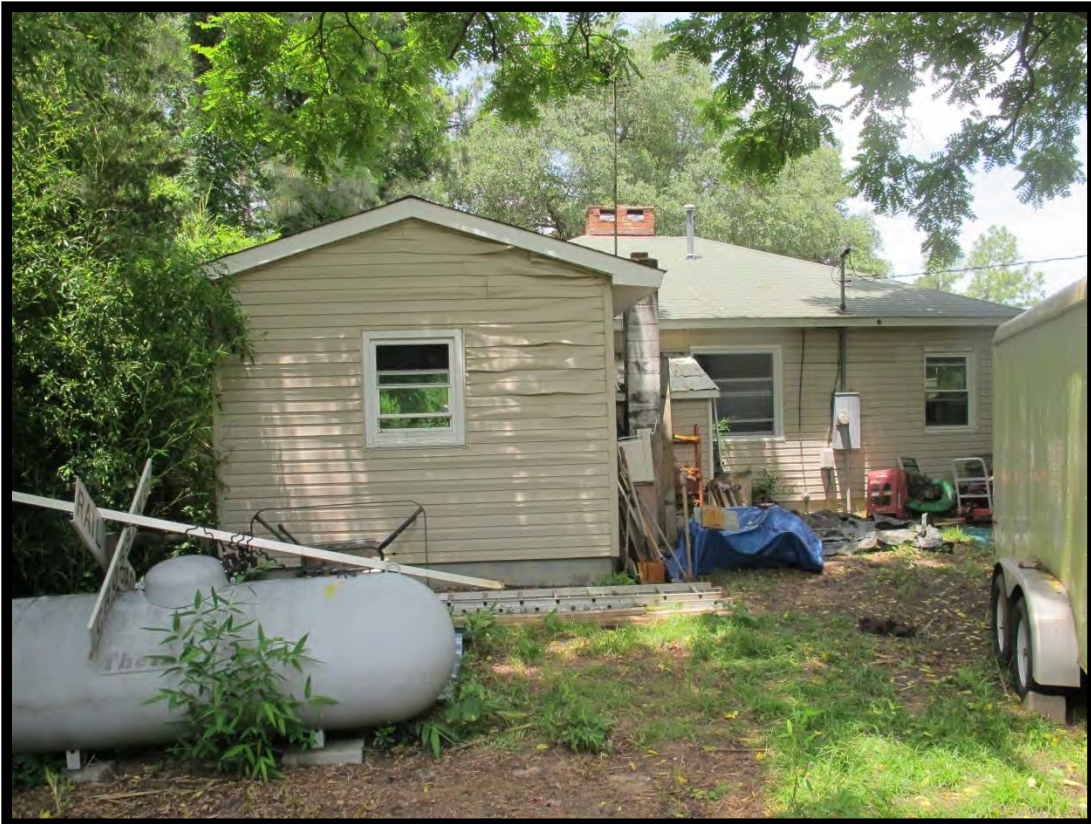
Figure 57: House, Looking Northwest.

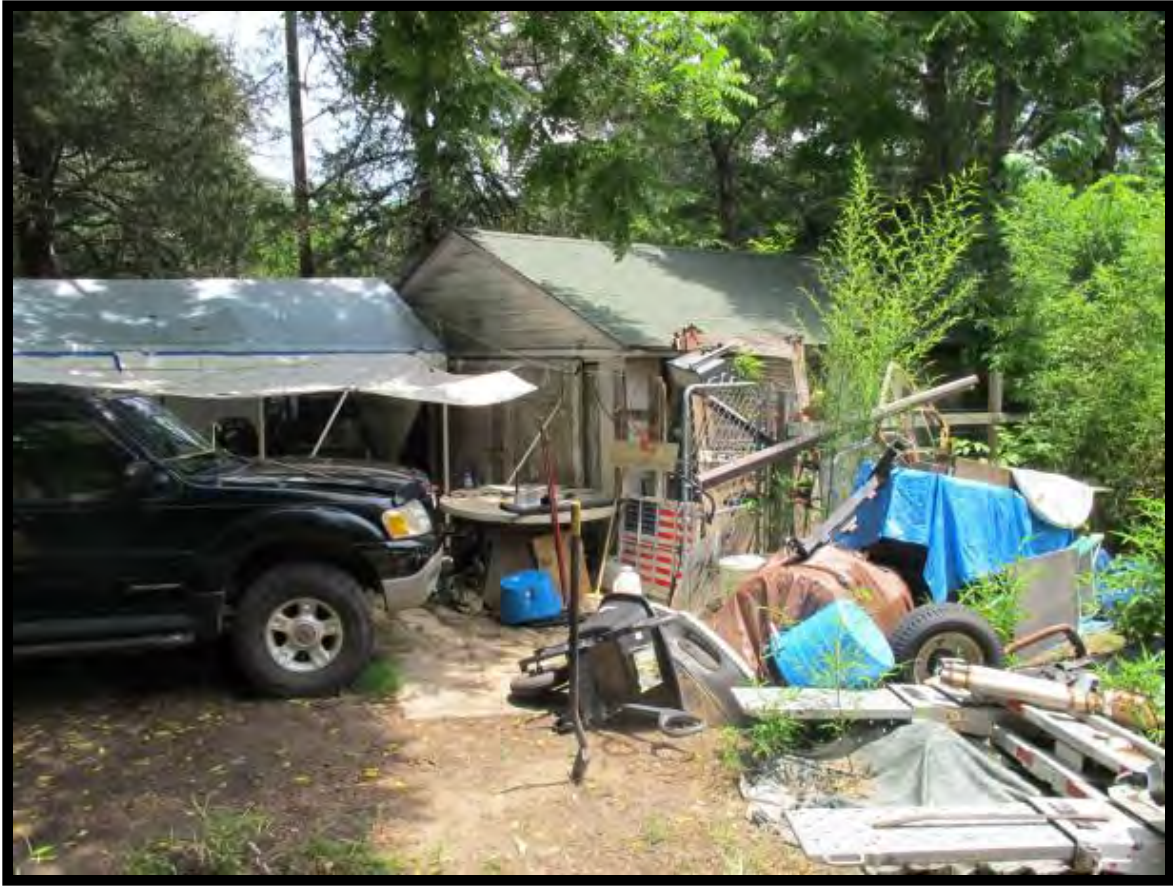
Located behind the dwelling is a front-gabled, concrete block one-car garage (Figure 58).

Figure 58: House, Garage Looking Southeast.

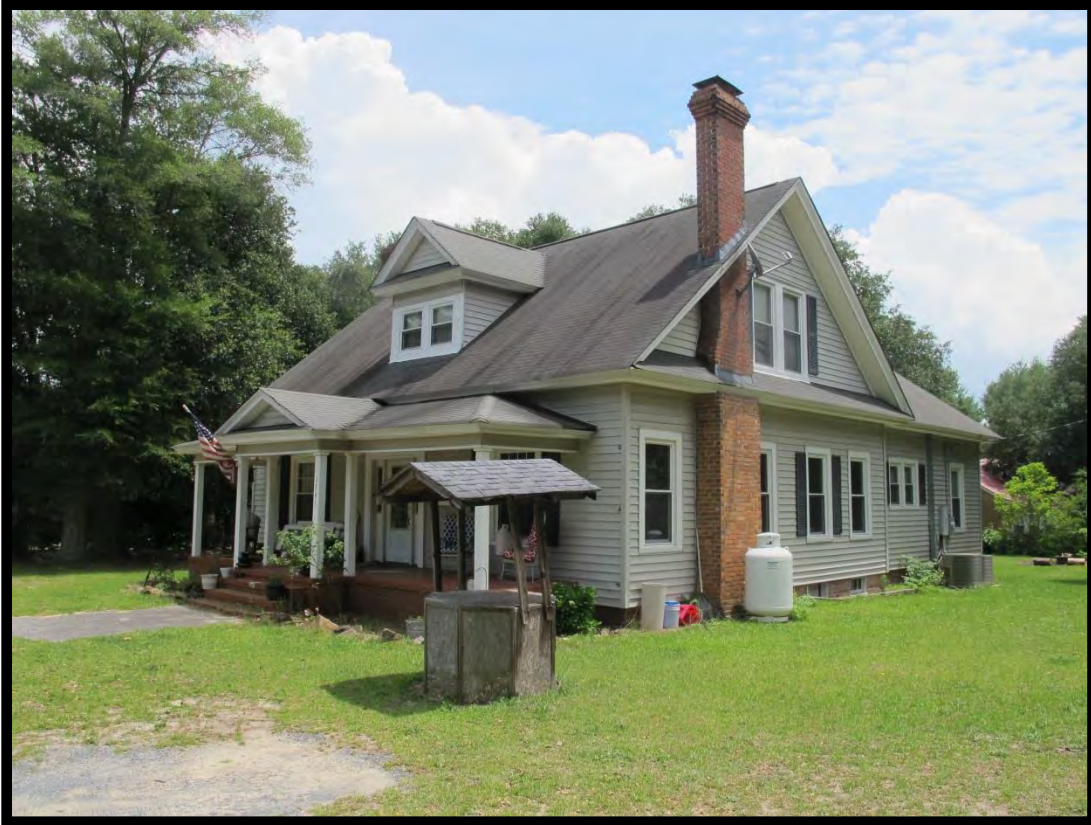
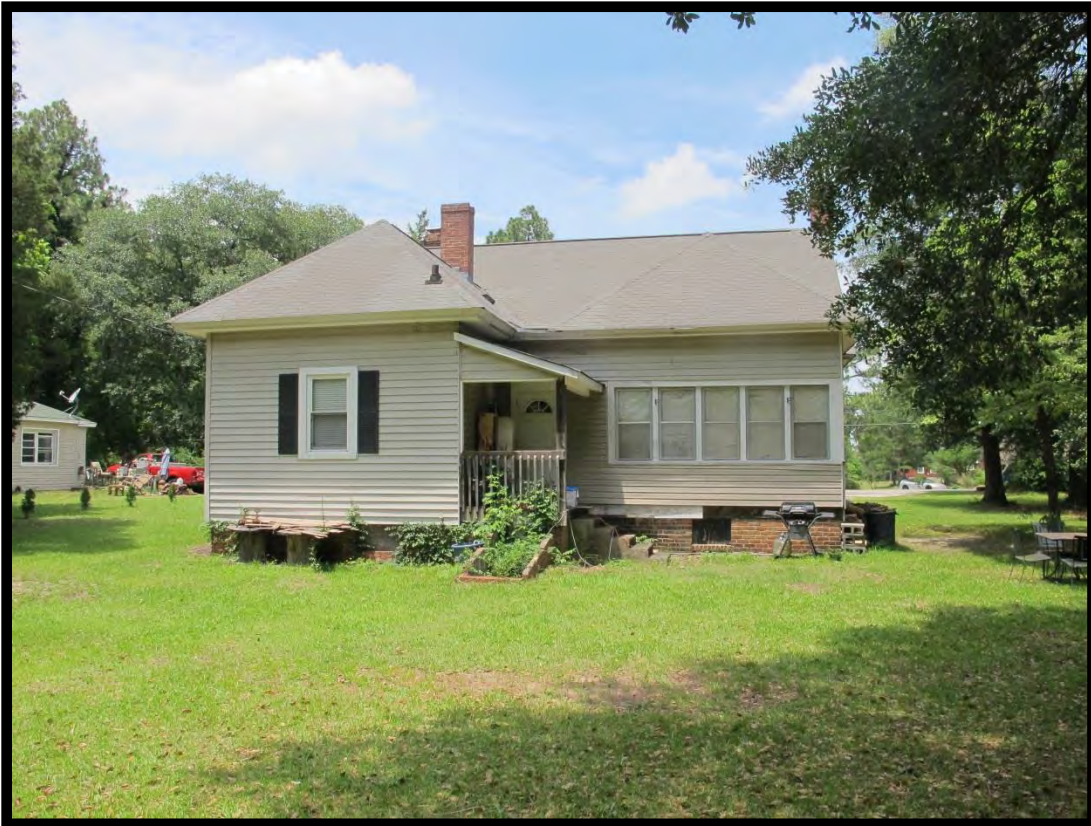
One-and-a-half-story, side-gabled dwelling with a hip-roofed porch with a projecting cross-gabled section, which shelters three bays on the northwest front elevation. Square posts support the porch. A gable-roofed dormer, with a double window, sits on the front slope of the roof, and exterior brick chimneys are located against the pent-roof enclosed northeast and southwest gable ends. Two, one-story, hip-roofed wings extends off the southeast (rear) elevation of the main block. The longer of the two is located on the left side of the rear elevation and has a small shed-roofed porch along its northeast (side) elevation. The shorter of the two wings is located to the right and appears to have functioned as a sunroom. The dwelling sits on a brick foundation, is clad in vinyl siding, and has one-over-one vinyl sash replacement windows, and eight-over-one vinyl sash replacement windows flanking the entry door on the front elevation (Figures 59 and 60).

Figure 59: Forest Von Canon House, Looking Southeast.

Figure 60: Forest Von Canon House, Looking Northwest.

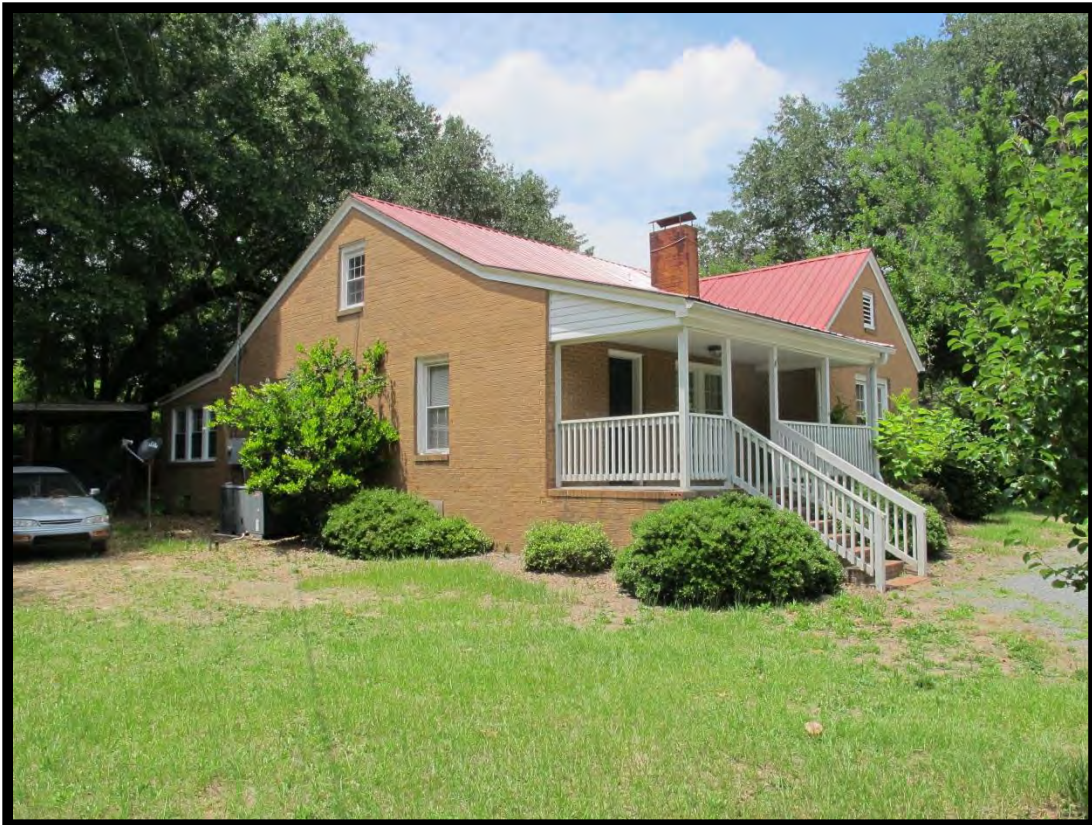
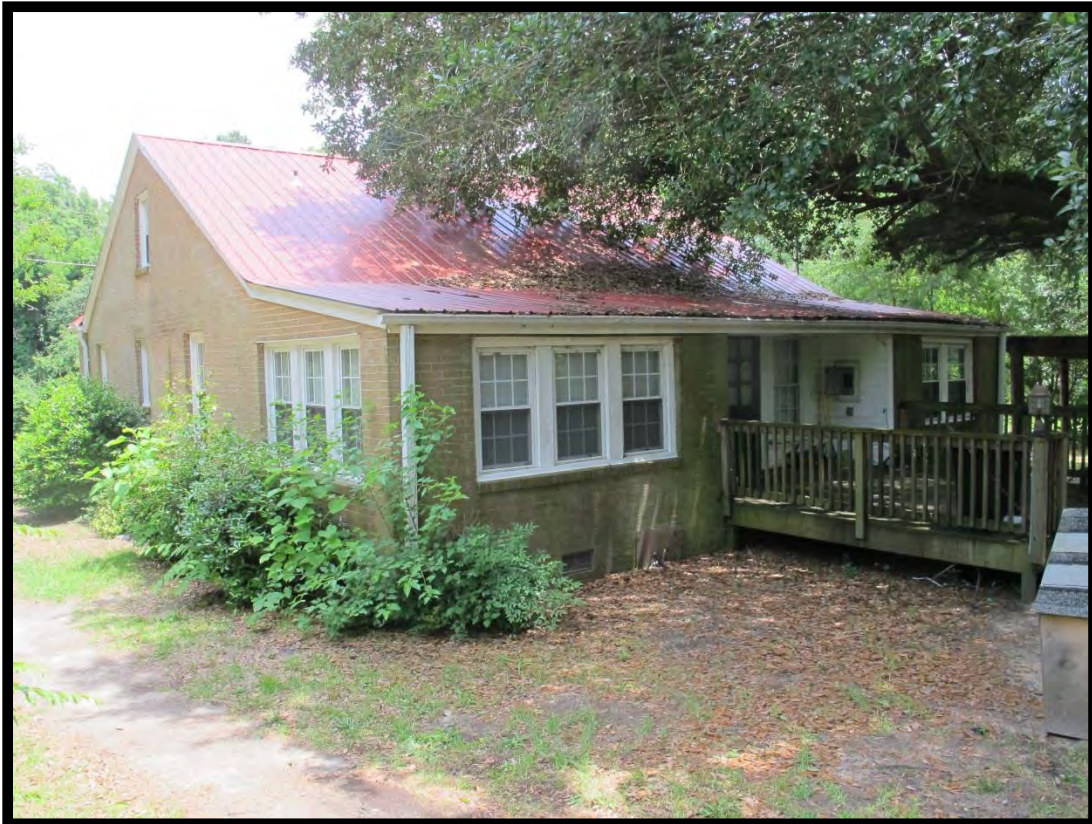
One-story, side-gabled dwelling, with a projecting front-gabled bay on the east (front) elevation of the dwelling. An engaged shed-roofed porch, supported by plain posts, flanks the projecting bay to the left and shelters the entry door and a double window on the front elevation. A deep engaged shed, with a small recessed porch, extends across the west (rear) elevation of the main block. The dwelling is clad in stretcher-bond brick and has six-over-six vinyl sash replacement windows (Figures 61 and 62).

Figure 61: House, Looking Northwest.

Figure 62: House, Looking Southeast.

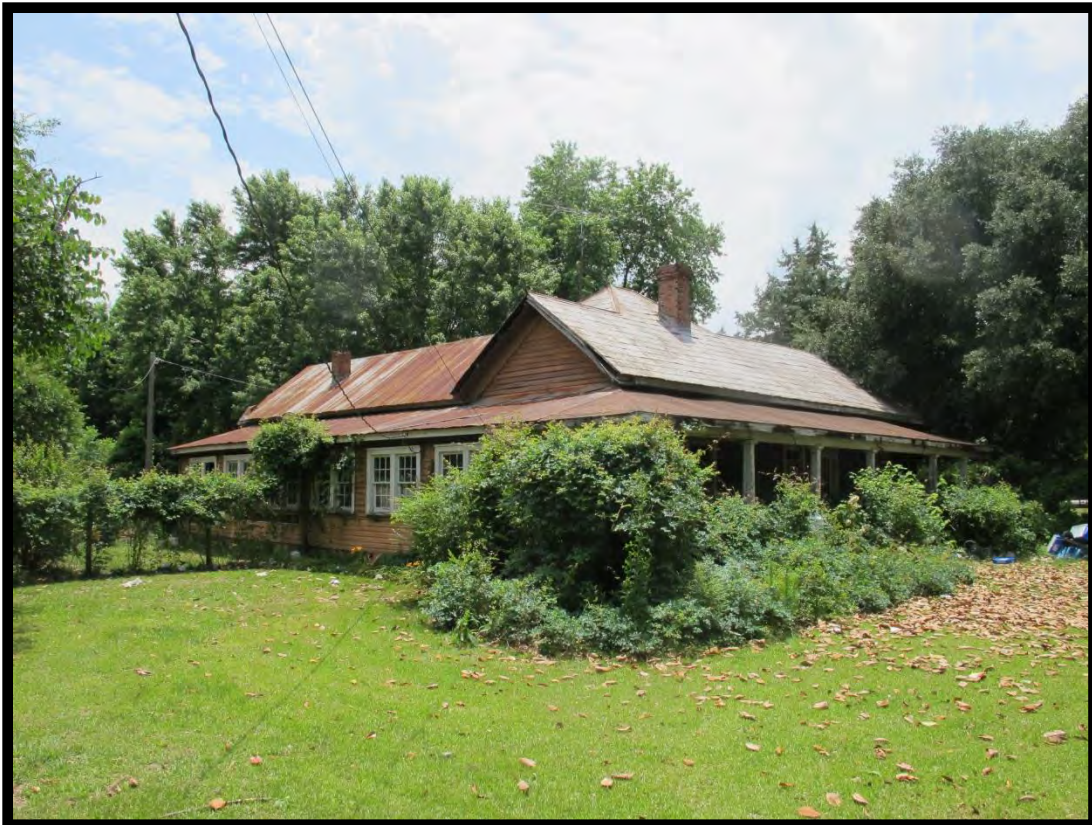
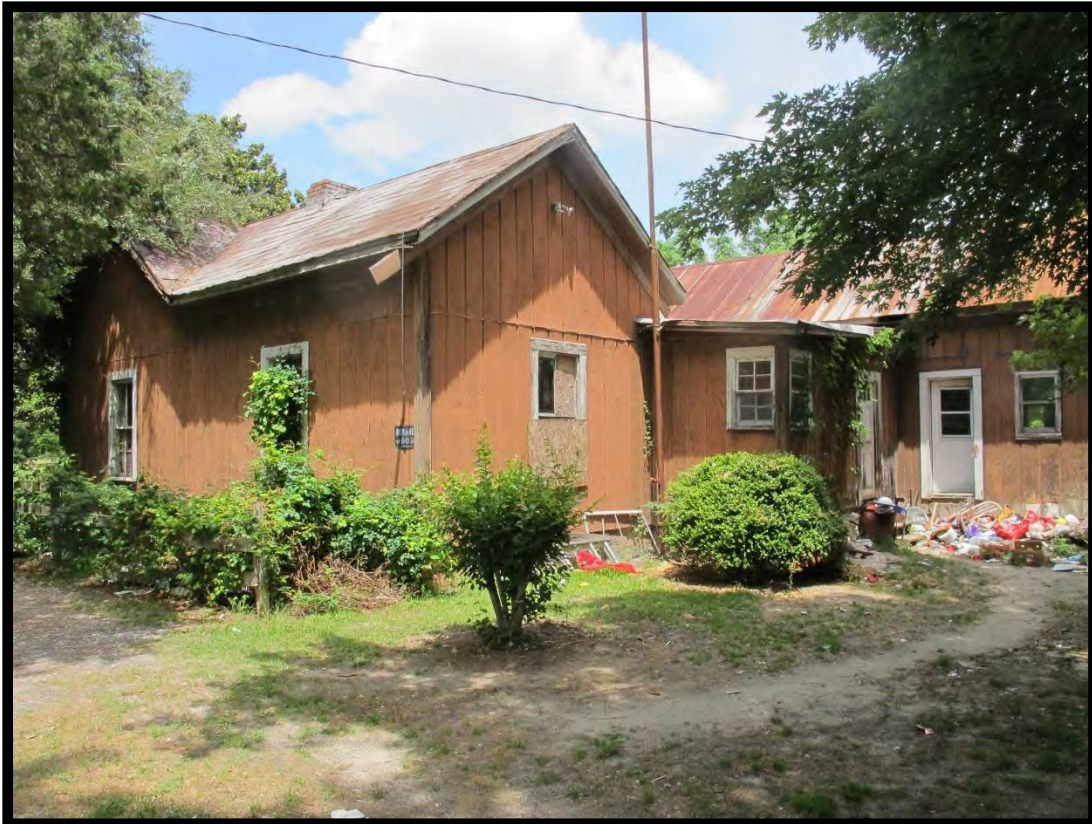
One-story, side-gabled dwelling, with a hip-roofed porch, supported by batter-box columns on brick pedestals, which shelters the four bays on the north (front) elevation. The porch wraps around the east gable end where it continuous along one of the east elevation of one of the rear wings, and is enclosed. A short and a long gable-roofed wing extends off the south (rear) elevation of the main block. The side elevation of the short wing is flush with the west gable end of the main block and the long wing with the east gable end. Located between the two wings is a peculiar hip-roofed section, which extends into a shed-roofed addition which extends just past the shorter of the two wings. The dwelling is clad in a combination of plain weatherboard siding, German, or drop, siding, and T1-11 siding, and has a variety of wooden sash windows, including two-over-two and six-over-six (Figures 63 and 64).

Figure 63: House, Looking Southwest.

Figure 64: House, Looking Northeast.

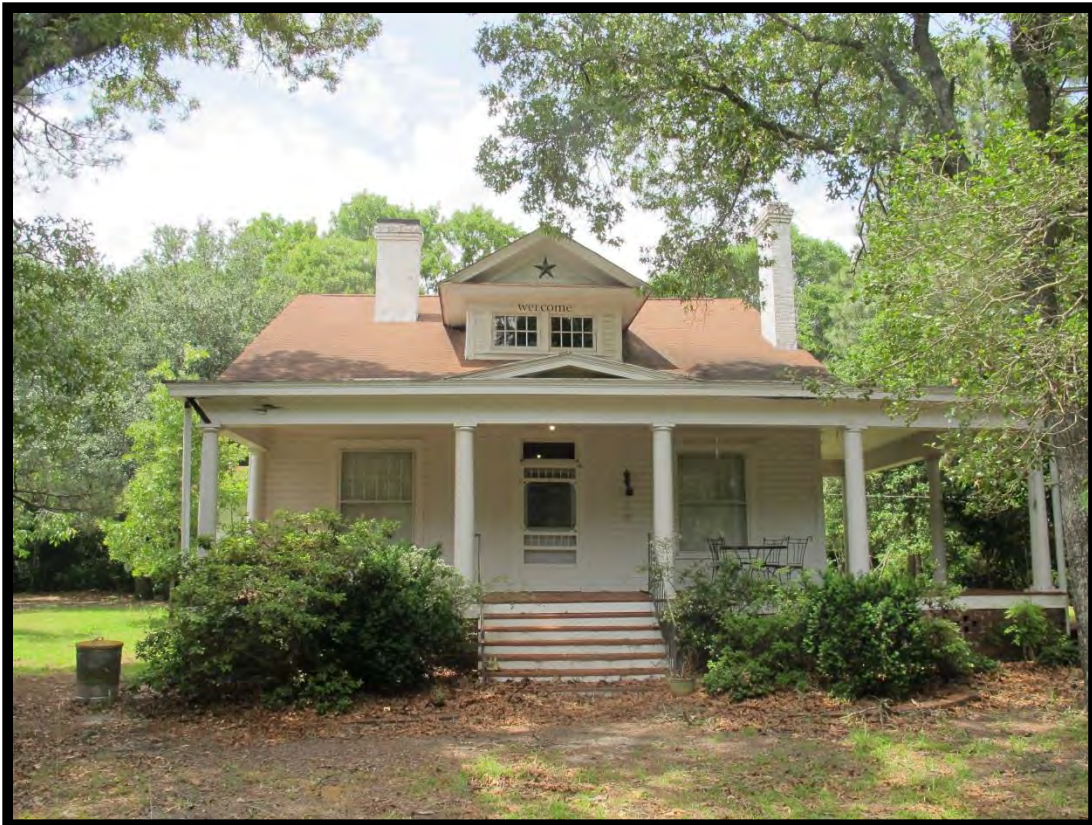
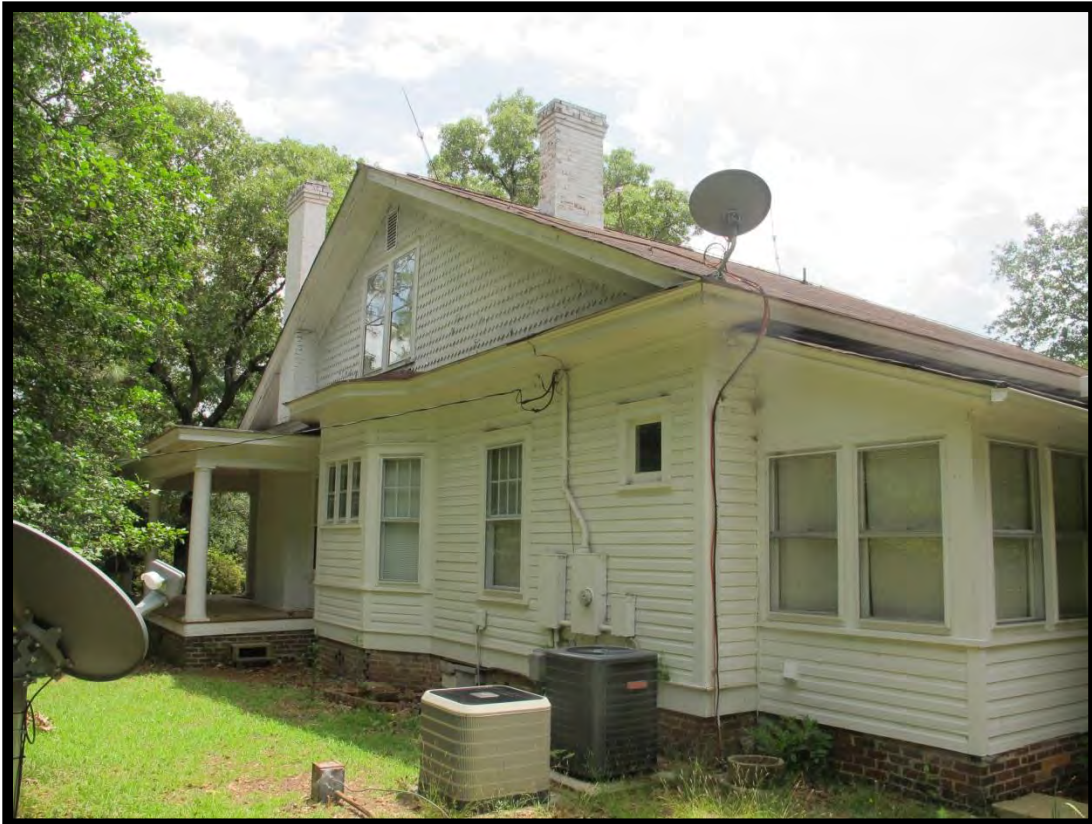
The Wilson-Cochran House is a one-and-a-half-story, side-gabled dwelling, with a hip-roofed porch, supported by classical columns, which shelters three bays on the southeast (front) elevation. The porch has a centrally placed shallow-pitched cross gable and partially wraps around the northeast gable end. A front-gabled dormer with a double six-light window sits on the front slope of the roof. Located against the northeast gable end is a polygonal bay, and a small gable-roofed wing extends off the southwest gable end. An enclosed shed-roofed porch runs across the northwest (rear) elevation of the dwelling. The dwelling sits on a brick foundation, is clad in German, or drop, siding, and has a combination of six-over-one, eight-over-one, ten-over-one, and six-over-six wooden sash windows, with large twelve-over-one wooden sash windows flanking the entry. Decorative shingles fill the gable peaks. Located against the northeast gable end is an exterior brick chimney, and interior brick chimneys pierce the front and rear slopes of the roof (Figures 68 and 69).

Figure 68: Wilson-Cochran House, Looking Northwest.

Figure 69: Wilson-Cochran House, Looking Southwest.

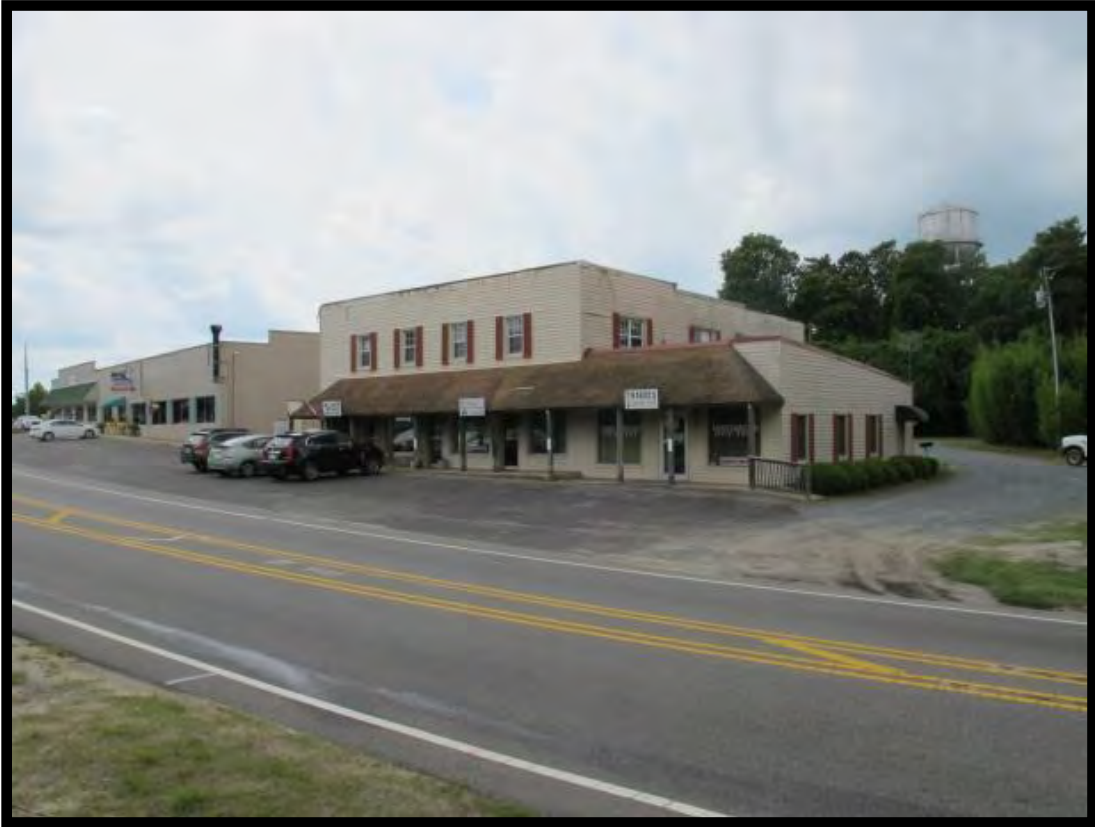
Figure 70: Commercial Block, Looking Southwest.

This two-story flat-roofed commercial building has a one-story, shed-roofed wing against its northwest (side) elevation. A simple hip-roofed porch, supported by plain posts shelters three business units on the two-story block, and a barbershop on the one-story wing. The two-story section has a stepped parapet wall. The building is clad in vinyl siding, and has vinyl sash replacement windows, with faux shutters on the second floor and the side elevations (Figures 70 and 71).
