Re: Widen NC 211 from SR 1241 (Holly Grove School Road) to NC 73 in West End,
R-5726, Moore County, ER 17-1302

RE: R-5726—Widen NC 211 from SR 1241 (Holy Grove Rd) to NC 73 in West End,
Moore County, ER 17-1302

NCR-0748

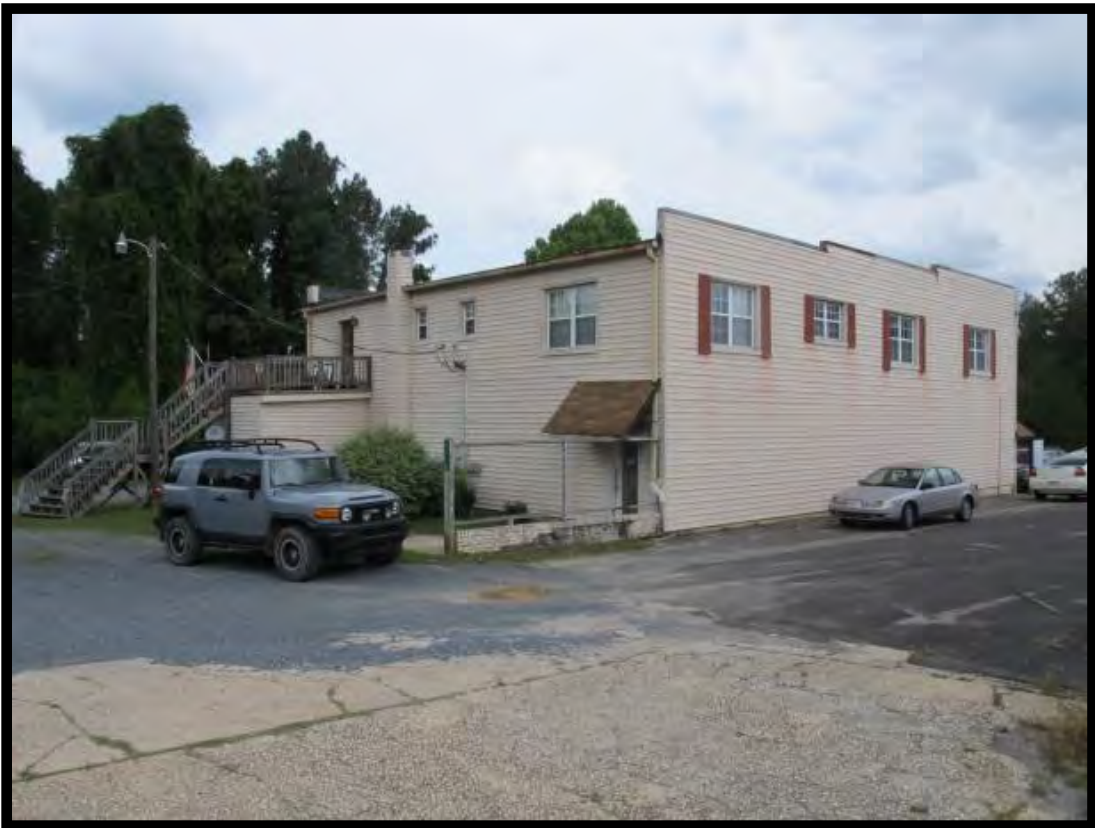
Figure 71: Commercial Block, Looking Southwest.

This two-story flat-roofed commercial building has a one-story, shed-roofed wing against its northwest (side) elevation. A simple hip-roofed porch, supported by plain posts shelters three business units on the two-story block, and a barbershop on the one-story wing. The two-story section has a stepped parapet wall. The building is clad in vinyl siding, and has vinyl sash replacement windows, with faux shutters on the second floor and the side elevations (Figures 70 and 71).

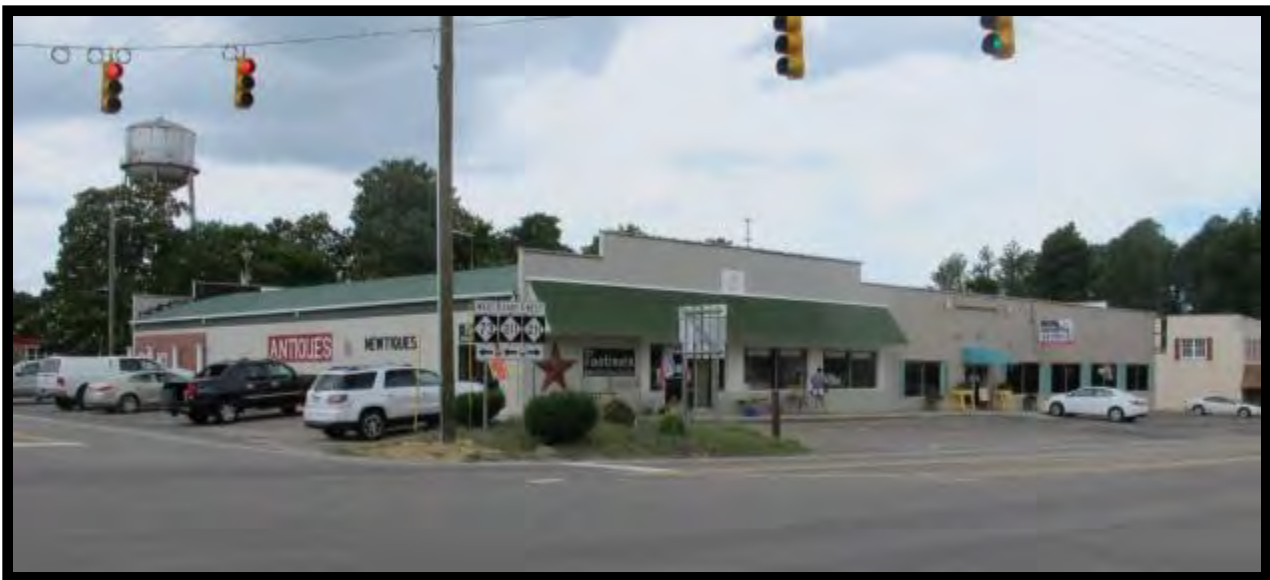
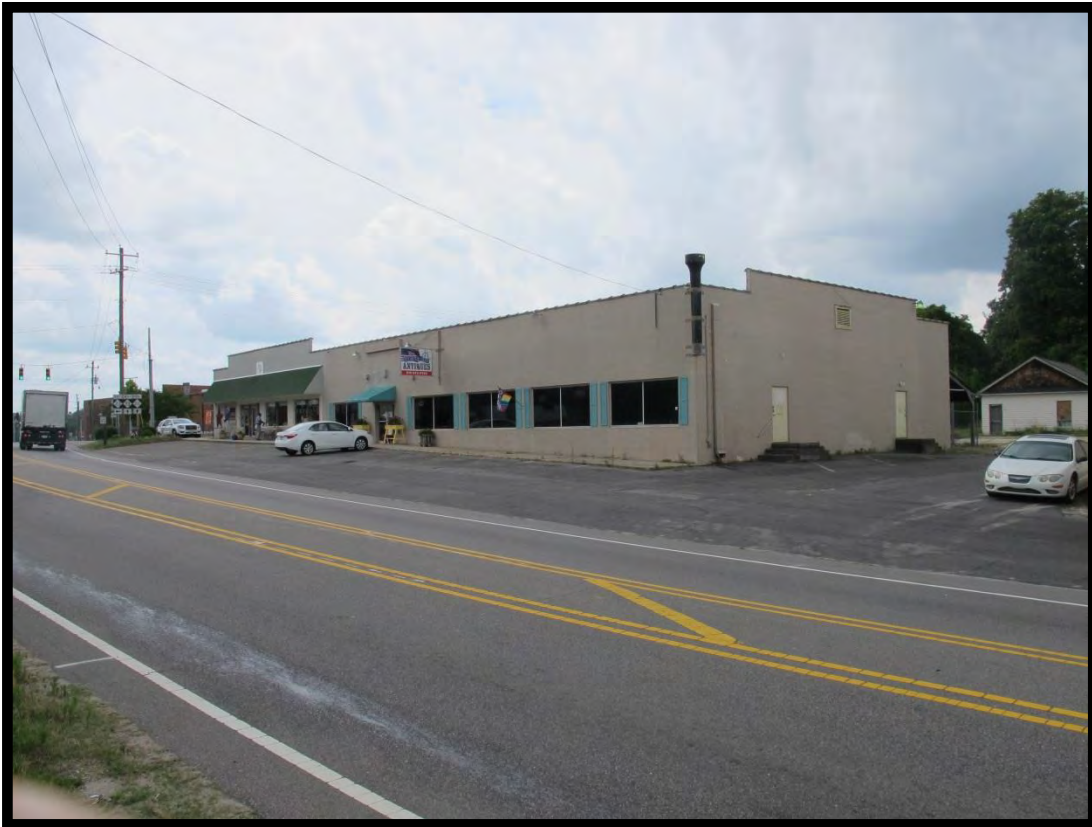
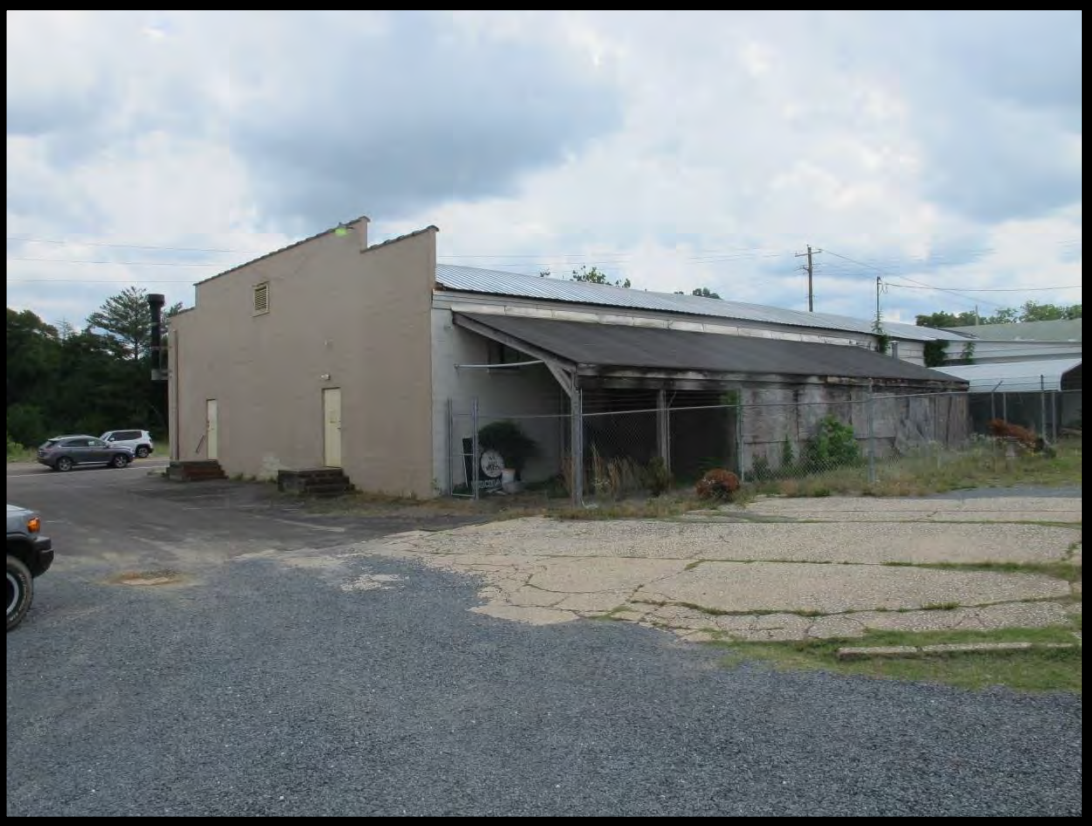
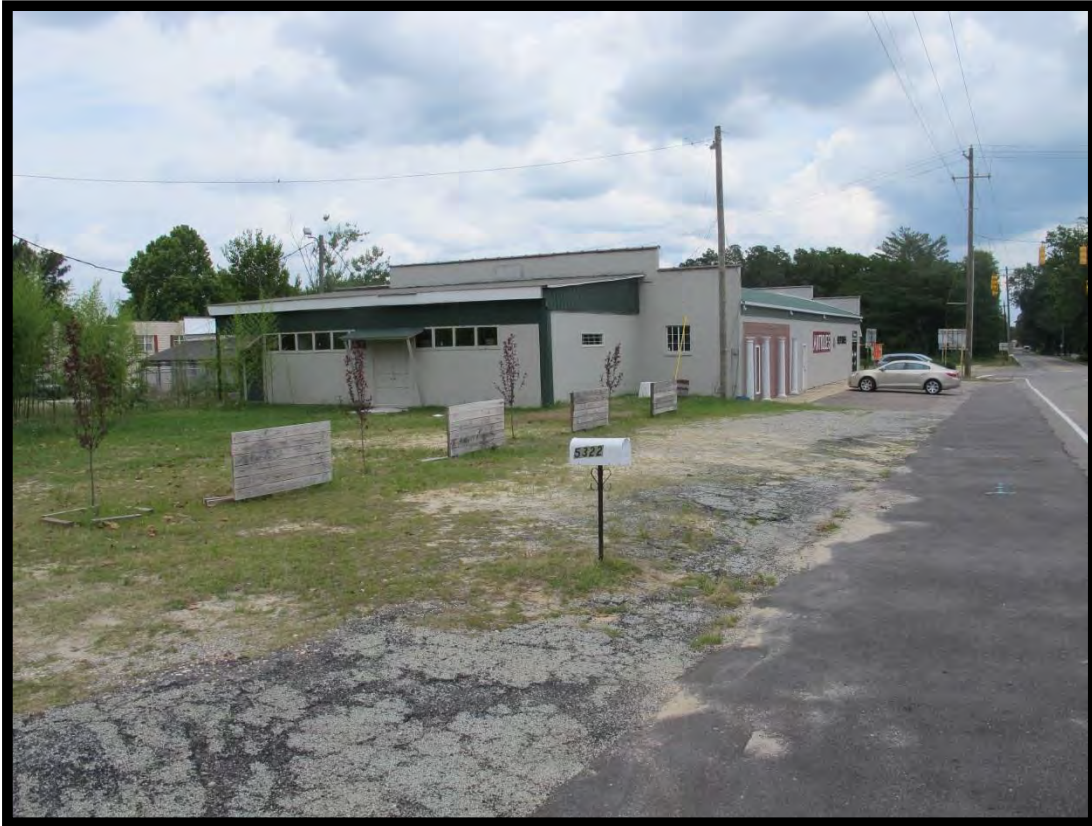
Two, connected, one-story, concrete-block buildings make up this commercial block. They both have stepped parapet walls with ridge tiles and a barrel vaulted metal roof. The building at 5326 NC 211 is placed lateral to the road. A metal awning shelters the double glazed entry doors, which are flanked by large double-light fixed store windows: one to the left, and four to the right. A shed-roofed wing extends off the west (rear) elevation of the building. At some point a partially enclosed frame shed addition was constructed against the rear elevation of the main block. The building at 5336 NC 211 is placed perpendicular to the road. A metal pent roof spans much of the east (front) parapet wall, and shelters a double glazed entry door, which is flanked to the right by two large double-light fixed store windows to the right. A shed-roofed addition extends off the west (rear) parapet wall (Figures 72 through 75).

Figure 72: Commercial Block, Looking Northwest. Note, 5336 to the left and 5326 to the right.

Figure 73: Commercial Block, Looking Southwest. Note, 5336 to the left and 5326 to the right.

Figure 74: Commercial Block (5326), Looking Southeast.

Figure 75: Commercial Block (5336), Looking Northeast.

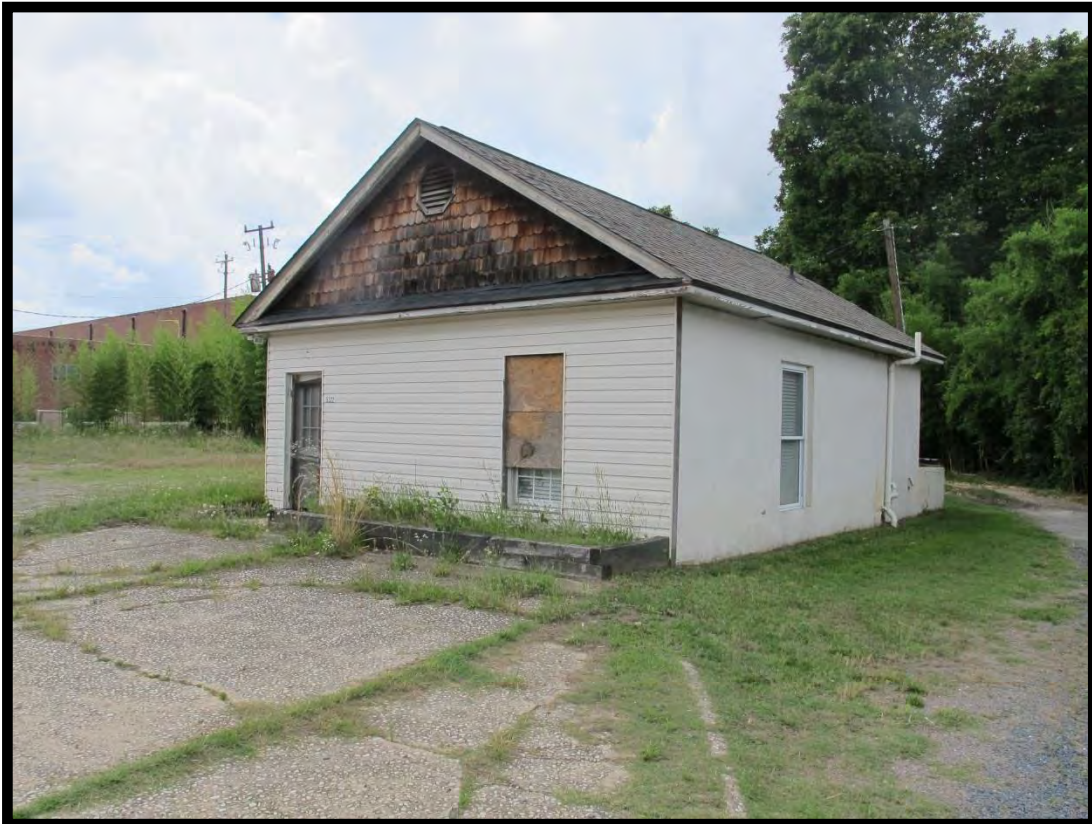
Located behind the building at 5326 NC 211 is a front-gable concrete block building, which has been converted into a dwelling, but was probably a garage (Figure 76).

Figure 76: Commercial Block, Former Garage Looking Southwest.

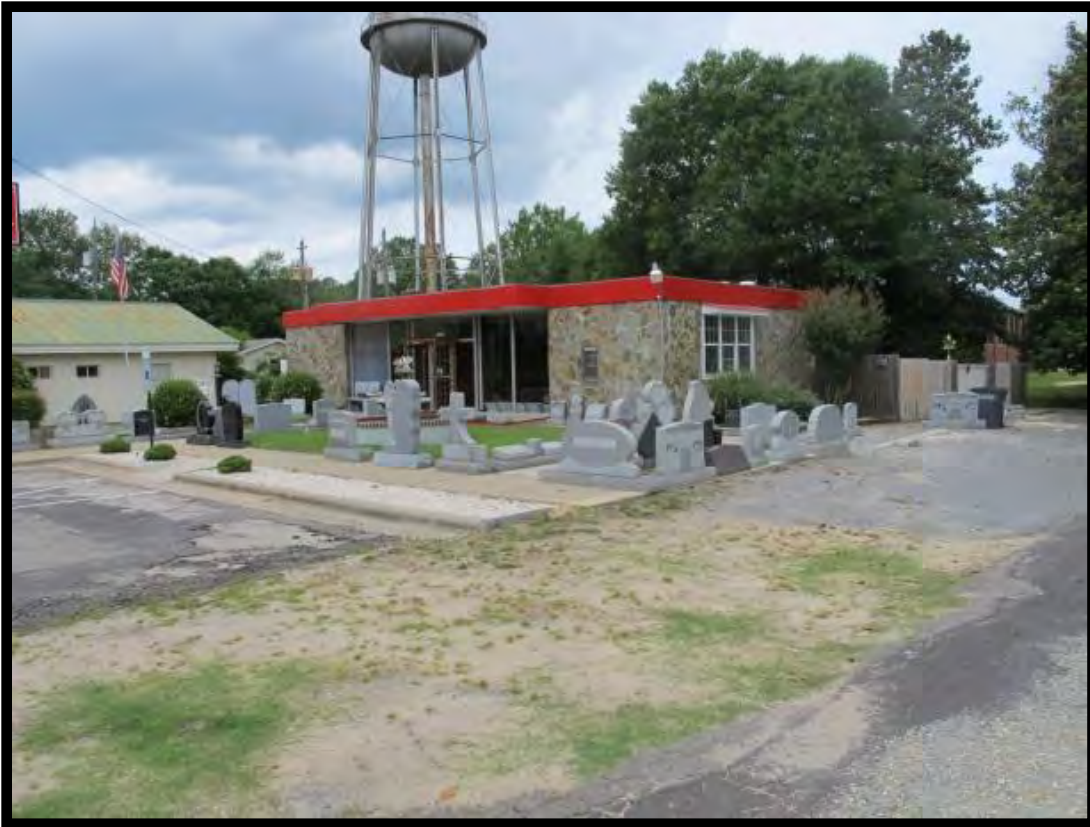
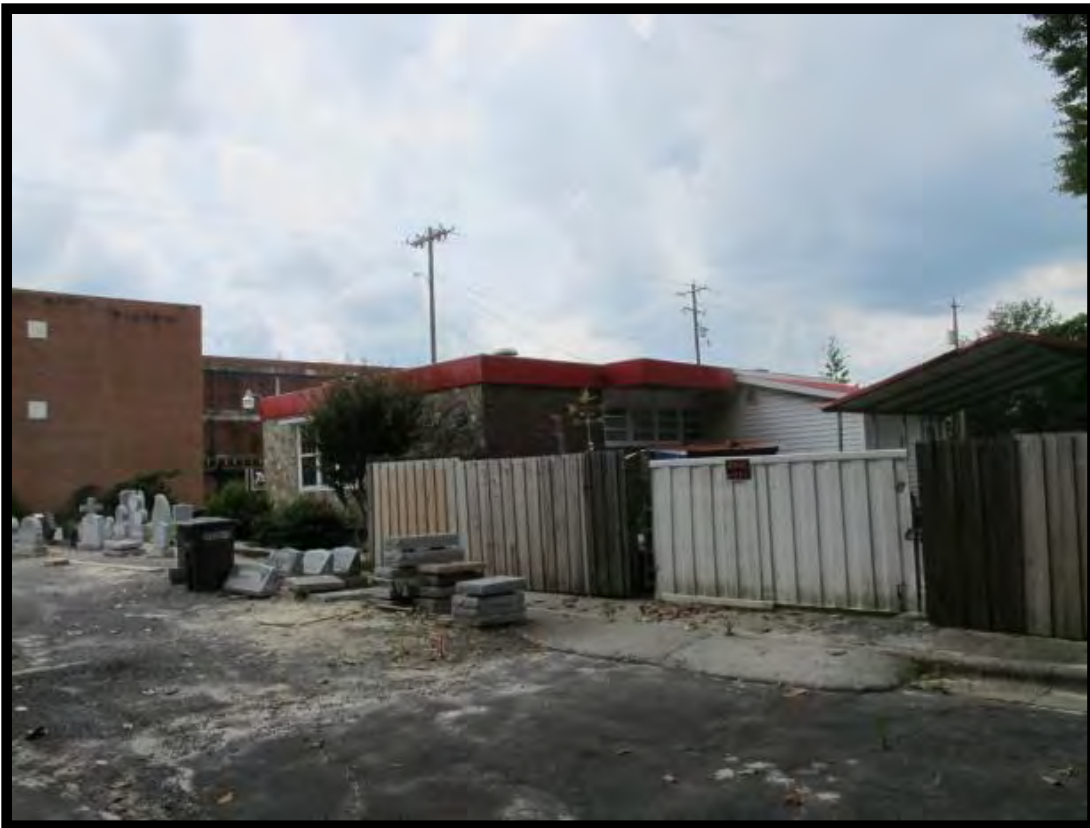
The (former) Carolina Bank is a modest one-story, flat-roofed mid-century modern building. The building has a rectangular footprint, with the roof projecting over sections on the south (front) and north (rear) elevations. On the front elevation the projecting roof shelters a slightly recessed entrance section consisting of double glazed doors, with a large fixed transom, and flanked by double floor-to-ceiling plate glass windows. On the rear the roof shelters a band of multi-pane windows. A band of three six-over-six vinyl sash windows, with a small pent roof, pierce the east (side) elevation of the bank. At some point a shed-roofed addition was constructed against the rear elevation. The front and side (east) elevation are clad in fieldstone veneer and the rear and west (side) elevation in brick (Figures 77 and 78).

Figure 77: (Former) Carolina Bank, Looking Northwest.

Figure 78: (Former) Carolina Bank, Looking Southwest.

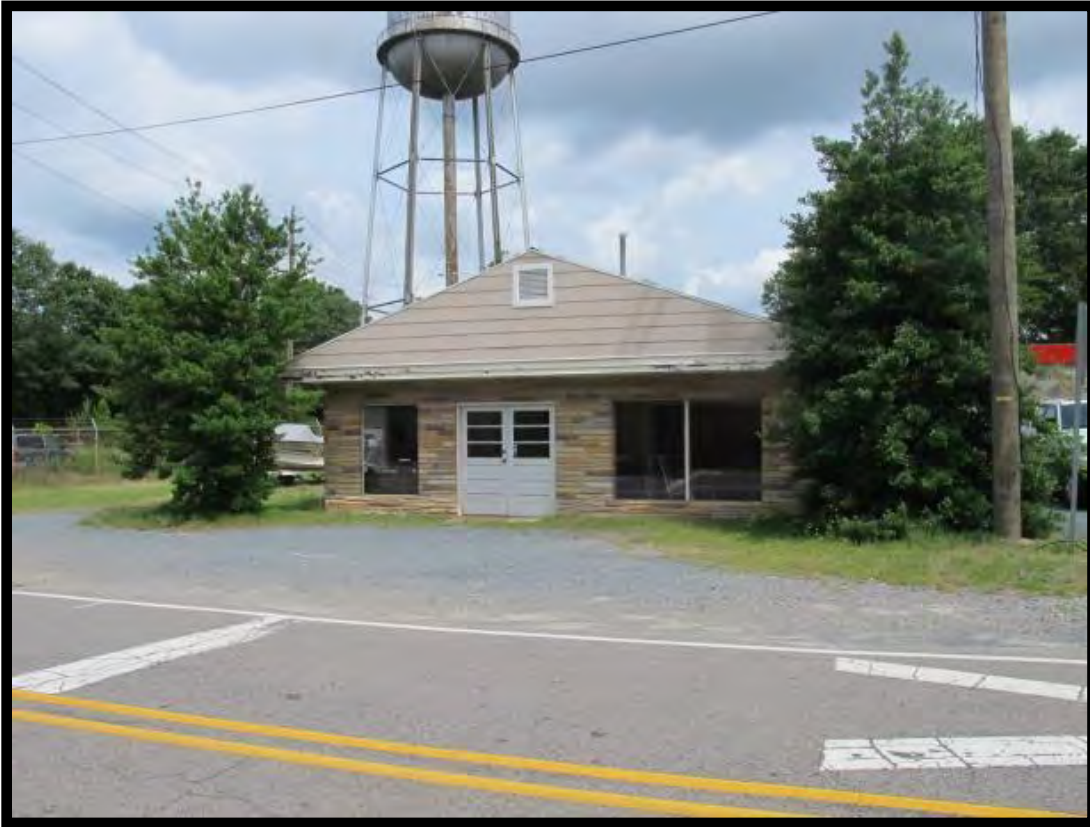
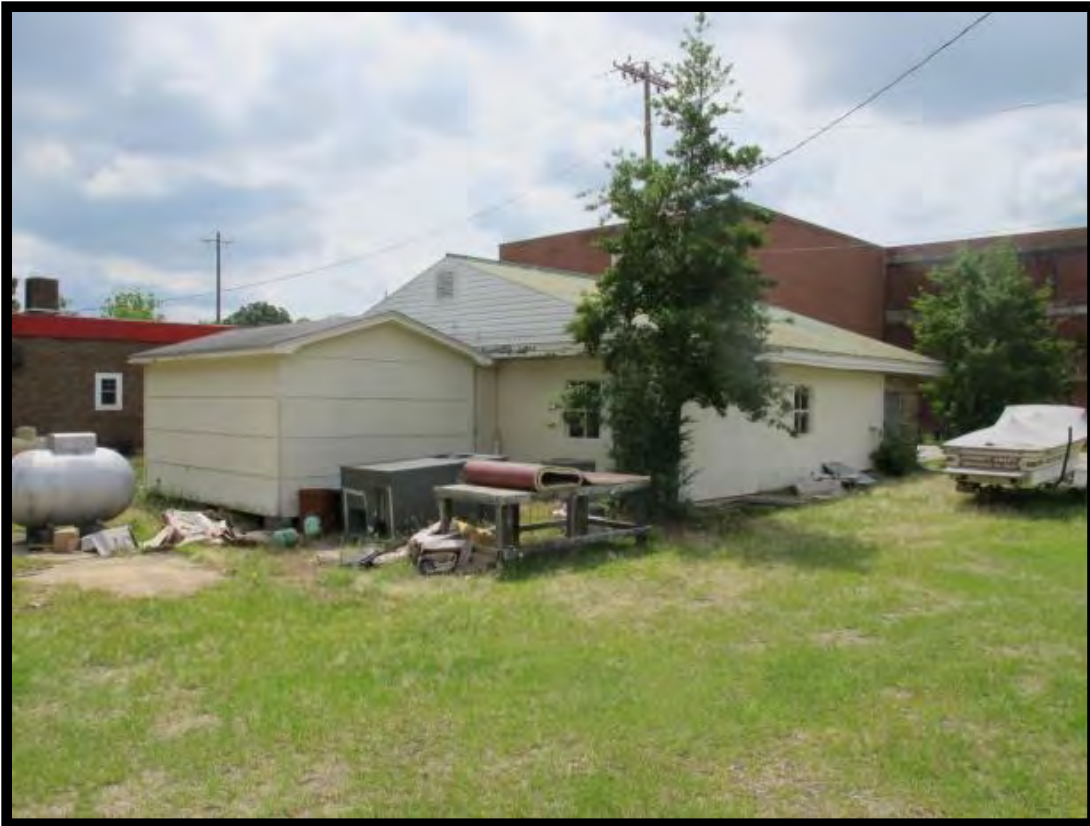
This one-story, front-gabled concrete block commercial building has a permastone veneer on the south (front) gable end. The double entry doors are placed off center and are flanked to the left by a single plate-glass window, and to the right by a double plate-glass window. A section of the permastone wraps around the west (side) elevation and surrounds a large plate-glass window. The remaining sections of the building are painted concrete block. Located on the west (side) elevation, near the north (rear) gable end is a sliding garage door. A four-light steel casement window flanks the garage door to the right and a second one is located in the rear gable end. A short, gable-roofed hyphen connects the main block to a one-story gable-roofed frame shed, placed perpendicular to the main building (Figures 79 and 80).

Figure 79: Commercial Building, Looking Northwest.

Figure 80: Commercial Building, Looking Southeast.

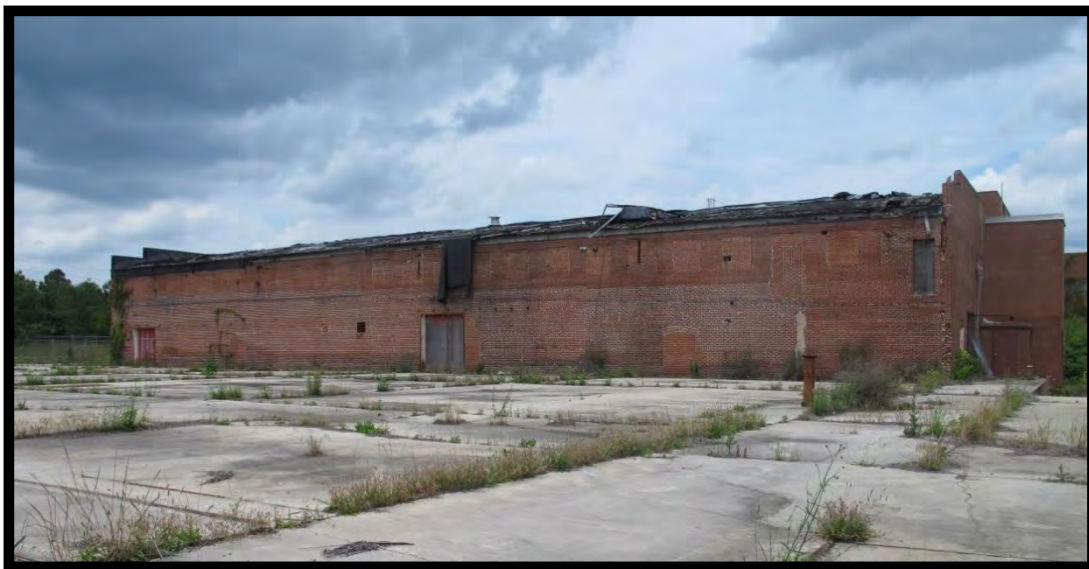
The factory closed around 2003, and many of the buildings were demolished (Figure 82). What survives today of the Sandhill Furniture Company is a two-story, brick building with stepped parapet walls at the east and west end and a barrel-vaulted roof (Figure 83). The other two buildings date to the Stanley Furniture Company period and are a one-story, side-gabled office

Figure 83: Sandhill Furniture Company, Oldest Factory Building, Looking Northwest.

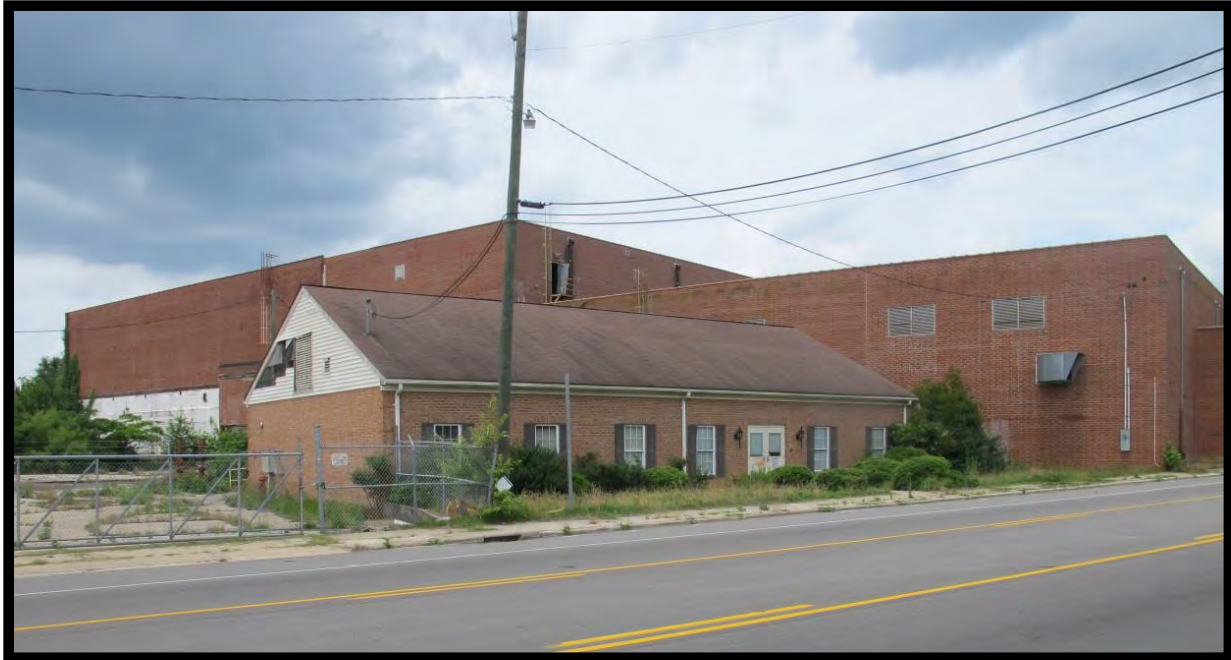
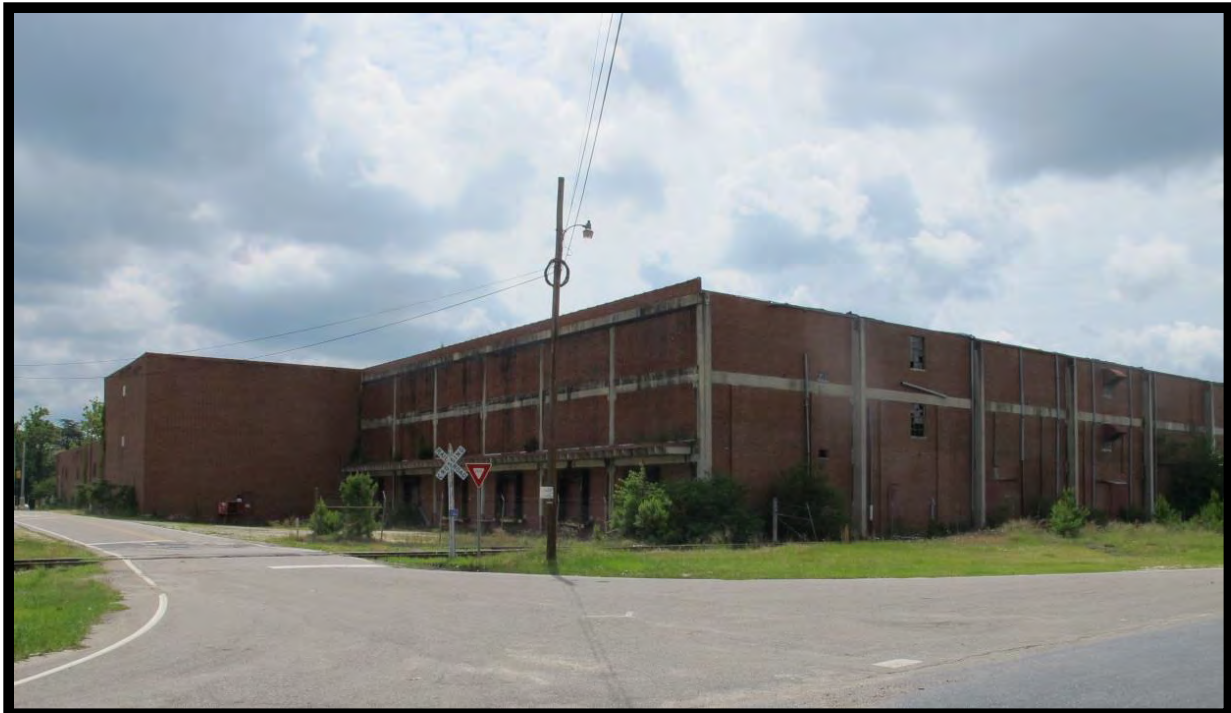
building, and a warehouse, with a two-story, and a three-story section, which was built around 1972 (Figures 84 and 85).

Figure 84: Sandhill Furniture Company, Office Building and Warehouse Looking Northwest.

Figure 85: Sandhill Furniture Company, Warehouse, Looking Southeast.

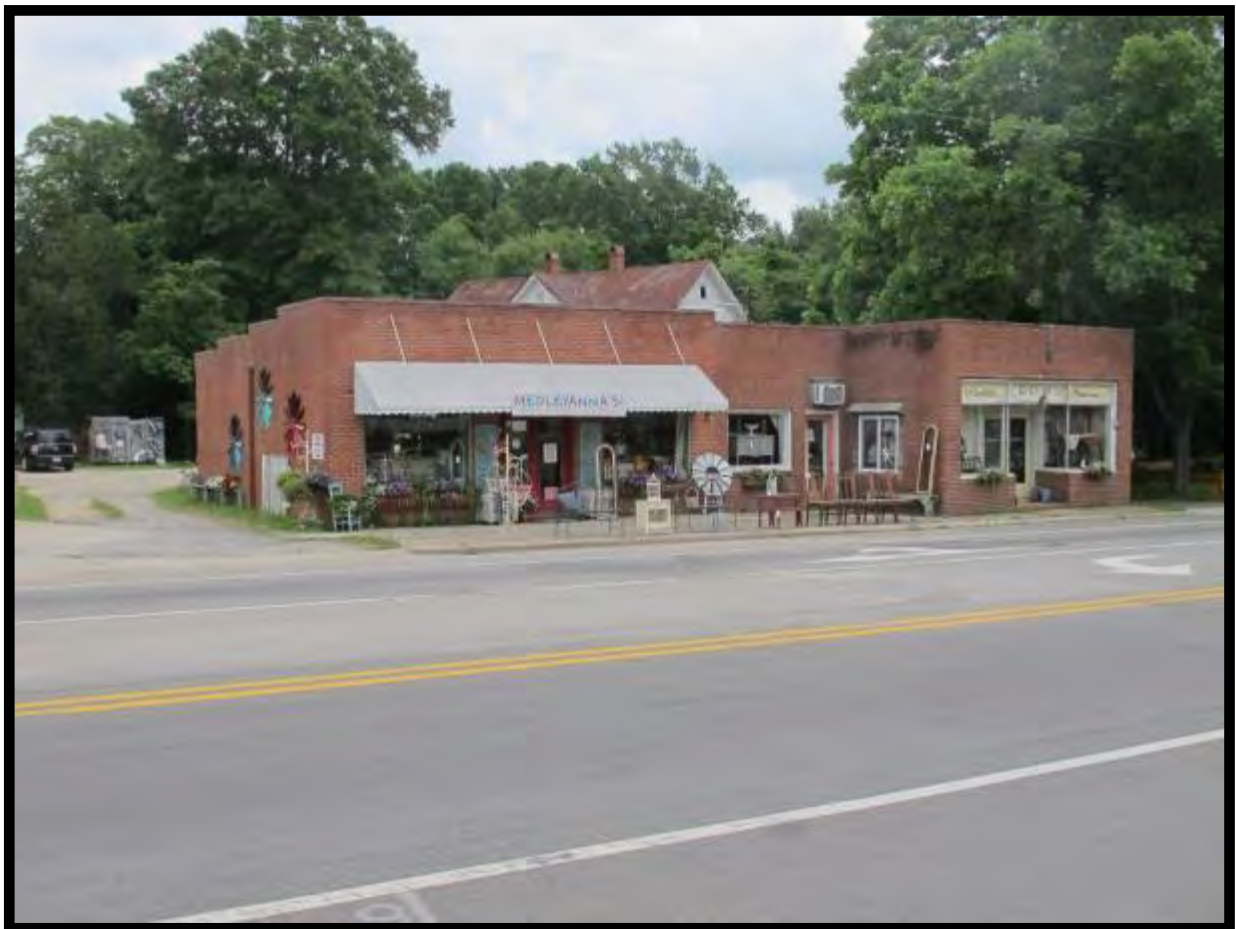
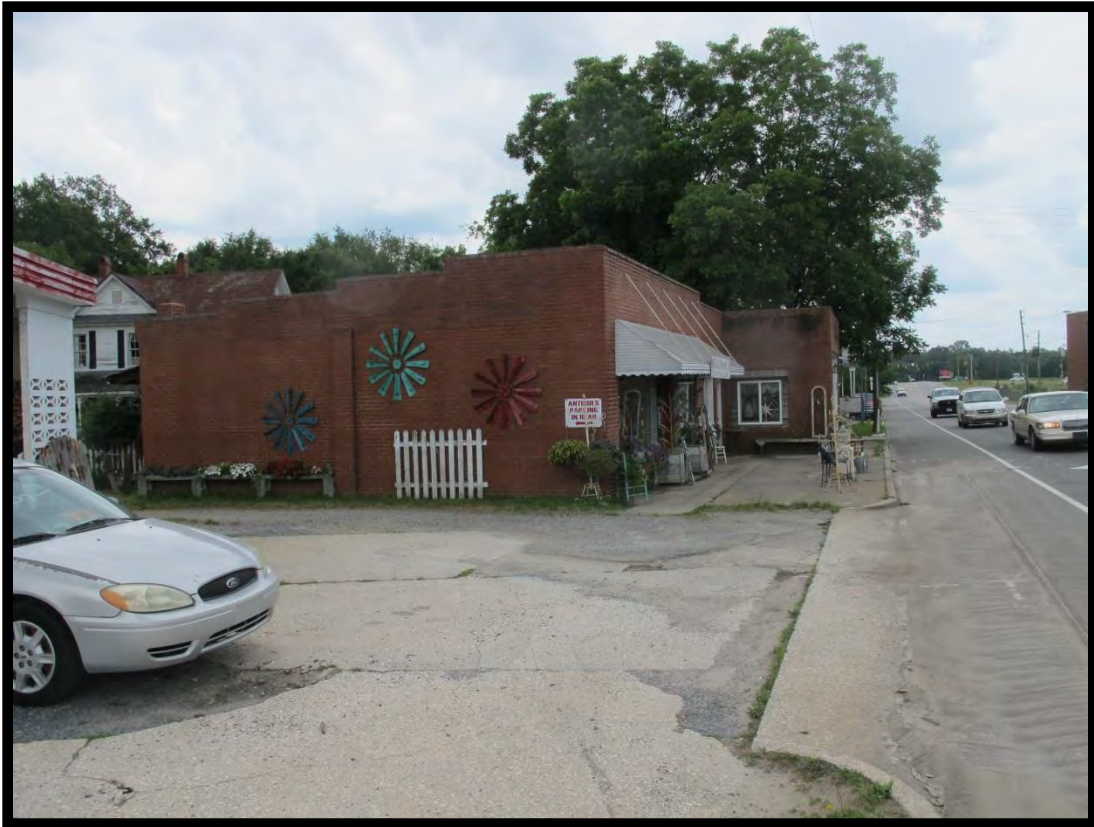
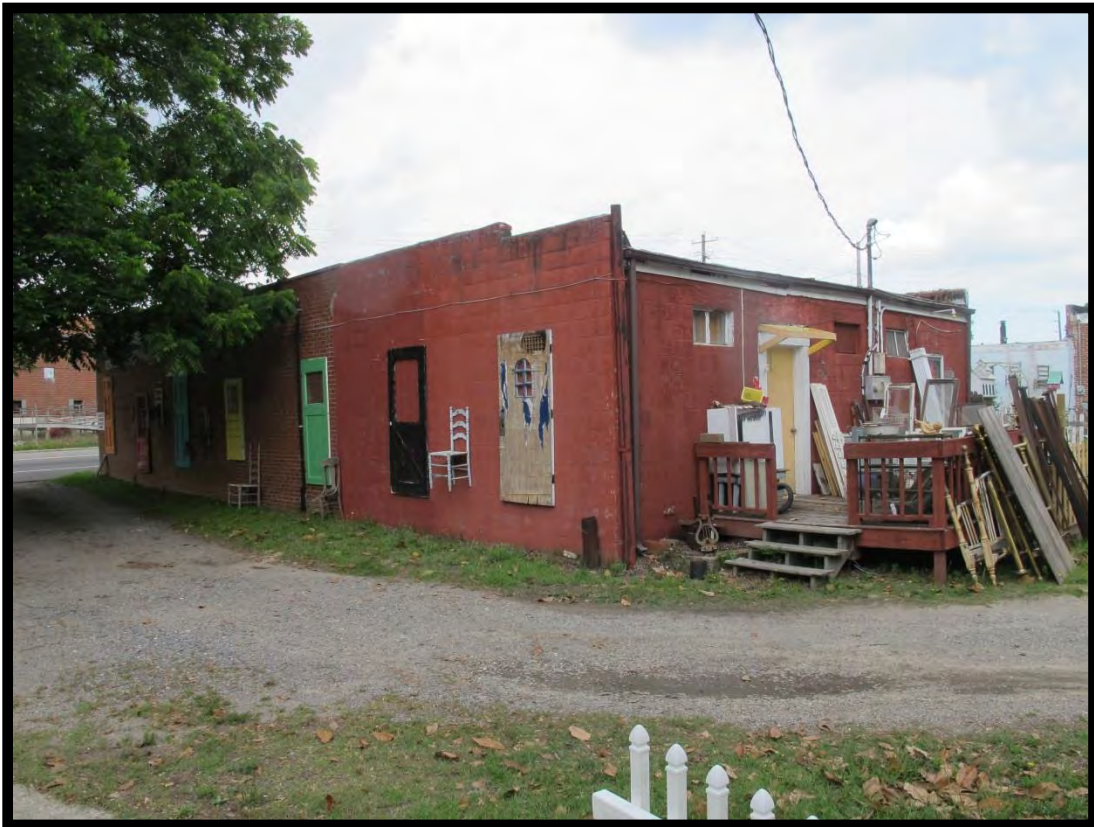
The block contains two connected one-story, flat roofed brick buildings with stepped parapet walls. The building at 5353 NC 211 has a rectangular footprint and is located on the left side of the block. A metal awning shelters the glazed double entry doors and the two large plate-glass store windows that flank it, on the northwest (front) elevation of the building. The building at 5357 NC 211 has a more irregular footprint with a substantial jog on the northwest (front) elevation. A section of the elevation is flush with the front elevation of 5353 and has a glazed door flanked by a plate-glass store window. The remainder of the elevation jogs several feet forward, with a double window on the northeast (side) elevation of the jog, and recessed double glazed doors flanked by large display windows on the front elevation. A concrete-block wing extends off the rear elevation of the main block (Figures 89 through 91).

Figure 89: Commercial Block, Looking Southeast. Note, 5353 to the left and 5357 to the right.

Figure 90: Commercial Block, View of 5353 Looking South.

Figure 91: Commercial Block, View of 5357 Looking Northwest.

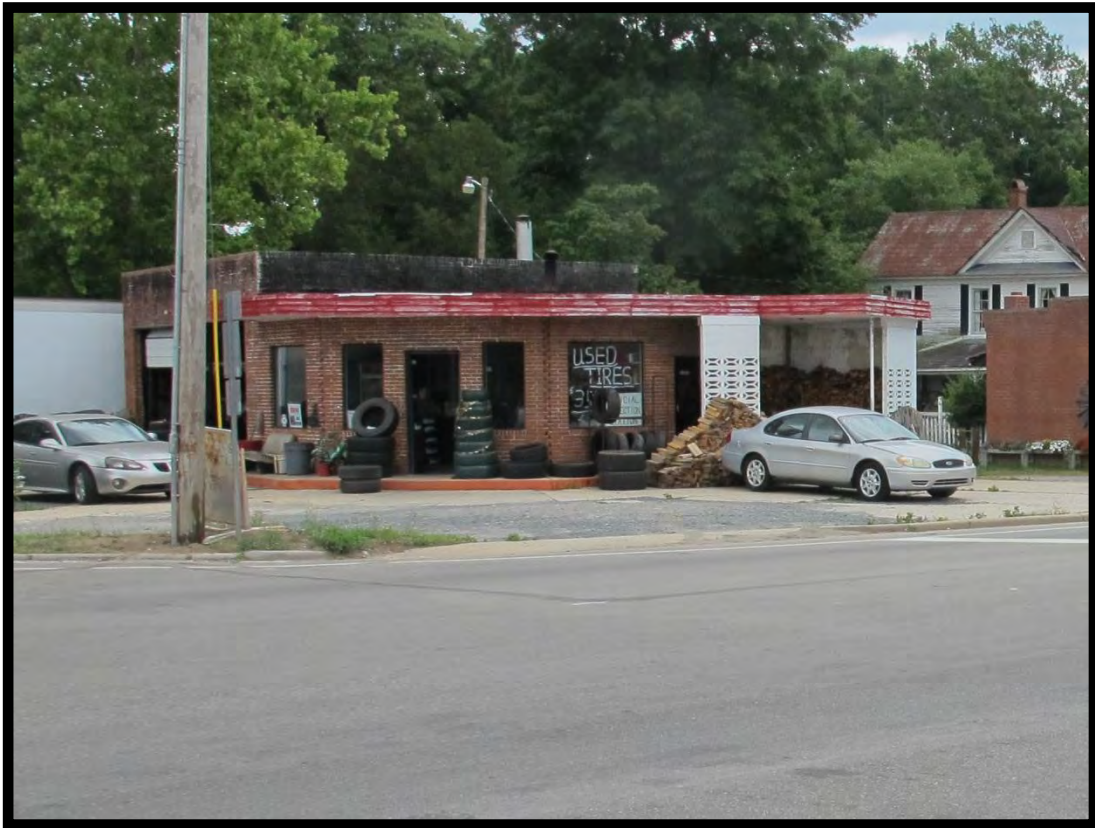
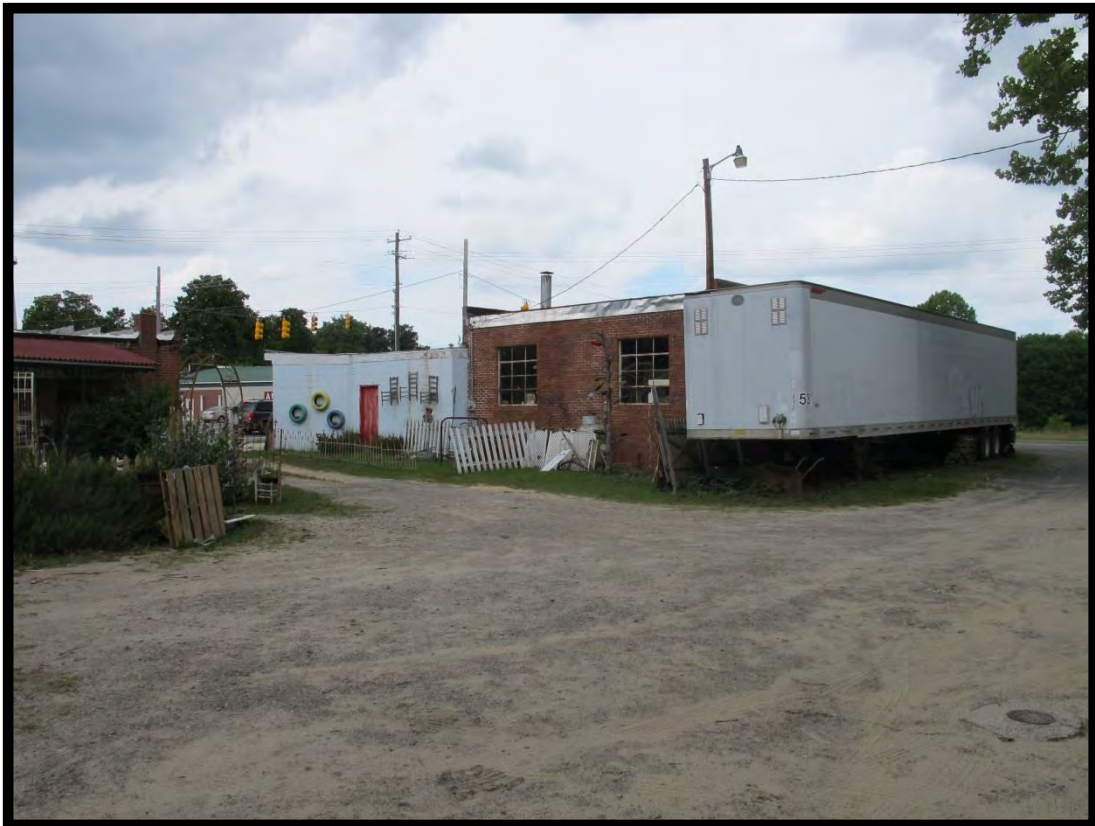
The (former) filling station consists of two distinct flat-roofed sections. The taller section is clad in brick and contains two garage bays that can be entered from the north (front) elevation and which faces NC 73. Large twelve-light steel-casement windows pierce the south (rear) elevation of the garage-bay section. Located against the west elevation of the garage bays is a slightly lower office section, with an irregular footprint. The office section has a cutaway corner, which faces the intersection of NC 211 and NC 73, and which contains the entry door flanked by two fixed-glass windows. The sections of the office, which face the public roads are clad in brick, with the concrete-block left exposed on the south (rear) elevation. Located at the southwest corner of the office section are pieced sections of concrete- block walls, which presumably conceal the entrances to the restrooms (Figures 92 and 93).

Figure 92: Lewis' Filling Station, Looking Southeast.

Figure 93: Lewis' Filling Station, Looking Northwest.

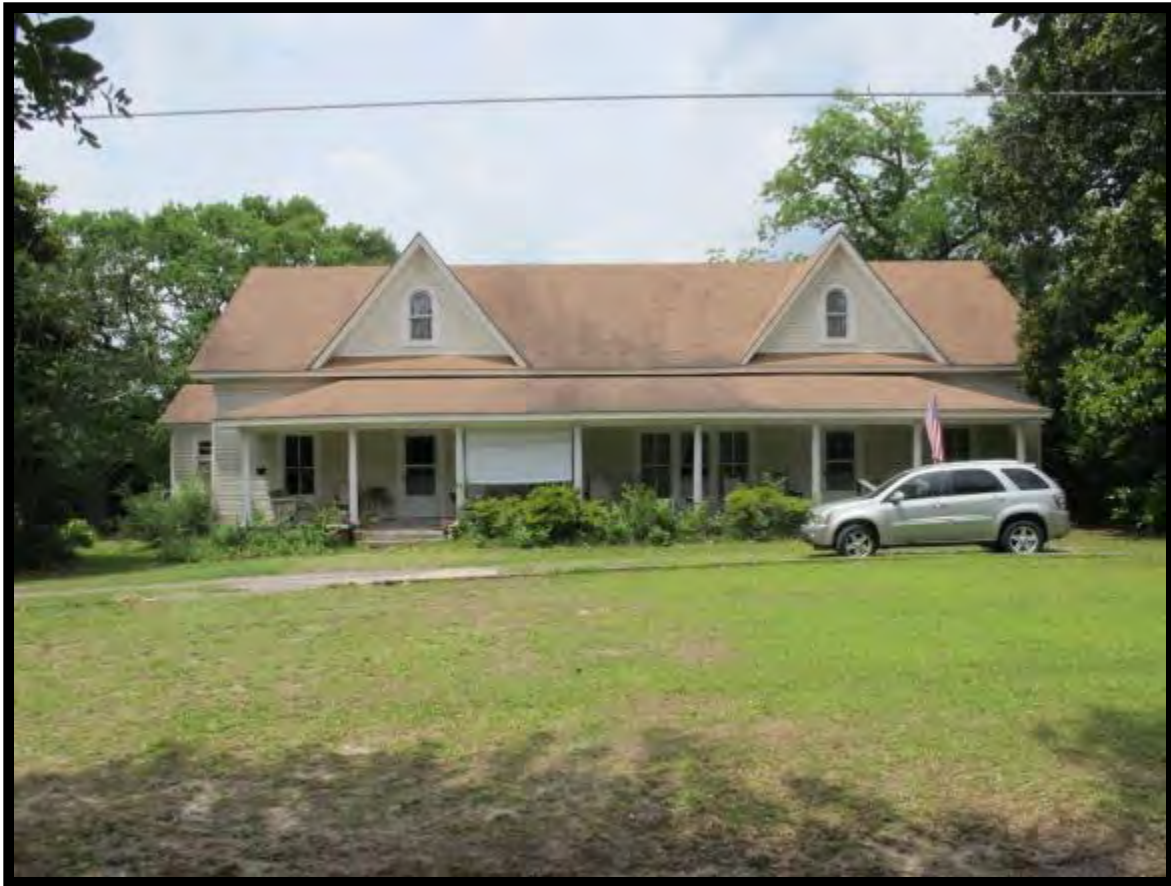
Figure 94: Moses C. McDonald House, Looking Southwest.

The Moses C. McDonald House, Store, and Carolina Handkerchief Factory are located on the west side of Knox Lane at the intersection with Mode Road. The buildings are dispersed across an 18.74-acre parcel with the dwelling sitting approximately 300 feet back from the road. The dwelling is surrounded by grass with a few shrubs and mature trees. A large section of the parcel is wooded (Figures 94 and 95).

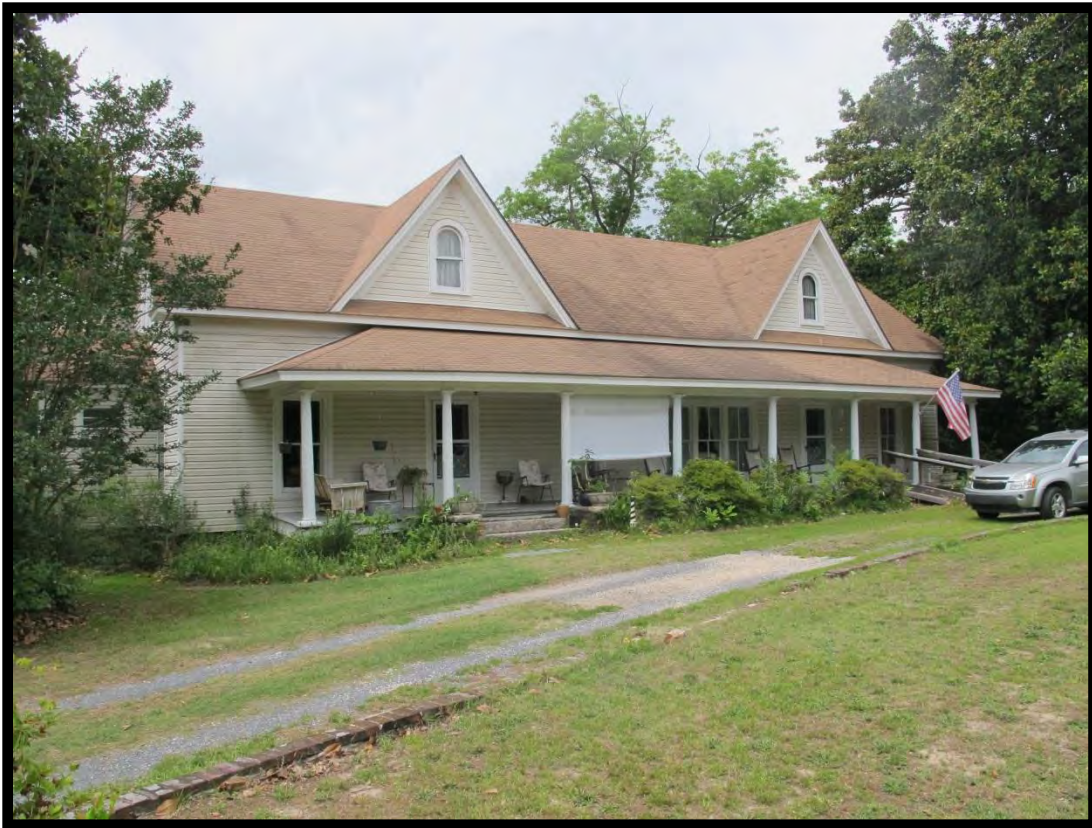
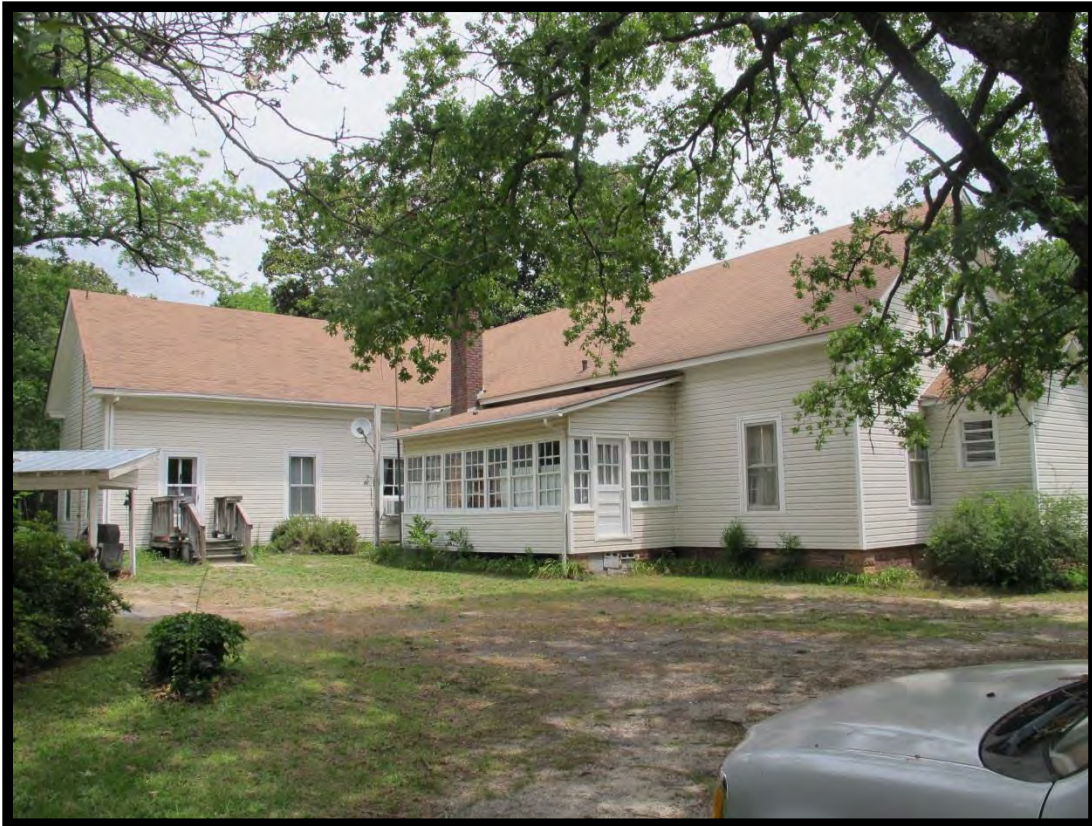
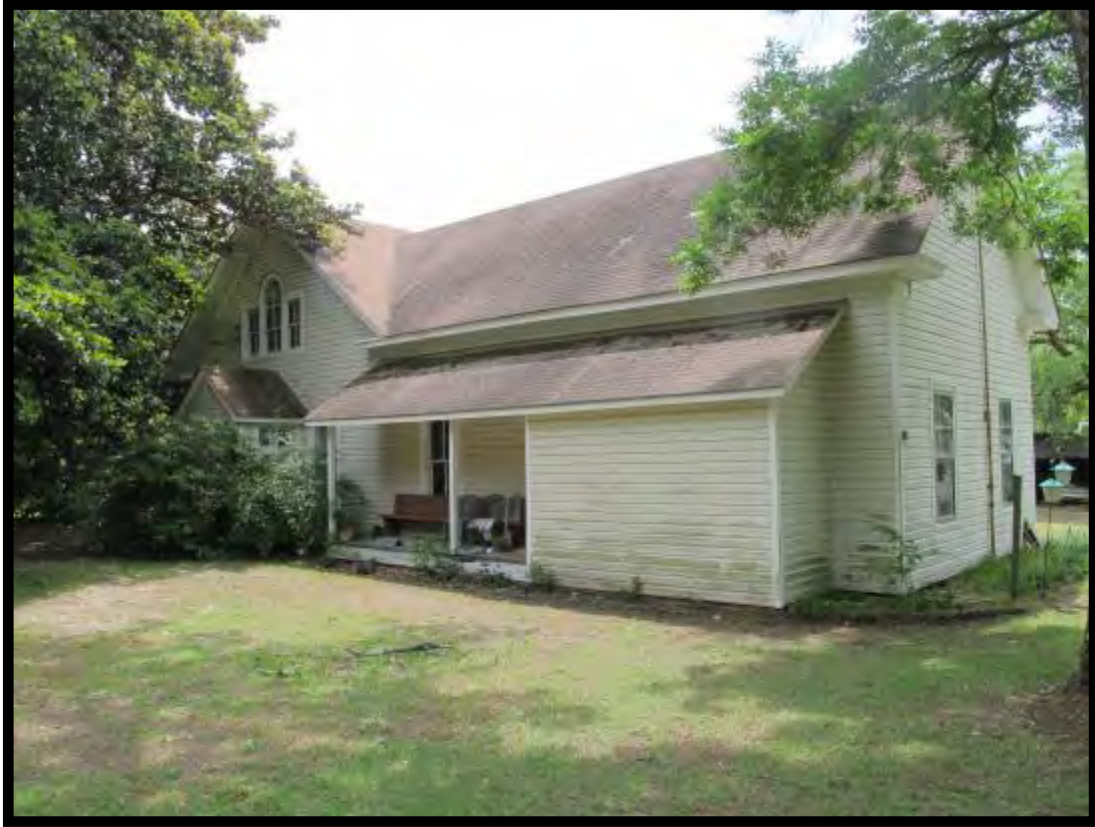
Built around 1910, the Moses C. McDonald House is an unusually long one-story, side-gabled dwelling with two decorative cross gables on the east (front) elevation of the dwelling and a hip-roofed porch, supported by classical columns, which shelters the six bays on the front elevation. The unusual shape could be attributed to the fact that the dwelling may have once functioned as a railroad hotel.⁸¹ A one-story, gable-roofed wing extends off the west (rear) elevation of the building and gives the dwelling an L-shaped footprint. A partially enclosed shed-roofed porch runs along the north (side) elevation of the rear wing, and located against the rear elevation of the main block is an enclosed shed-roofed porch. At some point two small gable-roofed additions were constructed against the north and south gable end of the main block. The dwelling sits on a rusticated concrete block pier foundation with brick infill, is clad in vinyl German, or drop, siding, and has two-over-two wooden sash windows. An unusual detail are the Palladian windows in the gable peaks of the main block. Located against the rear elevation of the main block is an exterior brick chimney (Figures 96 through 98).

Figure 96: Moses C. McDonald House, Looking Northwest.

Figure 97: Moses C. McDonald House, Looking Northeast.

Figure 98: Moses C. McDonald House, Looking Southeast.
