Re: Widen NC 211 from SR 1241 (Holly Grove School Road) to NC 73 in West End,
R-5726, Moore County, ER 17-1302

RE: R-5726—Widen NC 211 from SR 1241 (Holy Grove Rd) to NC 73 in West End,
Moore County, ER 17-1302

NCR-0748

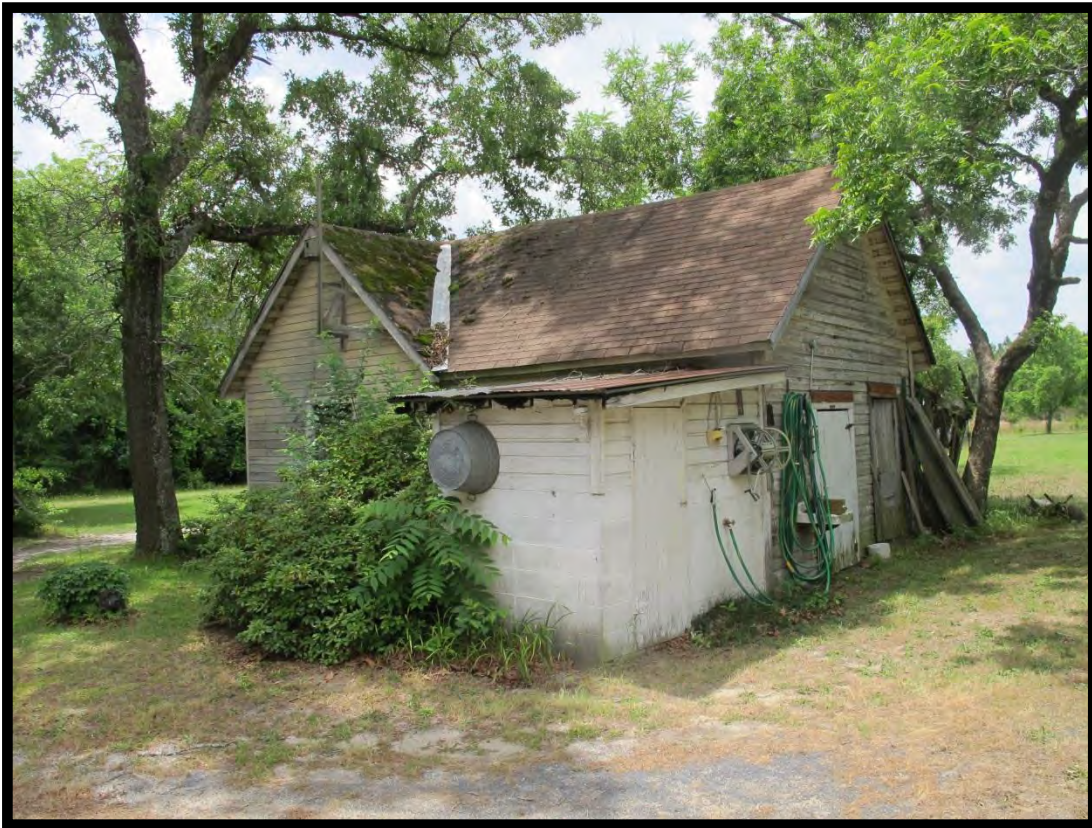
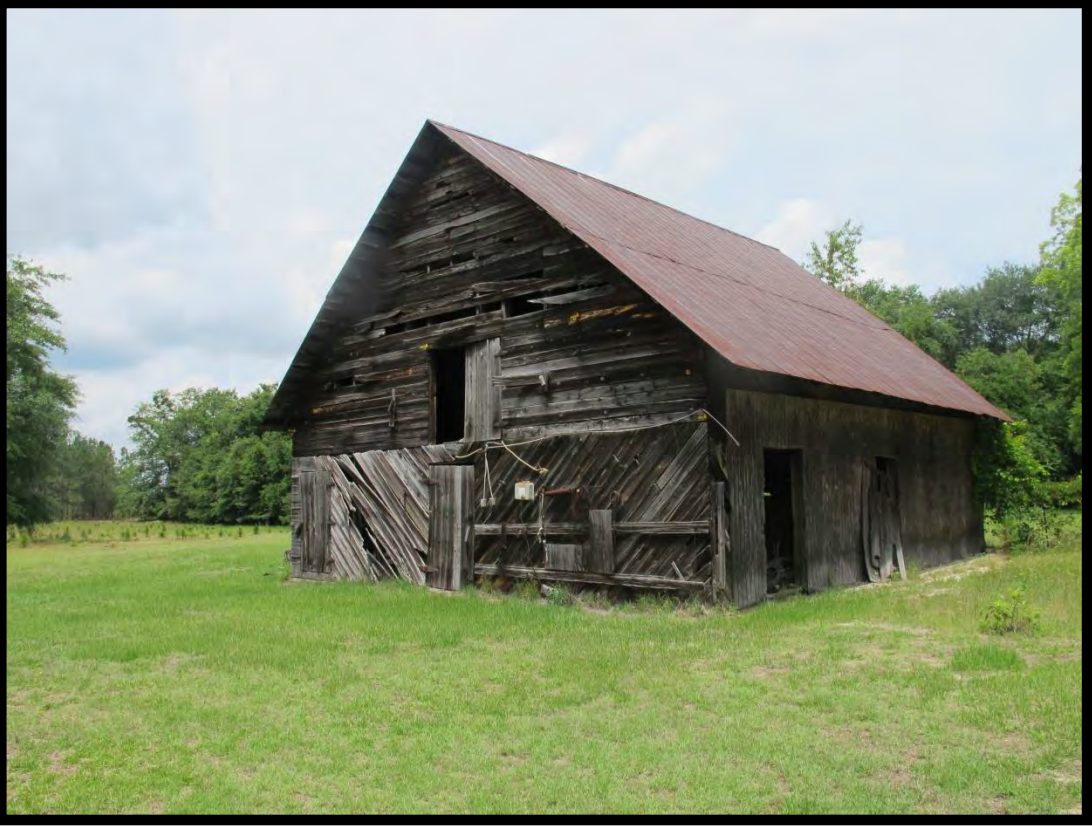
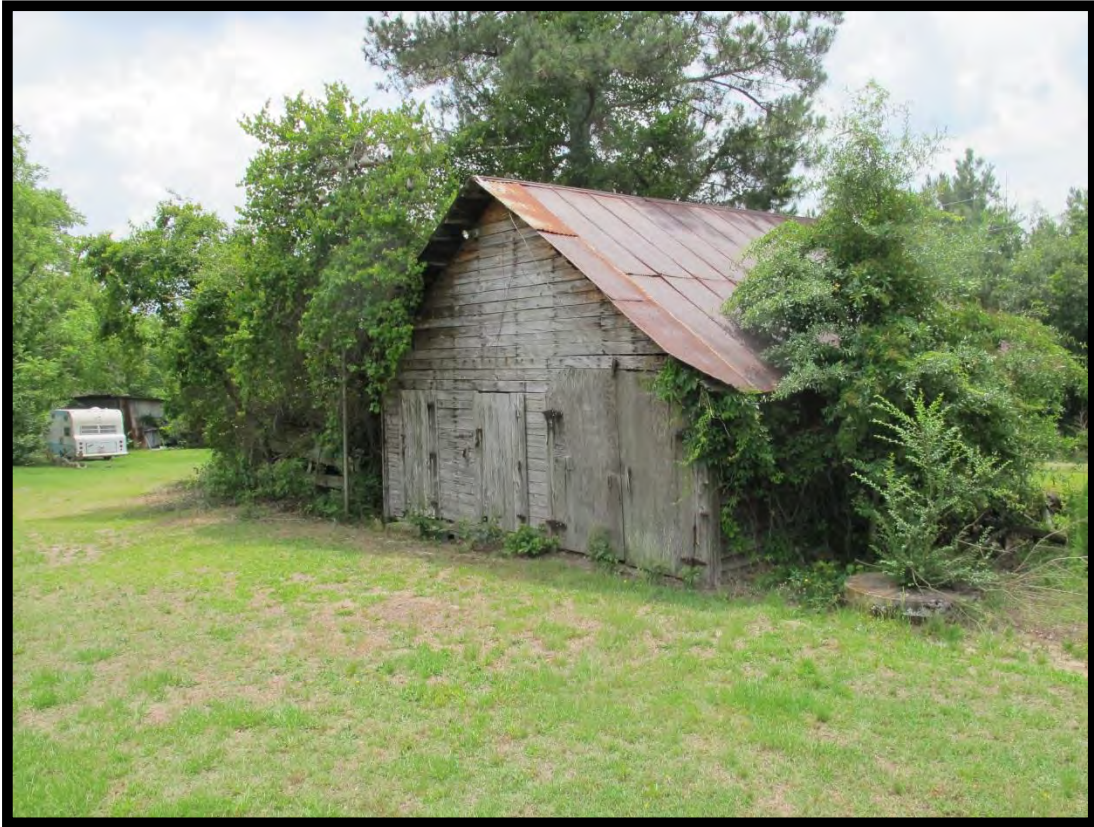
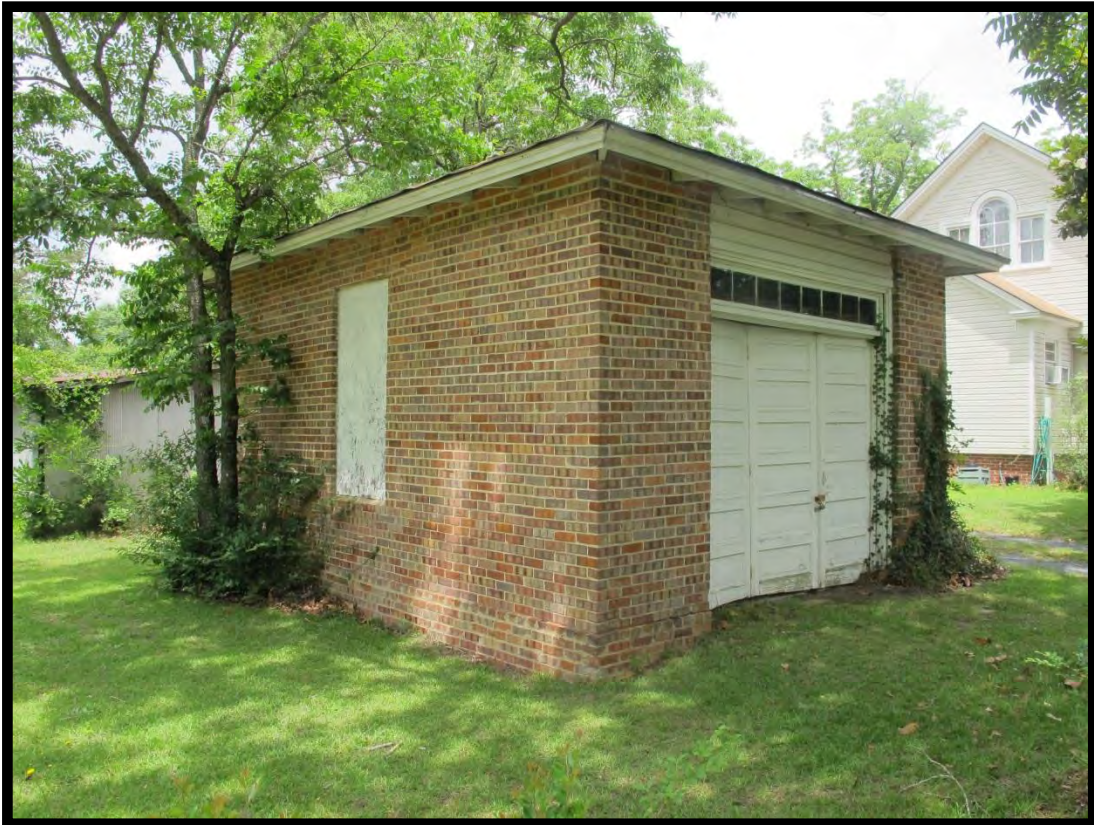
Located around the dwelling are a number of ancillary structures, some with domestic functions, others related to farming operations and commercial and industrial ventures of Moses C. McDonald. Located behind the dwelling is a one-story, gable-roofed building with an L-shaped footprint, which reportedly housed a smokehouse. Located against its east (front) elevation is a concrete-block and frame shed-roofed well house (Figure 99). Located behind this building is a one-and-a-half-story, front-gabled barn, and a front-gabled frame outbuilding (Figures 100 and 101). Located to the south of the dwelling is a hip-roofed brick garage. The walls are laid stretcher bond with variegated bricks with kiln marks and it has a tripartite folding door with an eight-light transom (Figure 102). West of the garage is a shed-roofed machine shed (Figure 103).

Figure 99: Moses C. McDonald House, Summer Kitchen/Smokehouse, Looking Southwest.

Figure 100: Moses C. McDonald House, Barn, Looking Northwest.

Figure 101: Moses C. McDonald House, Outbuilding, Looking Southeast.

Figure 102: Moses C. McDonald House, Garage, Looking Northwest.

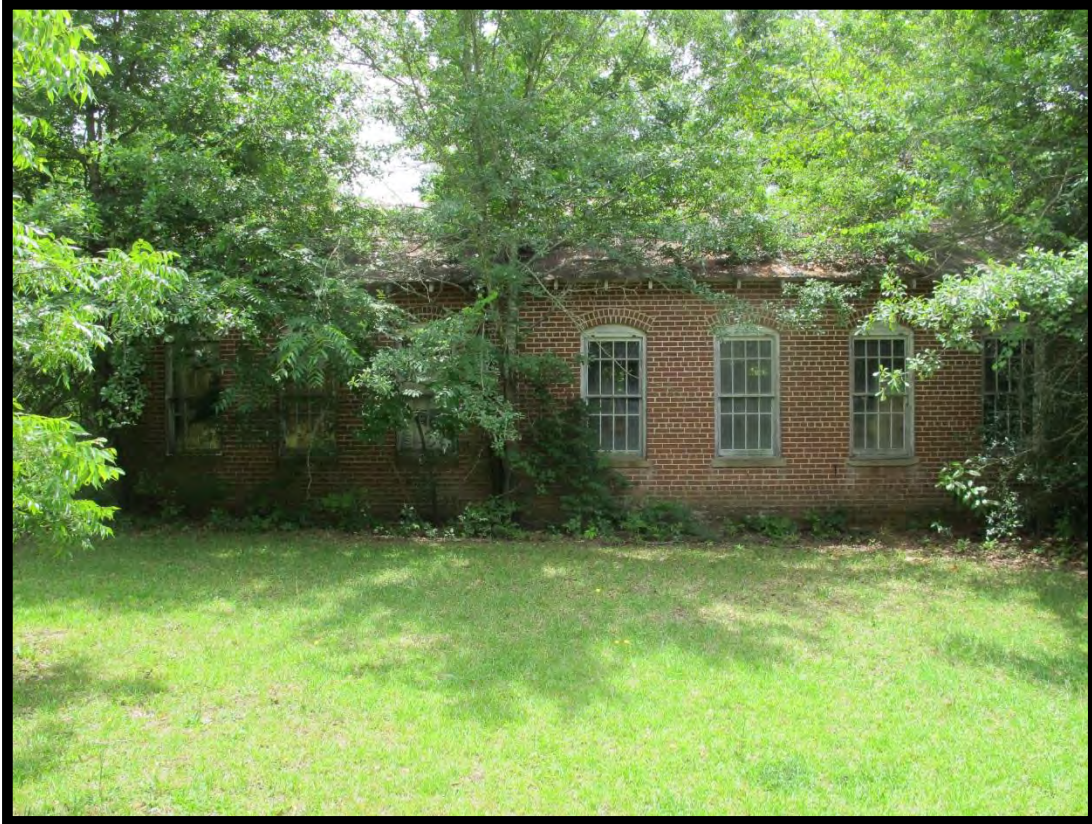
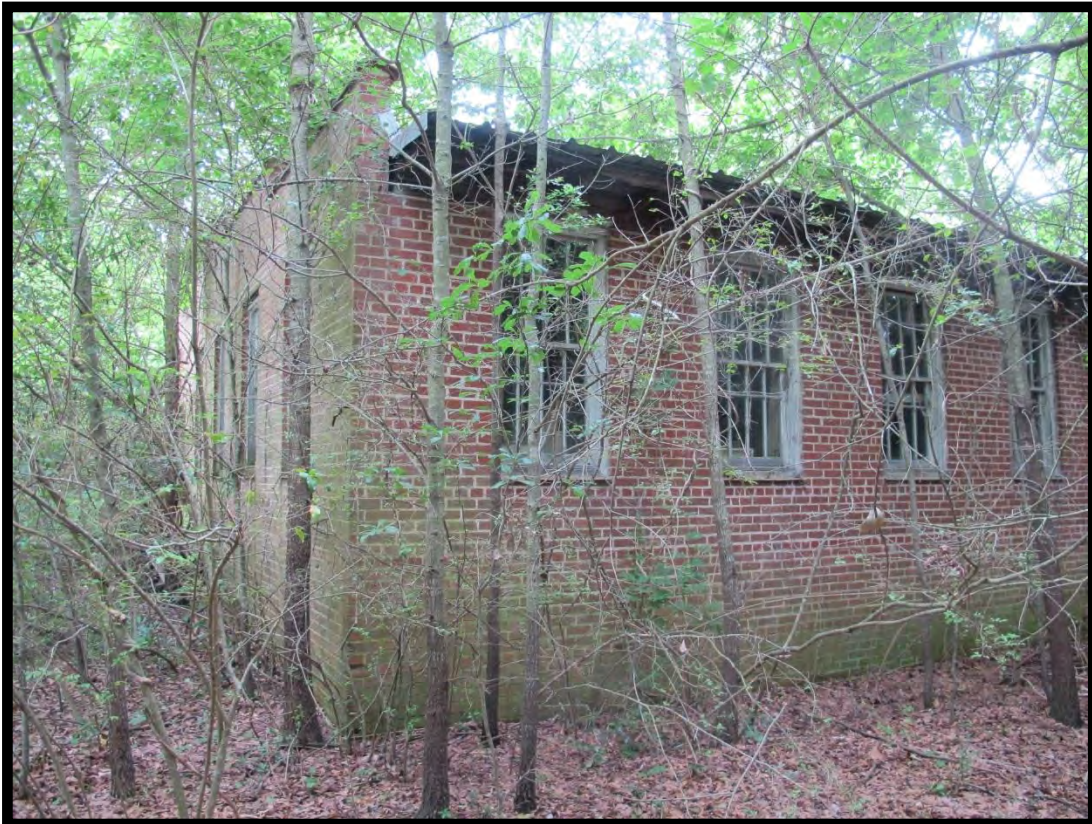
Located farther south is the handkerchief factory, which was built in the late 1930s. The building consists of two distinct sections. The main block is a front-gabled, three bay, brick section, with eleven segmental arched windows piercing the north and south (side) elevations. The walls are laid in five-over-one common bond and it has eight-over-eight wooden sash Craftsman-style windows. The roof has plain exposed rafter tails. Located against its southwest (rear) gable end is a slightly wider and taller brick section with a parapet wall. The walls are laid in five-over-one common bond and it has similar eight-over-eight wooden sash windows as the front section, but lacks the brick segmental arches (Figures 104 and 105). Located southeast of the factory, is a front-gabled terracotta brick storage building (Figure 106). Located along Knox Lane are two commercial buildings. At the north end of the property is a front-gabled frame store. A hip-roofed porch, supported by plain posts, shelters three bays on the northeast (front) gable end. A central double door is flanked by a window to the left and a door to the right. The building sits on brick piers and is clad in German, or drop, siding (Figure 107). At the south end is a two-story brick building with a parapet wall, which functioned as a grocery store and was built around 1912. The walls are laid in five-over-one common bond with the rows or headers being slightly darker, creating a decorative pattern. The first floor storefront had large store windows flanking a recessed double entry door. Brick pilasters, supporting a decorative cornice with dentils, flanked the store windows. The second-floor window bays on the front and side elevations have brick segmental arches (Figures 108 and 109). Located behind the brick store is a front-gabled storage building clad in corrugated metal siding (Figure 110).

Figure 104: Moses C. McDonald House, Handkerchief Factory, Looking South.

Figure 105: Moses C. McDonald House, Handkerchief Factory, Looking Southeast.

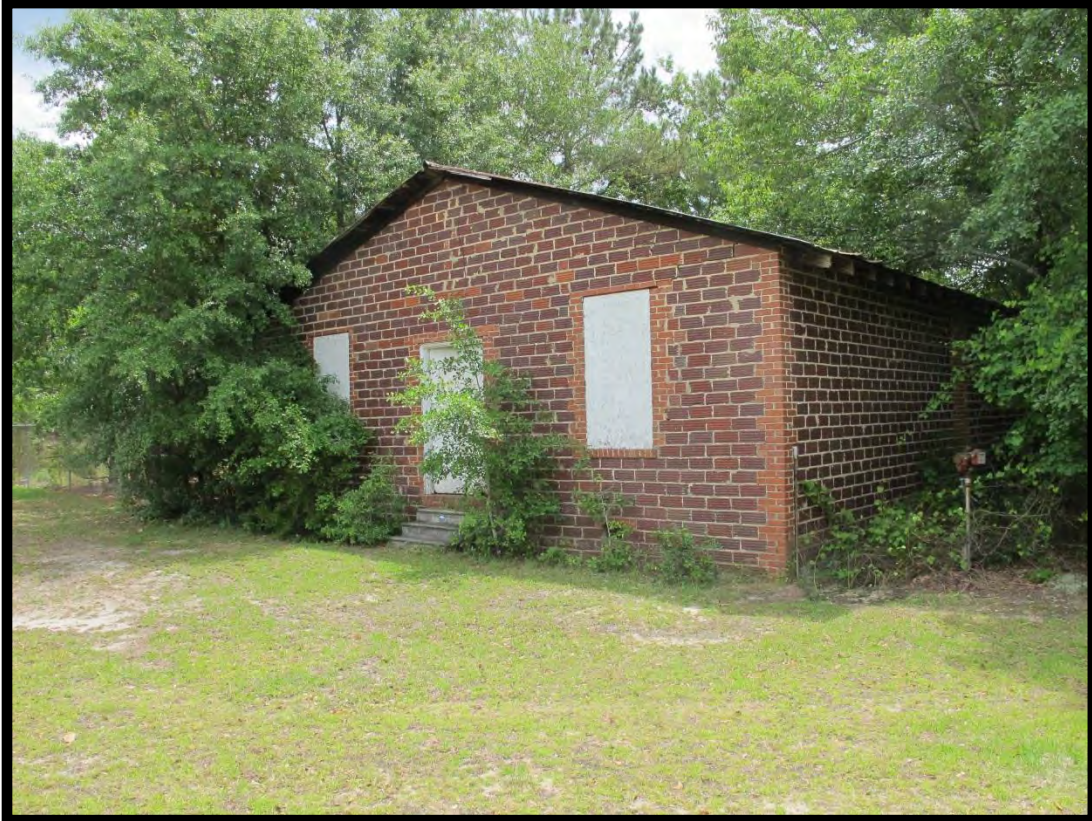
Figure 106: Moses C. McDonald House, Storage Building, Looking Southeast.

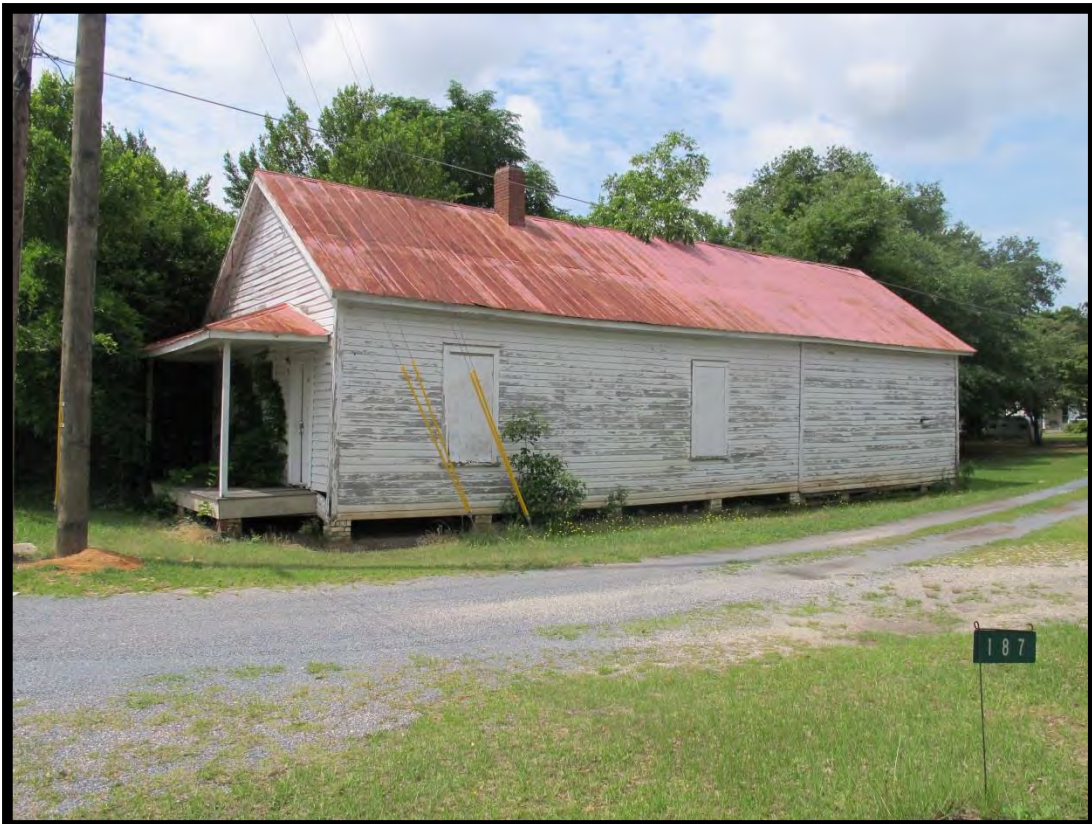
Figure 107: Moses C. McDonald House, Store, Looking Southwest.

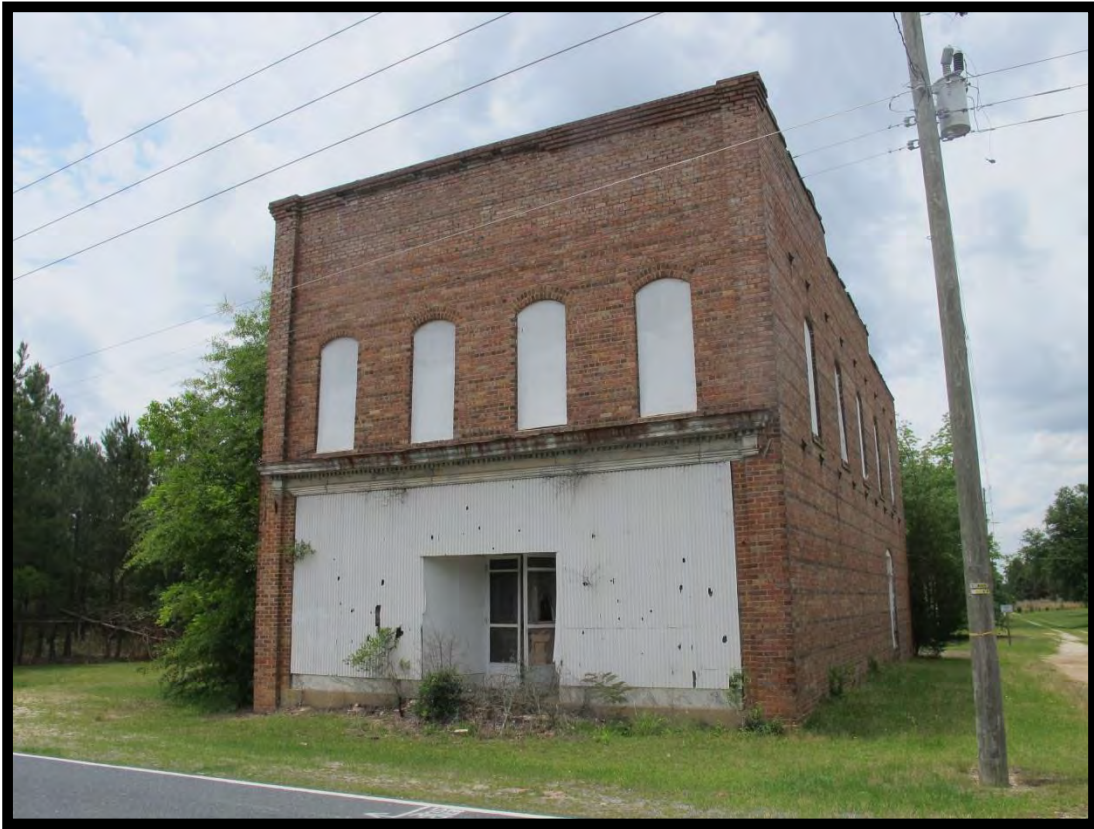
Figure 108: Moses C. McDonald House, Grocery Store, Looking Southwest.

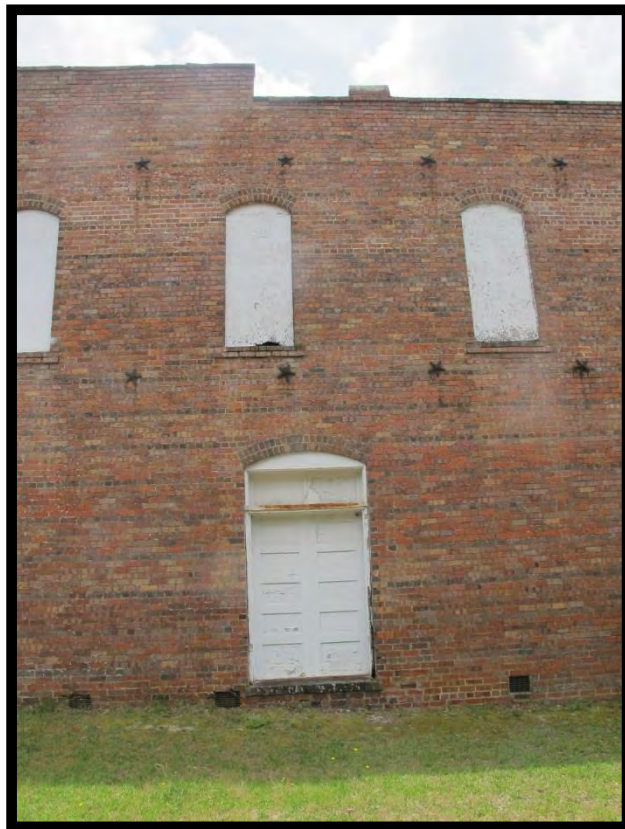
Figure 109: Moses C. McDonald House, Grocery Store, Detail of Northwest Elevation.

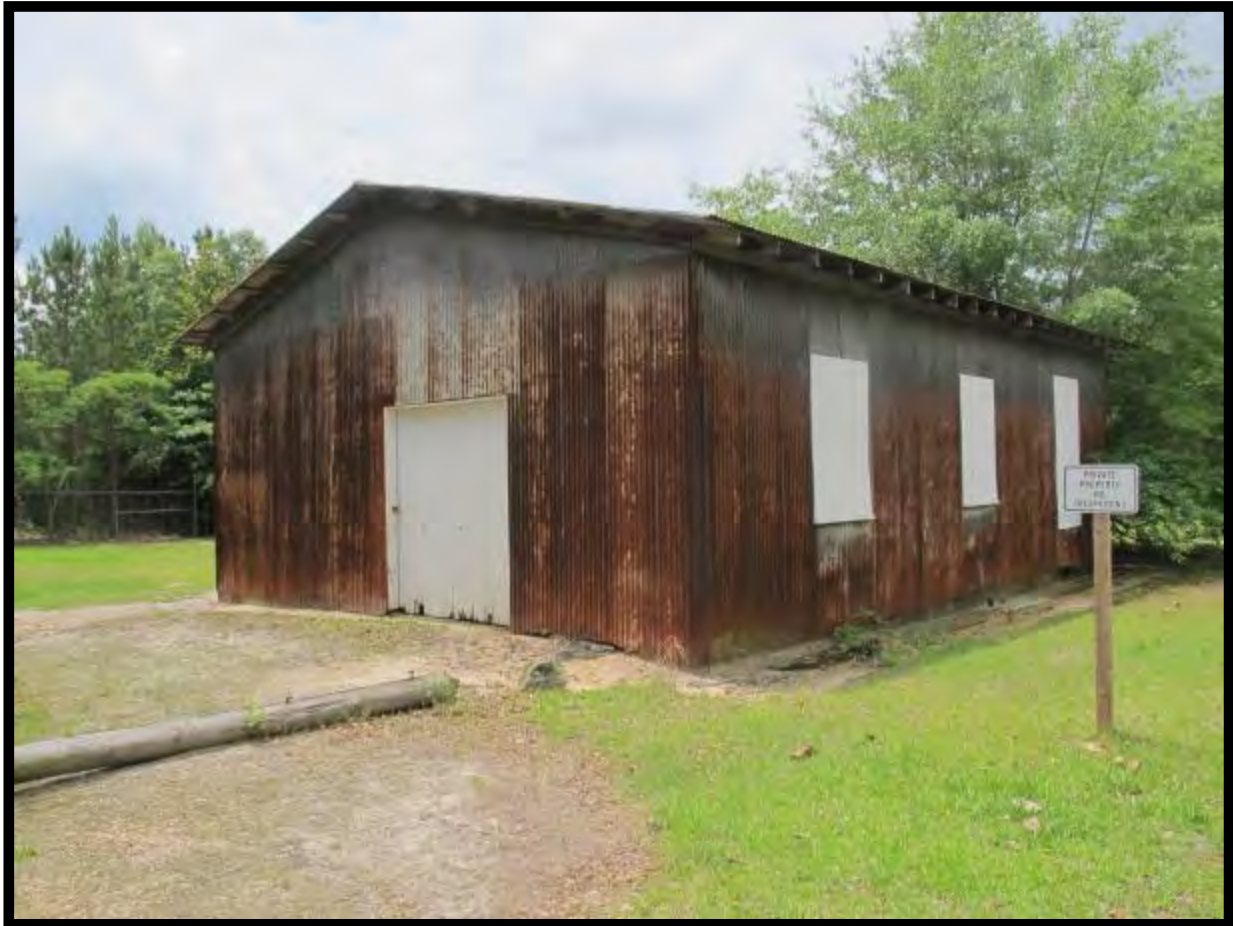
Figure 110: Moses C. McDonald House, Storage Building, Looking Southwest.

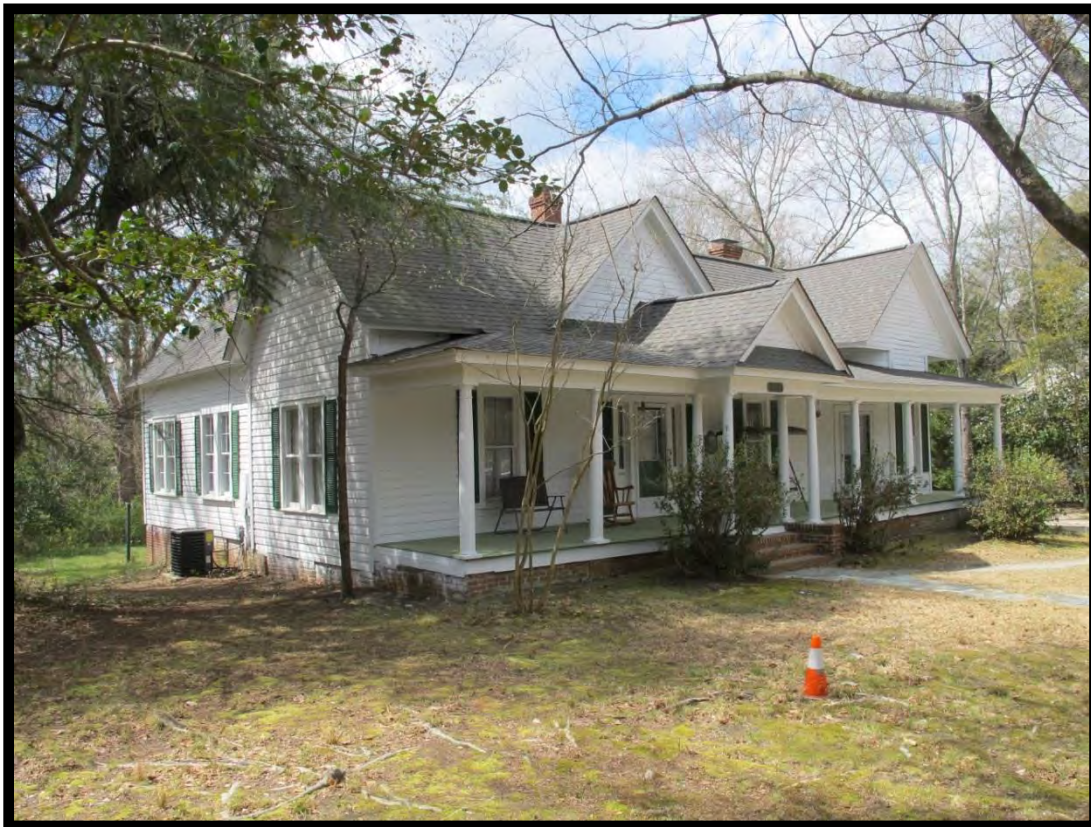
Figure 112: Graham-Thompson House (MR0092), Looking Southwest.

Despite the fact that the Moses C. McDonald House, Store, and Carolina Handkerchief Factory is a unique ensemble of buildings representing the life and work of Moses C. McDonald, and reflective of the development of West End, a small crossroads community, the individual resources lack significance and integrity. Whereas the house is unusual with its double triple-A roof, this can perhaps be explained by the possibility that it was built as a duplex and may have served as a railroad hotel. The triple-A form itself and even the use of multiple cross gables is not unusual, and examples survive elsewhere across Moore County, and North Carolina, such as the Graham-Thompson House (MR0092) in Aberdeen, which was built around 1902 and combines Classical features with elements from the Queen Anne style and retains a high level of integrity (Figure 112).

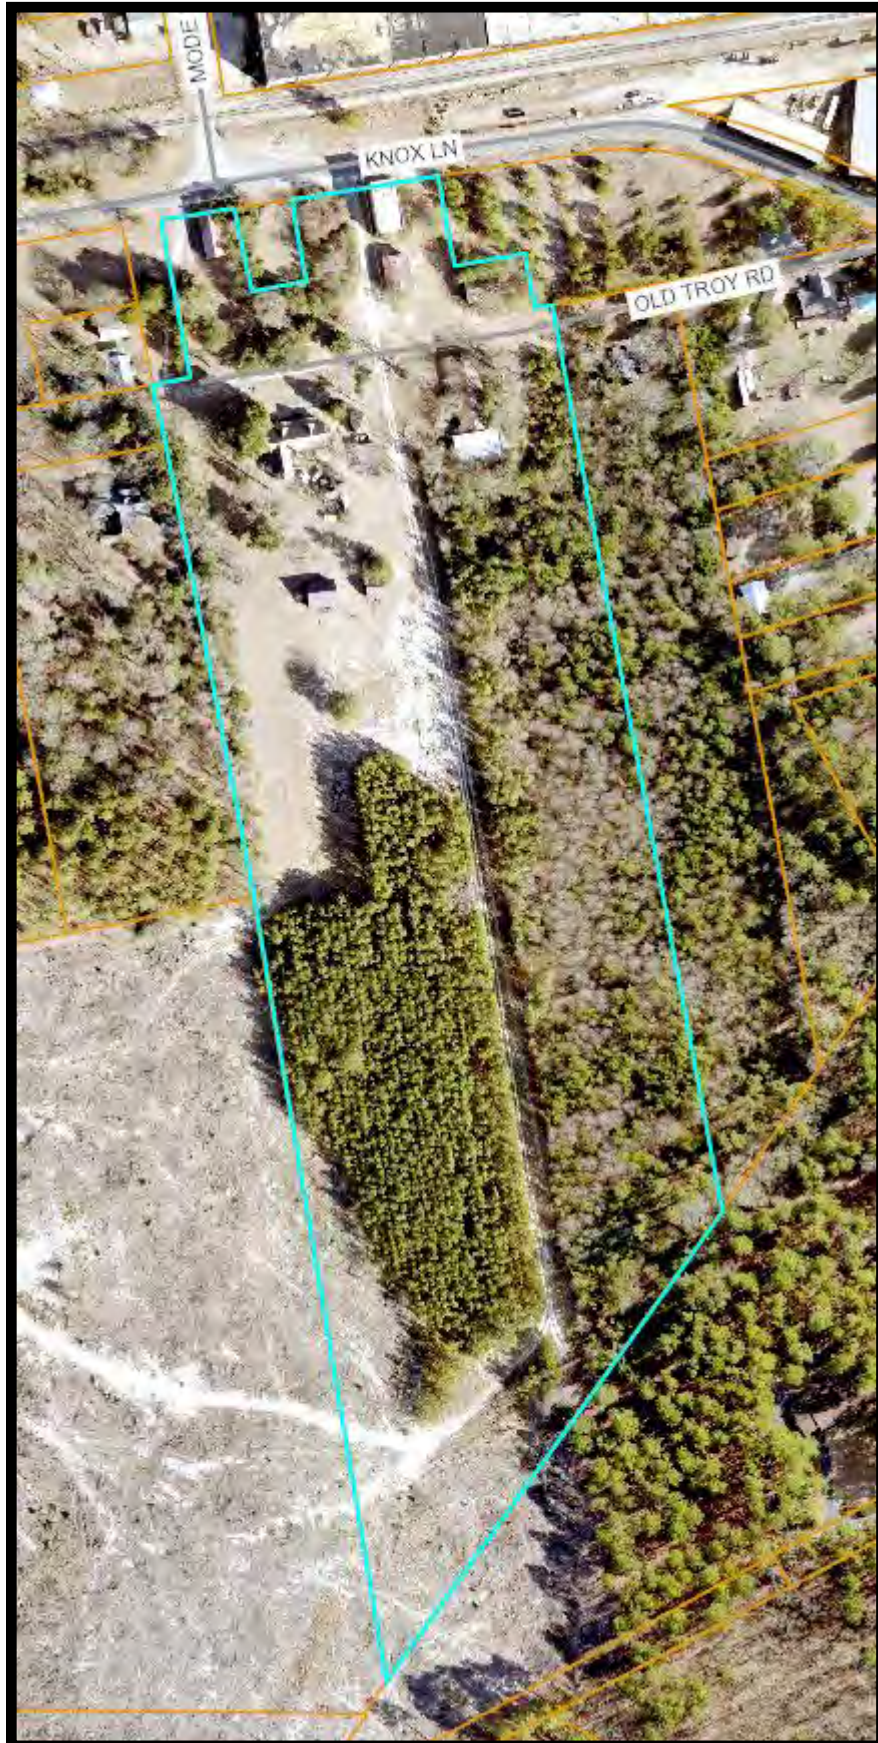
Figure 114: Moses C. McDonald House, Store, and Carolina Handkerchief Factory, Showing the NRHP Boundary.

The NRHP boundary for the Moses C. McDonald House, Store, and Carolina Handkerchief Factory has been drawn according to the guidelines of National Register Bulletin 21, *Defining Boundaries for National Register Properties*. The boundary is drawn to include the dwelling and the associated buildings as well as the surrounding landscape to provide its original setting (Figure 114). The boundary contains approximately 18.74 acres. The NRHP boundary is identified as parcel 852400922308 (Moore County PIN).

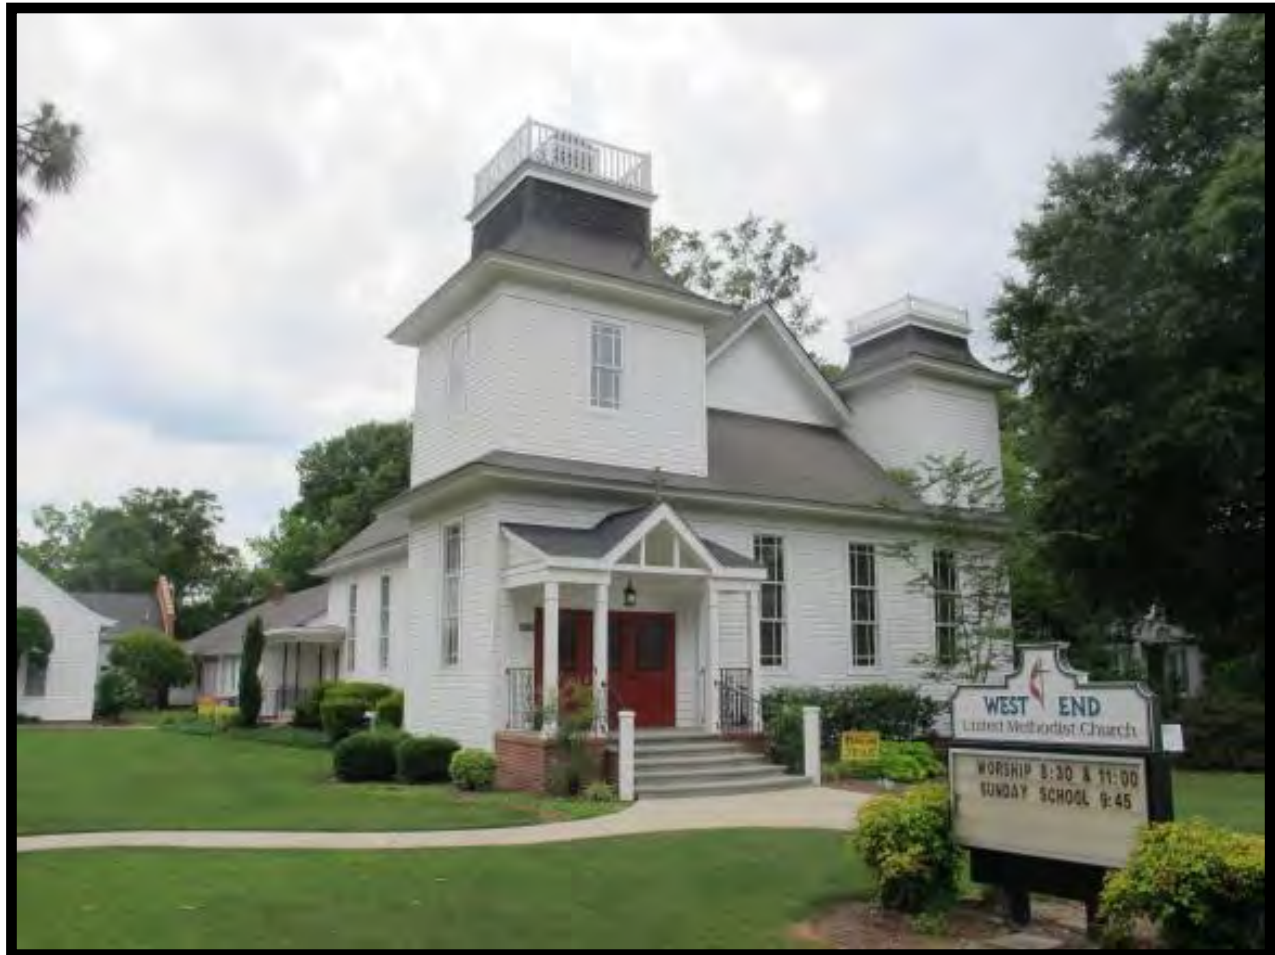
Figure 115: West End Methodist Church, Looking Southwest.

The property is located on the south side of NC 73, approximately 290 feet east of the intersection with NC 211. The church sits approximately 60 feet back from the road and is surrounded by a landscaped yard. A large paved parking area is located east of the church (Figures 115 and 116).

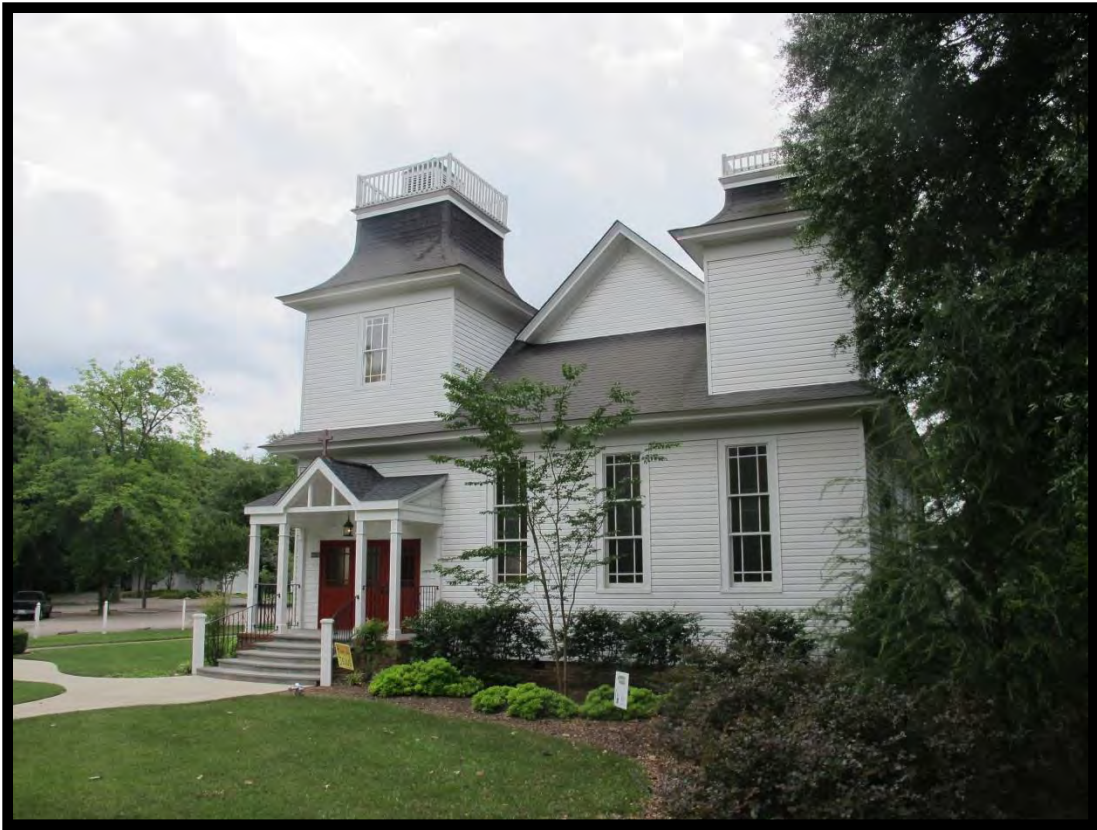
Figure 117: West End Methodist Church, Looking Southeast.

Built around 1915, West End Methodist Church has a rectangular sanctuary with two unequally sized square towers at the north (front) gable end of the church. The towers have unusual flared eaves topped by a balustrade. The smaller of the two towers is partially engaged and its west (side) elevation is flush with that of the sanctuary. The larger of the two towers is partially engaged and sits at the northeast corner of the sanctuary. It contains the formal entrance into the church. A shed-roofed section along the front gable end of the sanctuary connects the two towers. A small shed-roofed porch, with a decorative cross gabled shelters the three entry doors on the north (front) elevation of the larger tower. The church sits on a brick foundation, is clad in vinyl German, or drop, siding, and has triple-sash wooden windows with a Queen Anne-style division (Figures 117 and 118).

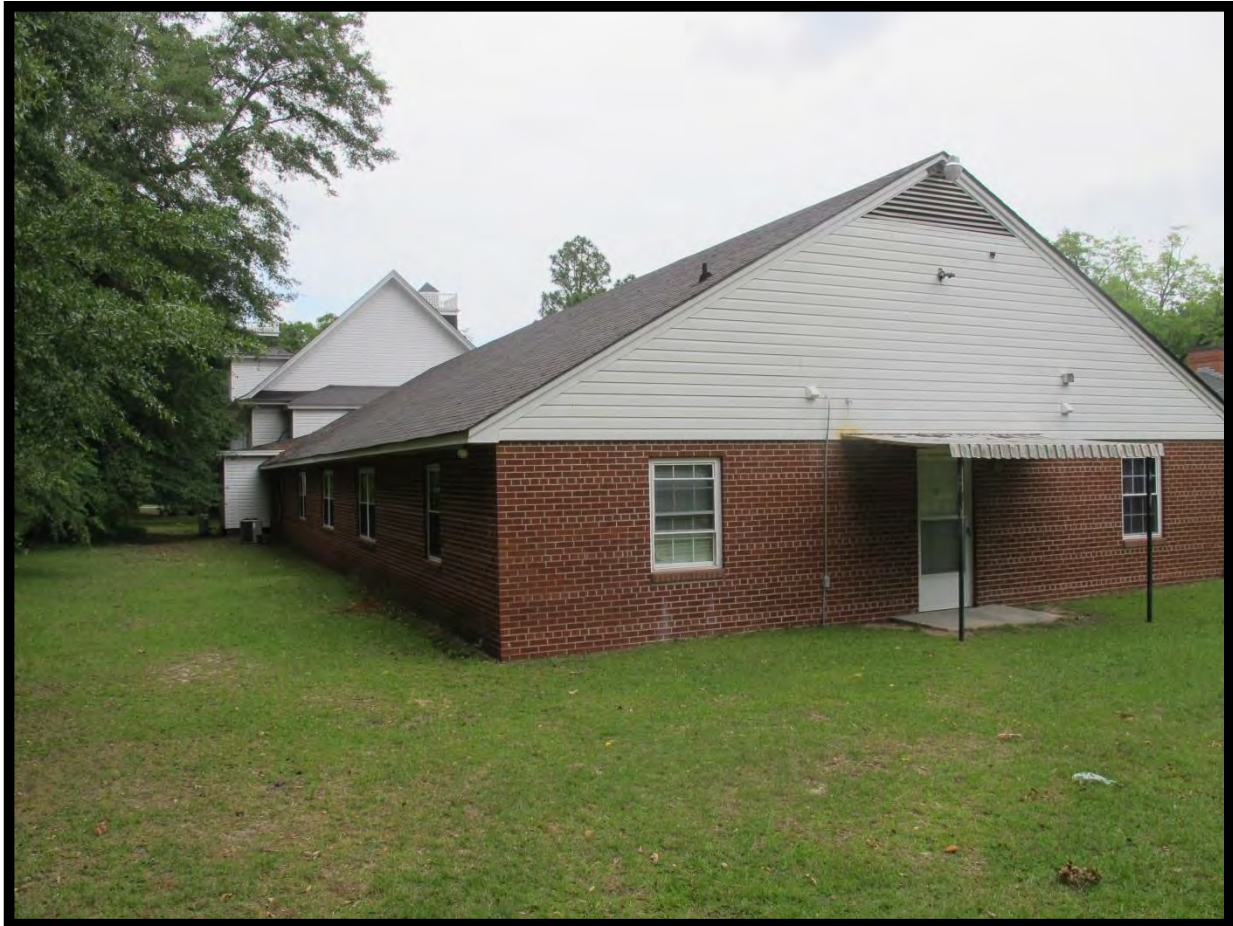
Figure 119: West End Methodist Church, Education Building, Looking Northeast.

Typical of churches in the area several ancillary structures are located around it, some of which are attached, or semi-attached. Extending off the south (rear) gable end of the sanctuary is a low gable-roof brick Education Building, which was constructed around 1956 (Figure 119).

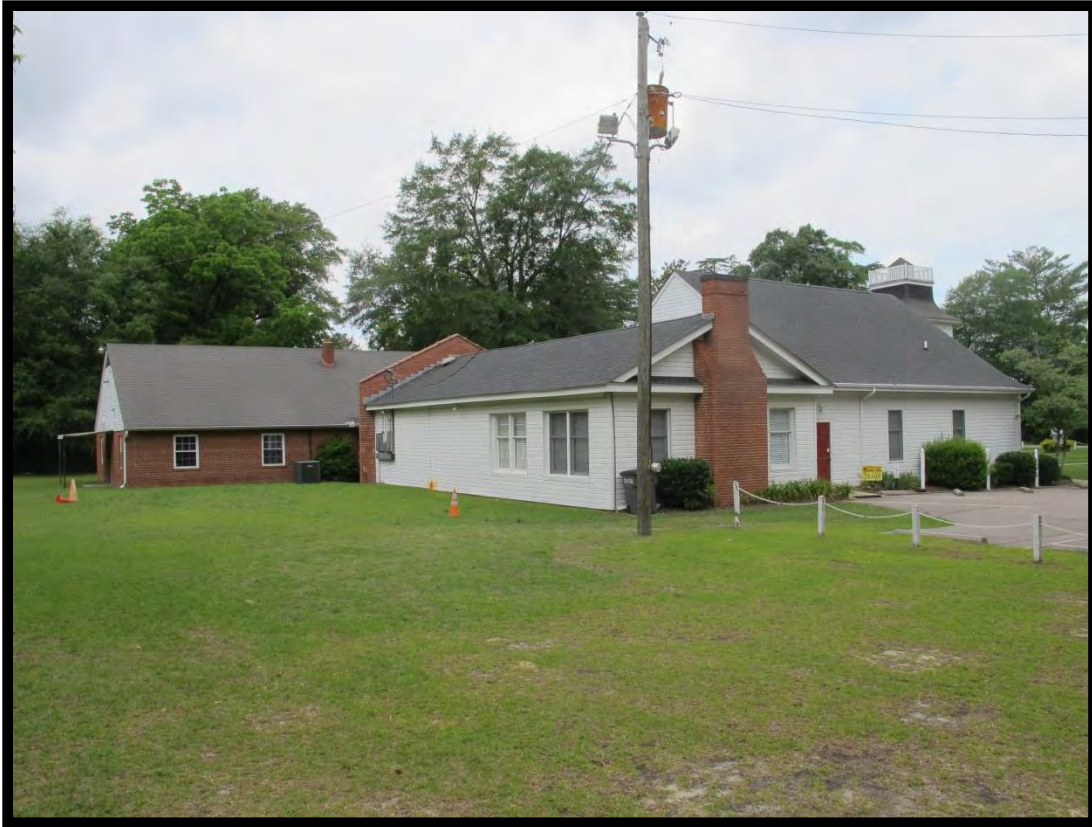
Located to the east of the Education Building is the Youth Building, which was constructed in the 1940s and expanded in 1985 (Figures 120 and 121). When the building was expanded it was also connected to the Education Building. The most recent addition was the Food Pantry Building, which is located southeast of the Youth Building. Also located behind the church is a front-gabled metal picnic shelter and a front-gabled garden shed (Figures 122 through 124).

Figure 120: West End Methodist Church, Youth Building, Looking Northeast.

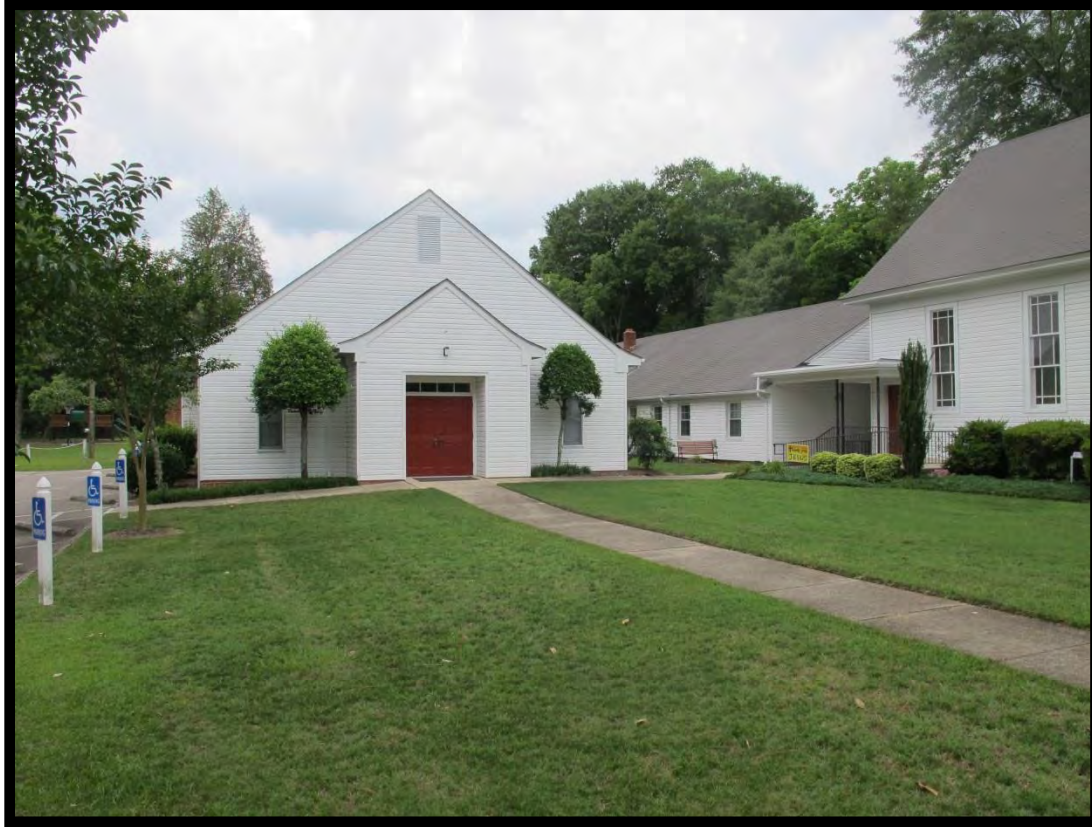
Figure 121: West End Methodist Church, Youth Building Addition, Looking Southwest.

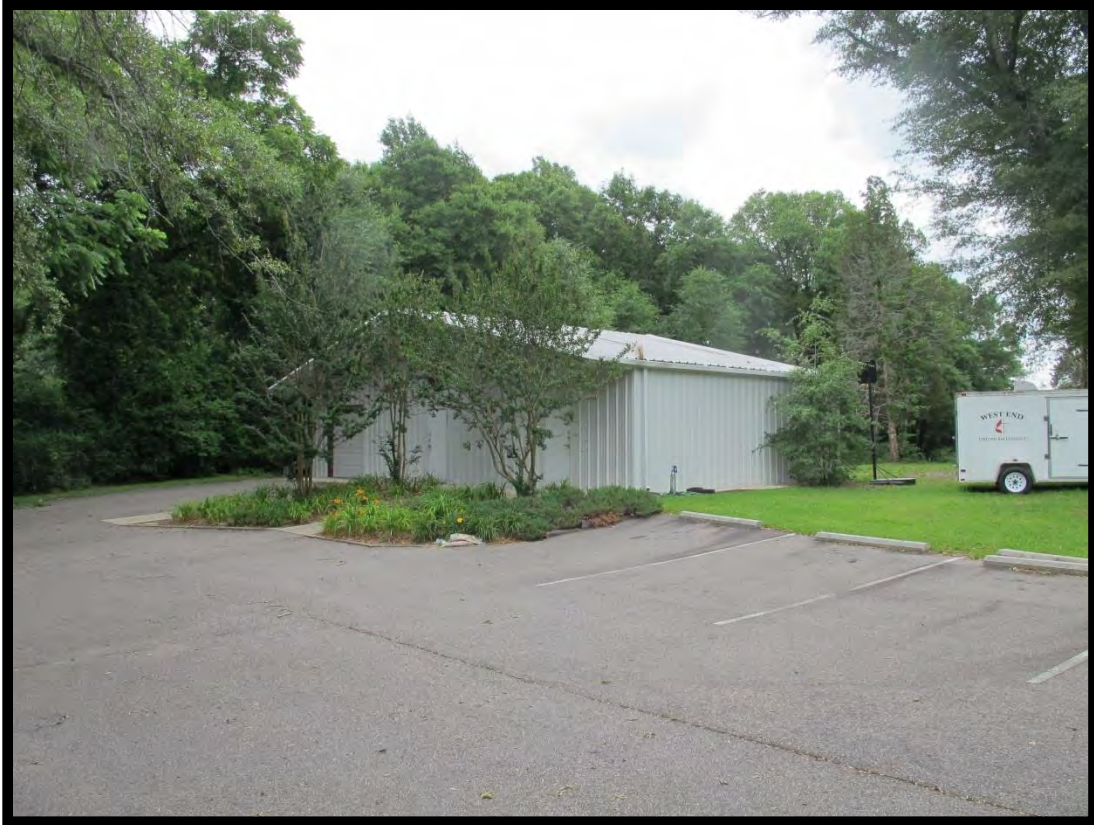
Figure 122: West End Methodist Church, Food Pantry Building, Looking Southeast.

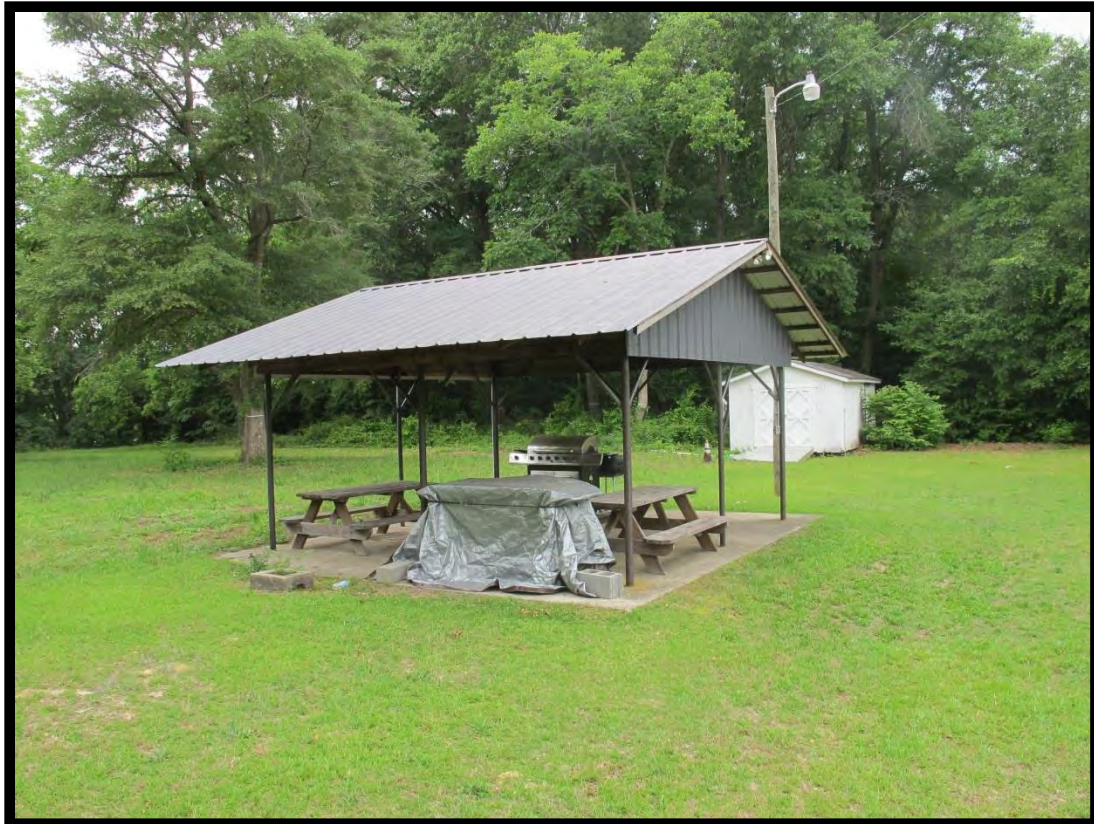
Figure 123: West End Methodist Church, Picnic Shelter, Looking Southwest.

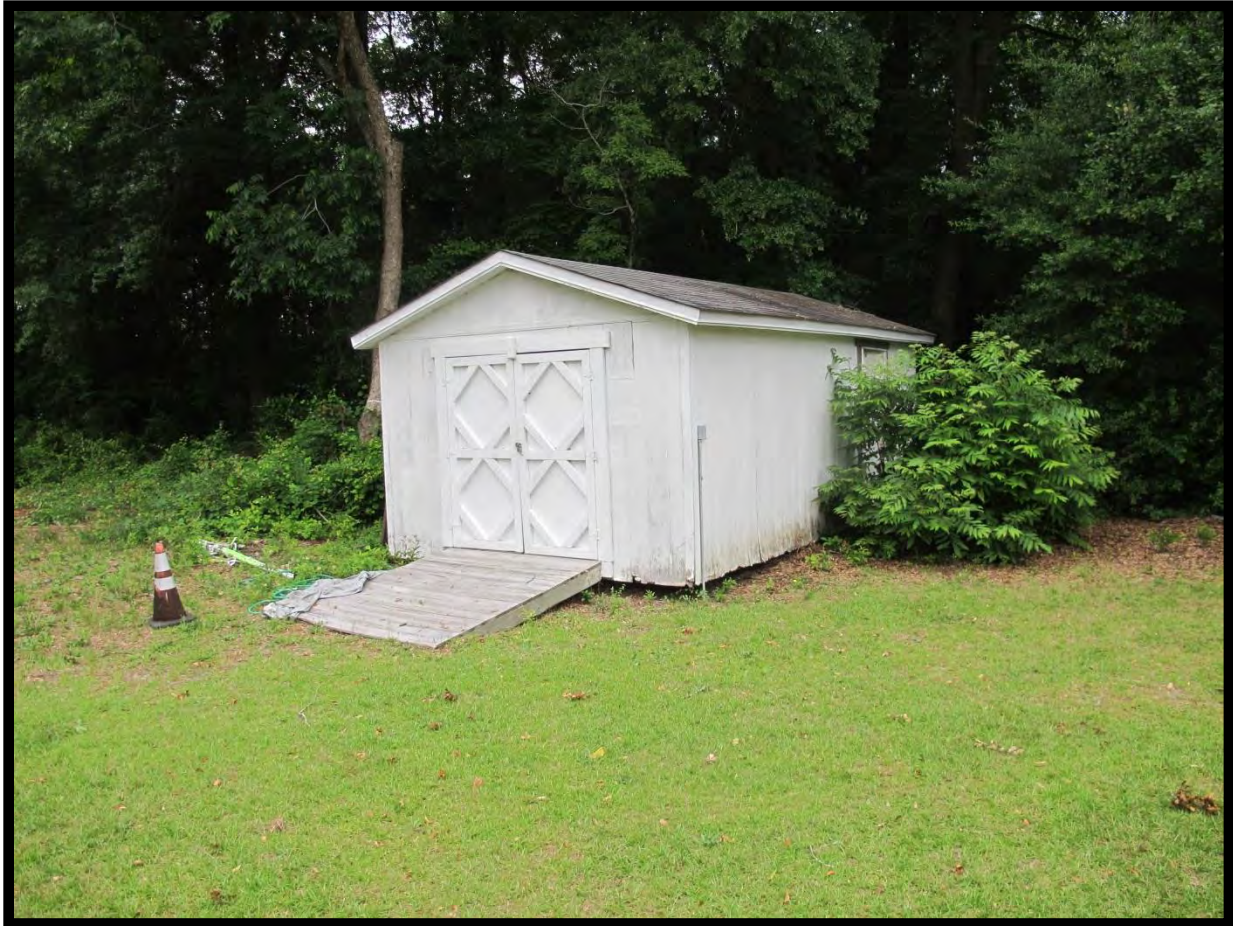
Figure 124: West End Methodist Church, Garden Shed, Looking Southwest.
