Re: Widen NC 211 from SR 1241 (Holly Grove School Road) to NC 73 in West End,
R-5726, Moore County, ER 17-1302

RE: R-5726—Widen NC 211 from SR 1241 (Holy Grove Rd) to NC 73 in West End,
Moore County, ER 17-1302

NCR-0748

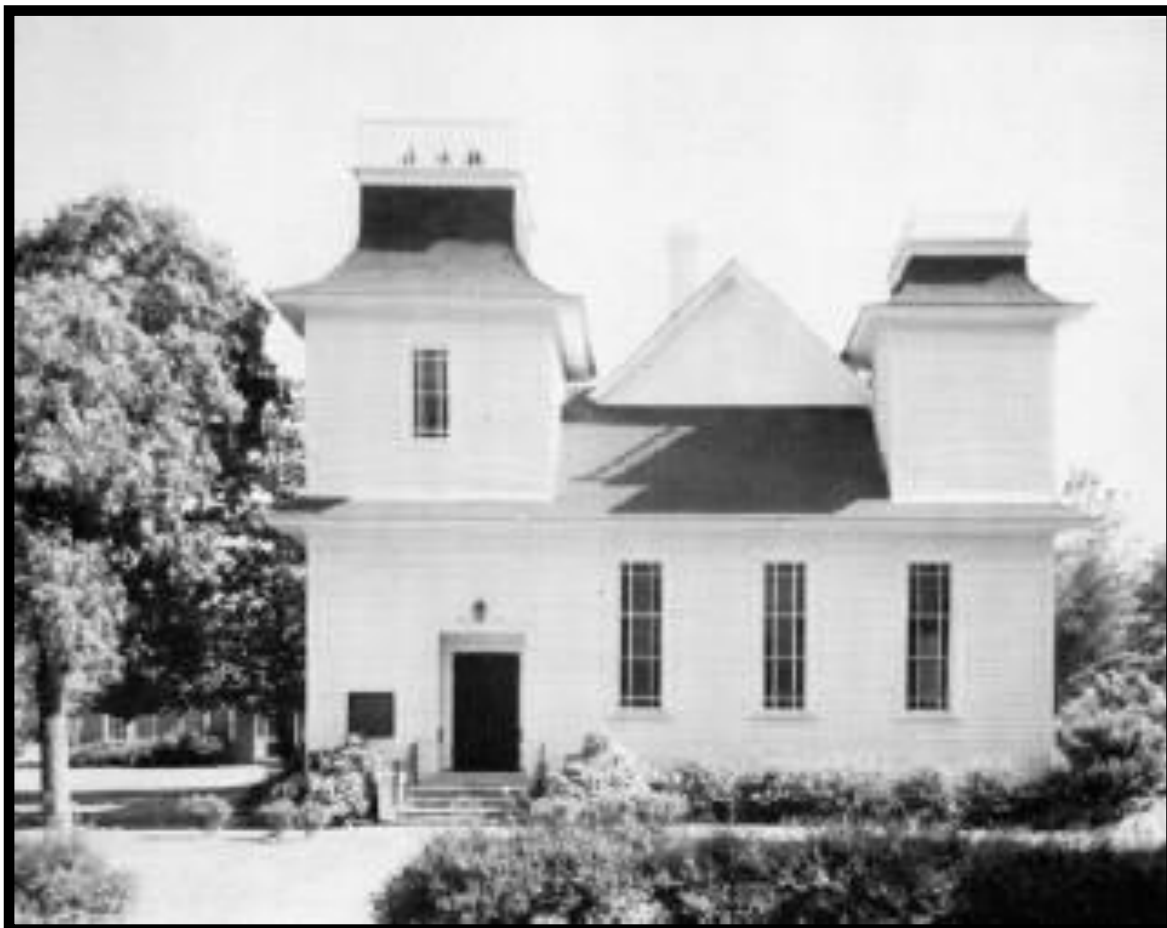
Figure 125: Undated Historic Photograph Showing the Original Configuration of the Entrance of West End Methodist Church (West End United Methodist Church 2017).

the twentieth century. Due to the additions and alterations the church retains a low level of integrity of materials and workmanship. The entrance configuration of the church was altered, replacing a more narrow recessed double door with a triple door and adding the small portico (Figure 125).

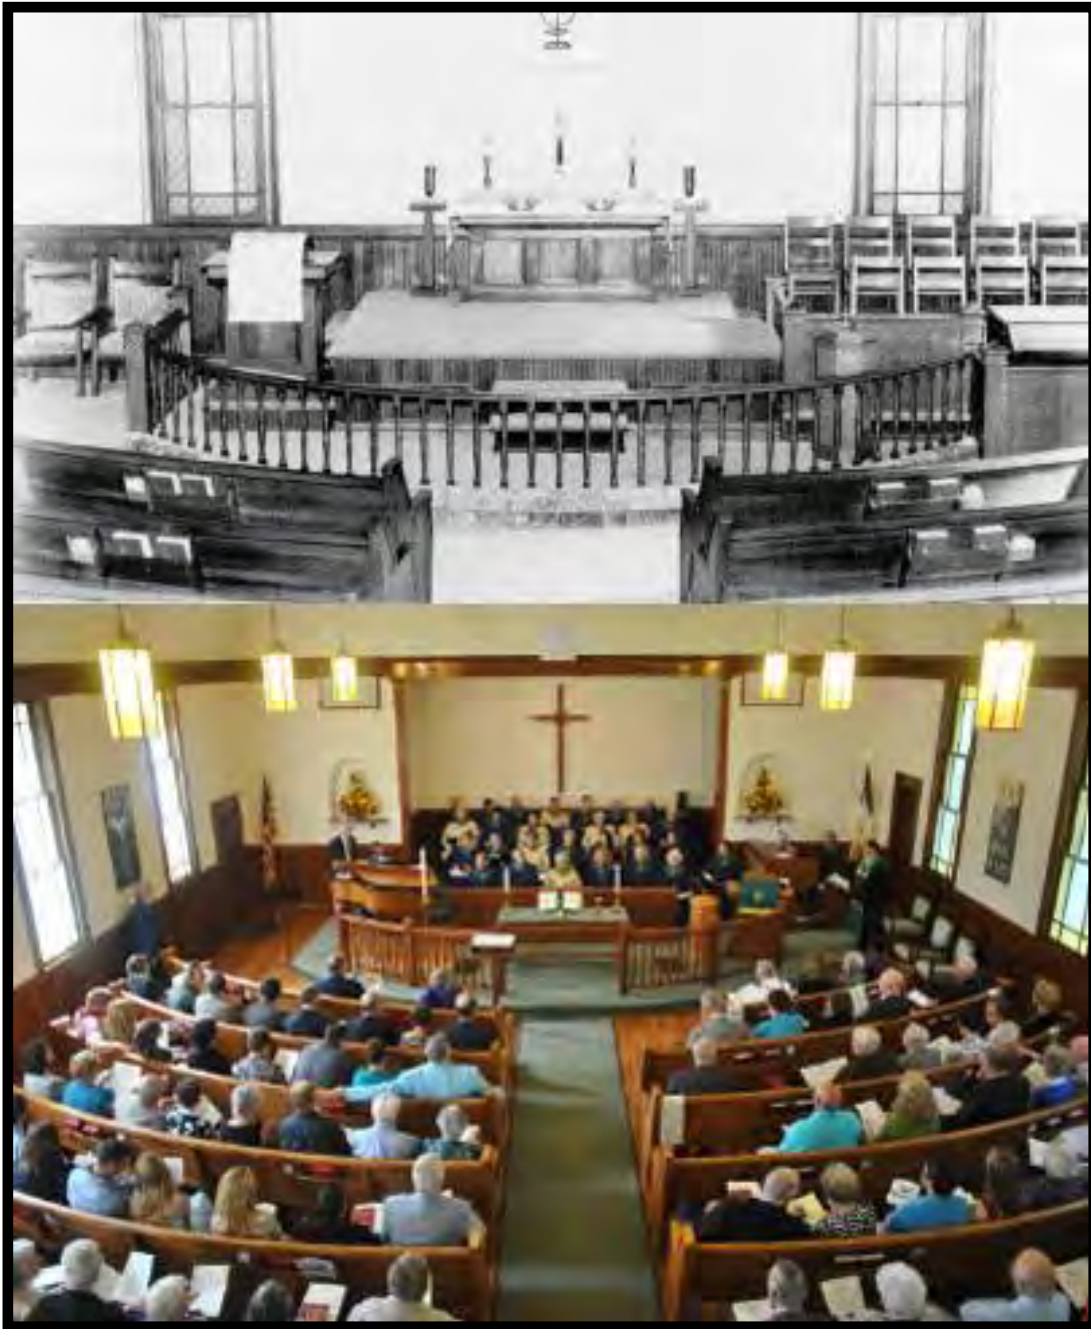
Photographs on the church's website also show that the interior has been changed, specifically the altar area (Figure 126). The property is associated with the establishment of the Methodist Episcopal church in the West End area.

Figure 126: Undated Photographs Showing the Original Appearance of the Altar and the Current Appearance of West End Methodist Church (West End United Methodist Church 2017).

building no longer retains its integrity of materials, feeling, and is therefore not recommended eligible under Criterion A.

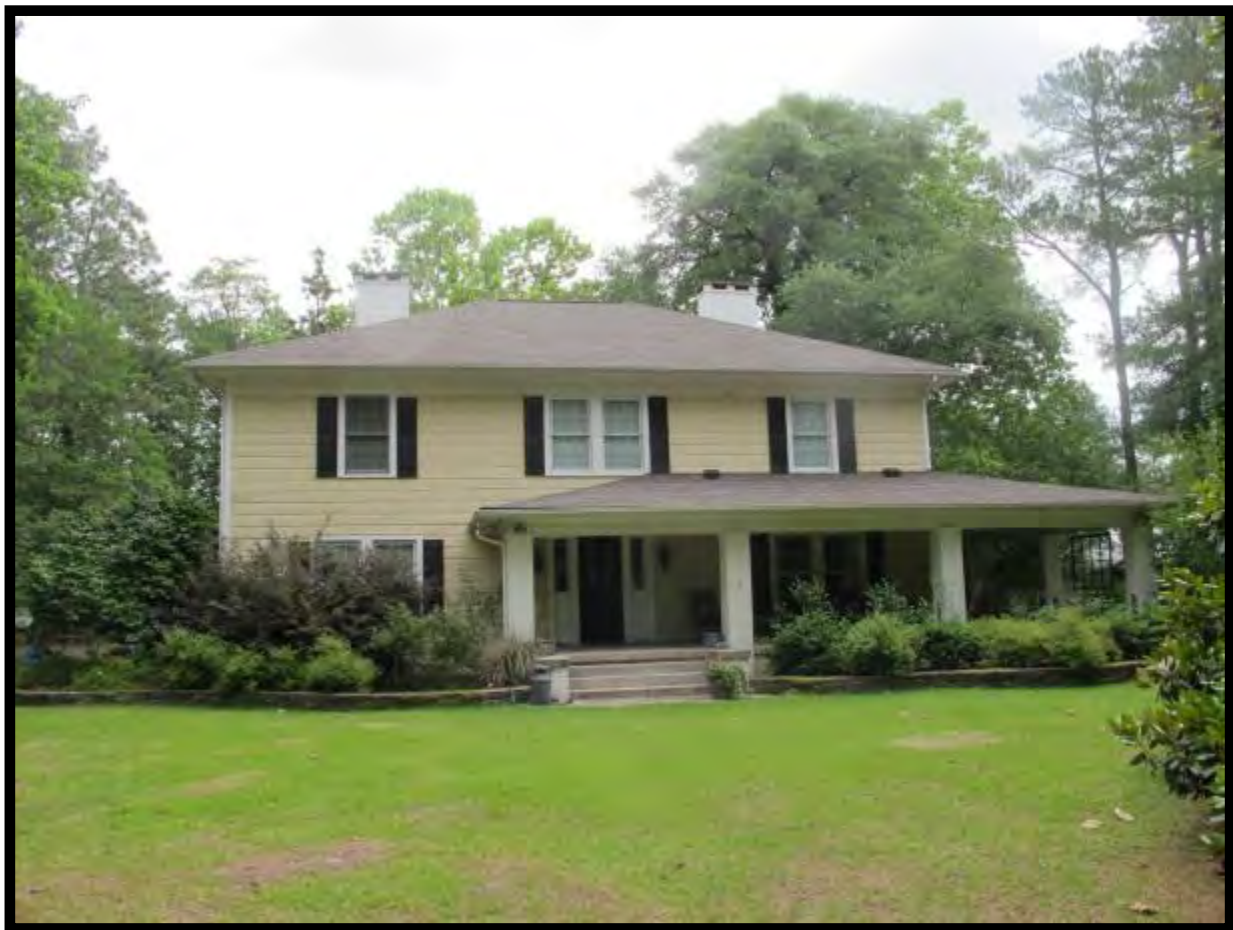
Figure 129: John & Mary Monroe House, Looking Northeast.

The John & Mary Monroe House is located on the northeast side of NC 211, approximately 1 mile north of the intersection of NC 211 and NC 73, and 200 feet southeast of the intersection with Pine Ridge Lane. The dwelling sits approximately 335 feet back from the road, on a wooded parcel with a landscaped yard (Figures 129 and 130).

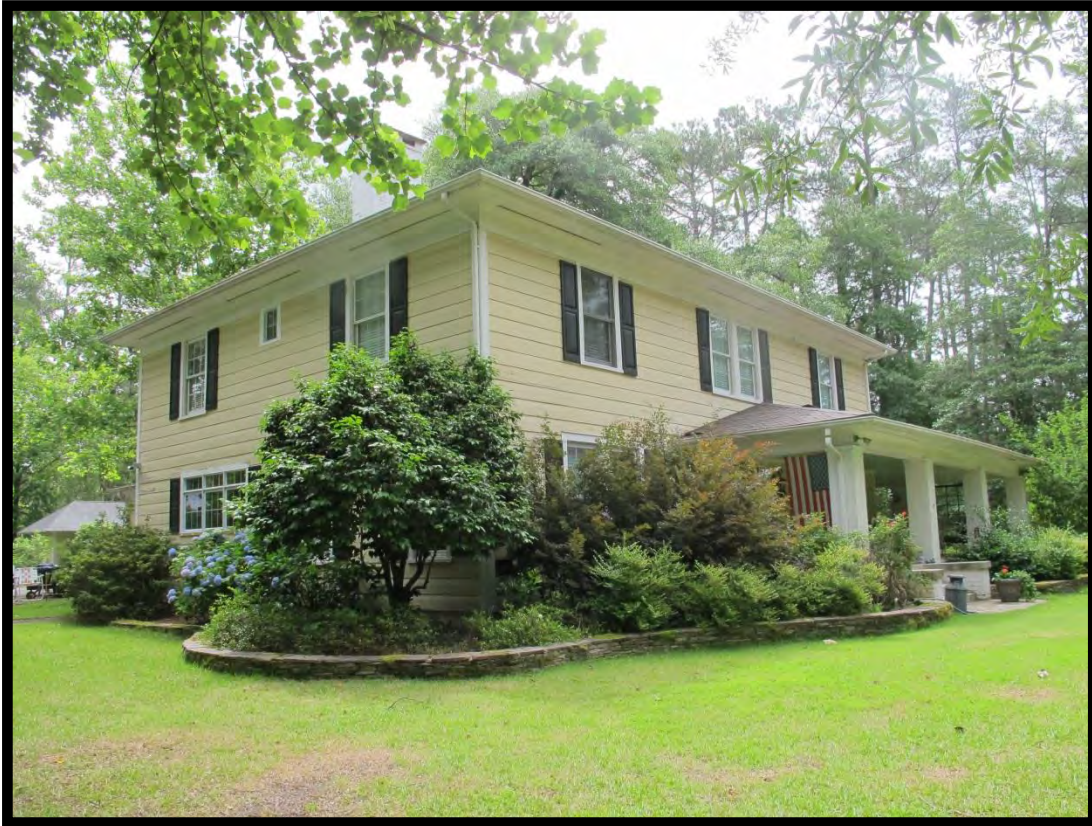
Built around 1923, the John & Mary Monroe House is a two-story, three-bay, hip-roofed Colonial Revival-style dwelling, of the type that was popular during the first three decades of the twentieth century. Double windows flank the entry door on the southwest (front) elevation of the dwelling. A hip-roofed porch, supported by square brick columns, covers two-thirds of the front elevation and wraps around the southeast (side) elevation. Located against the northeast (rear) elevation is an enclosed narrow hip-roofed porch, with a small shed-roofed addition off its northwest (side) elevation. Brick chimneys pierce through the southeast and northwest slopes of the roof. The dwelling sits on a continuous brick foundation, is clad in wide German, or drop, siding, and has vinyl sash replacement windows (Figures 131 and 132).

Figure 131: John & Mary Monroe House, Looking Southeast.

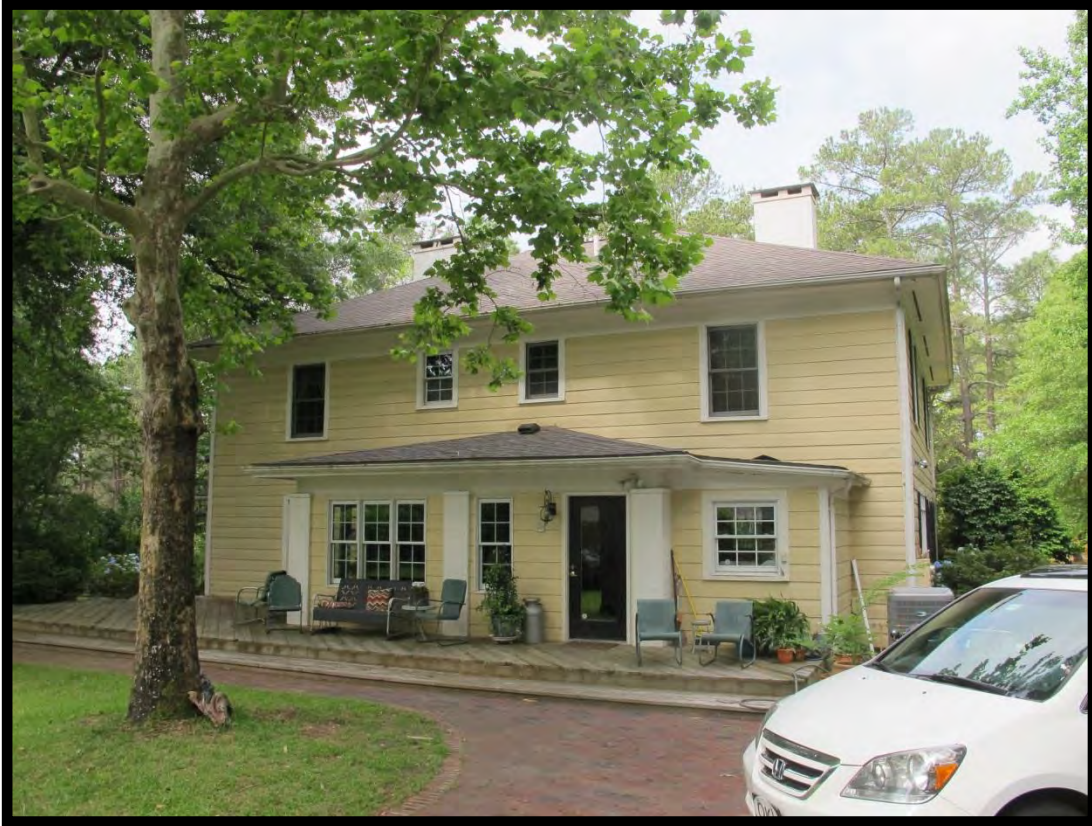
Figure 132: John & Mary Monroe House, Looking Southwest.

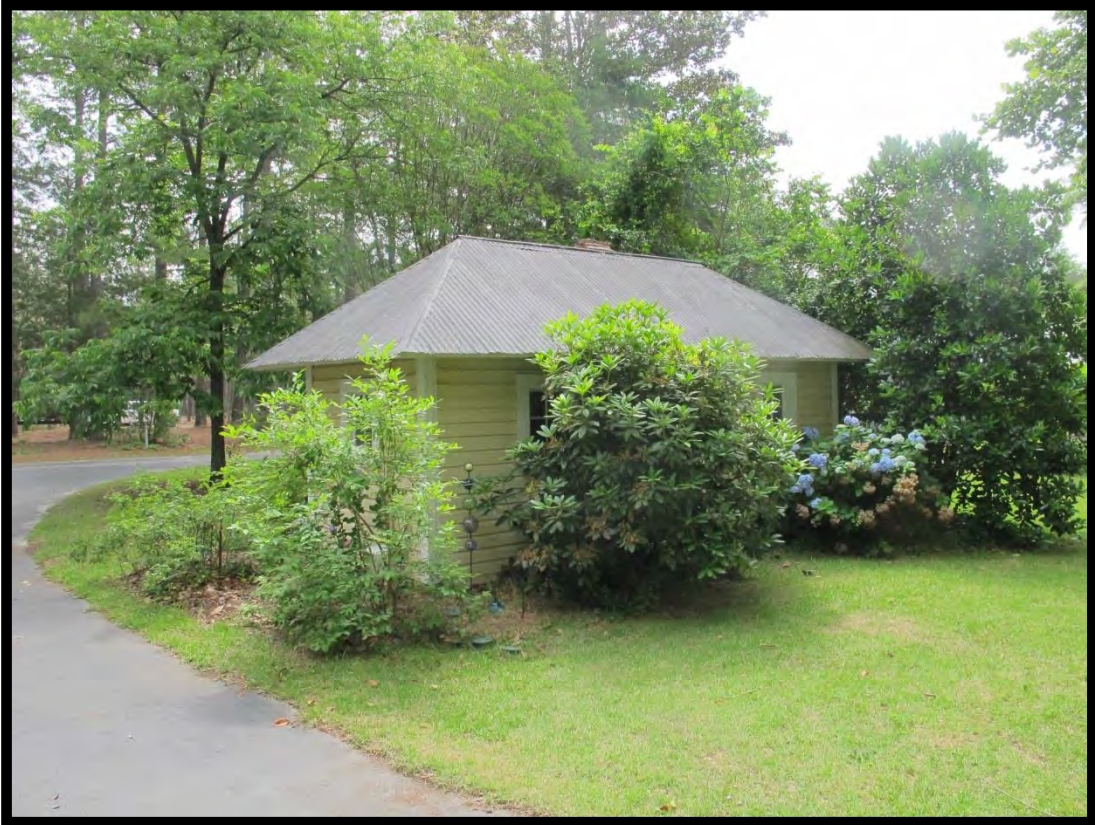
Located behind the dwelling are four outbuildings, two of which are historic. The two historic outbuildings, are a small, one-story, hip-roofed caretaker's cottage and a side-gabled workshop, with two gable-roofed wings. Two non-historic outbuildings are a modern front-gabled two-car garage and a gable-roofed pole barn (Figures 133 through 136).

Figure 133: John & Mary Monroe House, Caretaker's Cottage Looking East.

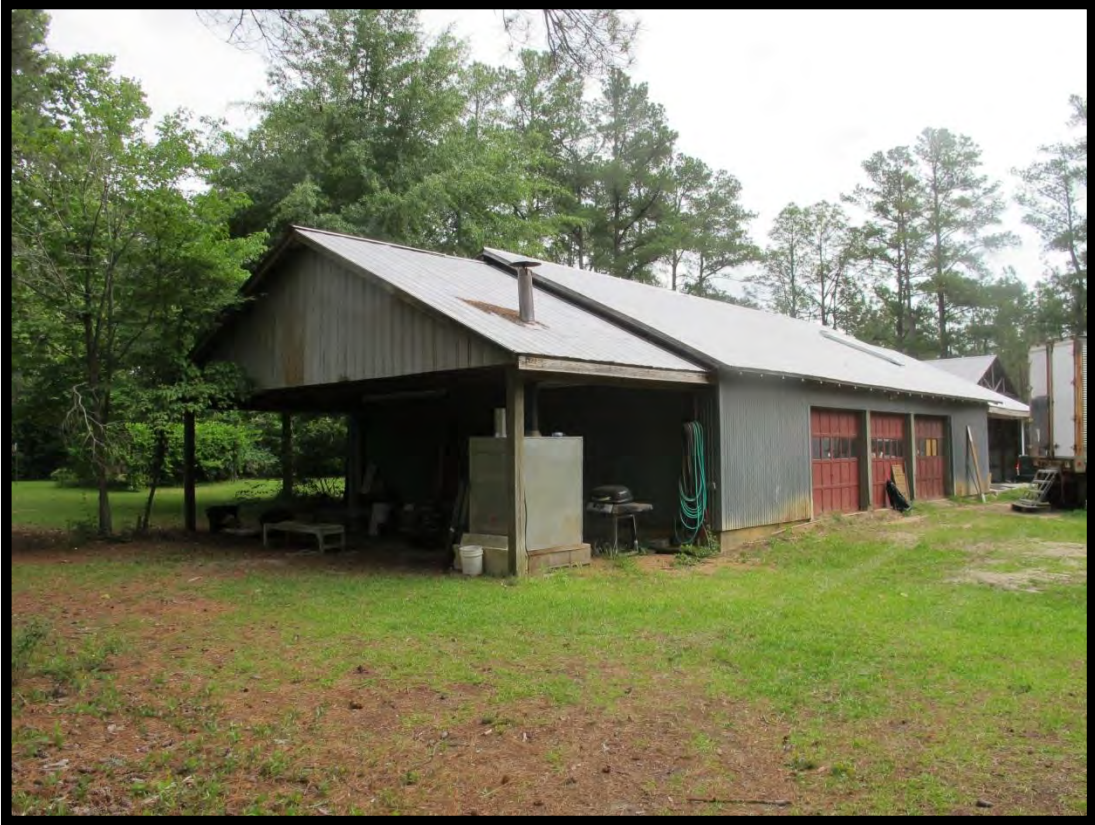
Figure 134: John & Mary Monroe House, Workshop Looking Northeast.

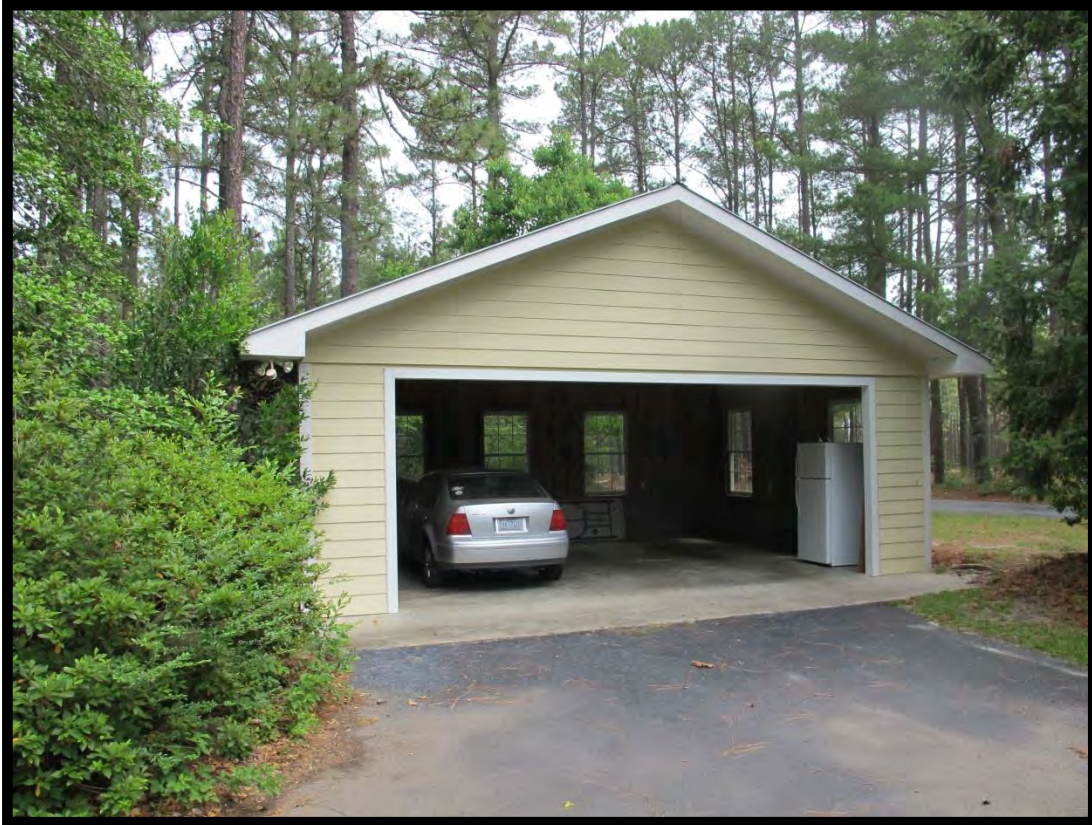
Figure 135: John & Mary Monroe House, Garage Looking North.

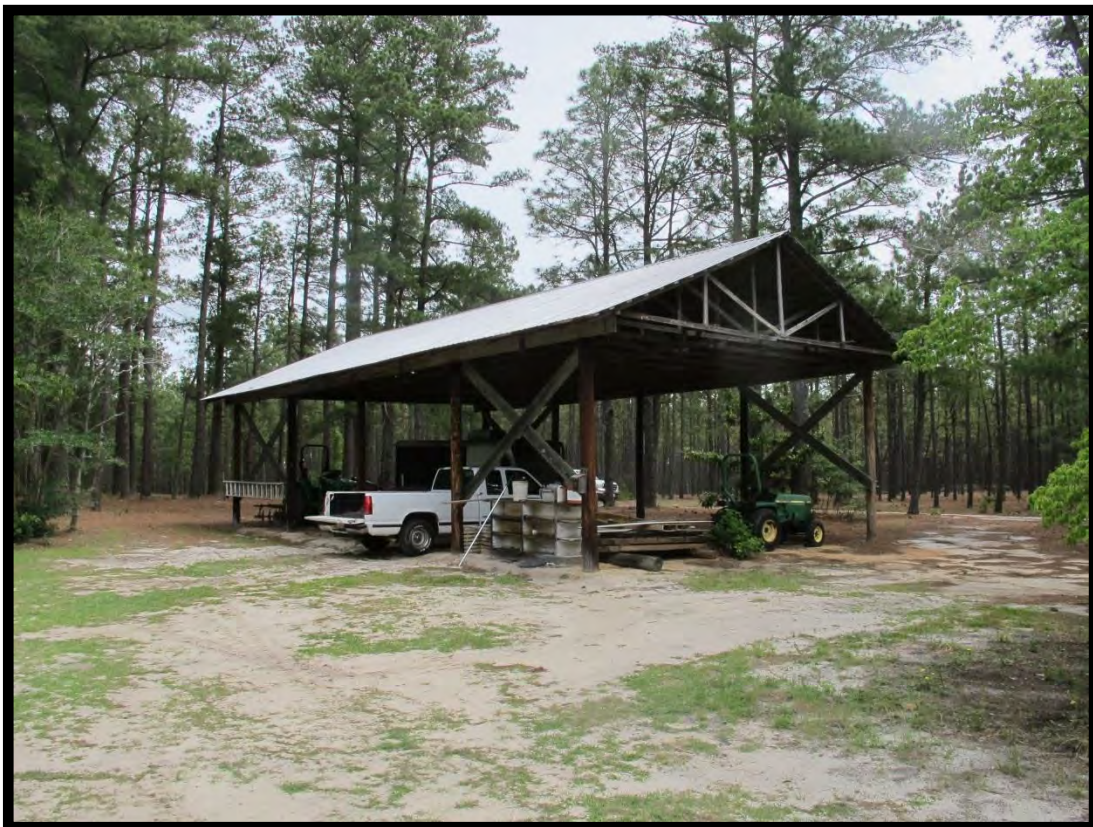
Figure 136: John & Mary Monroe House, Pole Barn Looking North.
